Rail Safety Investigation No 2008 / 03

# **Brief Report**

Pedestrian Fatality V/Line Train 8136 Ardeer 6 March 2008

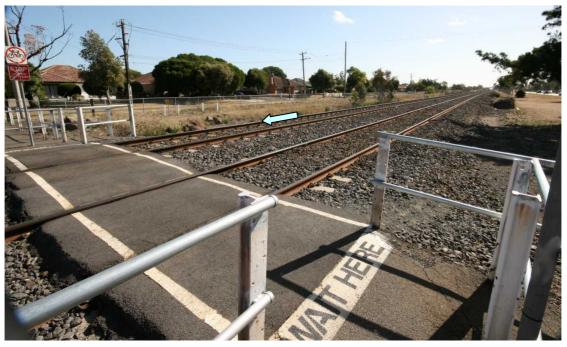
Figure 1. Pedestrian crossing viewed from direction of pedestrian approach

The crossing itself is perpendicular to the rail tracks and is 8.6 metres wide from wait line to wait line. The view of the track is open and clear in both directions.

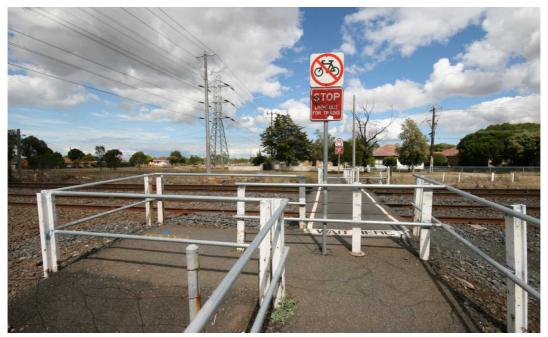
For a pedestrian approaching from the north, there is a long bounded pathway leading to a maze (crib) and warning signage. The signage was in part defaced by graffiti but was legible.

Figure 4. Pedestrian approach to maze and signage on northern side of crossing

The signage at the Tower Street pedestrian crossing was established under previous standards and does not comply with either the VRIOGS or the latest Australian Standard. This in itself is not considered unusual as it is common for there to be a lag between the introduction of new standards and signage upgrades.

While the non-compliance with current signage standards is therefore not considered directly contributory to this incident, the track manager's policy on signage including the standards applied and progressive upgrade is not clearly articulated within its procedural documentation.

That V/Line reviews and clearly articulates its policy on pedestrian crossing signage standards and the progressive upgrade of signage to the latest applicable standards.
