Office of the Chief Investigator
Transport Safety

**Marine Safety Investigation
Report No 2018/02**

**Navigational occurrence
MV Tomar and *MV CPO Jacksonville*
South Channel, Port Phillip
12 August 2018**

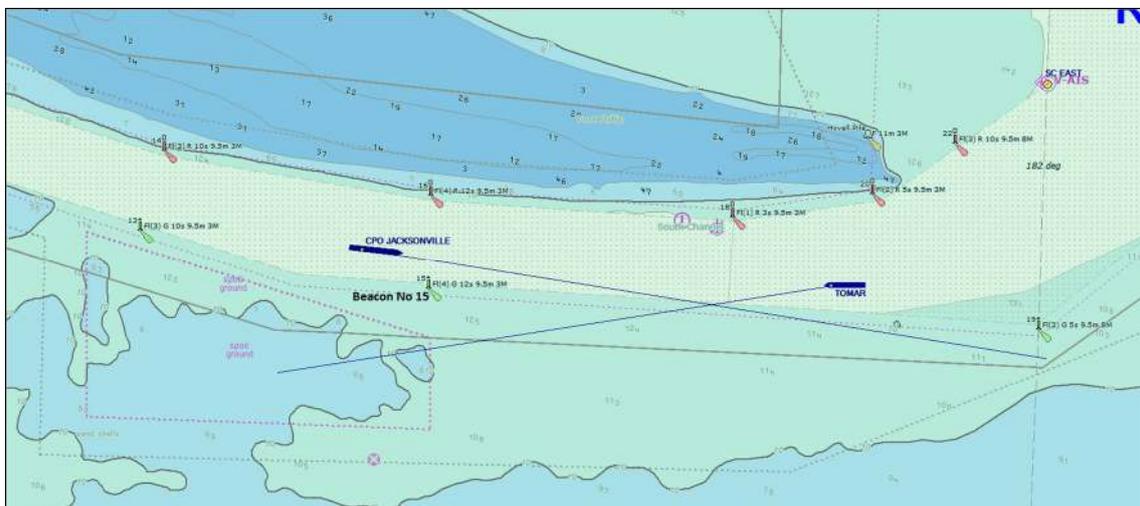
Figure 4: The relative positions of *Tomar* and *CPO Jacksonville* at 0313:15

At 0313:15, *Tomar* (now at a speed of 14.4 knots) was at the southern-most point of its turn and about 100 m from the edge of the channel on its port side (Figure 4). *Tomar* was fine on the port bow of *CPO Jacksonville* that was travelling at a speed of 17.8 knots. The distance between the two ships was about 1.1 nm (2,035 m).

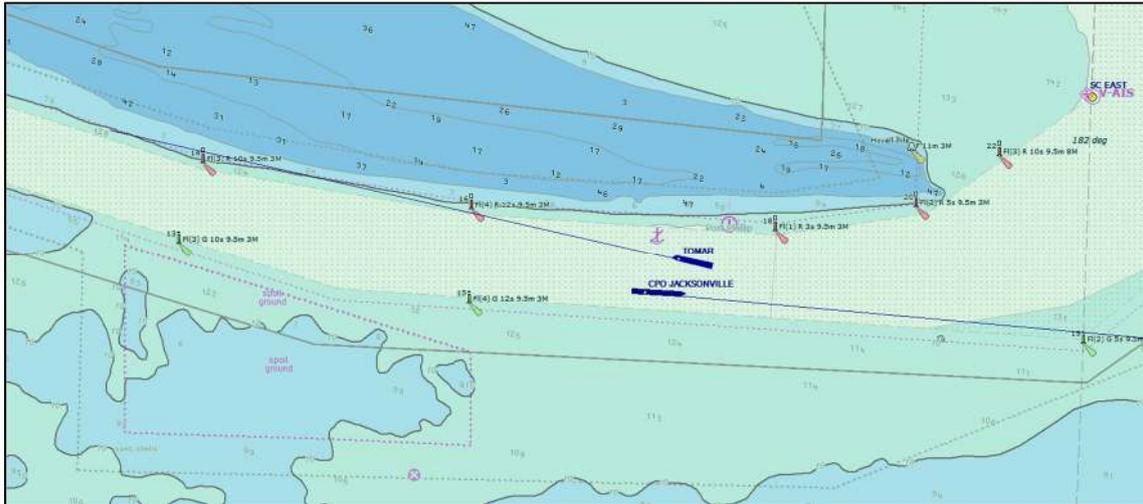
Figure 5: *Tomar* and *CPO Jacksonville* passing at 0315:20

Tomar maintained its turn to starboard, moving back towards the north side of the channel. The ships passed about 130 m apart (Figure 5).

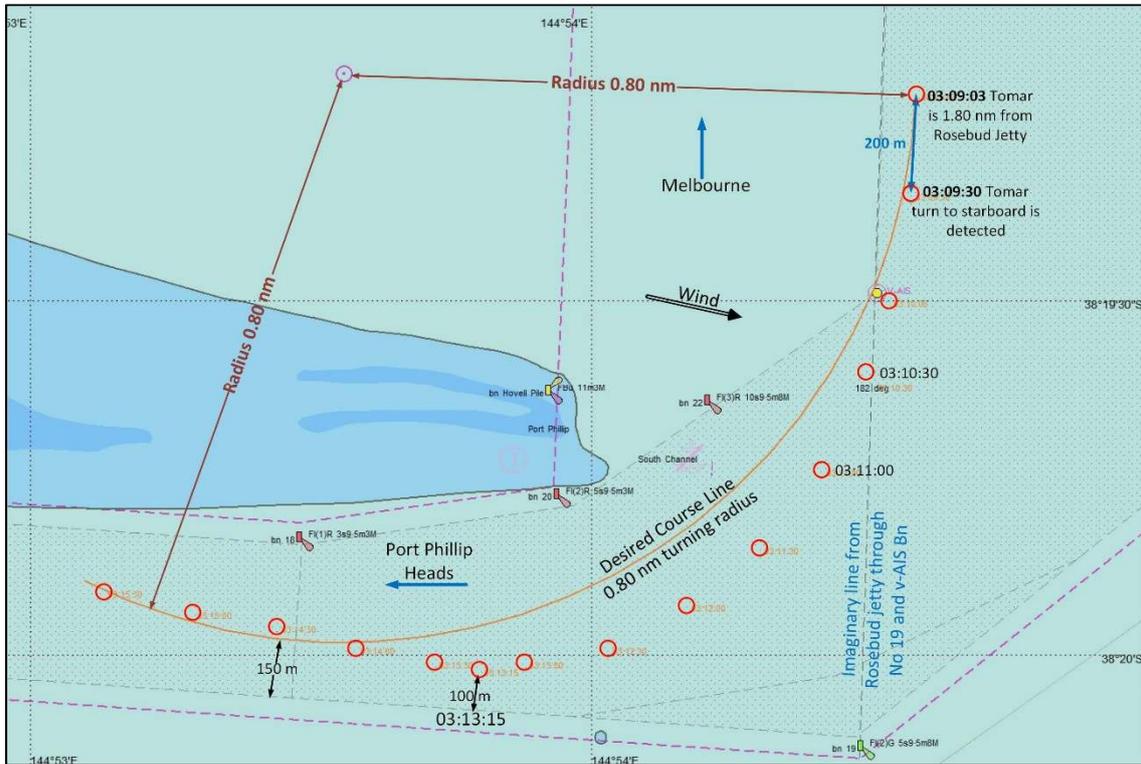
Figure 12: Track of *Tomar* plotted against the intended constant-radius turn

The plot indicates that *Tomar* traced a path wider than the 0.8 nm arc, coming to within about 100 m of the edge of the channel on its port side. The 0.8 nm arc comes to within about 150 m of the edge of the channel when approximately abeam No 18 beacon.²⁸

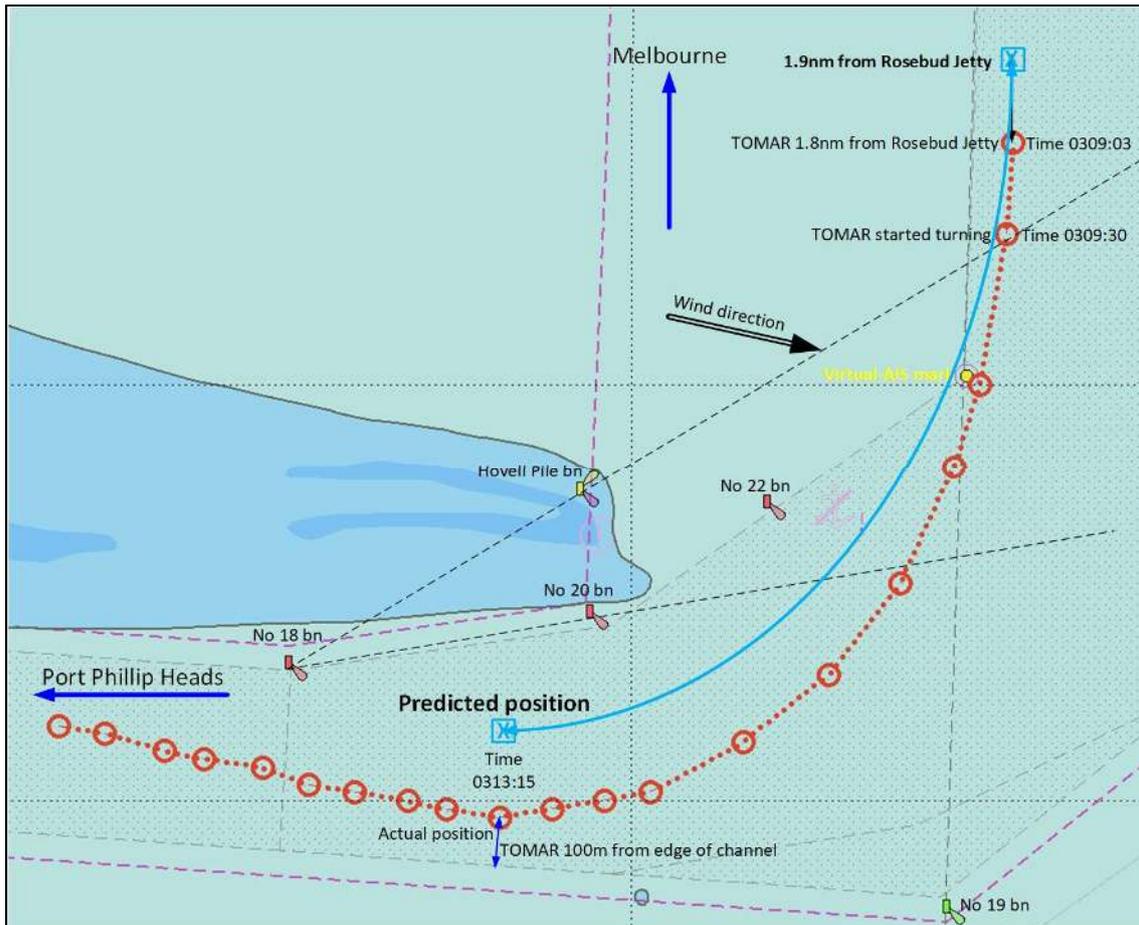
Figure 13: The track of *Tomar* (dotted red) compared to track if turn commenced 185 m earlier (blue)

The track of the *Tomar* was compared to a predicted track had the turn been commenced when 1.9 nm from Rosebud jetty (or about 185 m further north). In such a scenario and in the same environmental conditions, the ship would have turned tighter around Hovell Pile, and entered the narrowing section of South Channel at a location significantly further north (Figure 13).

It was concluded that the point at which *Tomar's* manoeuvre to round Hovell Pile was commenced, combined with the ship's turning radius, resulted in *Tomar* sailing south of the centreline of South Channel.

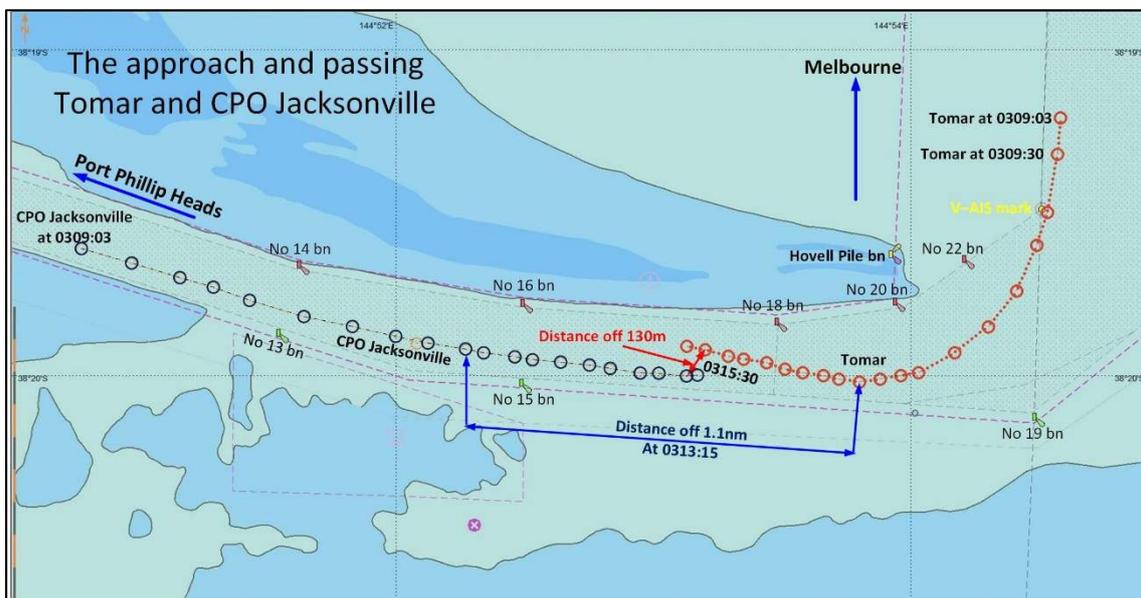
Figure 14: The tracks of *Tomar* and *CPO Jacksonville* until passing

The closest point of approach occurred between 0315:20 and 0315:30, when the ships passed about 130 m apart (shipside to shipside) (Figure 14). The pilot of *CPO Jacksonville* then adjusted that ship's course to port.

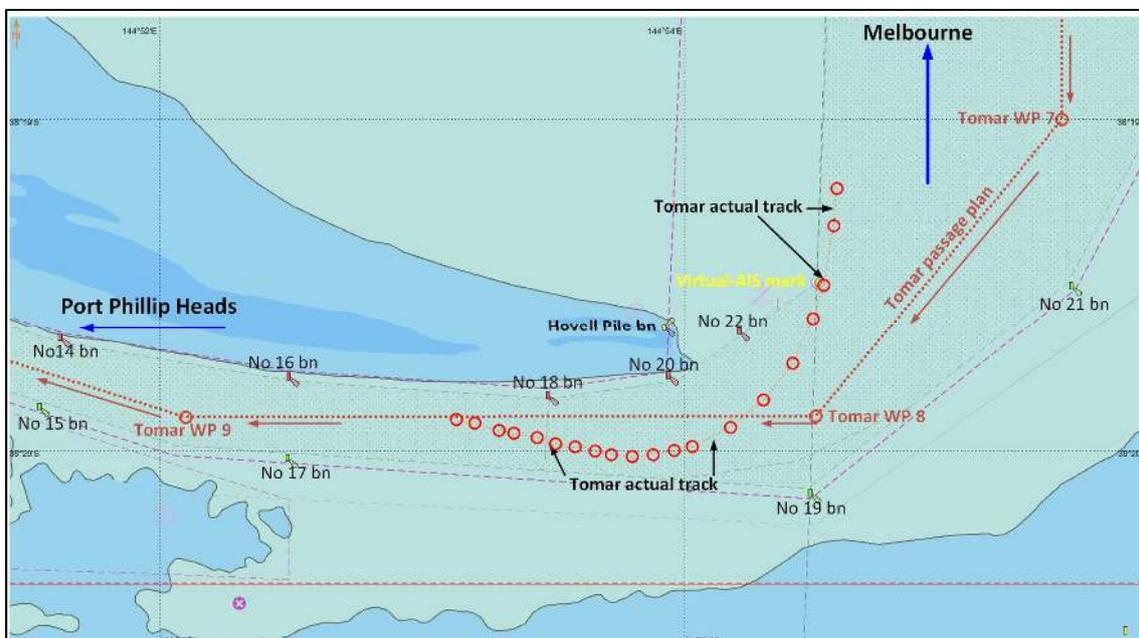
Figure 15: *Tomar's* passage plan versus its actual track

The actual track of the ship deviated from the ship's passage plan (Figure 15).
