Reaction to fire test report

Test standard: [Ad-hoc test based off ISO 13785-1:2002](#)

System: [A cassetted aluminium composite panel wall system](#)

Job number: [RTF230111](#)

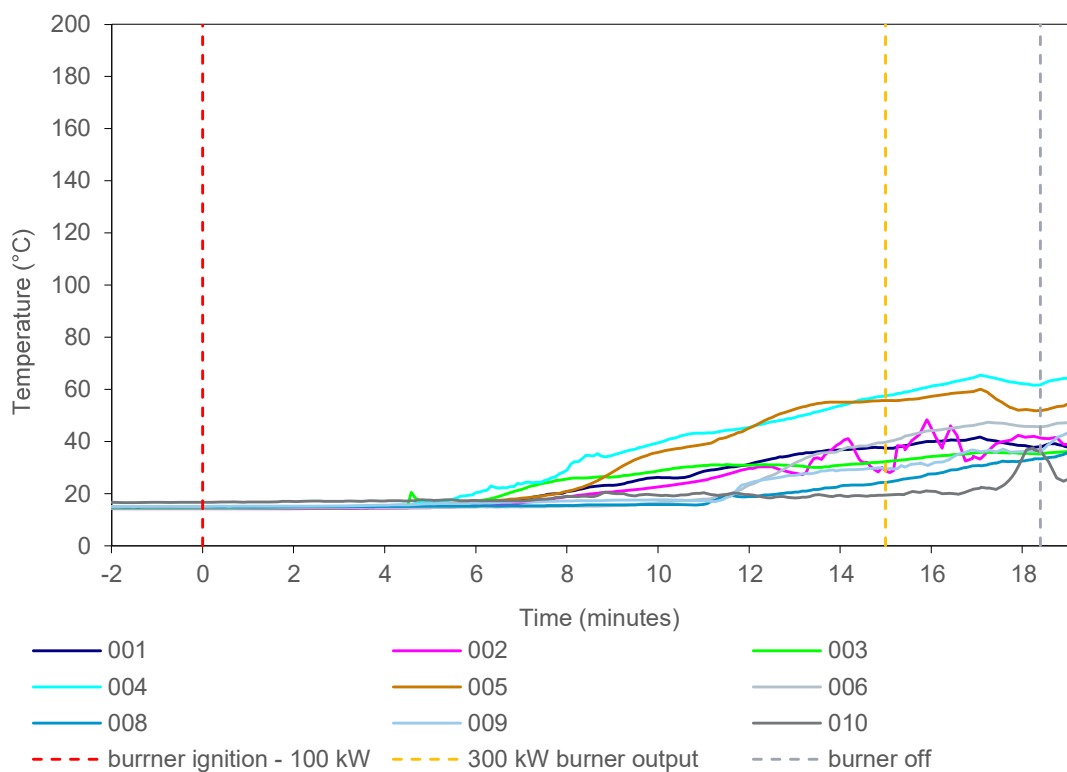
Figure 2 Internal temperature data collected by thermocouples placed within the cavity – between the internal and external segments of the specimen.

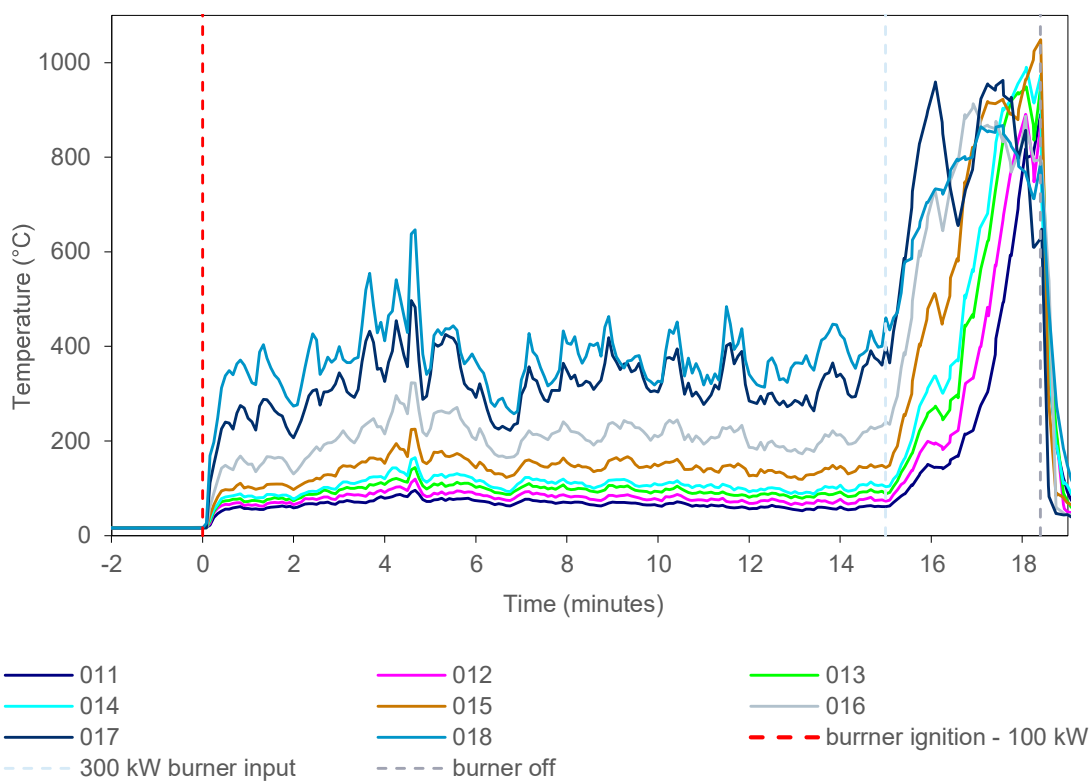
Figure 3 External temperature data collected by thermocouples placed 60 mm from the front face of the specimen.

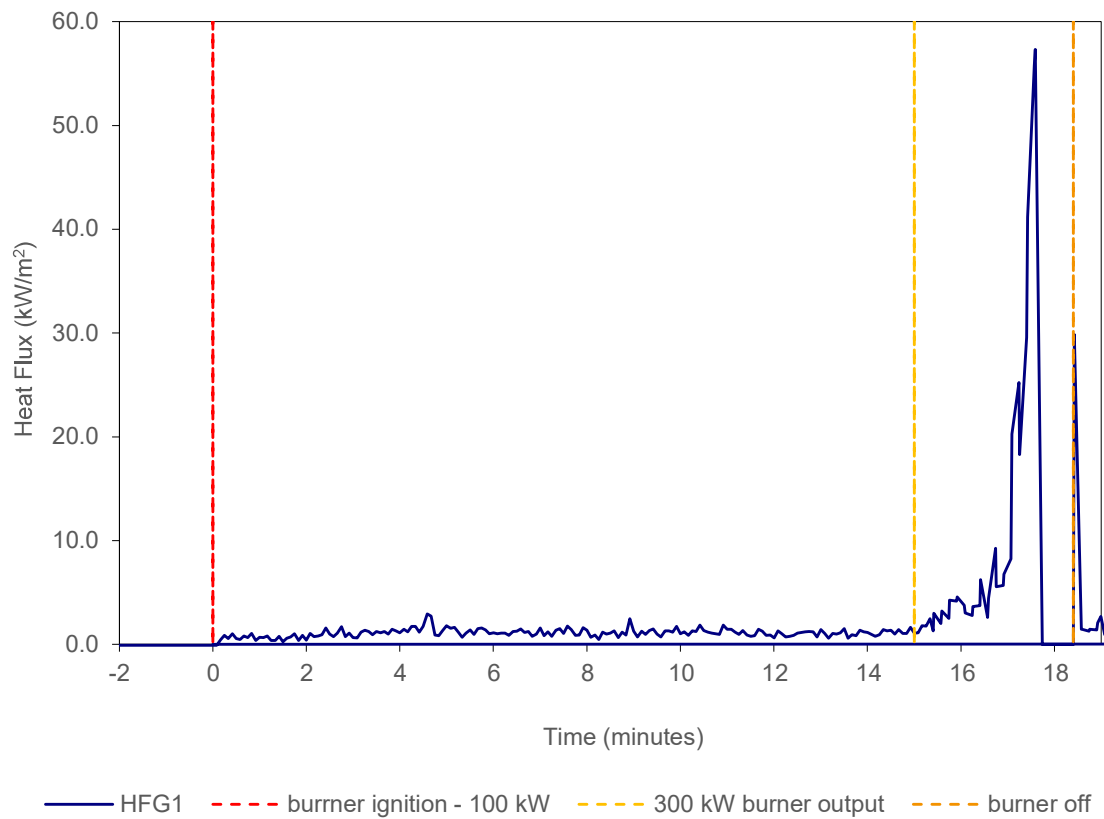
Figure 4 Heat flux data collected by heat flux gauges.

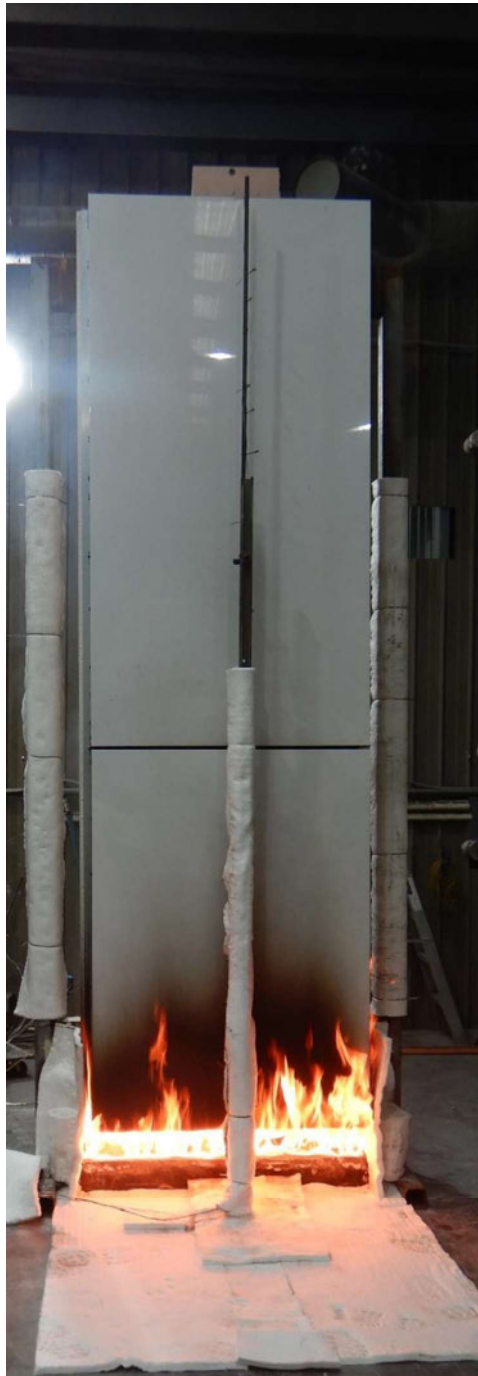
Figure 12 The specimen 1 minute 42 seconds into the test (burner output at 100 kW)

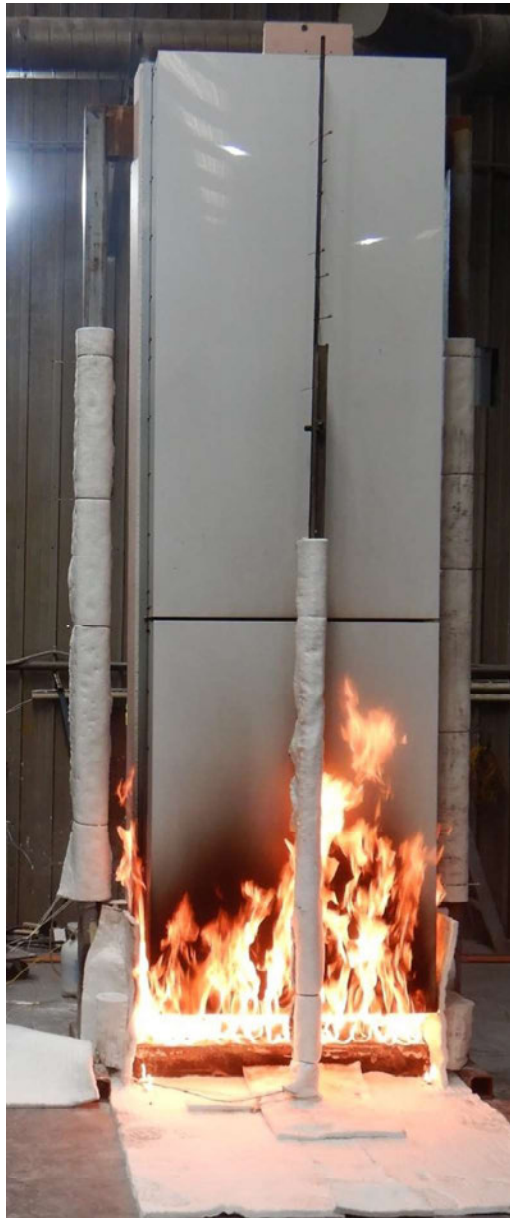
Figure 13 The specimen 3 minutes 11 seconds into the test (burner output at 100 kW)

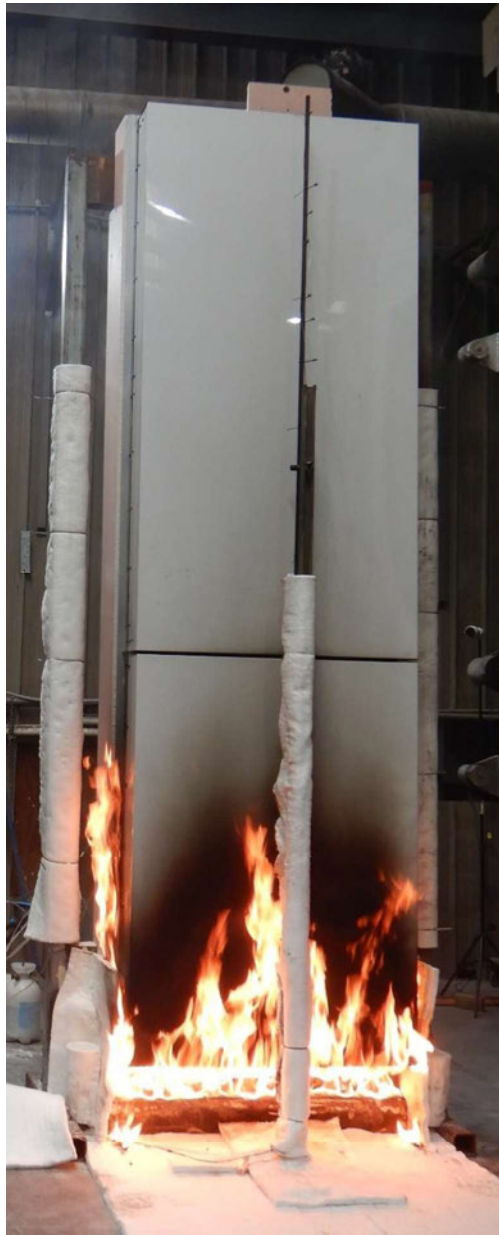
Figure 14 The specimen 4 minutes 53 seconds into the test (burner output at 100 kW)

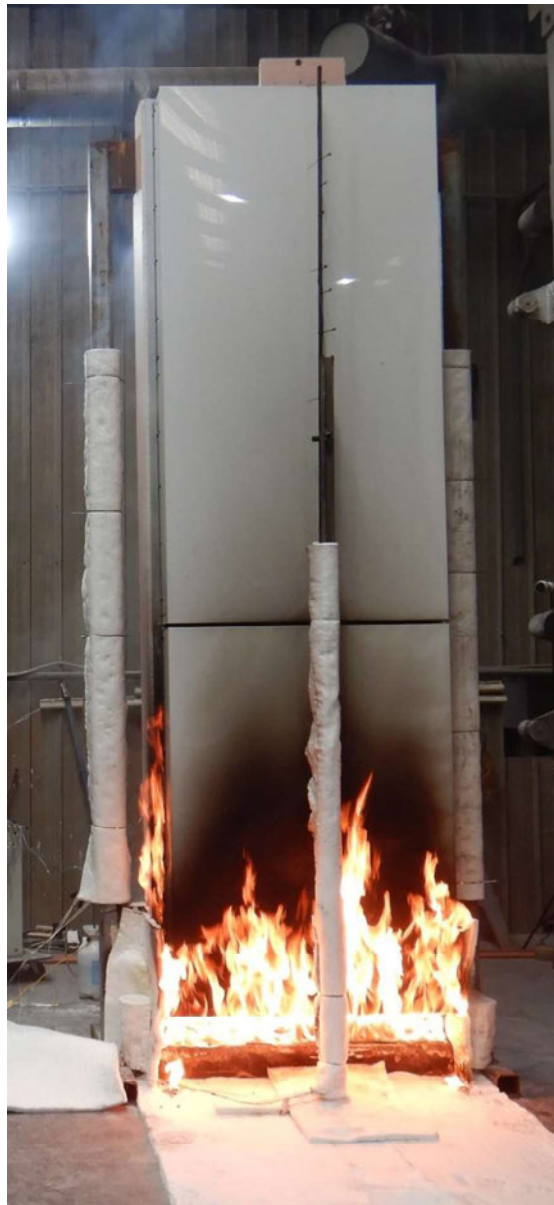
Figure 15 The specimen 9 minutes 53 seconds into the test (burner output at 100 kW)

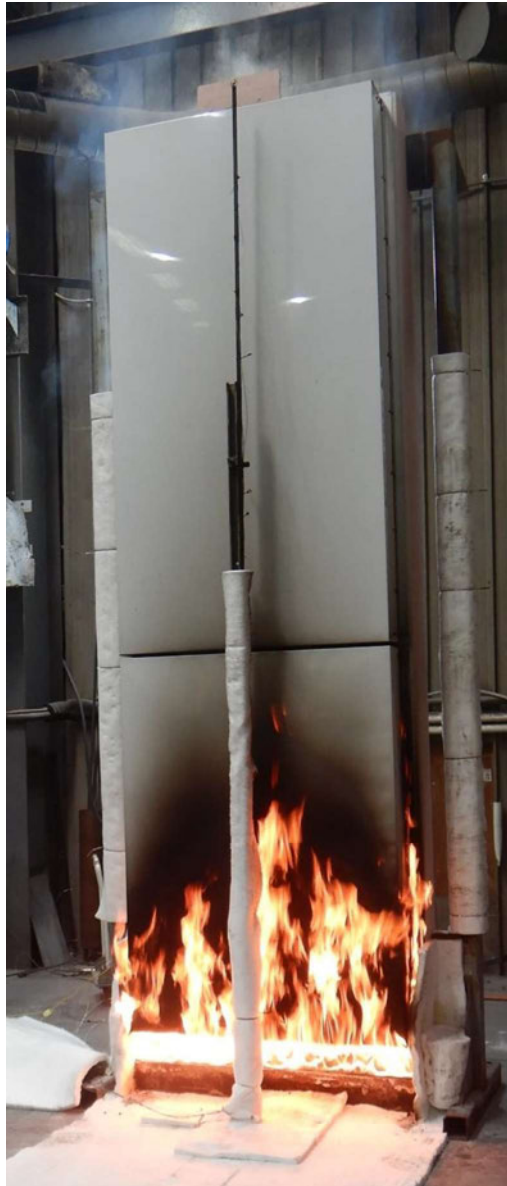
Figure 16 The specimen 13 minutes 14 seconds into the test (burner output at 100 kW)

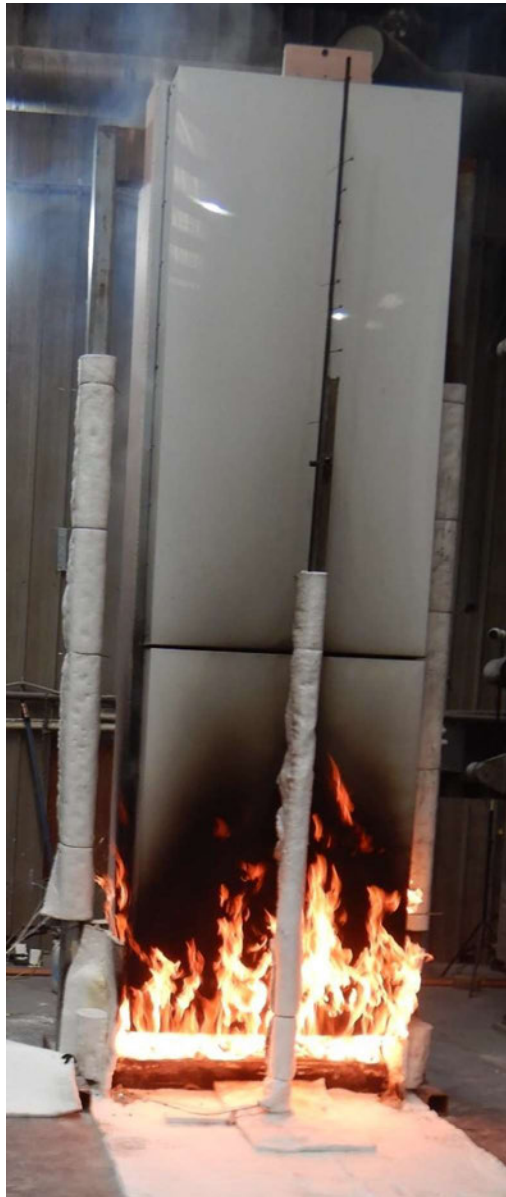
Figure 17 The specimen 14 minutes 45 seconds into the test (burner output at 100 kW)

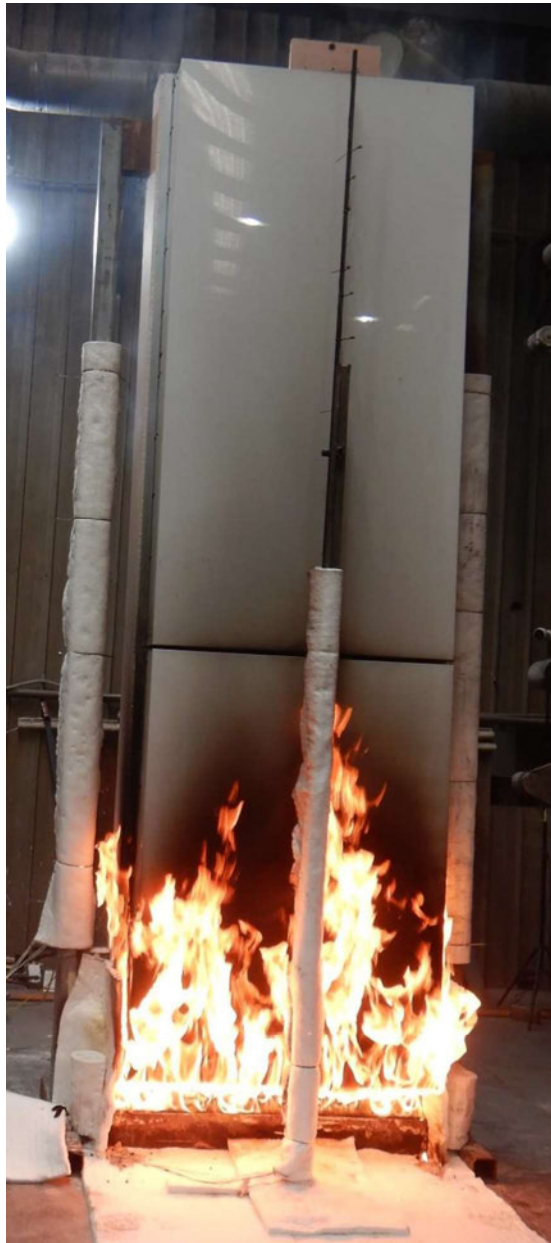
Figure 18 The specimen 15 minutes 2 seconds into the test (2 seconds after burner output was changed to 300 kW)

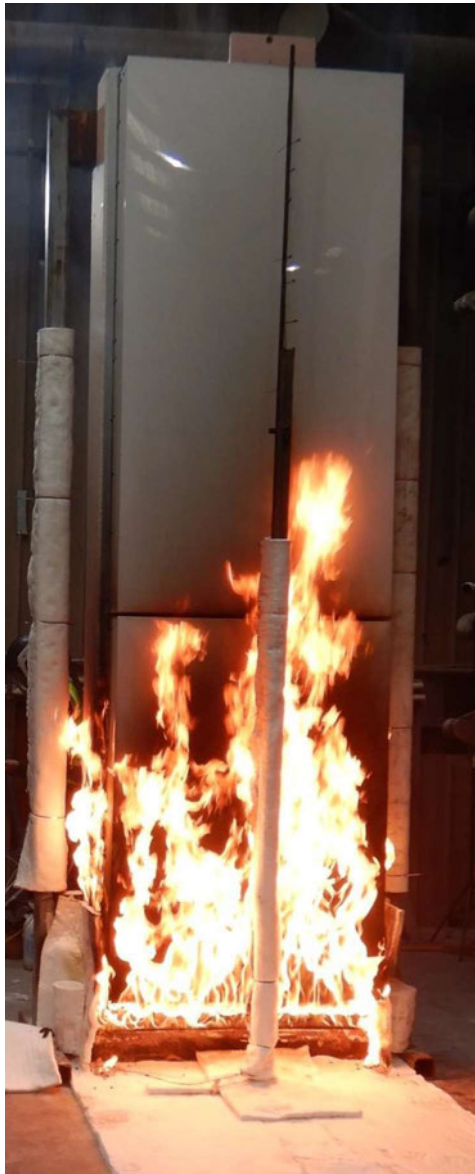
Figure 19 The specimen 15 minutes 41 seconds into the test (41 seconds after burner output was changed to 300 kW)

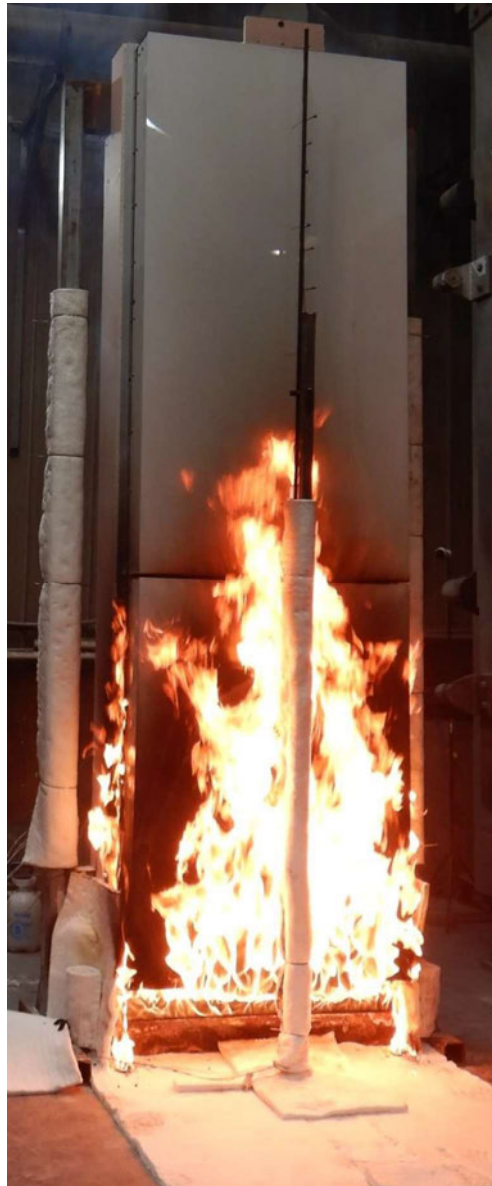
Figure 20 The specimen 15 minutes 56 seconds into the test (56 seconds after burner output was changed to 300 kW)

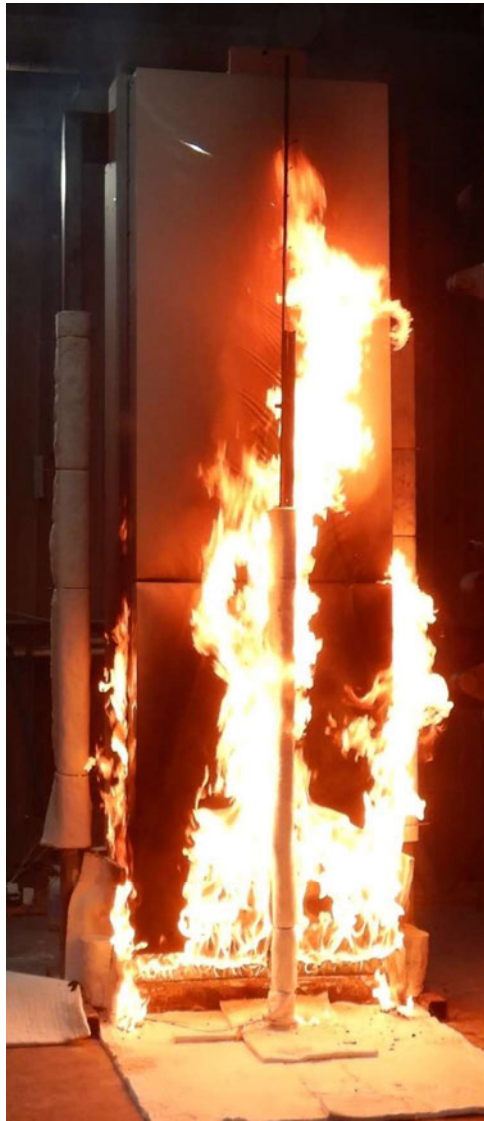
Figure 21 The specimen 16 minutes 55 seconds into the test (1 minute 55 seconds after burner output was changed to 300 kW)

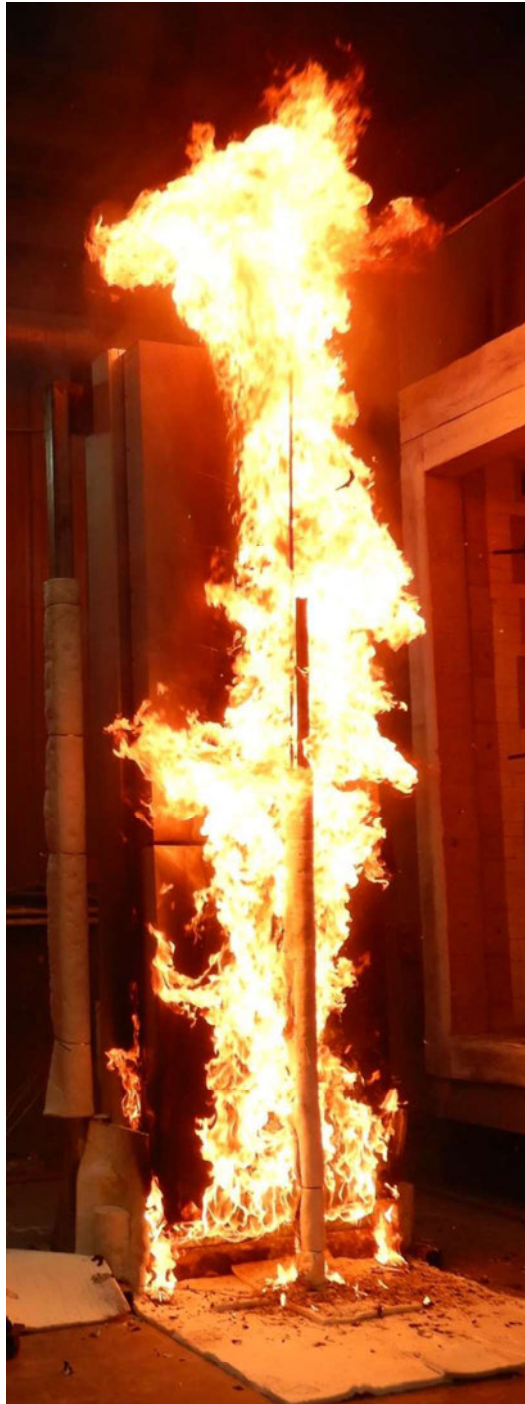
Figure 22 The specimen 17 minutes 45 seconds into the test (2 minutes 45 seconds after burner output was changed to 300 kW)

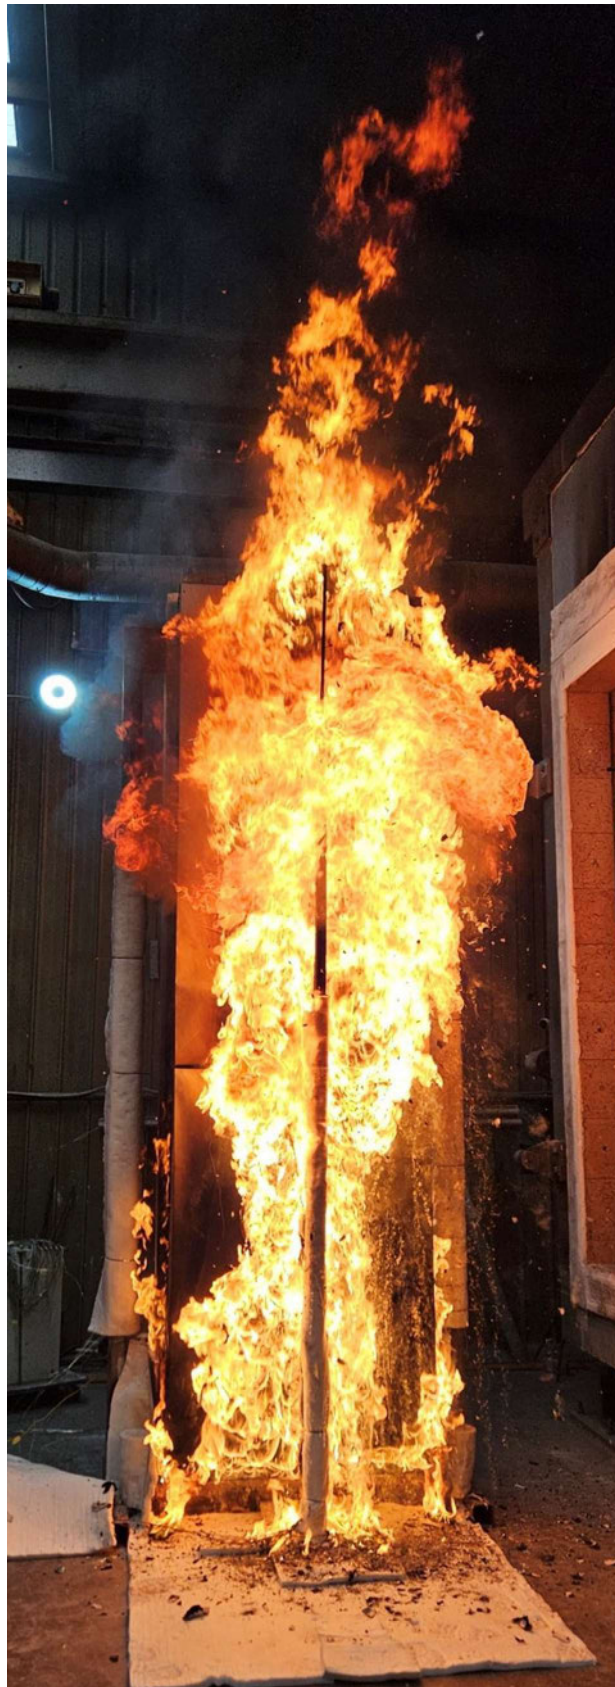
15	00	All	The burner output was increased to 300 kW.
15	14	A & B	Flaming had reached the second joint.
15	36	B1	The panel had started to discolour.
15	55	B2	Flames reached the middle section of the panel.
16	53	B3	Flames reached the top section of the panel.
17	09	B3	Flames reached the top of the specimen.
18	12	B3	It was observed that the cavity had opened up.
18	20	All	Flaming of the specimen was excessive. The power to the burner was cut and specimen was sprayed with water. The test ended.

Figure 23 The specimen 17 minutes 52 seconds into the test (2 minutes 52 seconds after burner output was changed to 300 kW)

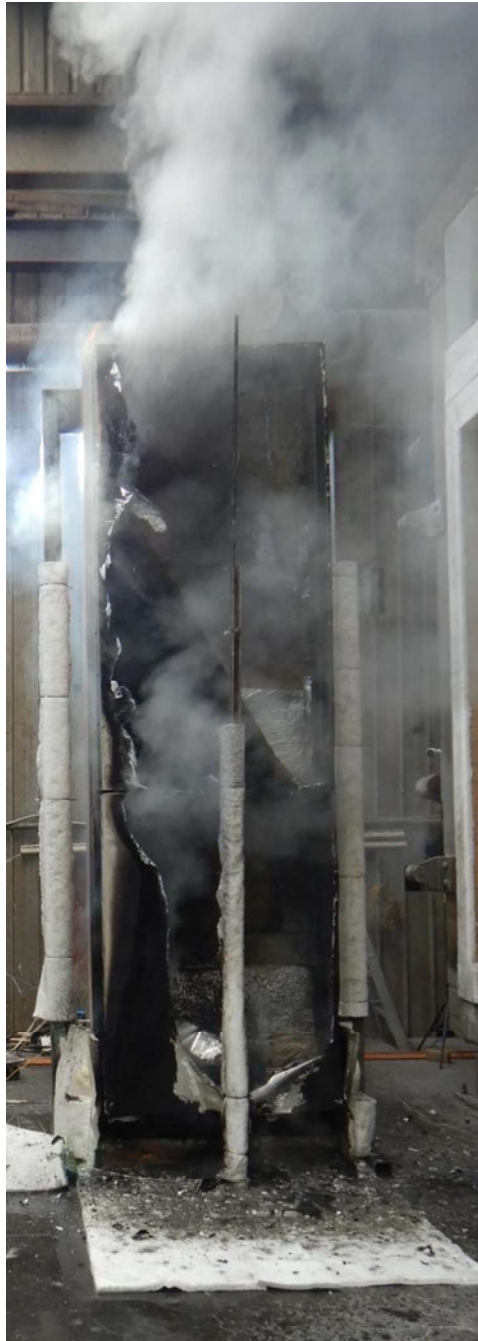
Figure 24 The specimen shortly after being sprayed with water

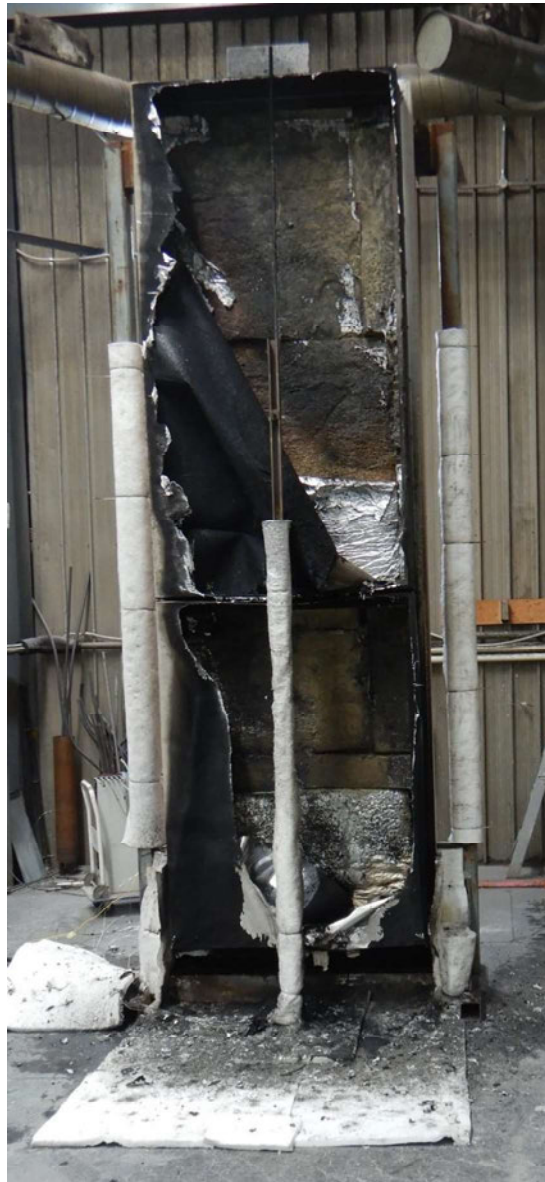
Figure 25 The specimen after the test.

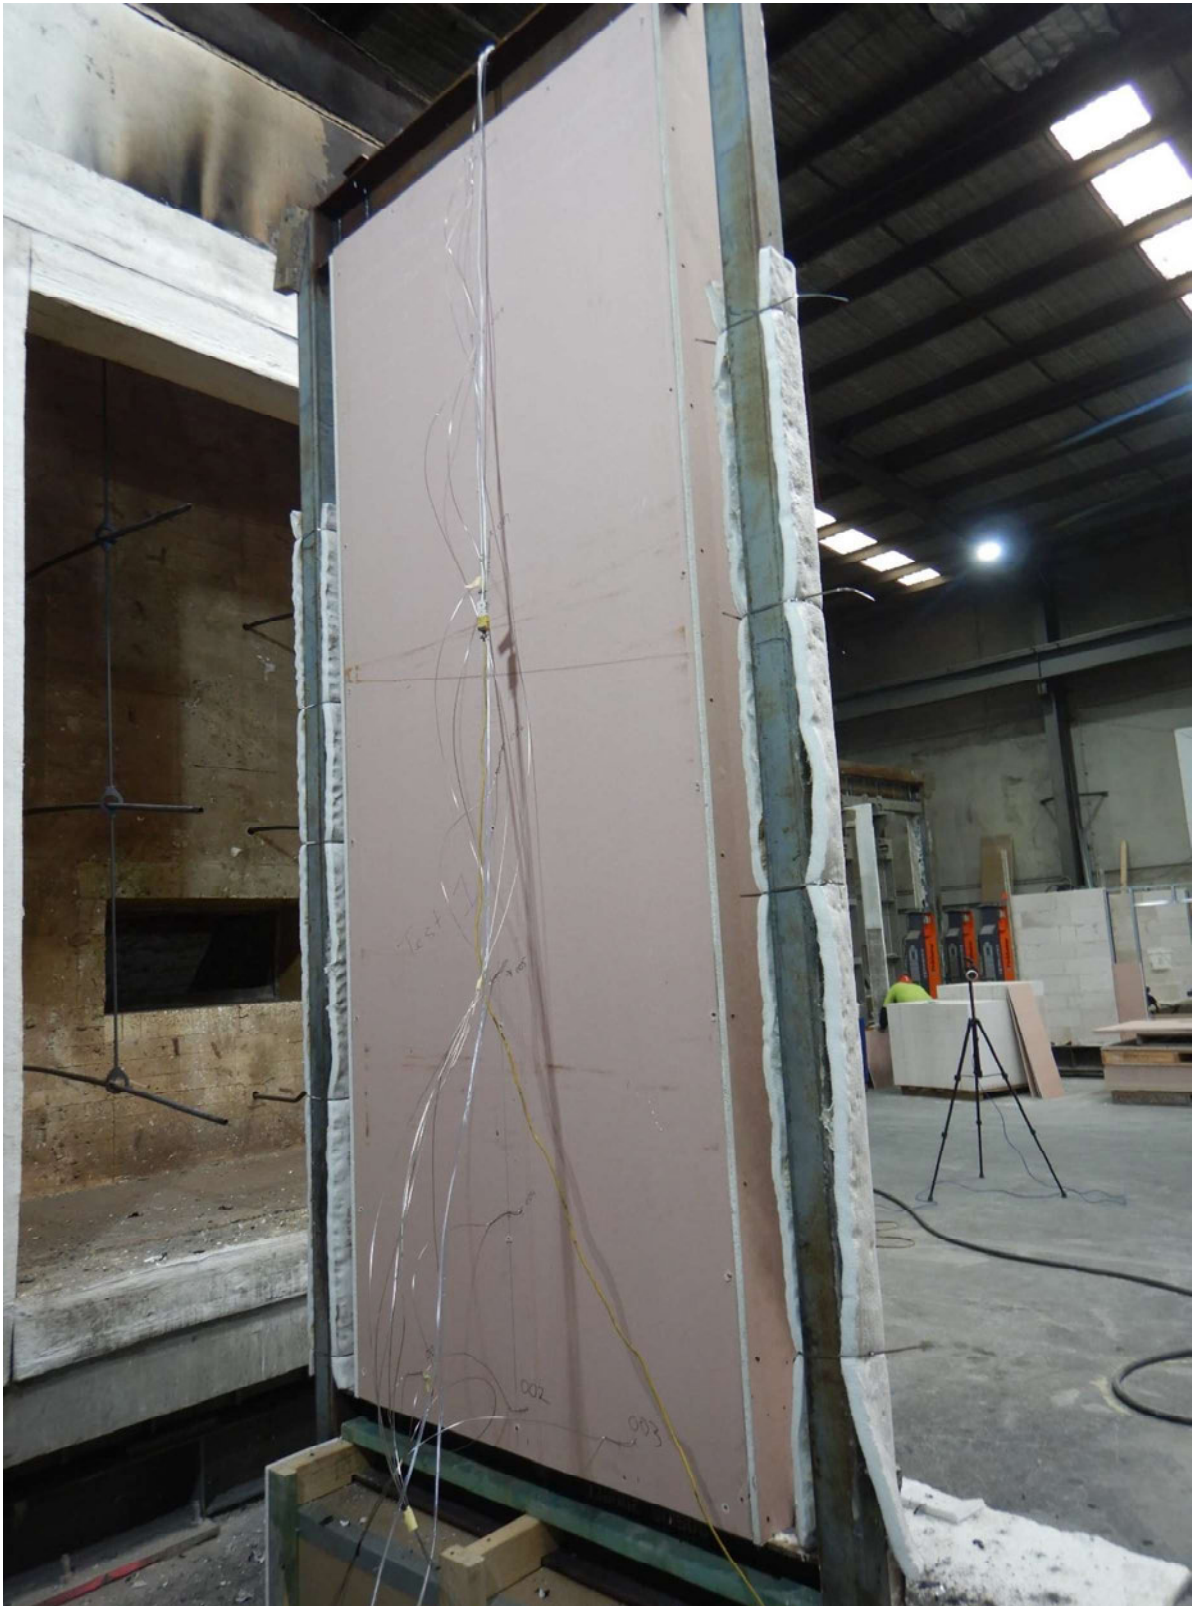
Figure 26 The specimen after the test – unexposed side.

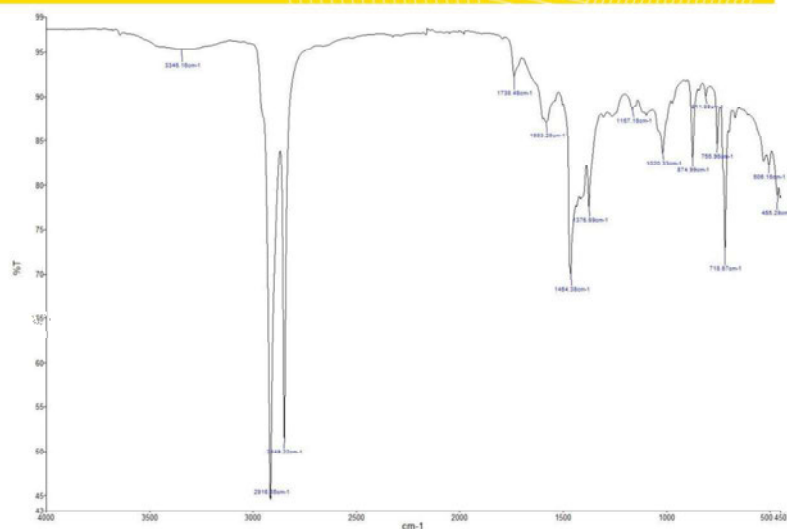
Figure 1. FT-IR spectrum of CSV #02

The cladding CSV #02 consisted of 80.9% poly(ethylene-vinyl acetate) (PEVA) polymer and 19.1% other inert material.

The cladding sample #1, CSV #02 is classified as ICA category A.

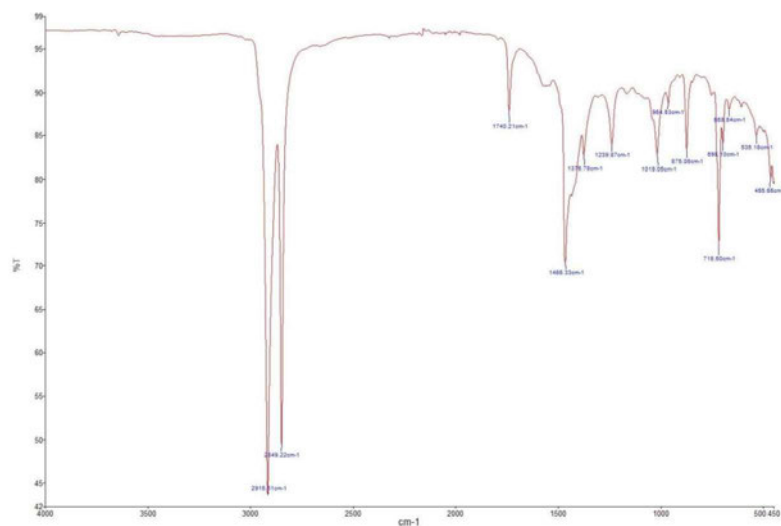
Figure 2. FT-IR spectrum of CSV #03

The cladding CSV #03 consisted of 78.1% poly(ethylene-vinyl acetate) (PEVA) polymer and 21.9% other inert material.

The cladding sample #2, CSV #03 is classified as ICA category A.

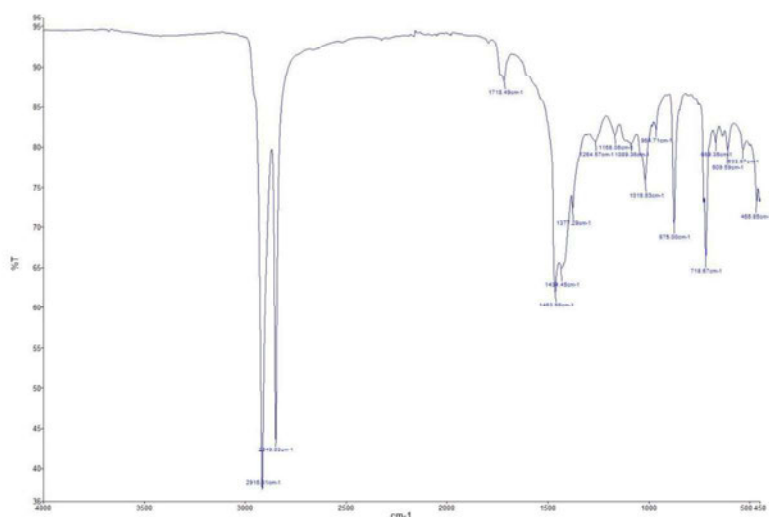
Figure 3 FT-IR spectrum of CSV #04

The cladding CSV #04 consisted of 2.1% magnesium hydroxide, 40.2% calcium carbonate, 7.9% other inert material and approximately 49.8% poly(ethylene-vinyl acetate) (PEVA) polymer.

The cladding sample 3, CSV #04 is classified as ICA category A.

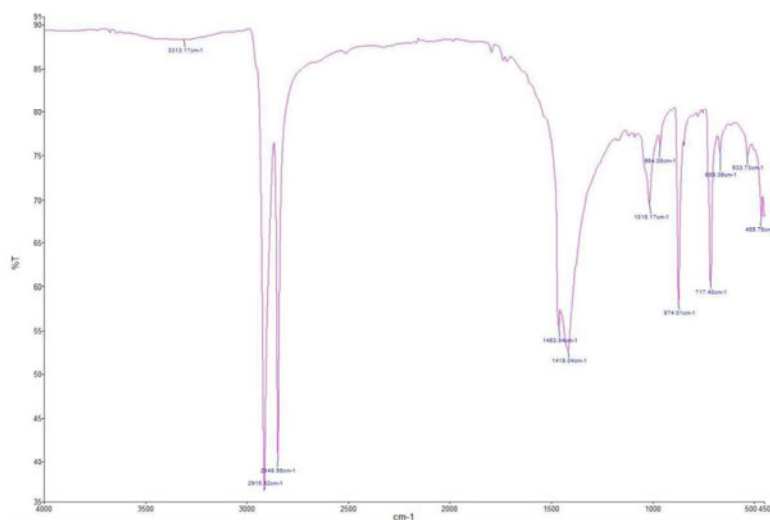
Figure 4 FT-IR spectrum of CSV #08

The cladding CSV #08 consisted of 3.8% magnesium hydroxide, 40.7% calcium carbonate, 12.9% other inert material and approximately 42.6% poly(ethylene-vinyl acetate) (PEVA) polymer.

The cladding sample 4, CSV #08 is classified as ICA category A.

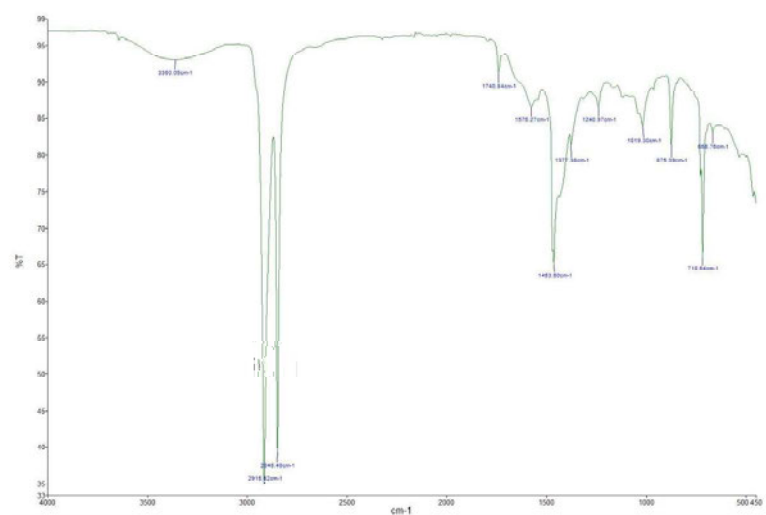
Figure 5 FT-IR spectrum of CSV #09

The cladding CSV #09 consisted of 81.1% poly(ethylene-vinyl acetate) (PEVA) polymer and 18.9% other inert material.

The cladding sample 5, CSV #09 is classified as ICA category A.
