Reaction to fire test report

Test standard: [Ad-hoc test based off ISO 13785-1:2002](#)

Test sponsor: [Cladding Safety Victoria \(CSV\)](#)

System: [A cassetted aluminium composite panel wall system](#)

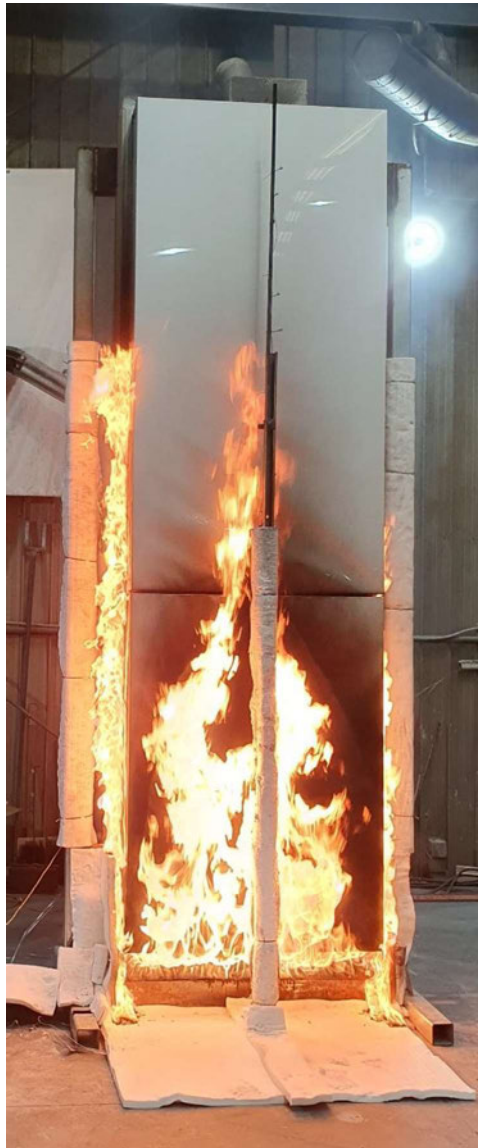
Figure 14 The specimen 9 minutes 20 seconds into the test (burner output at 200 kW)

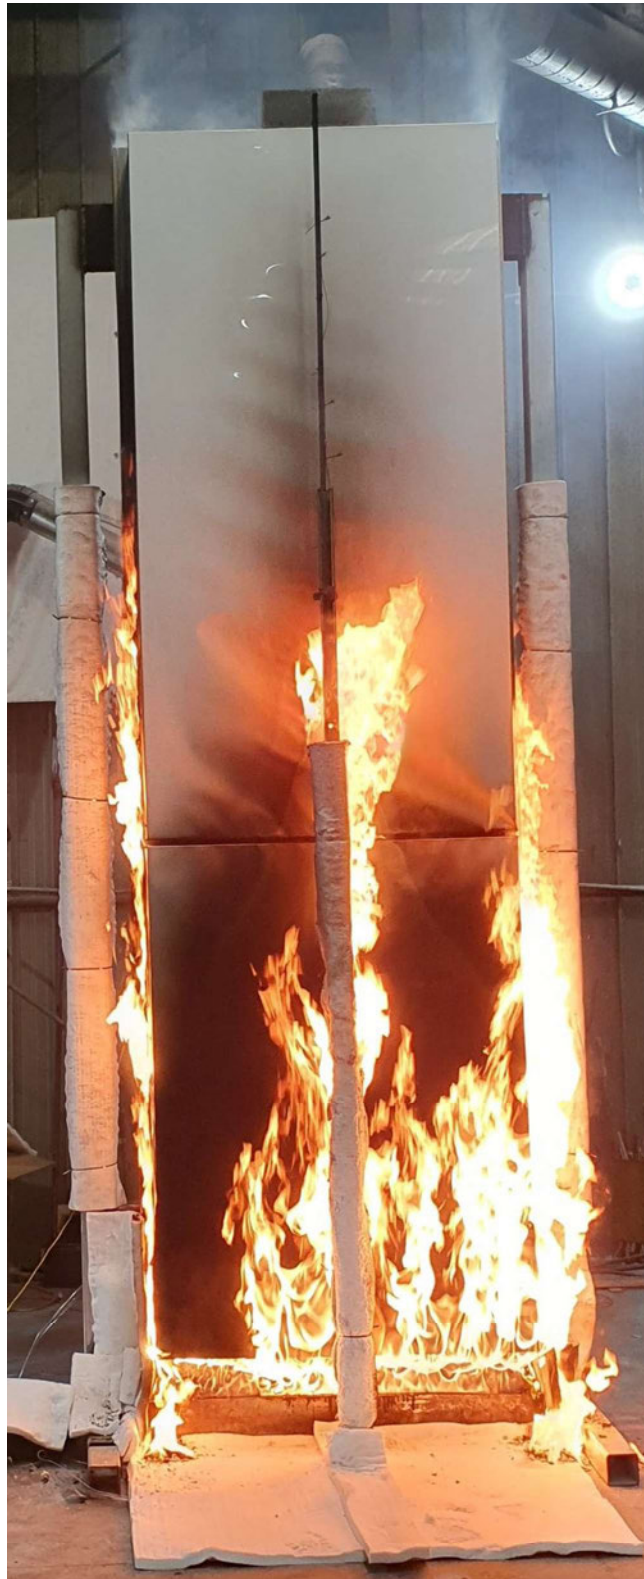
Figure 16 The specimen 13 minutes into the test (burner output at 200 kW)

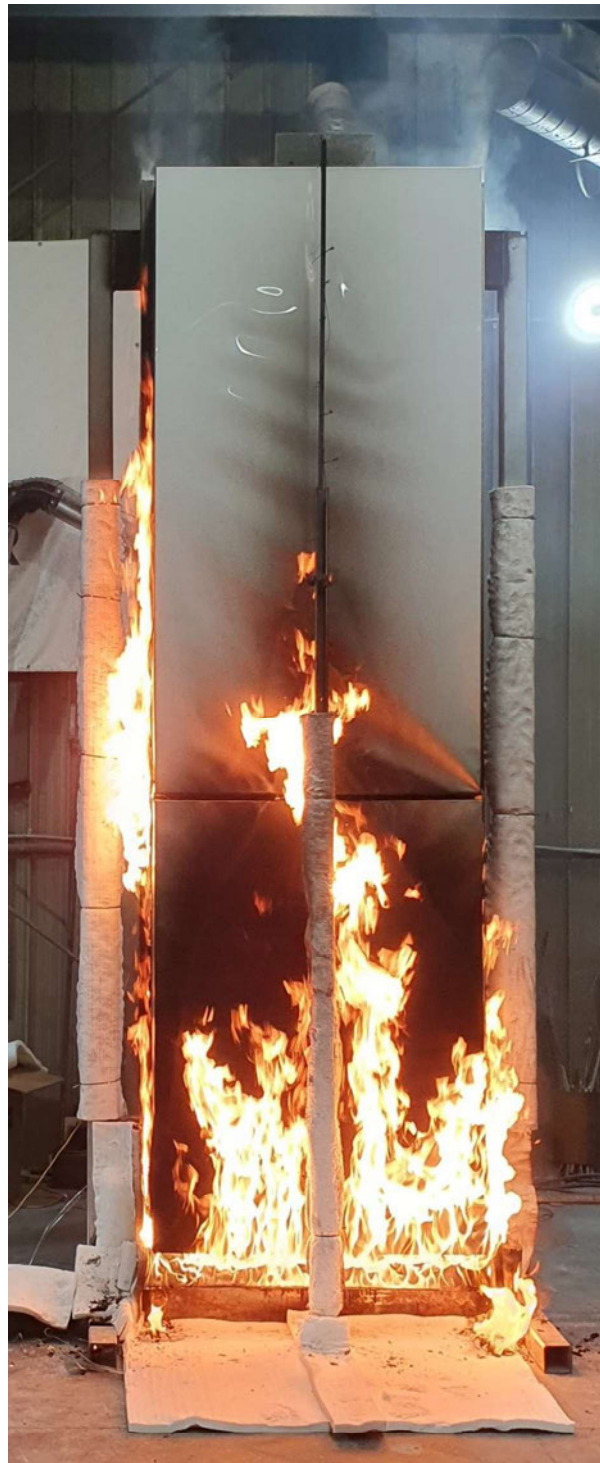
Figure 17 The specimen 15 minutes into the test (burner output at 200 kW)

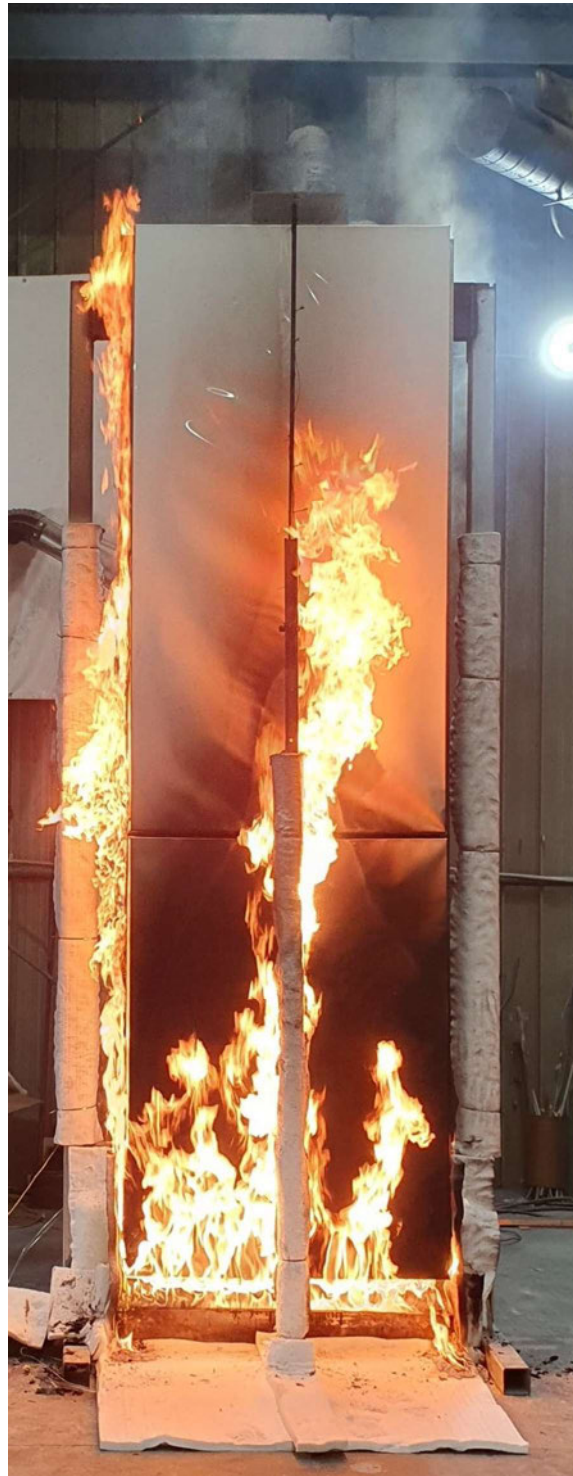
Figure 18 The specimen 17 minutes 30 seconds into the test (burner output at 200 kW)

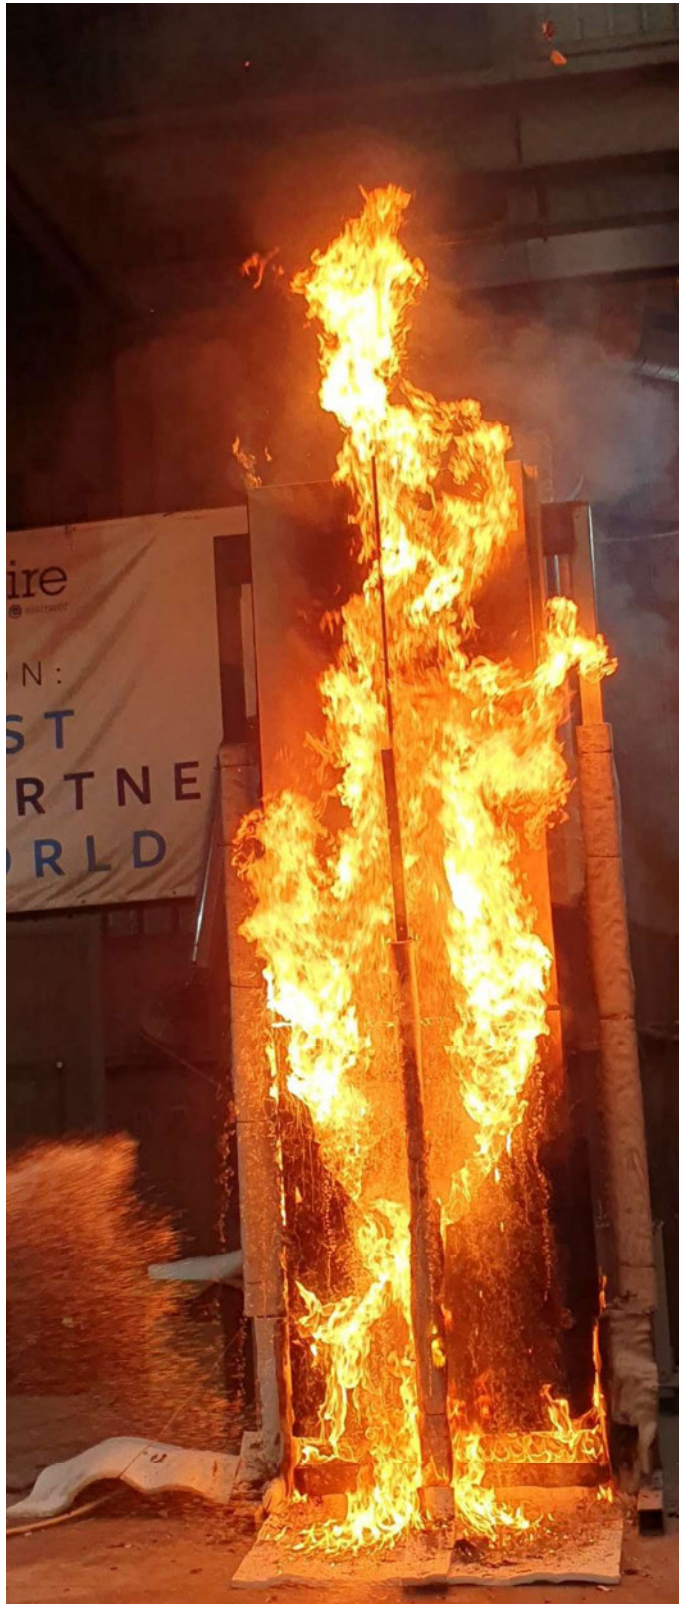
Figure 23 The specimen 20 minutes 51 seconds into the test (burner output at 200 kW) – at test termination.

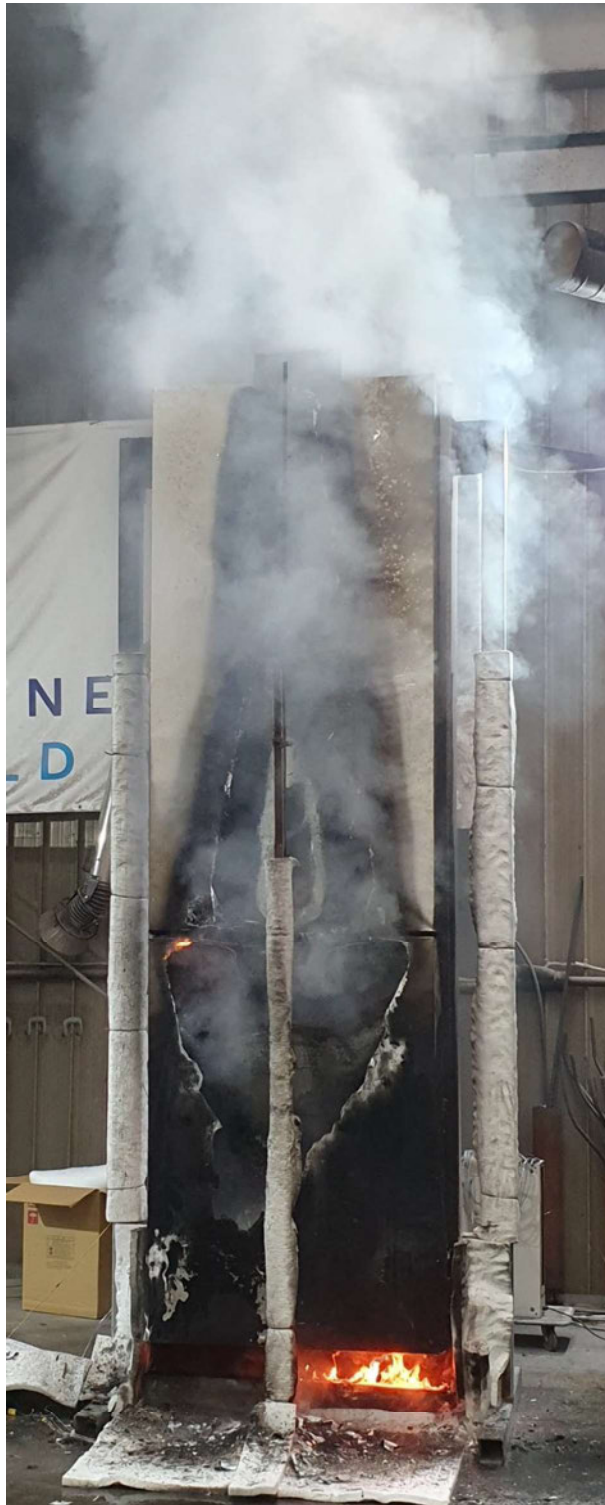
Figure 24 The specimen after the test.

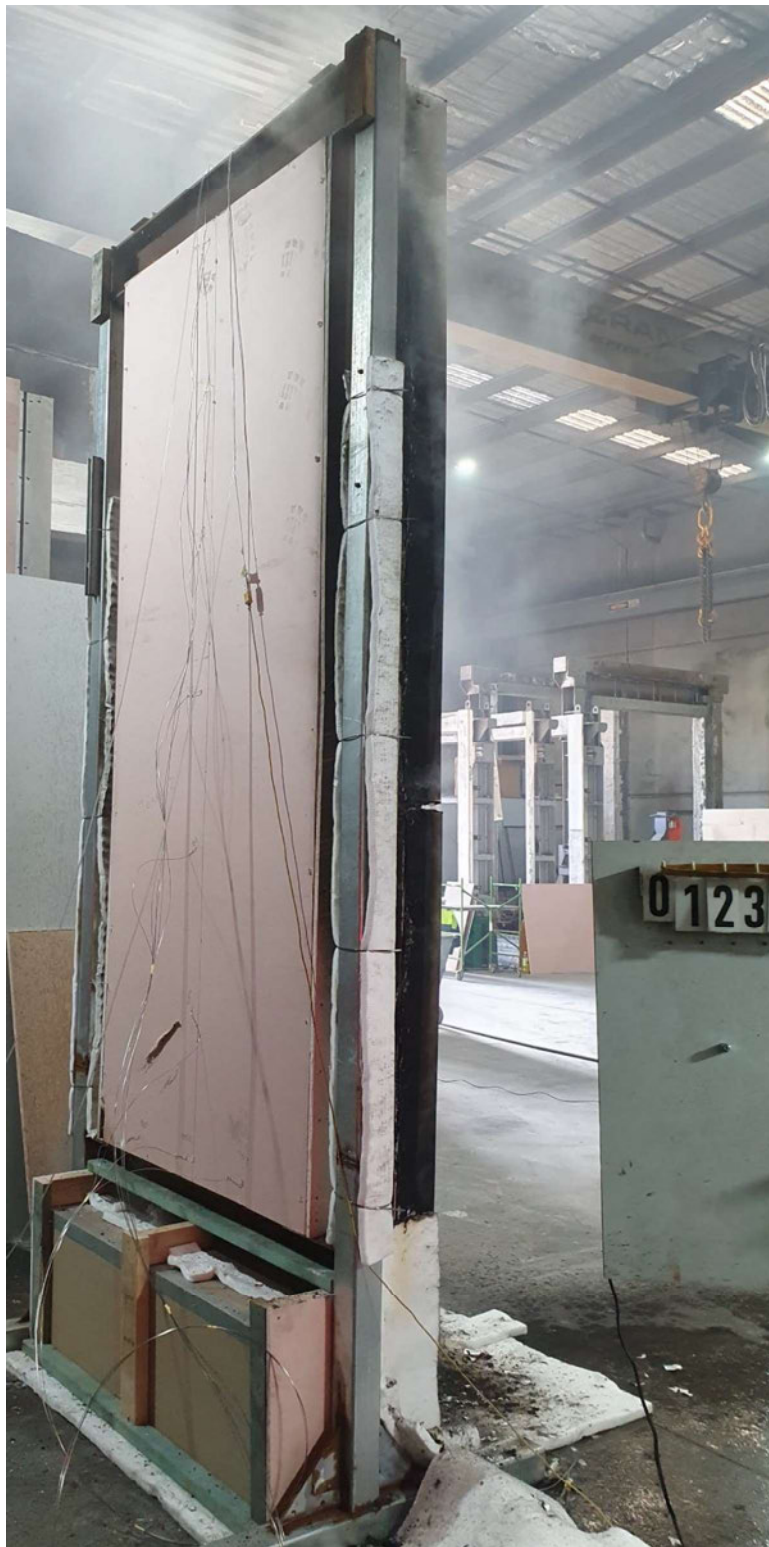
Figure 25 The specimen after the test – unexposed side.
