# Reaction to fire test report

Test standard: Ad-hoc test based off ISO 13785-1:2002

System: A cassetted aluminium composite panel wall system

Job number: RTF230139

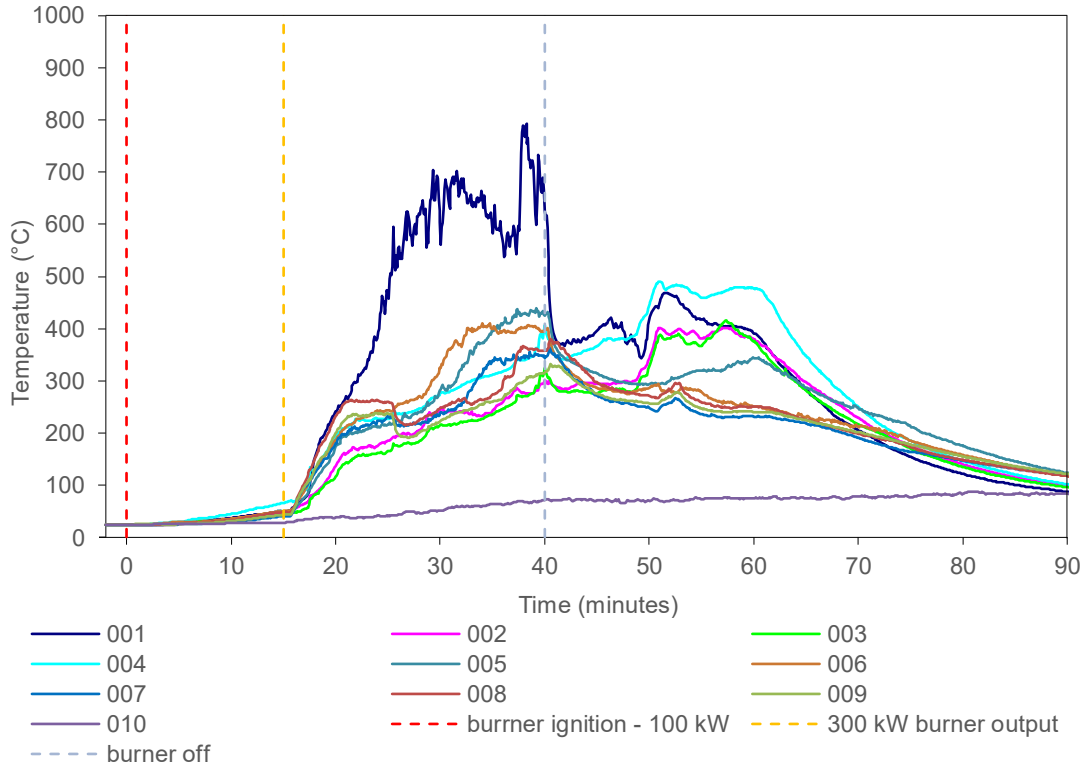
**Figure 2 Internal temperature data collected by thermocouples placed within the cavity – between the internal and external segments of the specimen.**

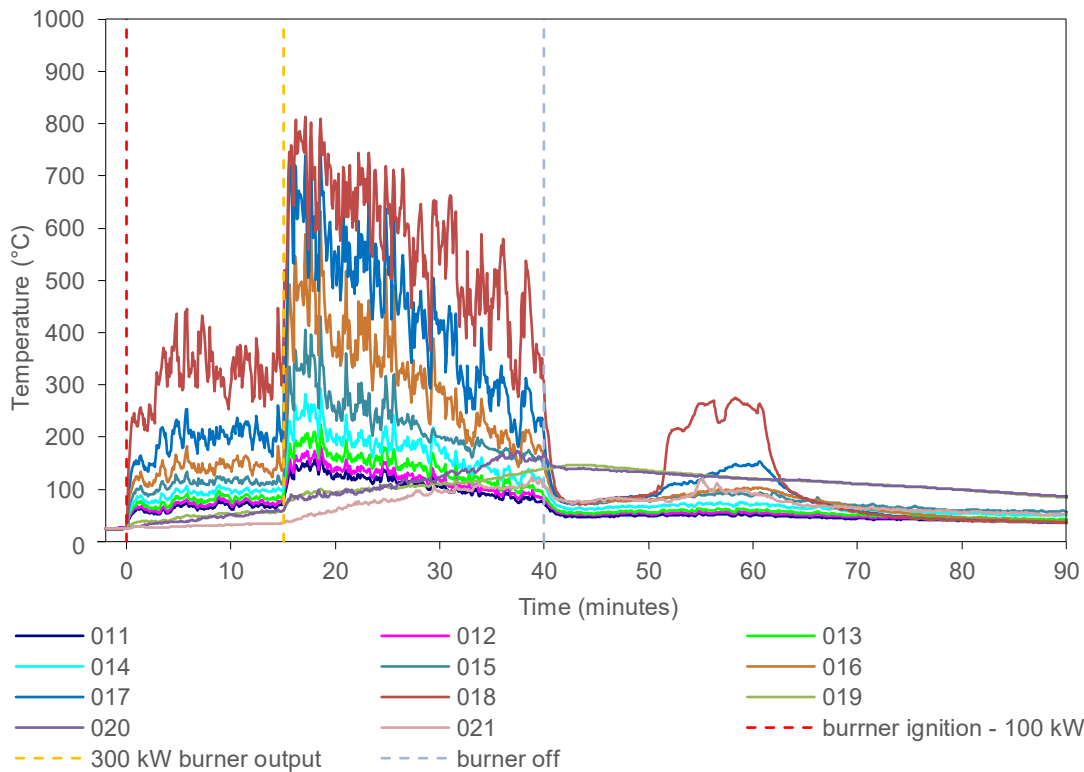
**Figure 3 External temperature data collected by thermocouples placed 60 mm from the front face of the specimen.**

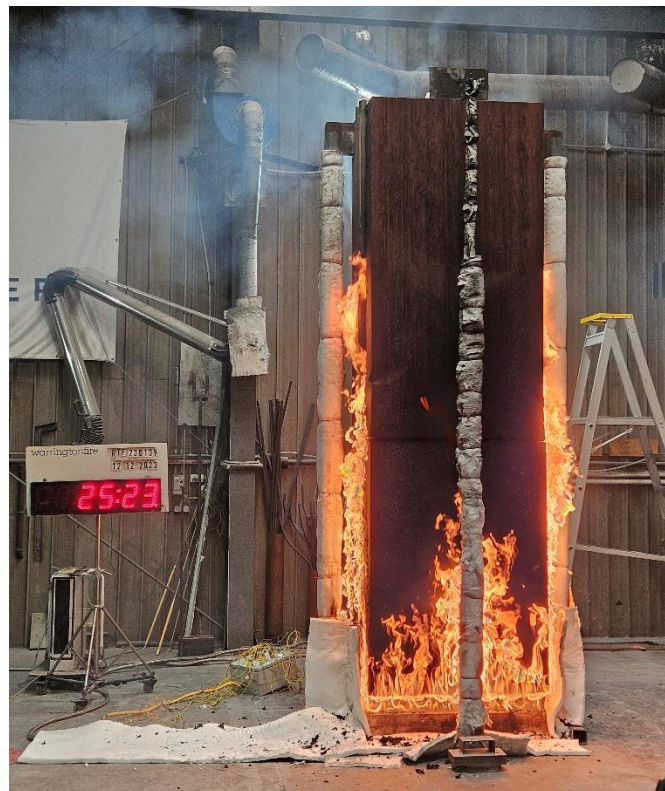
21	22	1C/2A	The joint sustained flaming which appeared to be independent of the burner, on the left side.
25	22	2A/2B/2C	A buildup of gas was released from the lower portion of the top panel. A hole had opened in the lower left side of the top panel.
26	07	All	Smoke emissions from the specimen had increased.
37	08	1A	A small flame was present at the back of the specimen below the plasterboard.
38	51	2A	Flaming at the corner of the panel increased.
40	00	All	The burner was switched off.
41	48	1A/1B/1C /2A	The specimen continued to flame at the sides.
49	00	2A	Flaming of the top panel decreased.
50	46	1A	A large pile of flaming debris collapsed out of the underside of the specimen at the centre.
54	24	1A	A large pile of flaming debris collapsed out of the underside of the specimen at the right.
54	25	1A/1B/1C	Flaming on the right side of the specimen increased.
54	55	1C/2A	Intermittent flaming at the joint.

Figure 19 The specimen 25 minutes 23 seconds into the test (10 minutes 23 seconds after burner output was changed to 300 kW)

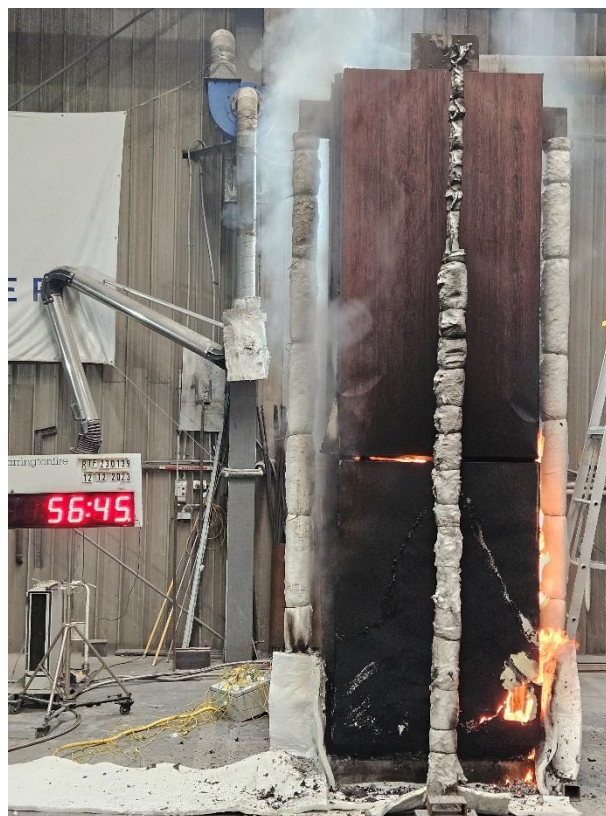
Time		Section	Observation
Min	Sec		
56	18	1A	The front face of the panel cracked open at the bottom right. The panel was flaming on the inside.
57	18	1A/1B/1C	The left side of the panel had stopped flaming.
69	19	All	Flaming decreased.
77	38	1C/2A	Flaming at the join ceased.
82	46	All	All visible flaming ceased.
90	00	All	The reaction to fire test ended.

Figure 25 The specimen 56 minutes 45 seconds into the test (16 minutes 45 seconds after burner was switched off)

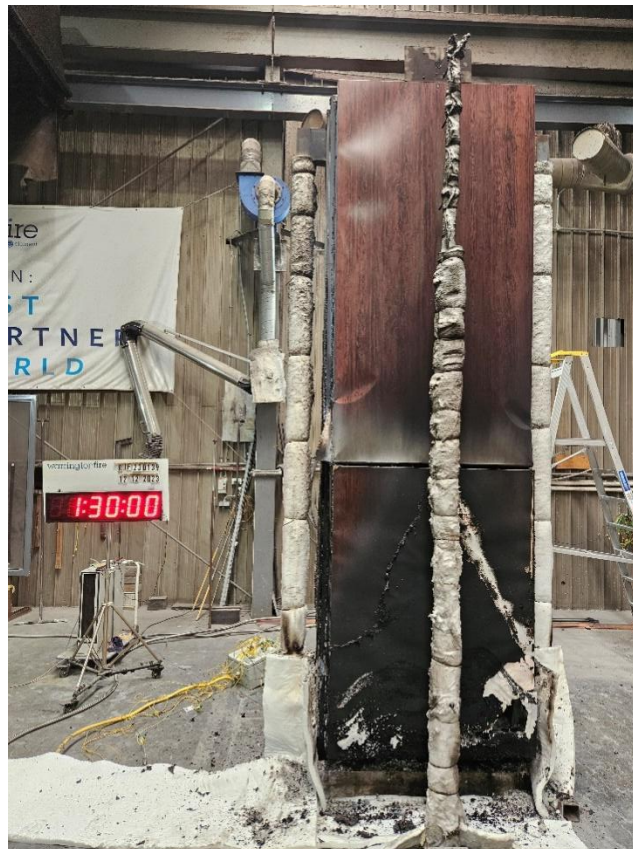
Figure 27 The specimen at the end of the test

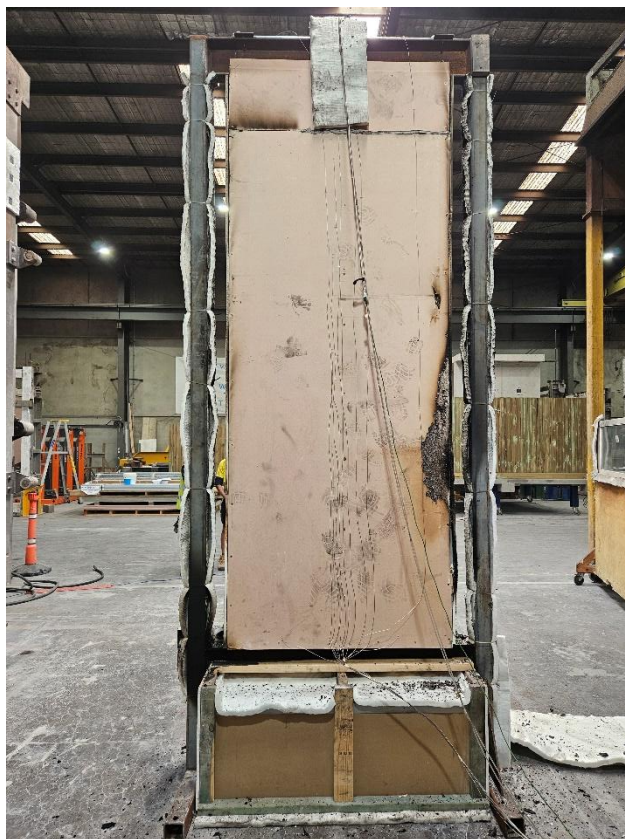
Figure 28 The specimen after the test – unexposed side.

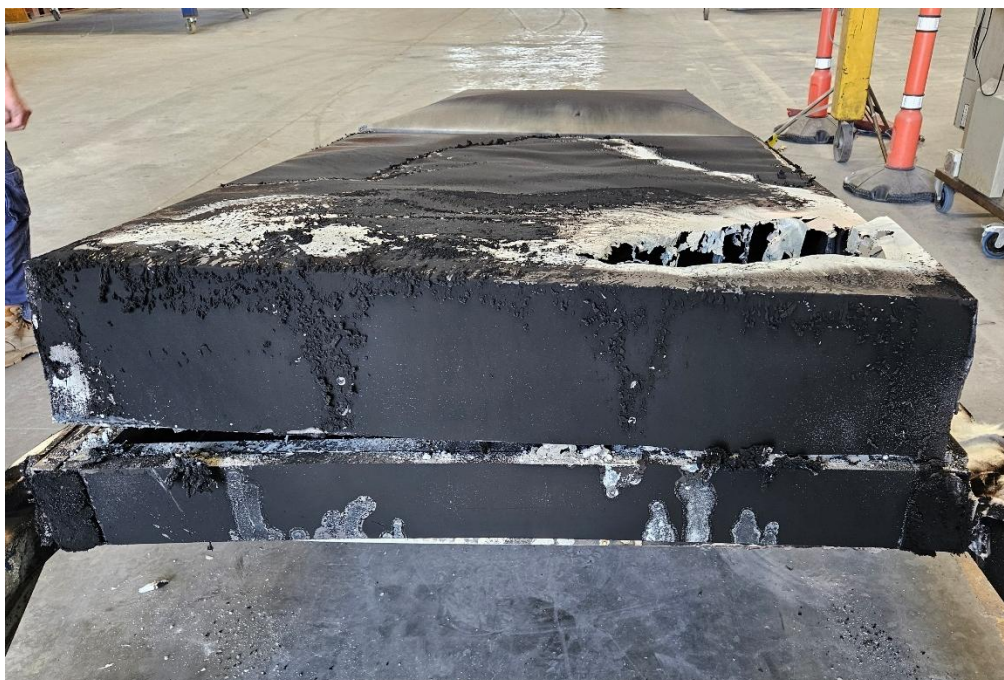
Figure 29 The specimen after the test – underside.
