Reaction to fire test report

Test standard: Ad-hoc test based off ISO 13785-1:2002

Test sponsor: Cladding Safety Victoria (CSV)

System: A cassetted aluminium composite panel wall system

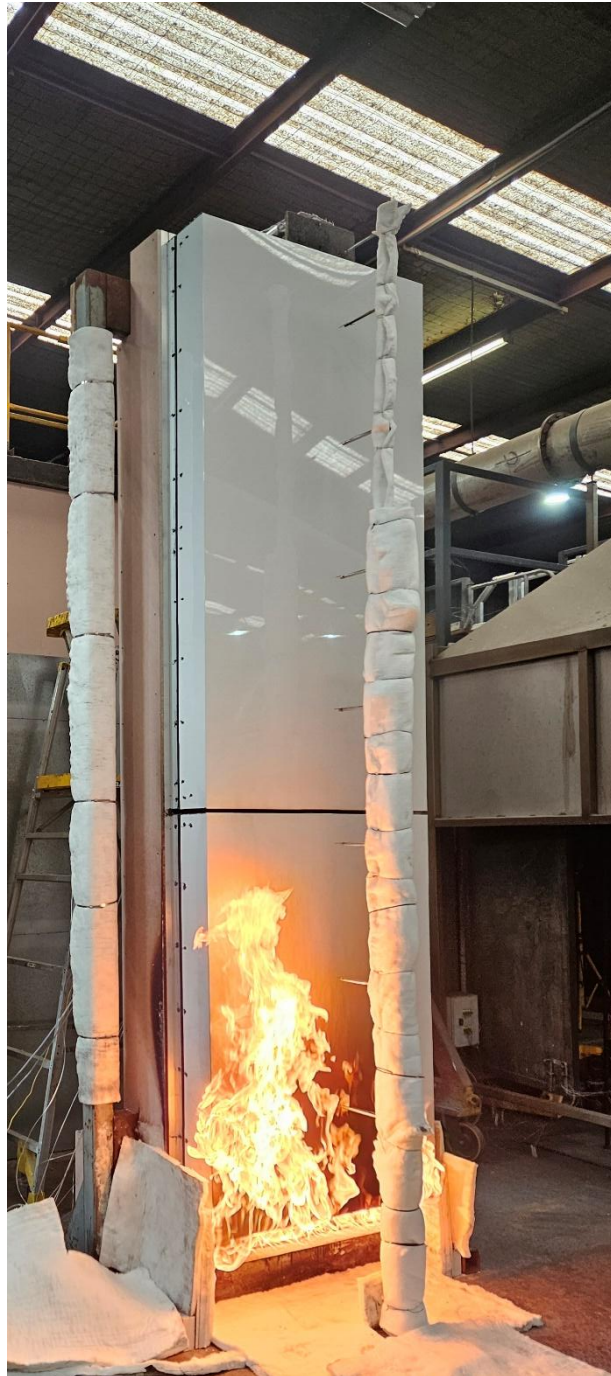
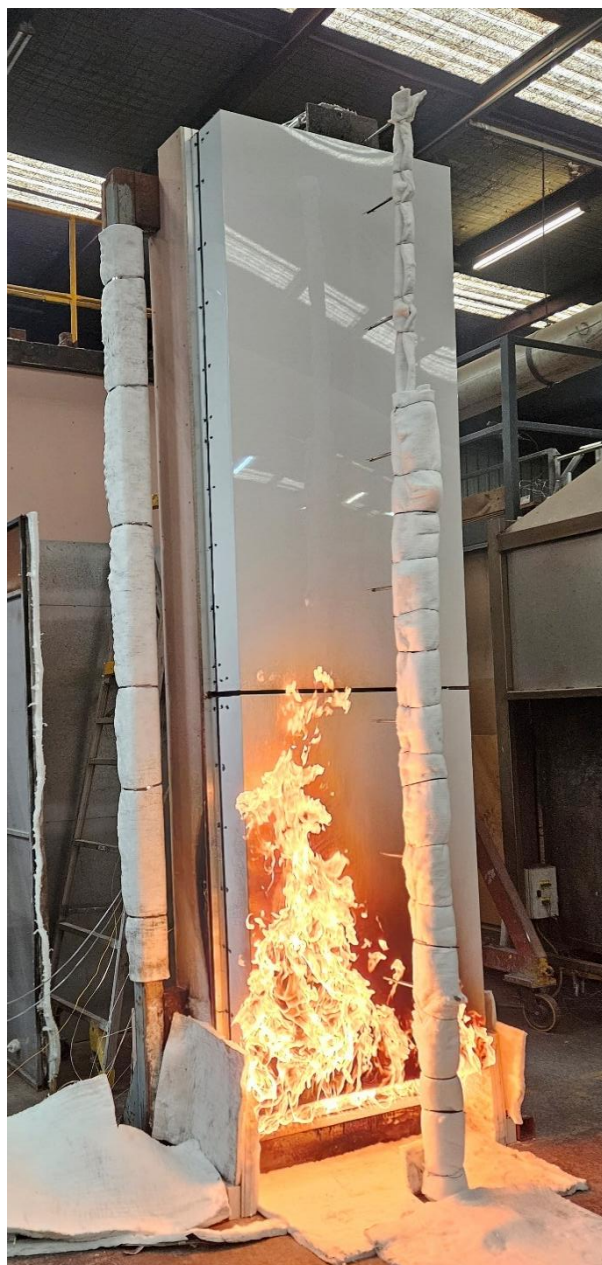
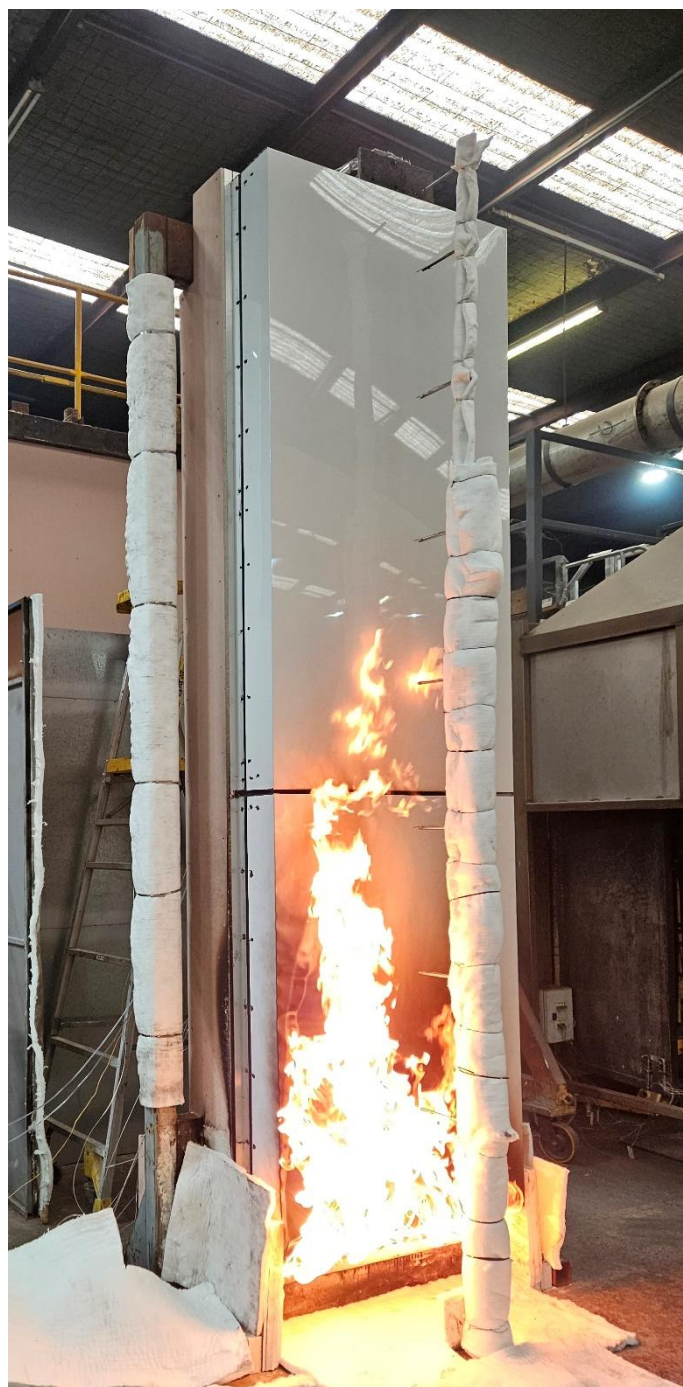
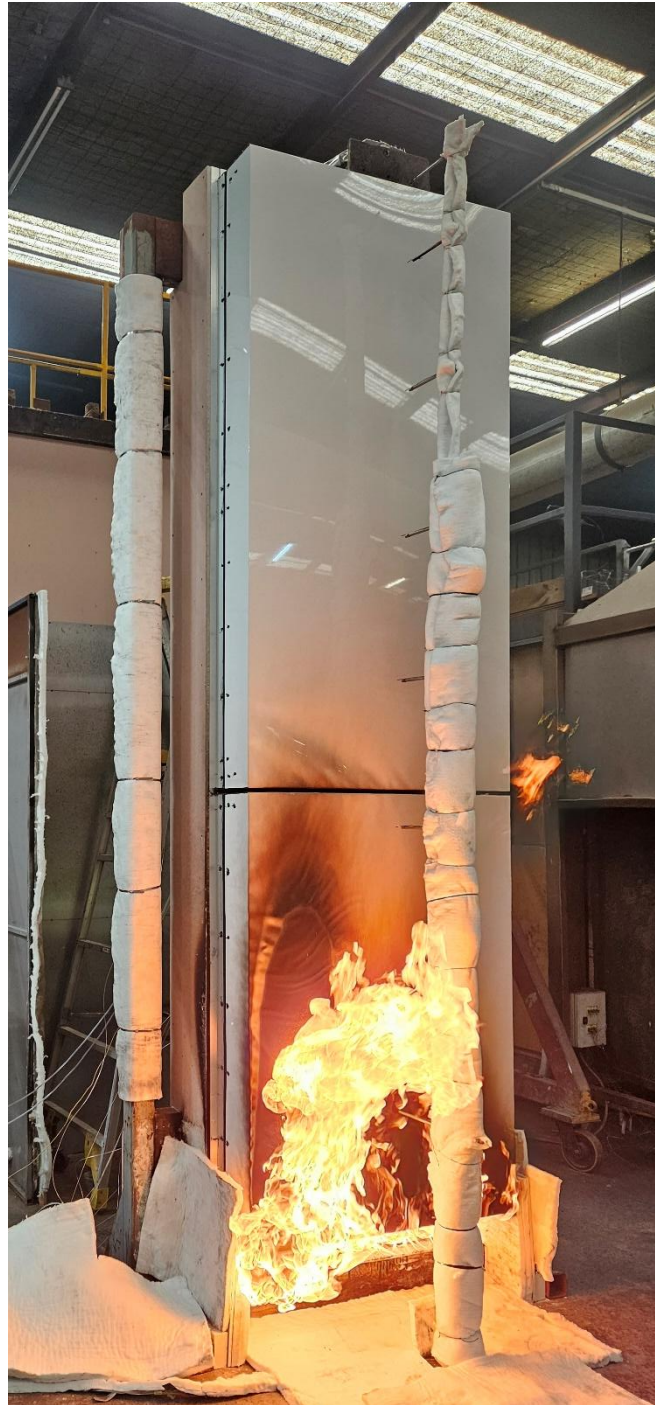
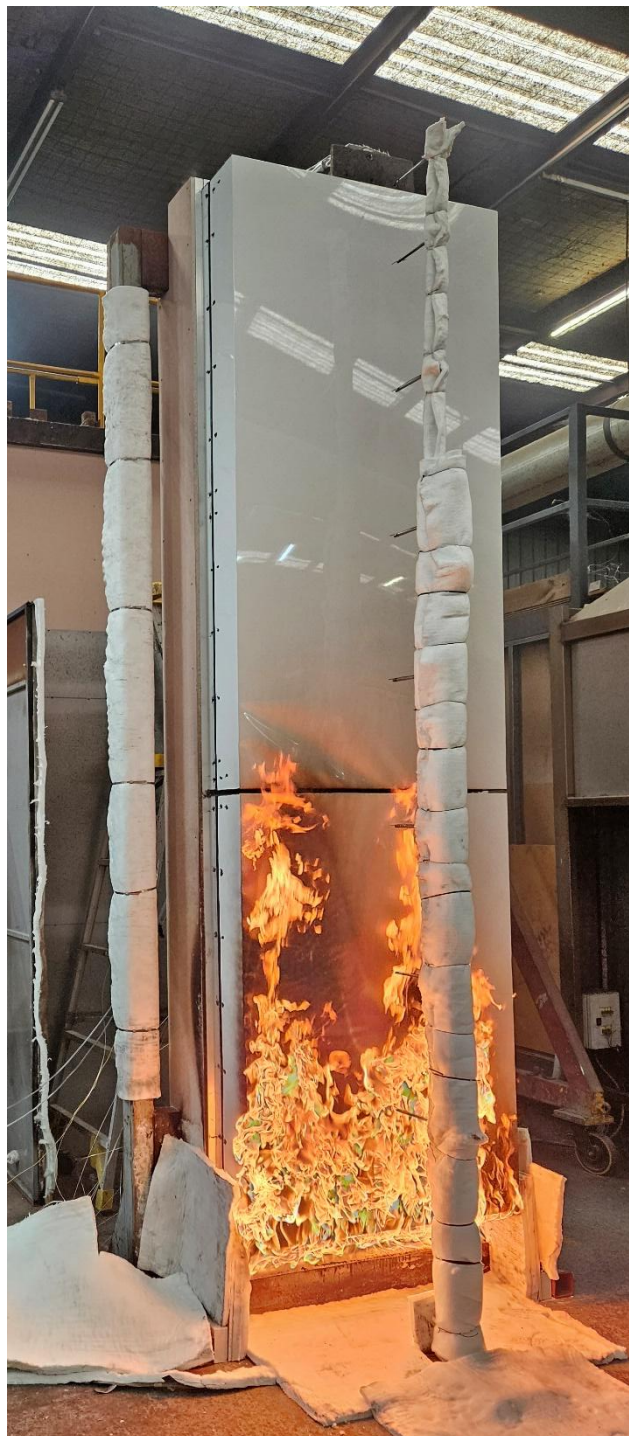
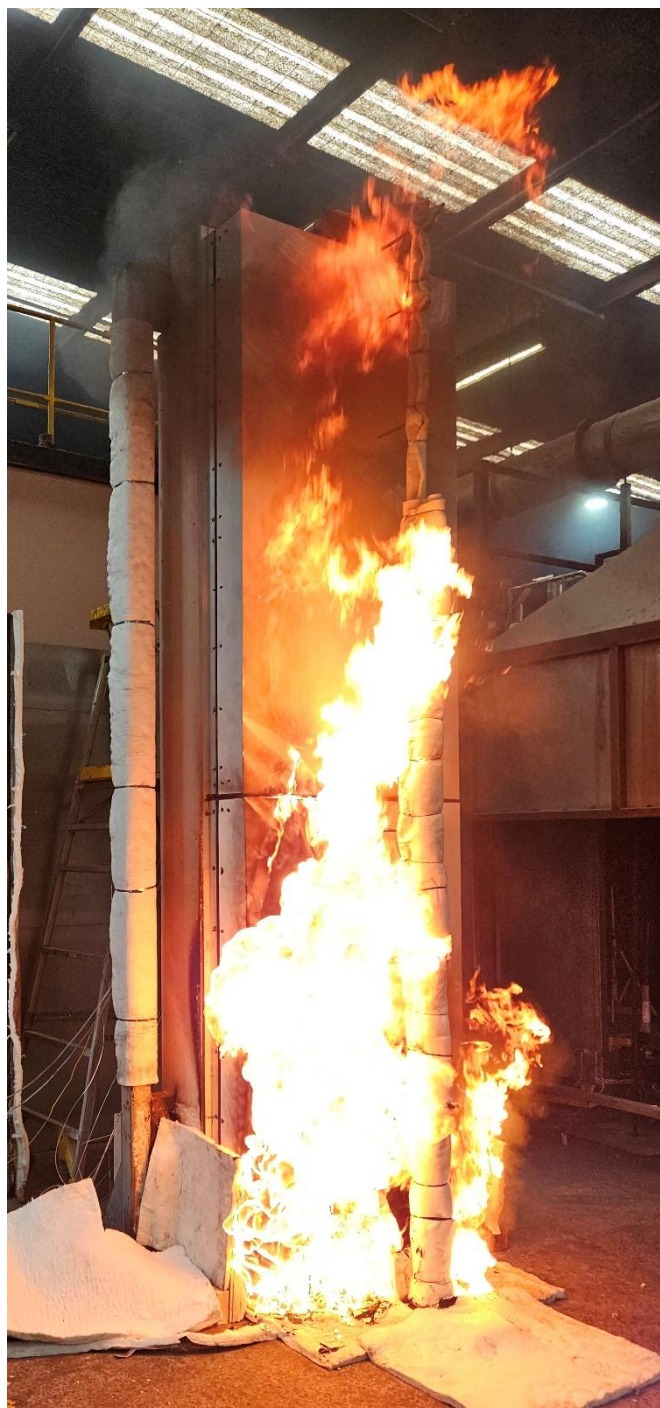
Time		Section	Observation
Min	Sec		
-2	00	All	Data collection started.
0	00	All	The reaction to fire test was started with the burner ignited with a heat output set at 200 kW.
0	06	A	Flames reached mid-height of the panel.
0	19	A1	There was discolouration on the front face of the panel.
0	36	A2	There was discolouration on the front face of the panel.
1	37	B1	Flames reached the bottom of the panel.
2	00	A1/A2	The panel started to deform.
2	21	A3	There was discolouration on the front face of the panel.
2	57	B1	There was discolouration on the front face of the panel.
3	43	A1	There was flaming dripping debris from the bottom of the specimen.
5	22	All of A	There was a large and sudden release of built-up gas causing flaming debris to shoot from the specimen.
5	55	All of A	The flames have engulfed the lower panel. It is possible that the core is contributing to the fire.
6	01	B3	Flames reached this section of the specimen.

Figure 12 The specimen 1 minute into the test (burner output at 200 kW)

Figure 13 The specimen 2 minutes into the test (burner output at 200 kW)

Figure 14 The specimen 3 minutes into the test (burner output at 200 kW)

Figure 15 The specimen 4 minutes into the test (burner output at 200 kW)

Figure 16 The specimen 5 minutes into the test (burner output at 200 kW)

Figure 17 The specimen 6 minutes into the test (burner output at 200 kW)

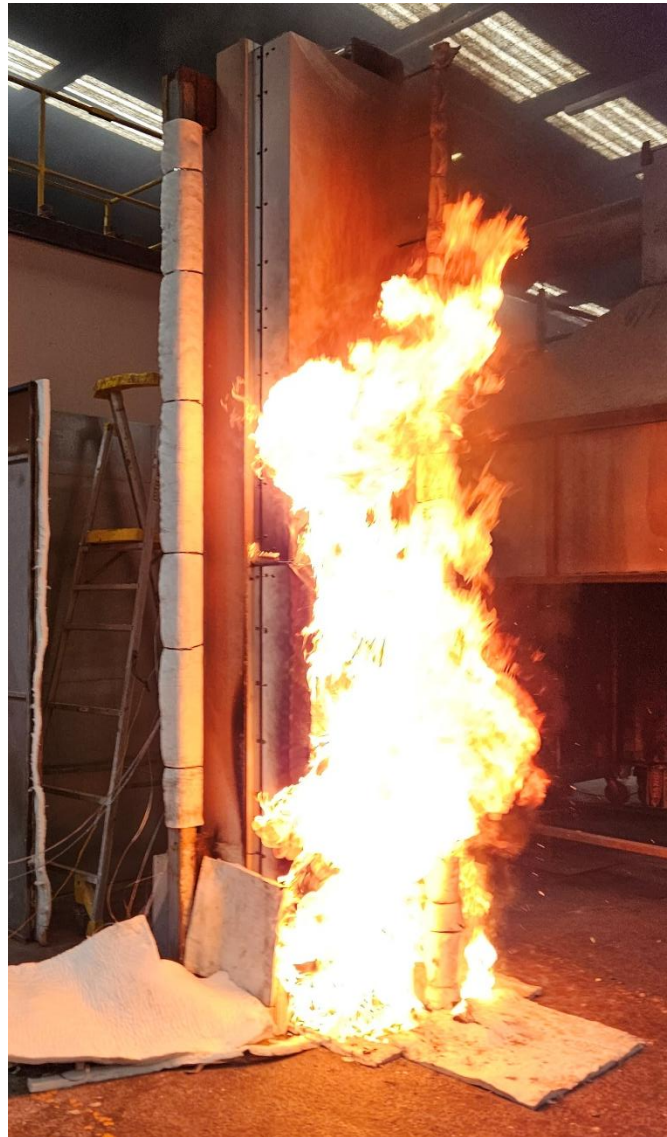
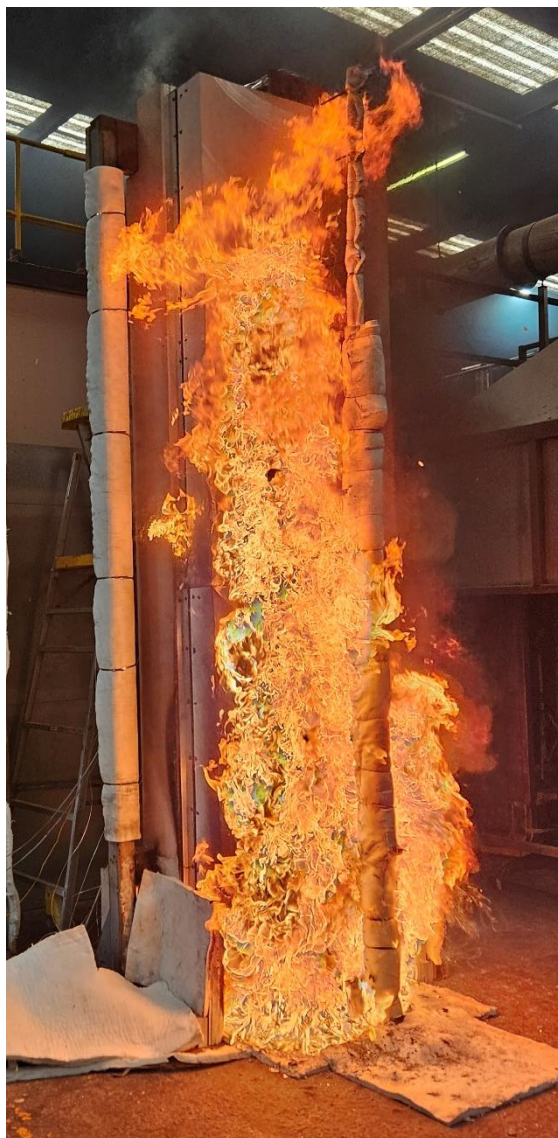
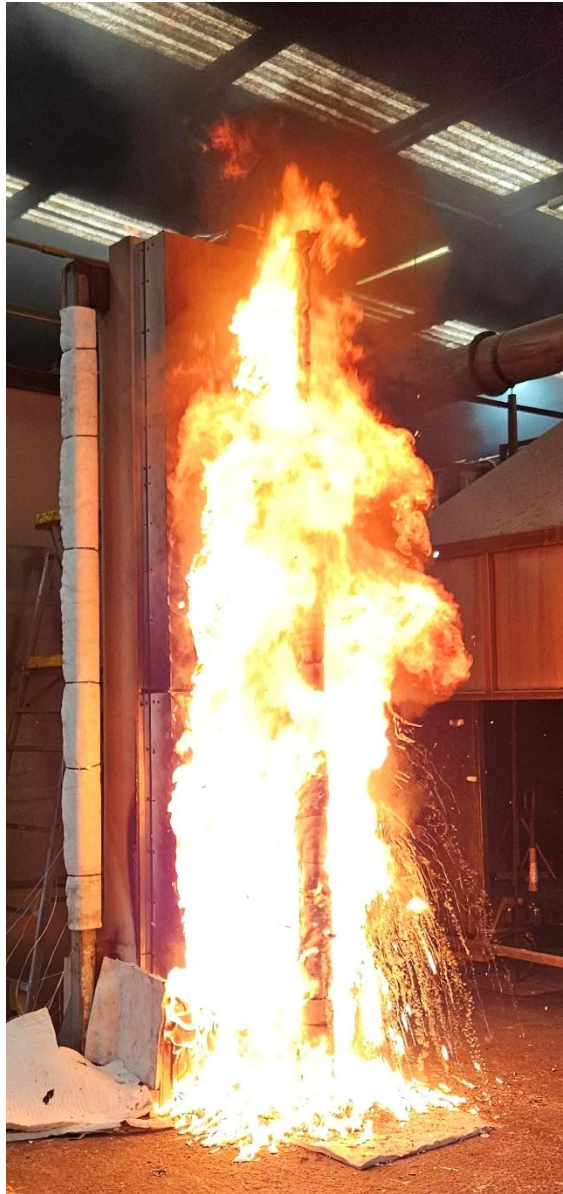
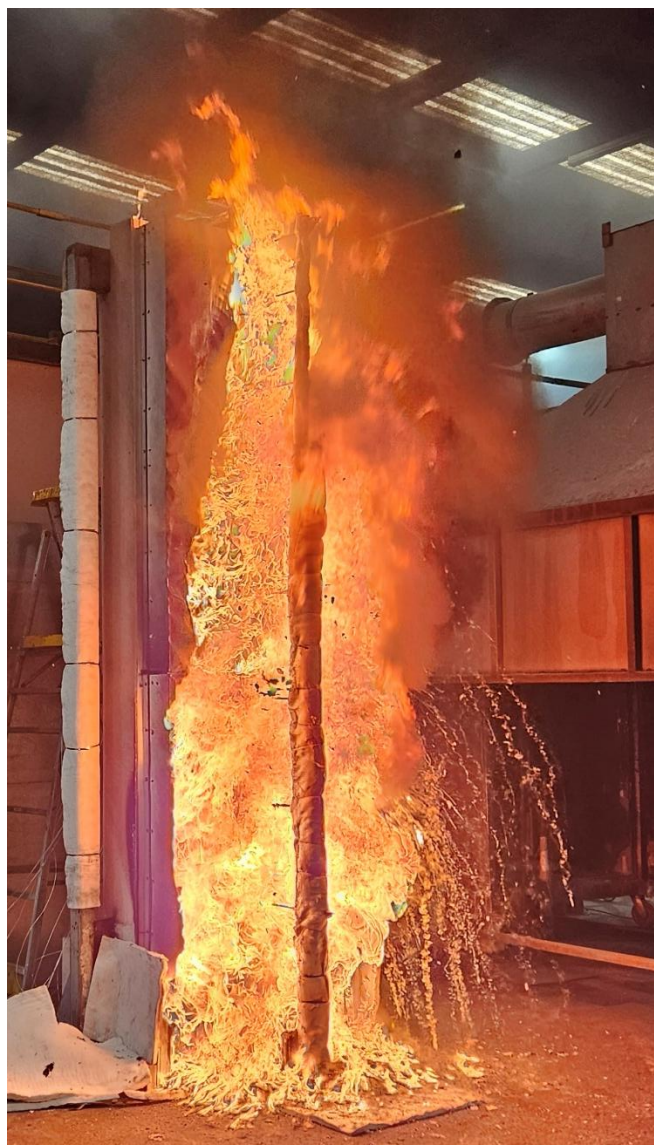
6	23	All	The panels have opened up and the core material is contributing to the fire.
6	48	All	Flaming of the specimen was excessive. The power to the burner was cut and specimen was sprayed with water. The test ended.

Figure 18 The specimen 6 minutes 17 seconds into the test (burner output at 200 kW)

Figure 19 The specimen 6 minutes 22 seconds into the test (burner output at 200 kW)

Figure 20 The specimen 6 minutes 37 seconds into the test (burner output at 200 kW)

Figure 21 The specimen 6 minutes 46 seconds into the test (burner output at 200 kW) – 2 seconds before end of test.

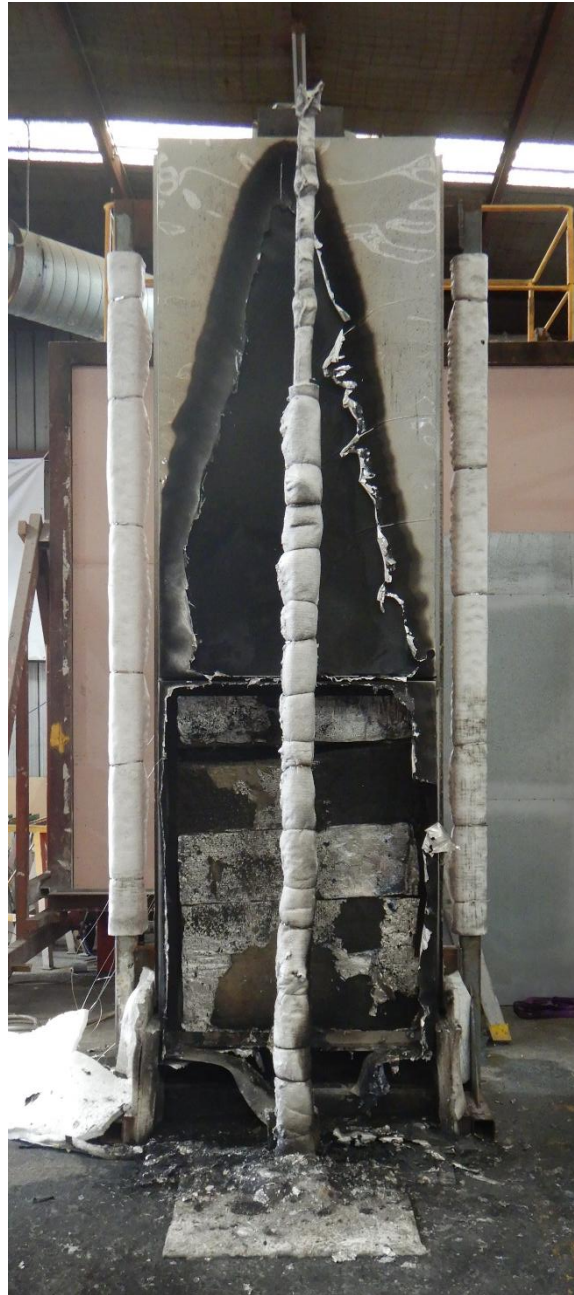
Figure 22 The specimen after the test
