Reaction to fire test report

Test standard: BS 8414-2:2015

Test sponsor: Cladding Safe Victoria

Product: Aluminium composite panel façade

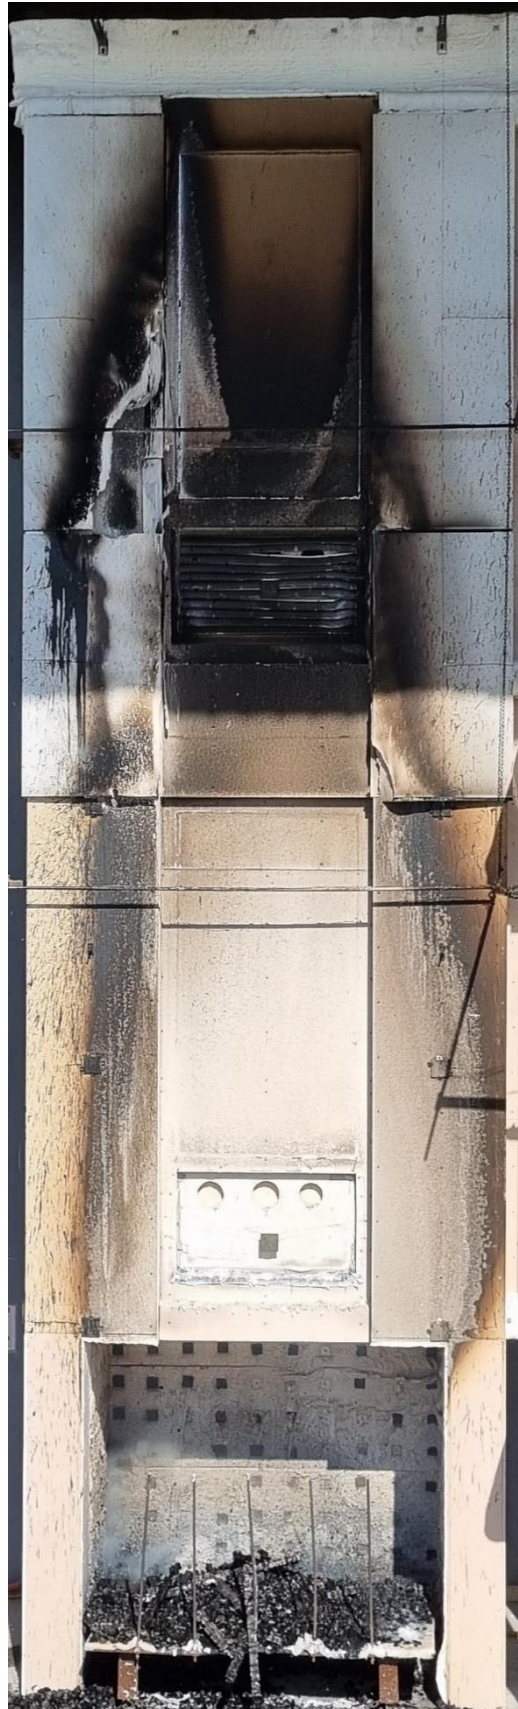
Figure 43 The external wall system on completion of the test – main wall

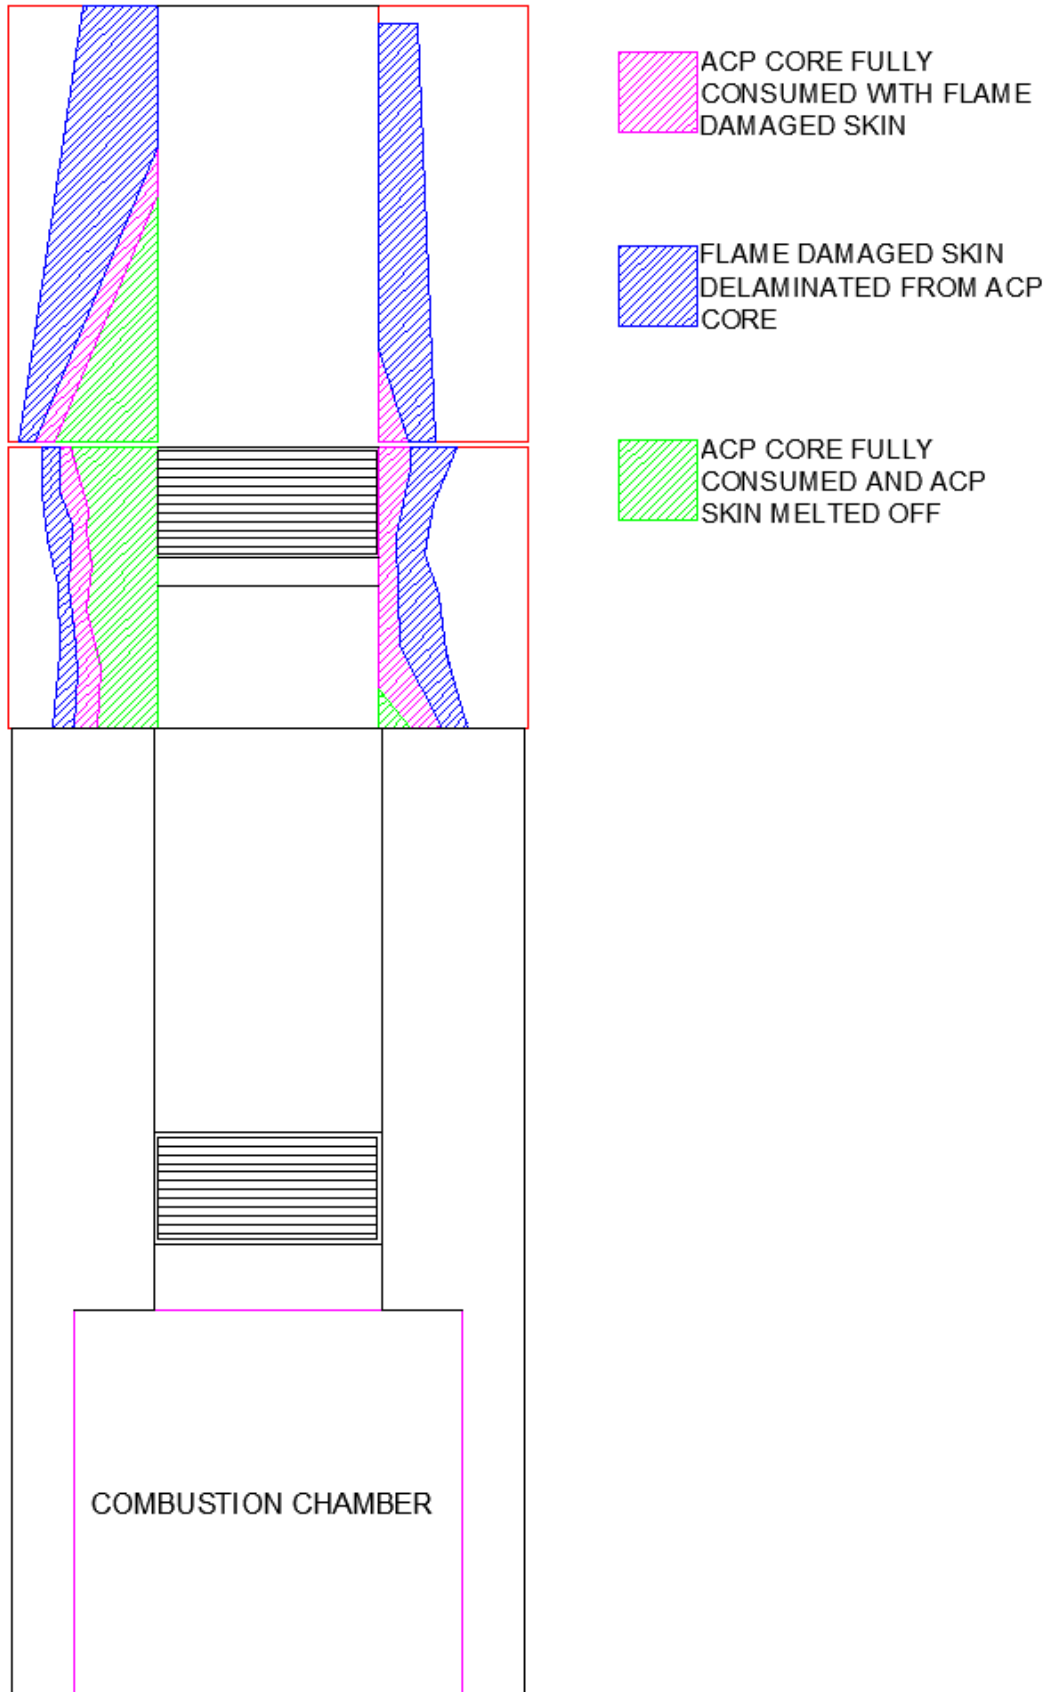
Approximately 0.9 m² of the ACP had the core fully consumed and both ACP skins melting off.

Approximately 0.5 m² of the ACP had the core fully consumed and flame damaged skin.

Approximately 1.7 m² of the ACP had the core partially consumed and the skin delaminated.

The first floor louvre had fully melted off, while the second floor louvre had deformed during the test.

The glazing perimeter sealant for the first floor was fully consumed, while the sealant for the second floor was partially consumed.

Approximately 9.2 m² of the plasterboard and AAC face had flame damage.

Figure 44 The post-test external wall system ACP damages – main wall

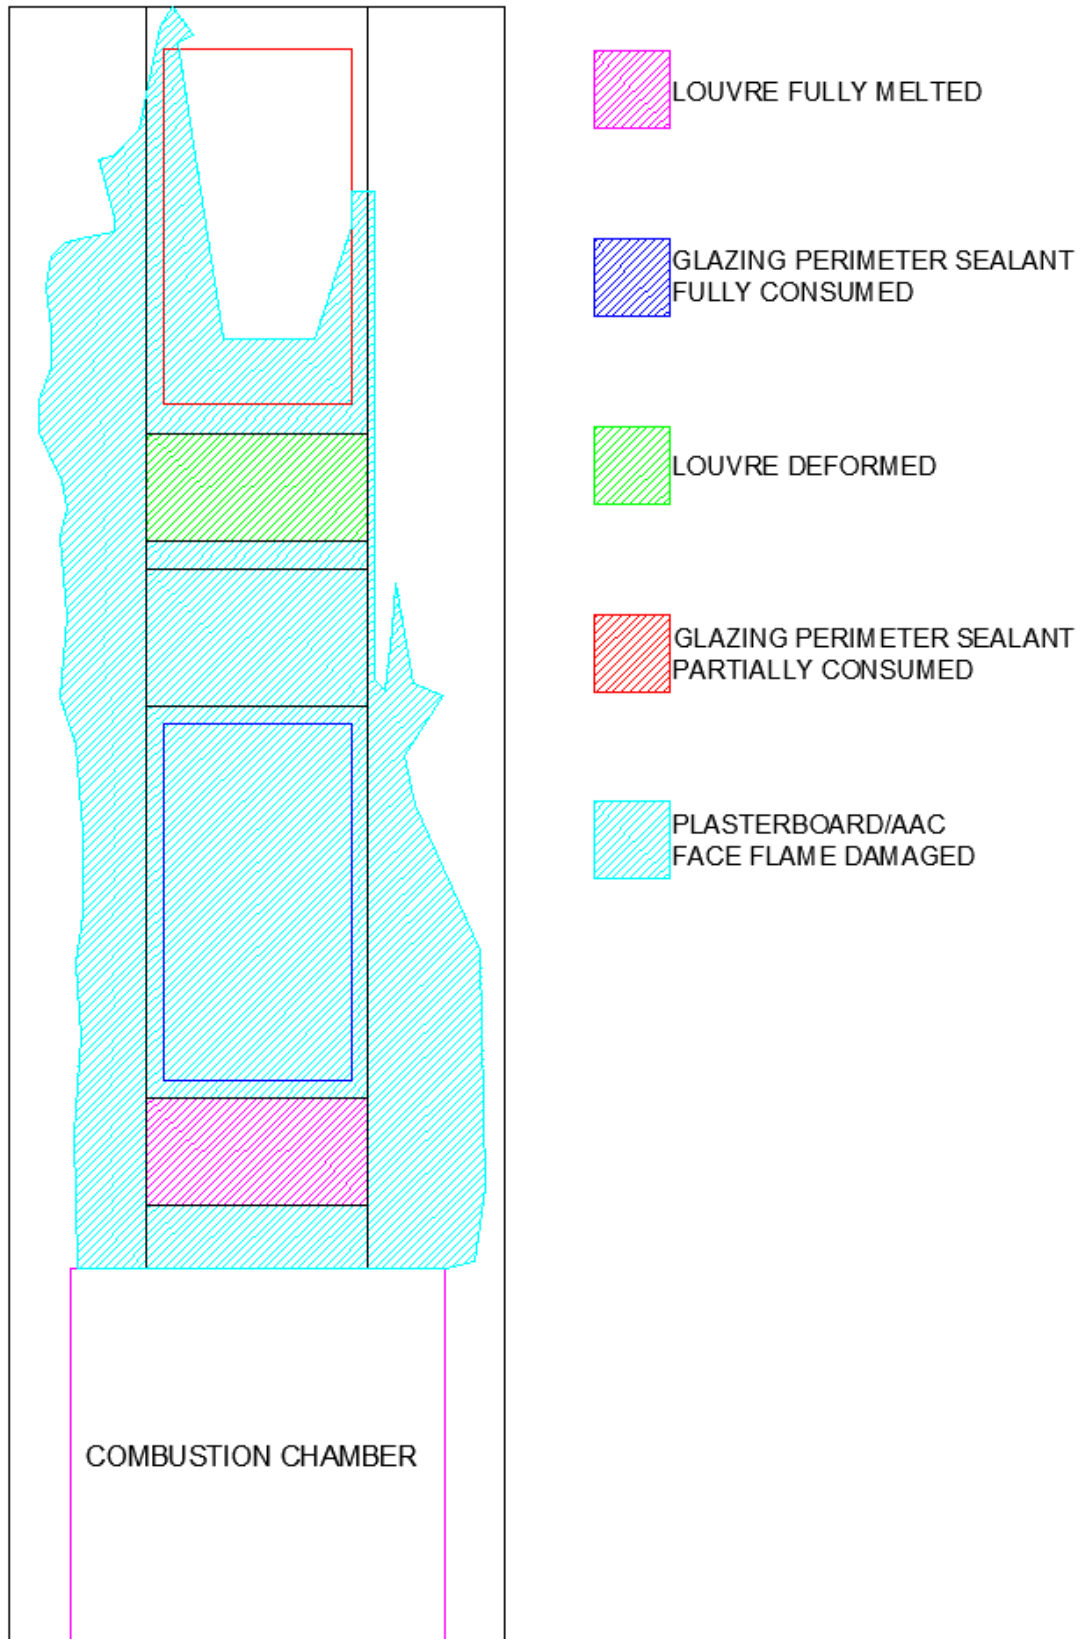
Figure 45 The post-test external wall system with the ACP removed – main wall
