Reaction to fire test report

Test standard: Ad hoc ISO 13785-1:2002 Part 1 – Intermediate-scale

System: Cassetted aluminium composite panel (ACP) – with a 45% PE core – wall system

Job number: RTF240032

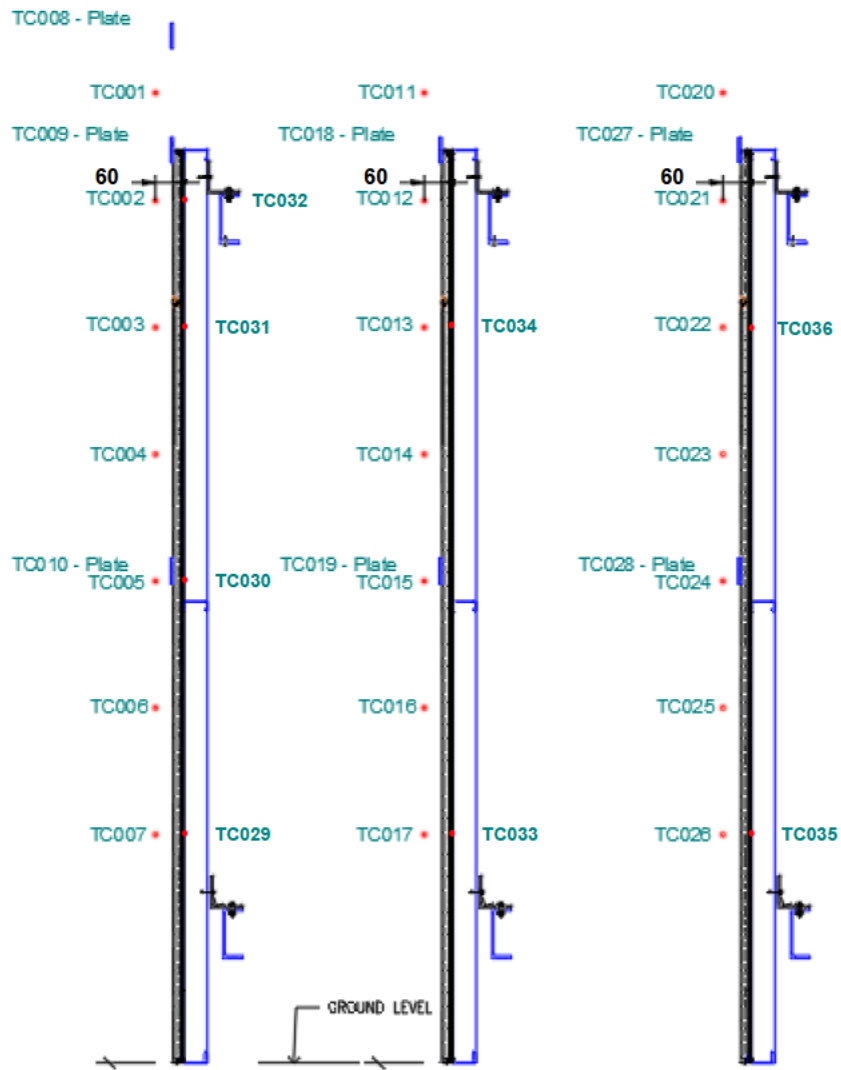
Figure 2 Instrumentation locations - sections

Item	Description
Installation method	
Test rig	The test rig frame was the main support for the test specimen. The test specimen, interconnected through studs and noggings, was fixed to the test ring using curtain wall brackets (item 8) and fixings (item 10) – see Figure 1, 2 and 4.
Cassette wall	The cassetted wall was composed of plasterboard (item 2), top/base tracks (item 4), studs (item 5), noggings (item 6) and the diagonal supports, which were screw fix together using aluminium rivets (item 12). The FR plasterboard (item 2) were fixed to the studs using tek screws (item 11). The aluminium cassette angles (item 7) were fixed to the FR plasterboard (item 2) using tek screws (item 11).
Cladding	The exposed face of the specimen was clad with cassetted ACPs (item 1) that were fixed to aluminium cassette angles (item 7) using wafer head screws (item 10) at about 325 mm centres.

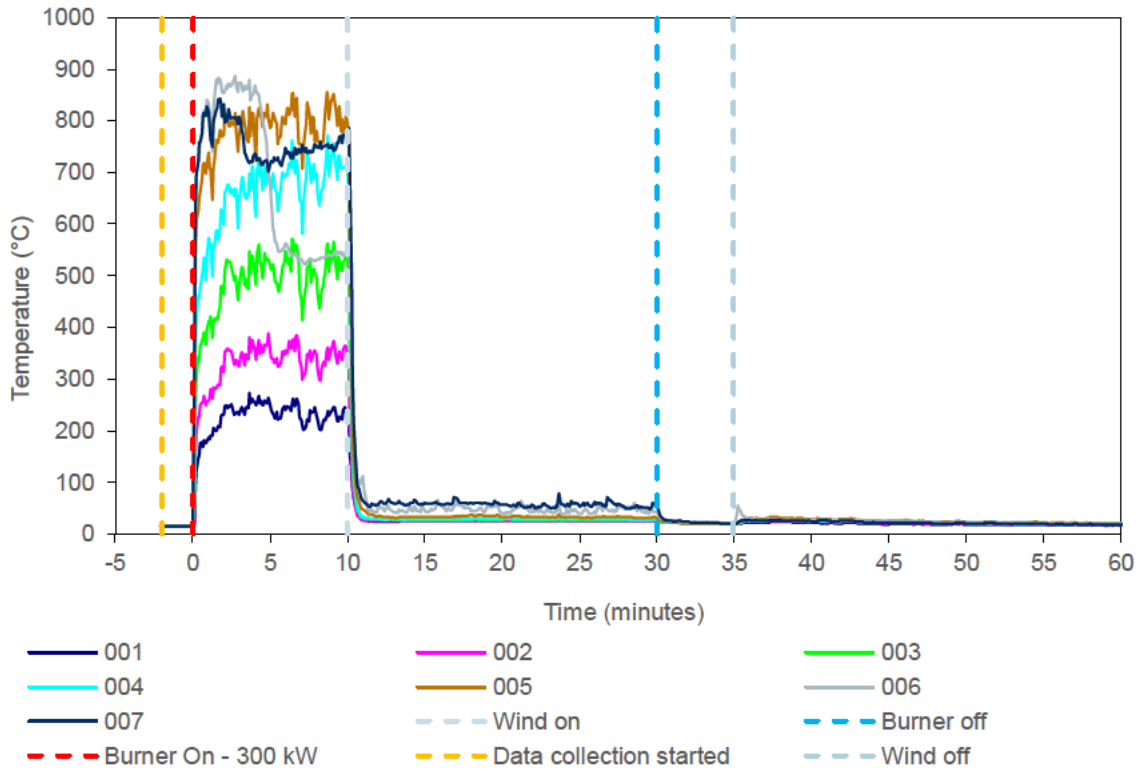
Figure 5 External temperature data collected by thermocouples placed 60 mm from the front face of the specimen – in-line with the burner

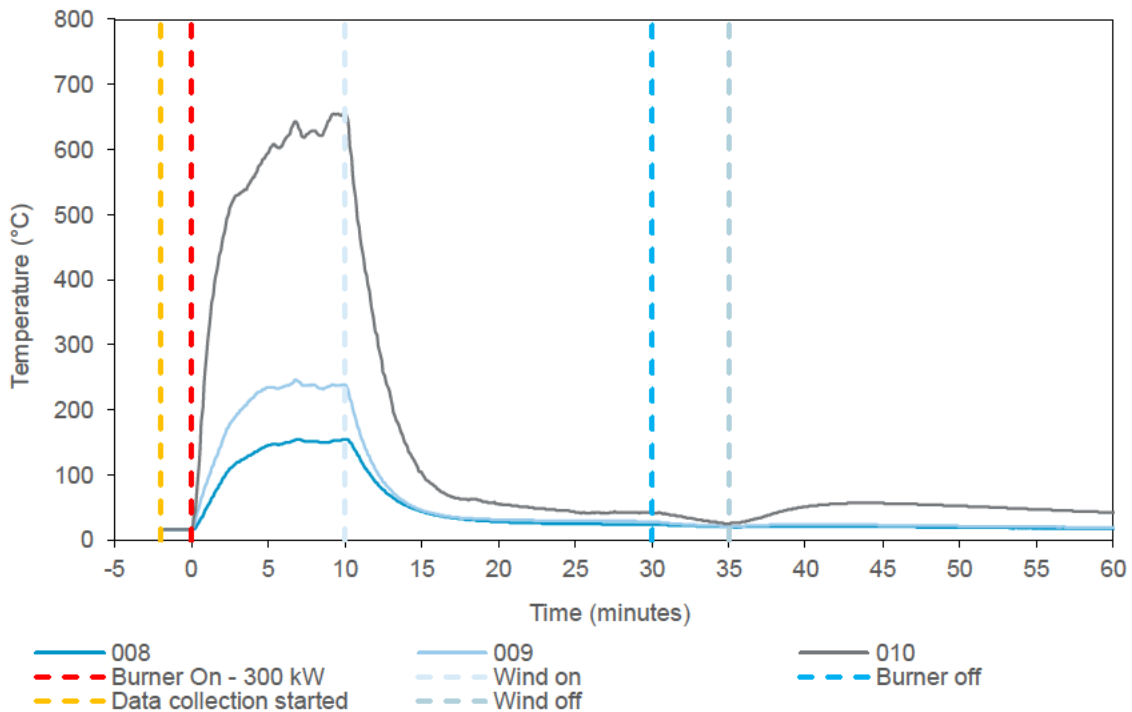
Figure 6 External temperature data collected by plate thermocouples in-line with ACP – in-line with the burner

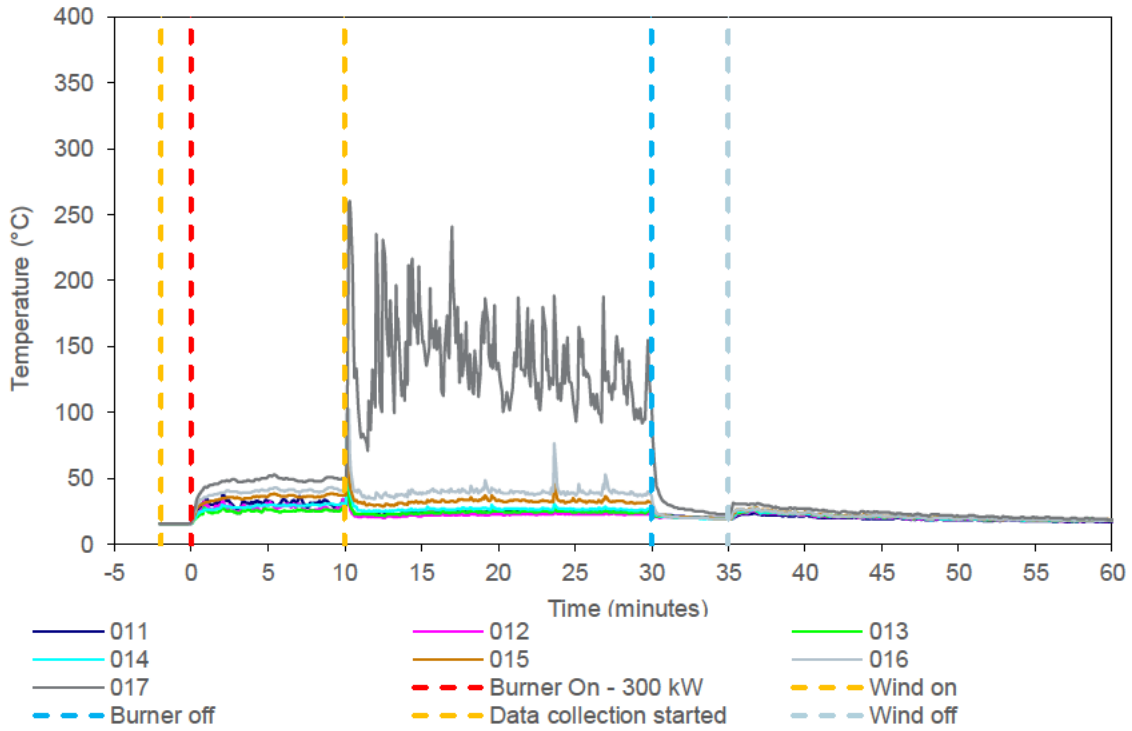
Figure 7 External temperature data collected by thermocouples placed 60 mm from the front face of the specimen – central module

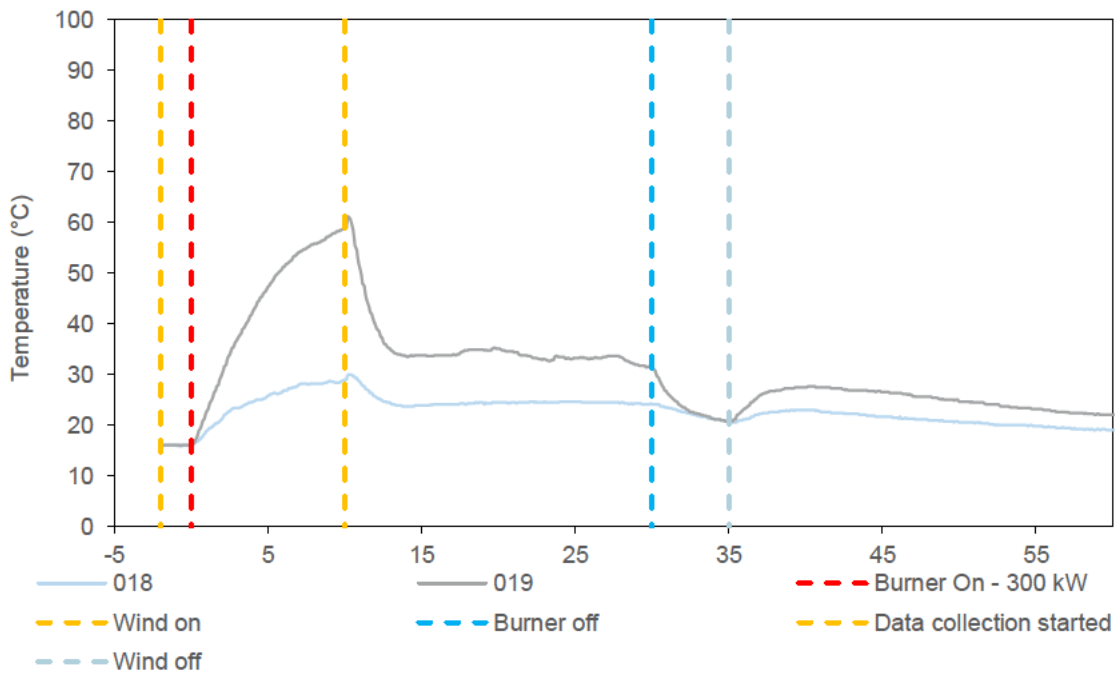
Figure 8 External temperature data collected by plate thermocouples in-line with ACP – central module

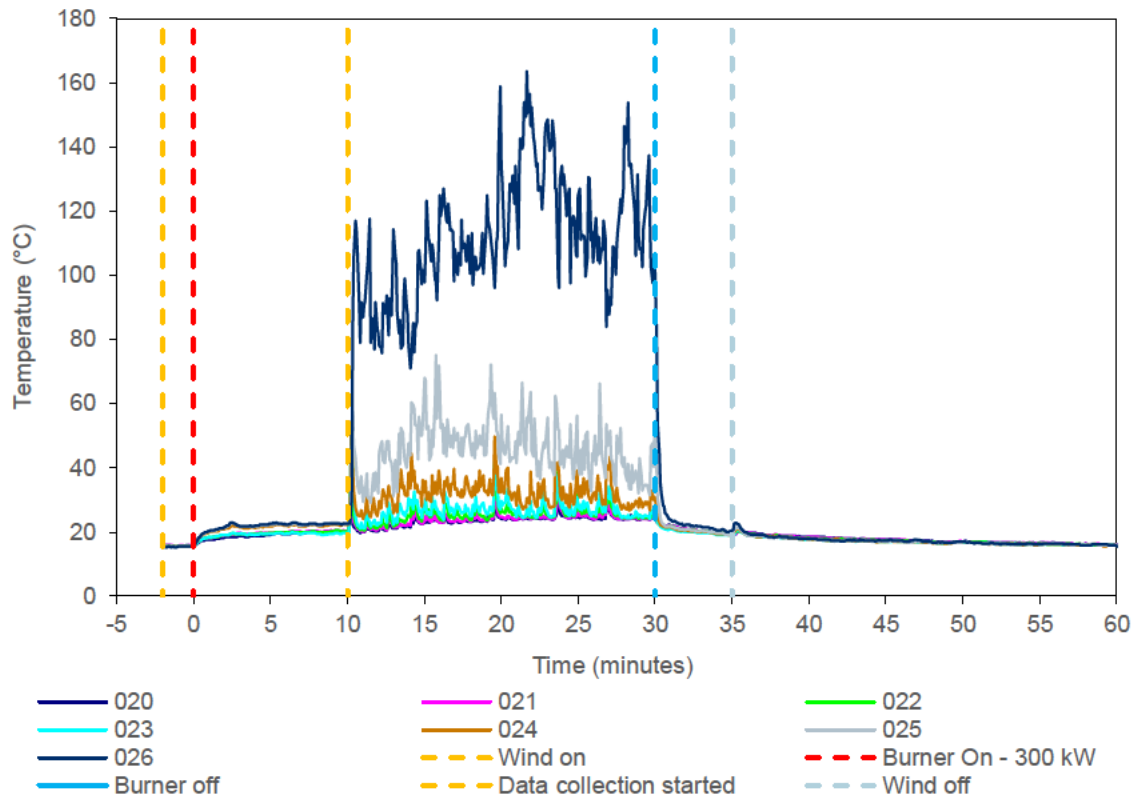
Figure 9 External temperature data collected by thermocouples placed 60 mm from the front face of the specimen – away from the burner

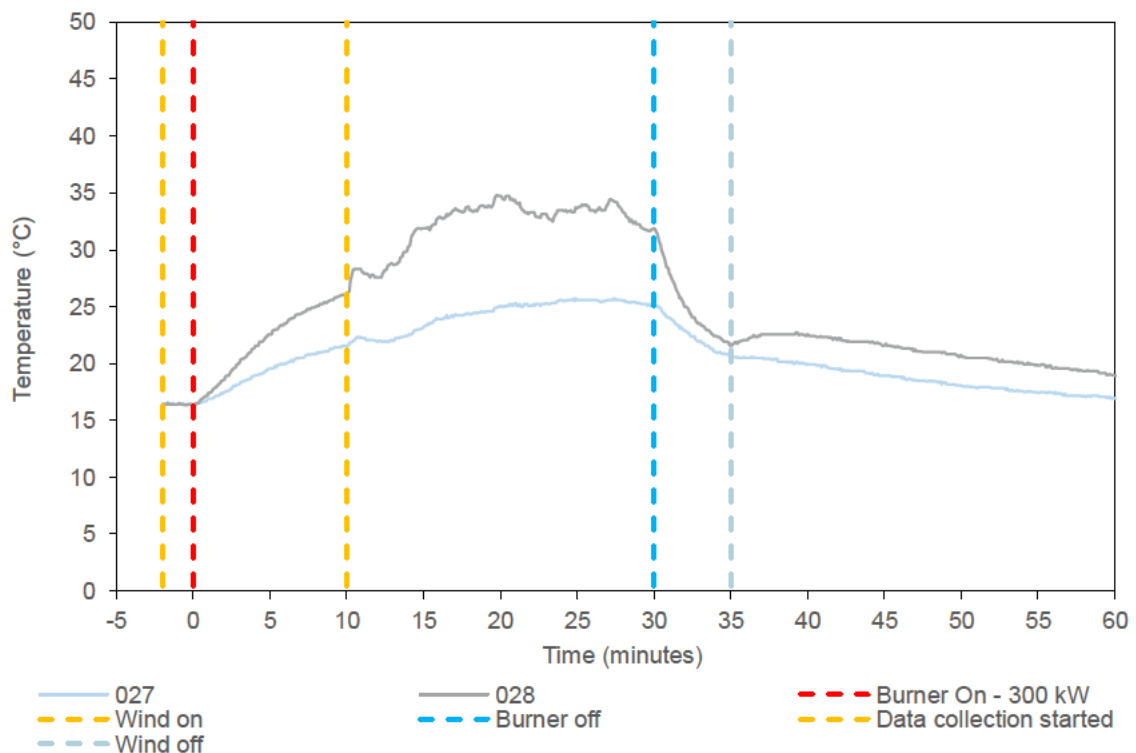
Figure 10 External temperature data collected by plate thermocouples in-line with ACP – away from the burner

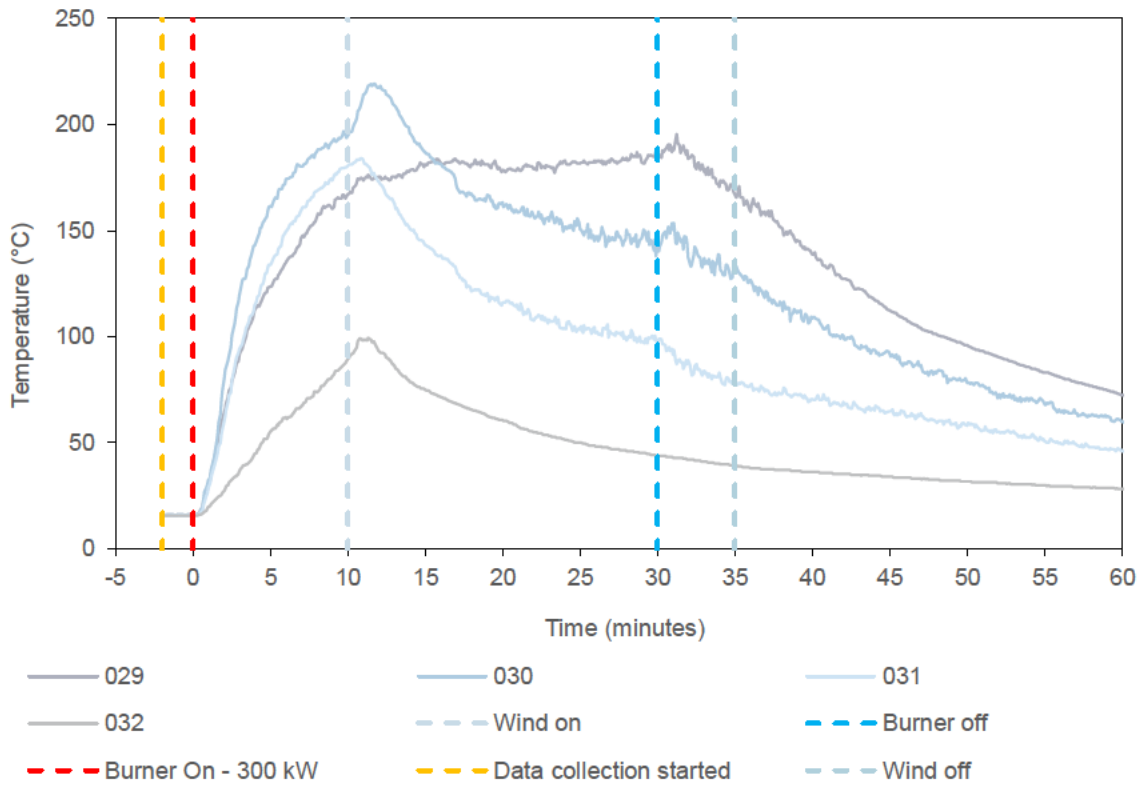
Figure 11 Internal temperature data collected by cavity thermocouples – in-line with the burner

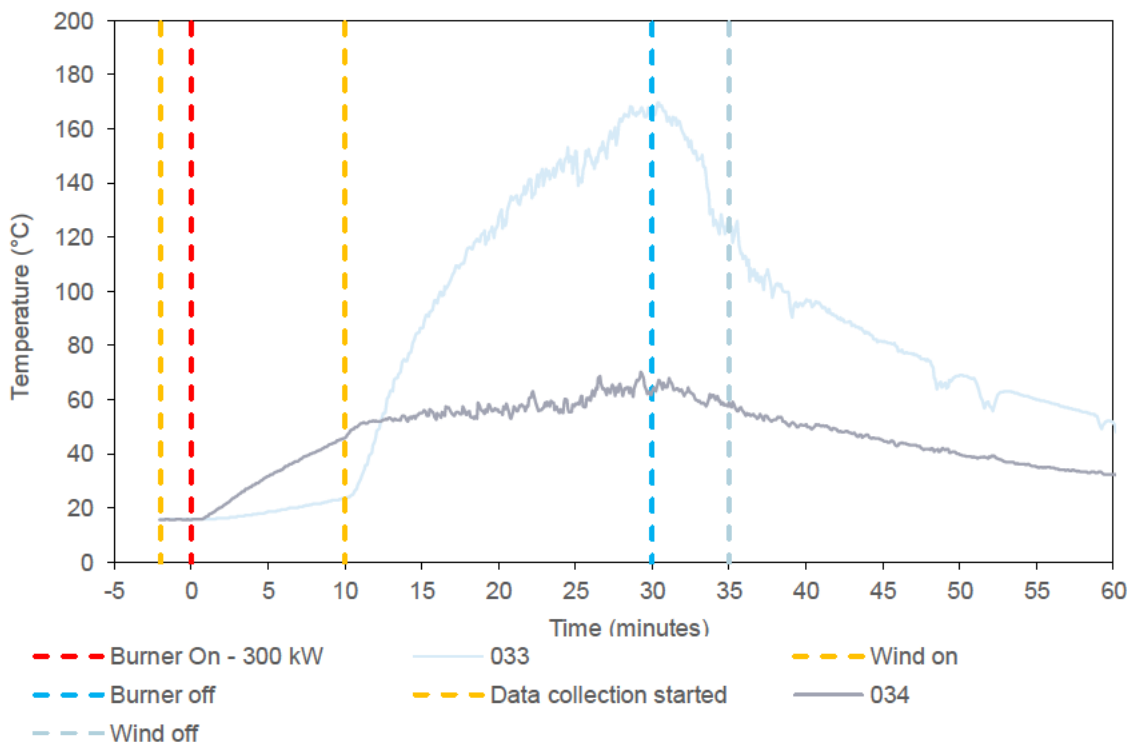
Figure 12 Internal temperature data collected by cavity thermocouples – central module

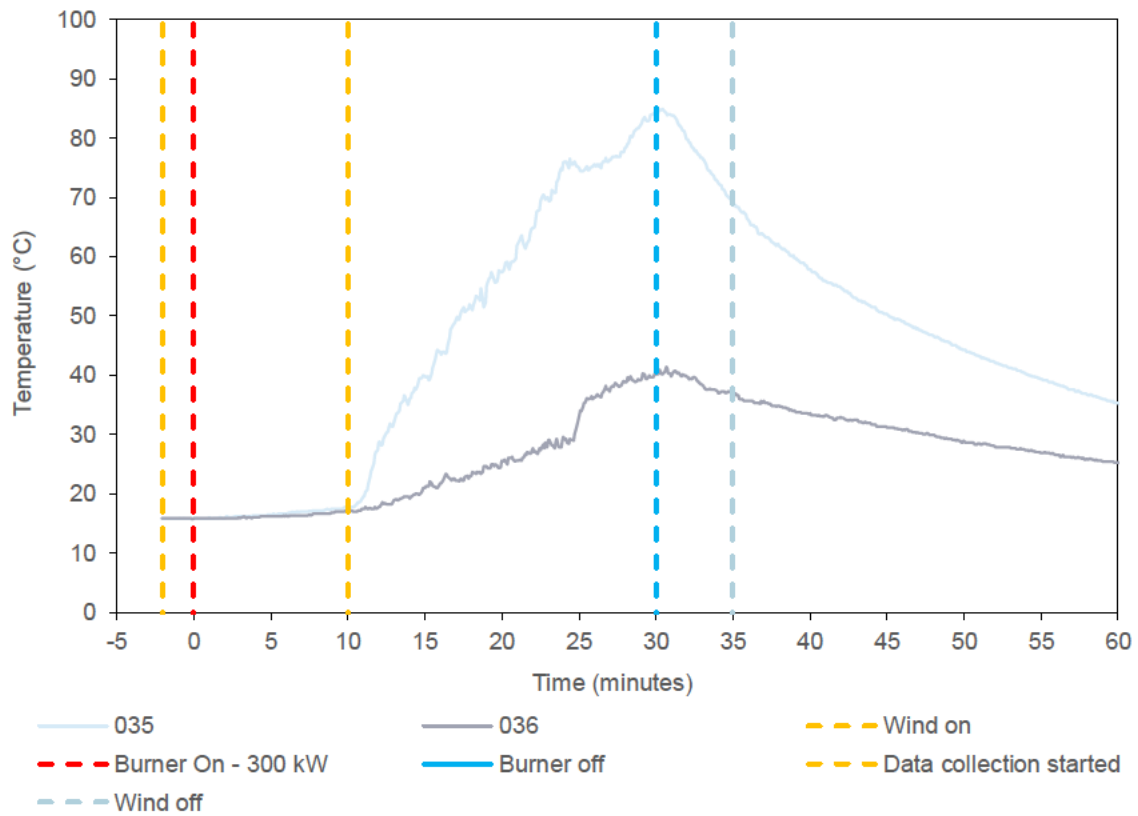
Figure 13 Internal temperature data collected by cavity thermocouples – away from the burner

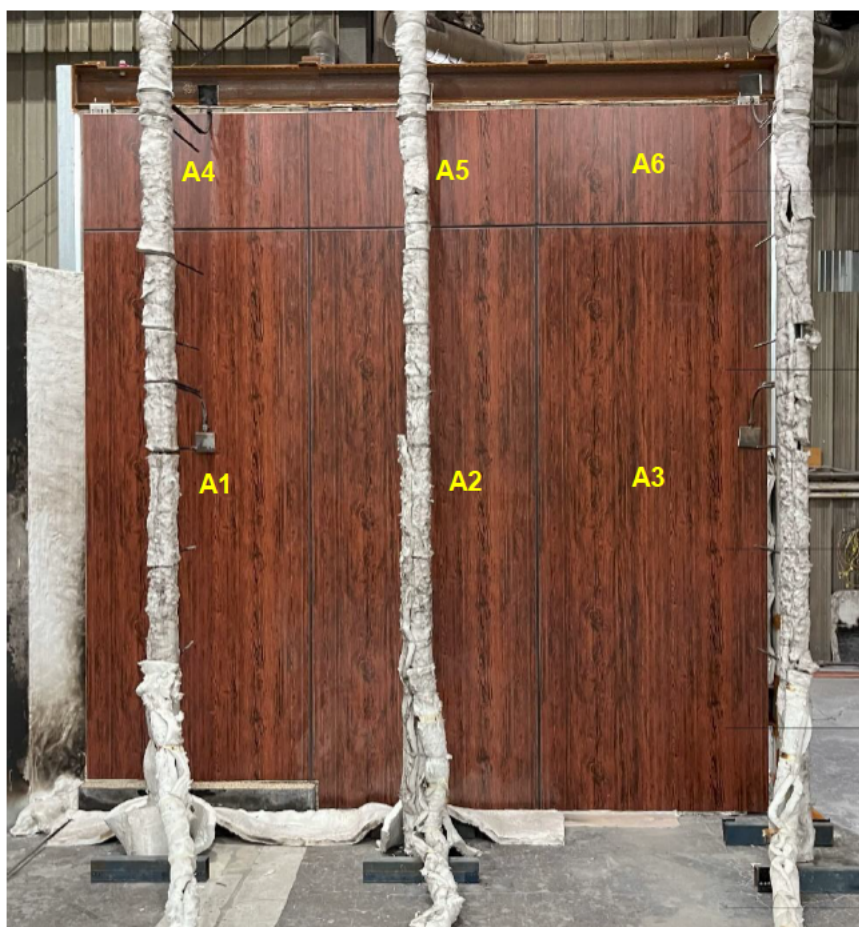
Figure 14 Designation of section for the test observation

Table 4 shows the observations of any significant behaviour of the specimen during the test. Figure 14 shows the panel designations sighted in the observations.

Time		Des.	Observation
Min	Sec		
Pre-test			Within an hour period prior to the test period and data collection the wind was turned on and wind measurements and steady state conditions were recorded.
		A1	The wind speed just below TC005 was 0.8 – 1.9 m/s.
		A2	The wind speed just below TC015 was 0.9 – 2.3 m/s.
		A3	The wind speed just below TC024 was 1.9 – 2.4 m/s.
-2	00	All	Data logger started. Fan is turned off.
0	00	All	Burner on 300 kW. Stopwatch was started 2 sec before burner is on.
1	26	A1	Paint at the lower part was burned off.
2	29	A1	More paint burned off mid part
3	27	A4	Smoke observed from the back.

Time		Des.	Observation
Min	Sec		
5	39	A4	The middle part of A4 appeared to deform.
9	39	A1	Panel appeared to open up at area below TC6.
10	00	All	Fans turned on.
10	37	A1/A2	Flaming observed at the lower joint between A1 and A2.
11	25	A2	The lower part paint was burned off.
13	46	A2	The lower part appeared to open up.
14	37	A1	Smoke emission observed from A1 between TC7 and TC5.
17	49	A2/A3	Flaming observed at the lower joint between A2 and A3.
18	41	A2	The opened up area reached to the lower right edge of A2.
19	56	A3	The area close to the lower left edge deformed and part of the paint was burned off.
22	14	A1	The lower right corner opened up.
30	00	All	Burner was turned off.
30	30	A2/A3	Flaming observed at the joint between A2 and A3 at the lower part.
32	41	All	No flaming observed.
35	00	All	Fans turned off.
60	00	All	Test ended.

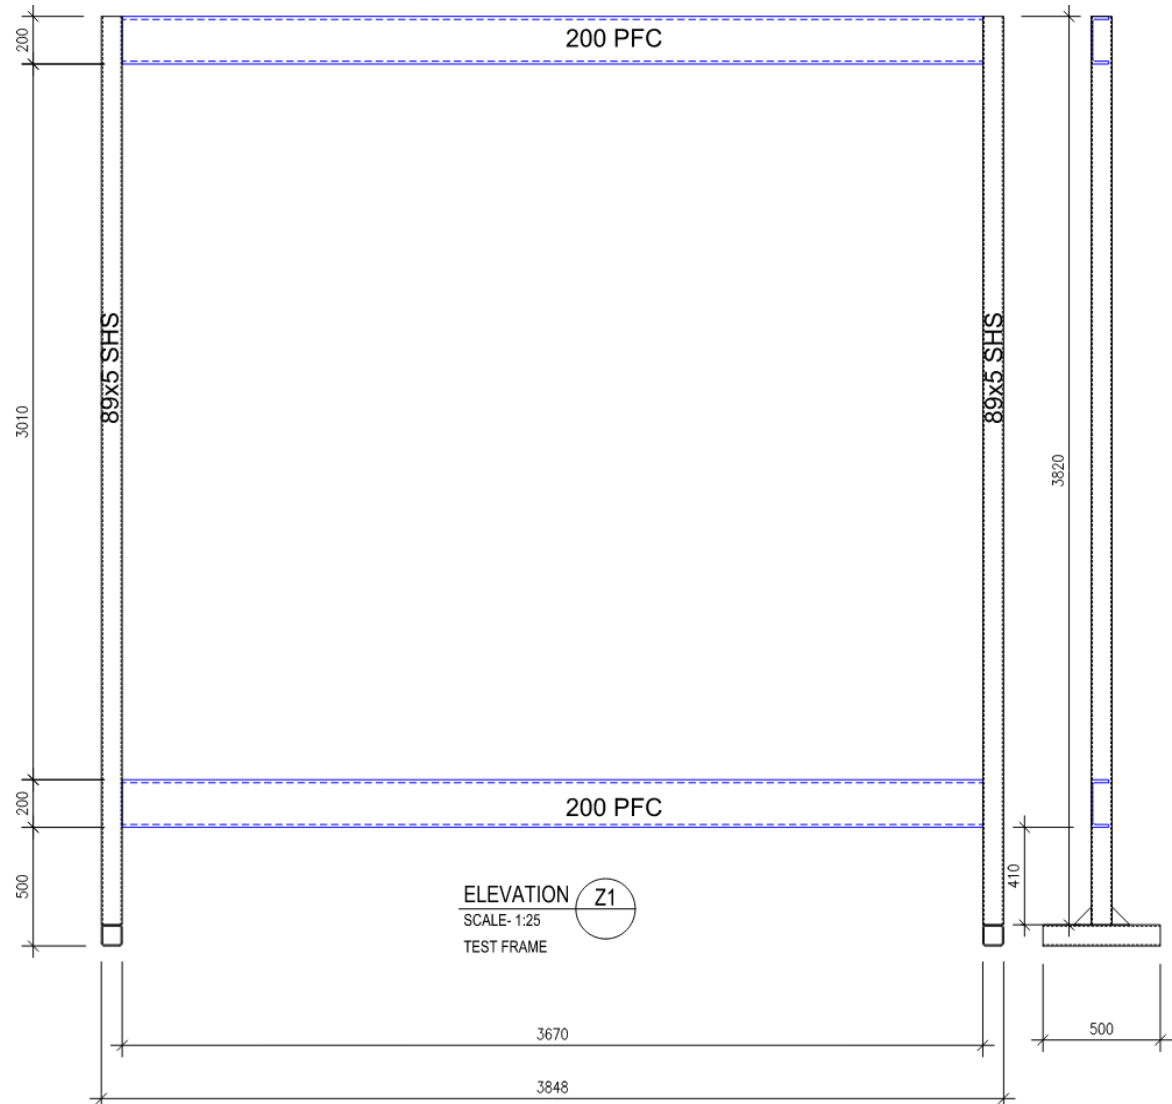
Figure 15 Elevation of rig support

The drawings of the test assembly in Figure 15 to Figure 18 were provided by the representatives of Warringtonfire. Dimensions, unless specified, are in mm. The Figure 17 was modified by Warringtonfire, where the locations of the Fixing Bracket and FR plasterboard were modified.

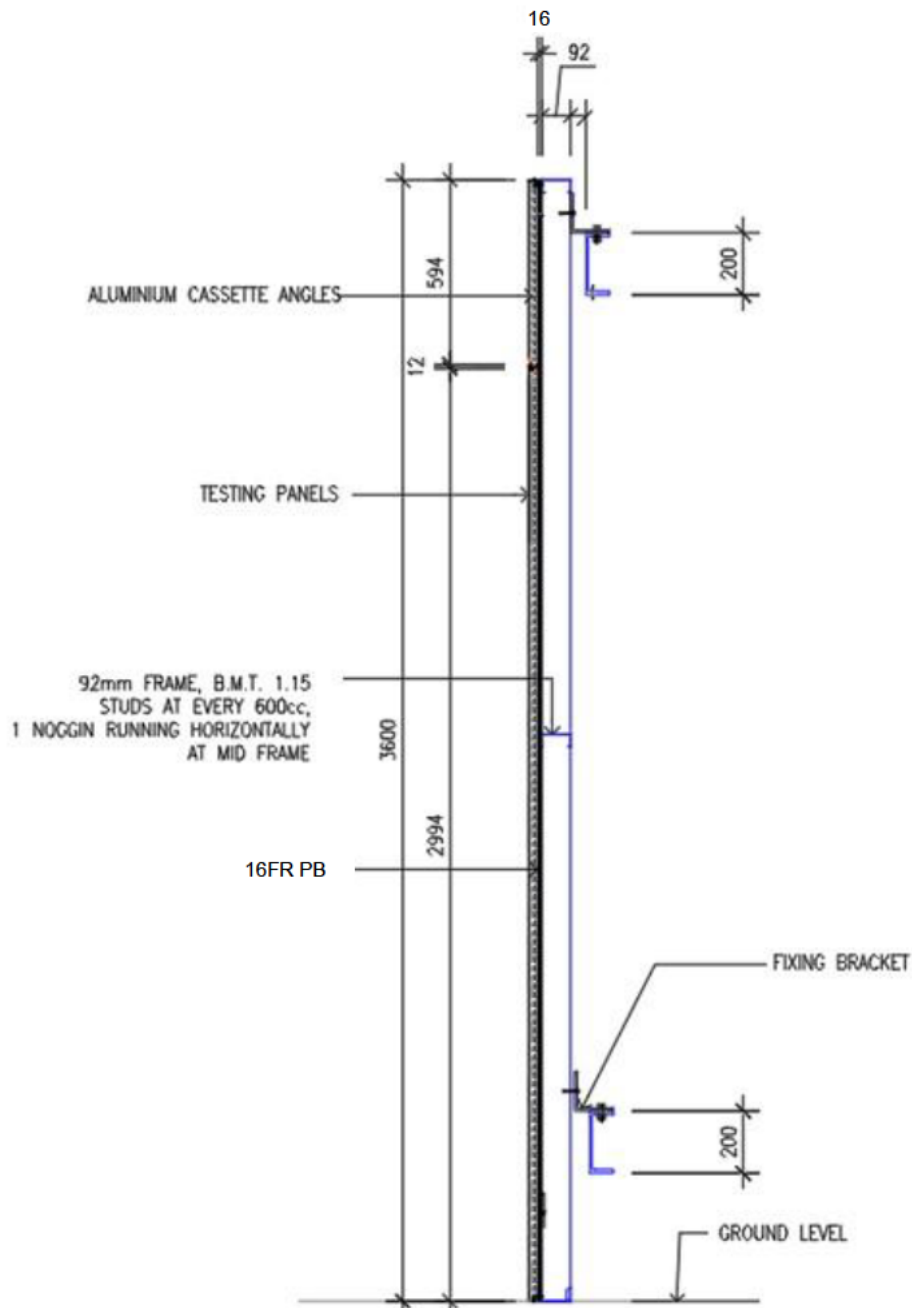
Figure 17 System assembly – vertical cross-sectional view

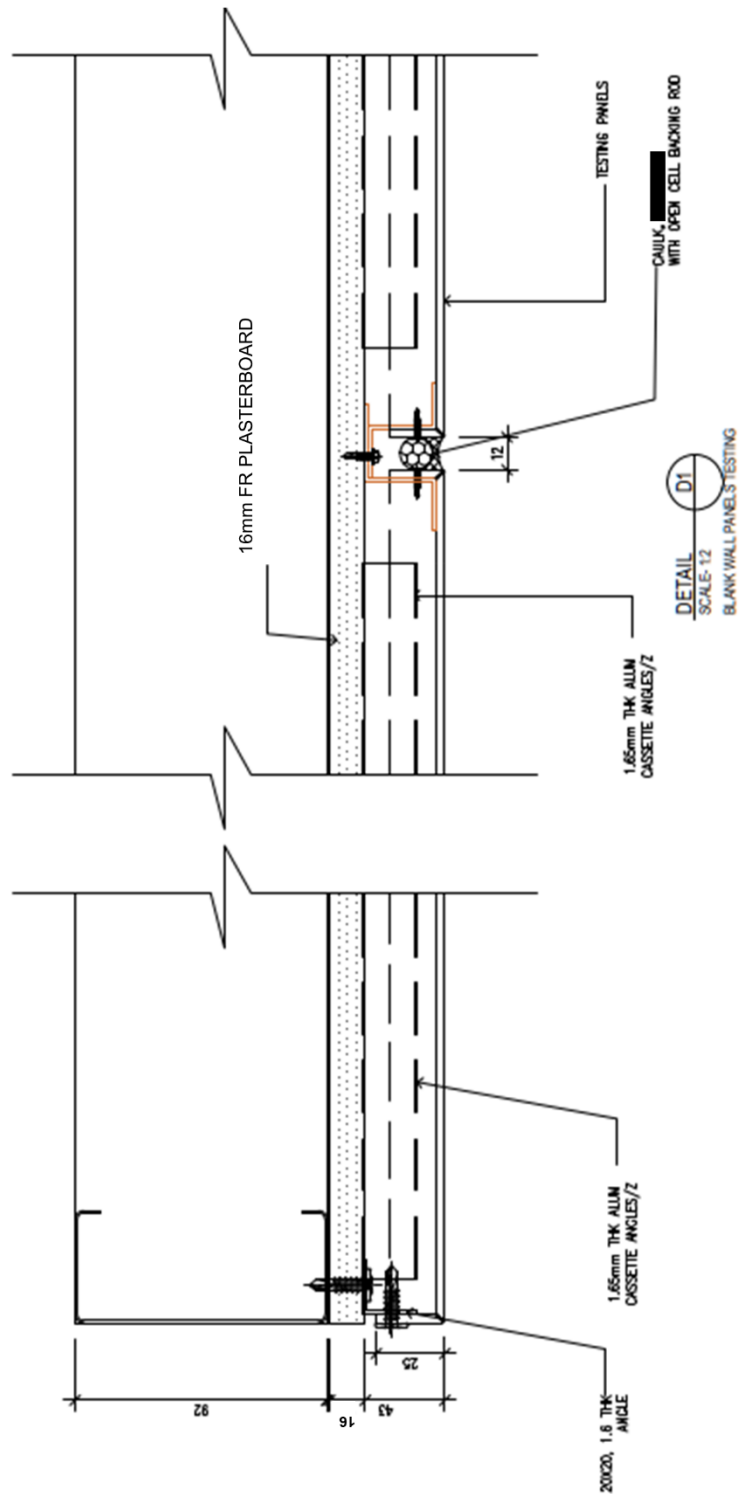
Figure 18 System assembly – vertical cross-sectional view

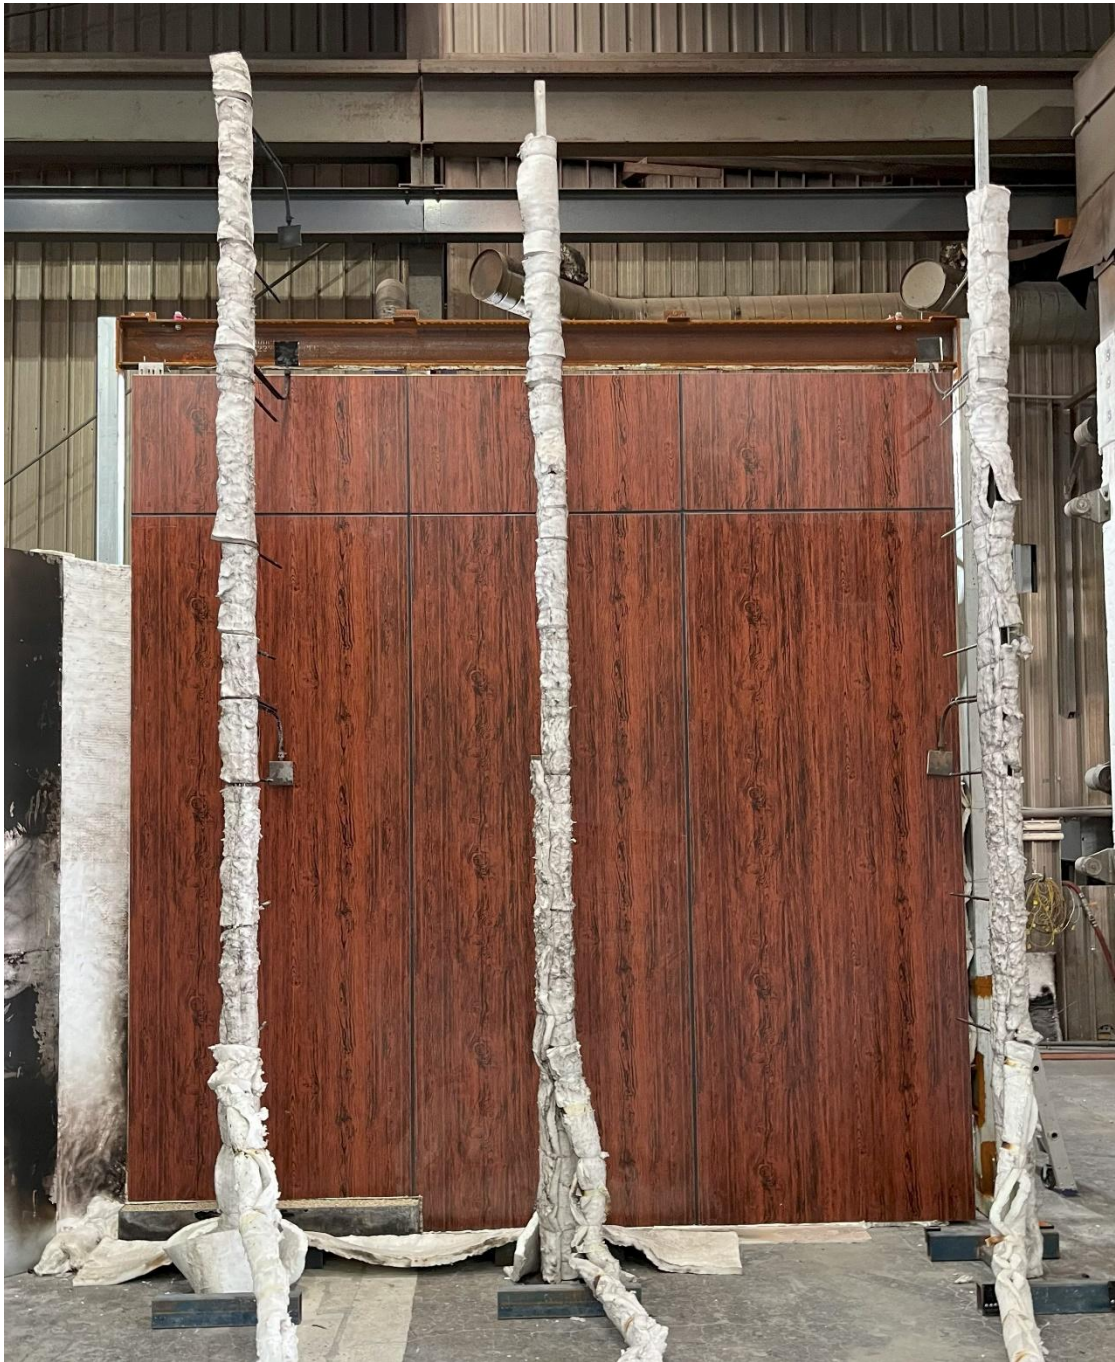
Figure 19 The specimen before the reaction to fire test – exposed side

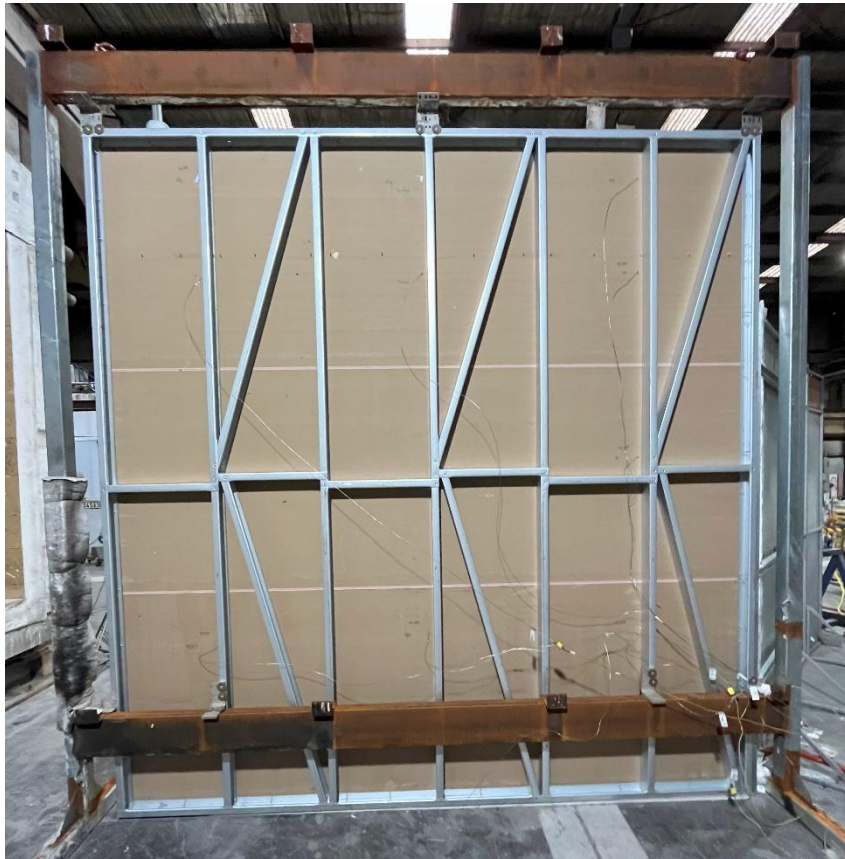
Figure 20 The specimen before the reaction to fire test - unexposed side

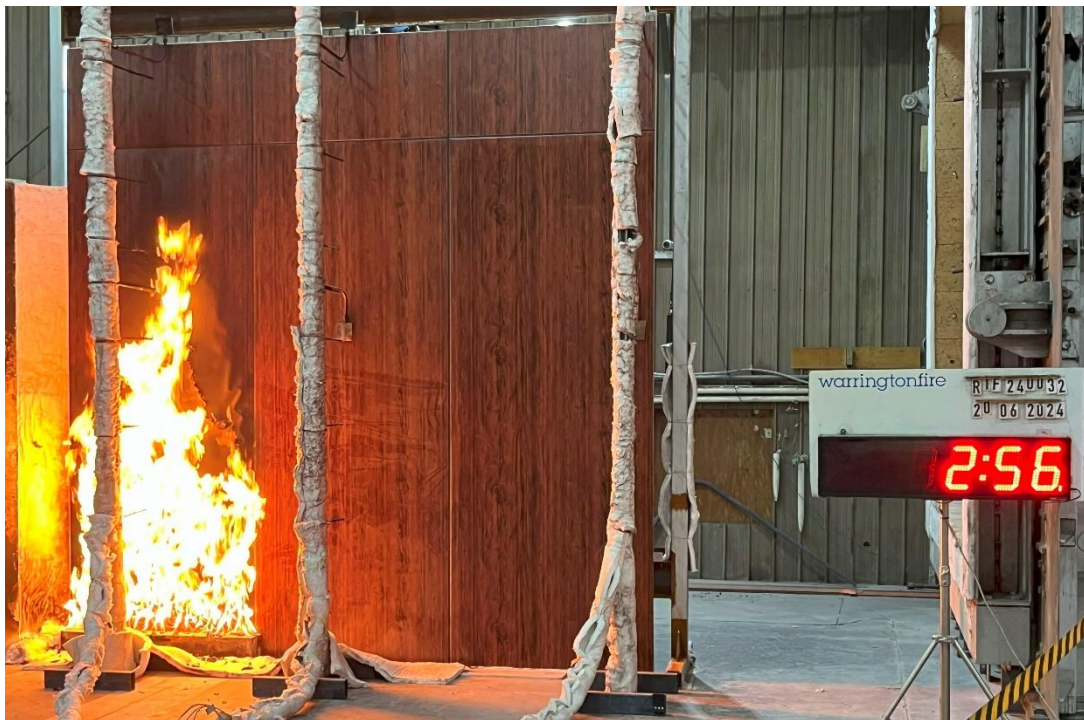
Figure 21 The specimen 2 minutes 56 seconds into the test (burner output at 300 kW)

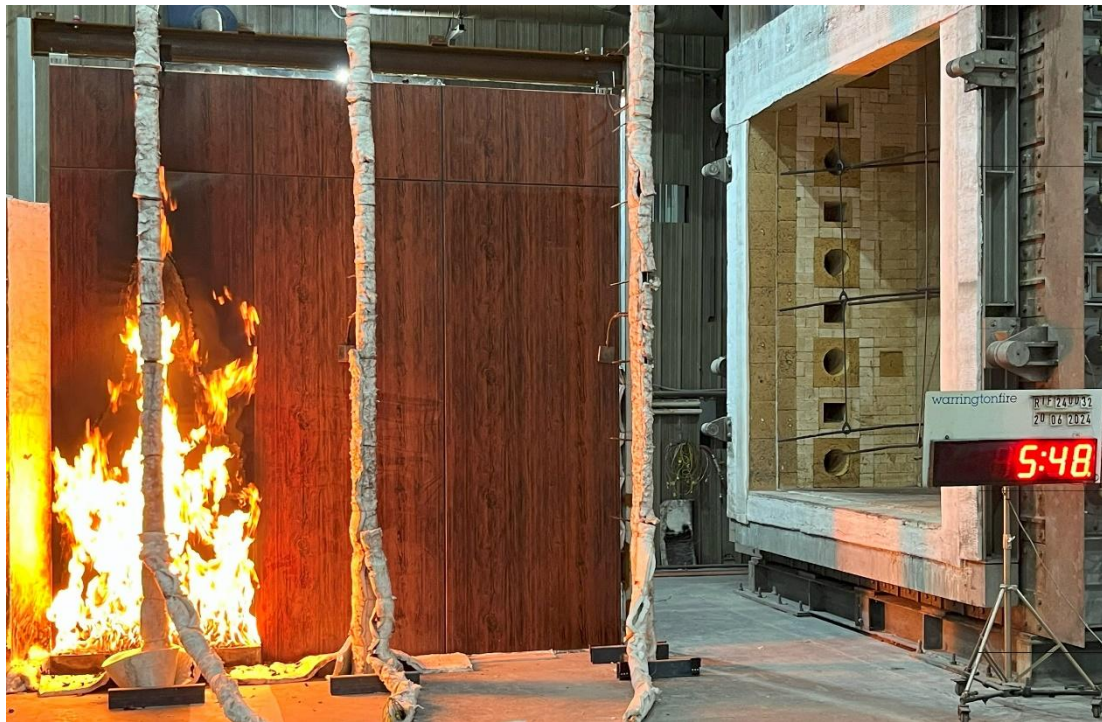
Figure 22 The specimen 5 minutes 48 seconds into the test (burner output at 300 kW)

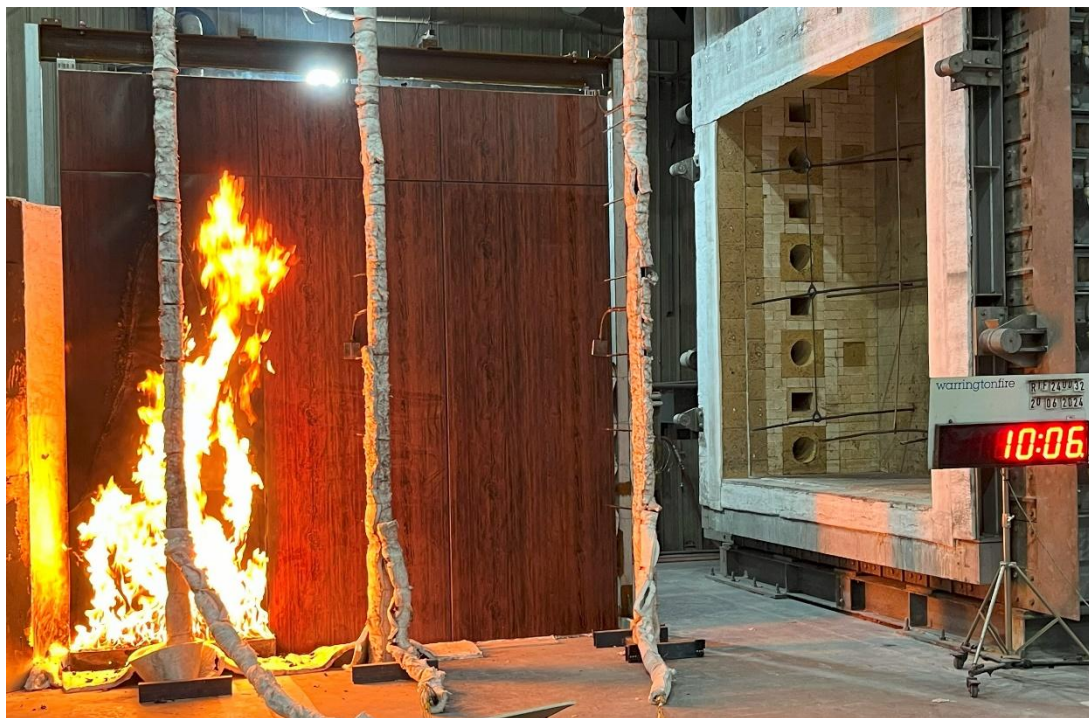
Figure 23 The specimen 10 minutes 6 seconds in the test (burner output at 300 kW)

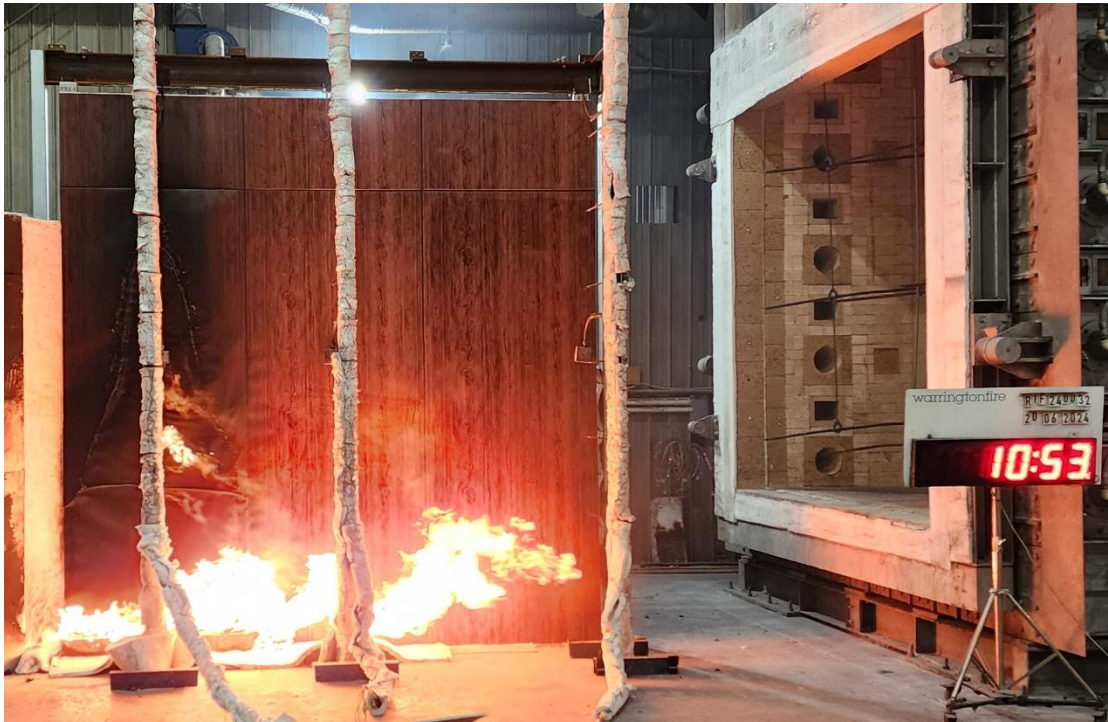
Figure 24 The specimen 10 minutes 53 seconds into the test (burner output at 300 kW)

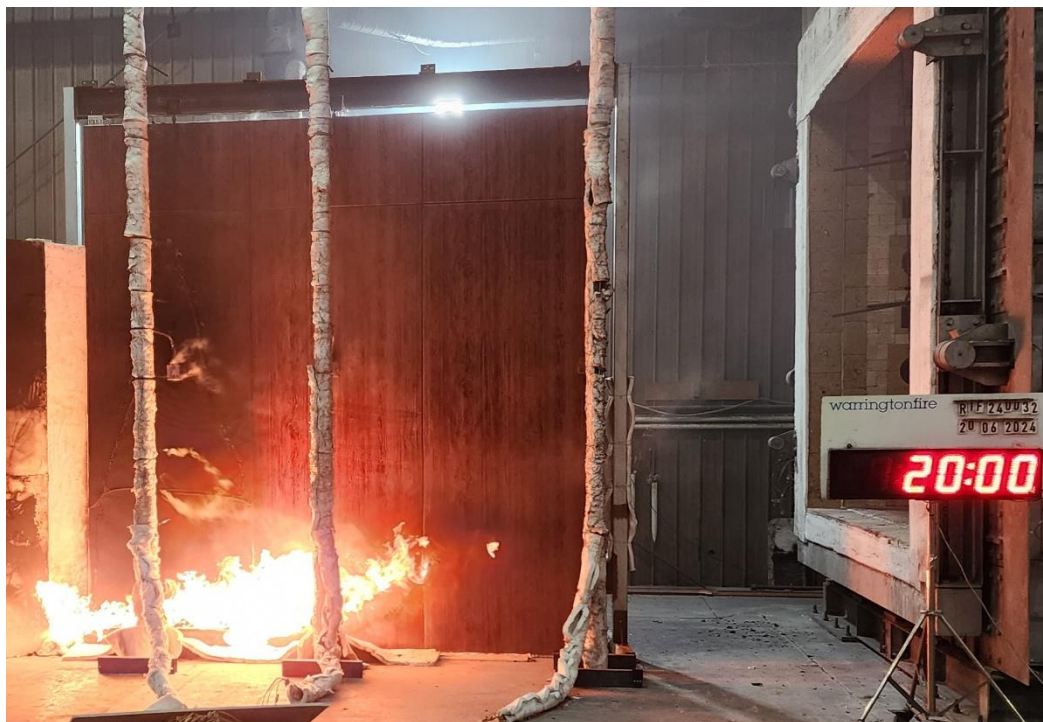
Figure 25 The specimen 20 minutes into the test (burner output at 300 kW)

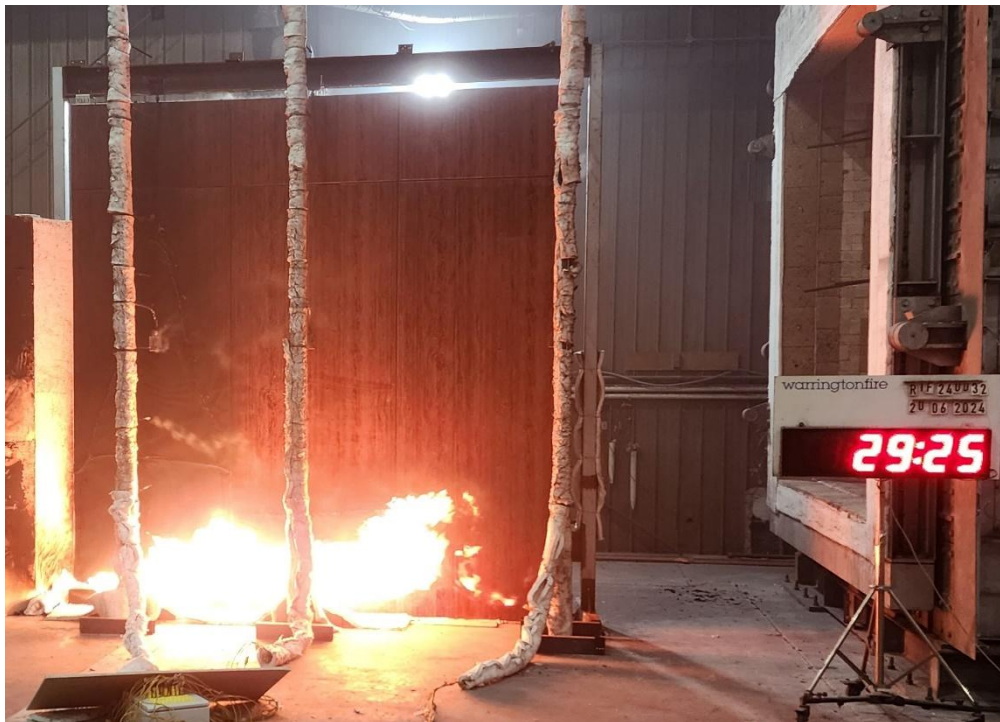
Figure 26 The specimen 29 minutes 25 seconds into the test (burner output at 300 kW)

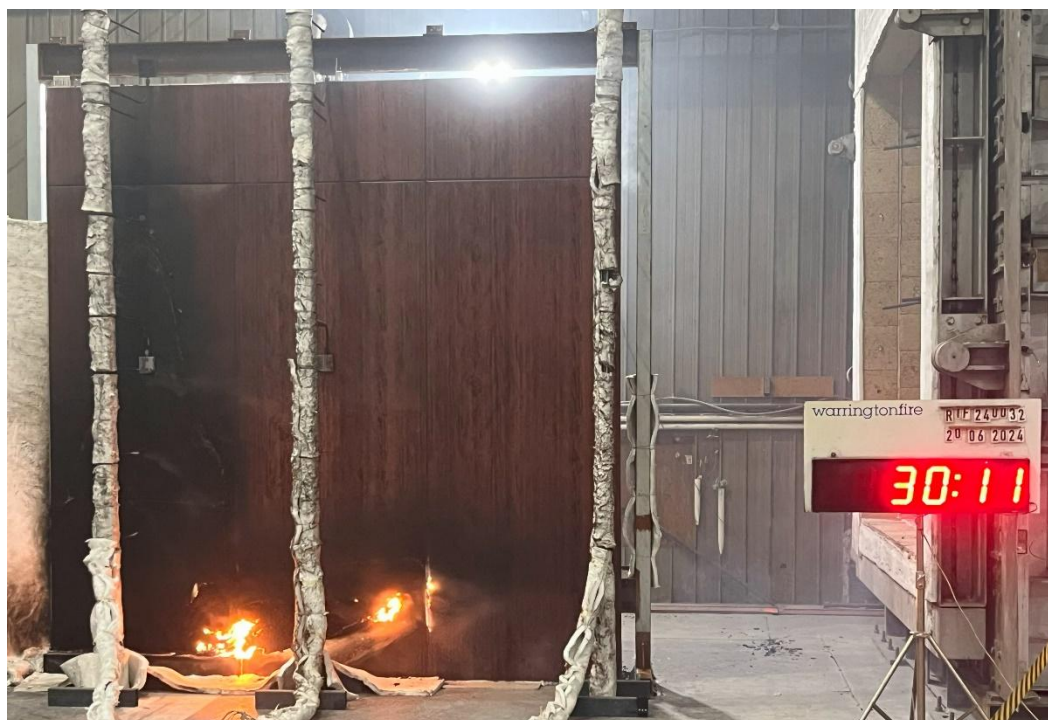
Figure 27 The specimen 30 minutes 11 seconds into the test (11 seconds after burner off)

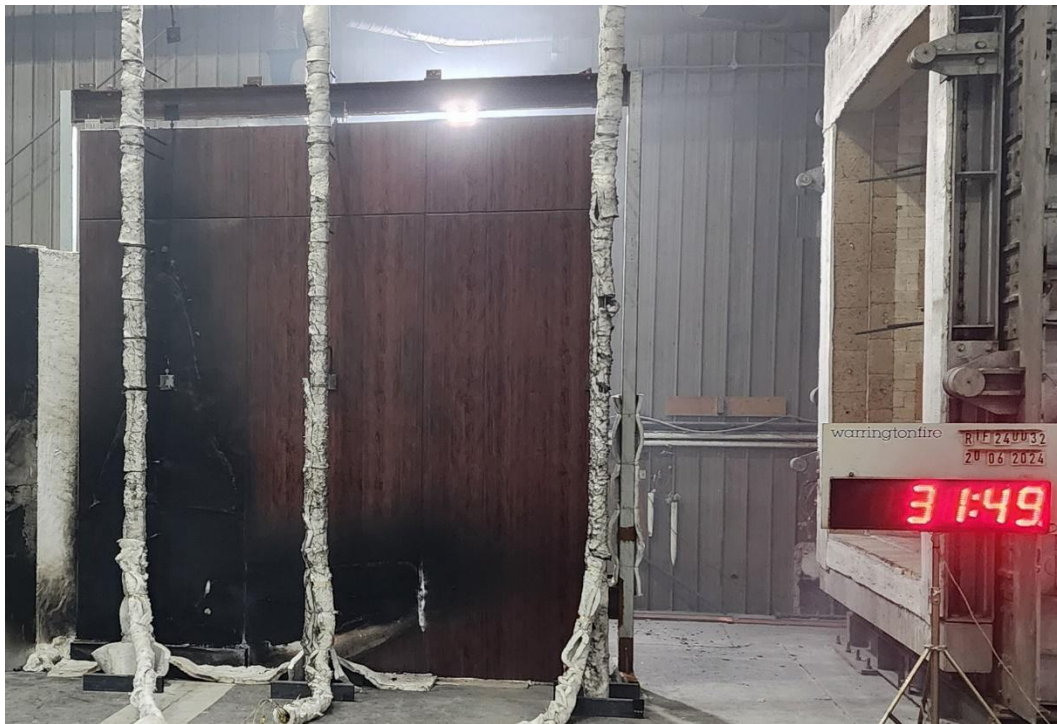
Figure 28 The specimen 31 minutes 49 seconds into the test (1 minutes 49 seconds after burner off)
