Reaction to fire test report

Test standard: Ad hoc ISO 13785-1:2002 Part 1 – Intermediate-scale

System: Cassetted aluminium composite panel (ACP) – with a 45% PE core – wall system

Job number: RTF240032

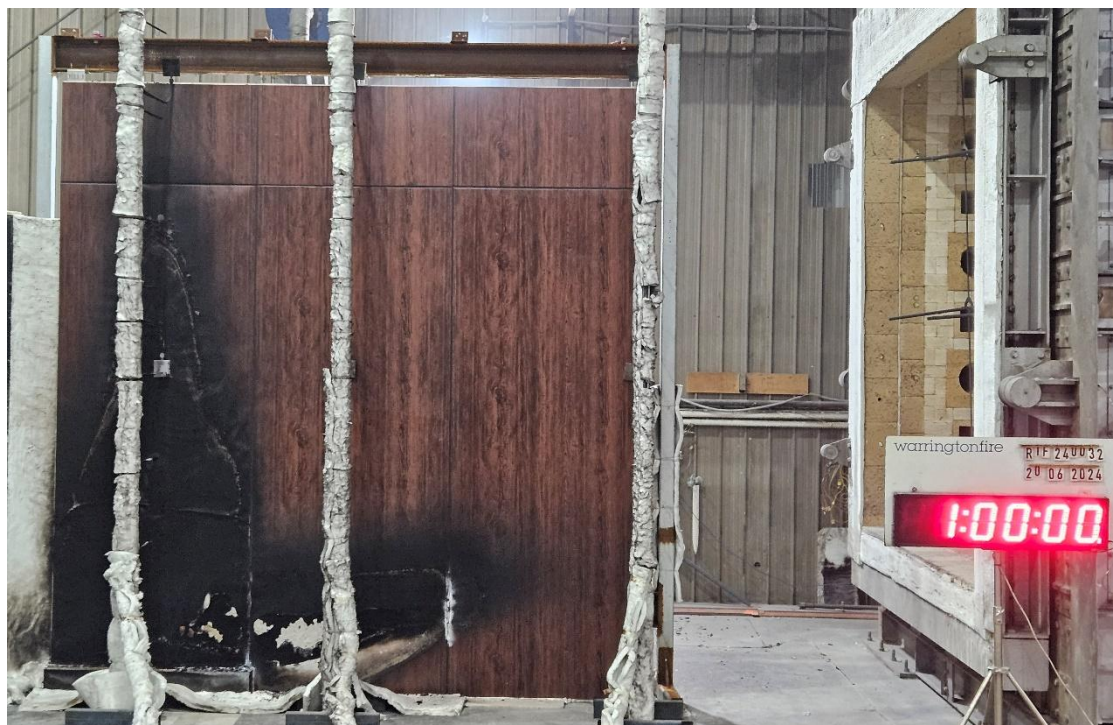
Figure 29 The specimen 60 minutes into the test (30 minutes after burner off)

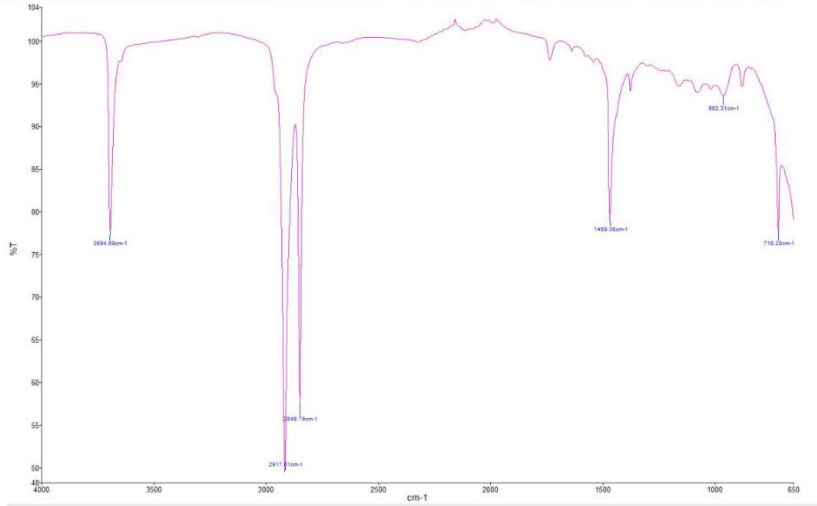
Figure 1. FT-IR spectrum of Sample #1

The aluminium metal was removed from the ACPs cladding polymer, and the flat surface of the polymer samples was abraded to remove any surface adhesive. The surface of each sample was analysed directly by FTIR. The FT-IR spectrum is presented in Figures 1-2.

The cladding sample #1 consisted of consisted of 45.3% magnesium hydroxide, 6.1% calcium carbonate, 4.8% other inert material and approximately 43.9% polyethylene/EVA copolymer.

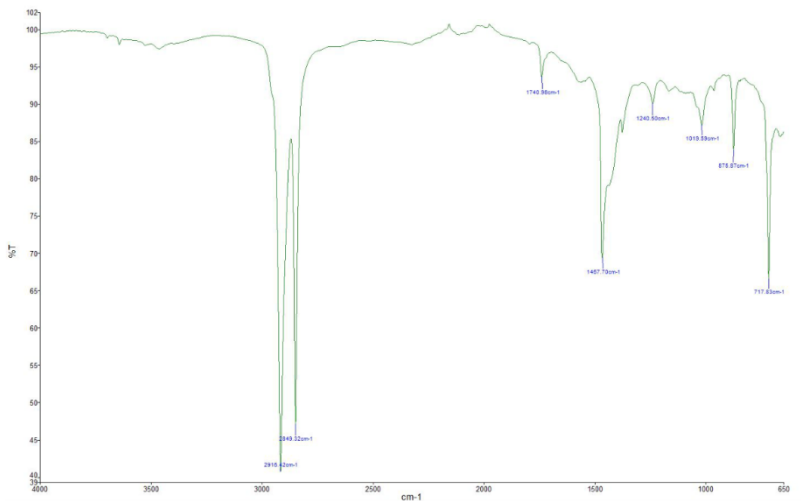
Figure 2. FT-IR spectrum of sample #2

The cladding sample#2 consisted of consisted of 21.6% inert material and approximately 78.4% polyethylene/EVA copolymer.
