Reaction to fire test report

Test standard: Ad-hoc test based on ISO 13785-1:2002

System: ACP with 45 % polyethylene core external façade cladding system

Job number: RTF240050

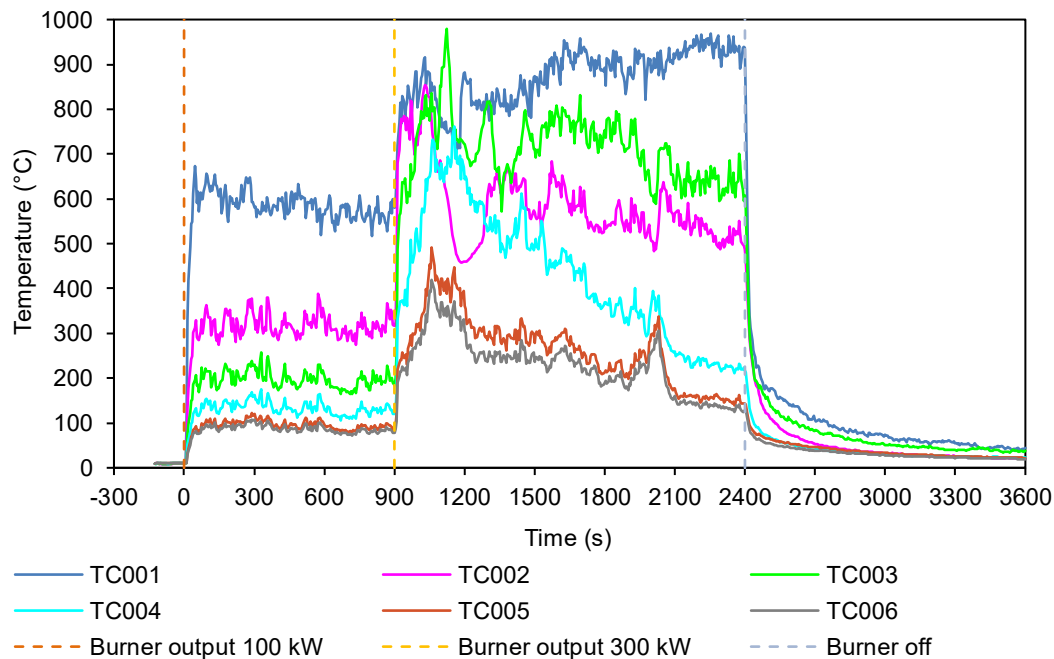
Figure 1 50 mm from the exposed face – Temperature vs time

Test duration	60 minutes	
Instrumentation and equipment	<ul style="list-style-type: none"> 6 mineral insulated metal sheathed (MIMS) Type K thermocouples with an overall diameter of 1.5 mm with the measuring junction insulated from the sheath were positioned at various heights, 50 mm in front of the outer face of the test specimen along its vertical centreline. Refer to Figure 13 and Figure 14 in Appendix C for details on positioning. 3 MIMS Type K thermocouples with an overall diameter of 1.5 mm with the measuring junction insulated from the sheath were positioned at various heights at mid-depth of the framing cavity of the test specimen. Refer to Figure 13 and Figure 14 in Appendix C for details on positioning. The fire source was a propane (95 % purity) gas fuelled box burner; 1.2 m wide × 0.1 m deep × 0.15 m tall. The burner was located on the floor in front of the specimen, with the back edge of the burner in line with the exposed face of the specimen. The incident heat flux 50 mm above and in line with the exposed face of the test specimen was measured using a Schmidt-Boelter type heat flux gauge with a range of 0 - 50 kW/m². The products of combustion were collected in an exhaust hood located centrally above the exposed face of the tested specimen. The hood was connected to an exhaust duct 400 mm in diameter, which had instruments inside to measure the conditions and properties of the combustion products during the test. The hood had specifications based on those given in AS ISO 9705:2003 (R2016), with the only differences being that all four sides had 1 m blanking sheet extensions, and there was no fire test room. The volume flow rate was determined using a bidirectional pressure probe attached to a differential pressure transmitter together with a type K MIMS thermocouple positioned near the probe. Smoke obscuration measurements were made using a helium-neon laser smoke photometer, as outlined in Annex H of ISO 9705-1:2016. The temperature of the exhaust stream near the light beam was measured using a type K MIMS thermocouple.

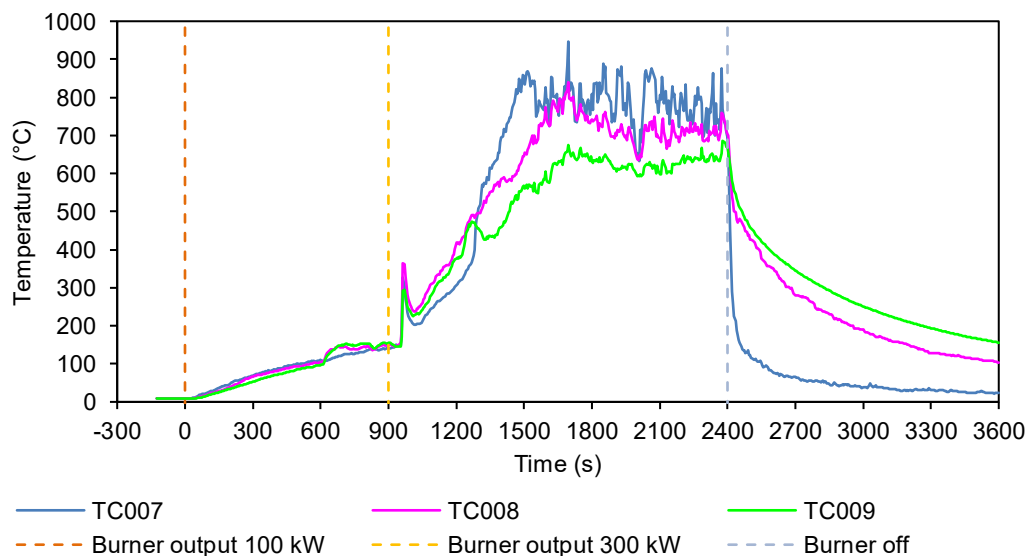
Figure 2 Cavity – Temperature vs time

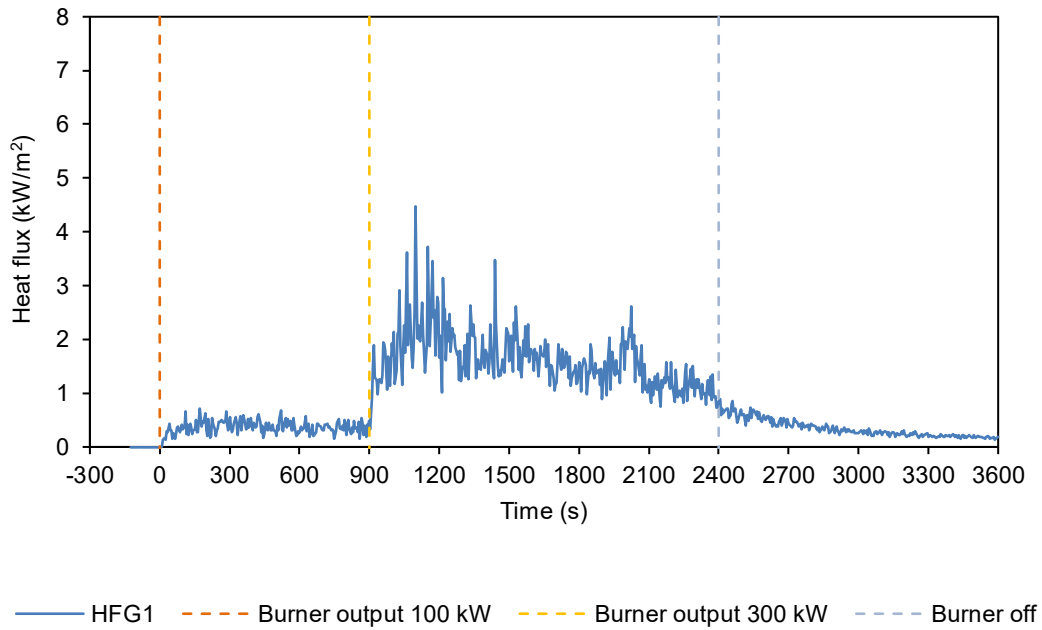
Figure 3 Heat flux vs time

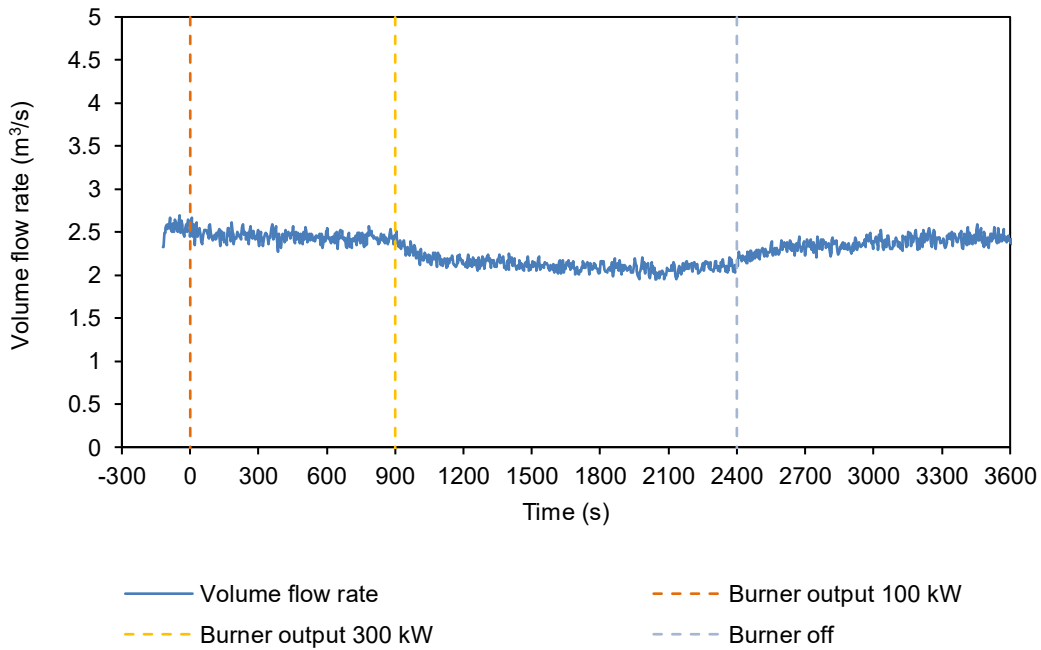
Figure 4 Volume flow rate in duct vs time

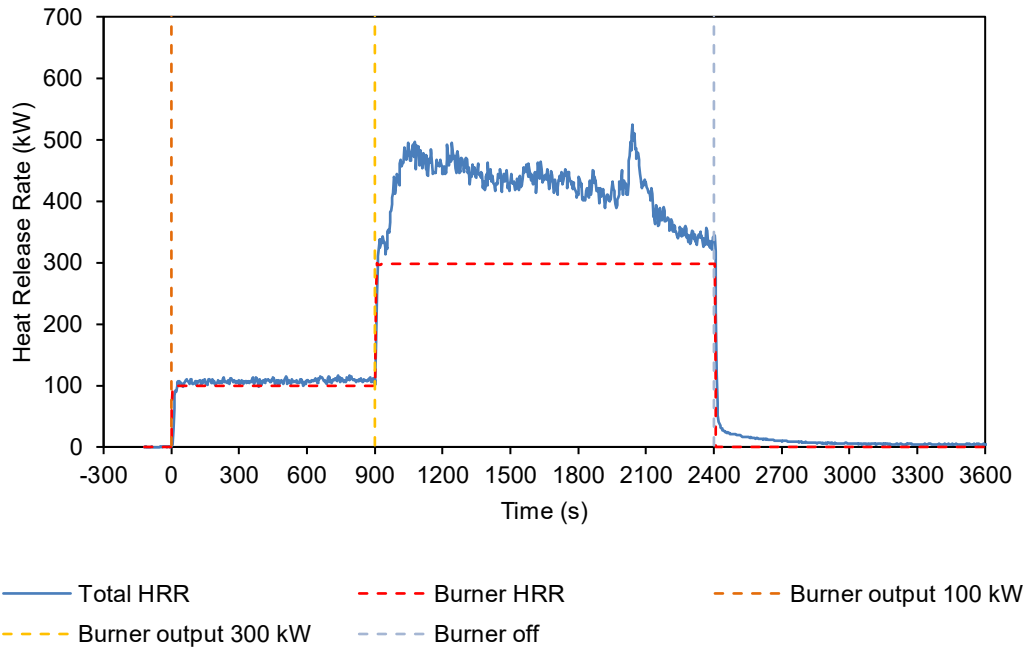
Figure 5 Heat release rate (HRR) of specimen and burner vs time

Test procedure	<ul style="list-style-type: none"> At least 2 minutes of baseline data was collected prior to burner ignition. Temperature and heat flux data was collected at 5 s intervals, while the combustion products sampling data was collected at 3 s intervals. The heat output from the burner was held at 100 kW for 15 minutes, then 300 kW for the following 25 minutes. The burner was then turned off and data was recorded for the following 20 minutes.

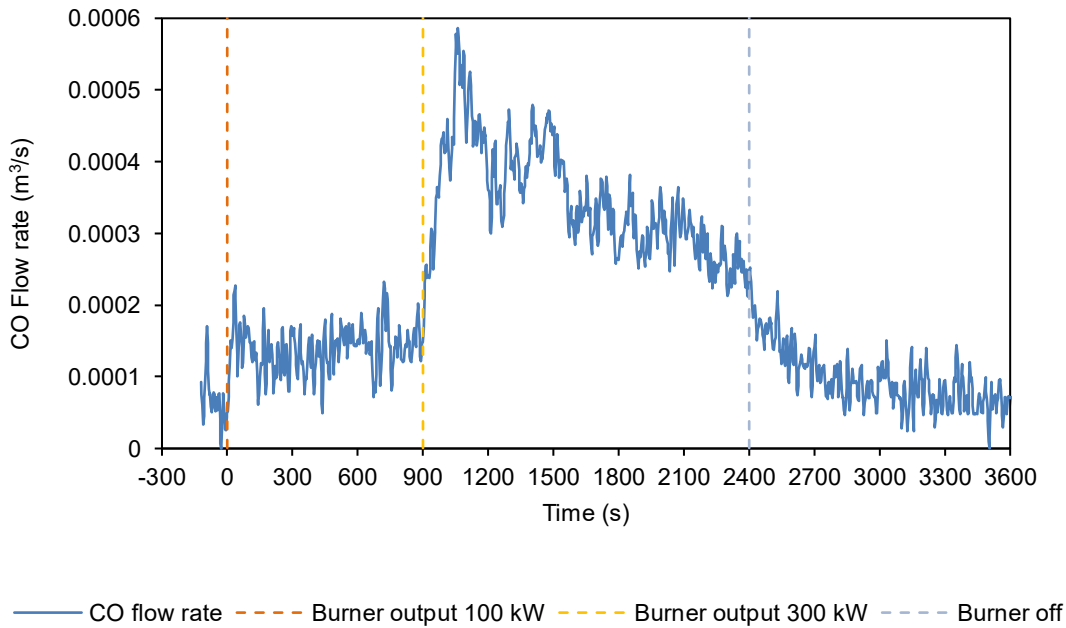
Figure 6 Production of carbon monoxide vs time, at reference temperature and pressure

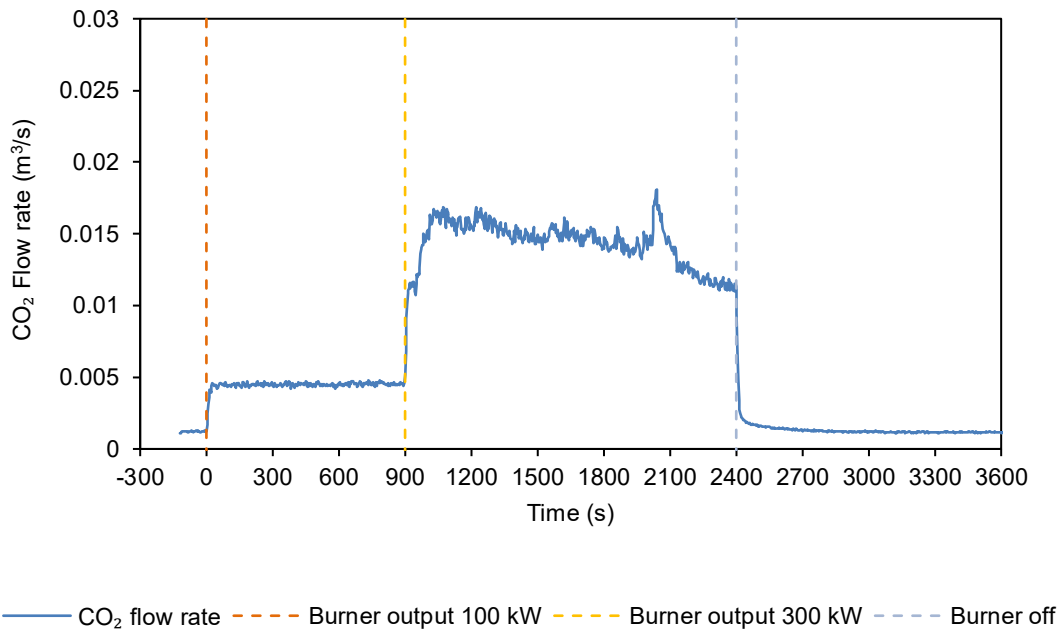
Figure 7 Production of carbon dioxide vs time, at reference temperature and pressure

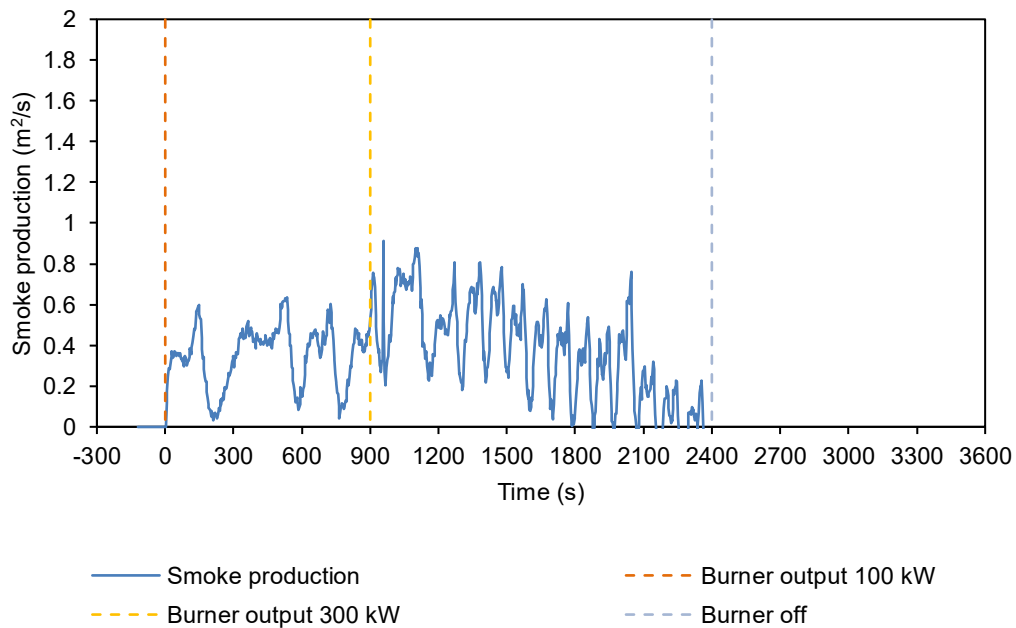
Figure 8 Production of light obscuring smoke vs time, at reference temperature and pressure

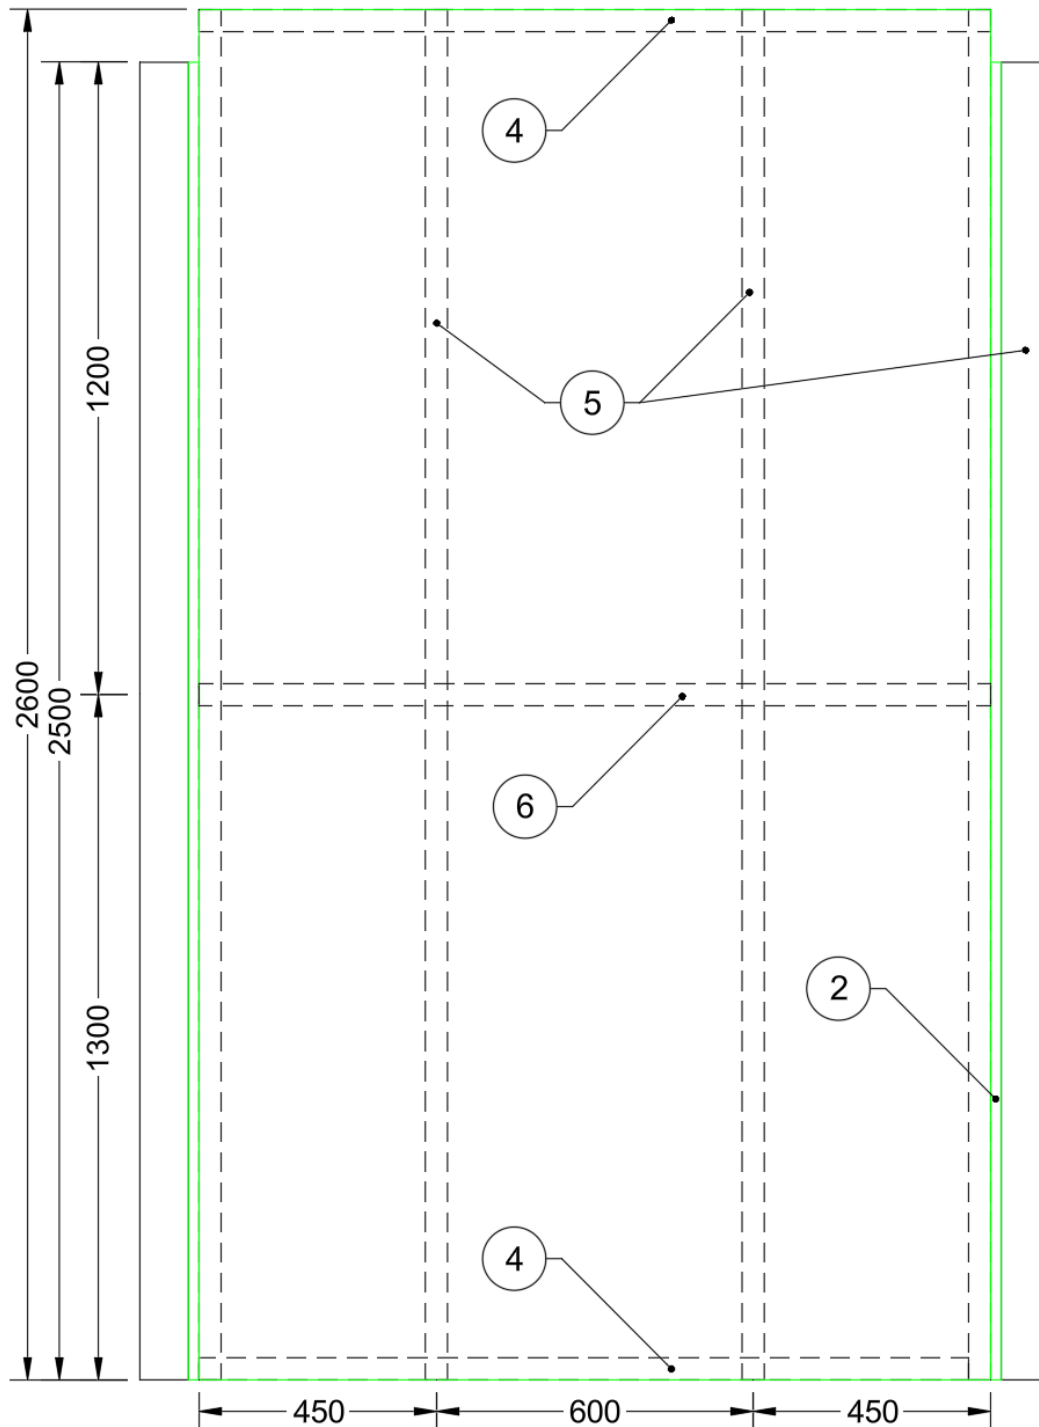
Figure 9 Elevation of rig support

The drawings of the test assembly in Figure 9 to Figure 14 were provided by the representatives of Warringtonfire. Dimensions, unless specified, are in mm. The leaders in the drawings represent the items listed in section 2.1.

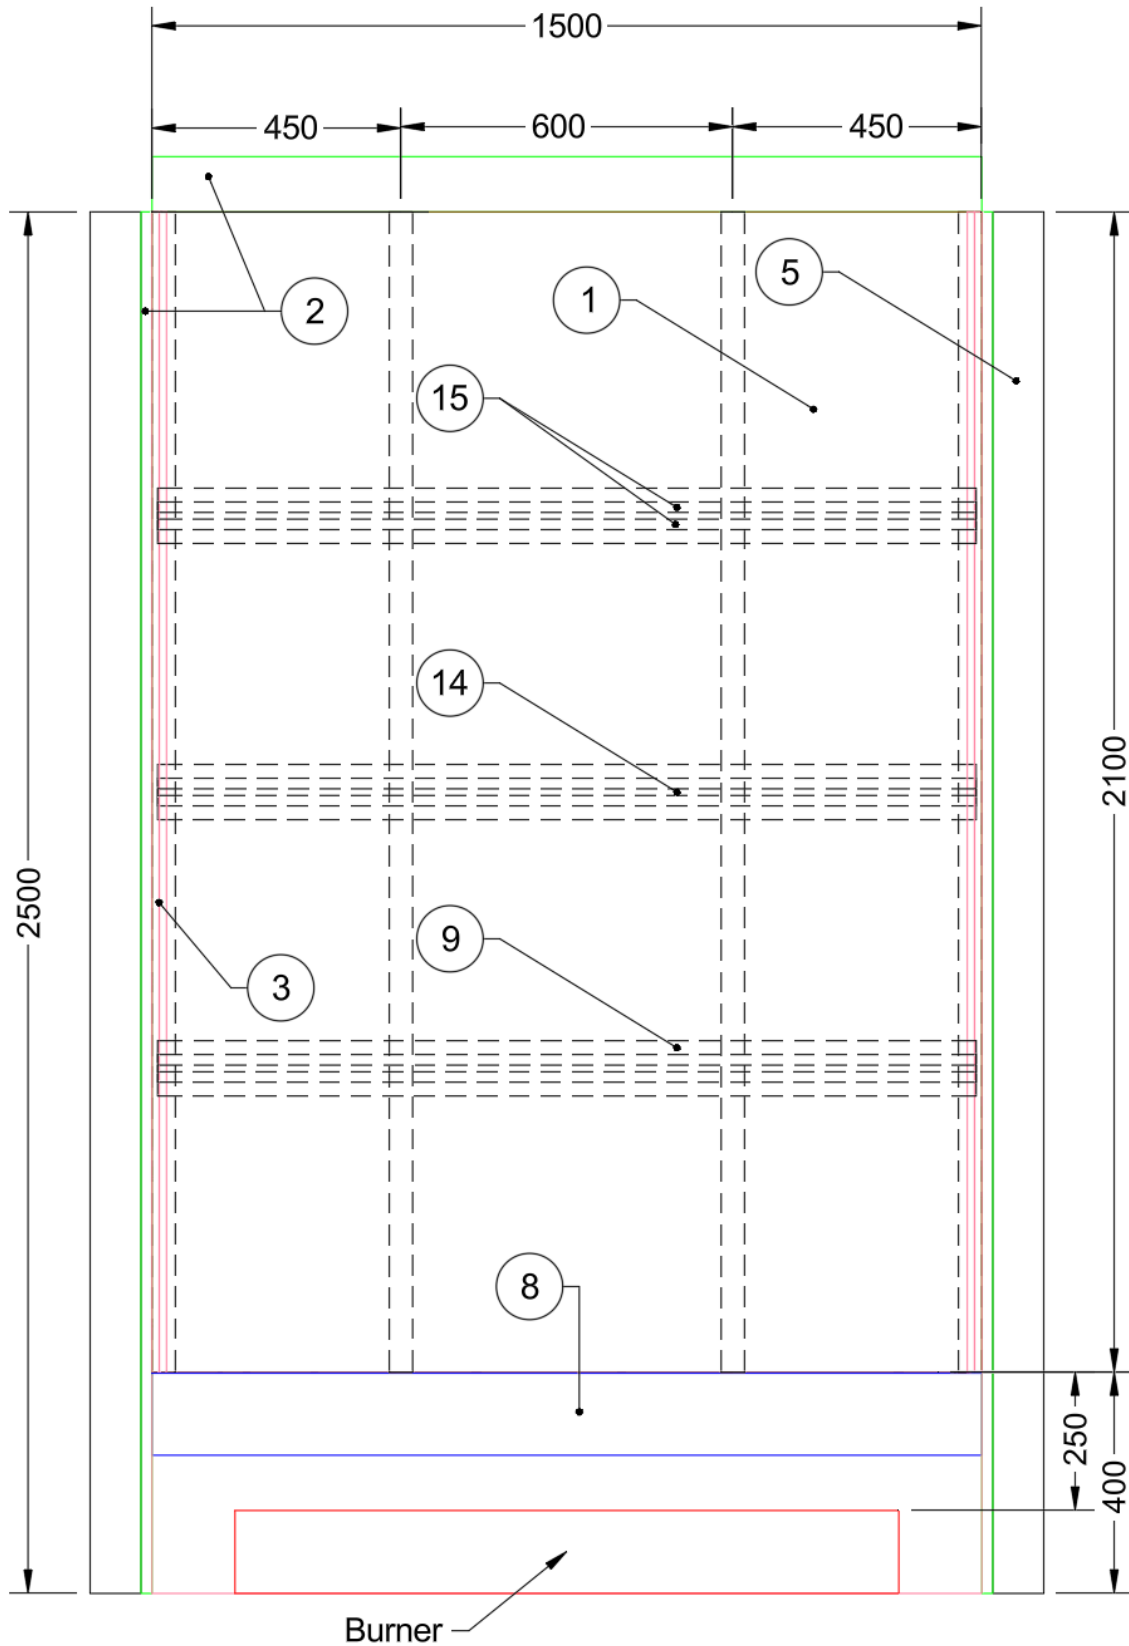
Figure 10 System assembly – Exposed side elevation

Item	Description	
	Installation	Used to fix the ACP panels (item 1) to the stiffeners (item 9).
Installation method		
Specimen wall frame	The specimen wall frame consisted of steel framing (items 4,5 and 6) fixed together using framing screws (item 10). It was clad on the back face with plasterboard (item 3) secured at 300 mm centres with board screws (item 11).	
Blanking walls	The test rig blanking walls consisted of three sperate assemblies of steel framing (items 4, 5 and 6) fixed together using framing screws (item 10) and clad on the fire exposed side with calcium silicate board (item 2). The two sides and the back where fixed to one another to form an alcove nominally 1500 mm wide by 888 mm deep.	
Overall size	Back blanking wall	1500 mm wide × 2600 mm tall
	Side blanking walls	1000 mm wide × 2500 mm tall
	Specimen	1500 mm wide × 2100 mm tall
ACP cladding	The exposed face of the specimen was clad with cassetted ACP (item 1) that was folded nominally 20 mm in and fixed to equal angles (item 7) using cassette screws (item 13) at nominal 250 mm centres to form a nominally 25 mm deep cassette. The face of the ACP was in line with the edge of the flashing (item 8).

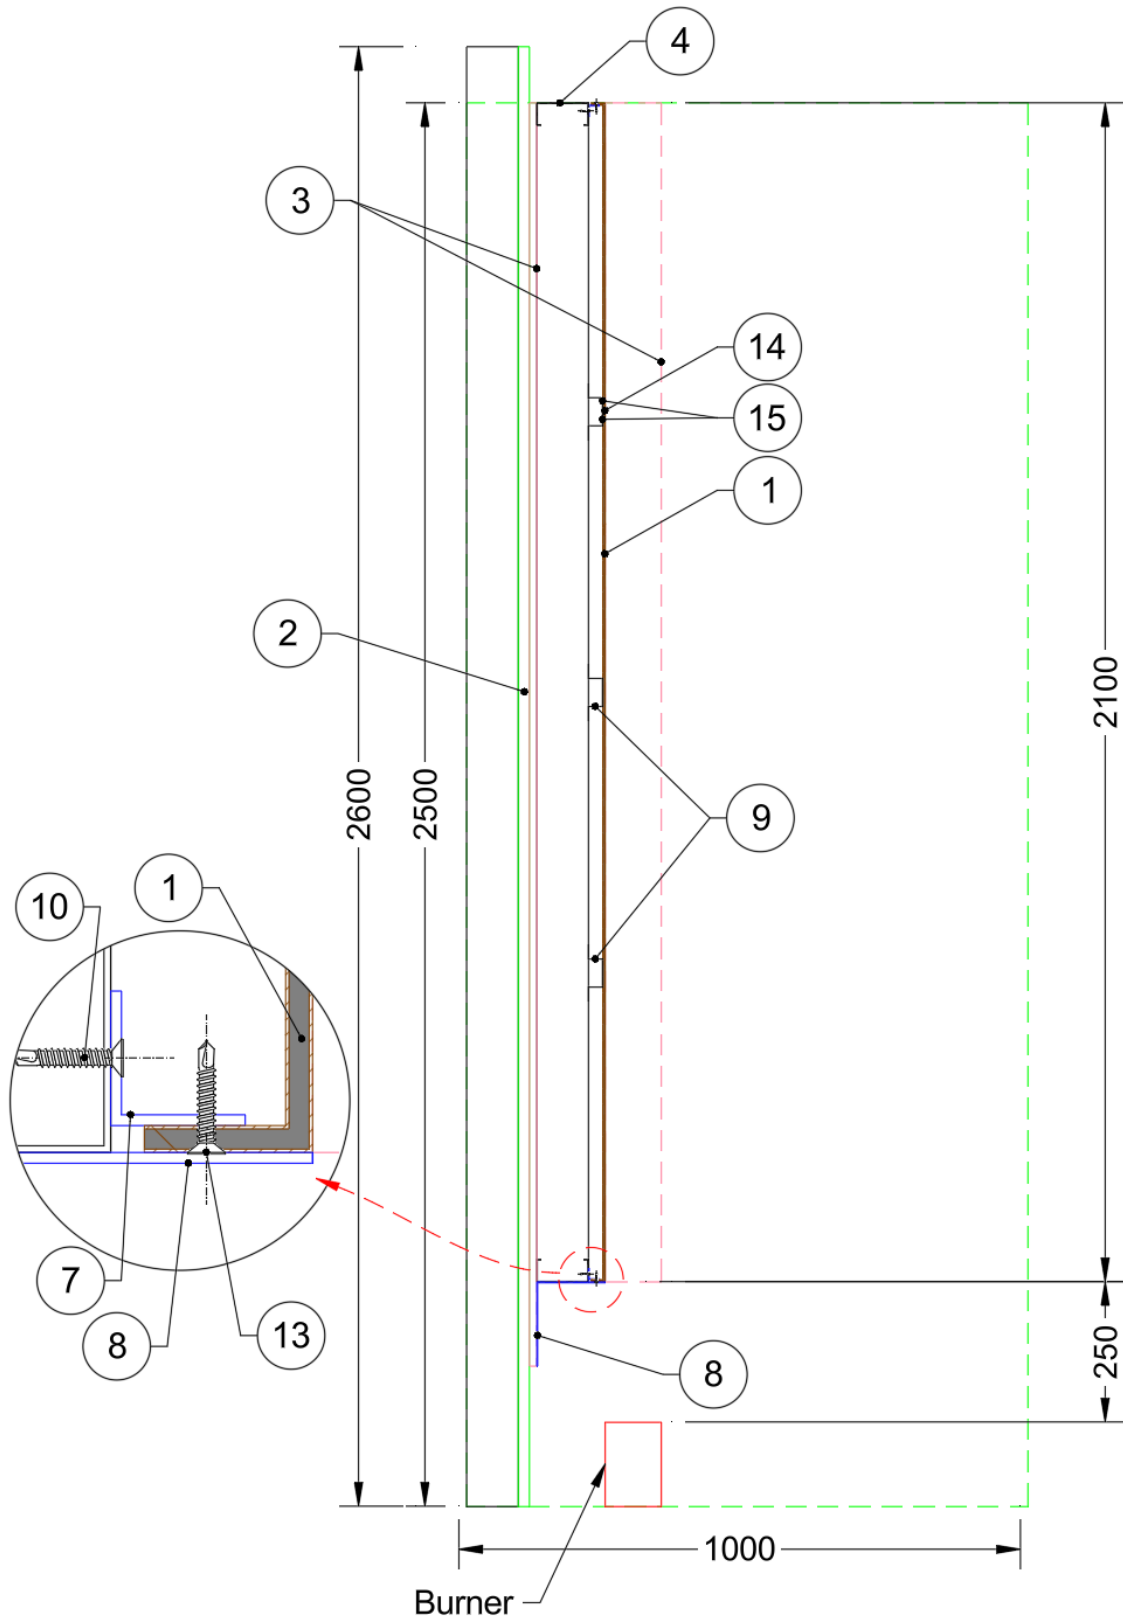
Figure 11 System assembly – vertical cross-sectional view

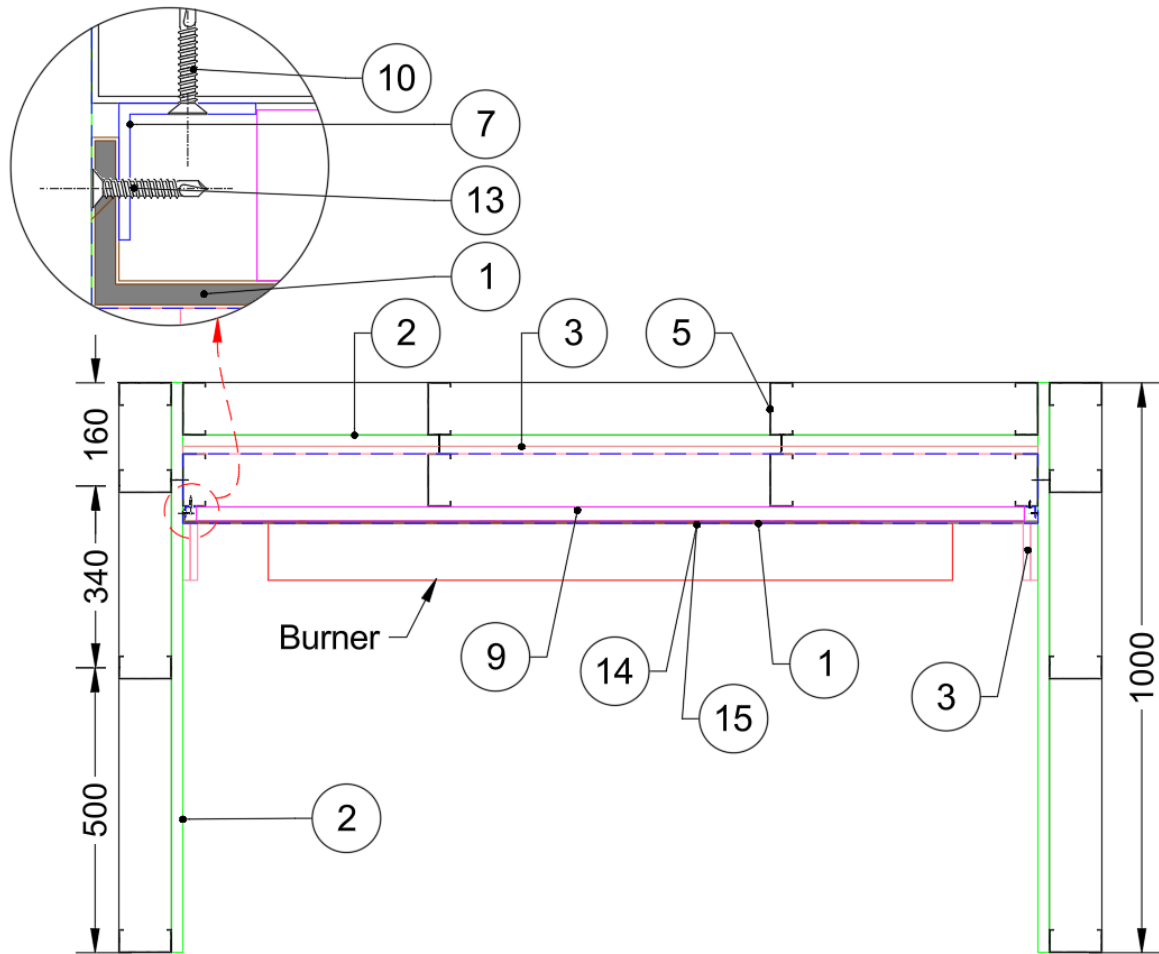
Figure 12 System assembly – horizontal mid height cross-sectional view

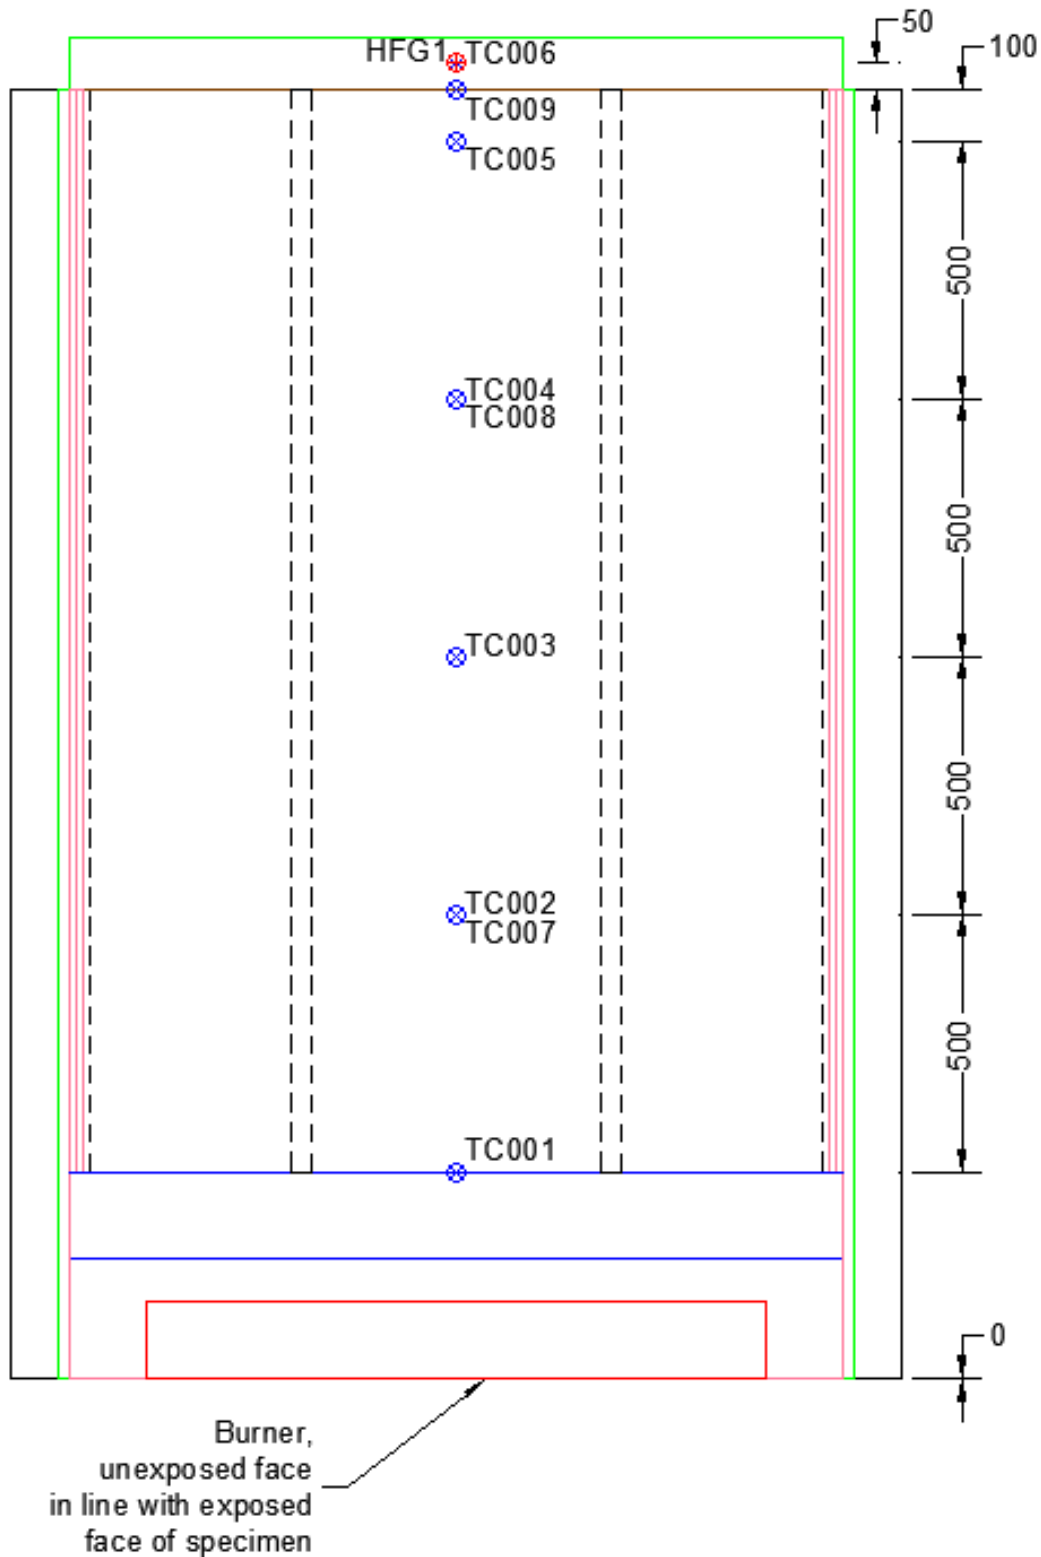
Figure 13 Instrumentation locations – Exposed side view

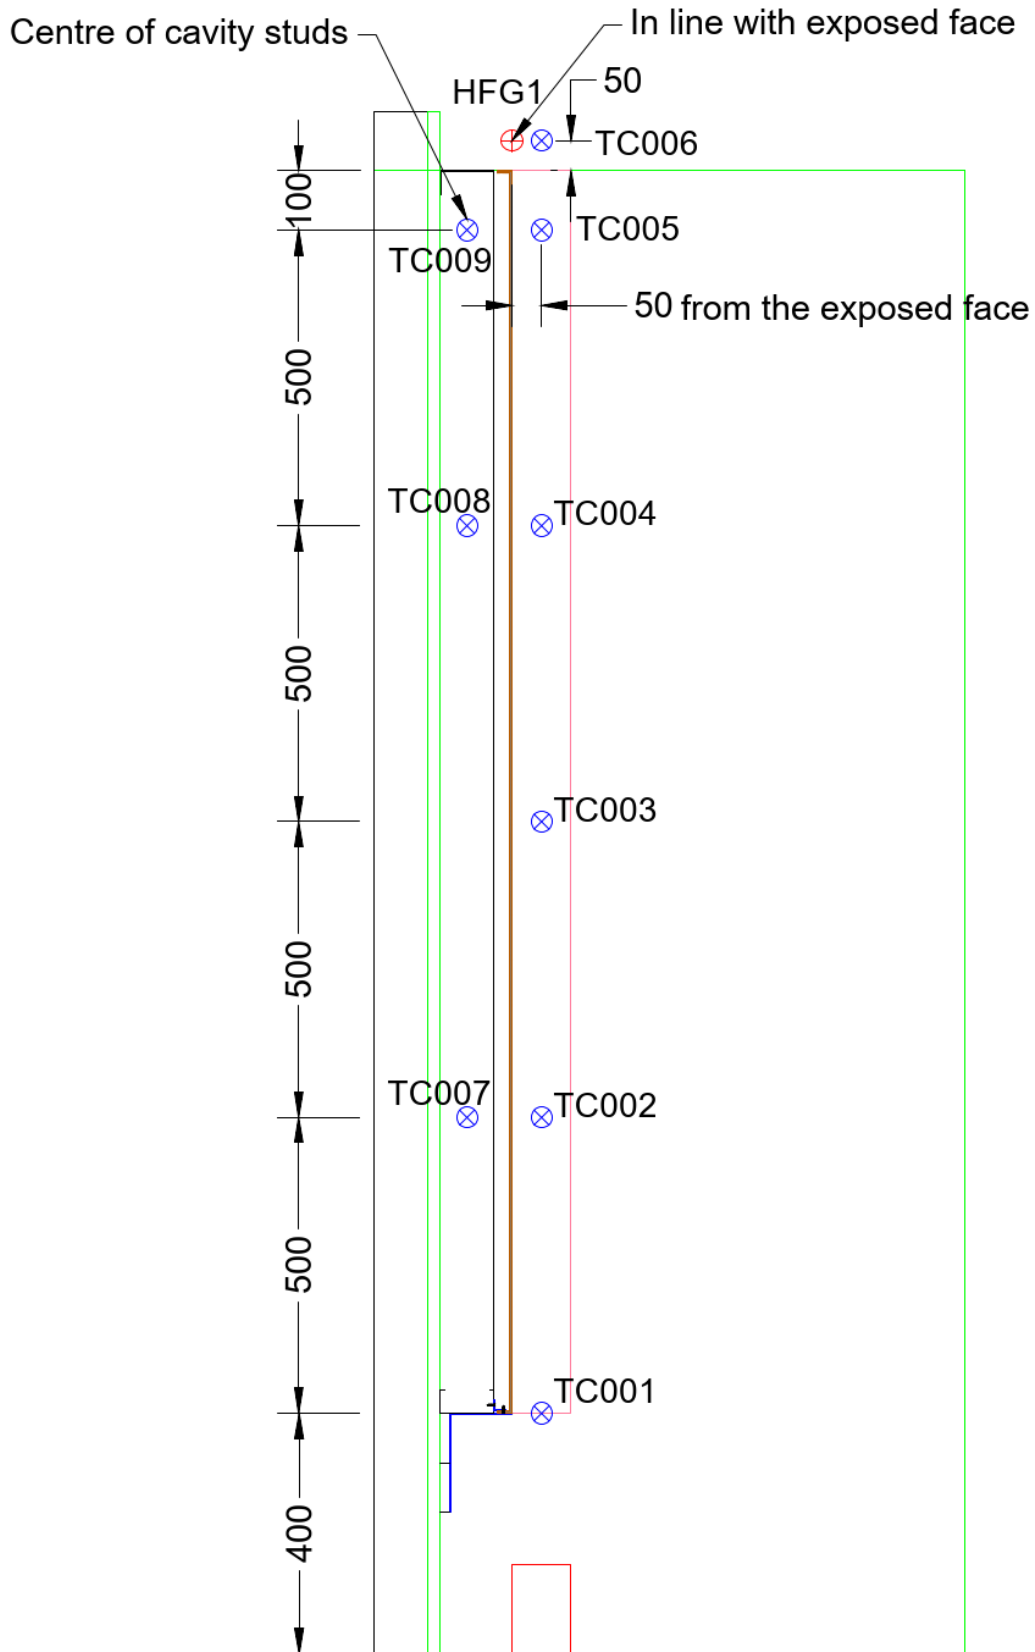
Figure 14 Instrumentation locations – Vertical cross-sectional view

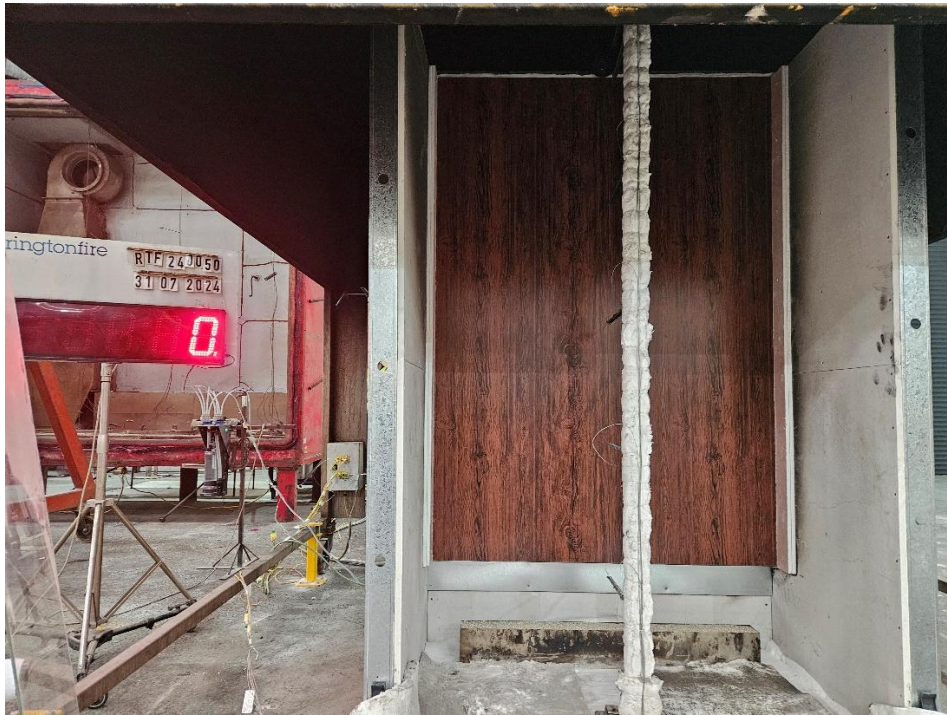
Figure 15 The specimen before the reaction to fire test – exposed side

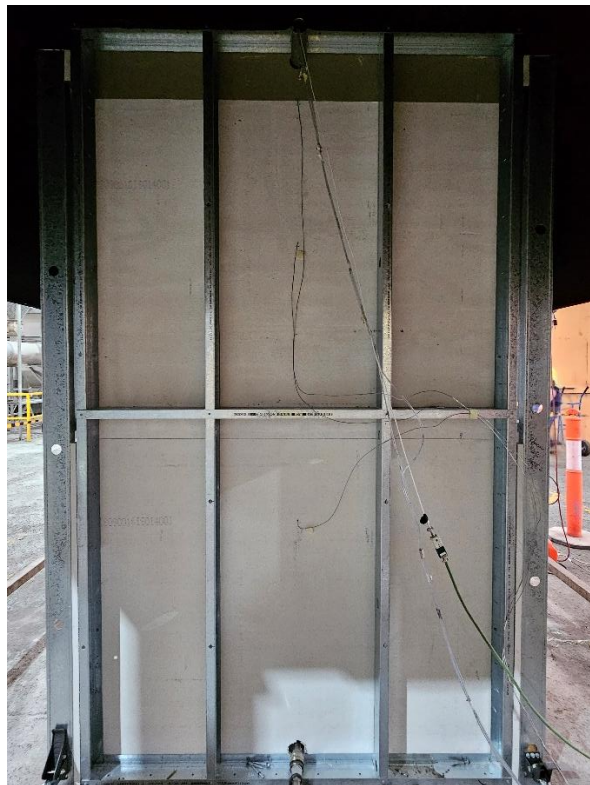
Figure 16 The specimen (unexposed side) before the reaction to fire test

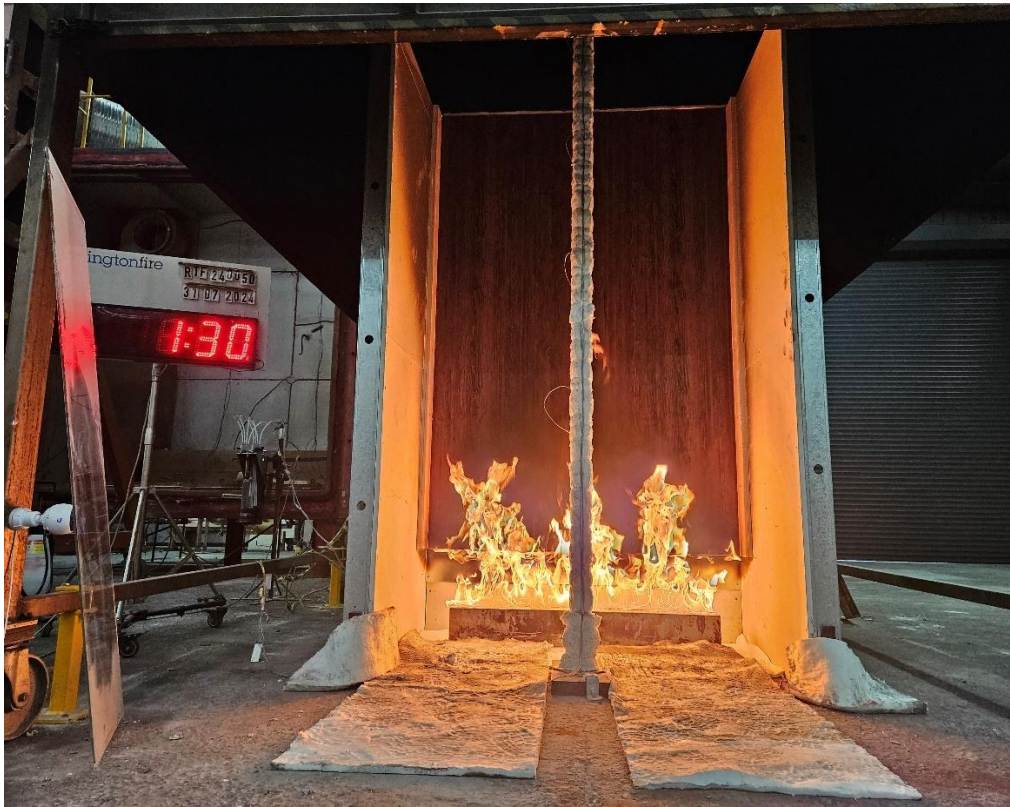
Figure 17 The specimen 1 minutes 30 seconds into the test (burner output at 100 kW)

Time		Observation
Min	Sec	
-2	00	Data collection started.
0	00	The reaction to fire test was started with the burner ignited with a heat output set at 100 kW.
1	18	Bottom steel angle started to bend due to the heat.
1	08	Smoke started emitting from the bottom portion of the specimen.
1	40	The Bottom of panel started to discolour.
2	04	Paint started to flake off from the bottom side of the specimen.
3	45	The Bottom of panel flaked off area has gotten wider.
6	05	The Bottom panel steel skin started darkening.
8	10	The Panel started melting from the bottom side.
15	00	The heat output of the burner was increased to 300 kW.
15	20	More face paint flaking from the mid-section.
15	52	Burst of gas was released from the bottom, causing deformation predominantly at the bottom left corner.
16	35	The first layer of panel opened at the bottom of the panel due to melting.
17	00	More face paint flakes off from the top section of the panel.

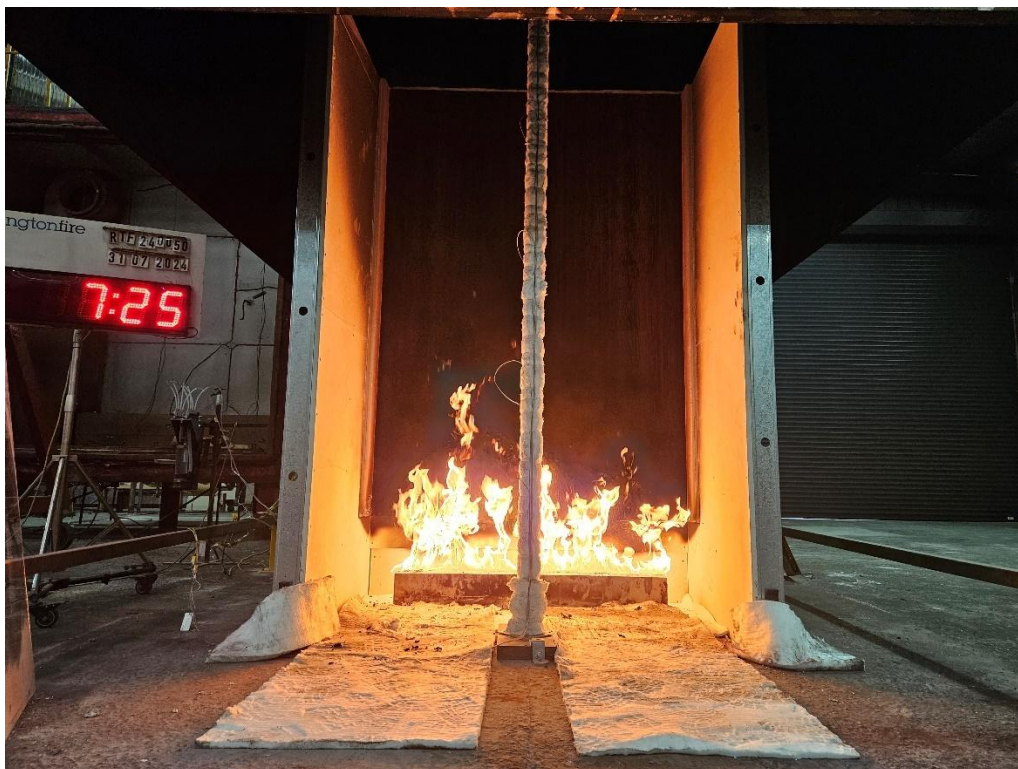
Figure 18 The specimen 7 minutes 25 seconds into the test (burner output at 100 kW)

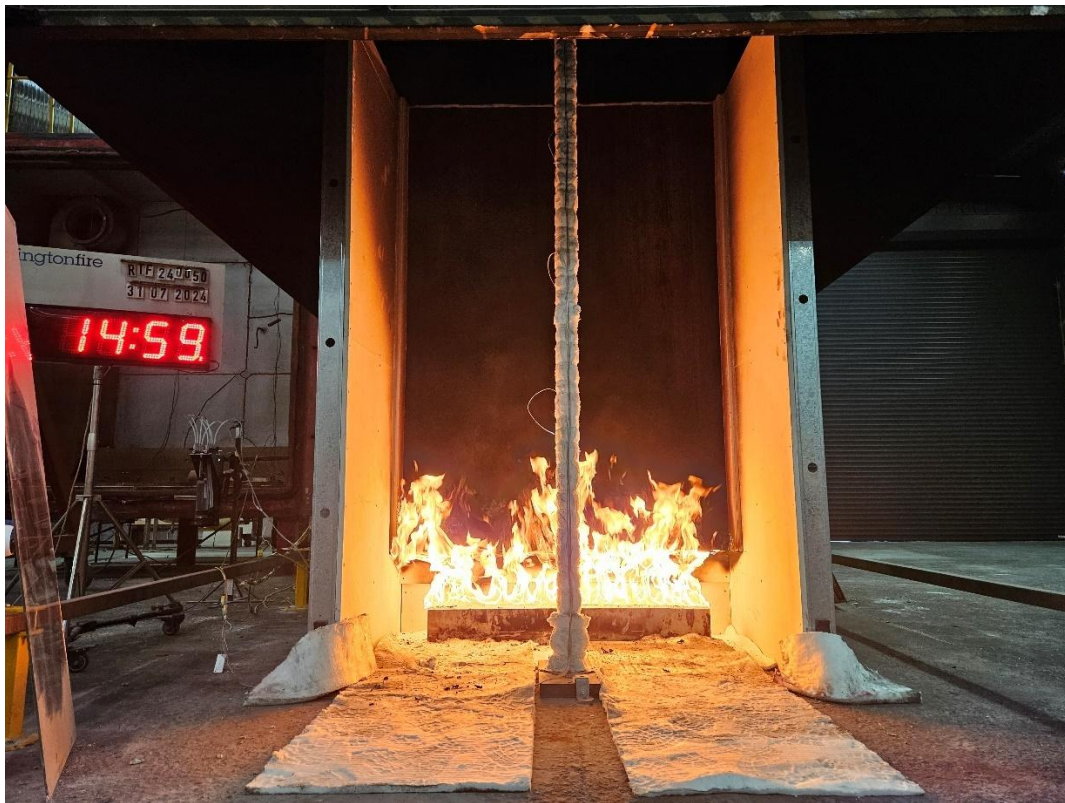
Figure 19 The specimen 14 minutes 59 seconds into the test (burner output at 100 kW)

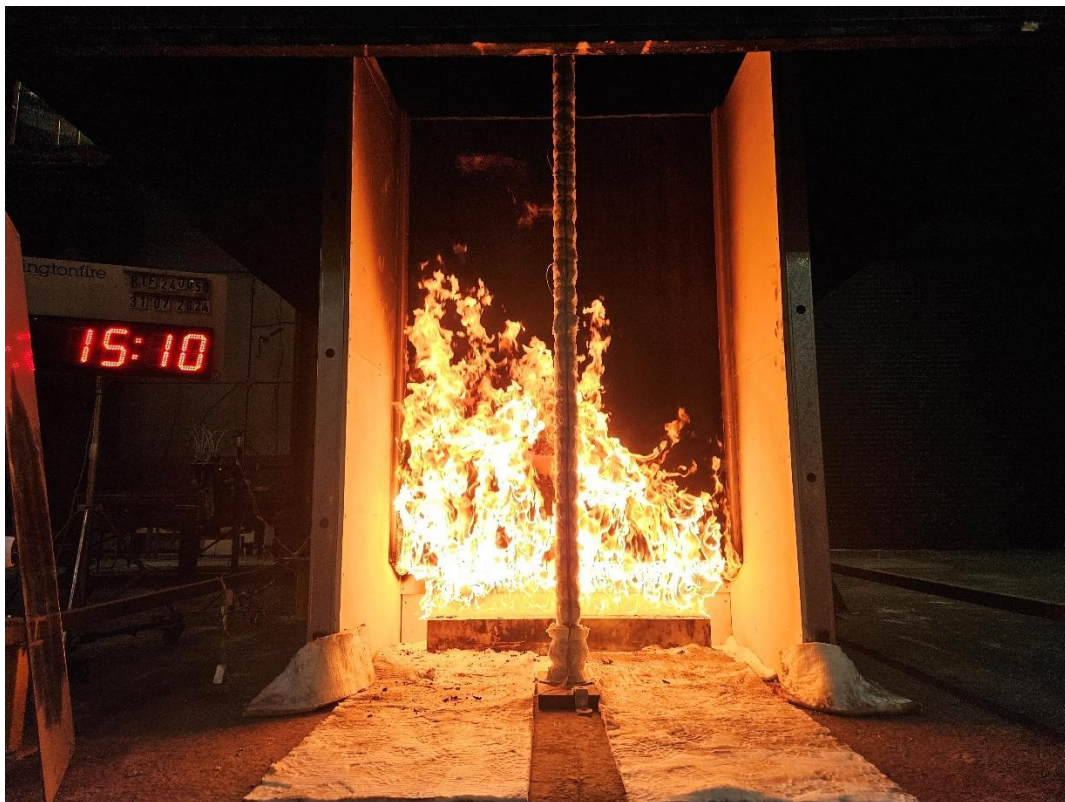
Figure 20 The specimen 15 minutes 10 seconds into the test (burner output at 300 kW)

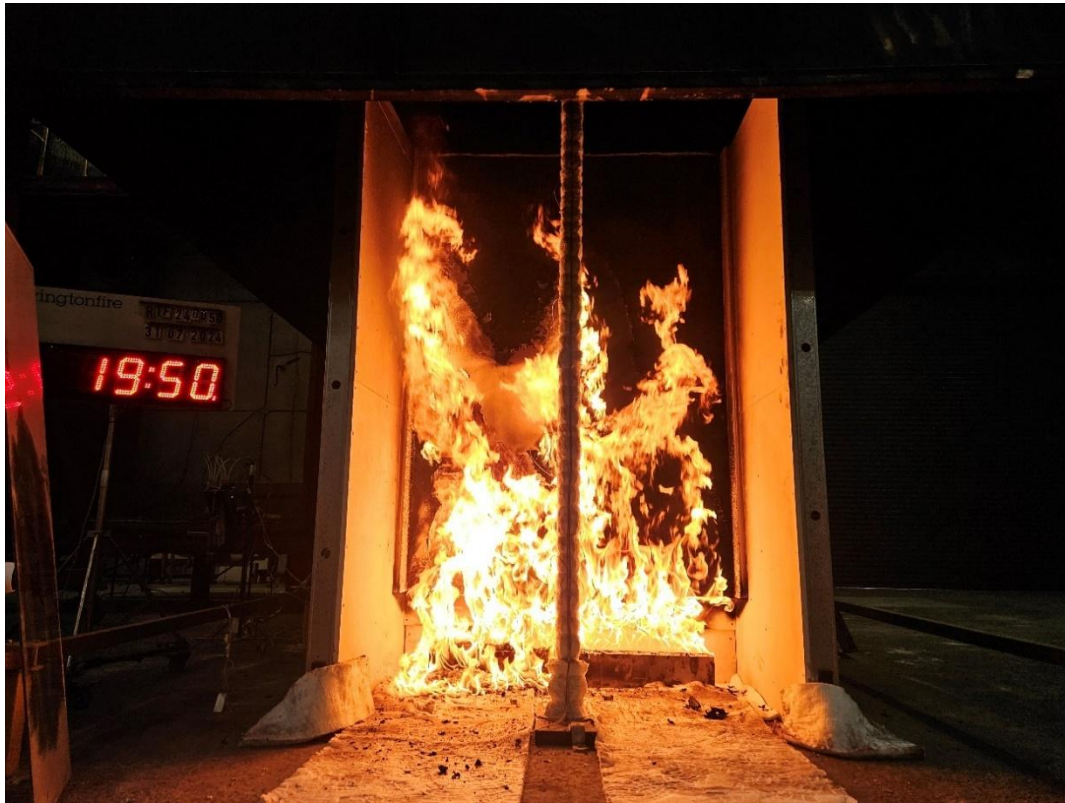
Figure 21 The specimen 19 minutes 50 seconds into the test (burner output at 300 kW)

18	04	The Panel fully opened at the bottom through to cavity.
19	26	The Panel opening spread to mid-section.
26	45	Independent flaming from behind panel on the left side.
32	20	More panel melted from the bottom side and the internal framing is visible.
40	00	Burner was turned off.
60	00	The reaction to fire test was ended.

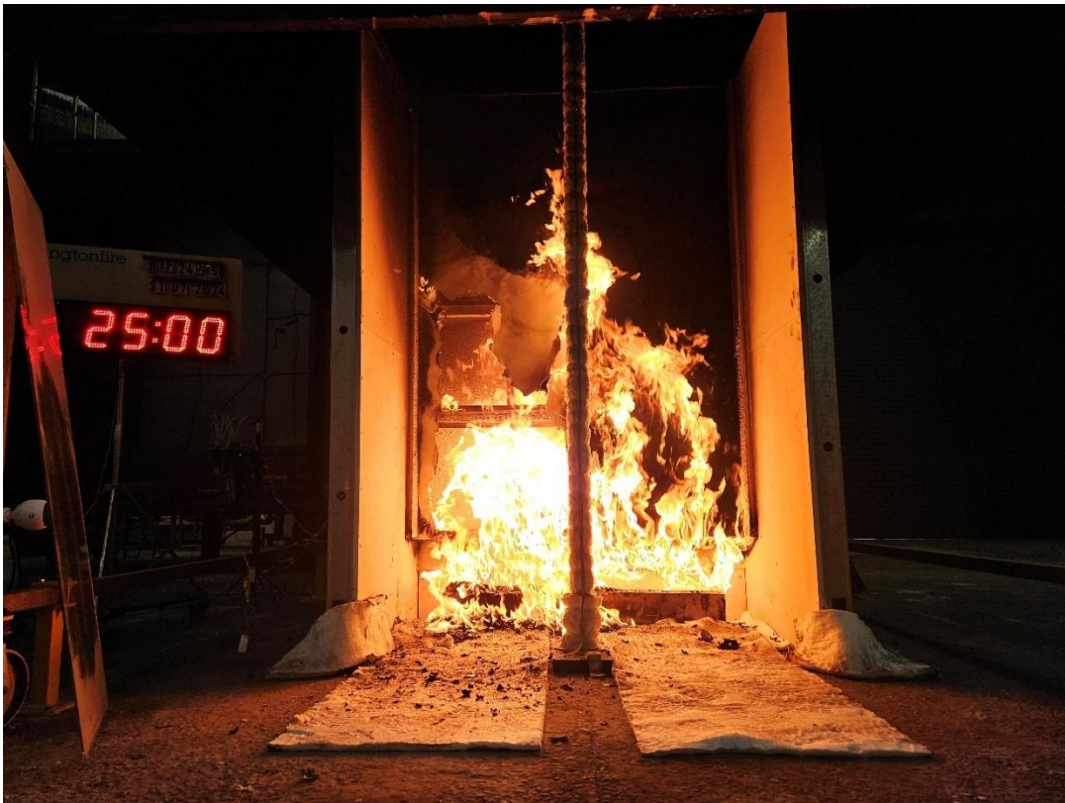
Figure 22 The specimen 25 minutes into the test (burner output at 300 kW)
