Reaction to fire test report

Test standard: Ad-hoc test based on ISO 13785-1:2002

System: ACP with 45 % polyethylene core external façade cladding system

Job number: RTF240050

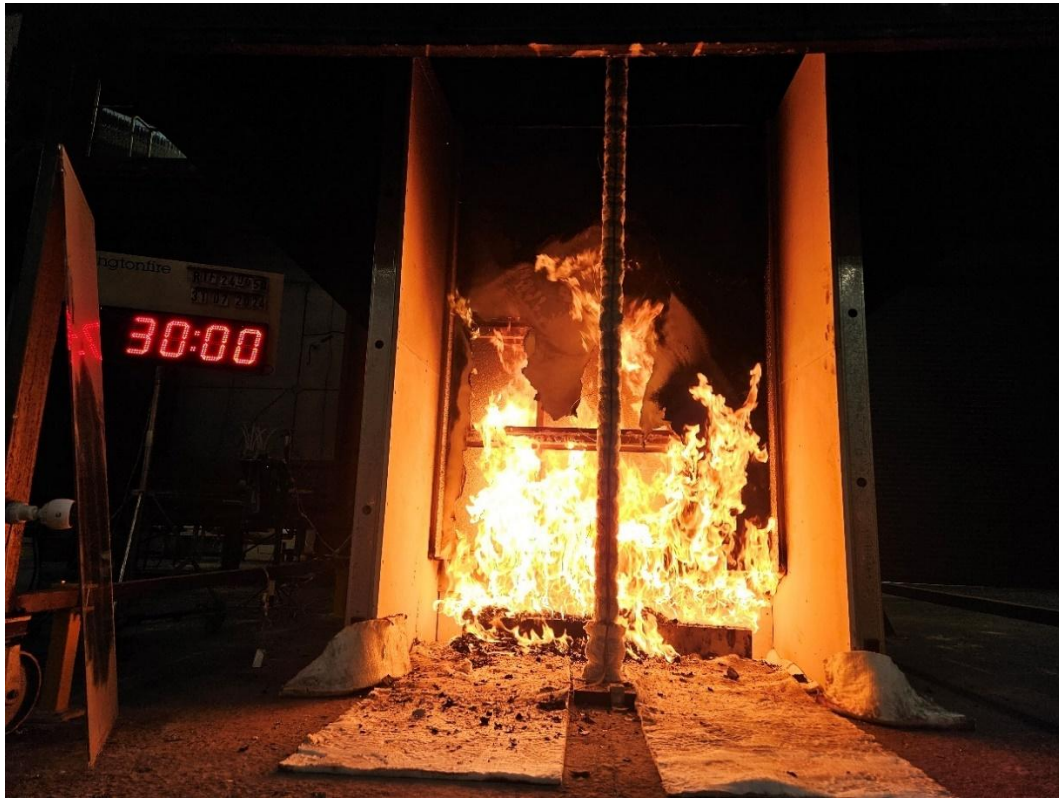
Figure 23 The specimen 30 minutes into the test (burner output at 300 kW)

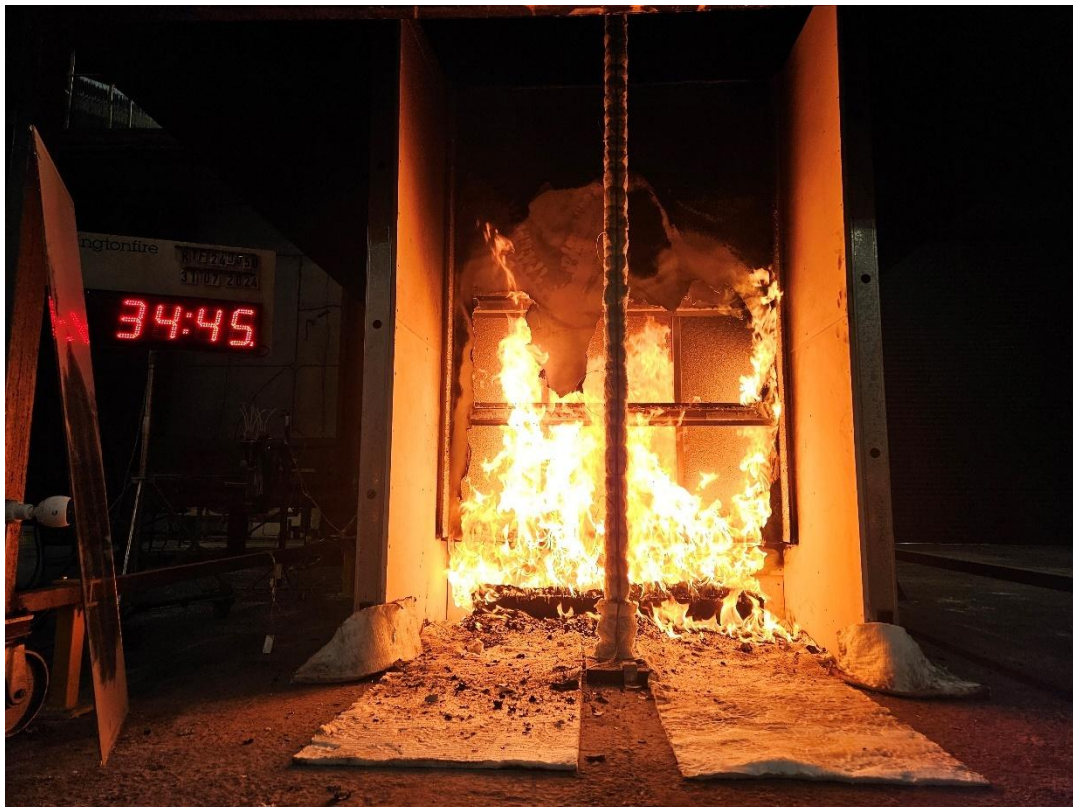
Figure 24 The specimen 34 minutes 45 seconds into the test (burner output at 300 kW)

18	04	The Panel fully opened at the bottom through to cavity.
19	26	The Panel opening spread to mid-section.
26	45	Independent flaming from behind panel on the left side.
32	20	More panel melted from the bottom side and the internal framing is visible.
40	00	Burner was turned off.
60	00	The reaction to fire test was ended.

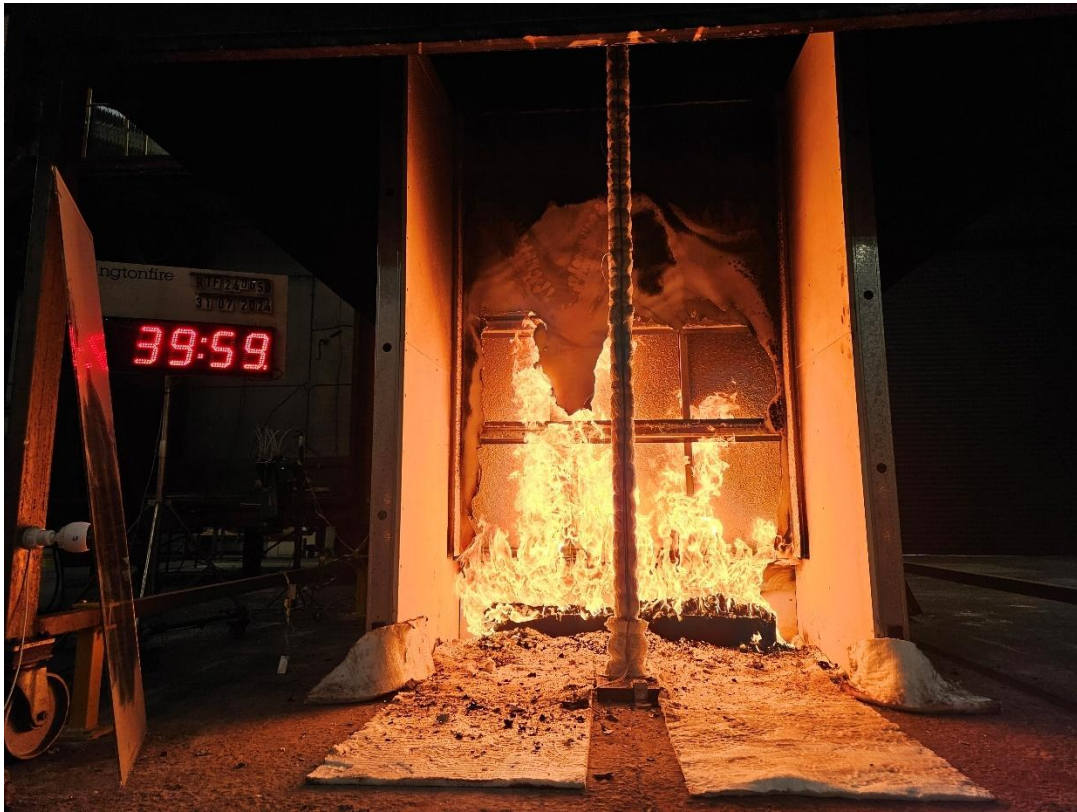
Figure 25 The specimen 39 minutes 59 seconds into the test (burner output at 300 kW)

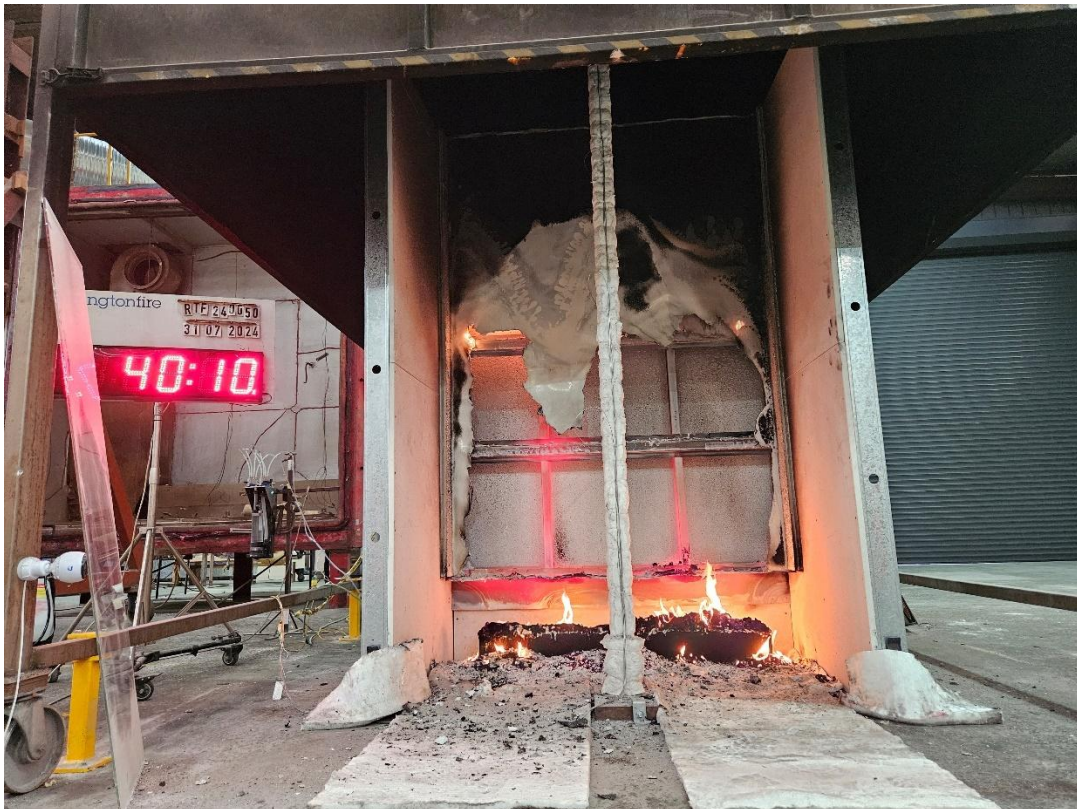
Figure 26 The specimen 40 minutes 10 seconds into the test (burner off)

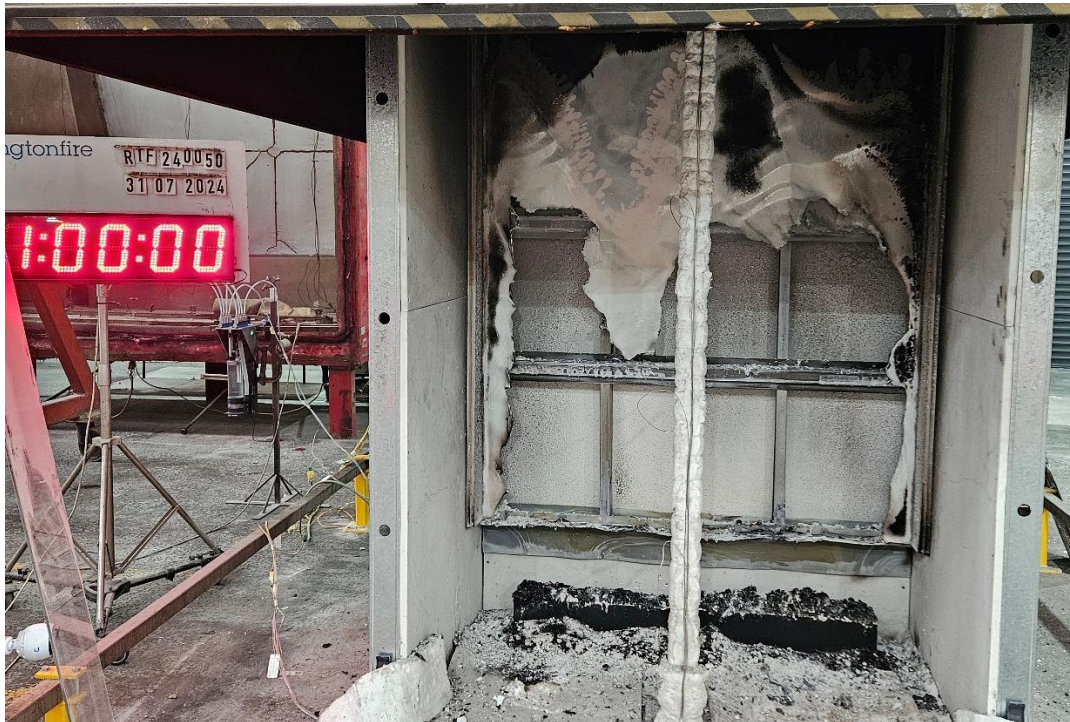
Figure 27 The specimen at end of test – exposed side

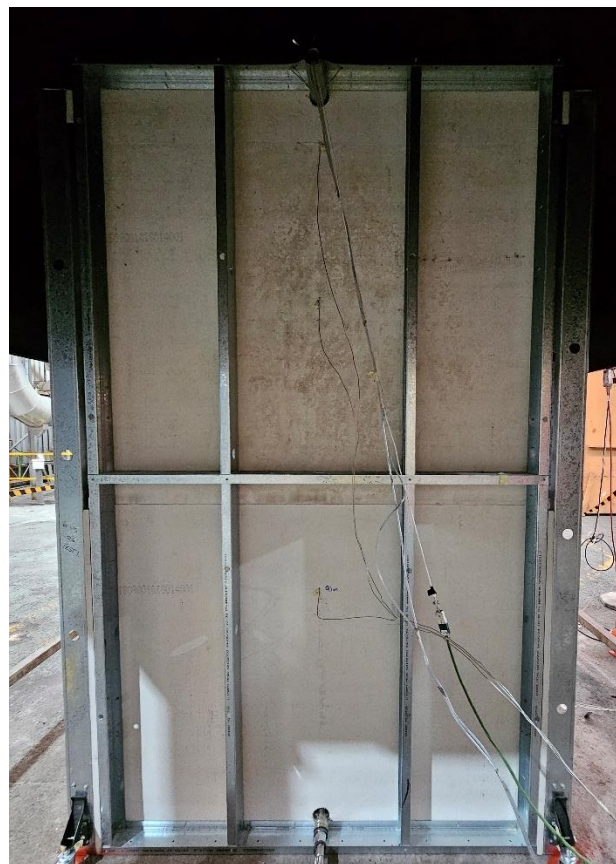
Figure 28 The specimen at end of test – unexposed side

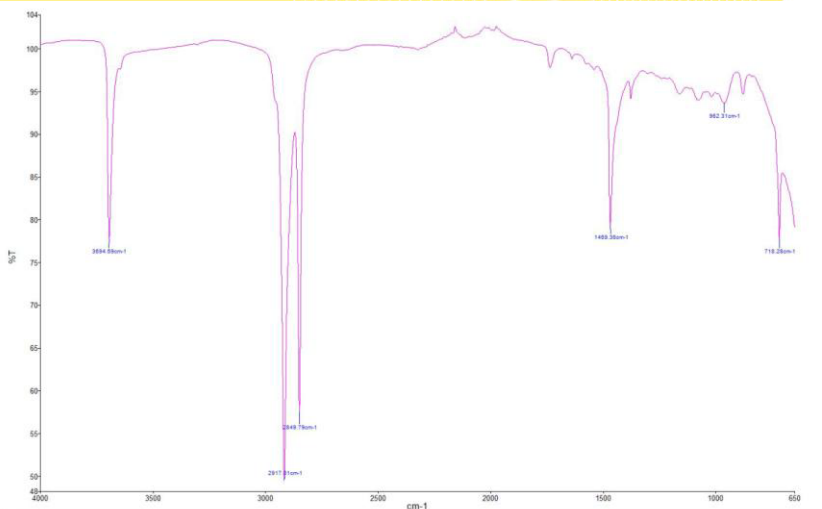
Figure 1. FT-IR spectrum of Sample #1

The aluminium metal was removed from the ACPs cladding polymer, and the flat surface of the polymer samples was abraded to remove any surface adhesive. The surface of each sample was analysed directly by FTIR. The FT-IR spectrum is presented in Figures 1-2.

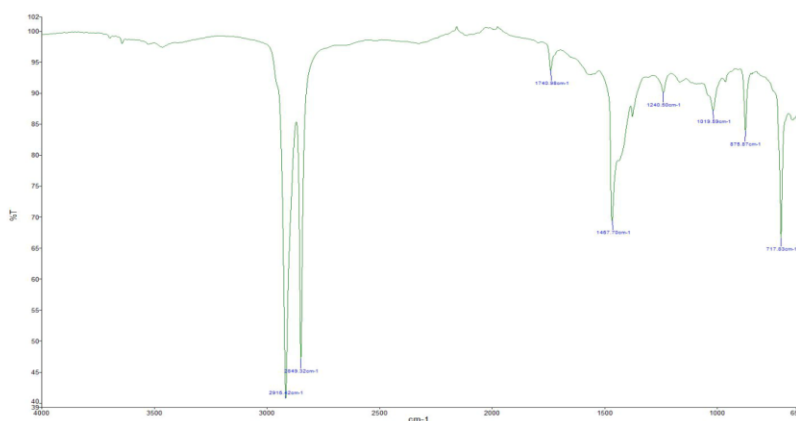
Figure 2. FT-IR spectrum of sample #2
