# Reaction to fire test report

Test standard: Ad-hoc test based on ISO 13785-1:2002

System: ACP with 45 % polyethylene core external façade cladding system with PET wall insulation

Job number: RTF240052

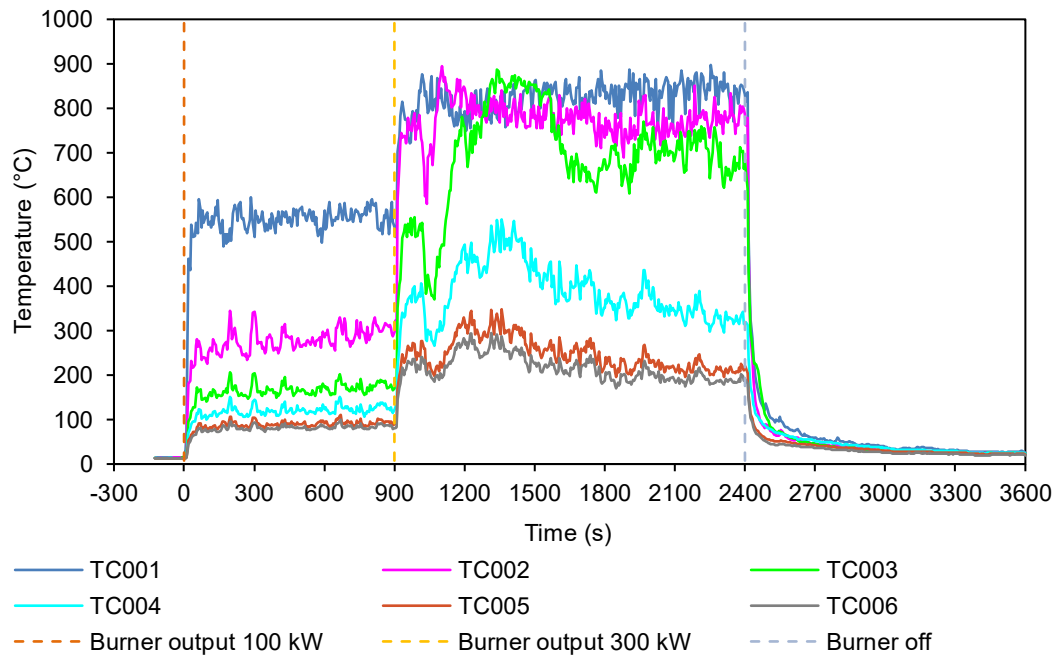
**Figure 1 50 mm from the exposed face – Temperature vs time**

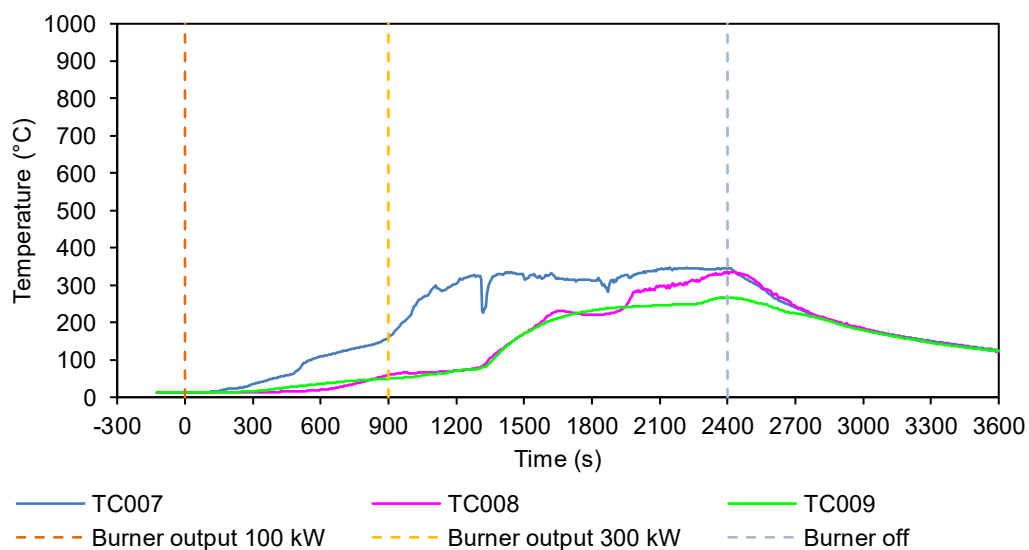
**Figure 2 Cavity – Temperature vs time**

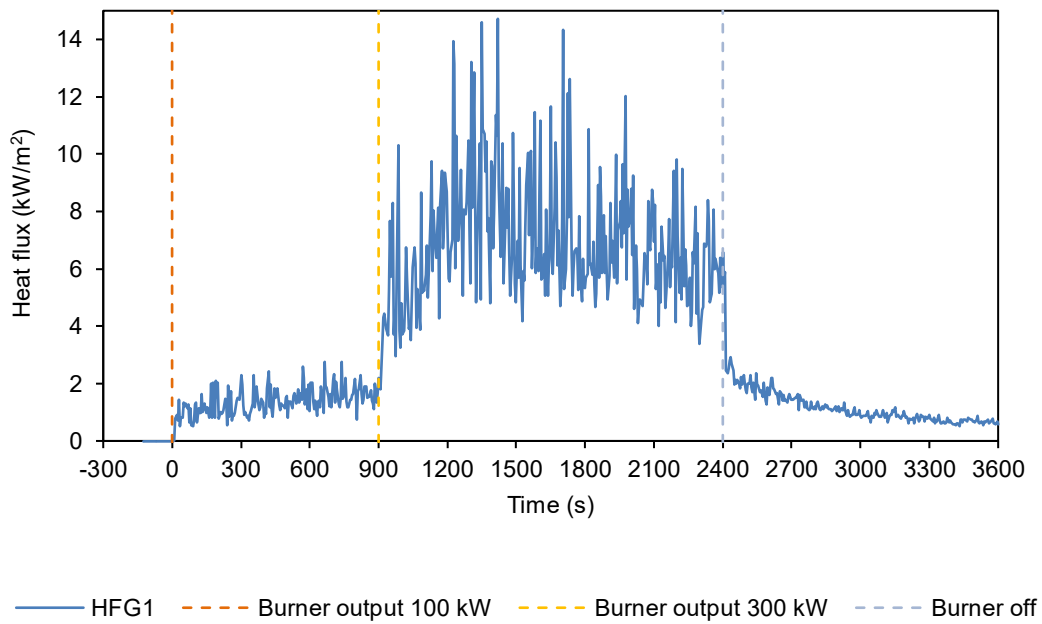
**Figure 3 Heat flux vs time**

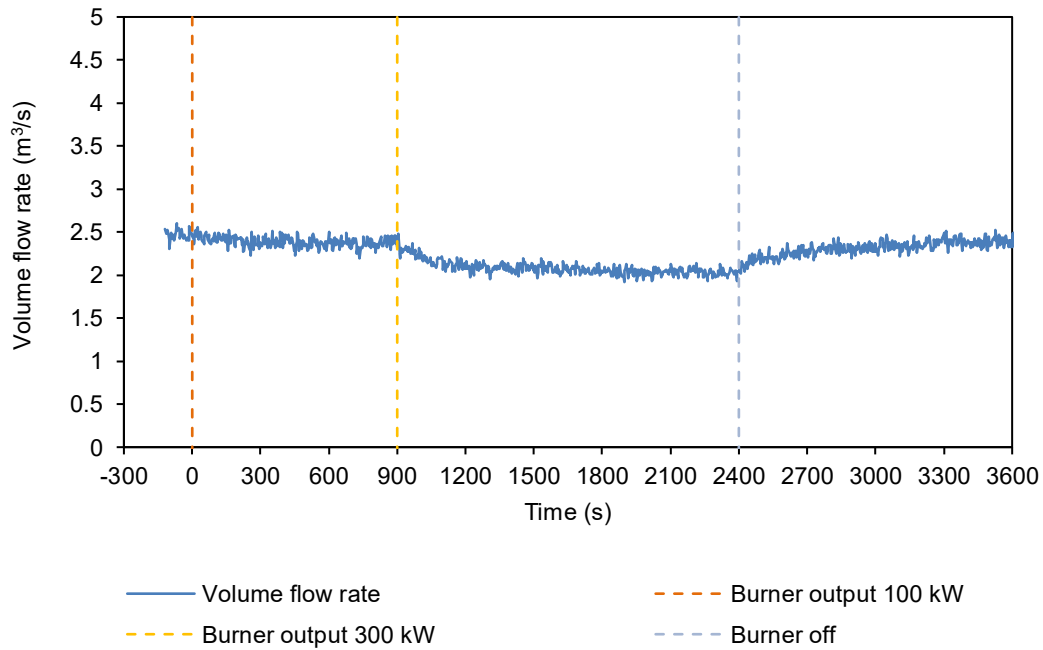
**Figure 4 Volume flow rate in duct vs time**

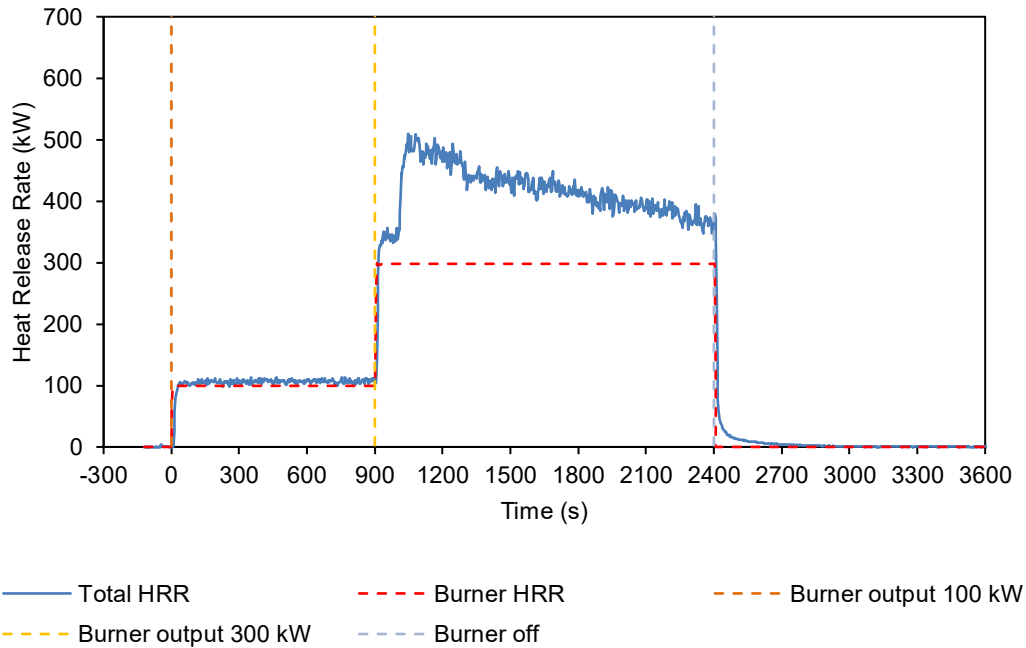
**Figure 5 Heat release rate (HRR) of specimen and burner vs time**

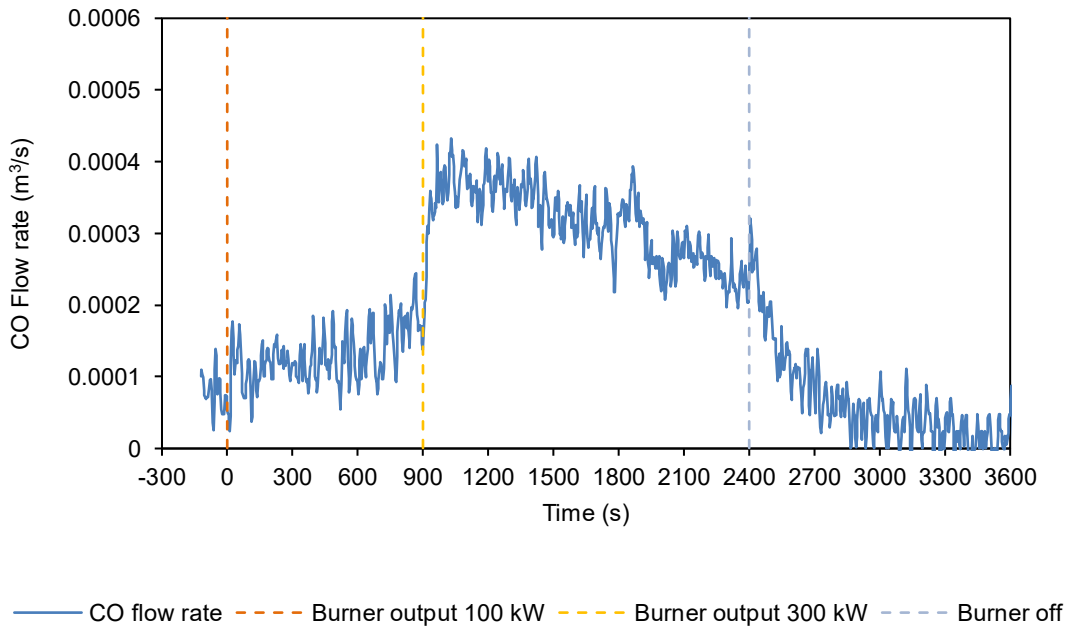
**Figure 6 Production of carbon monoxide vs time, at reference temperature and pressure**

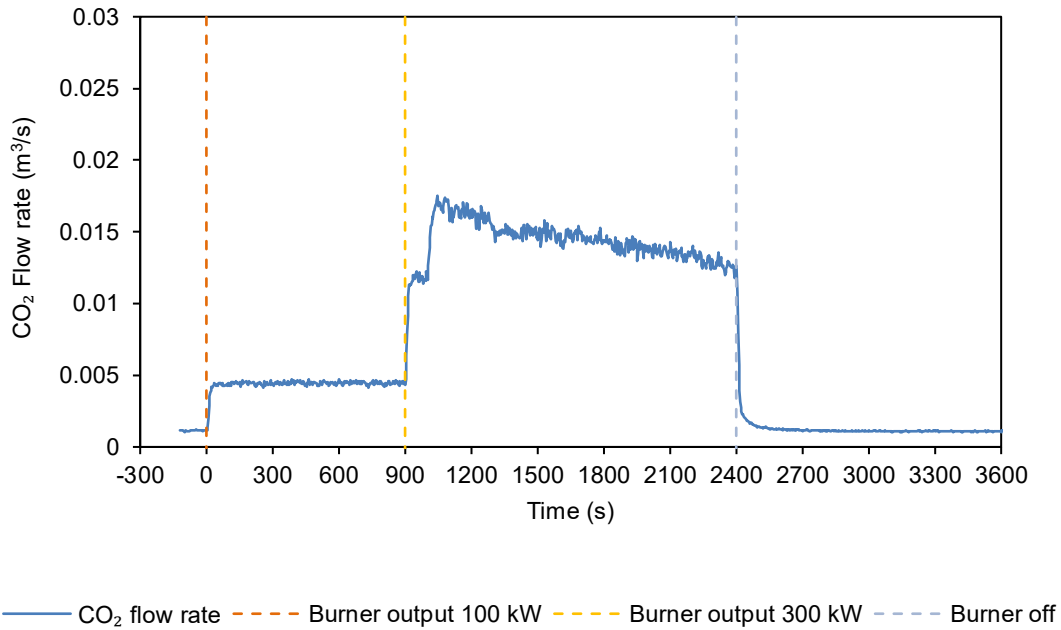
**Figure 7 Production of carbon dioxide vs time, at reference temperature and pressure**

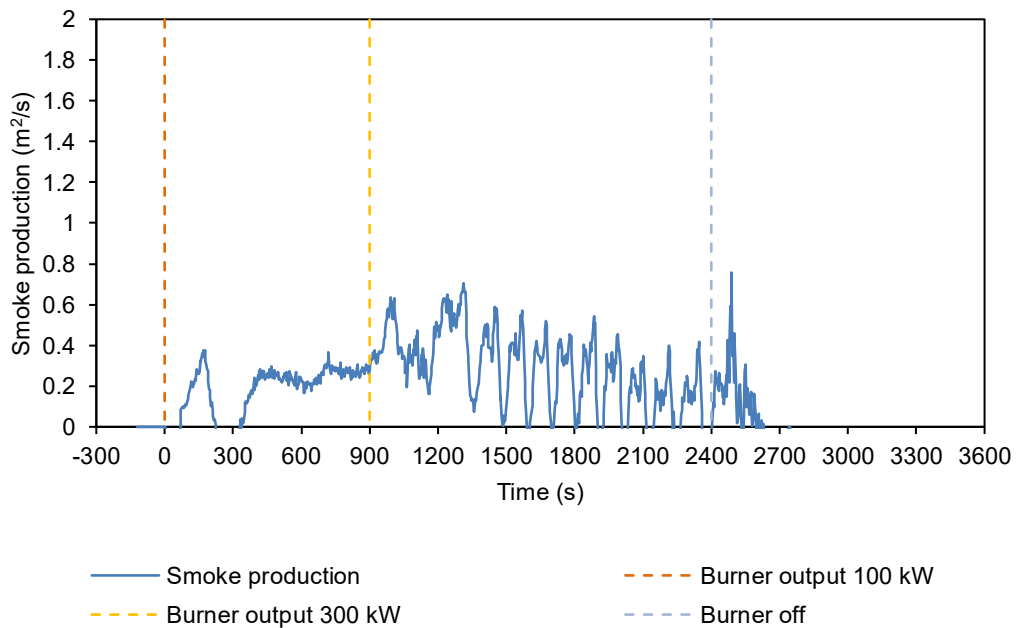
**Figure 8 Production of light obscuring smoke vs time, at reference temperature and pressure**

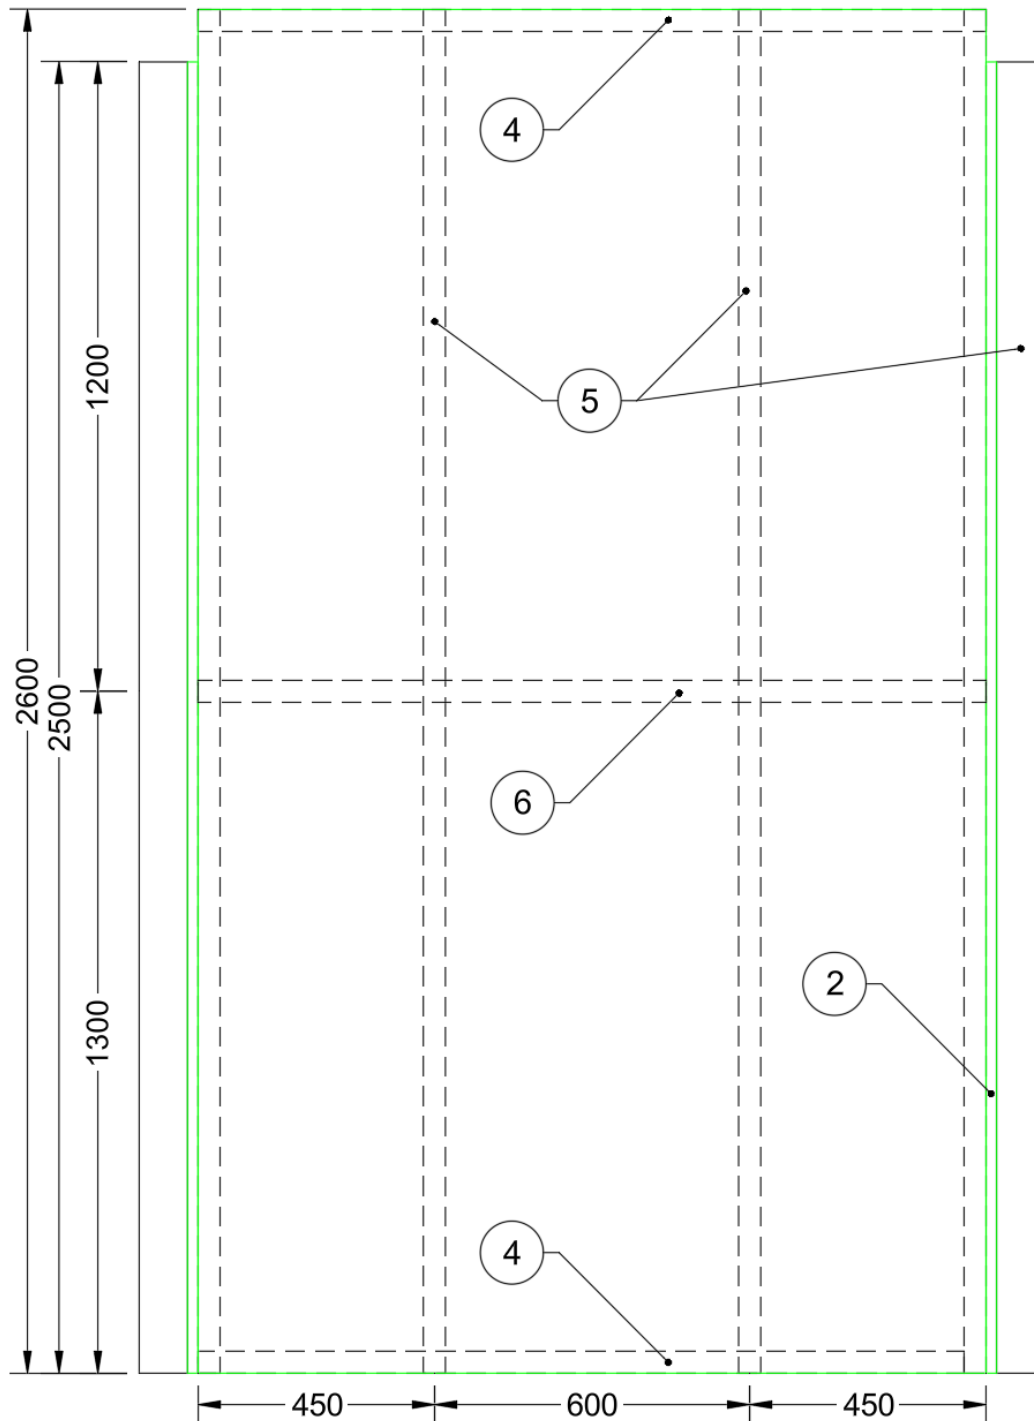
**Figure 9 Elevation of rig support**

The drawings of the test assembly in Figure 9 to Figure 14 were provided by the representatives of Warringtonfire. Dimensions, unless specified, are in mm. The leaders in the drawings represent the items listed in section 2.1.

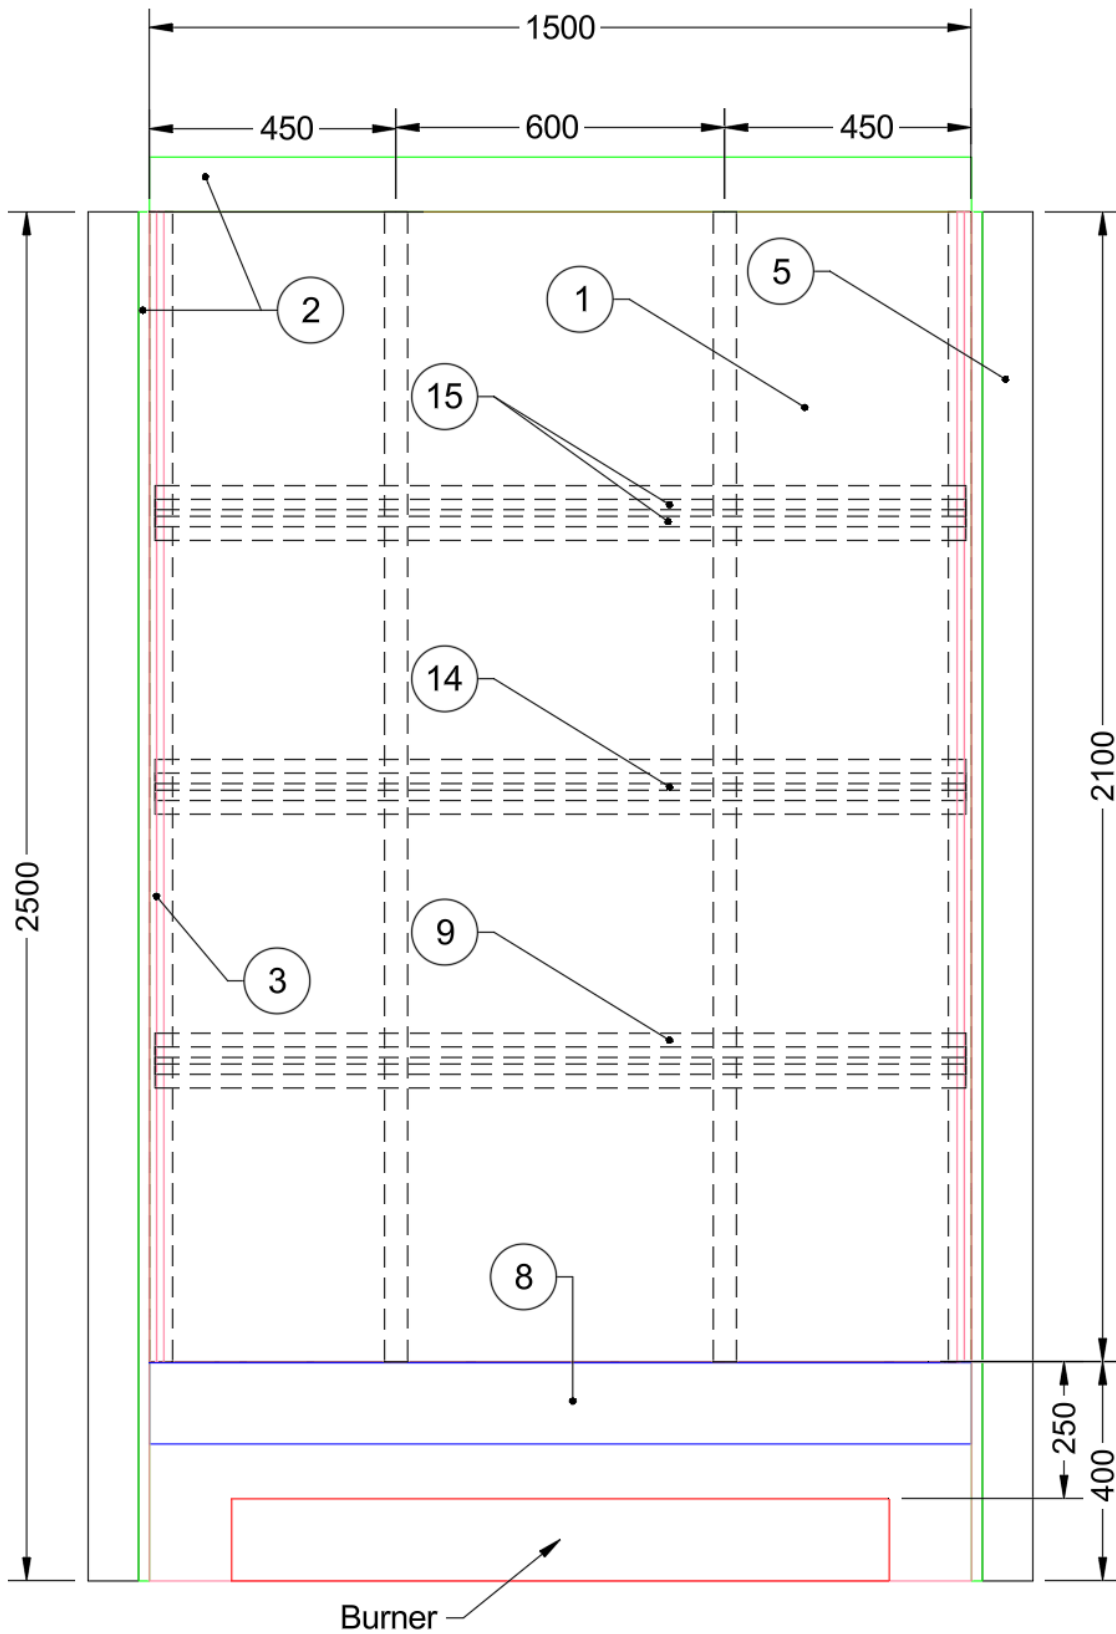
**Figure 10 System assembly – Exposed side elevation**

Overall size	Back blanking wall	1500 mm wide × 2600 mm tall
	Side blanking walls	1000 mm wide × 2500 mm tall
	Specimen	1500 mm wide × 2100 mm tall
ACP cladding	The exposed face of the specimen was clad with casseted ACP (item 1) that was folded nominally 20 mm in and fixed to equal angles (item 7) using cassette screws (item 13) at nominal 250 mm centres to form a nominally 25 mm deep cassette. The face of the ACP was in line with the edge of the flashing (item 8). The wall cavity of the specimen was filled with the insulation (item 16).

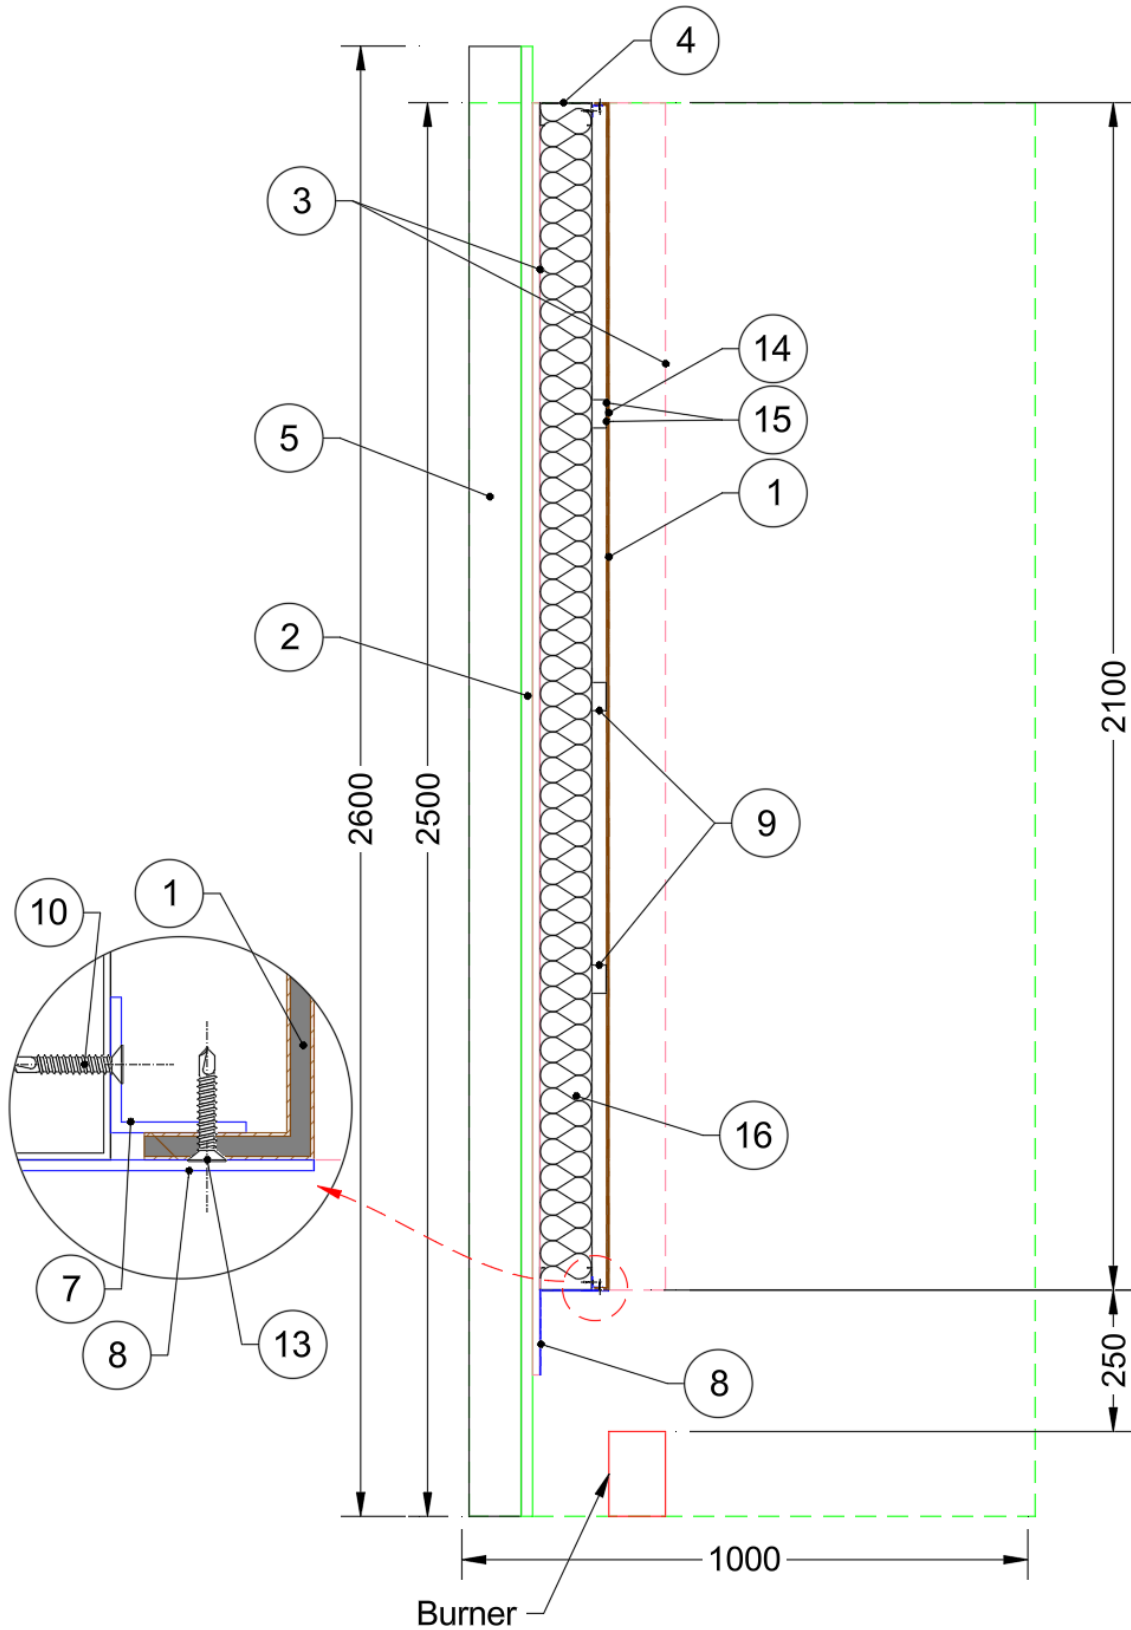
**Figure 11 System assembly – vertical cross-sectional view**

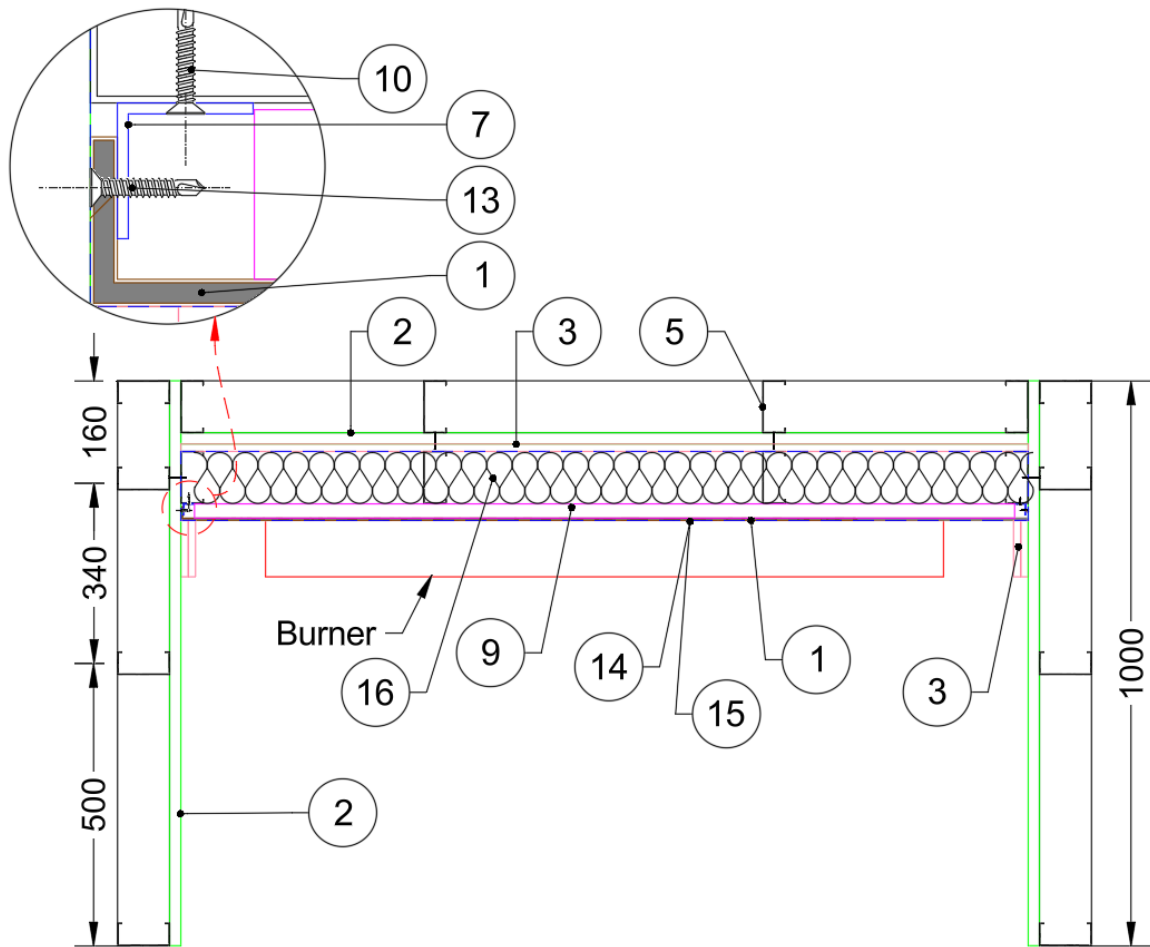
**Figure 12 System assembly – horizontal mid height cross-sectional view**

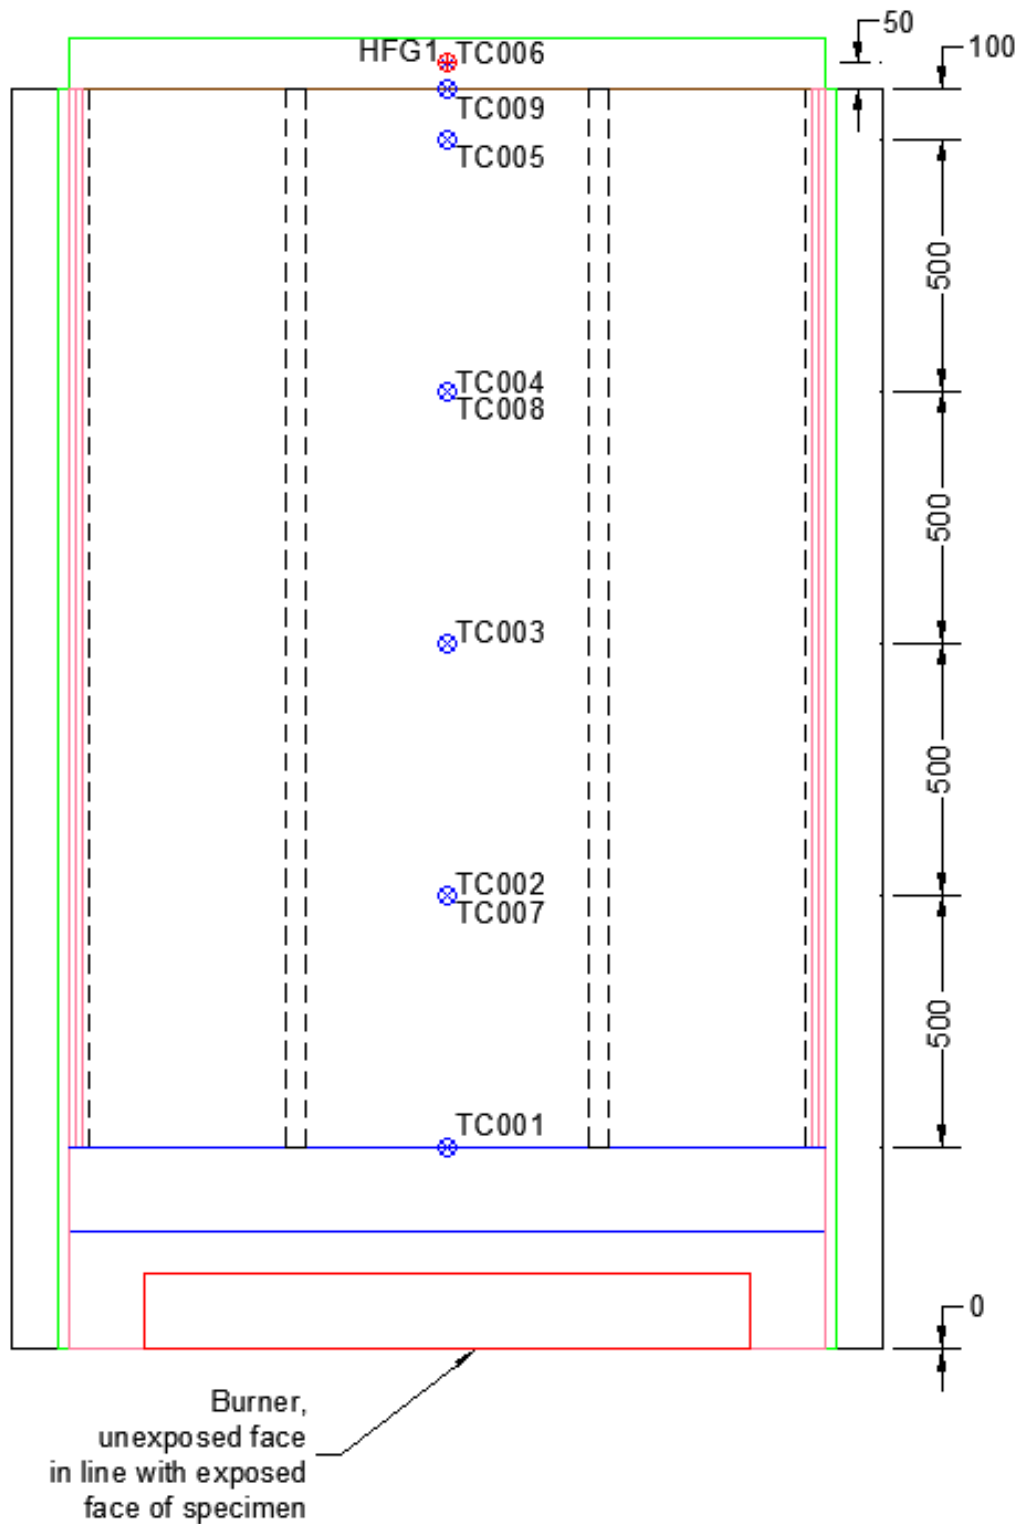
**Figure 13 Instrumentation locations – Exposed side view**

Initial horizontal wind speed	0.1 to 0.2 m/s (measured at a horizontal distance of 500 mm away from the façade face before the test)	
Test duration	60 minutes	
Instrumentation and equipment	<ul style="list-style-type: none"> <li>6 mineral insulated metal sheathed (MIMS) Type K thermocouples with an overall diameter of 1.5 mm with the measuring junction insulated from the sheath were positioned at various heights, 50 mm in front of the outer face of the test specimen along its vertical centreline. Refer to Figure 13 and Figure 14 in Appendix C for details on positioning.</li> <li>3 MIMS Type K thermocouples with an overall diameter of 1.5 mm with the measuring junction insulated from the sheath were positioned at various heights at mid-depth of the framing cavity of the test specimen. Refer to Figure 13 and Figure 14 in Appendix C for details on positioning.</li> <li>The fire source was a propane (95 % purity) gas fuelled box burner; 1.2 m wide × 0.1 m deep × 0.15 m tall. The burner was located on the floor in front of the specimen, with the back edge of the burner in line with the exposed face of the specimen.</li> <li>The incident heat flux 50 mm above and in line with the exposed face of the test specimen was measured using a Schmidt-Boelter type heat flux gauge with a range of 0 - 50 kW/m<sup>2</sup>.</li> <li>The products of combustion were collected in an exhaust hood located centrally above the exposed face of the tested specimen. The hood was connected to an exhaust duct 400 mm in diameter, which had instruments inside to measure the conditions and properties of the combustion products during the test. The hood had specifications based on those given in AS ISO 9705:2003 (R2016), with the only differences being that all four sides had 1 m blanking sheet extensions, and there was no fire test room.</li> <li>The volume flow rate was determined using a bidirectional pressure probe attached to a differential pressure transmitter together with a type K MIMS thermocouple positioned near the probe.</li> <li>Smoke obscuration measurements were made using a helium-neon laser smoke photometer, as outlined in Annex H of ISO 9705-1:2016.</li> <li>The temperature of the exhaust stream near the light beam was measured using a type K MIMS thermocouple.</li> </ul>

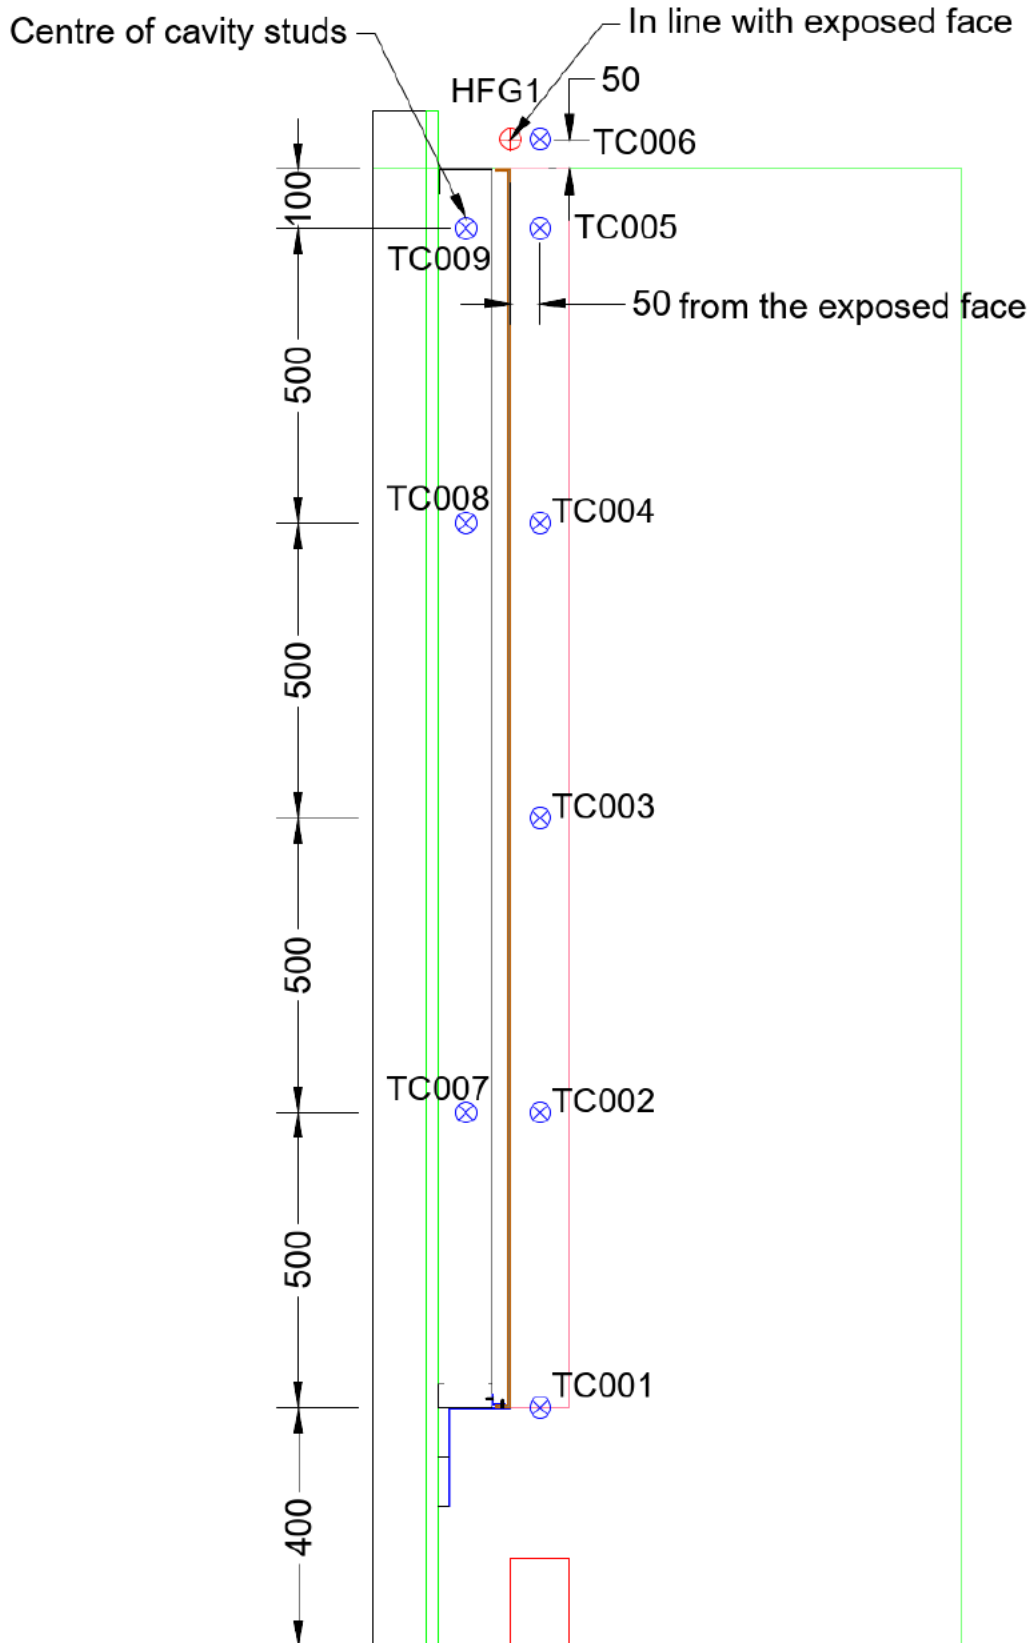
**Figure 14 Instrumentation locations – Vertical cross-sectional view**

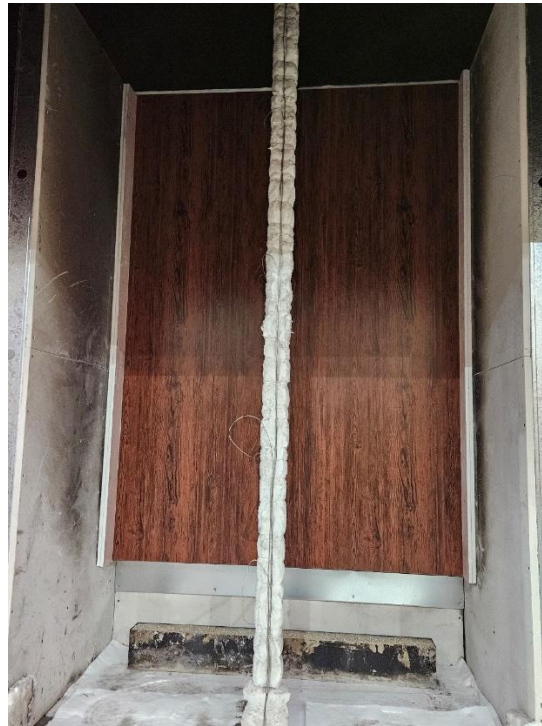
**Figure 16** The specimen before the reaction to fire test – exposed side

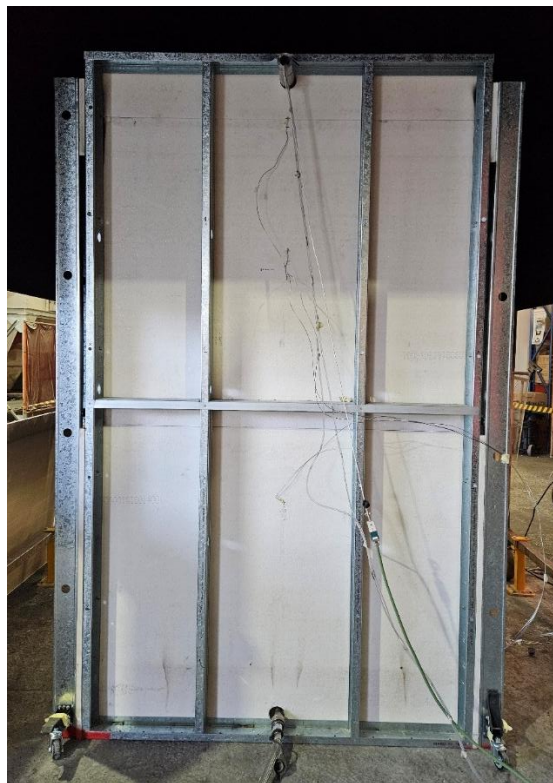
**Figure 17** The specimen (unexposed side) before the reaction to fire test

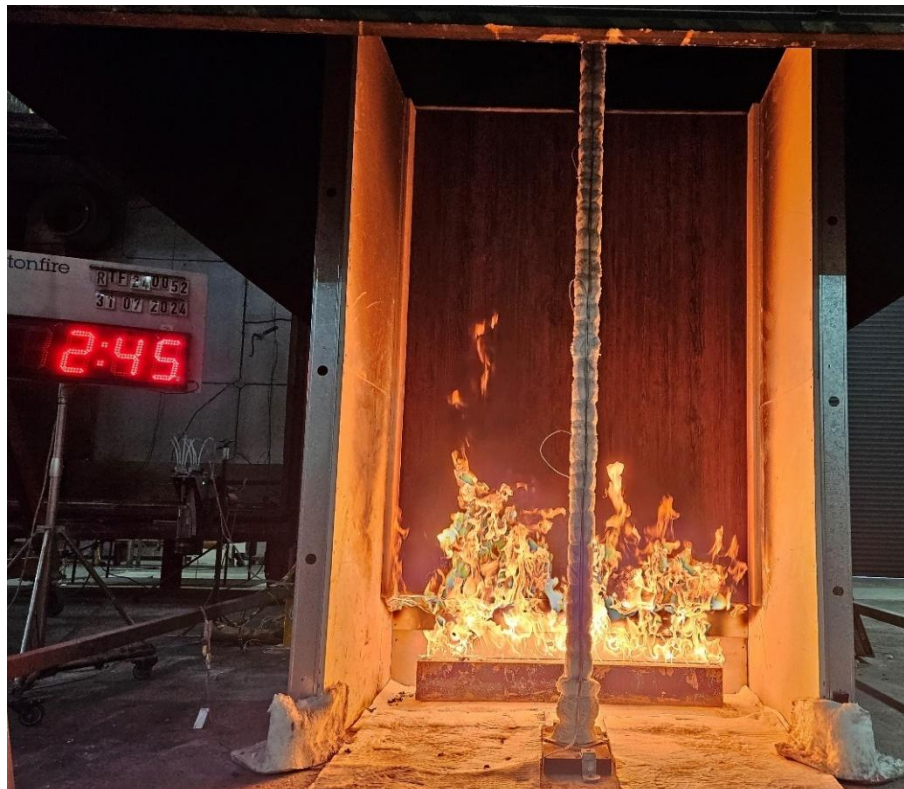
**Figure 18** The specimen 2 minutes 45 seconds into the test (burner output at 100 kW)

Time		Observation
Min	Sec	
-2	00	Data collection started.
0	00	The reaction to fire test was started with the burner ignited with a heat output set at 100 kW.
1	11	The bottom steel angle started to bend due to the heat.
2	22	Paint started to flake off from the bottom side of the specimen.
2	46	Colour at the bottom of the panel continued to fade and material started charring.
7	55	Material at the bottom side started melting and dripping on the top of burner.
15	00	The heat output of the burner was increased to 300 kW.
15	37	The first layer of the panel opened at the bottom side.
16	30	The bottom of the panel opened through to the insulation.
17	25	The panel opening continued upwards on the left side towards mid-section.
19	30	Fire reached the top side of specimen on the left side.
20	45	Molten material was dripping on the top of burner and floor.
25	35	Independent flaming on the left side of the panel was observed.

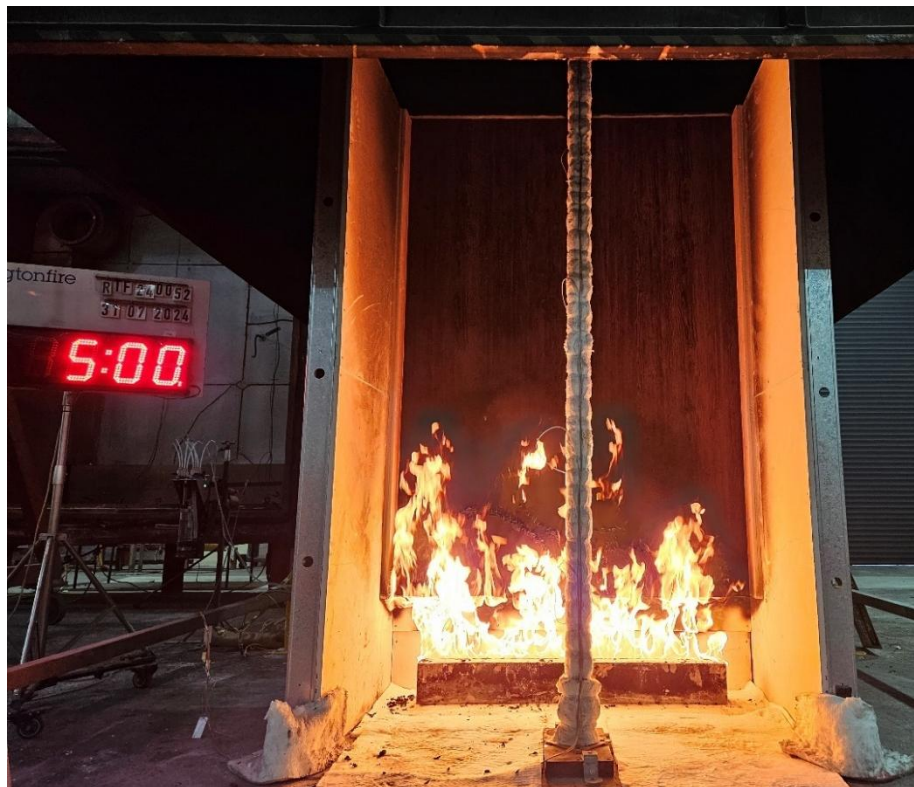
**Figure 19** The specimen 5 minutes into the test (burner output at 100 kW)

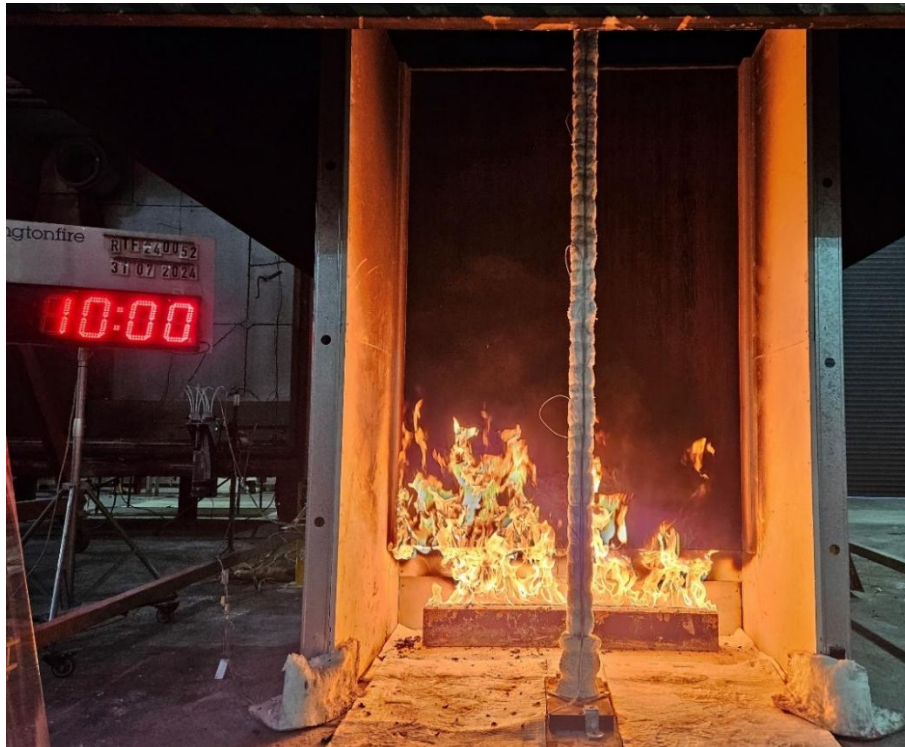
**Figure 20** The specimen 10 minutes into the test (burner output at 100 kW)

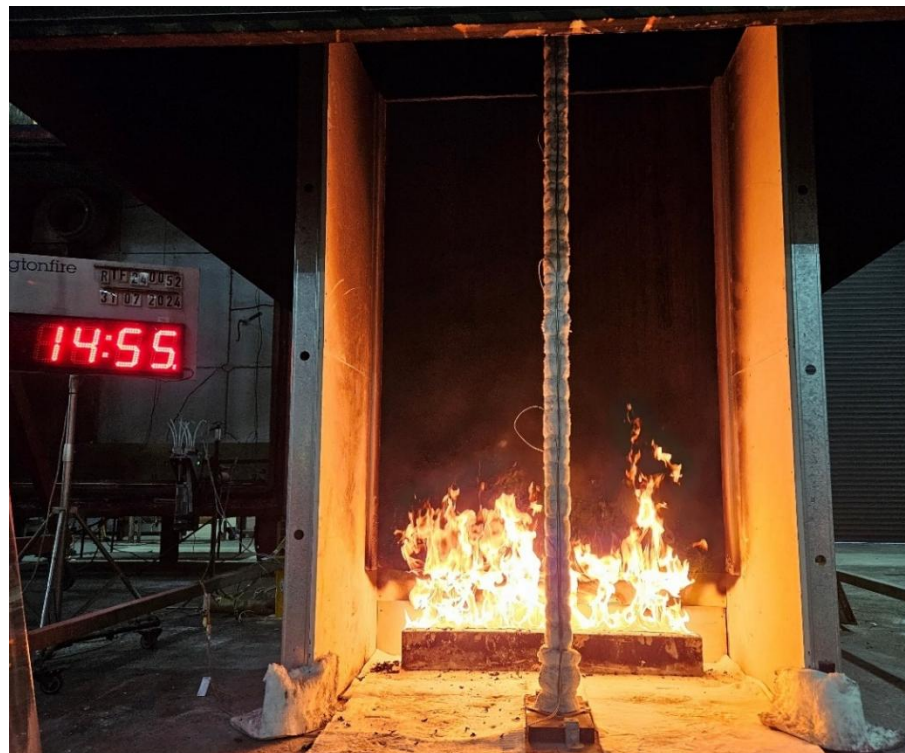
**Figure 21** The specimen 14 minutes 55 seconds into the test (burner output at 100 kW)

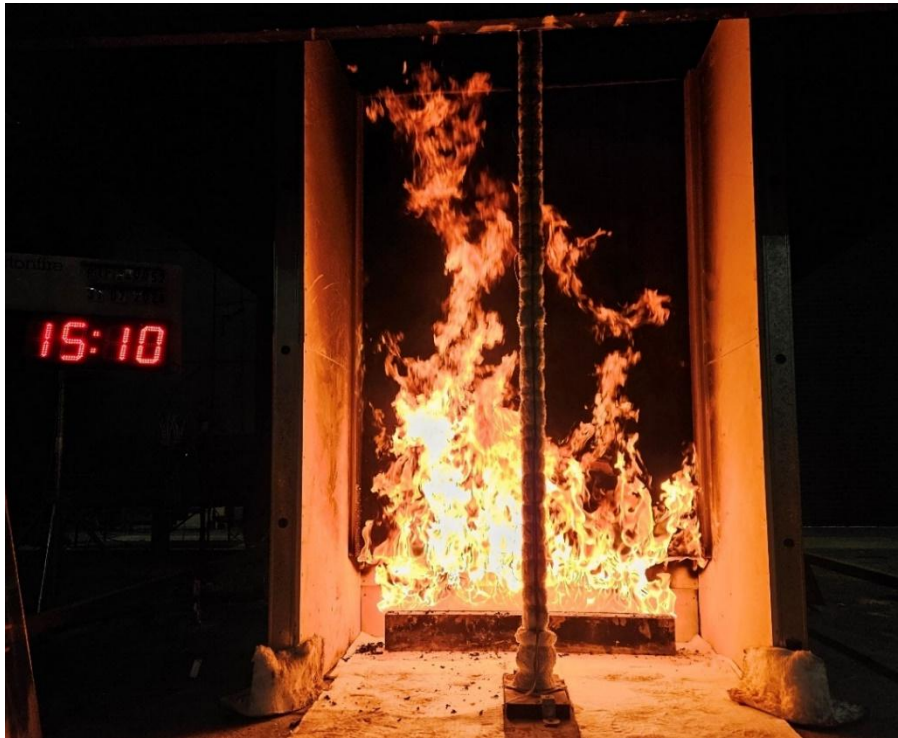
**Figure 22** The specimen 15 minutes 10 seconds into the test (burner output at 300 kW)

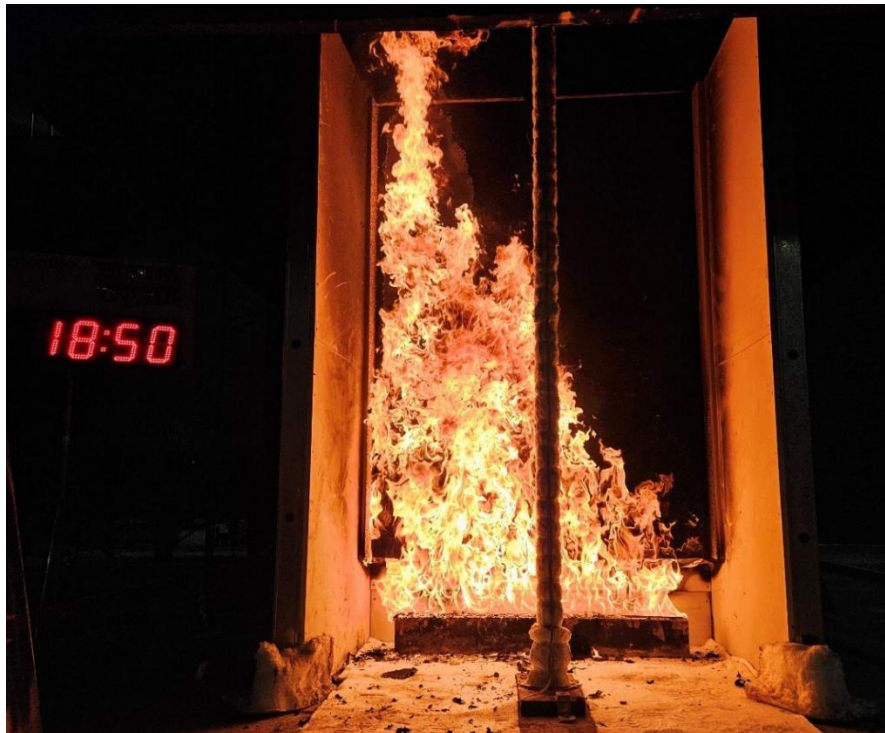
**Figure 23** The specimen 18 minutes 50 seconds into the test (burner output at 300 kW)

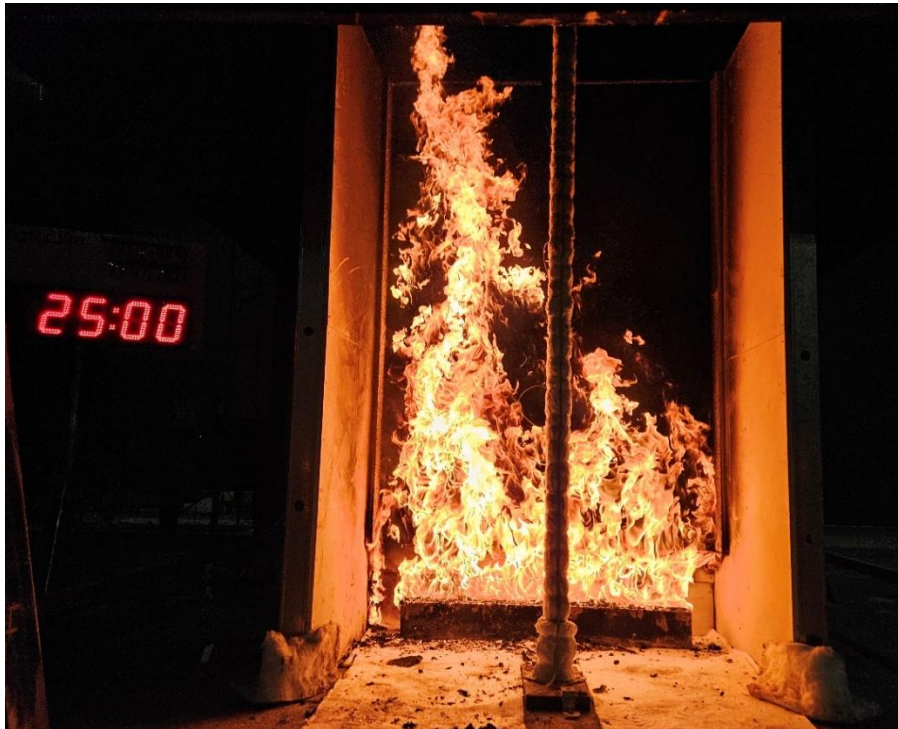
**Figure 24** The specimen 25 minutes into the test (burner output at 300 kW)

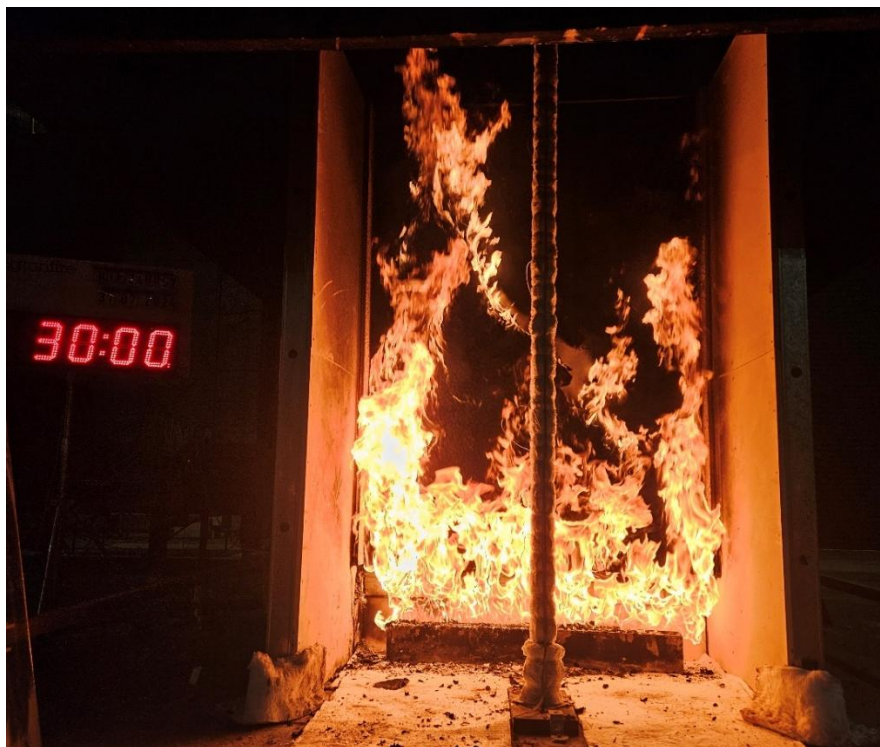
**Figure 25** The specimen 30 minutes into the test (burner output at 300 kW)

29	40	The right side of the panel started opening.
35	10	Most of the panel skin was charred from bottom to the mid-section.
40	00	Burner was turned off.
41	08	Some flaming is still there at the bottom side of the panel.
42	30	Burned skin of the panel kept charring.
45	10	Burned material kept charring on the floor.
45	33	All the flaming died off.
60	00	The reaction to fire test was ended.
