# Reaction to fire test report

Test standard: Ad-hoc test based on ISO 13785-1:2002

System: ACP with 45 % polyethylene core external façade cladding system with PET wall insulation

Job number: RTF240052

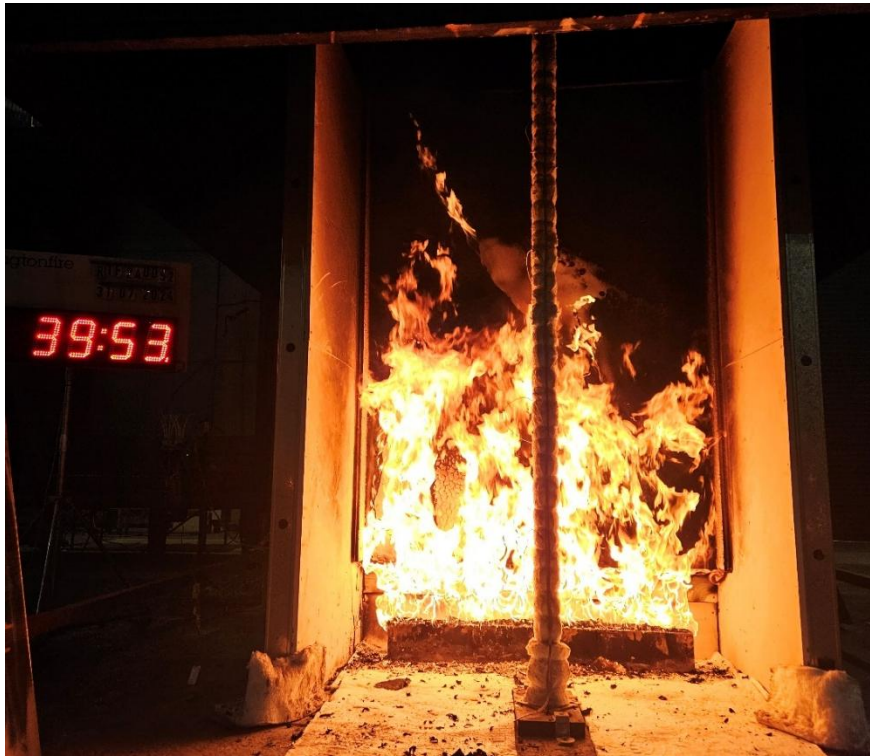
**Figure 26** The specimen 39 minutes 53 seconds into the test (burner output at 300 kW)

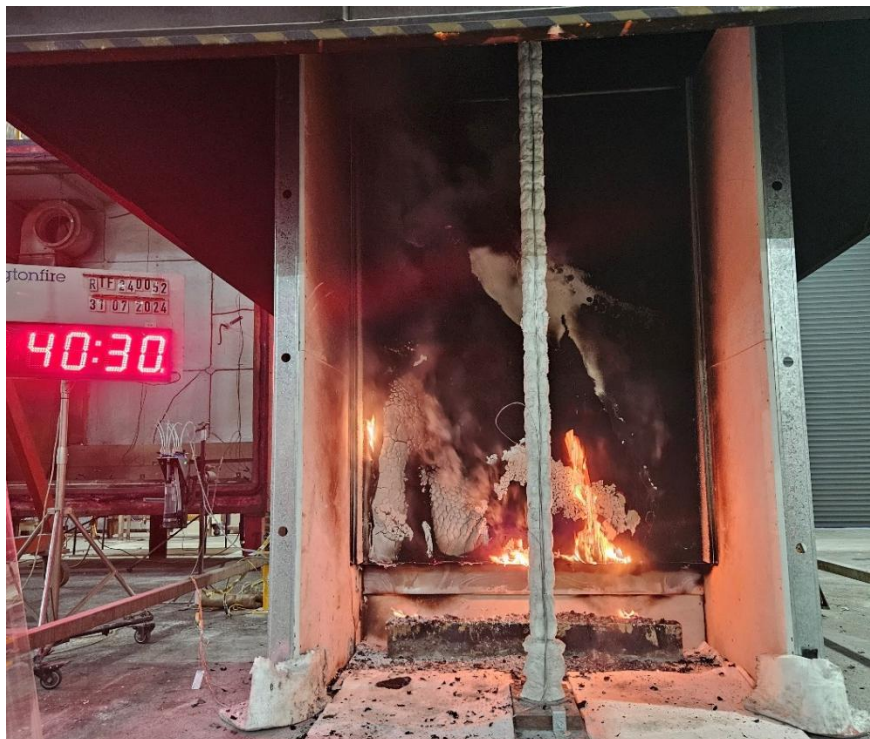
**Figure 27** The specimen 40 minutes 30 seconds into the test (burner off)

29	40	The right side of the panel started opening.
35	10	Most of the panel skin was charred from bottom to the mid-section.
40	00	Burner was turned off.
41	08	Some flaming is still there at the bottom side of the panel.
42	30	Burned skin of the panel kept charring.
45	10	Burned material kept charring on the floor.
45	33	All the flaming died off.
60	00	The reaction to fire test was ended.

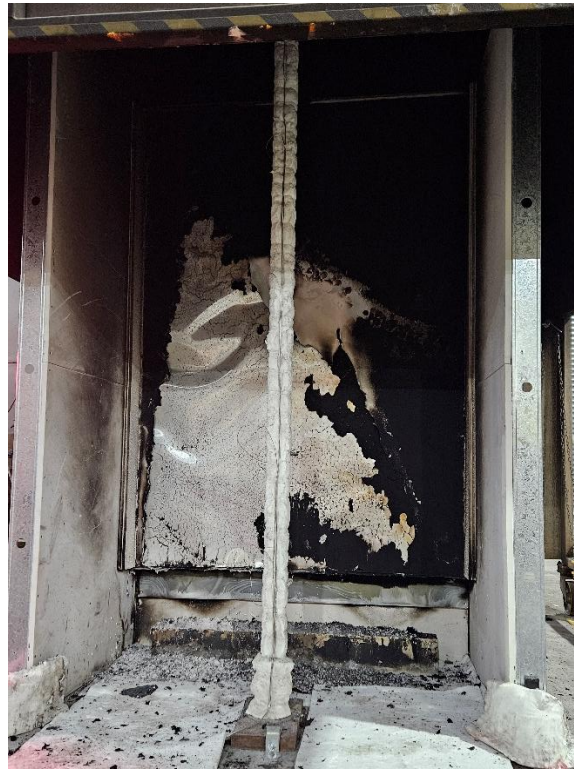
**Figure 28** The specimen at end of test – exposed side

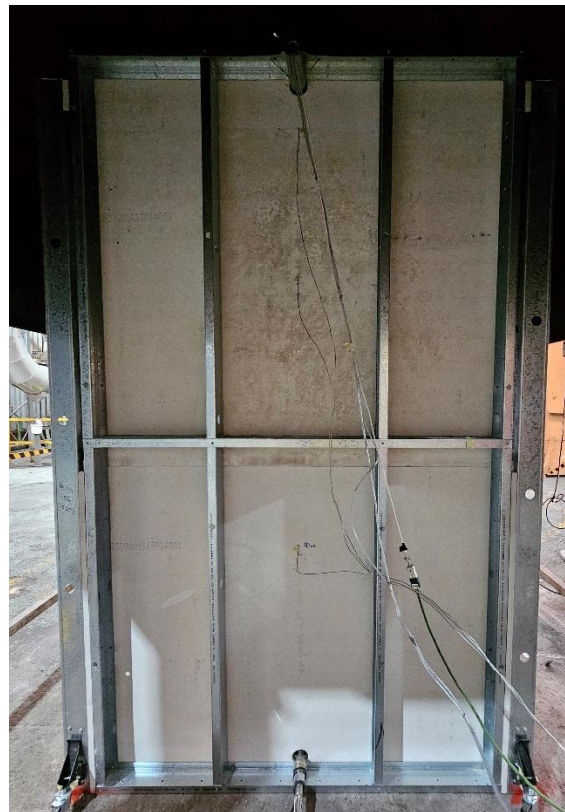
**Figure 29** The specimen at end of test – unexposed side

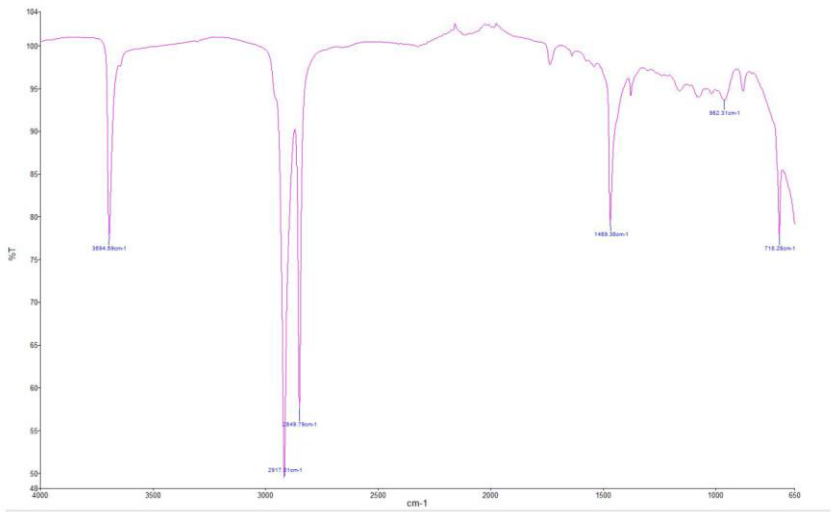
Figure 1. FT-IR spectrum of Sample #1

The aluminium metal was removed from the ACPs cladding polymer, and the flat surface of the polymer samples was abraded to remove any surface adhesive. The surface of each sample was analysed directly by FTIR. The FT-IR spectrum is presented in Figures 1-2.

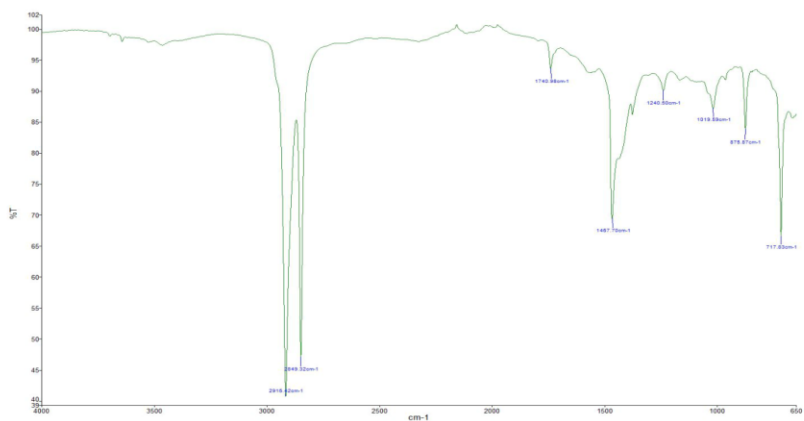
Figure 2. FT-IR spectrum of sample #2
