Reaction to fire test report

Test standard: Ad-hoc test based off ISO 13785-1:2002

System: A cassetted aluminium composite panel wall system

Job number: RTF230139

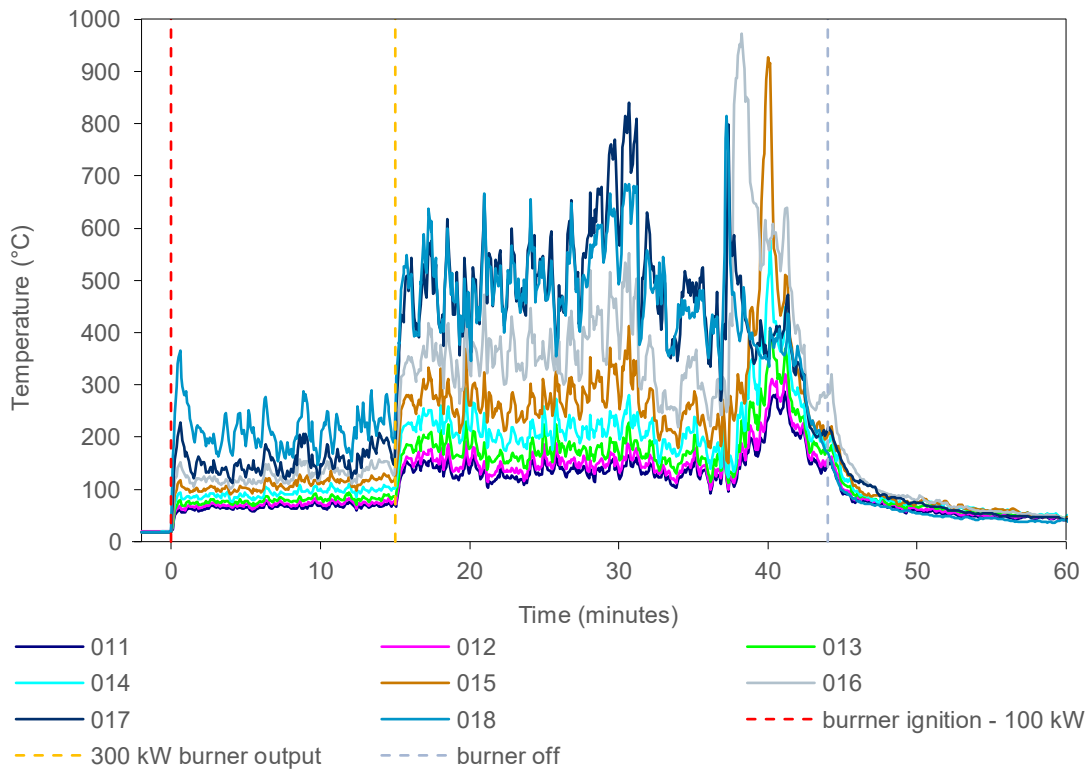
Figure 3 External temperature data collected by thermocouples placed 60 mm from the front face of the specimen.

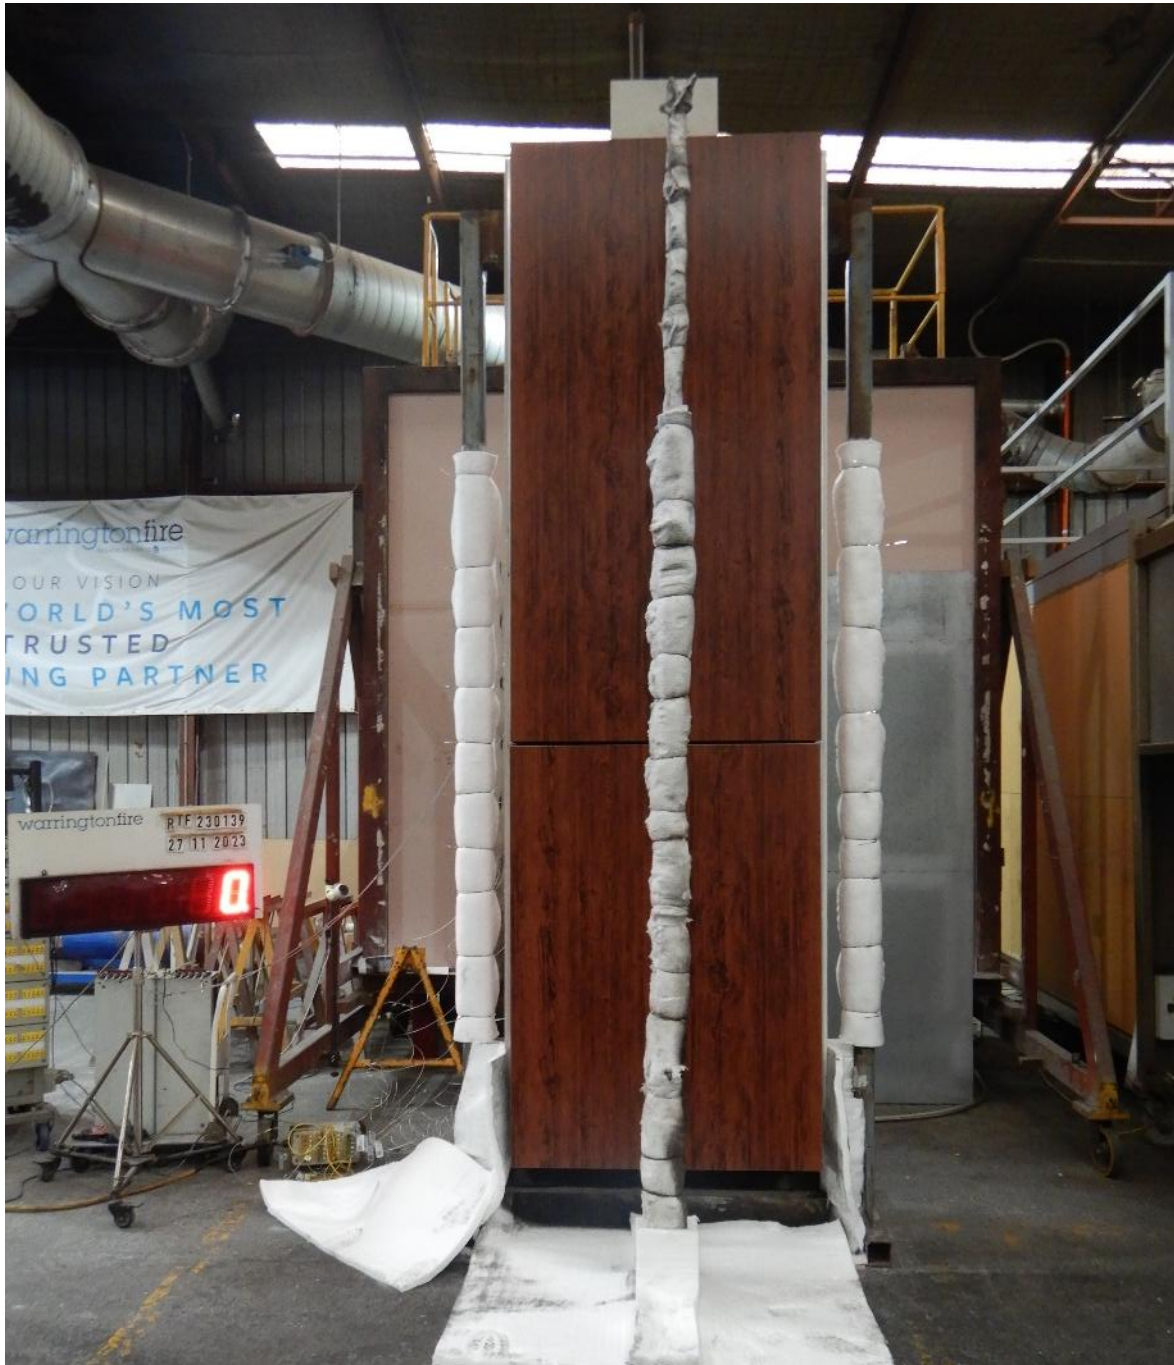
Figure 11 The specimen before the reaction to fire test

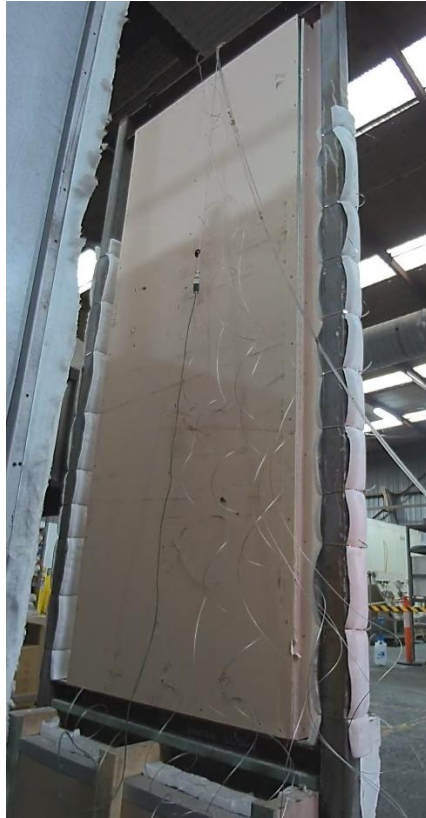
Figure 12 **The specimen before the reaction to fire test – unexposed side**

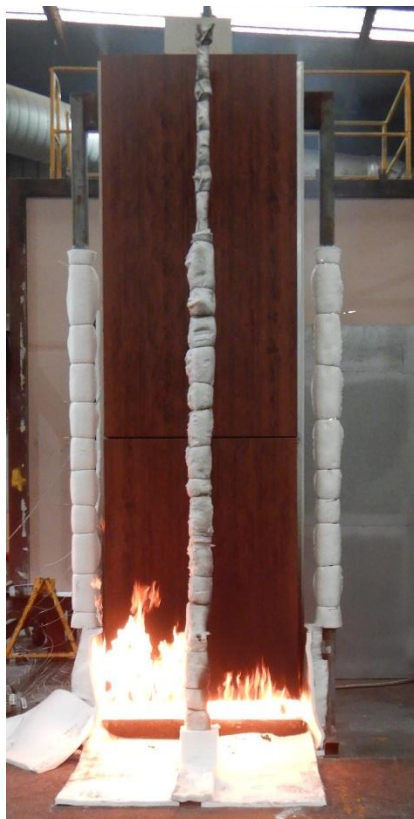
Figure 13 **The specimen 3 minutes 58 seconds into the test (burner output at 100 kW)**

Time		Section	Observation
Min	Sec		
-2	00	All	Data collection started.
0	00	All	The reaction to fire test was started with the burner ignited with a heat output set at 100 kW.
2	30	All	Smoke was emitted from the top corners of the test rig.
3	11	1A	Flaming debris fell from the left side.
3	47	1A	The skin had become discoloured.
4	37	1A	Flaming debris fell from the left side and continued flaming for longer than 20 seconds.
6	56	1A	Flaming debris fell from the right side and continued flaming for longer than 20 seconds.
10	30	All	Smoke was emitted from the plasterboard cavity at the top of the test rig.
15	00	All	The burner output was increased to 300 kW.
15	09	1C	Flames were consistently reaching up to section 1C.
15	52	1A/1B/1C	The panel skin was peeling off.
16	06	All	A buildup of gas was released from the sides of the specimen.
16	30	1A	The core of the panel had become exposed on the left side.
17	20	2A	Flames were consistently reaching up to section 2A.

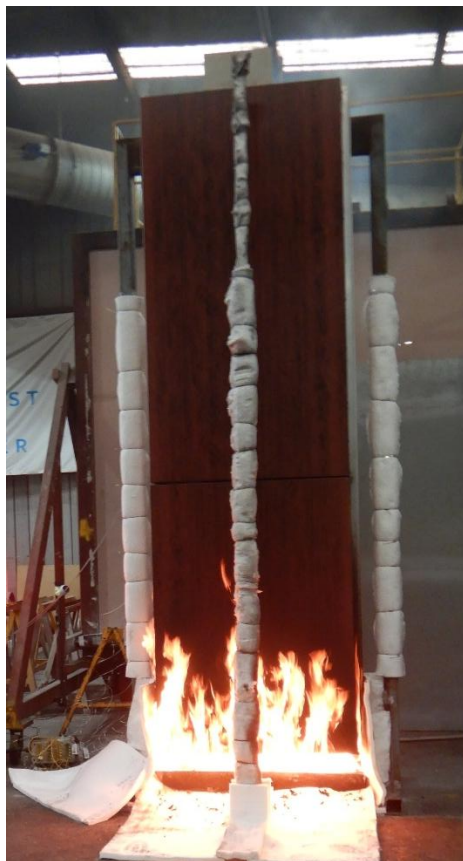
Figure 14 The specimen 8 minutes 49 seconds into the test (burner output at 100 kW)

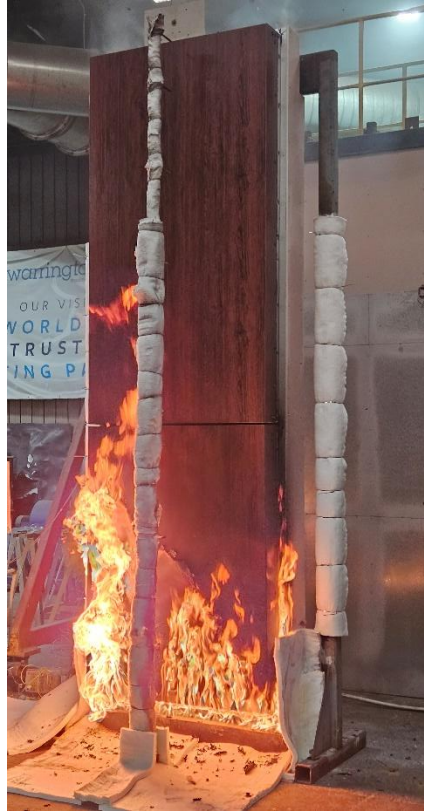
Figure 16 **The specimen 16 minutes 12 seconds into the test (1 minute 12 seconds after burner output was changed to 300 kW)**

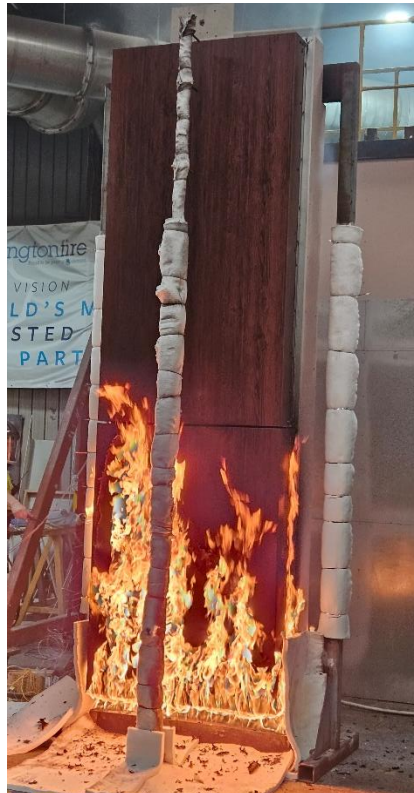
Figure 17 **The specimen 18 minutes 44 seconds into the test (3 minutes 44 seconds after burner output was changed to 300 kW)**

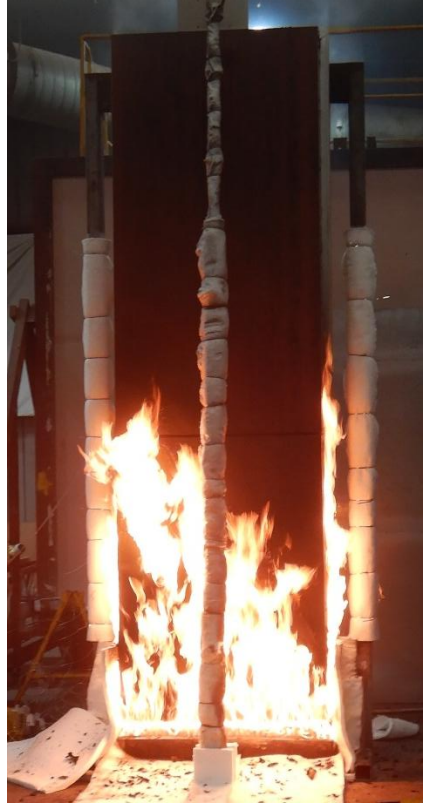
Figure 18 The specimen 21 minutes 40 seconds into the test (6 minutes 40 seconds after burner output was changed to 300 kW)

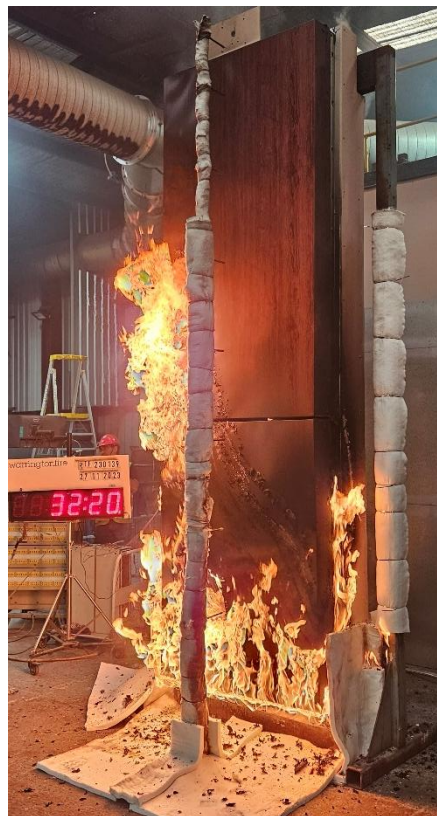
Figure 19 The specimen 32 minutes 20 seconds into the test (17 minutes 20 seconds after burner output was changed to 300 kW)

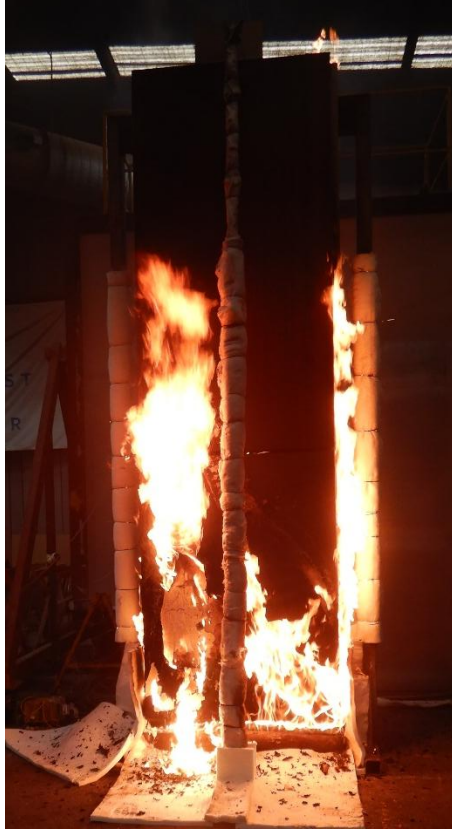
Figure 20 **The specimen 36 minutes 37 seconds into the test (21 minutes 37 seconds after burner output was changed to 300 kW)**

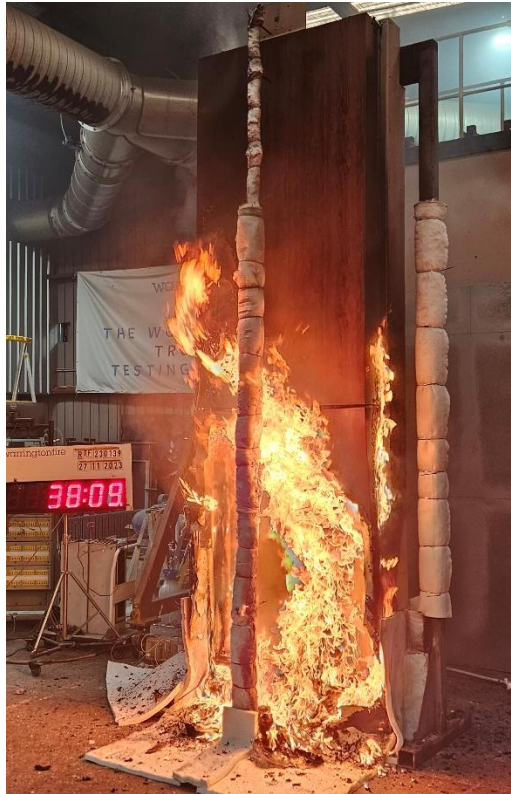
Figure 21 The specimen 38 minutes 9 seconds into the test (23 minutes 9 seconds after burner output was changed to 300 kW)

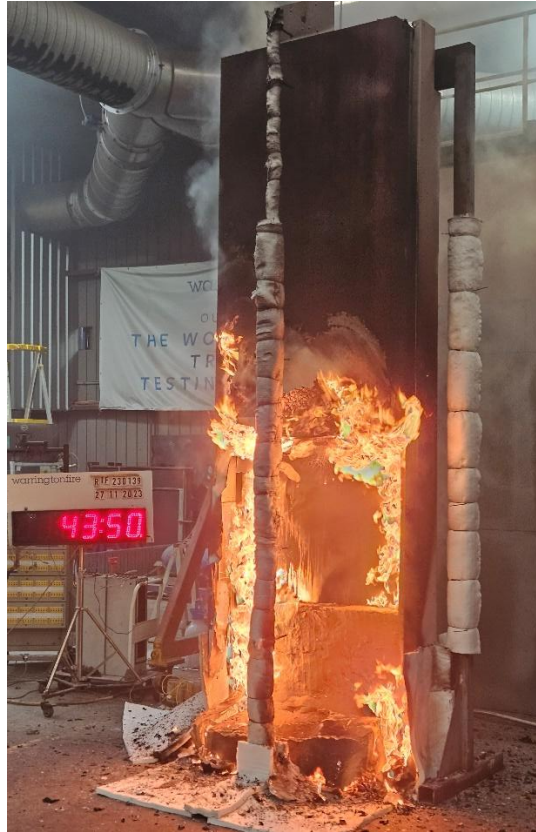
Figure 22 The specimen 43 minutes 50 seconds into the test (28 minutes 50 seconds after burner output was changed to 300 kW)

43	28	All	A large piece of insulation fell on and covered the burner.
44	00	All	The burner was switched off.
45	30	1A/1C/2A	The debris continued to flame on and around the burner. The join between the two panels at sections 1C and 2A continued to flame.
52	00	2A/2B	External flaming ceased. Flaming continued inside the upper panel cavity.
58	50	All	Internal flaming had decreased significantly.
60	00	All	The reaction to fire test ended.

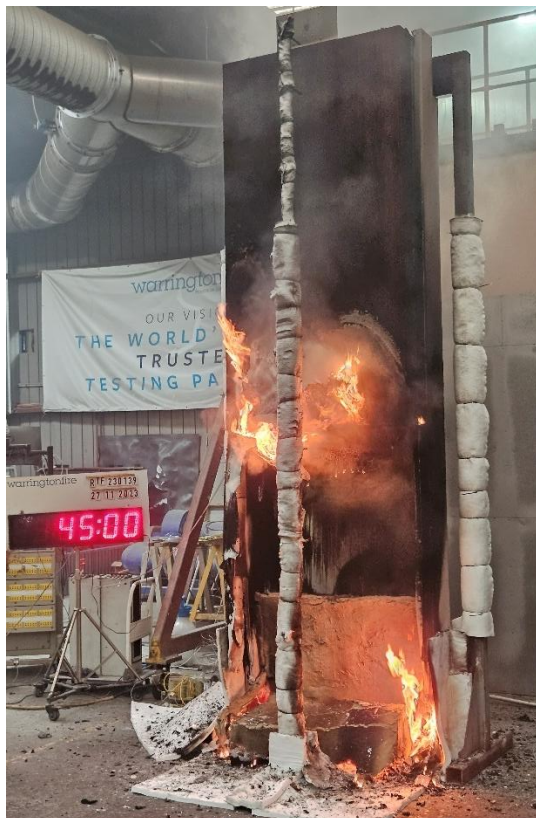
Figure 23 The specimen 45 minutes into the test (1 minute after burner was switched off)

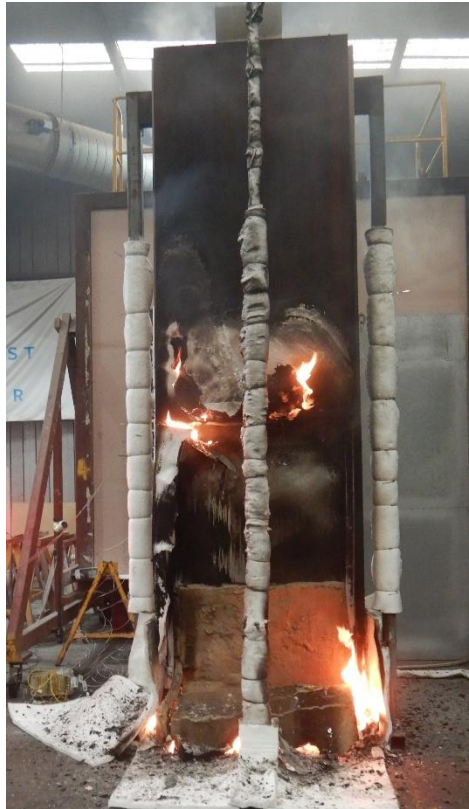
Figure 24 The specimen 47 minutes 58 seconds into the test (3 minutes 58 seconds after burner was switched off)

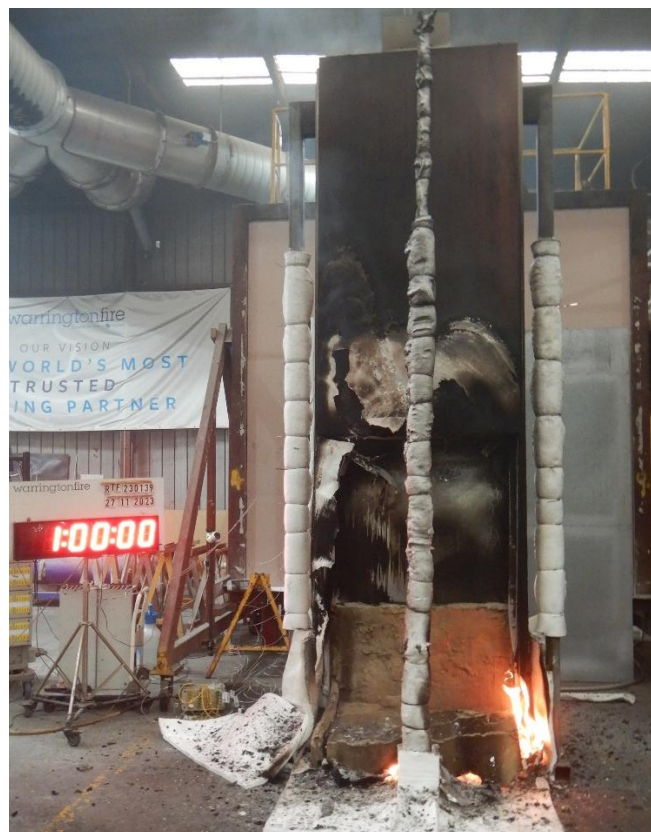
Figure 25 The specimen at the end of the test

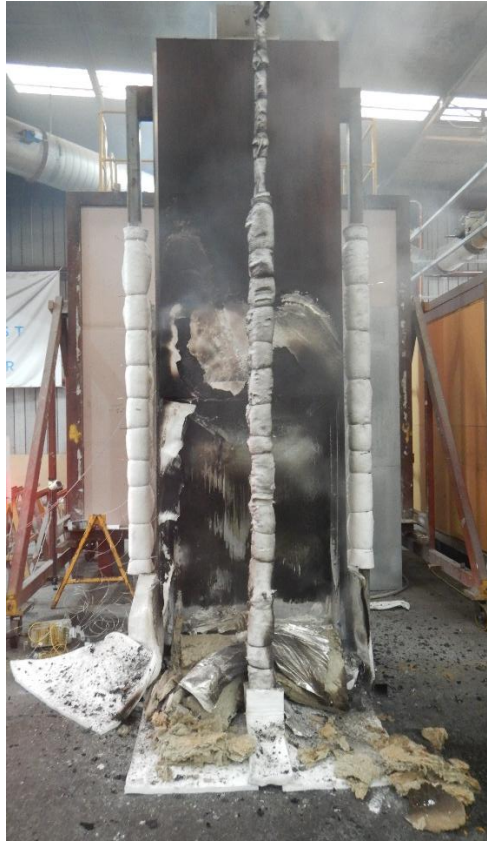
Figure 26 The specimen after the test, after being sprayed with water.

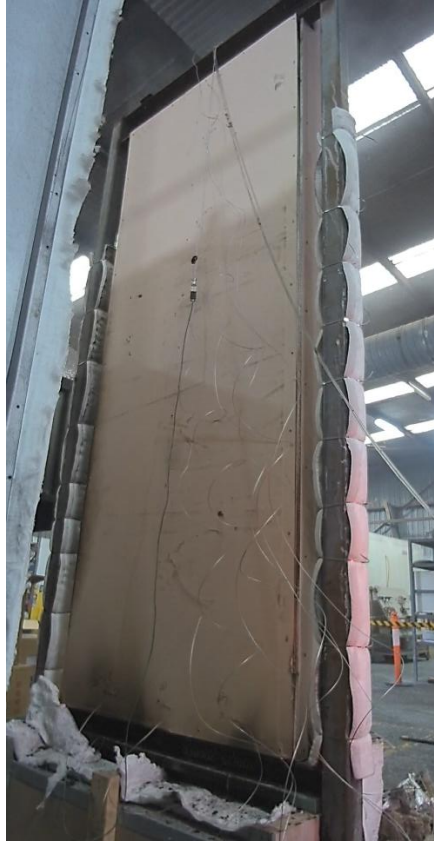
Figure 27 **The specimen after the test – unexposed side.**

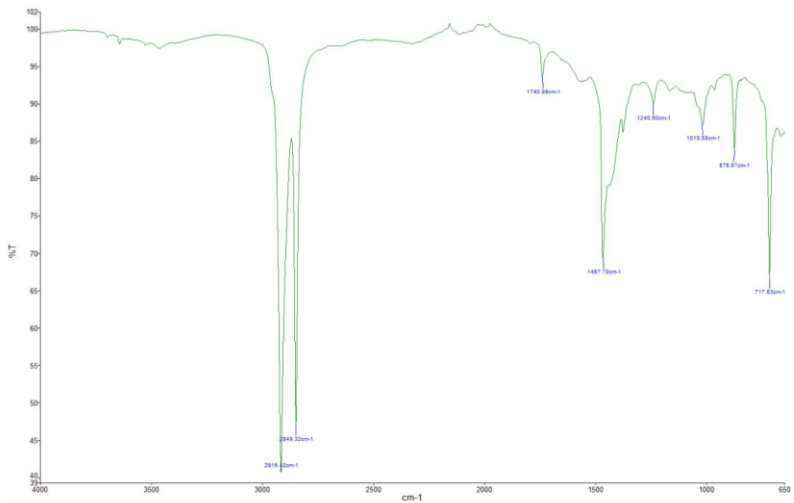
Figure 2. FT-IR spectrum of sample #2

The aluminium metal was removed from the ACPs cladding polymer, and the flat surface of the polymer samples was abraded to remove any surface adhesive. The surface of each sample was analysed directly by FTIR. The FT-IR spectrum is presented in Figures 1-2.

The cladding sample#2 consisted of consisted of 21.6% inert material and approximately 78.4% polyethylene/EVA copolymer.
