Reaction to fire test report

Test standard: Ad-hoc test based off ISO 13785-1:2002

System: A cassetted aluminium composite panel wall system

Job number: RTF230139

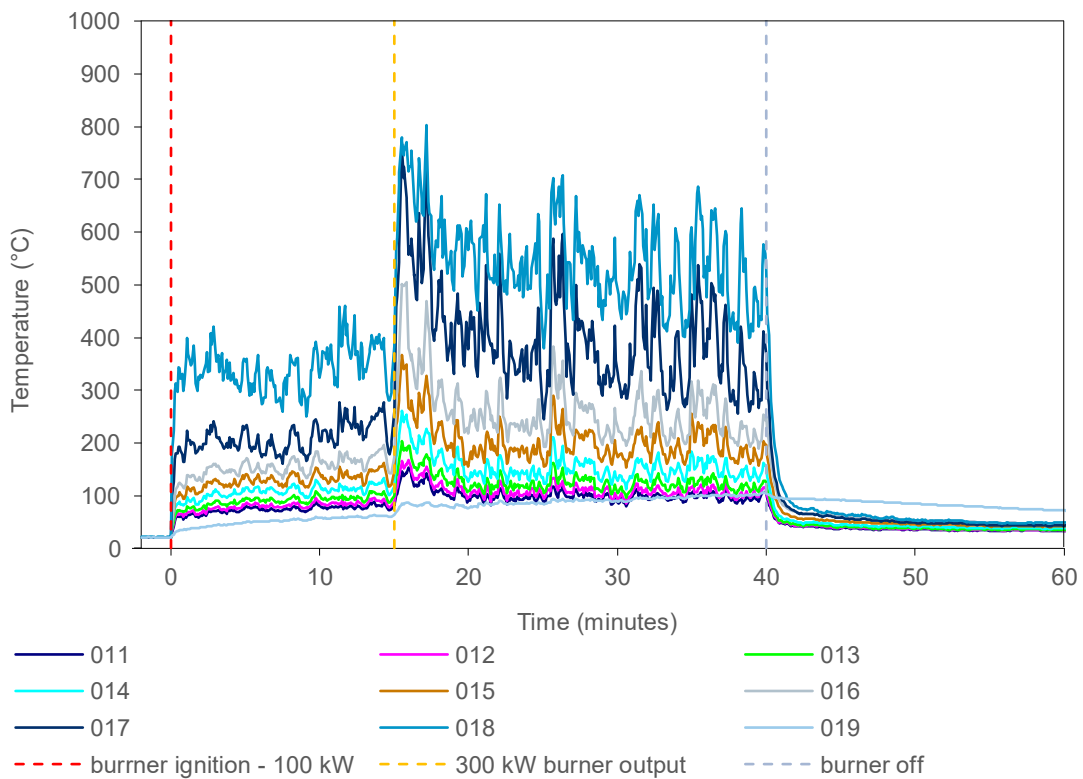
Figure 3 External temperature data collected by thermocouples placed 60 mm from the front face of the specimen.

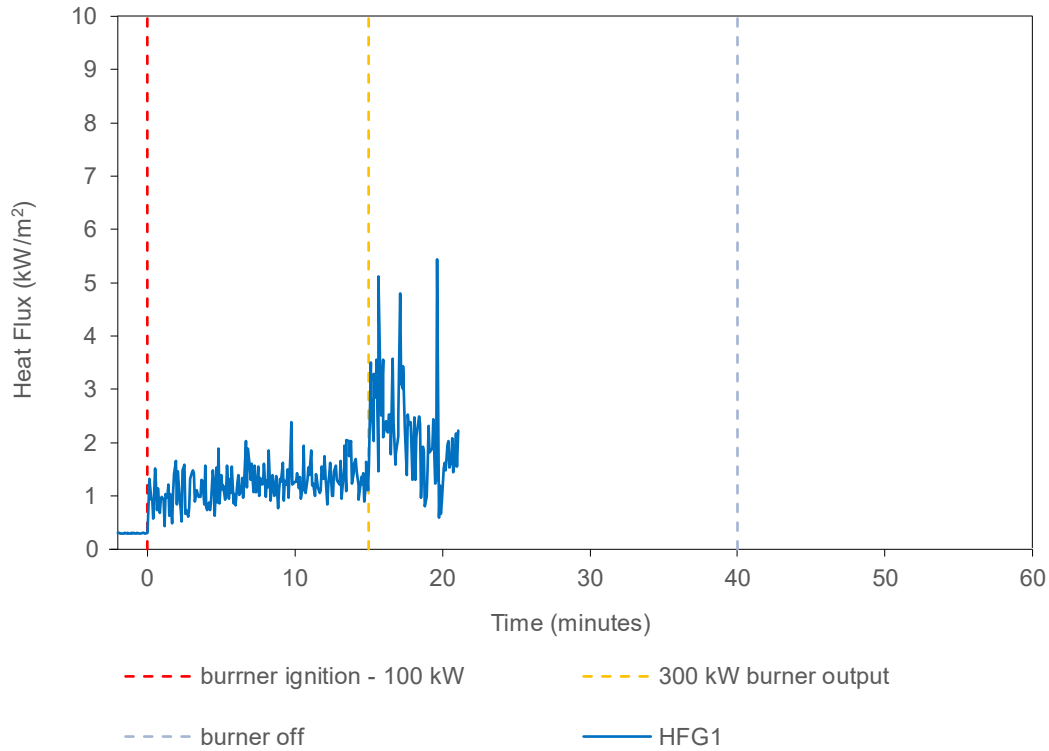
Figure 4 Heat flux data collected by heat flux gauge.

Note: At 21 minutes 7 seconds, the water cooling pipe became disconnected from the heat flux gauge.

20	35	All	A buildup of gas was released out from the sides of the specimen.
21	07	All	The water cooling pipe became disconnected from the heat flux gauge.
21	19	All	Significant flaming was present on the right side of the specimen, to a height of 2B.
22	09	2A	The corners of the panel were deforming outwards.
29	00	1C/2A	The join sustained flaming on the left side, which appeared to be independent of the burner.
40	00	All	The burner was switched off.
42	55	1A/2A	The panel was flaming at the edges.
44	10	1C/2A	Intermittent flaming was present in the join between the two panels.
45	55	All	External flaming had decreased, and smoke emissions had increased.
50	27	All	External flaming ceased.
60	00	All	The reaction to fire test ended.

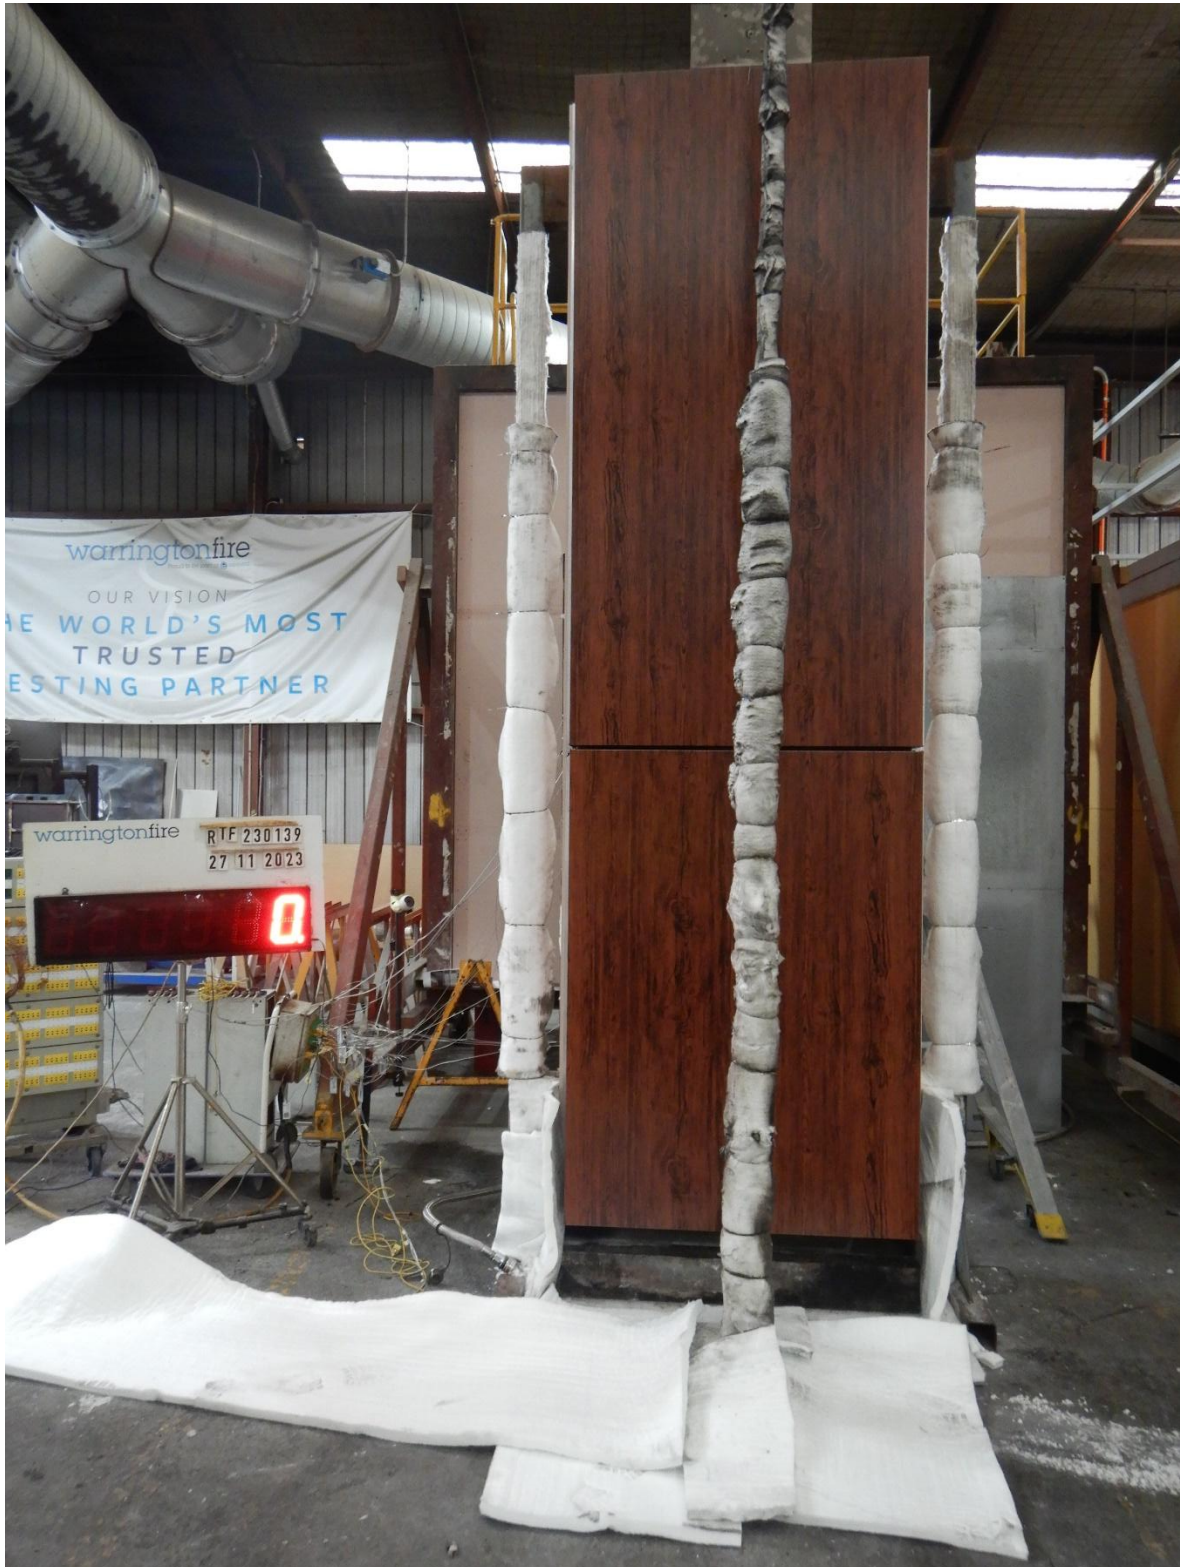
Figure 11 The specimen before the reaction to fire test

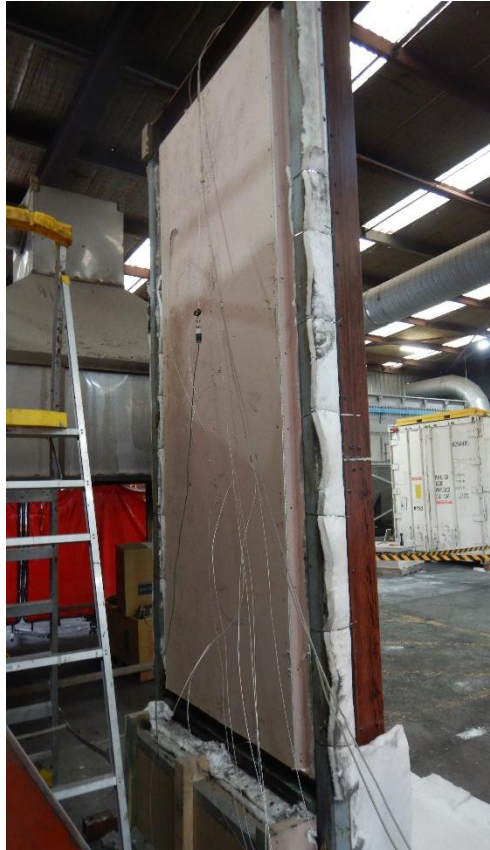
Figure 12 The specimen before the reaction to fire test – unexposed side

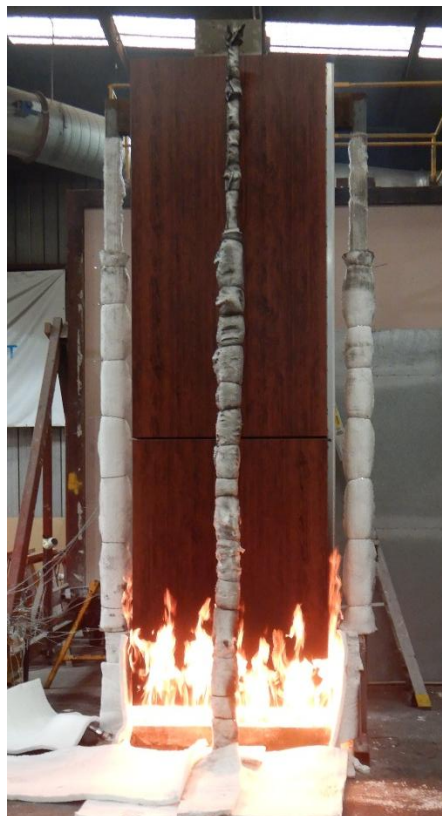
Figure 13 The specimen 2 minutes 44 seconds into the test (burner output at 100 kW)

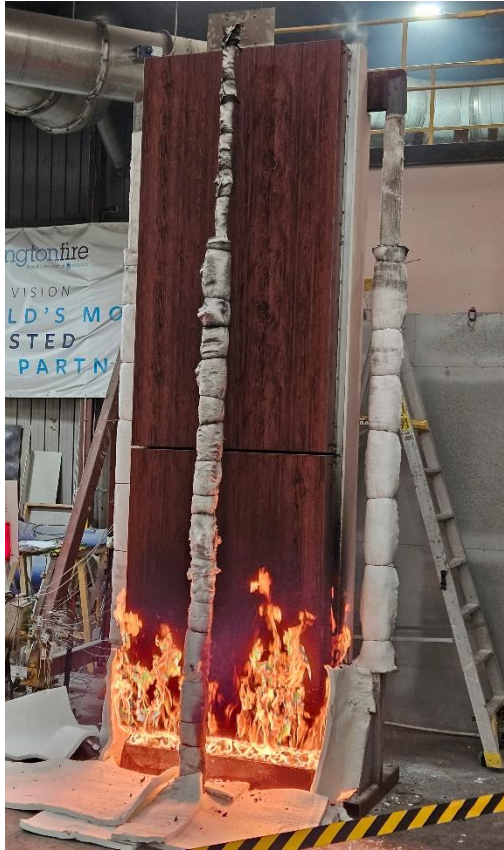
Figure 14 The specimen 8 minutes 35 seconds into the test (burner output at 100 kW)

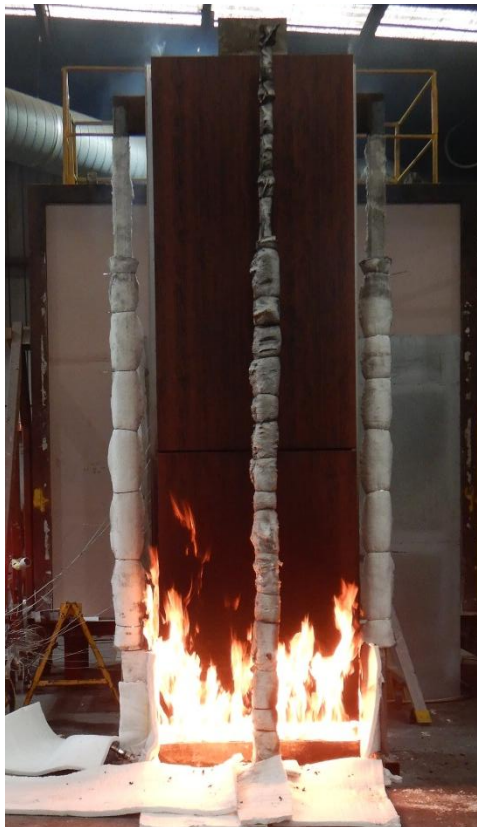
Figure 15 The specimen 14 minutes 55 seconds into the test (burner output at 100 kW)

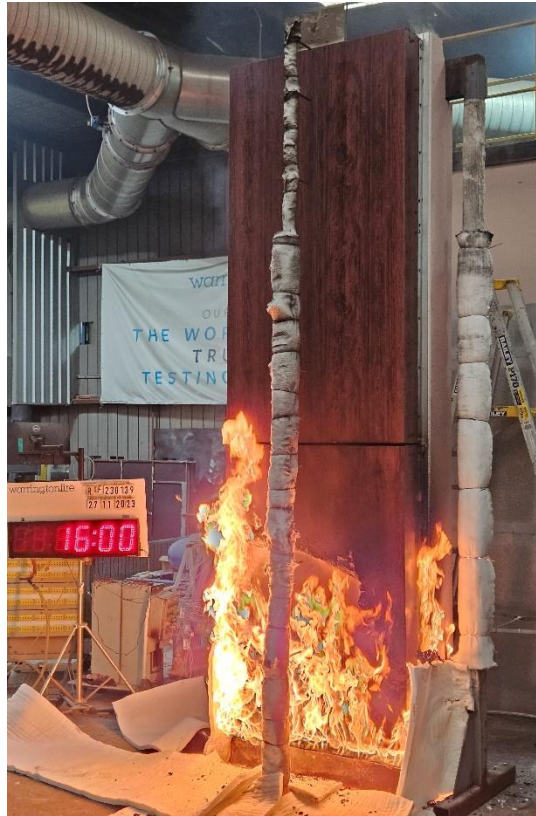
Figure 16 The specimen 16 minutes into the test (1 minute after burner output was changed to 300 kW)

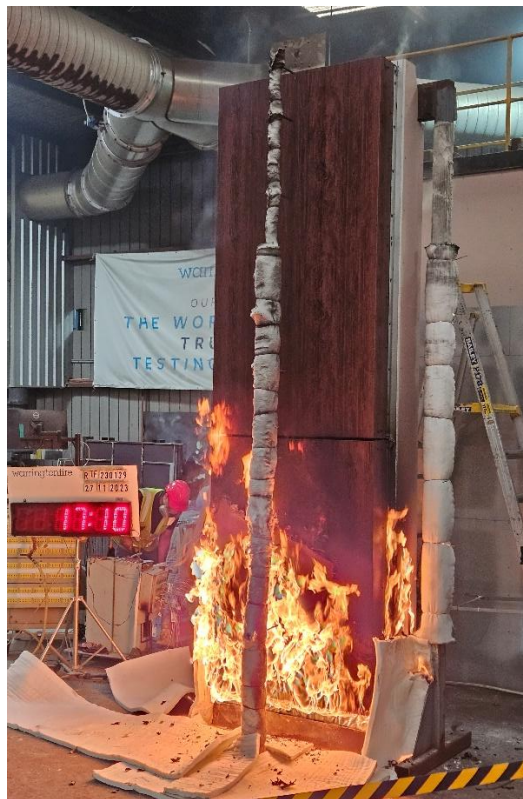
Figure 17 The specimen 17 minutes 10 seconds into the test (2 minutes 10 seconds after burner output was changed to 300 kW)

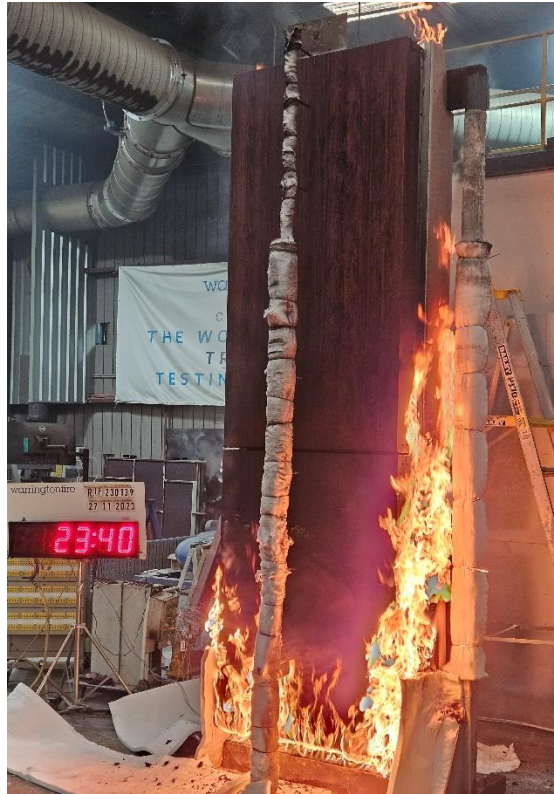
Figure 18 The specimen 23 minutes 40 seconds into the test (8 minutes 40 seconds after burner output was changed to 300 kW)

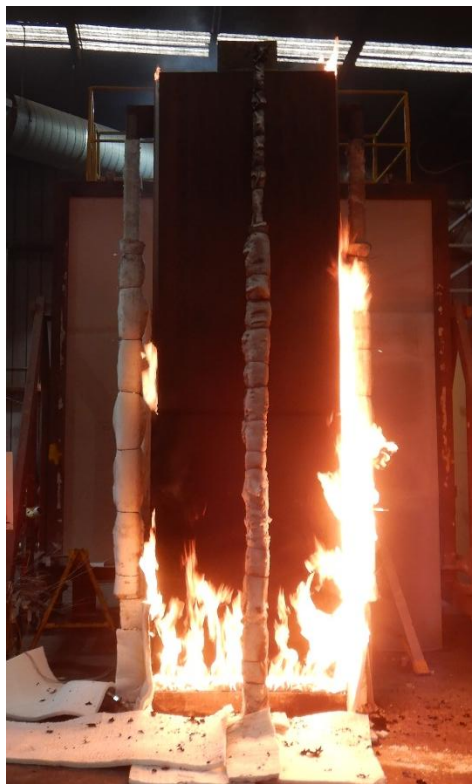
Figure 19 The specimen 29 minutes 50 seconds into the test (14 minutes 50 seconds after burner output was changed to 300 kW)

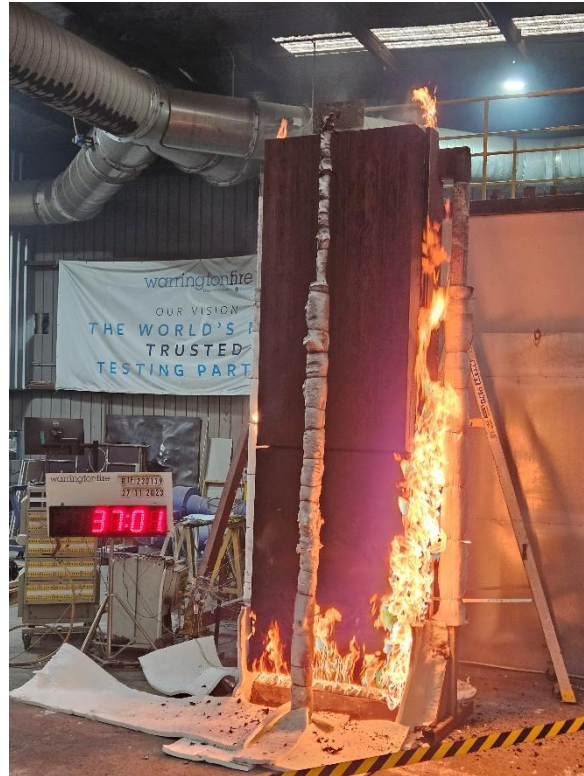
Figure 20 The specimen 37 minutes 1 second into the test (22 minutes 1 second after burner output was changed to 300 kW)

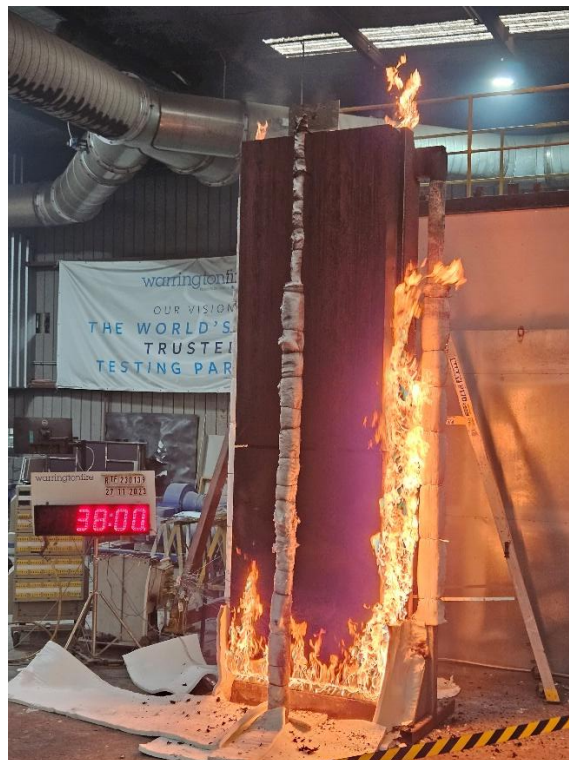
Figure 21 The specimen 38 minutes into the test (23 minutes after burner output was changed to 300 kW)

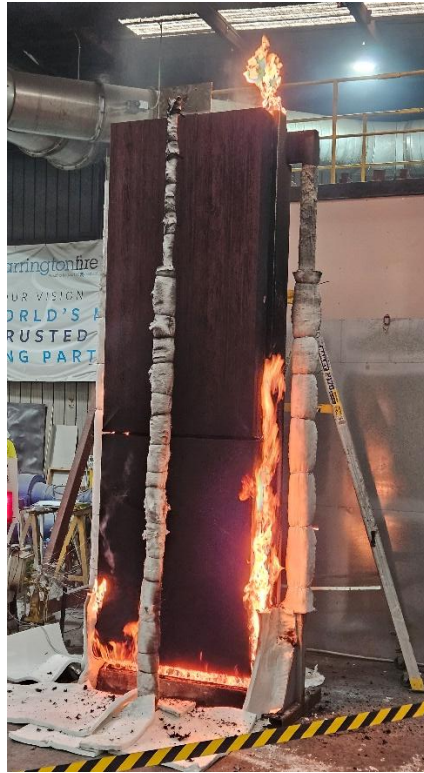
Figure 22 **The specimen 40 minutes 30 seconds into the test (30 seconds after burner was switched off)**

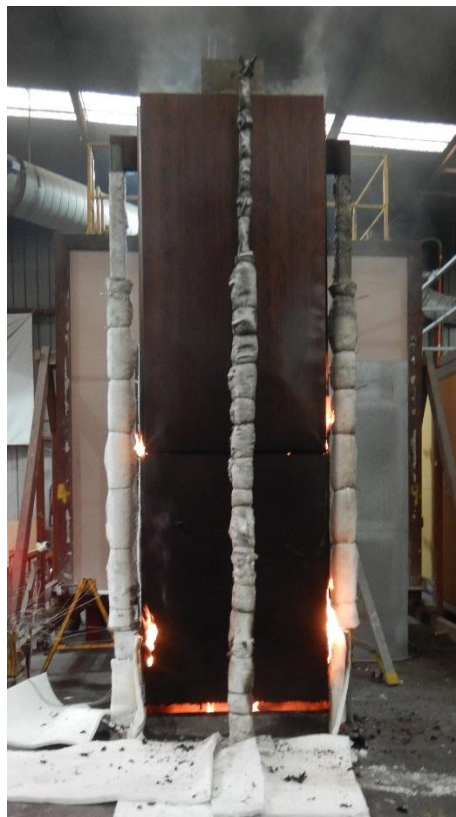
Figure 23 **The specimen 42 minutes 25 seconds into the test (2 minutes 25 seconds after burner was switched off)**

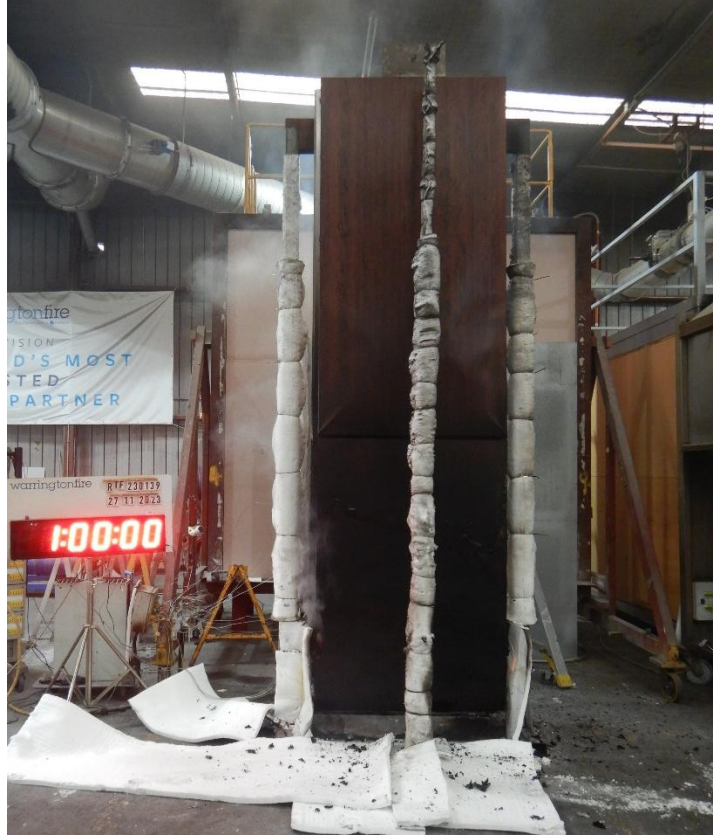
Figure 24 The specimen at the end of the test

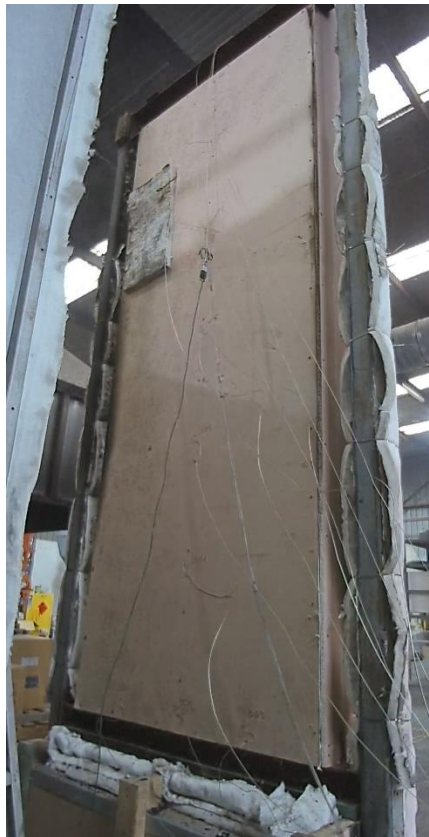
Figure 25 The specimen after the test – unexposed side
