Reaction to fire test report

Test standard: Ad-hoc test based off ISO 13785-1:2002

System: A cassetted aluminium composite panel wall system

Job number: RTF230139

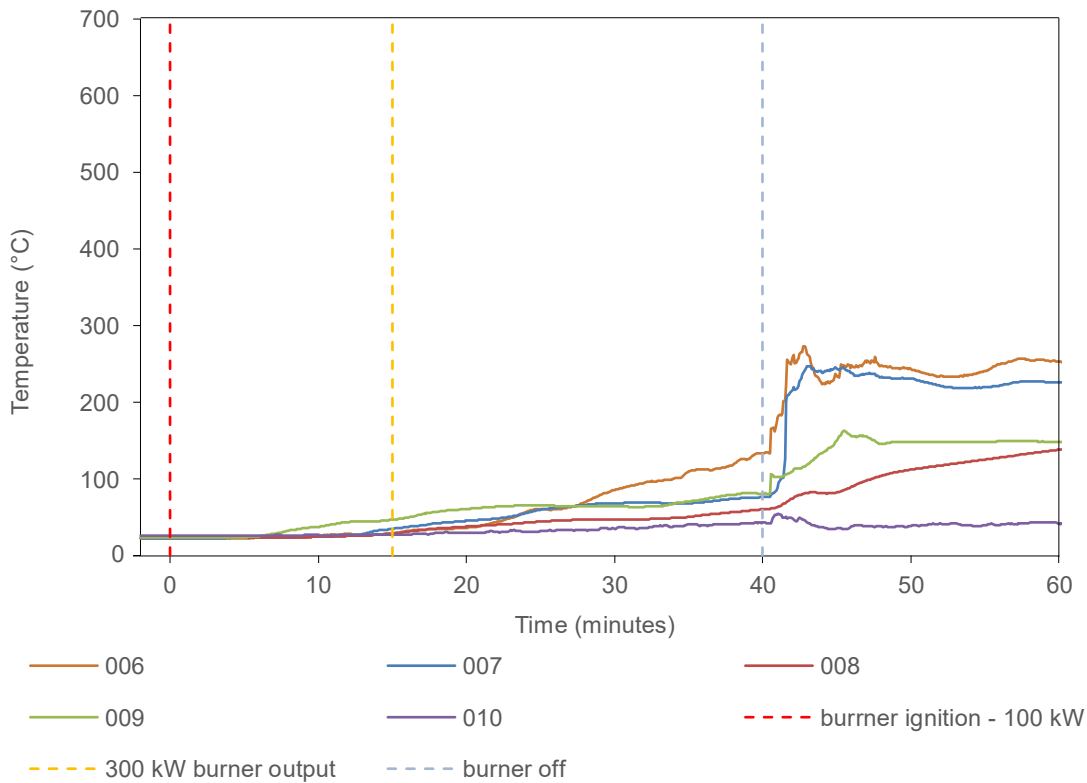
Figure 3 Internal temperature data collected by thermocouples placed within the cavity – between the internal and external segments of the specimen.

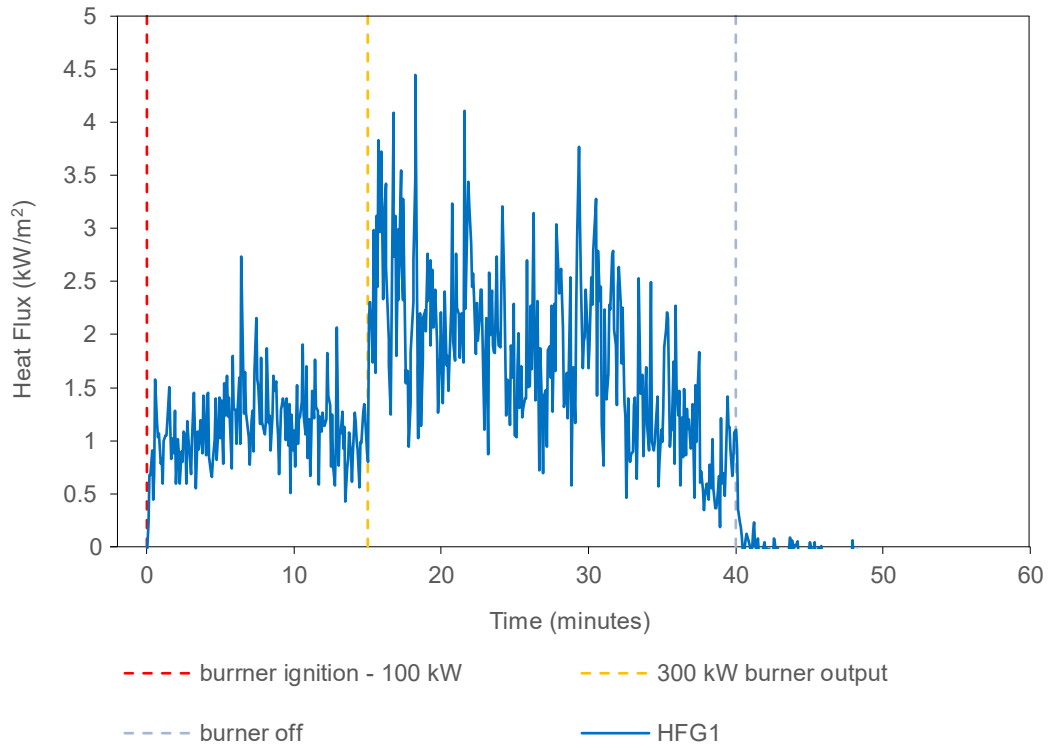
Figure 6 Heat flux data collected by heat flux gauge.

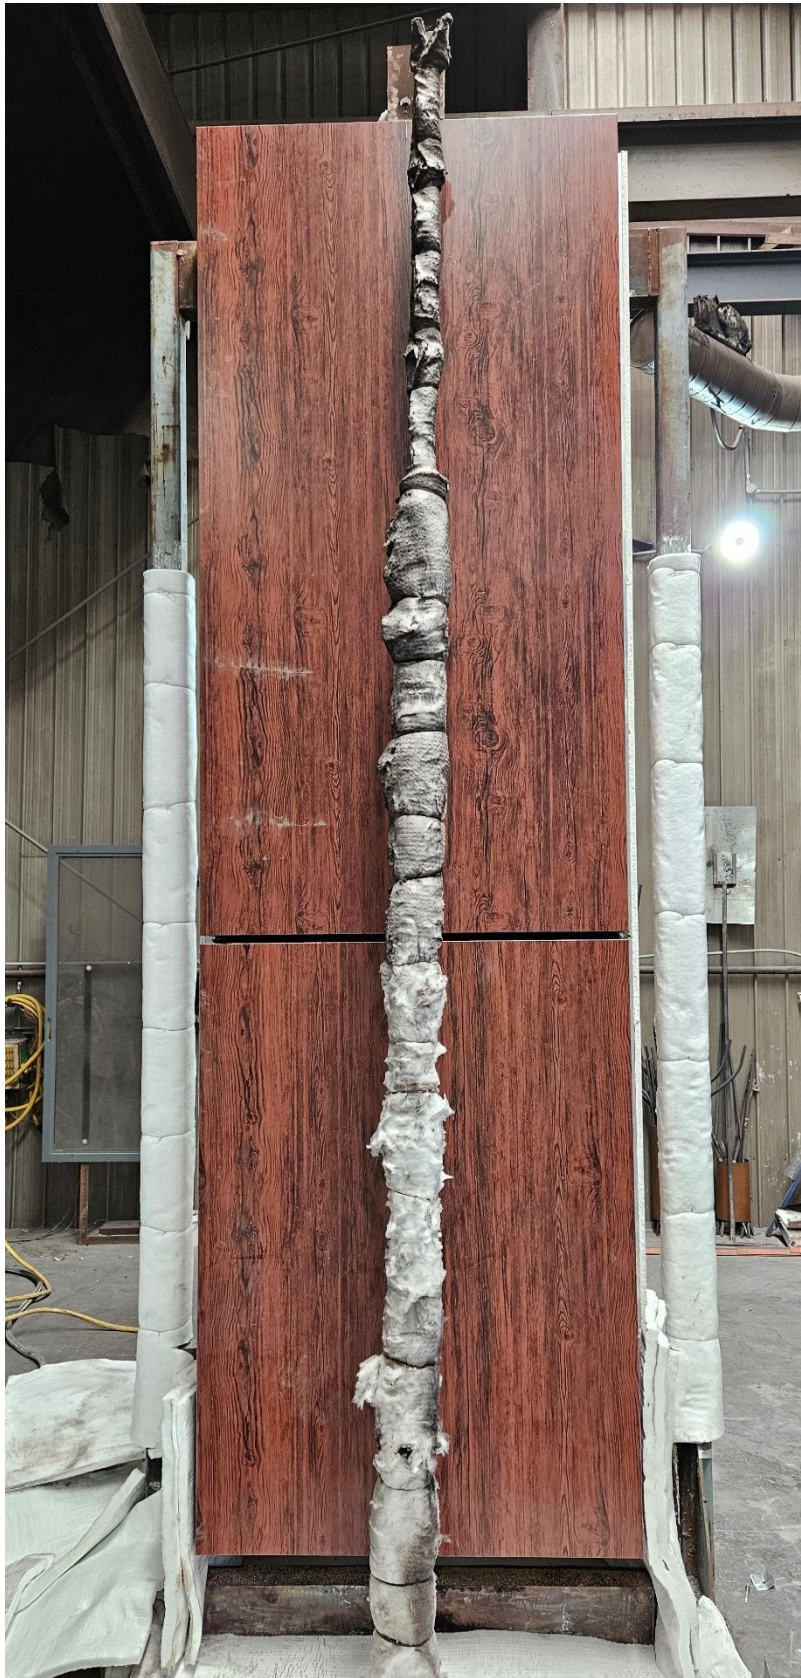
Figure 13 The specimen before the reaction to fire test

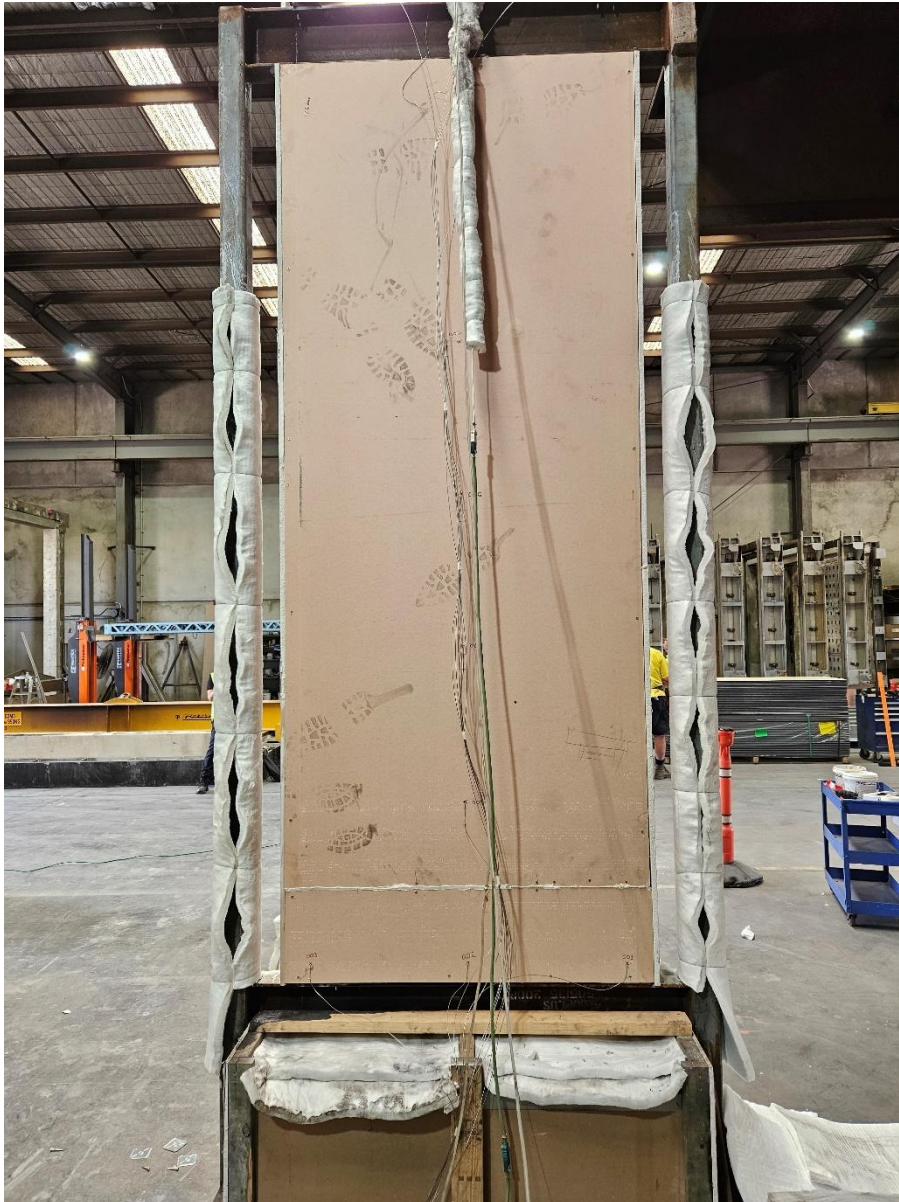
Figure 14 The specimen before the reaction to fire test – unexposed side

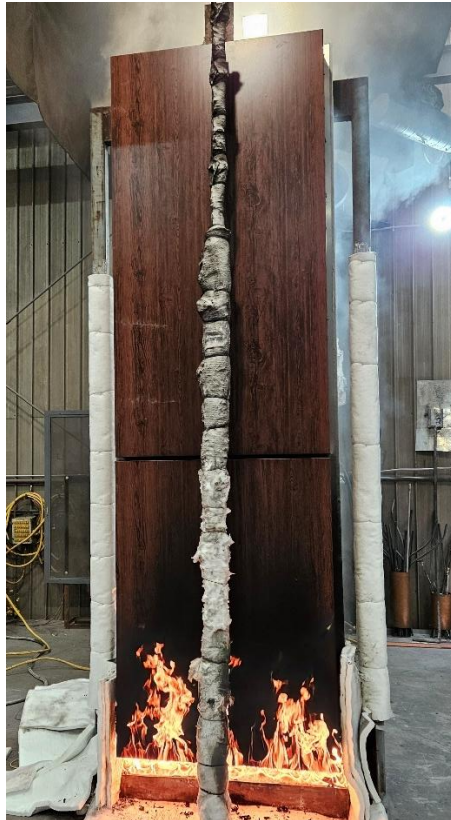
Figure 15 The specimen 12 minutes 56 seconds into the test (burner output at 100 kW)

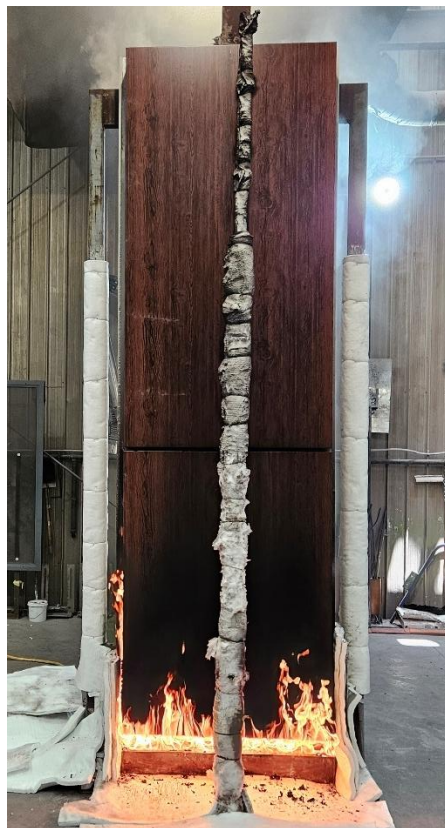
Figure 16 The specimen 14 minutes 59 seconds into the test (burner output at 100 kW)

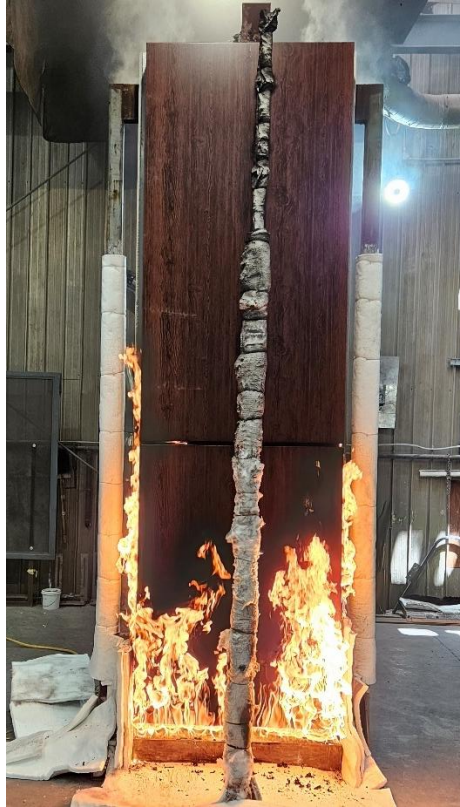
Figure 17 **The specimen 15 minutes 30 seconds into the test (30 seconds after burner output was changed to 300 kW)**

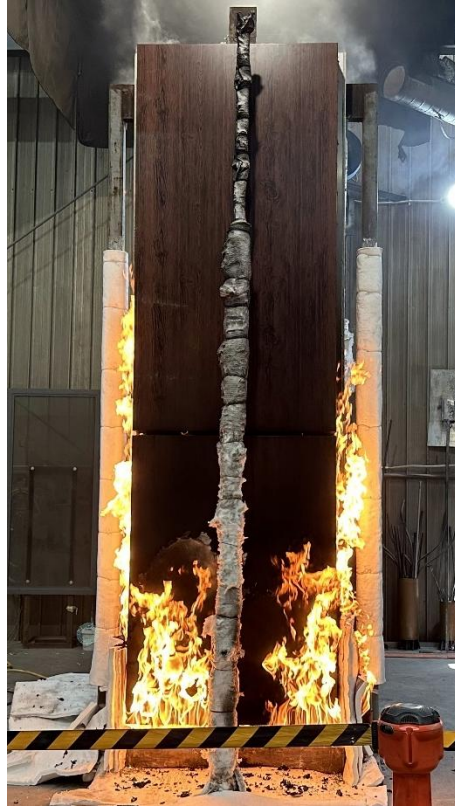
Figure 18 **The specimen 20 minutes into the test (5 minutes after burner output was changed to 300 kW)**

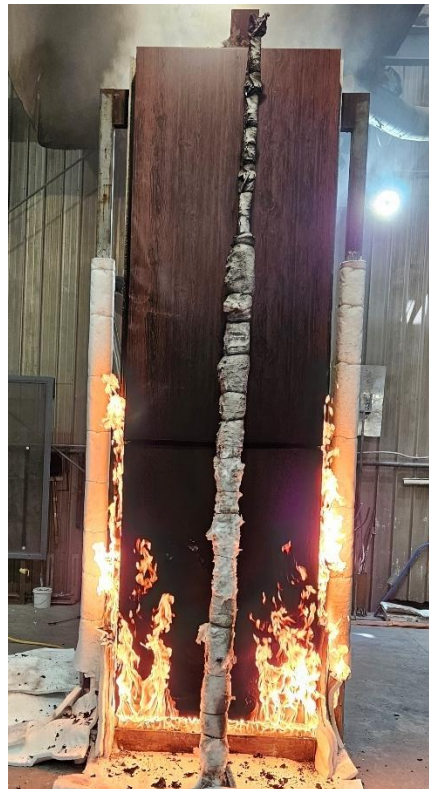
Figure 19 **The specimen 33 minutes into the test (8 minutes after burner output was changed to 300 kW)**

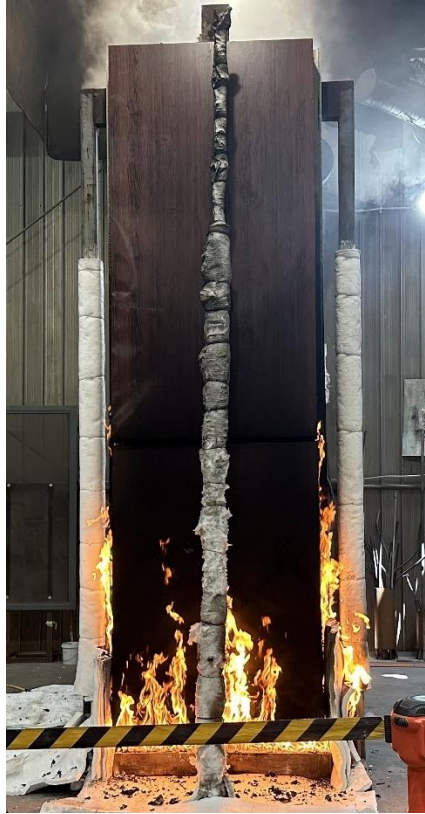
Figure 20 **The specimen 39 minutes 42 seconds into the test (24 minutes 42 seconds after burner output was changed to 300 kW)**

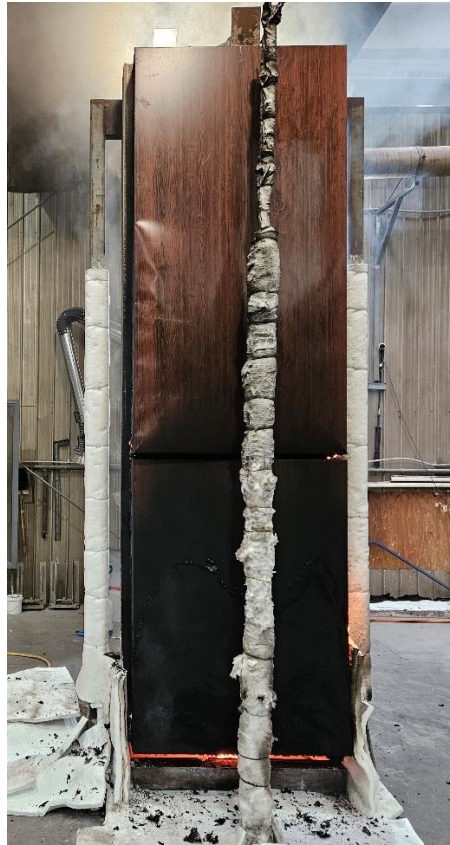
Figure 21 **The specimen 41 minutes 50 seconds into the test (1 minute 50 seconds after burner was switched off)**

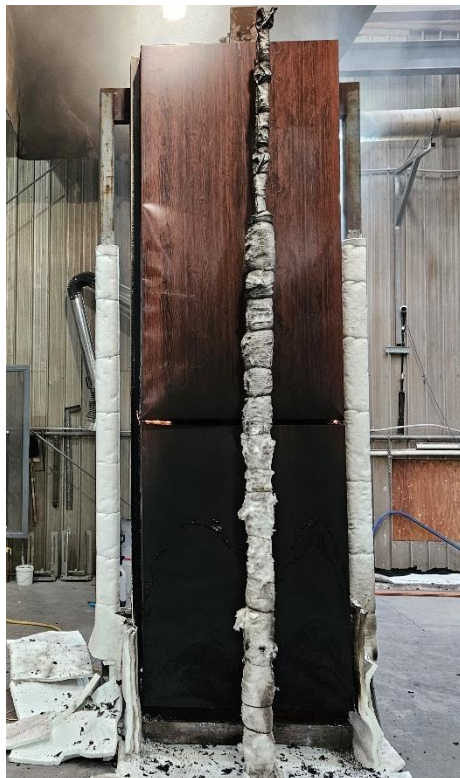
Figure 22 **The specimen 50 minutes 3 seconds into the test (10 minutes 3 seconds after burner was switched off)**

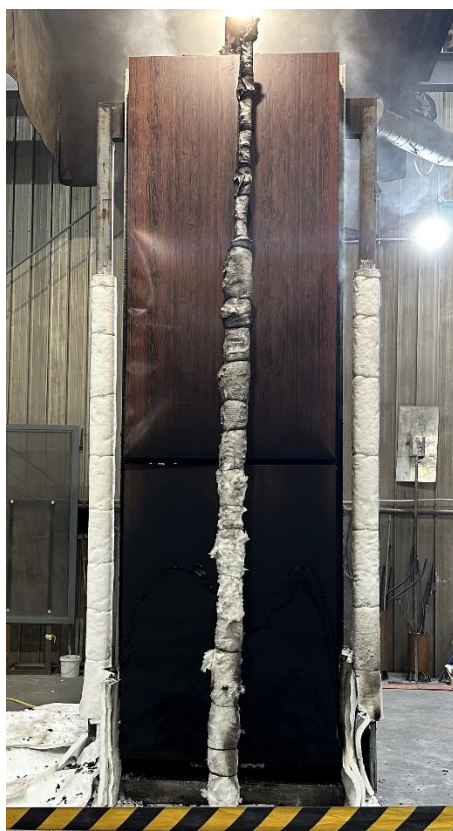
Figure 23 **The specimen at the end of the test**

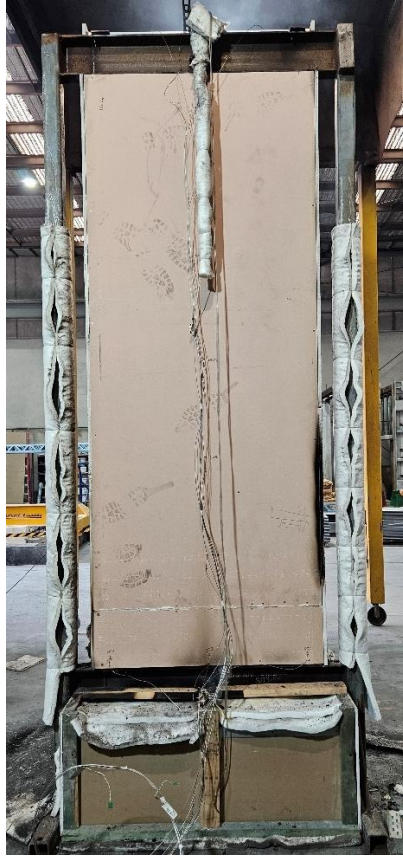
Figure 24 The specimen after the test – unexposed side.
