# Reaction to fire test report

Test standard: Ad-hoc test based off ISO 13785-1:2002 with an additional wind component

System: Aluminium composite panel (ACP) and glazing external wall cladding system

Job number: RTF230150

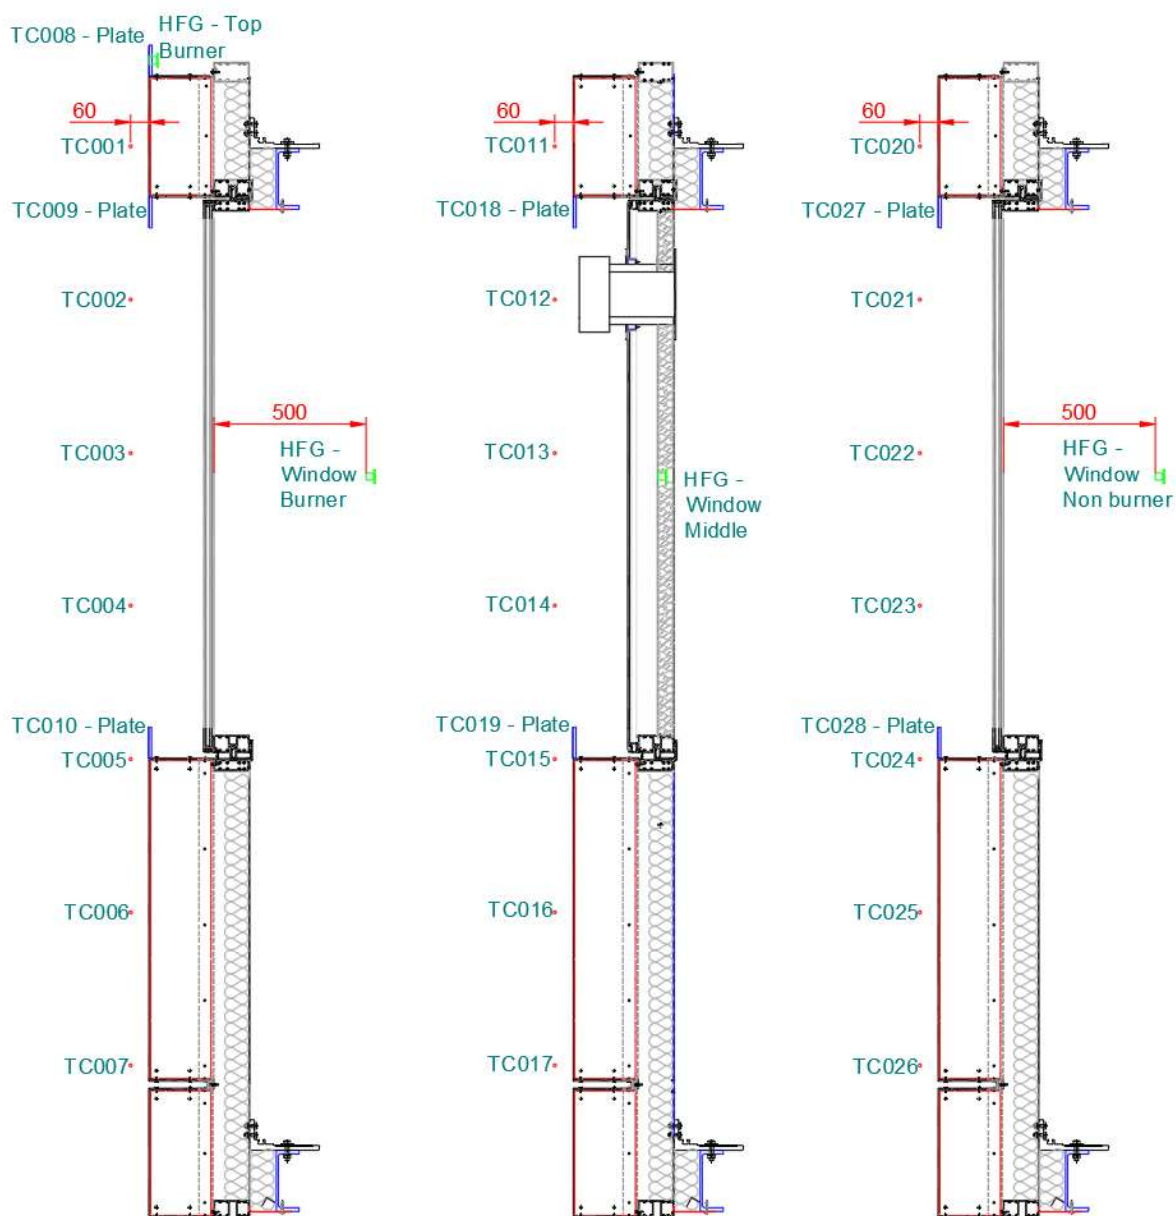
**Figure 2 Instrumentation locations – sections**

| Item | Detail |
|---|---|
| Instrumentation and equipment | <ul style="list-style-type: none"> <li>• 21 mineral insulated metal sheathed (MIMS) Type K thermocouples with an overall diameter of 1.5 mm with the measuring junction insulated from the sheath were positioned 60 mm in front of the face of the test specimen. Refer to Figure 1 and Figure 2 for details on positioning.</li> <li>• The incident heat flux on the top of the specimen in line with the front face of test specimen was measured using a Schmidt-Boelter type heat flux gauge with a range of 0-100 kW/m<sup>2</sup>.</li> <li>• The incident heat flux 500 mm behind the outer glazings – burner side and non-burner side – was measured using two Schmidt-Boelter type heat flux gauges with a range of 0-20 kW/m<sup>2</sup>, respectively.</li> <li>• The incident heat flux 80 mm behind the central glazing was measured using a Schmidt-Boelter type heat flux gauge with a range of 0-20 kW/m<sup>2</sup>.</li> <li>• Temperatures above and below the cladding were measured by seven 100 mm × 100 mm × 0.7 mm plate thermocouples with mineral insulated metal sheathed (MIMS) Type K thermocouples with an overall diameter of 1 mm with the measuring junction electrically insulated from the sheath. The thermocouple hot junction was fixed to the geometric centre of the plate by a small steel strip made from the same material as the plate. The plate thermocouples included 97 mm × 97 mm × 10 mm inorganic insulation pads. Before the first use of the plate thermocouples, they were aged by being exposed to heat in a fire-resistance test furnace for 90 min under the standard temperature/time curve. Refer Figure 1 and Figure 2 for details on positioning.</li> <li>• The fire source was a propane (95% purity) gas burner 1.2 m long × 0.1 m deep × 0.15 m tall. The burner was placed on the floor below the specimen with approximately 40 mm overlap with the front of the ACP. A shield for the burner made from FR plasterboard and Hebel block work – having a cavity 1.2 m × 0.12 m, 500 mm above the floor - was used during the baseline data test.</li> <li>• Airflow across the front of the specimen was provided by a square array of 4-off pedestal fans. 3 blades with a fan diameter of 750 mm. The centre of the fans were located at the approximate heights of 1.5 m and 2.3 m from the floor and 0.5 m and 1.3 m from the guide wall. The fans were at the settings that provided the airflow listed in Table 4.</li> <li>• A guide wall – 2.8 m tall × 3.0 m wide was butted up to the specimen and blanking wall and placed at a 45° angle in relation to the specimen.</li> <li>• The horizontal wind speed was measured using a hot wire anemometer.</li> </ul> |

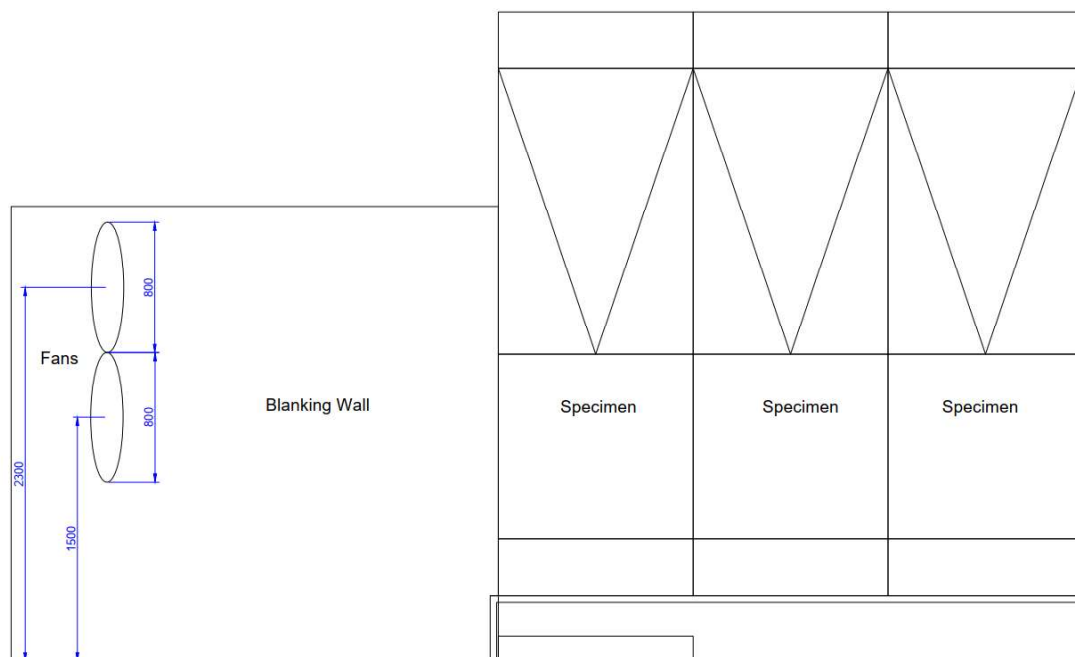
**Figure 3 Instrumentation locations – Elevation**

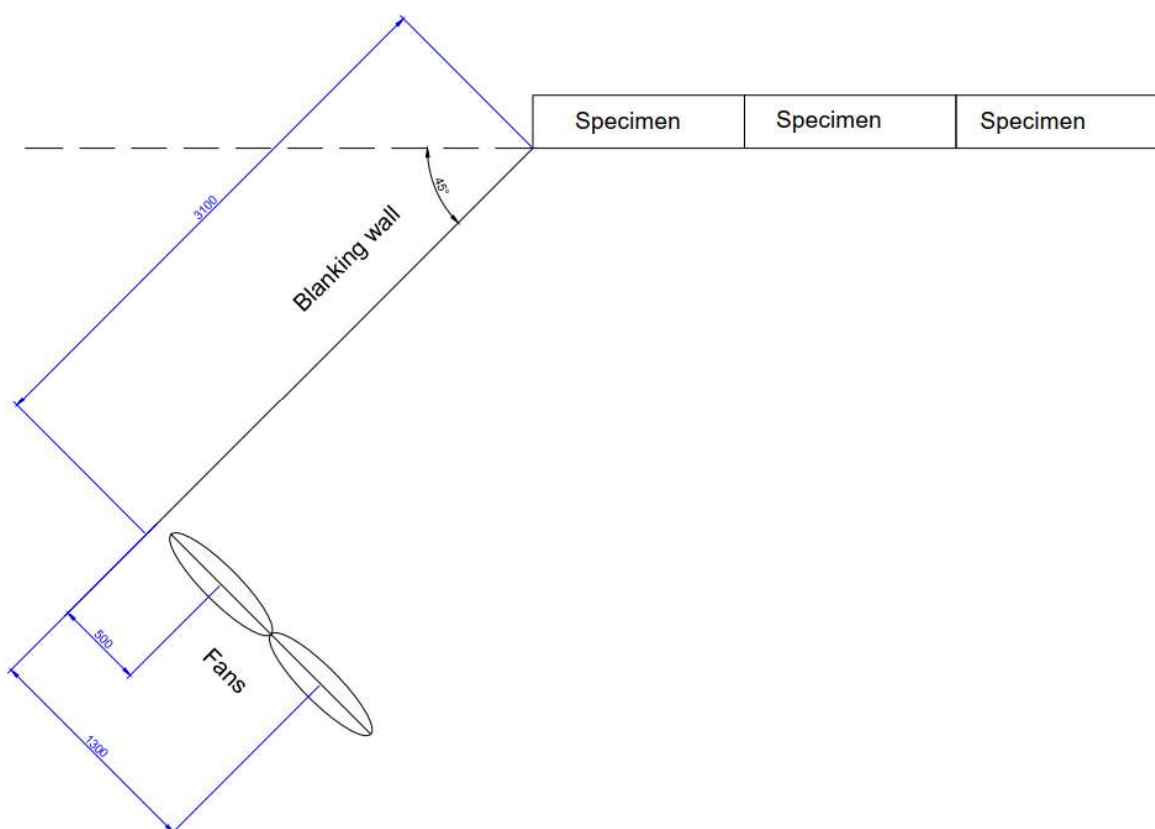
**Figure 4 Instrumentation locations – Plan view**

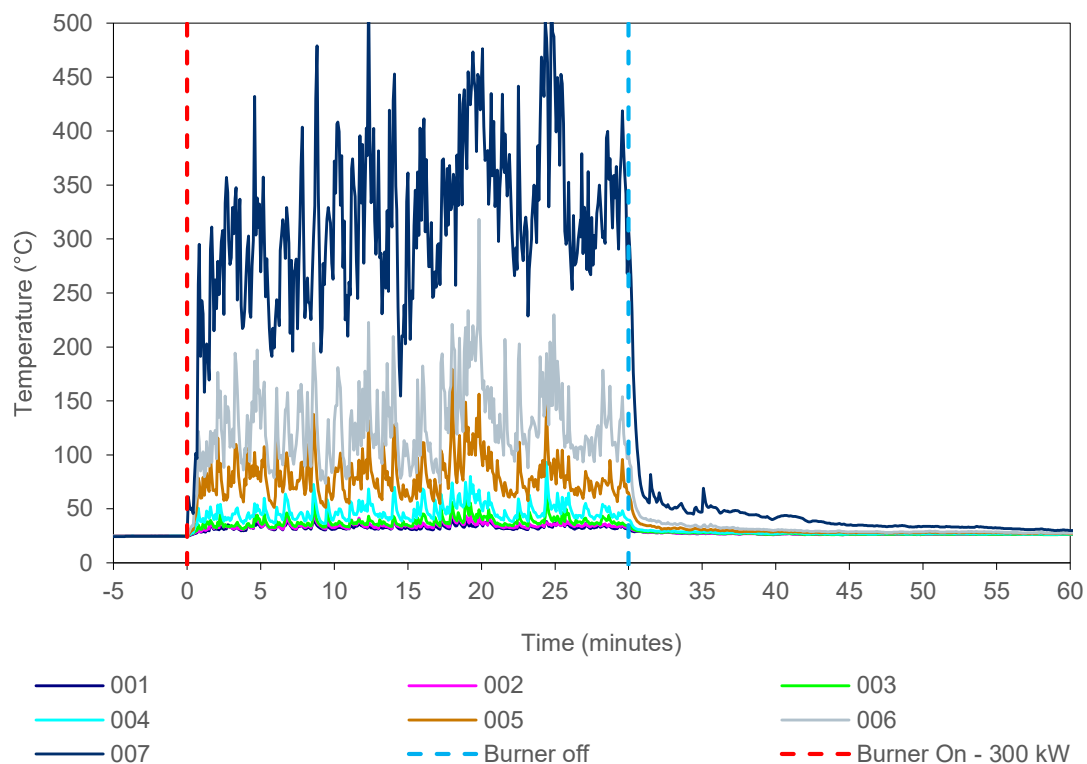
**Figure 5** External temperature data collected by thermocouples placed 60 mm from the front face of the specimen - in-line with the burner.

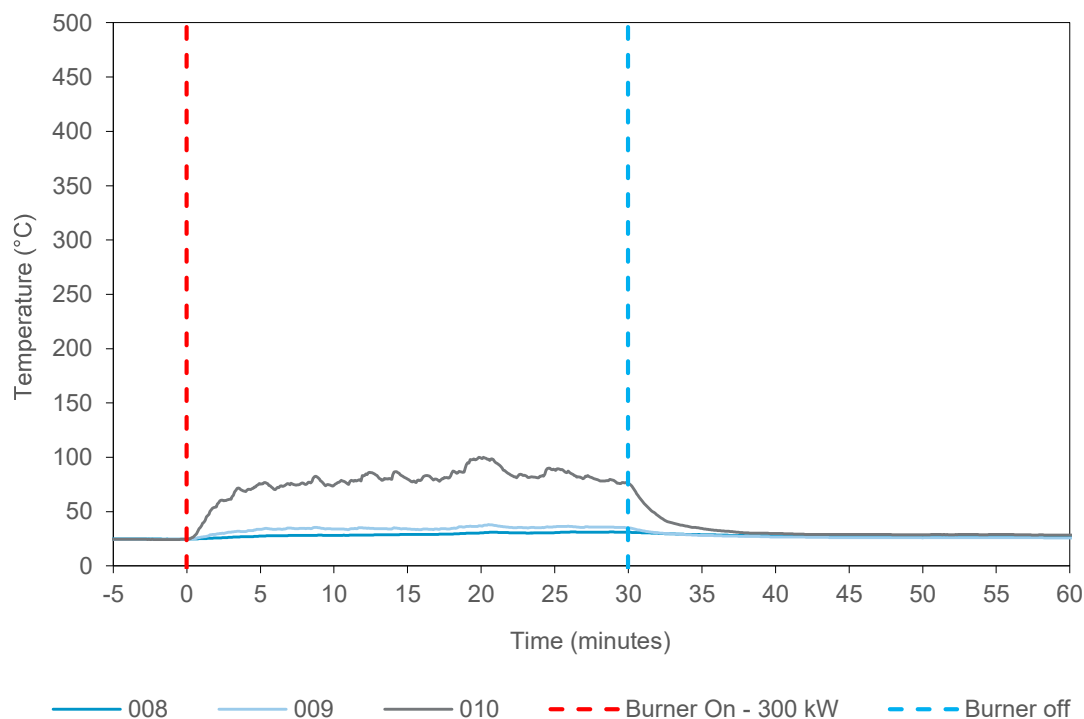
**Figure 6** External temperature data collected by thermocouples in-line with ACP, above and below, respectively - in-line with the burner.

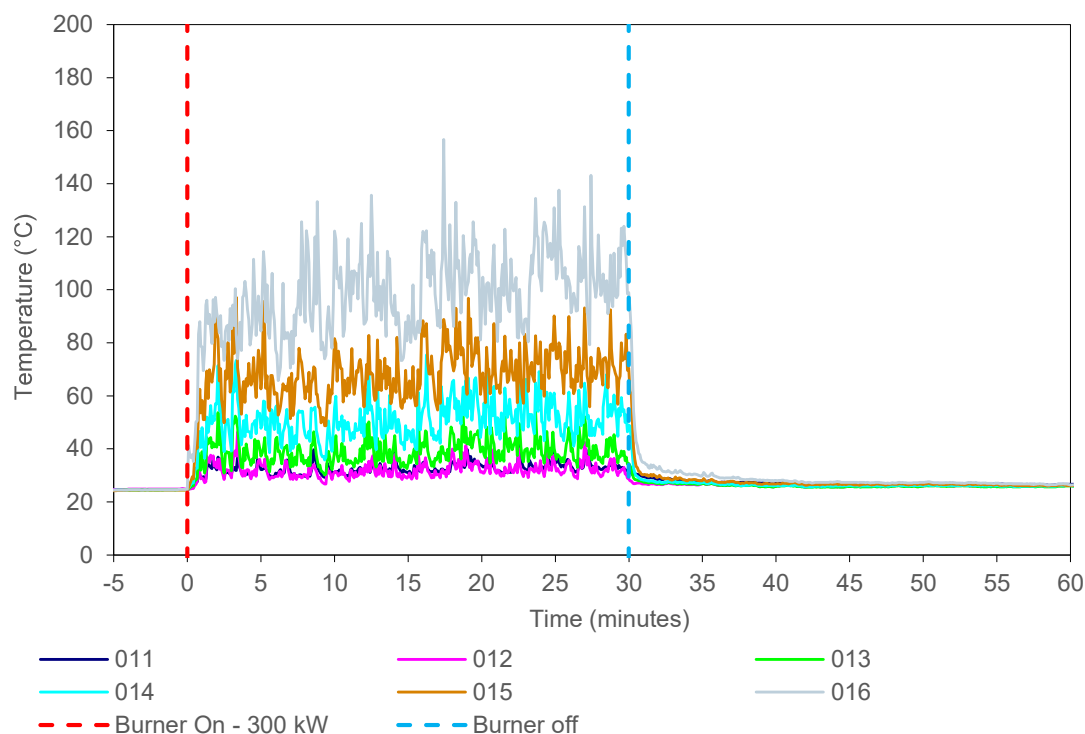
**Figure 7** External temperature data collected by thermocouples placed 60 mm from the front face of the specimen – central module.

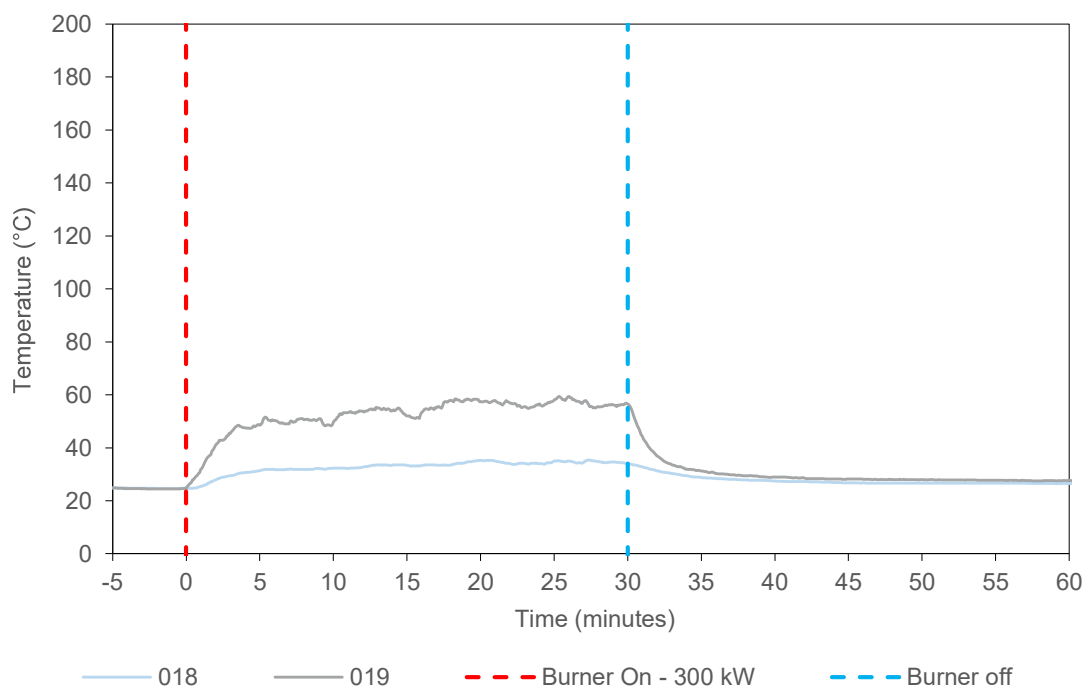
**Figure 8** External temperature data collected by thermocouples in-line with ACP, above and below, respectively – central module.

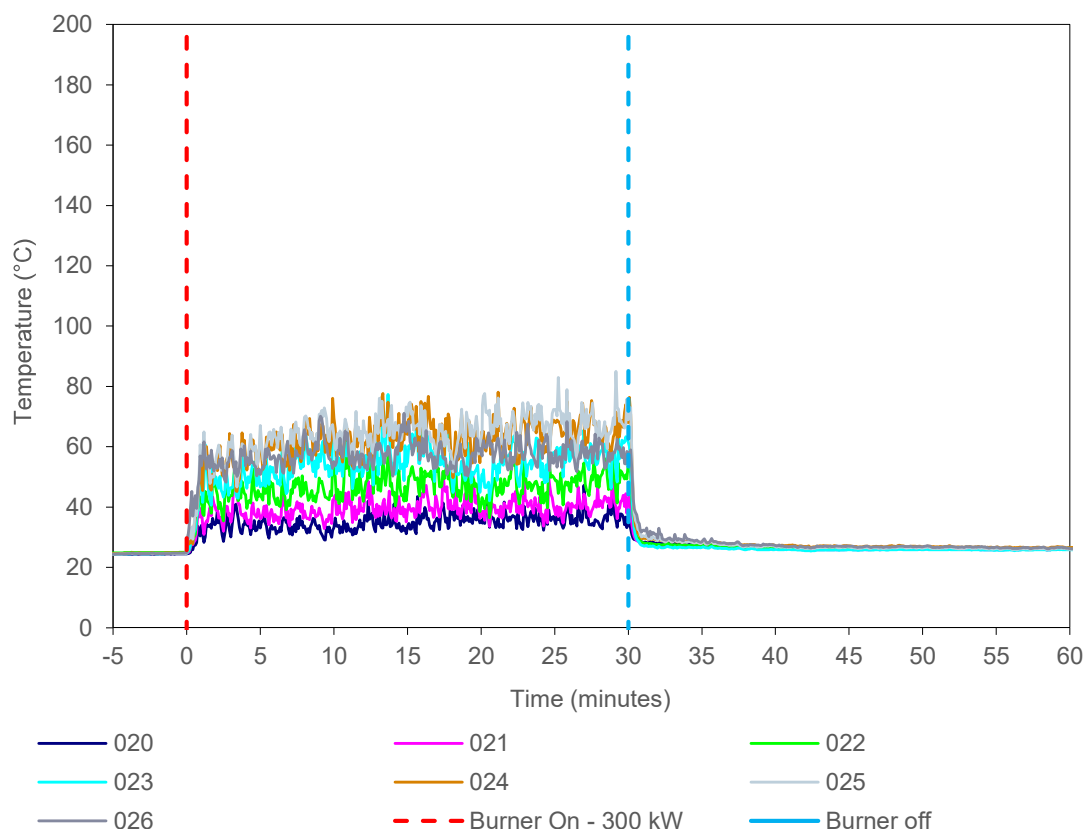
**Figure 9** External temperature data collected by thermocouples placed 60 mm from the front face of the specimen – away from burner.

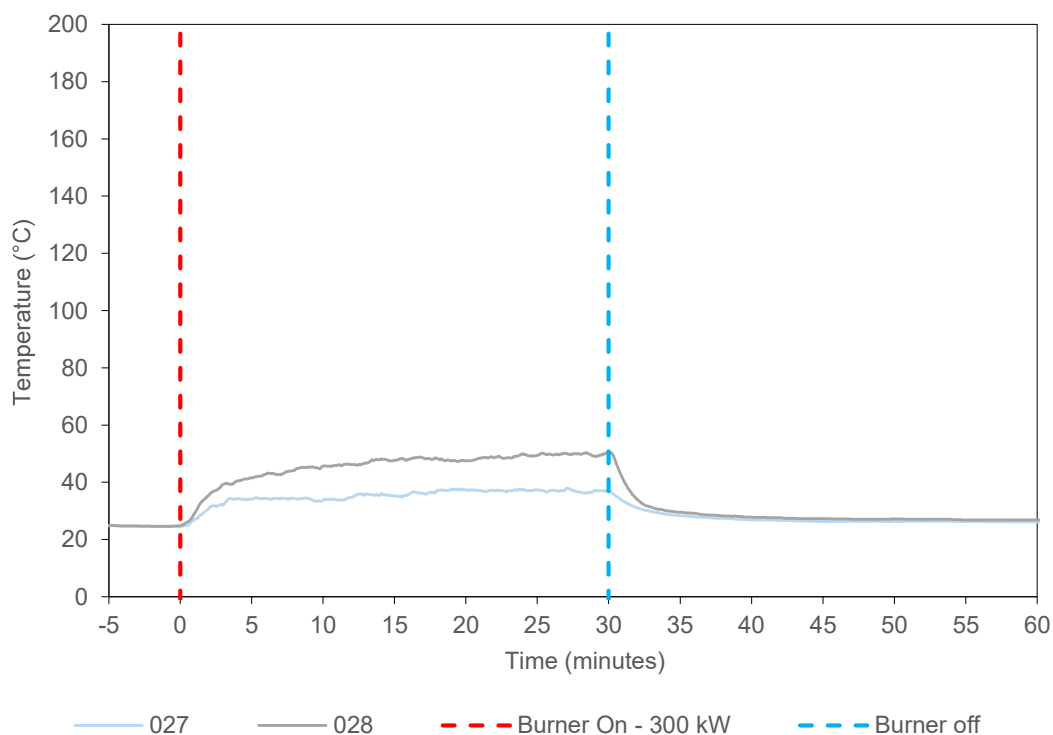
**Figure 10** External temperature data collected by thermocouples in-line with ACP, above and below, respectively – away from burner.

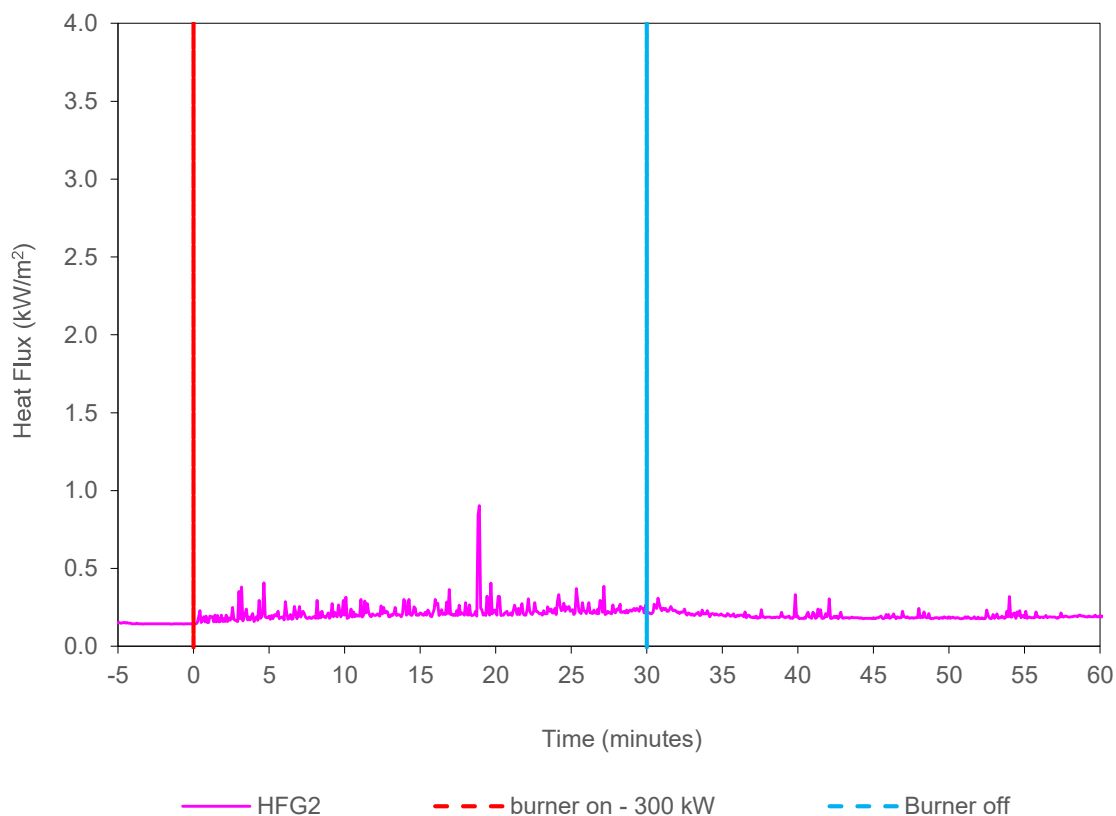
**Figure 11** Heat flux data collected by heat flux gauge at the top of the specimen above the burner.

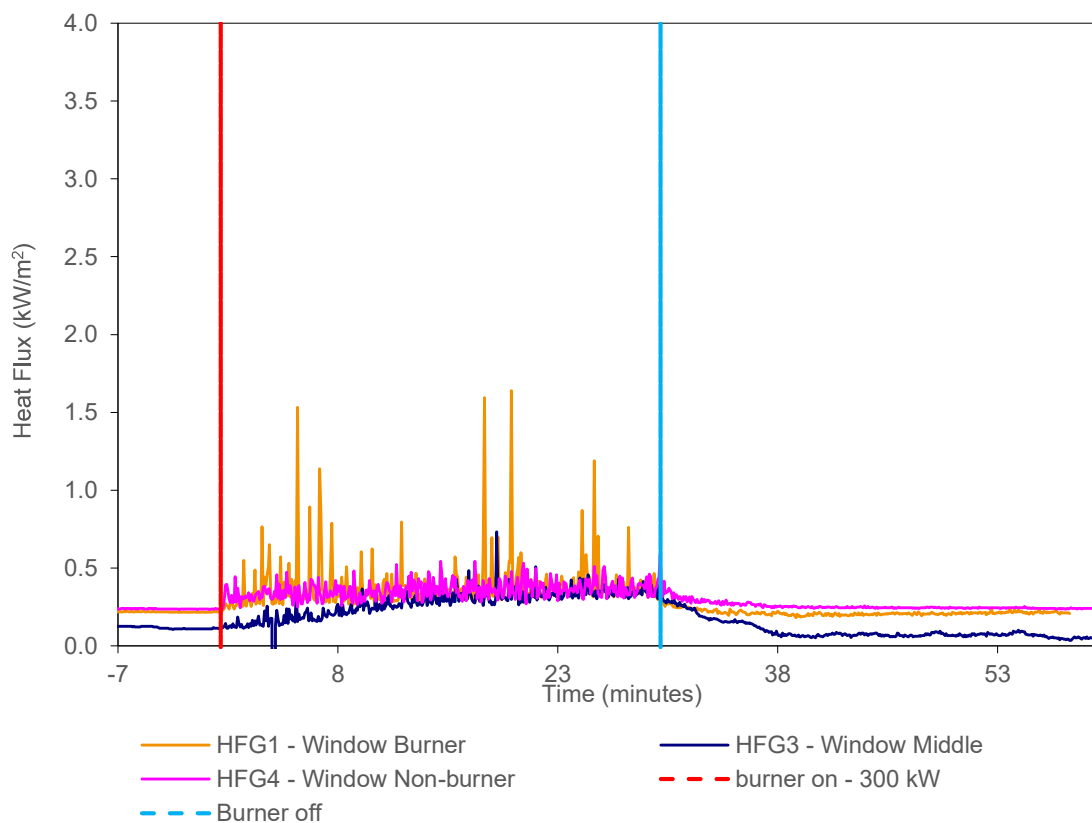
**Figure 12** Heat flux data collected by heat flux gauges behind the glazing units.

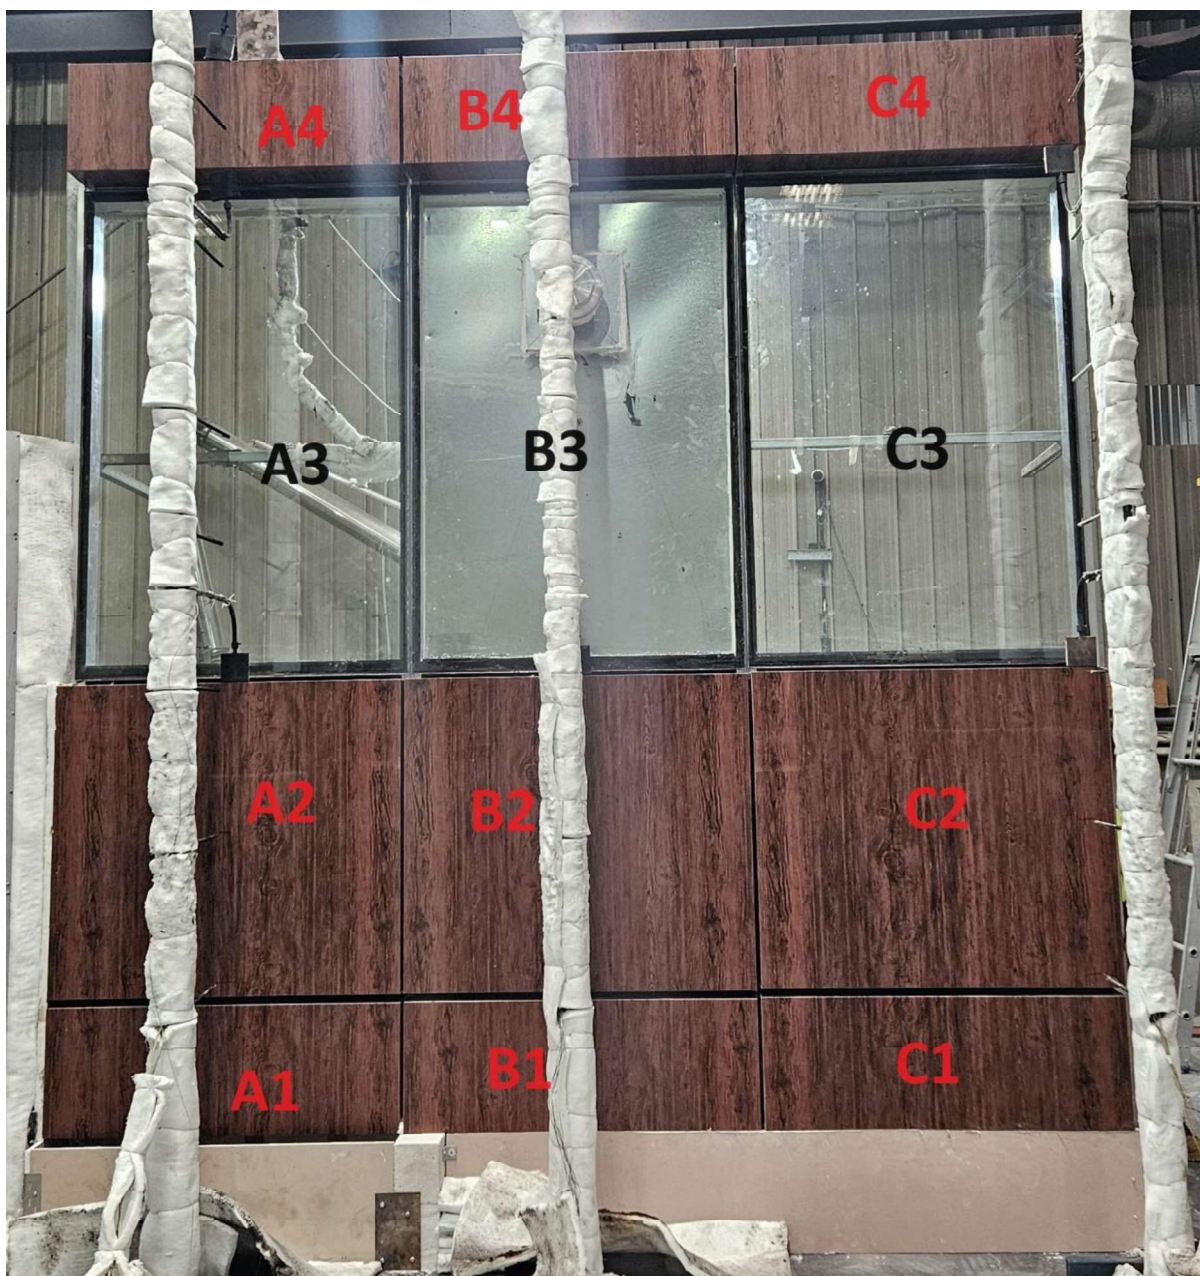
**Figure 13 Designation of section for the test observations.**

Table 4 shows the observations of any significant behaviour of the specimen during the test. Figure 13 shows the panel and glazing designations sighted in the observations.

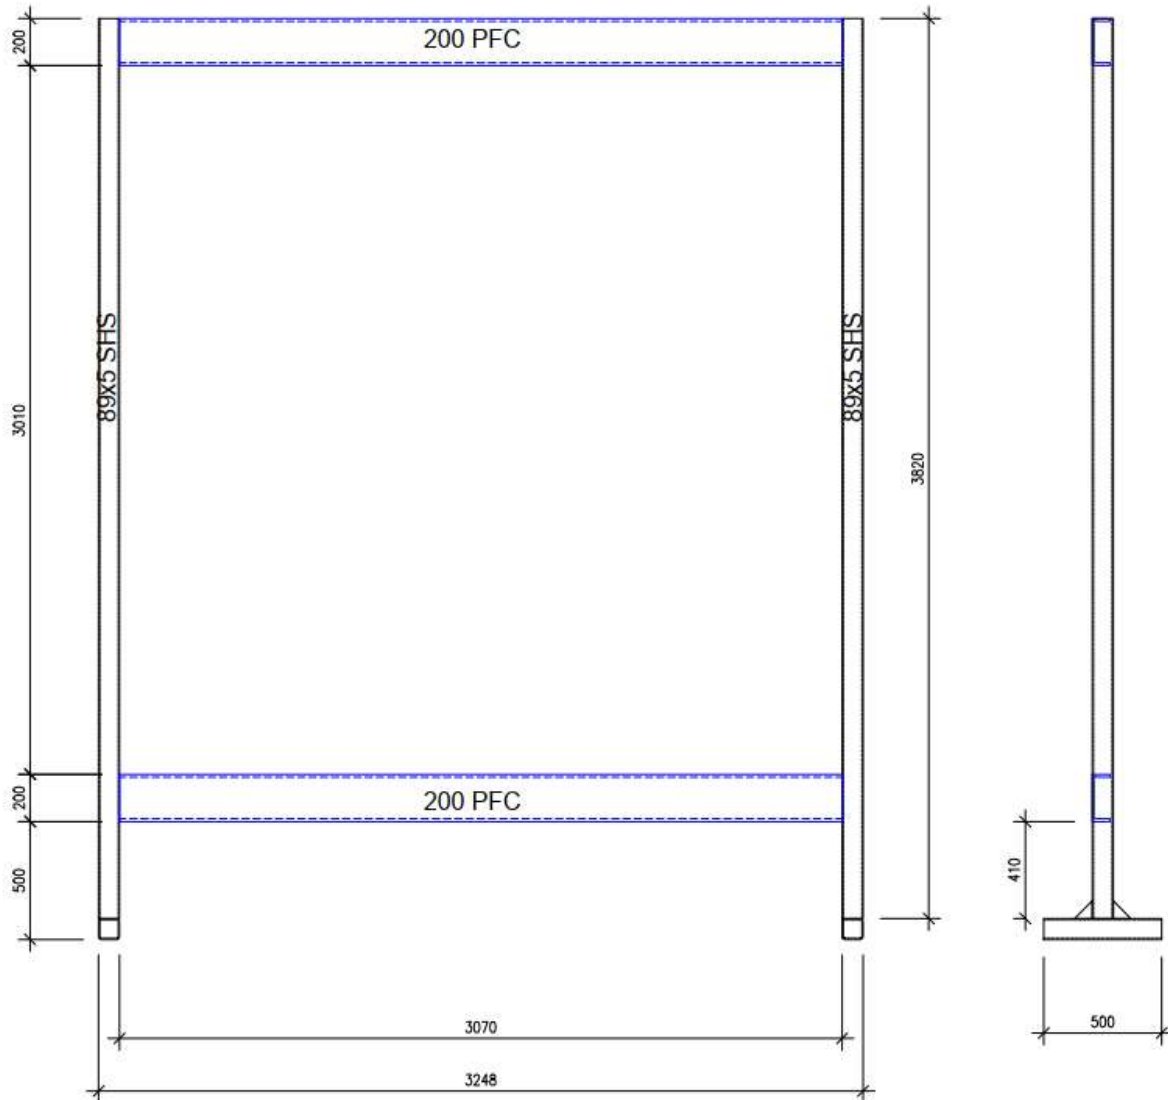
**Figure 14 Elevation of rig support.**

| Item | Description | |
|---|---|---|
| | Size | 90 mm × 90 mm × 5 mm thick and 200 mm × 90 mm × 10 mm thick – refer to Figure 14. |

| Test rig: | The test rig frame (item 5) was the main support for the test specimen, however, there were two C-purlin sections that acted as false slabs (200 mm tall). The test specimen, 3-off modules – interconnected through aluminium framing (item 6), was fixed to the test rig using curtain wall brackets (item 10) and fixings (item 24) – see Figure 16 & Figure 17. Each module extended from the bottom of the specimen to the top. |

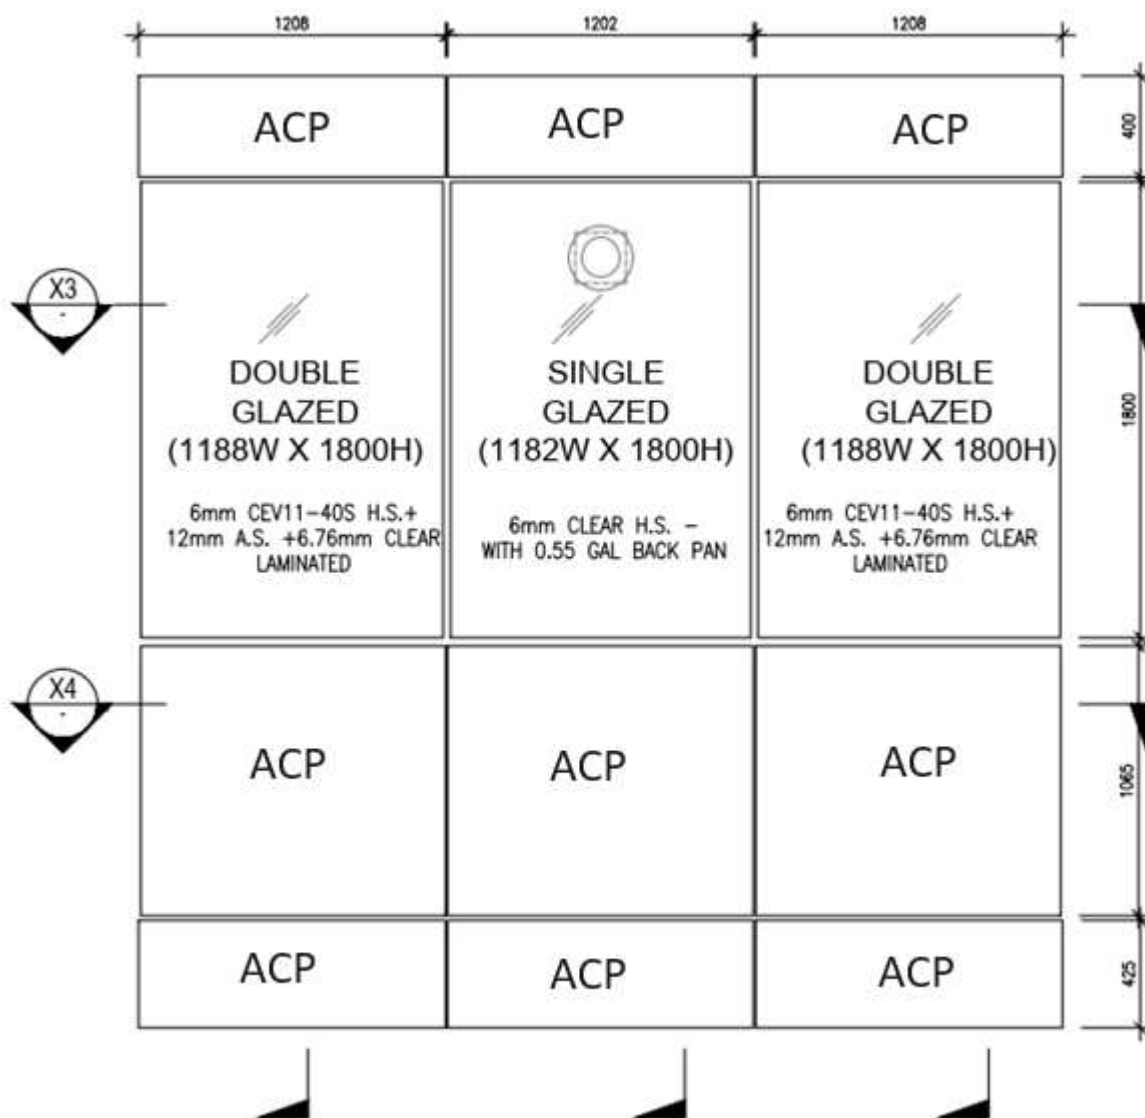
**Figure 15 System assembly – Front view**

| Glazing | The glazing, both double (item 3) and single (item 4), were attached to the aluminium framing (item 6) as shown in Figure 15 to Figure 20 and Figure 21. The glazing was sealed around the perimeter with weather sealant (item 15). |

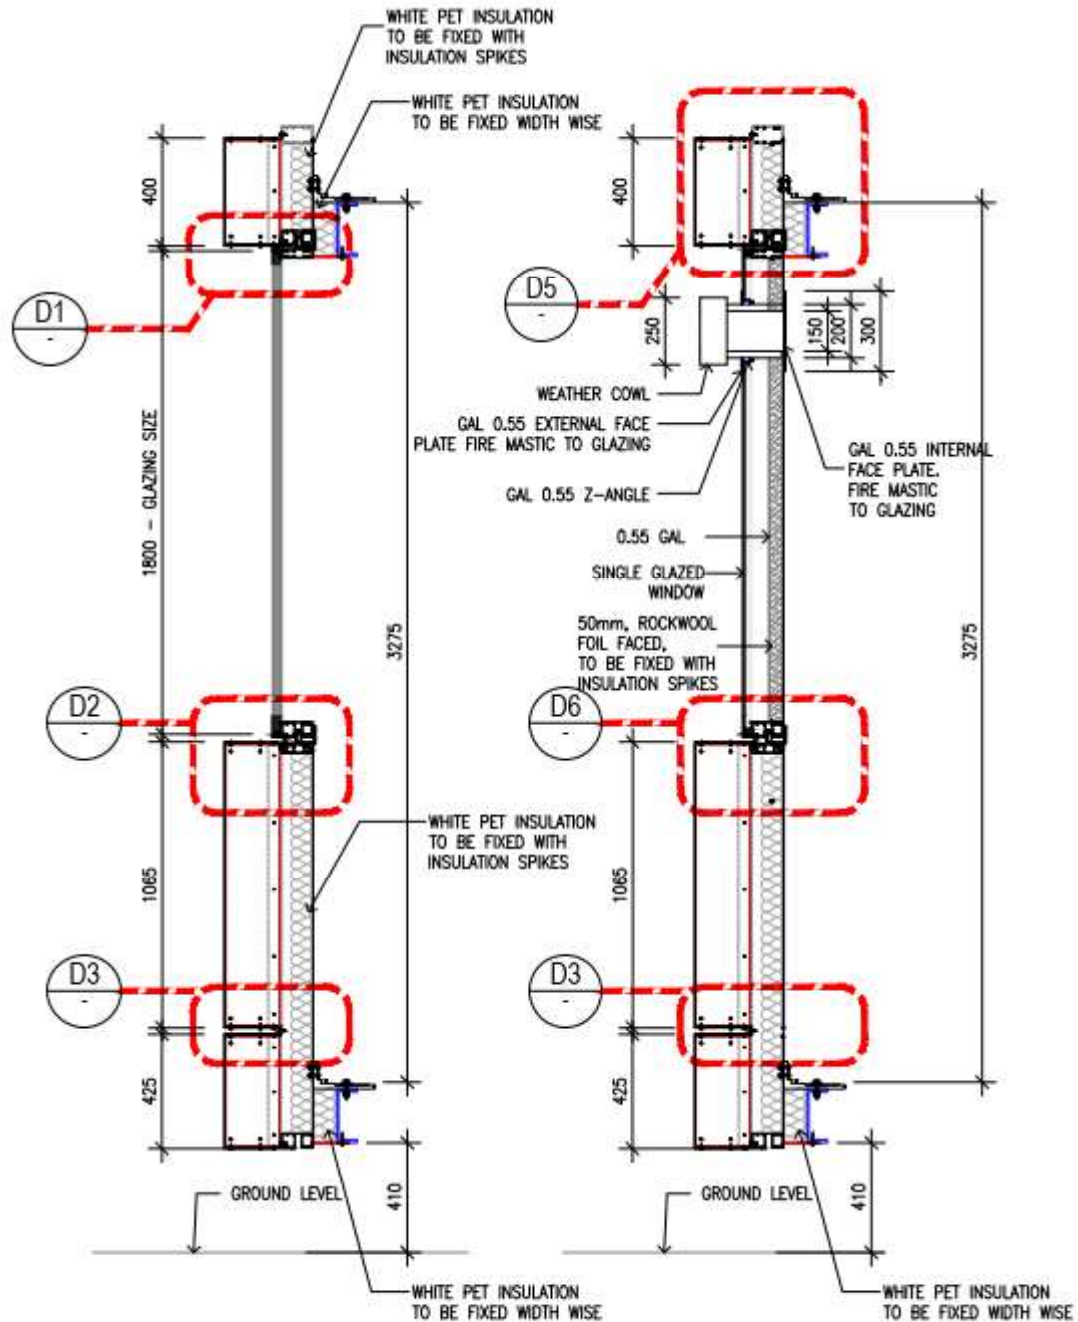
**Figure 16 System assembly – vertical cross-sectional view.**

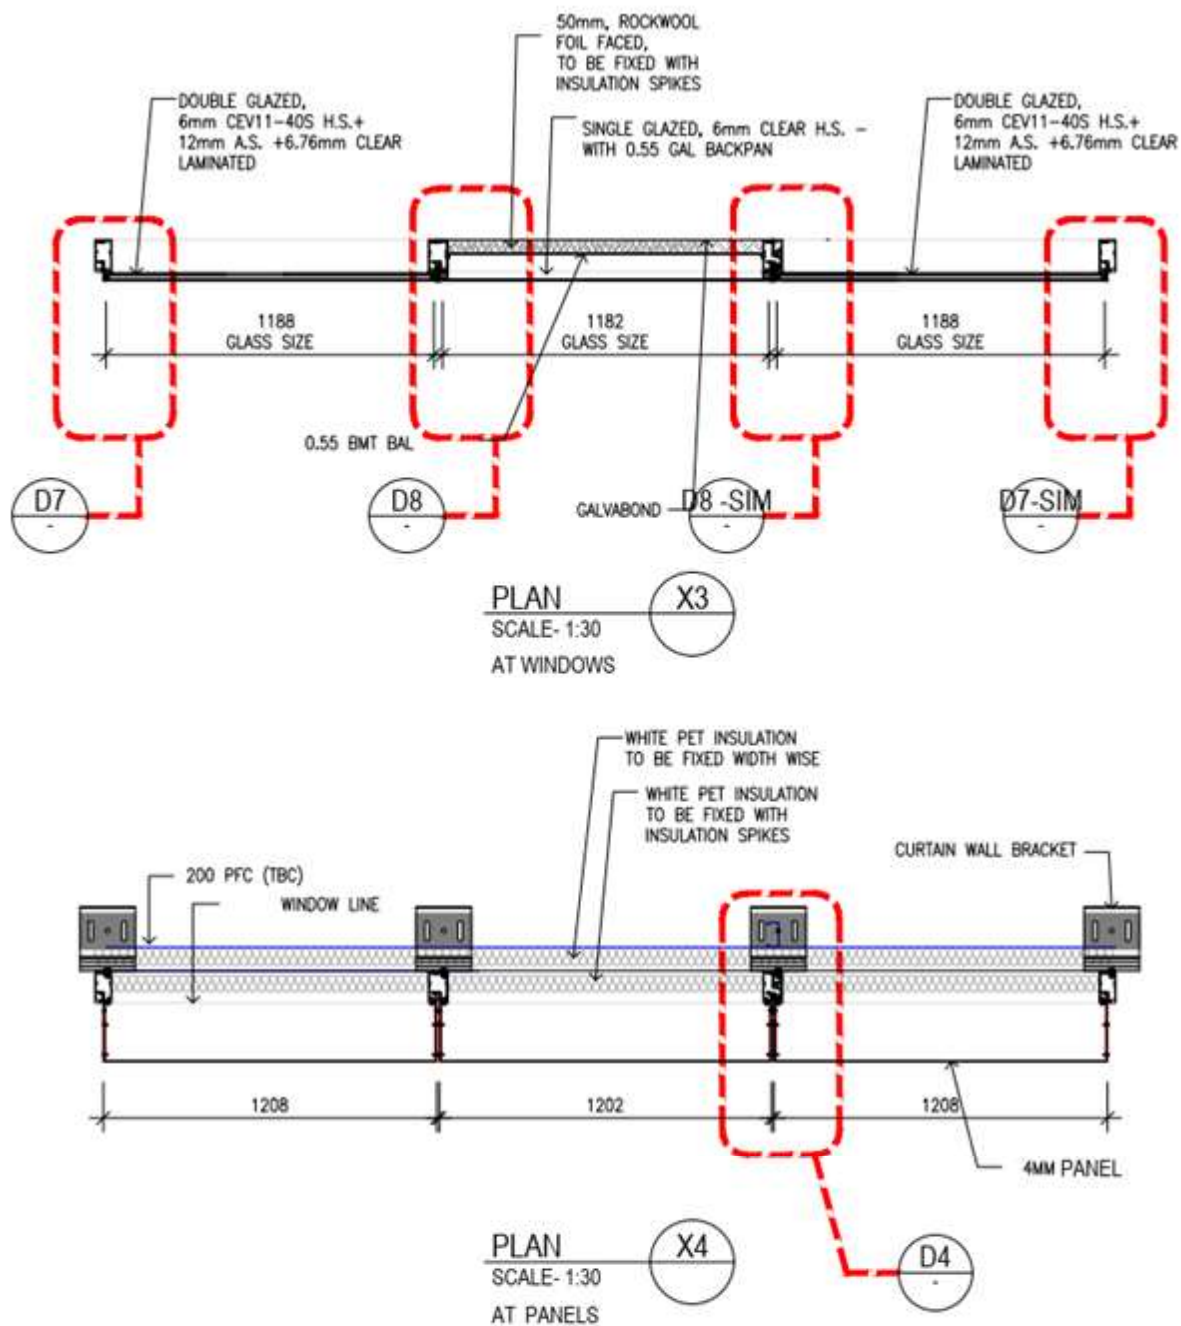
**Figure 17 System assembly – vertical cross-sectional view.**

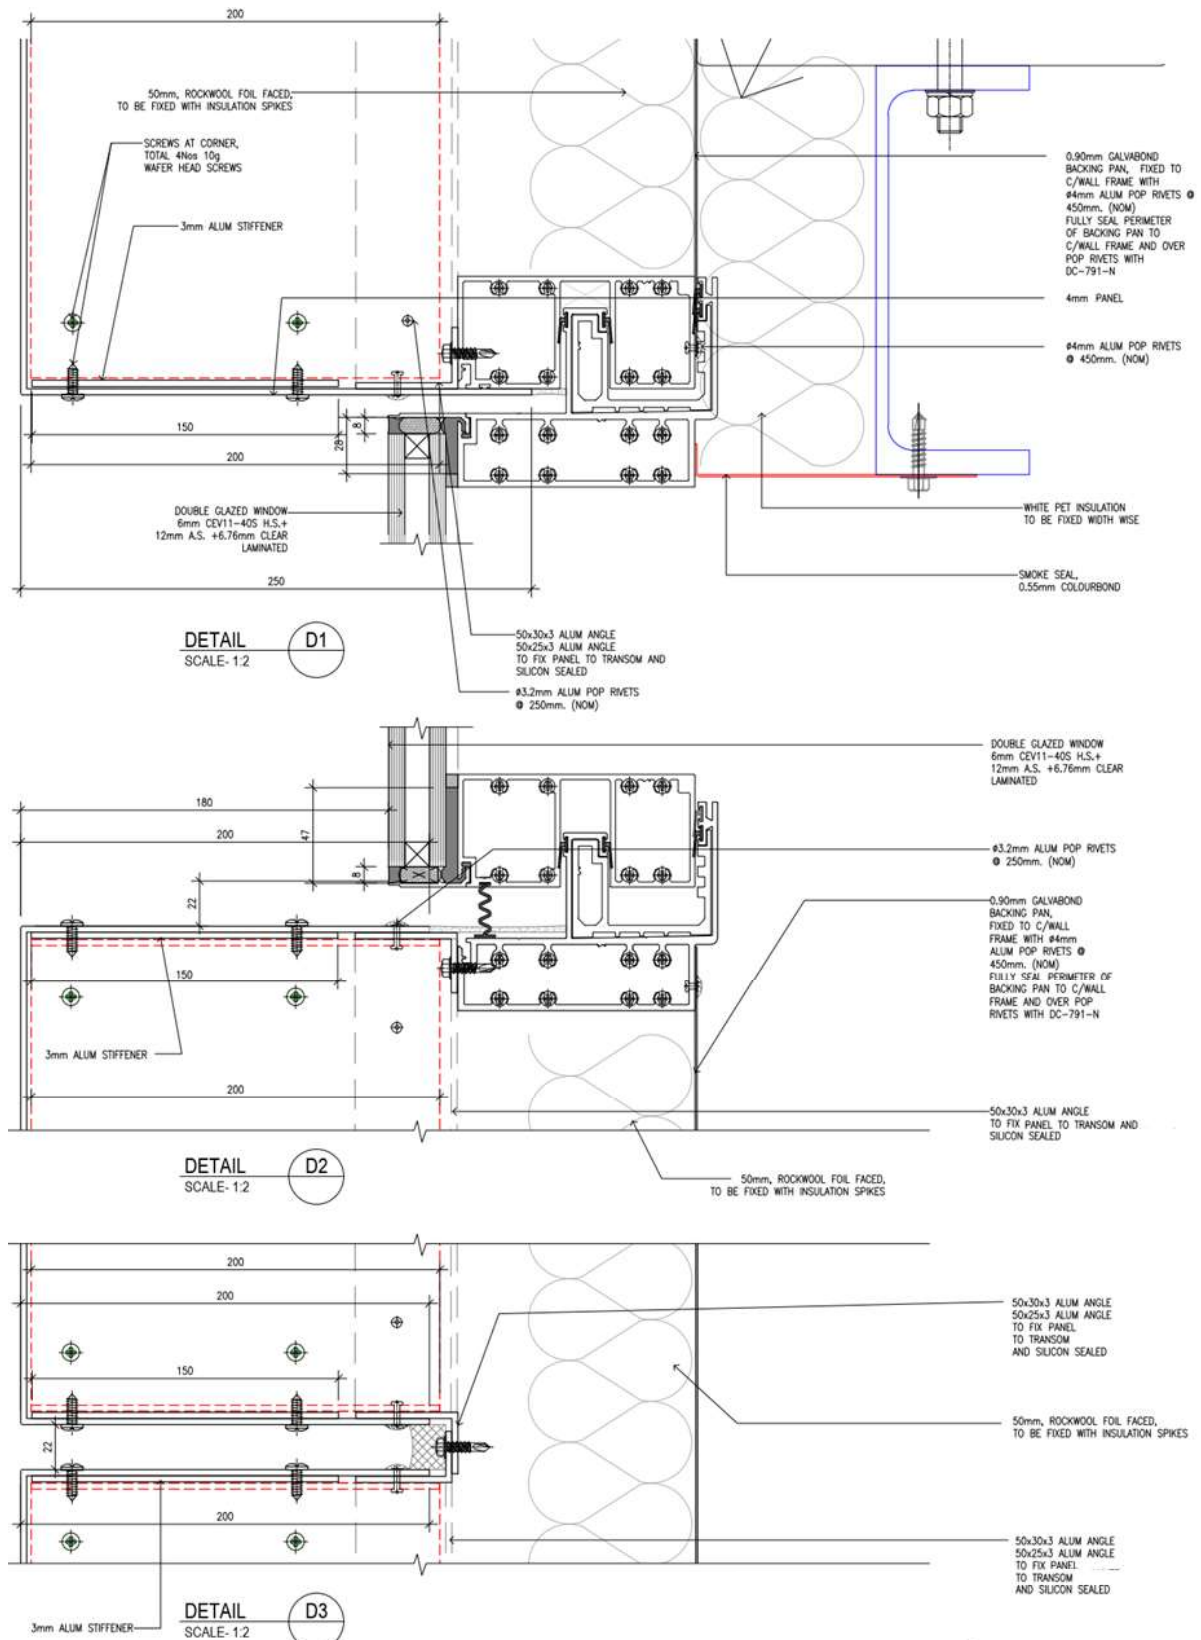
**Figure 18 System assembly – Vertical cross-sectional view.**

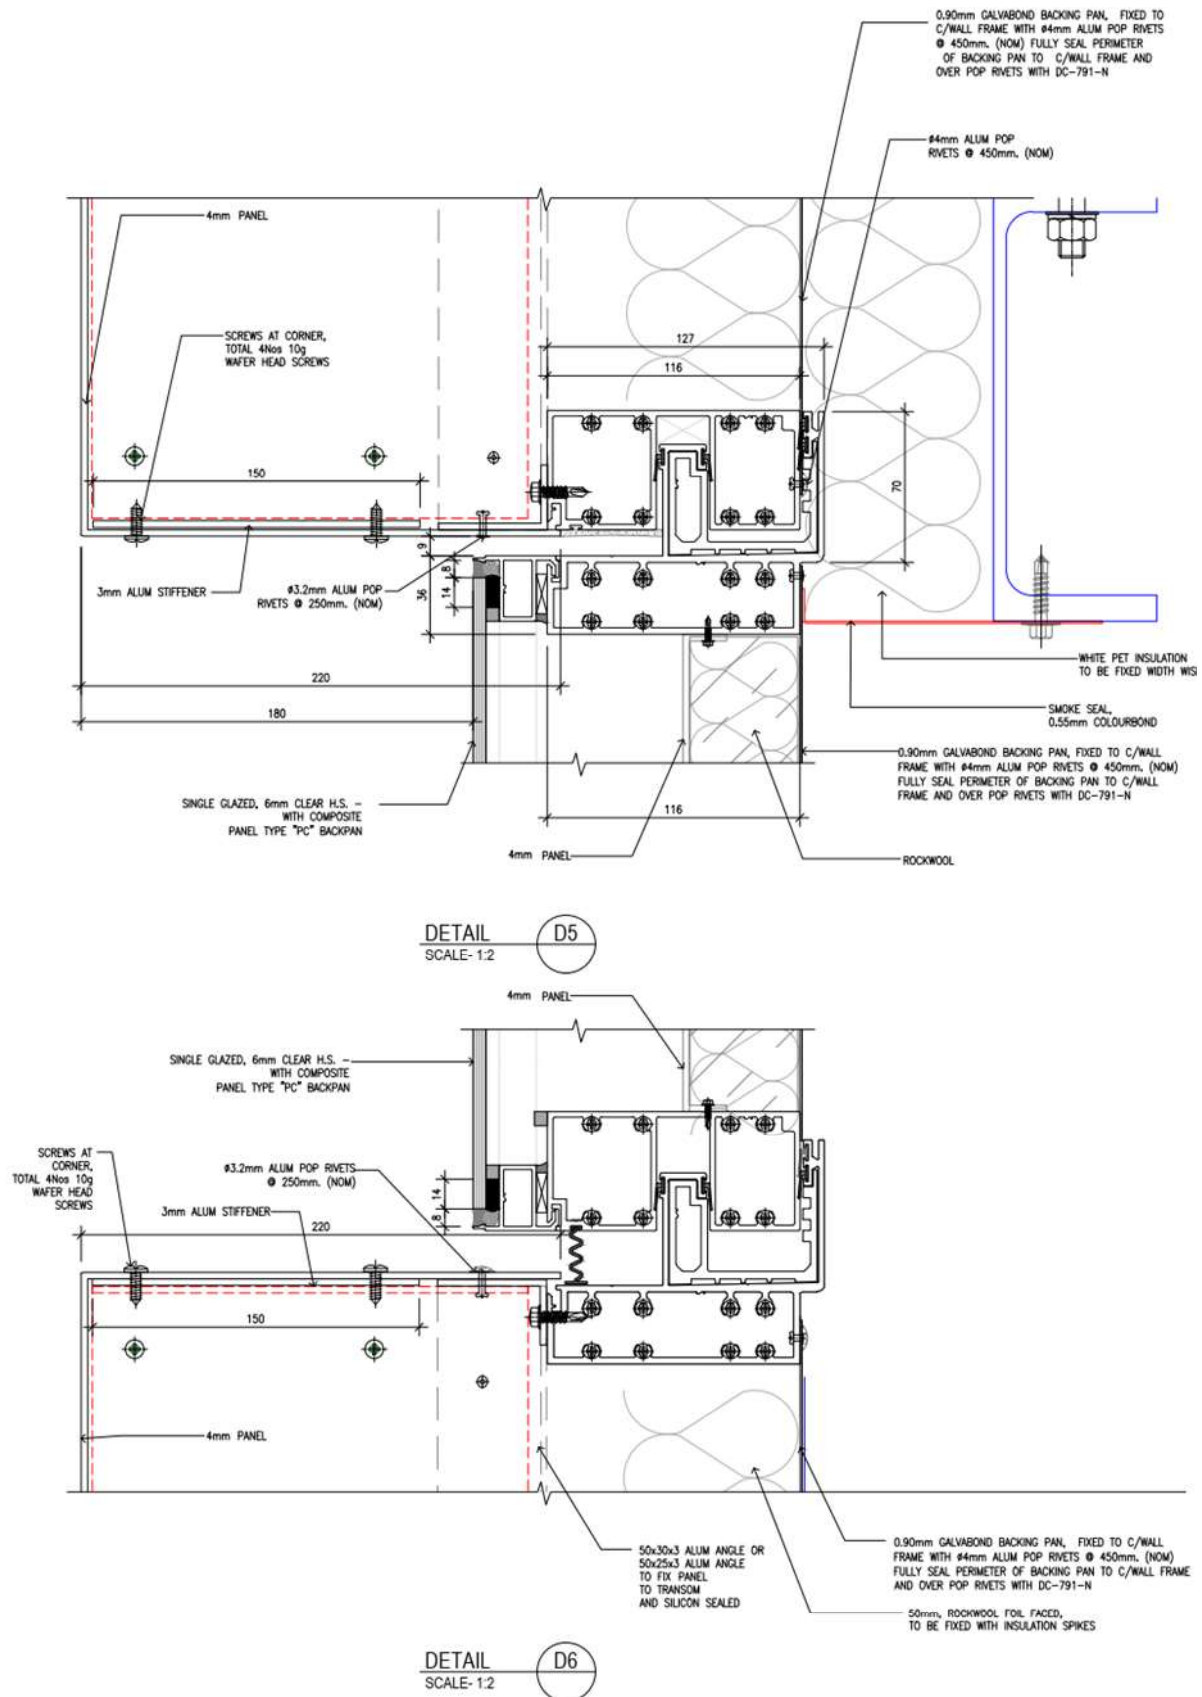
**Figure 19 System assembly – Vertical cross-sectional view.**
