# Reaction to fire test report

Test standard: Ad-hoc test based off ISO 13785-1:2002 with an additional wind component

System: Aluminium composite panel (ACP) and glazing external wall cladding system

Job number: RTF230150

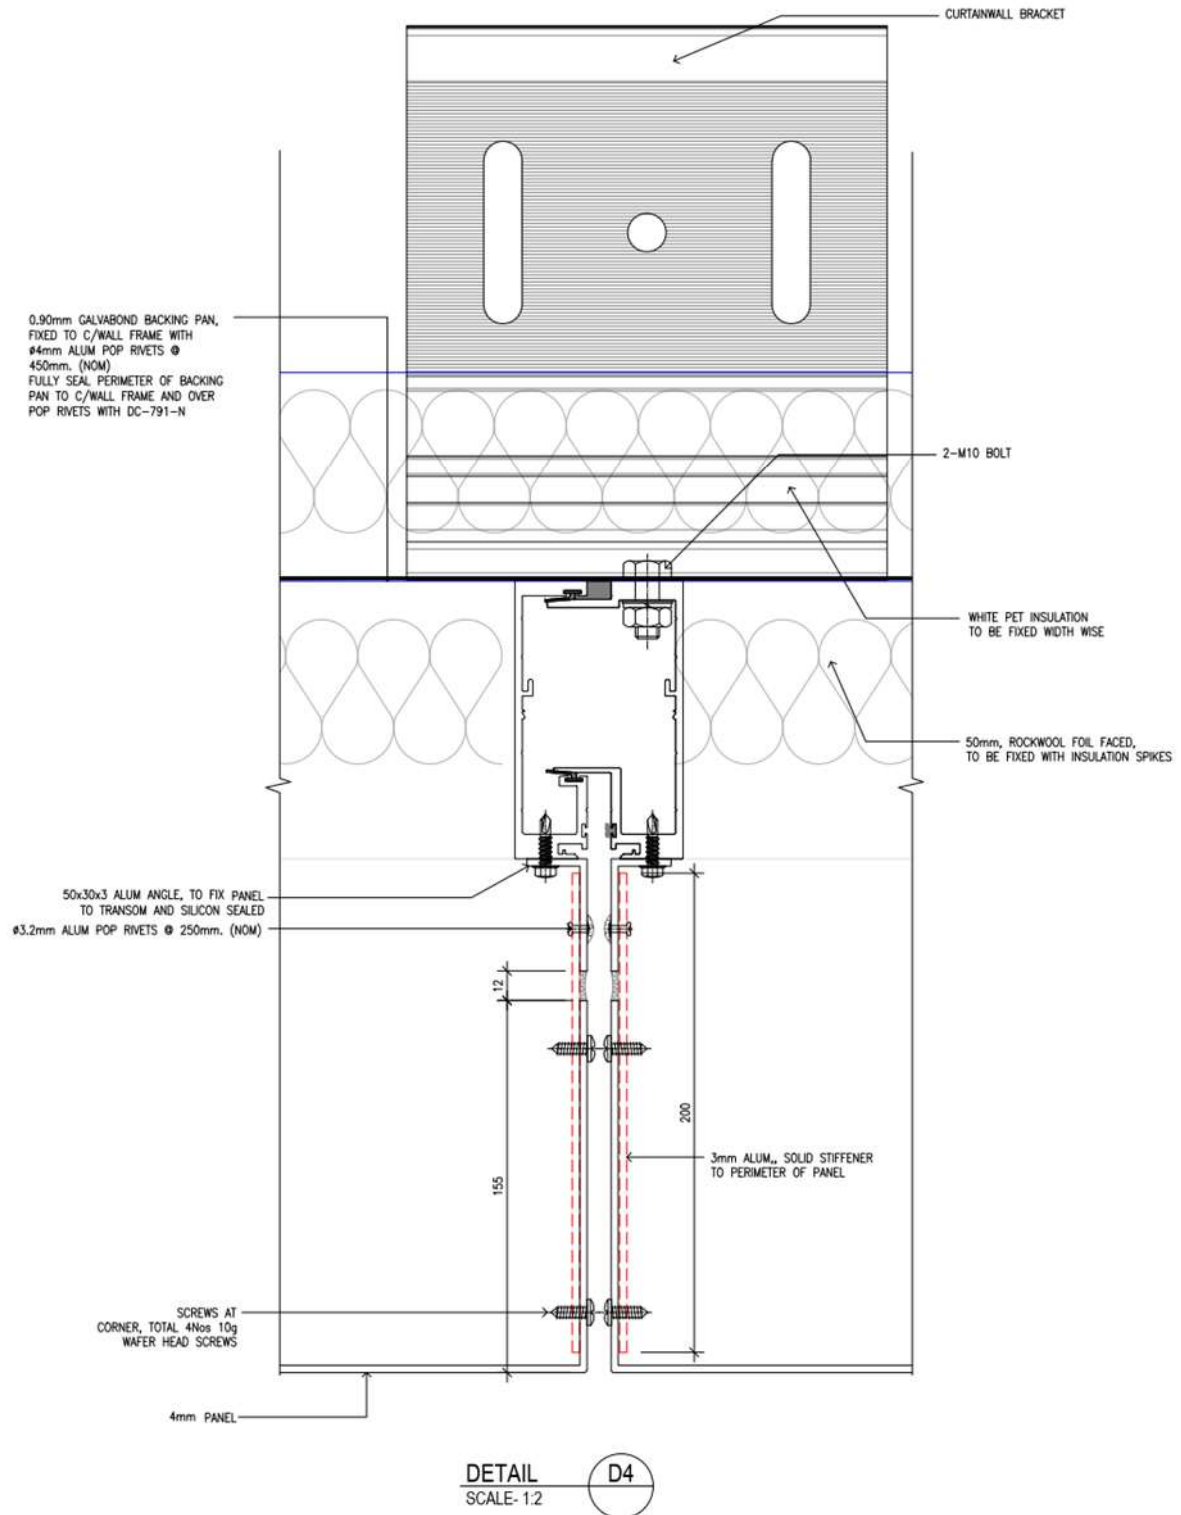
**Figure 20 System assembly – vertical cross-sectional view.**

| Glazing | The glazing, both double (item 3) and single (item 4), were attached to the aluminium framing (item 6) as shown in Figure 15 to Figure 20 and Figure 21. The glazing was sealed around the perimeter with weather sealant (item 15). |

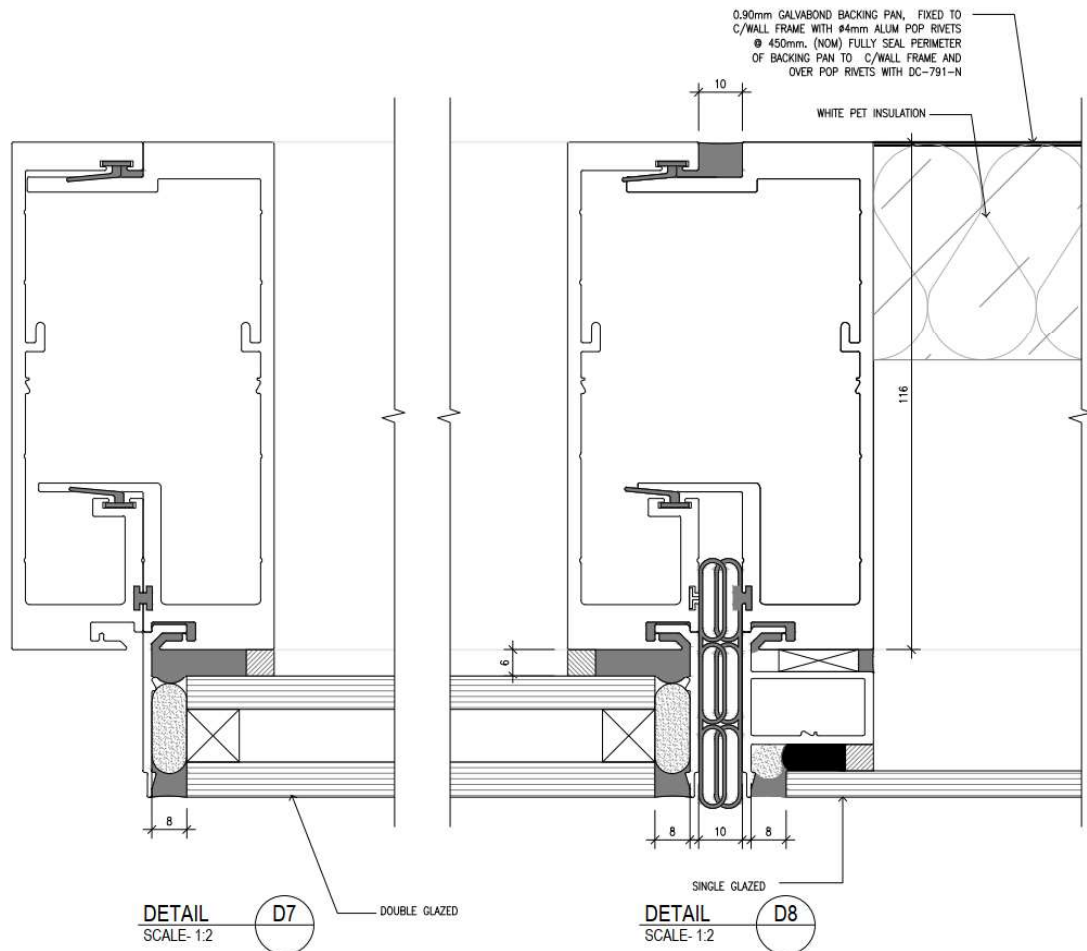
**Figure 21 System assembly – vertical cross-sectional view.**

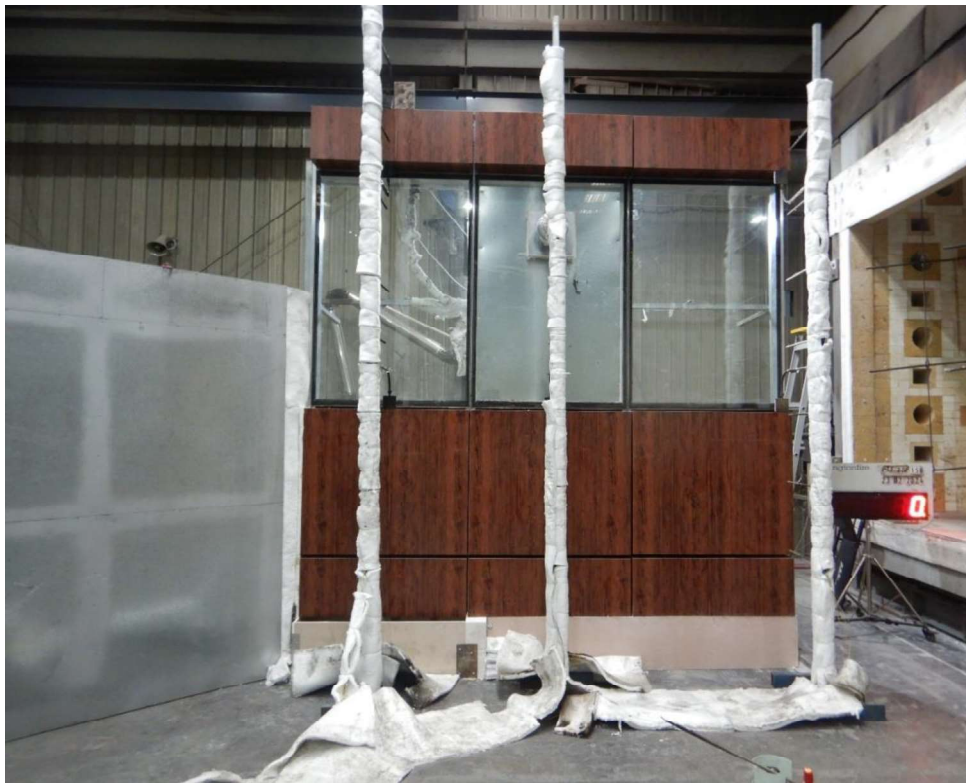
**Figure 22** The specimen and test setup (angled - exposed side) before the reaction to fire test

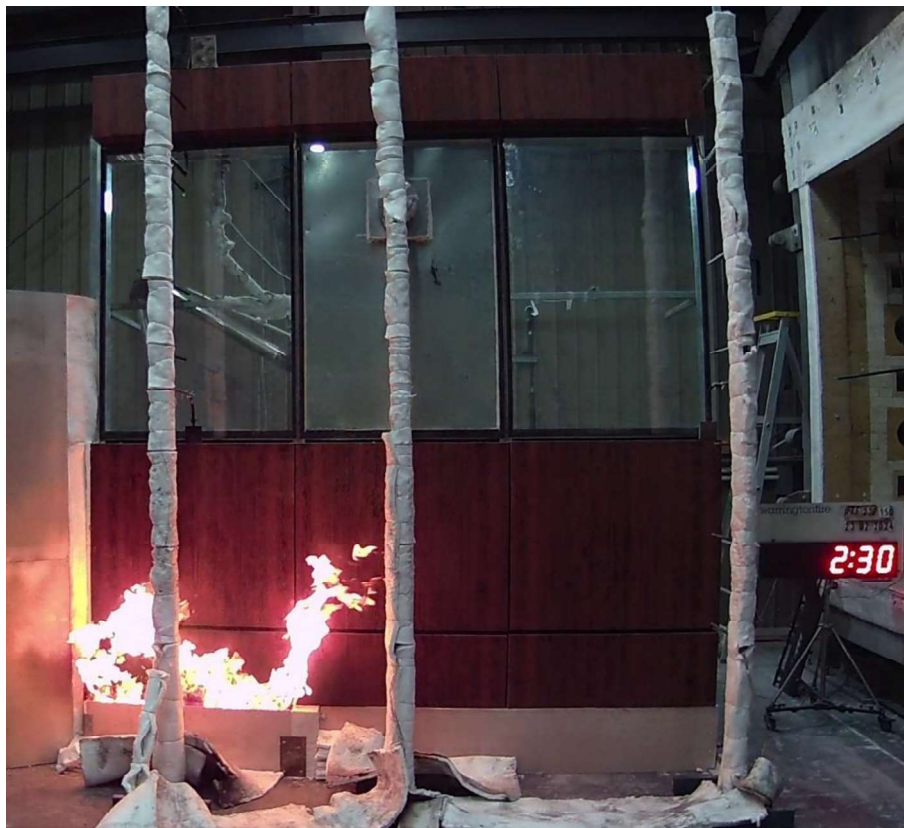
**Figure 25** The specimen 2 minutes 30 seconds into the test (burner output at 300 kW and wind on)

| Time | | Des. | Observation |
|---|---|---|---|
| 2 | 20 | A1 | The bottom paint started to burn upward. |

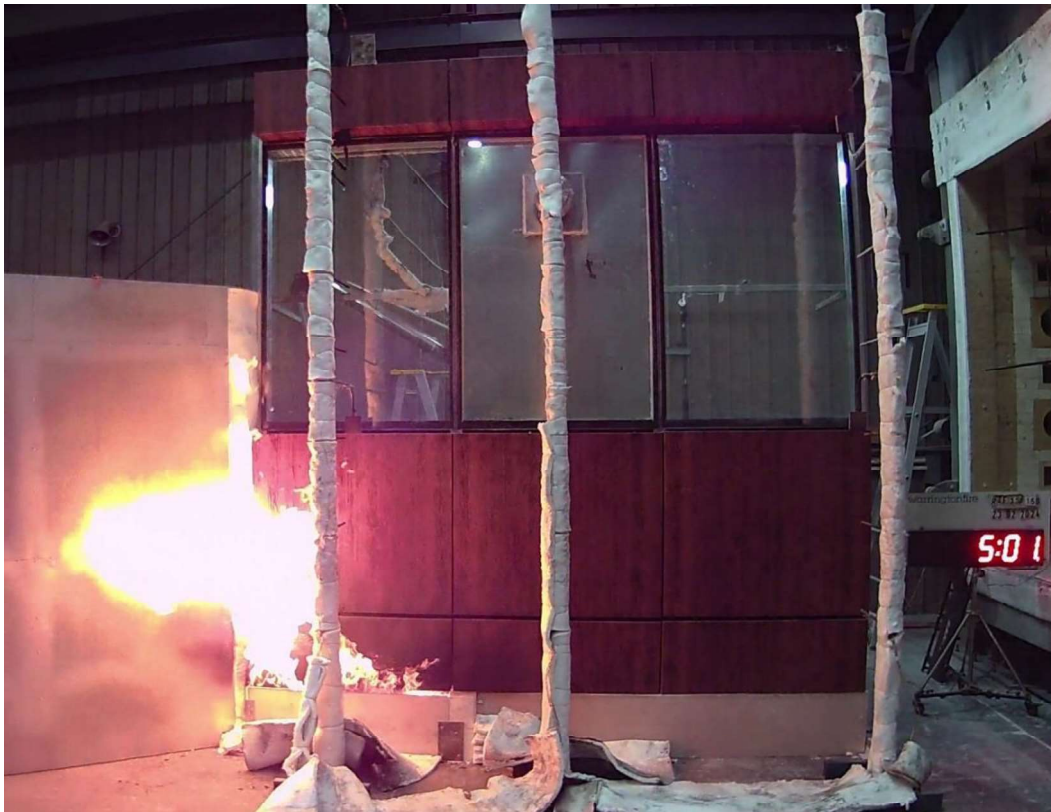
**Figure 26** The specimen 5 minutes 1 second into the test (burner output at 300 kW and wind on)

| Time | | Des. | Observation |
|---|---|---|---|
| 5 | 03 | B1 | The panel face was discolouring. |

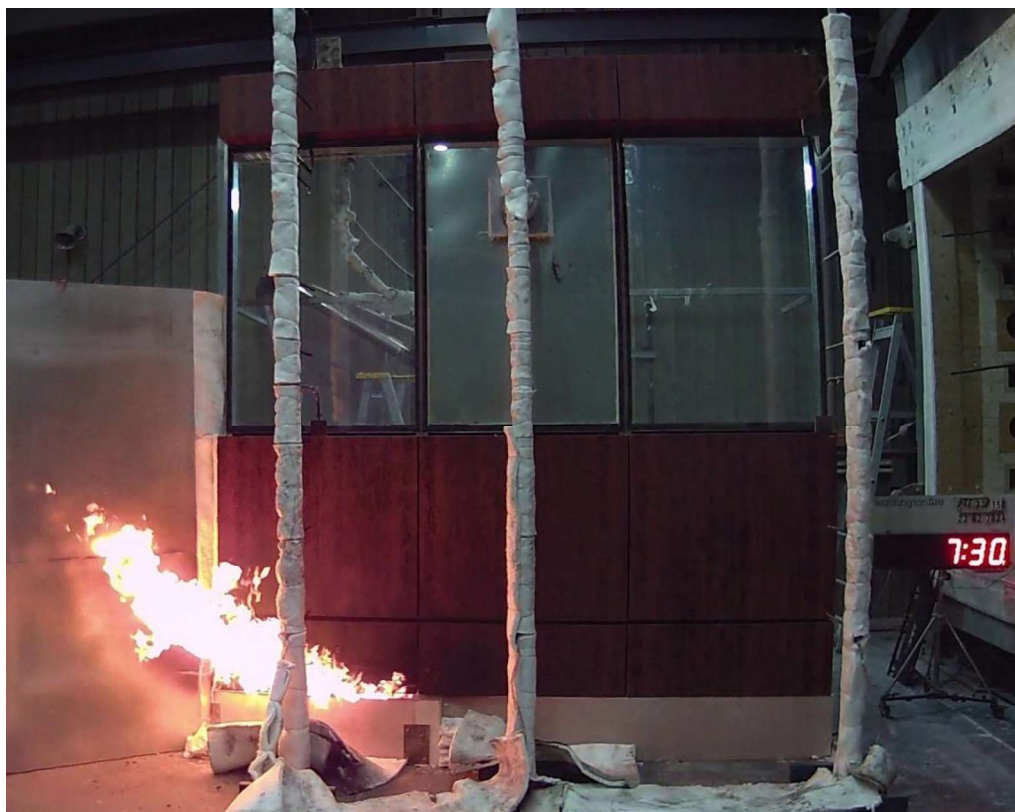
**Figure 27** The specimen 7 minutes 30 seconds into the test (burner output at 300 kW and wind on)

| Time | | Des. | Observation |
|---|---|---|---|
| 7 | 15 | B1 | The panel face was flaking off. |

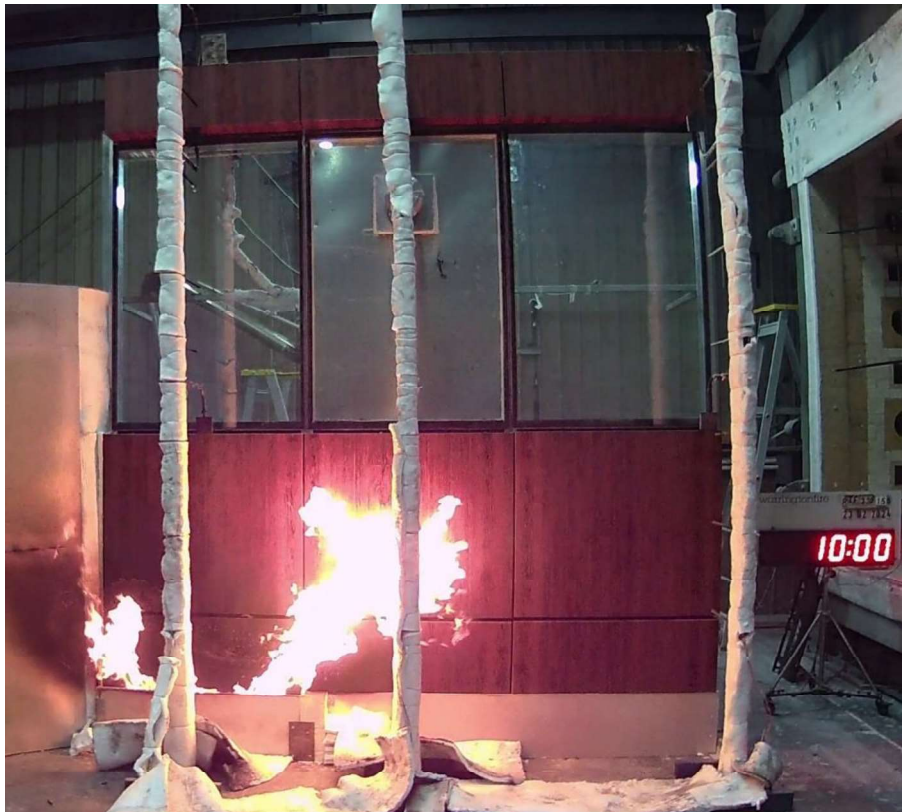
**Figure 28 The specimen 10 minutes into the test (burner output at 300 kW and wind on)**

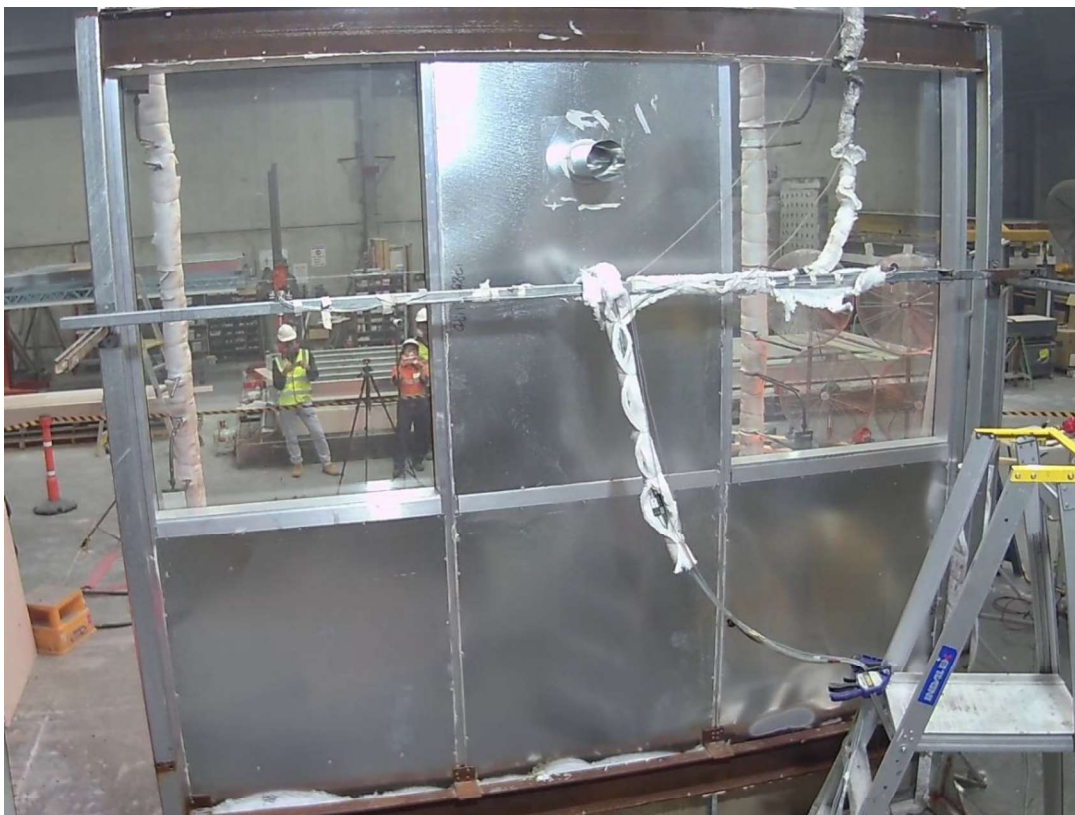
**Figure 33** The unexposed side of the specimen 30 minutes into the test (burner off and wind on).

| Time | | Des. | Observation |
|---|---|---|---|
| 29 | 15 | A/B | There was smoke emitting on the unexposed side. |

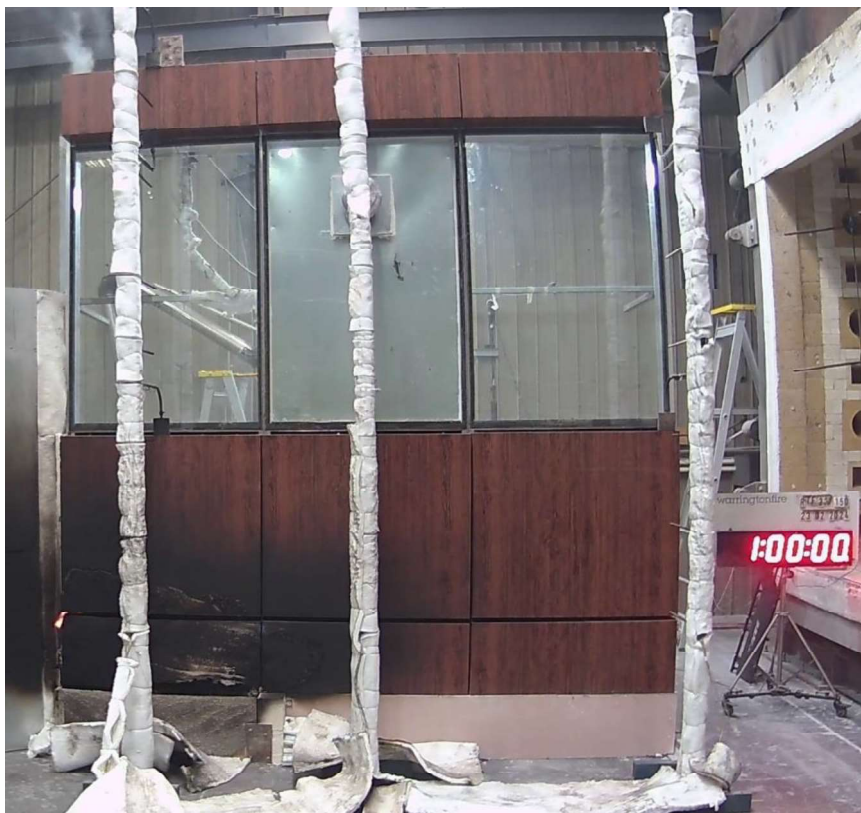
**Figure 43** The specimen at the end of test.

| Time | | Des. | Observation |
|---|---|---|---|
| 60 | 00 | All | There was still some flaming. The test was ended. |

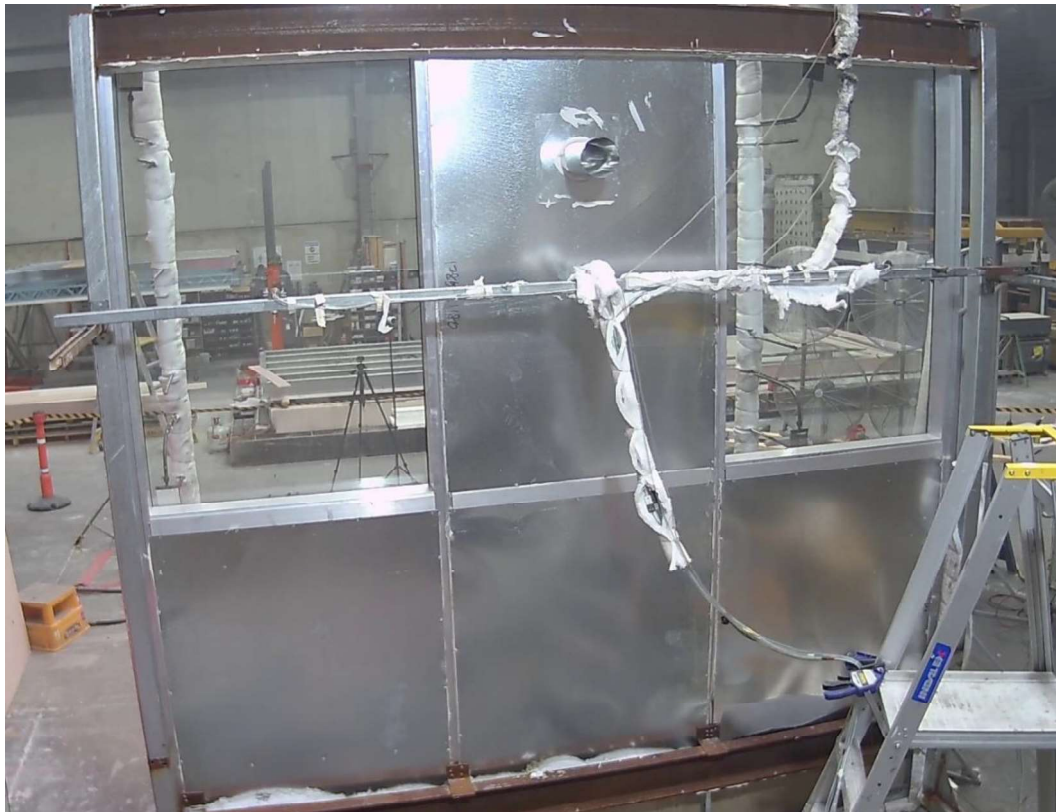
**Figure 44** The unexposed side of the specimen at the end of test.

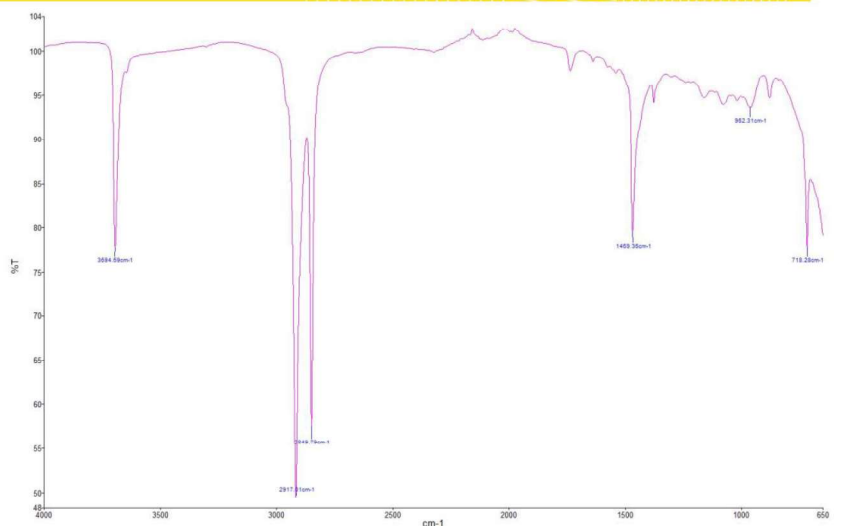
Figure 1. FT-IR spectrum of Sample #1

The aluminium metal was removed from the ACPs cladding polymer, and the flat surface of the polymer samples was abraded to remove any surface adhesive. The surface of each sample was analysed directly by FTIR. The FT-IR spectrum is presented in Figures 1-2.

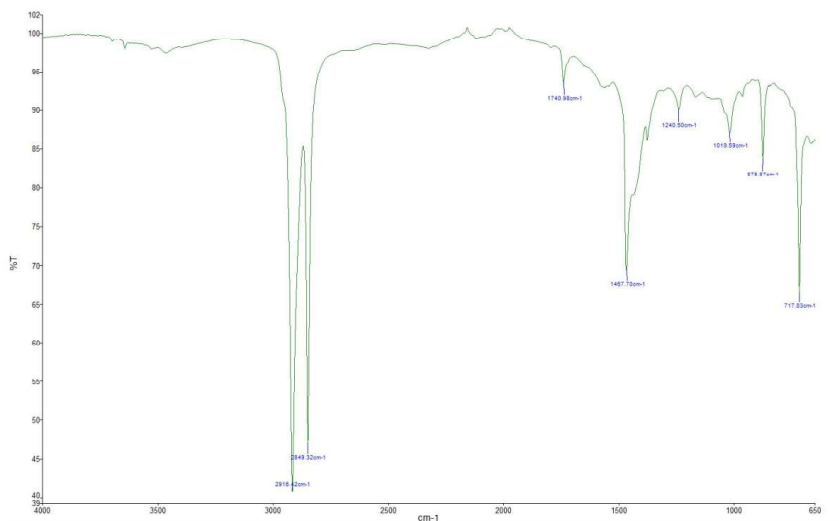
Figure 2. FT-IR spectrum of sample #2
