Reaction to fire test report

Test standard: Ad hoc ISO 13785-1:2002 Part 1 – Intermediate-scale

System: Cassetted aluminium composite panel (ACP) - with a 30% PE core – wall system

Job number: RTF240031

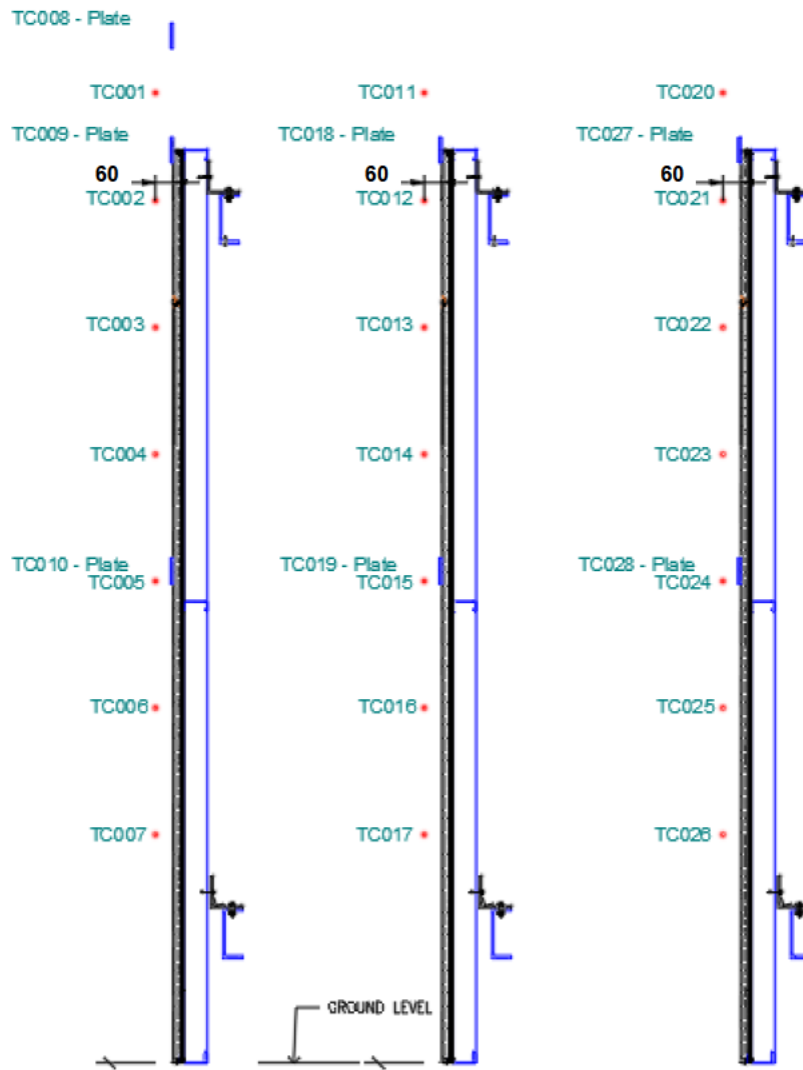
Figure 2 Instrumentation locations - sections

Item	Description
Test rig	The test rig frame was the main support for the test specimen. The test specimen, interconnected through studs and noggings, was fixed to the test ring using curtain wall brackets (item 8) and fixings (item 10) – see Figure 1, 2 and 4.
Cassette wall	The cassetted wall was composed of plasterboard (item 2), top/base tracks (item 4), studs (item 5), noggings (item 6) and the diagonal supports, which were screw fix together using aluminium rivets (item 12). The FR plasterboard (item 2) were fixed to the studs using tek screws (item 11). The aluminium cassette angles (item 7) were fixed to the FR plasterboard (item 2) using tek screws (item 11).
Cladding	The exposed face of the specimen was clad with cassetted ACPs (item 1) that were fixed to aluminium cassette angles (item 7) using wafer head screws (item 10) at about 325 mm centres.

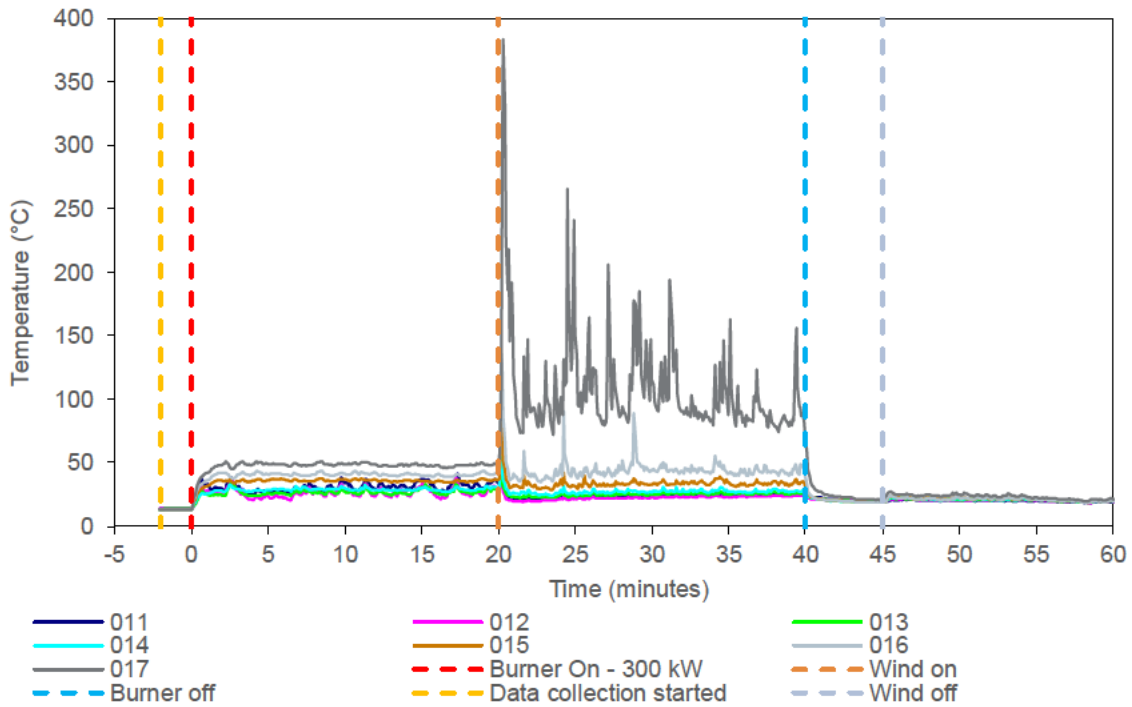
Figure 7 External temperature data collected by thermocouples placed 60 mm from the front face of the specimen – central module

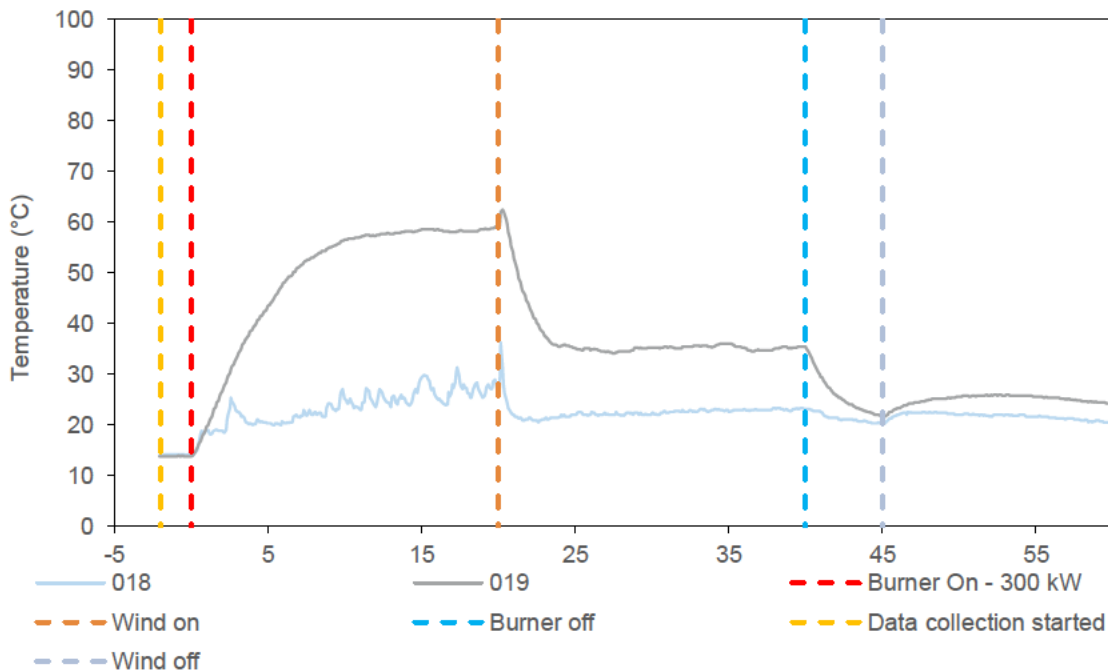
Figure 8 External temperature data collected by plate thermocouples in-line with ACP – central module

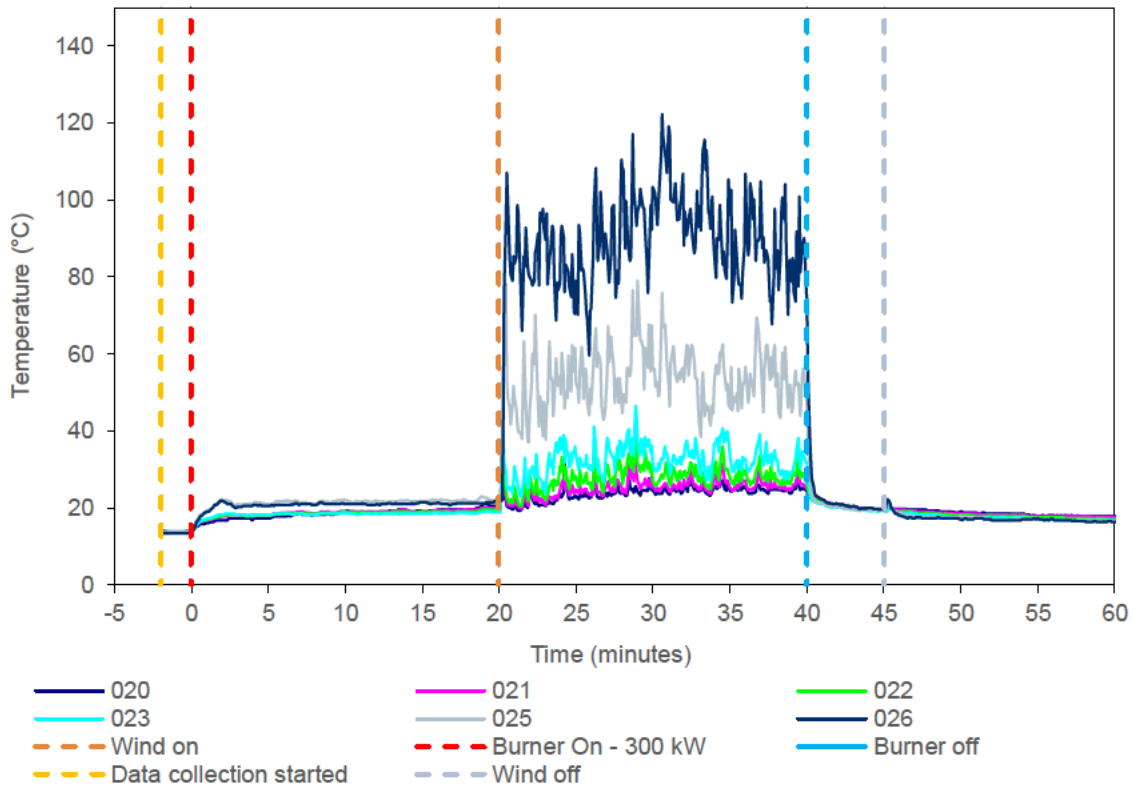
Figure 9 External temperature data collected by thermocouples placed 60 mm from the front face of the specimen – away from the burner

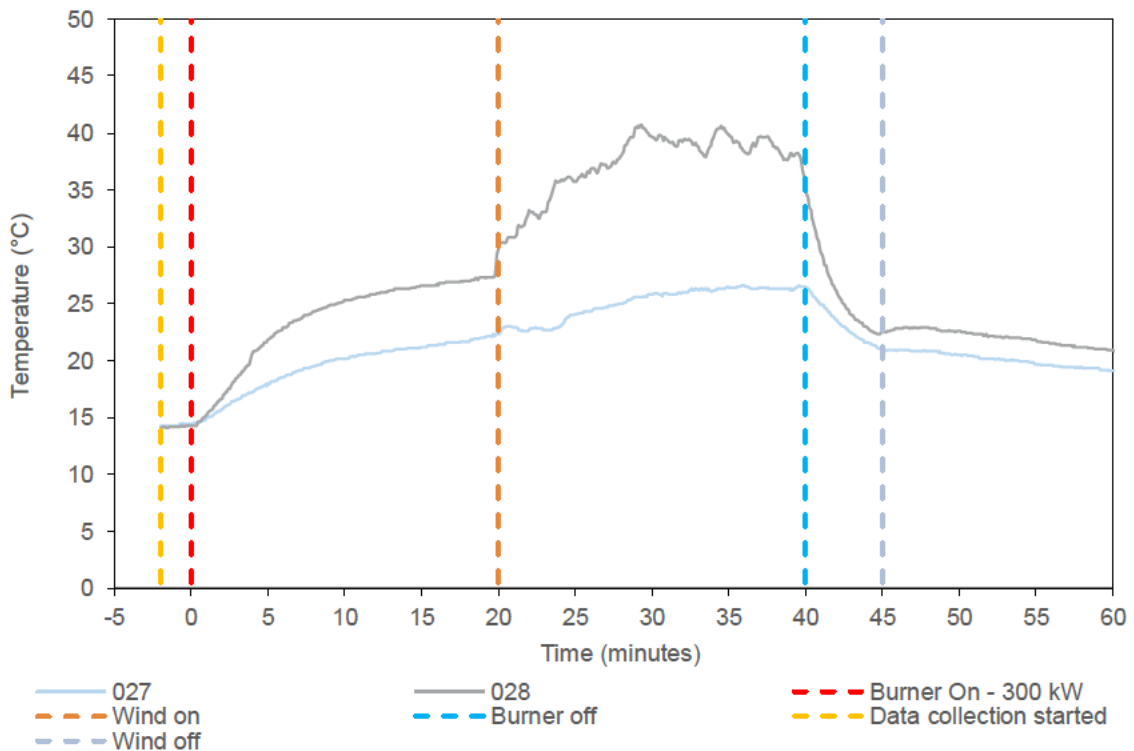
Figure 10 External temperature data collected by plate thermocouples in-line with ACP – away from the burner

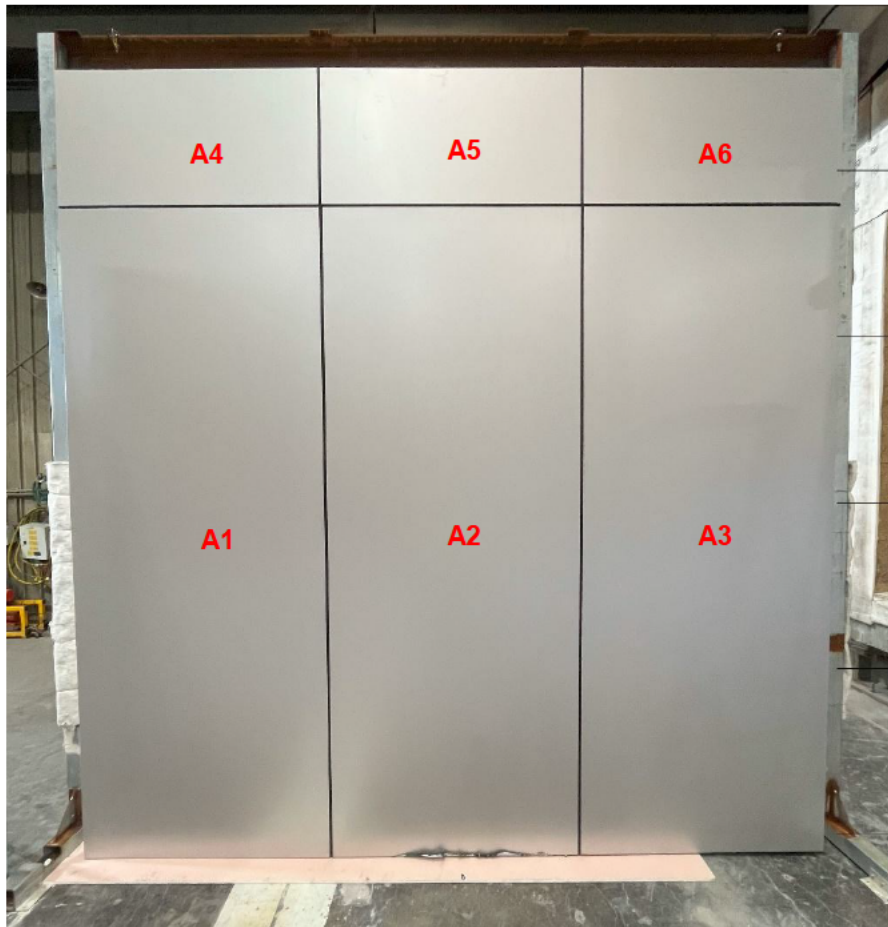
Figure 11 Designation of section for the test observation

Table 4 shows the observations of any significant behaviour of the specimen during the test. Figure 11 shows the panel designations sighted in the observations.

Time		Des.	Observation
Min	Sec		
Pre-test			Within an hour period prior to the test period and data collection the wind was turned on and wind measurements and steady state conditions were recorded.
		A1	The wind speed just below TC005 was 0.6 – 2.2 m/s.
		A2	The wind speed just below TC015 was 0.7 – 2.1 m/s.
		A3	The wind speed just below TC024 was 2.2 – 2.3 m/s.
-2	00	All	Data logger started. Fan is turned off.
0	00	All	Burner on 300 kW
1	11	A1	The paint had burned off on the lower part.
4	15	A1	The lower part panel appeared to deform
9	14	A1/A2	Smoke emission from the joint between A1 and A2.

Time		Des.	Observation
Min	Sec		
9	58	A1/A2	The lower middle part appeared to deform
17	46	All	Smoke observed from the top left edge of the frame.
19	17	A1	Panel appeared to open up.
19	51	A1/A2	Flaming observed at the lower joint between A1 and A2.
20	00	All	Fans turned on.
20	44	A1	Opened up can be clearly seen at the location between TC7 and TC8.
21	35	All	Smoke emission observed from the back.
22	19	A2	The skin was burnt off on the lower part of the panel.
25	47	A3	The area around the lower left edge slightly deforms.
28	39	A2	The lower part of the panel appeared to open up below TC17.
30	51	A2/A3	Flaming at the lower joint between A2 and A3. Charring at the lower left edge of A3.
40	00	All	Burner turned off.
40	23	A1/A2	Flaming observed at the lower part of A2 and the right corner of A1
42	38	All	No flaming observed.
45	00	All	Fans turned off.
60	00	All	Test was ended.

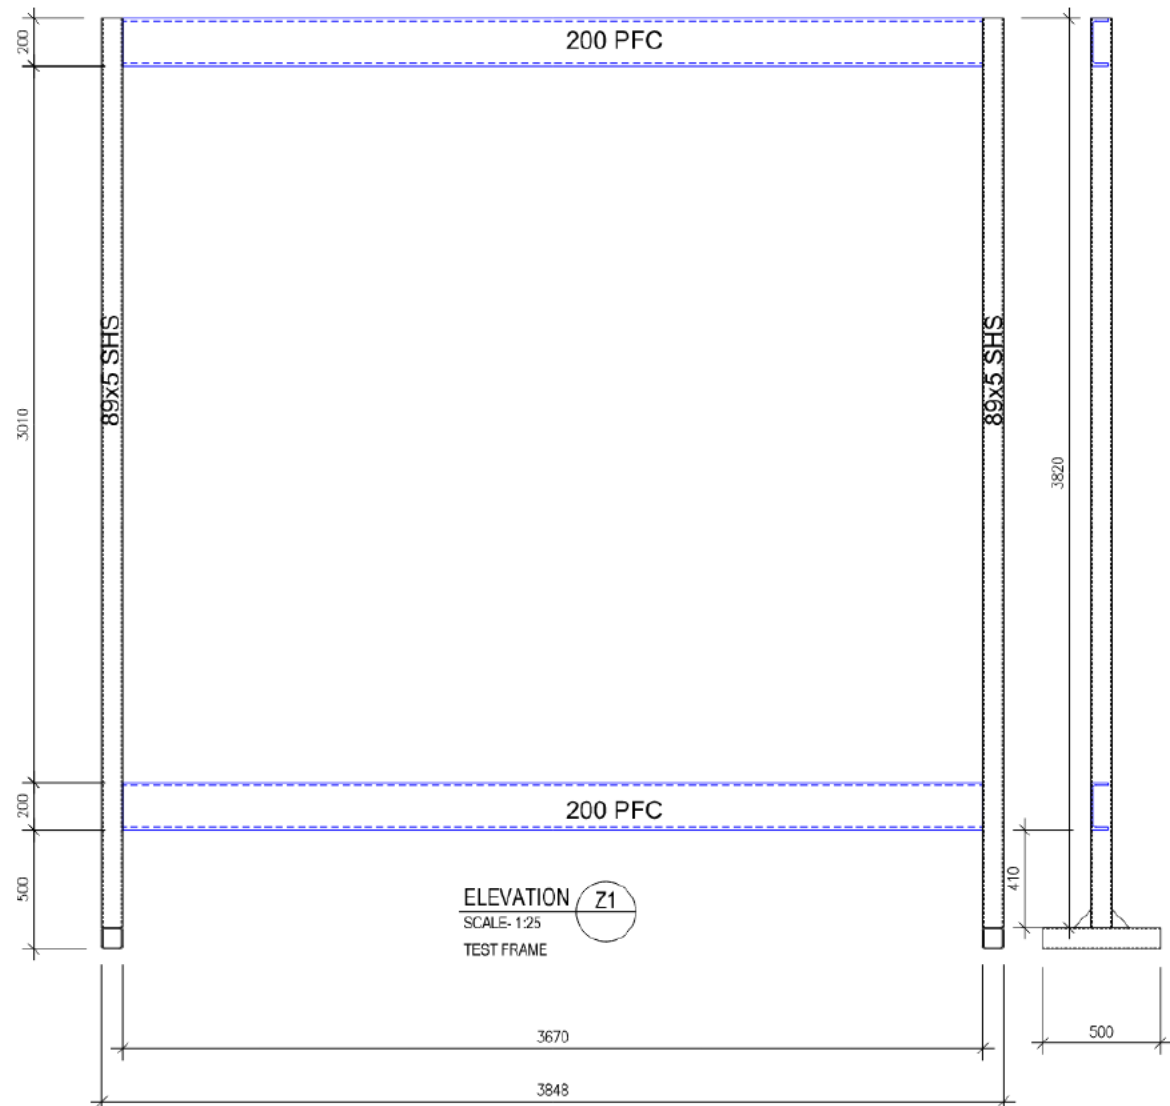
Figure 12 Elevation of rig support

The drawings of the test assembly in Figure 12 to Figure 15 were provided by the representatives of Warringtonfire. Dimensions, unless specified, are in mm. The Figure 14 was modified by Warringtonfire, where the locations of the Fixing Bracket and FR plasterboard were modified.

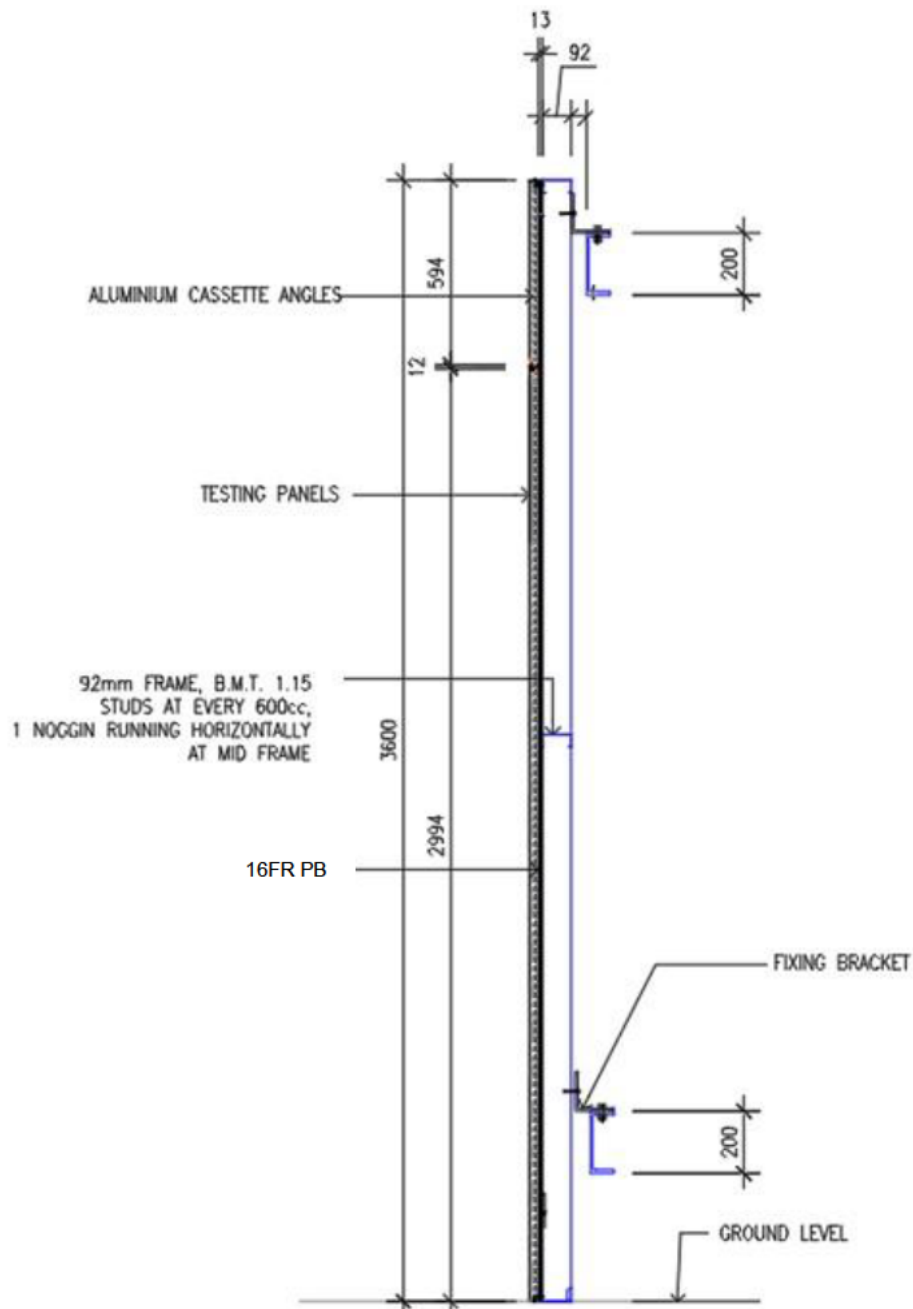
Figure 14 System assembly – vertical cross-sectional view

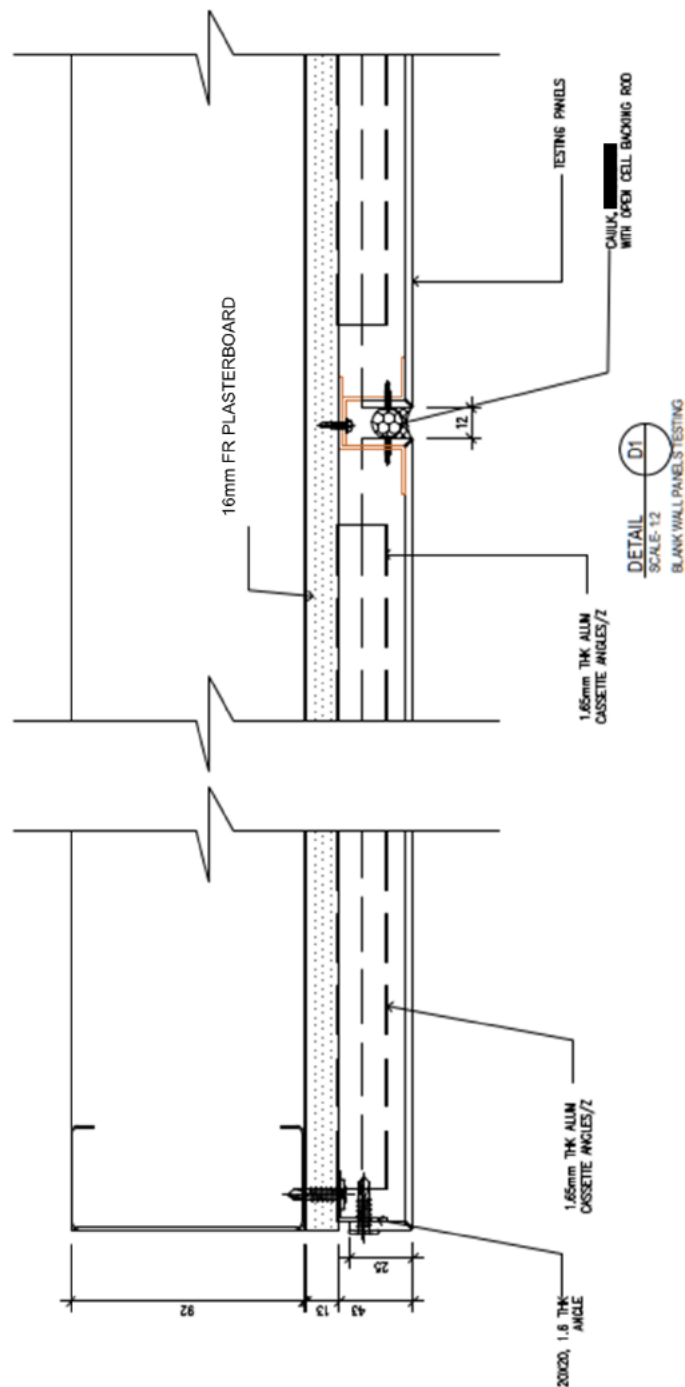
Figure 15 System assembly – vertical cross-sectional view

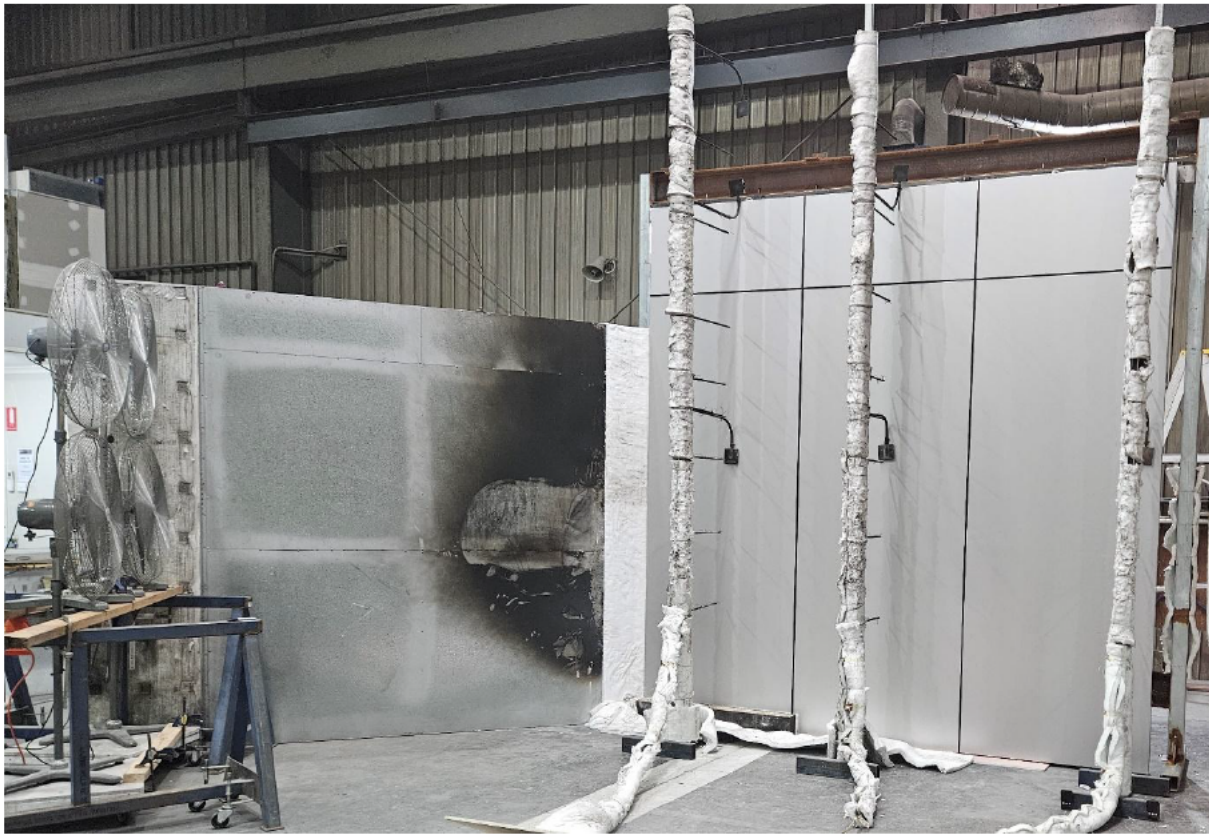
Figure 16 The specimen and test setup (angled – exposed side) before the reaction to fire test

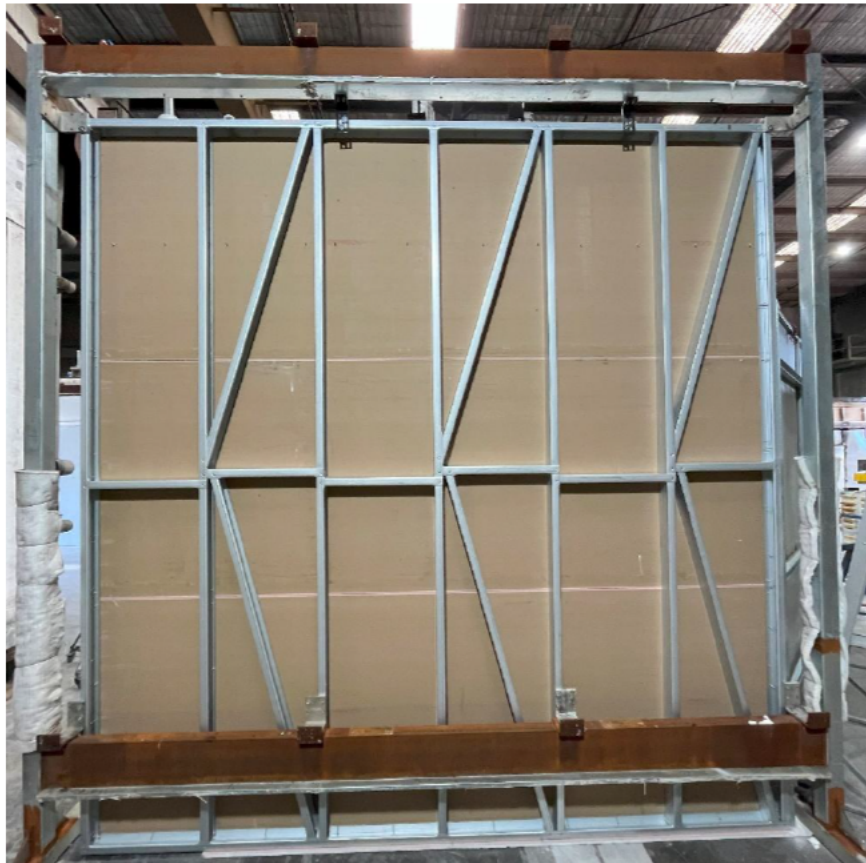
Figure 17 The specimen before the reaction to fire test - unexposed side

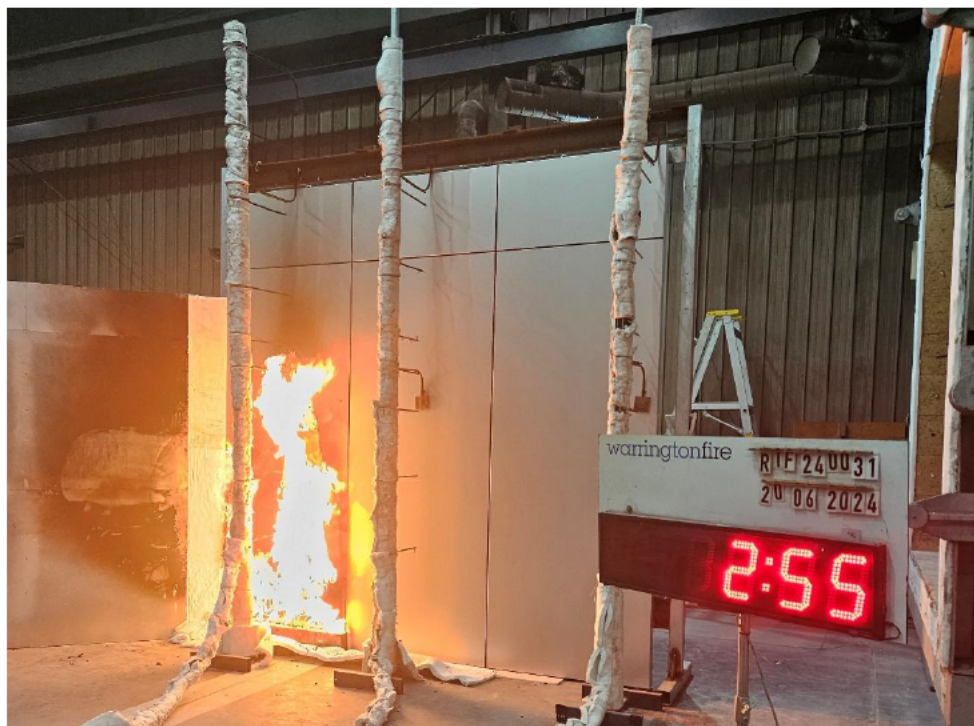
Figure 18 The specimen 2 minutes 55 seconds into the test (burner output at 300 kW)

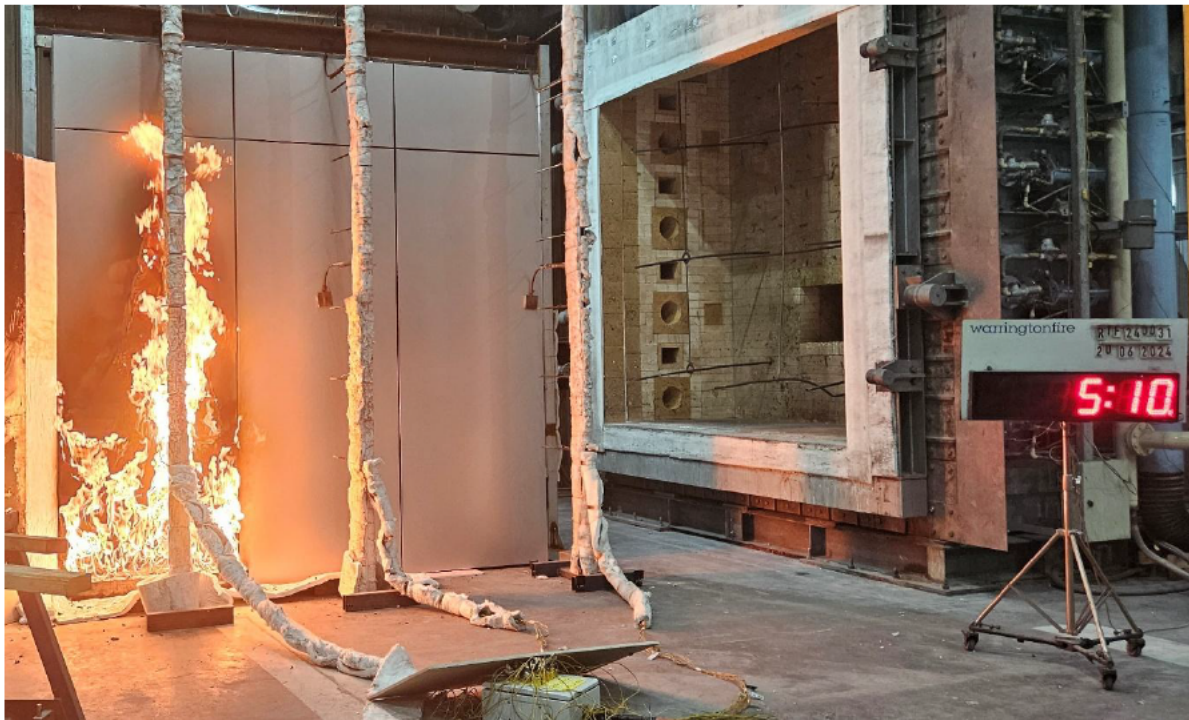
Figure 19 The specimen 5 minutes 10 seconds into the test (burner output at 300 kW)

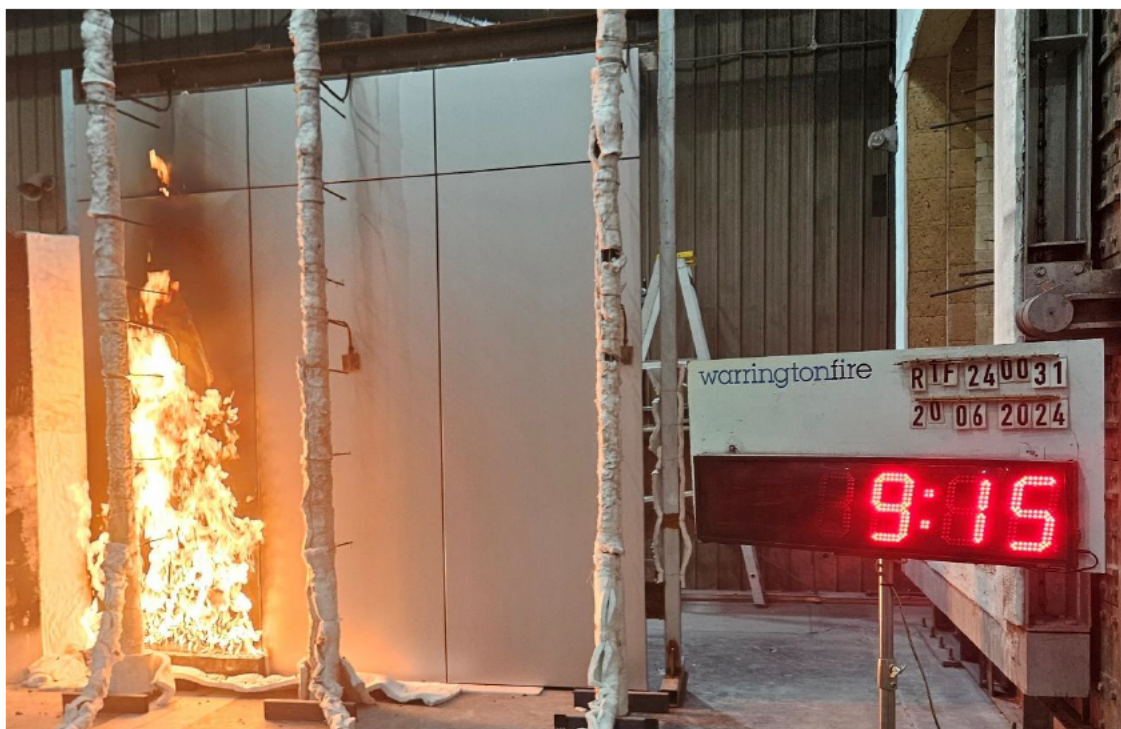
Figure 20 The specimen 9 minutes 15 seconds into the test (burner output at 300 kW)

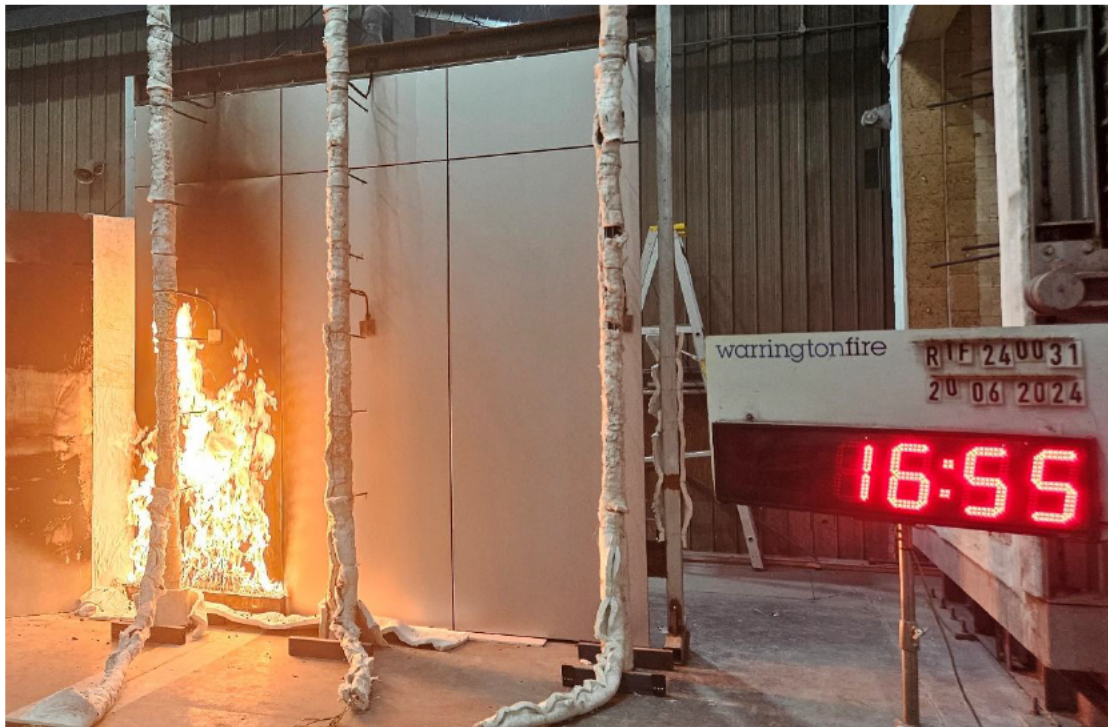
Figure 21 The specimen 16 minutes 55 seconds into the test (burner output at 300 kW)

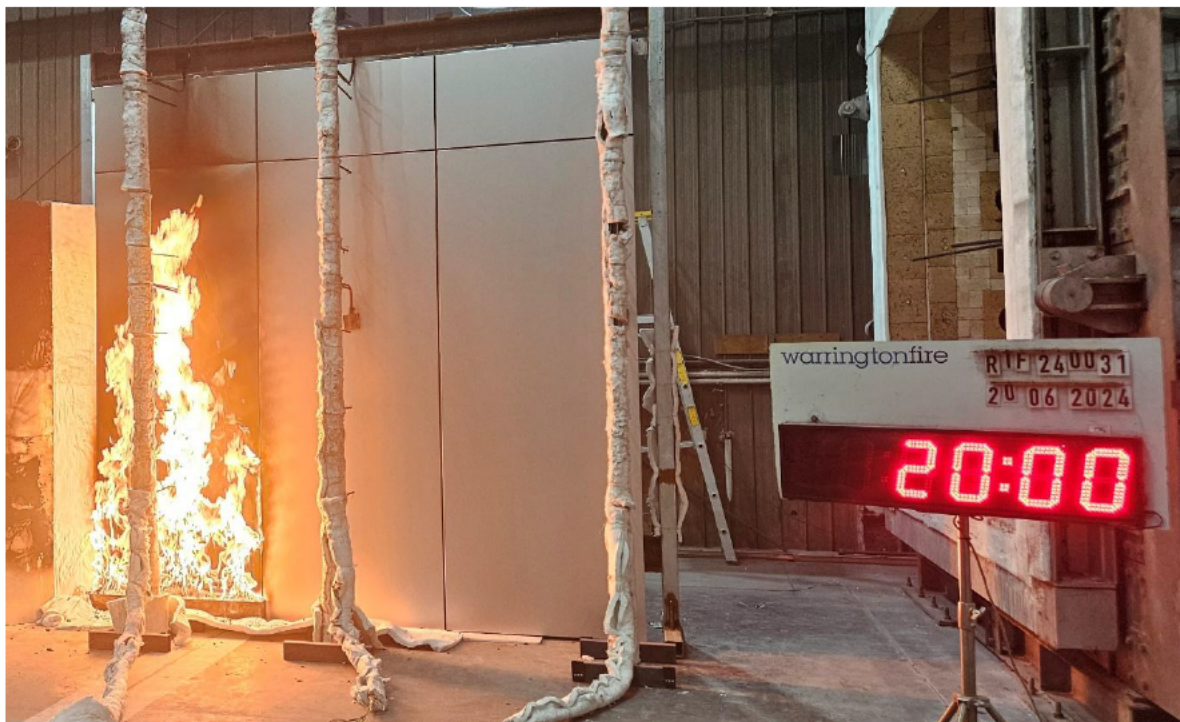
Figure 22 The specimen 20 minutes into the test (burner output at 300 kW)

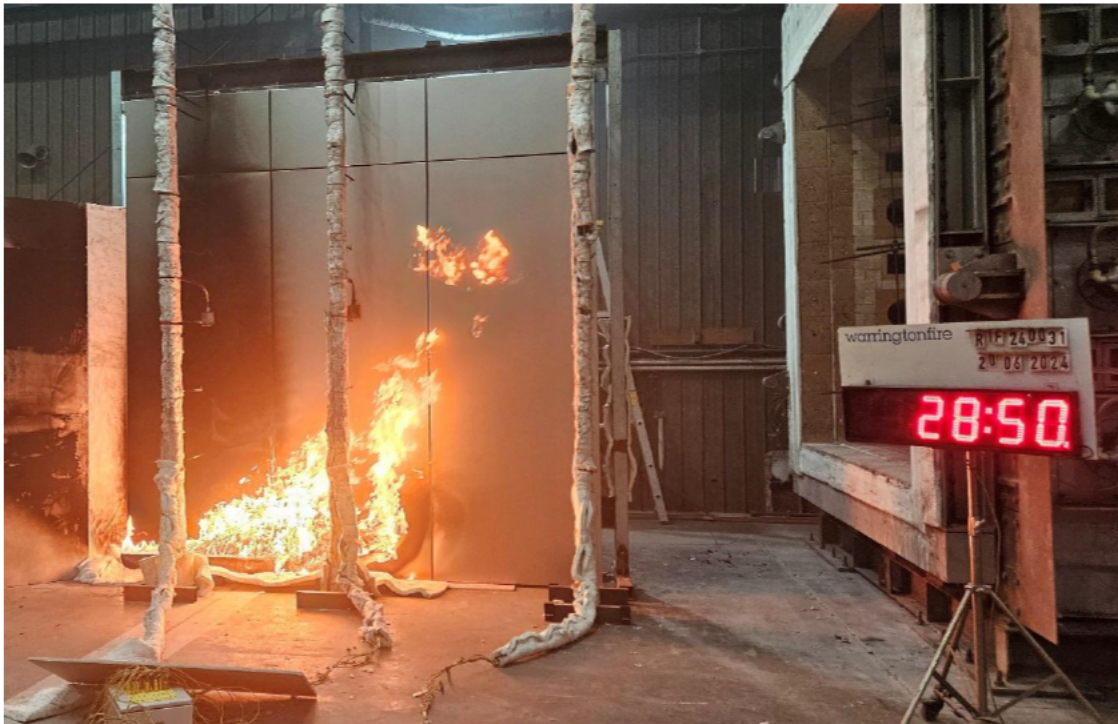
Figure 23 The specimen 28 minutes 50 seconds into the test (burner output at 300 kW)

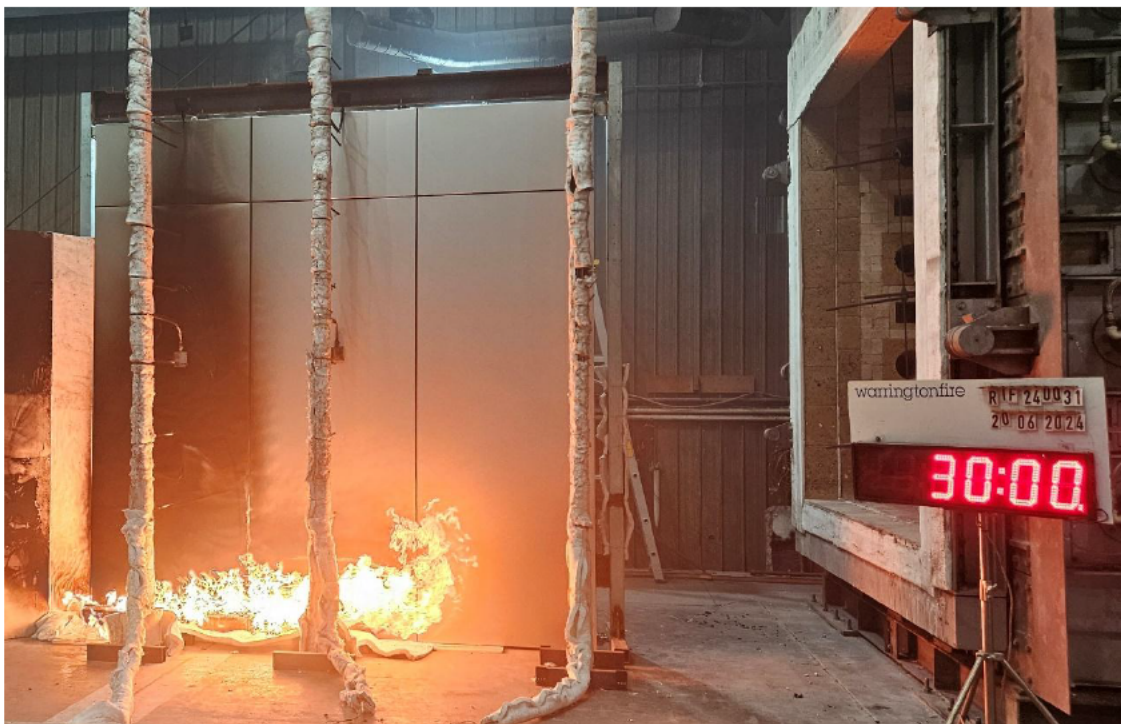
Figure 24 The specimen 30 minutes into the test (burner output at 300 kW)

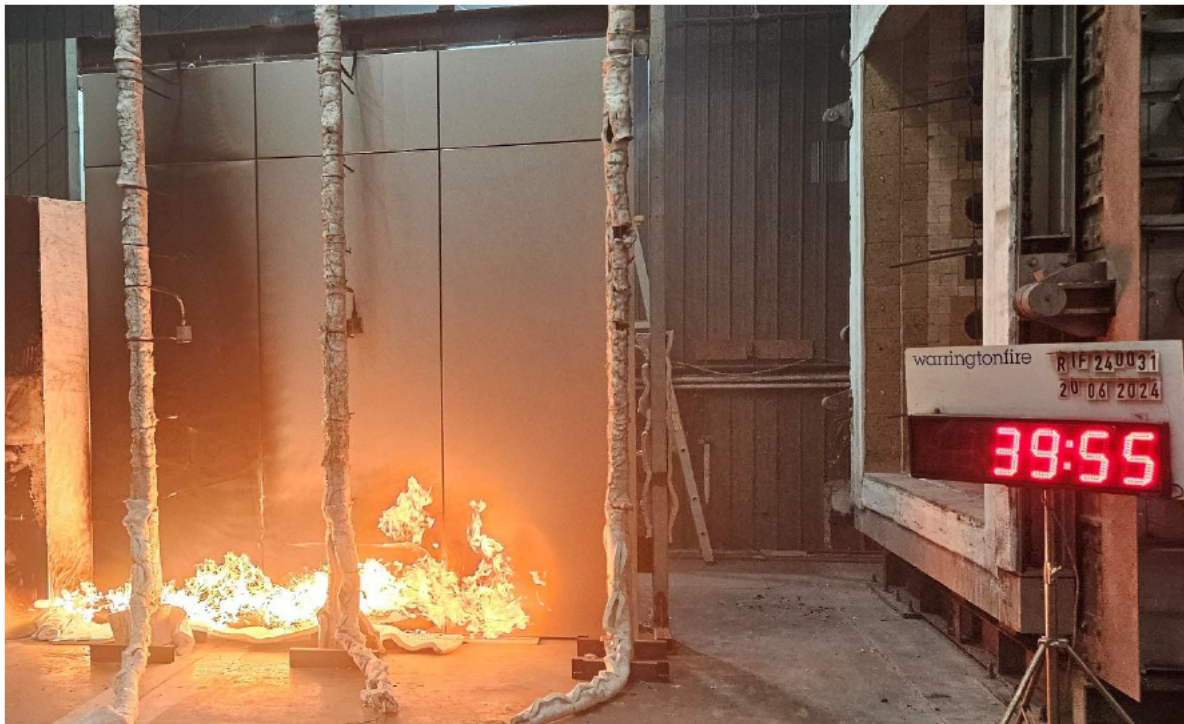
Figure 25 The specimen 39 minutes 55 seconds into the test (burner output at 300 kW)

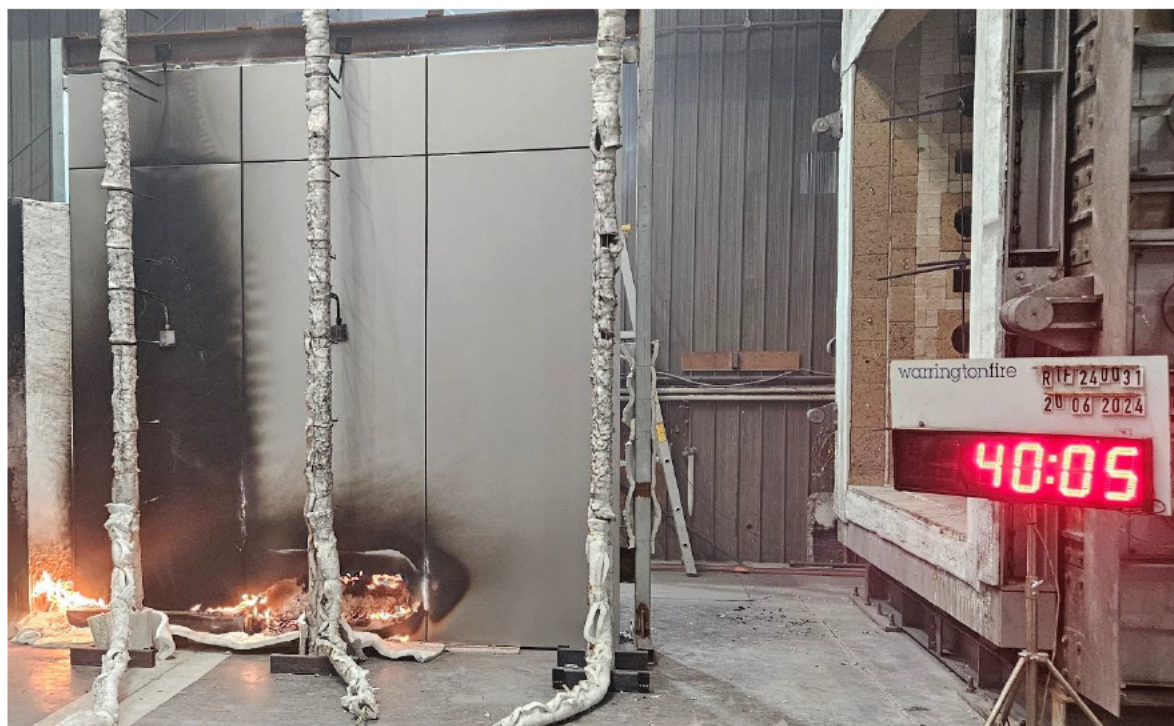
Figure 26 The specimen 40 minutes 5 seconds into the test (5 seconds after burner off)

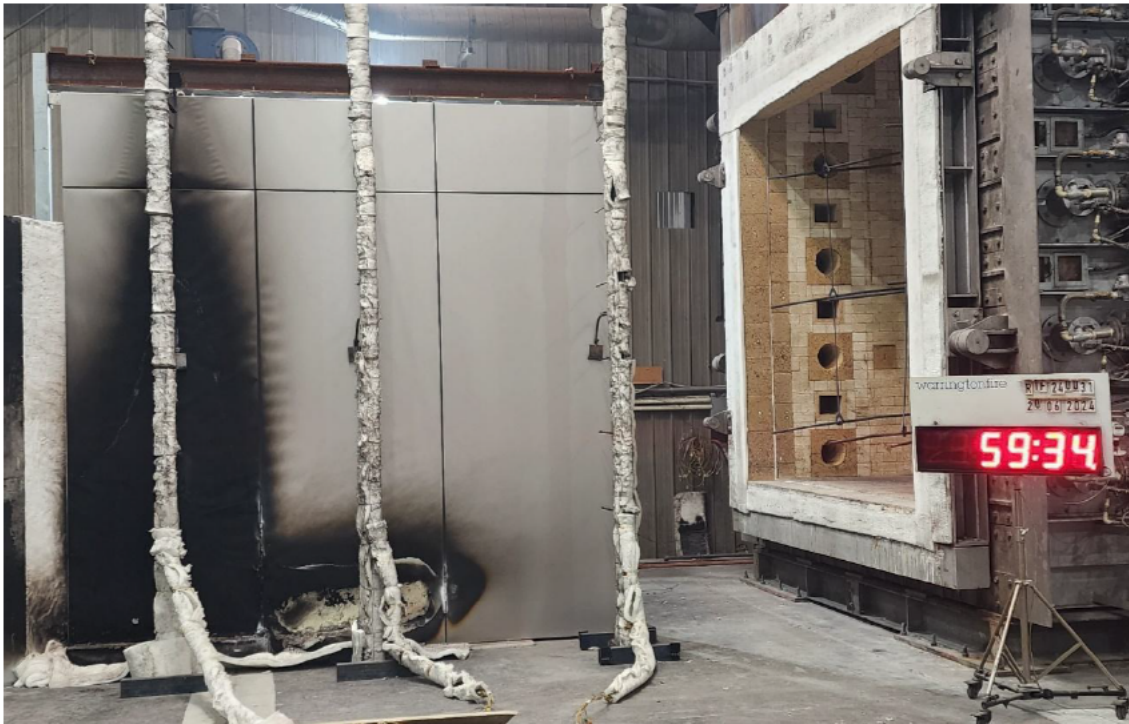
Figure 27 The specimen 59 minutes 34 seconds into the test (19 minutes 34 seconds after burner off)

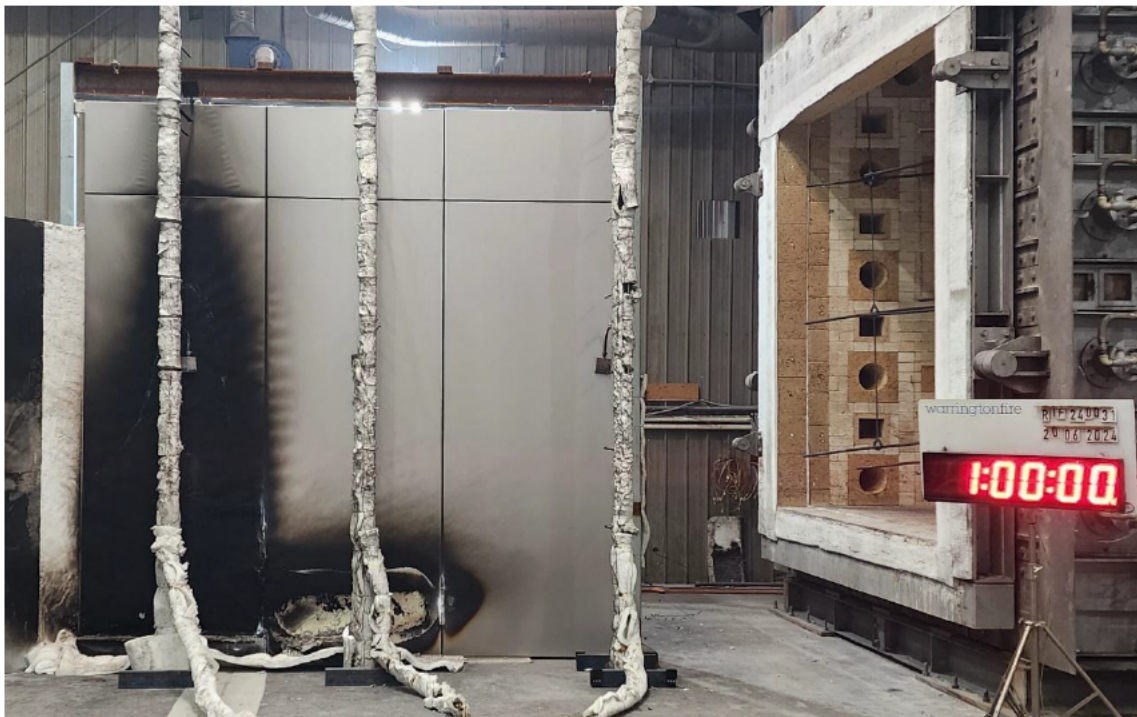
Figure 28 The specimen 60 minutes into the test (20 minutes after burner off)
