Reaction to fire test report

Test standard: Ad-hoc test based on ISO 13785-1:2002

System: ACP with 30 % polyethylene core external façade cladding system with PET wall insulation

Job number: RTF240049

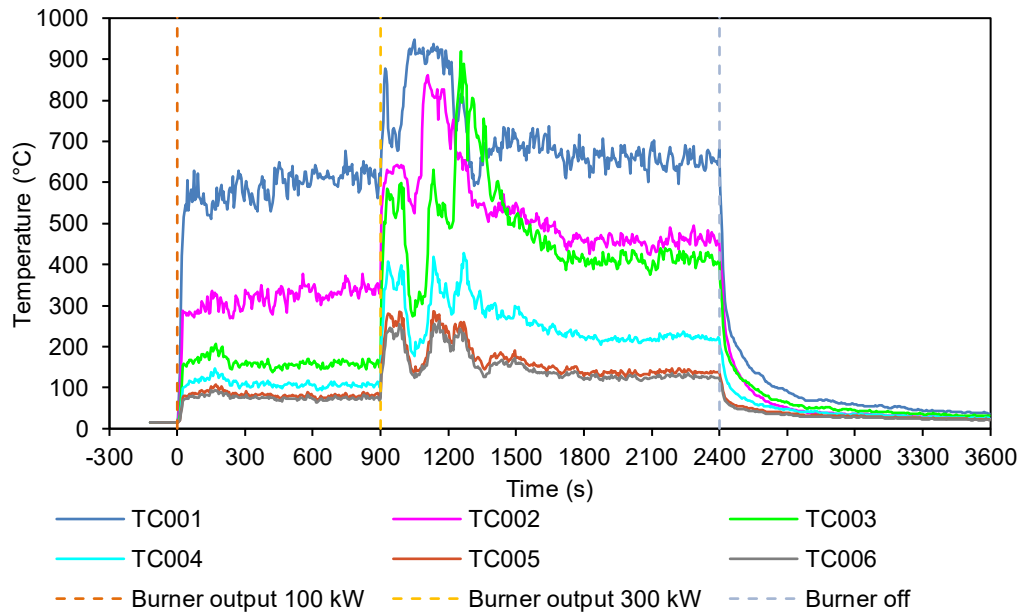
Figure 1 50 mm from the exposed face – Temperature vs time

Test duration	60 minutes	
Instrumentation and equipment	<ul style="list-style-type: none"> 6 mineral insulated metal sheathed (MIMS) Type K thermocouples with an overall diameter of 1.5 mm with the measuring junction insulated from the sheath were positioned at various heights, 50 mm in front of the outer face of the test specimen along its vertical centreline. Refer to Figure 13 and Figure 14 for details on positioning. 3 MIMS Type K thermocouples with an overall diameter of 1.5 mm with the measuring junction insulated from the sheath were positioned at various heights in the mid-depth the framing cavity of the test specimen. Refer to Figure 13 and Figure 14 for details on positioning. The fire source was a propane (95% purity) gas fuelled box burner; 1.2 m wide × 0.1 m deep × 0.15 m tall. The burner was located on the floor in front of the specimen, with the back edge of the burner in line with the exposed face of the specimen. The incident heat flux 50 mm above and in line with the exposed face of the test specimen was measured using a Schmidt-Boelter type heat flux gauge with a range of 0 - 50 kW/m². The products of combustion were collected in an exhaust hood located centrally above the exposed face of the tested specimen. The hood was connected to an exhaust duct 400 mm in diameter, which had instruments inside to measure the conditions and properties of the combustion products during the test. The hood had specifications based on those given in AS ISO 9705:2003 (R2016), with the only differences being that all four sides had 1 m blanking sheet extensions, and there was no fire test room. The volume flow rate was determined using a bidirectional pressure probe attached to a differential pressure transmitter together with a type K MIMS thermocouple positioned near the probe. Smoke obscuration measurements were made using a helium-neon laser smoke photometer, as outlined in Annex H of ISO 9705-1:2016. The temperature of the exhaust stream near the light beam was measured using a type K MIMS thermocouple.

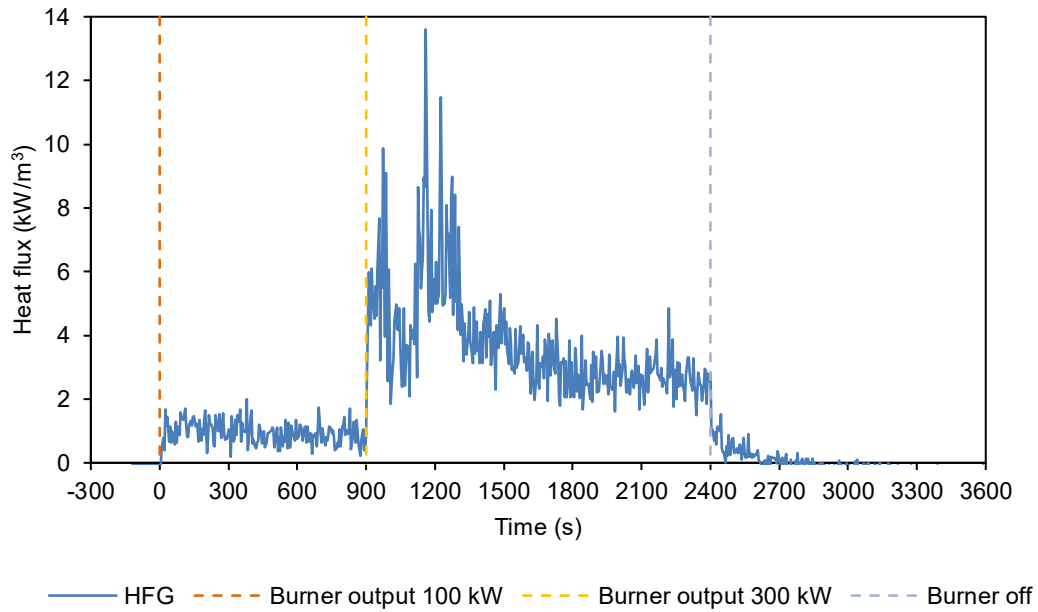
Figure 3 Heat flux vs time

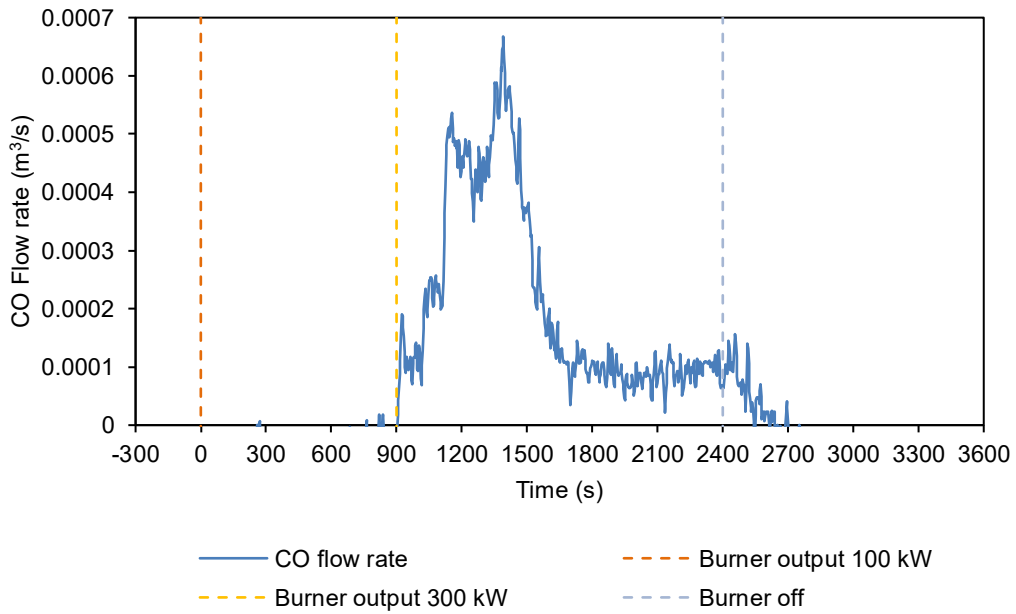
Figure 6 Production of carbon monoxide vs time, at reference temperature and pressure

Item	Detail
	<ul style="list-style-type: none"> An exhaust sampling probe sampled the combustion products which were then analysed by a gas purity analyser. The oxygen concentration during the test was determined by a paramagnetic oxygen sensor and the carbon monoxide and carbon dioxide concentrations were determined using an infrared sensor. The horizontal wind speed was measured using a hot wire anemometer at a horizontal distance of 500 mm away from the centre of the exposed face of the tested specimen. A Fourier Transform Infrared Spectroscopy (FTIR) gas analyser was connected to the exhaust duct and operated by representatives of the test sponsor to sample the products of combustion during the test.
System response	<ul style="list-style-type: none"> A step calibration was carried out to determine the system response time. The gas burner was placed centrally and 1 m below the exhaust hood and subjected to a stepwise change in heat release shown in Table 4. Data from instruments was collected and analysed every 3 seconds. At steady state conditions, the difference between the mean rate of heat release over 1 minute calculated from the measured oxygen consumption and that calculated from the metered gas output did not exceed $\pm 5\%$ for each level of heat output – and therefore complied with the requirements of Section 10.1 of AS ISO 9705:2003 (R2016). The system response time was determined by calculating the average time taken for the measured rate of heat release to be within 10% of the metered gas calculated rate of heat release. System response data is listed in Table 4 and the system response has been calculated to be 24 s

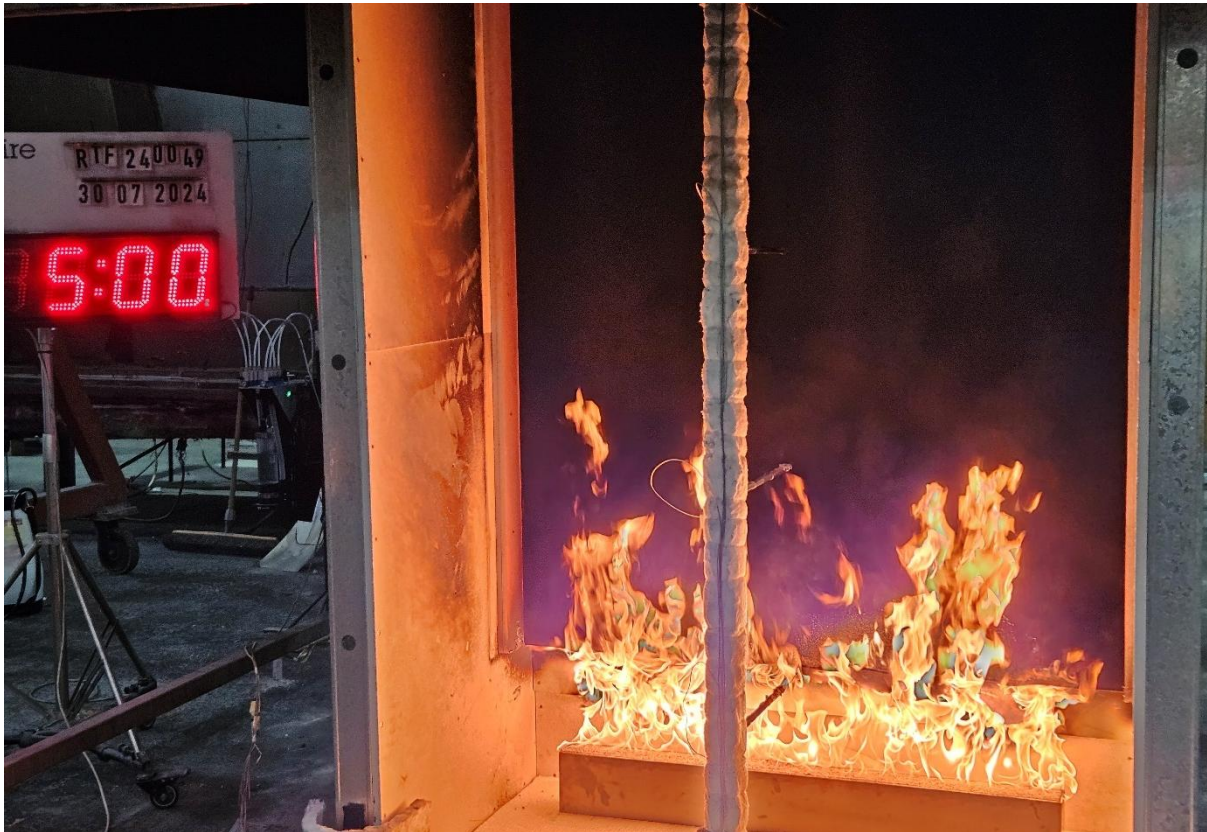
Figure 17 The specimen 5 minutes into the test (burner output at 100 kW)

Time		Observation
Min	Sec	
-2	00	Data collection started.
0	00	The reaction to fire test was started with the burner ignited with a heat output set at 100 kW.
1	45	The flashing below the specimen began to deform.
4	00	There was smoke emission from the unexposed side of the specimen.
7	18	The lower portion of the specimen began to deform.
8	20	The coating on the lower portion of the exposed face of the panel began to peel and char.
15	00	The heat output of the burner was increased to 300 kW.
15	02	Flames intermittently reached to the top of the panel.
15	28	Debris fell from the panel, onto the burner.
16	40	An opening formed in the lower portion of the panel.
17	11	Flaming debris fell from the specimen.
22	00	The opening in the panel became larger.
40	00	The burner was turned off.
51	45	All visible flaming stopped.
60	00	The reaction to fire test was ended.

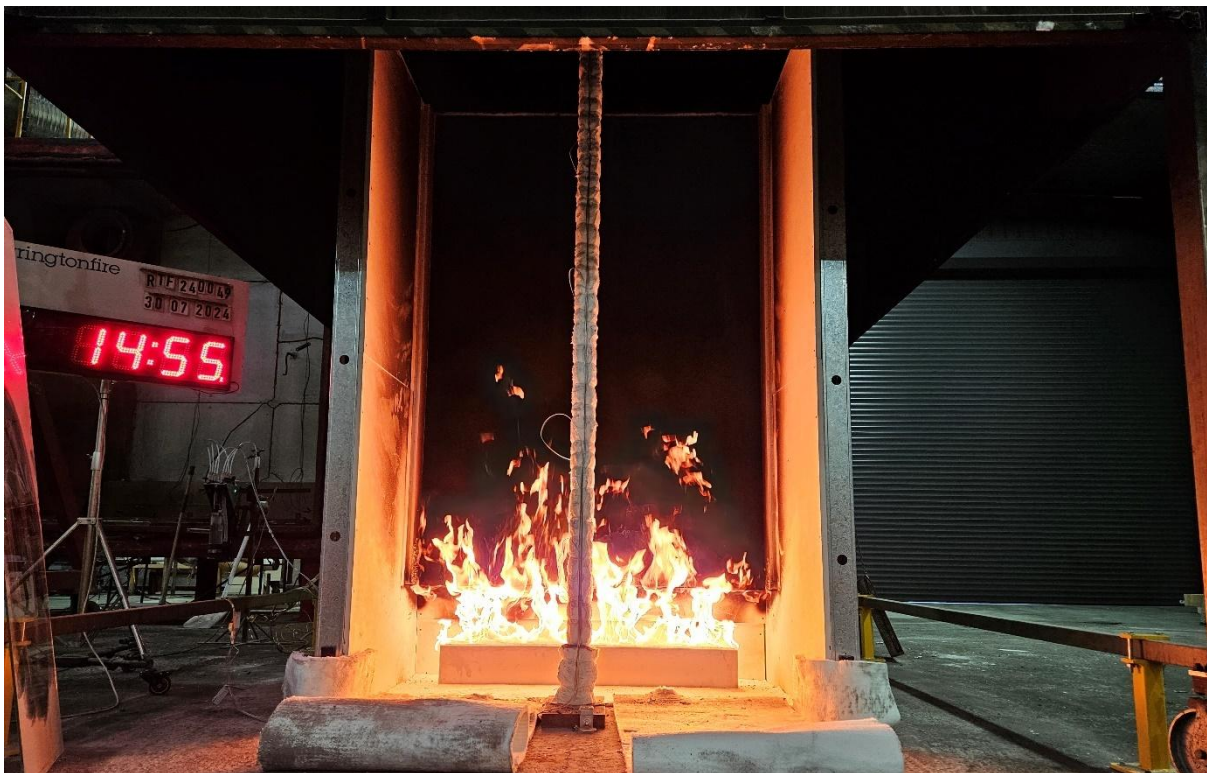
Figure 18 The specimen 14 minutes 55 seconds into the test (burner output at 100 kW)

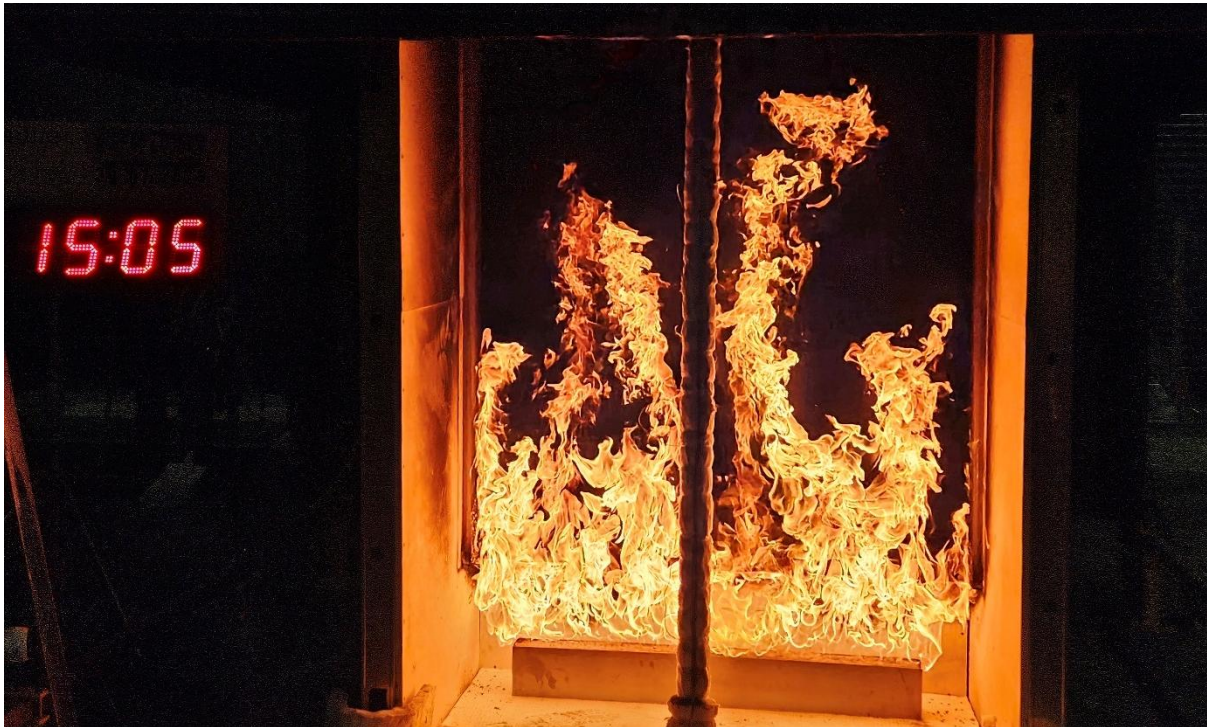
Figure 19 The specimen 15 minutes 5 seconds into the test (burner output at 300 kW)

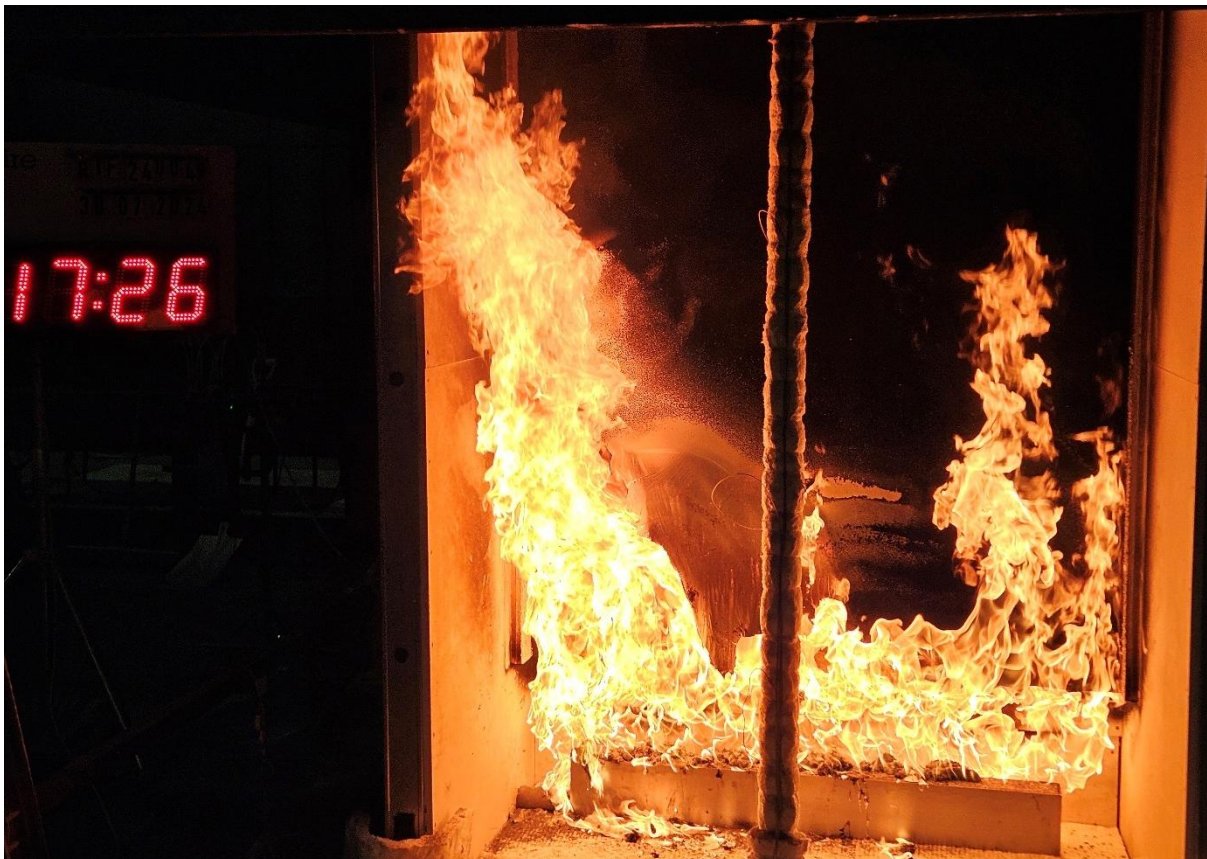
Figure 20 The specimen 17 minutes 26 seconds into the test (burner output at 300 kW)

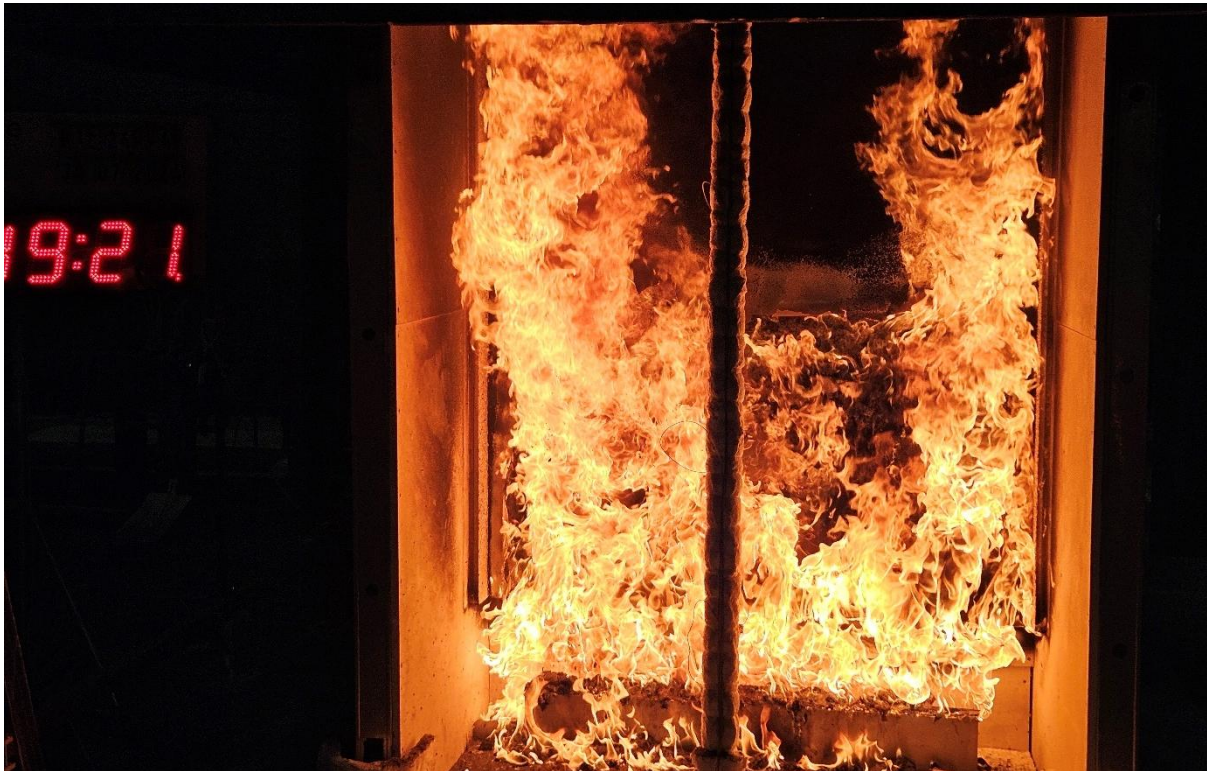
Figure 21 The specimen 19 minutes 21 seconds into the test (burner output at 300 kW)

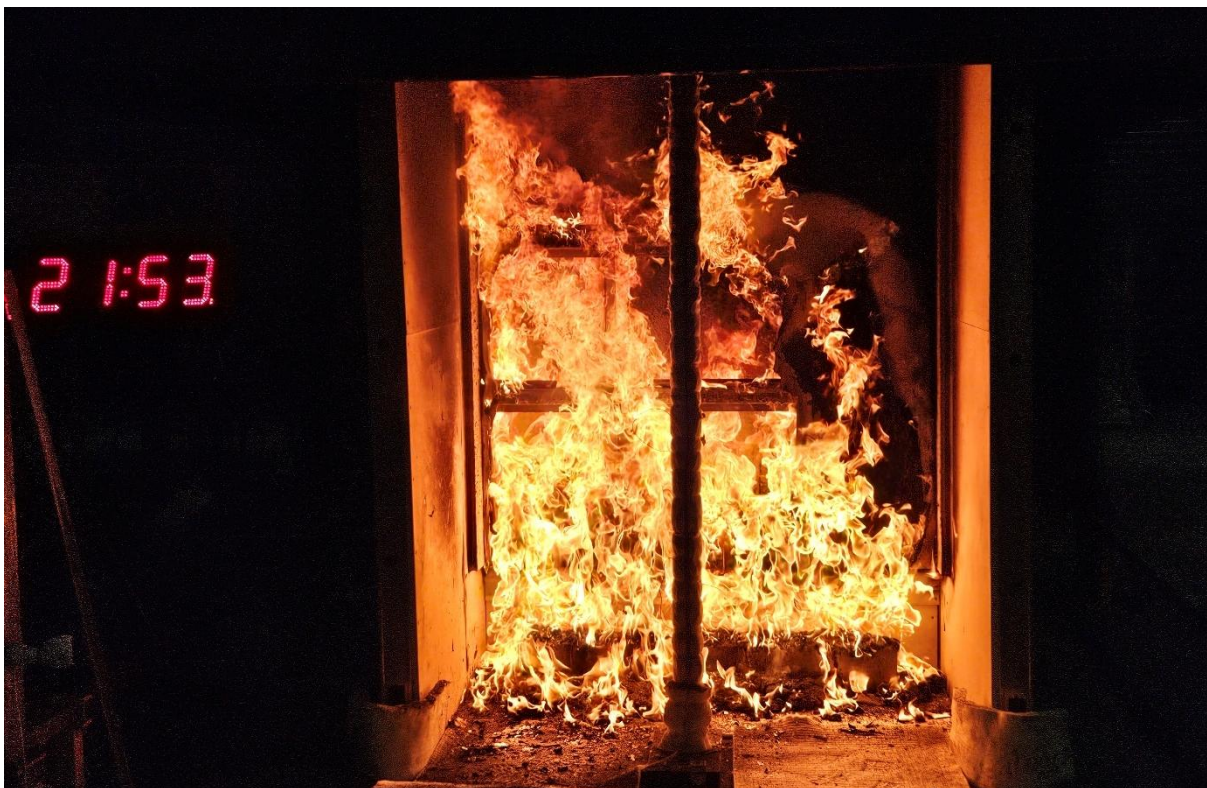
Figure 22 The specimen 21 minutes 53 seconds into the test (burner output at 300 kW)

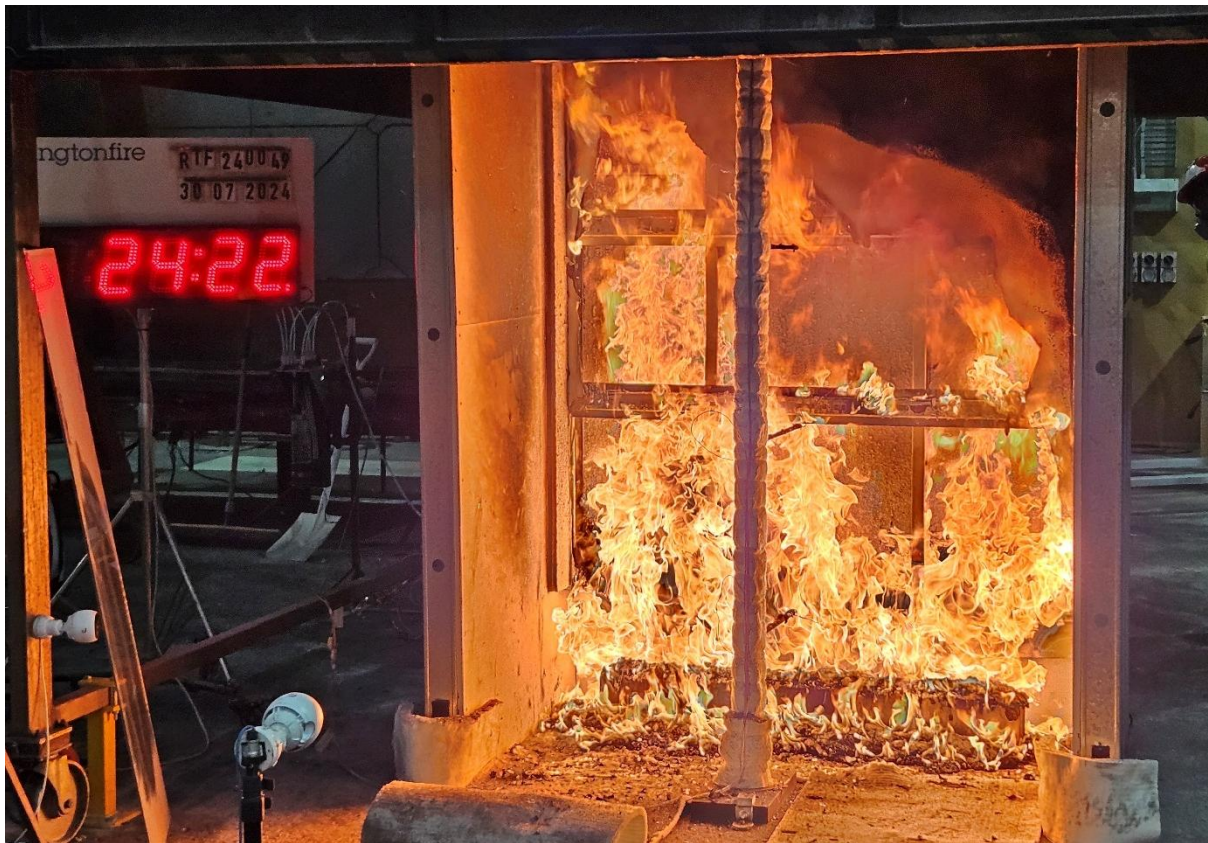
Figure 23 The specimen 24 minutes 22 seconds into the test (burner output at 300 kW)

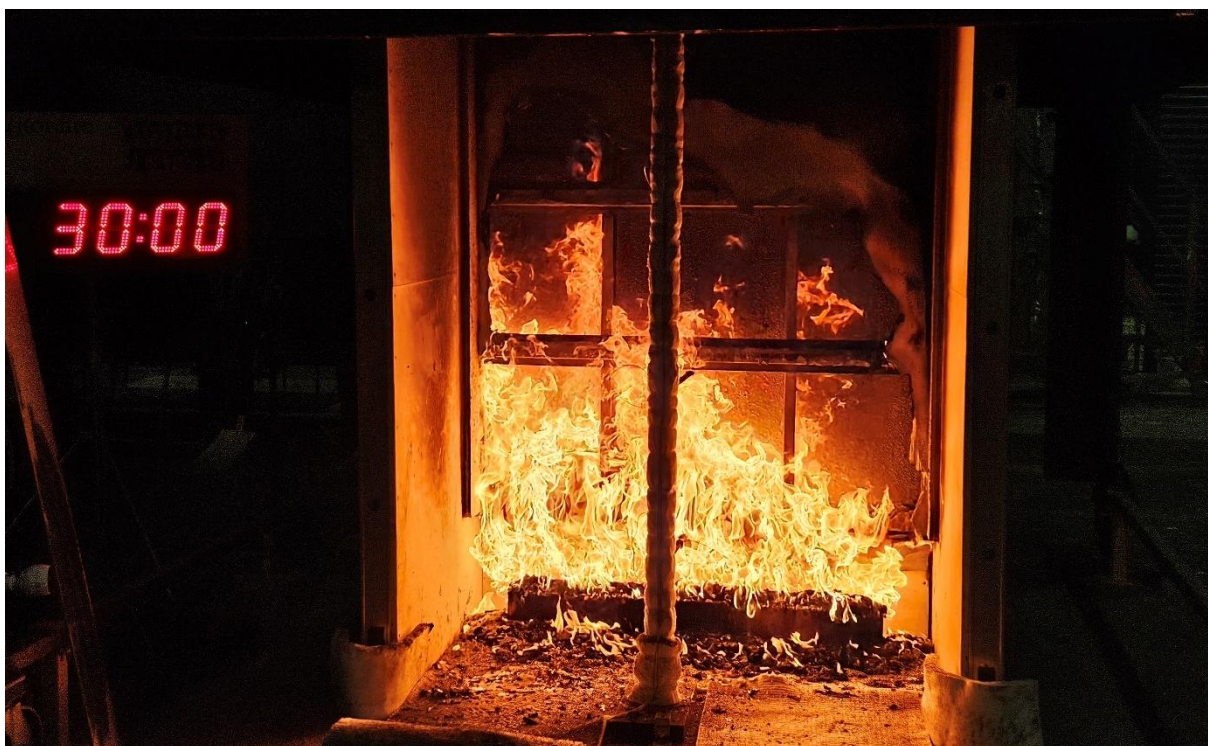
Figure 24 The specimen 30 minutes into the test (burner output at 300 kW)

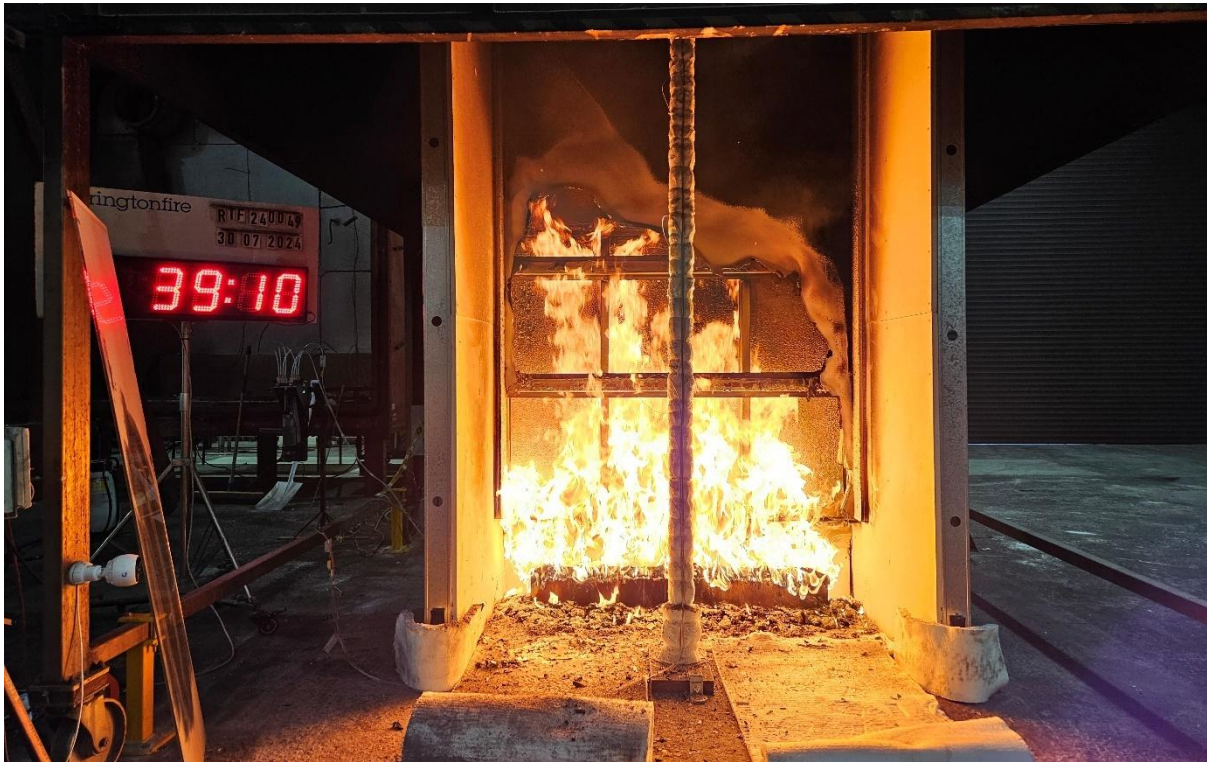
Figure 25 The specimen 39 minutes 10 seconds into the test (burner output at 300 kW)

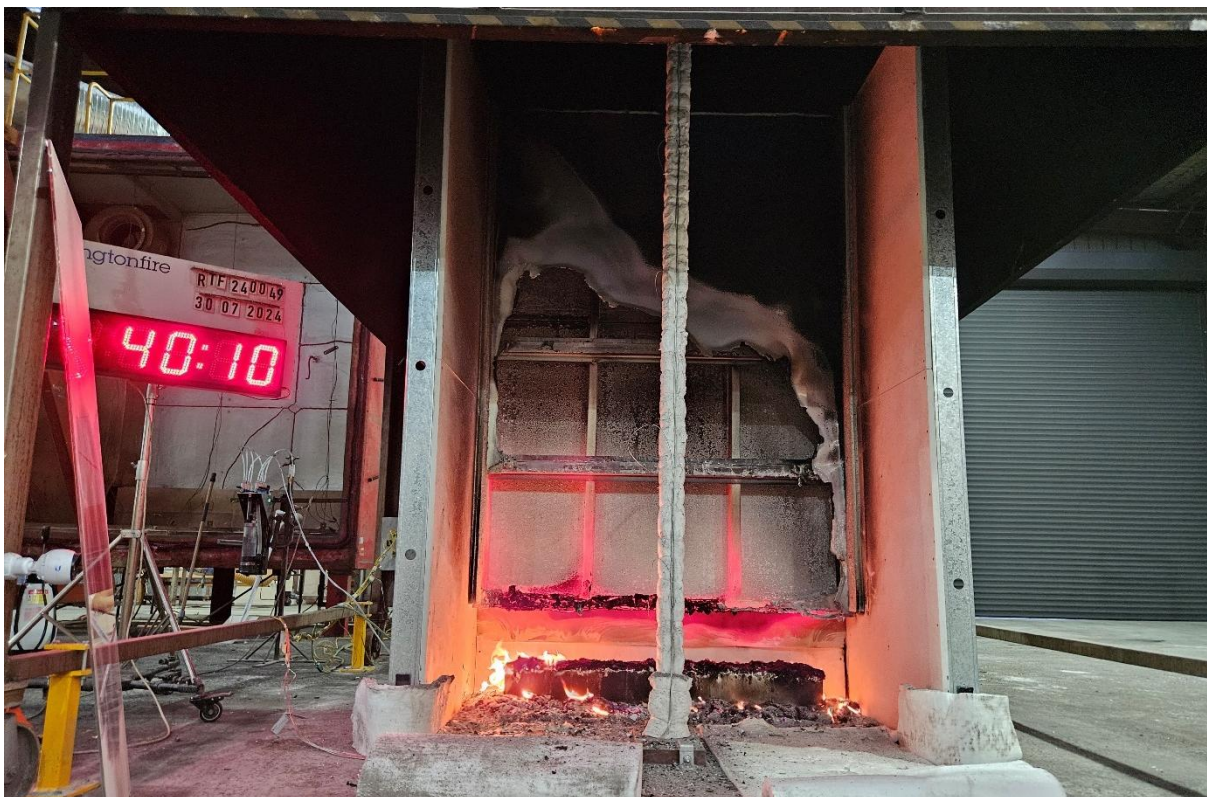
Figure 26 The specimen 40 minutes 10 seconds into the test (burner off)

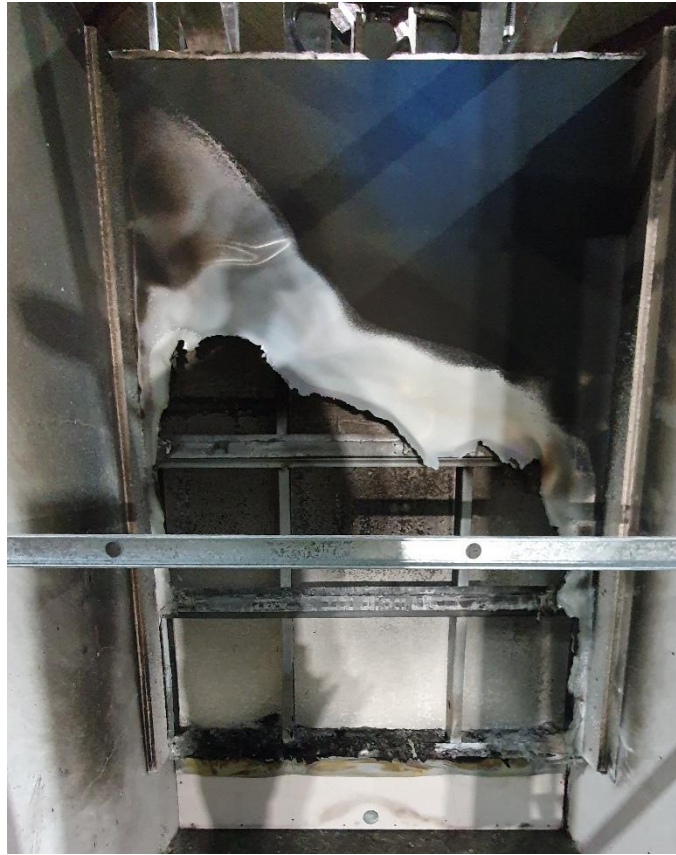
Figure 27 The specimen after the reaction to fire test – exposed side

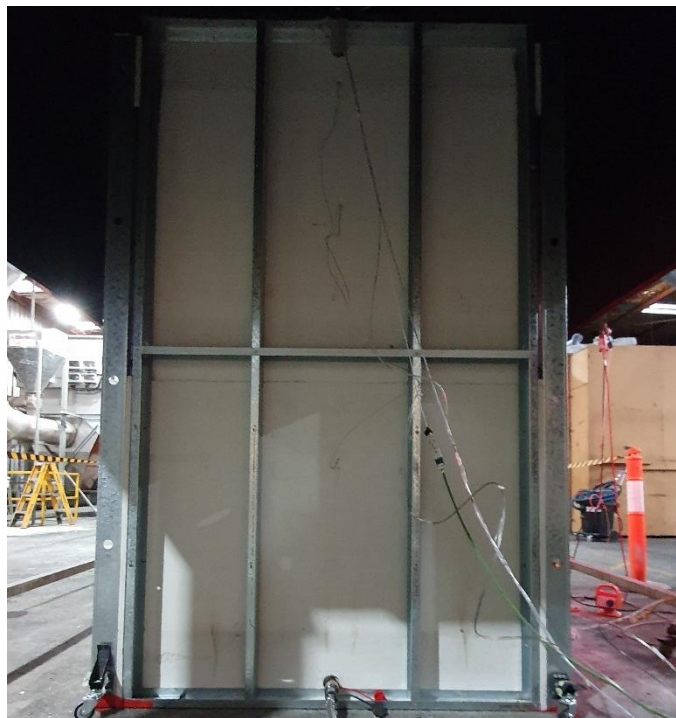
Figure 28 The specimen after the reaction to fire test – unexposed side
