Reaction to fire test report

Test standard: Ad-hoc test based off ISO 13785-1:2002

System: Aluminium composite panel wall system representative of the in-situ wall located at [REDACTED]
[REDACTED] – Scenario 1 - Test 1

Job number: RTF220102

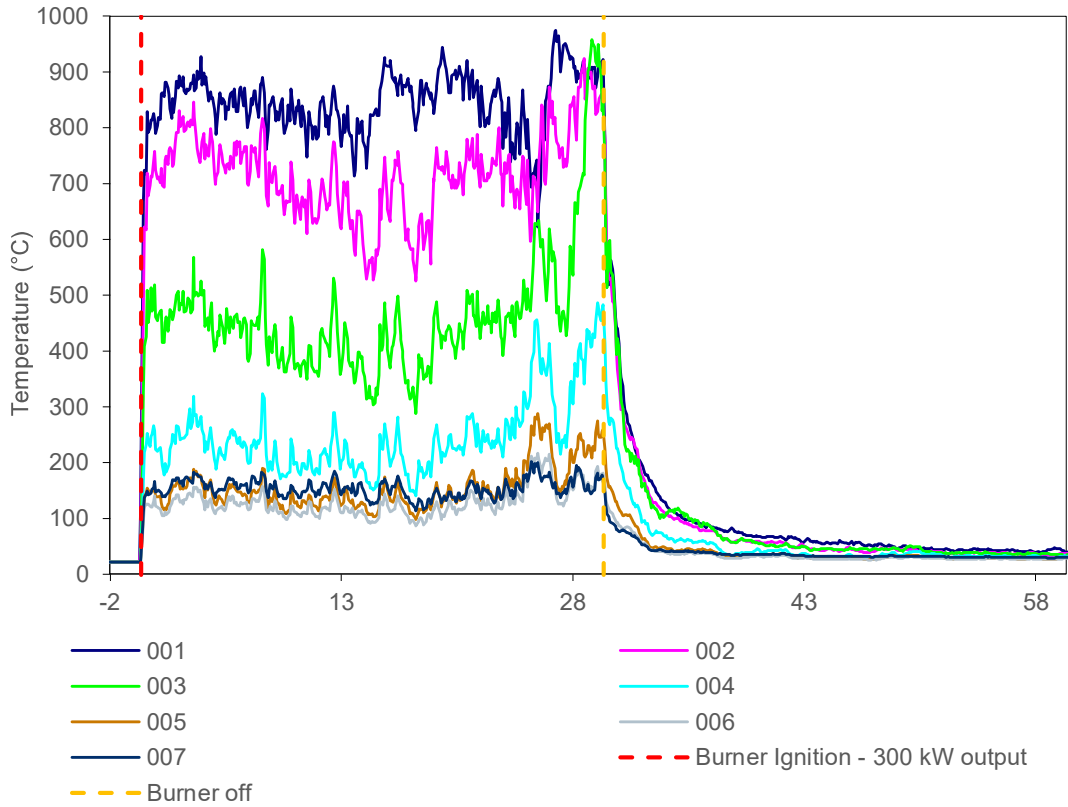
Figure 3 External temperature data collected by thermocouples placed 60 mm from the front face of the specimen - in-line with the burner.

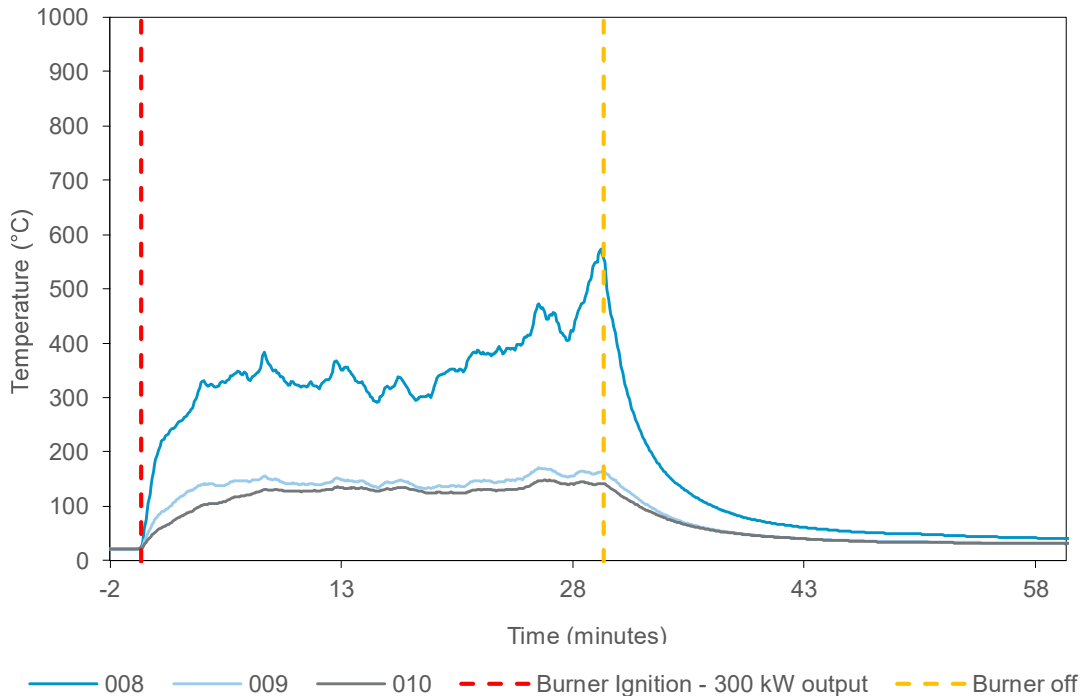
Figure 4 External temperature data collected by plate thermocouples in-line with ACP, above and below, respectively - in-line with the burner.

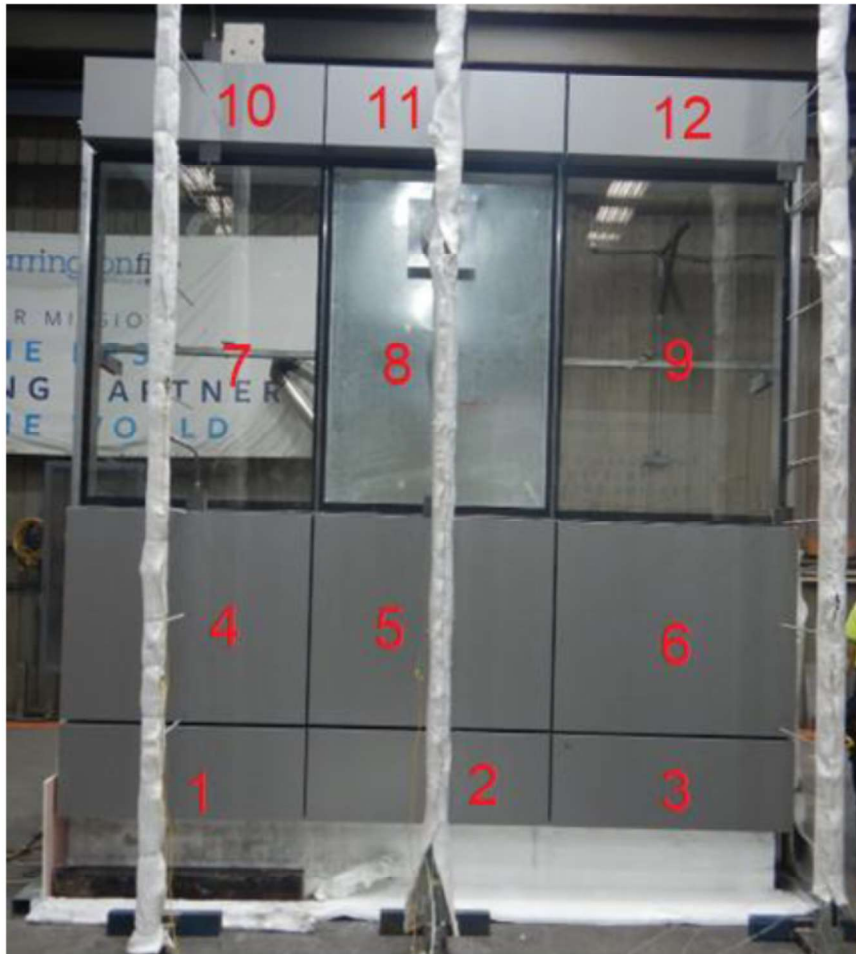
Figure 11 Designation of section for the test observations.

Table 4 shows the observations of any significant behaviour of the specimen during the test. Figure 10 shows the panel and glazing designations sighted in the observations.

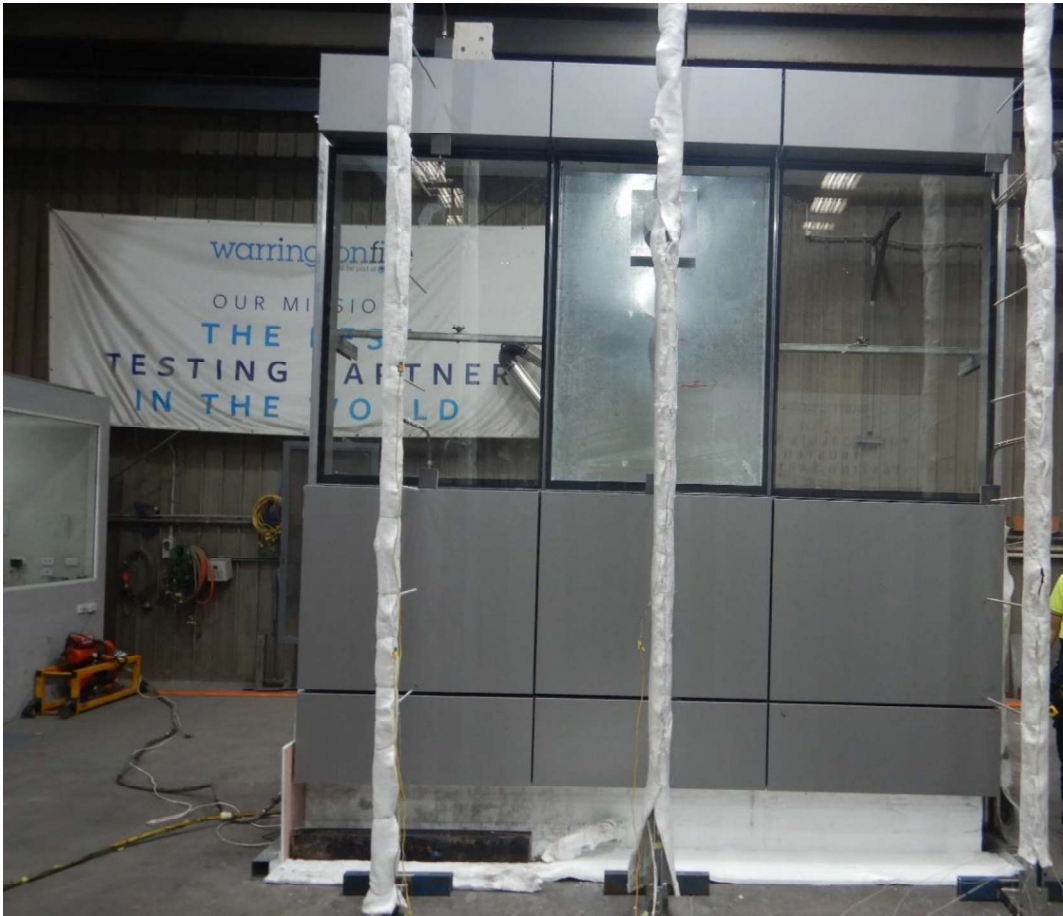
Figure 20 The specimen (exposed side) before the reaction to fire test

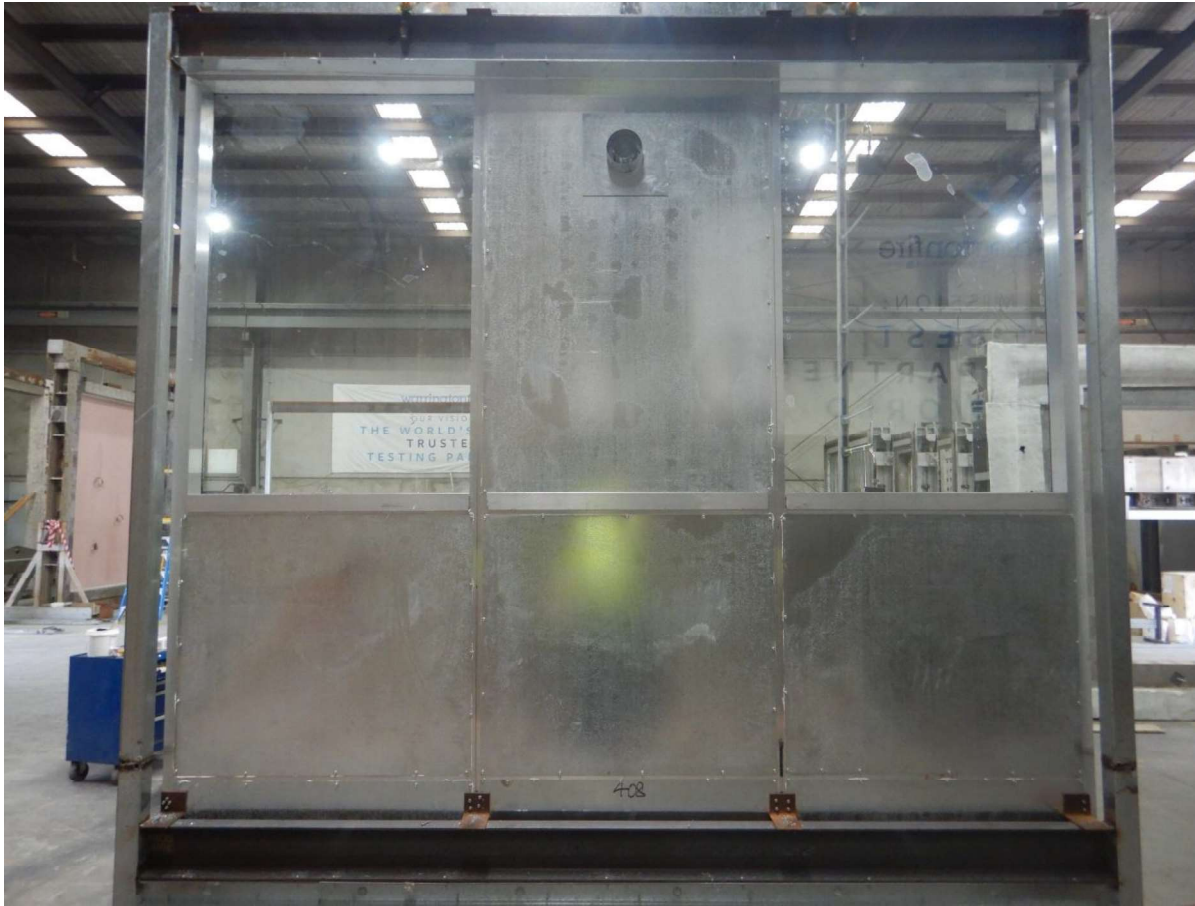
Figure 21 **The specimen (unexposed side) before the reaction to fire test**

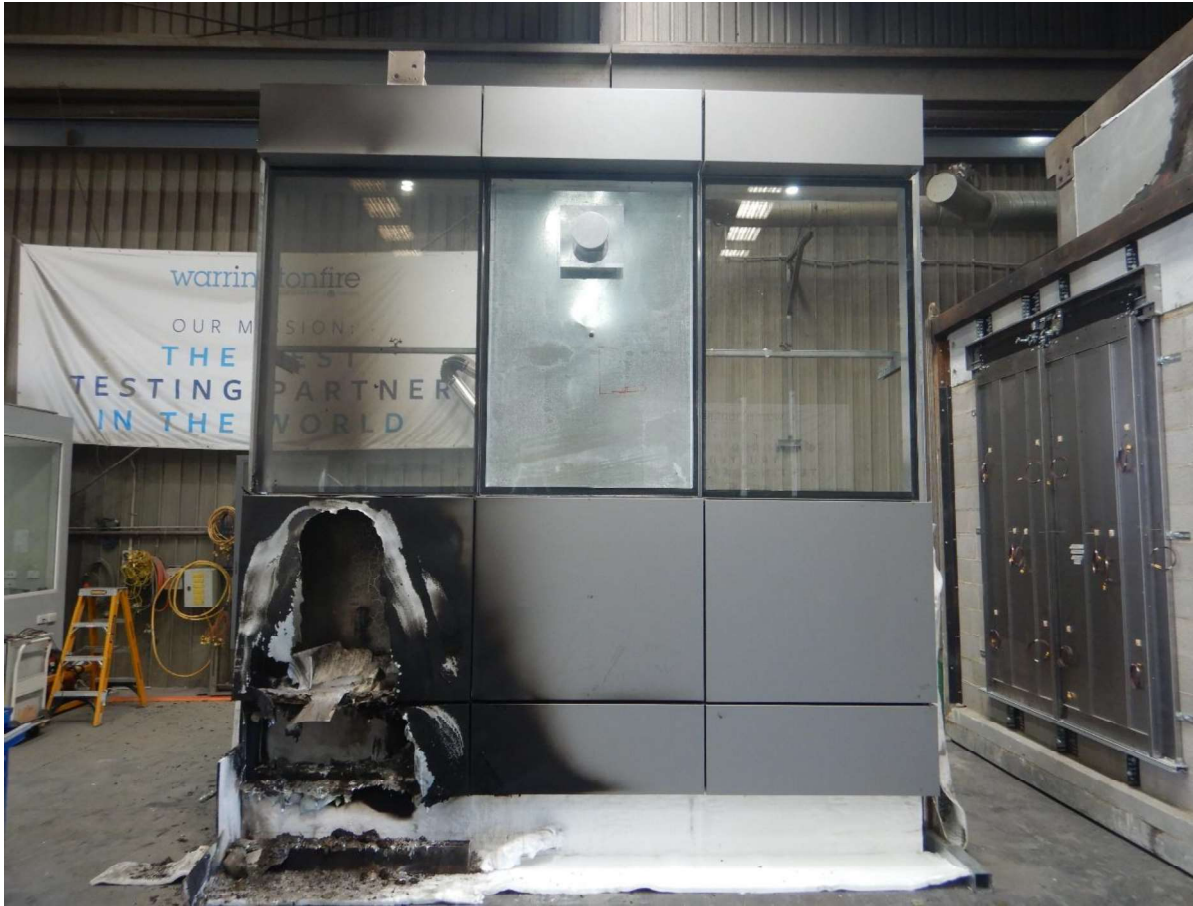
Figure 60 The specimen at end of test – exposed side.
