# Reaction to fire test report

Test standard: Ad-hoc test based off ISO 13785-1:2002

System: Aluminium composite panel wall system representative of the in-situ wall located at [REDACTED]  
[REDACTED] - Scenario 1 - Test 2

Job number: RTF220102

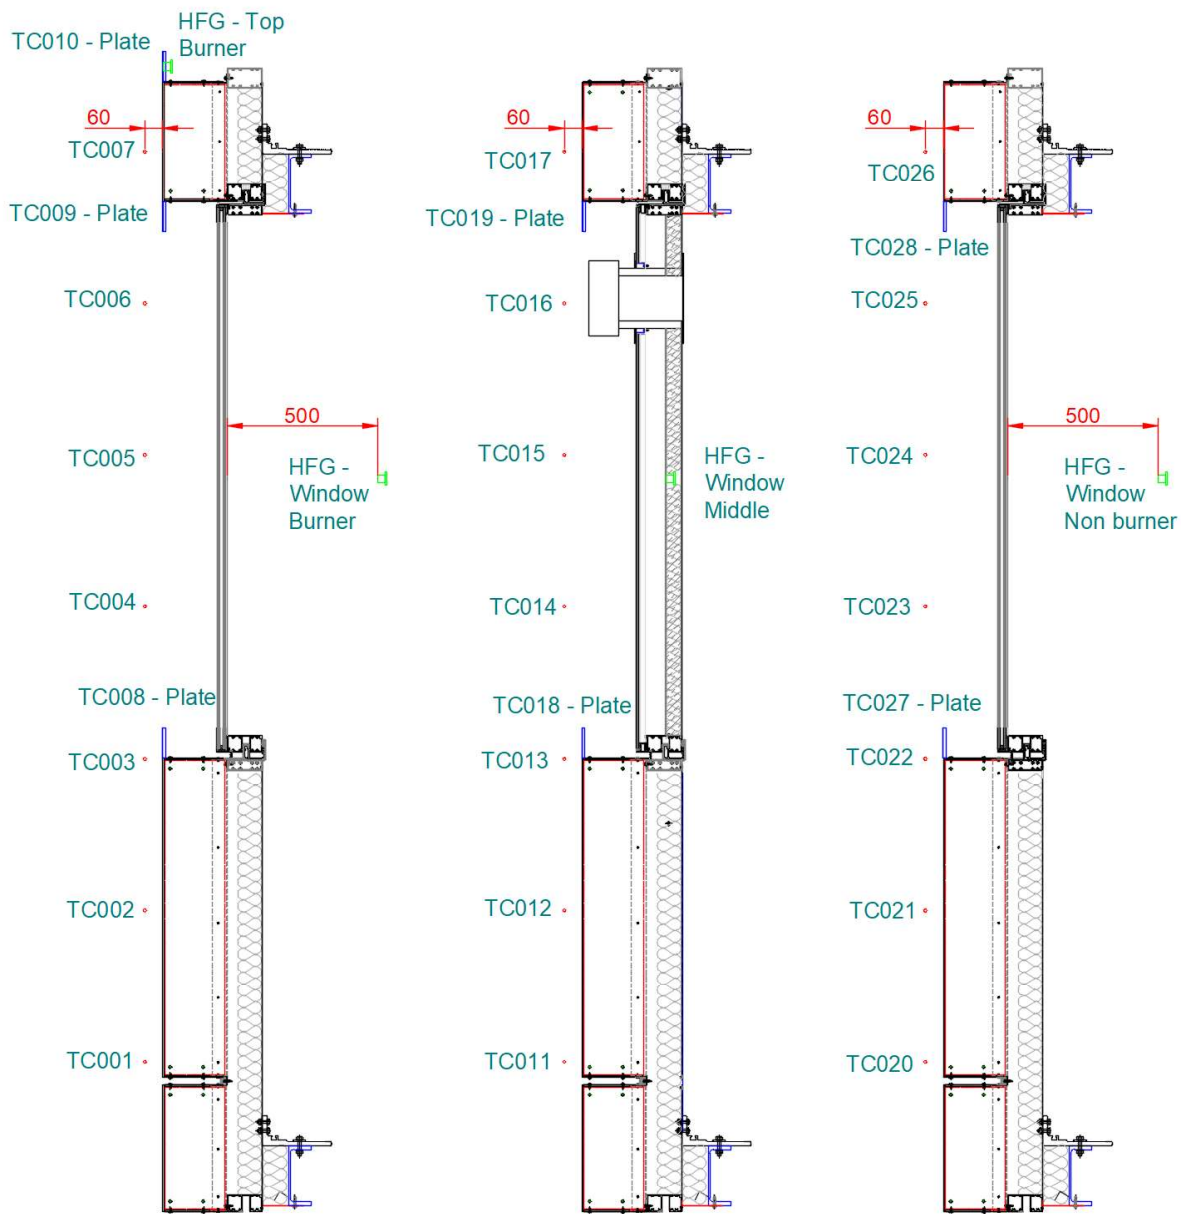
Figure 2 Instrumentation locations – sections

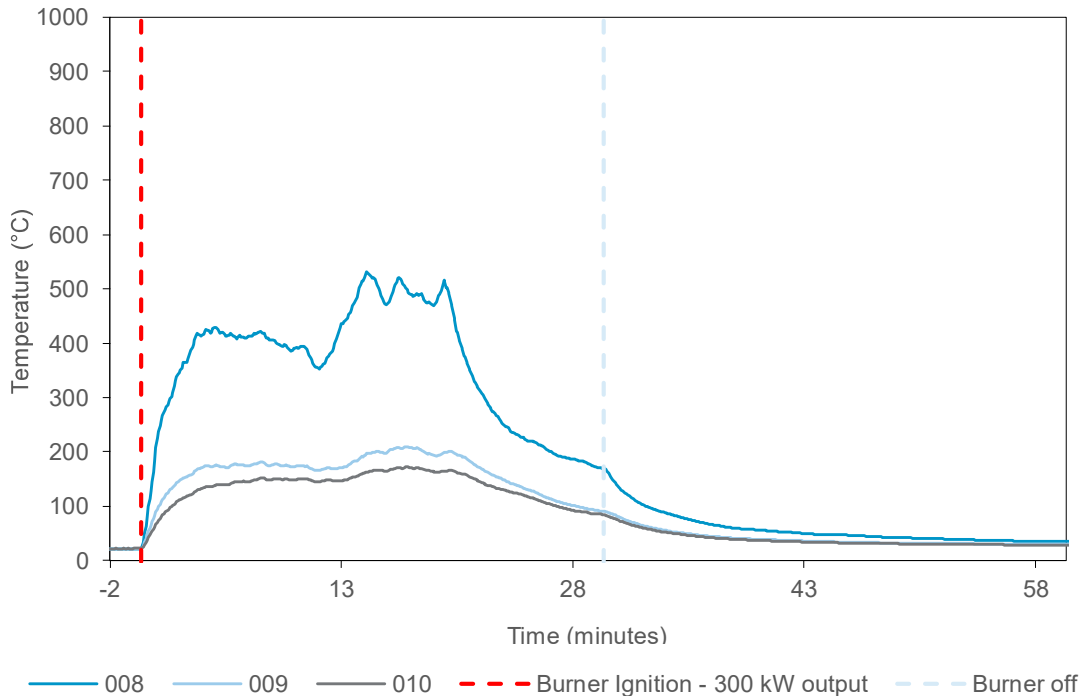
**Figure 4 External temperature data collected by thermocouples in-line with ACP, above and below, respectively - in-line with the burner.**

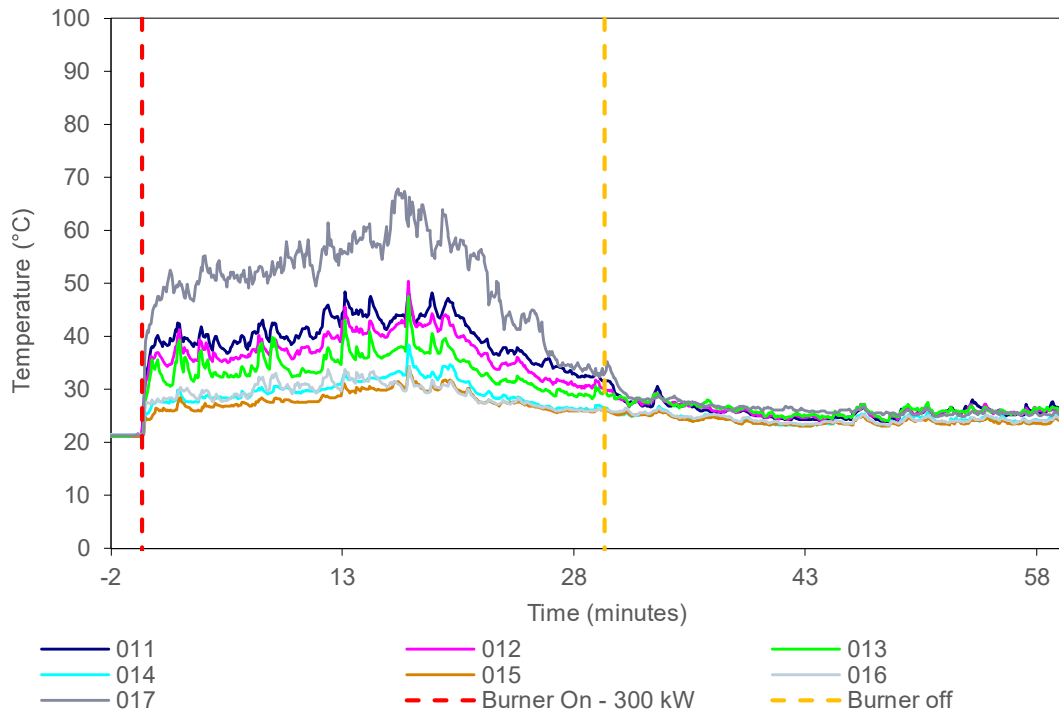
**Figure 5 External temperature data collected by thermocouples placed 60 mm from the front face of the specimen – central module.**

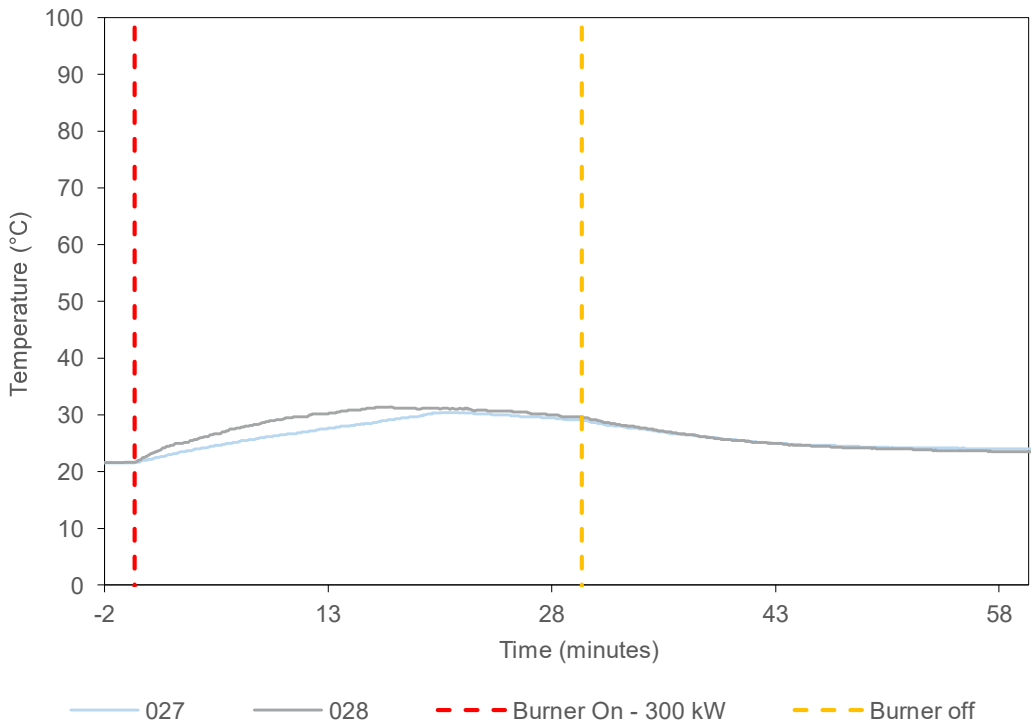
**Figure 8 External temperature data collected by thermocouples in-line with ACP, above and below, respectively – away from burner.**

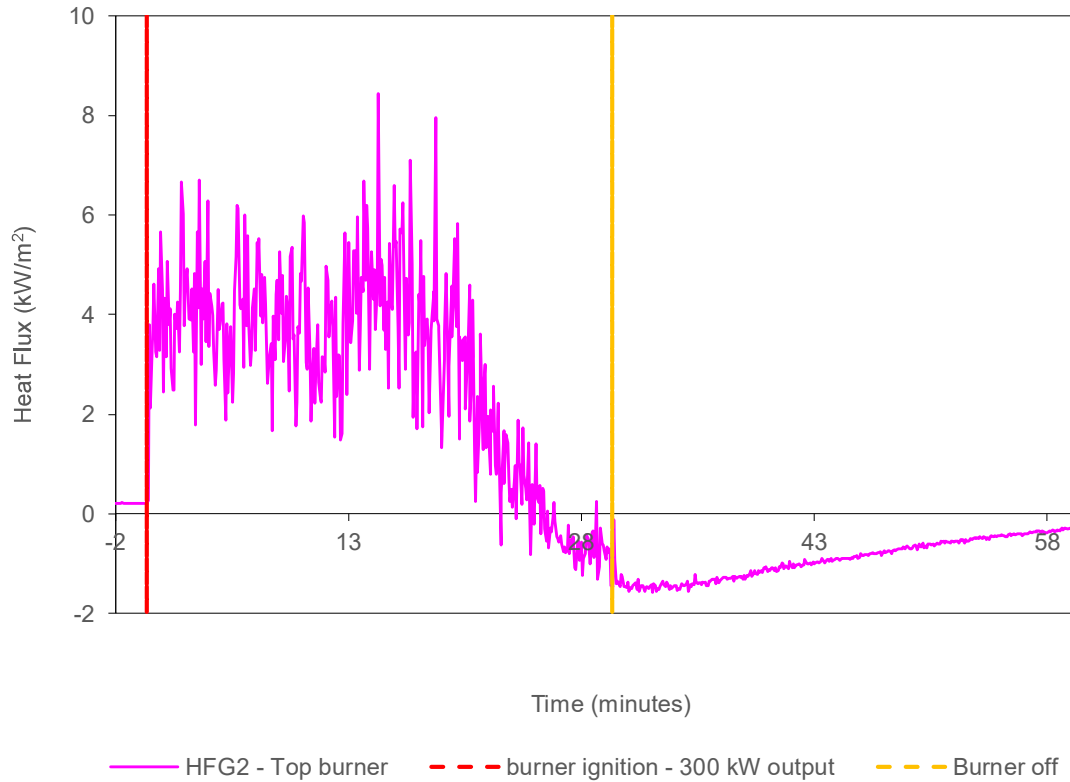
**Figure 9 Heat flux data collected by heat flux gauge at the top of the specimen above the burner.**

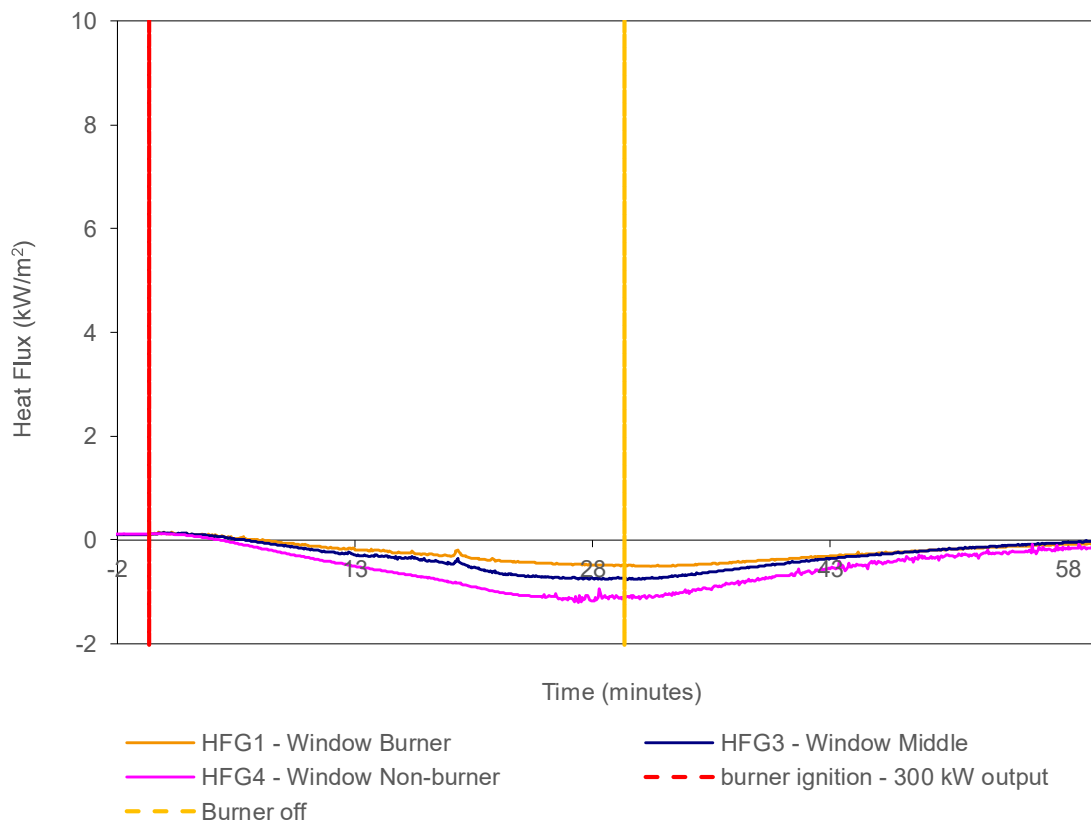
**Figure 10 Emitted heat flux measured by heat flux gauges behind the glazing units.**

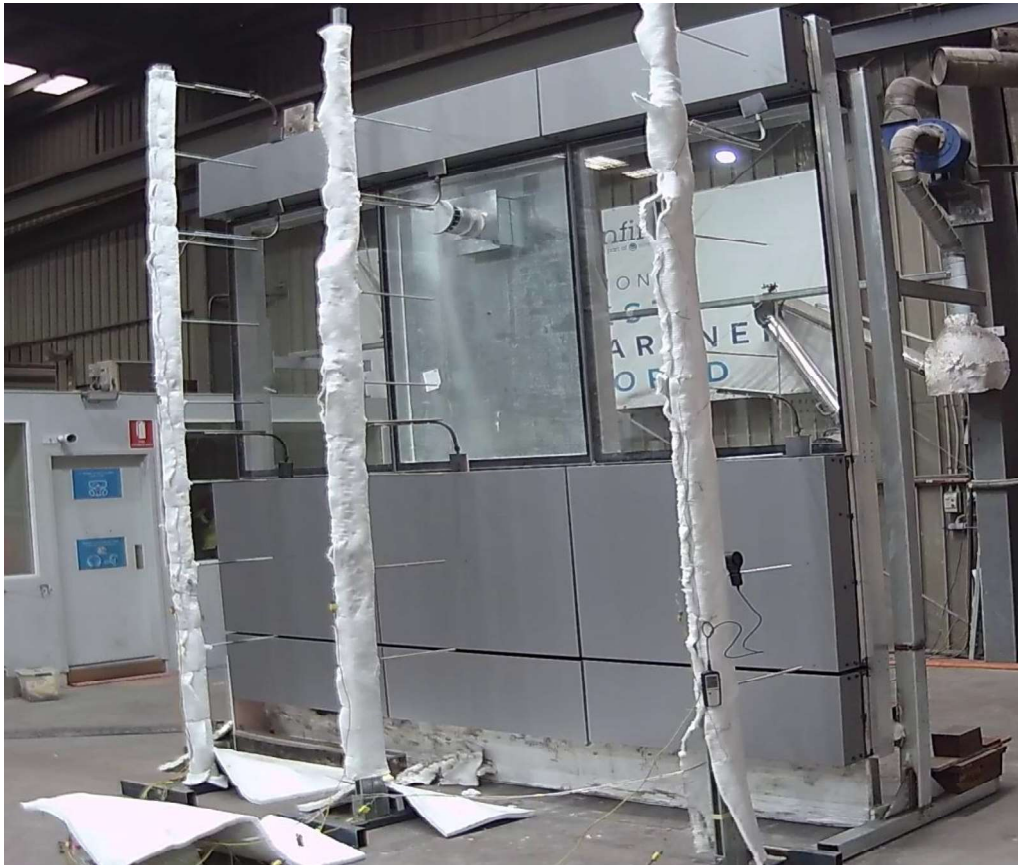
Figure 20 The specimen (angled - exposed side) before the reaction to fire test

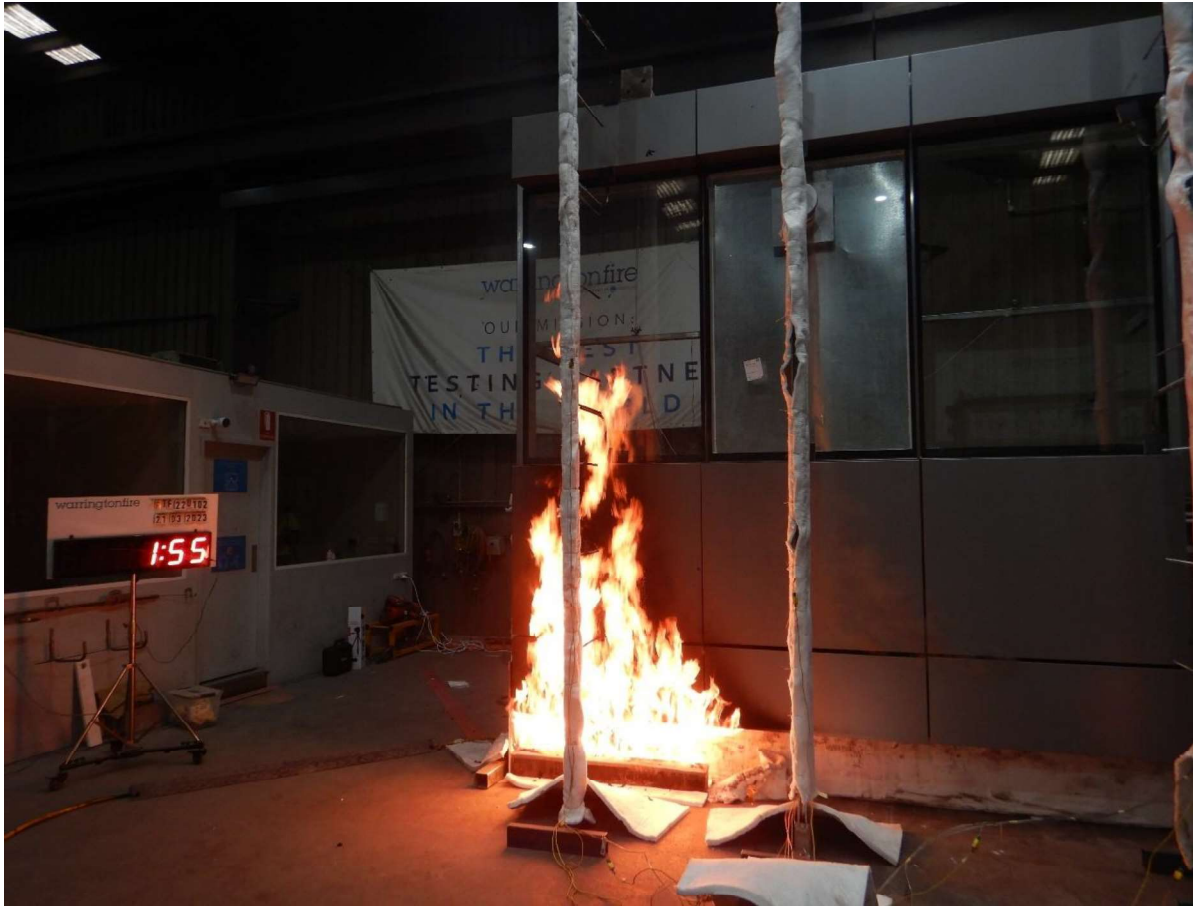
Figure 22 The specimen 1 minute 55 seconds into the test (burner output at 300 kW)

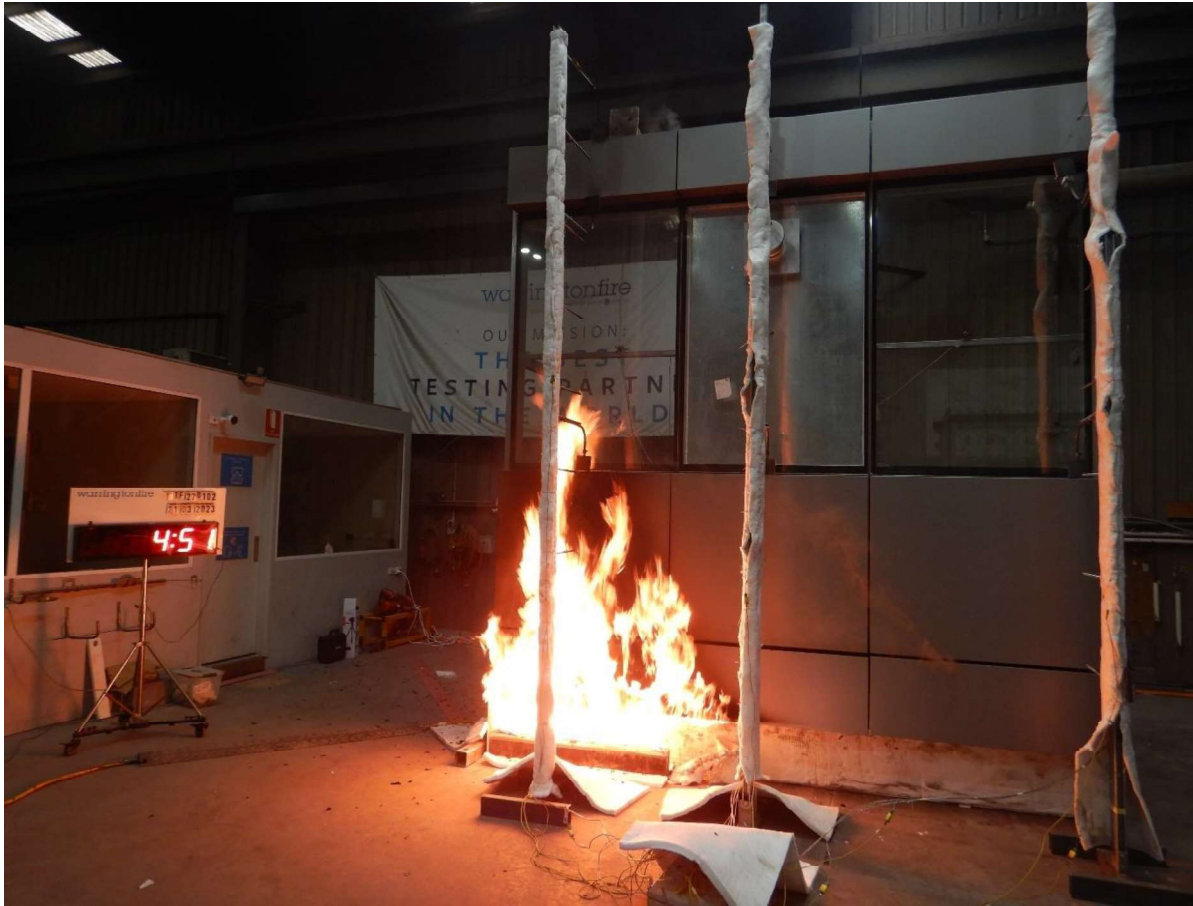
Figure 23 The specimen 4 minutes 51 seconds into the test (burner output at 300 kW)

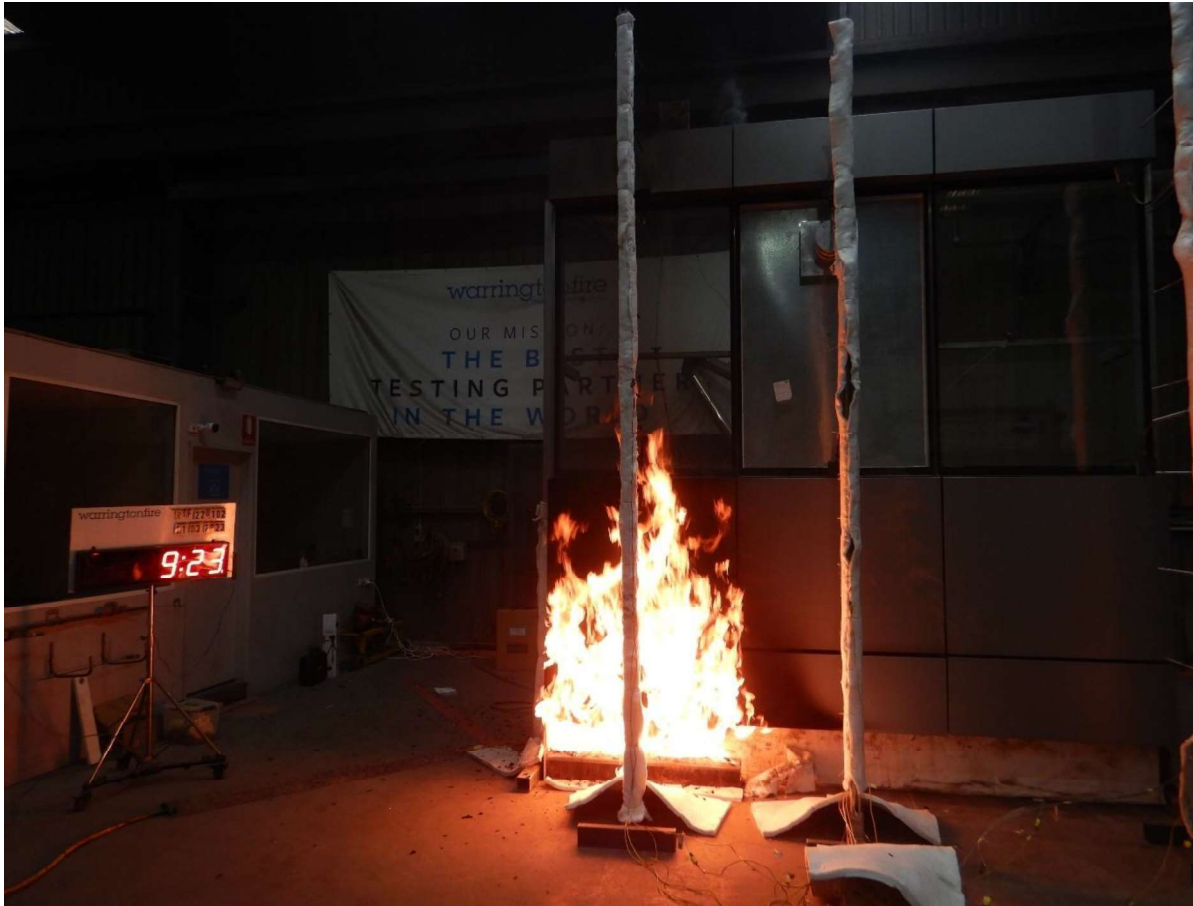
Figure 24 The specimen 9 minutes 23 seconds into the test (burner output at 300 kW)

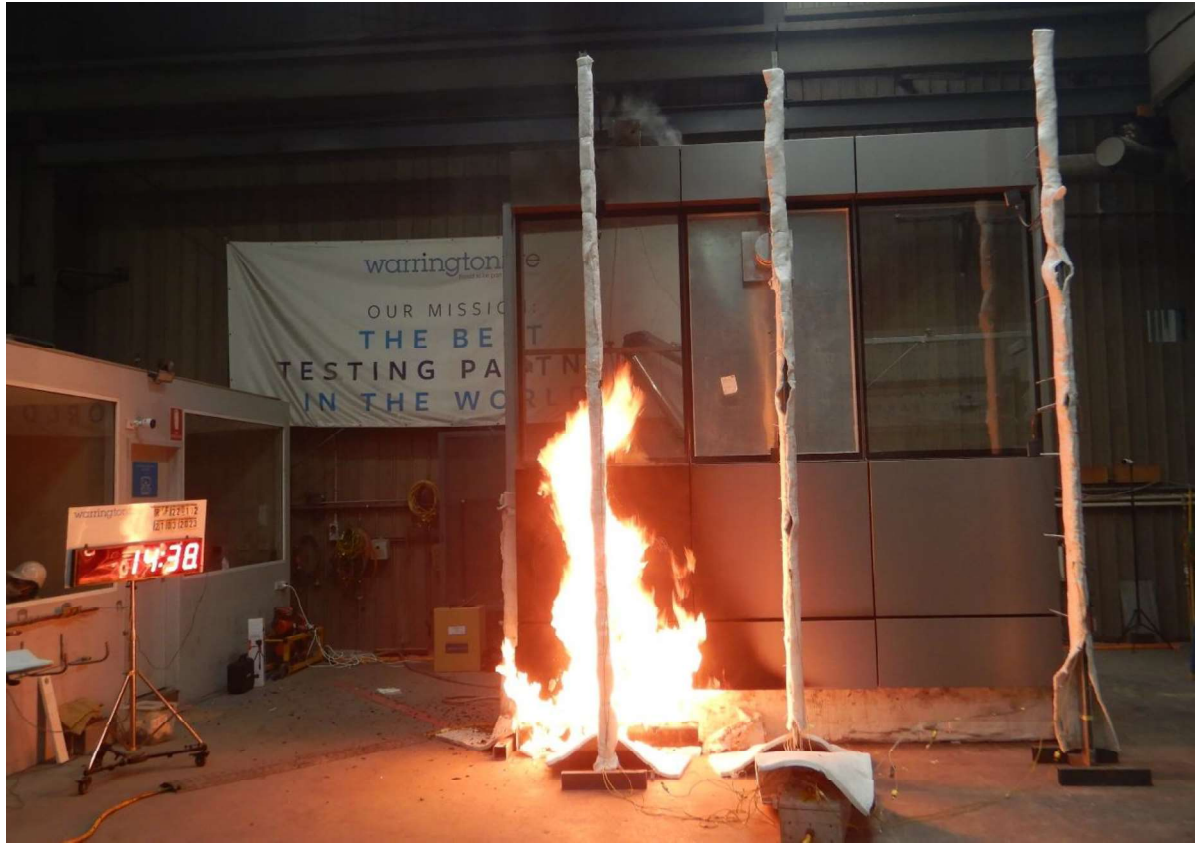
Figure 25 The specimen 14 minutes 38 seconds into the test (burner output at 300 kW)

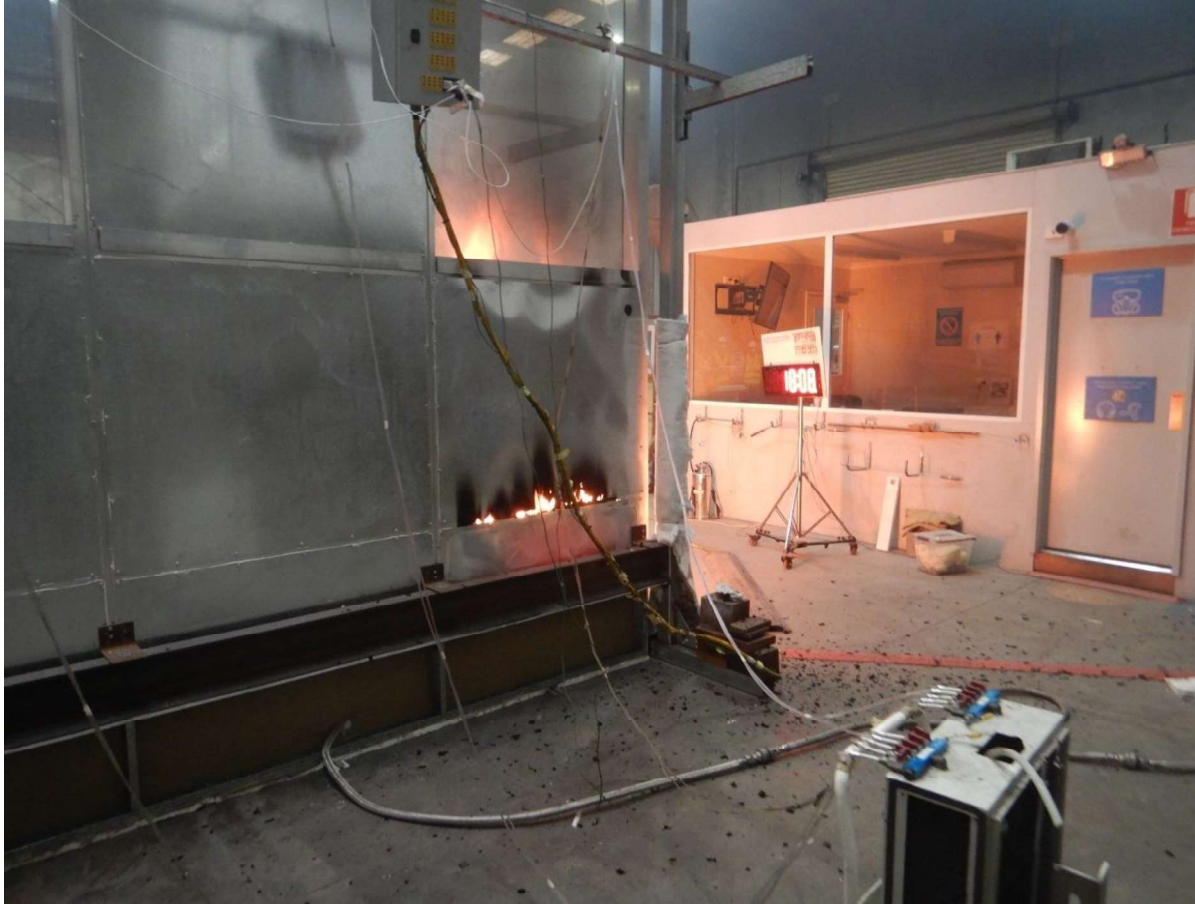
Figure 26 The specimen 18 minutes 8 seconds into the test (burner output at 300 kW) - unexposed side.

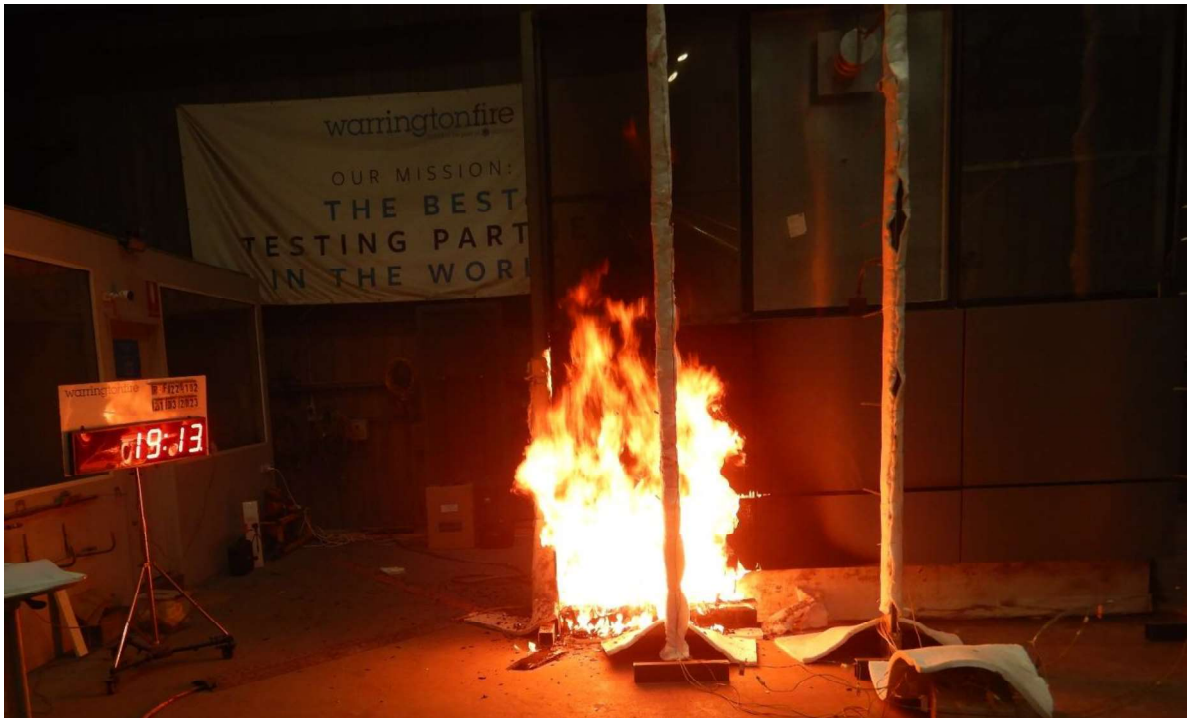
Figure 27 The specimen 20 minutes into the test (burner output at 300 kW).

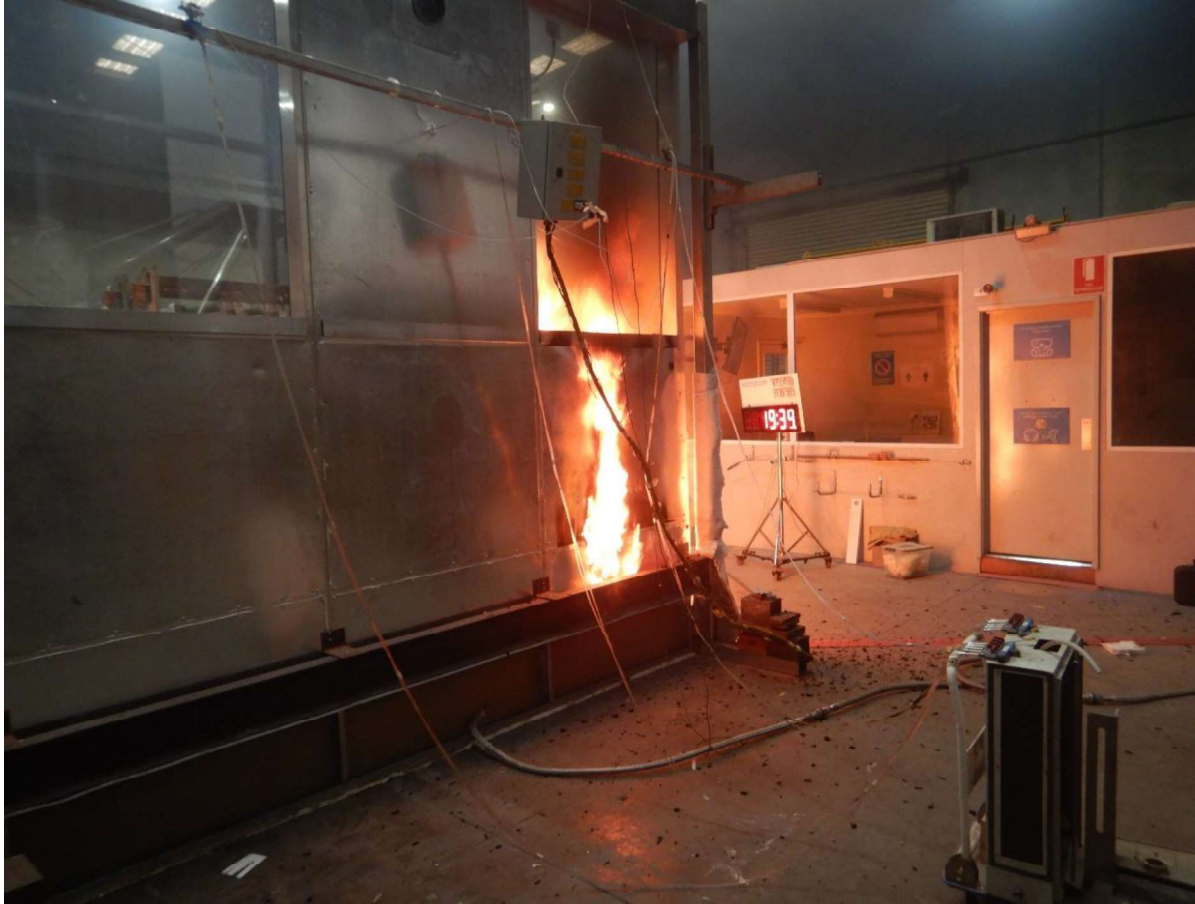
Figure 28 **The specimen (unexposed side view) 19 minutes 39 seconds into the test (burner output at 300 kW).**

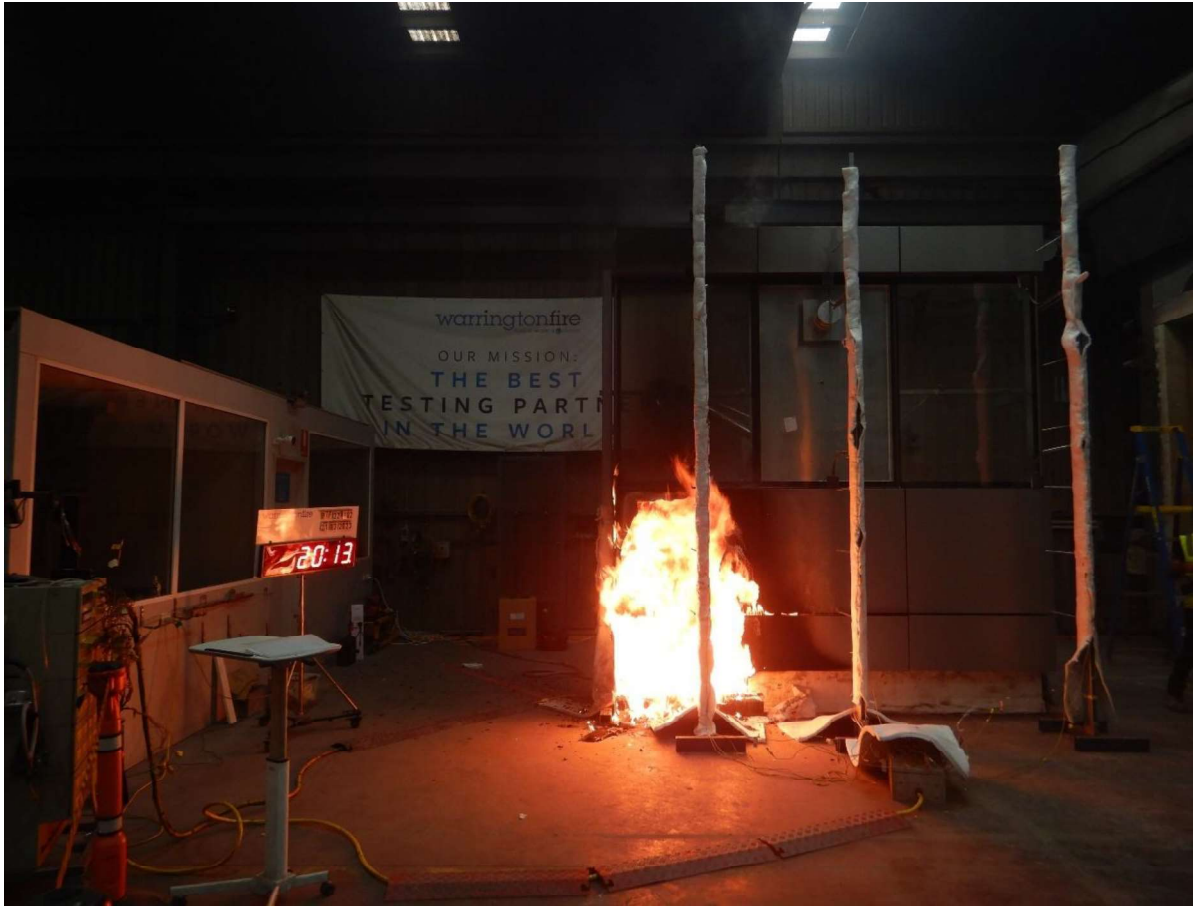
Figure 29 The specimen 20 minutes 13 seconds into the test (burner output at 300 kW).

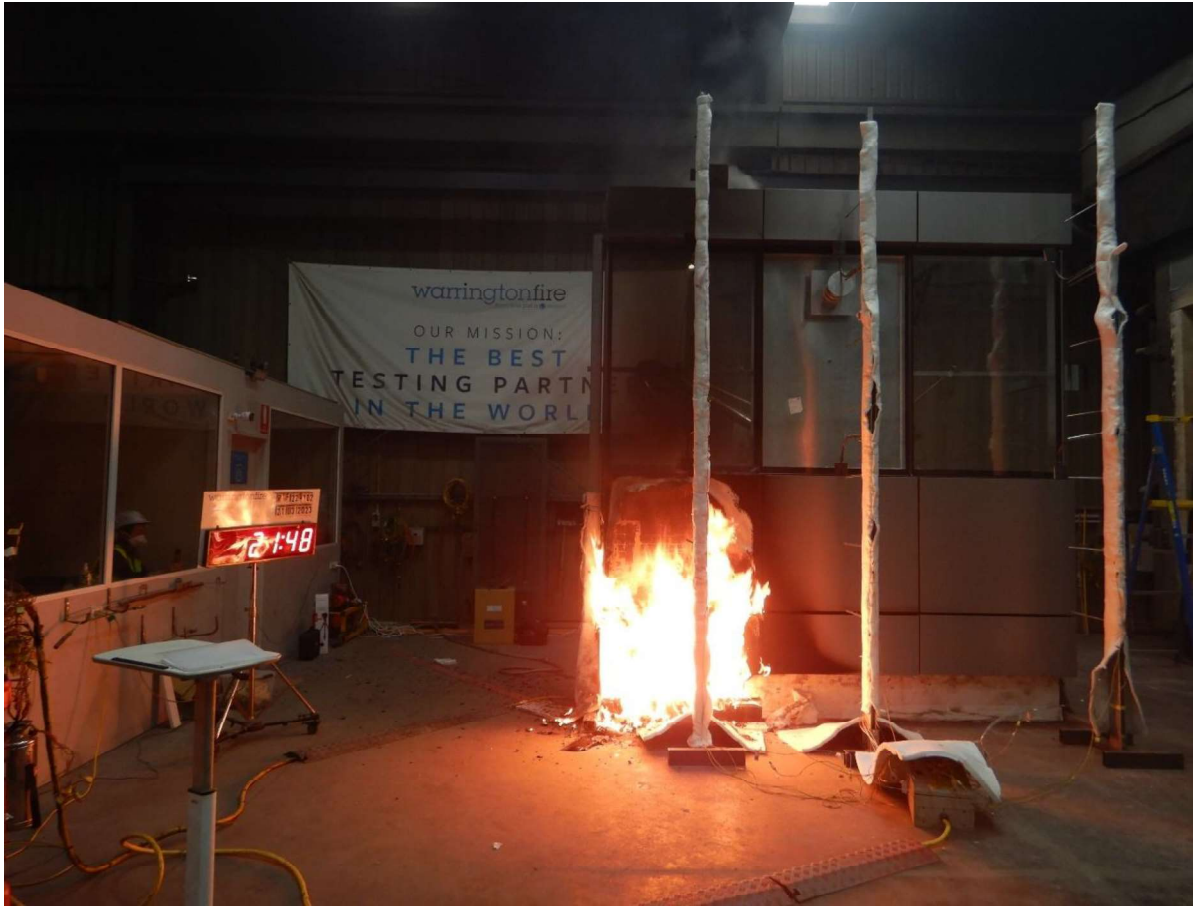
Figure 30 The specimen 21 minutes 48 seconds into the test (burner output at 300 kW).

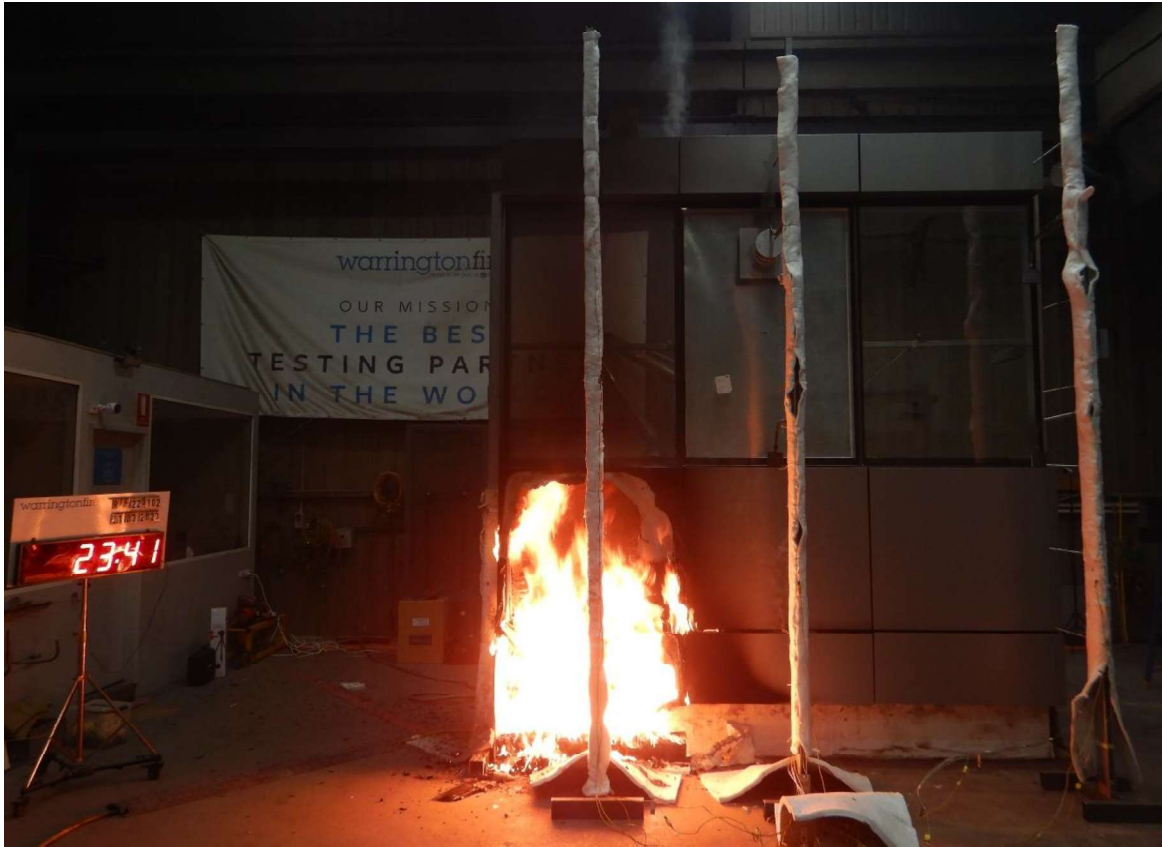
Figure 31 The specimen 23 minutes 41 seconds into the test (burner output at 300 kW).

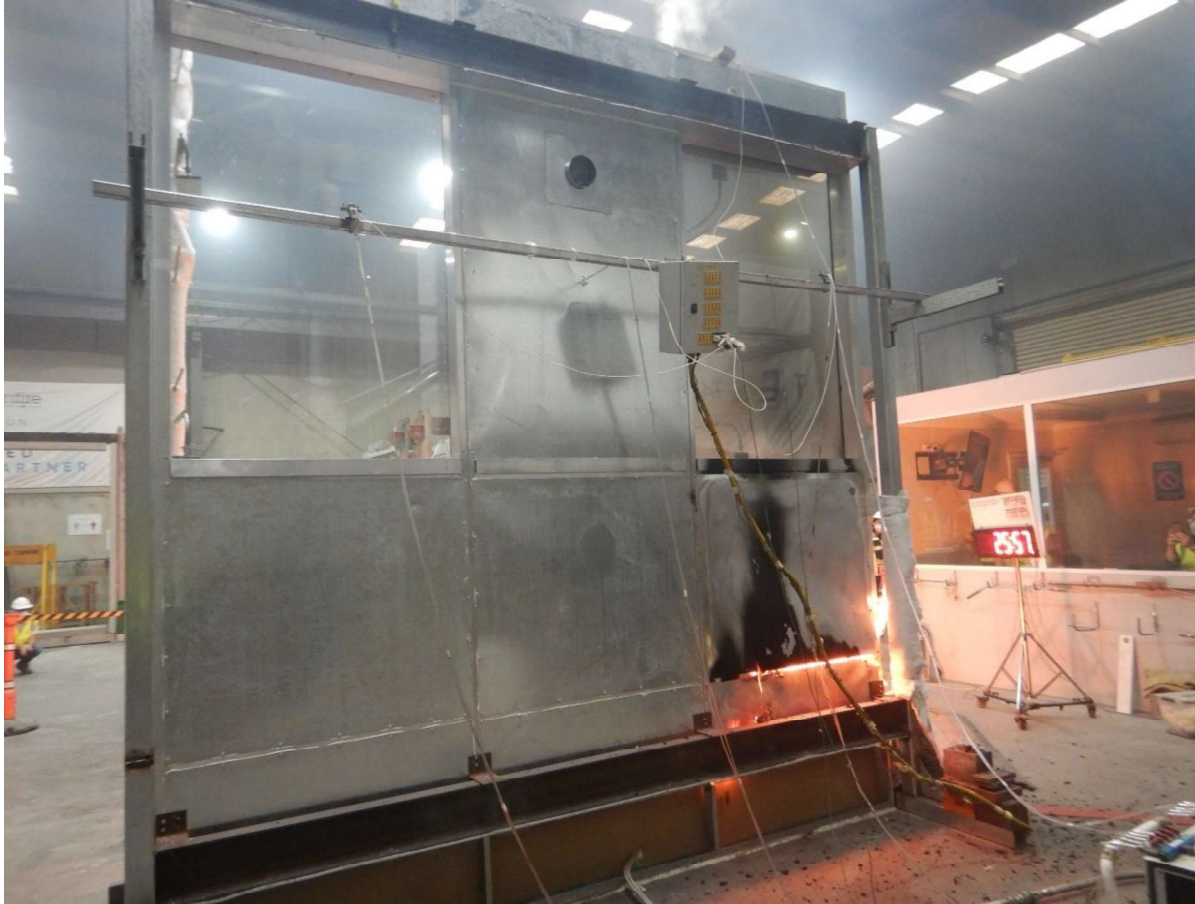
**Figure 32 The specimen 25 minutes 57 seconds into the test (burner output at 300 kW) – unexposed side.**

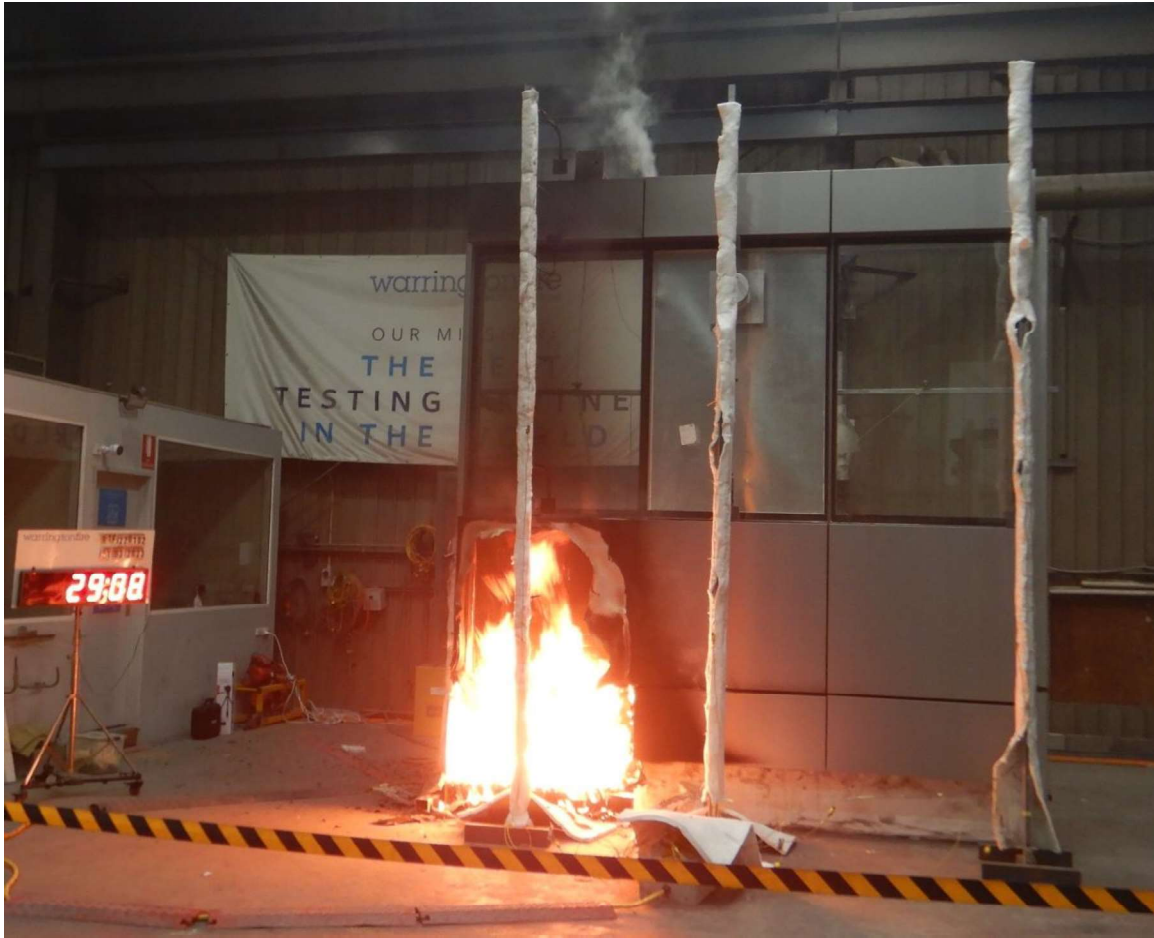
Figure 33 The specimen 29 minutes into the test.

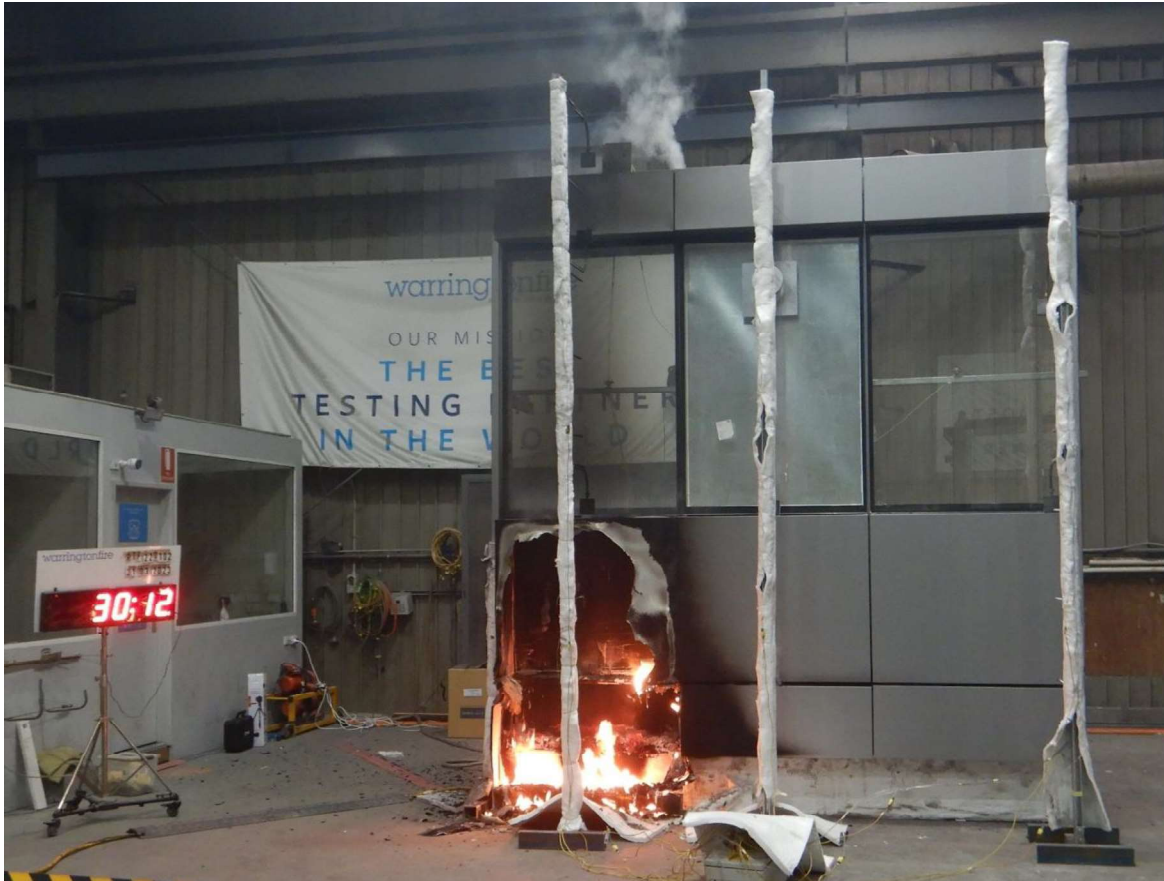
Figure 34 **The specimen 30 minutes 12 seconds into the test – just after burner is turned off.**

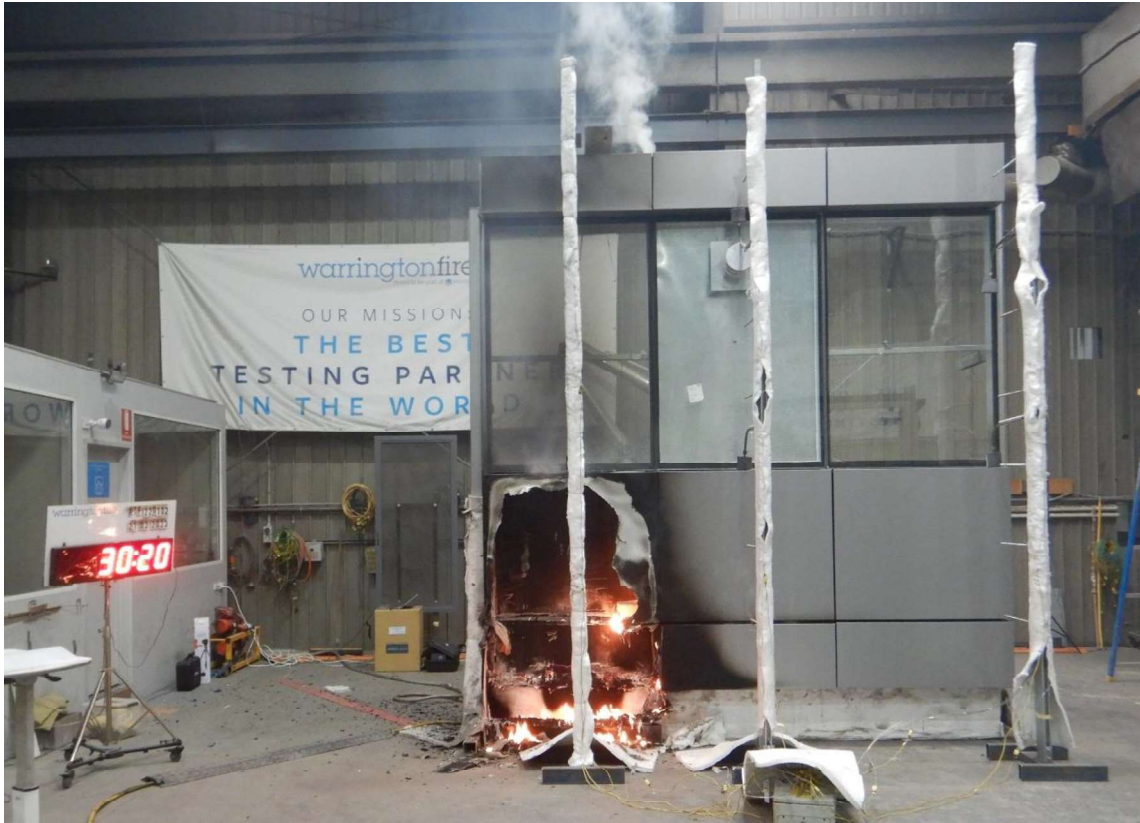
Figure 35 The specimen 30 minutes 20 seconds into the test (burner off).

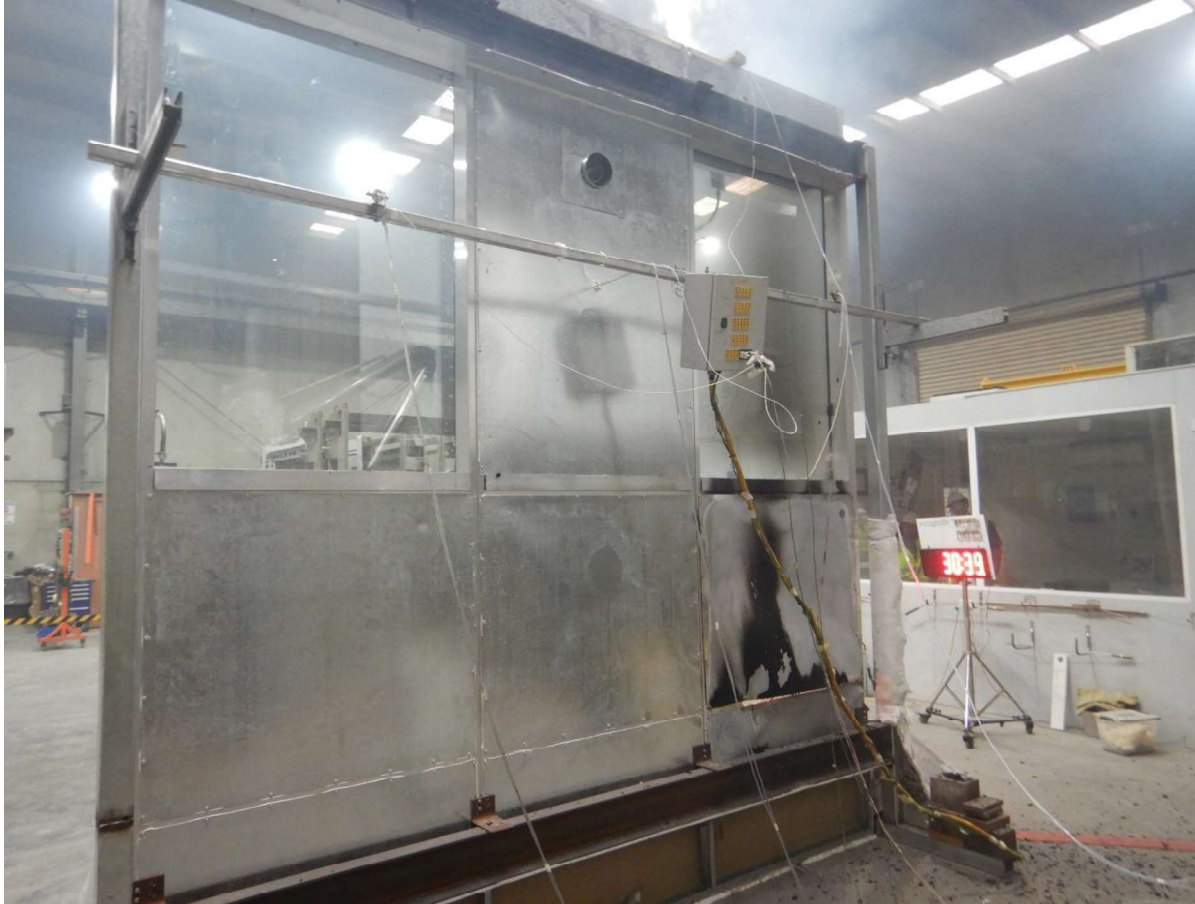
**Figure 36 The specimen 30 minutes 39 seconds into the test (burner off) – unexposed side.**
