# Reaction to fire test report

Test standard: Ad-hoc test based off ISO 13785-1:2002

System: Aluminium composite panel wall system representative of the in-situ wall located at [REDACTED]  
[REDACTED] - Scenario 1 - Test 2

Job number: RTF220102

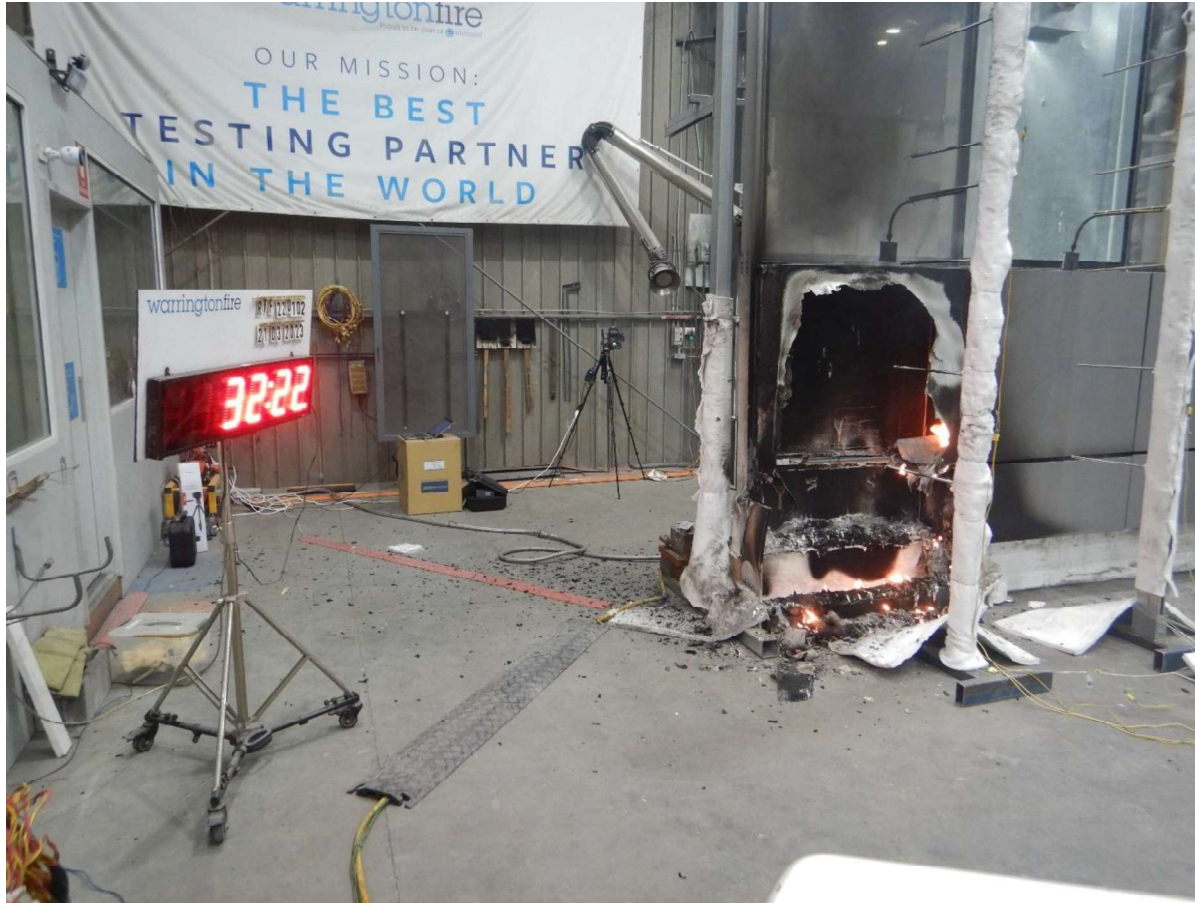
Figure 37 The specimen 32 minutes 22 seconds into the test (burner off).

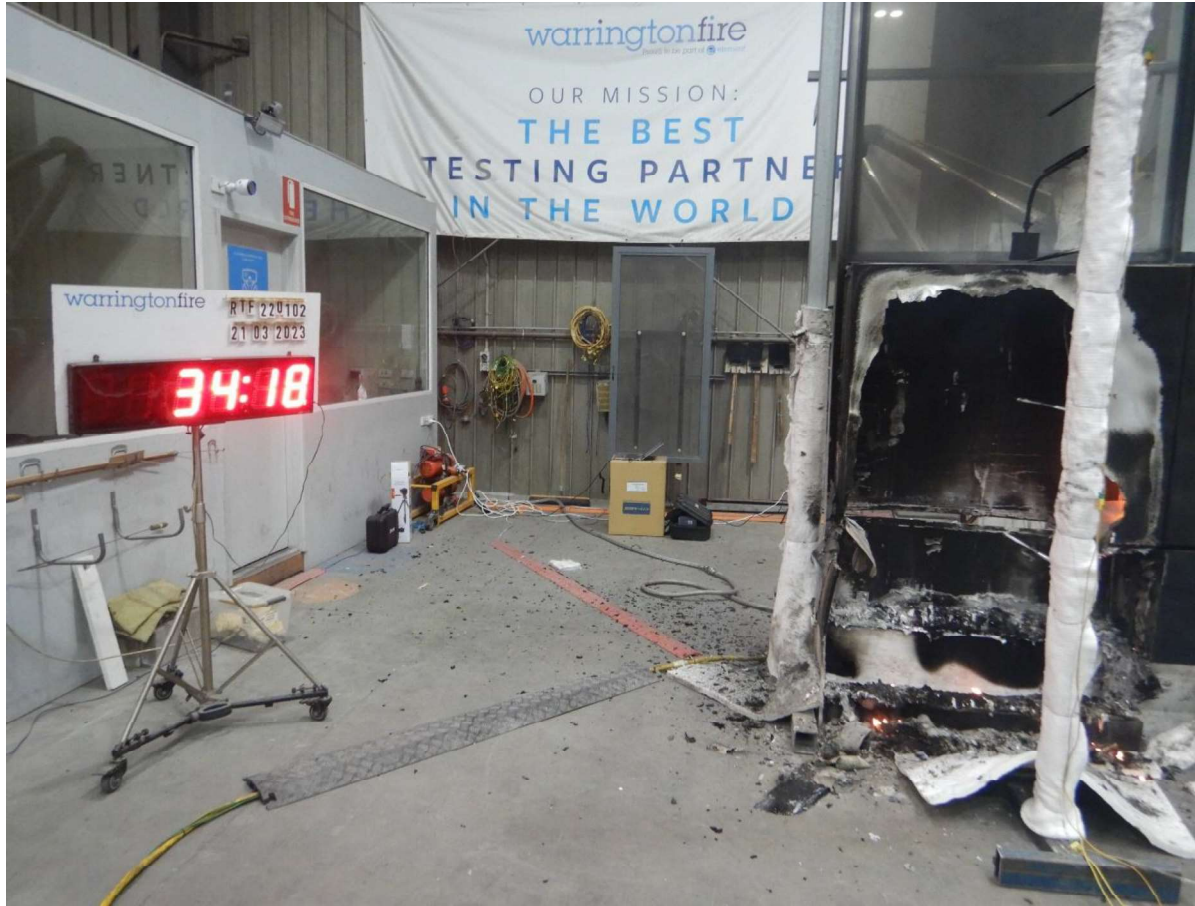
Figure 38 The specimen 34 minutes 18 seconds into the test (burner off).

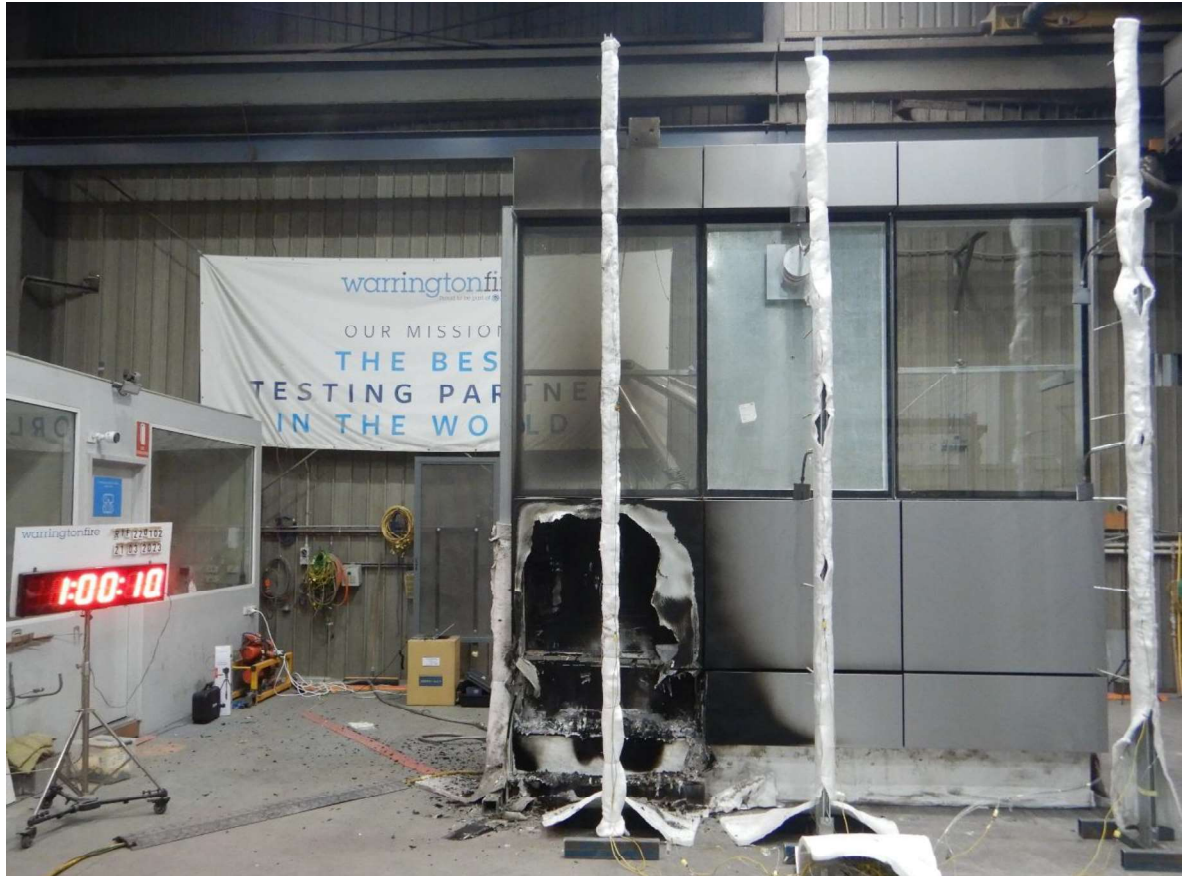
Figure 39 The specimen at end of test – exposed side.
