# Reaction to fire test report

Test standard: Ad-hoc test based off ISO 13785-1:2002

System: Aluminium composite panel wall system representative of the in-situ wall located at [REDACTED]  
[REDACTED] – Scenario 1 - Test 3

Job number: RTF220102

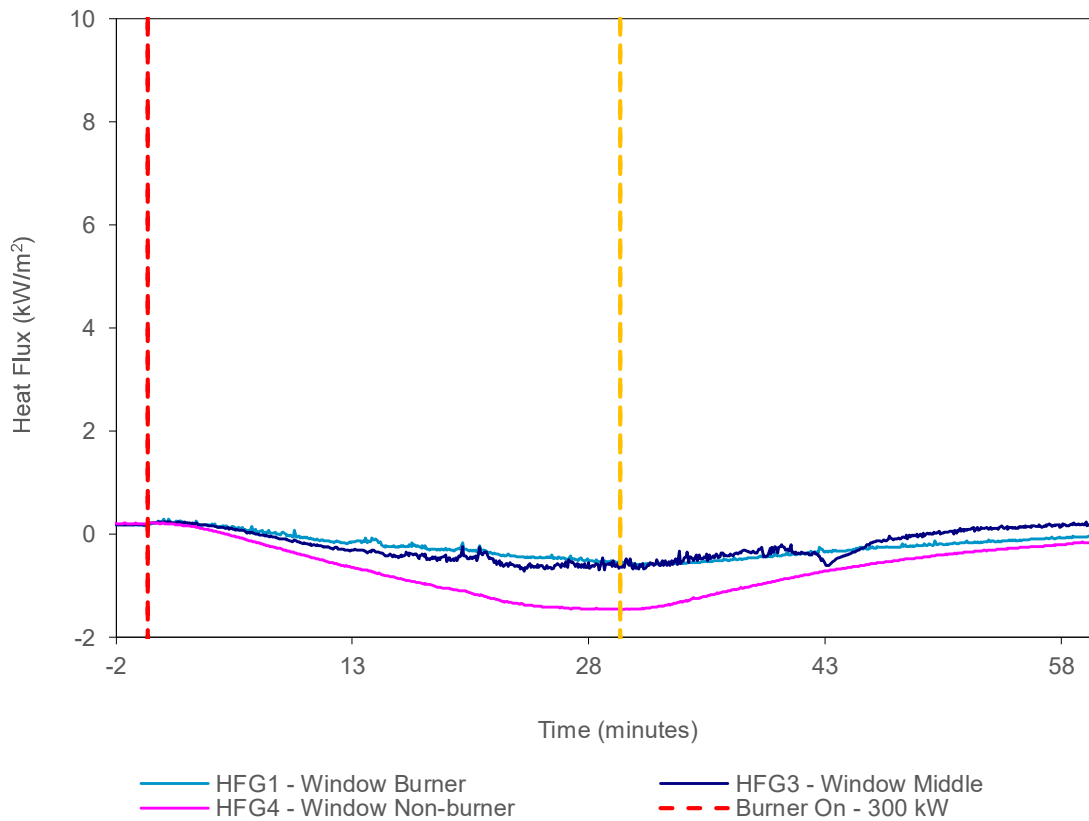
**Figure 10 Emitted heat flux measured by heat flux gauges behind the glazing units.**

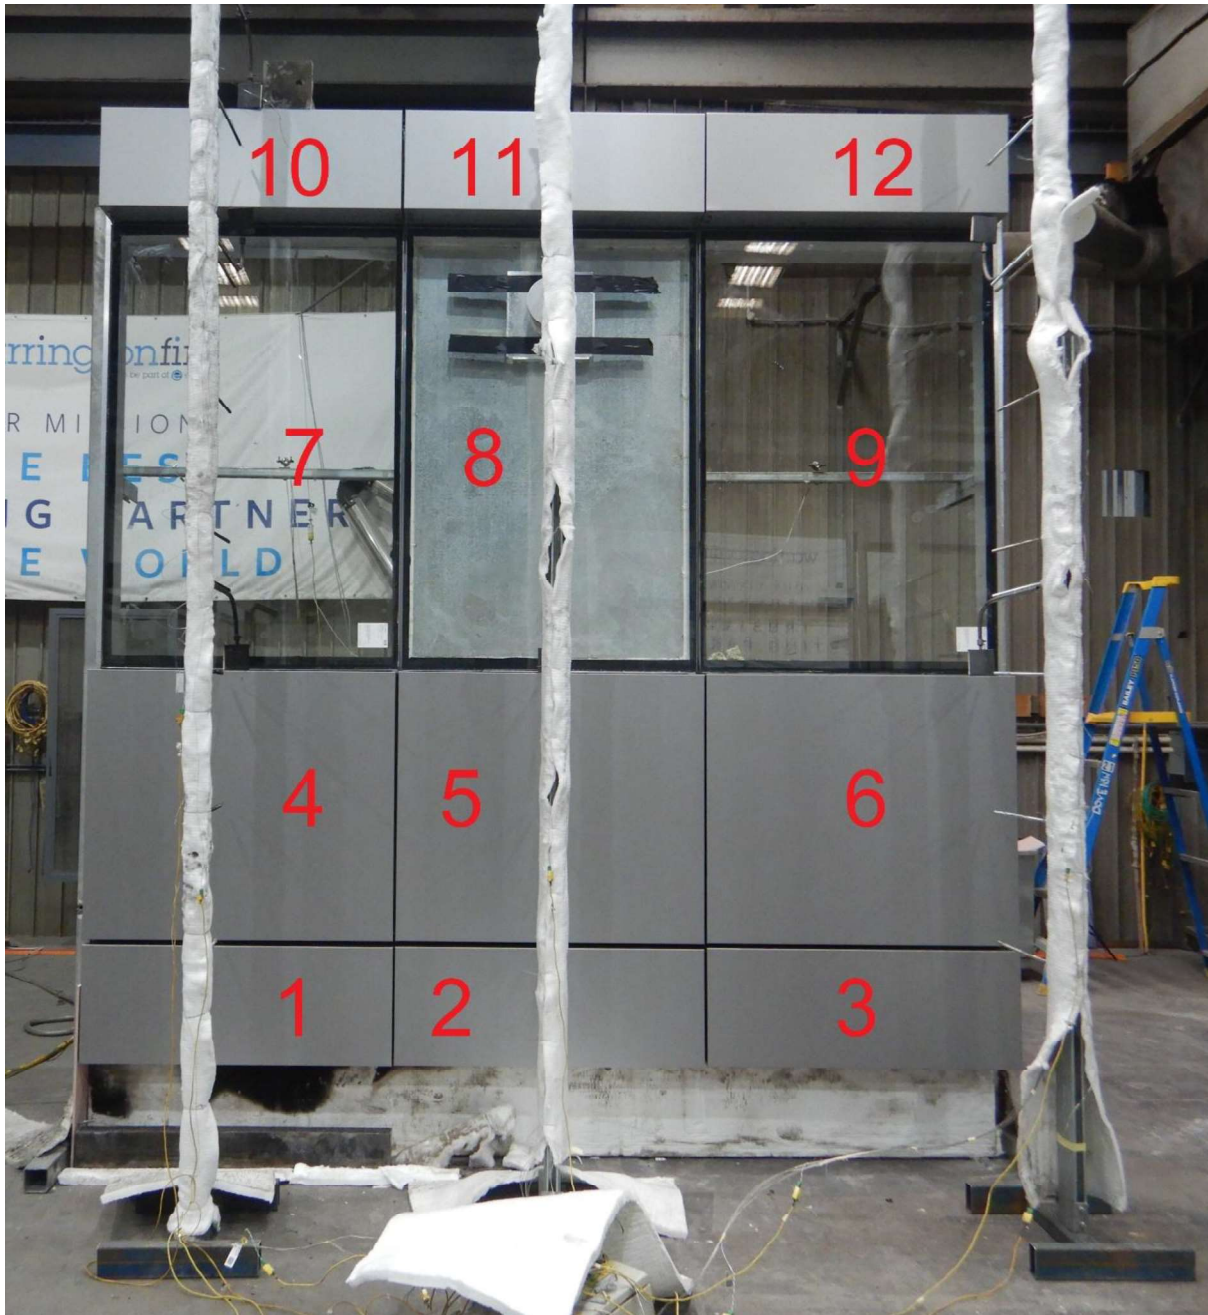
**Figure 11 Designation of section for the test observations.**

Table 4 shows the observations of any significant behaviour of the specimen during the test. Figure 10 shows the panel and glazing designations sighted in the observations.

Time		Observation
Min	Sec	
-2	00	Data collection started.
0	00	The reaction to fire test was started with the burner ignited with a heat output set at 300 kW.
0	10	Flames (from the burner) reached the top of section 4.
0	26	Flames spread horizontally to the bottom of section 2.
0	40	Smoke is emitting from between sections 2 and 5.
0	50	Smoke is emitting from the top of the specimen.
1	15	There is dense smoke emitting from between sections 2 and 5.
1	30	There is burnt paint floating in the air.
3	16	There is smoke emitting from the east edge of section 3.
3	44	Section 2 had deformed bending outward.
4	11	Section 4 had deformed.
5	01	There is smoke emitting from between the join of sections 4 and 5.
5	30	There is smoke emitting on the unexposed side of sections 1 and 2.
12	02	The bottom of the panel of section 5 has discoloured.
13	47	The section 1 panel has opened up.
14	30	The section 4 panel has opened up.

15	10	The back-pans of section 1 and 4 have warped.
15	20	There is fire on the unexposed side between sections 1 and 4.
15	56	The smoke seal on the unexposed in on fire.
17	43	A large piece of flaming debris has fallen from section 4.
19	36	A large piece of flaming debris has fallen from section 1.
20	40	There is sustained flaming at section 2.
21	11	Section 1 has fully burnt/degraded/fallen away.
25	34	There is fire of the seal of section 7 window.
27	57	The fire of the seal of section 7 window has disappeared
28	05	There is fire on the unexposed side of section 4.
28	24	The fire on the unexposed side of section 4 has extinguished.
30	00	The burner was turned off.
31	11	Some debris and parts of Section 1 and 4 are still burning.
38	06	Mostly all of the flames have self-extinguished.
41	00	All flames have self-extinguished.
60	00	The test was ended.

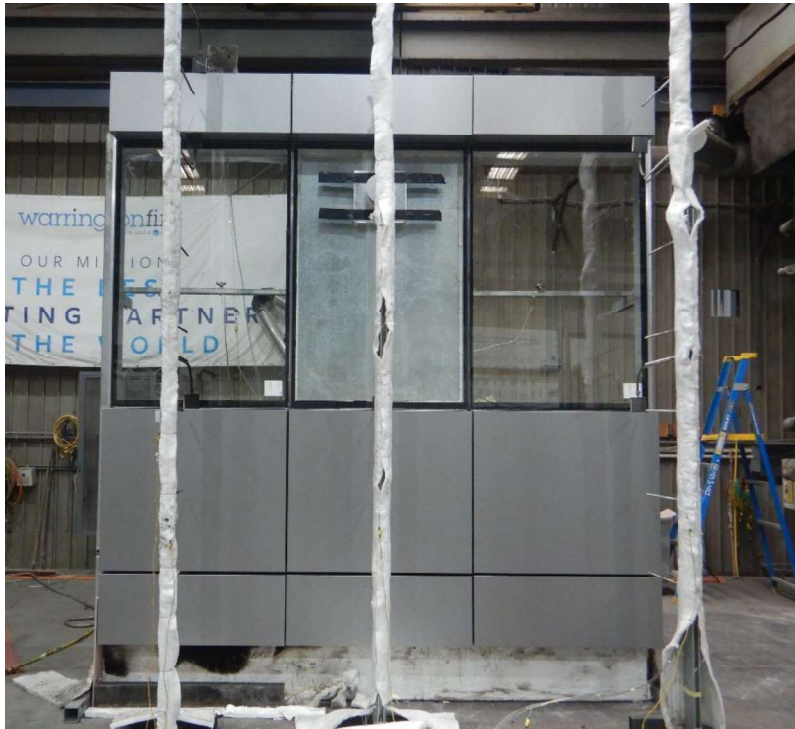
Figure 20 **The specimen (exposed side) before the reaction to fire test**

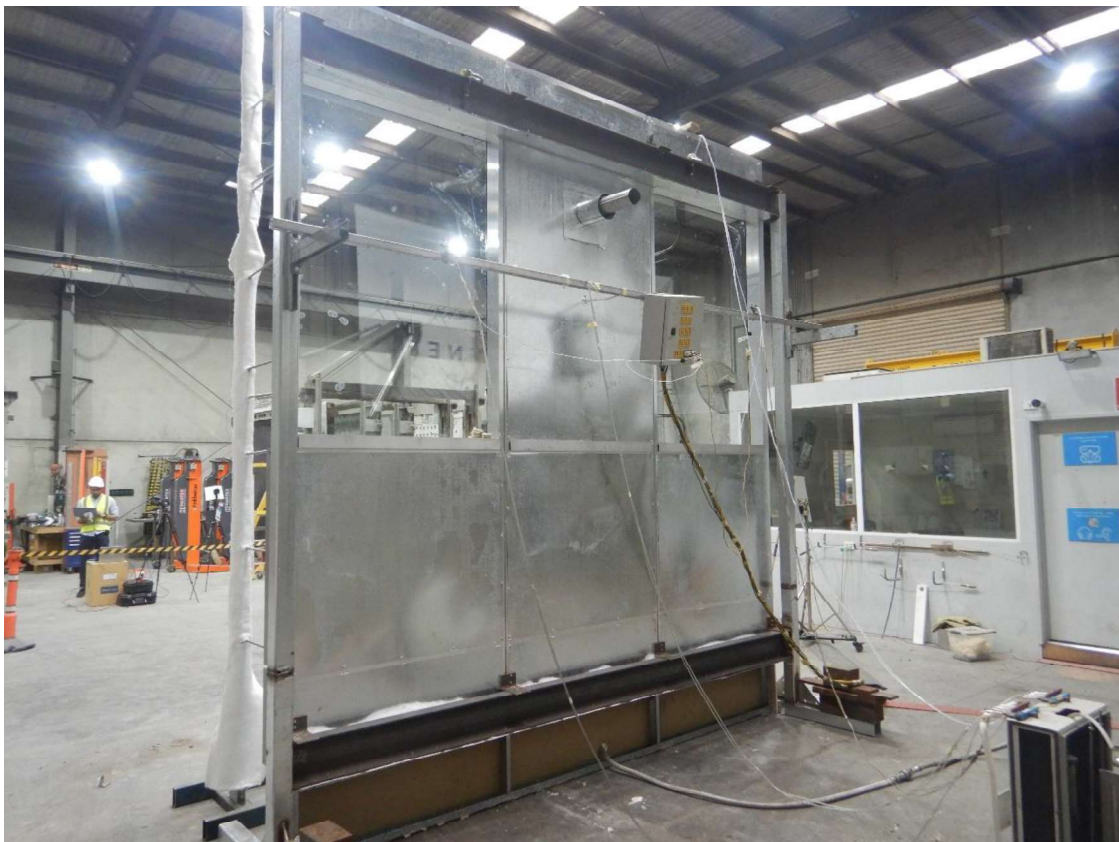
Figure 21 **The specimen (unexposed side) before the reaction to fire test**

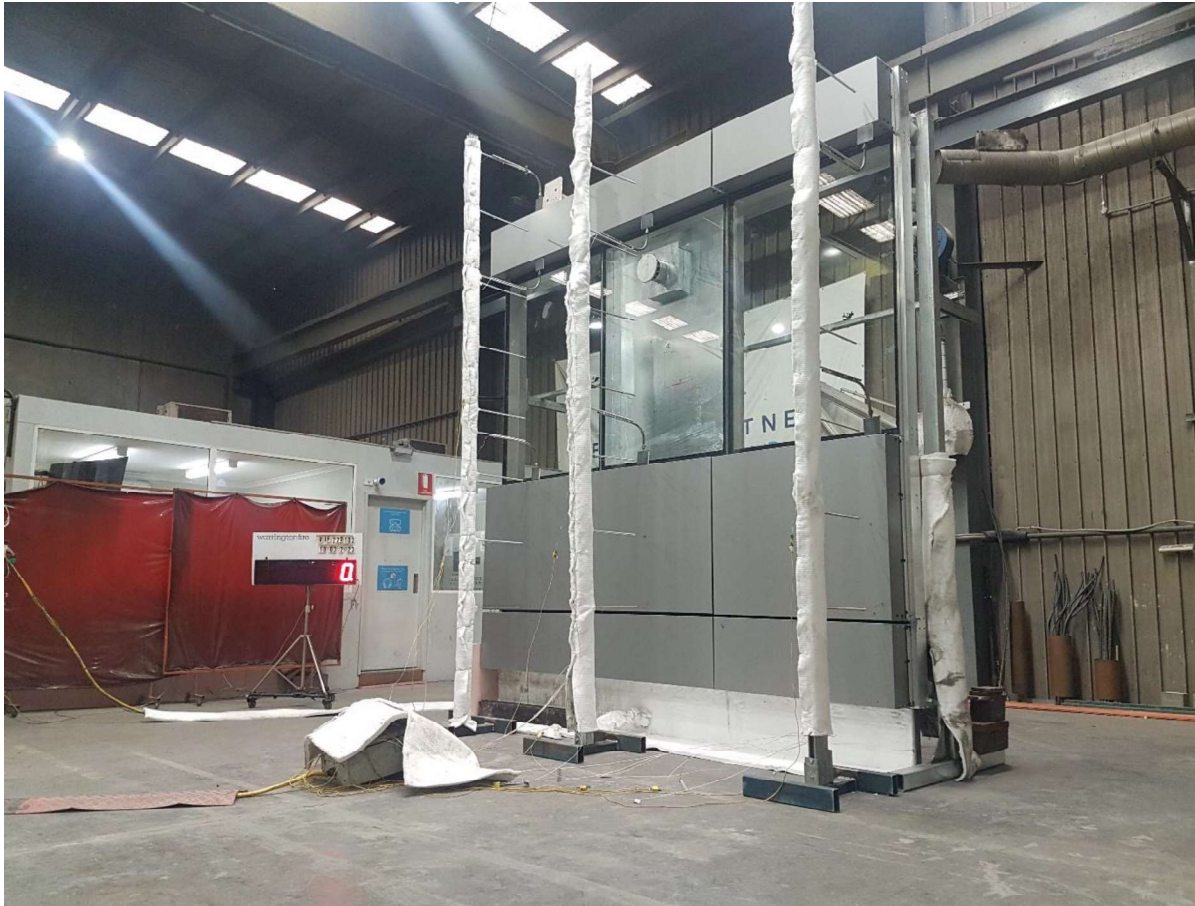
Figure 22 The specimen (angled - exposed side) before the reaction to fire test

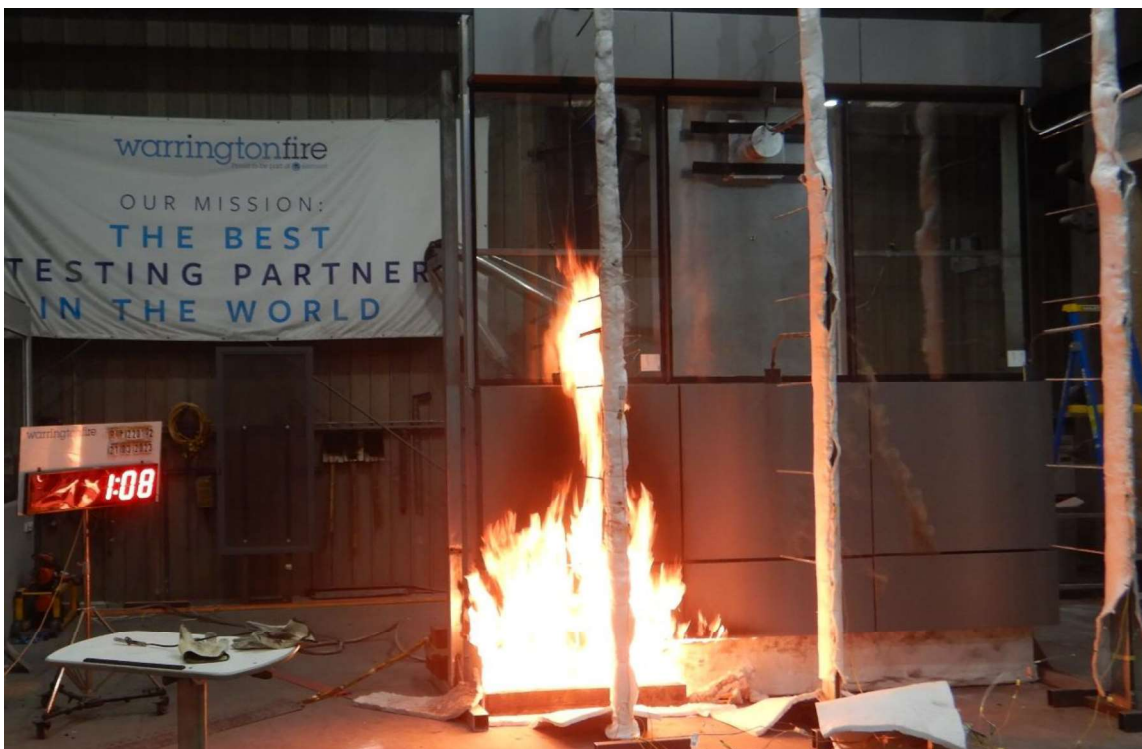
Figure 23 The specimen 1 minute 8 seconds into the test (burner output at 300 kW)

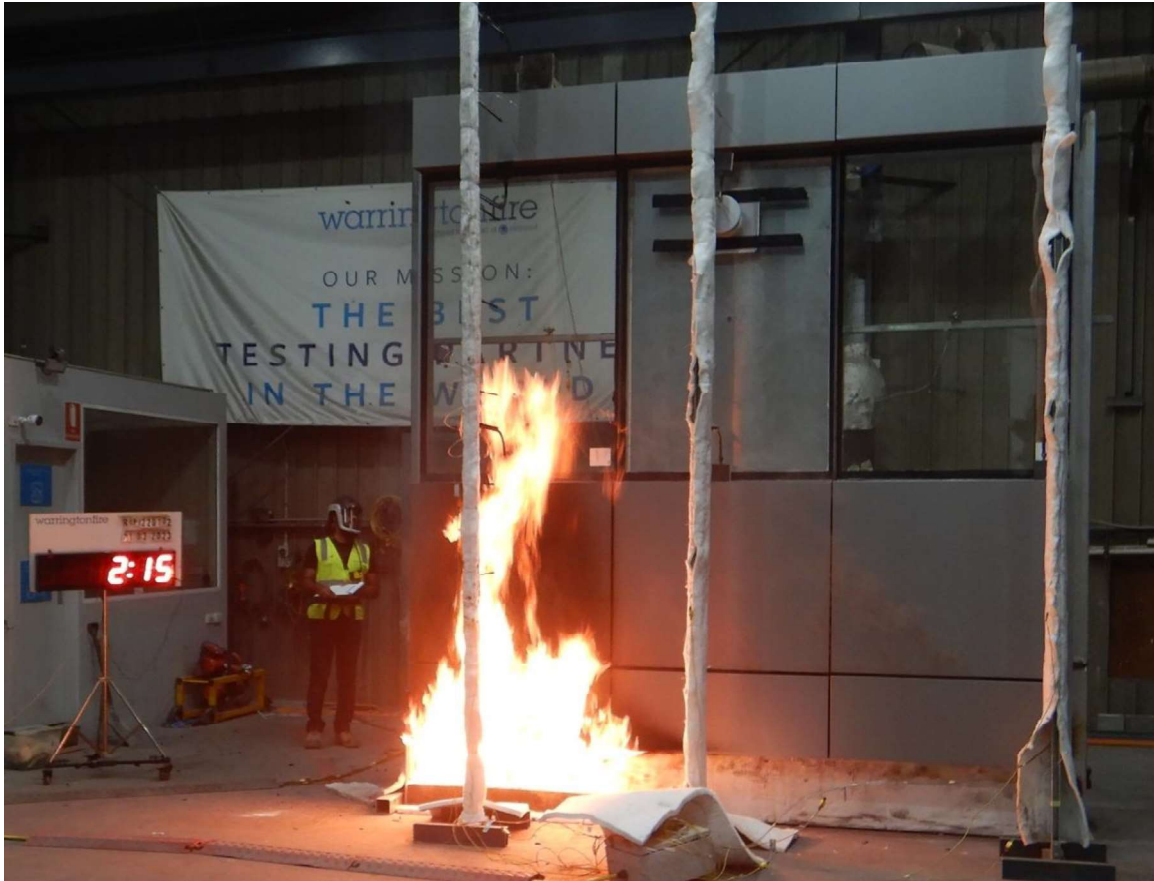
Figure 24 The specimen 2 minutes 14 seconds into the test (burner output at 300 kW)

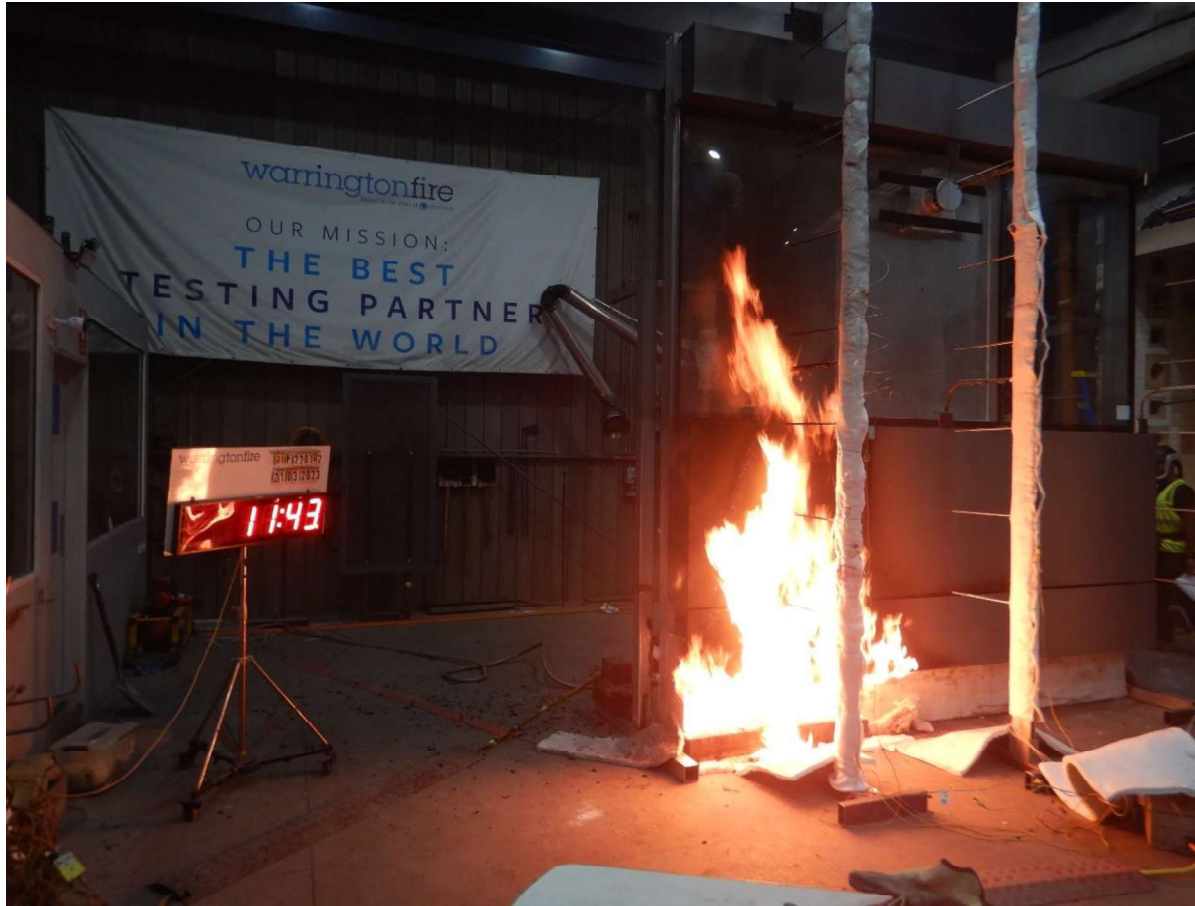
Figure 25 The specimen 11 minutes 43 seconds into the test (burner output at 300 kW)

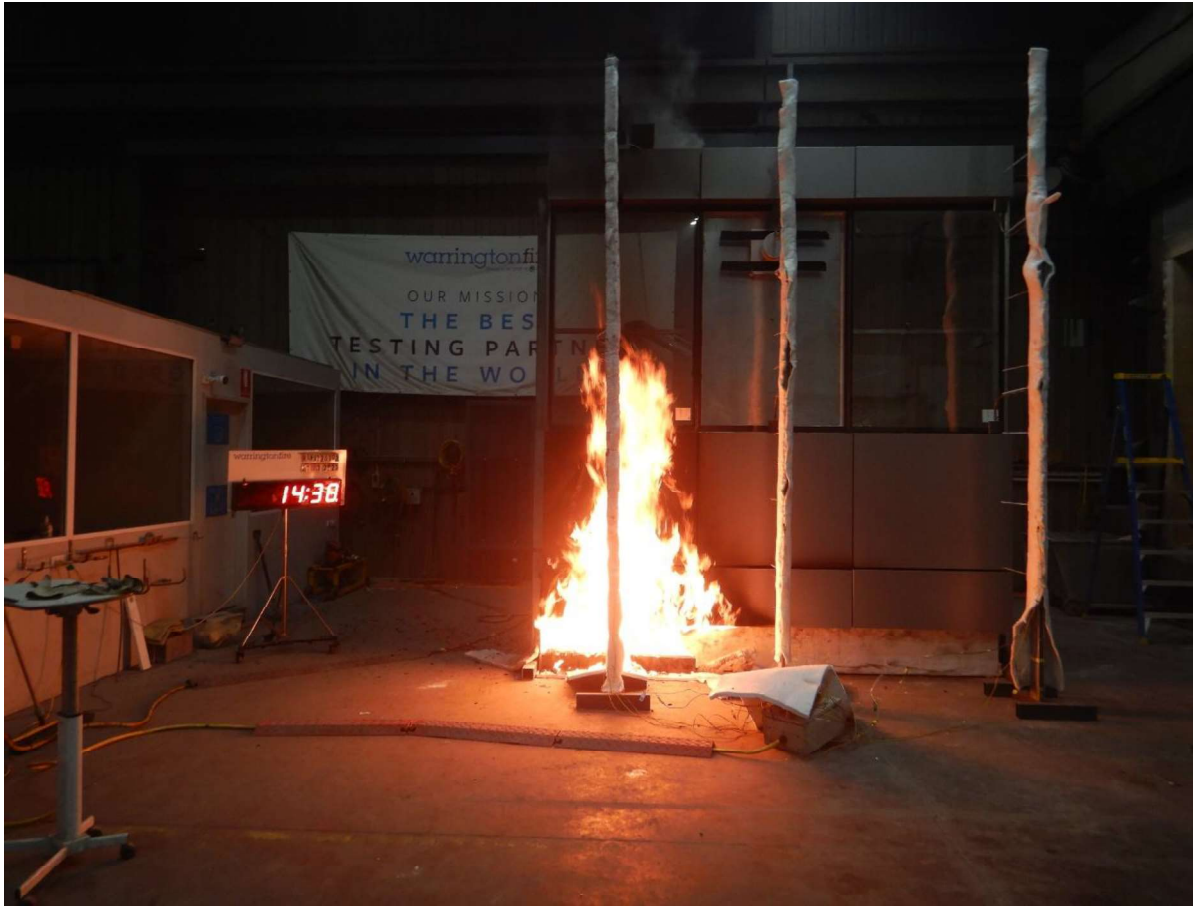
Figure 26 The specimen 14 minutes 38 seconds into the test (burner output at 300 kW)

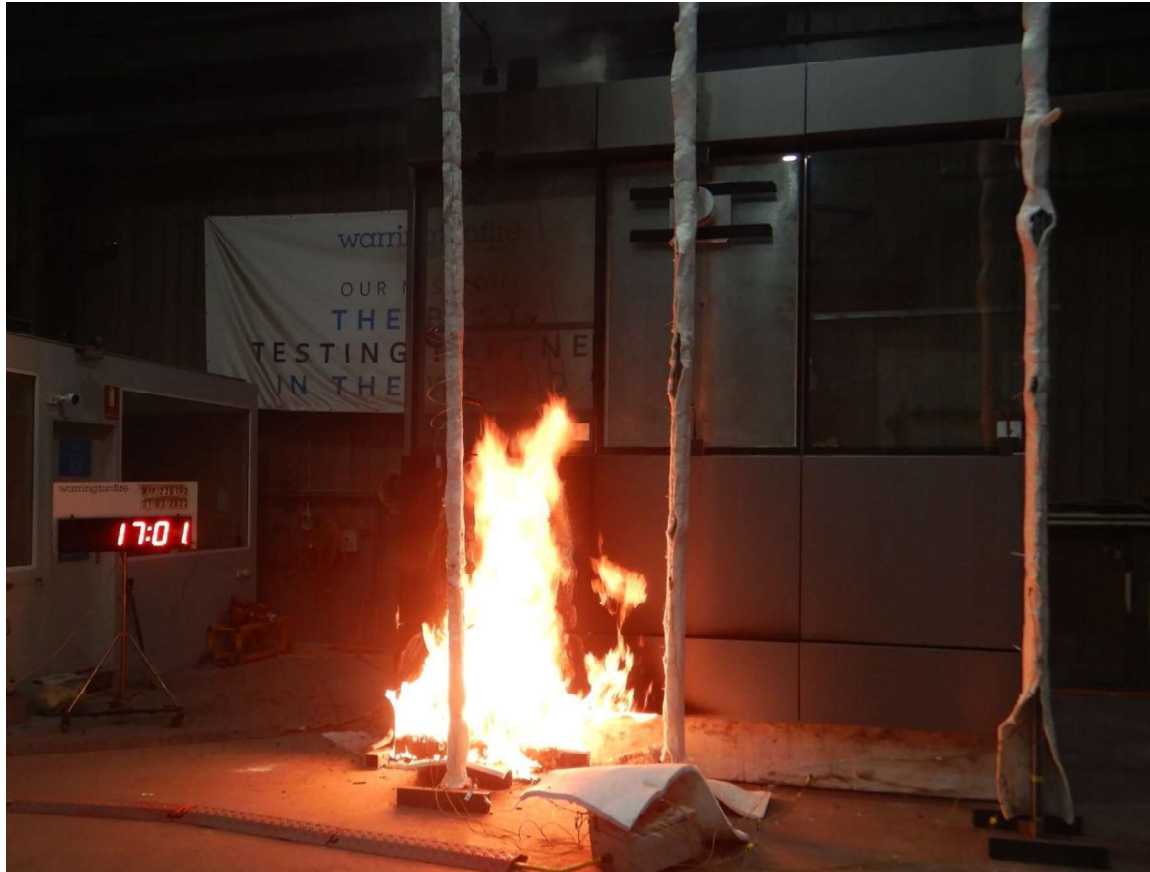
Figure 27 The specimen 17 minutes 1 second into the test (burner output at 300 kW)

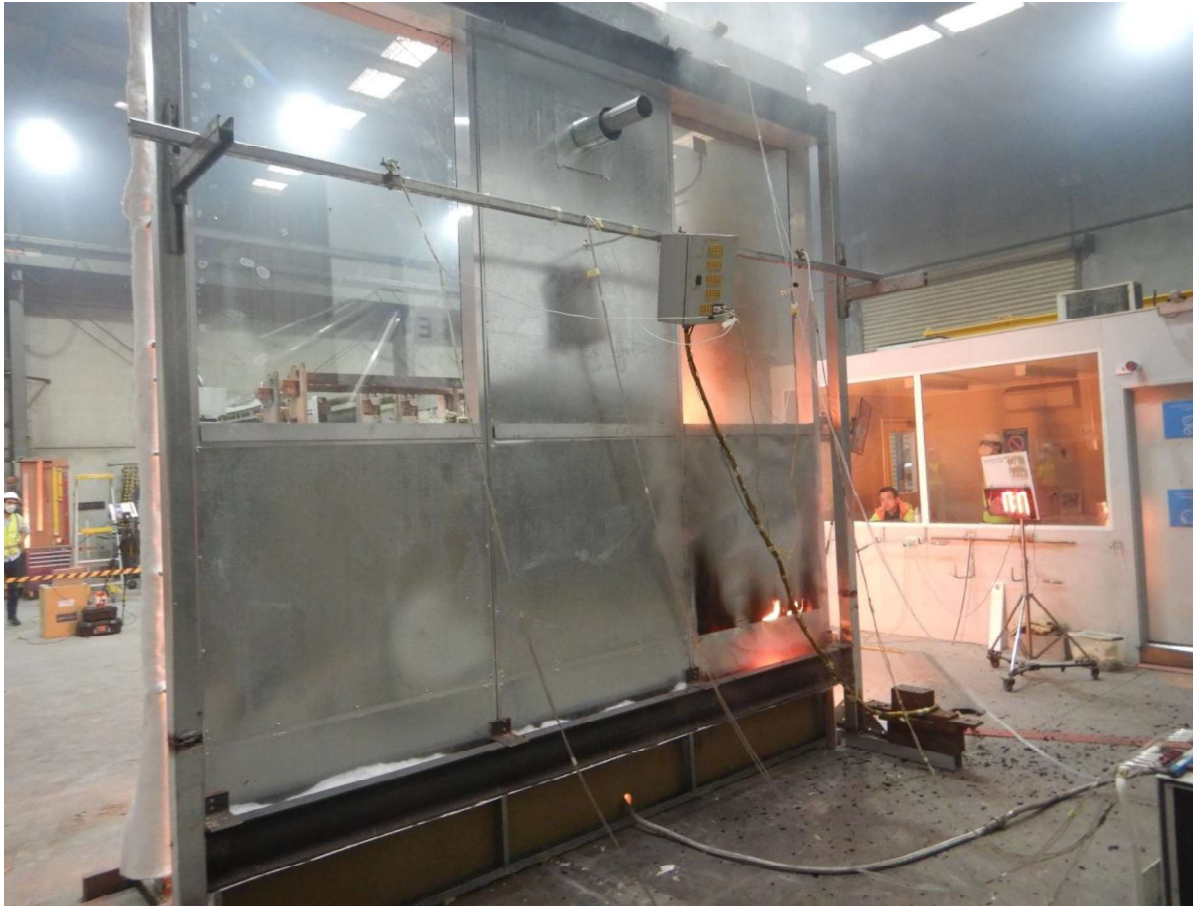
**Figure 28 The specimen 17 minutes 17 seconds into the test (burner output at 300 kW) – unexposed side.**

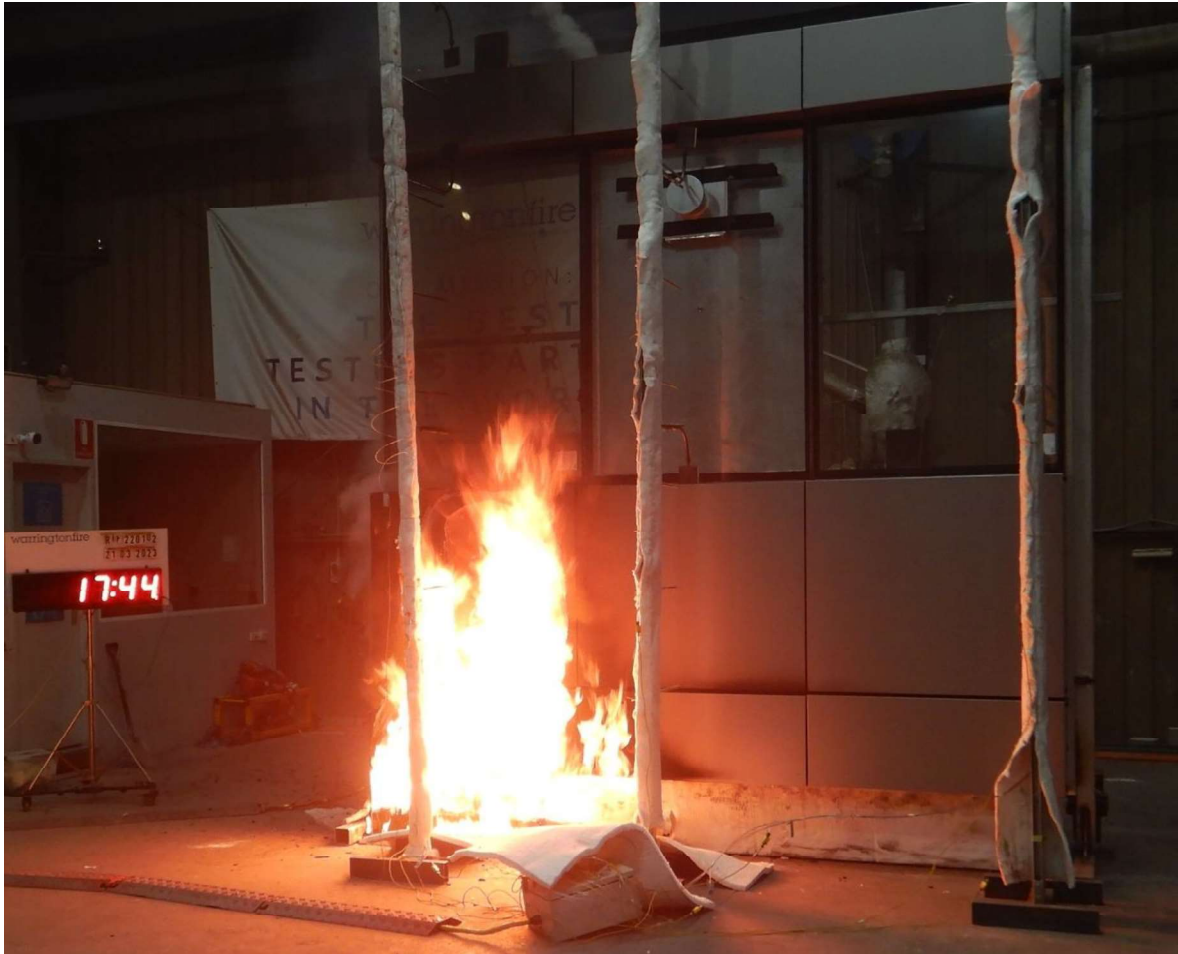
Figure 29 The specimen 17 minutes 44 seconds into the test (burner output at 300 kW).

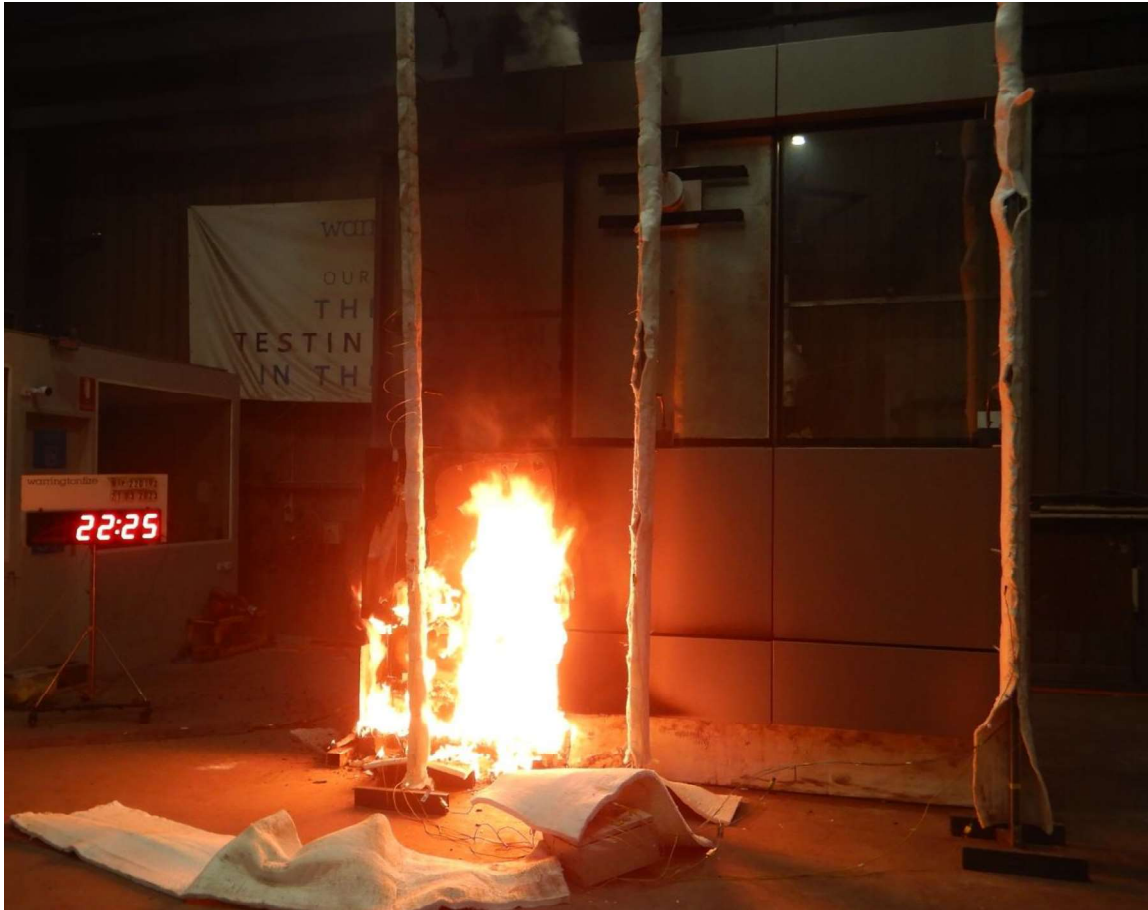
Figure 32 The specimen 22 minutes 25 seconds into the test (burner output at 300 kW).

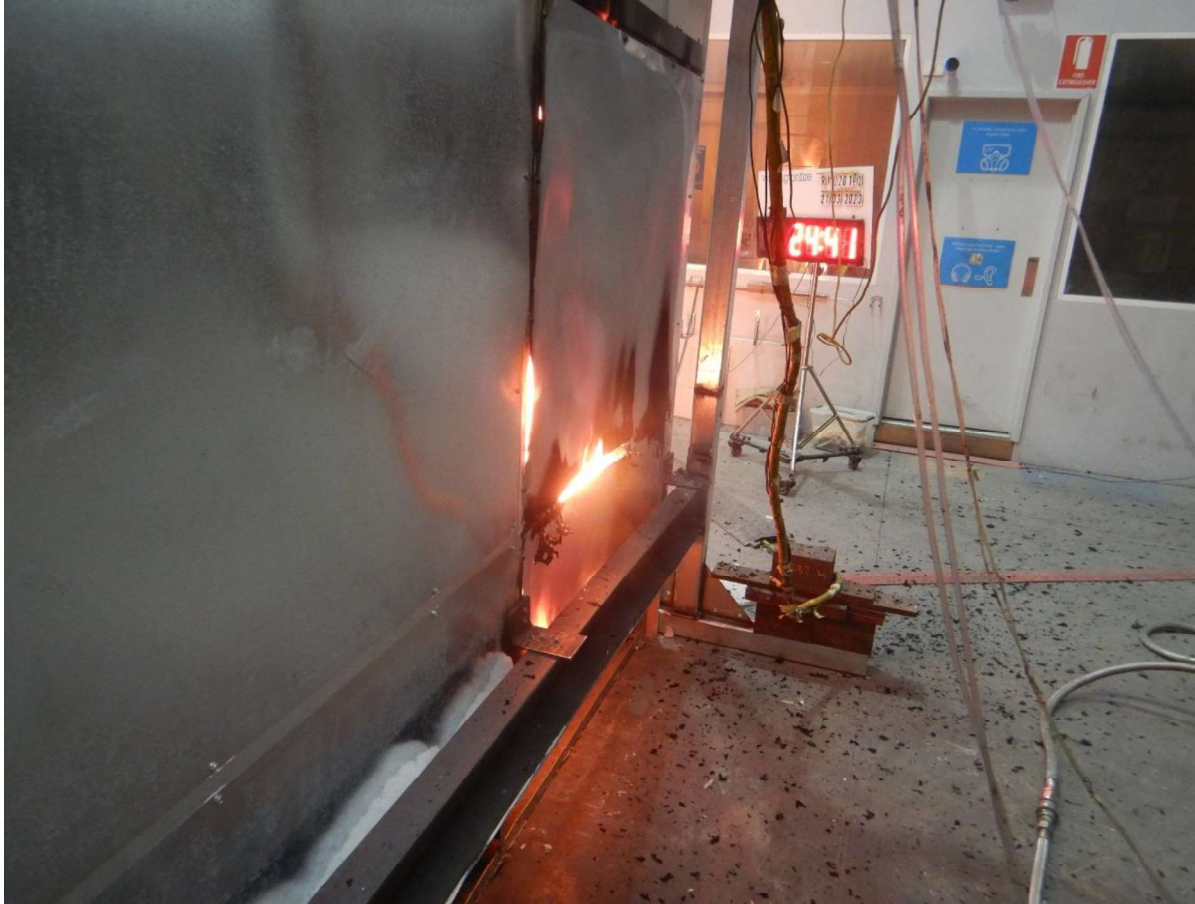
**Figure 33 The specimen 24 minutes 41 seconds into the test (burner output at 300 kW) – unexposed side.**

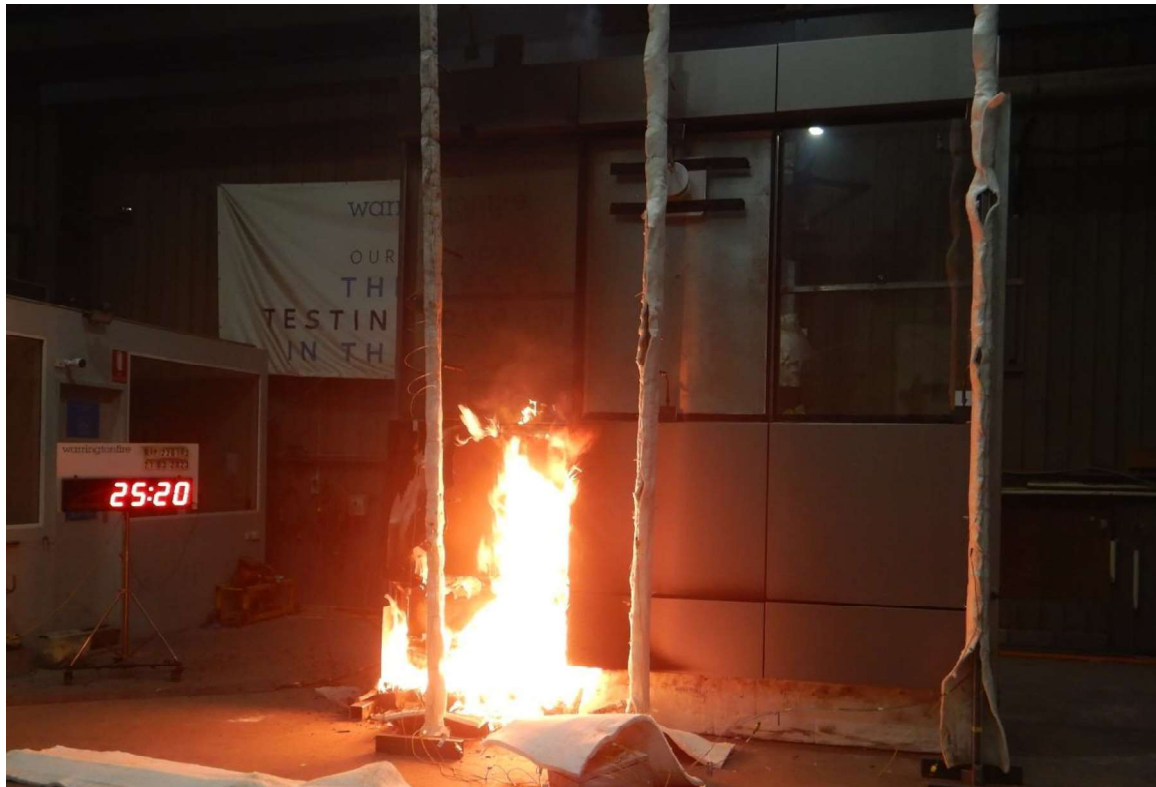
Figure 34 **The specimen 25 minutes 20 seconds into the test (burner output at 300 kW) – unexposed side.**

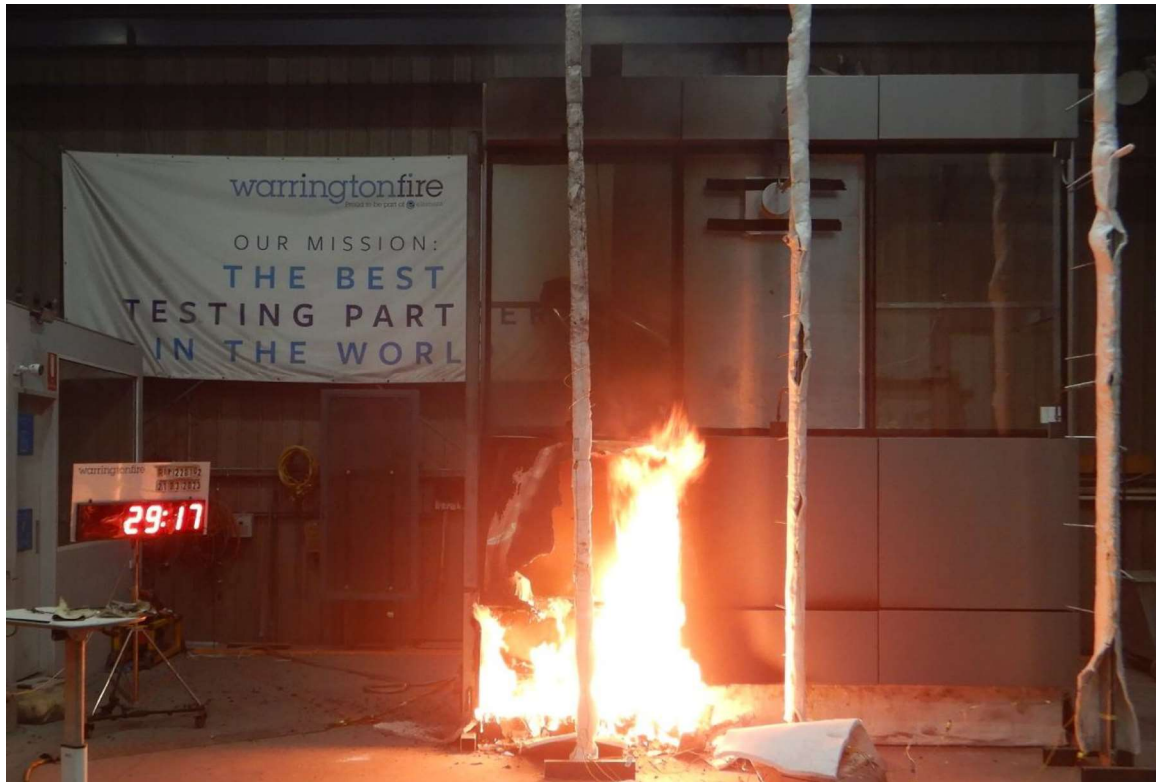
Figure 35 **The specimen 29 minutes 17 seconds into the test (burner output at 300 kW).**

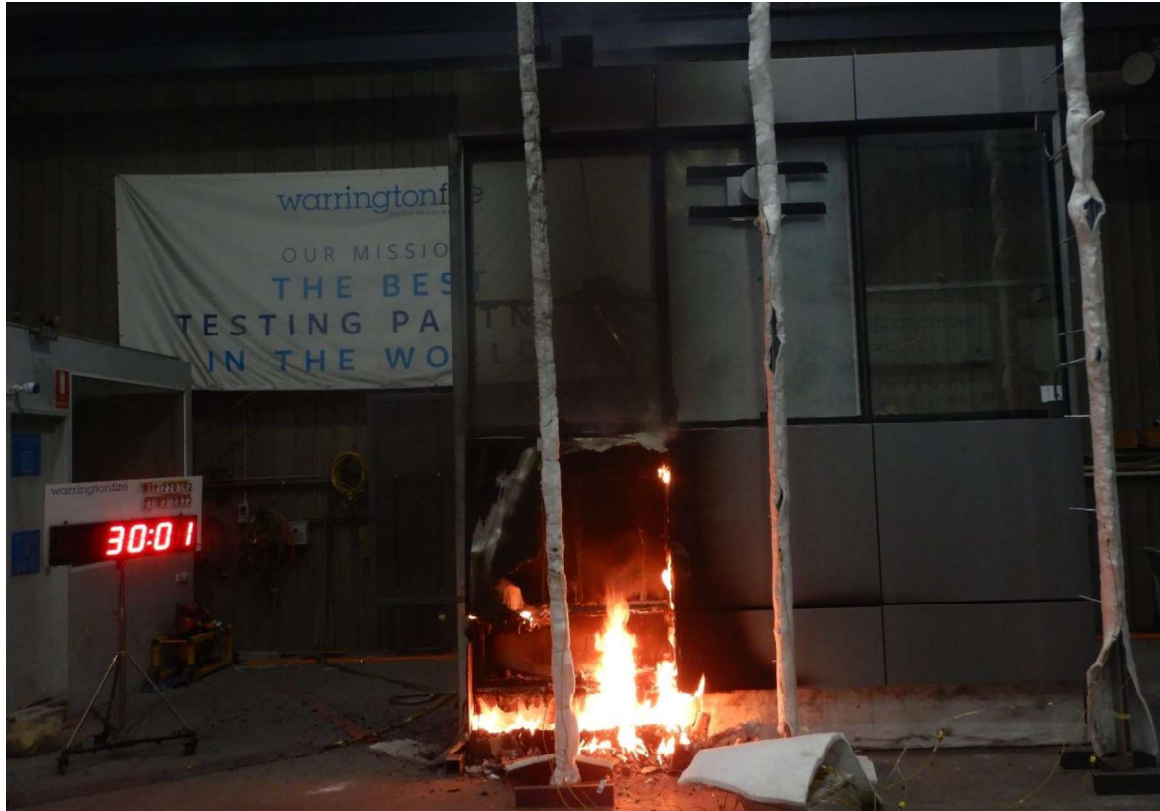
Figure 36 The specimen 30 minutes (1 second) into the test - burner turned off.

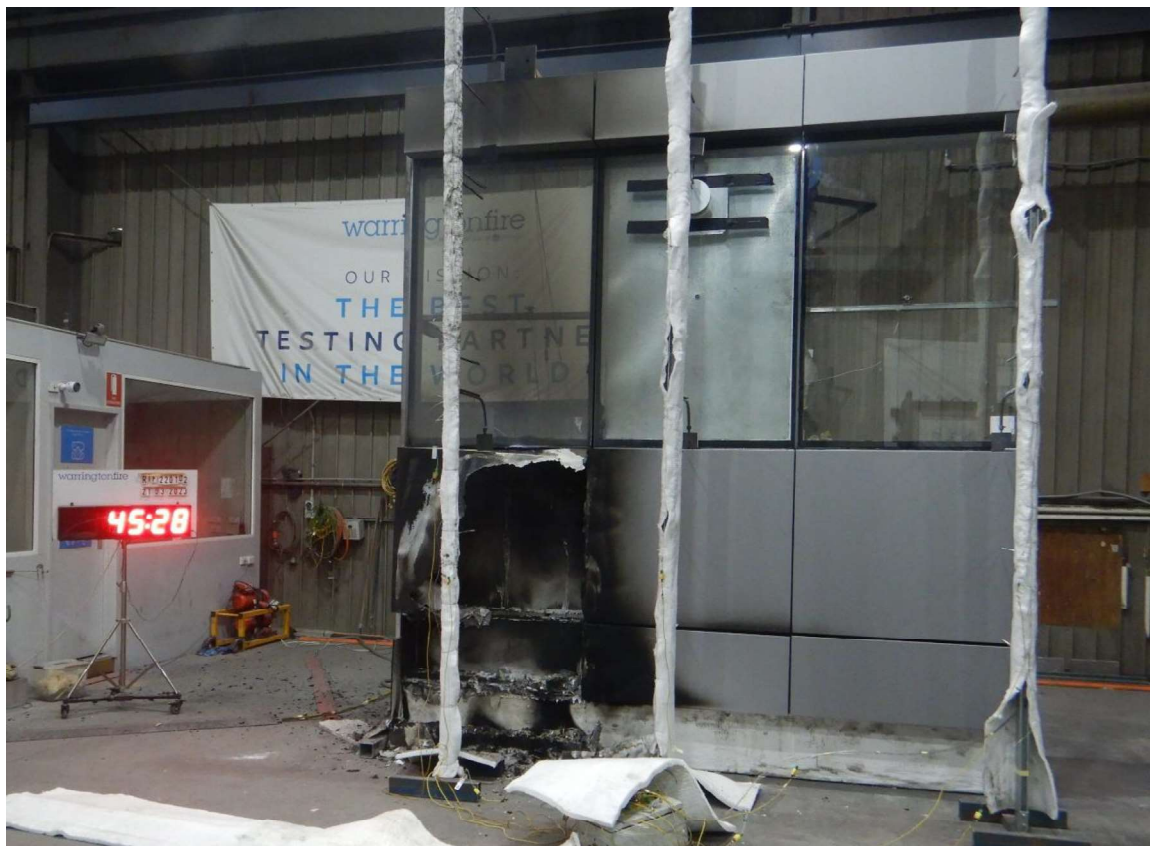
Figure 37 The specimen 45 minutes 28 seconds into the test (burner off).

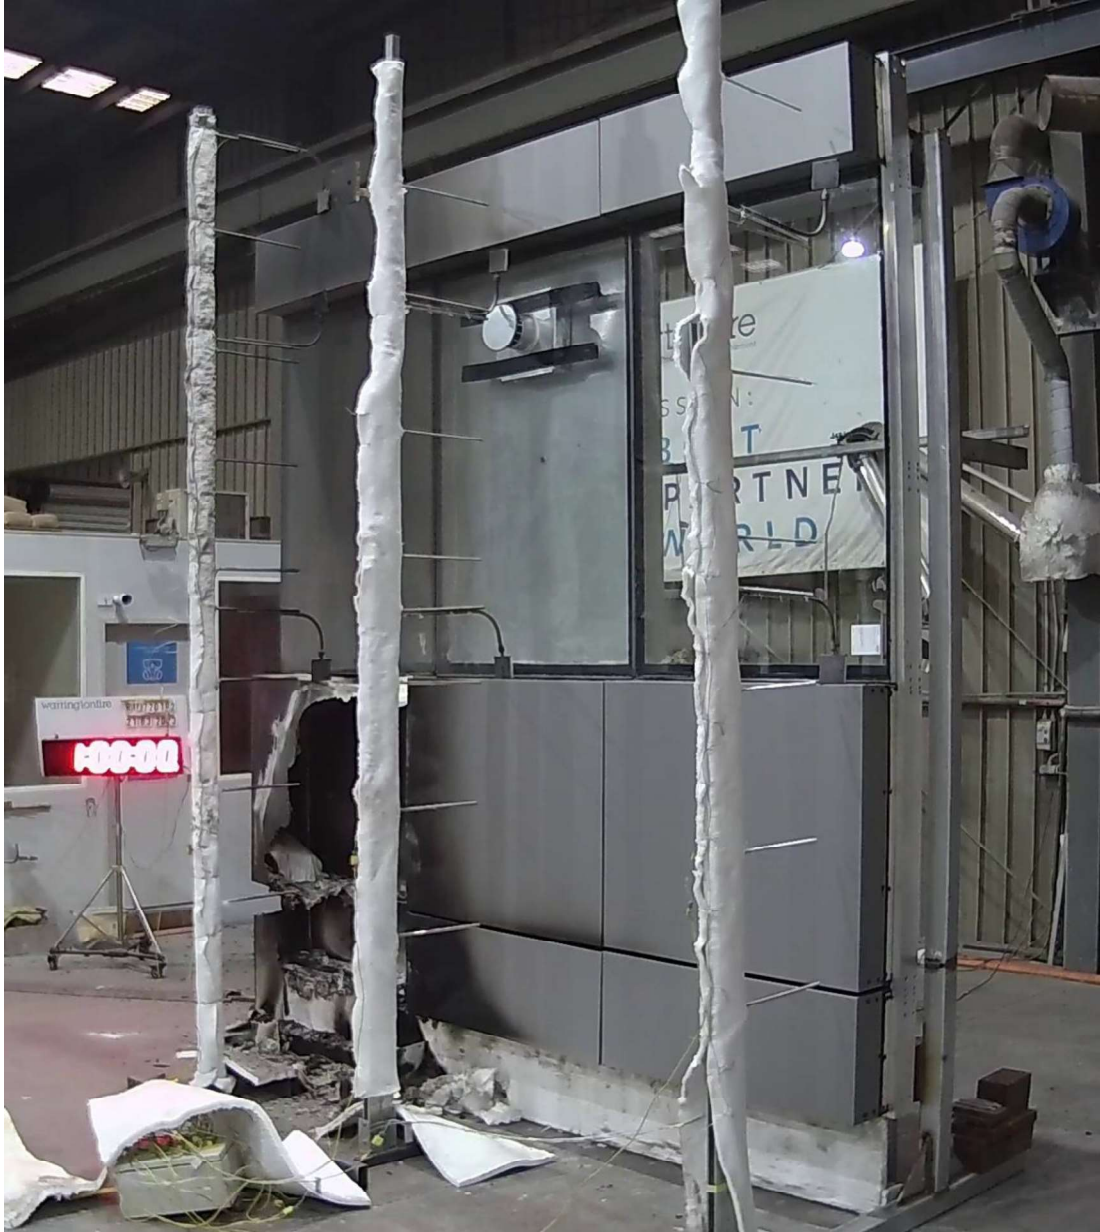
Figure 38 The specimen at end of test.

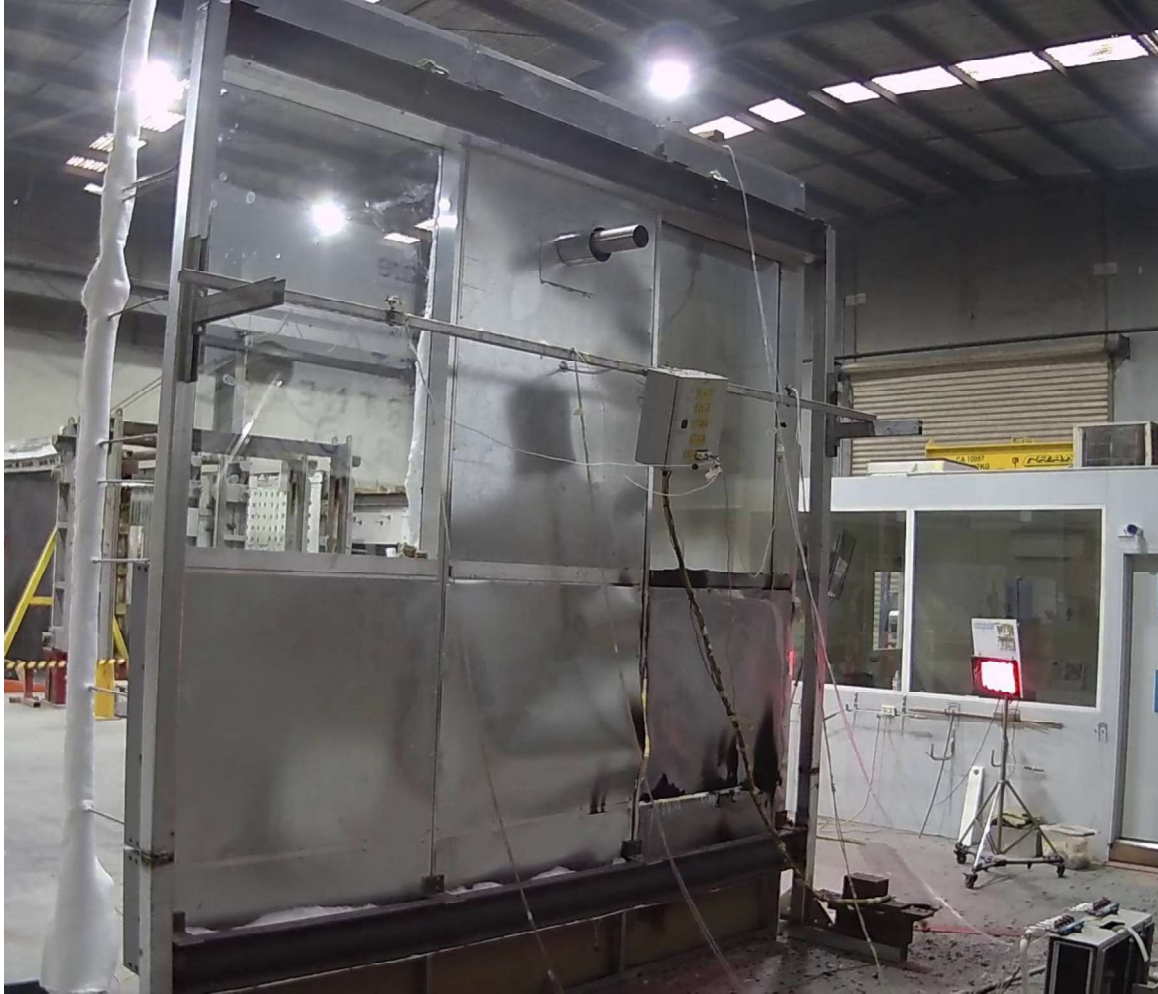
Figure 39 **The specimen at end of test – unexposed side.**
