Reaction to fire test report

Test standard: Ad-hoc test based off ISO 13785-1:2002

System: Aluminium composite panel wall system representative of the in-situ wall located at [REDACTED]
[REDACTED] – Scenario 2 - Test 1

Job number: RTF220104

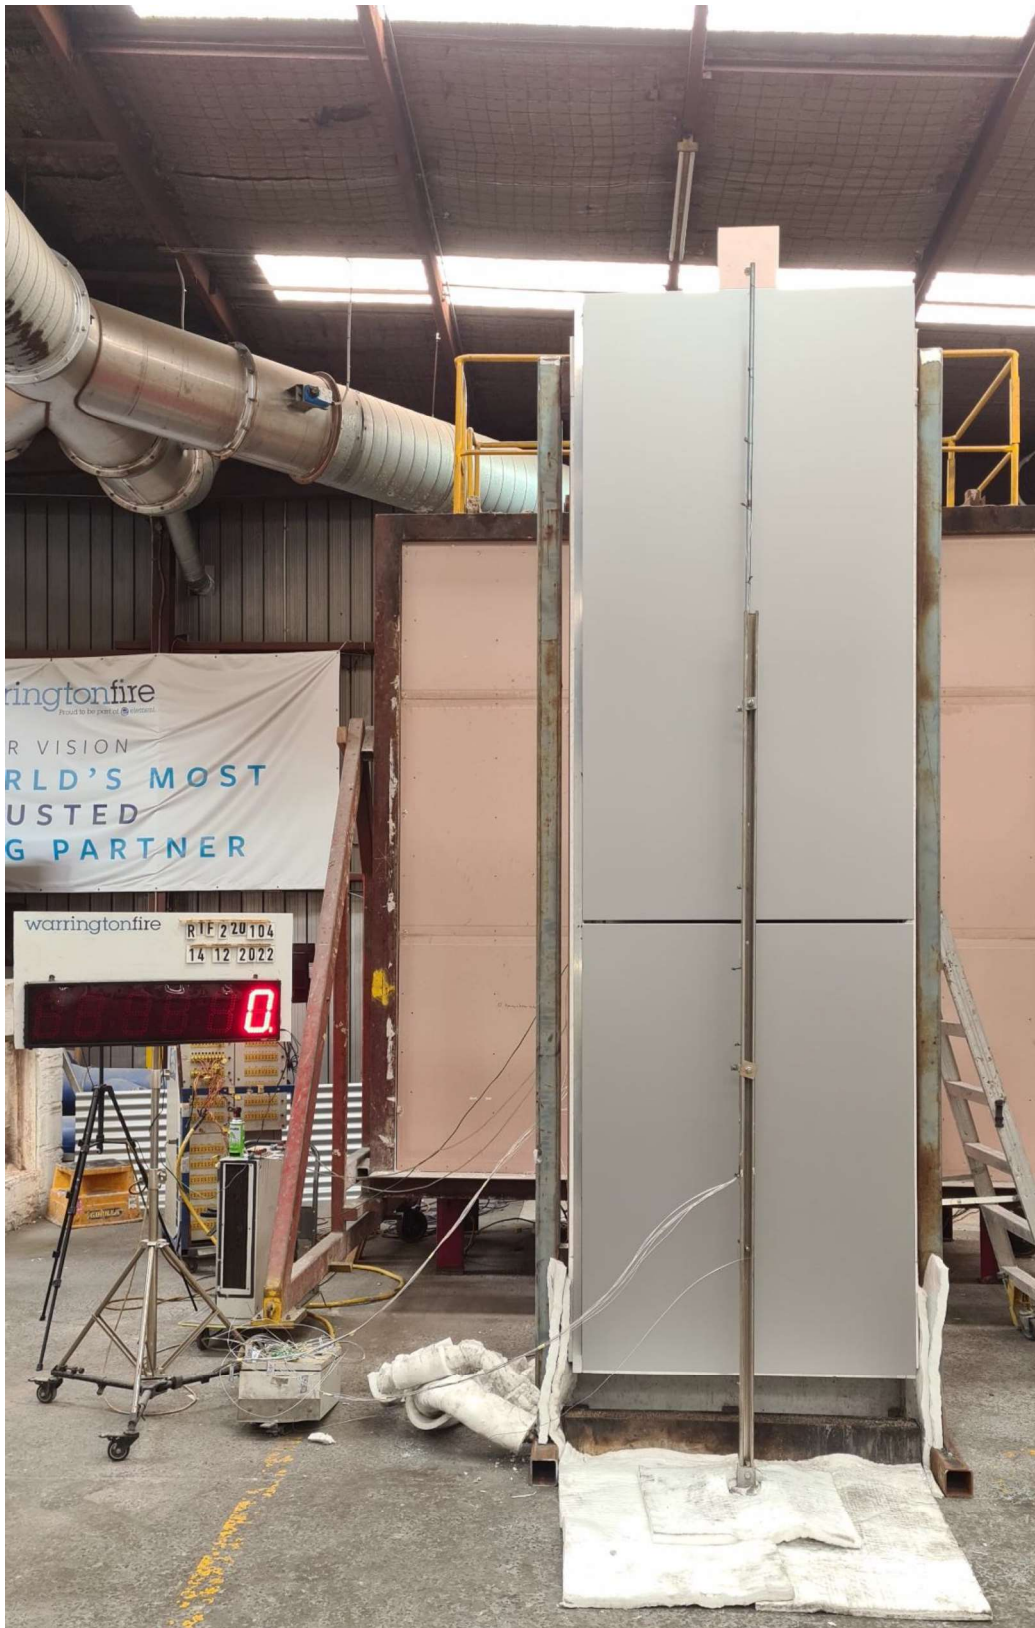
Figure 9 The specimen before the reaction to fire test

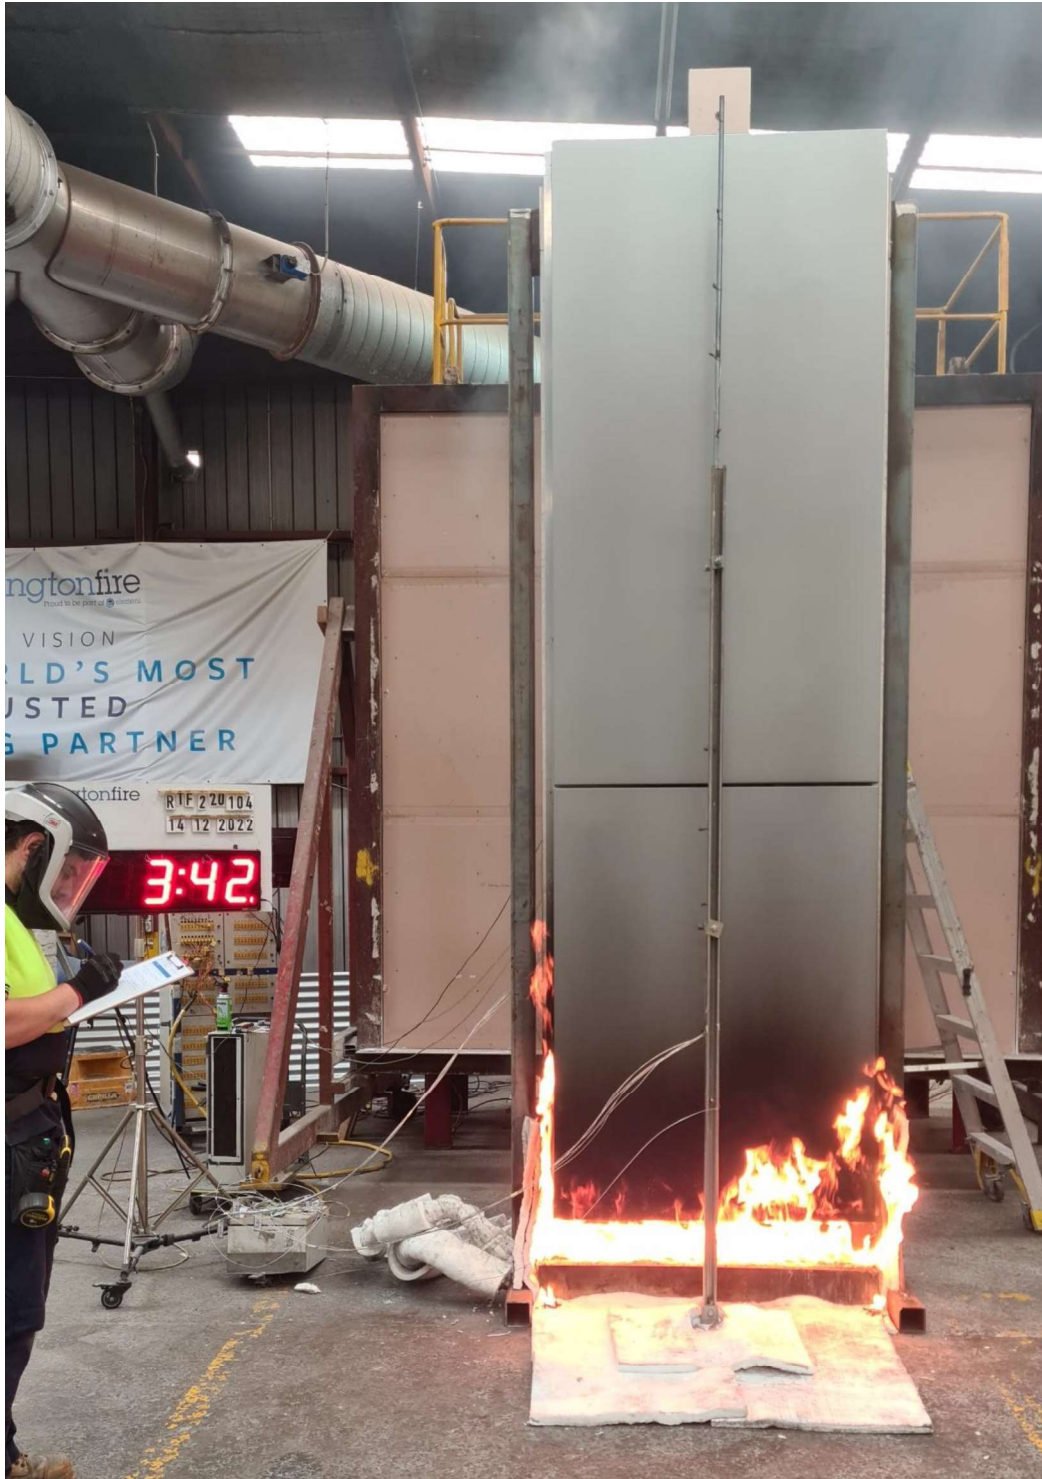
Figure 10 **The specimen 3 minutes 42 seconds into the test (burner output at 100 kW)**

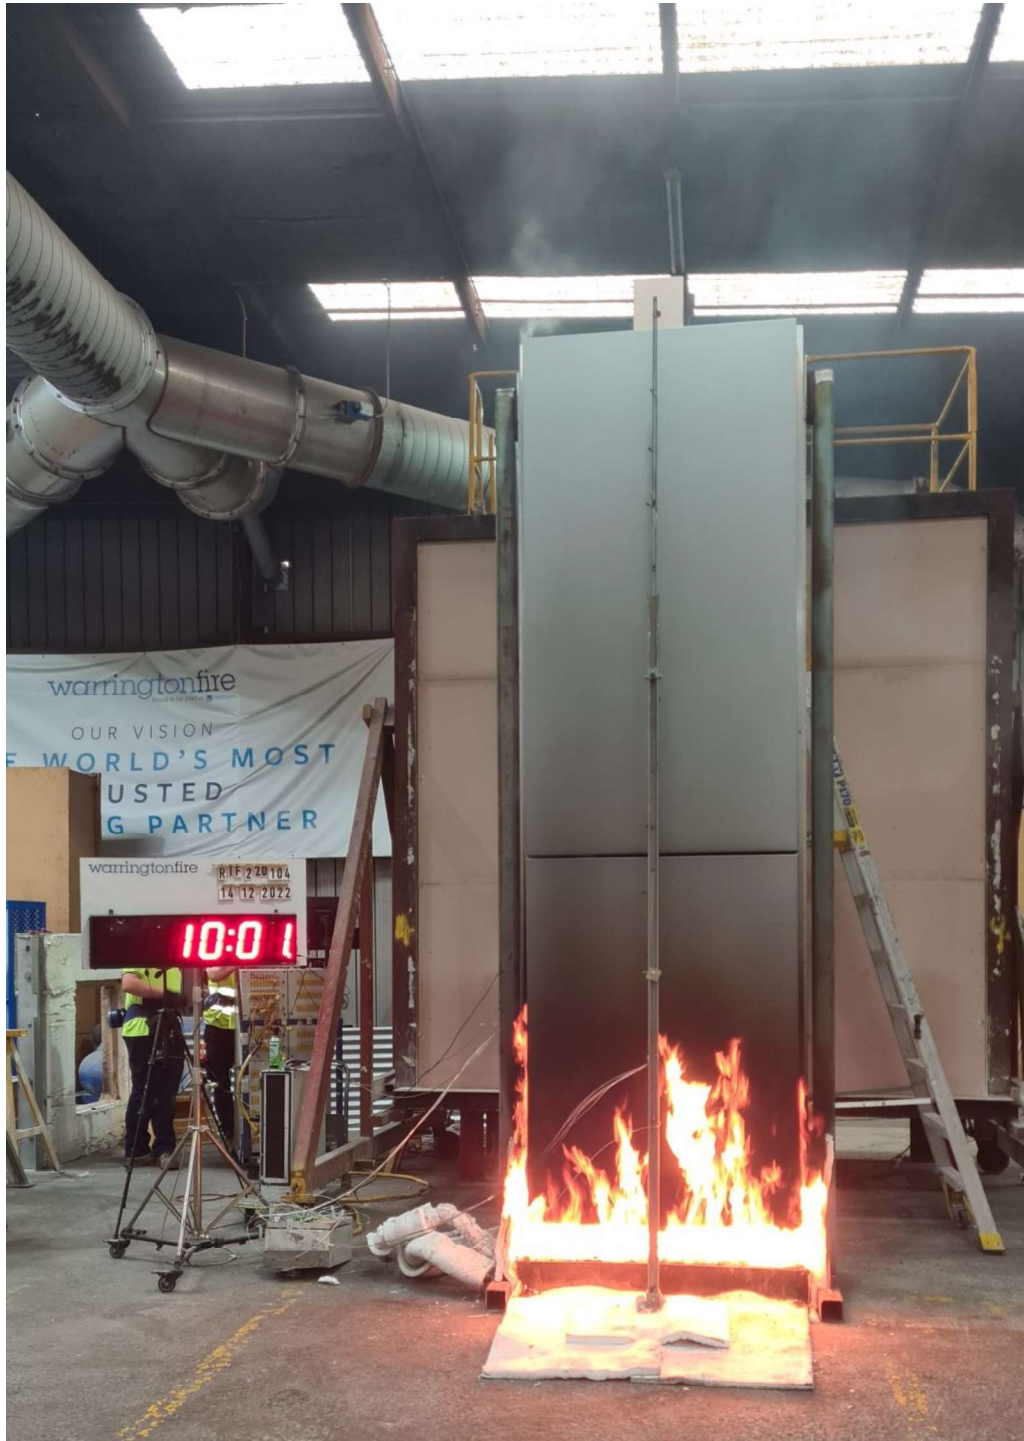
Figure 11 **The specimen 10 minutes 1 second into the test (burner output at 100 kW)**

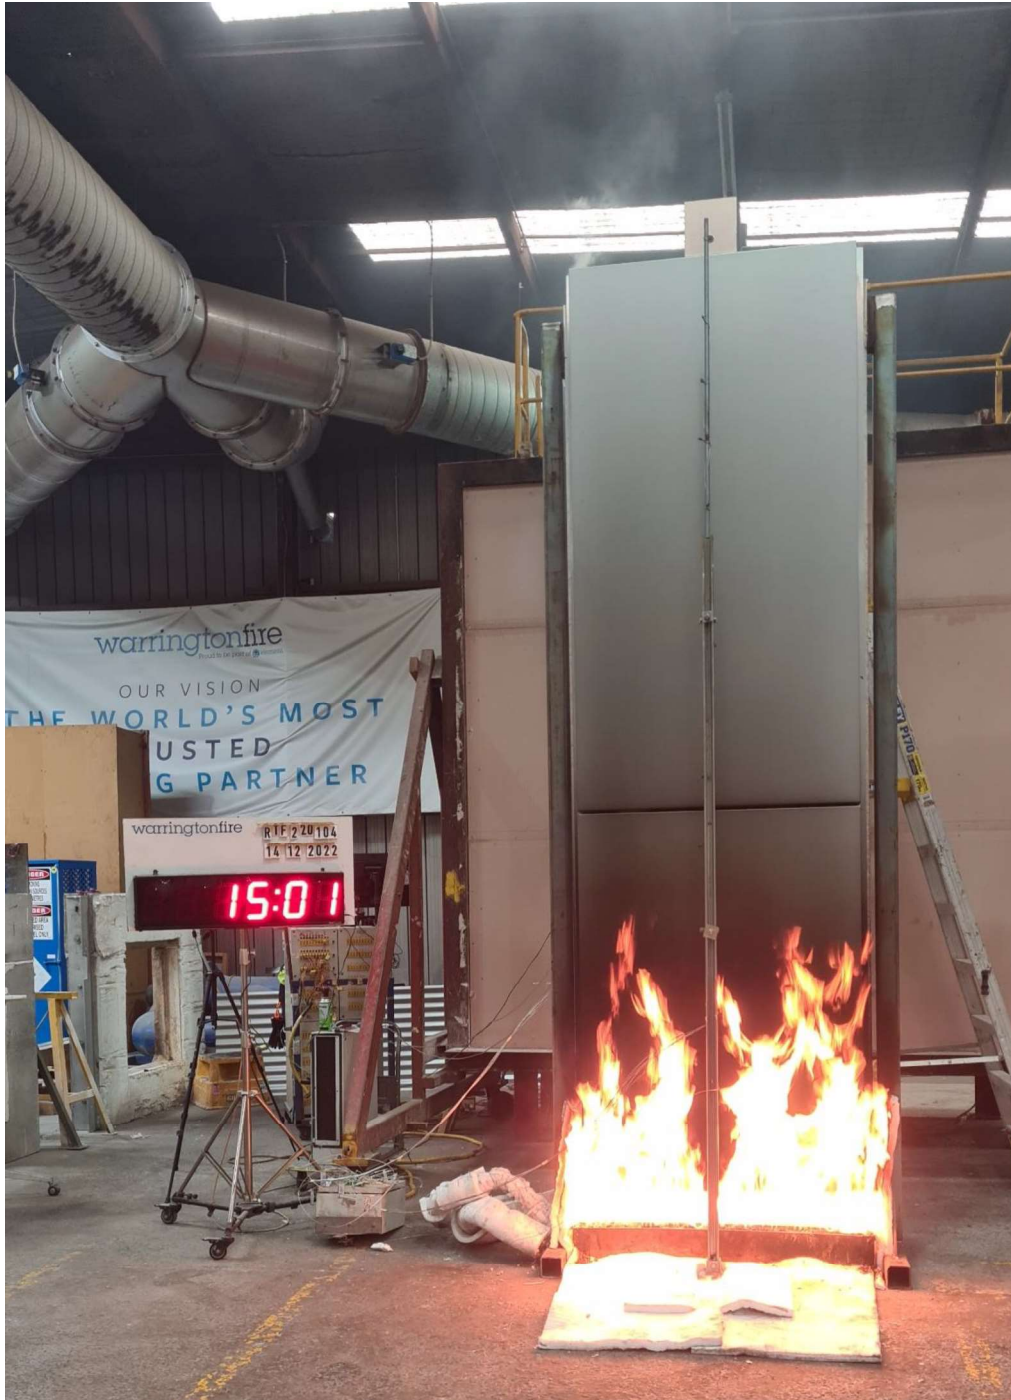
Figure 12 **The specimen 15 minutes 1 second into the test (burner output at 100 kW changed to 300 kW)**

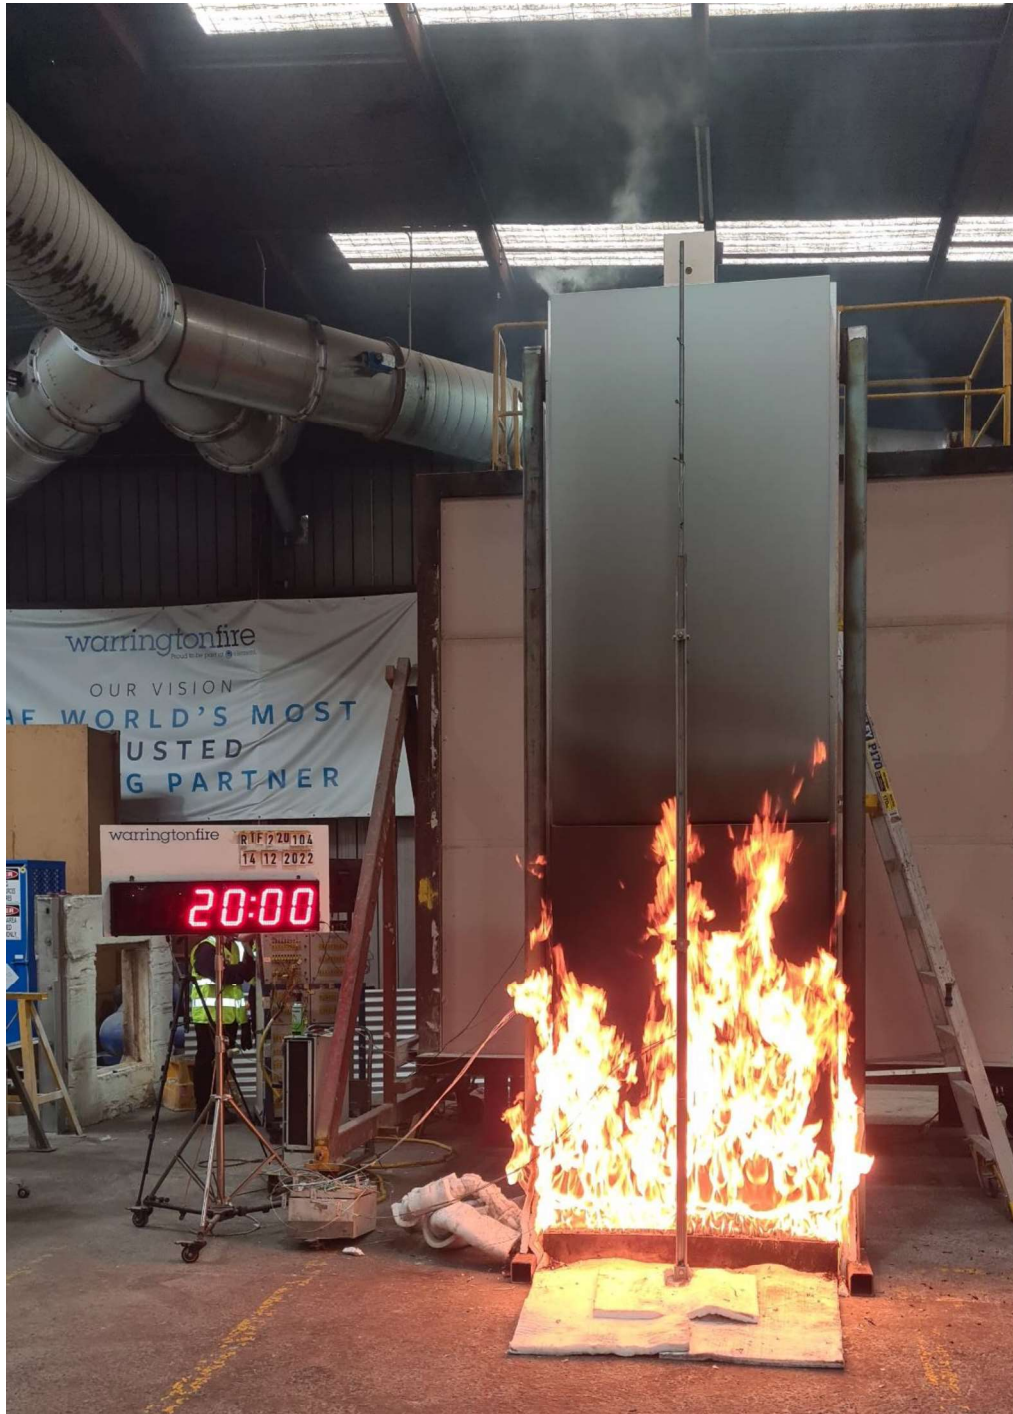
Figure 13 **The specimen 20 minutes into the test (5 minutes after burner output was increased to 300 kW)**

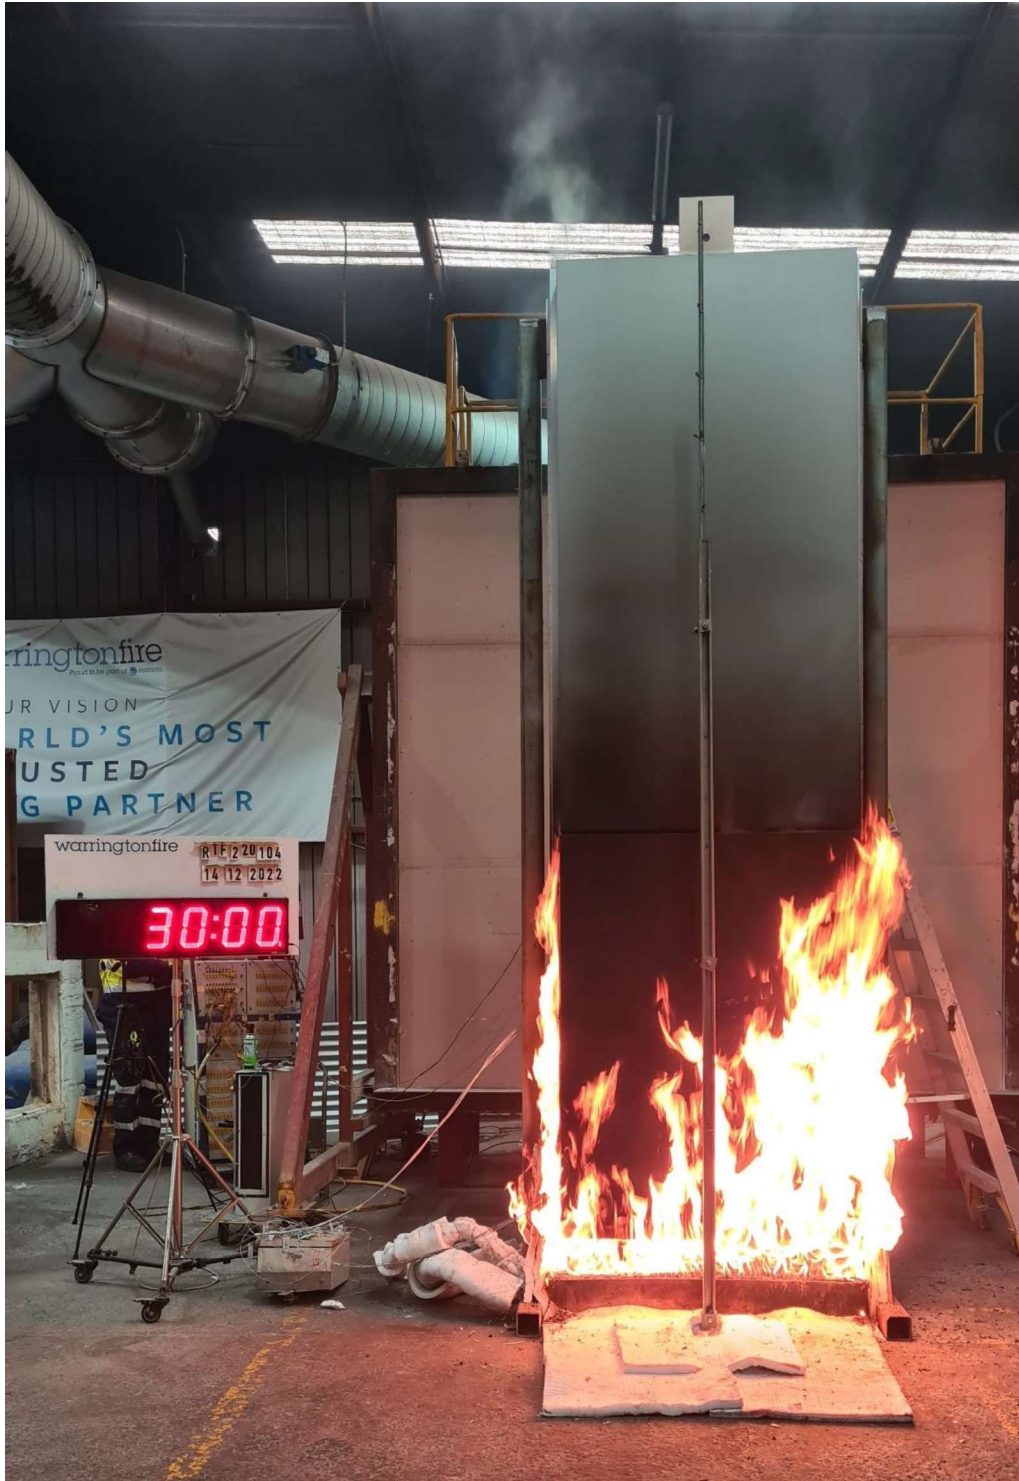
Figure 14 The specimen 30 minutes into the test (15 minutes after burner output was increased to 300 kW)

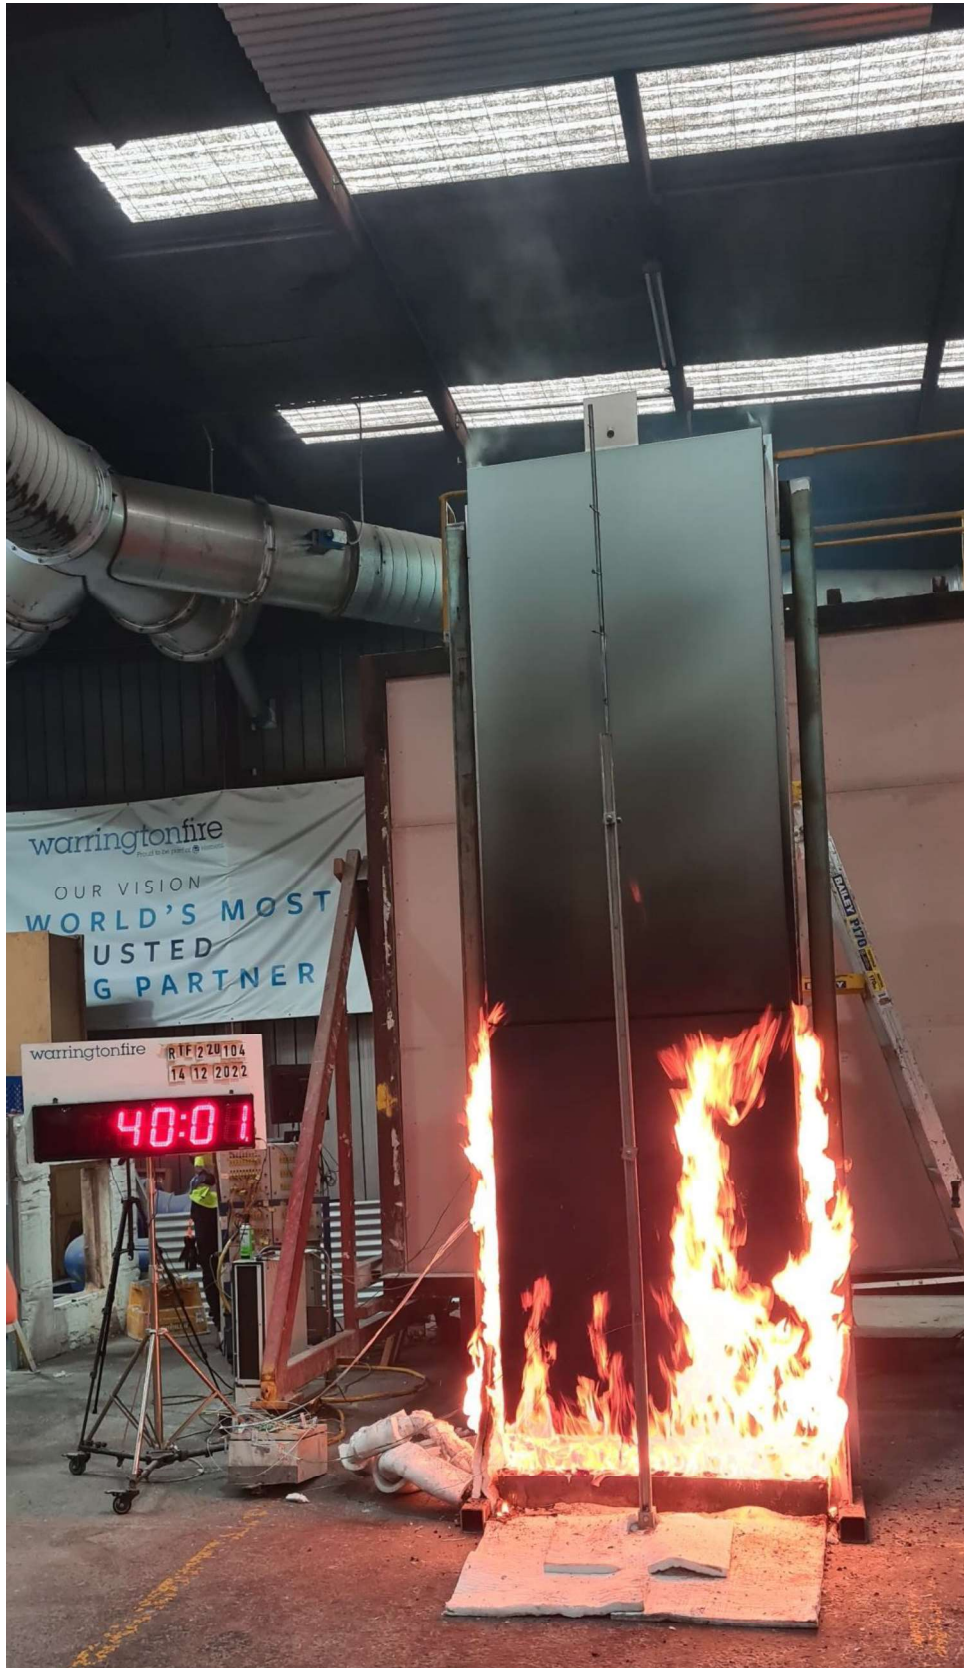
Figure 15 The specimen 40 minutes 1 second into the test (25 minutes 1 second after burner output was increased to 300 kW) – burner turned off.

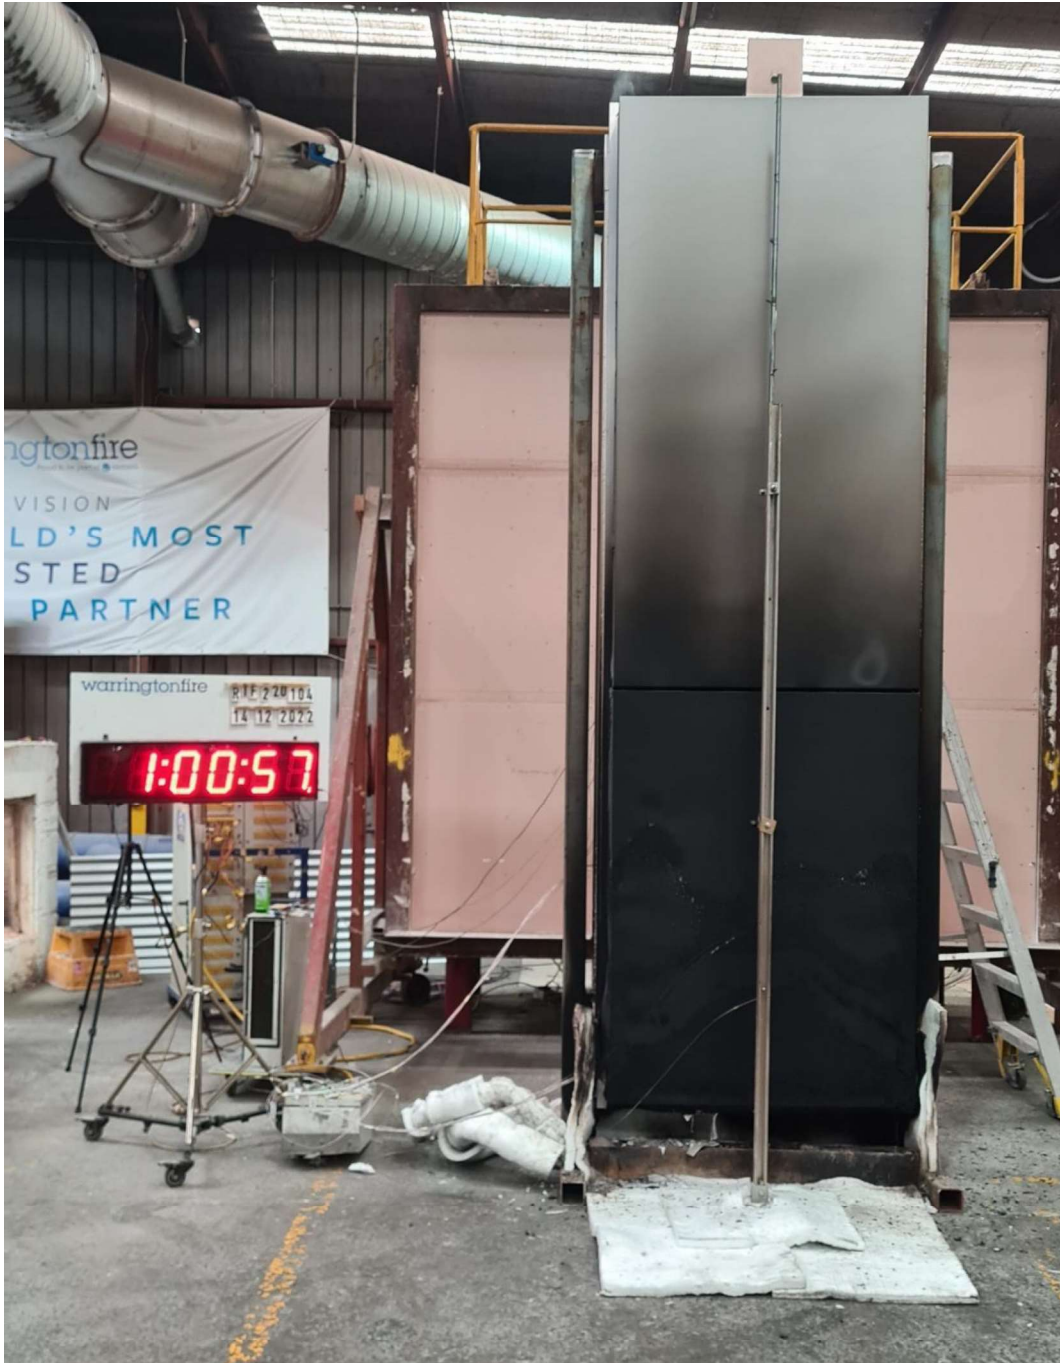
Figure 16 The specimen at the end of test.
