Reaction to fire test report

Test standard: Ad-hoc test based off ISO 13785-1:2002

System: Aluminium composite panel wall system representative of the in-situ wall located at [REDACTED]
[REDACTED] – Scenario 2 - Test 2

Job number: RTF220104

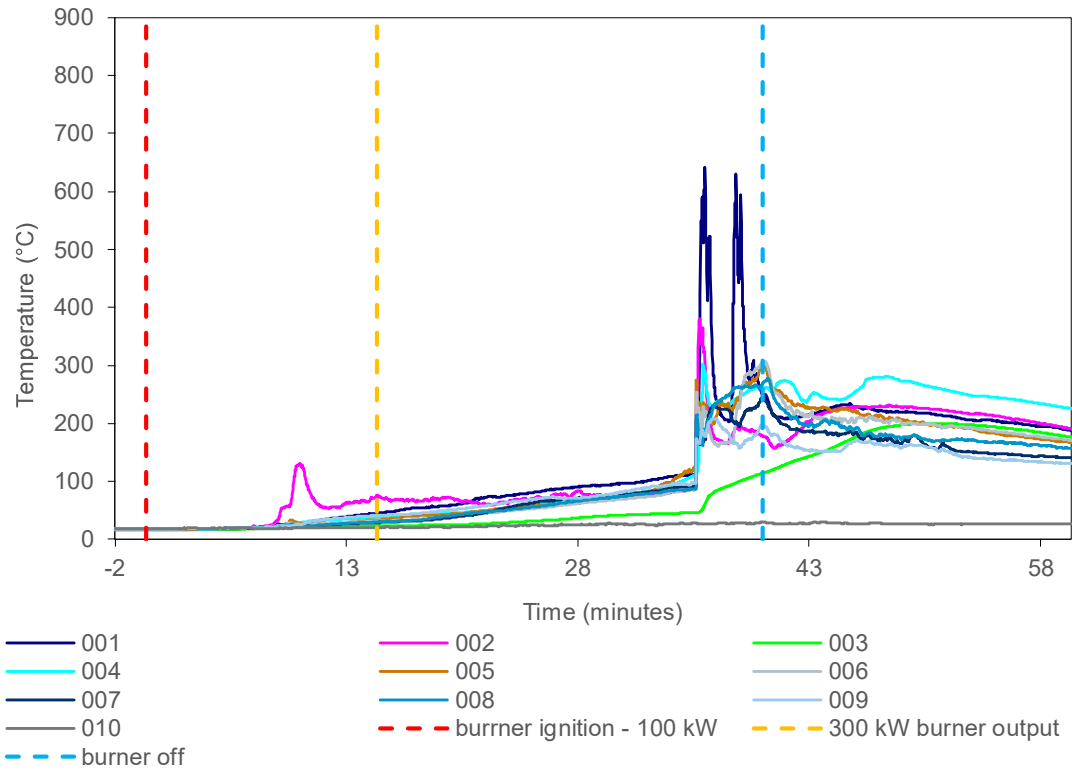
Figure 2 Internal temperature data collected by thermocouples placed within the cavity – between the internal and external segments of the specimen.

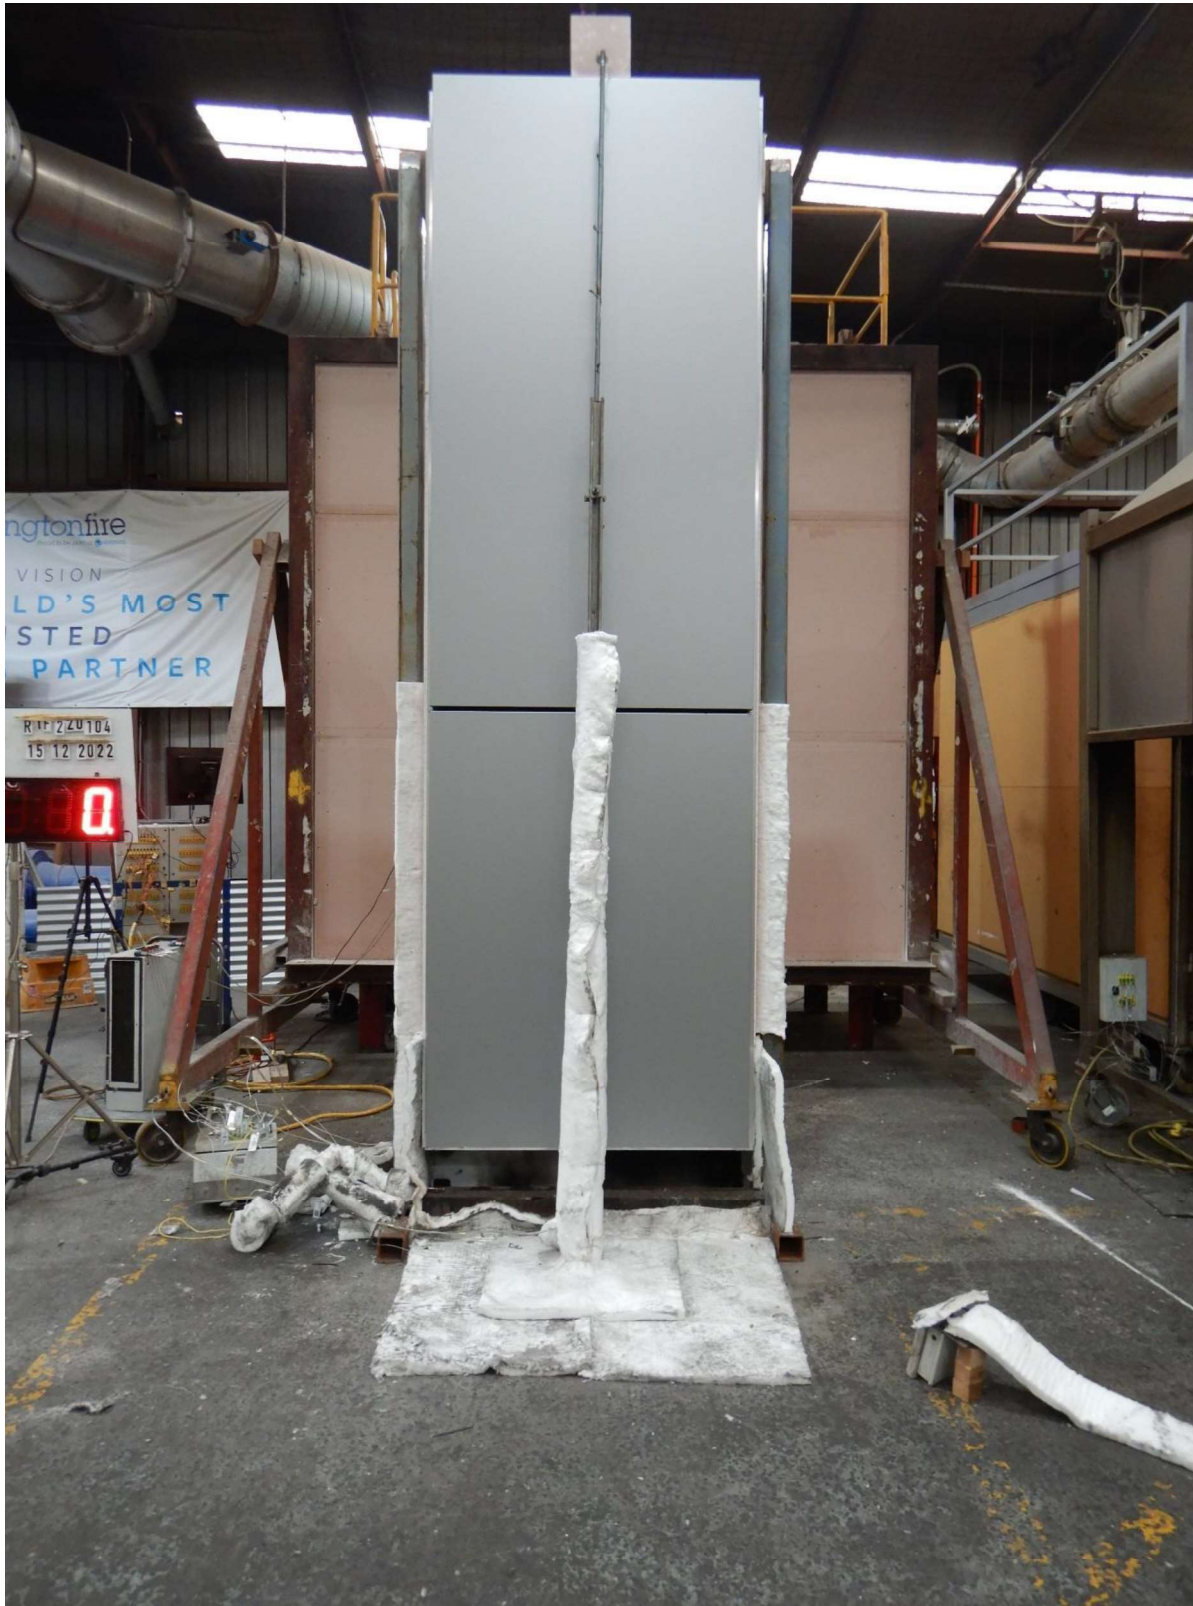
Figure 9 The specimen before the reaction to fire test

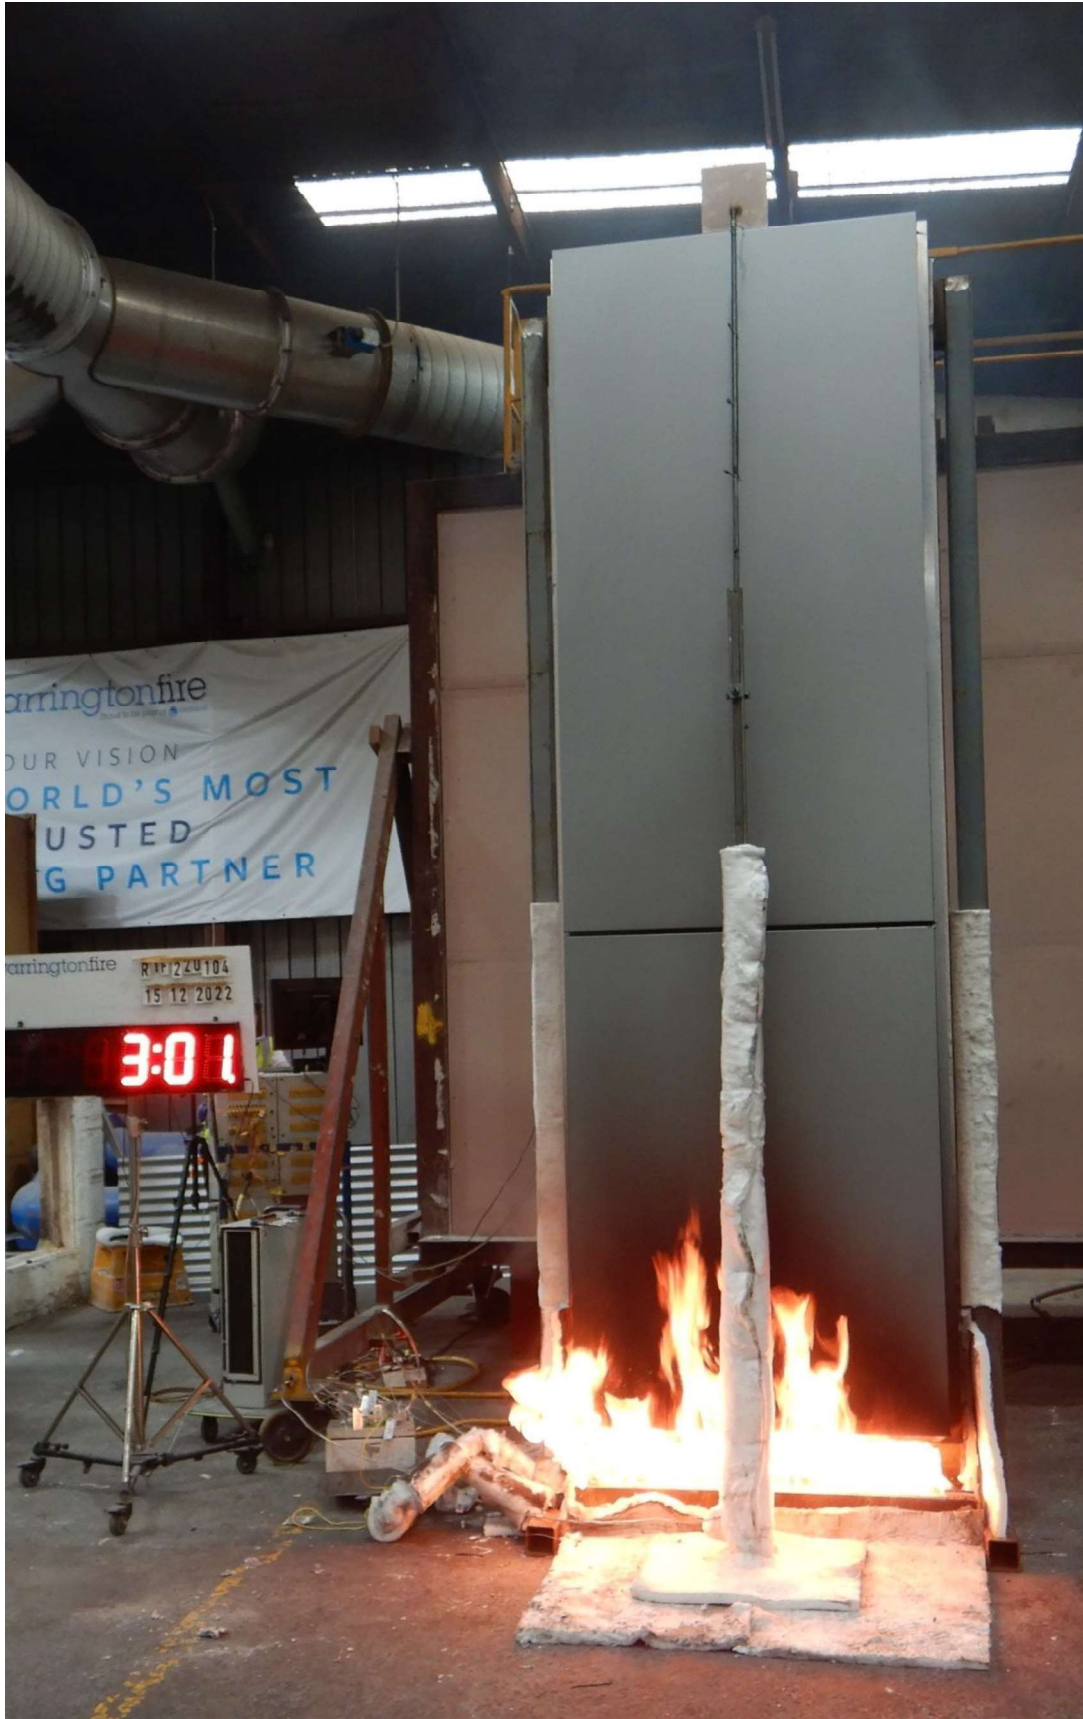
Figure 10 The specimen 3 minutes 1 second into the test (burner output at 100 kW)

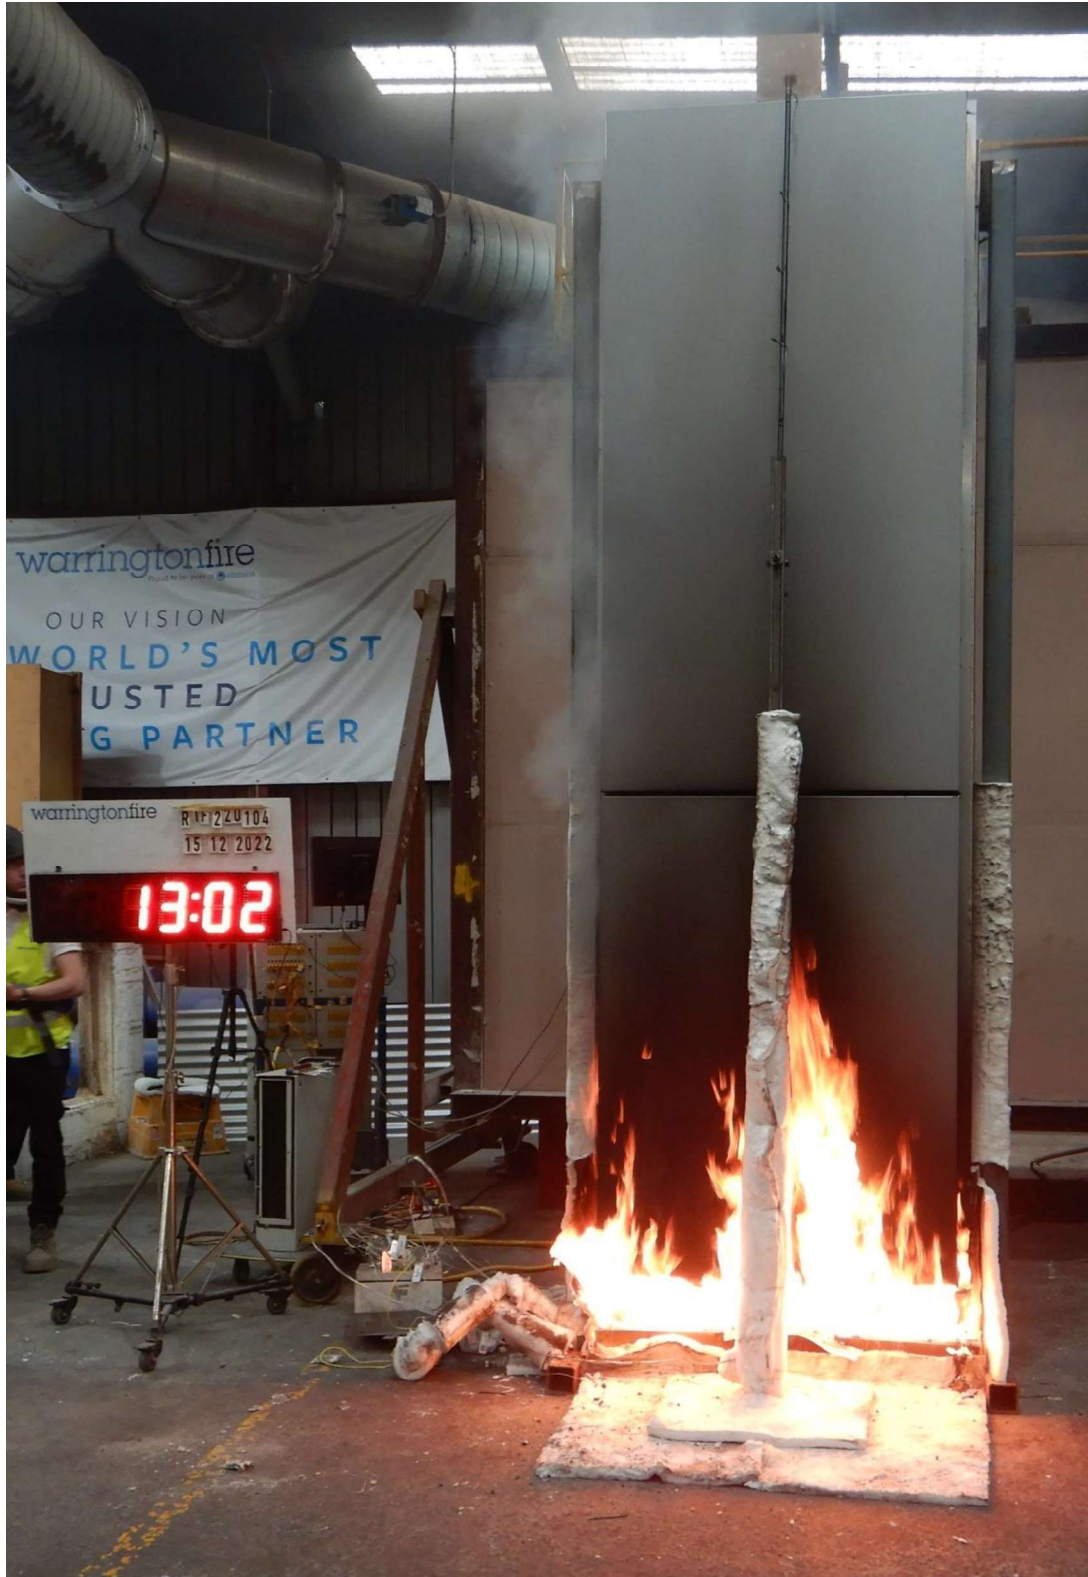
Figure 11 The specimen 13 minutes 2 seconds into the test (burner output at 100 kW)

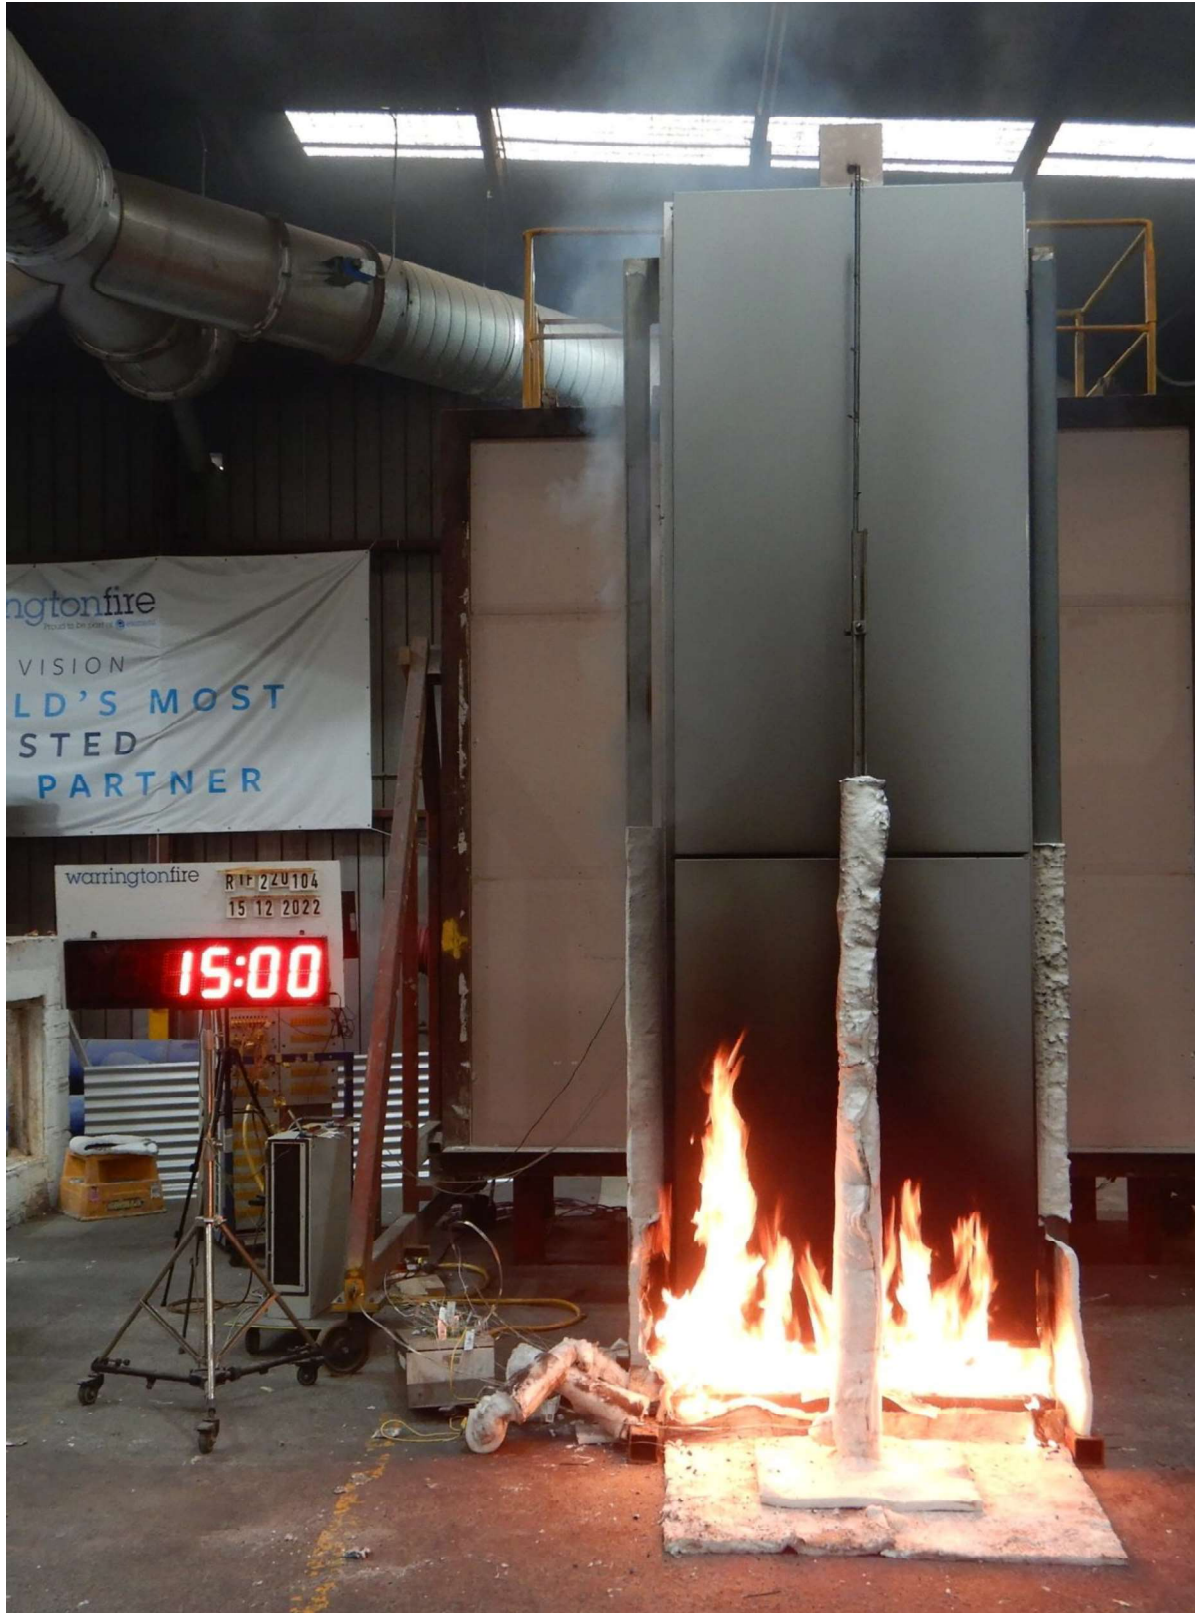
Figure 12 **The specimen 15 minutes into the test (burner output at 100 kW changed to 300 kW)**

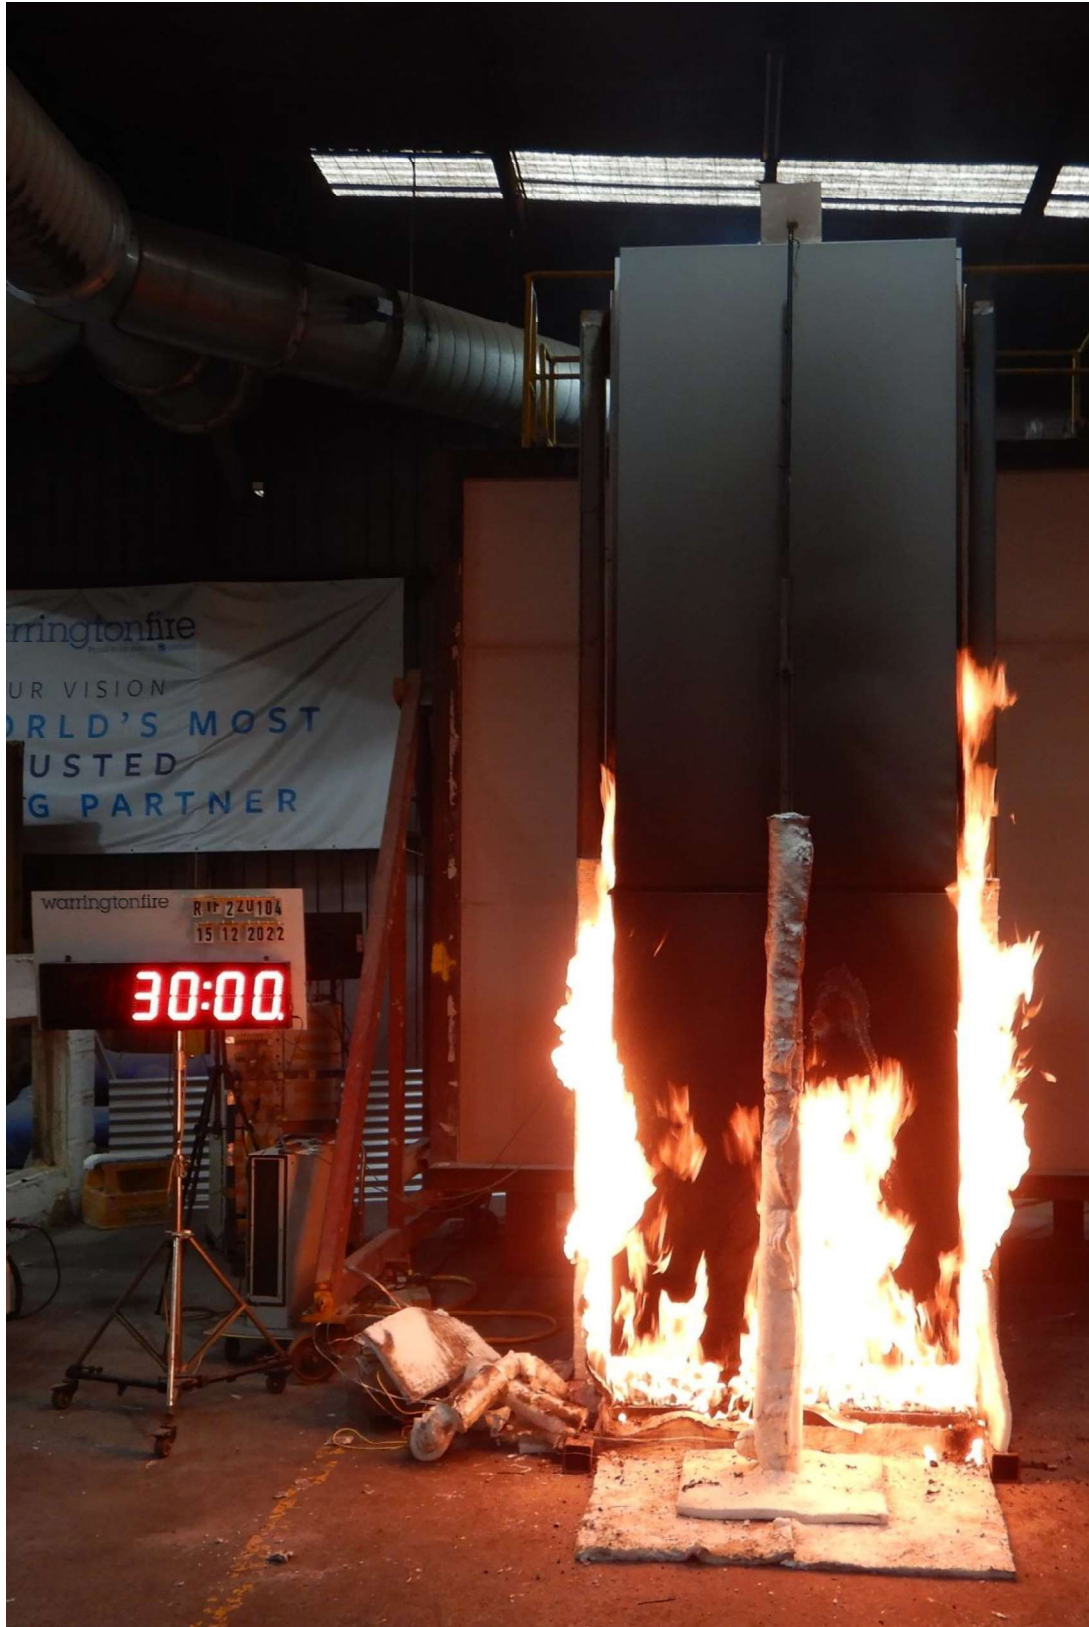
Figure 13 **The specimen 30 minutes into the test (15 minutes after burner output was increased to 300 kW)**

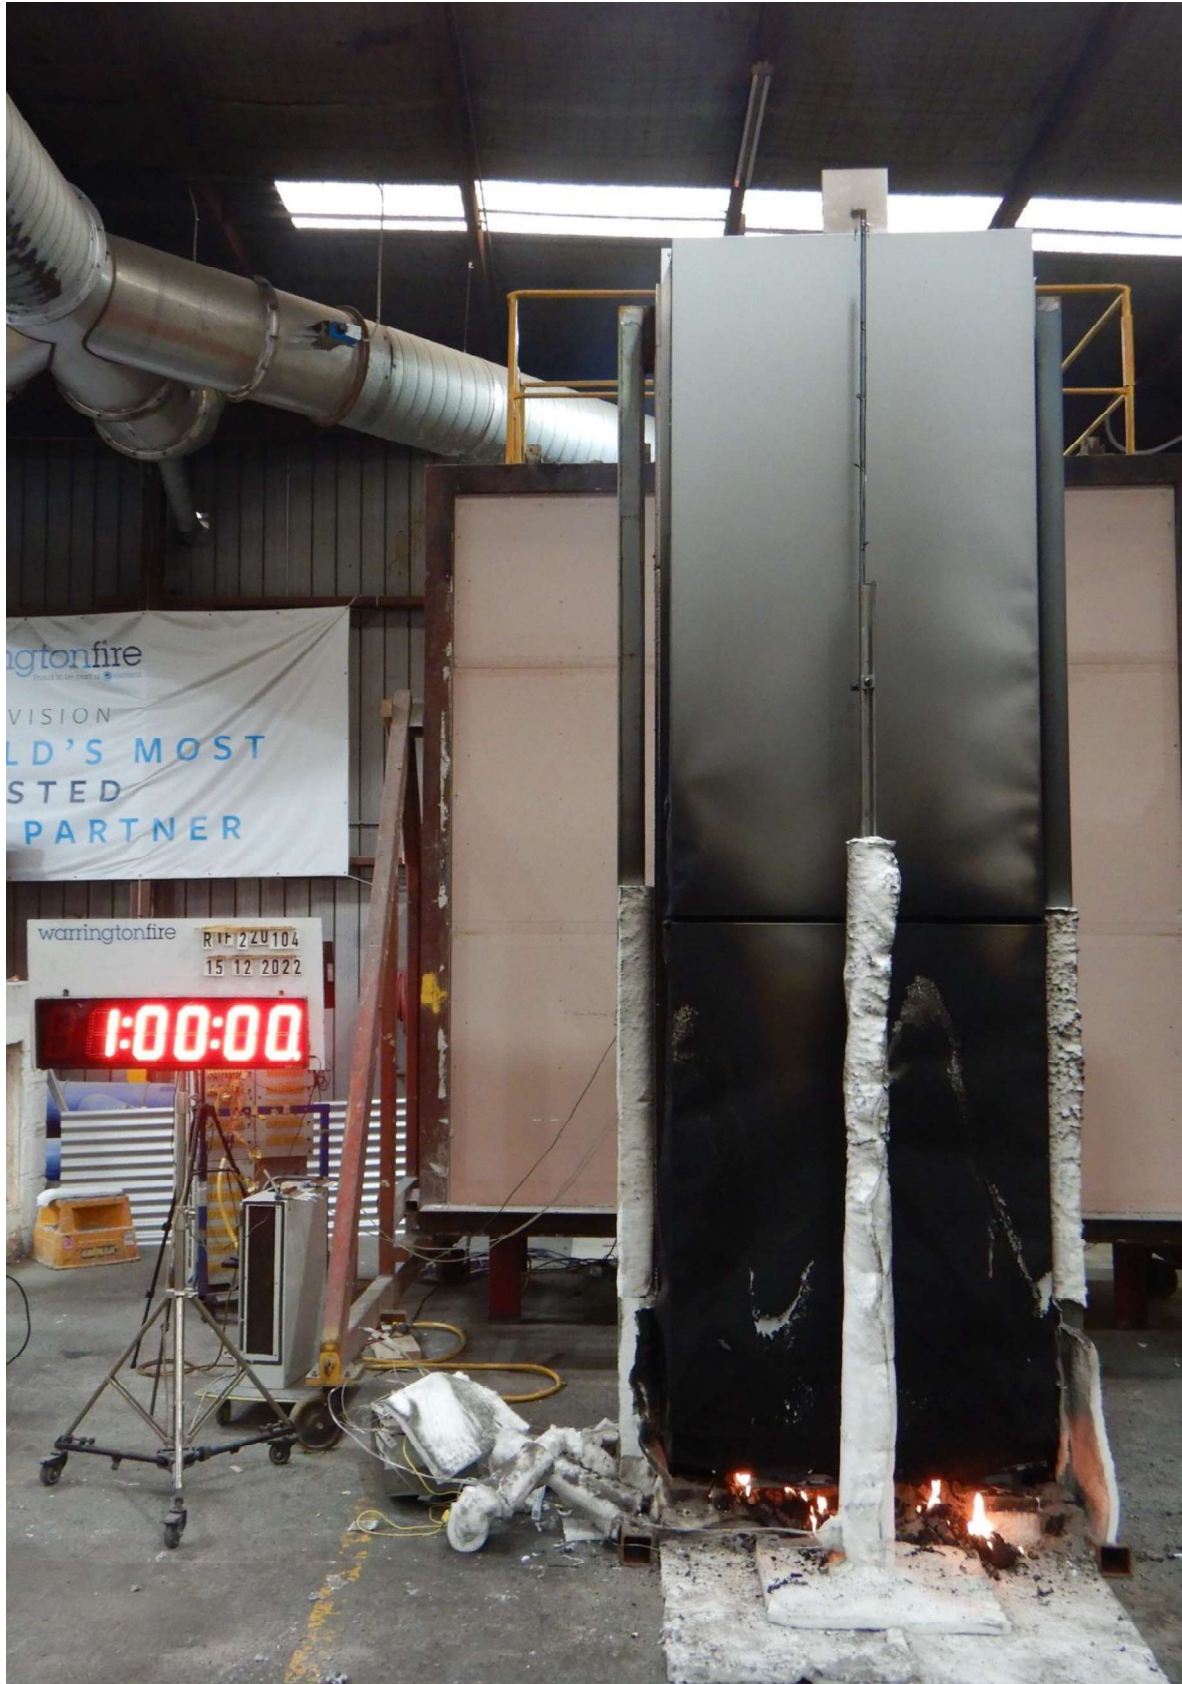
Figure 15 The specimen at the end of test.
