Reaction to fire test report

Test standard: Ad-hoc test based off ISO 13785-1:2002

System: Aluminium composite panel wall system representative of the in-situ wall located at [REDACTED]
[REDACTED] – Scenario 2 - Test 3

Job number: RTF220104

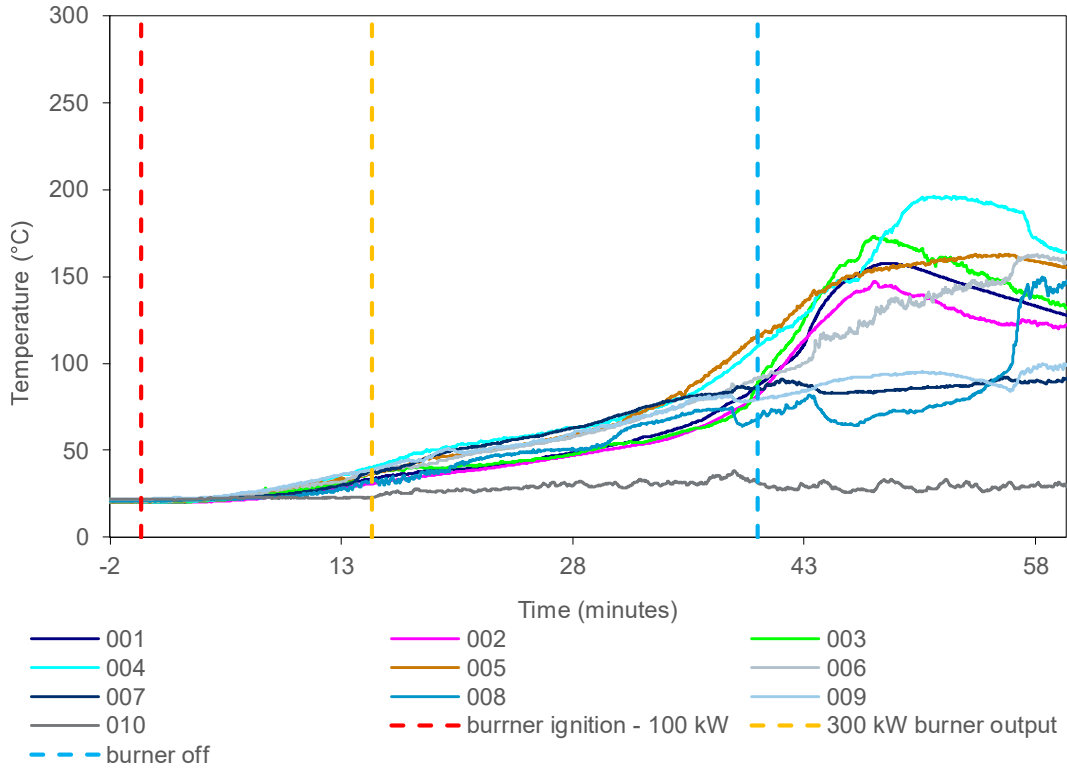
Figure 2 Internal temperature data collected by thermocouples placed within the cavity – between the internal and external segments of the specimen.

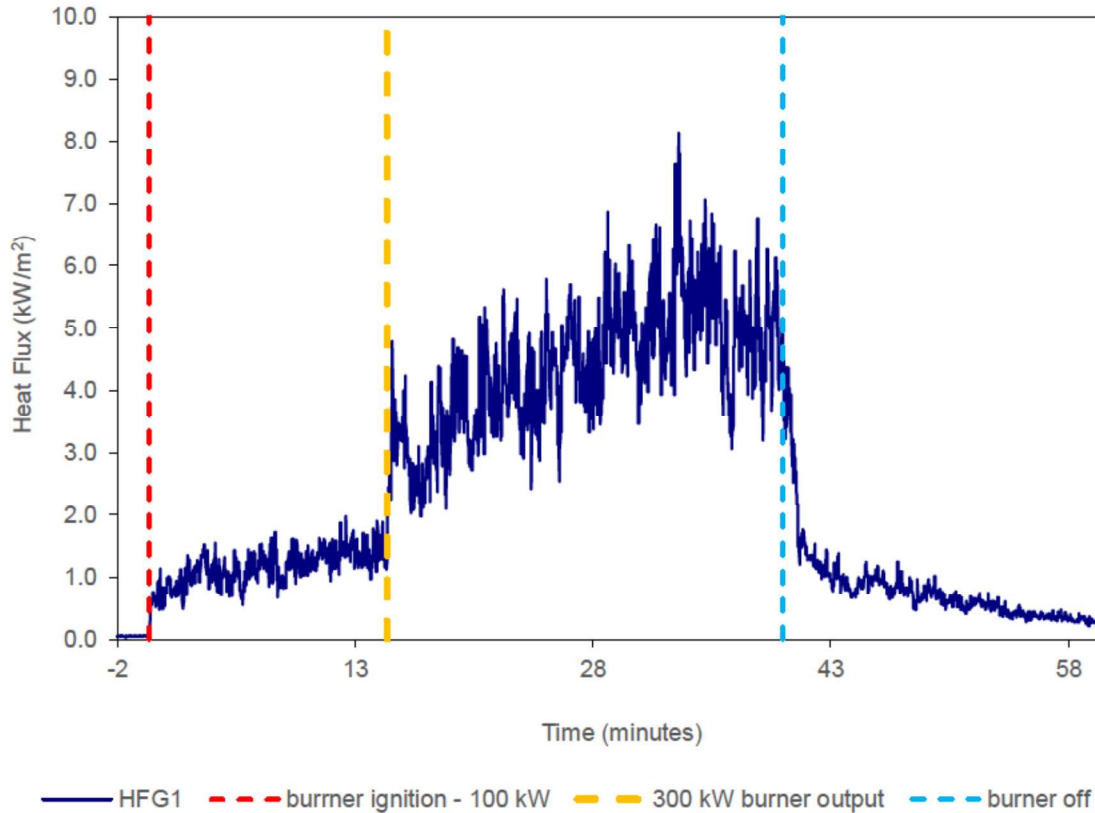
Figure 4 Heat flux data collected by heat flux gauges.

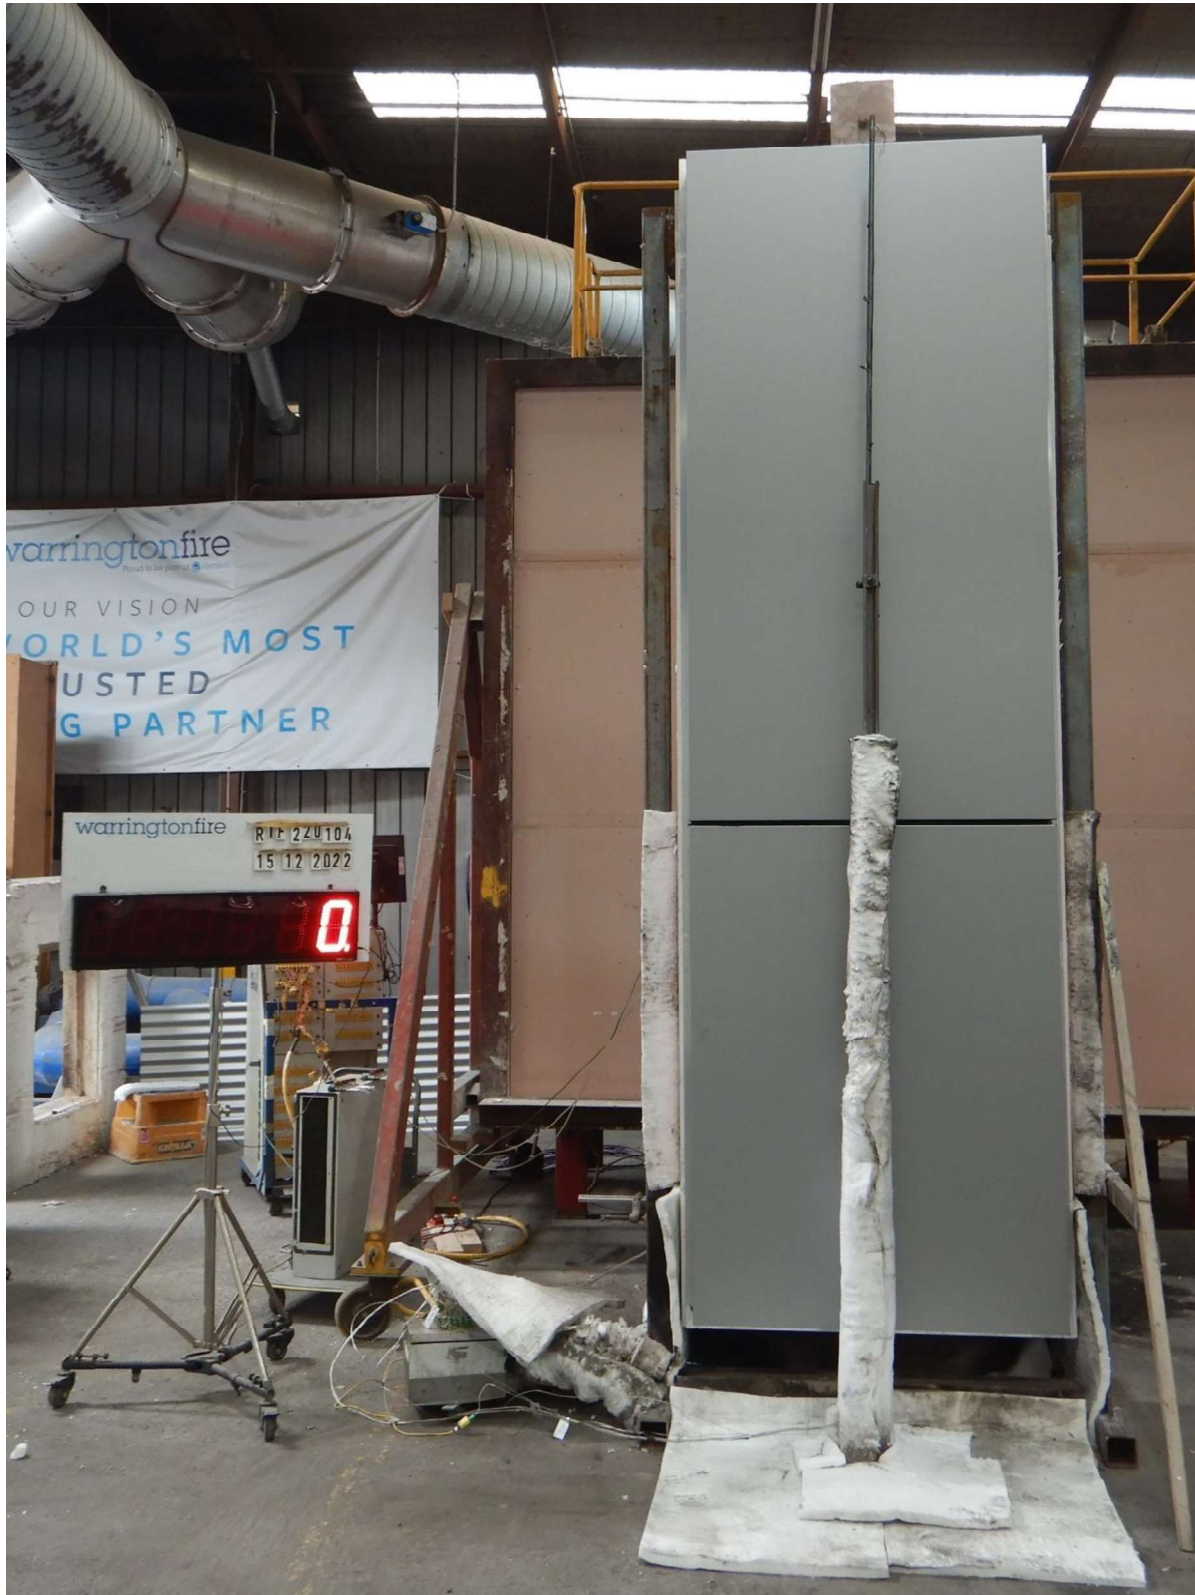
Figure 9 The specimen before the reaction to fire test

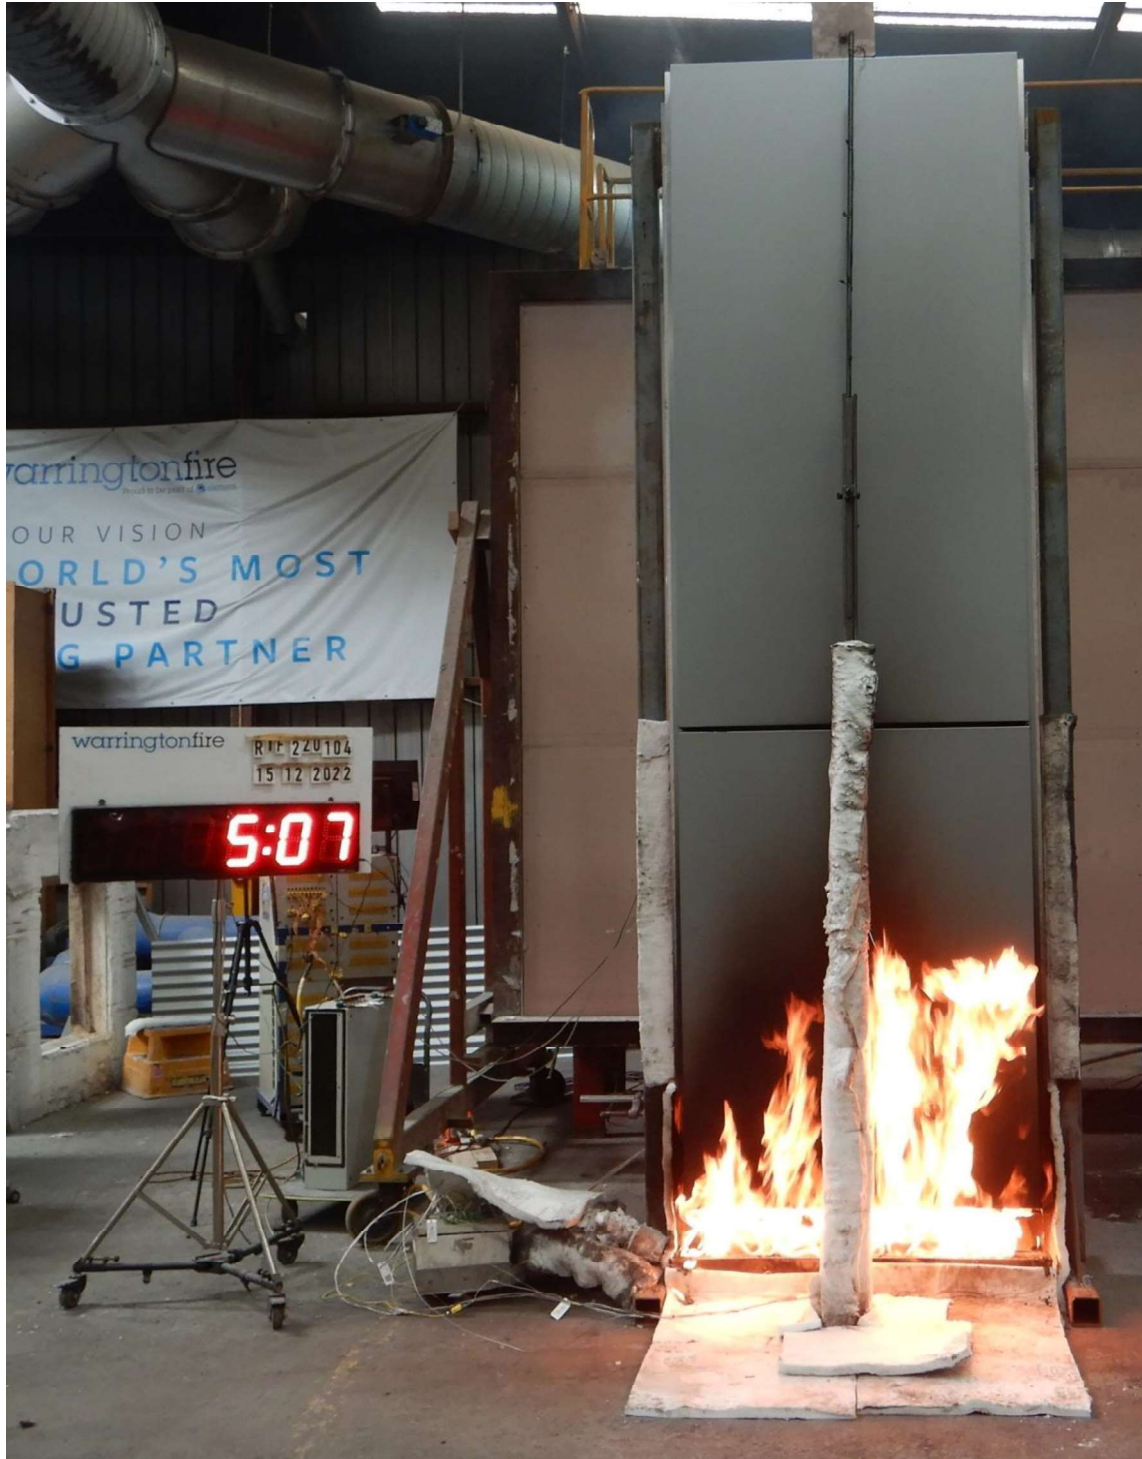
Figure 10 The specimen 5 minutes 7 seconds into the test (burner output at 100 kW)

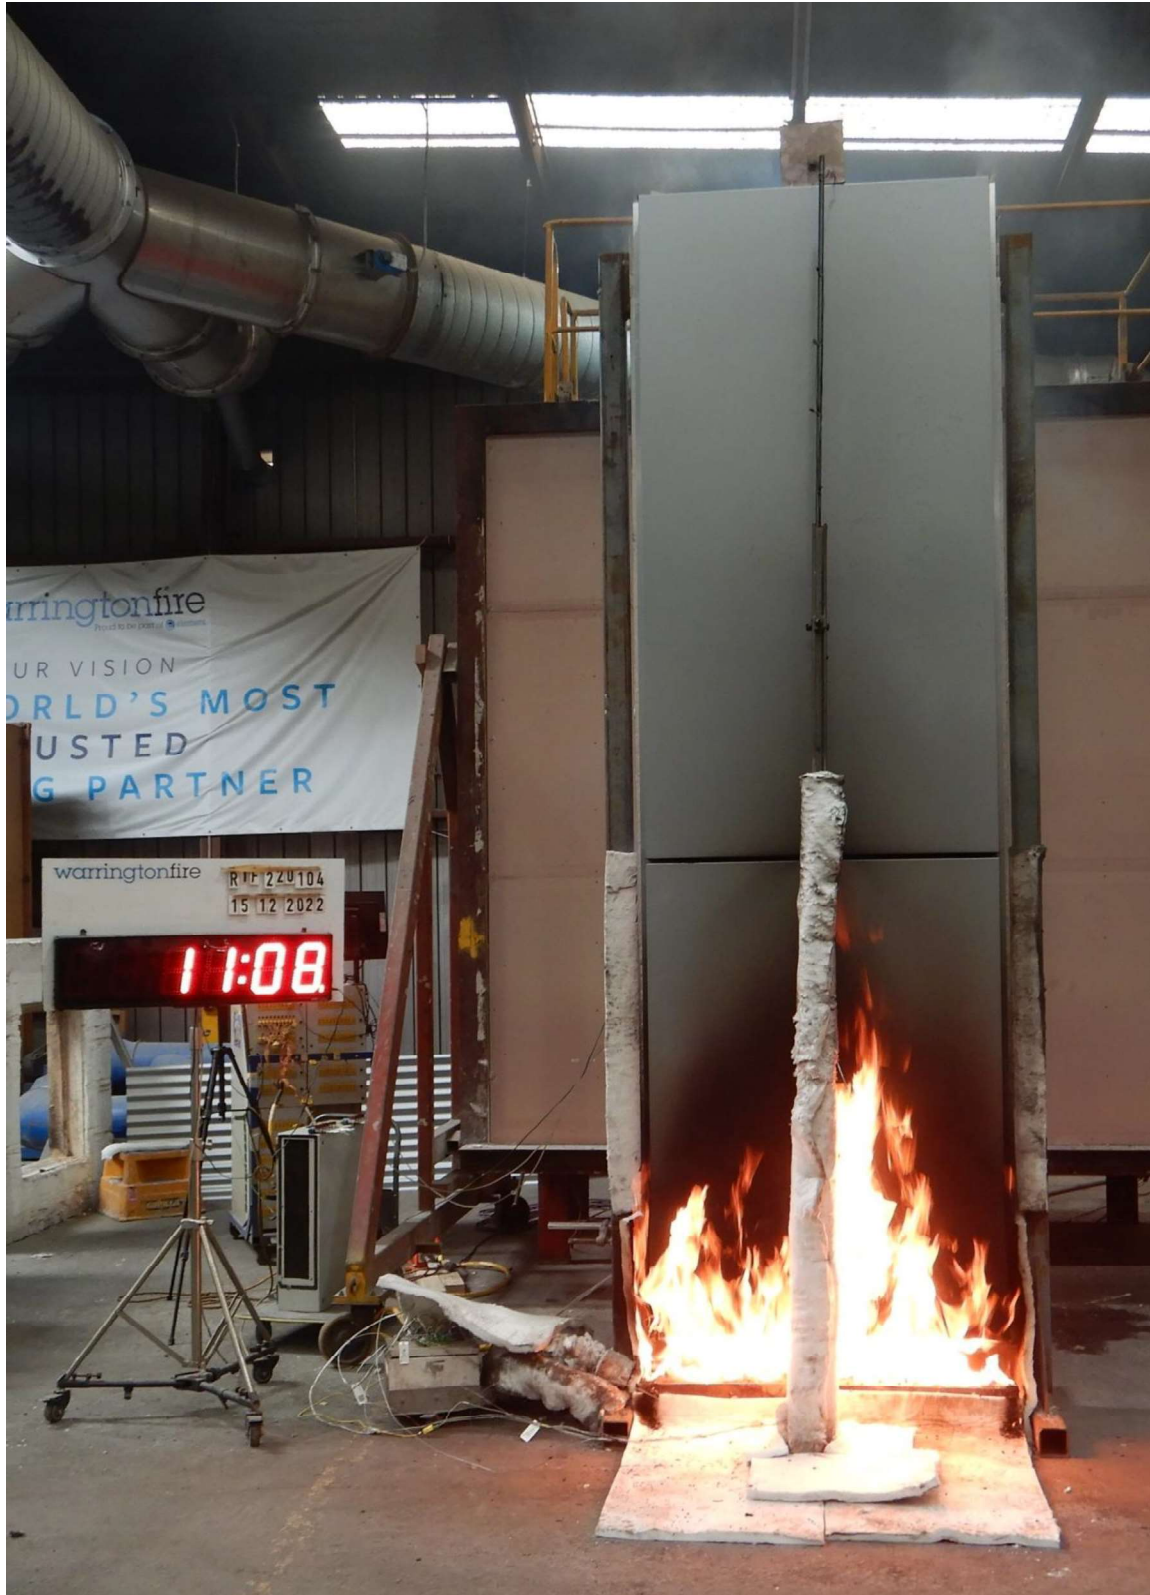
Figure 11 The specimen 11 minutes 8 seconds into the test (burner output at 100 kW)

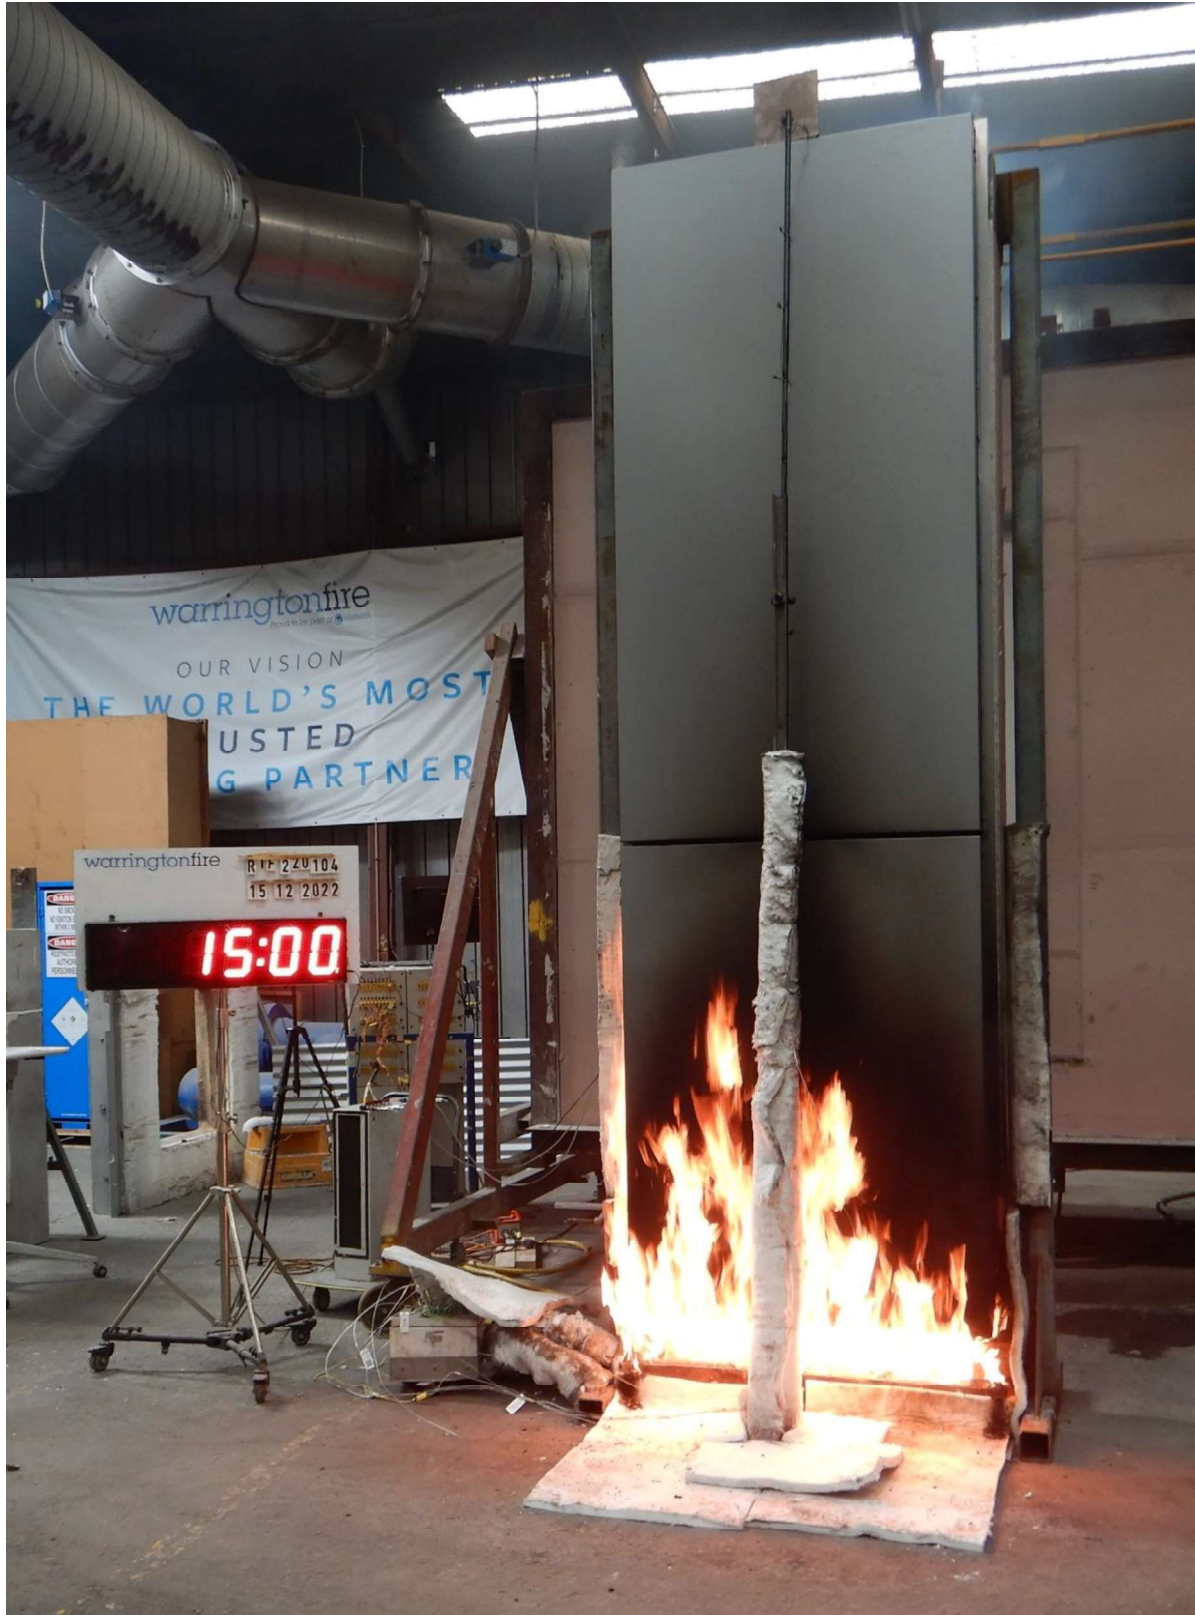
Figure 12 **The specimen 15 minutes into the test (burner output at 100 kW changed to 300 kW)**

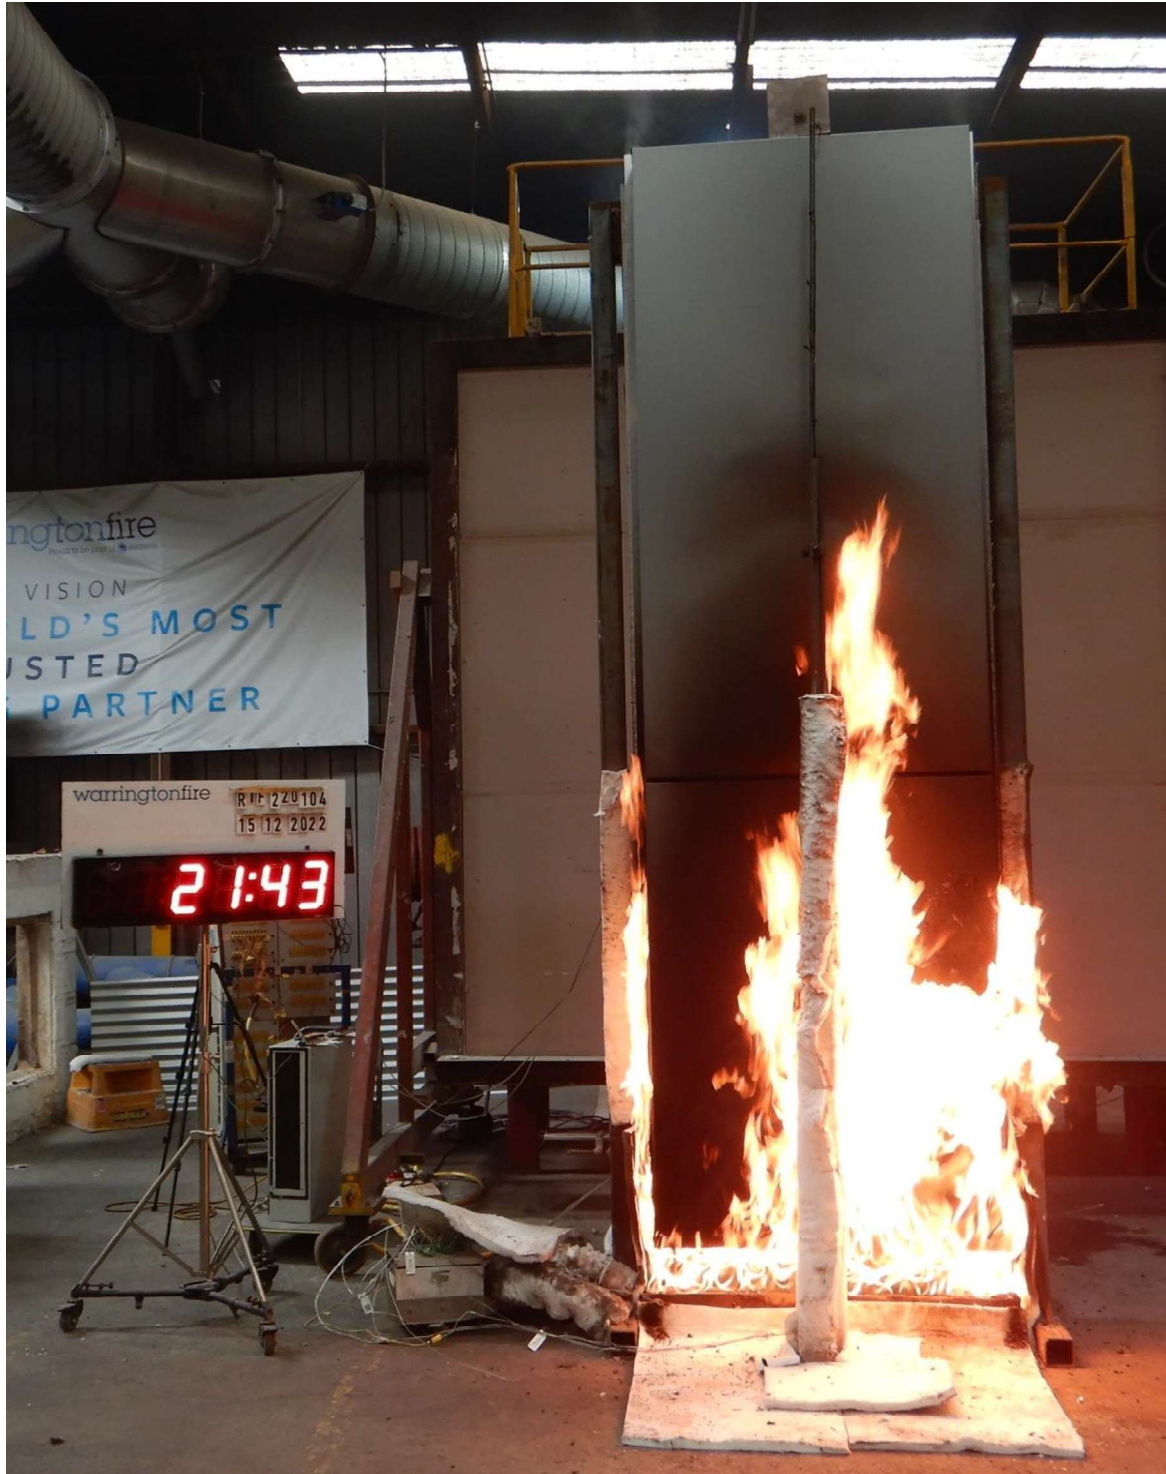
Figure 13 The specimen 21 minutes 43 seconds into the test (6 minutes 43 seconds after burner output was increased to 300 kW)

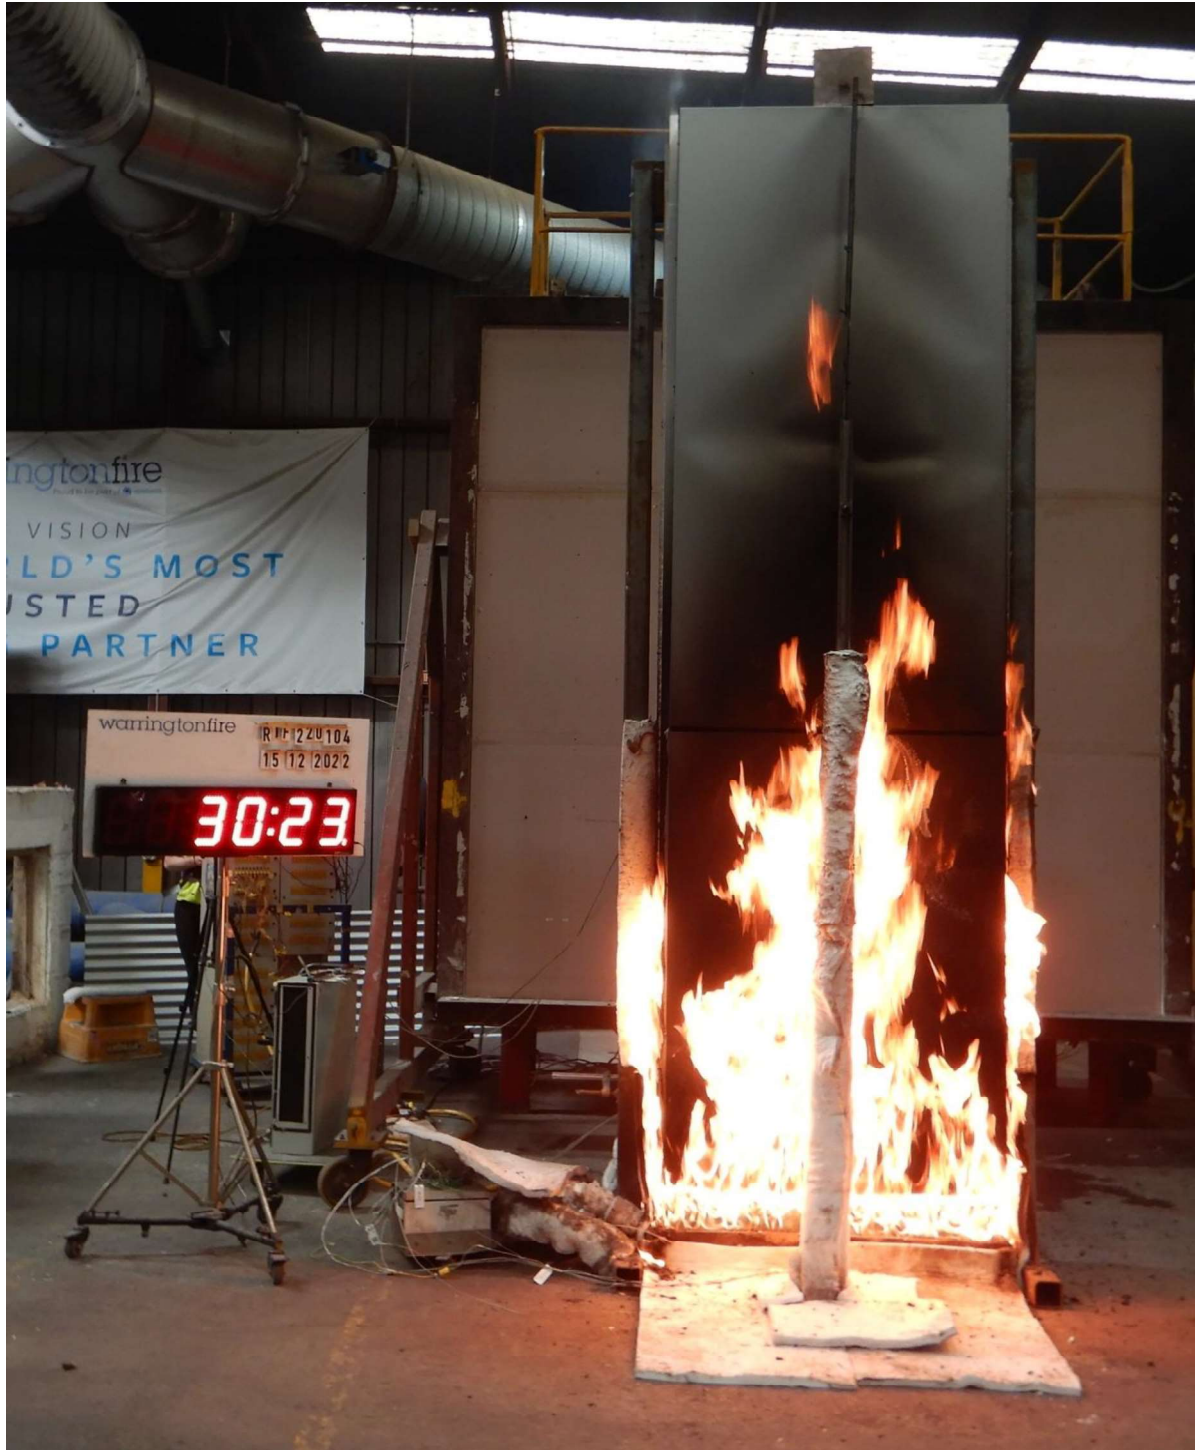
Figure 14 **The specimen 30 minutes 23 seconds into the test (15 minutes 23 seconds after burner output was increased to 300 kW)**

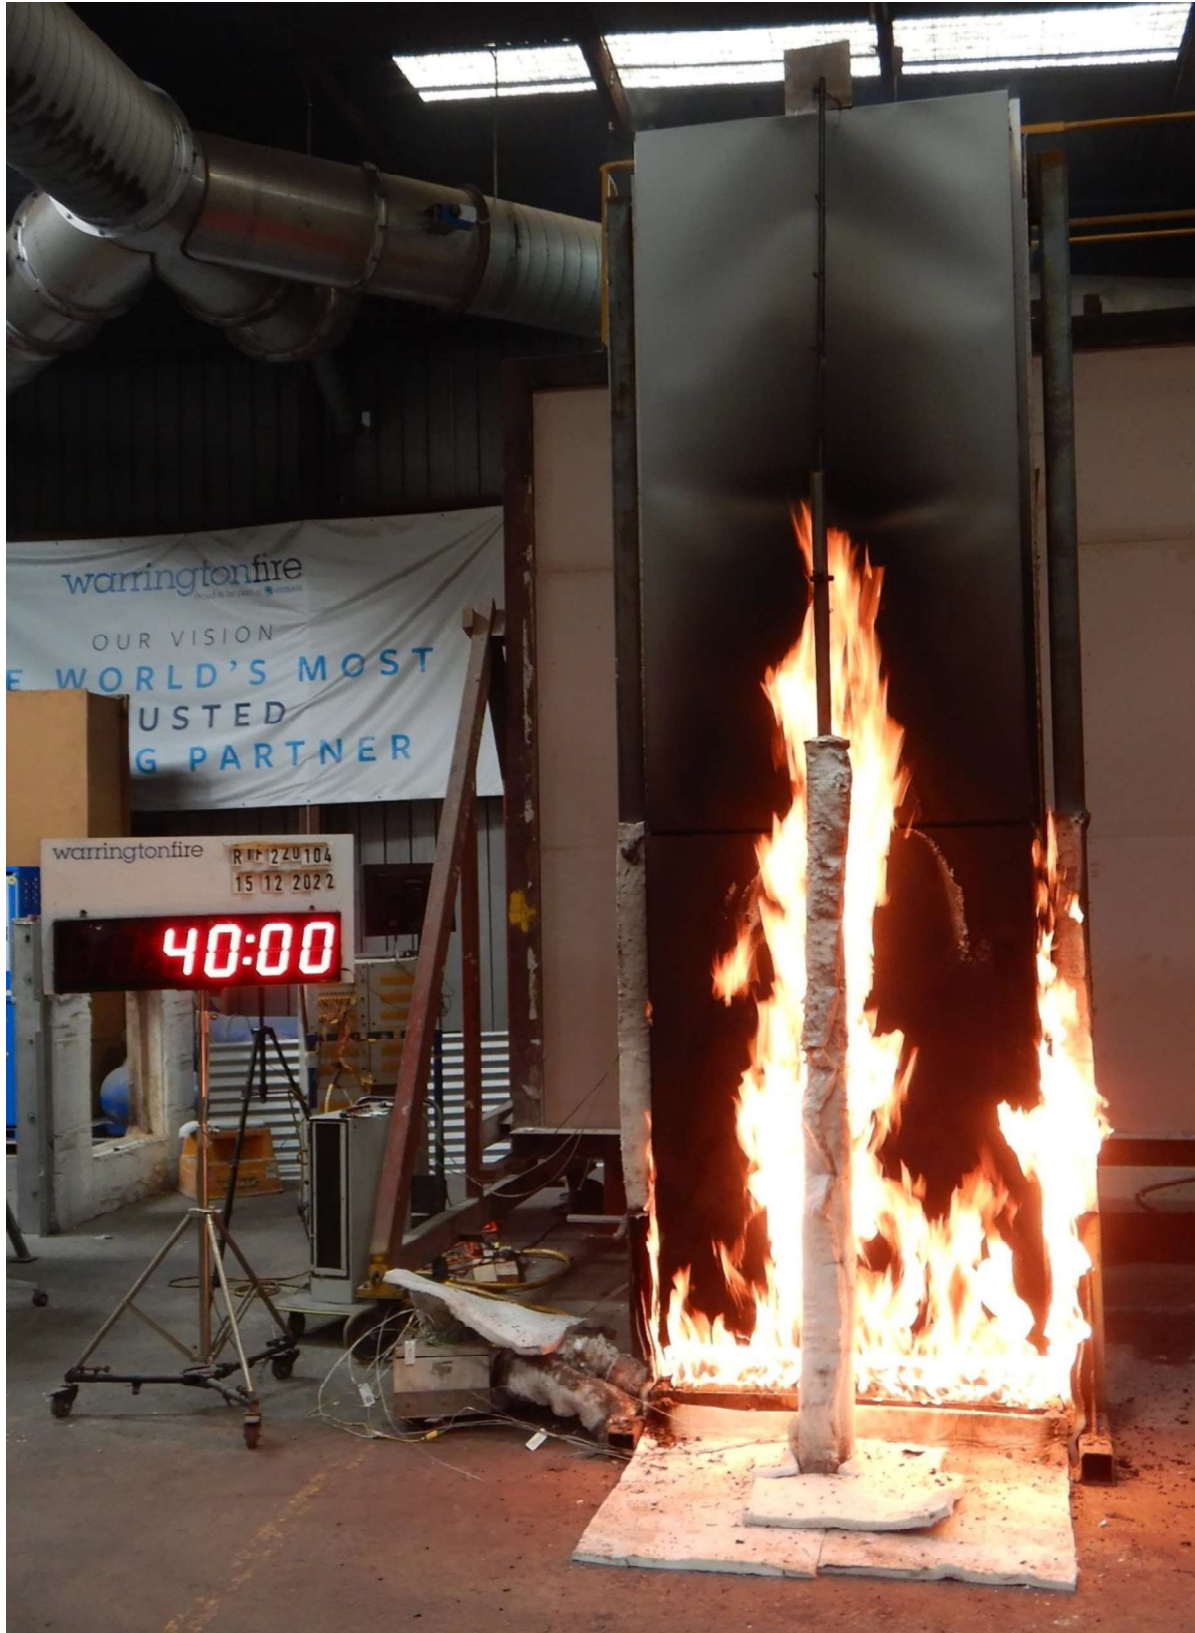
Figure 15 **The specimen 40 minutes into the test (25 minutes after burner output was increased to 300 kW) – burner turned off.**

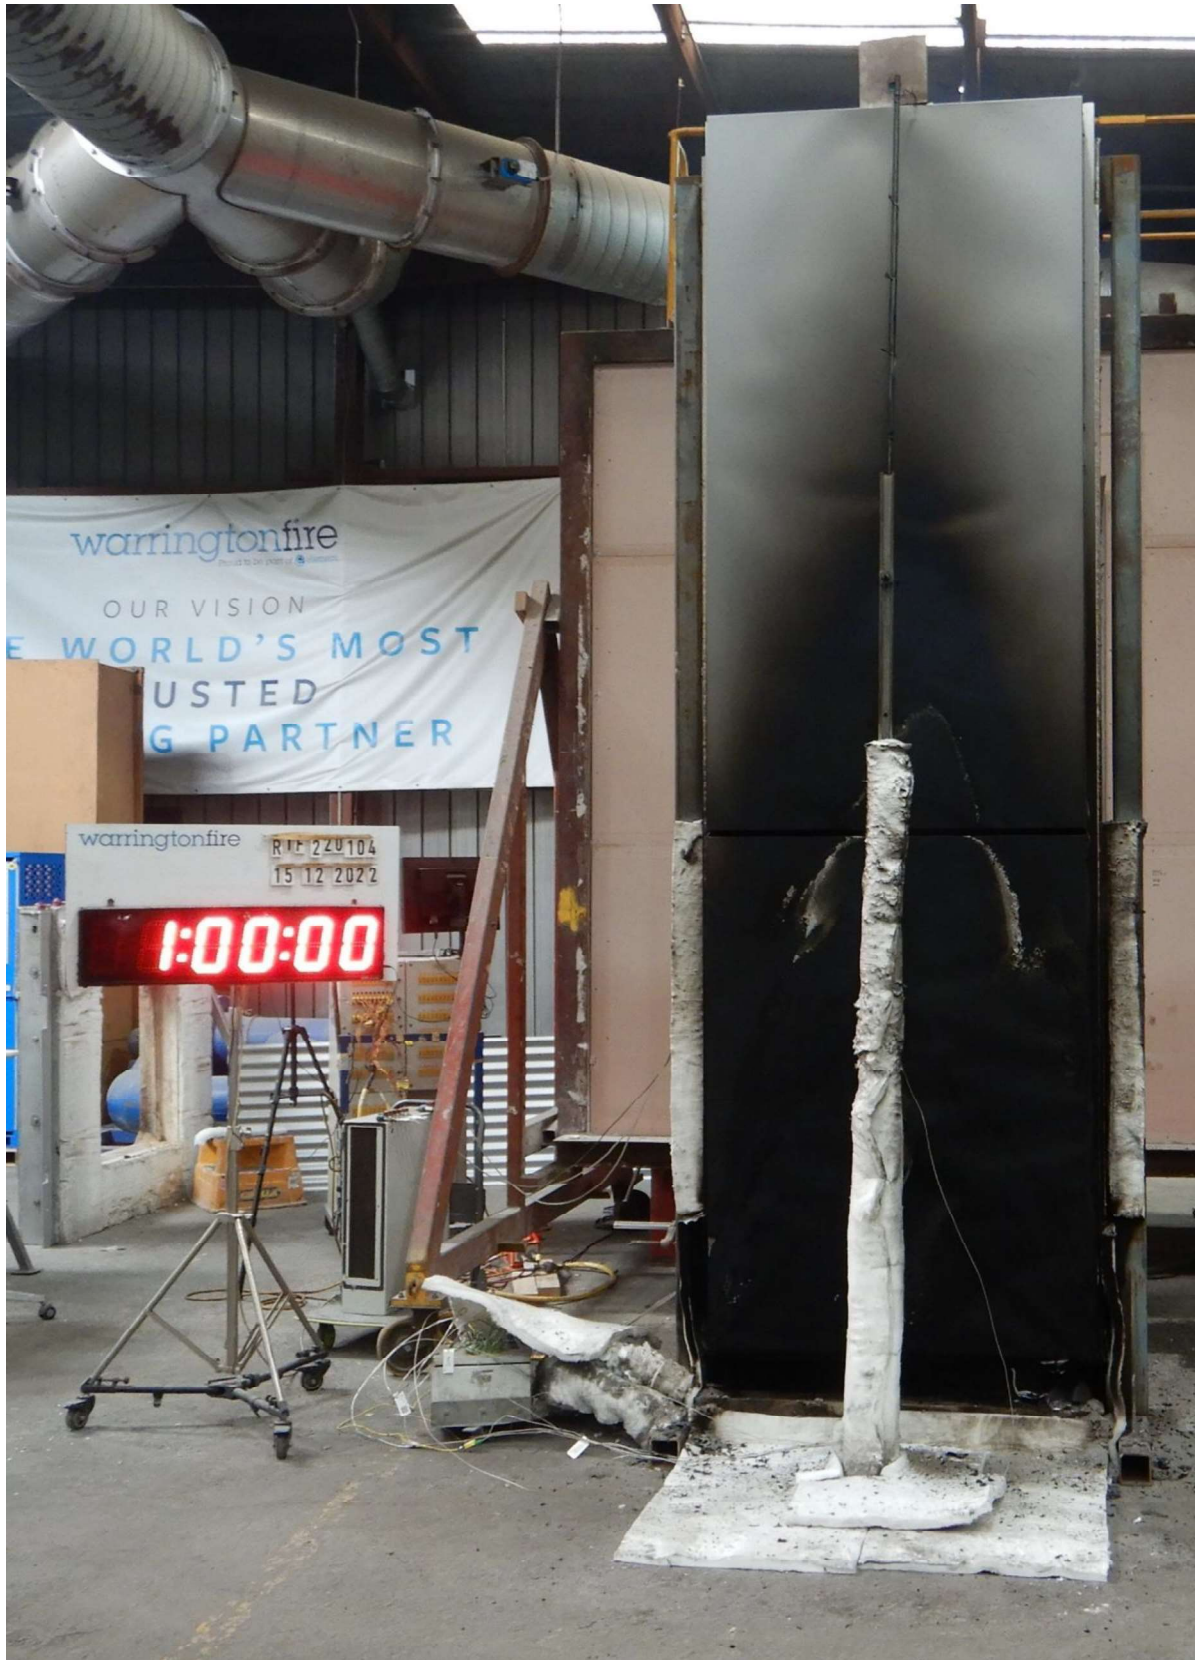
Figure 16 The specimen at the end of test.
