# Reaction to fire test report

Test standard: Ad-hoc test based off ISO 13785-1:2002

System: An aluminium composite panel (ACP) wall system and a mock balcony setup representative of an in-situ façade - [REDACTED]

Job number: RTF230083

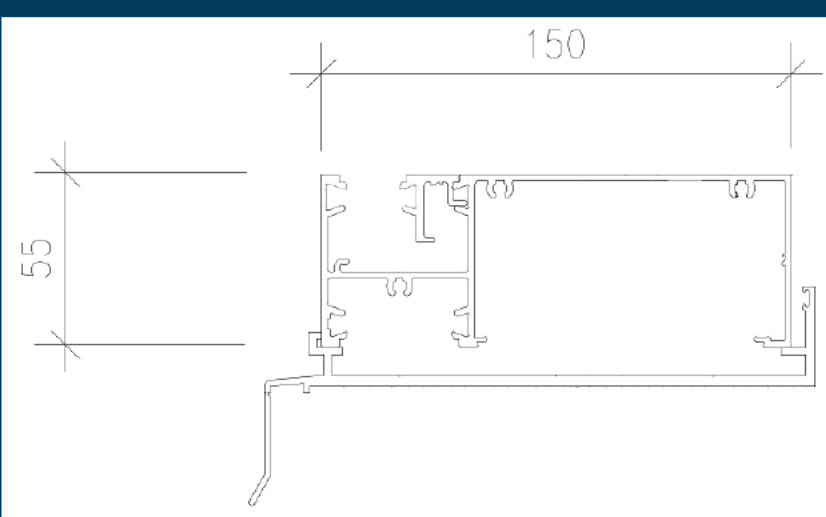
</div> </div>
Material	6060 T5 aluminium alloy
Manufacturer/Supplier	██████████
Installation	Installed above the cladding board (item 4) compartment residing over the SHS unit (item 5).
<b>Installation method</b>	
Test Rig:	The test rig frame (item 5) was the main support for the test specimen. The specimen was fixed to the test rig via the aluminium framing (item 6). The SHS was also used at the false floor level. Steel studs (item 9) were also used at the false floor level.
External wall:	<p>The aluminium framing (item 6) consisted of extrusions around the perimeter and vertically down the centre of the wall sections. To the back of the aluminium framing was screw (item 20) fixed – at 200 mm centres around the perimeter – steel back-panels (item 4). Also to the aluminium framing were furring channel clips (item 8) – screw (item 17) fixed at ~1200 mm centres vertically. Slotted into the clips were steel furring channels (item 7). Within the furring channels polyester insulation (item 10) was fitted. Two layers of plasterboard (item 2) were screw (item 16) fixed to the back of the furring channels. Screw fixings were at 600 mm centres for the first layer and 200 mm to 300 mm centres.</p> <p>To the front face of the back-pan (item 4) was installed mineral wool insulation (item 11). ACP (item 1) was used to clad the majority of the front side of the aluminium framing (item 6). The ACPs (item 1) were “glazed in” the aluminium framing inside grooves and behind aluminium beads. The perimeter of the visible ACP and aluminium framing was sealed with a 10 mm bead of sealant (item 12).</p>

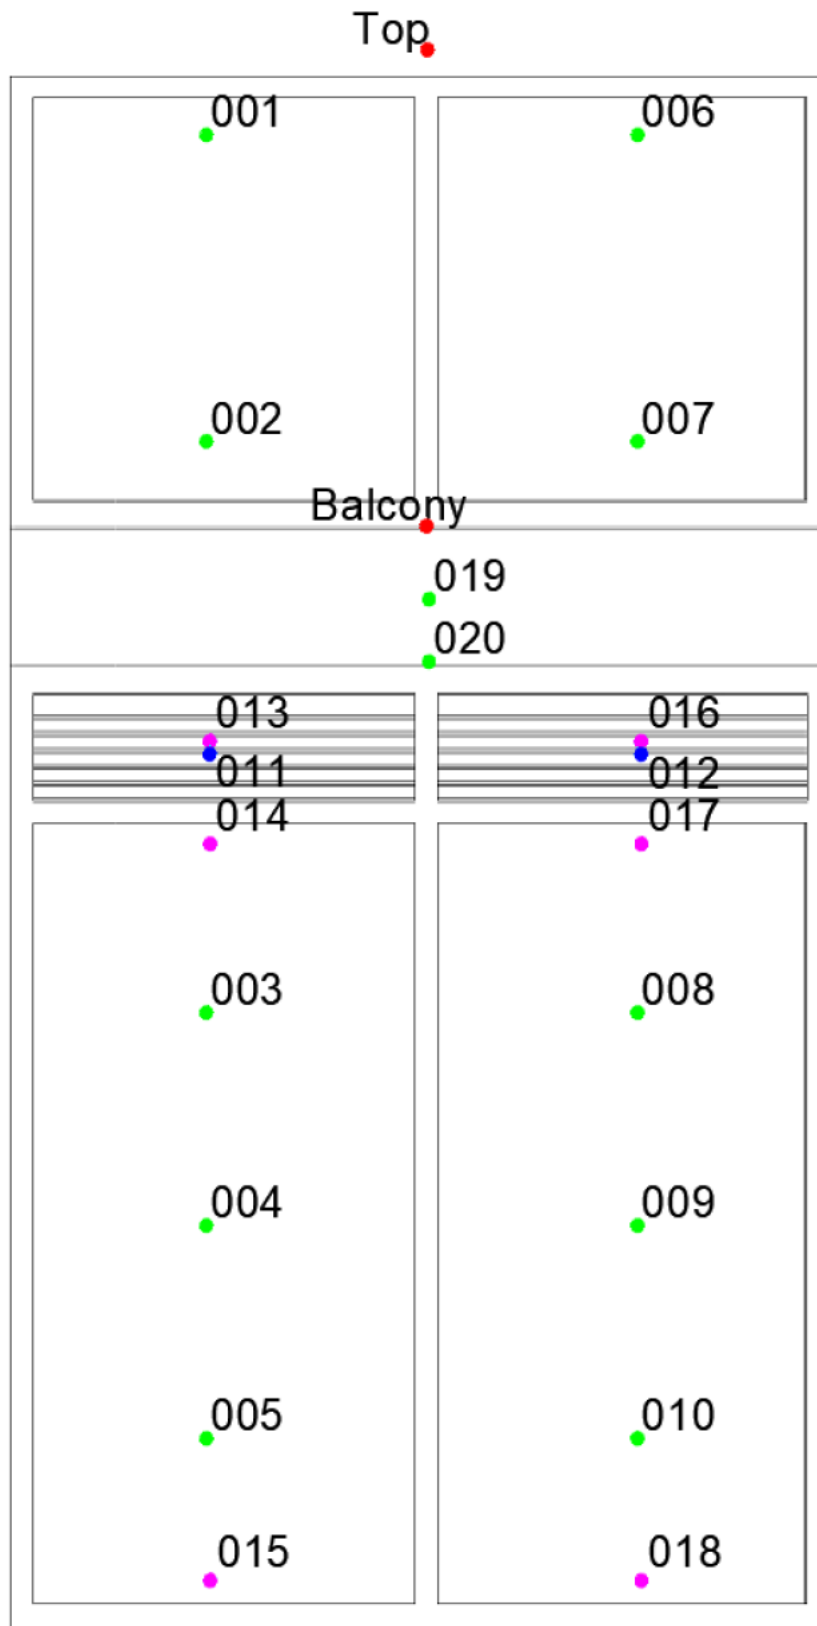
**Figure 1 Instrumentation positions – View from in front of specimen**

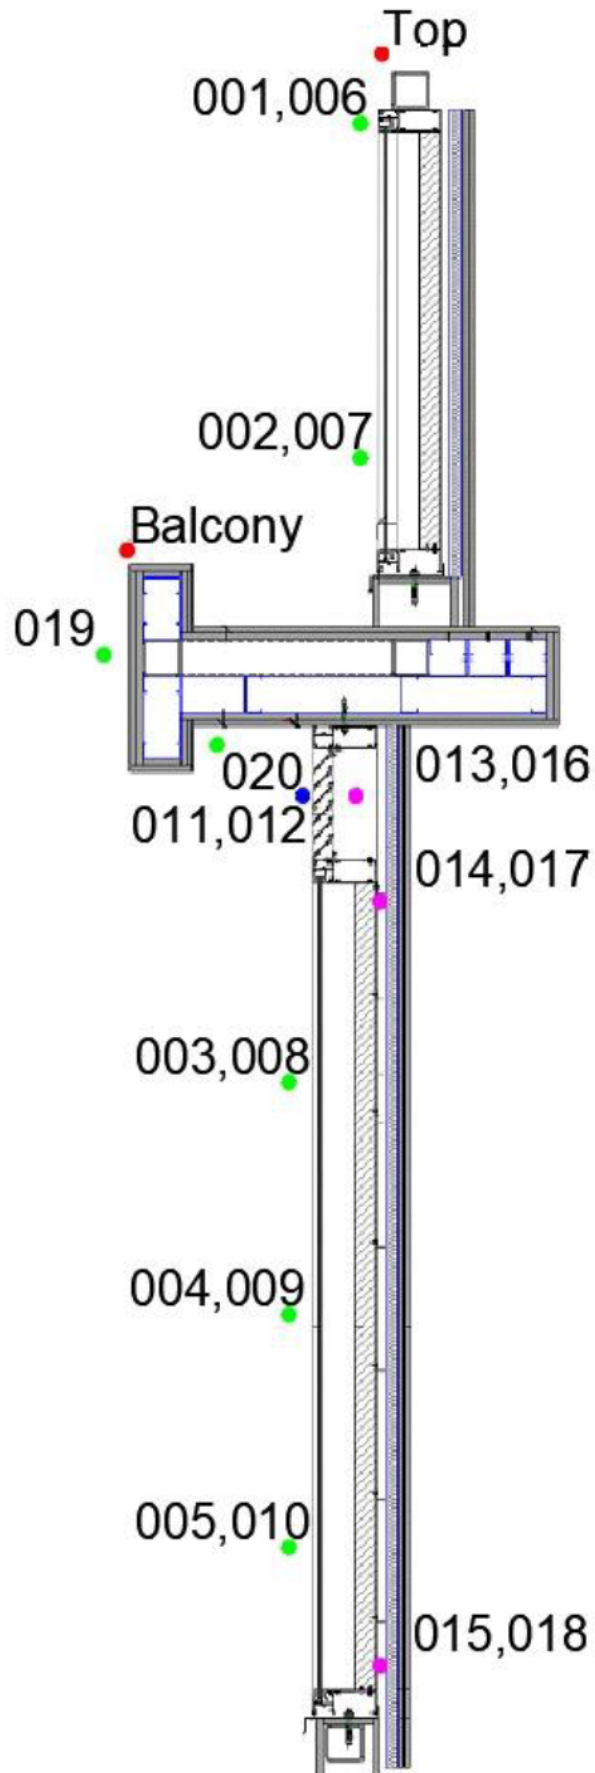
**Figure 2 Instrumentation positions – View from in front of specimen**

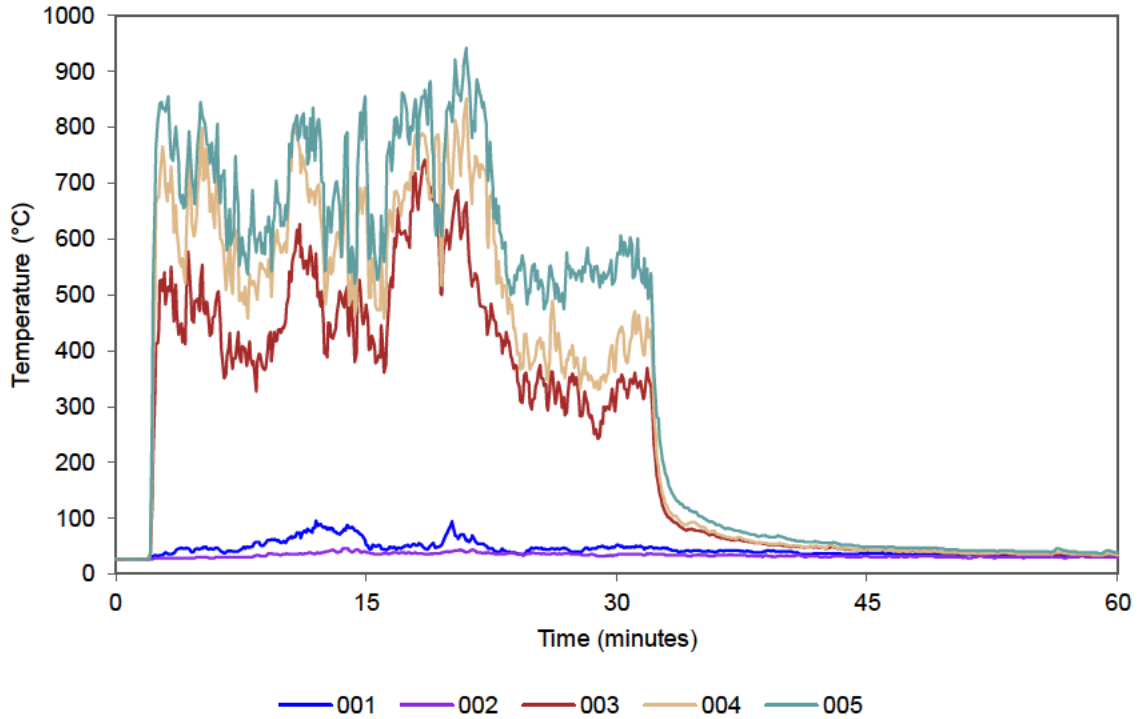
**Figure 3** External temperature data collected by thermocouples placed 50 mm from the front face of the specimen – East facade

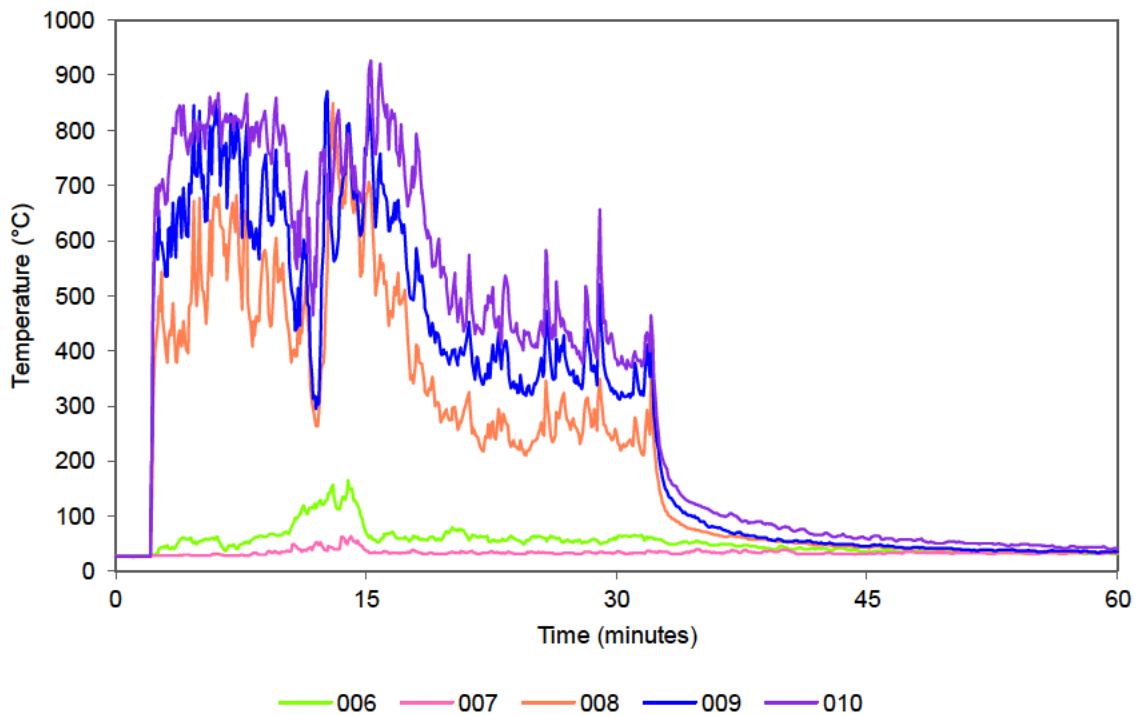
**Figure 4** External temperature data collected by thermocouples placed 50 mm from the front face of the specimen – West facade

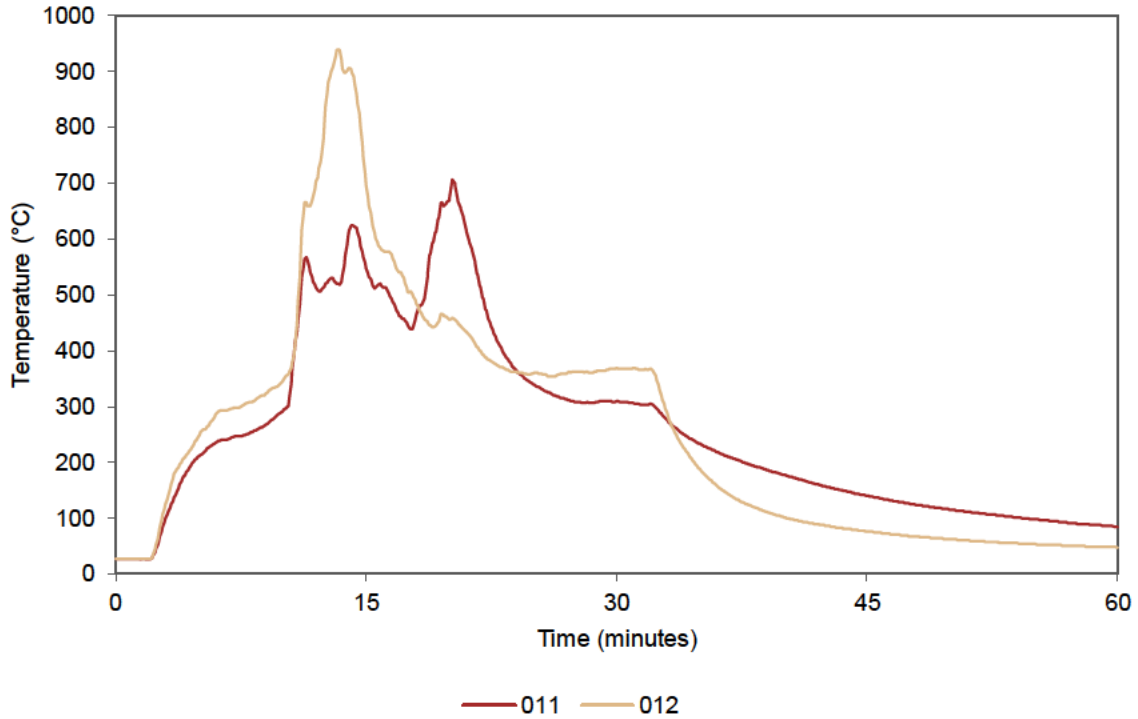
**Figure 5 External temperature data collected by plate thermocouples placed 50 mm from the front face of the specimen**

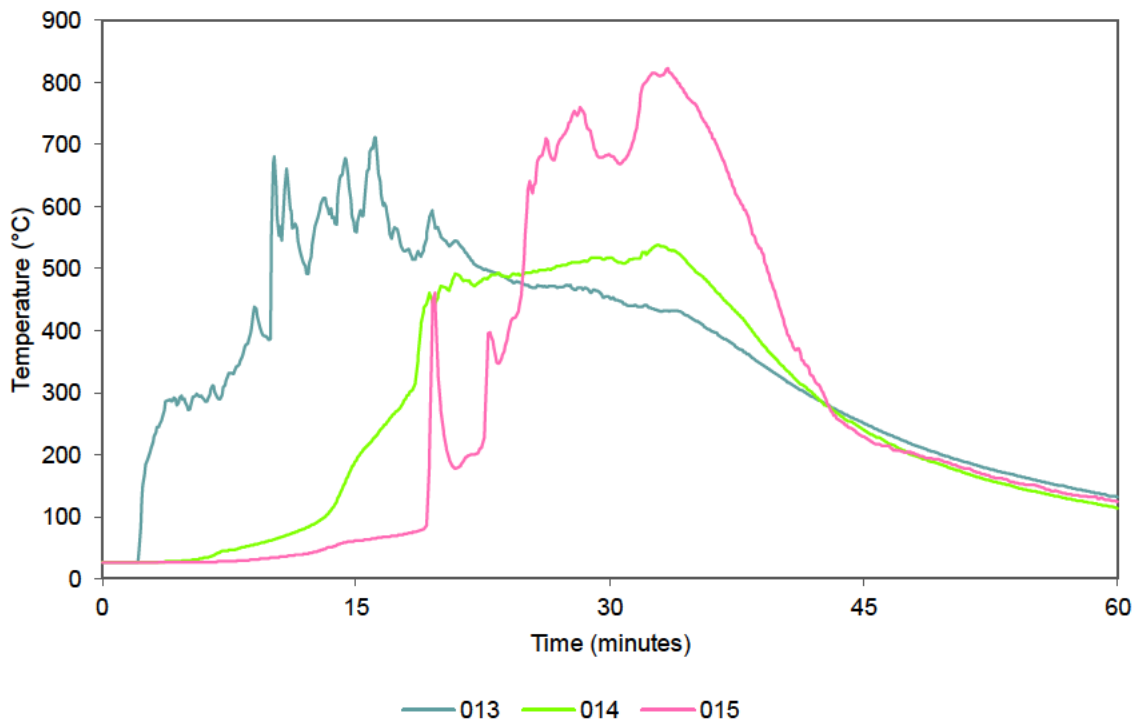
**Figure 6 Internal temperature data collected by thermocouples placed within the cavity – between the internal and external segments of the specimen – East façade**

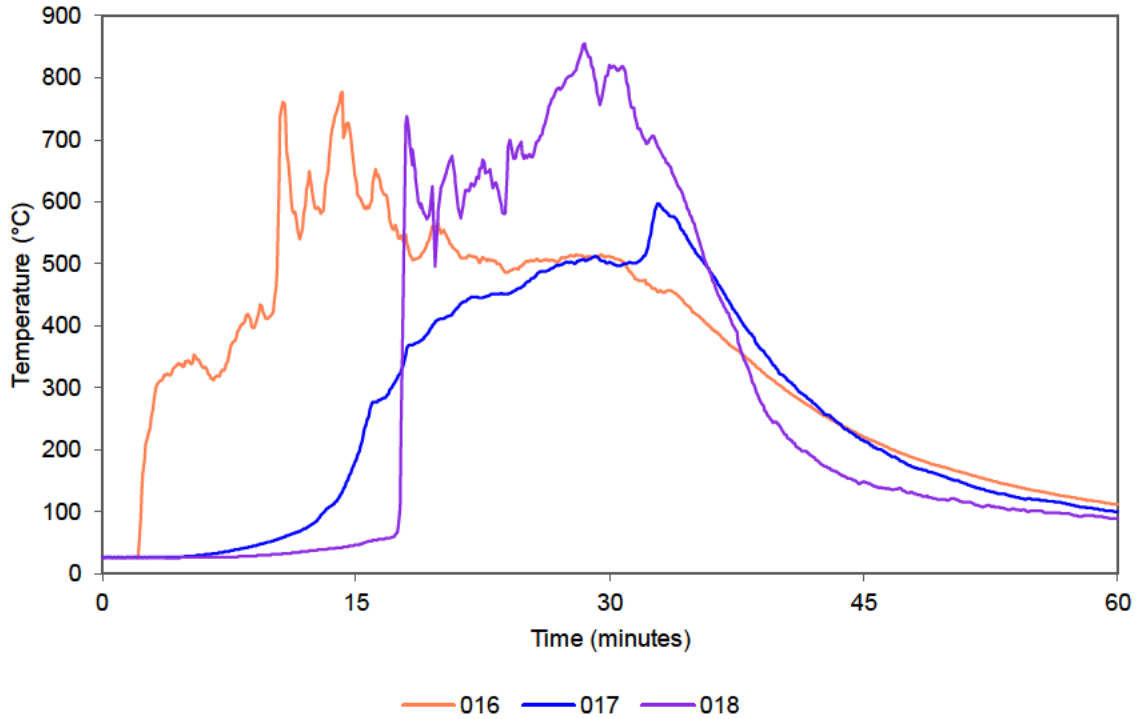
**Figure 7** Internal temperature data collected by thermocouples placed within the cavity – between the internal and external segments of the specimen – West façade

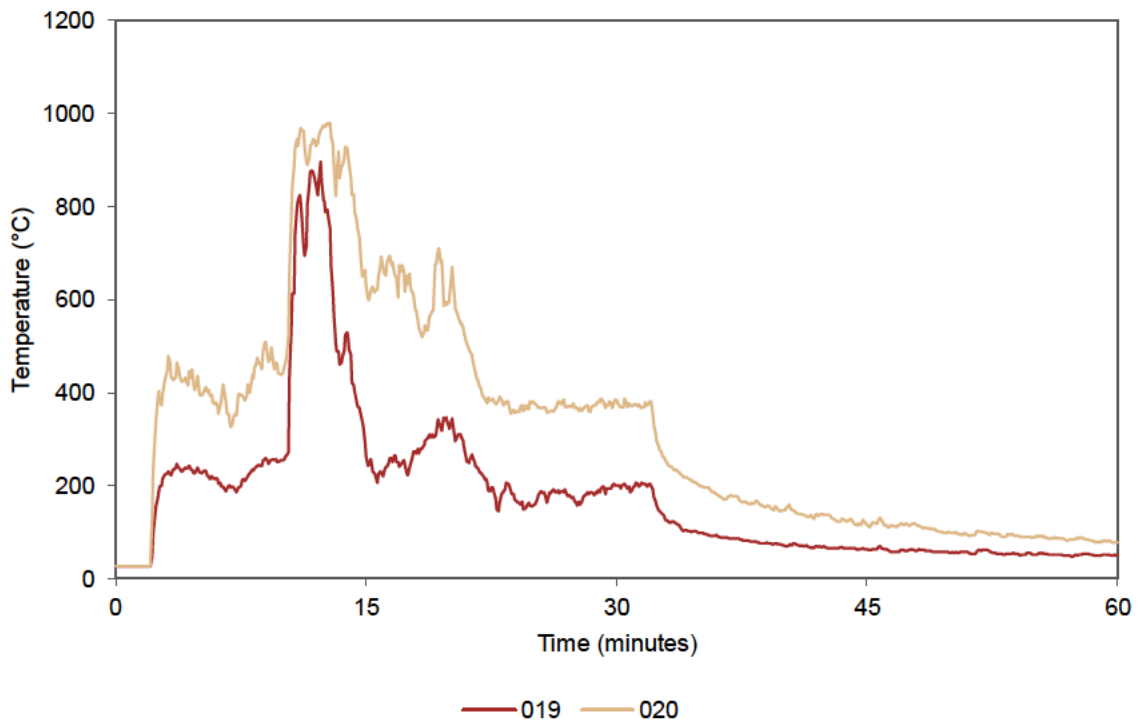
**Figure 8** External temperature data collected by thermocouples placed 50 mm from balcony face and underside cavity

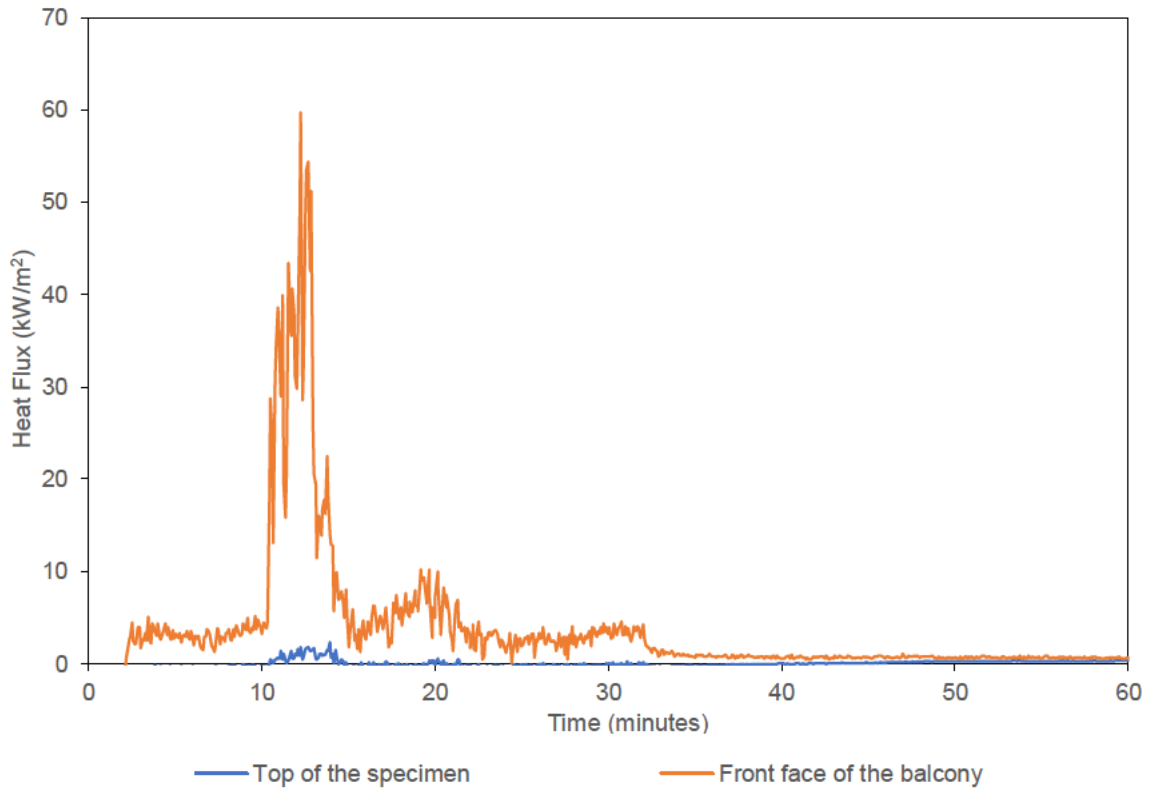
**Figure 9 Heat flux data collected by heat flux gauges**

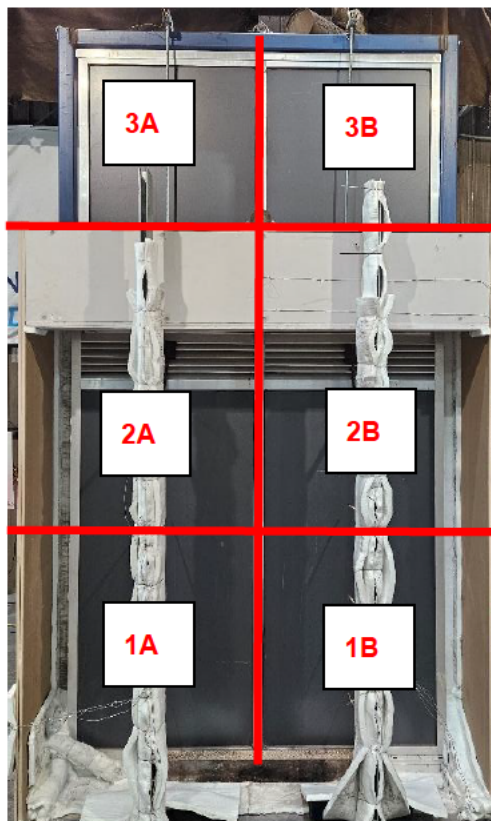
**Figure 10 Designation for test specimen observations**

Time		Section	Observation
Min	Sec		
-2	00	All	Data collection started.
0	00	All	The reaction to fire test was started with the burner ignited to a 300 kW heat output.
0	29	2	The flames had reached the balcony underside.
0	52	2	Smoke started to emit from the panels.
1	07	1A/1B	The panels started to deform.
1	15	1A/1B	Debris started to fall from the panel faces.
1	44	2A/2B	Debris started to fall from the panel faces.
2	30	2A/2B	The panels started to deform.
2	50	2A/2B	The louvres started to deform.
3	21	2B	Intermittent flaming was observed at the top left corner.
4	36	2B	The flaming at the top left corner became sustained.
4	49	2A	Intermittent flaming was observed coming from behind the louvres.
5	48	2B	Sustained flaming was observed coming from behind the louvres.
7	24	2A/2B	Flames started to escape from the joint between 2A and 2B.
7	58	2A	The flames escaping from the louvres became sustained.
8	15	1/2	A buildup of gas was released from the specimen.

8	29	3	Flames had reached the top of the balcony front face.
8	47	2	The panels started to fall off, revealing the cavity behind.
11	19	2B	Most of the panel facing had detached.
12	02	2	Some molten debris started to fall from the louvres.
13	43	2A	The panel facing opened up at the top right corner.
14	50	2A/1A	The panel started to detach.
16	00	2B	The steel back pan started to deform.
16	40	2A	Molten debris started falling from the front panel.
17	30	2A	More molten debris fell from the panel.
17	36	2A	Flaming debris started to fall from the section.
20	30	All	The density of the smoke escaping from the specimen had increased.
25	00	1/2	Most of the back pan had deformed.
28	40	A/B	Flames started to escape from the middle joint.
30	00	All	The burner was turned off. Some independent flaming was still present.
33	33	A/B	Some independent flaming was still observed at the joint.
49	00	A/B	The flaming at the joint had died.

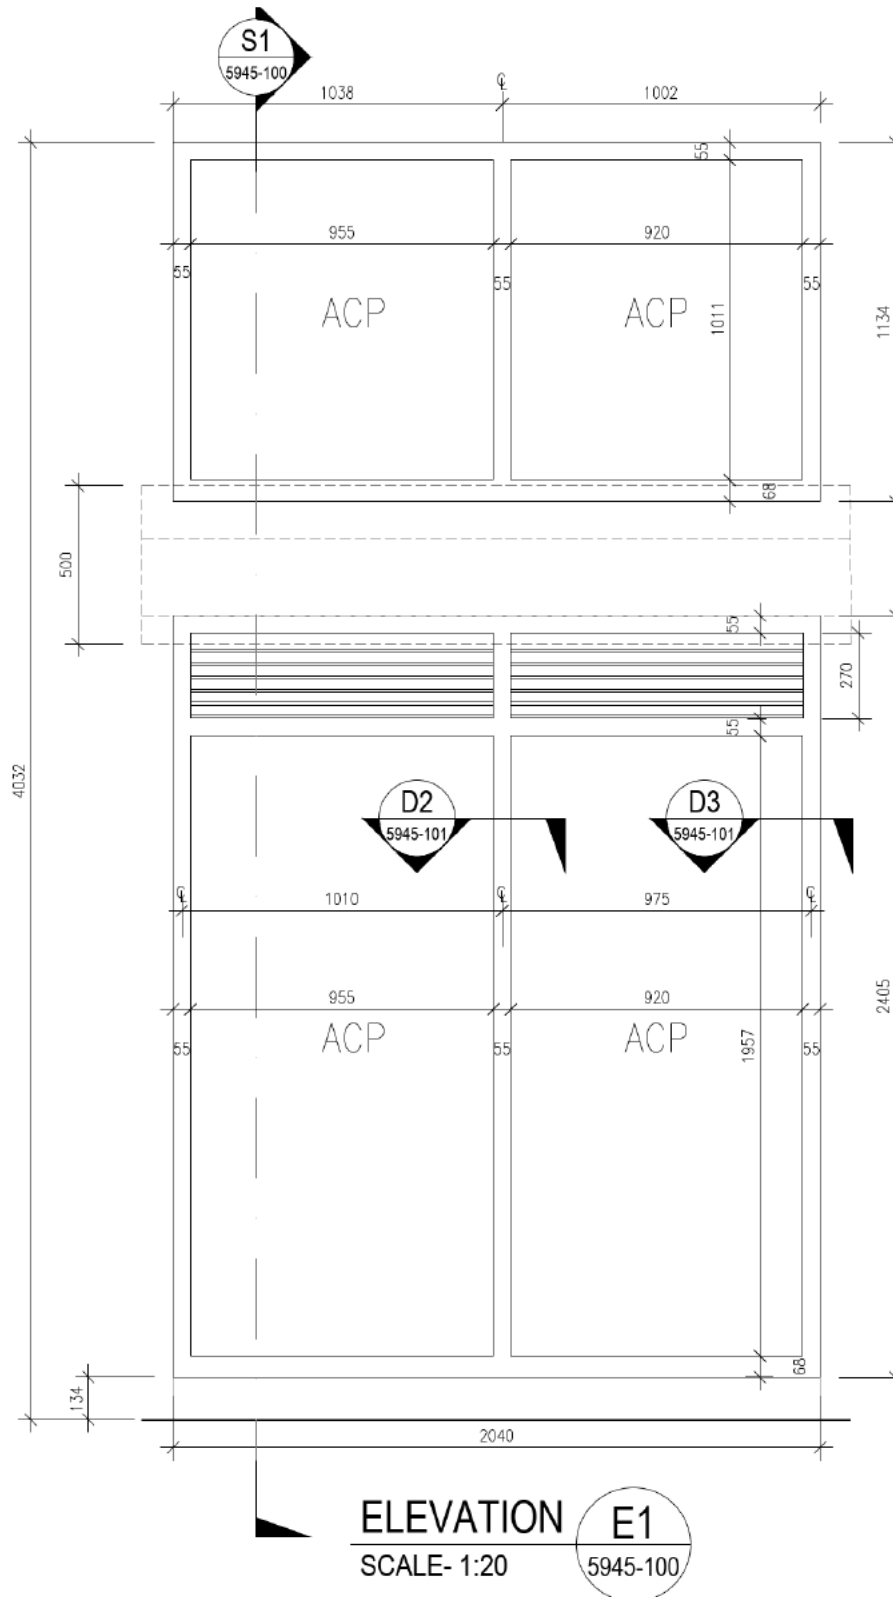
**Figure 11 Elevation of rig support.**

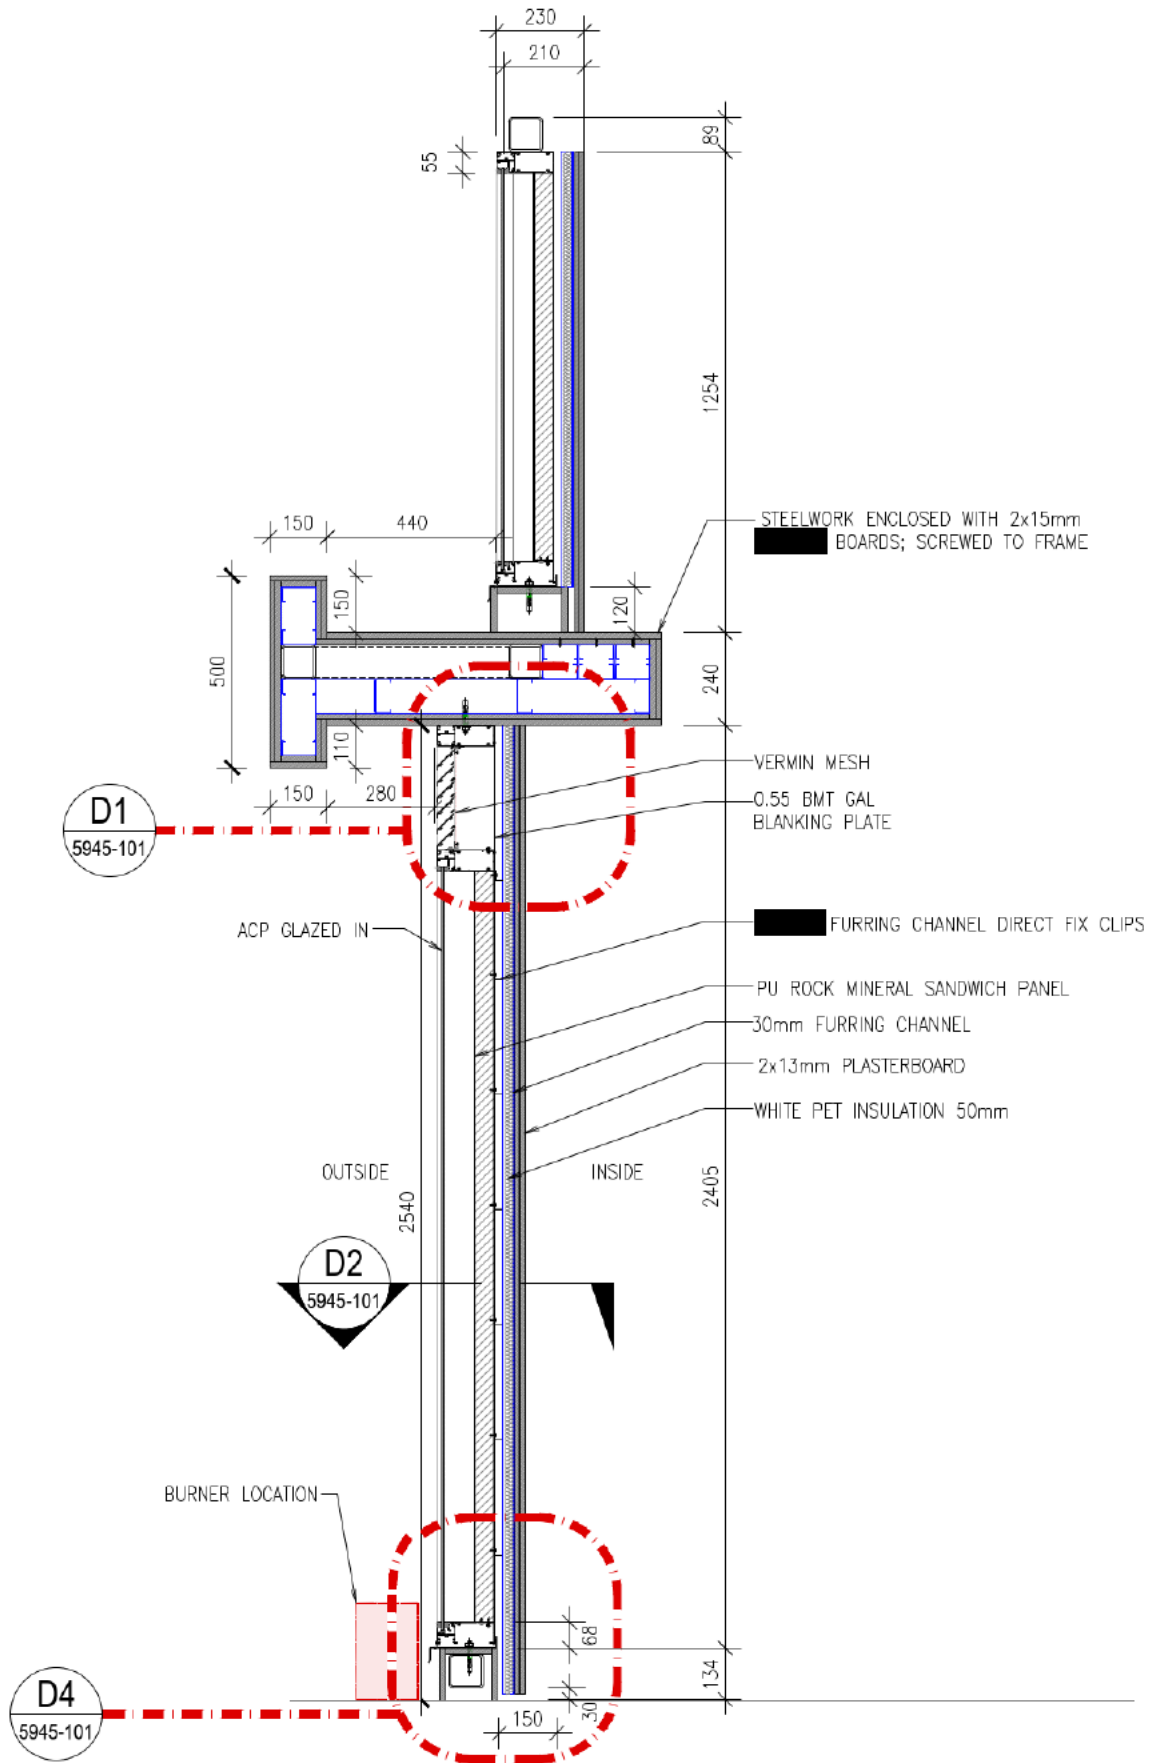
**Figure 12 System assembly – Front and side view**

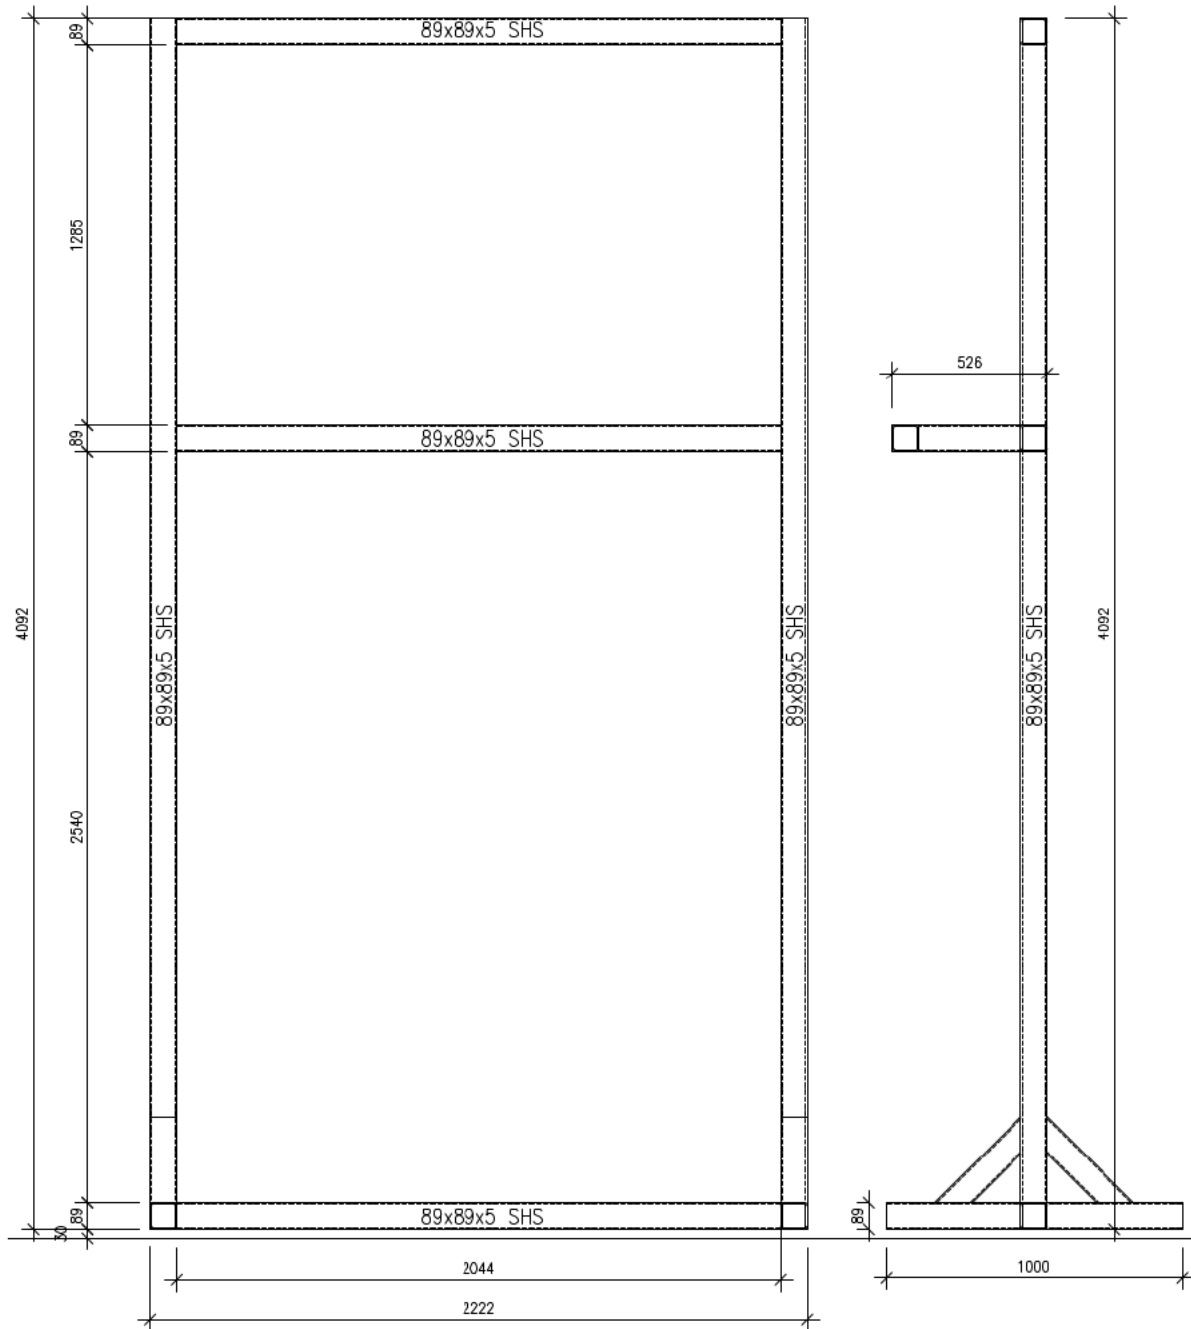
**Figure 13 System assembly – Test frame**

5.	Item name	Test rig frame - 90 × 90 SHS frame
	Size	90 mm × 90 mm × 5 mm thick – refer to Figure 13
6.	Item name	██████████ frame mullion ██████████
	Profile

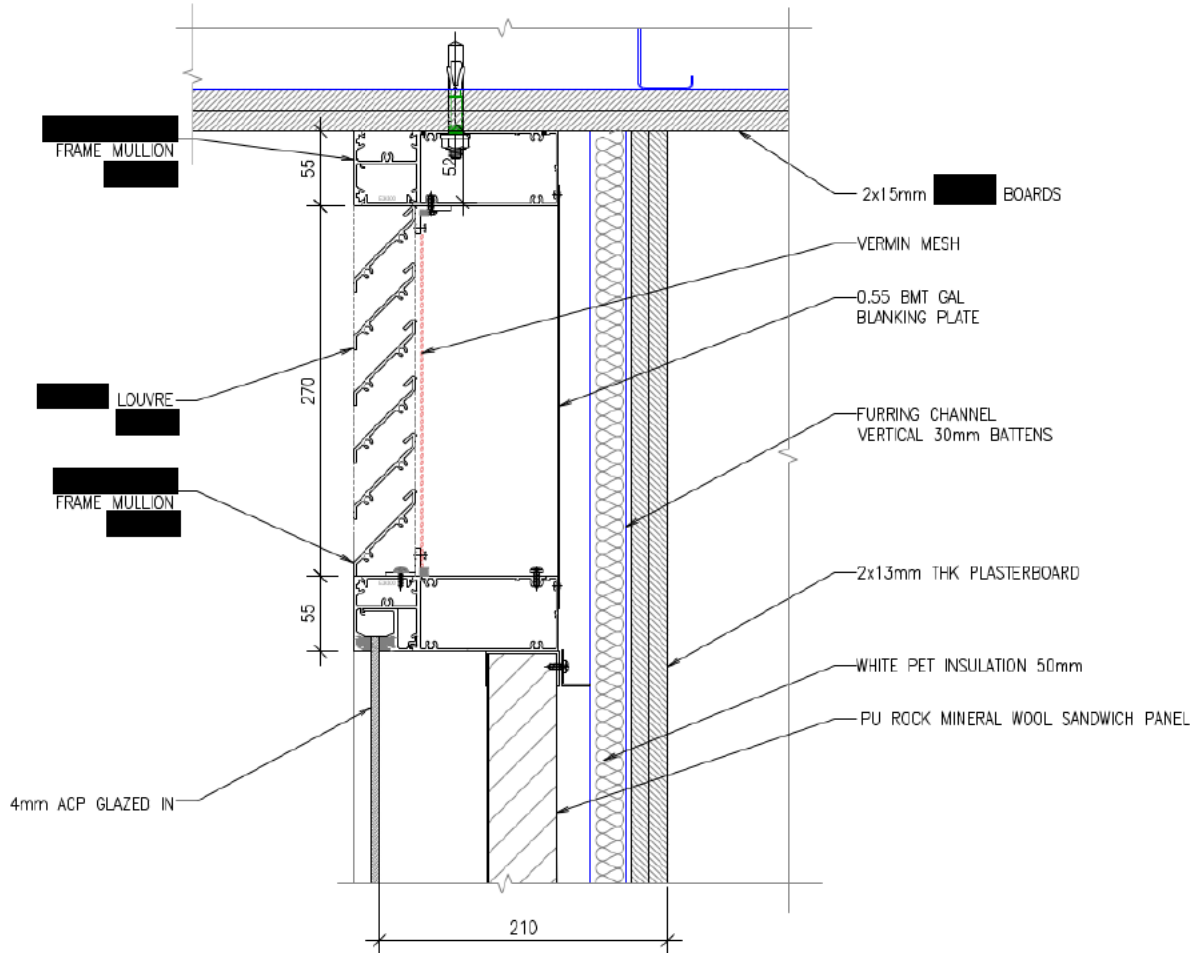
**Figure 14 System detail – Detail D1**

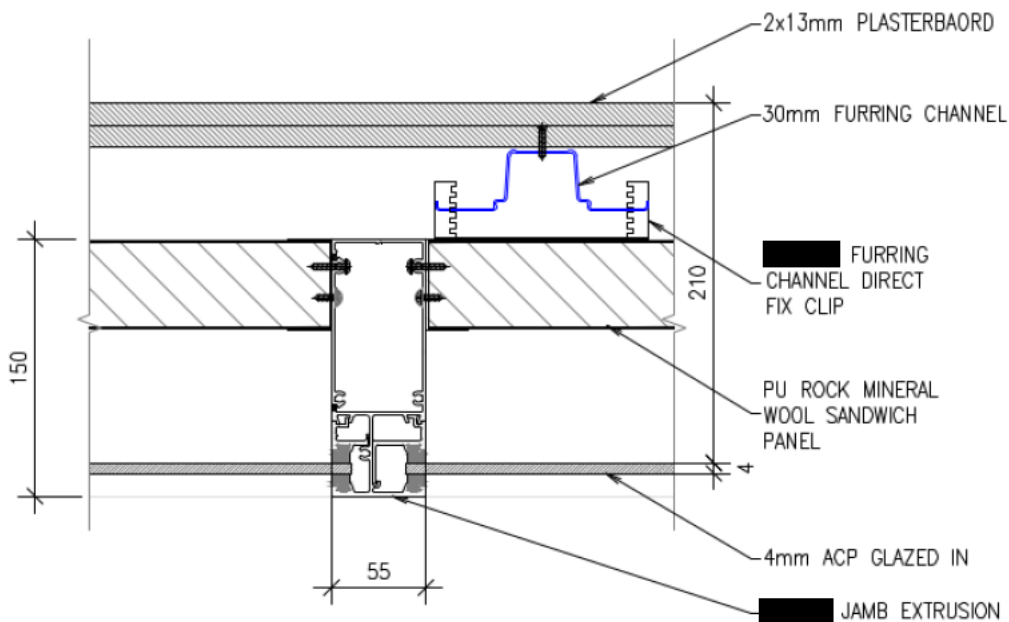
**Figure 15 System detail – Detail D2**

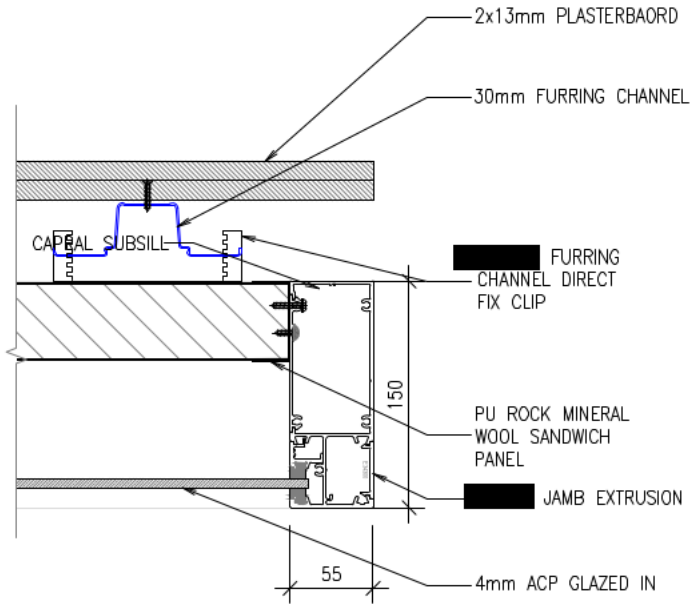
**Figure 16 System detail – Detail D3**

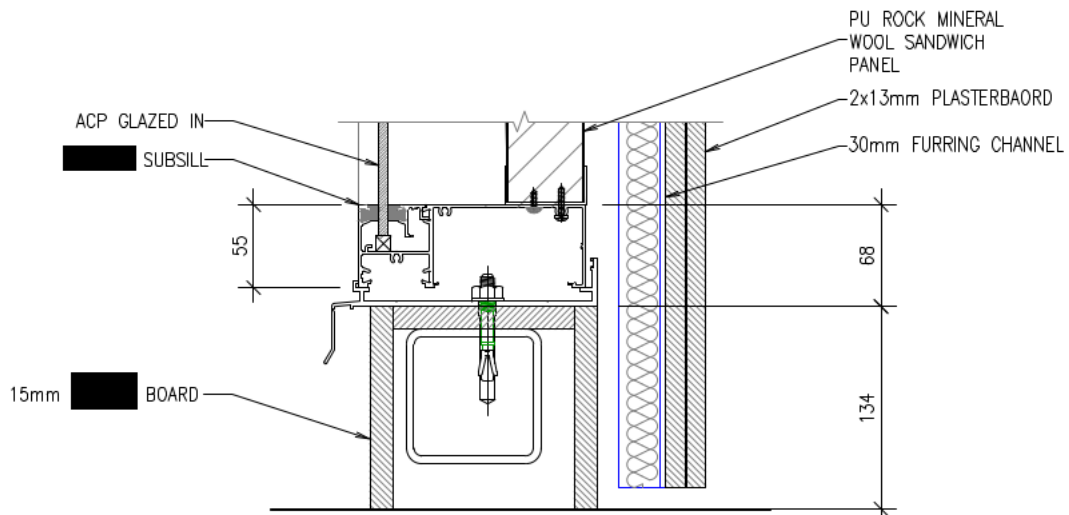
**Figure 17 System detail – Detail D4**

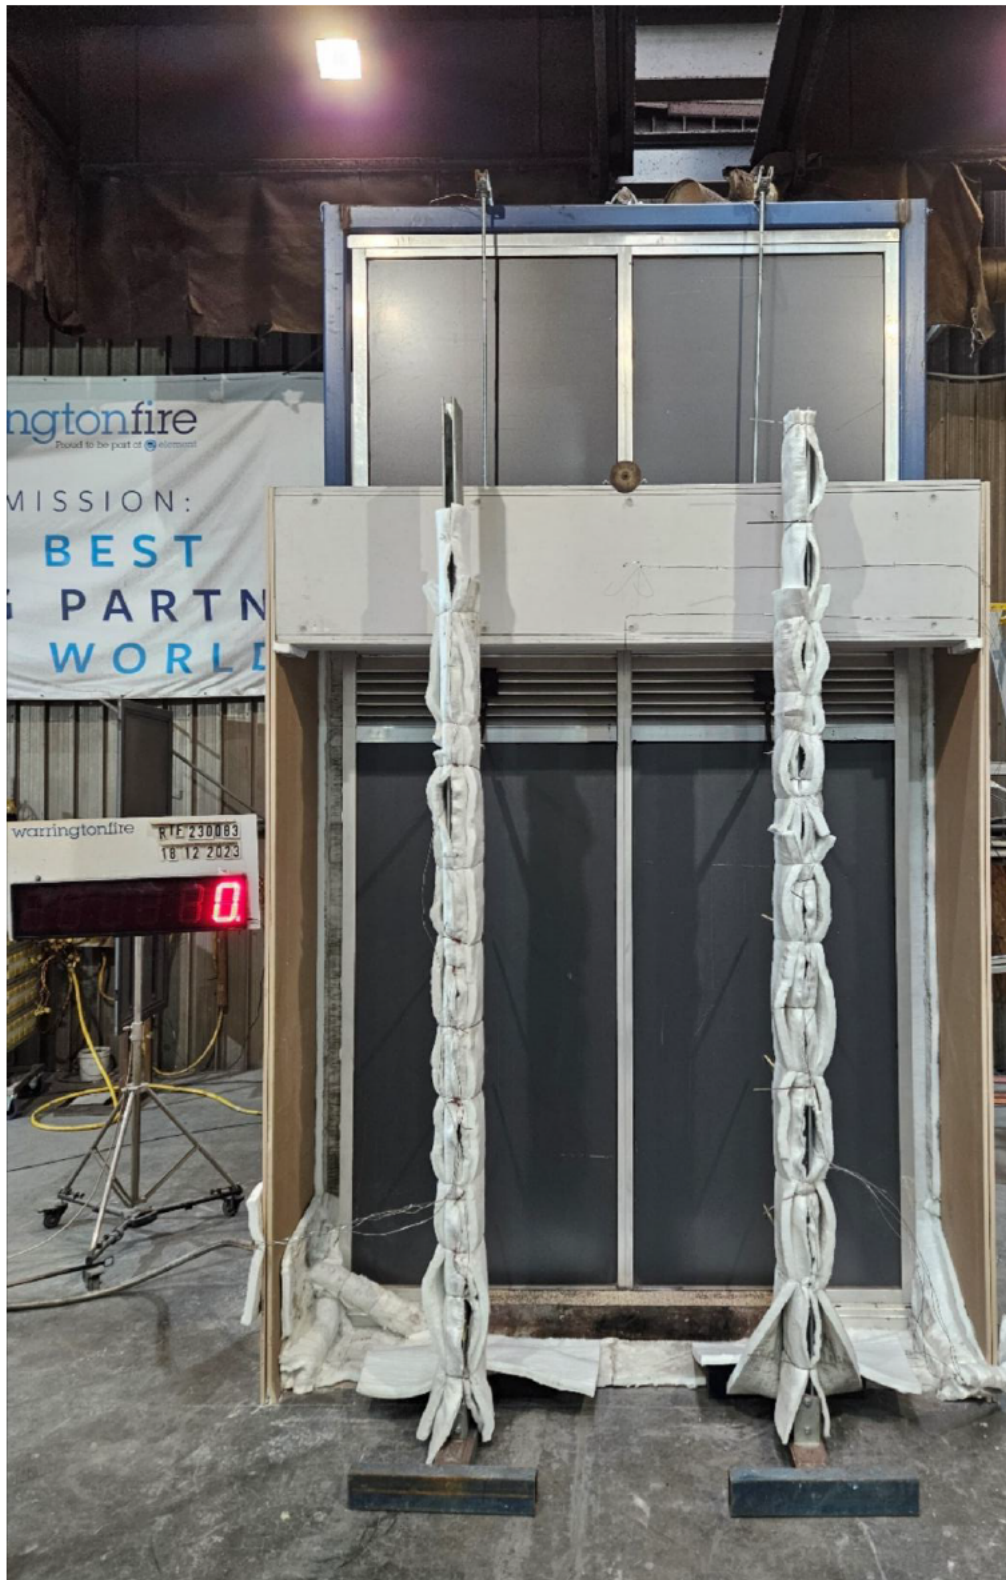
**Figure 18** The specimen before the reaction to fire test

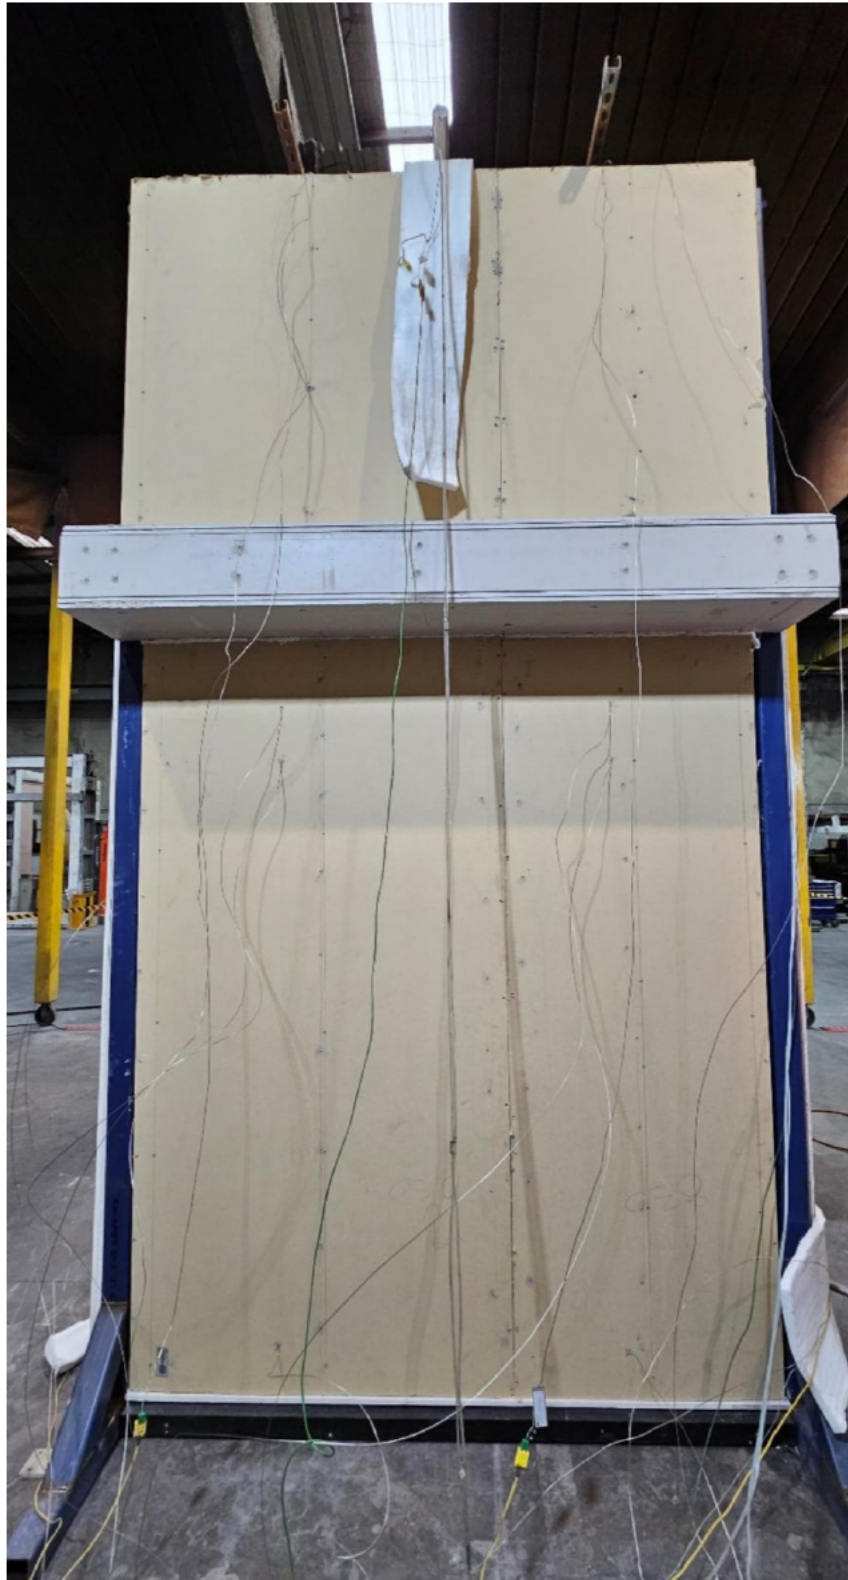
**Figure 19** The specimen before the reaction to fire test – unexposed side

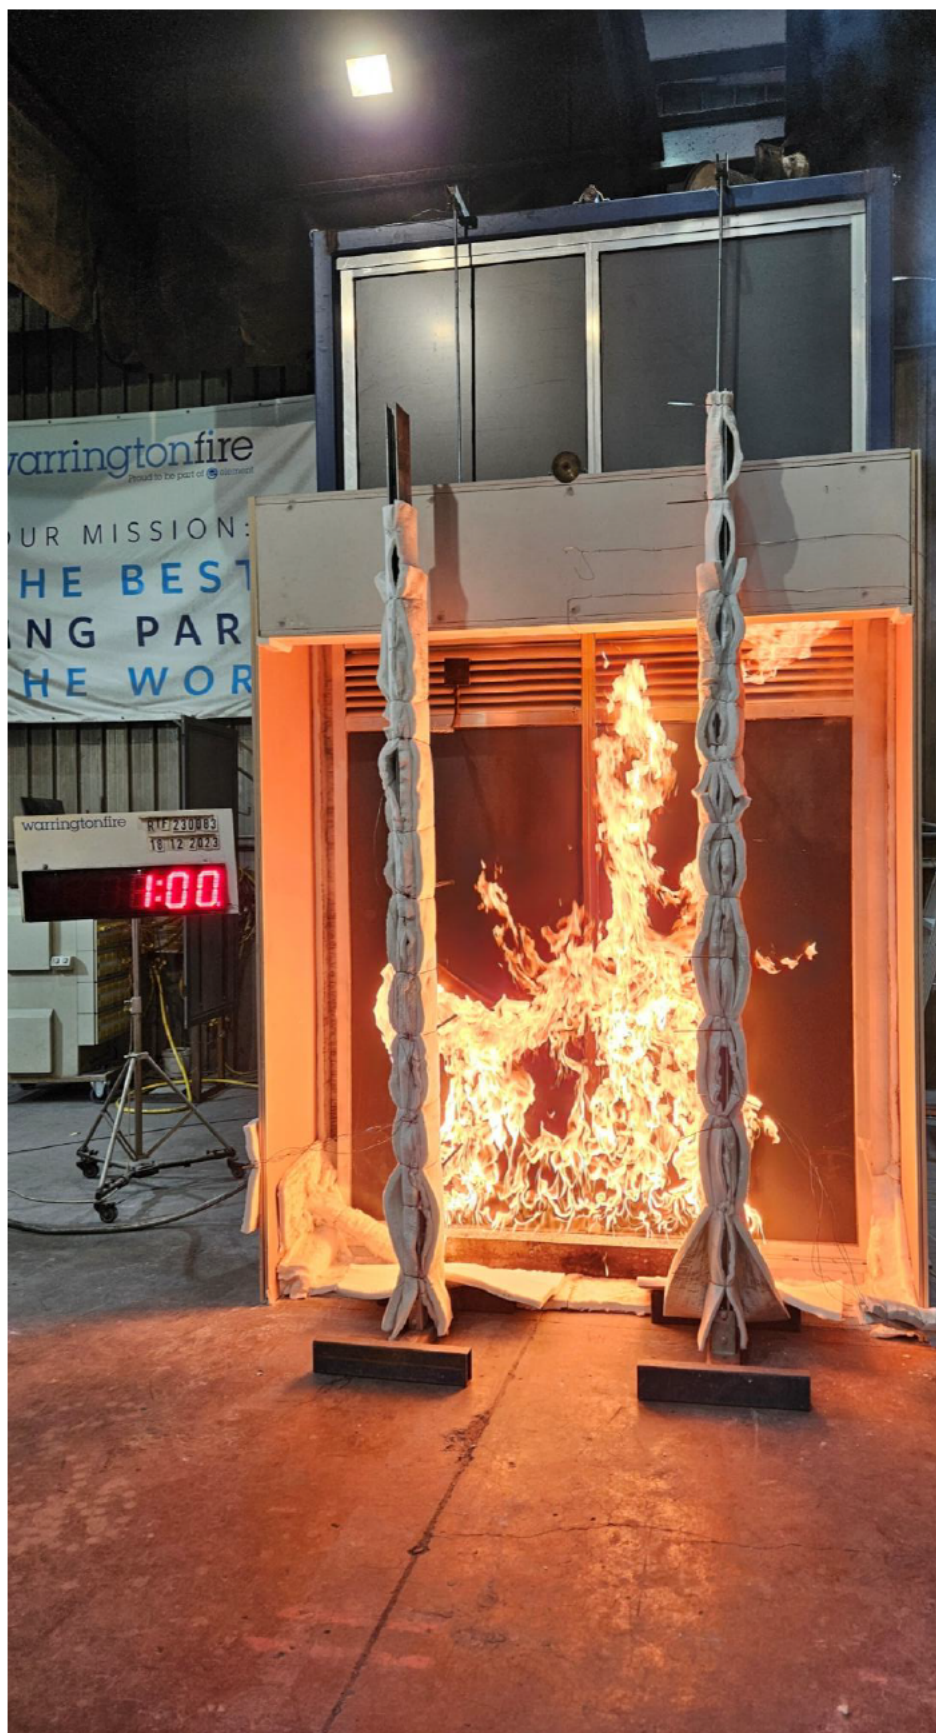
**Figure 20** The specimen 1 minute into the test (burner output set to 300 kW for the duration of the test)
