# Reaction to fire test report

Test standard: Ad-hoc test based off ISO 13785-1:2002

System: An aluminium composite panel (ACP) wall system and a mock balcony setup representative of an in-situ façade - [REDACTED]

Job number: RTF230083

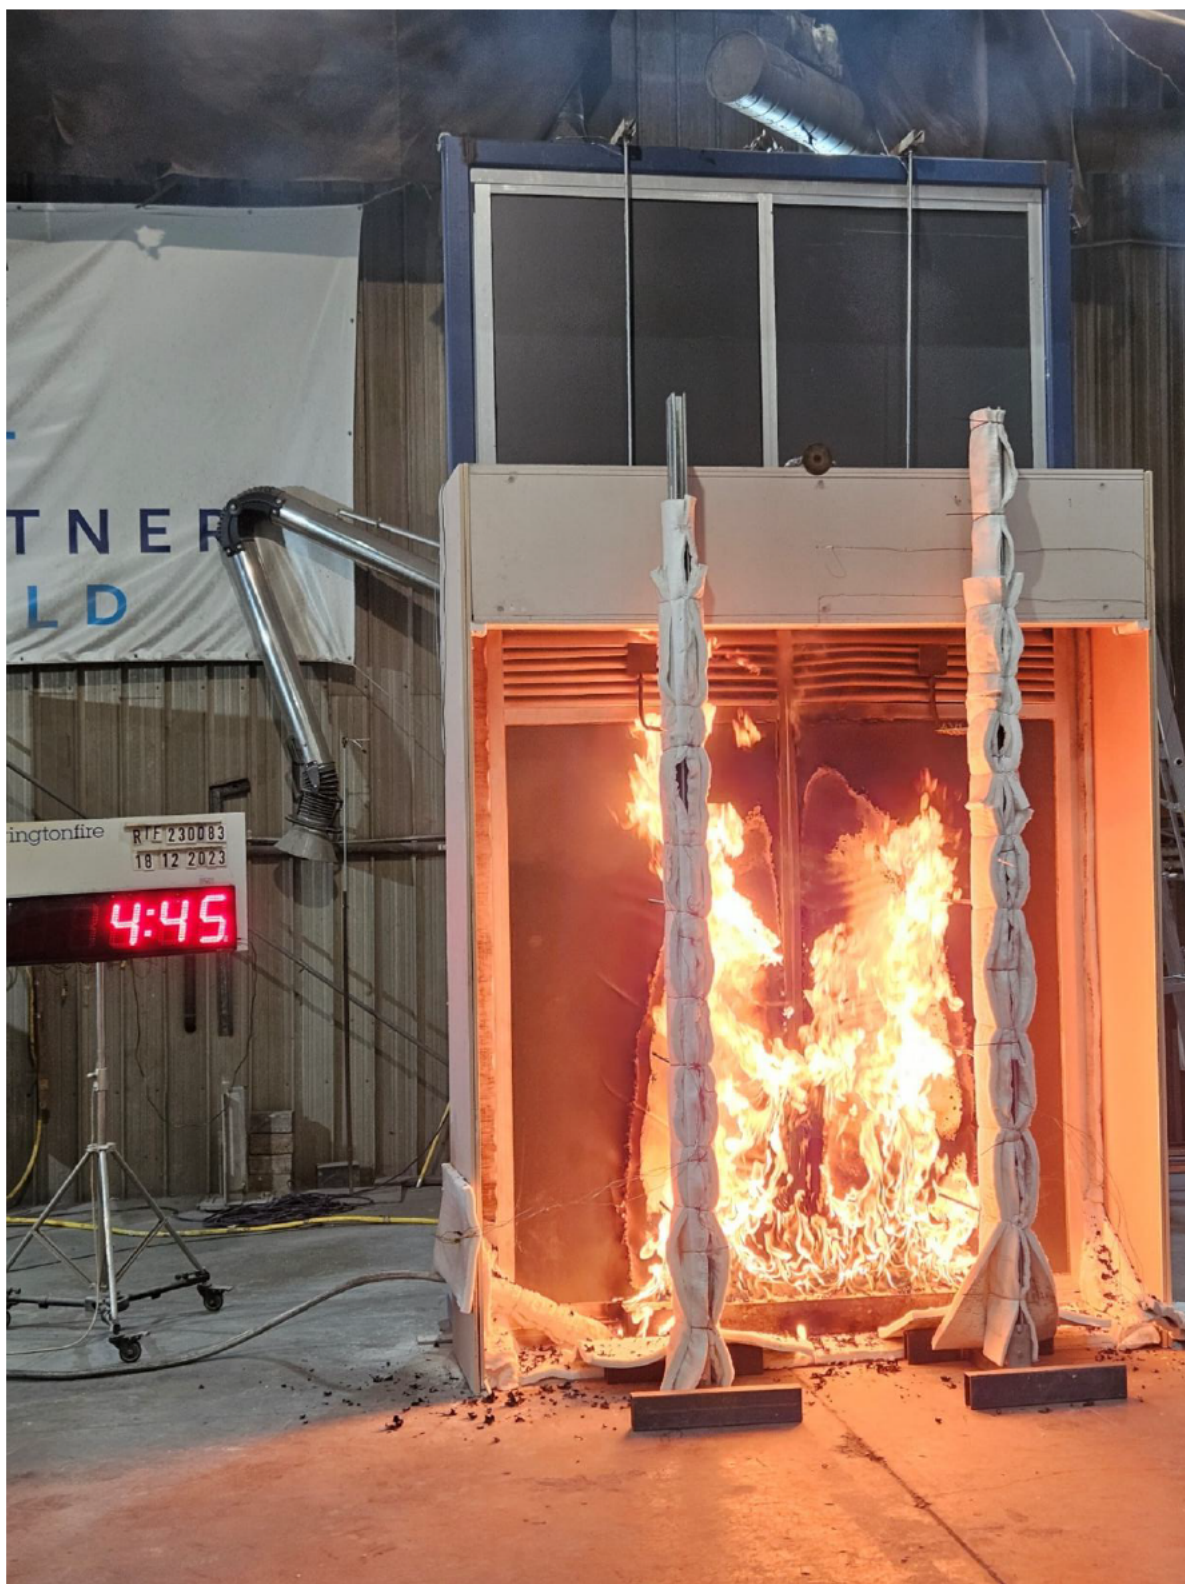
**Figure 21 The specimen 4 minutes 45 seconds into the test**

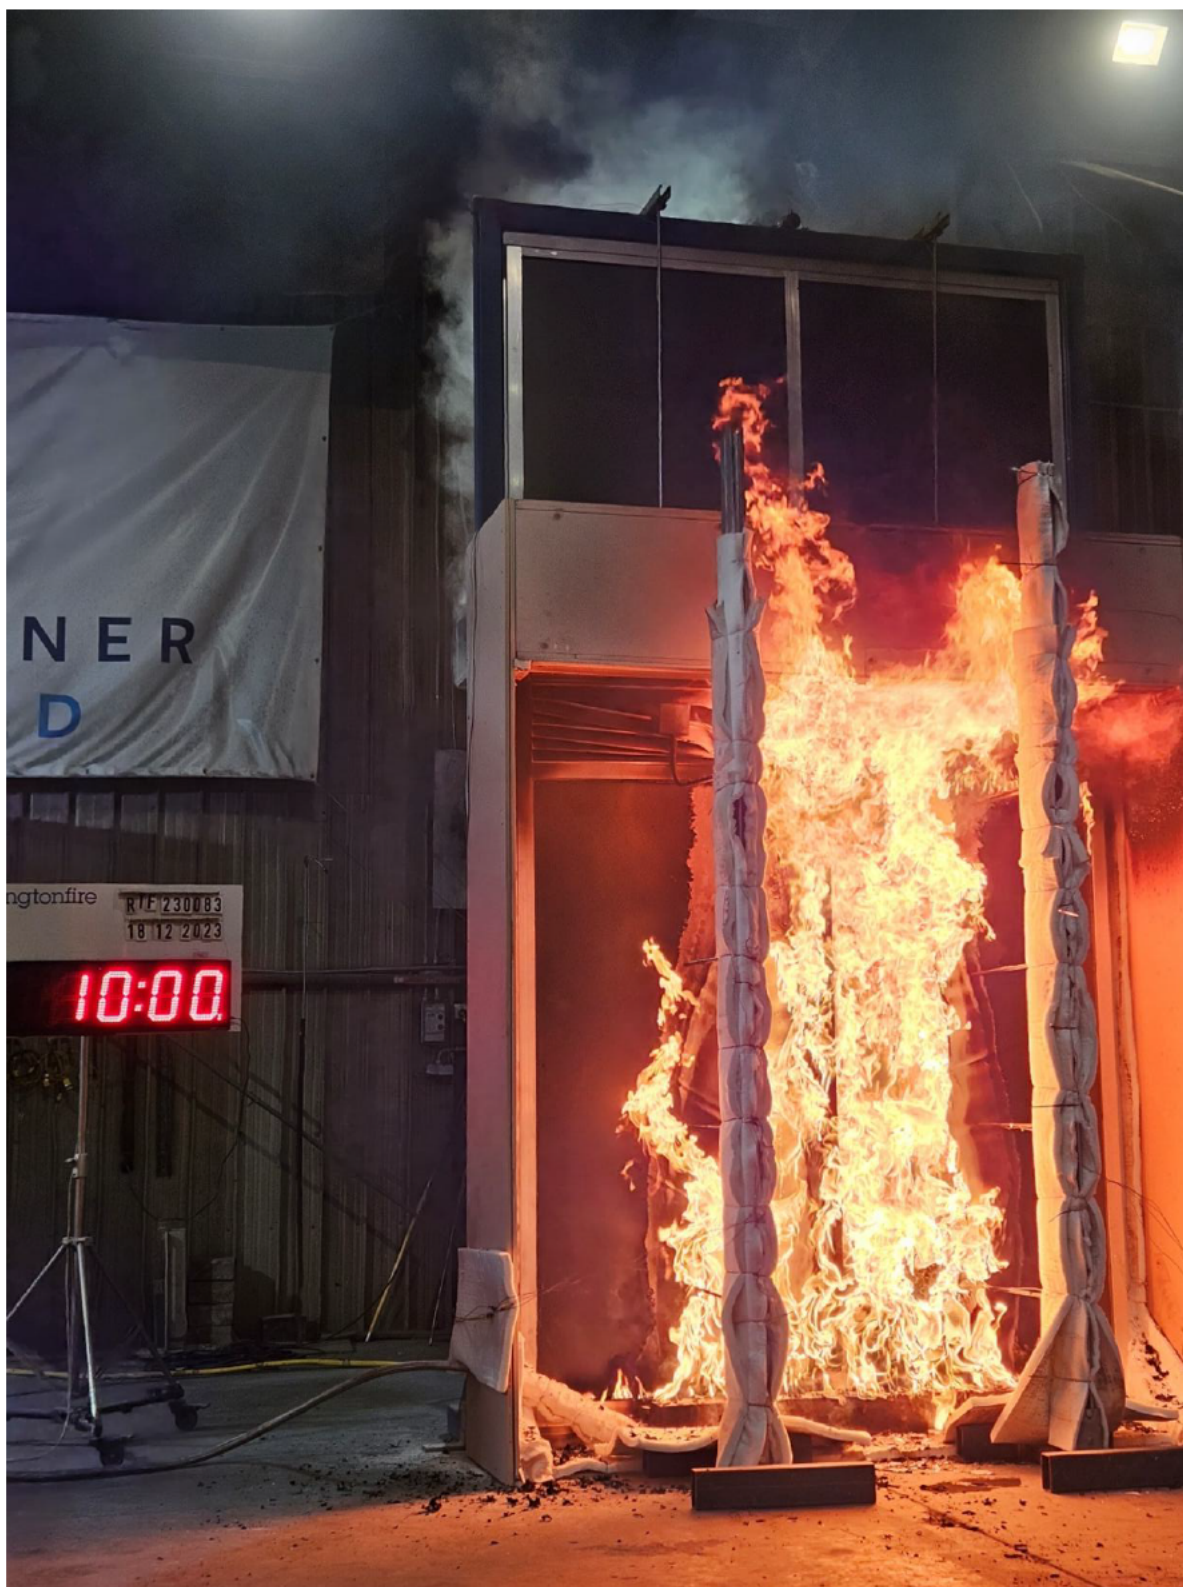
**Figure 22** The specimen 10 minutes into the test

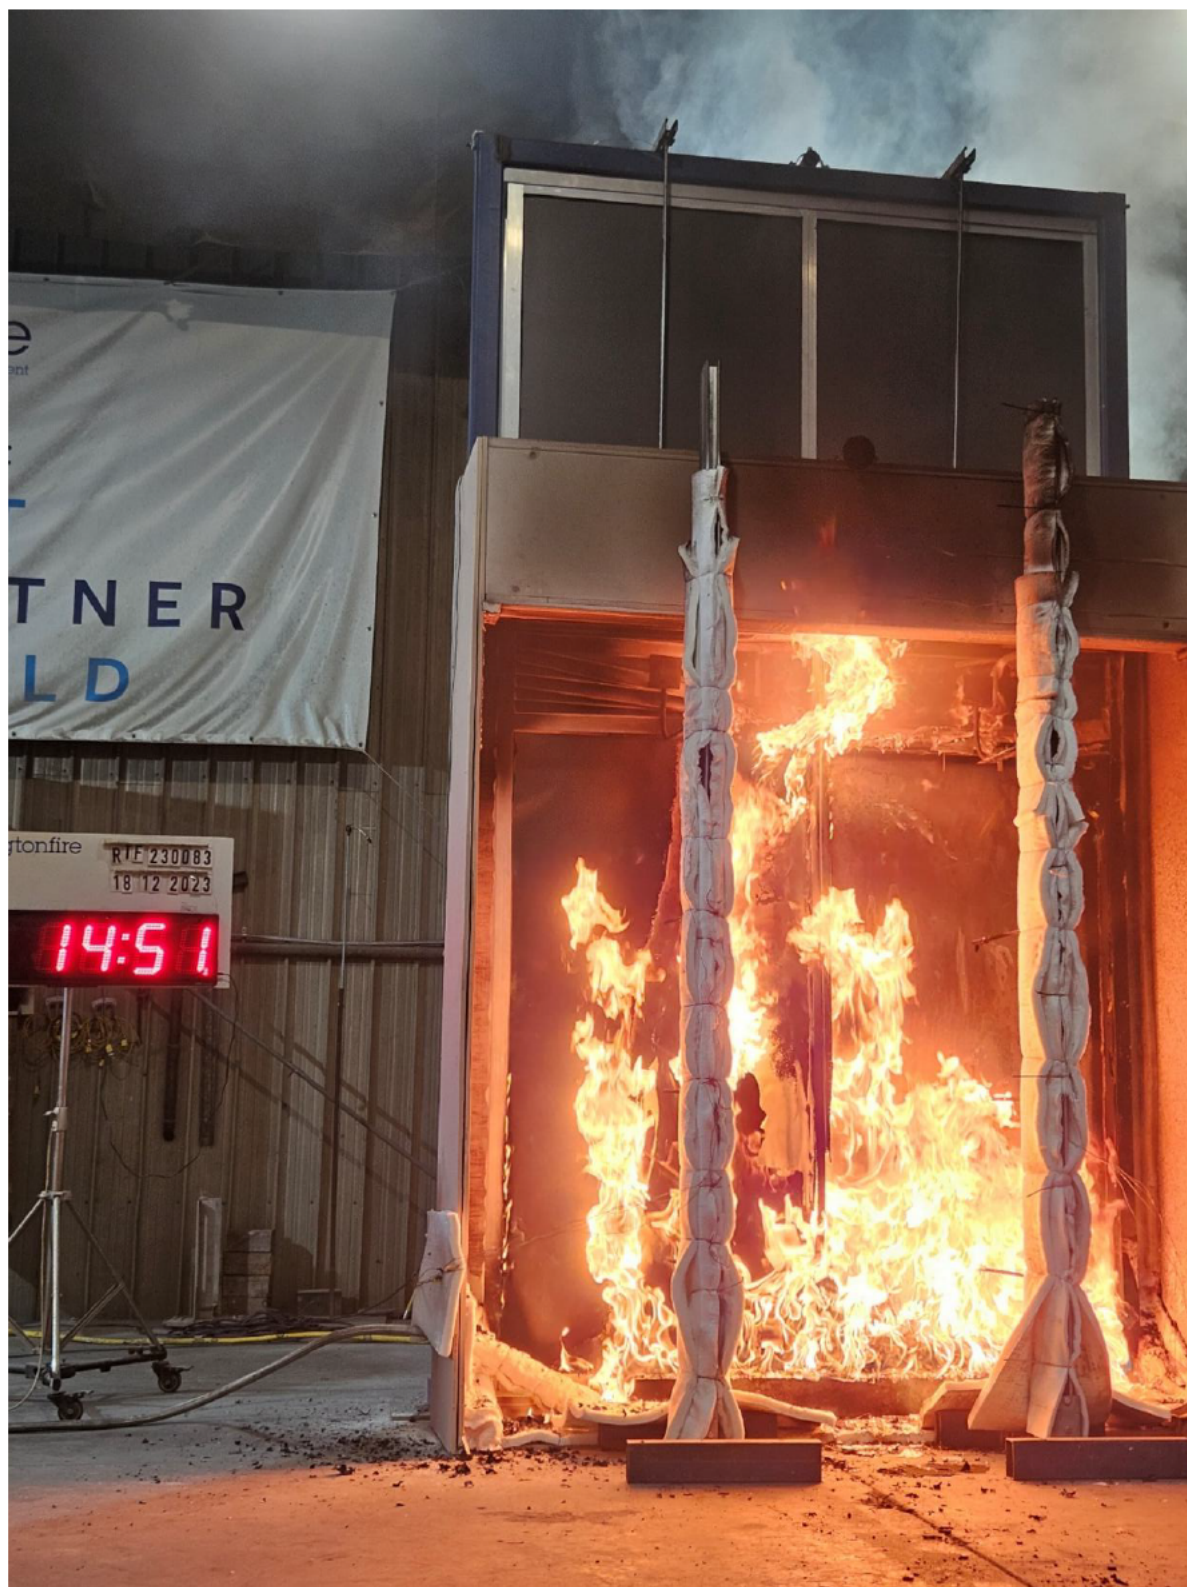
**Figure 23 The specimen 14 minutes 51 seconds into the test**

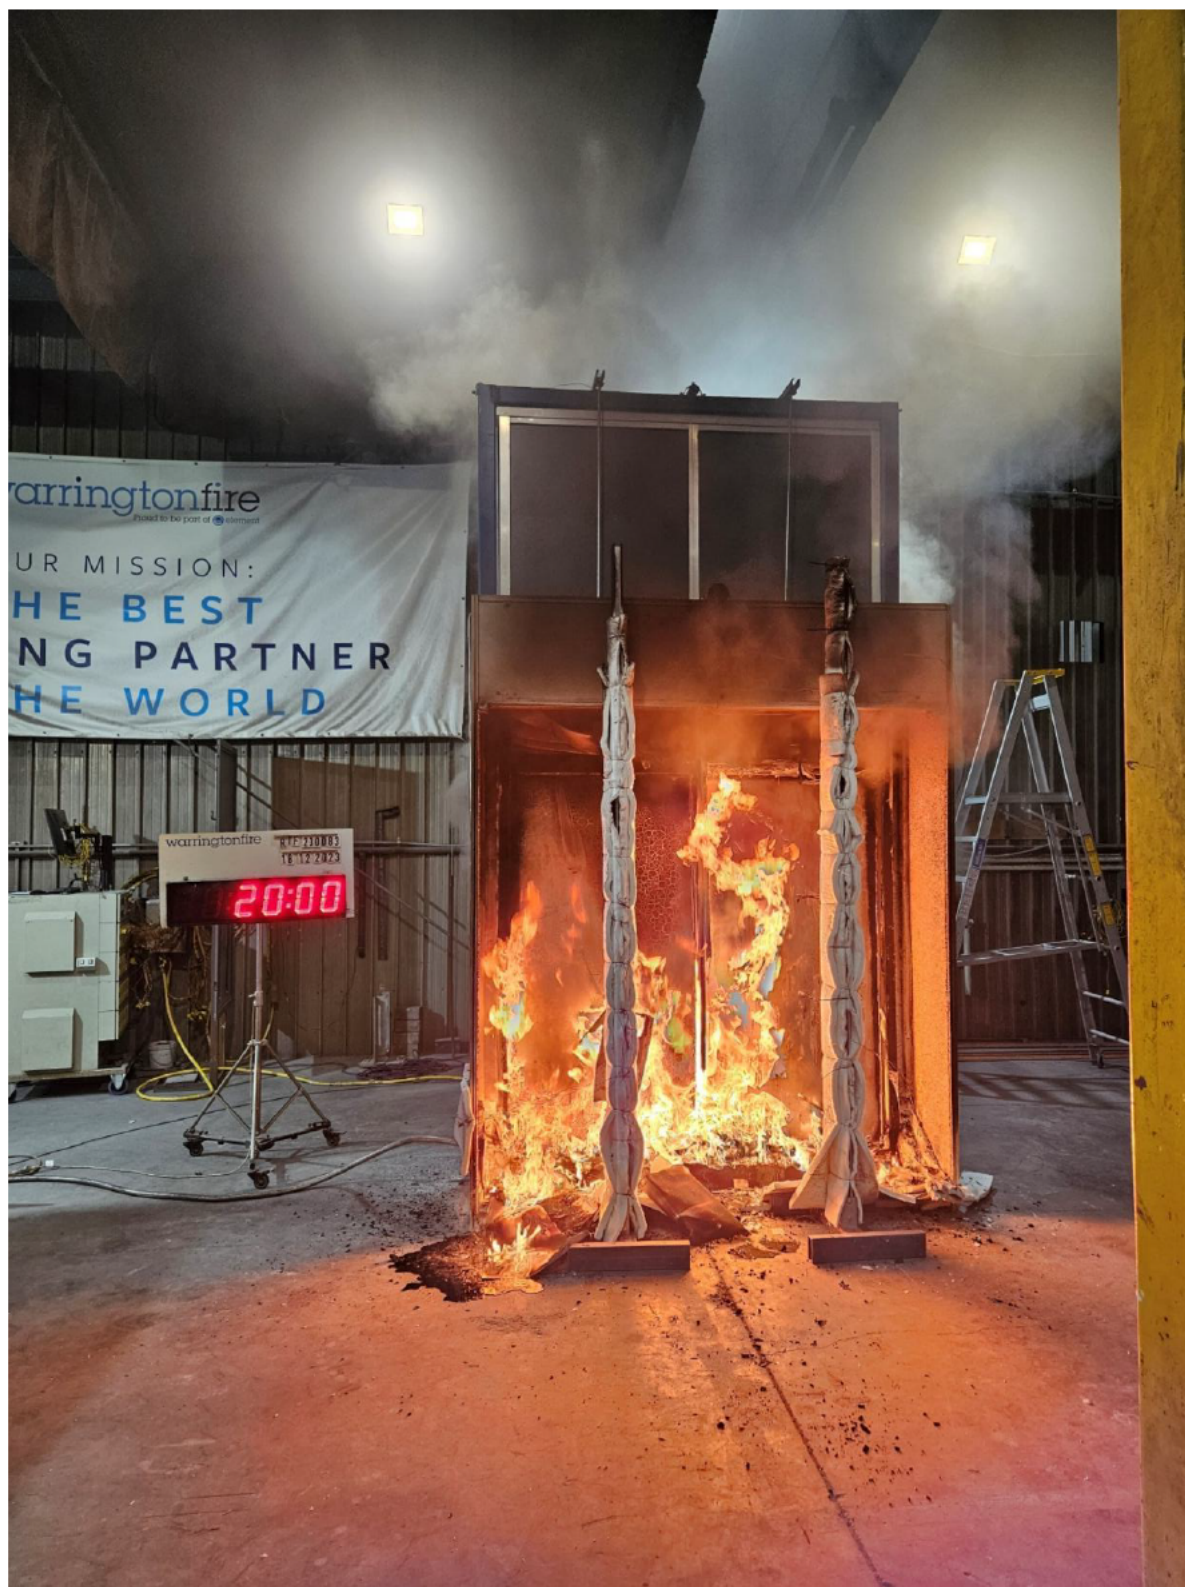
**Figure 24** The specimen 20 minutes into the test

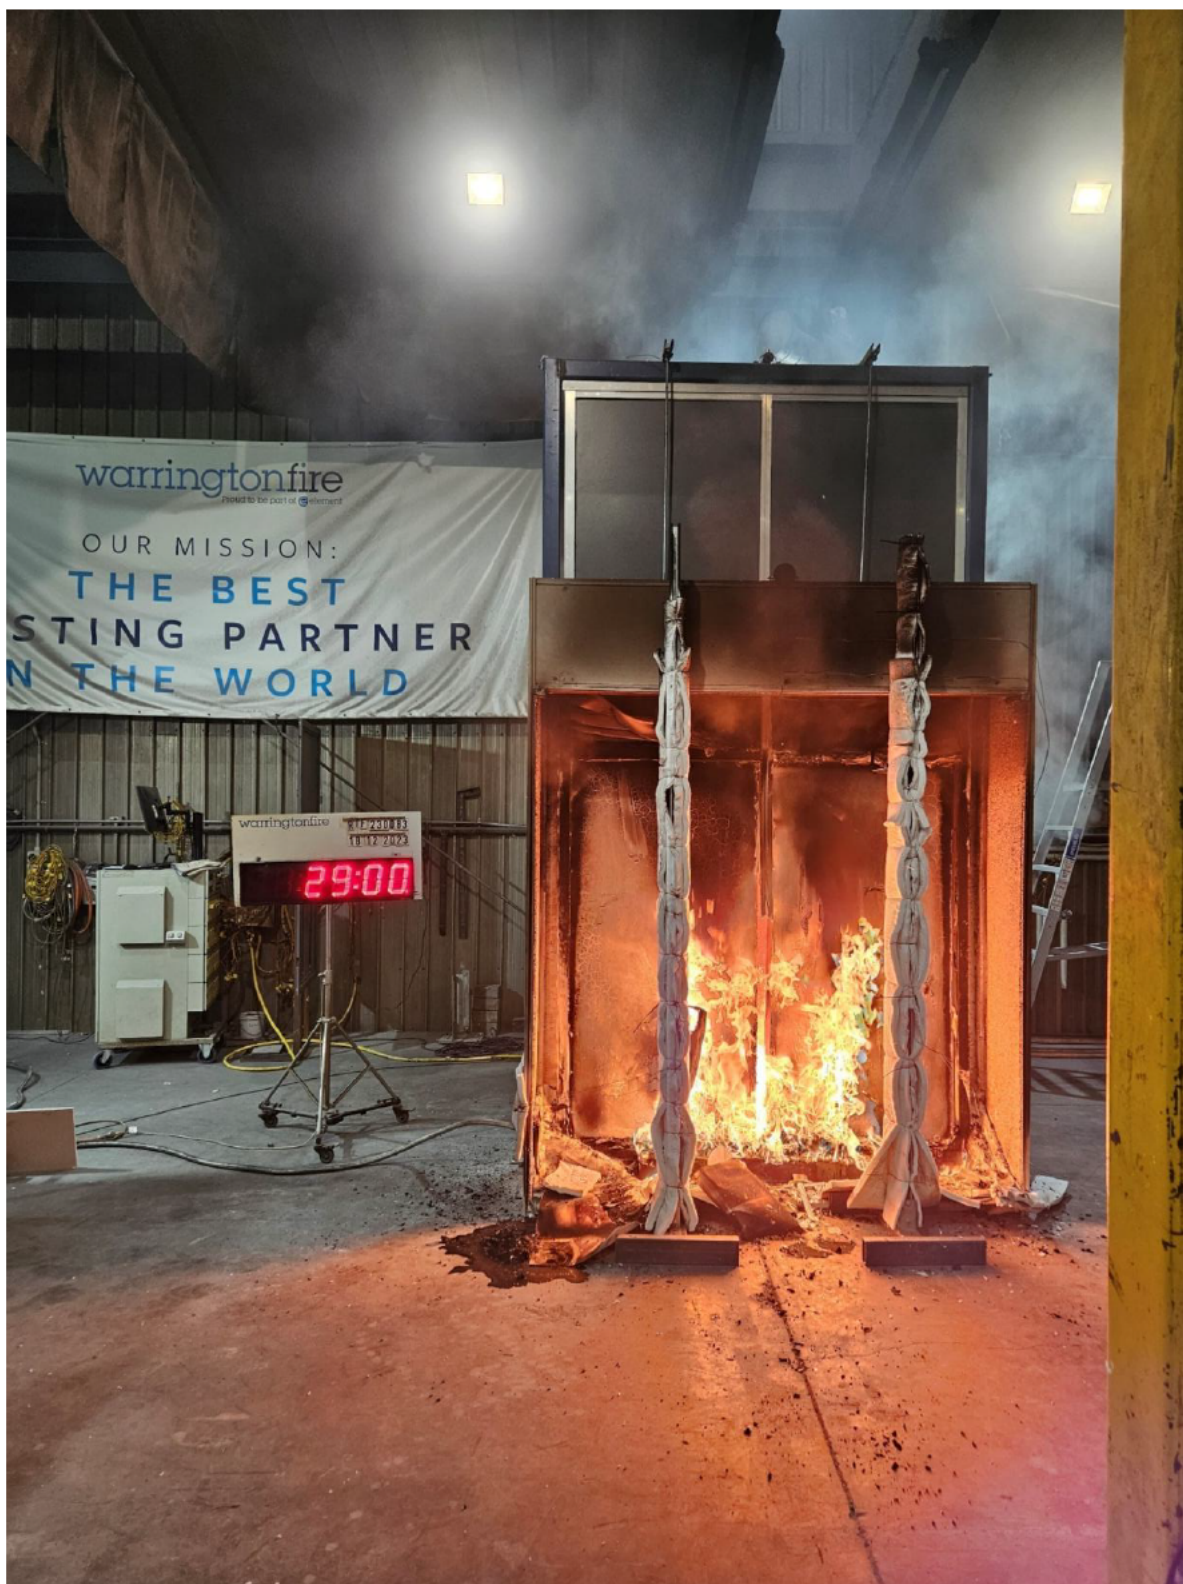
**Figure 25** The specimen 29 minutes into the test

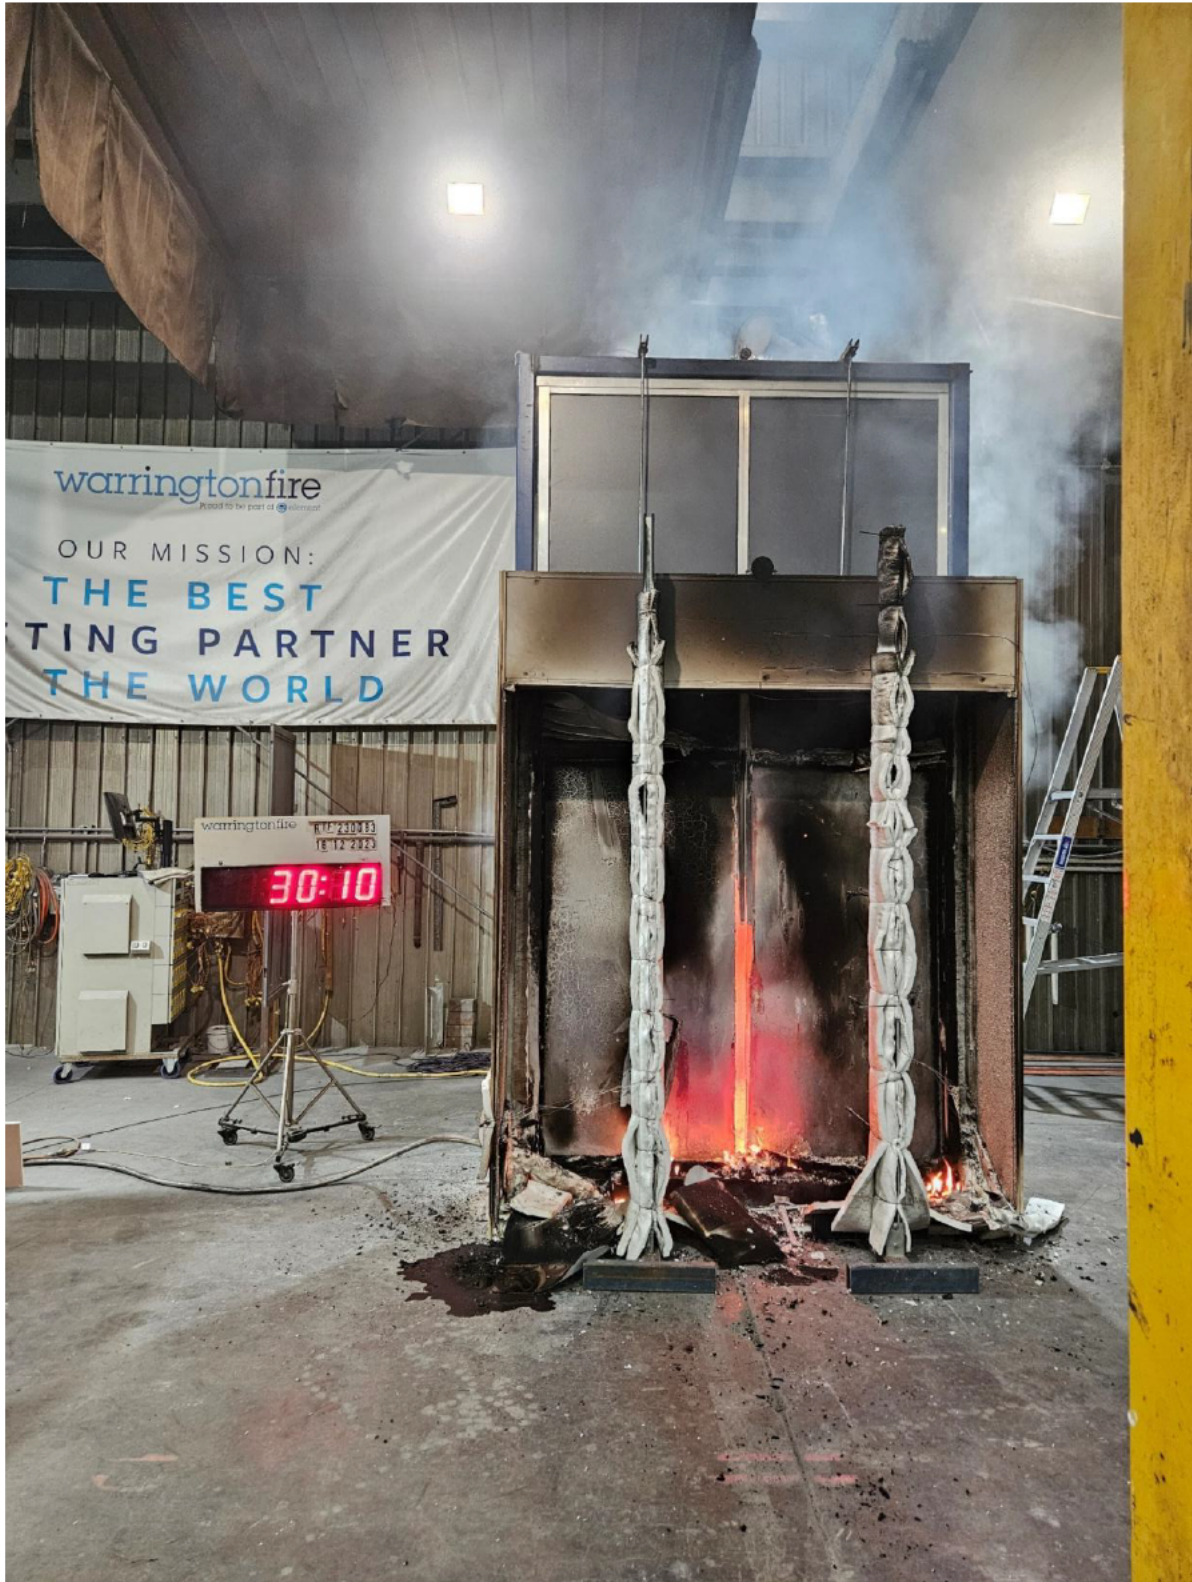
**Figure 26** The specimen 10 seconds after the burner was turned off (30 minutes 10 seconds into the test)

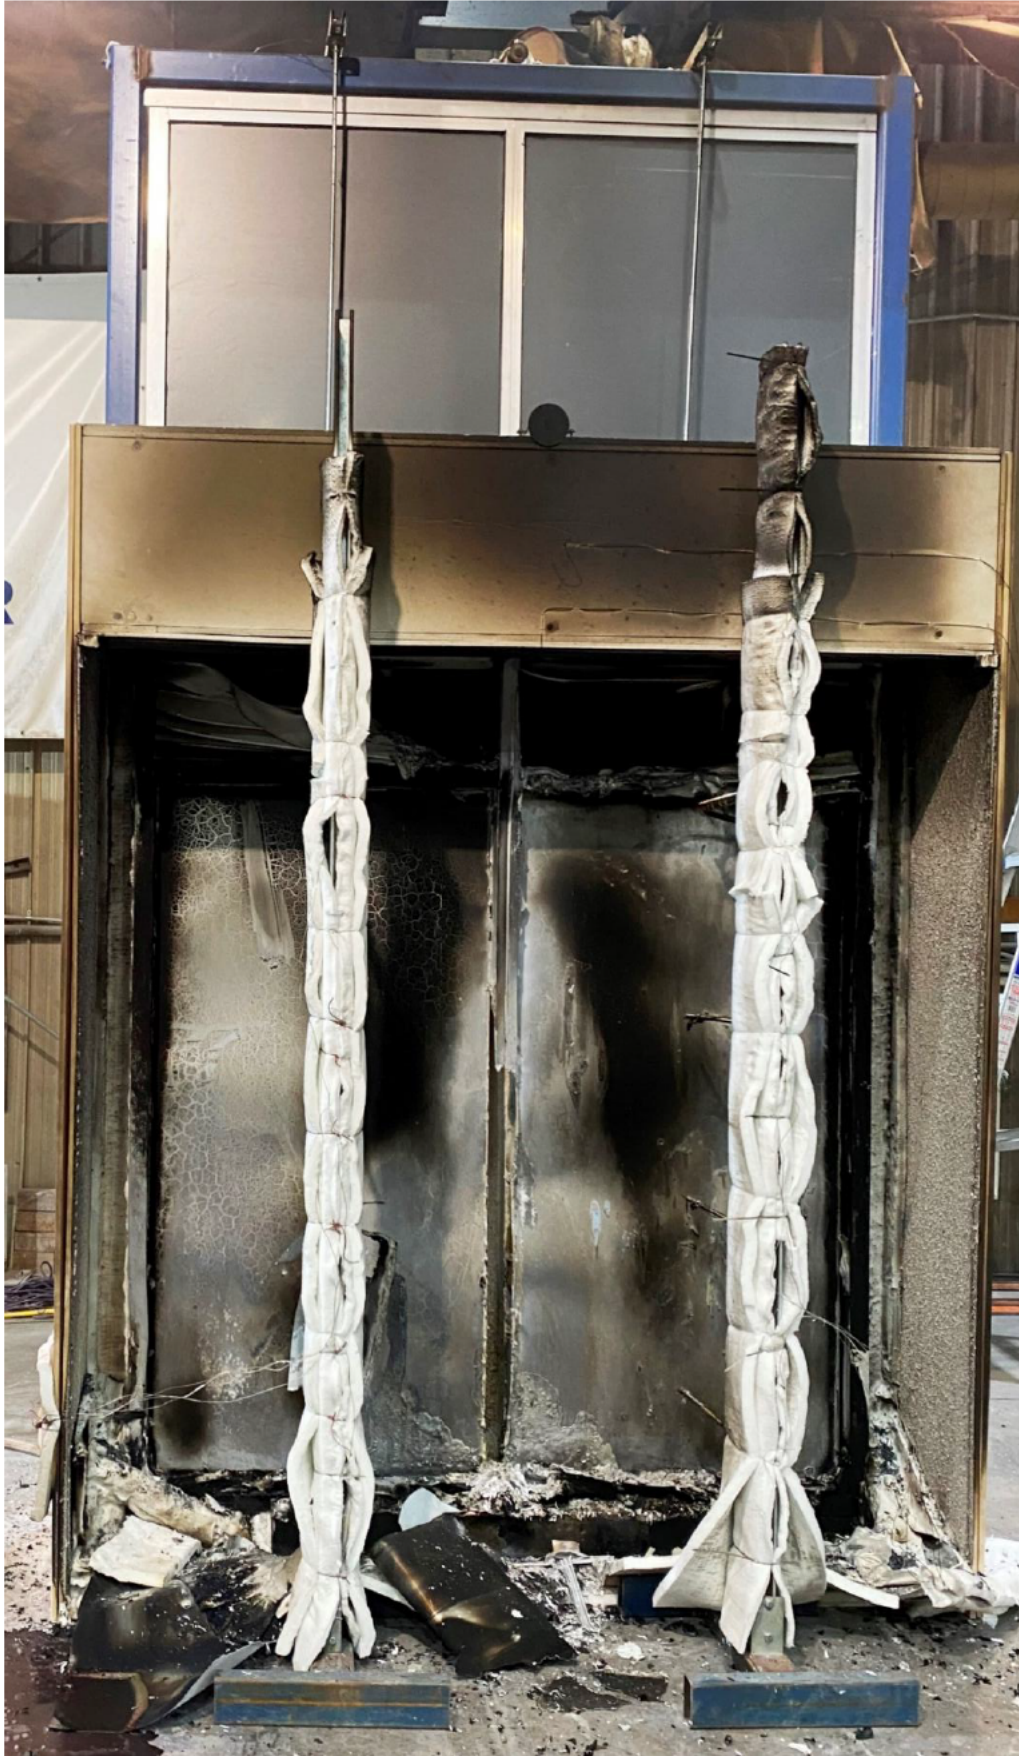
**Figure 27** The specimen after the test.

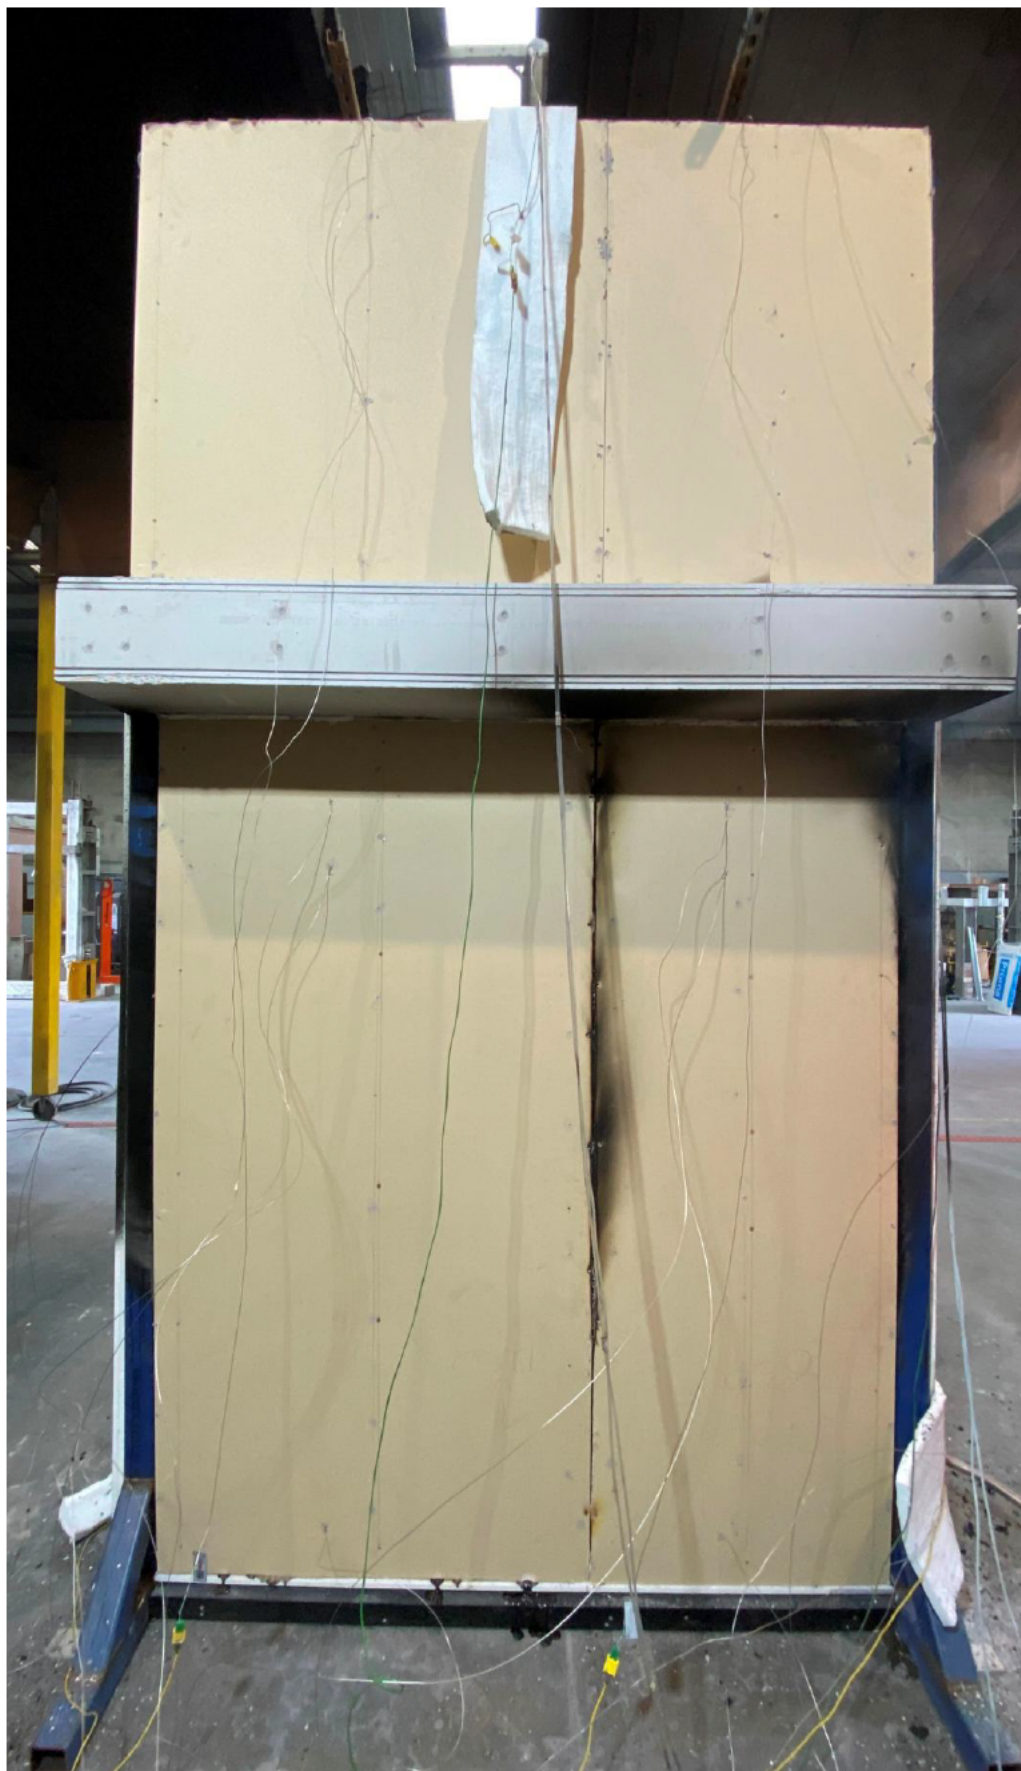
**Figure 28 The specimen after the test – unexposed side.**

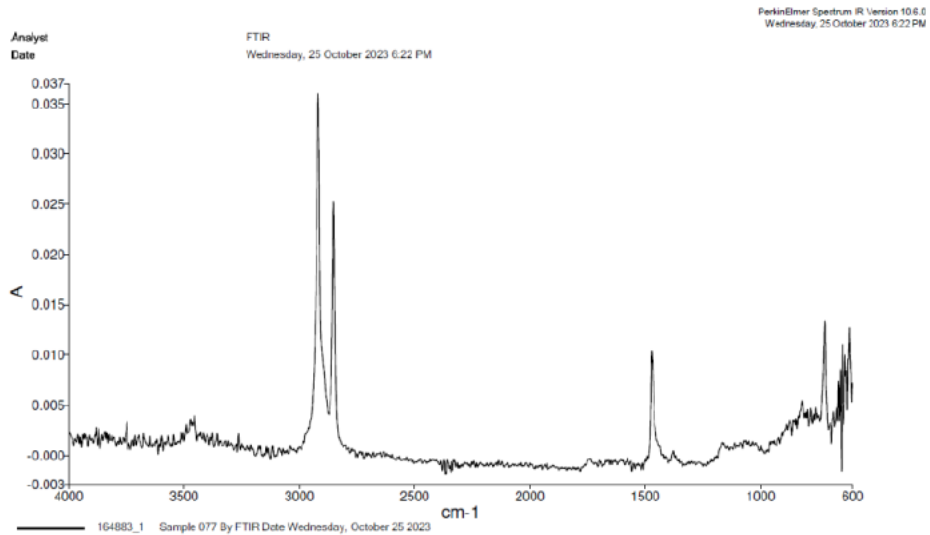
**Figure 1: Sample 164883 - FTIR of Building Façade System.**

Sample ID	Sample Type	Core Colour	ATR-FTIR Spectra
164883	ACP	Black	Figure 1
164884	ACP	Black	Figure 2

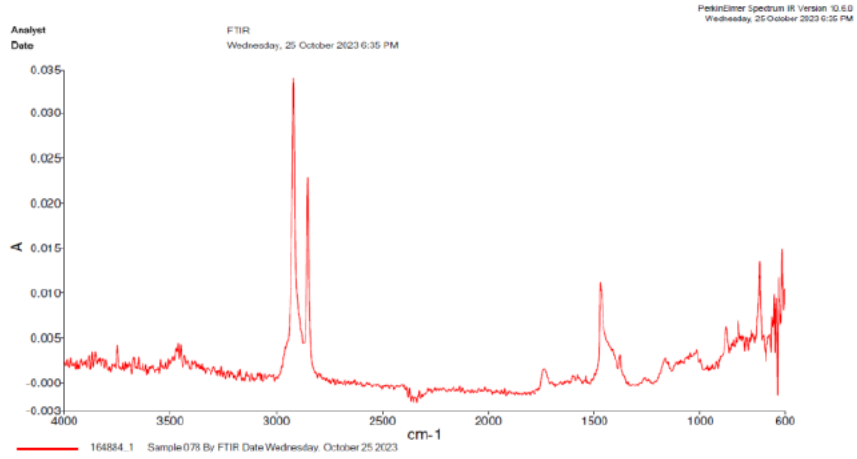
**Figure 2: Sample 164884 - FTIR of Building Façade System.**

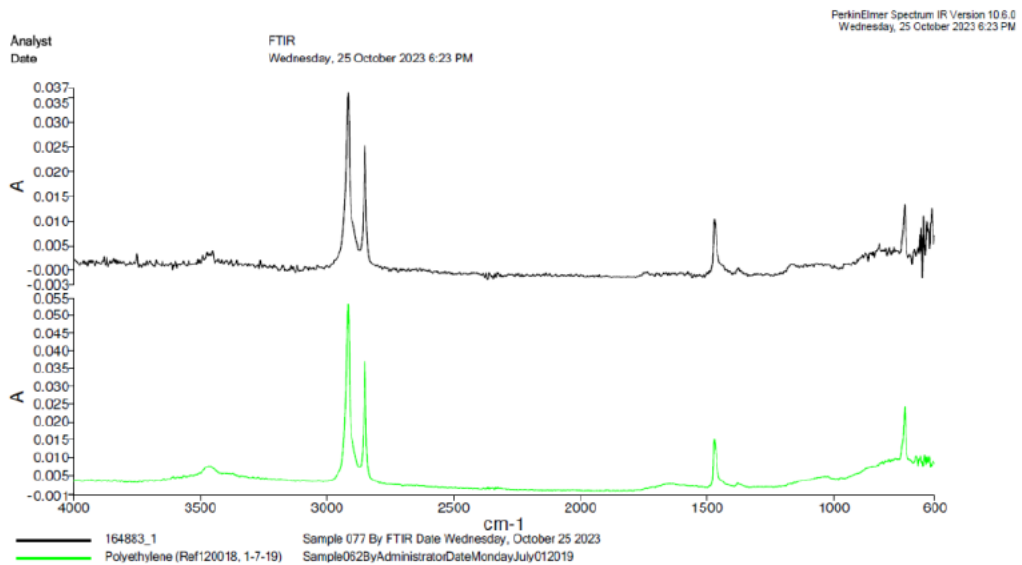
**Figure 3: - FTIR Spectral Comparisons of Known Material with Sample 164883.**

Sample ID	Sample Type	Core Colour	Identified Major Components by FTIR	Figure
164883	ACP	Black	Polyethylene with no filler	Figure 3
164884	ACP	Black	Polyethylene with unidentified filler	Figure 4

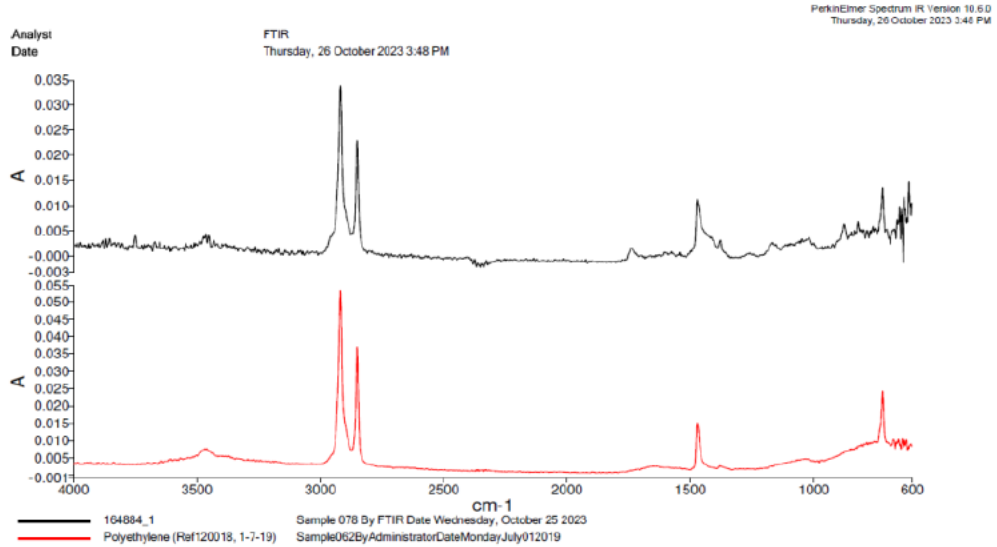
**Figure 4: - FTIR Spectral Comparisons of Known Material with Sample 164884.**

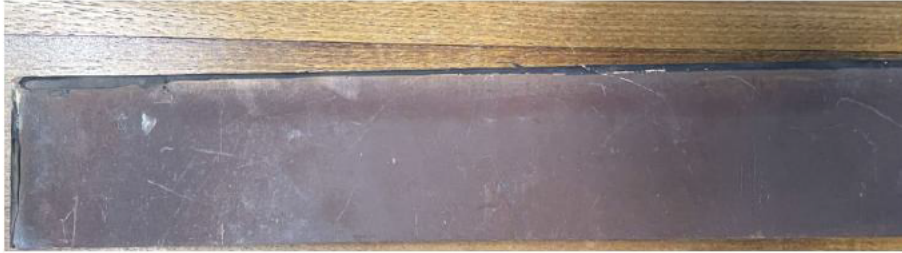
**Photo 3, Sample 164884 as received.**
