Reaction to fire test report

Test standard: Ad-hoc test based off ISO 13785-1:2002

System: An aluminium composite panel (ACP) wall system and a mock balcony setup representative of an in-situ façade - [REDACTED]

Job number: RTF230084

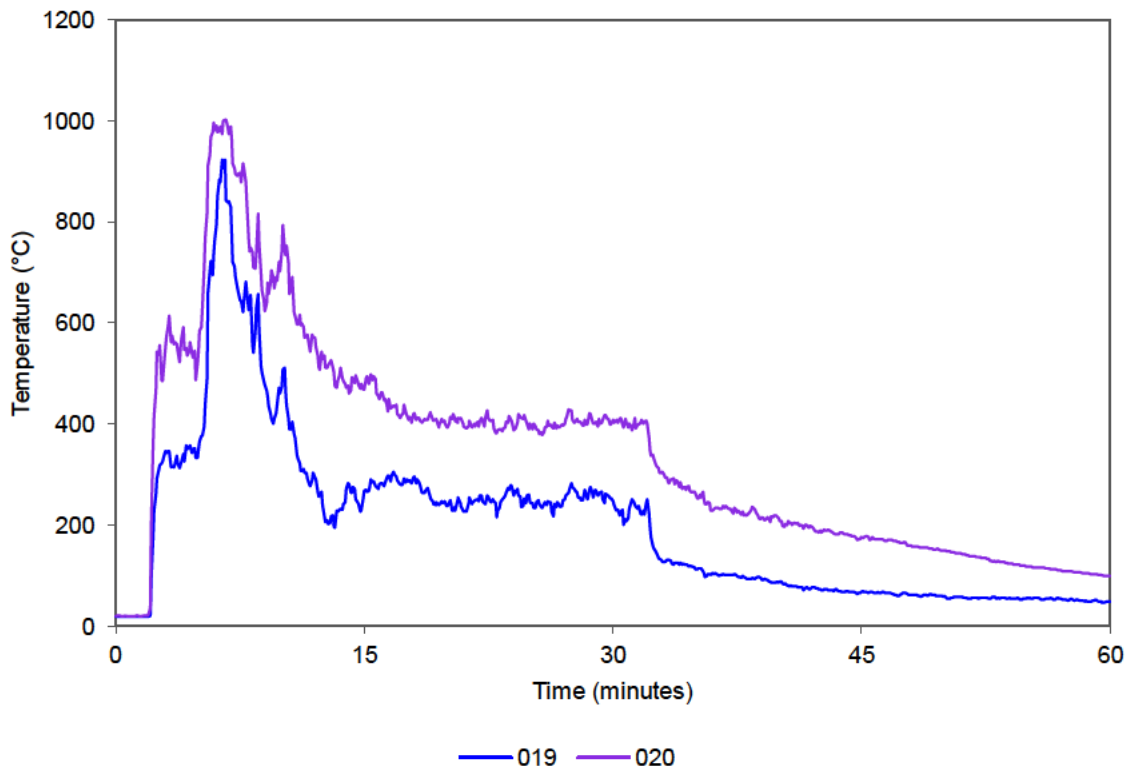
Figure 8 External temperature data collected by thermocouples placed 50 mm from balcony face and underside cavity

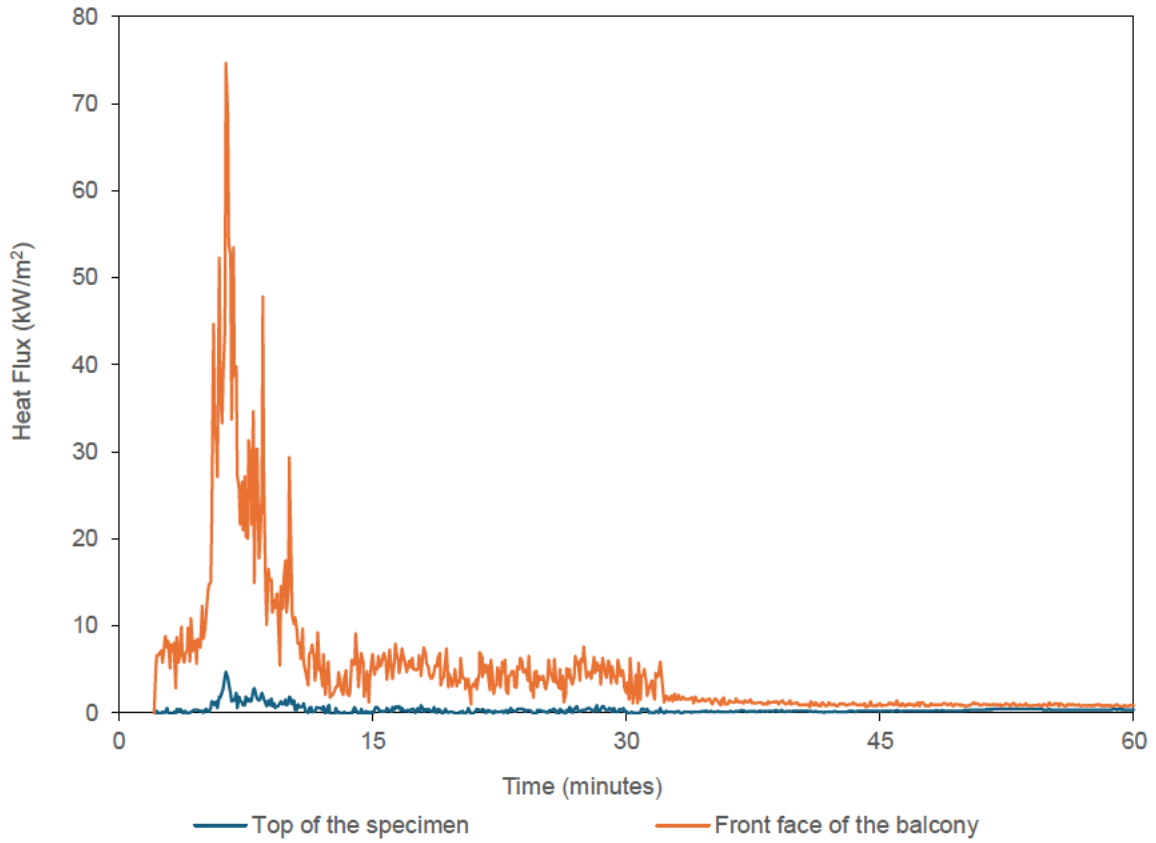
Figure 9 Heat flux data collected by heat flux gauges

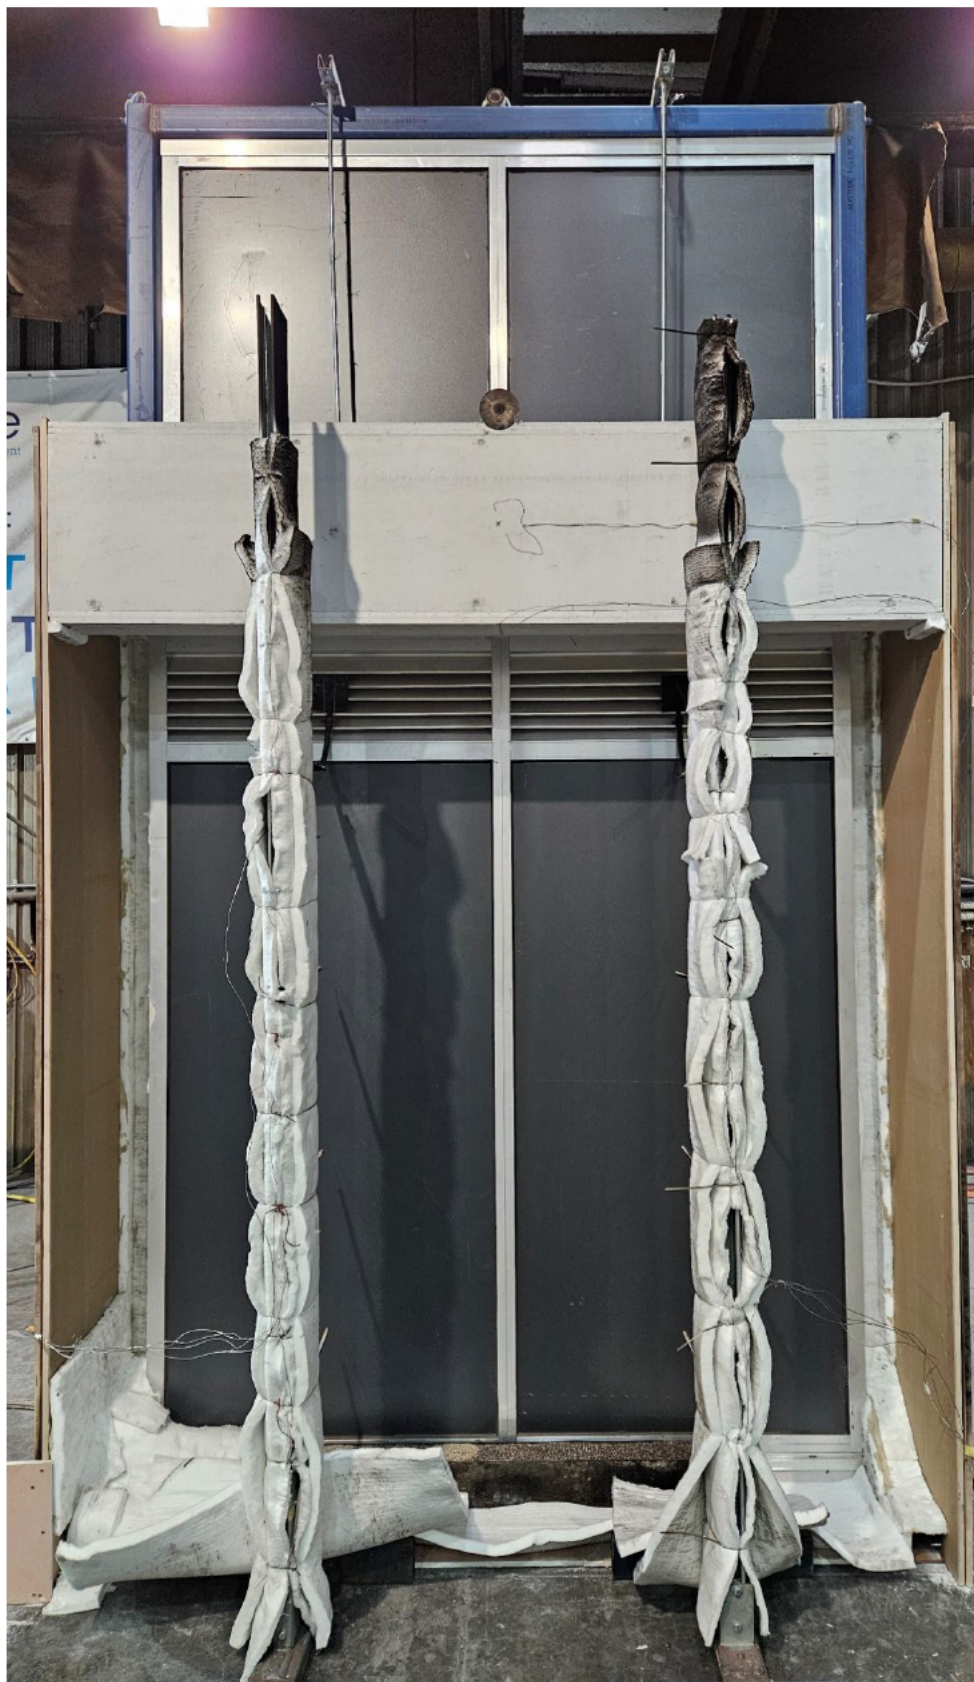
Figure 18 The specimen before the reaction to fire test

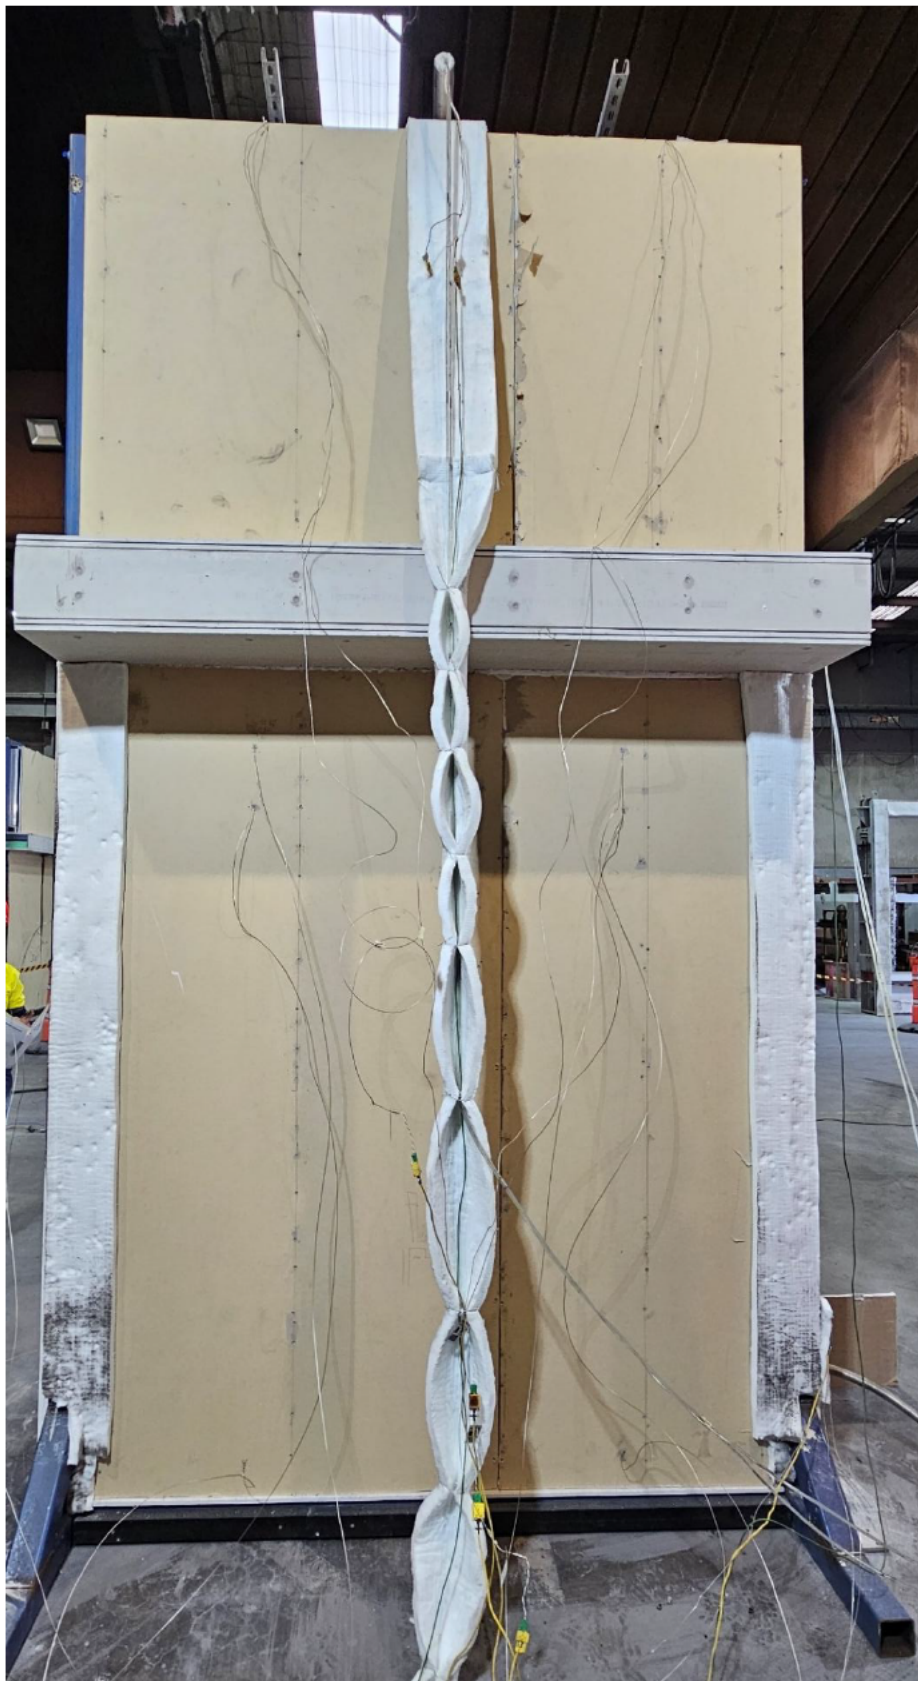
Figure 19 The specimen before the reaction to fire test – unexposed side

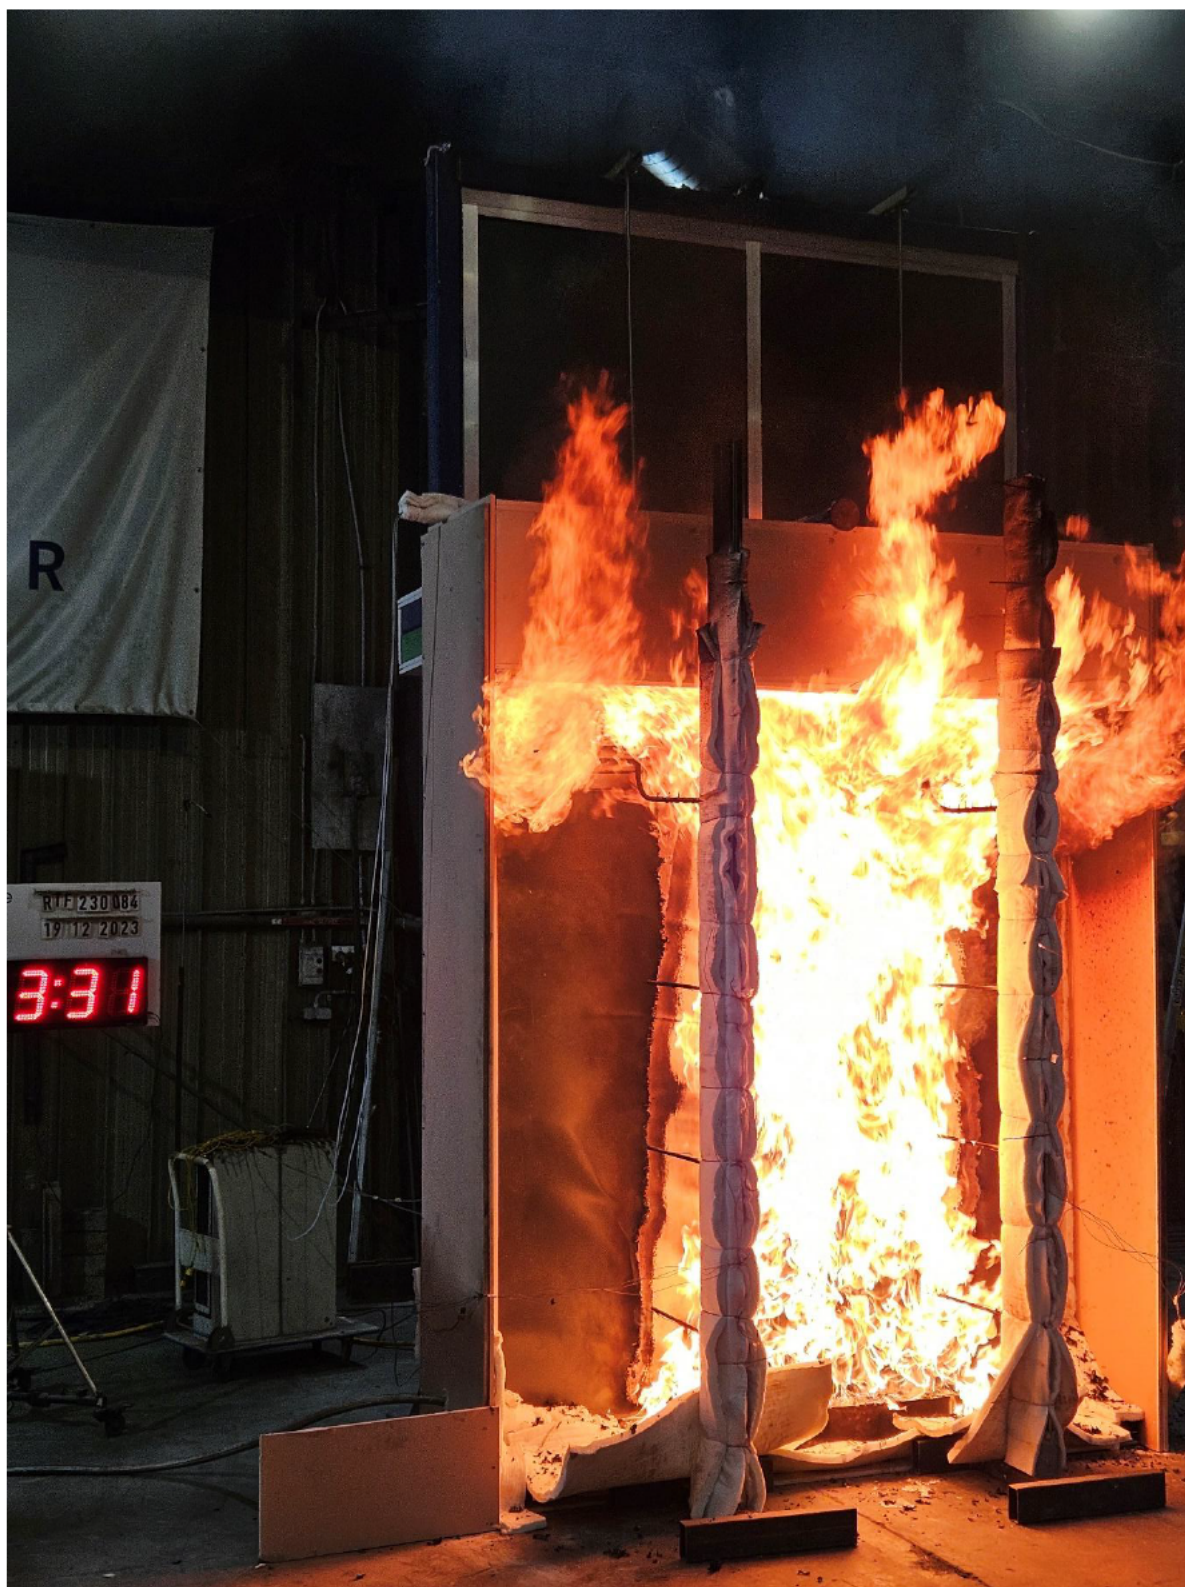
Figure 21 The specimen 3 minutes 31 seconds into the test

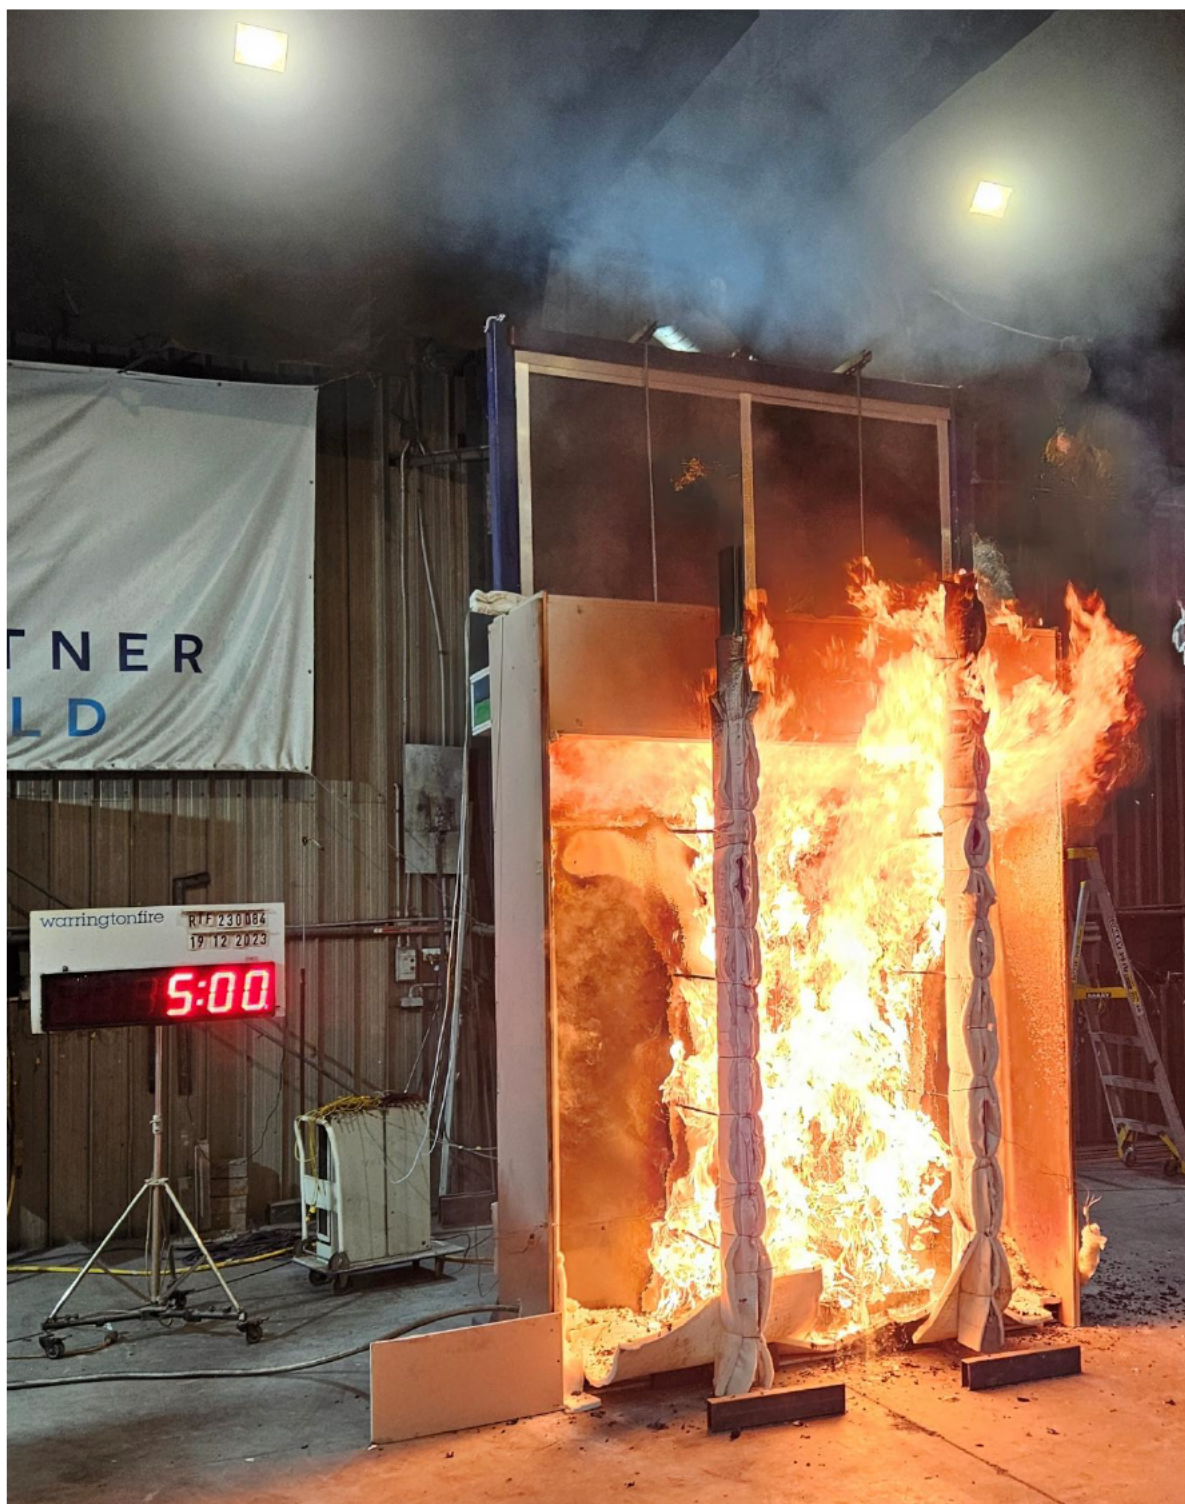
Figure 22 The specimen 5 minutes into the test

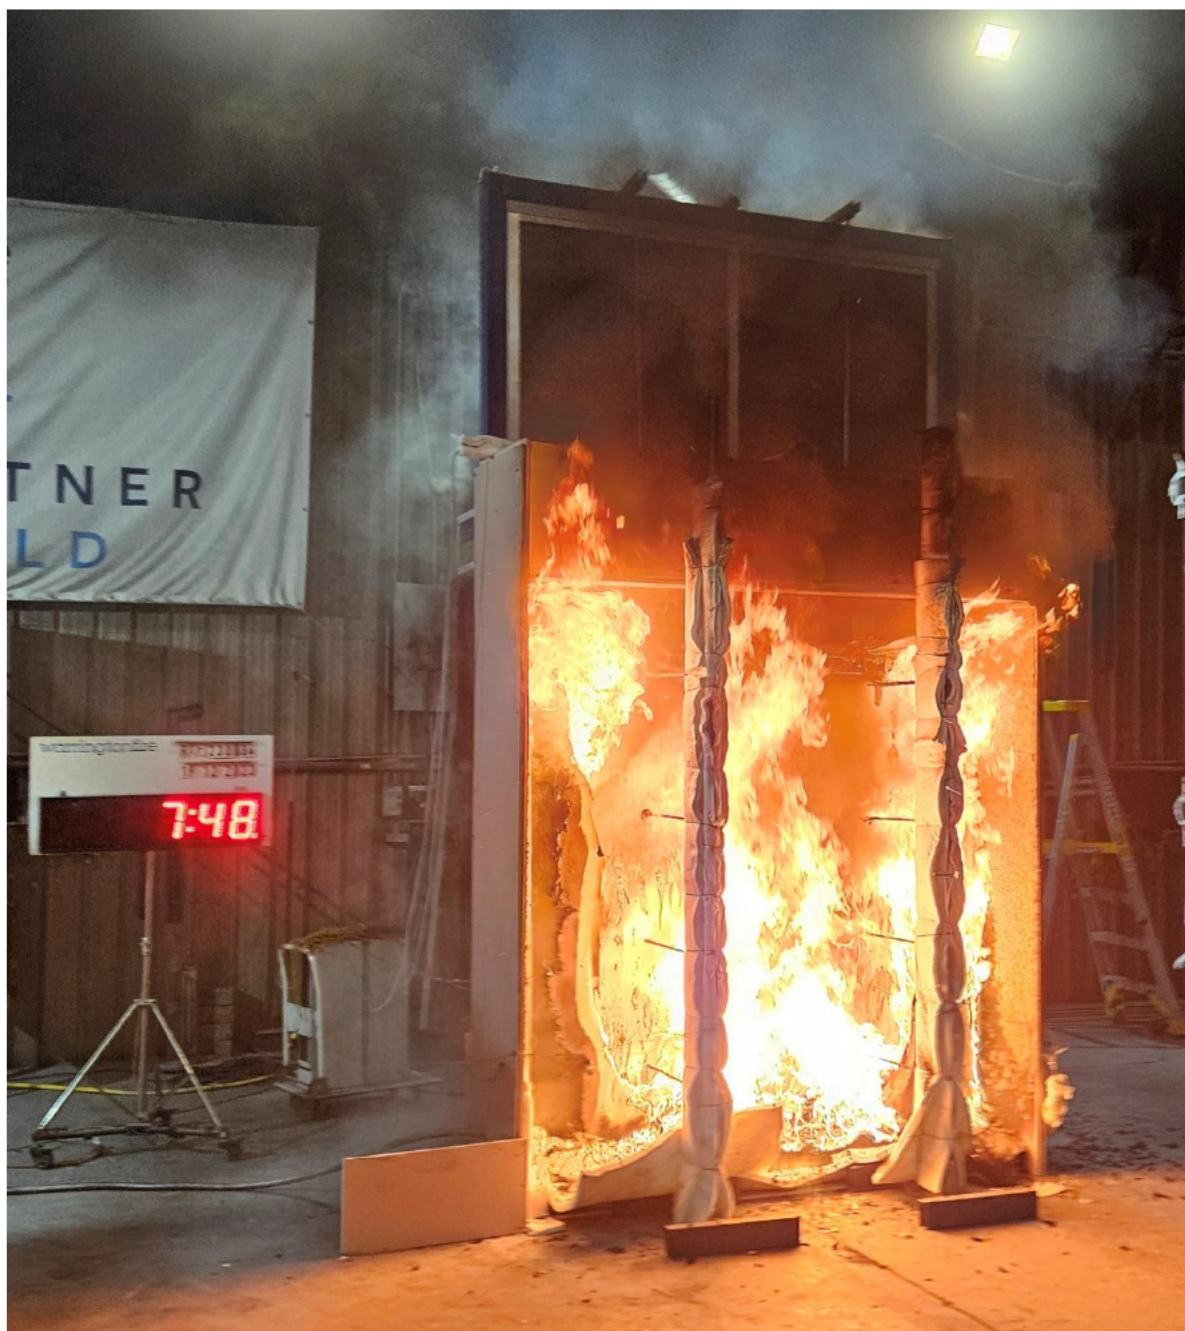
Figure 23 The specimen 7 minutes 48 seconds into the test

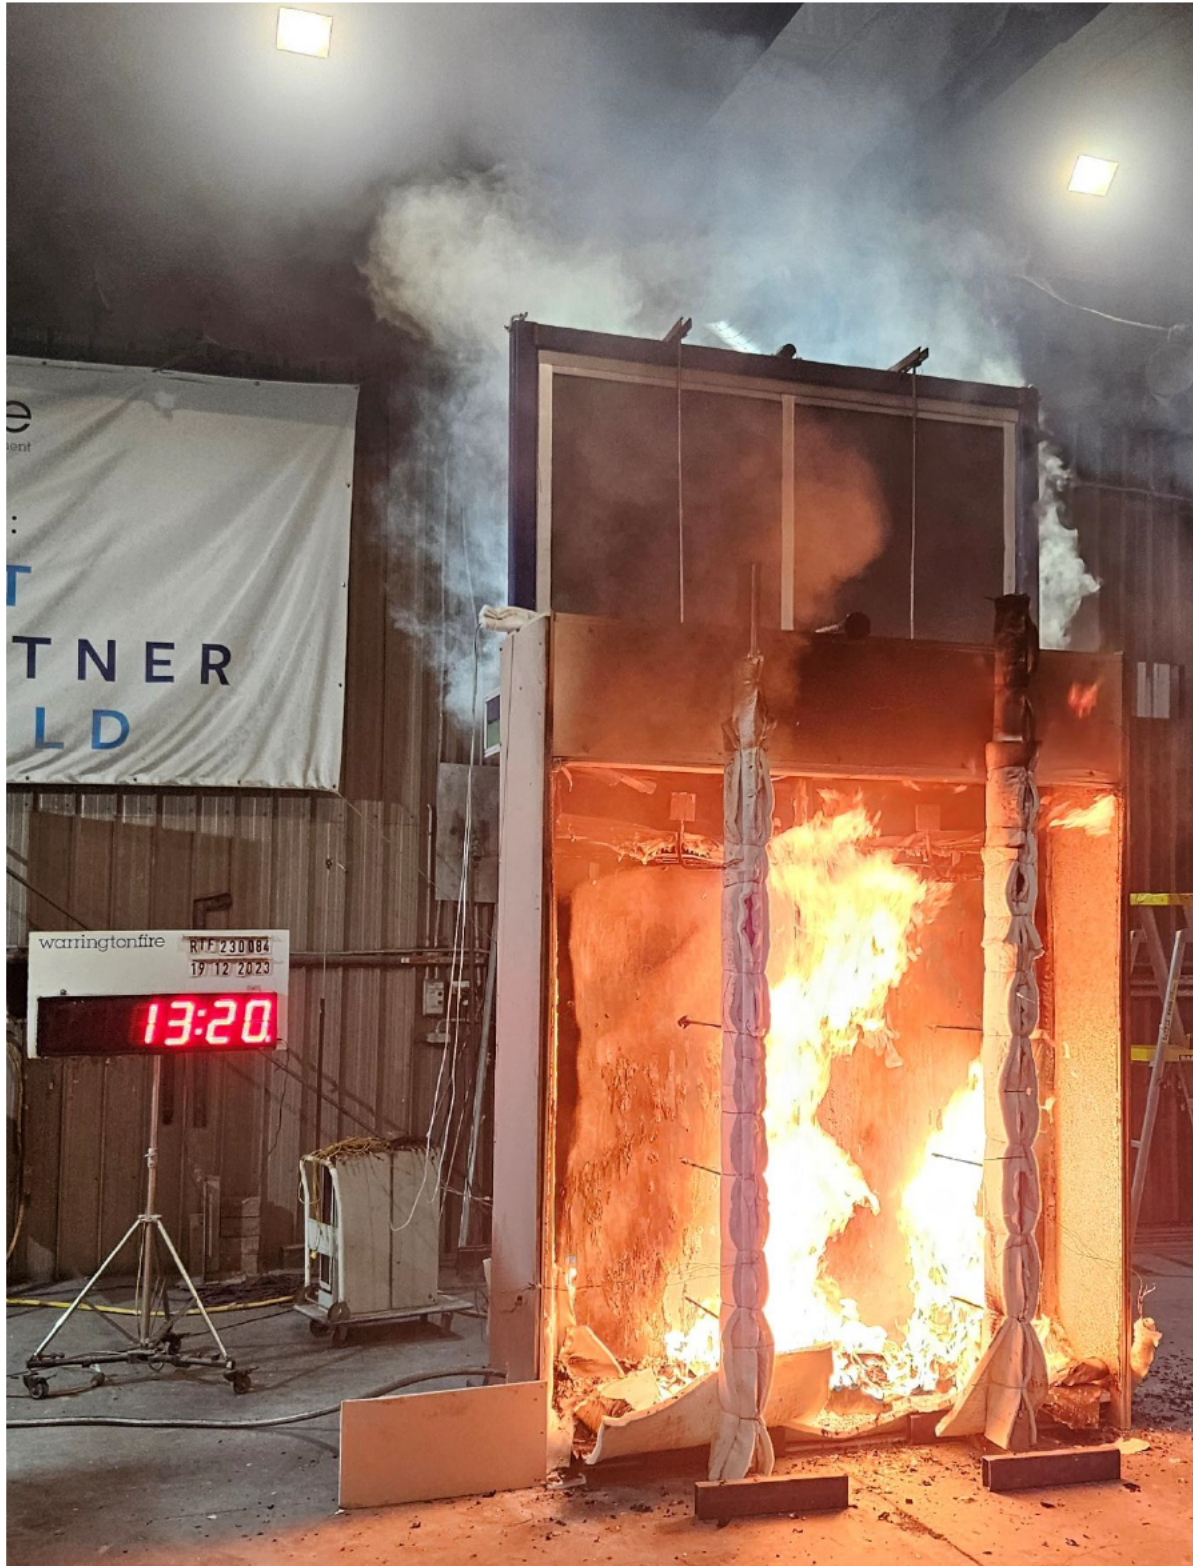
Figure 24 The specimen 13 minutes 20 seconds into the test

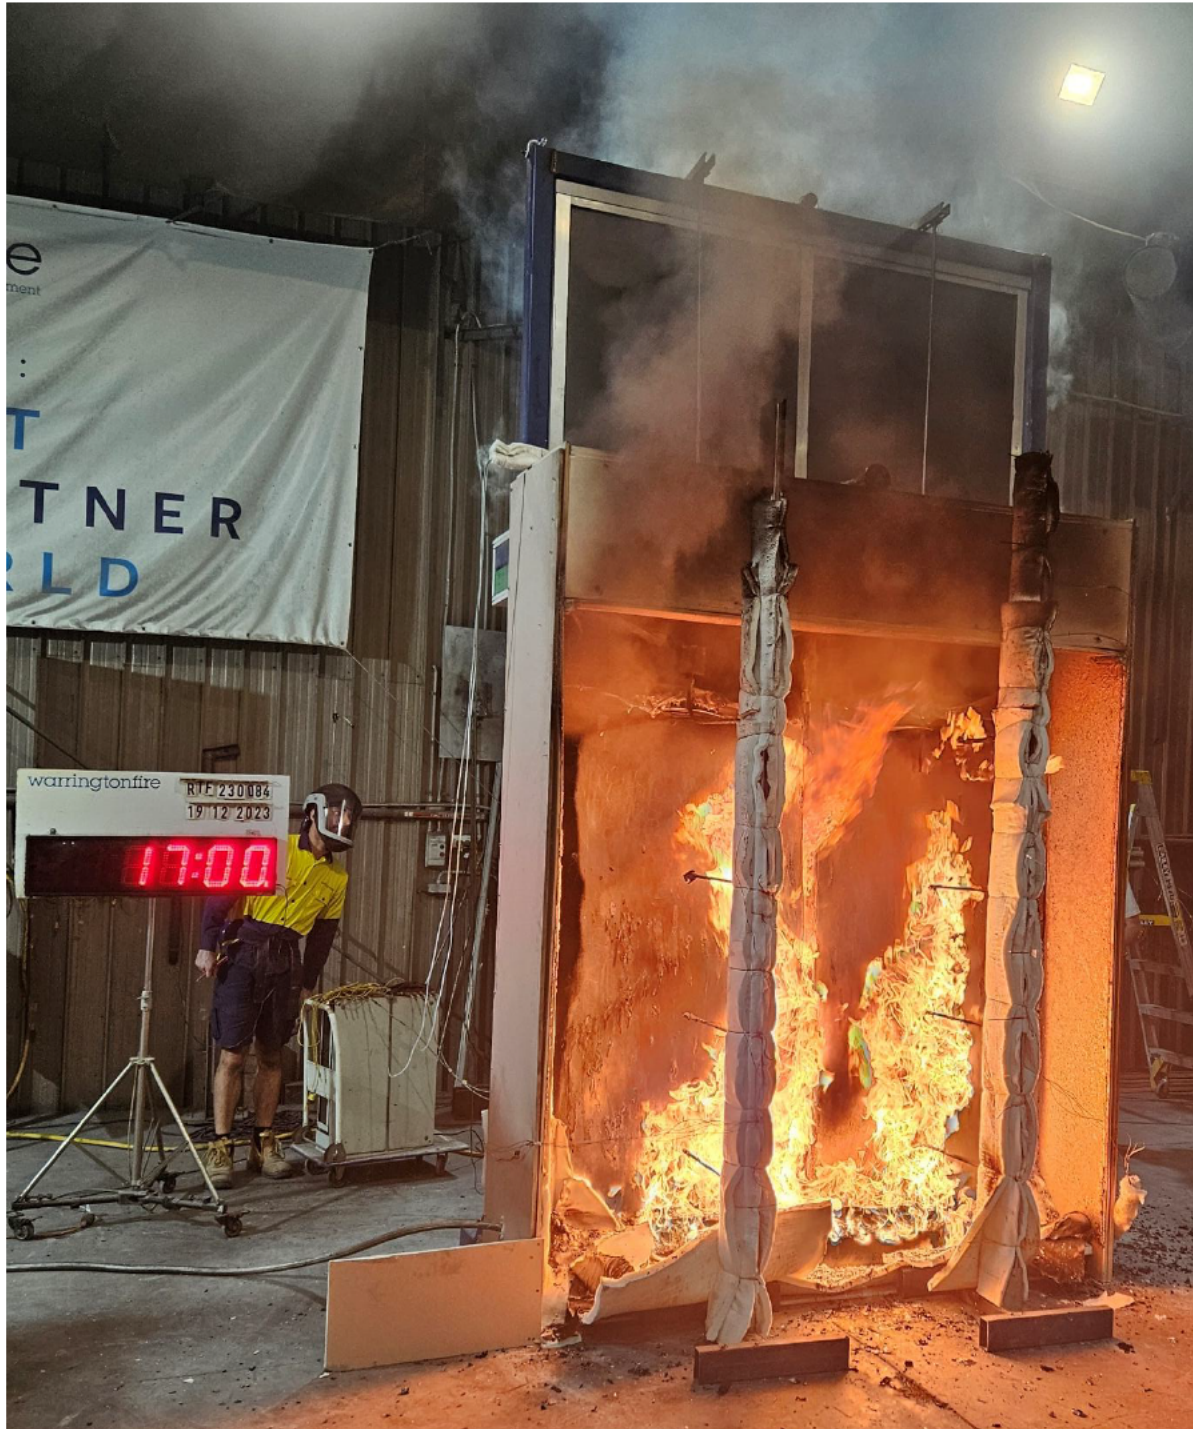
Figure 25 The specimen 17 minutes into the test

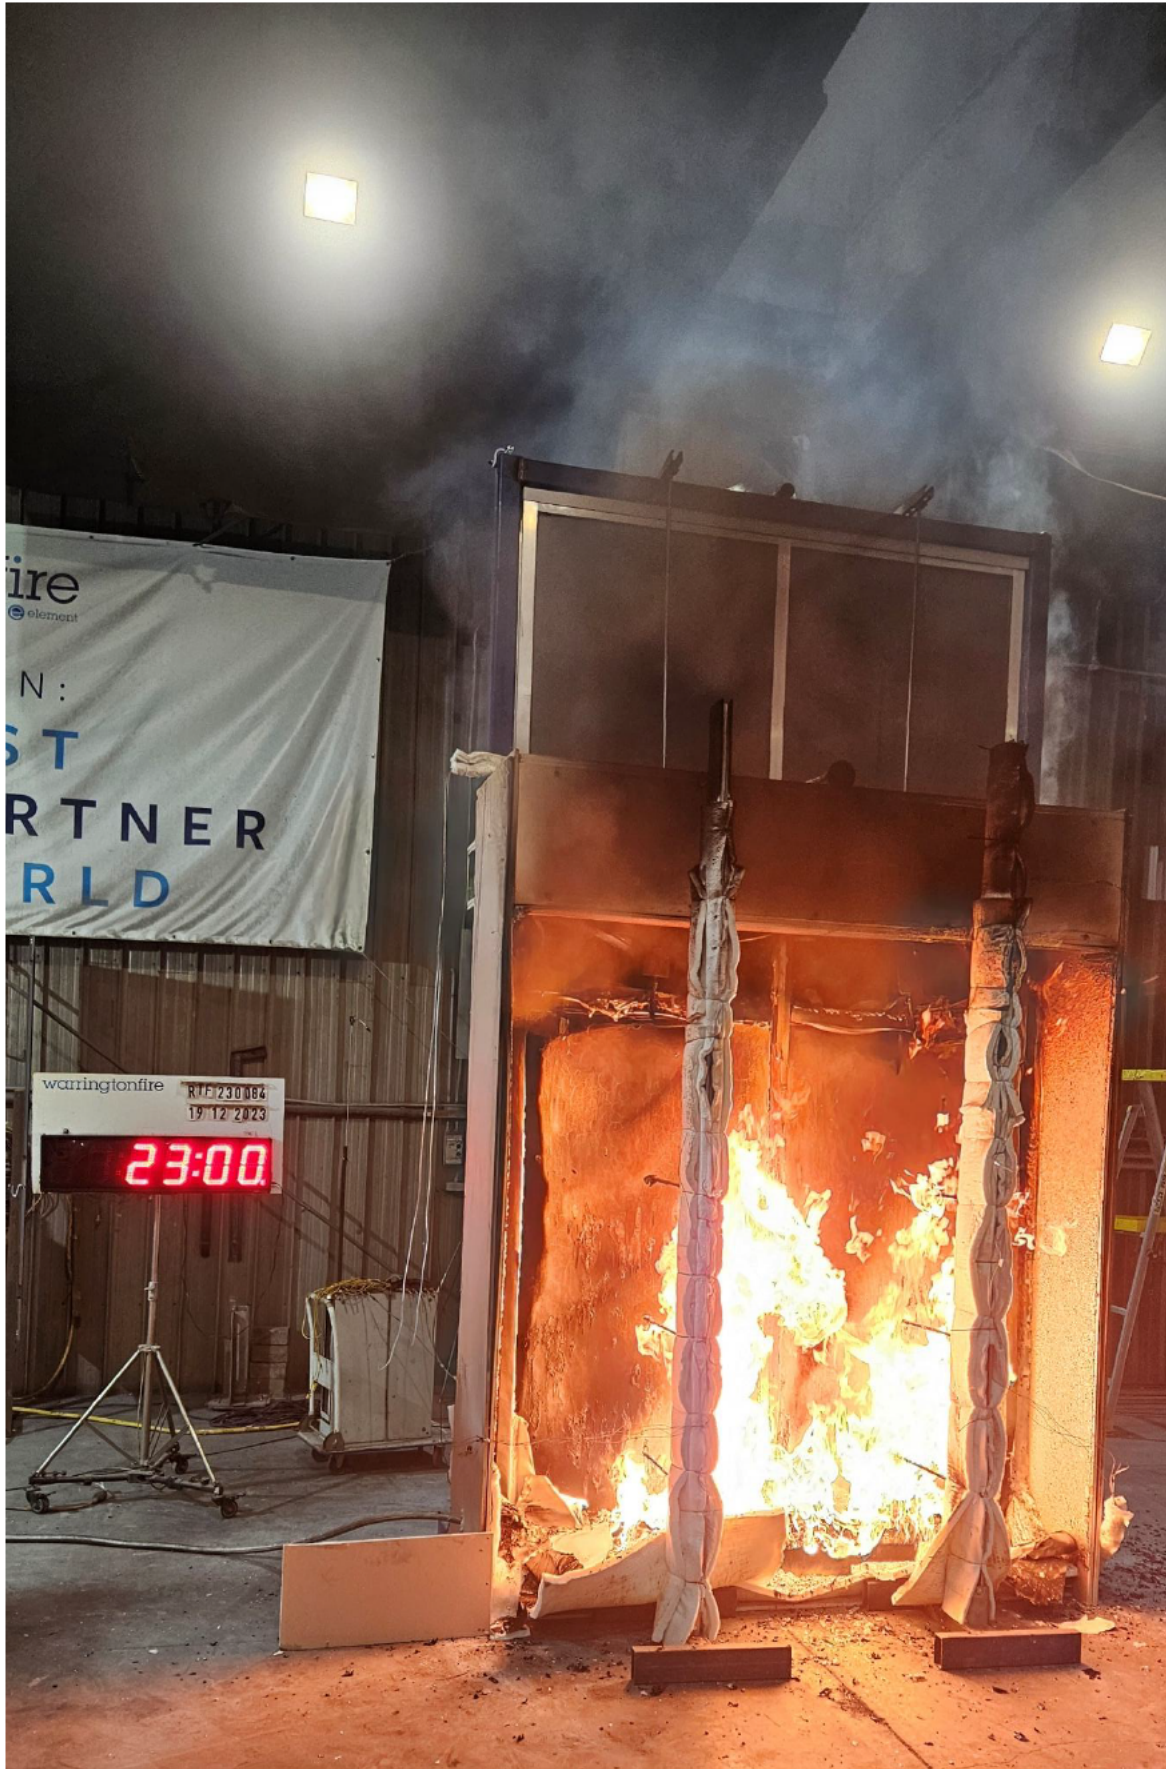
Figure 26 The specimen 23 minutes into the test

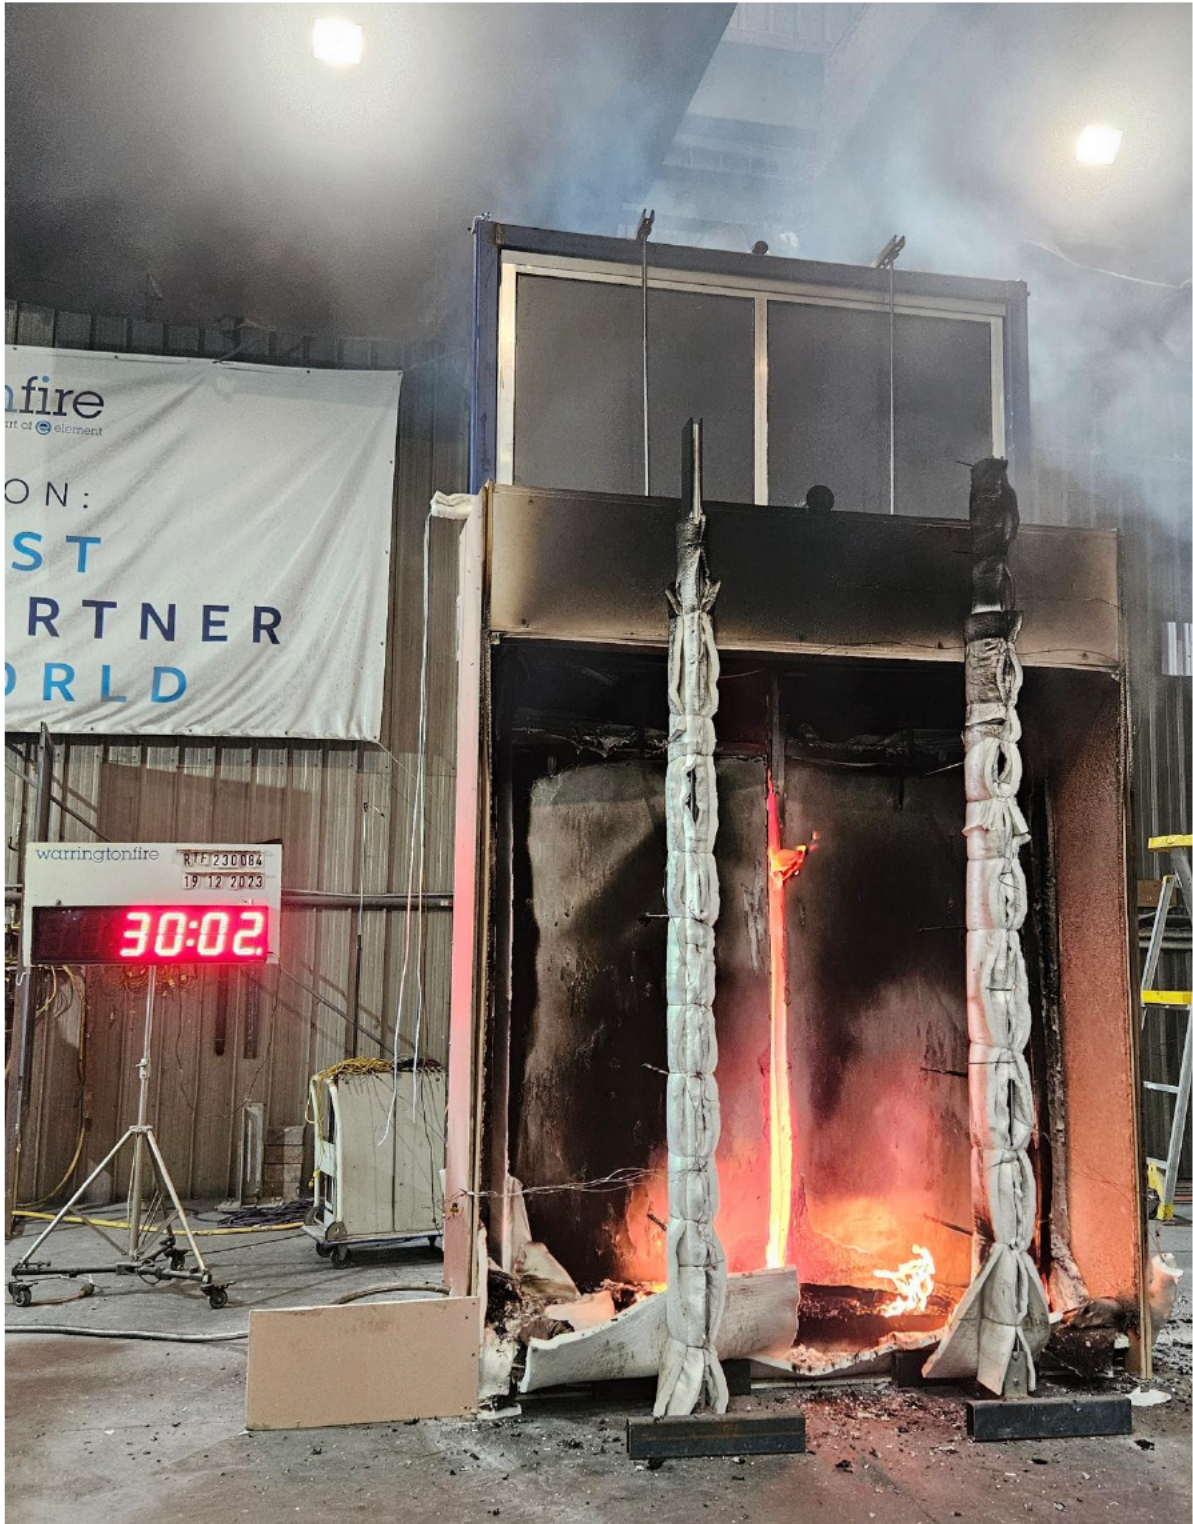
Figure 27 The specimen 2 seconds after the burner was turned off (30 minutes 2 seconds into the test)

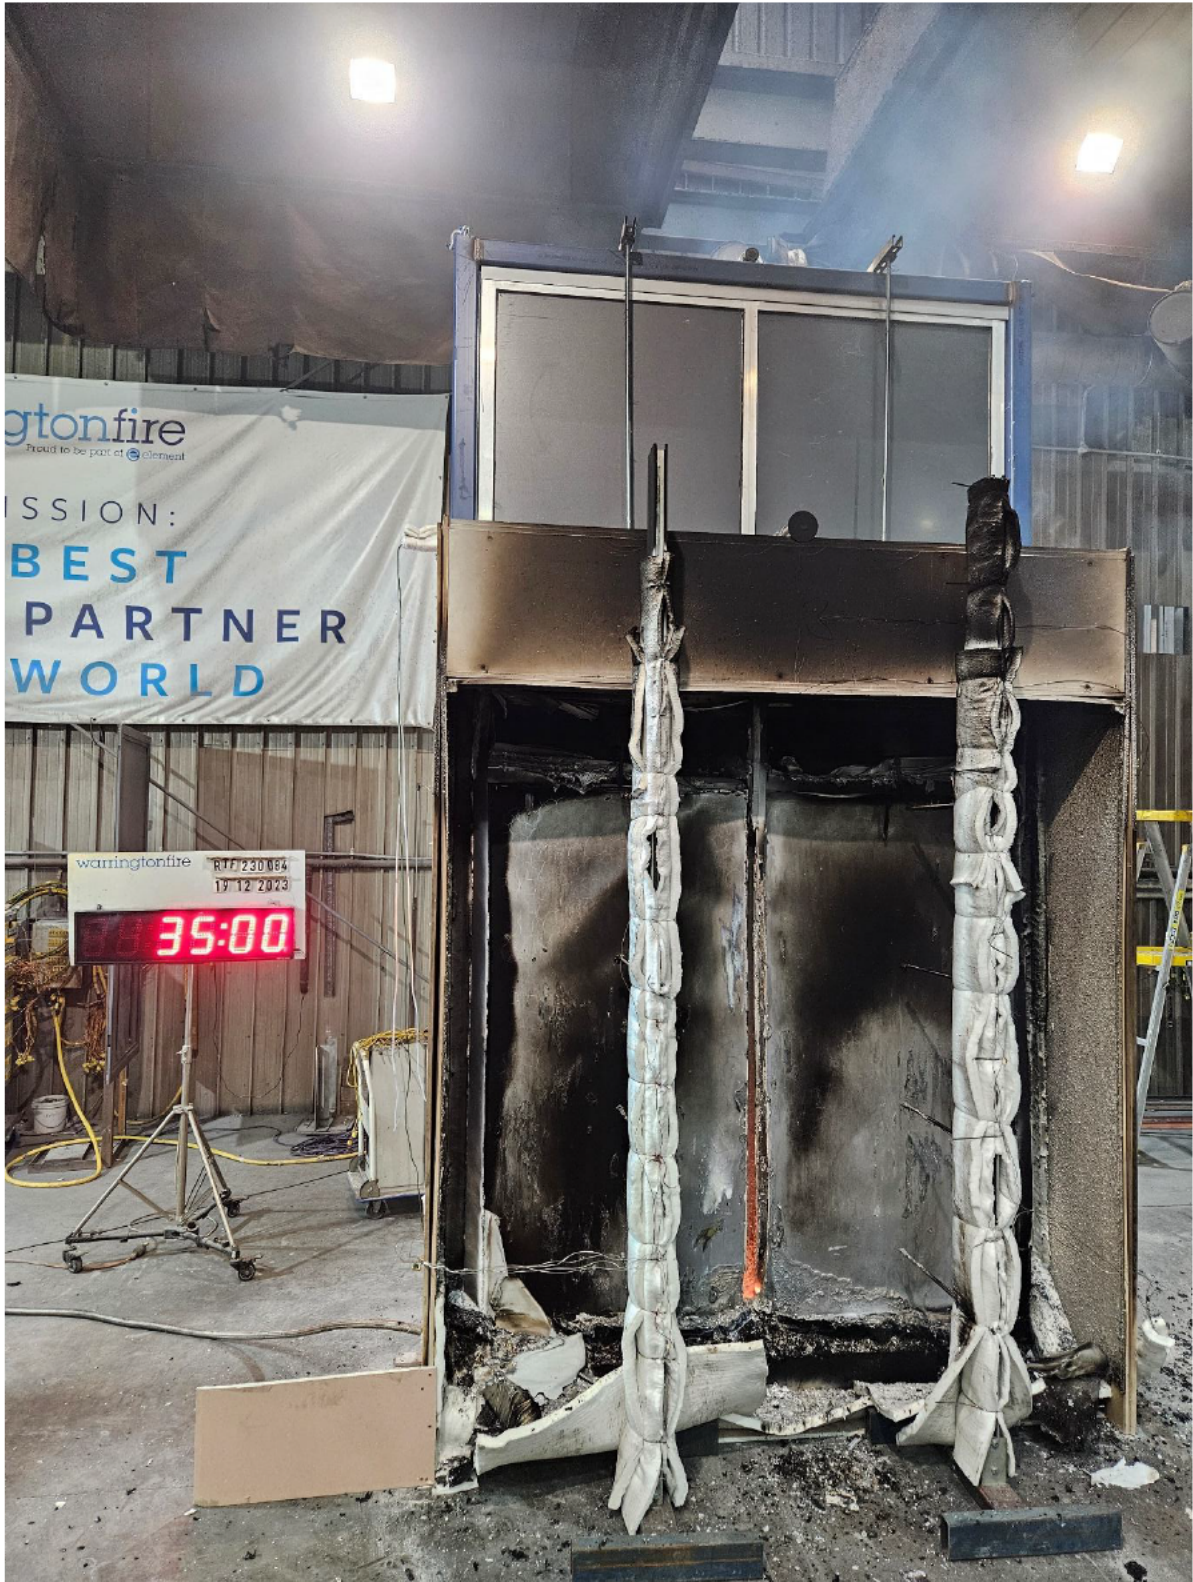
Figure 28 The specimen 5 minutes after the burner was turned off (35 minutes into the test)

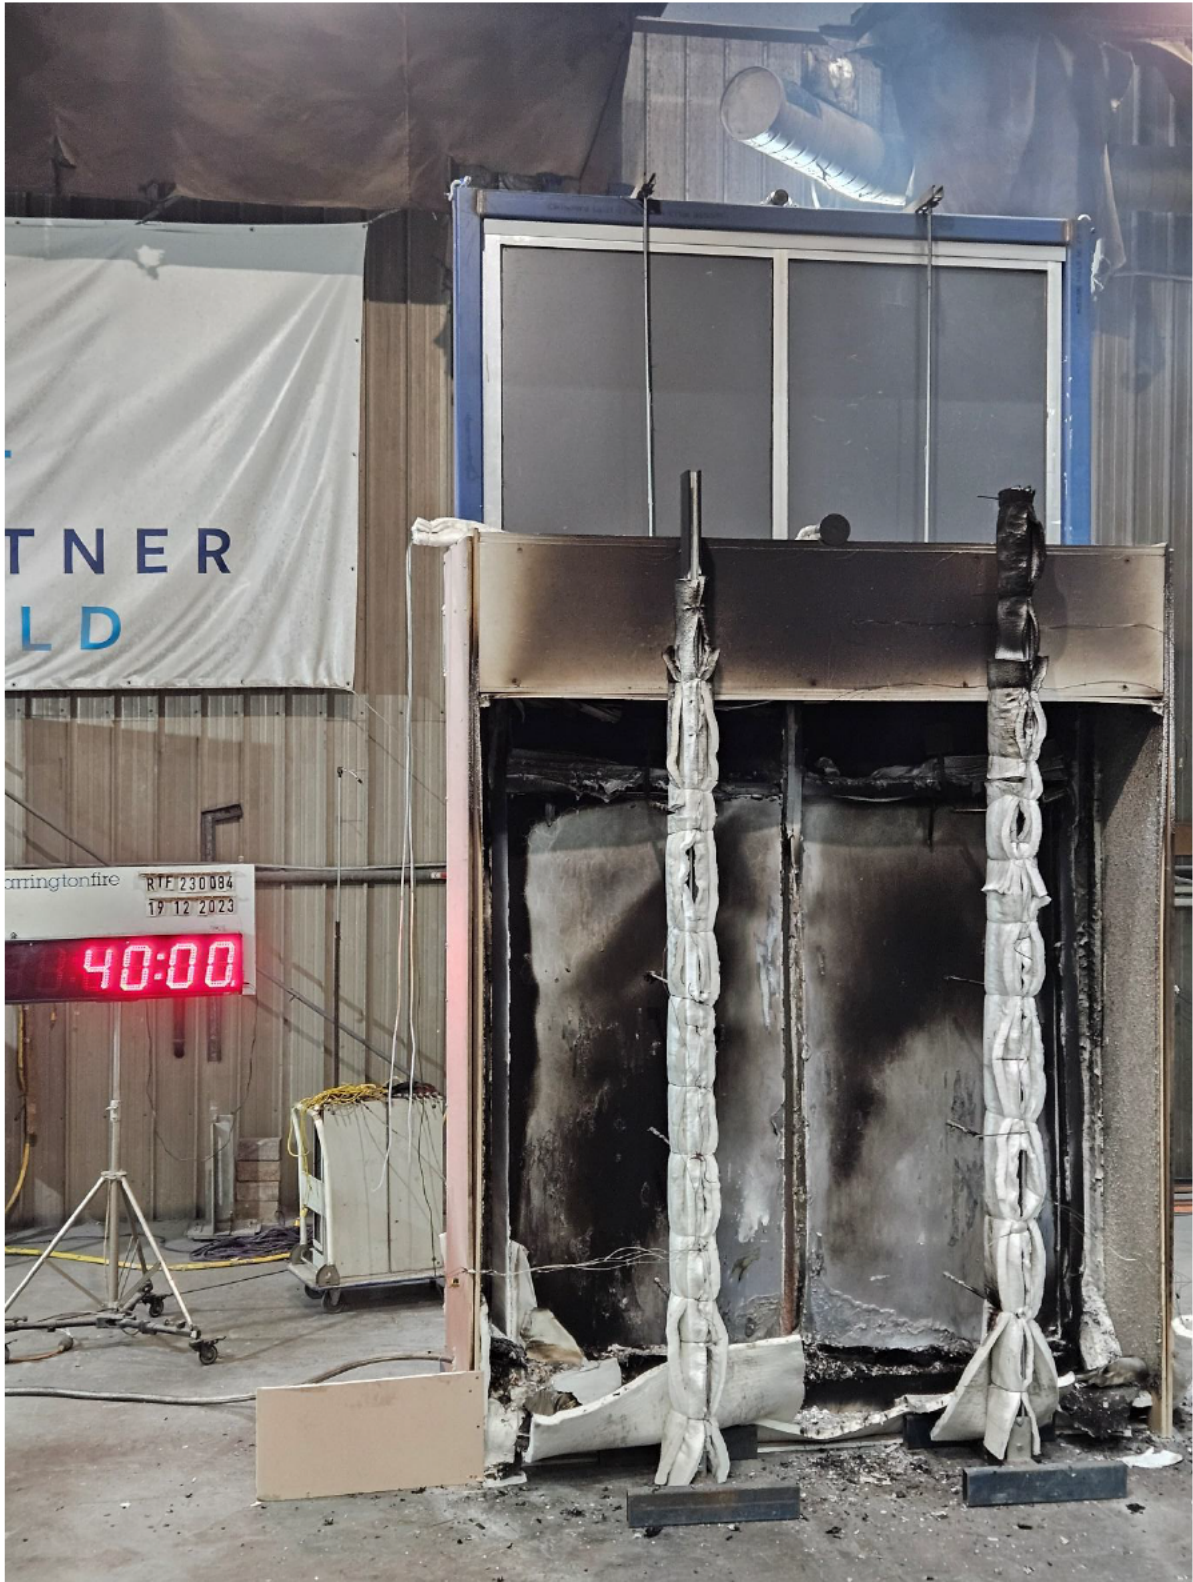
Figure 29 The specimen 10 minutes after the burner was turned off (40 minutes into the test)
