Reaction to fire test report

Test standard: Ad-hoc test based off ISO 13785-1:2002

System: An aluminium composite panel (ACP) wall system and a mock balcony setup representative of an in-situ façade - [REDACTED]

Job number: RTF230084

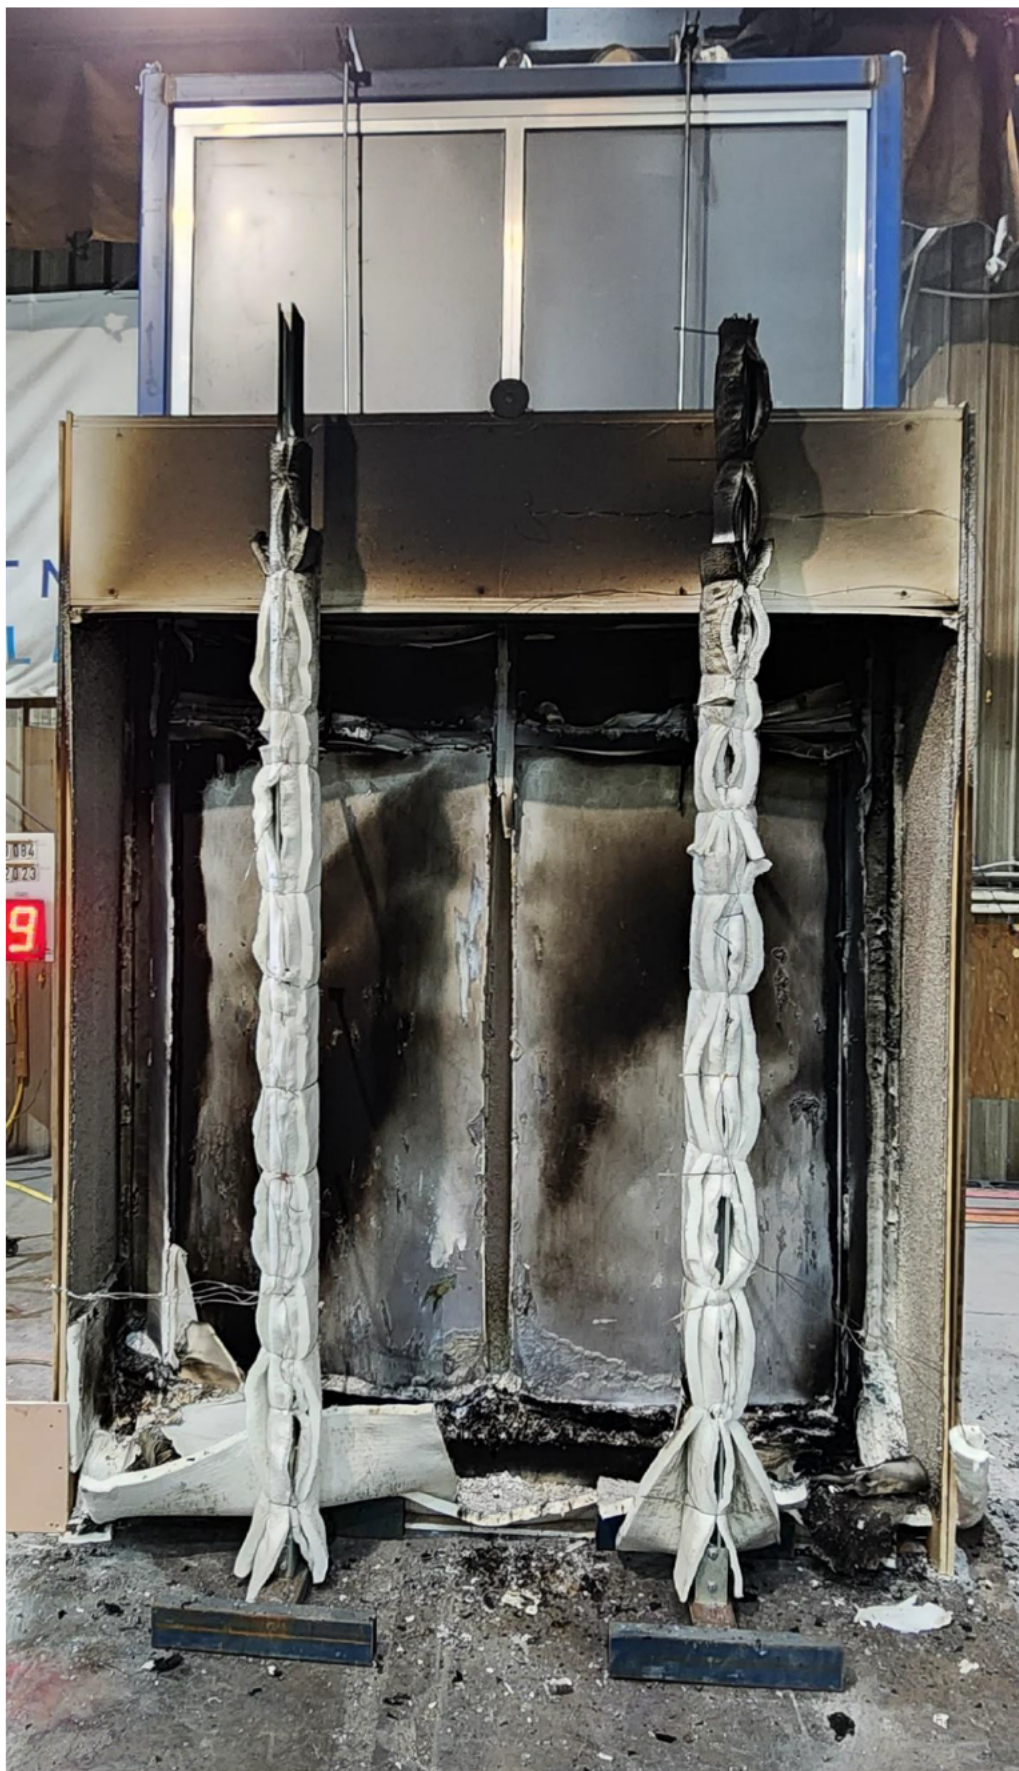
Figure 30 The specimen after the test.

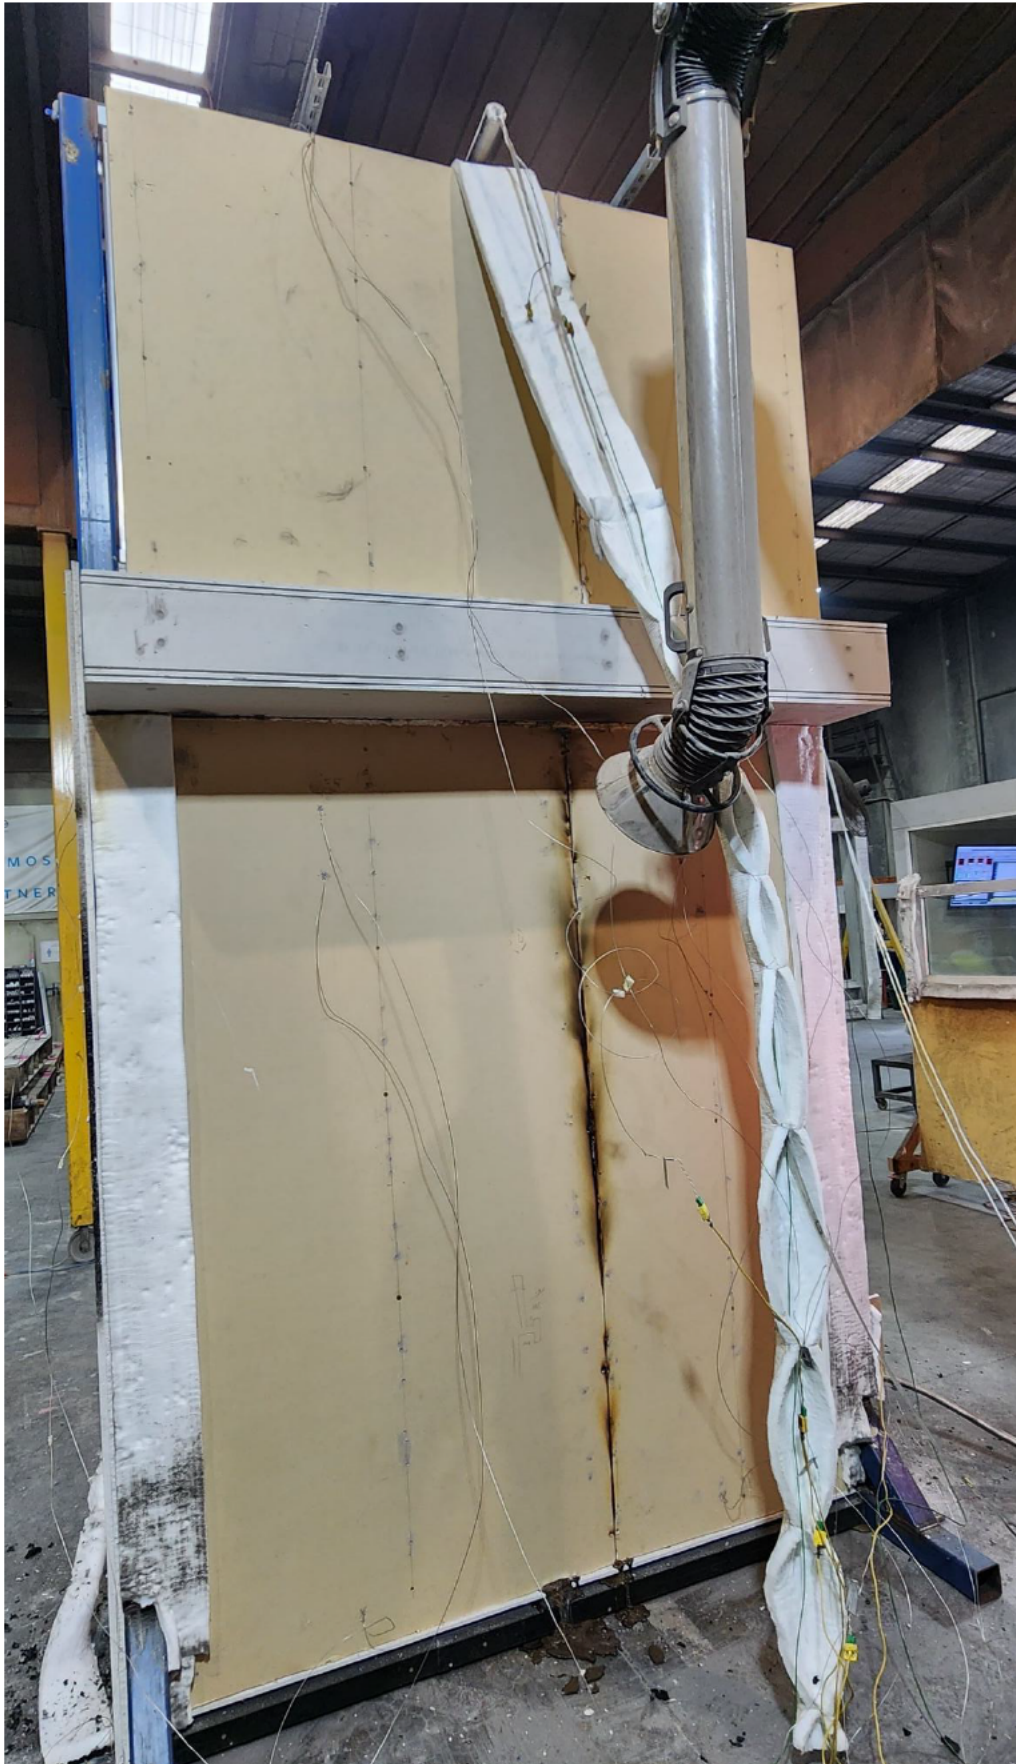
Figure 31 The specimen after the test – unexposed side.
