# Reaction to fire test report

Test standard: Ad-hoc test based on ISO 13785-1:2002

System: ACP with 100 % polyethylene core external façade cladding system (mechanically fixed)

Job number: RTF240053

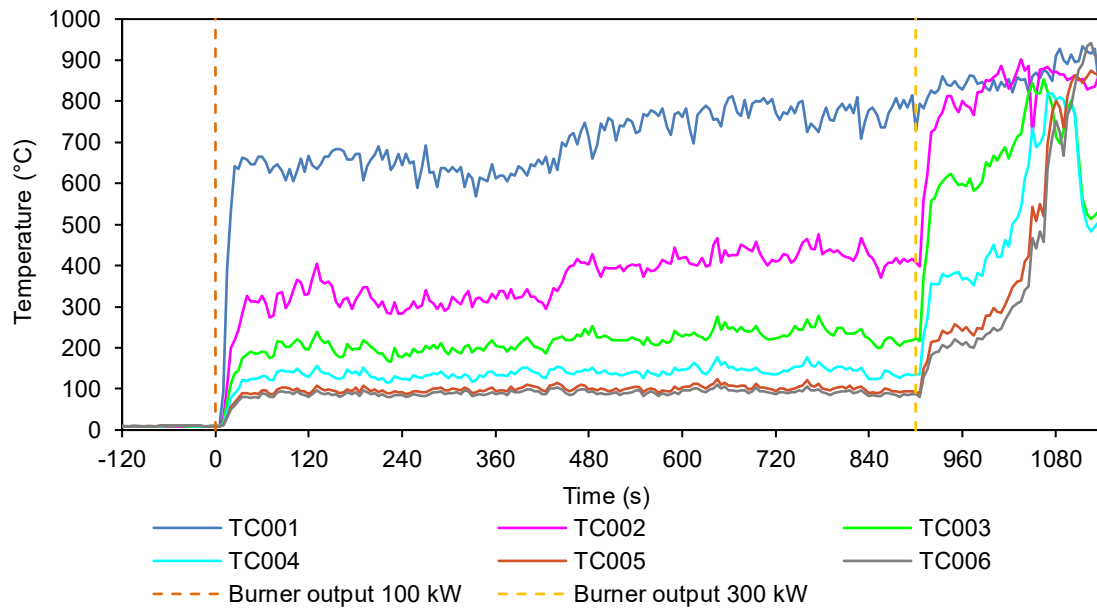
**Figure 1 50 mm from the exposed face – Temperature vs time**

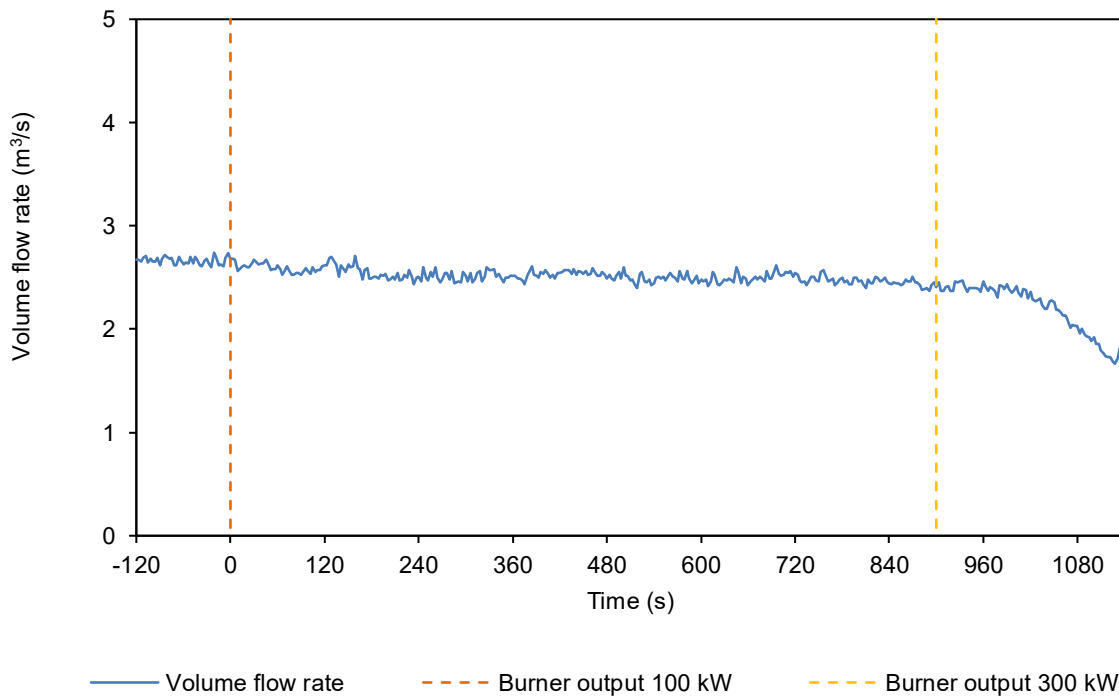
**Figure 4 Volume flow rate in duct vs time**

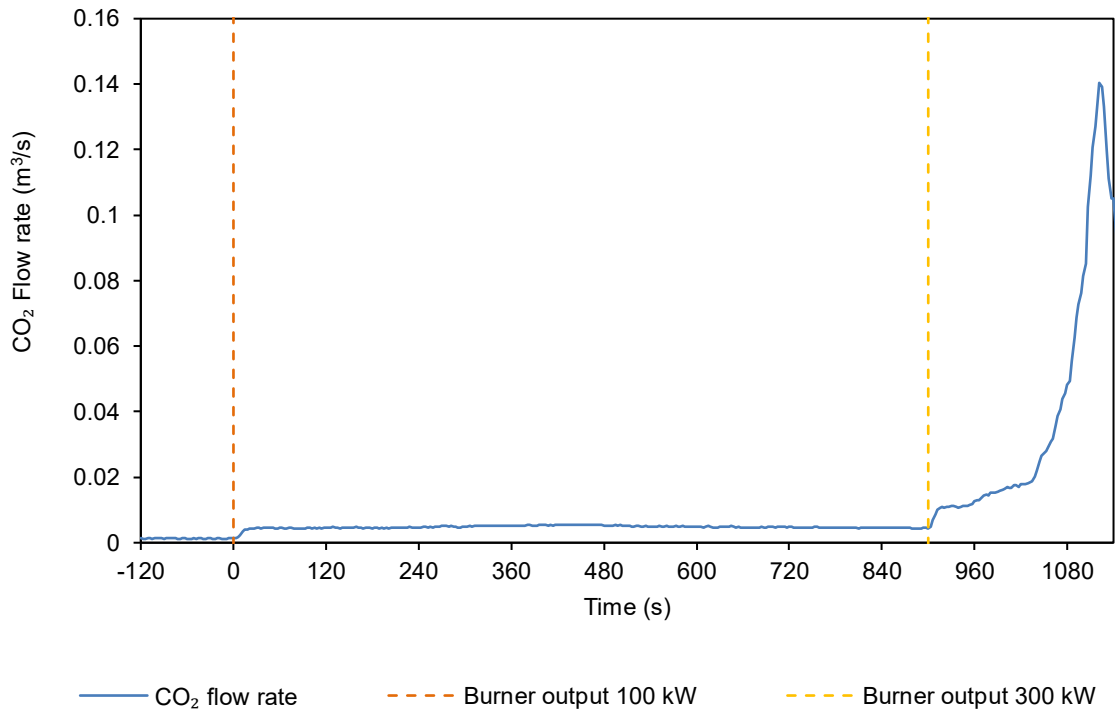
**Figure 7 Production of carbon dioxide vs time, at reference temperature and pressure**

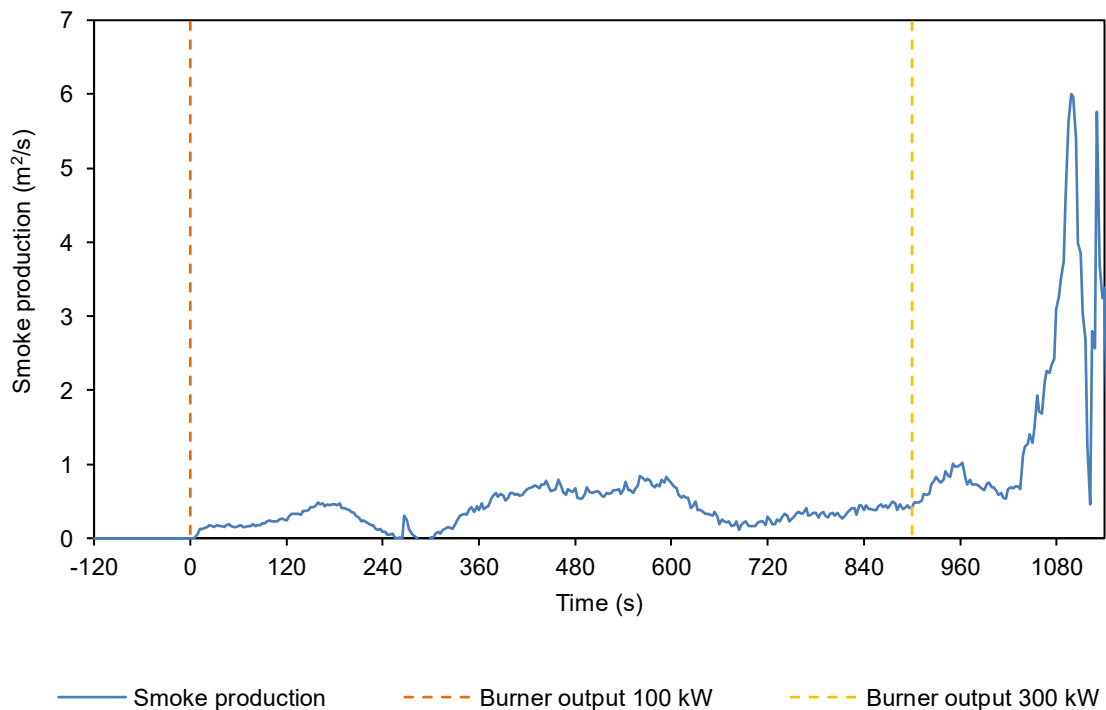
**Figure 8 Production of light obscuring smoke vs time, at reference temperature and pressure**

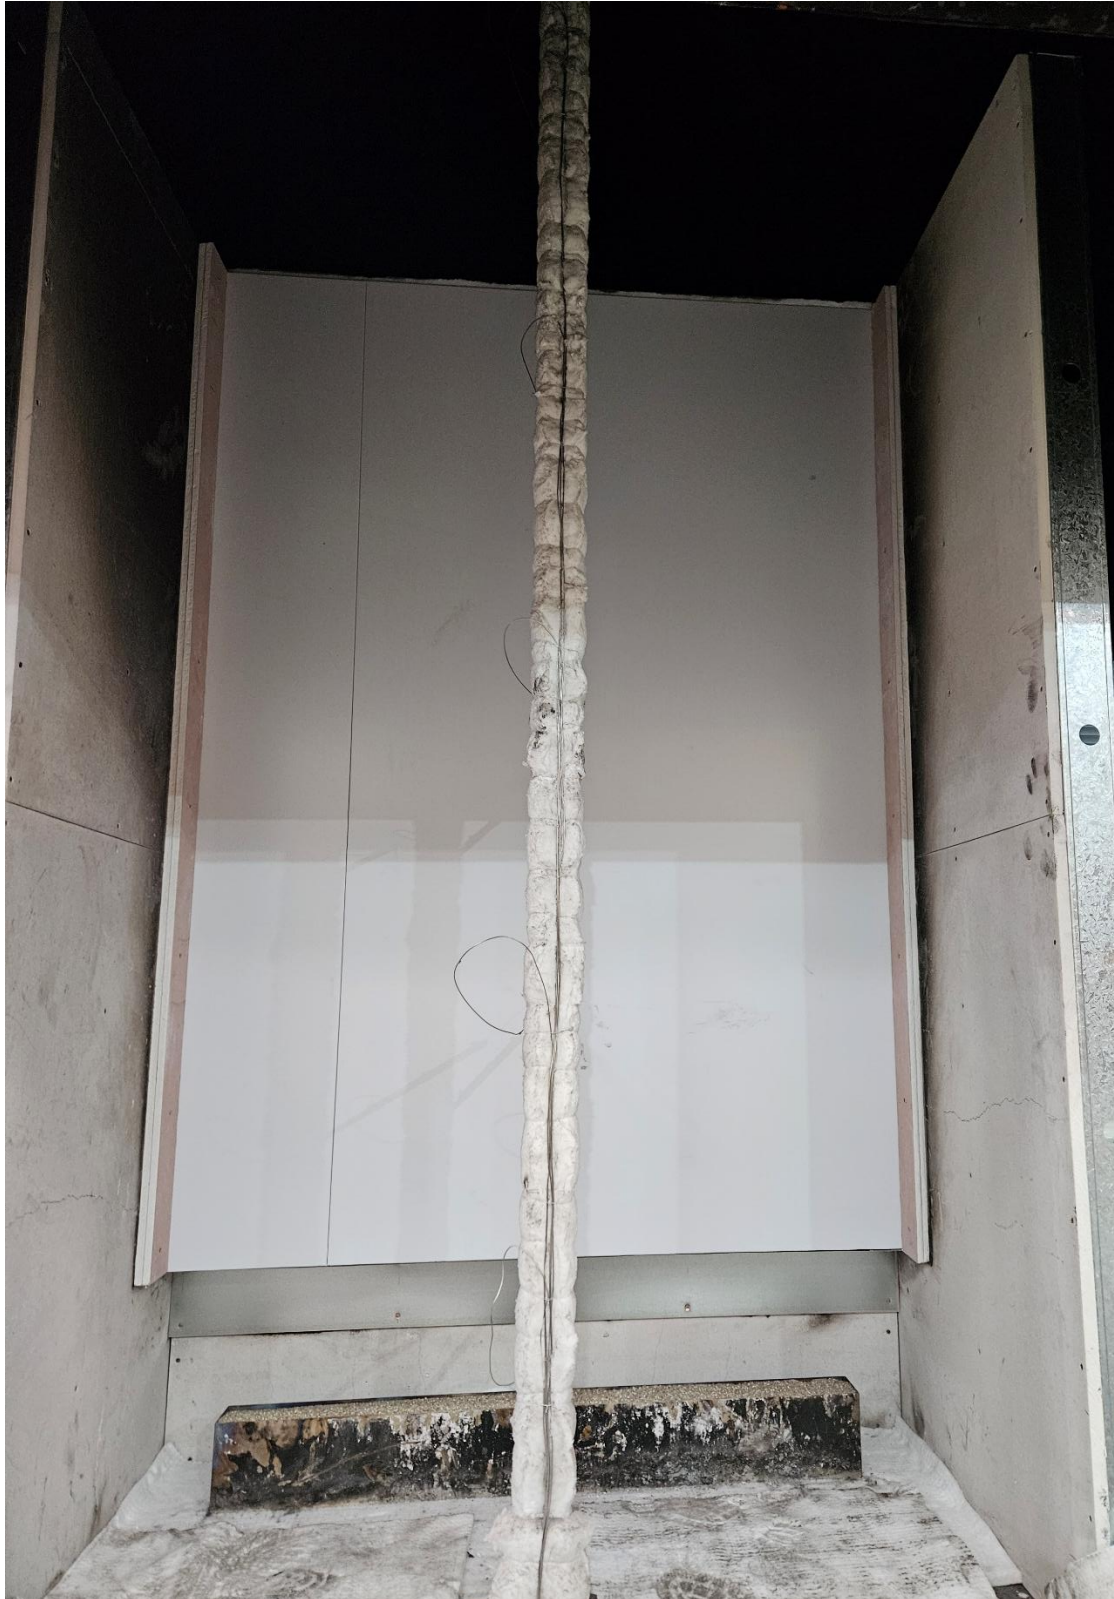
**Figure 15** The specimen before the reaction to fire test – exposed side

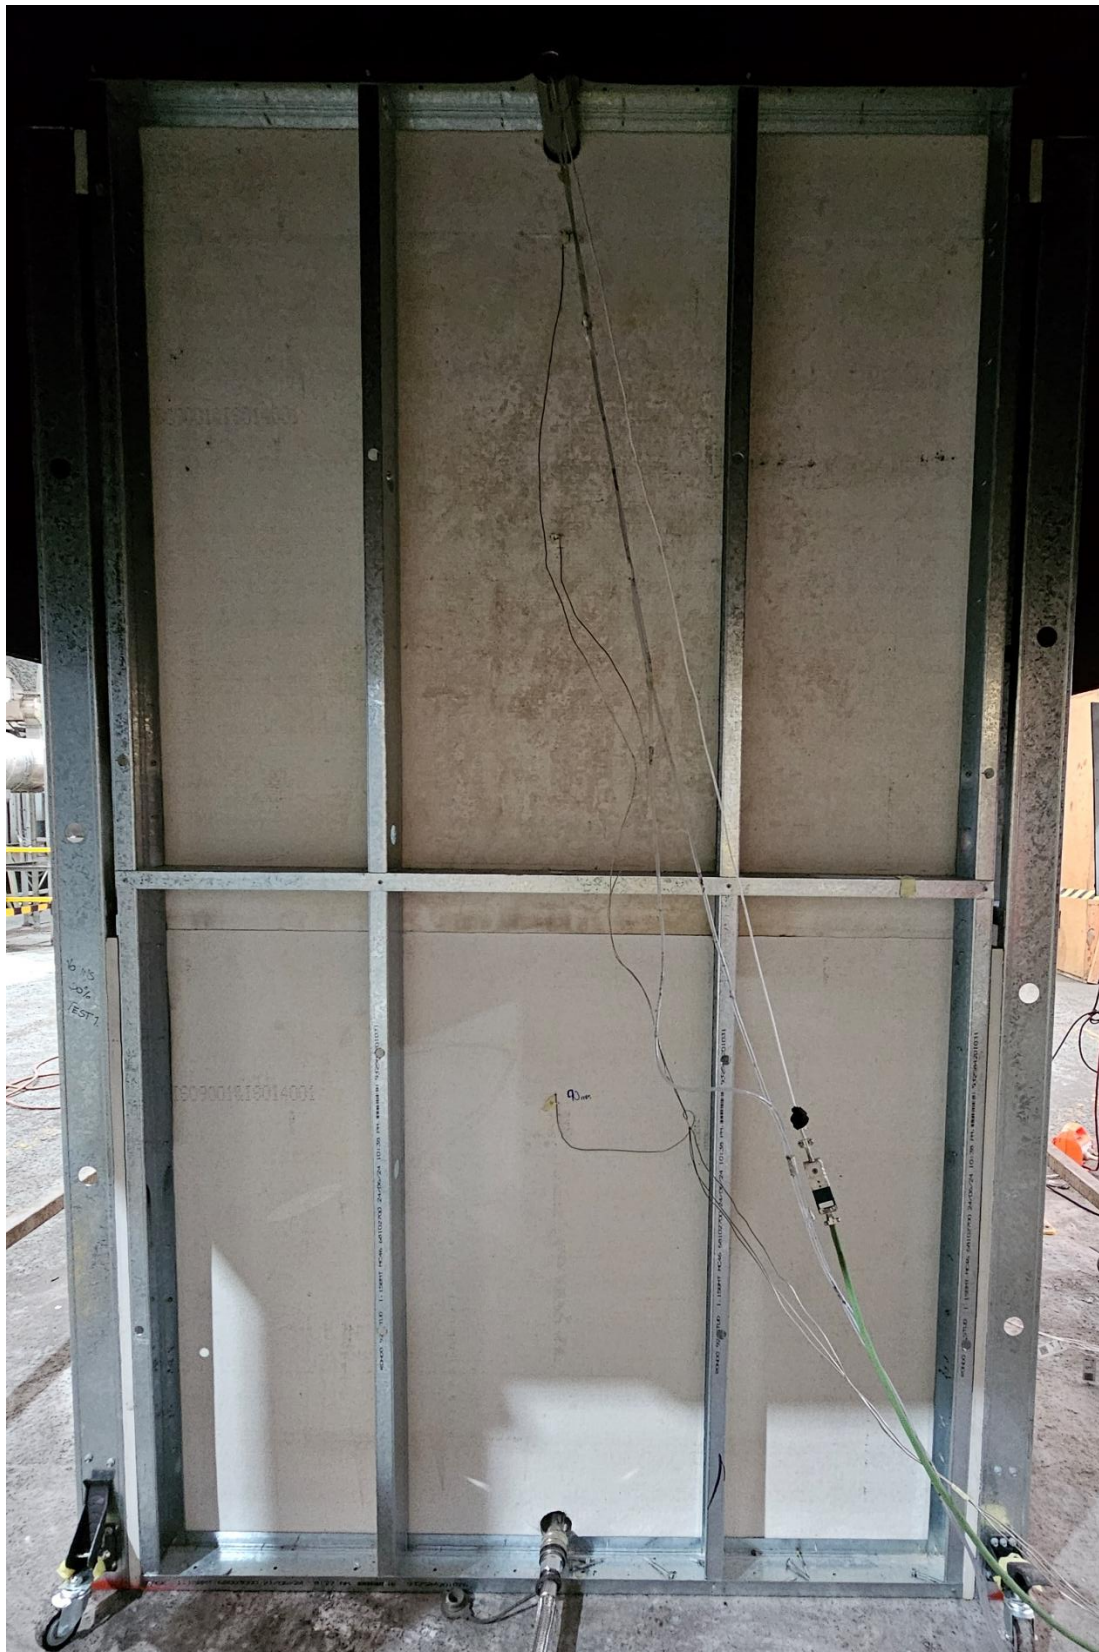
**Figure 16 The specimen before the reaction to fire test – unexposed side**

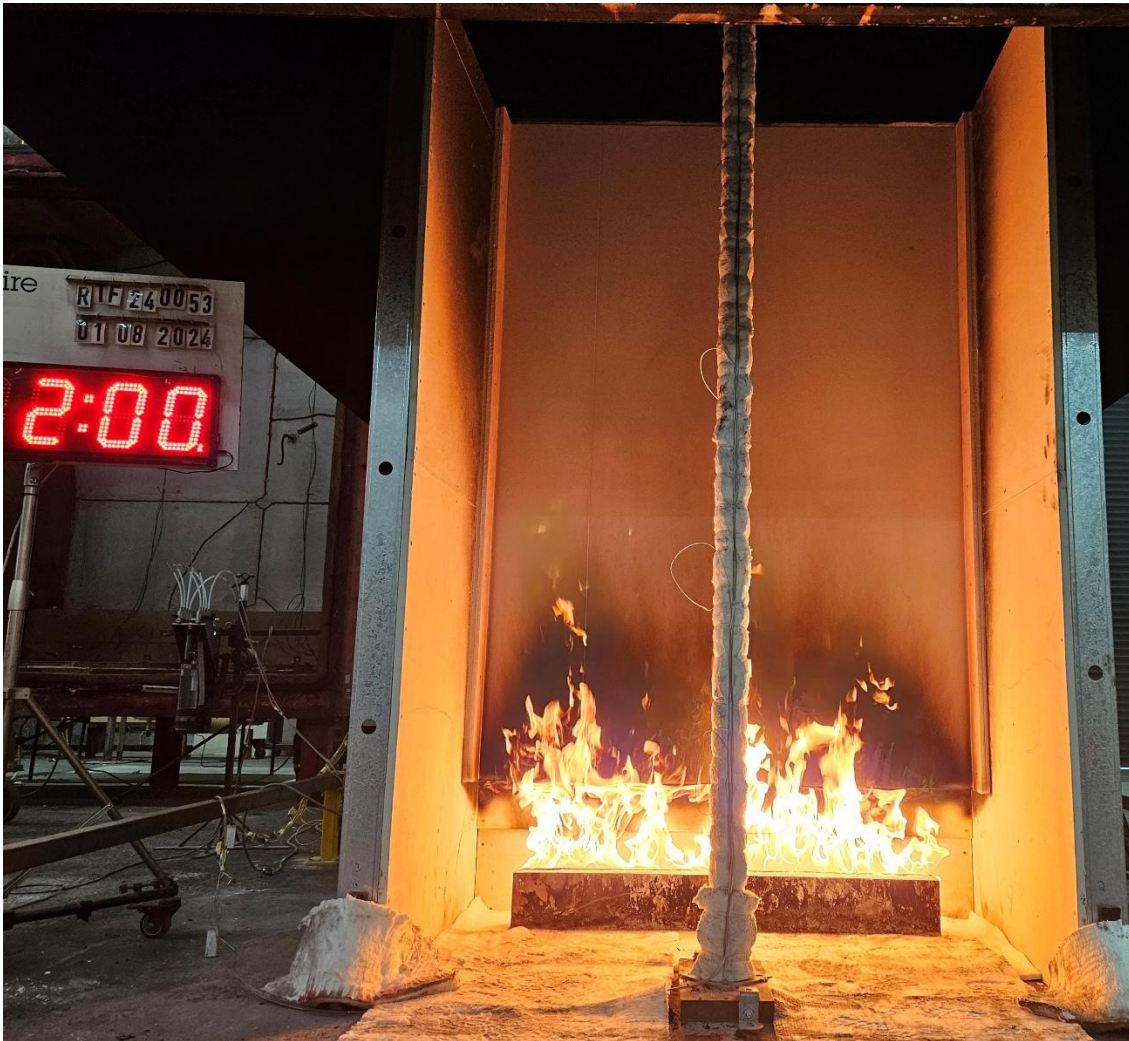
**Figure 17 The specimen 2 minutes into the test (burner output at 100 kW)**

Time		Observation
Min	Sec	
-2	00	Data collection started.
0	00	The reaction to fire test was started with the burner ignited with a heat output set at 100 kW.
0	29	Smoke was emitting from the specimen. Discolouration started at the bottom section of the panels.
2	37	The bottom section of the panels started to deform.
3	15	A crack was observed at the bottom section of east side of the panel.
4	07	Flaming debris fell from the specimen.
6	11	Flaming on the bottom of the west side wall.
7	22	Smoke was emitting from the west corner of the back wall.
13	20	The panel joint started to open.
15	00	The heat output of the burner was increased to 300 kW.
16	19	Flaming on the west corner of the back wall.
17	05	Flaming on the east corner of the back wall.
17	24	The panel joint opened up more.
18	30	A heat release rate of 2.5MW was recorded.
19	00	The reaction to fire test was ended and the specimen was sprayed with water by the test operators. The test was stopped due to safety concerns.

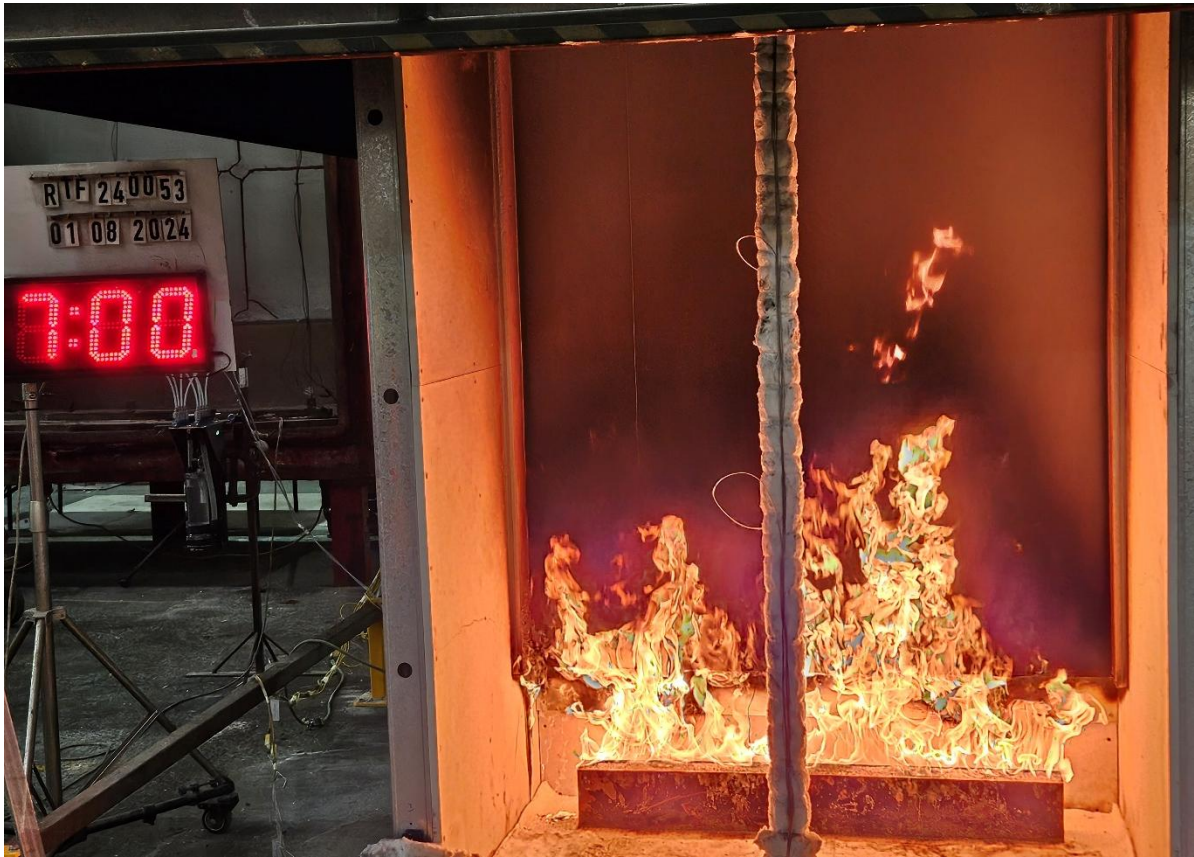
**Figure 18** The specimen 7 minutes into the test (burner output at 100 kW)

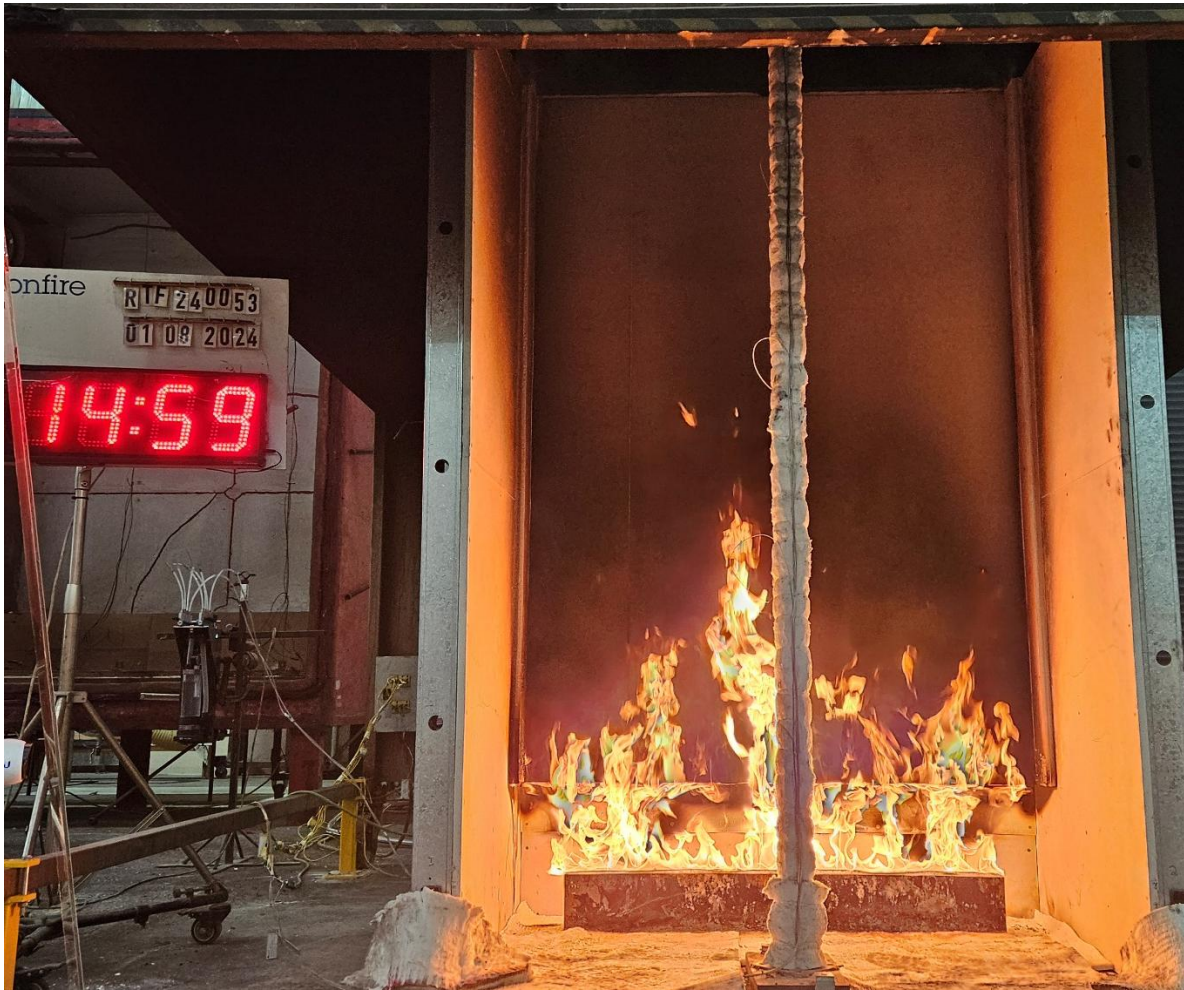
**Figure 19 The specimen 14 minutes 59 seconds into the test (burner output at 100 kW)**

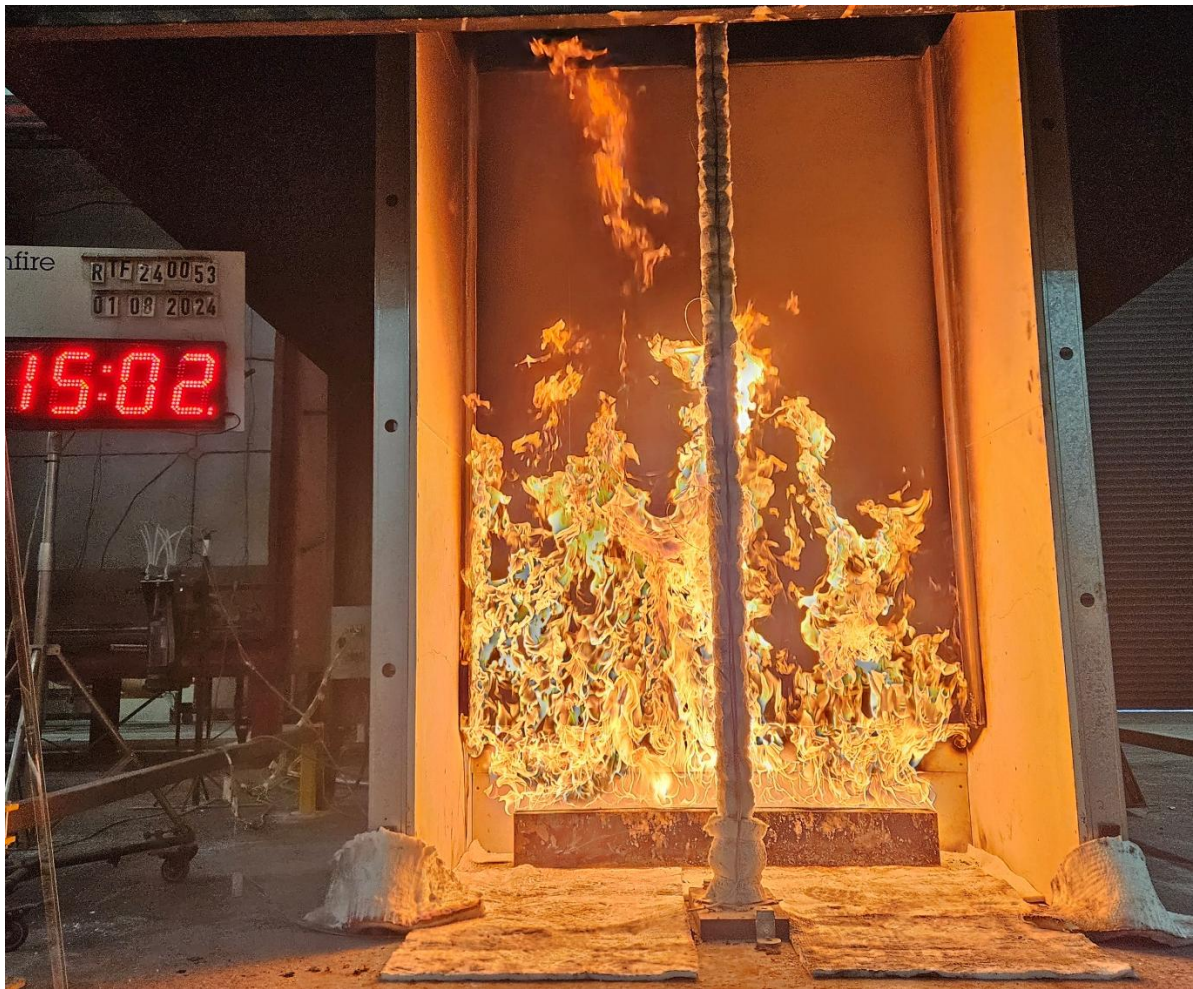
**Figure 20 The specimen 15 minutes 02 seconds into the test (burner output at 300 kW)**

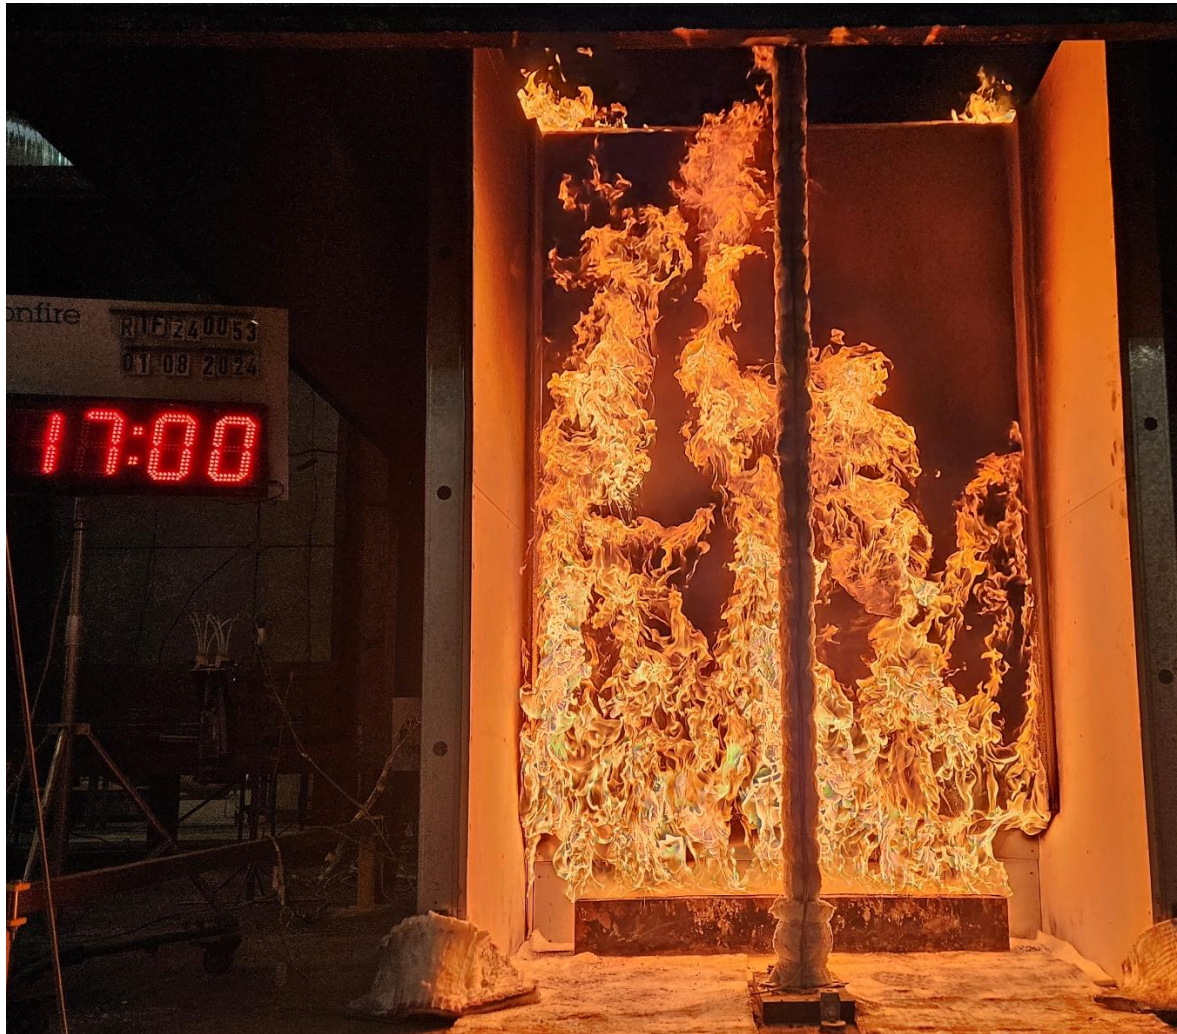
**Figure 21 The specimen 17 minutes into the test (burner output at 300 kW)**

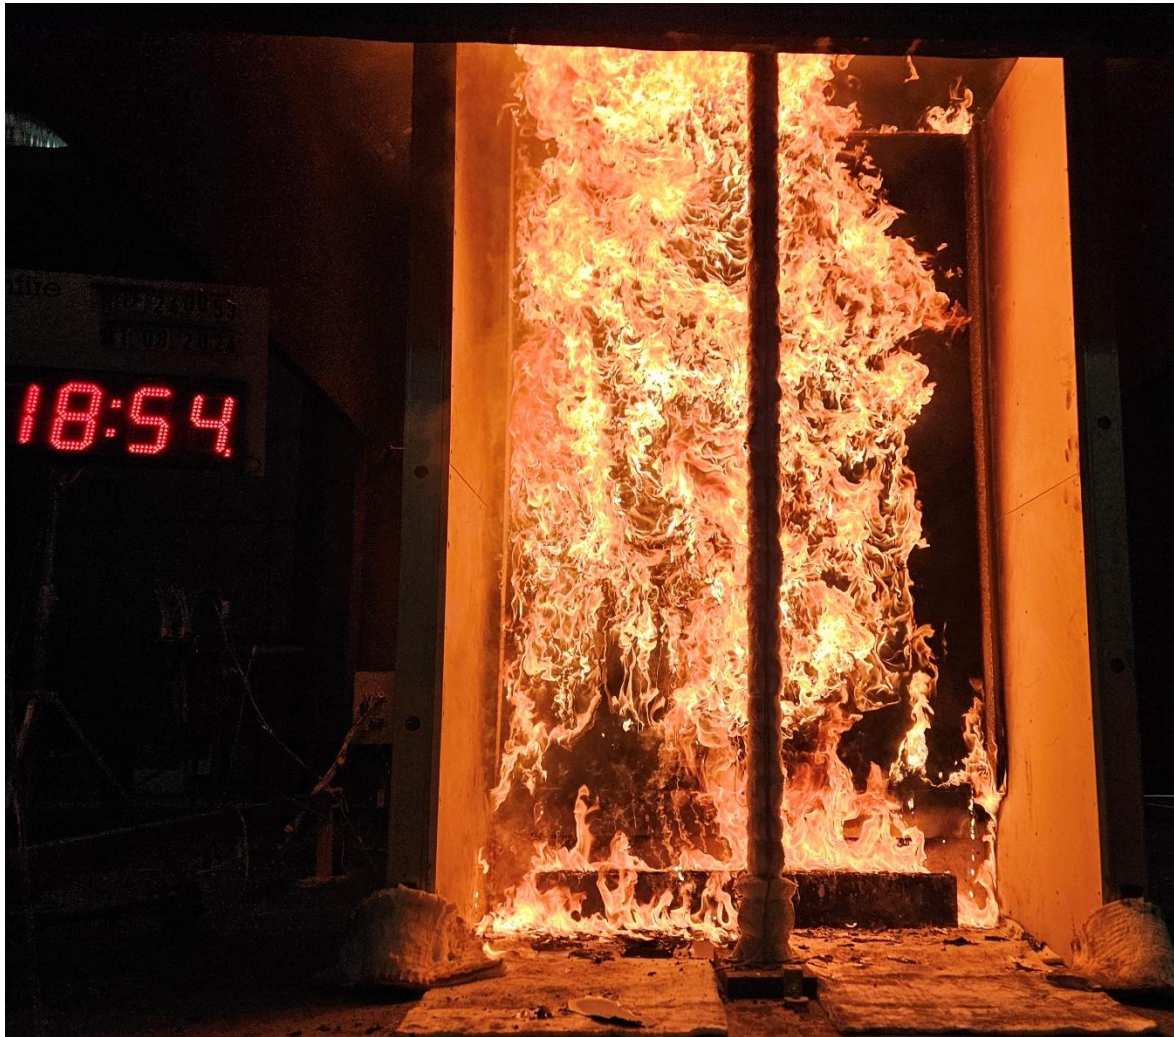
**Figure 22 The specimen 18 minutes 54 seconds into the test (burner output at 300 kW)**

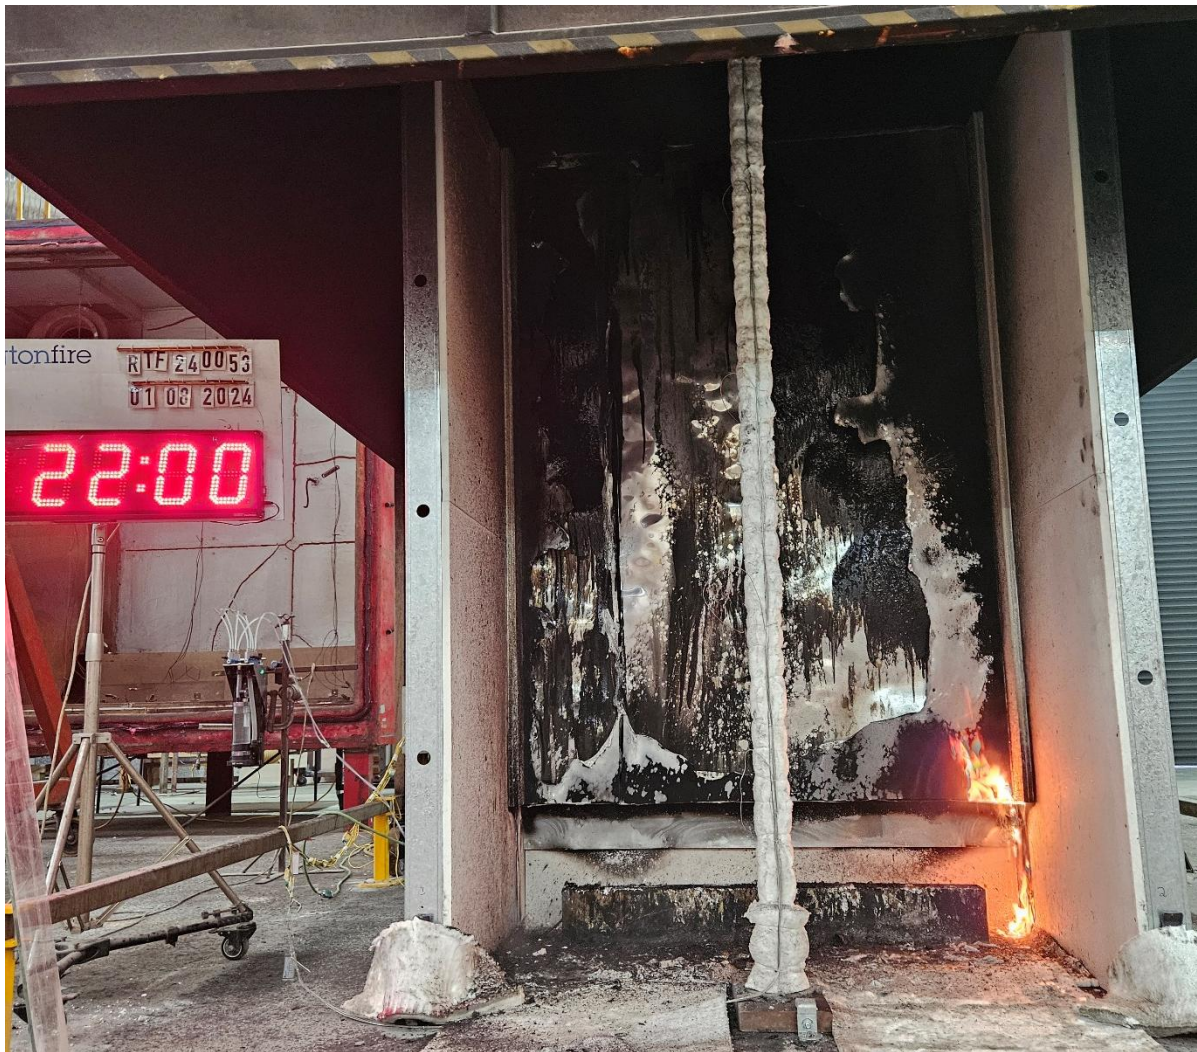
**Figure 23** The specimen at end of the reaction to fire test – exposed side

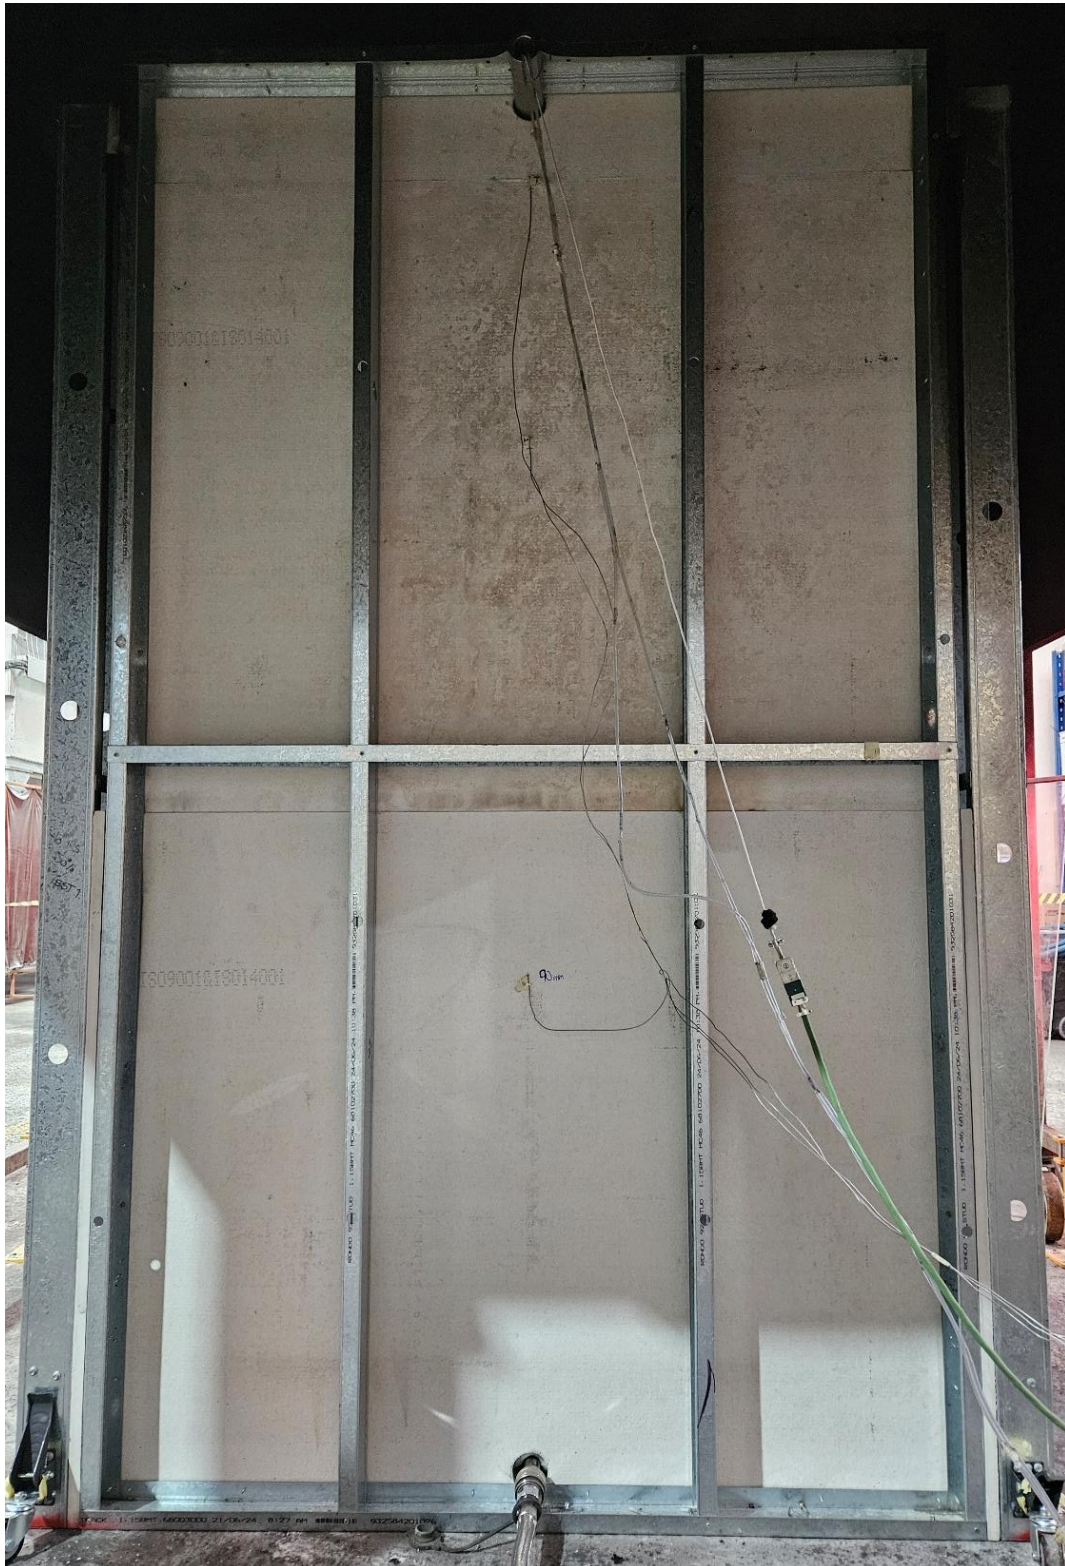
**Figure 24** The specimen after the reaction to fire test – unexposed side

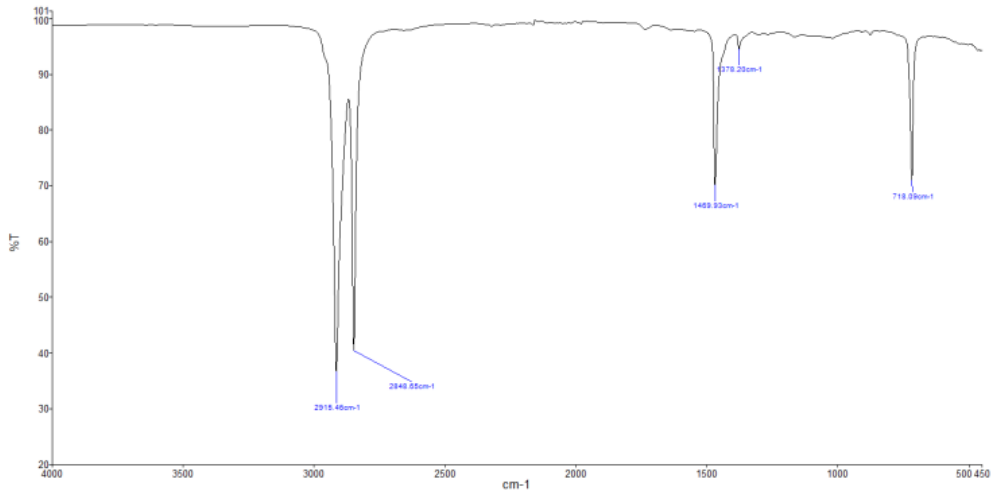
Figure 1. FT-IR spectrum of sample #1

The aluminium metals were removed from the ACPs cladding polymer, and the flat surface of the polymer sample was abraded to remove any surface adhesive. The surface of the sample was analysed directly by FTIR. The FT-IR spectra are presented in Figures 1-3.
