Reaction to fire test report

Test standard: Ad-hoc test based on ISO 13785-1:2002

System: ACP with 100 % polyethylene core external façade cladding system (adhesively fixed)

Job number: RTF240054

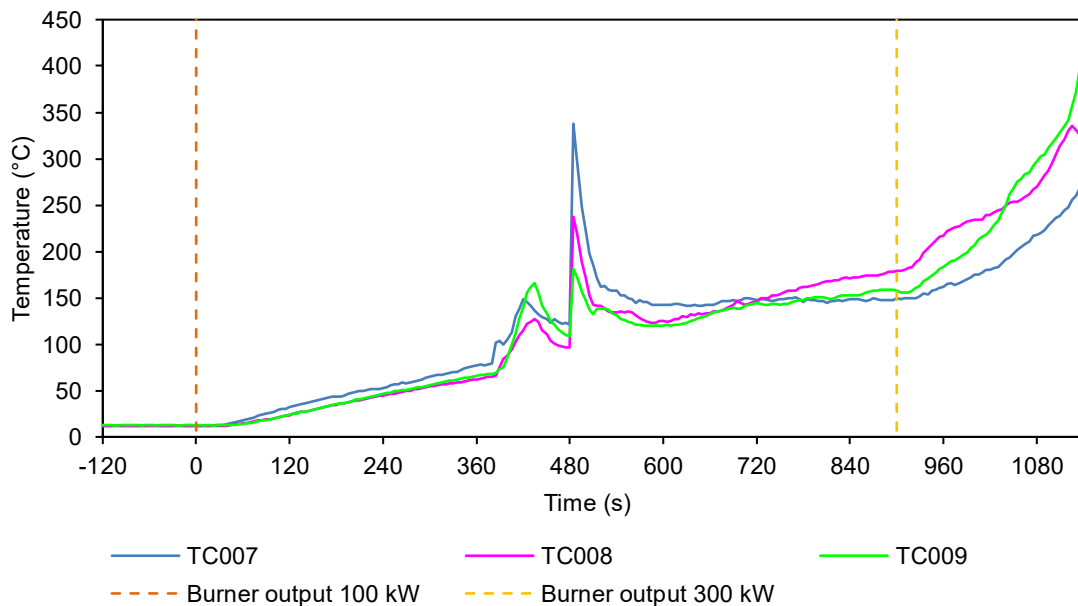
Figure 2 Cavity – Temperature vs time

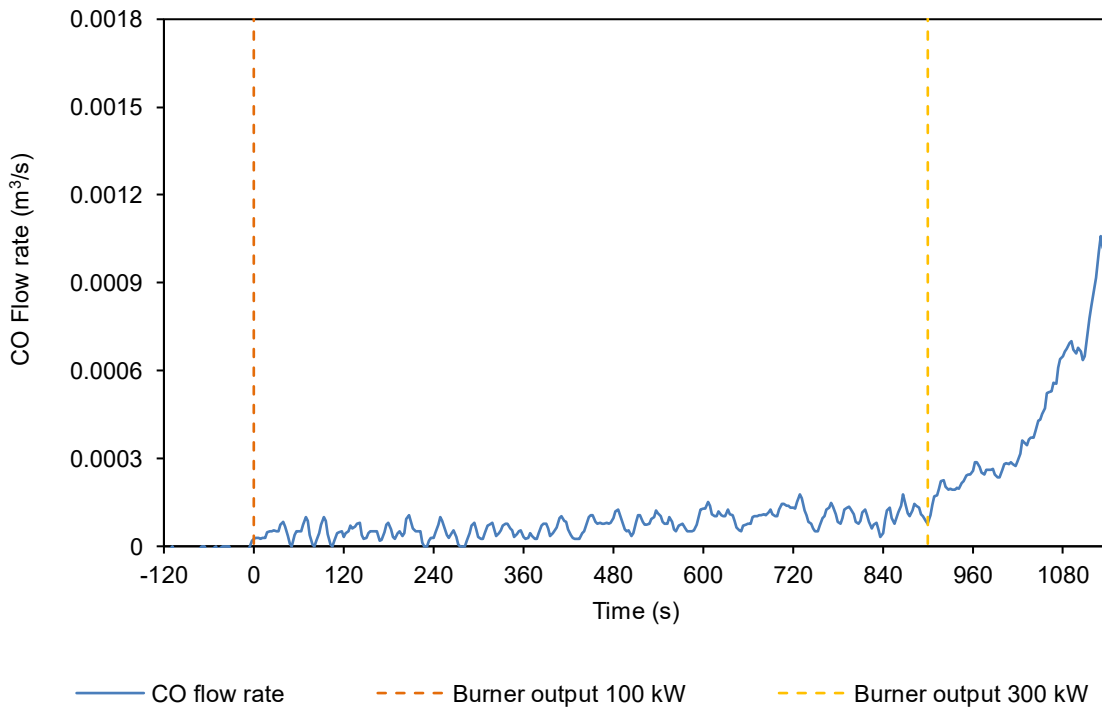
Figure 6 Production of carbon monoxide vs time, at reference temperature and pressure

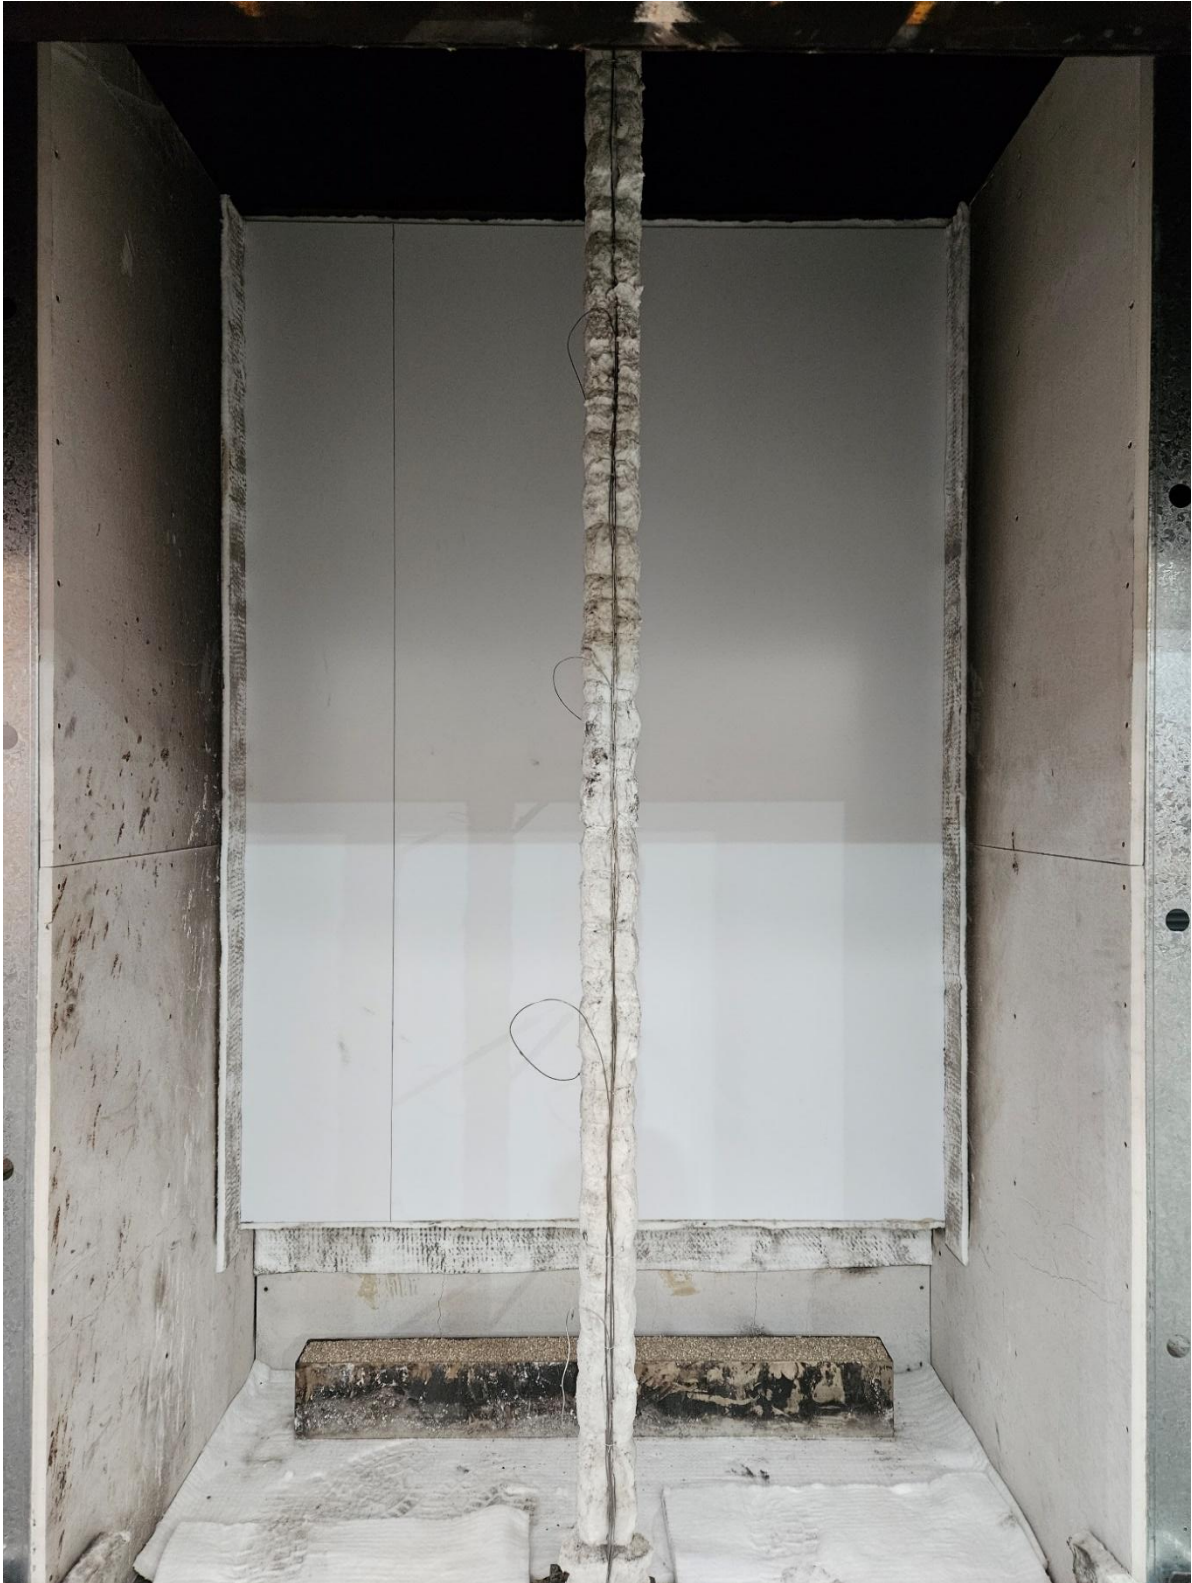
Figure 15 The specimen before the reaction to fire test – exposed side

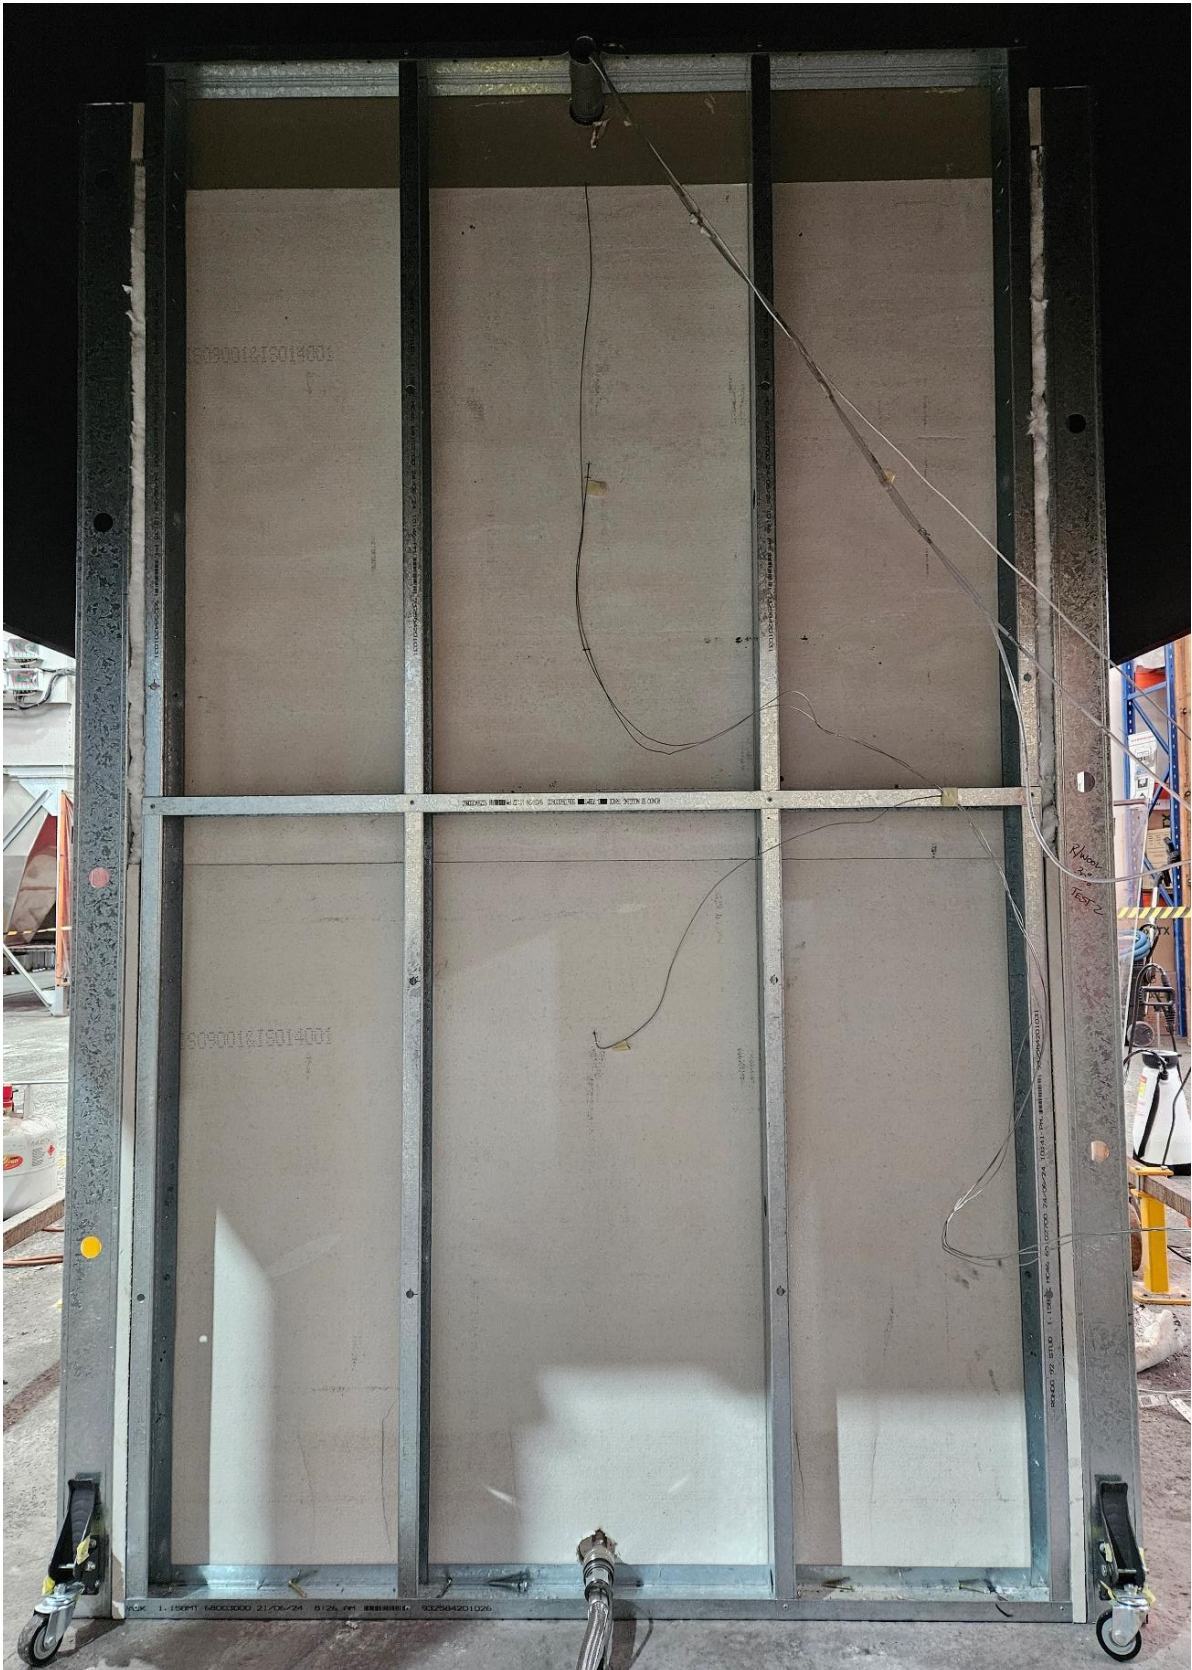
Figure 16 The specimen before the reaction to fire test – unexposed side

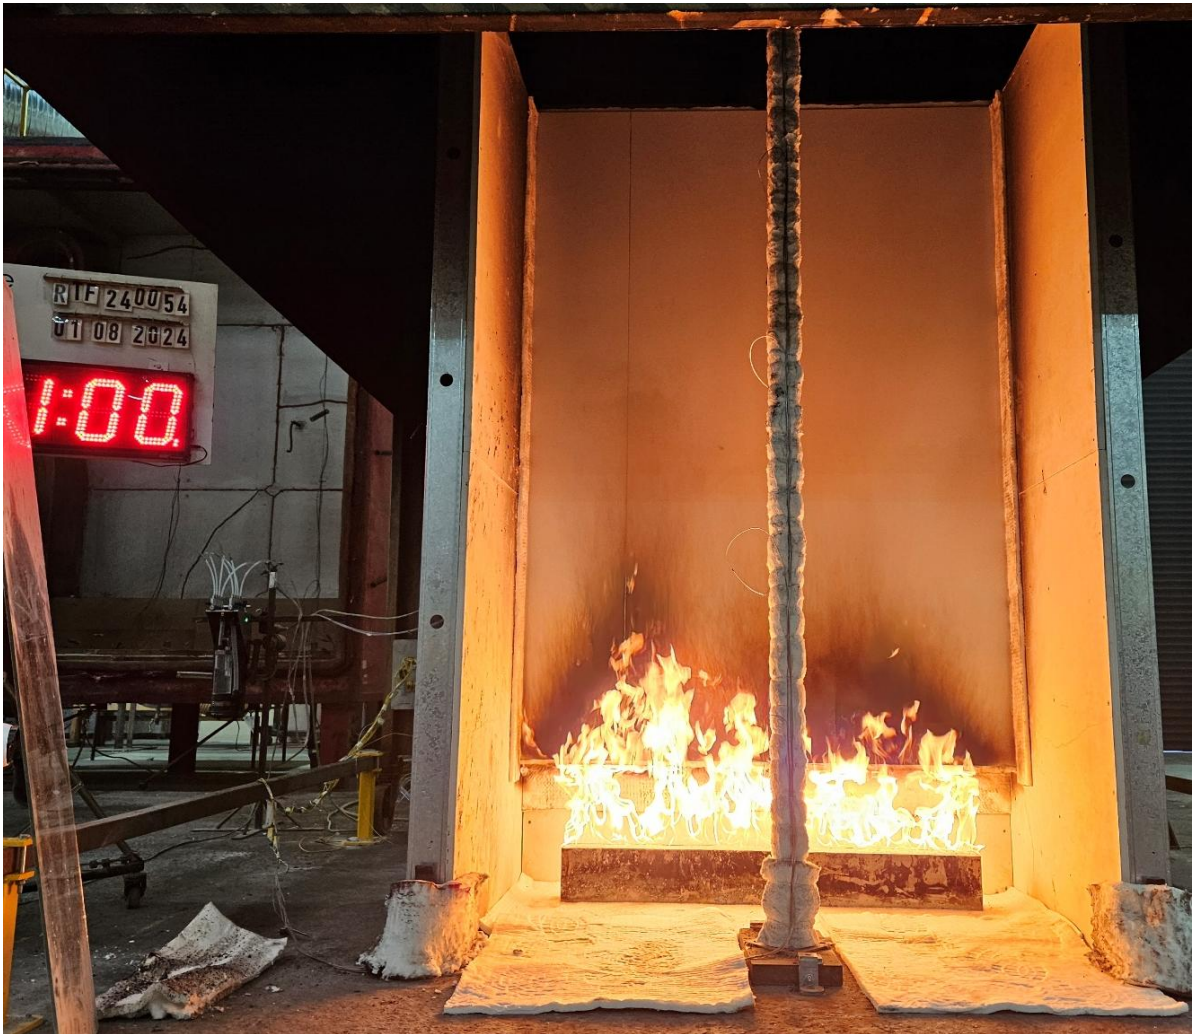
Figure 17 The specimen 1 minute into the test (burner output at 100 kW)

Time		Observation
Min	Sec	
-2	00	Data collection started.
0	00	The reaction to fire test was started with the burner ignited with a heat output set at 100 kW.
0	21	Smoke was emitting from the exposed face of the panels. Discolouration started at the bottom section of the panels.
2	56	The bottom section of the panels started to deform.
7	01	Flaming on the bottom of the west side wall.
7	36	Flaming debris were falling from the specimen.
12	42	The panel vertical joint started to open.
14	05	Flaming on the bottom of the panel, at the west side corner.
15	00	The heat output of the burner was increased to 300 kW.
16	44	The panel joint opened up more.
17	06	Flaming on the west corner of the back wall.
18	06	A heat release rate of 2.5 MW was recorded.
18	33	Most of the panels burned off.
19	00	The reaction to fire test was ended and the specimen was sprayed with water by the test operators. The test was stopped due to safety concerns.

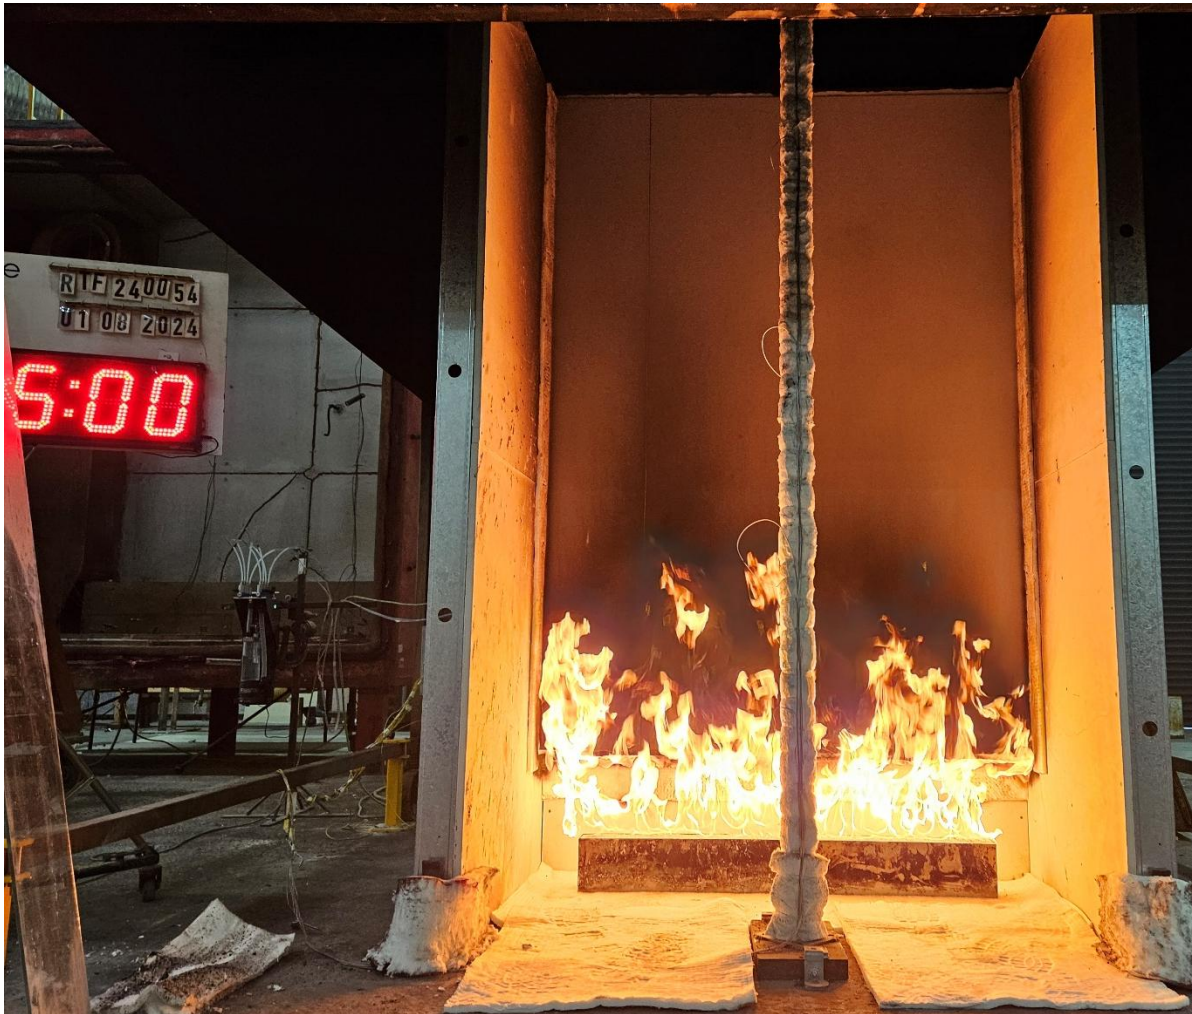
Figure 18 The specimen 5 minutes into the test (burner output at 100 kW)

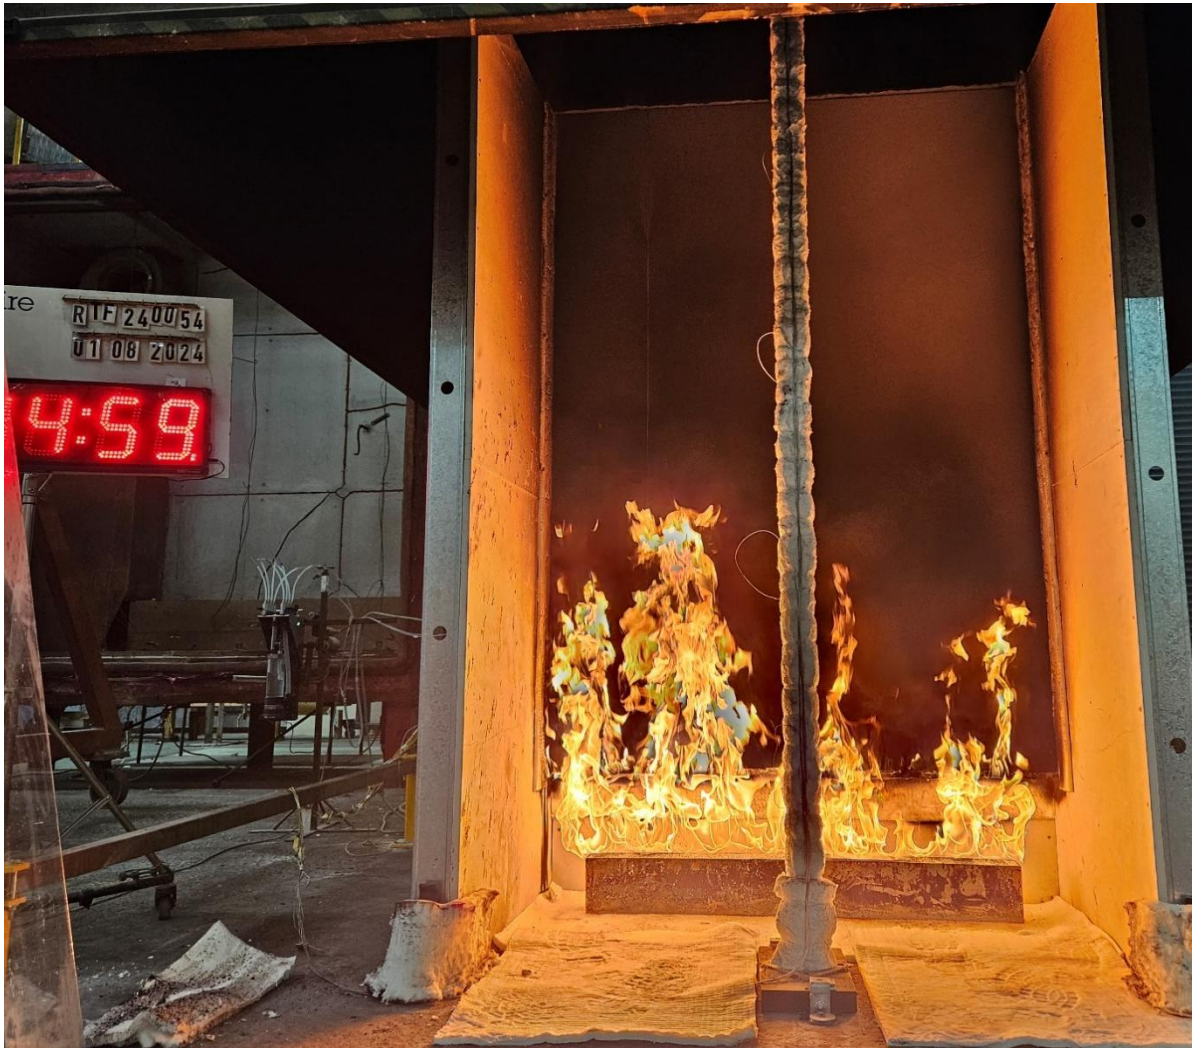
Figure 19 The specimen 14 minutes 59 seconds into the test (burner output at 100 kW)

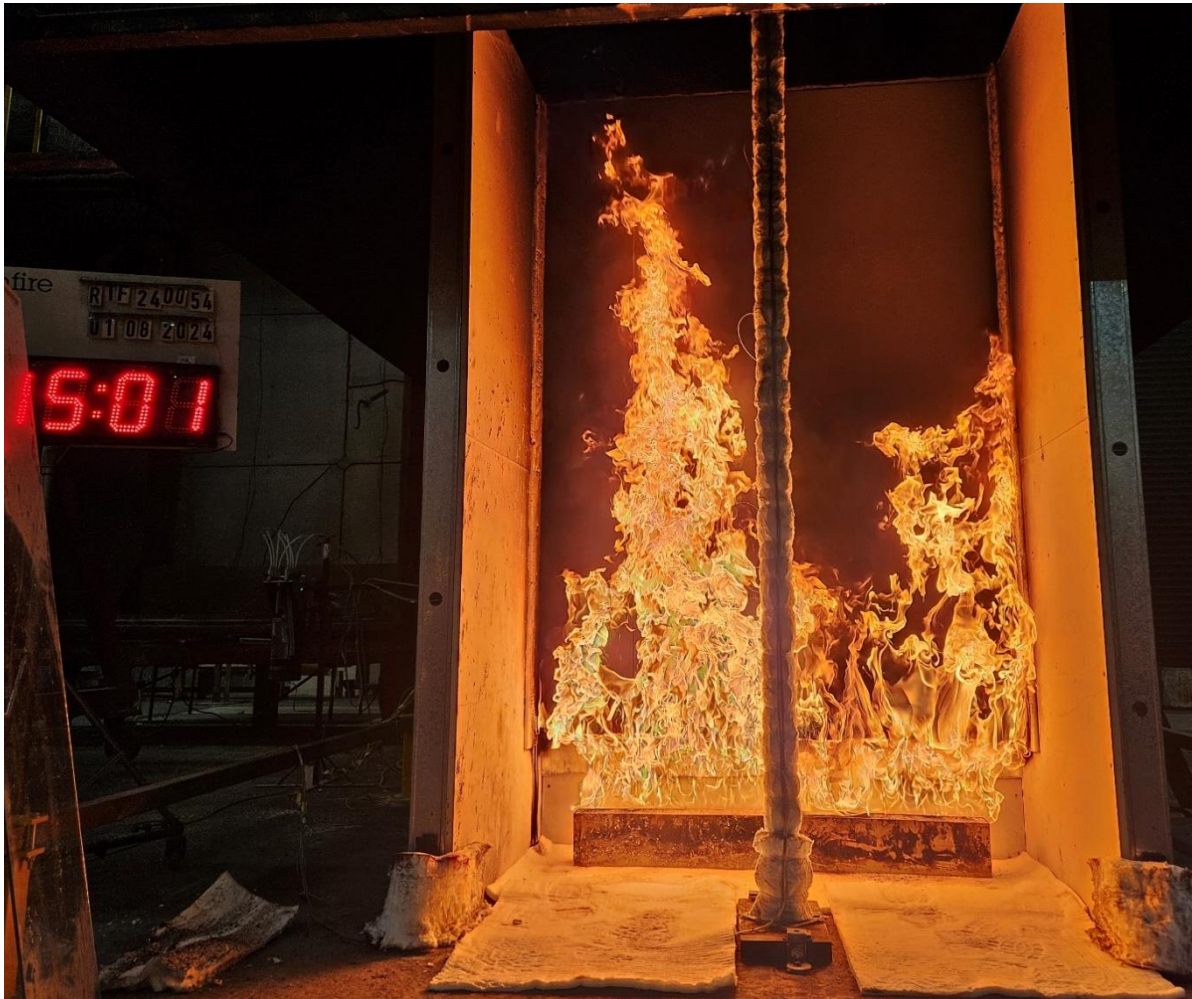
Figure 20 The specimen 15 minutes 01 seconds into the test (burner output at 300 kW)

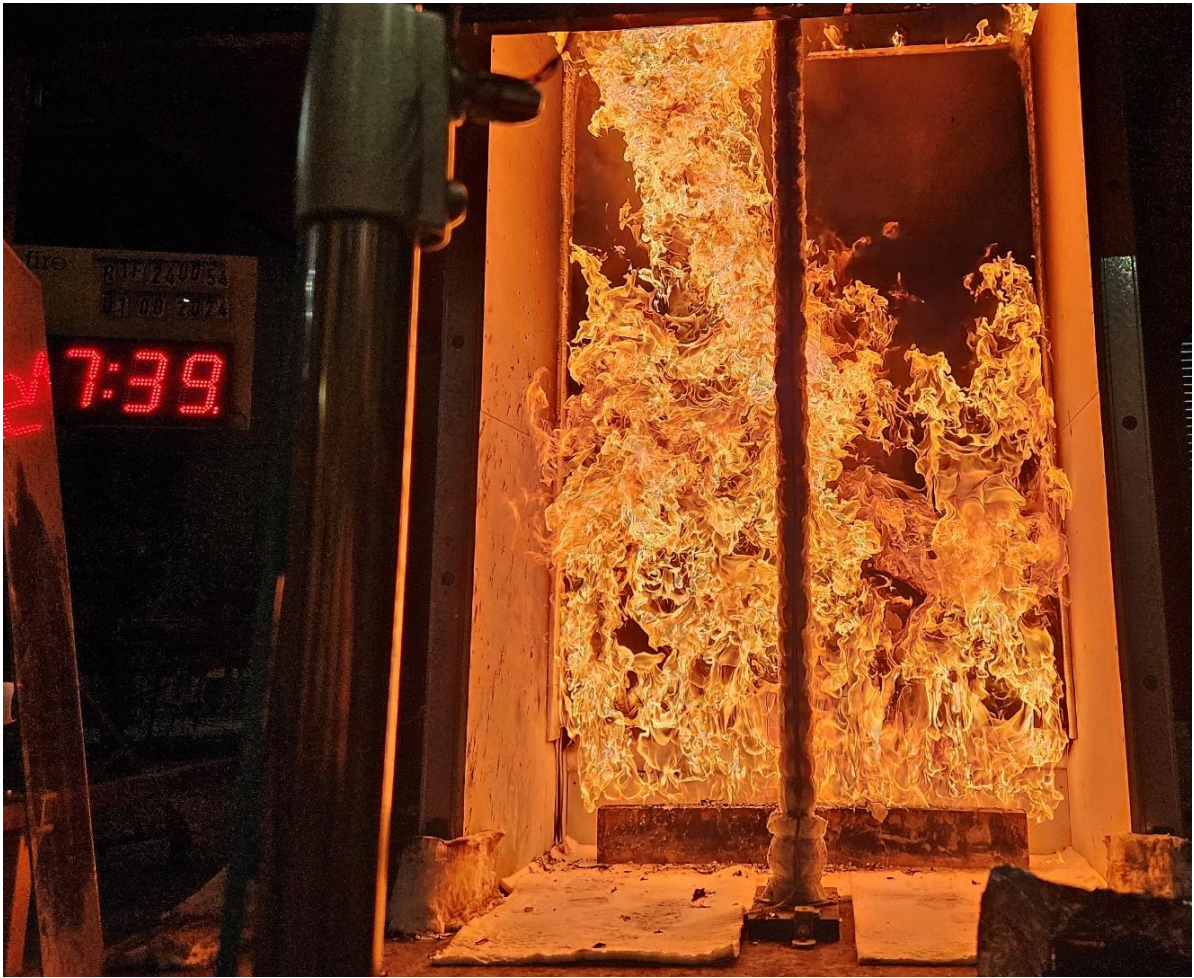
Figure 21 The specimen 17 minutes 39 seconds into the test (burner output at 300 kW)

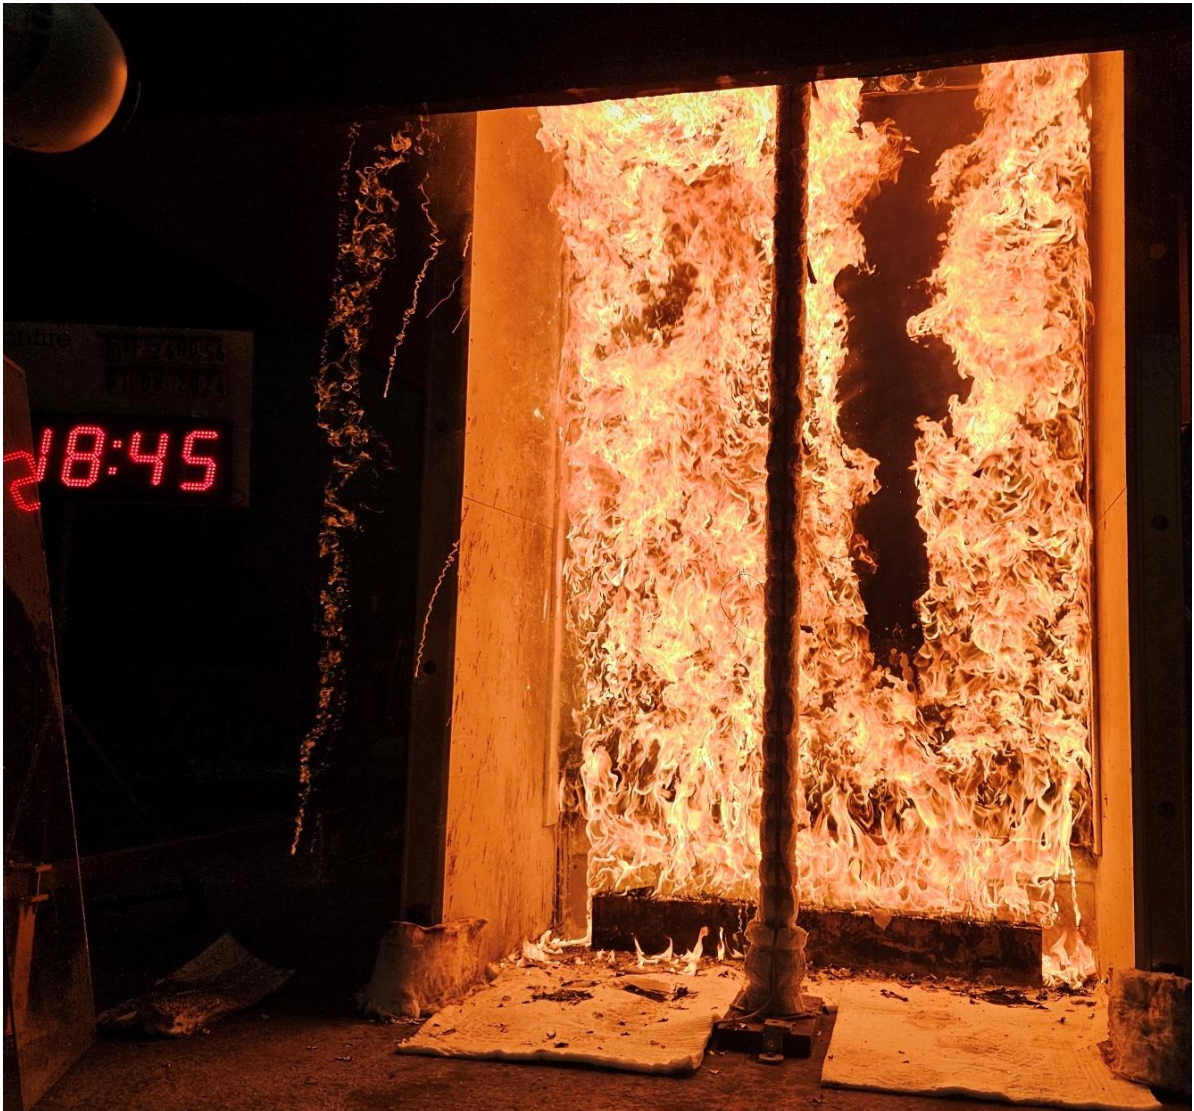
Figure 22 The specimen 18 minutes 45 seconds into the test (burner output at 300 kW)

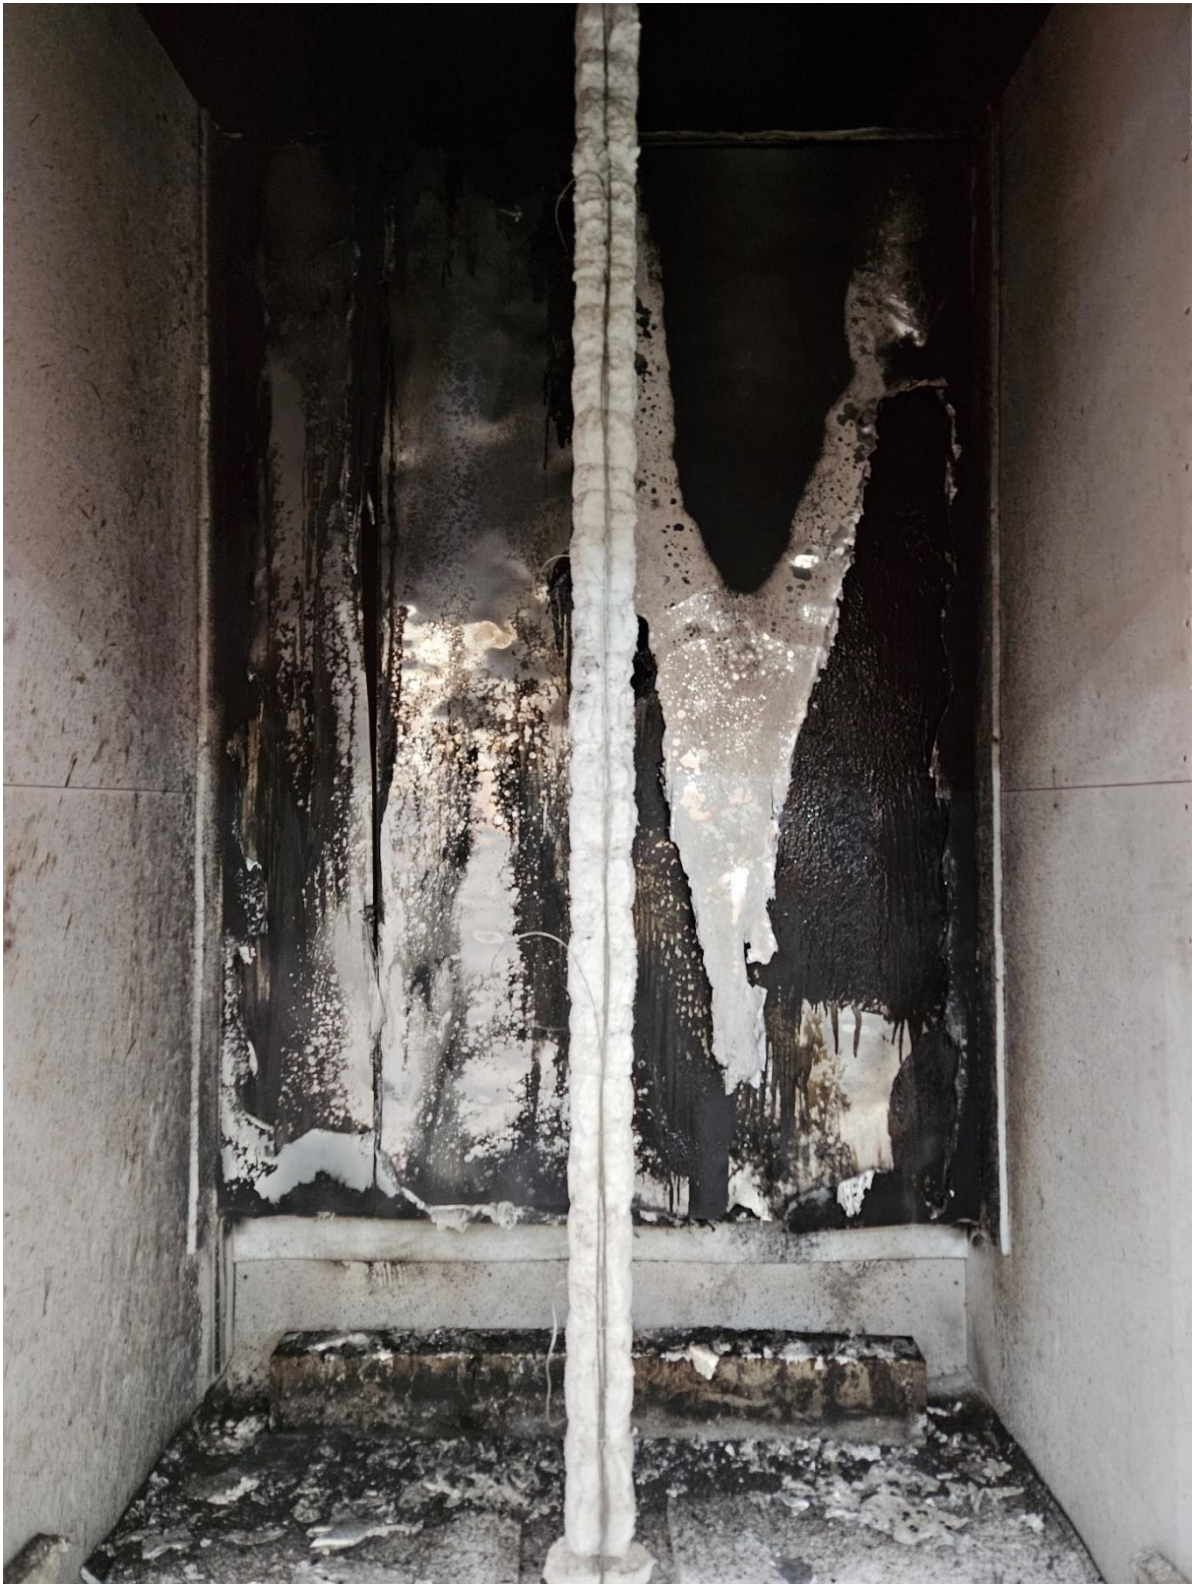
Figure 23 The specimen at end of the reaction to fire test – exposed side

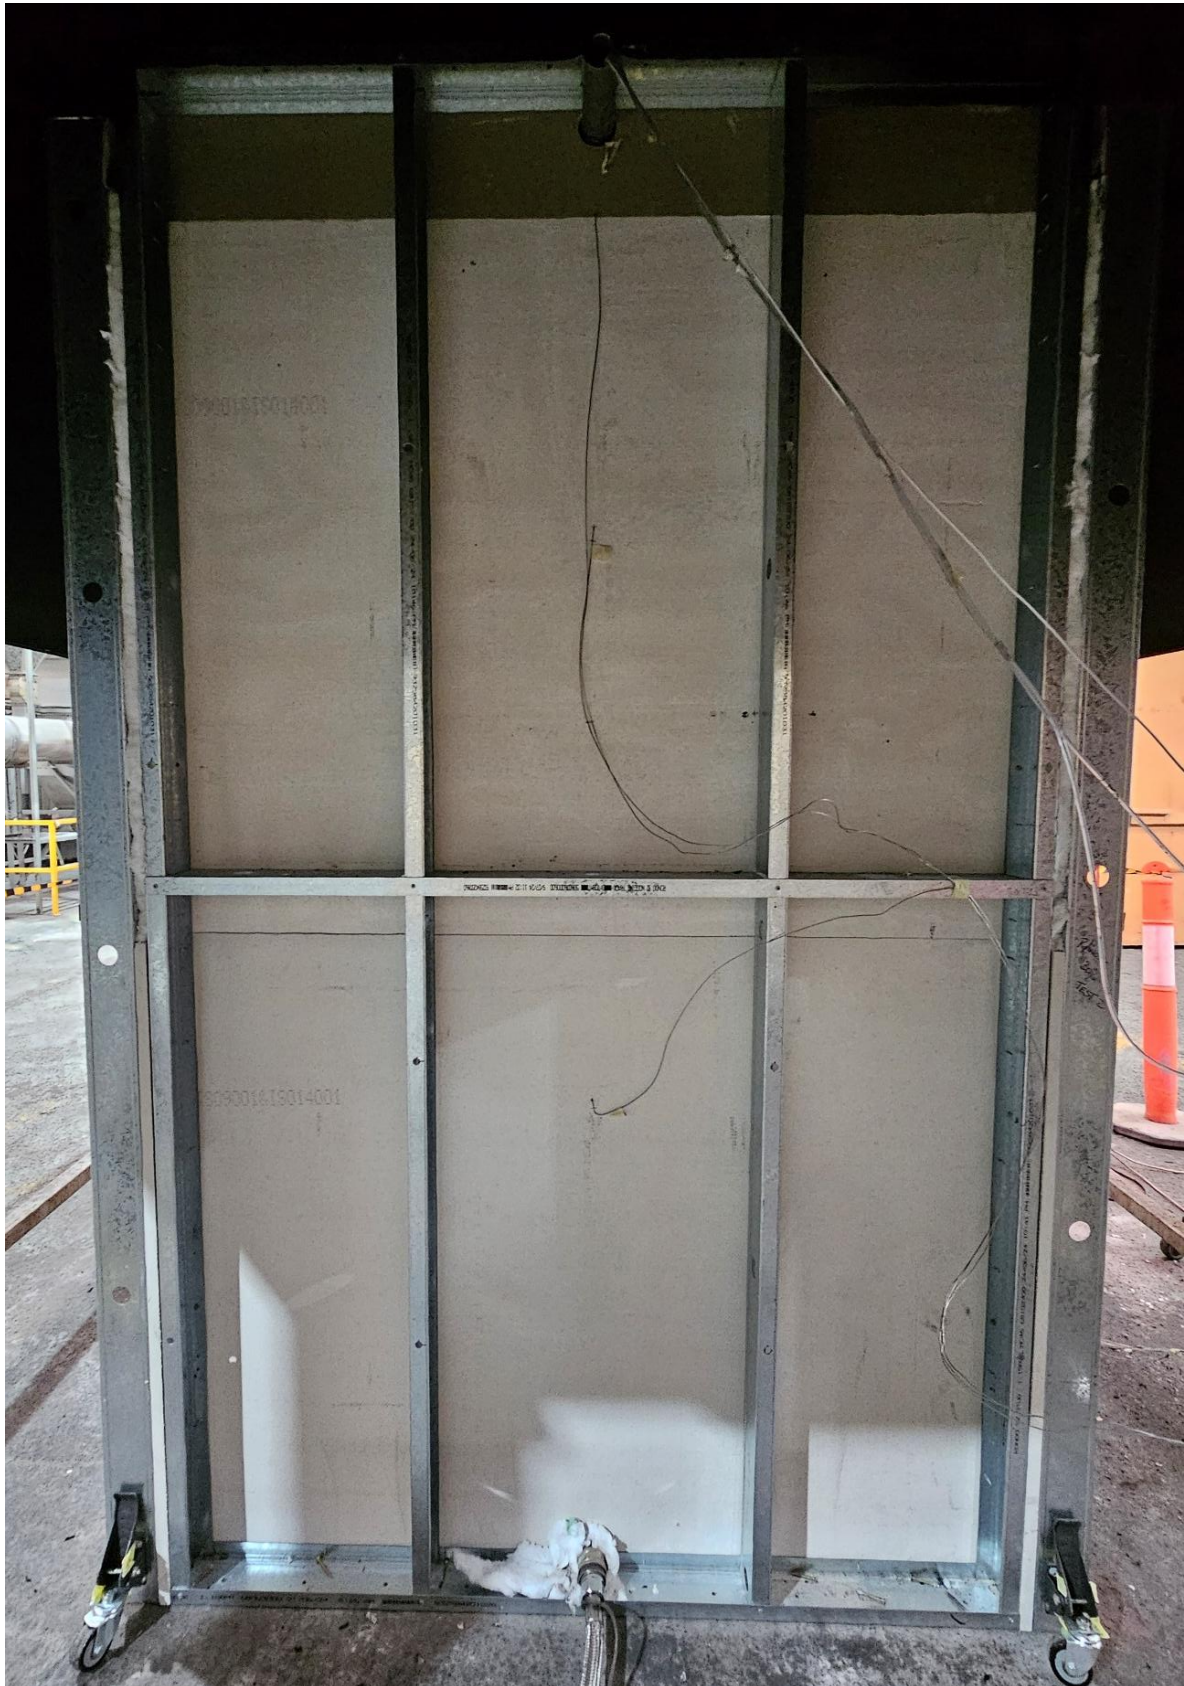
Figure 24 The specimen after the reaction to fire test – unexposed side
