Reaction to fire test report

Test standard: Ad-hoc test based on ISO 13785-1:2002

System: ACP with 100 % polyethylene core external façade cladding system (mechanically and adhesively fixed) with PET wall insulation

Job number: RTF240106

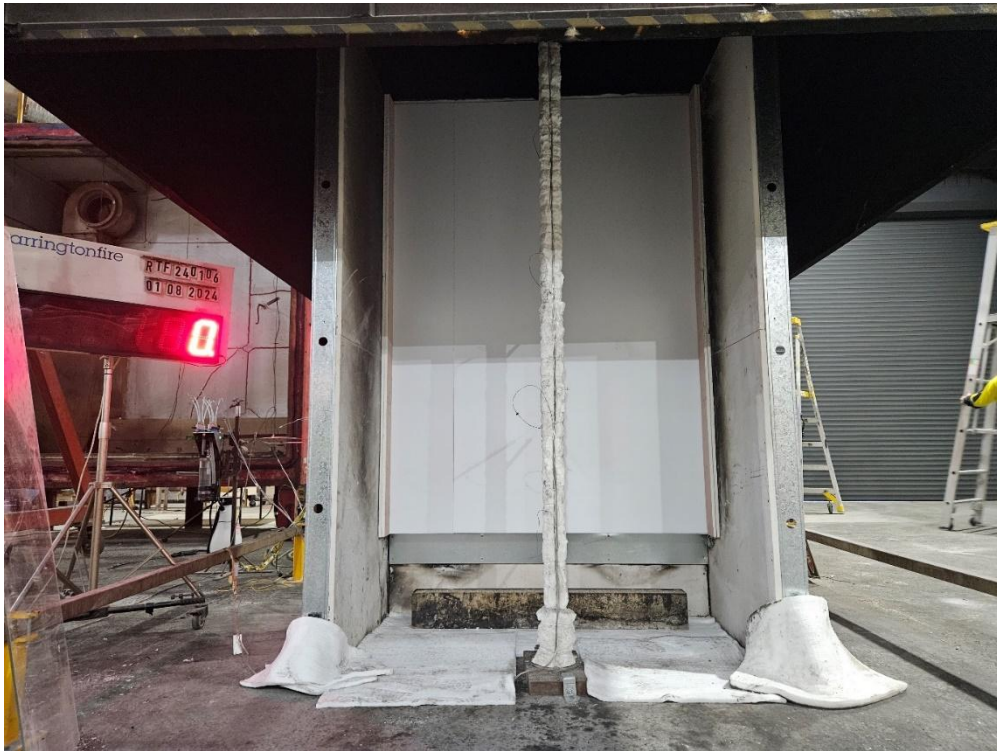
Figure 15 The specimen before the reaction to fire test – exposed side

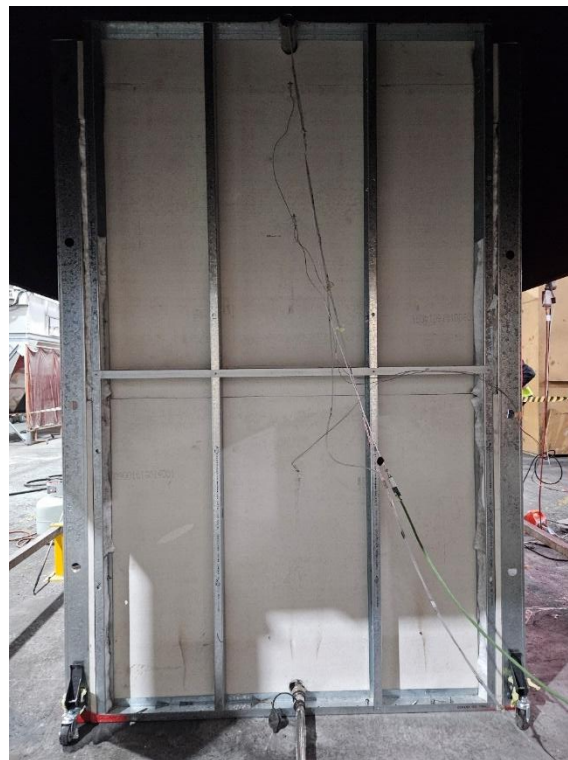
Figure 16 The specimen before the reaction to fire test – unexposed side

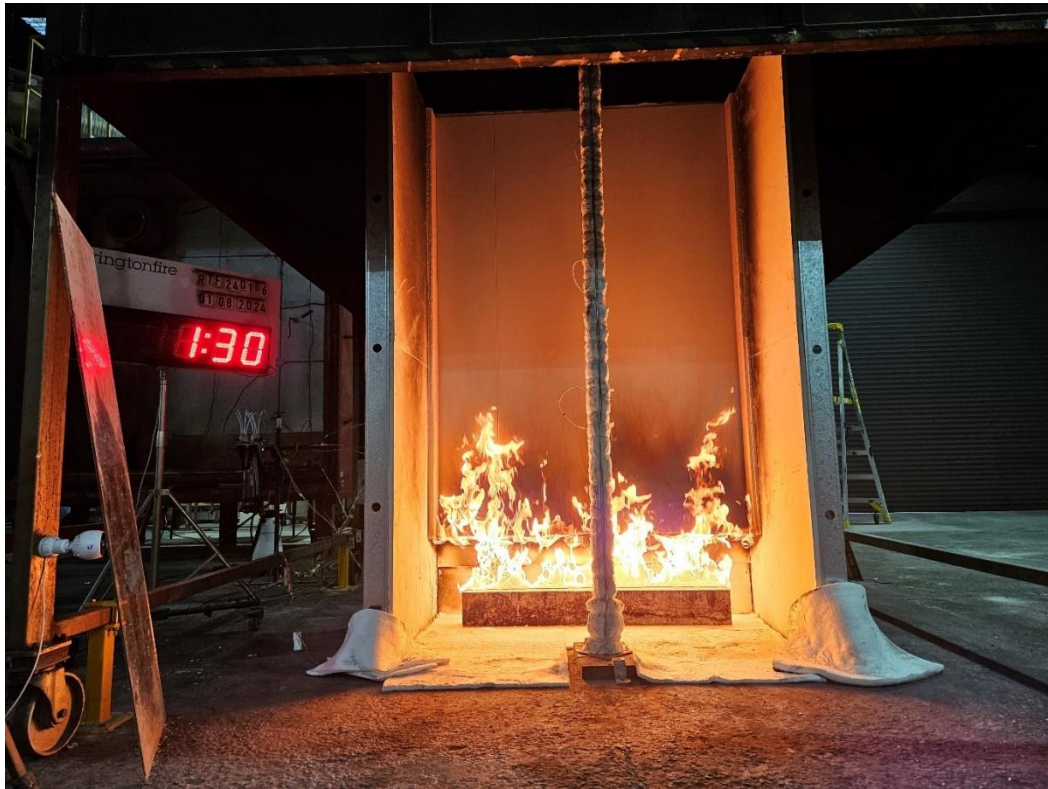
Figure 17 The specimen 1 minute 30 seconds into the test (burner output at 100 kW)

Time		Observation
Min	Sec	
-2	00	Data collection started.
0	00	The reaction to fire test was started with the burner ignited with a heat output set at 100 kW.
0	30	The panels started to darken at the bottom edge.
0	45	The steel angle underneath the cladding started to deform.
3	22	Molten material started to drip down from the cladding.
4	20	Flaming molten debris started to drip down from the cladding.
5	00	The darkened area of the panel had reached mid height.
5	15	Smoke started to escape from the west vertical edge of the back of the specimen.
5	45	Independent flaming of the panel had reached to the mid height of the specimen.
6	00	The face of the capping plasterboards on the side of the cladding started to char.
7	00	Flaming molten debris continued to drip down for the cladding.
7	15	The full face of the panels had darkened.
7	20	Flames started to escape from the corner between the bottom steel angle and the enclosure.

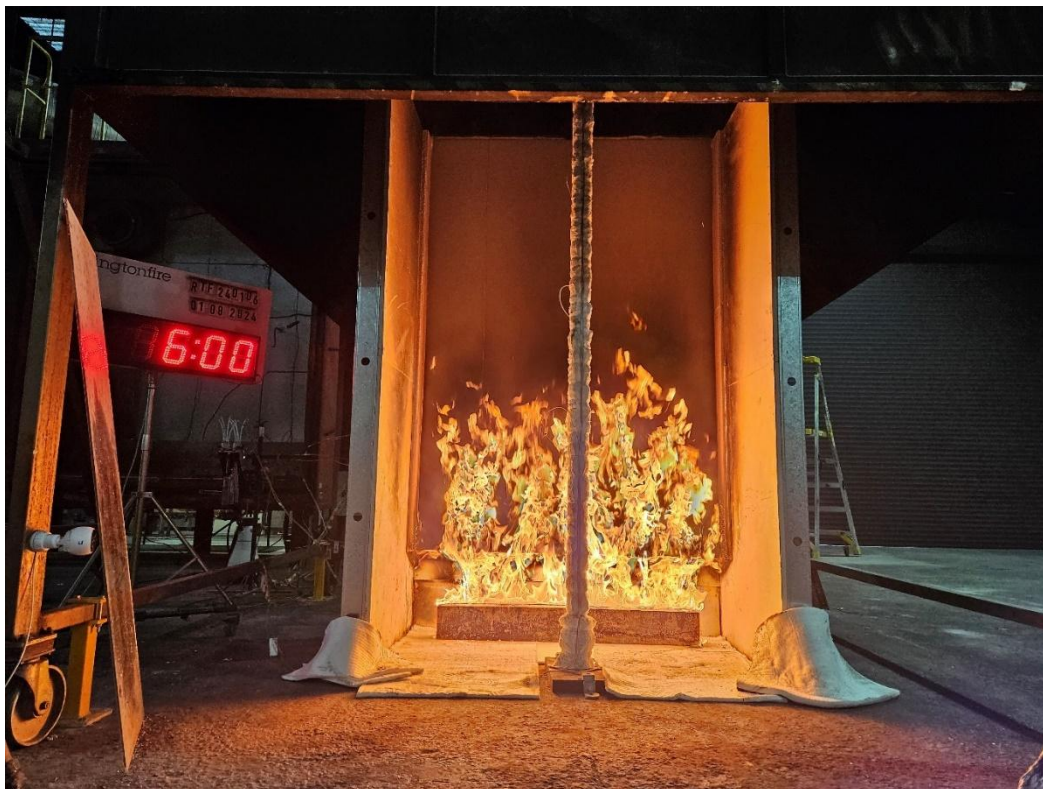
Figure 18 The specimen 6 minutes into the test (burner output at 100 kW)

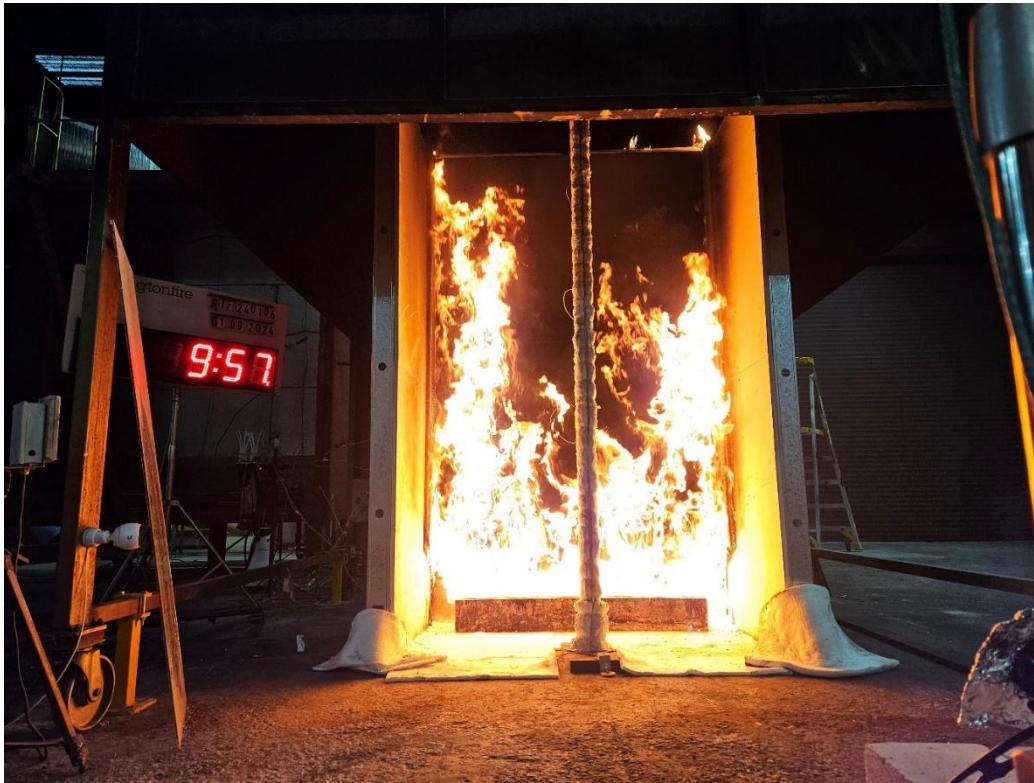
Figure 19 The specimen 9 minutes 57 seconds into the test (burner output at 100 kW)

7	50	The independent flaming of the panel had almost reached the top of the cladding.
8	30	The flames had reached the top of the cladding, with the top west corner of the cladding flaming.
12	00	The flames had extended past the cladding, and had reached into the exhaust hood duct.
12	30	1 MW heat release rate was recorded. The majority of the debris on the floor was still flaming.
14	30	The cladding had been consumed up to the mid height.
15	00	The heat output of the burner was increased to 300 kW.
16	00	More of the cladding had been consumed and melted off.
17	00	Almost all of the front skin of the cladding had melted off.
17	30	Flames started to escape from the east edge of the back of the cladding.
25	00	The burner was turned off.
27	00	The reaction to fire test was ended.

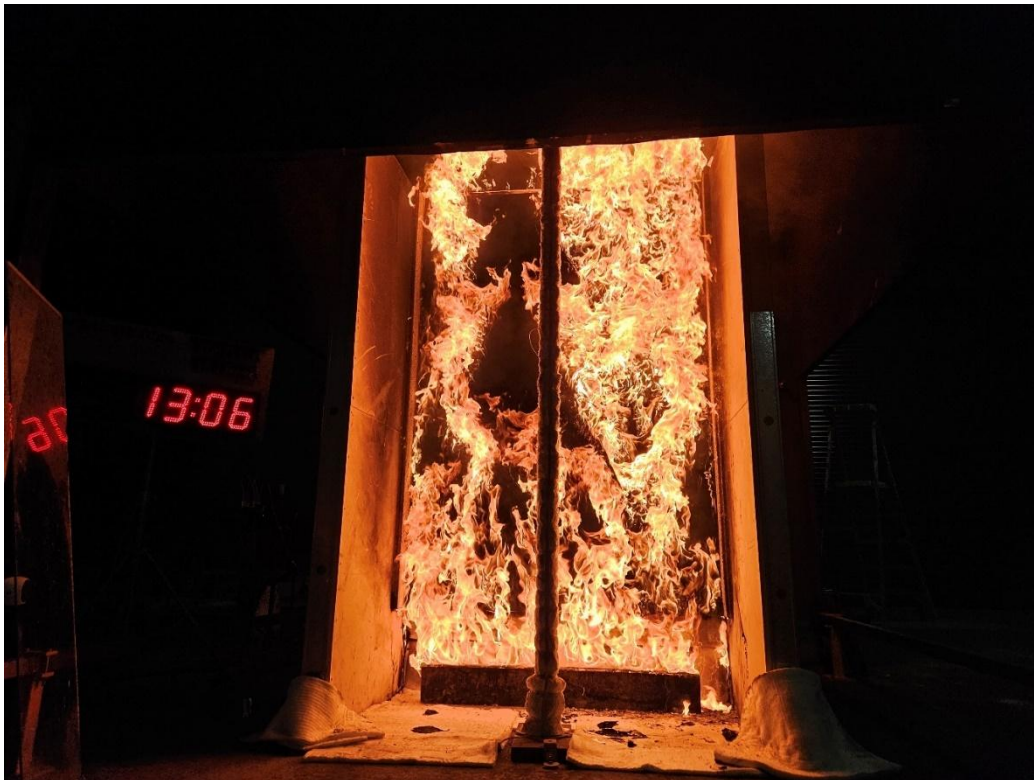
Figure 20 The specimen 13 minutes 06 seconds into the test (burner output at 100 kW)

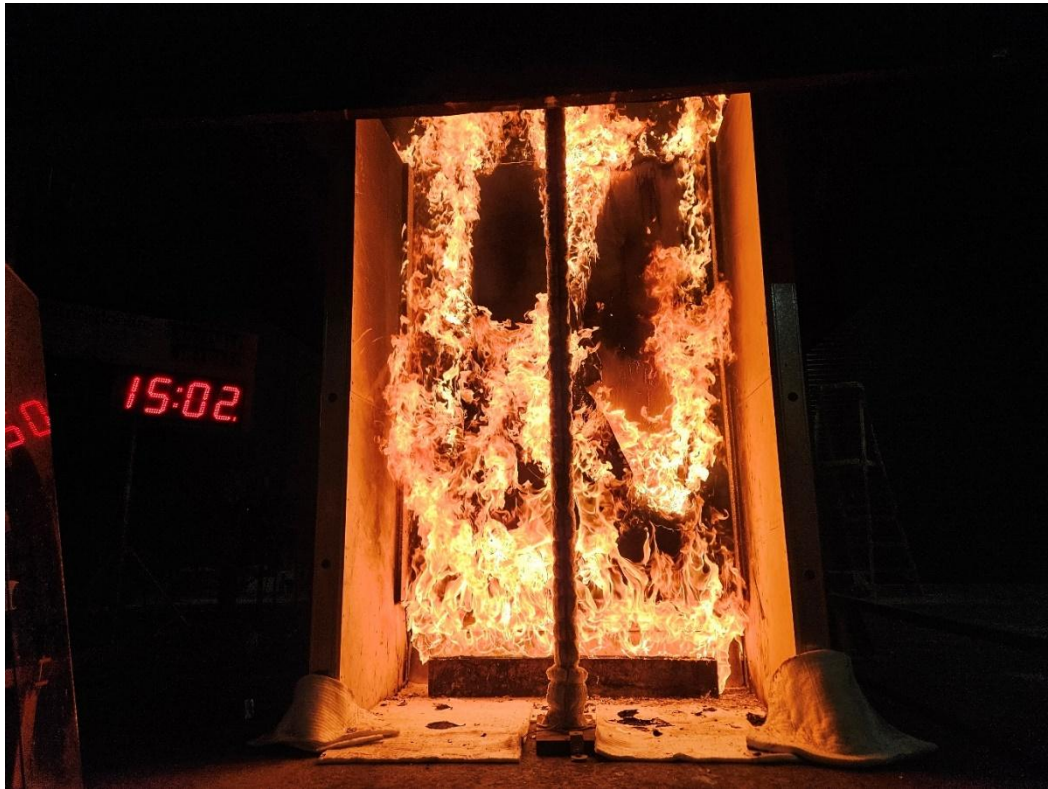
Figure 21 The specimen 15 minutes 02 seconds into the test (burner output at 300 kW)

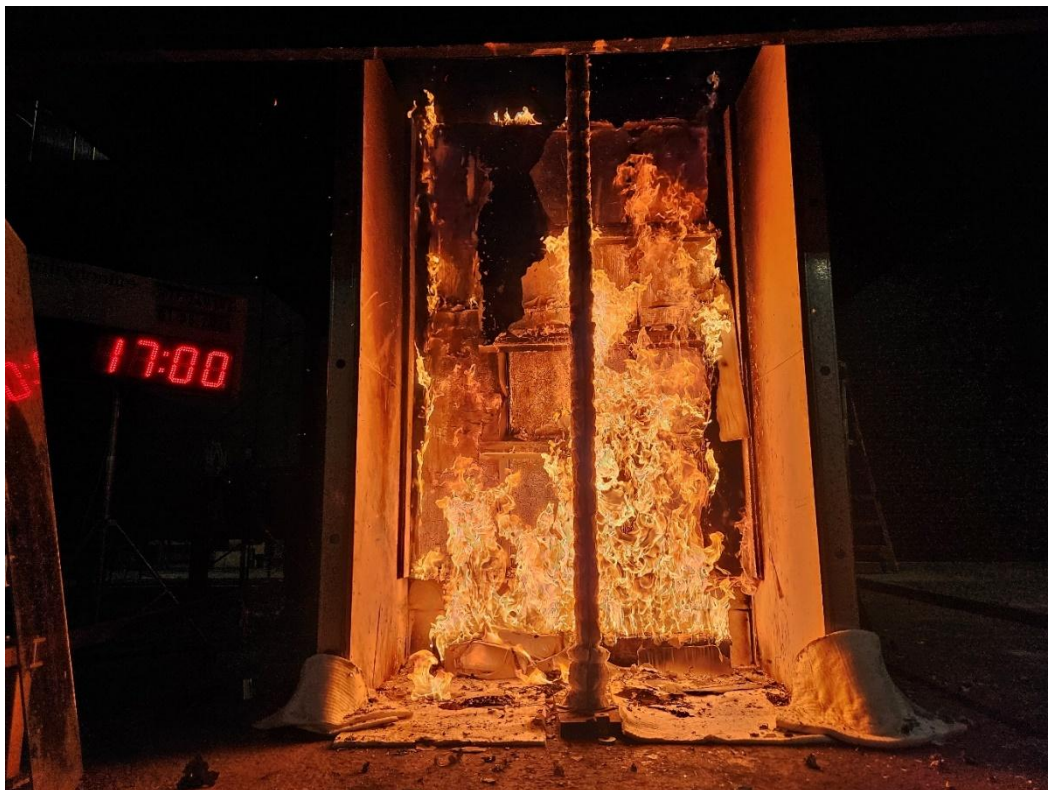
Figure 22 The specimen 17 minutes into the test (burner output at 300 kW)

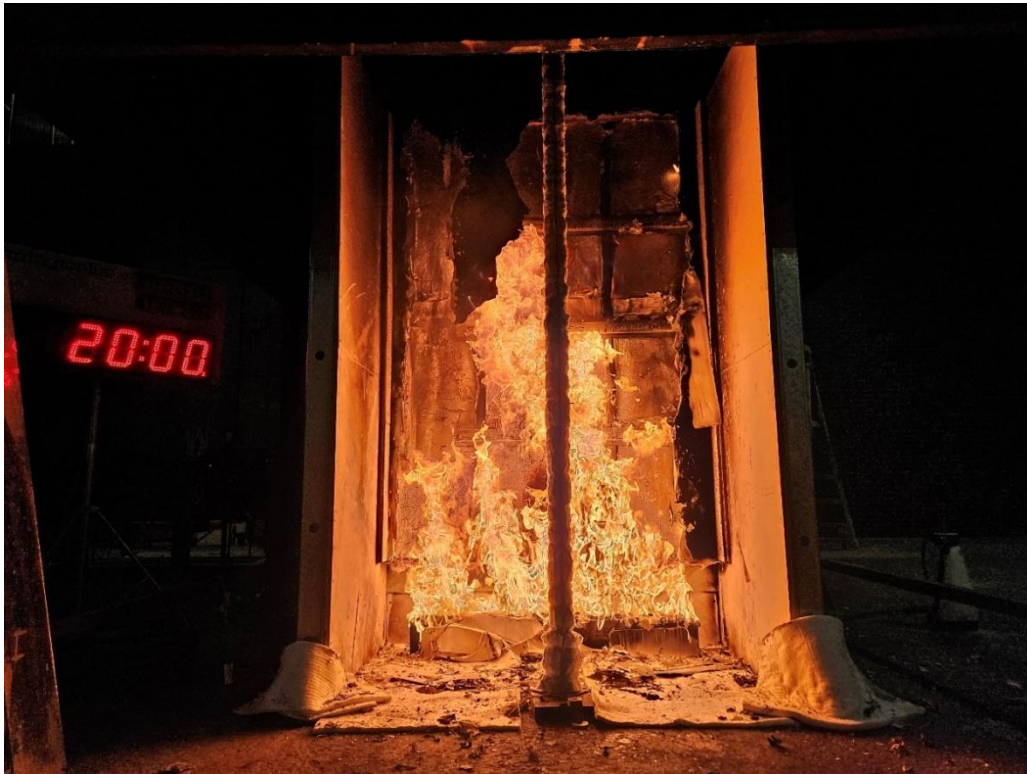
Figure 23 The specimen 20 minutes into the test (burner output at 300 kW)

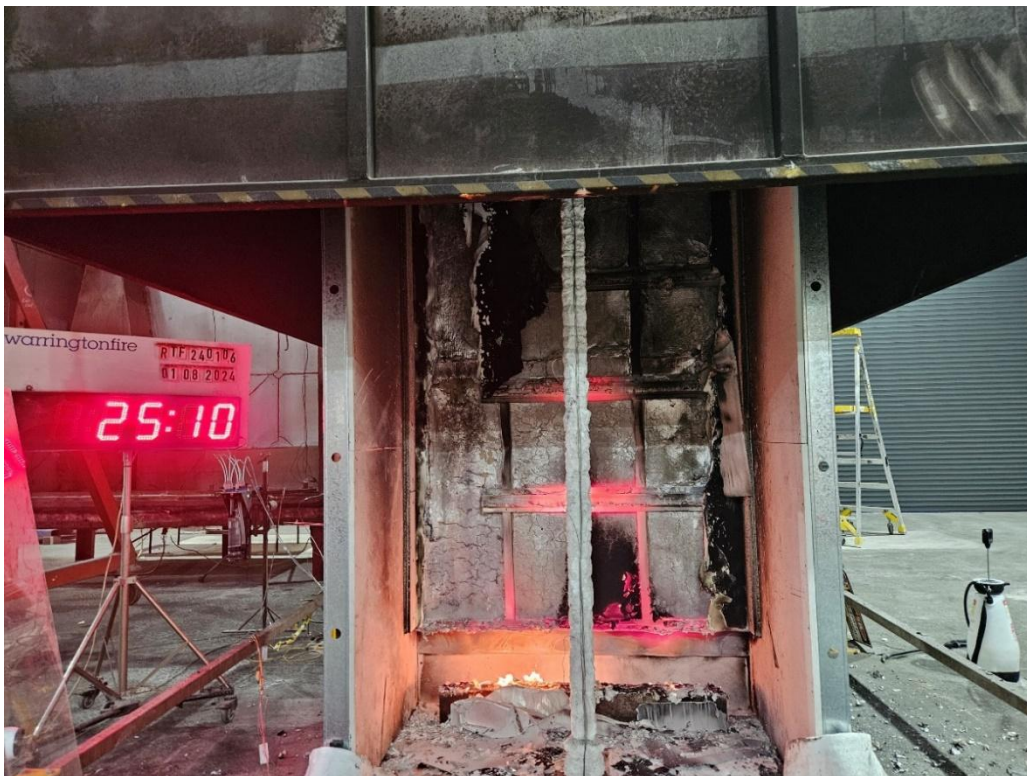
Figure 24 The specimen 25 minutes 10 seconds into the test (10 seconds after the burner was turned off)

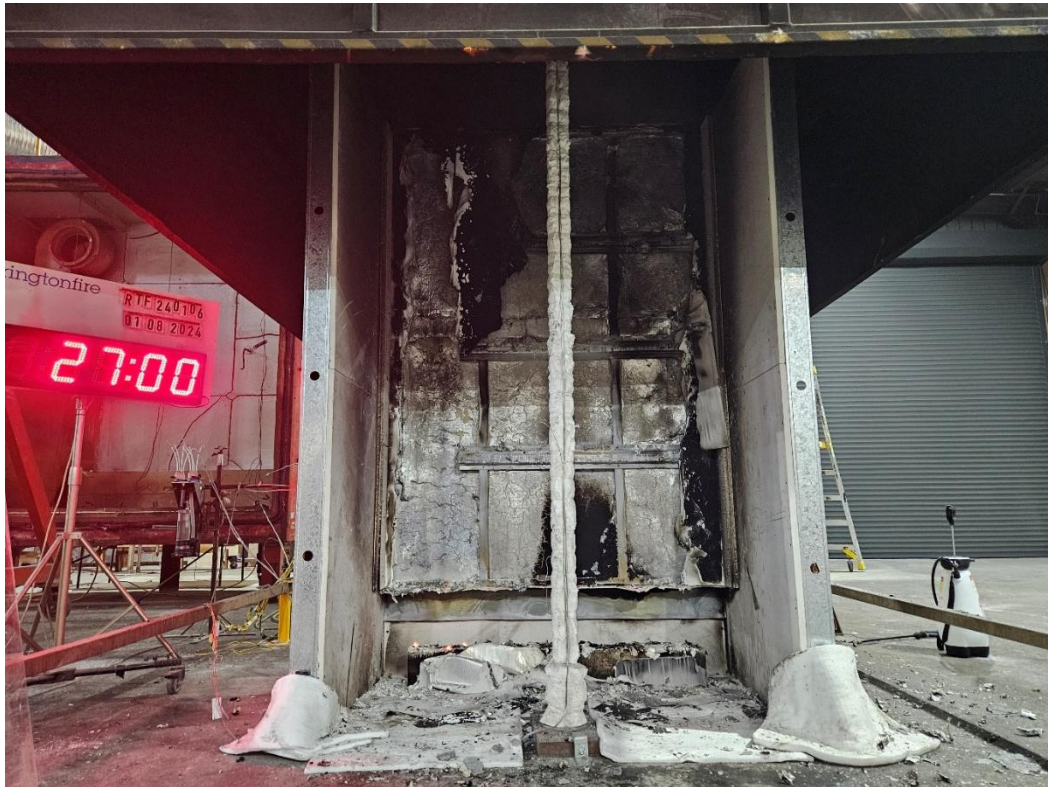
Figure 25 The specimen at end of the reaction to fire test – exposed side

Note: A photograph of the unexposed side of the specimen was not recorded at the end of the reaction to fire test, but no visual changes were observed.
