# Reaction to fire test report

Test standard: Ad-hoc test based on ISO 13785-1:2002

System: ACP with 100 % polyethylene core external façade cladding system (mechanically fixed) with stonewool wall insulation

Job number: RTF240055

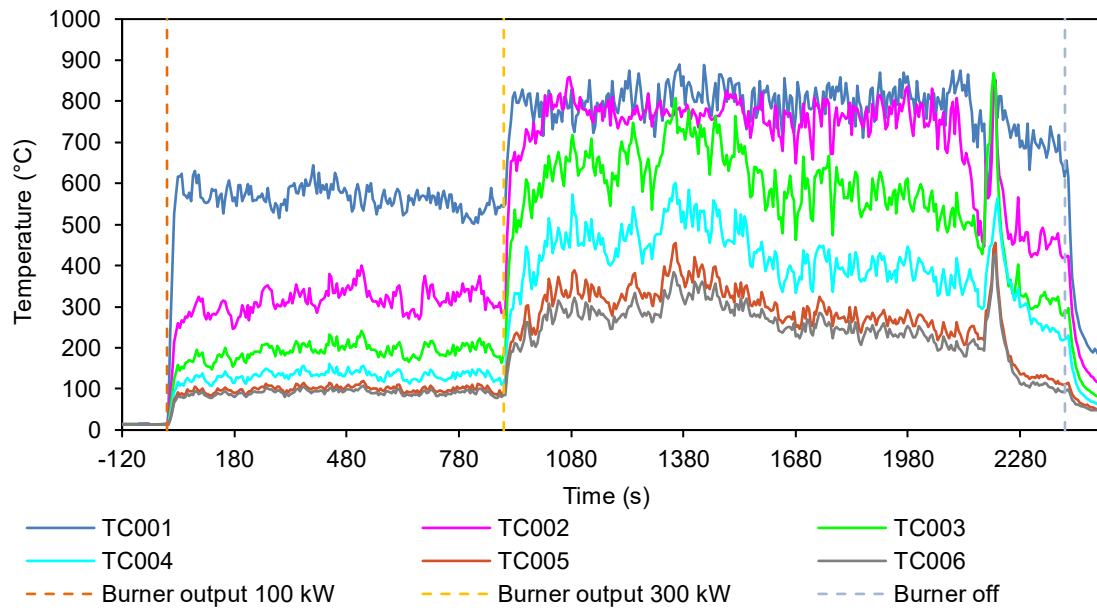
**Figure 1 50 mm from the exposed face – Temperature vs time**

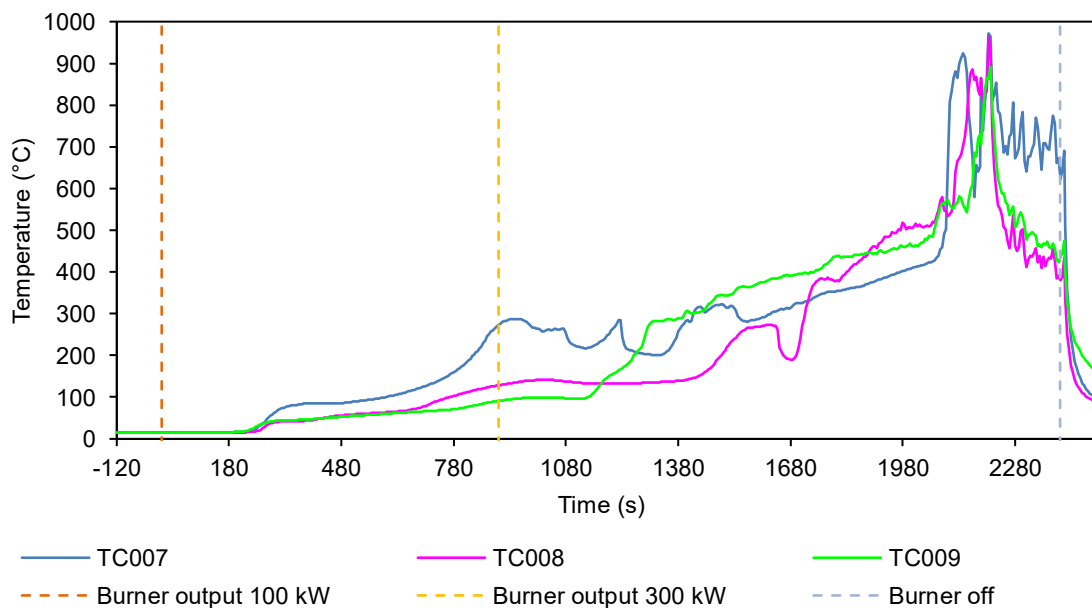
**Figure 2 Cavity – Temperature vs time**

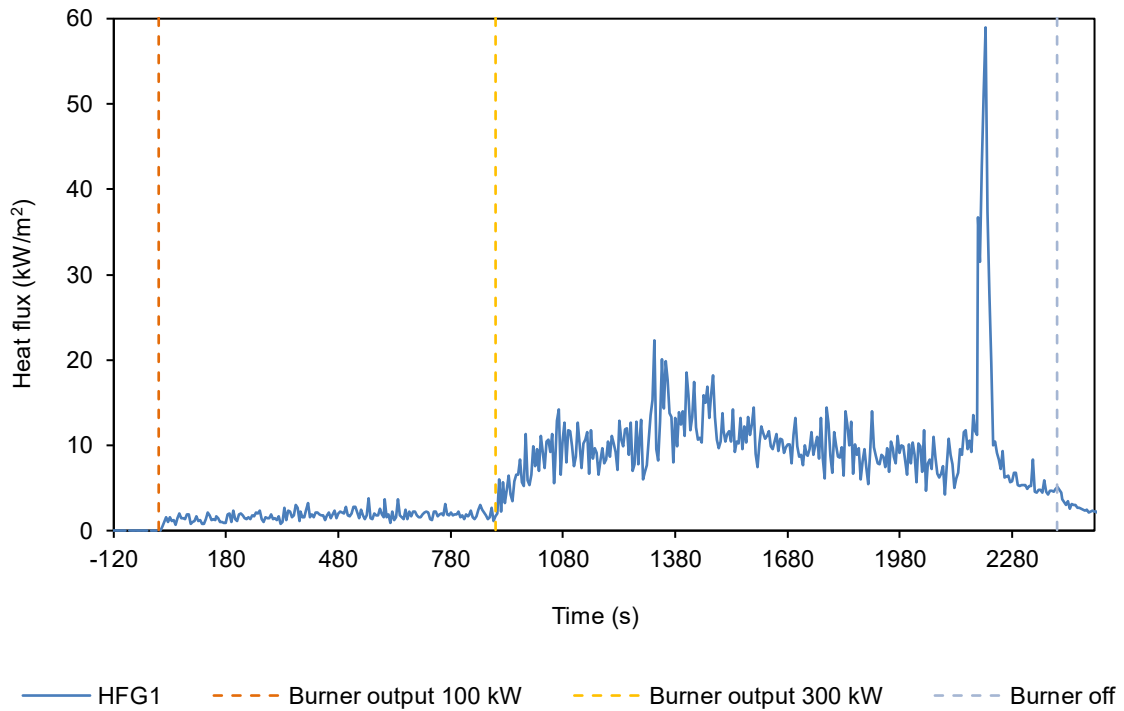
**Figure 3 Heat flux vs time**

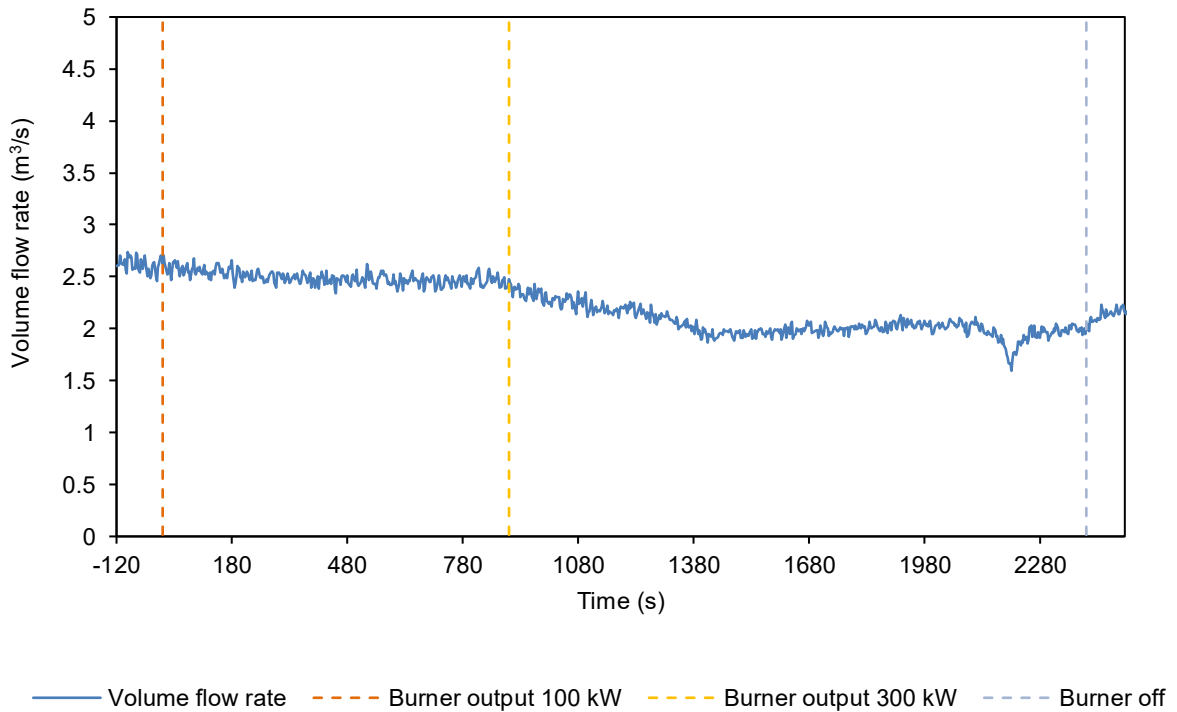
**Figure 4 Volume flow rate in duct vs time**

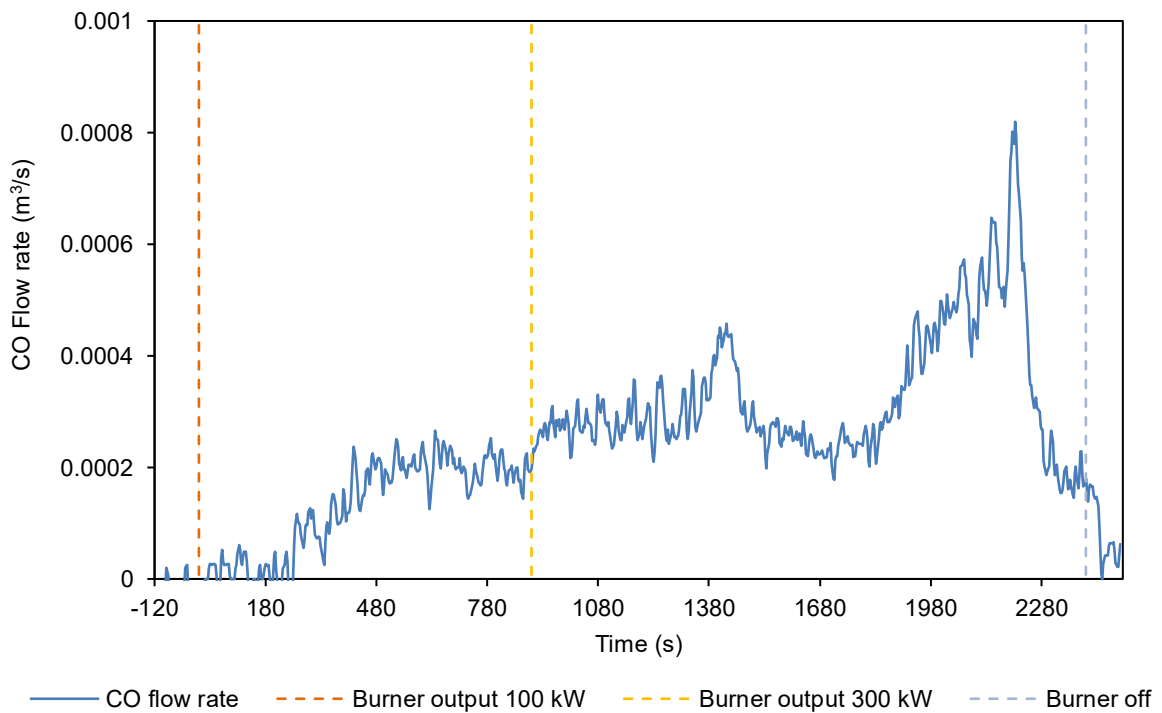
**Figure 6 Production of carbon monoxide vs time, at reference temperature and pressure**

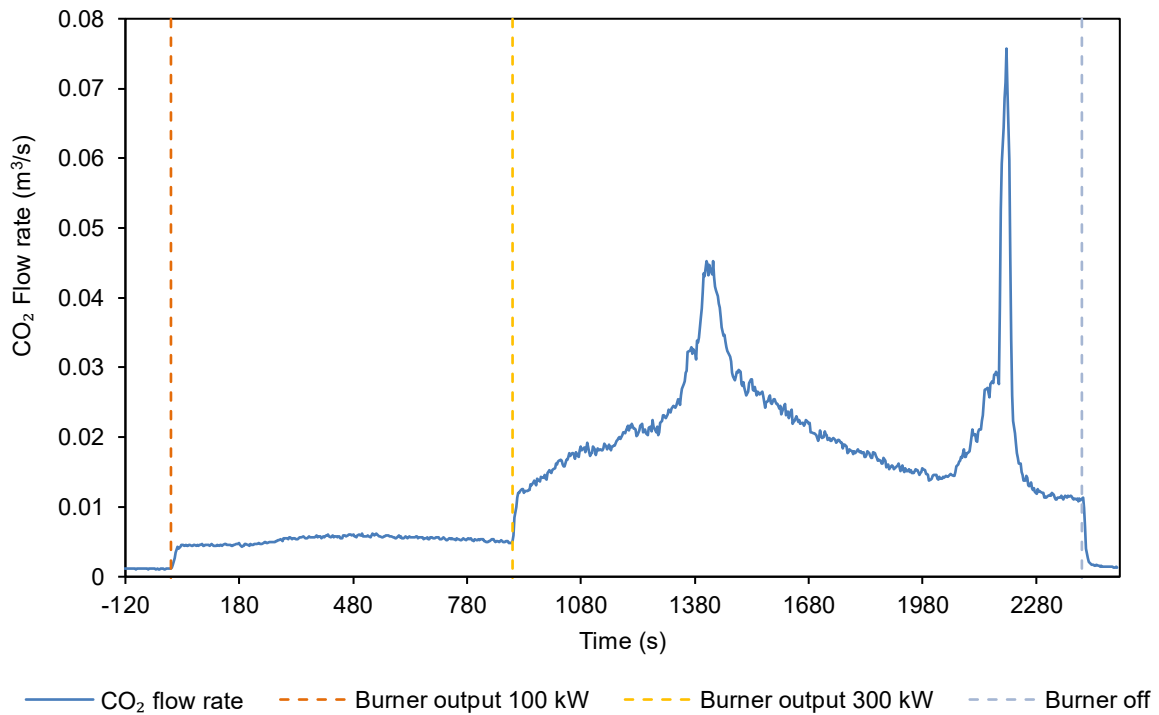
**Figure 7 Production of carbon dioxide vs time, at reference temperature and pressure**

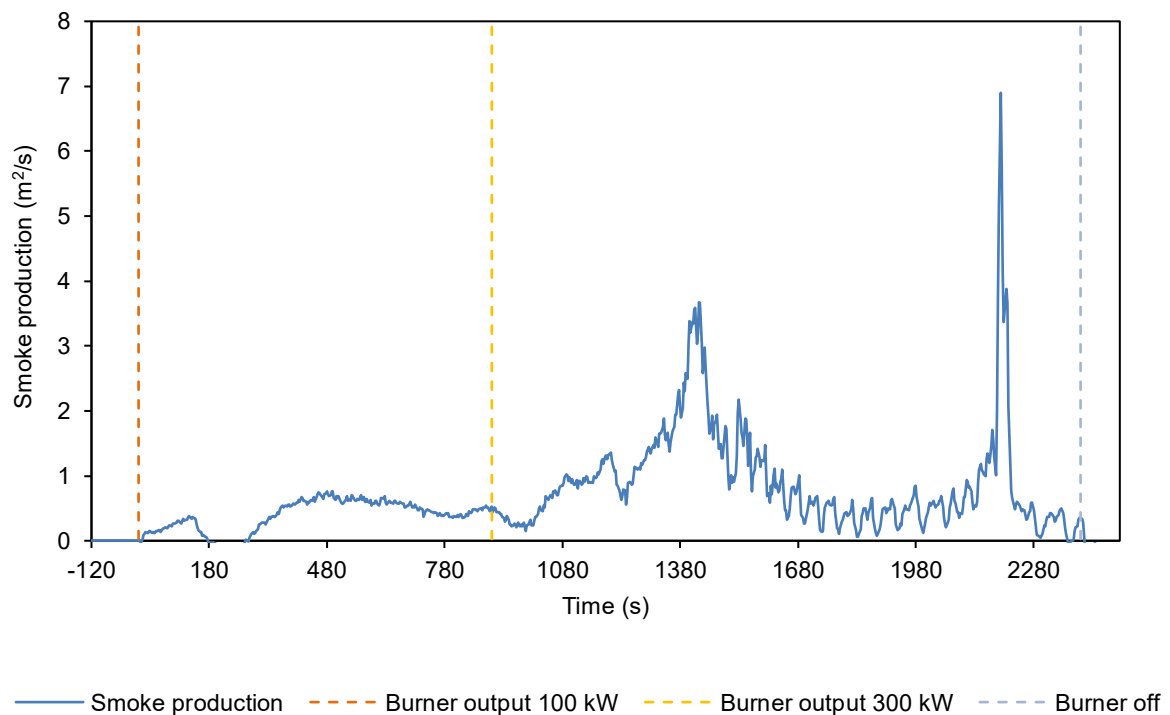
**Figure 8 Production of light obscuring smoke vs time, at reference temperature and pressure**

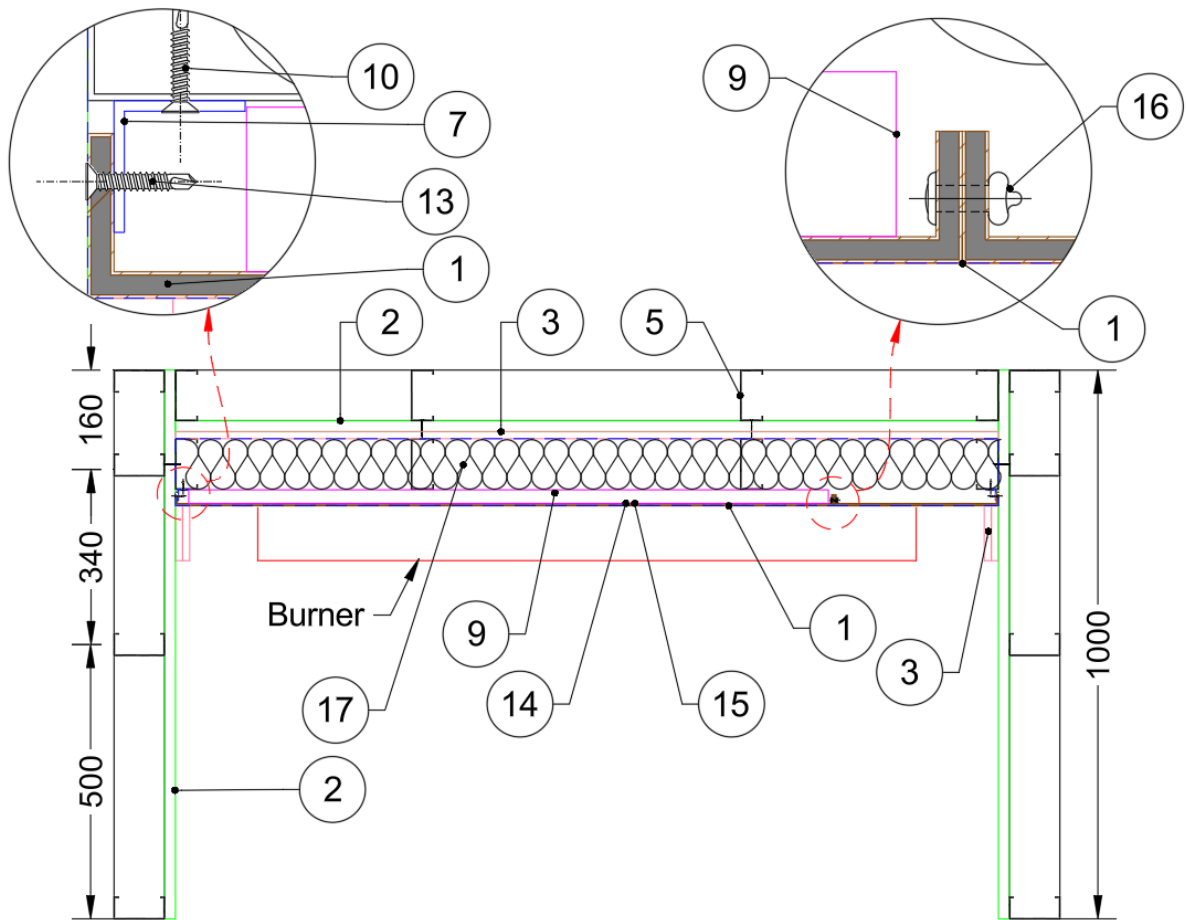
**Figure 12 System assembly – Horizontal cross-section B-B**

The drawings of the test assembly in Figure 9 to Figure 12 were prepared by representatives of Warringtonfire. The leaders in the drawings represent the items listed in section 2.1. All measurements, unless specified, are in mm.

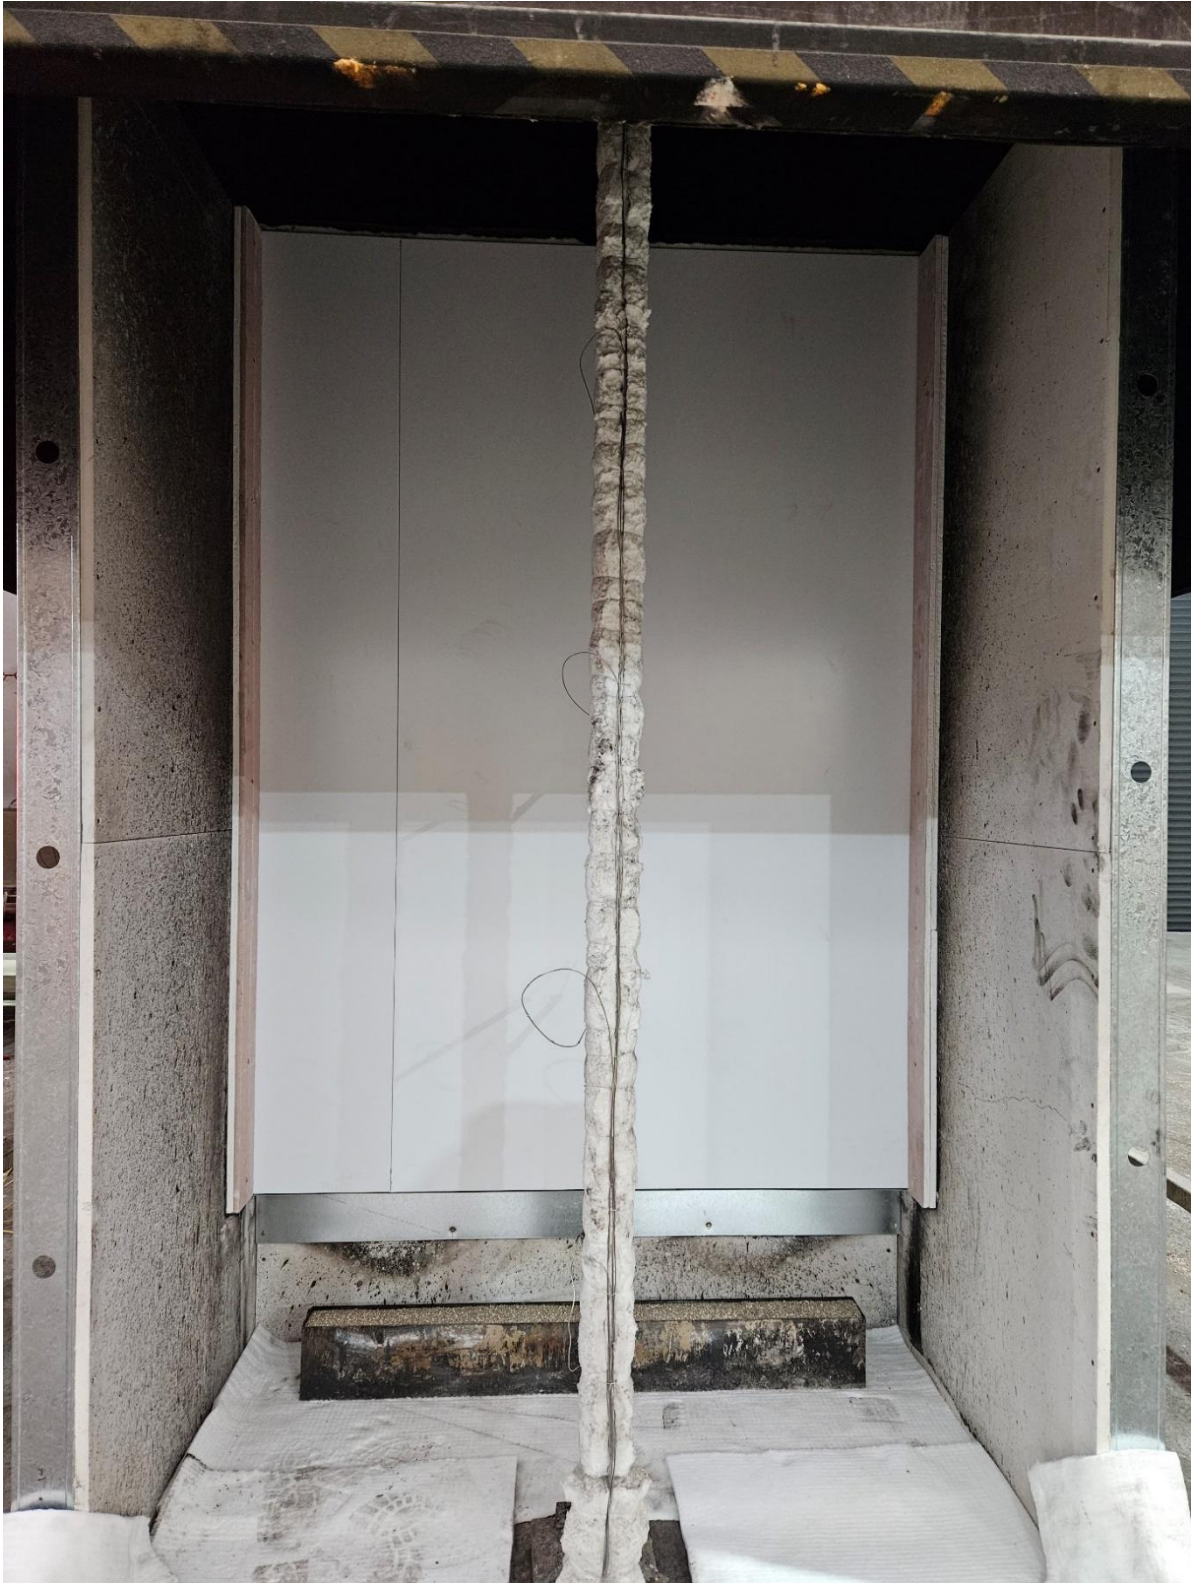
**Figure 15** The specimen before the reaction to fire test – exposed side

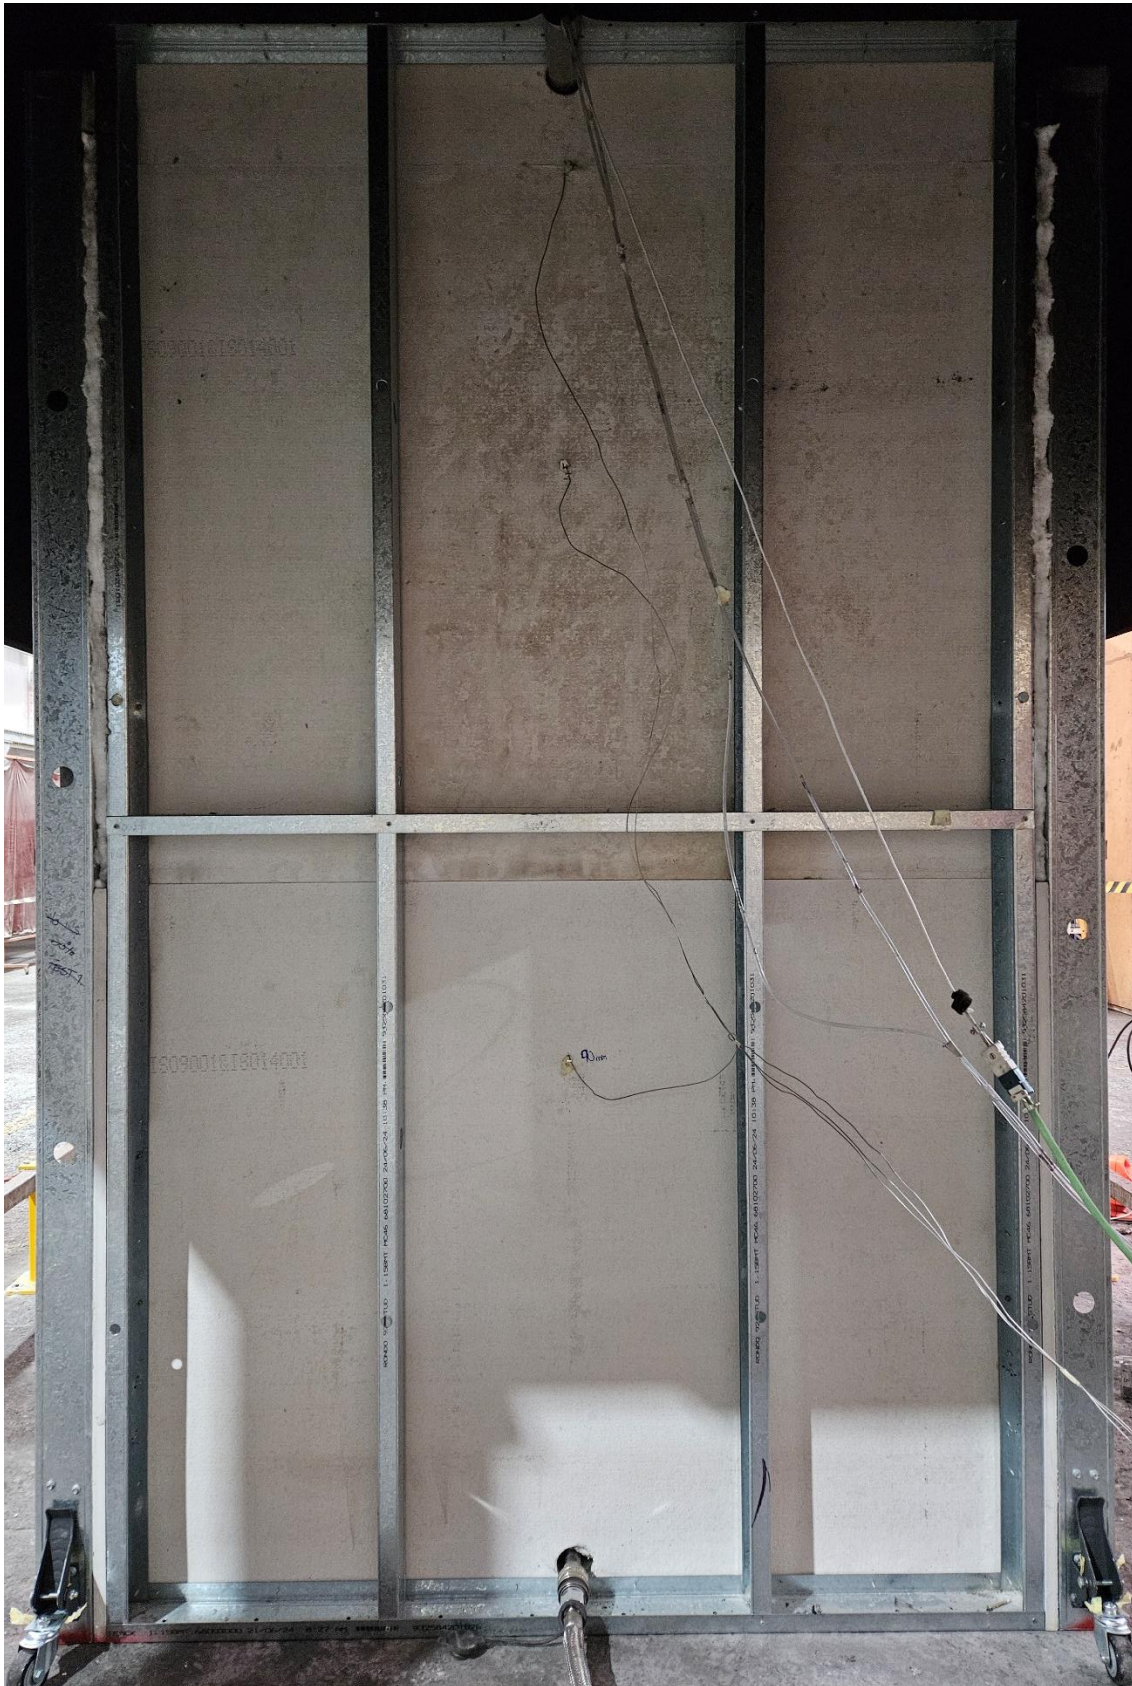
**Figure 16 The specimen before the reaction to fire test – unexposed side**

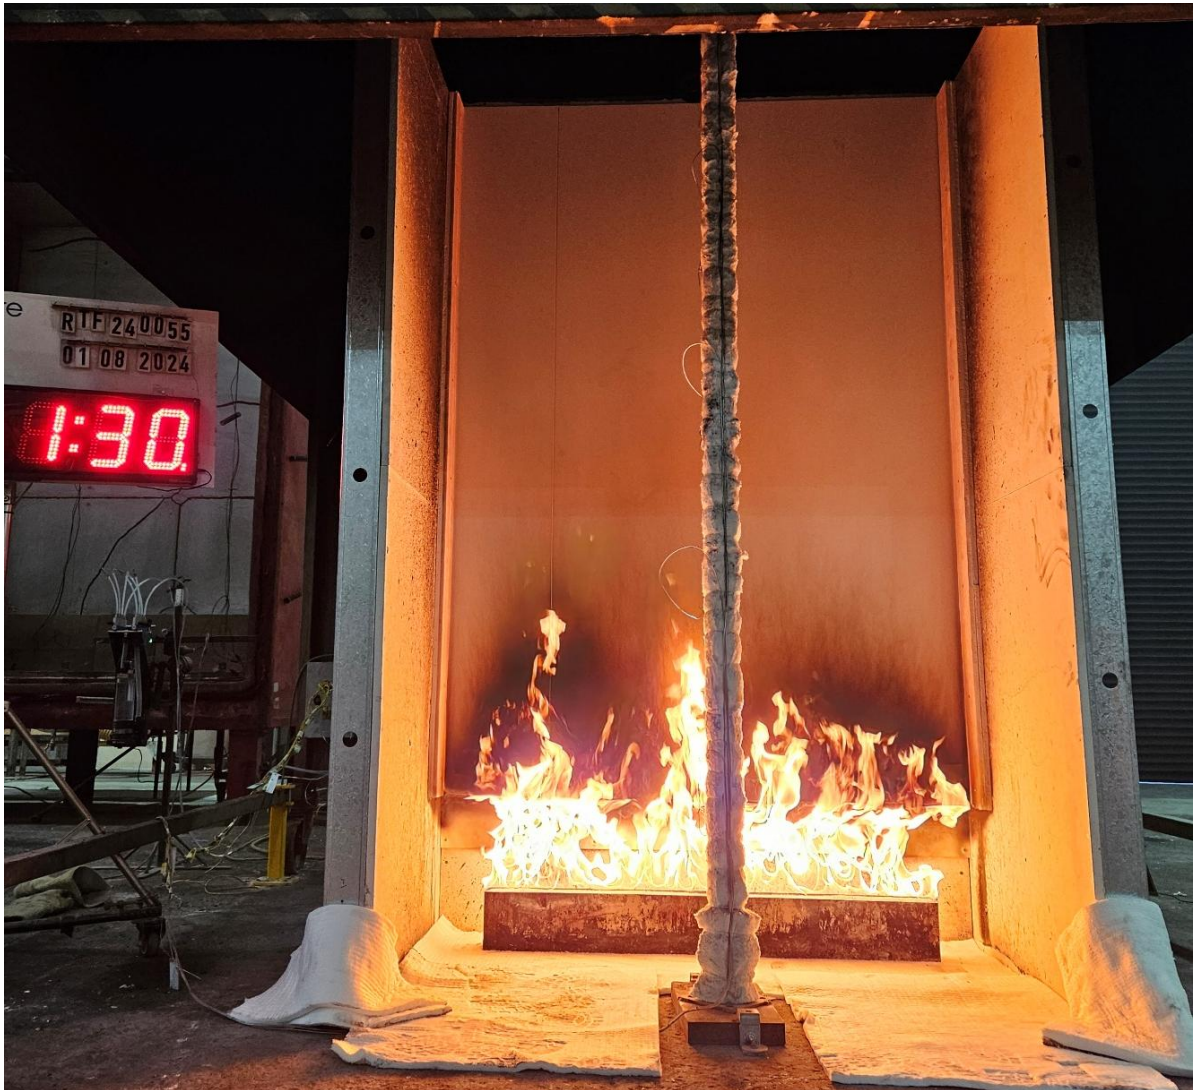
**Figure 17** The specimen 1 minutes 30 seconds into the test (burner output at 100 kW)

Time		Observation
Min	Sec	
-2	00	Data collection started.
0	00	The reaction to fire test was started with the burner ignited with a heat output set at 100 kW.
0	22	Discolouration started at the bottom section of the panels.
1	20	Steel angle at the bottom of the specimen started to deform.
3	30	Plasterboard strips at the side started to char.
3	50	Panels face started melting with flaming debris falling from the specimen.
9	05	Panels are fully darkened.
13	00	More molten panels were falling off.
15	00	The heat output of the burner was increased to 300 kW.
15	20	Flames reached the top of the specimen.
16	30	More flaming debris were falling from the specimen.
17	00	Smoke was emitting from the vertical edges of the back wall.
17	20	Flaming on the calcium silicate boards at the corners below the steel angle.
19	33	Flaming at the east vertical edge of the back wall.
22	30	More flaming debris kept falling. Two big openings can be seen at the vertical edges of the specimen.

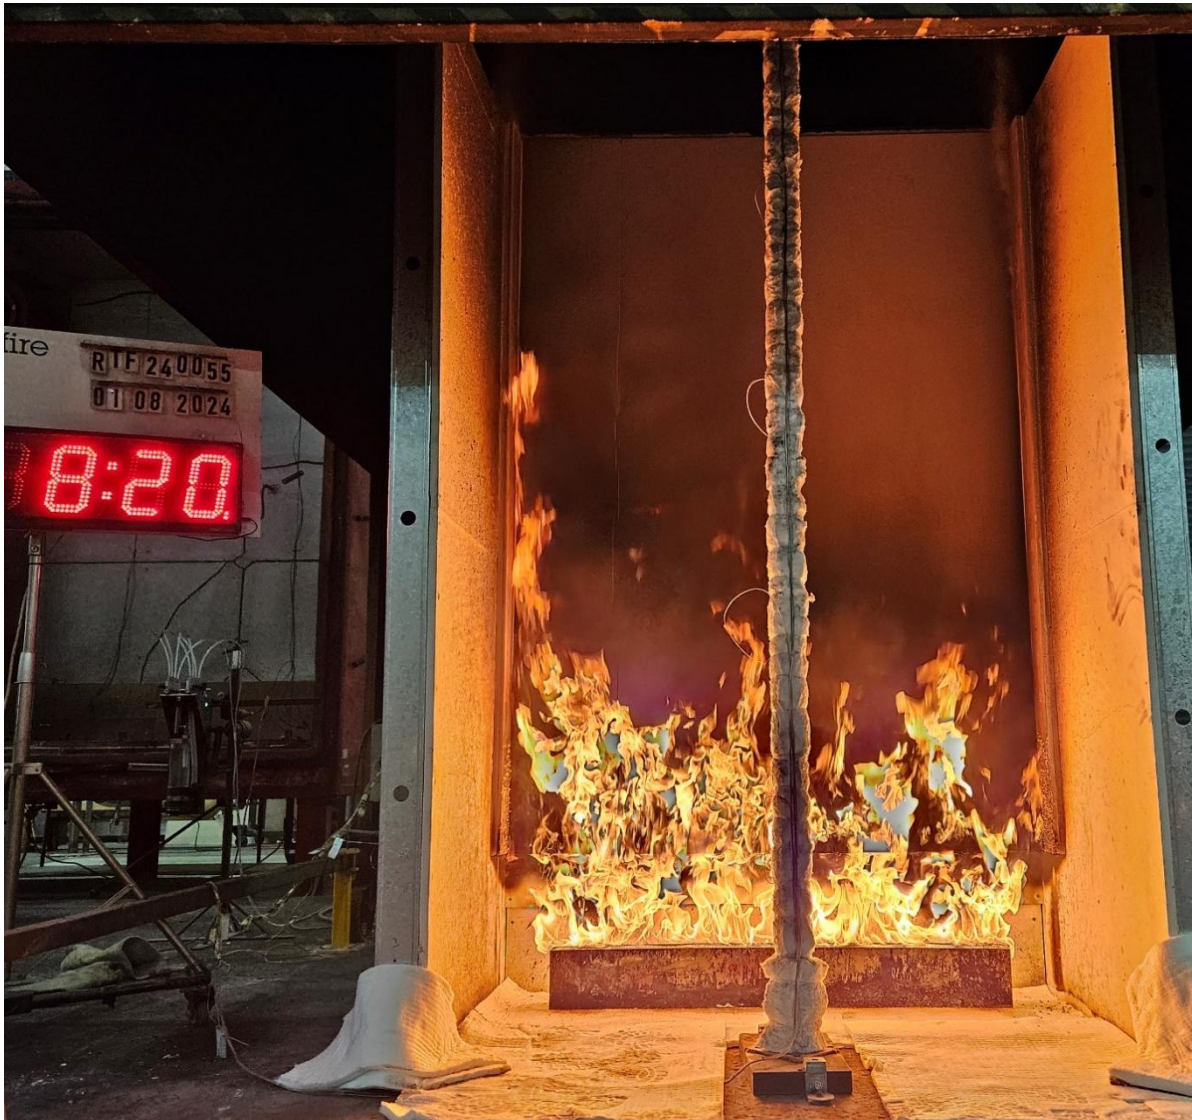
**Figure 18 The specimen 8 minutes 20 seconds into the test (burner output at 100 kW)**

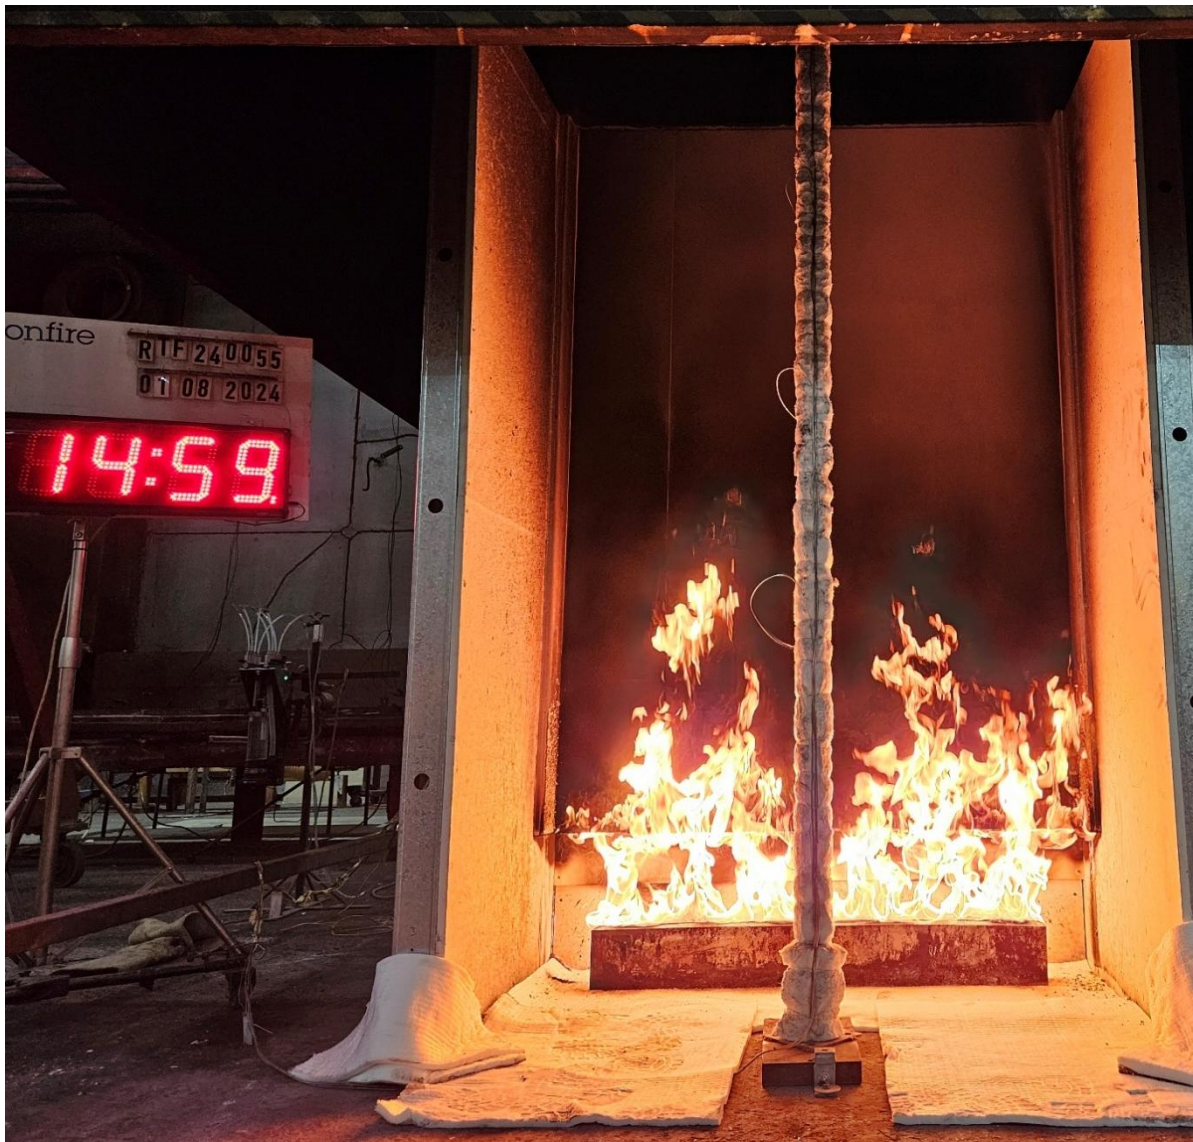
**Figure 19** The specimen 14 minutes 59 seconds into the test (burner output at 100 kW)

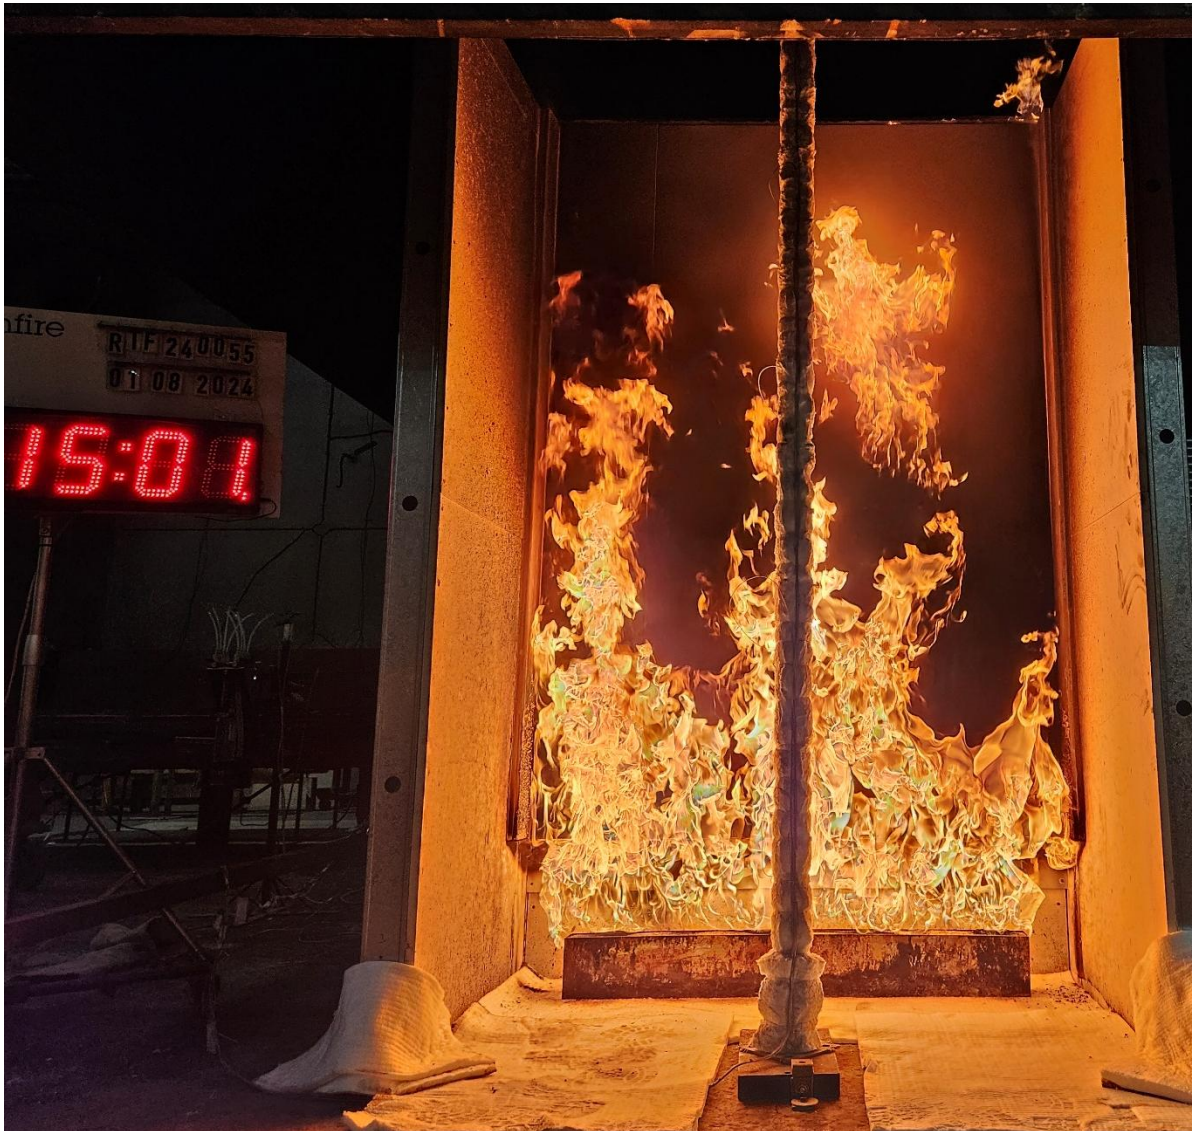
**Figure 20** The specimen 15 minutes 01 seconds into the test (burner output at 300 kW)

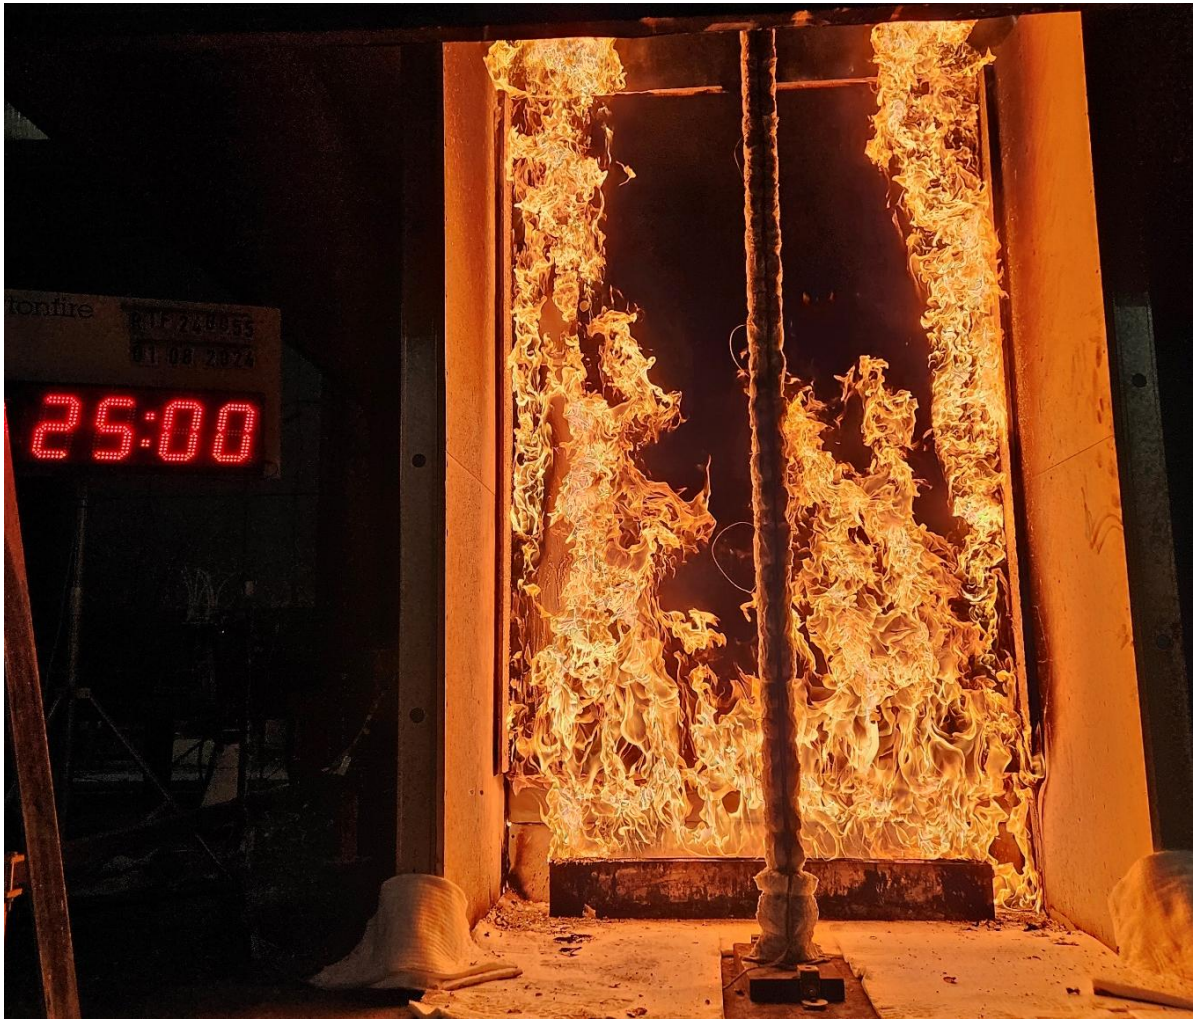
**Figure 21 The specimen 25 minutes into the test (burner output at 300 kW)**

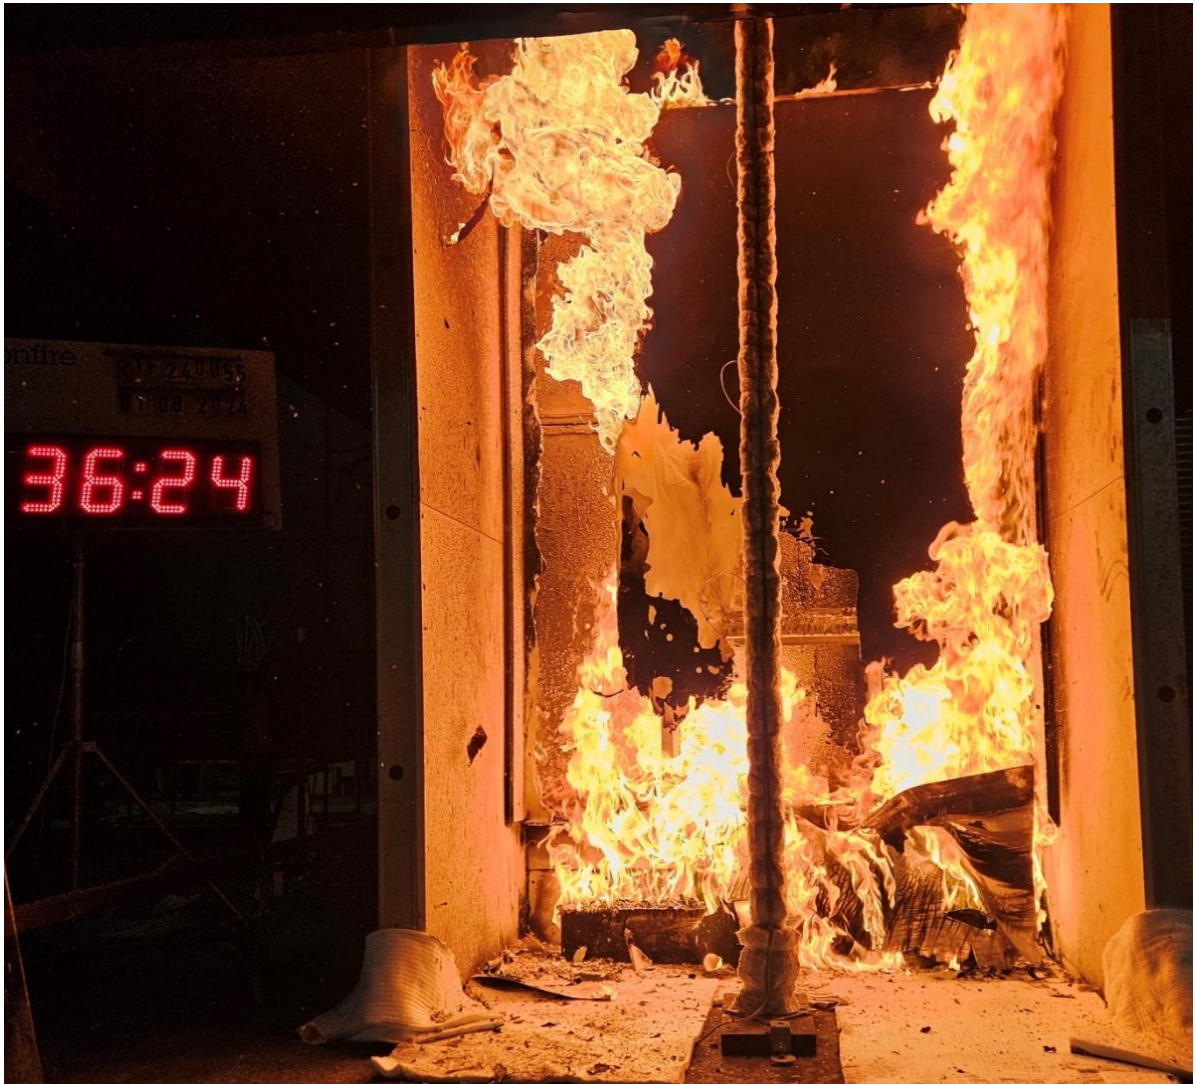
**Figure 22 The specimen 36 minutes 24 seconds into the test (burner output at 300 kW)**

36	00	Half of the panels were burned off.
36	20	Big chunk of the panel fell off.
36	50	Most of the panels fell off except for small section at the top.
40	00	The burner was turned off
42	00	The reaction to fire test was ended.

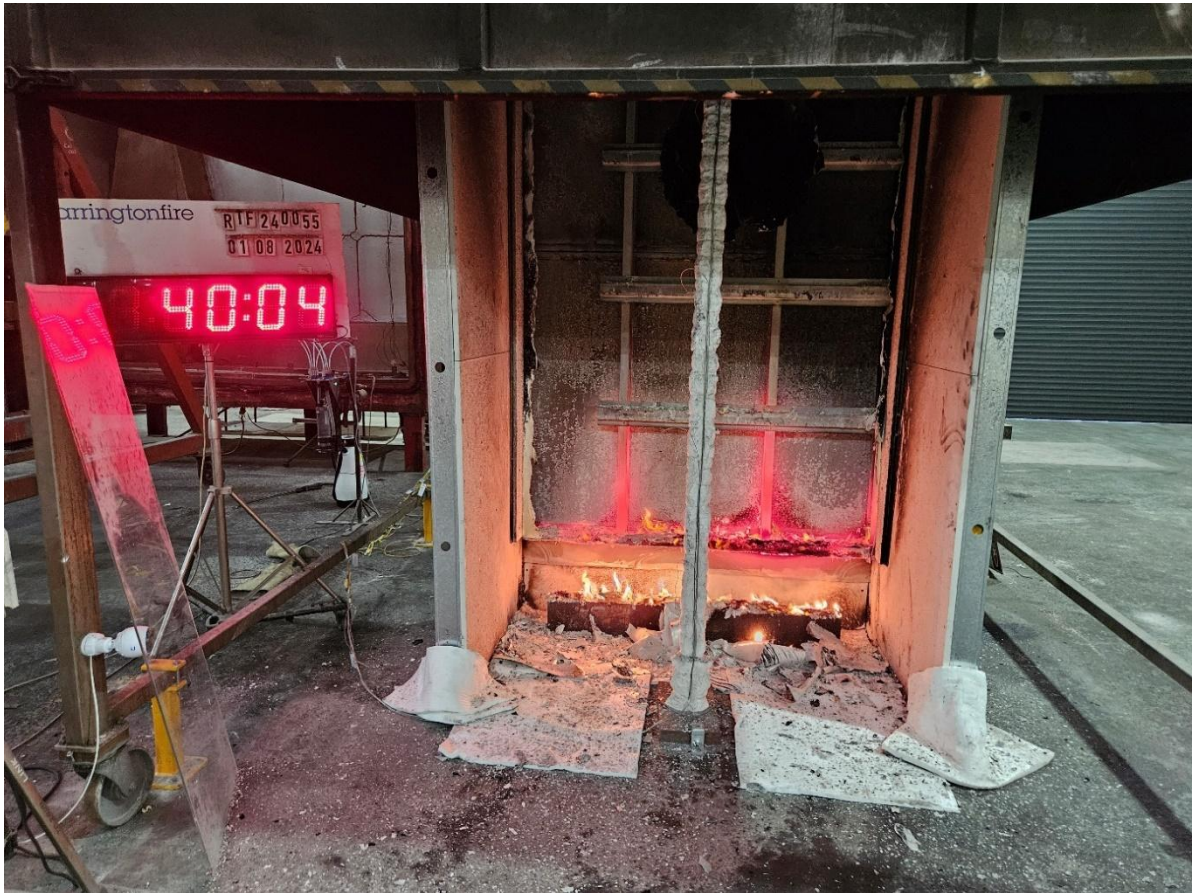
**Figure 23 The specimen 40 minutes 04 seconds into the test (burner off)**

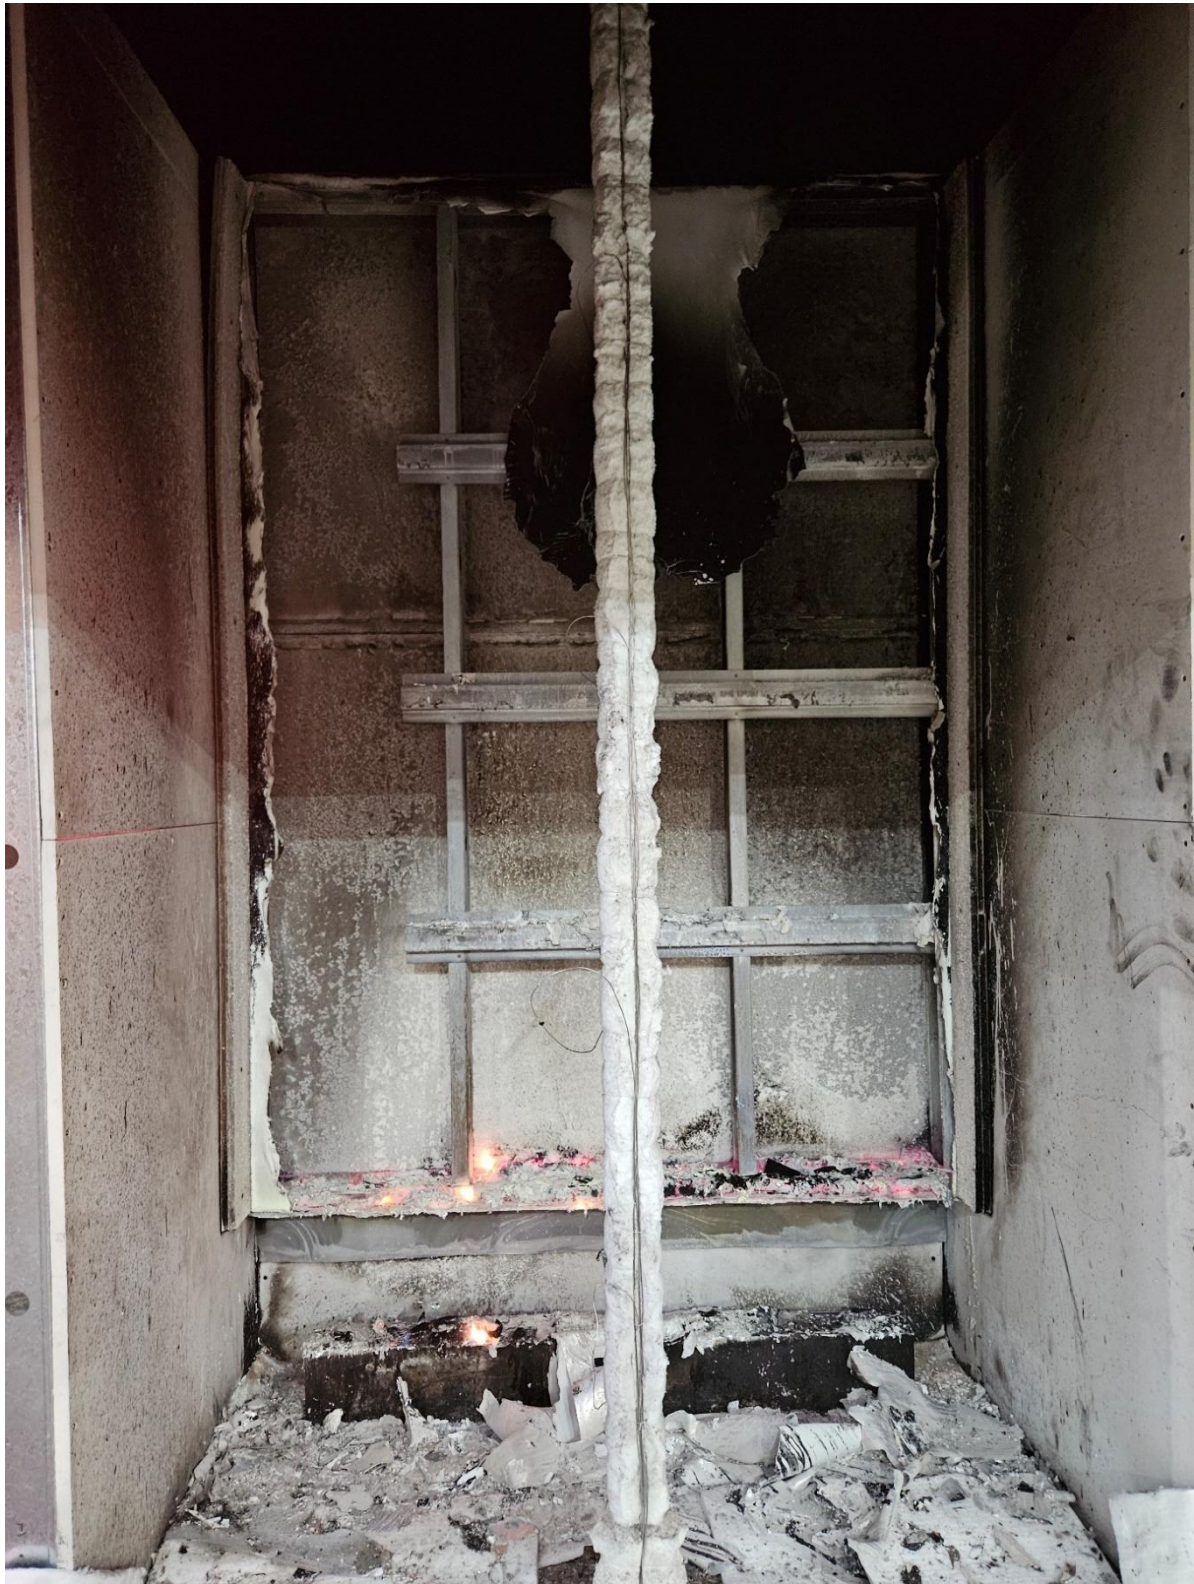
**Figure 24** The specimen at end of the reaction to fire test – exposed side
