# Reaction to fire test report

Test standard: Ad-hoc test based on ISO 13785-1:2002

System: ACP with 100 % polyethylene core external façade cladding system (mechanically fixed) with stonewool wall insulation

Job number: RTF240055

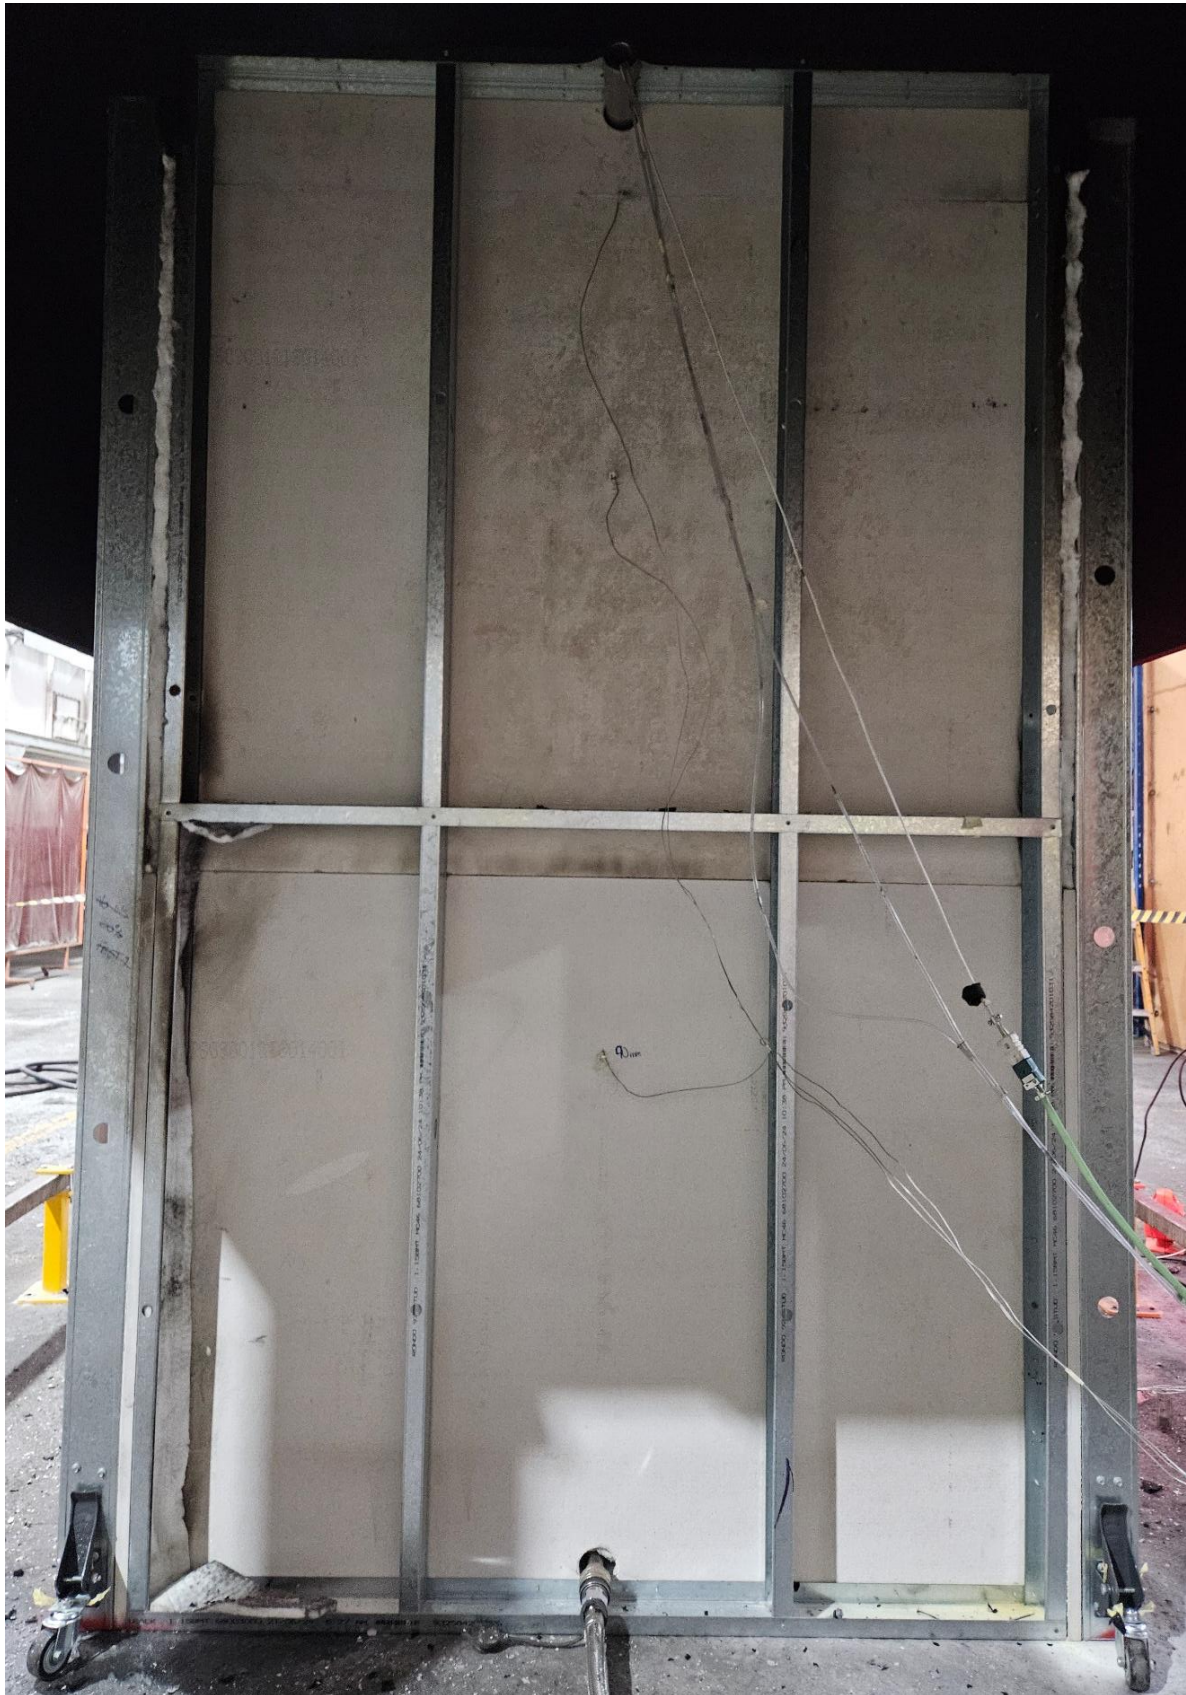
**Figure 25** The specimen after the reaction to fire test – unexposed side
