Reaction to fire test report

Test standard: Ad-hoc test based off ISO 13785-1:2002 with an additional wind component

System: Aluminium composite panel (ACP) and glazing external wall cladding system

Job number: RTF230143

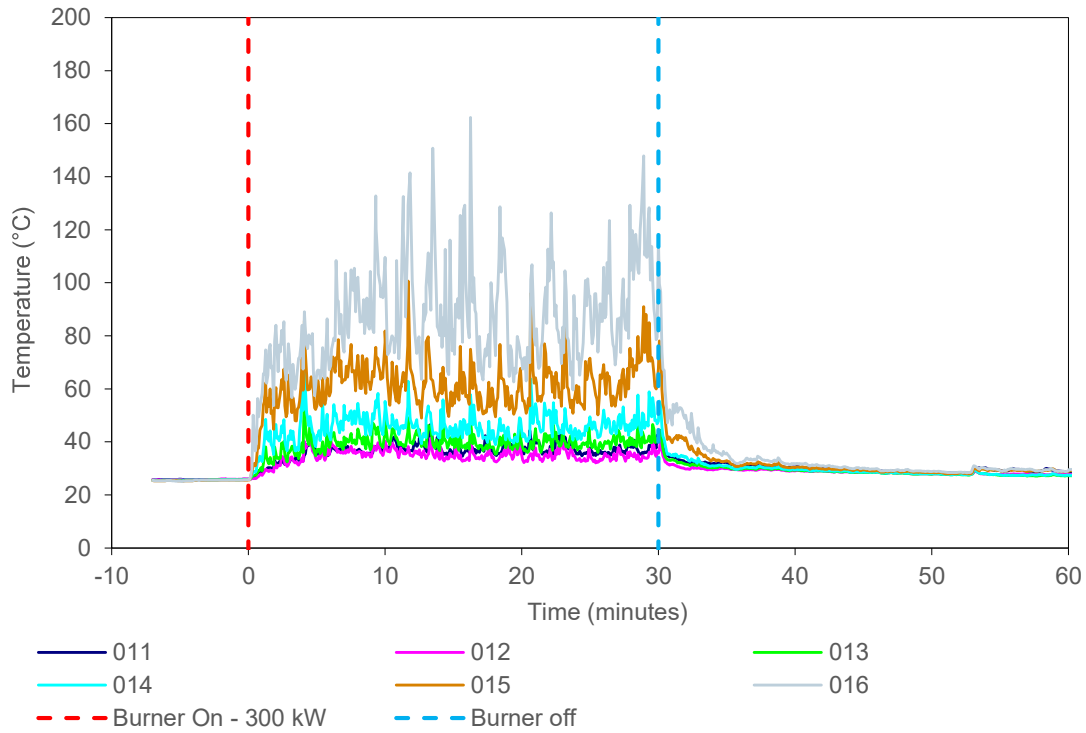
Figure 7 External temperature data collected by thermocouples placed 60 mm from the front face of the specimen – central module

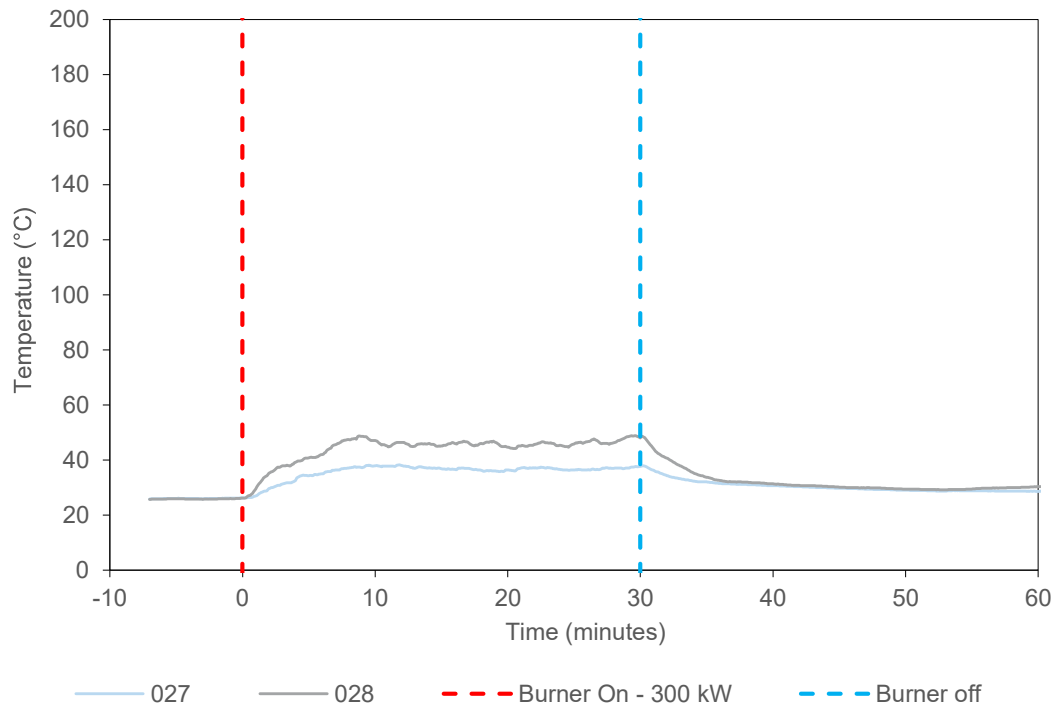
Figure 10 External temperature data collected by thermocouples in-line with ACP, above and below, respectively – away from burner

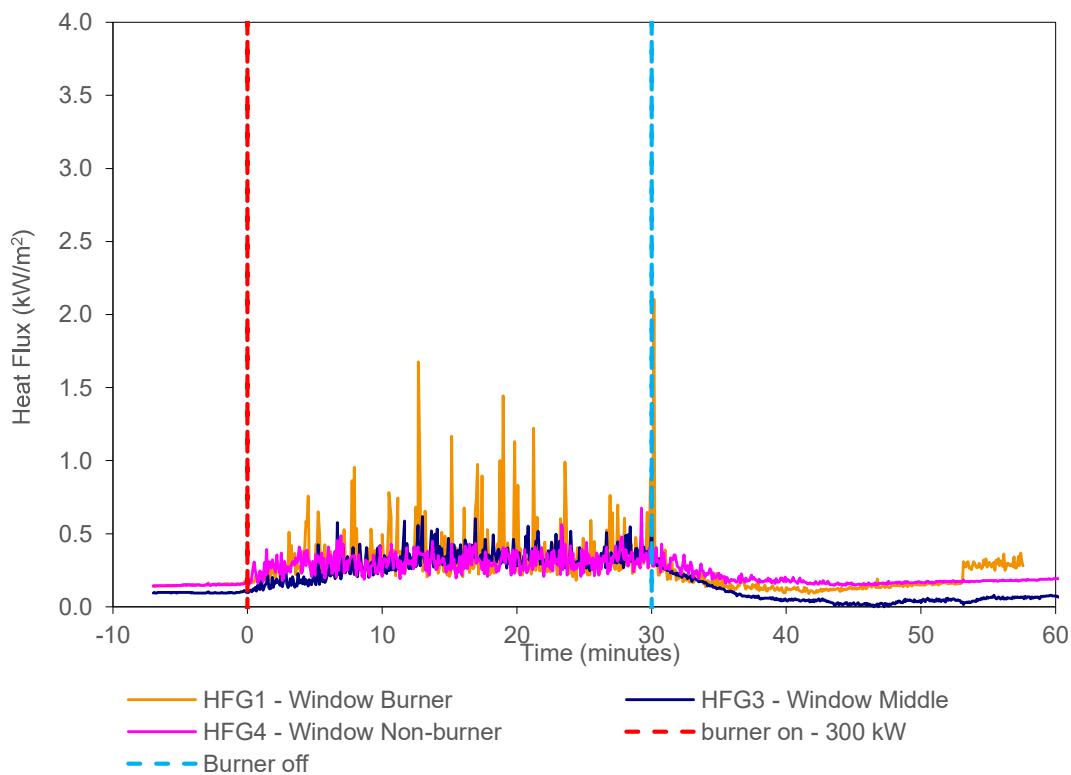
Figure 12 Emitted heat flux measured by heat flux gauges behind the glazing units

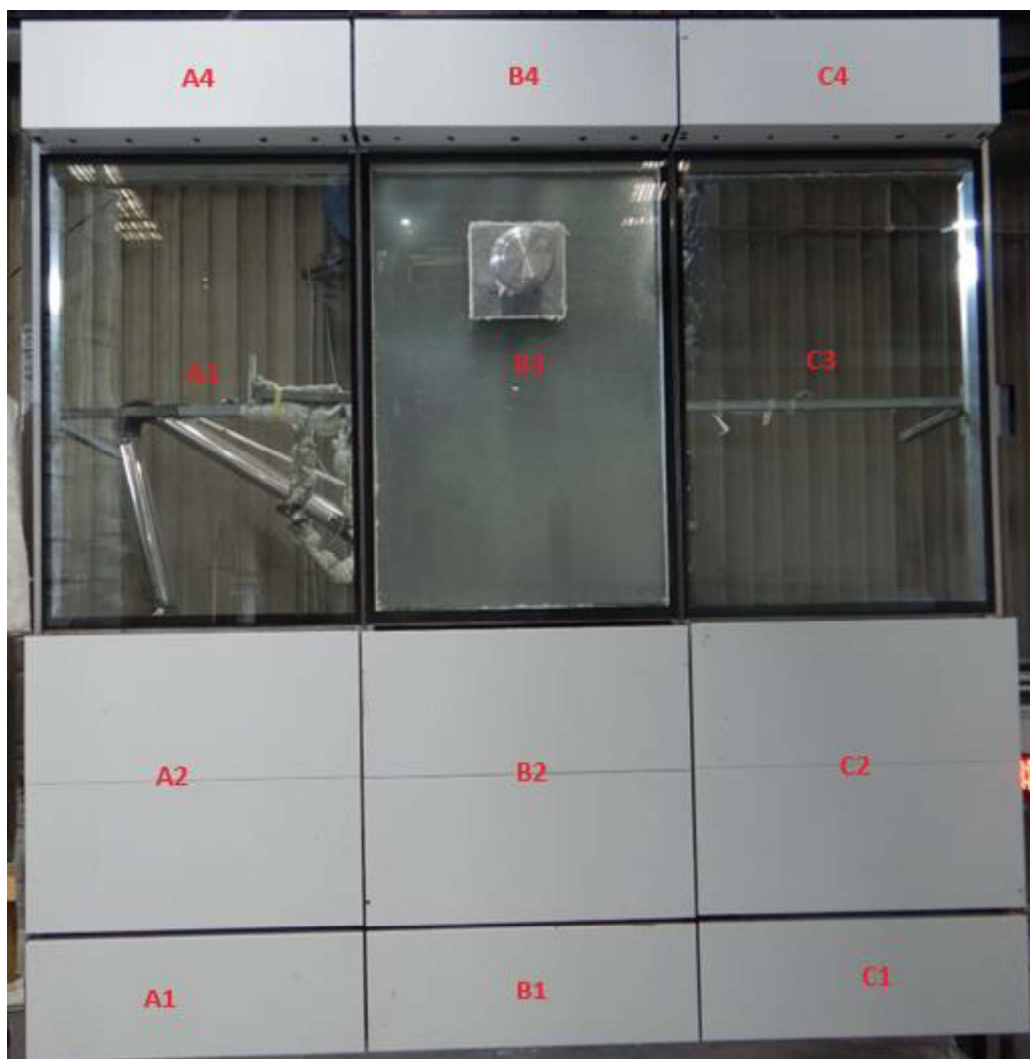
Figure 13 Designation of section for the test observations

Table 4 shows the observations of any significant behaviour of the specimen during the test. Figure 13 shows the panel and glazing designations sighted in the observations.

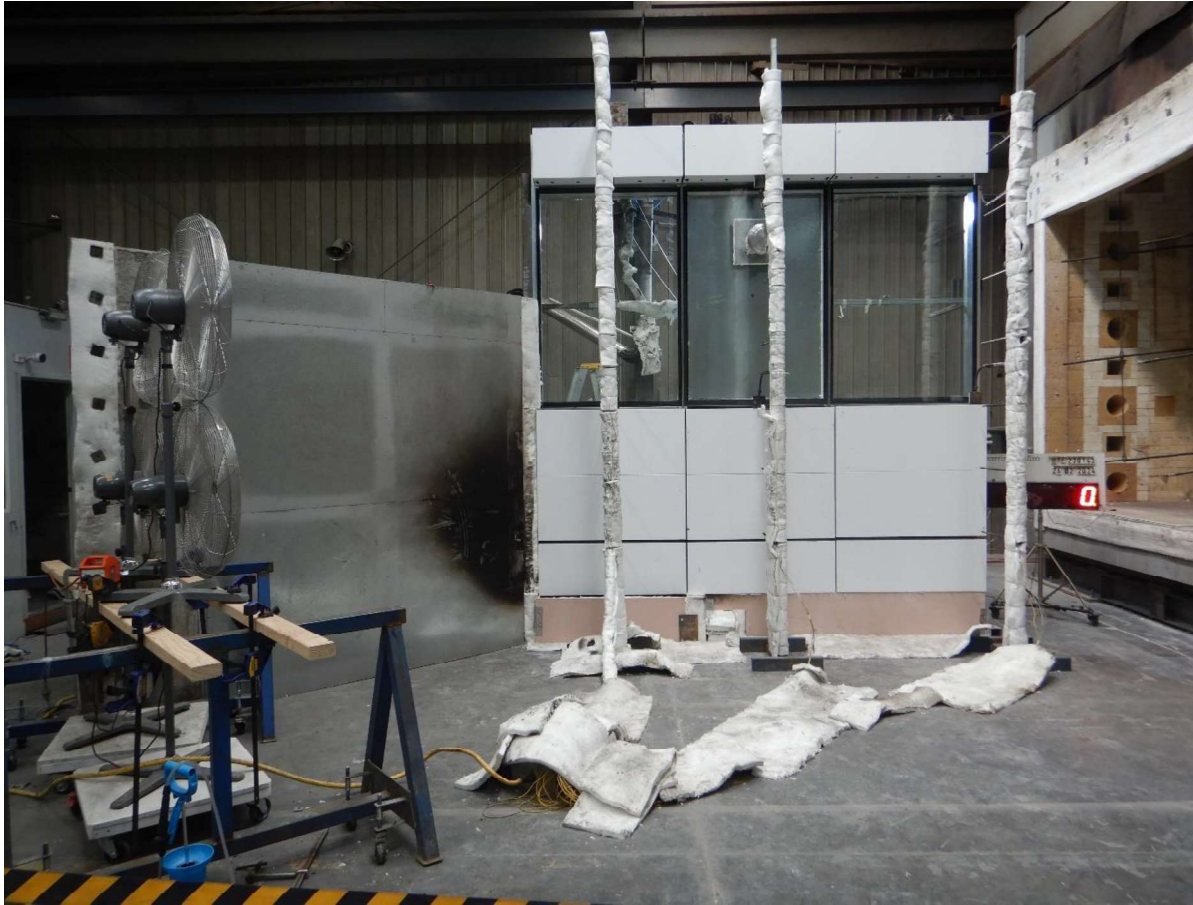
Figure 23 The specimen and test setup (angled - exposed side) before the reaction to fire test

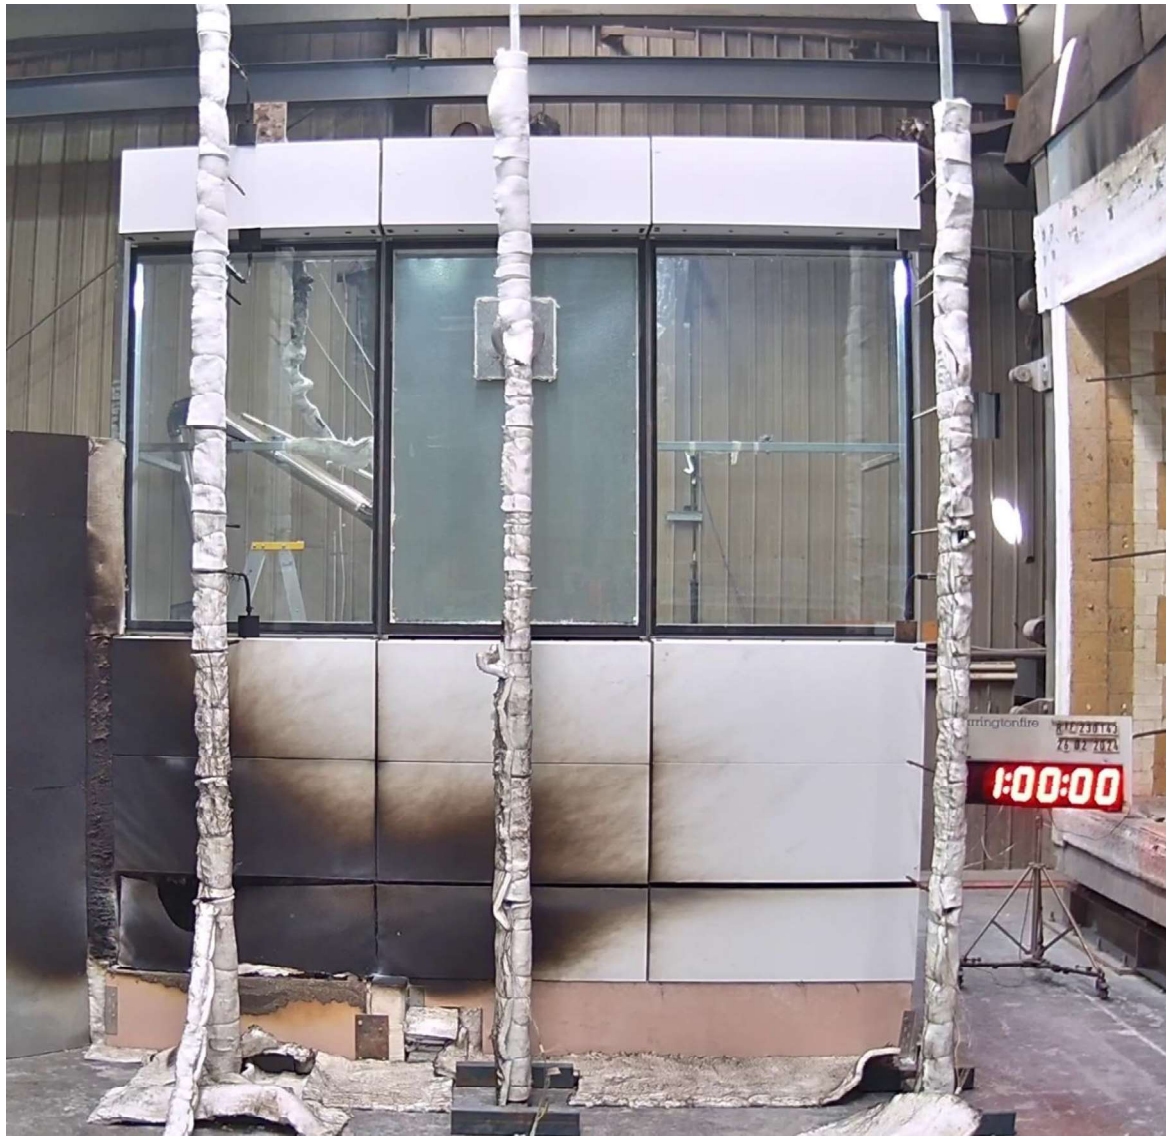
Figure 48 The specimen at the end of test.

A1/A2	Still flaming at the join.
		B1/B2	Still flaming at the join.
32	00	C1/C2	Joint is flaming.
33	15	A2	Horizontal join smoking.
34	50	A	The smoke seal on the unexposed side is flaming.
35	00	A	A lot of smoke released.
37	26	A2	The bottom had opened up.
37	40	A1	The panel had opened up.
38	30	C1/C2	There is consistent flamed spread in the join.
44	00	A	Flaming on the unexposed side has stopped.
48	30	All	The flames have died down.
52	00	All	The flames have died down a little more.
52	40	All	The fans were turned off at request of the test sponsor.
54	58	A	Flames were almost non-existent.
57	30	A2	There is flaming at the bottom of the panel. This appears to be the only flaming.
60	00	All	The test was ended. There was still some flaming at the bottom of A2.

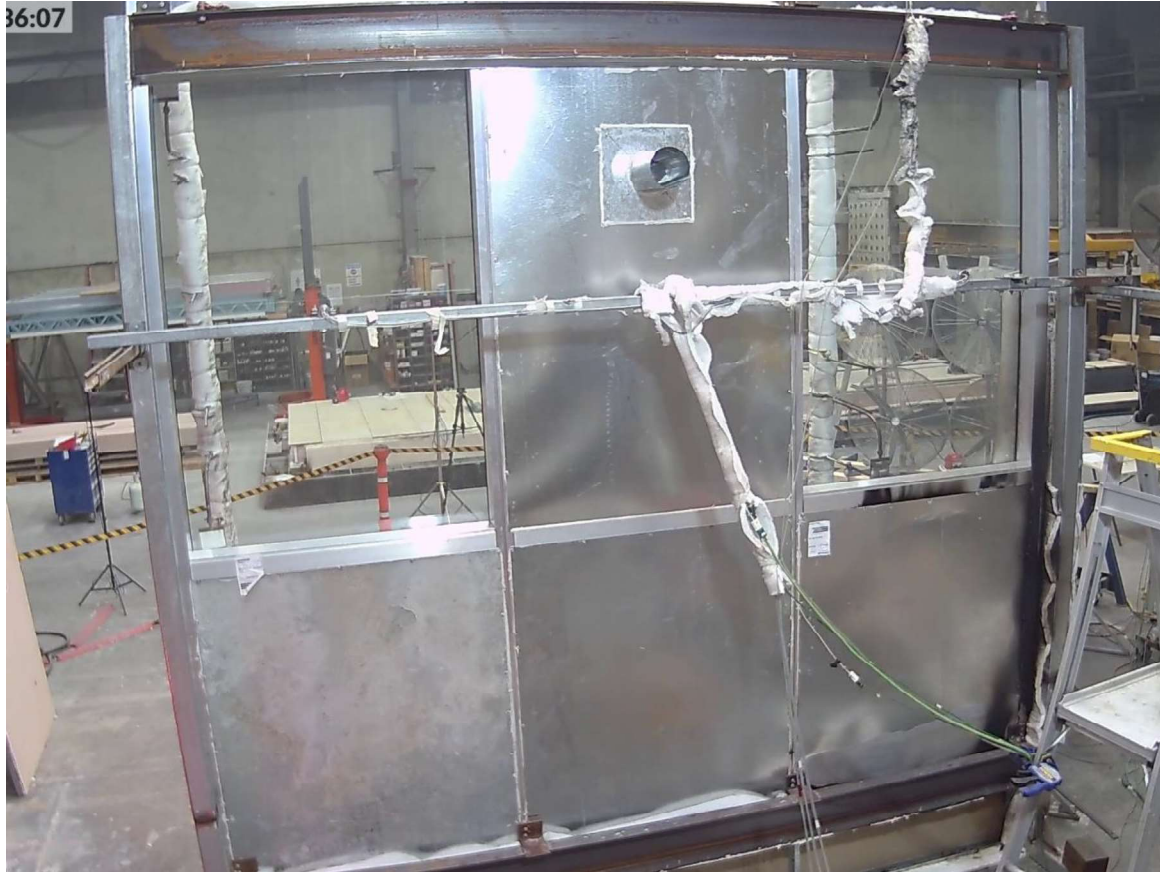
Figure 49 The unexposed side of the specimen at the end of test.
