Reaction to fire test report

Test standard: Ad-hoc test based off ISO 13785-1:2002

System: Aluminium composite panel curtain wall system nominated as being representative of the in-situ wall located at [REDACTED] – test 3

Job number: RTF250225

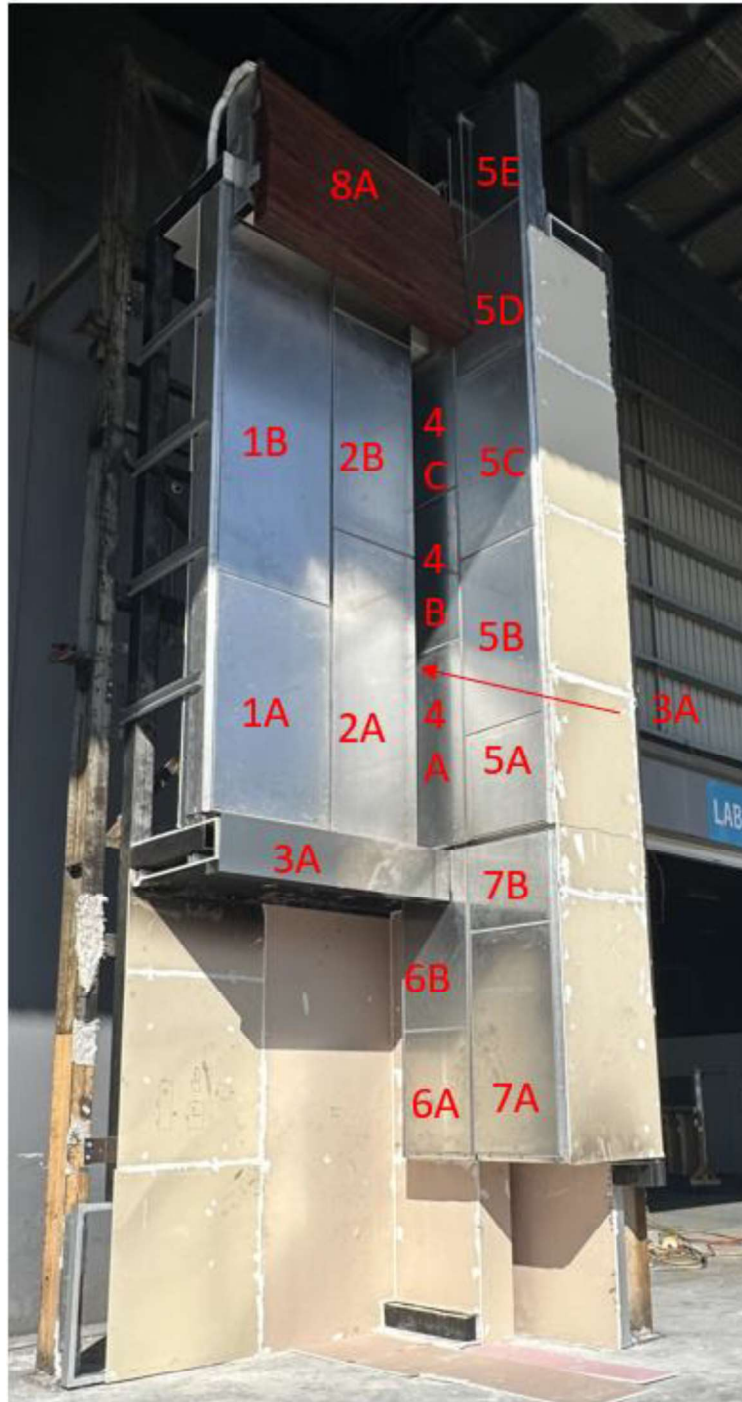
Figure 37 Designation for the test specimen observations

Figure 37 shows the designations for the test specimen observations.
