REACTION TO FIRE TEST REPORT

Test standard: Ad-hoc test based on ISO 13785-1:2002

Test sponsor: Cladding Safety Victoria

Product: Aluminium composite panel curtain wall system nominated as being representative of [REDACTED]
[REDACTED]-Test 3

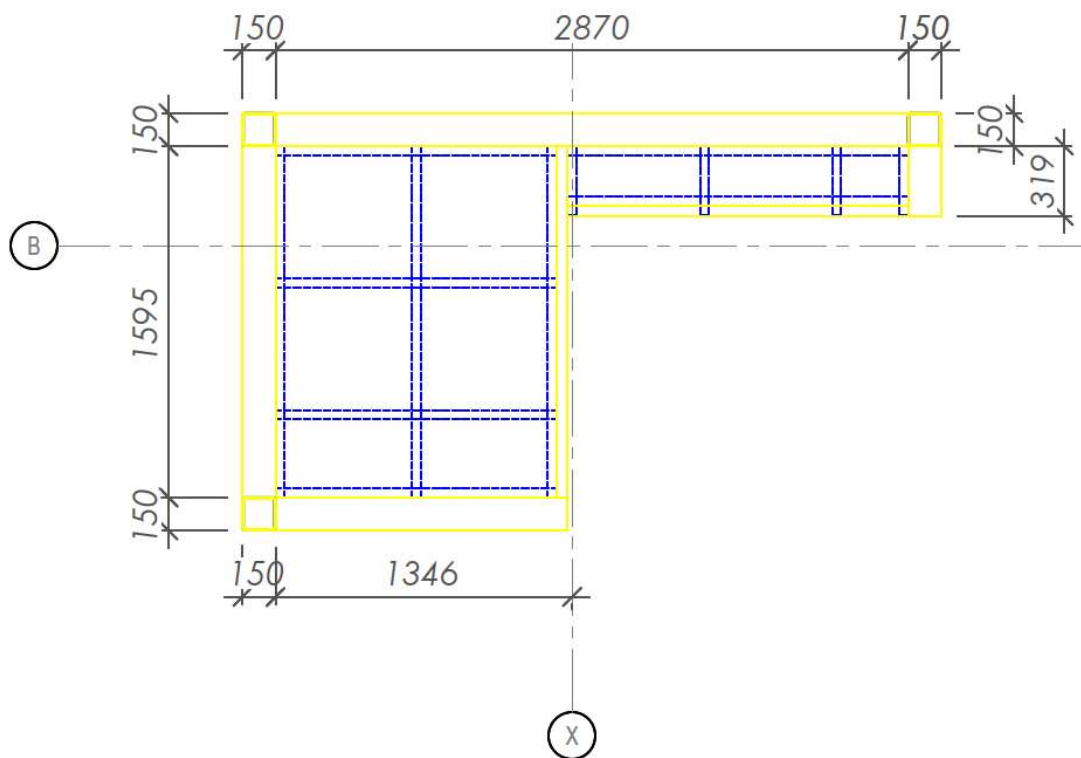
Figure 8 Plan view – steel frame layout

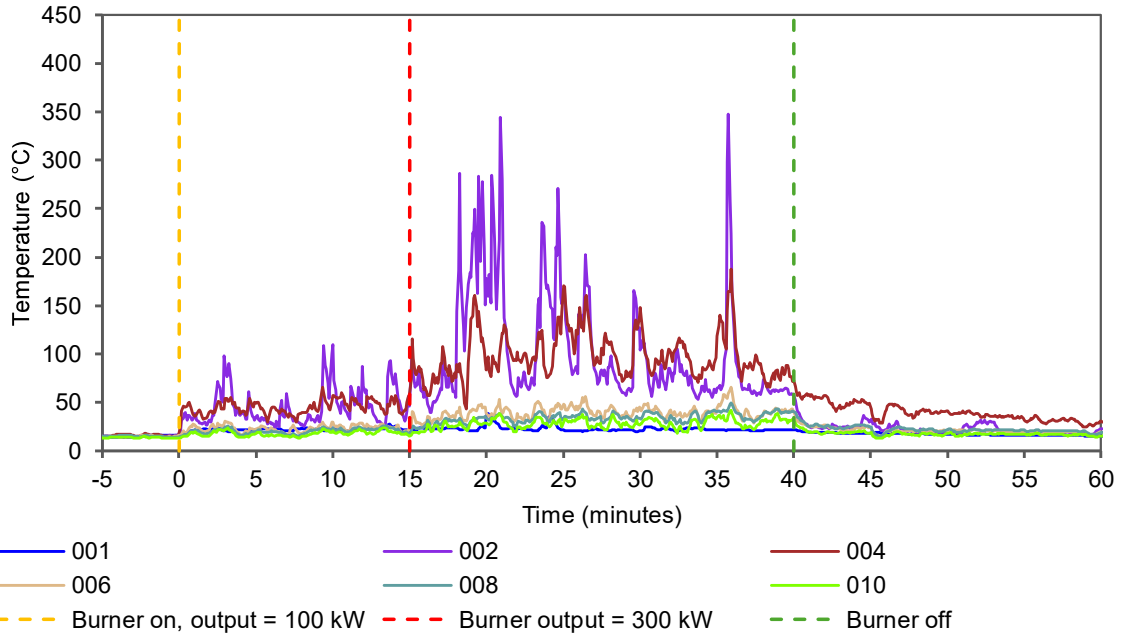
Figure 14 External surface temperatures at various heights on cladding close to the burner – temperature vs time

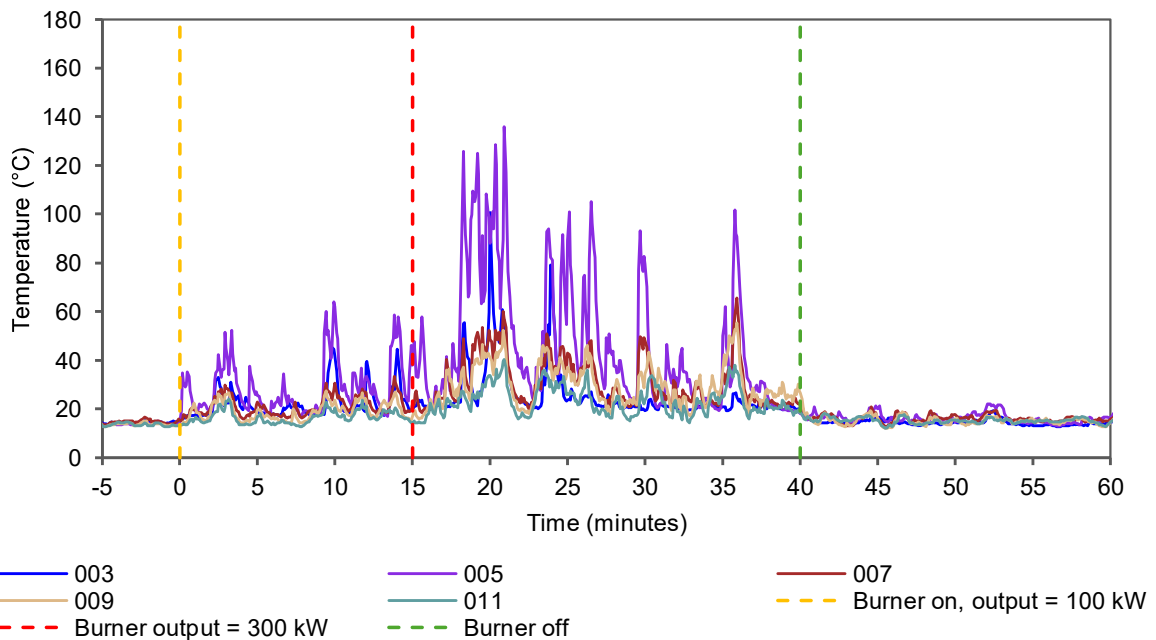
Figure 15 External surface temperatures at various heights on cladding away from the burner – temperature vs time

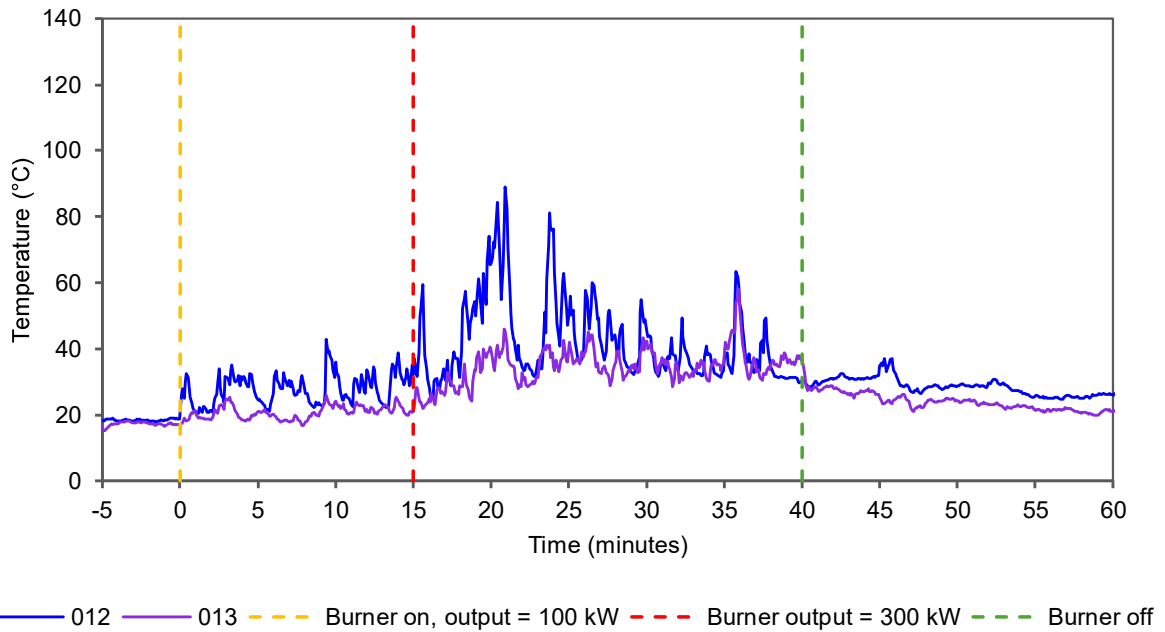
Figure 16 Cavity temperatures behind the 3D architectural modules – temperature vs time

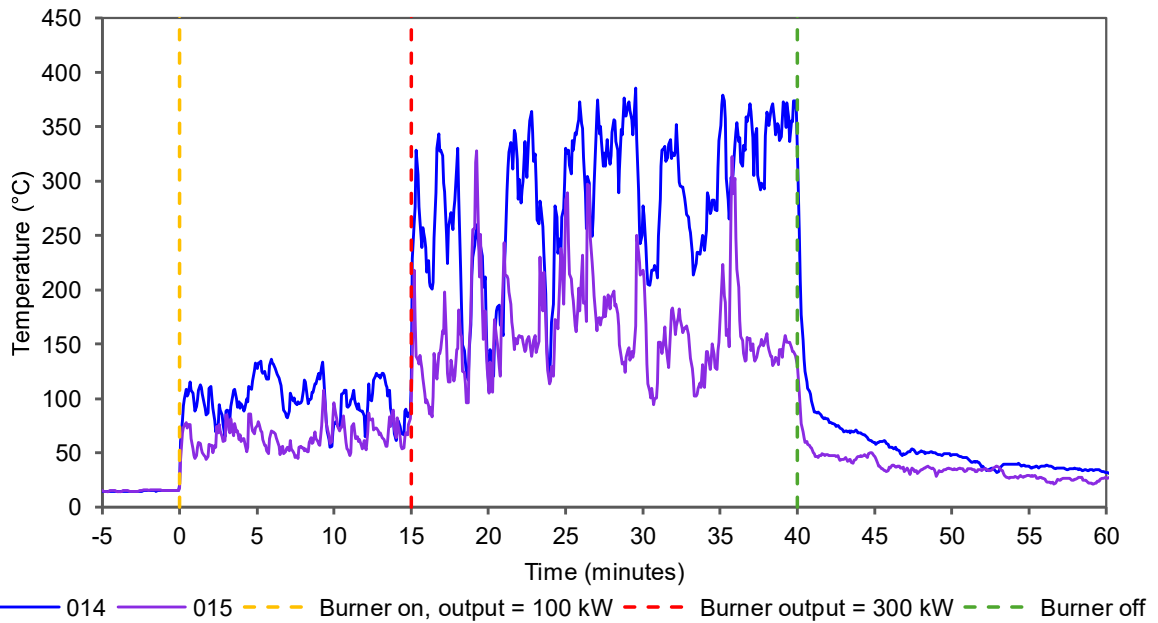
Figure 17 Surface temperature at level 1 balcony adjoining surfaces – temperature vs time

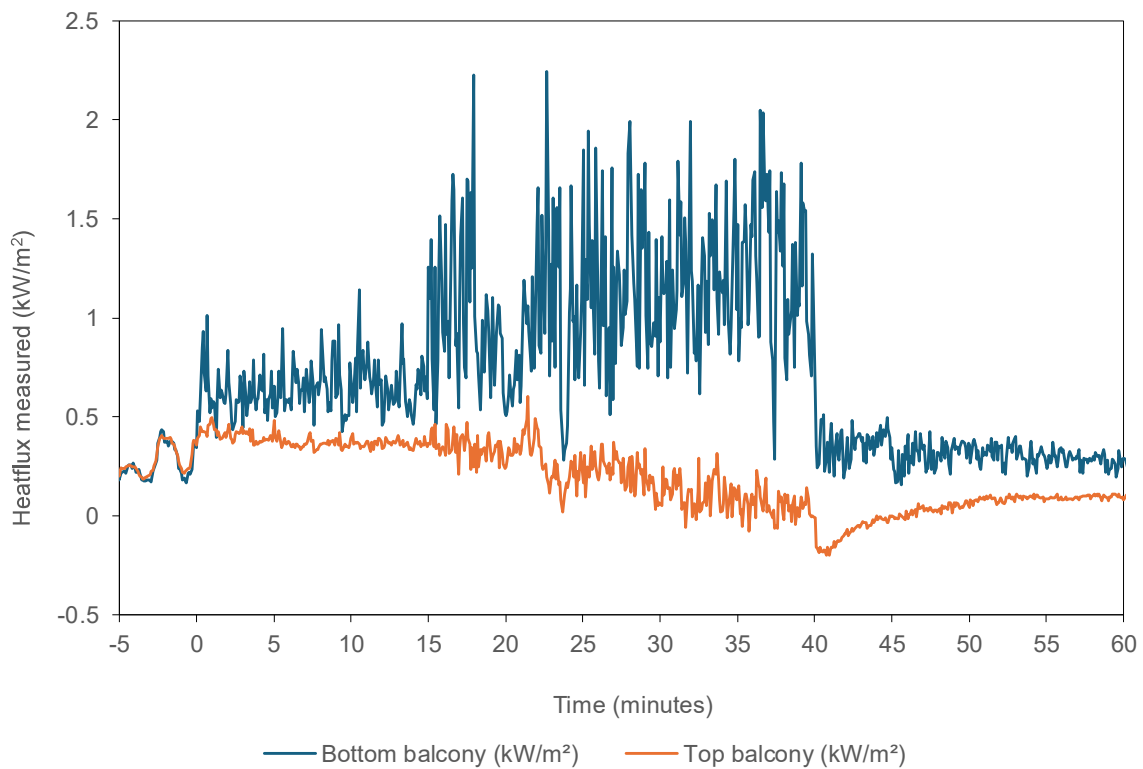
Figure 29 Measured heatflux data collected by the HFGs – Heat flux vs time

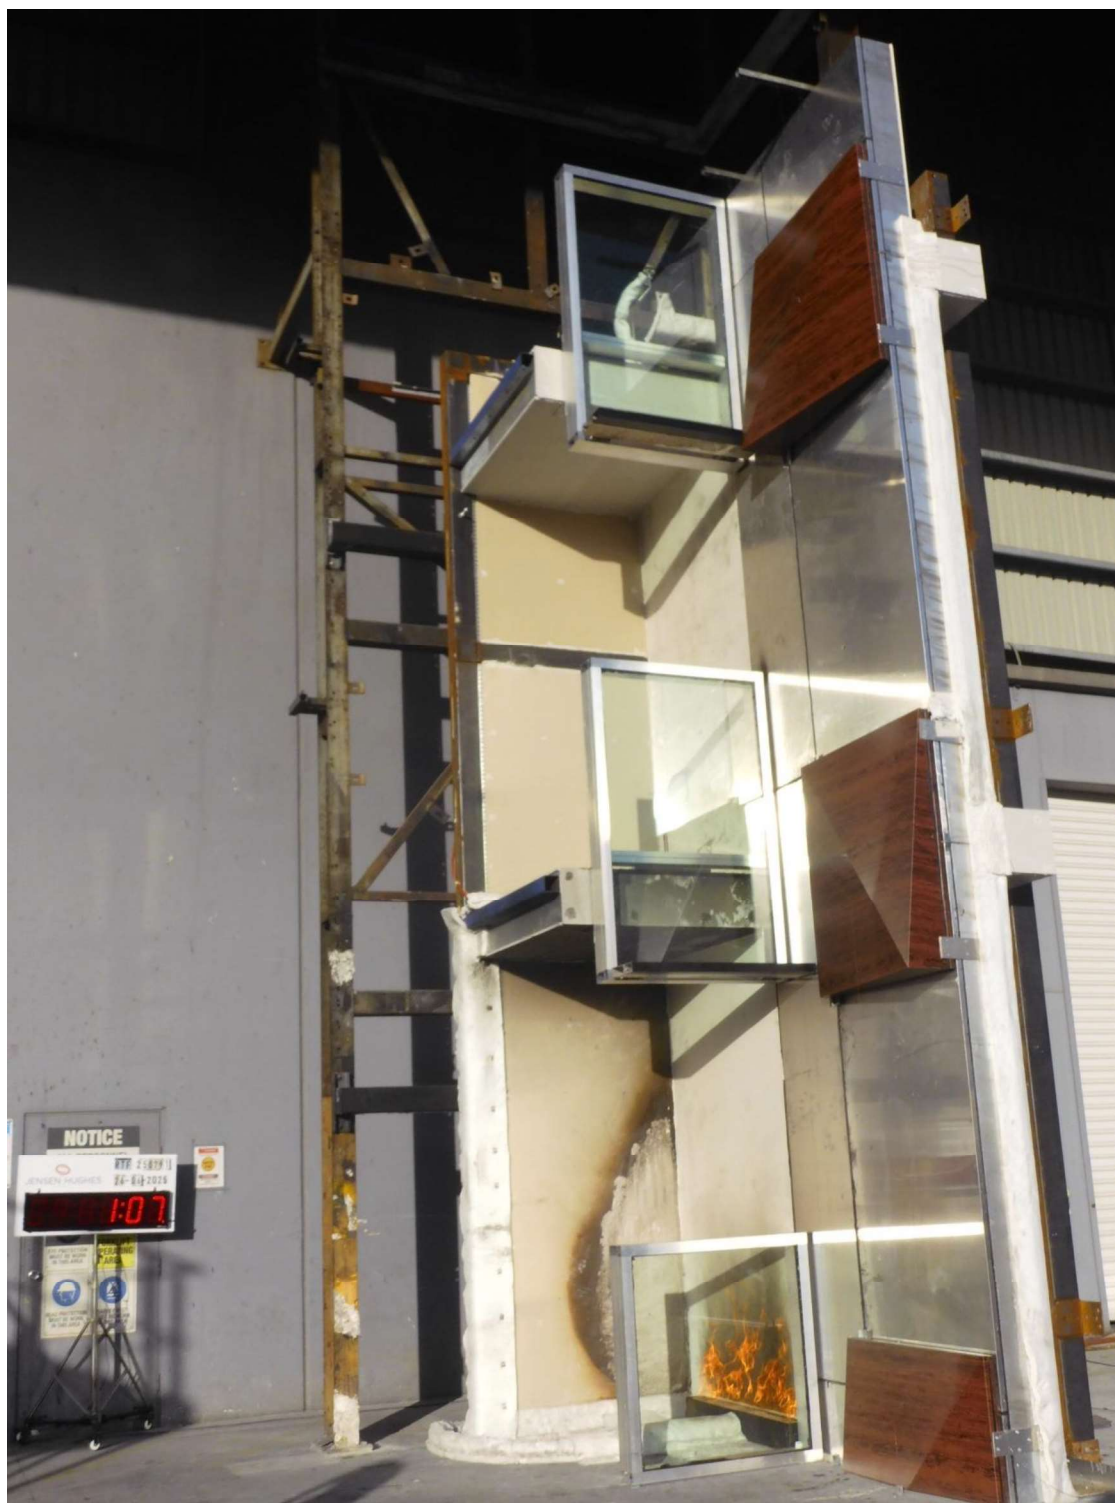
Figure 31 The specimen 1 minute 7 seconds into the test with the burner at 100 kW.

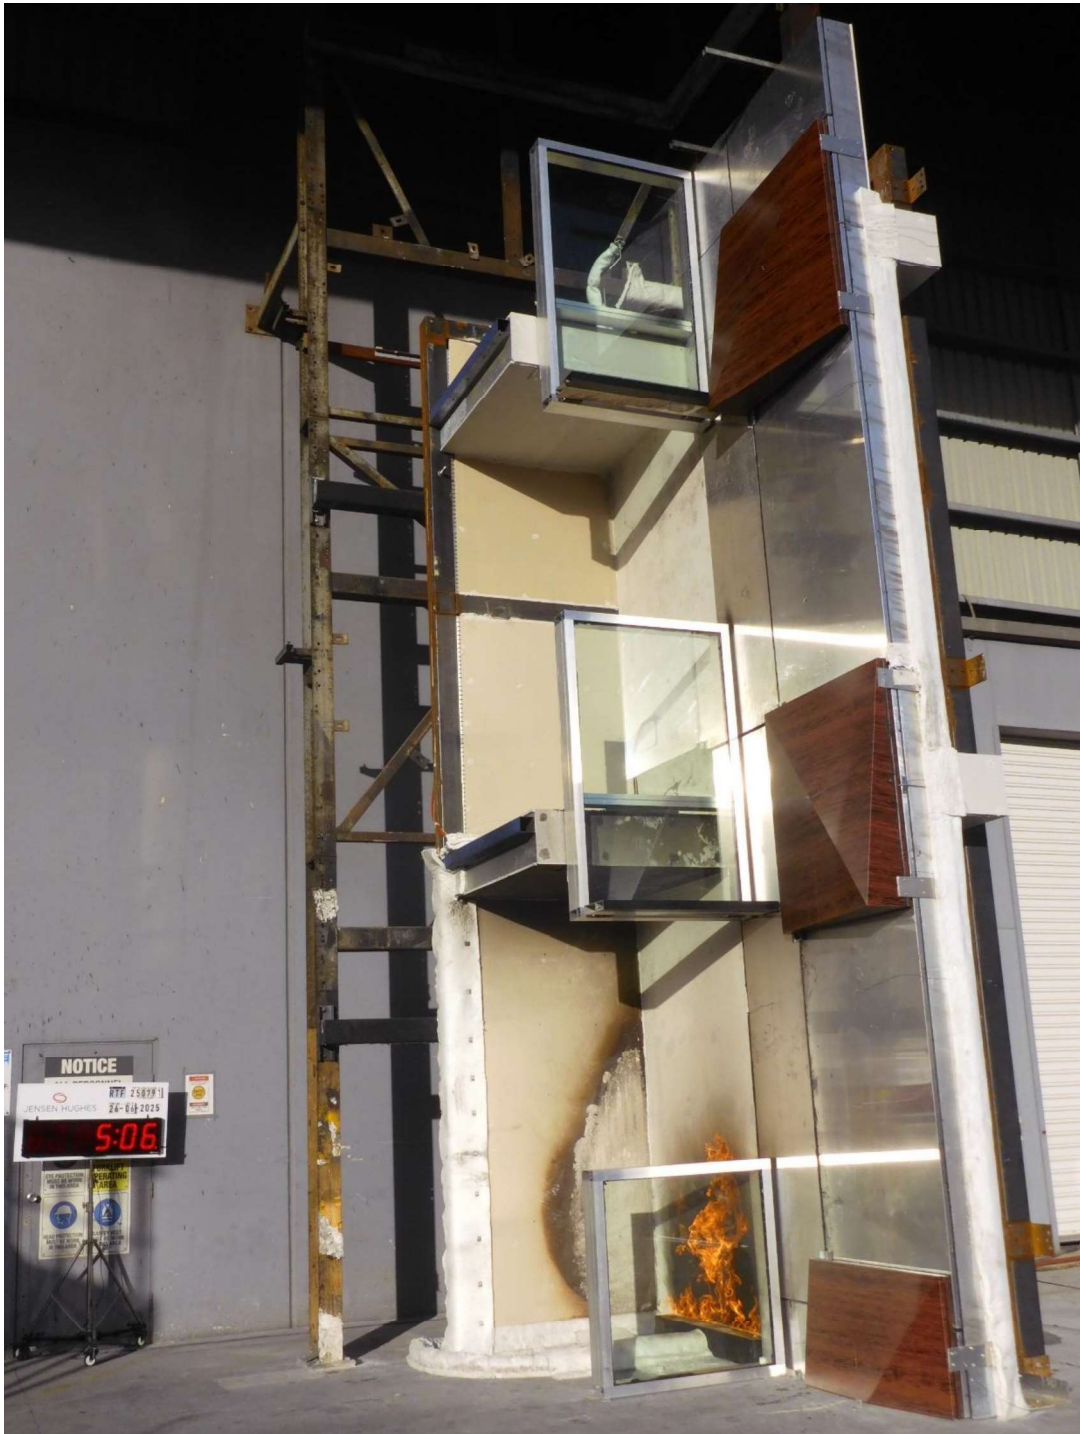
Figure 32 The specimen 5 minutes 6 seconds into the test with the burner at 100 kW.

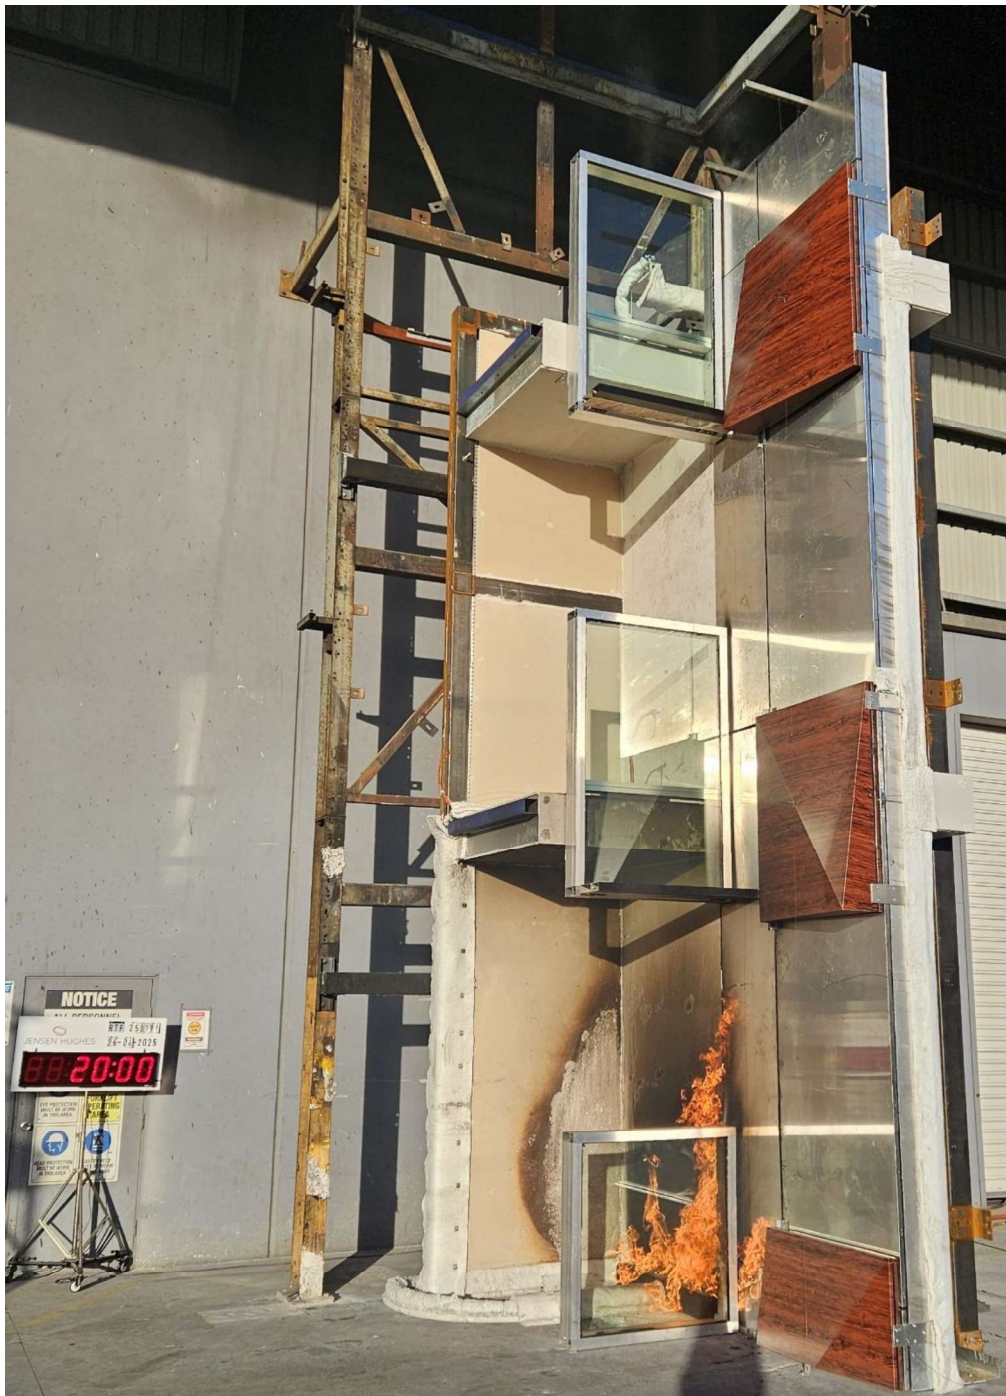
Figure 35 The specimen 20 minutes into the test – 5 minutes after the burner output was increased to 300 kW.

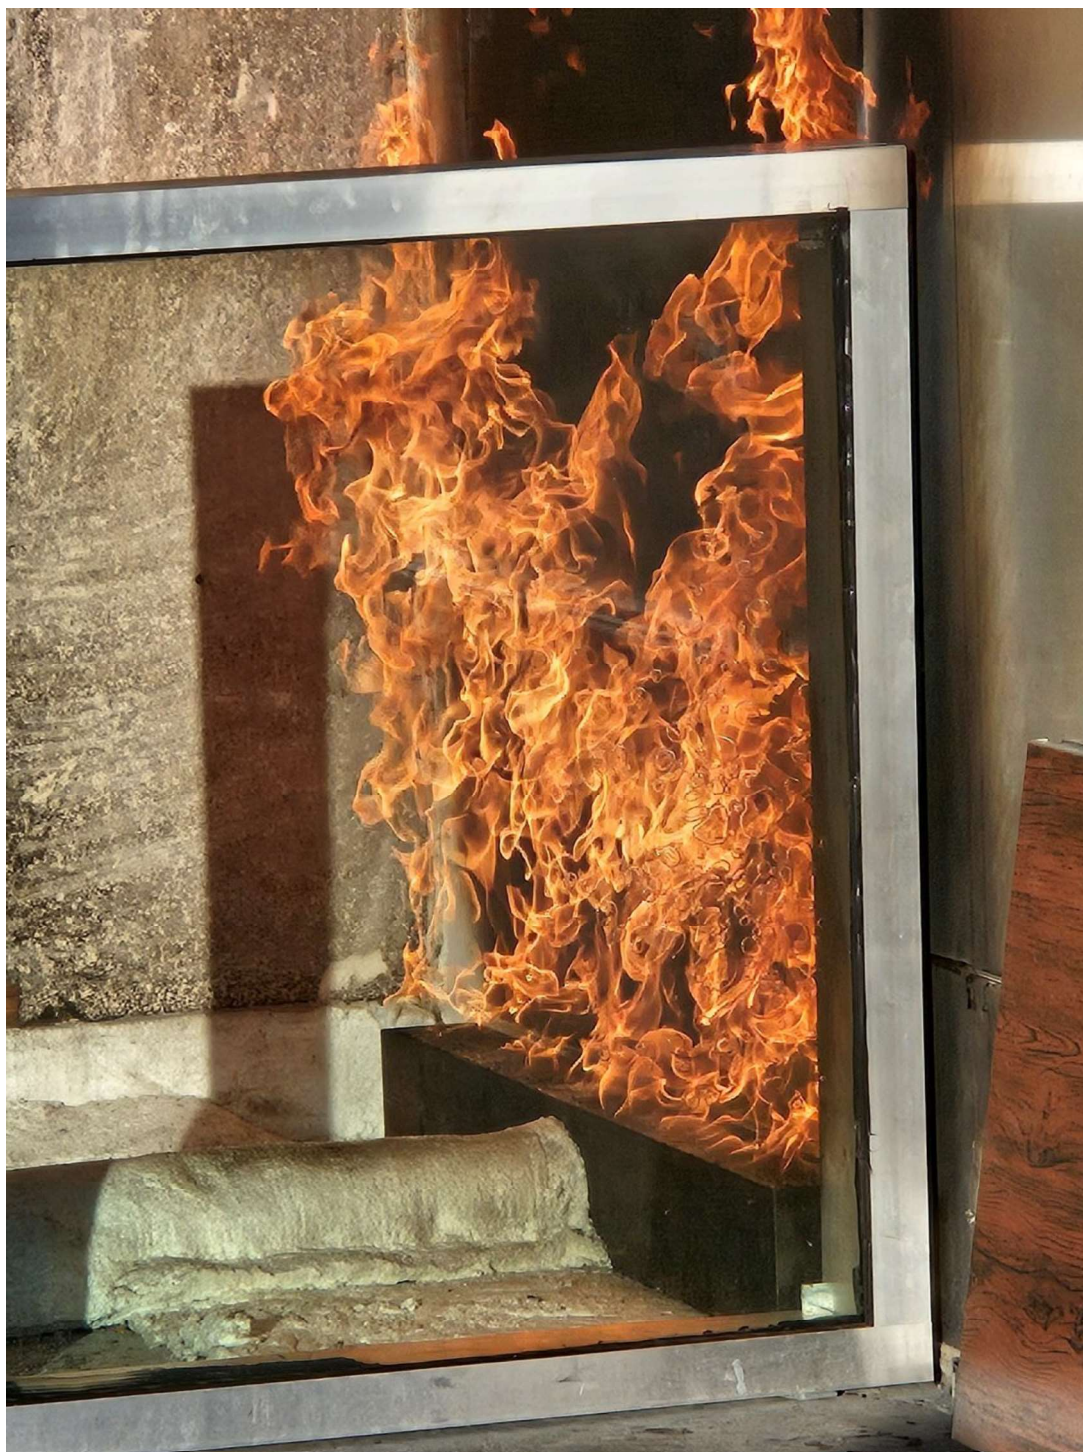
Figure 36 The specimen after 20 minutes into the test – formation of bubbles in the PVB interlayer of glazing.

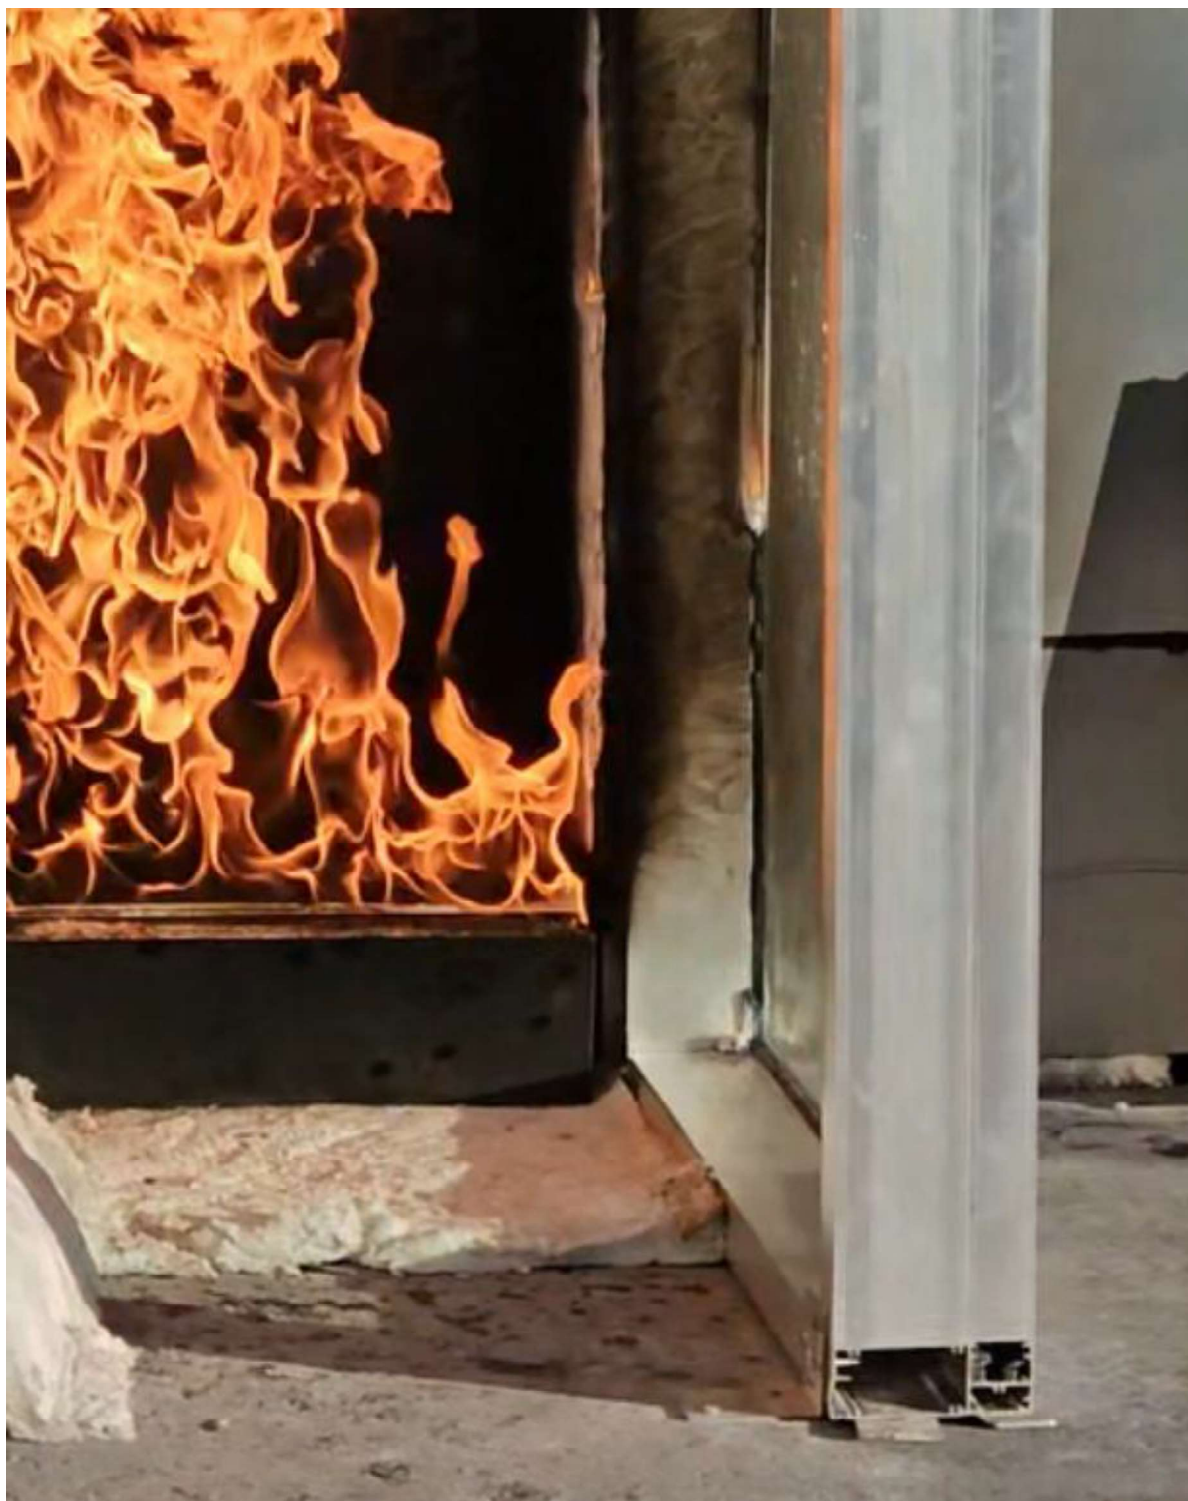
Figure 37 The specimen after 20 minutes into the test – sealant around the ground level balustrade on fire.

26	02	A2	Sealant melted on the joint between the bottom level balustrade frame and glazing.
28	40	A2	Smoke emitted from the bottom level balustrade frame.
37	57	A2	Smoke emitted from the unexposed side of the bottom glazing.
40	00	All	The burner was turned off.
40	16	A2	Smoke continued to emit from the bottom level balustrade frame.
41	21	A2	Smoke continued to emit from the unexposed face of main wall
60	00	All	The reaction to fire test was ended.

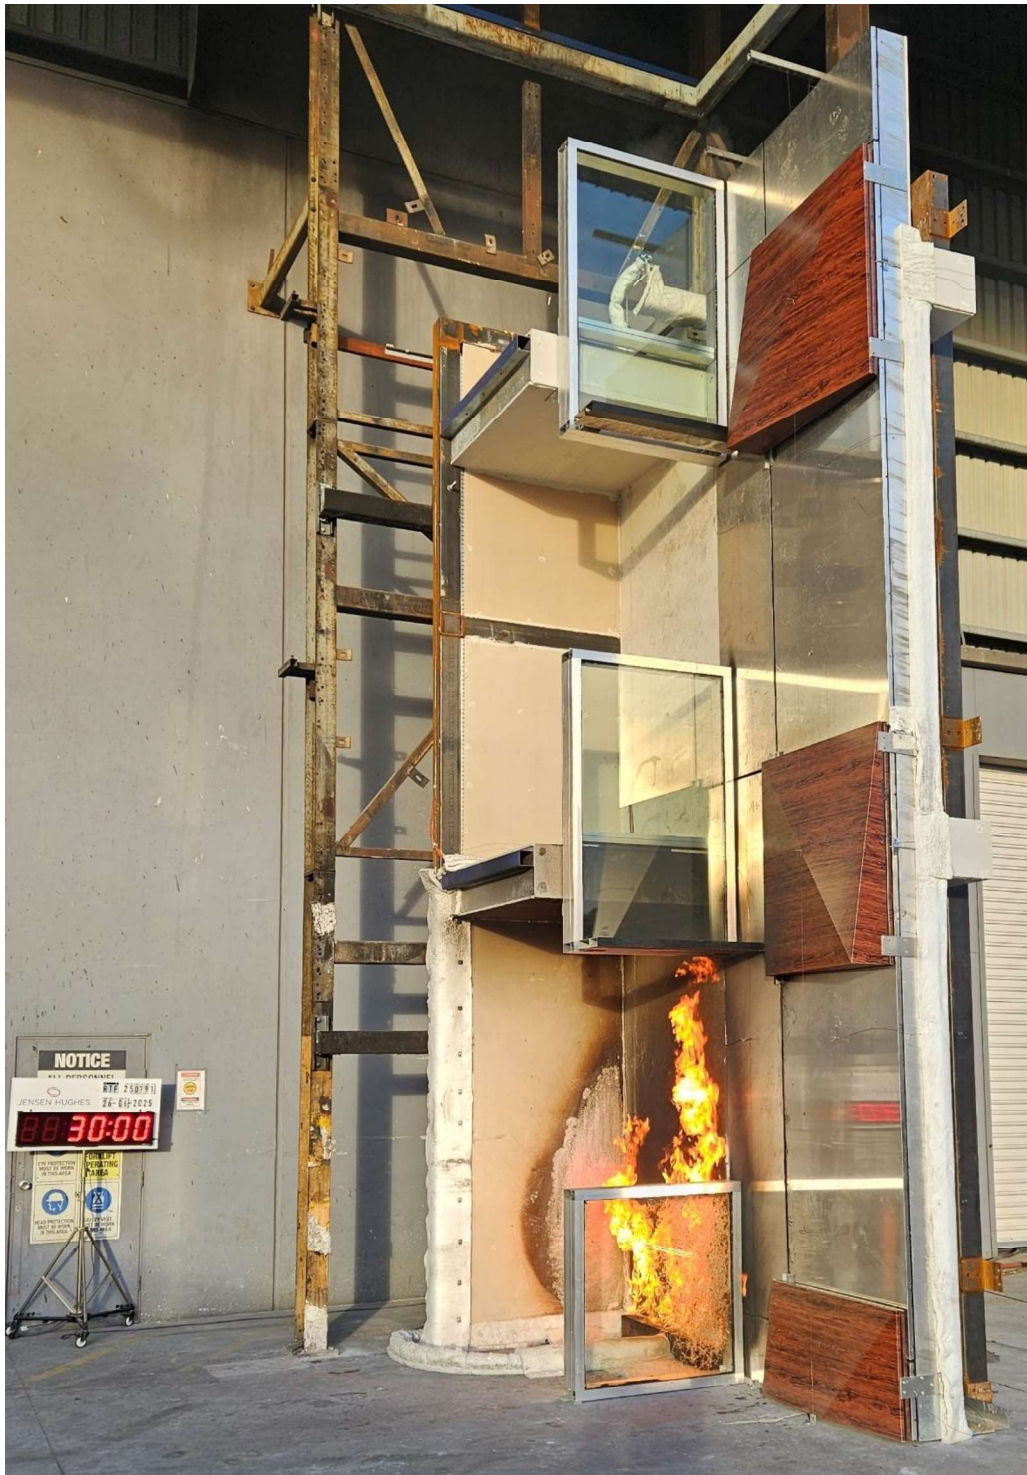
Figure 38 The specimen 30 minutes into the test – 15 minutes after the burner output was increased to 300 kW.

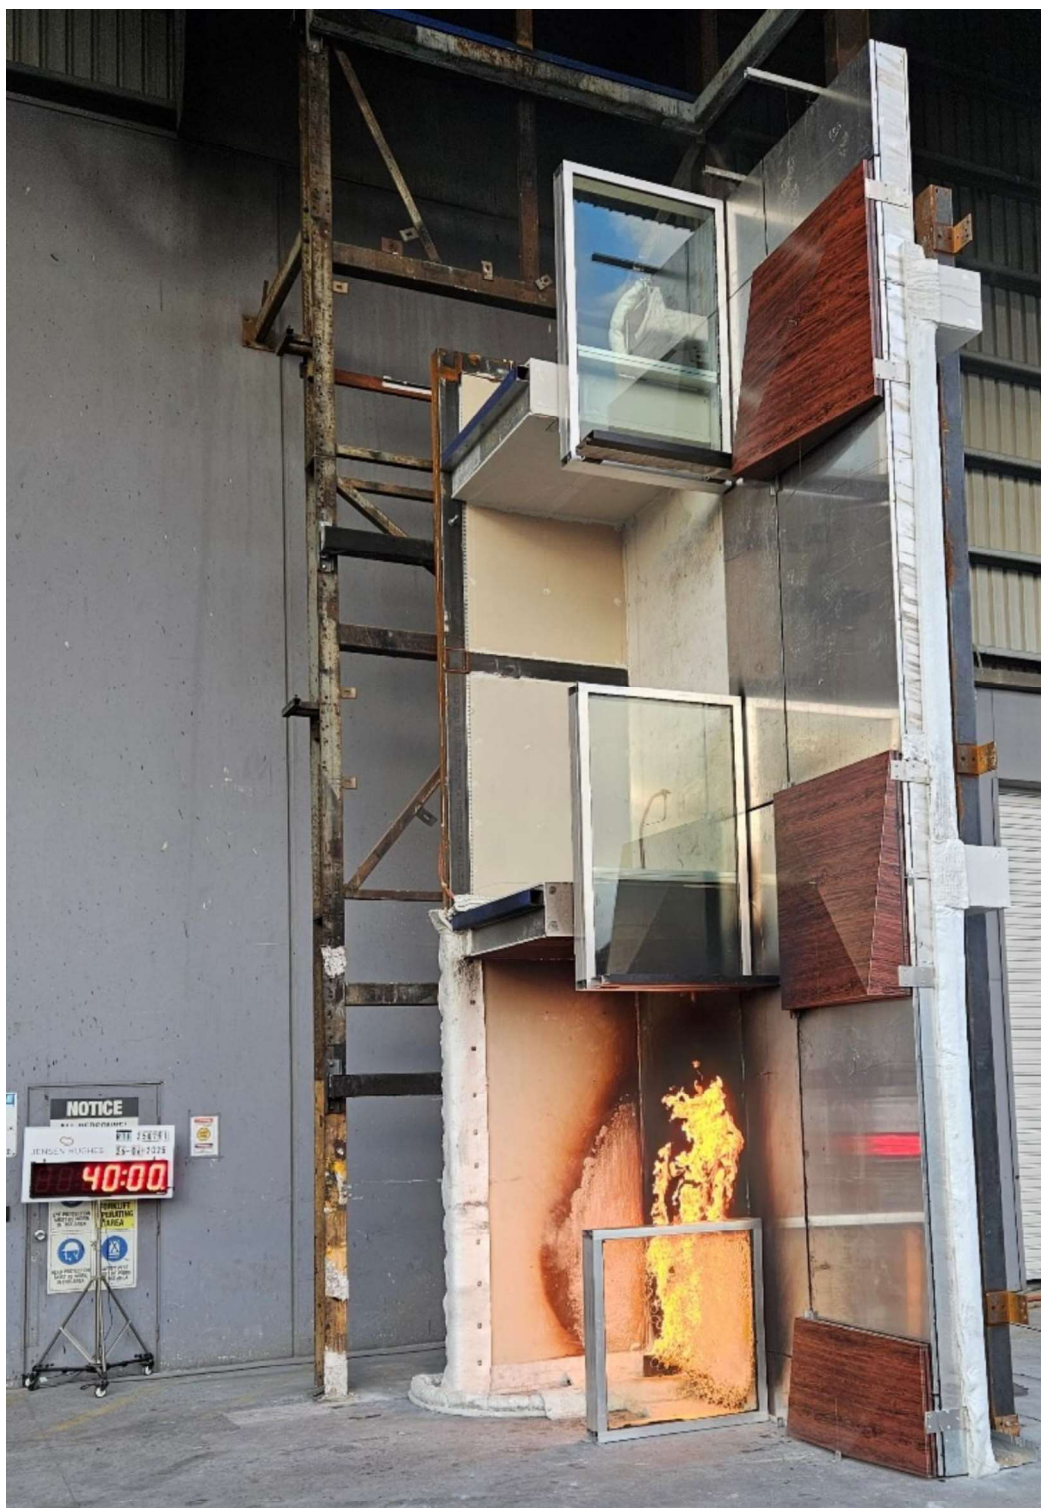
Figure 39 The specimen 40 minutes into the test – 25 minutes after the burner output was increased to 300 kW - burner was turned off

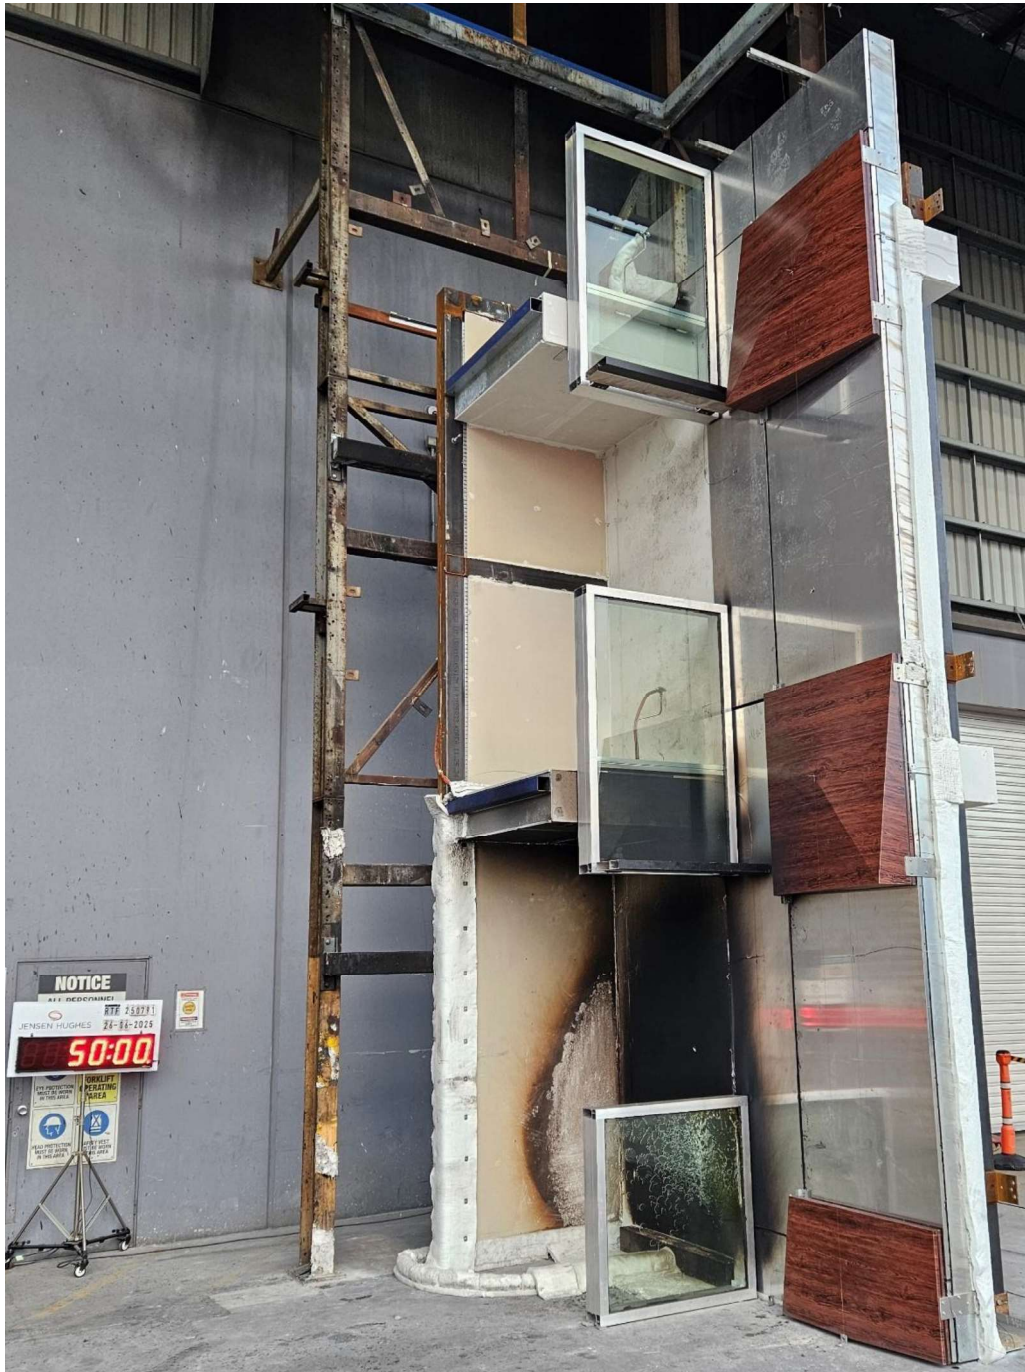
Figure 40 The specimen 50 minutes into the test – 35 minutes after the burner output was increased to 300 kW.

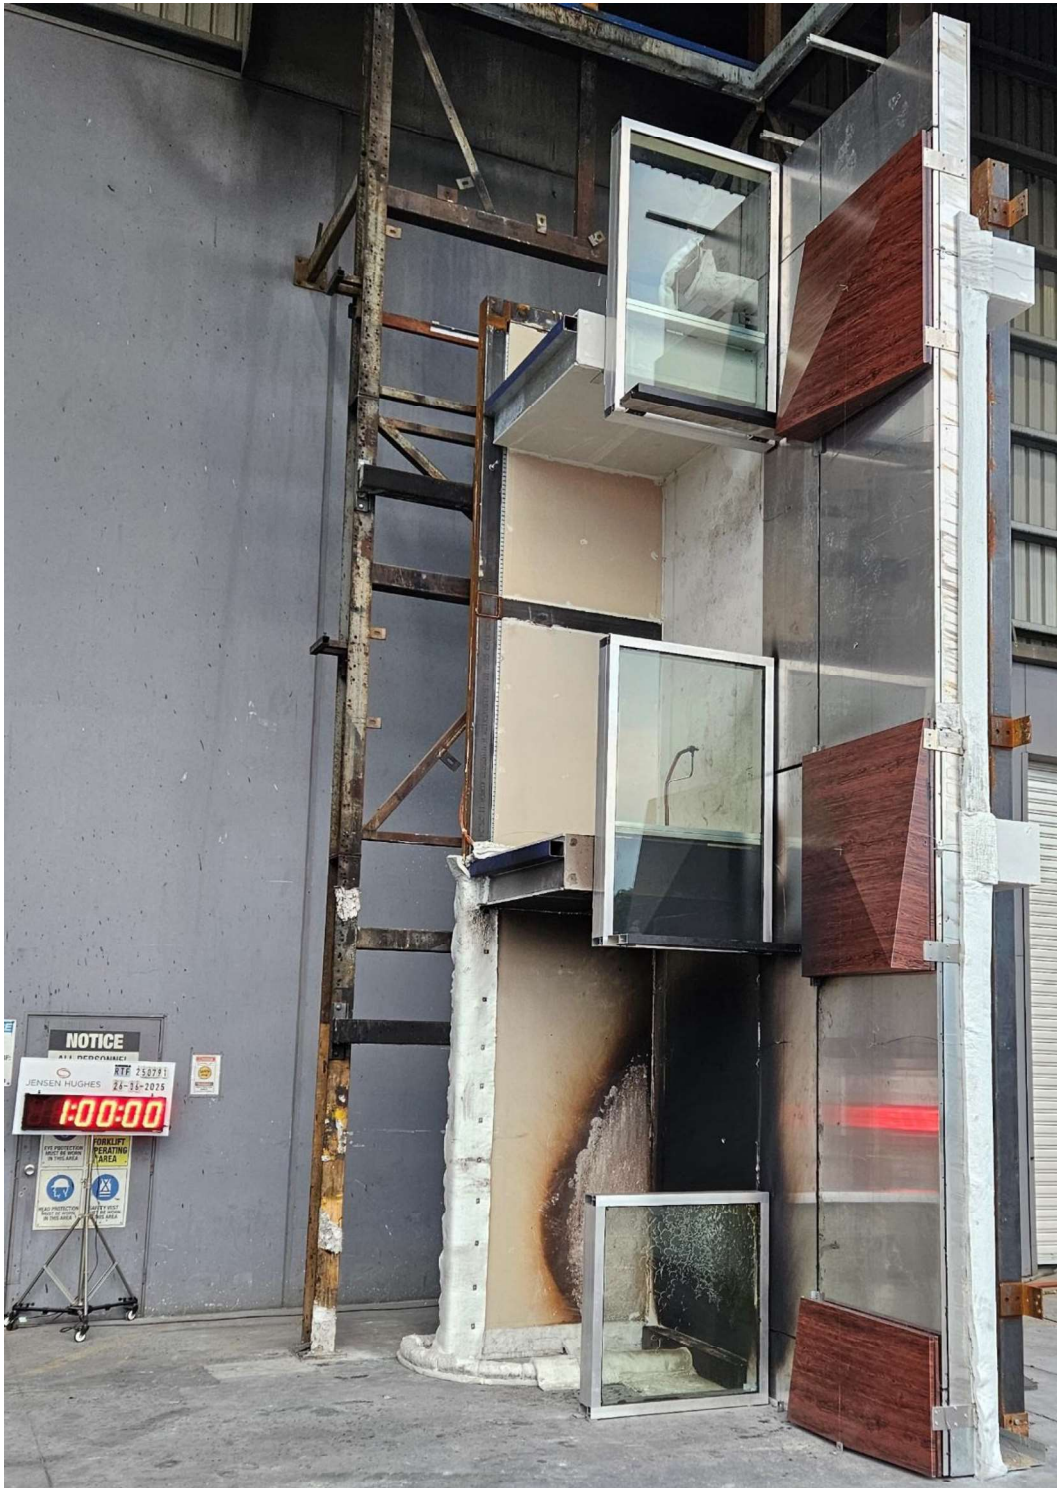
Figure 41 Specimen at the end of the test.

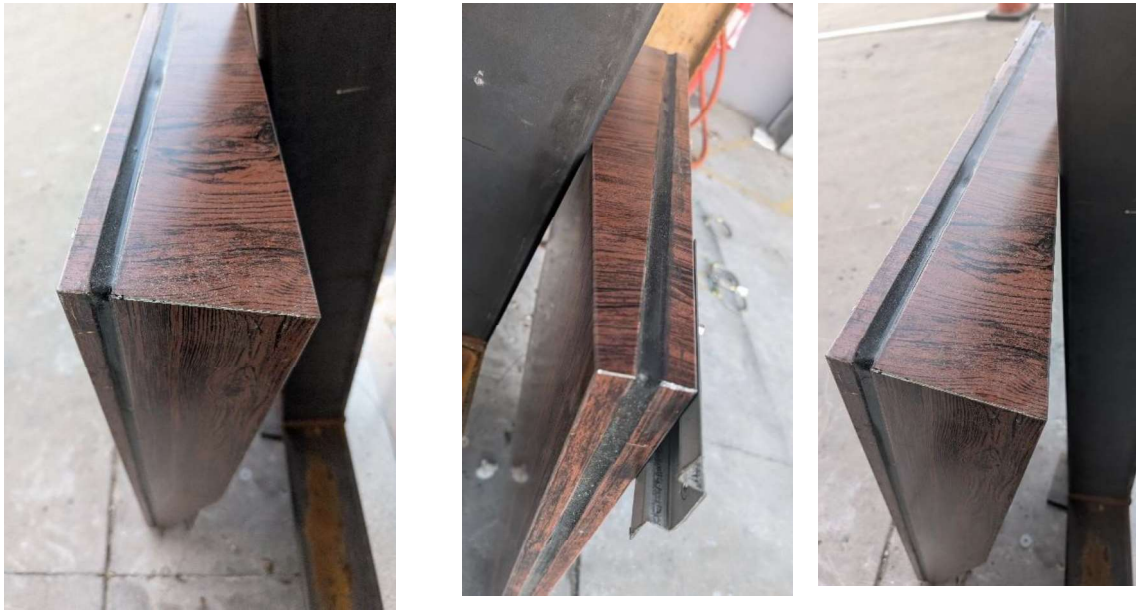
Figure 42 Post test condition of the ground level architectural module

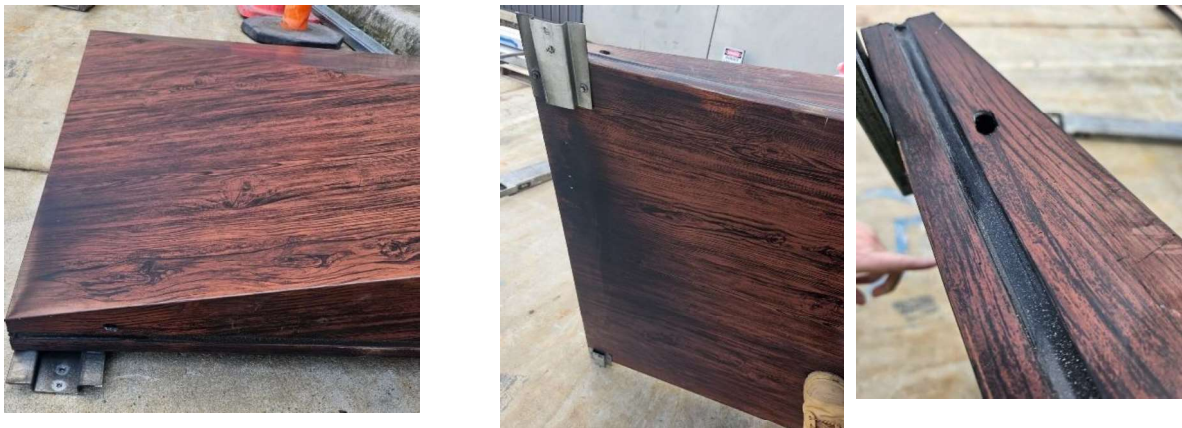
Figure 43 Post test condition of level 1 architectural module

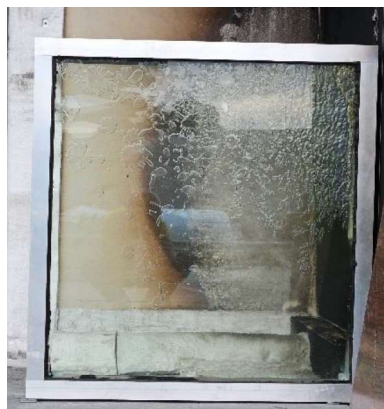
Figure 44 Post test condition of the ground level balustrade

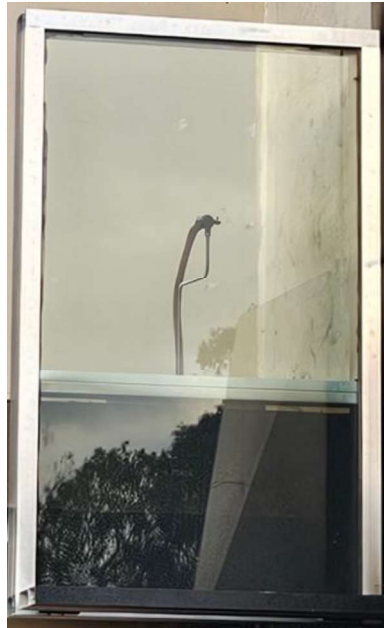
Figure 45 Post test condition of level 1 balustrade

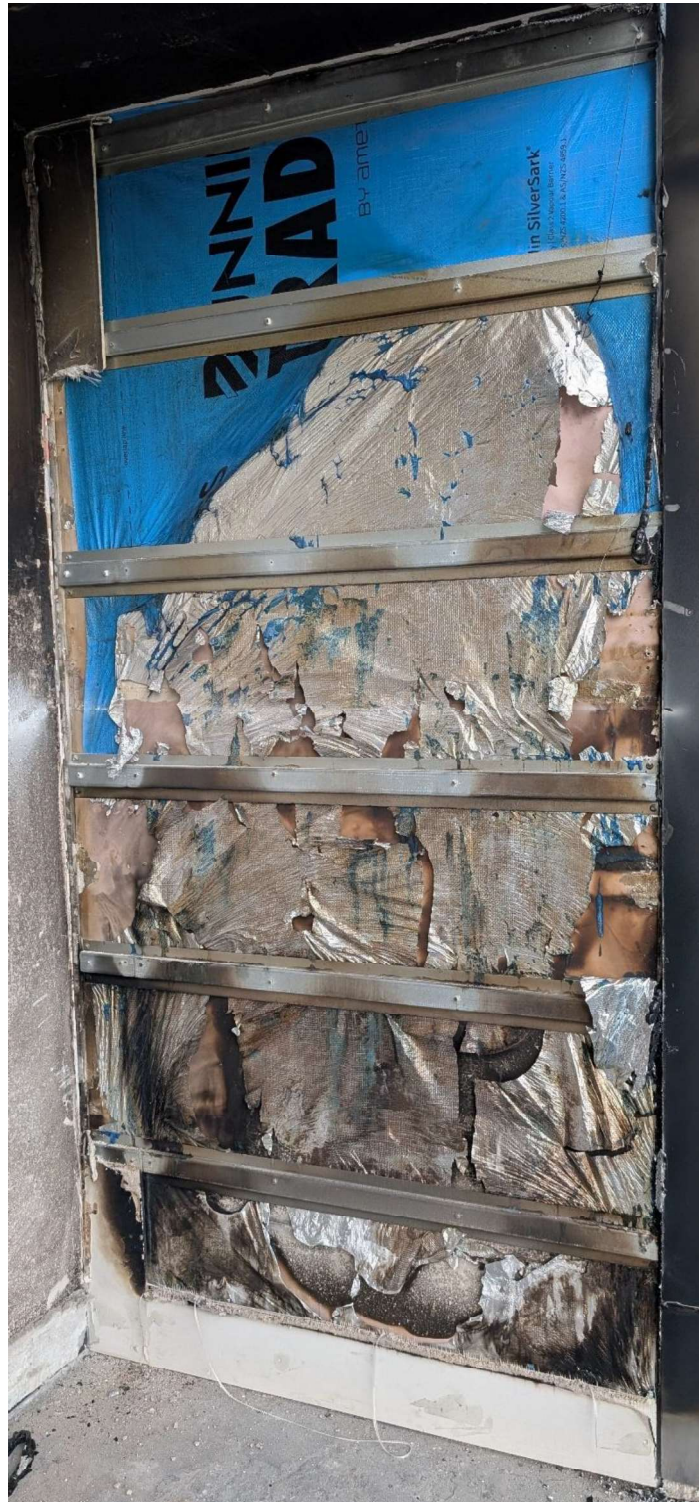
Figure 46 Post test condition behind the MgO board.

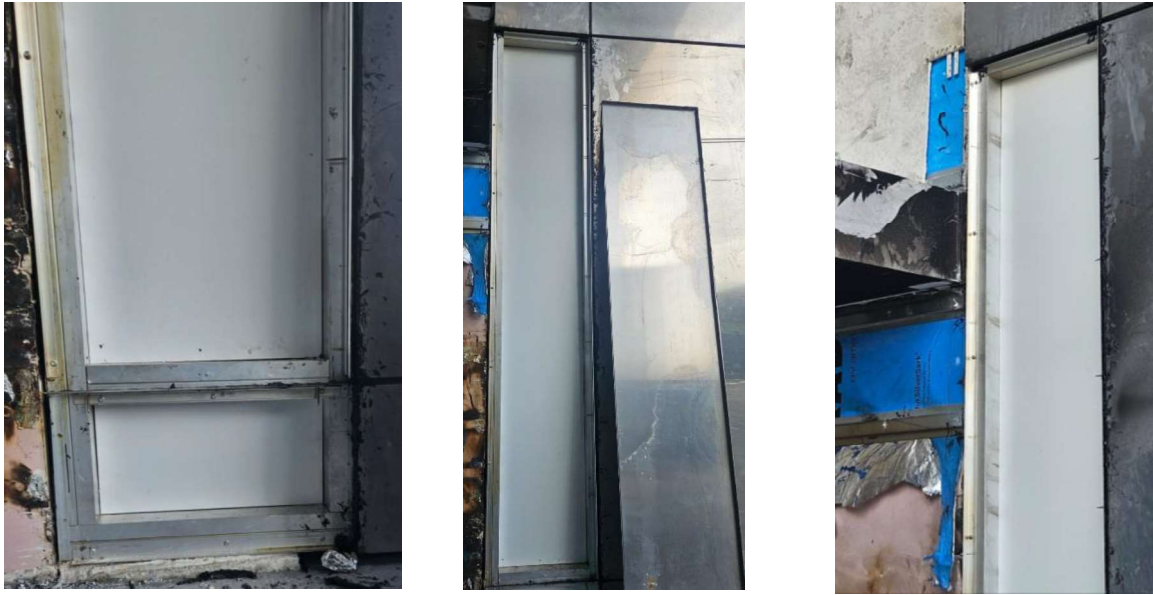
Figure 47 Post test condition of the ACP back pan.
