REACTION TO FIRE TEST REPORT

Test standard: Ad-hoc test based on ISO 13785-1:2002

Test sponsor: Cladding Safety Victoria

Product: Aluminium composite panel curtain wall system nominated as being representative of [REDACTED]
[REDACTED]-Test 3

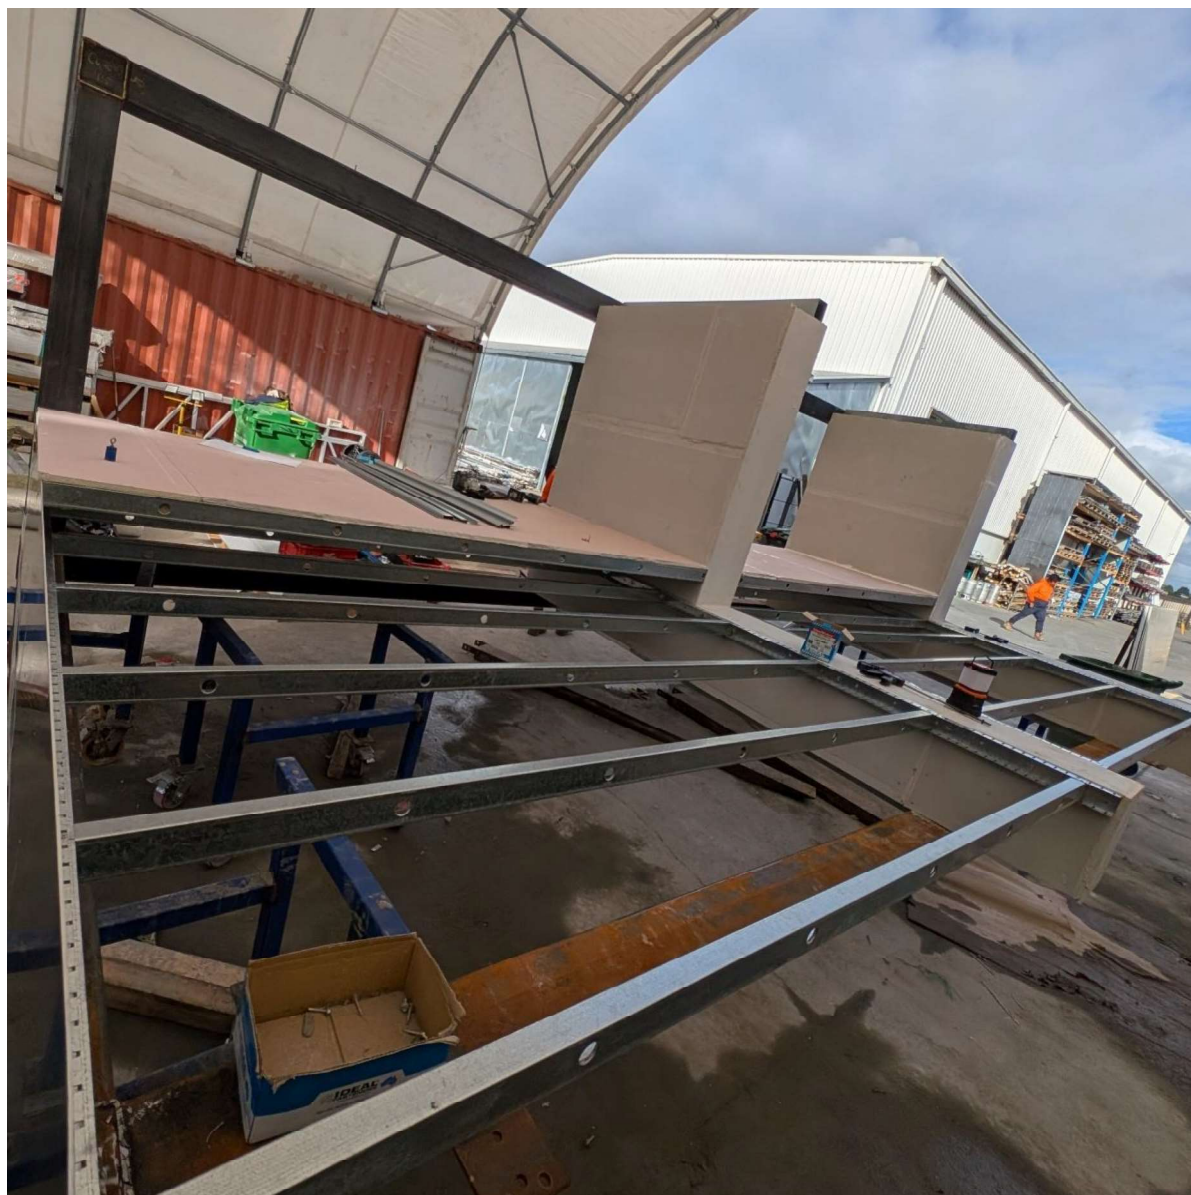
Figure 48 test jig during construction

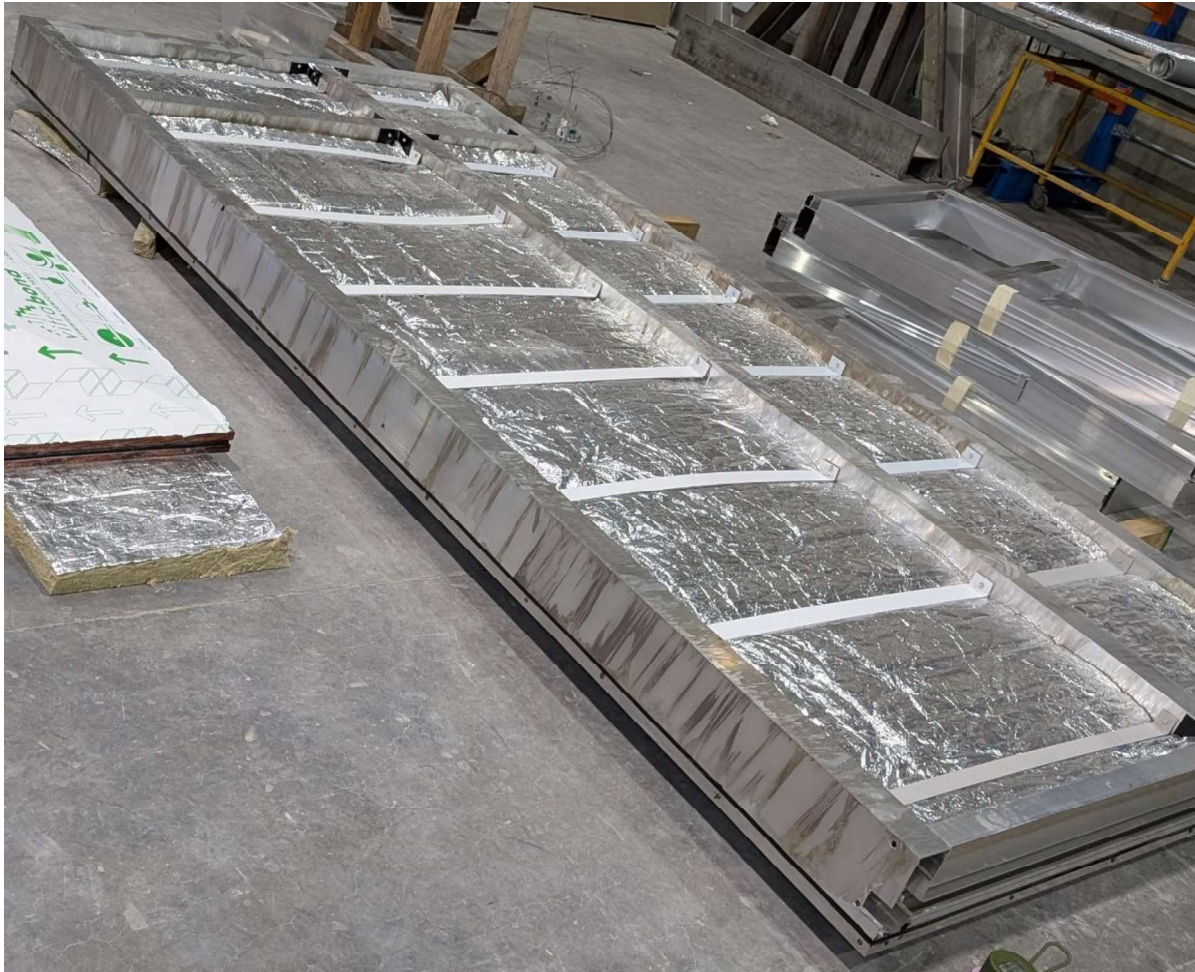
Figure 49 unexposed side of ACP curtainwall module

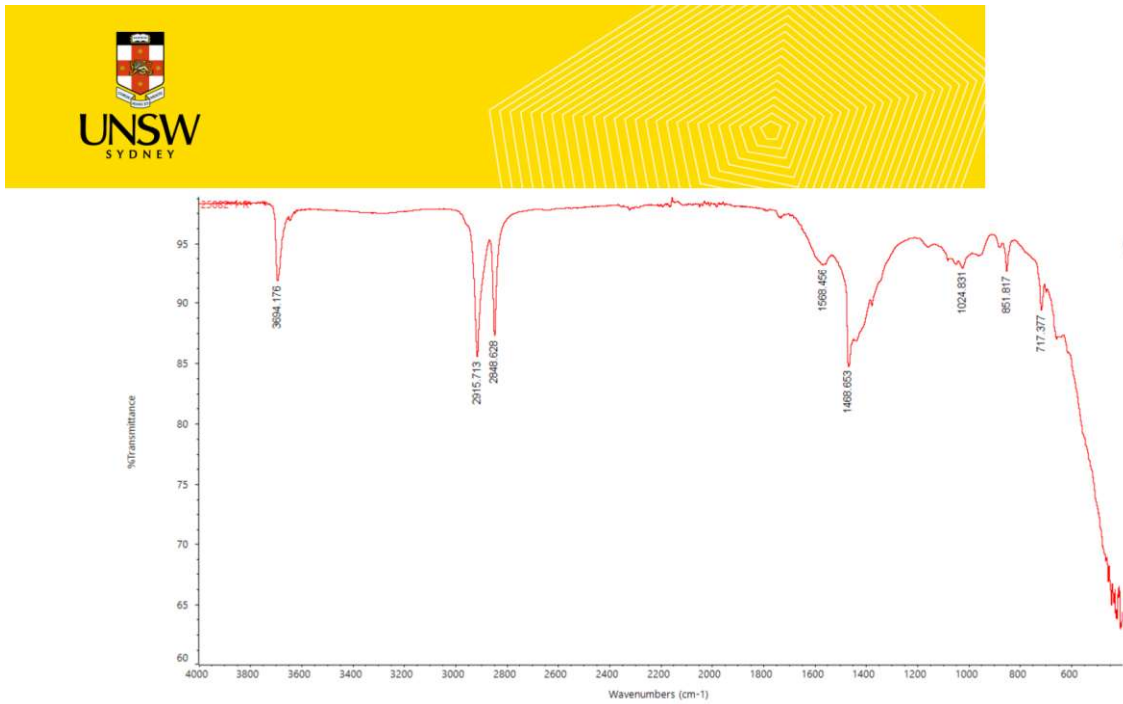
Figure 1. FT-IR spectrum of sample 1
