REACTION TO FIRE TEST REPORT

Test standard: Ad-hoc test based on ISO 13785-1:2002

Product: Aluminium composite panel curtain wall system nominated as being representative of [REDACTED]

Job number: RTF121570

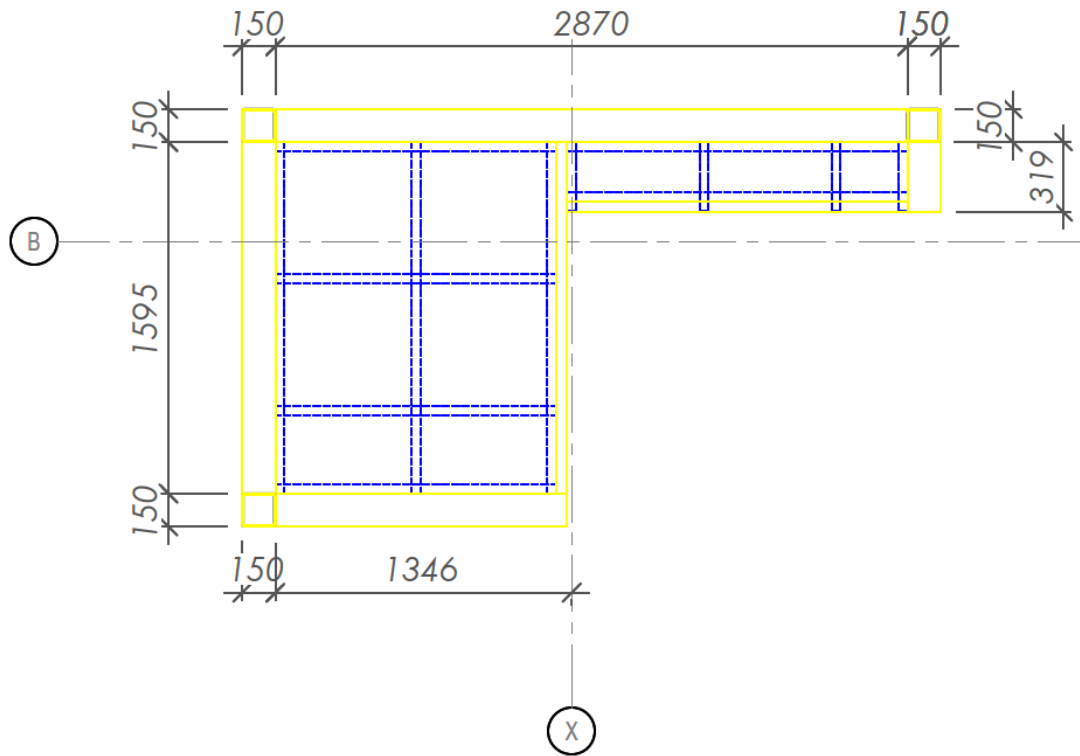
Figure 8 Plan view – steel frame layout

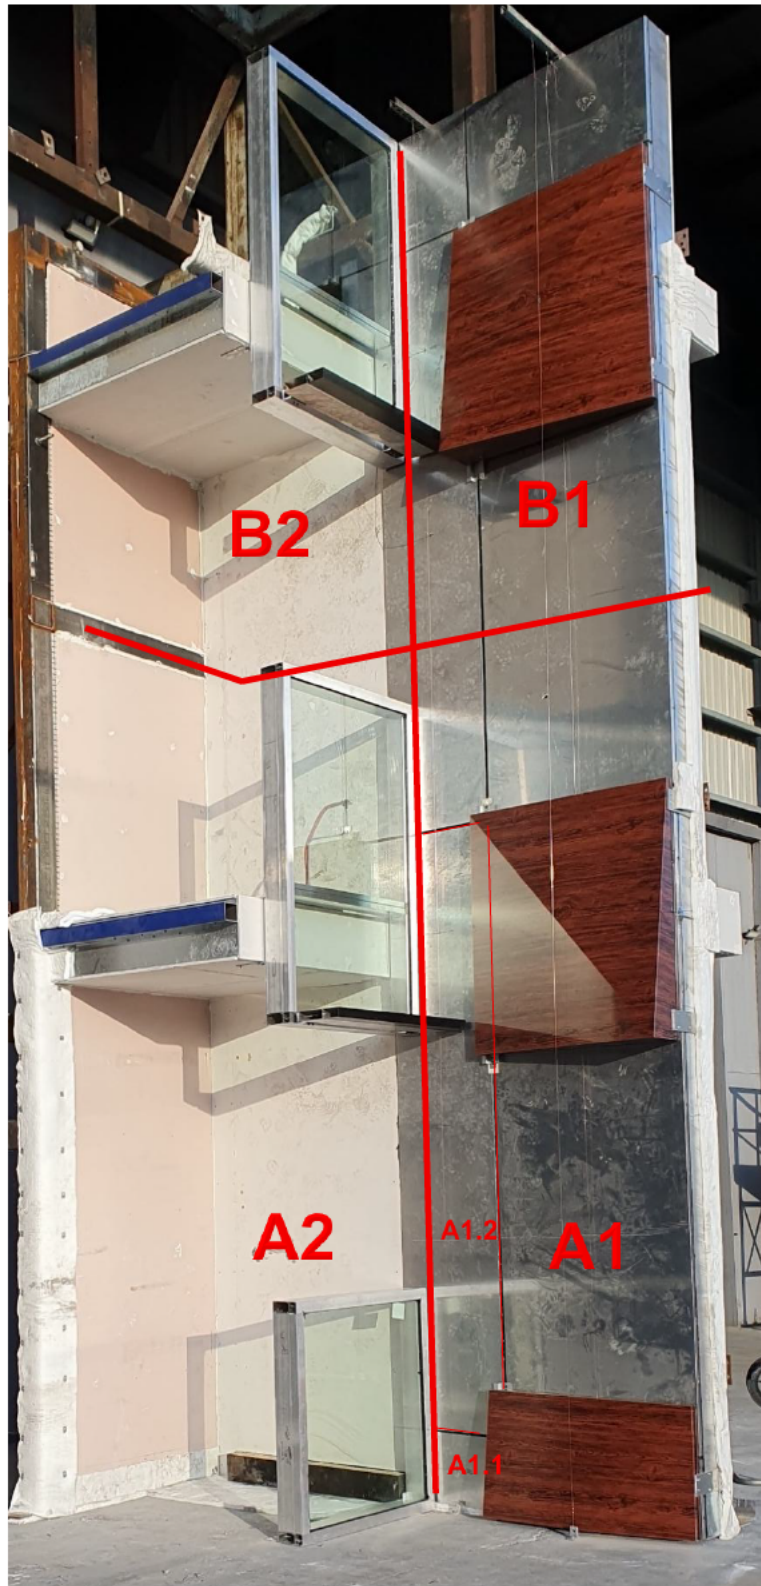
Figure 13 Designation for the test specimen observations

Time		Section	Observation
Min	Sec		
-5	00	All	Data collection started
0	00	All	The reaction to fire test started. The burner was ignited with the output set to a heat release rate of 100 kW.
6	45	A2	Lower edge of the aluminium cladding close to the ground level glazing started darkening.
7	40	A1	Flames intermittently exited towards the wing wall through the gap between the ground level balustrade and the wing wall.
11	02	A1.1	Flames intermittently hit the lower edge of the bottom aluminium cladding.
15	00	All	The burner output was set to a heat release rate of 300 kW.
15	56	A2	Flame reached the bottom of level 1 balustrade.
17	30	A2	The sealant on the lower glazing was on fire.
18	40	A2	Bubbles had appeared on the ground level glazing.
19	46	A1.2	Flames reached up to the aluminium cladding edge behind the glazing (A2).
21	23	A2	The ground level glazing cracked.
25	14	A2	The burner side edge of the aluminium cladding below level 1 balustrade had discoloured.

36	10	A2	The ground level glazing yellowed.
39	11	A2	The bottom section of level 1 glazing discoloured.
40	00	All	The burner was turned off.
40	54	A2	The exposed side of ground level glazing had independent flaming.
42	30	A2	Some smoke started emitting from the south side of the ground level glazing without any visible flame.
48	47	A2	The ground level glazing shattered.
51	43	A2	The ground level glazing shattered further.
60	00	All	The reaction to fire test was ended.

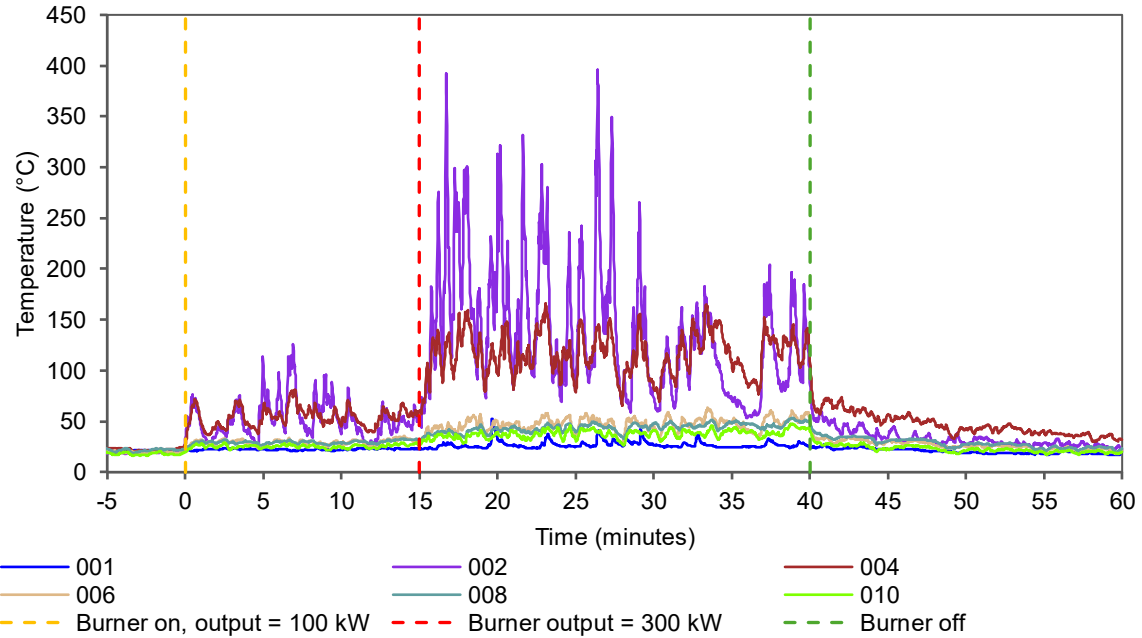
Figure 14 External surface temperatures at various heights on cladding close to the burner – temperature vs time

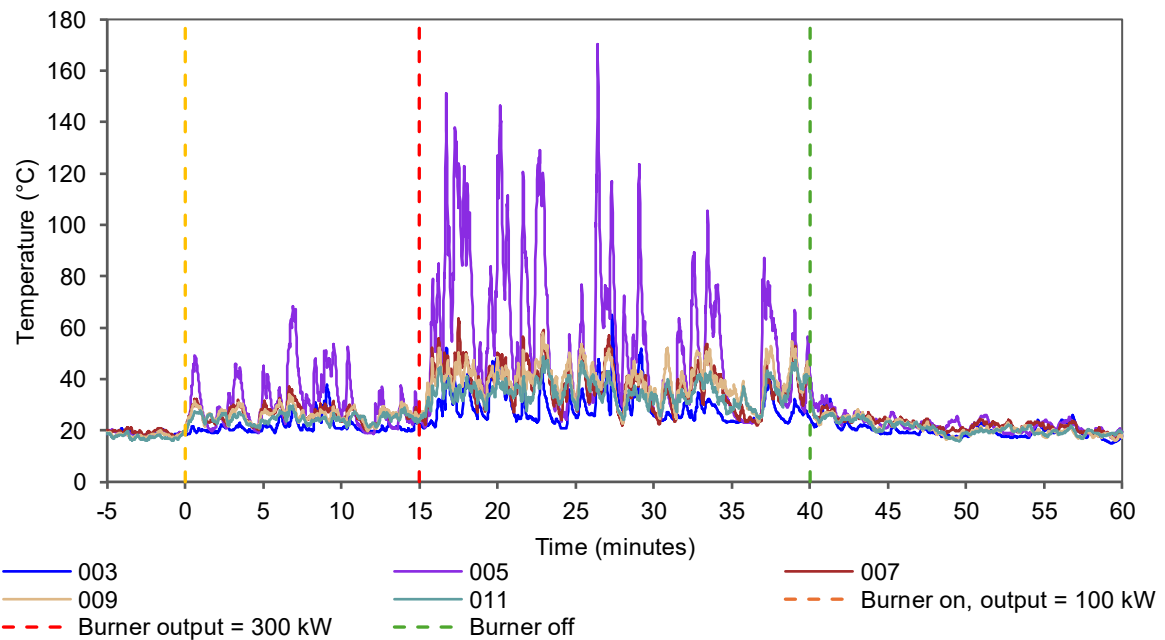
Figure 15 External surface temperatures at various heights on cladding away from the burner – temperature vs time

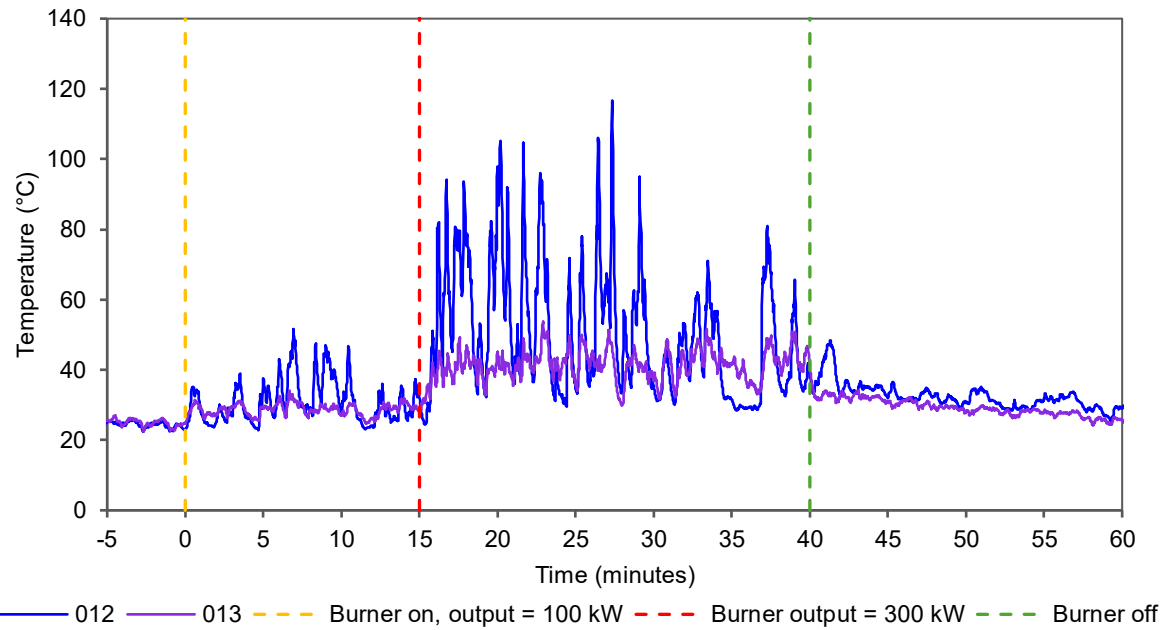
Figure 16 Cavity temperatures behind the 3D architectural modules – temperature vs time

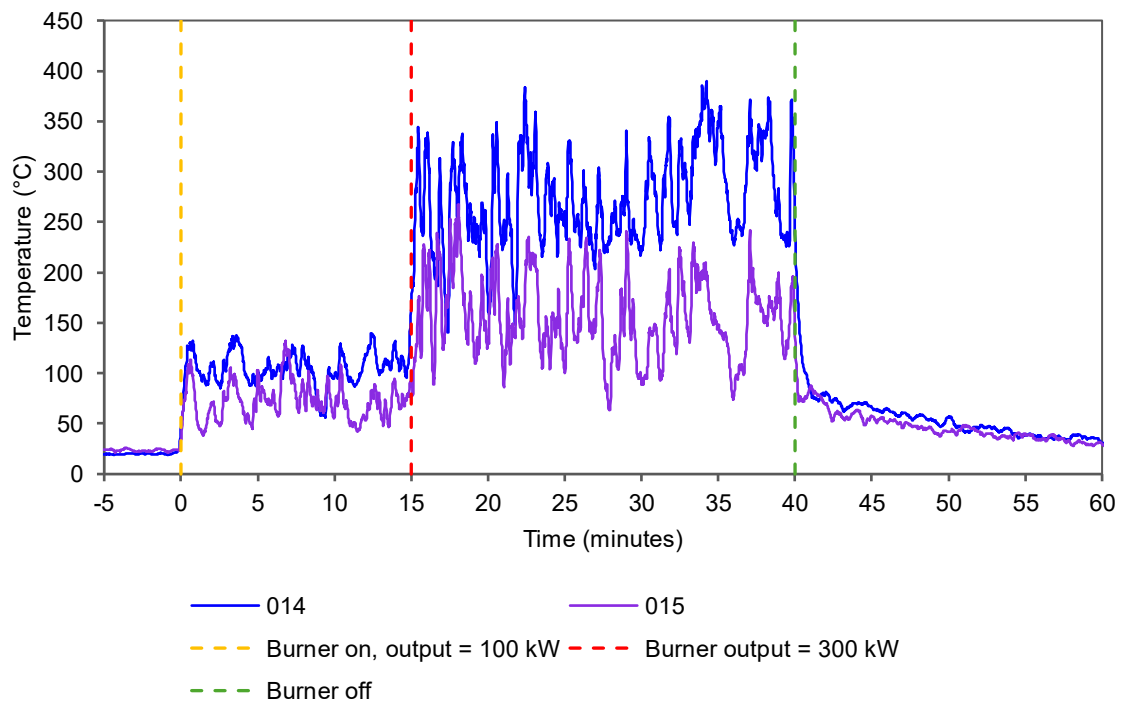
Figure 17 Surface temperature at level 1 balcony adjoining surfaces – temperature vs time

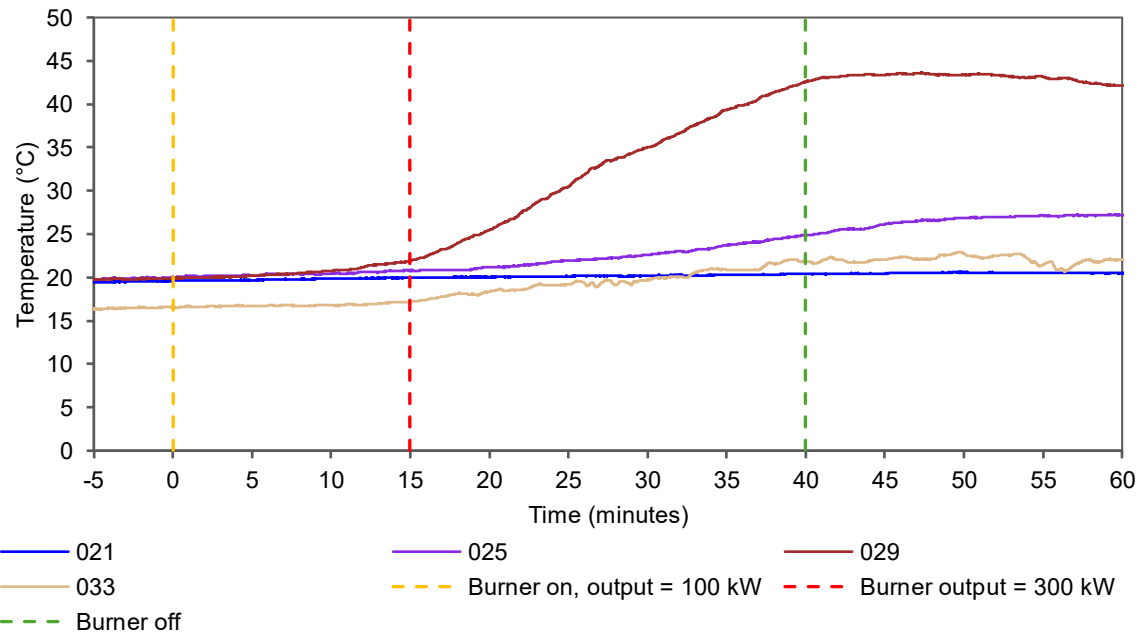
Figure 23 Cavity temperatures between the back pan and plasterboard of modules 2, 4, 6 and 8 – temperature vs time

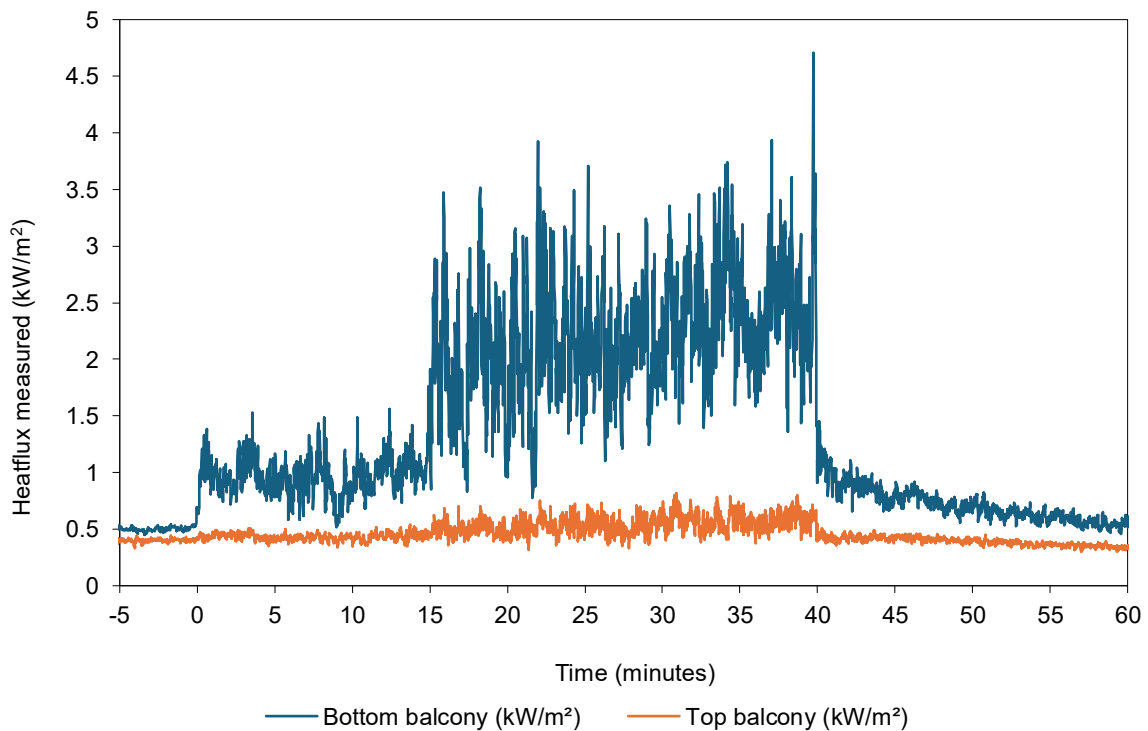
Figure 29 Measured heatflux data collected by the HFGs – Heat flux vs time

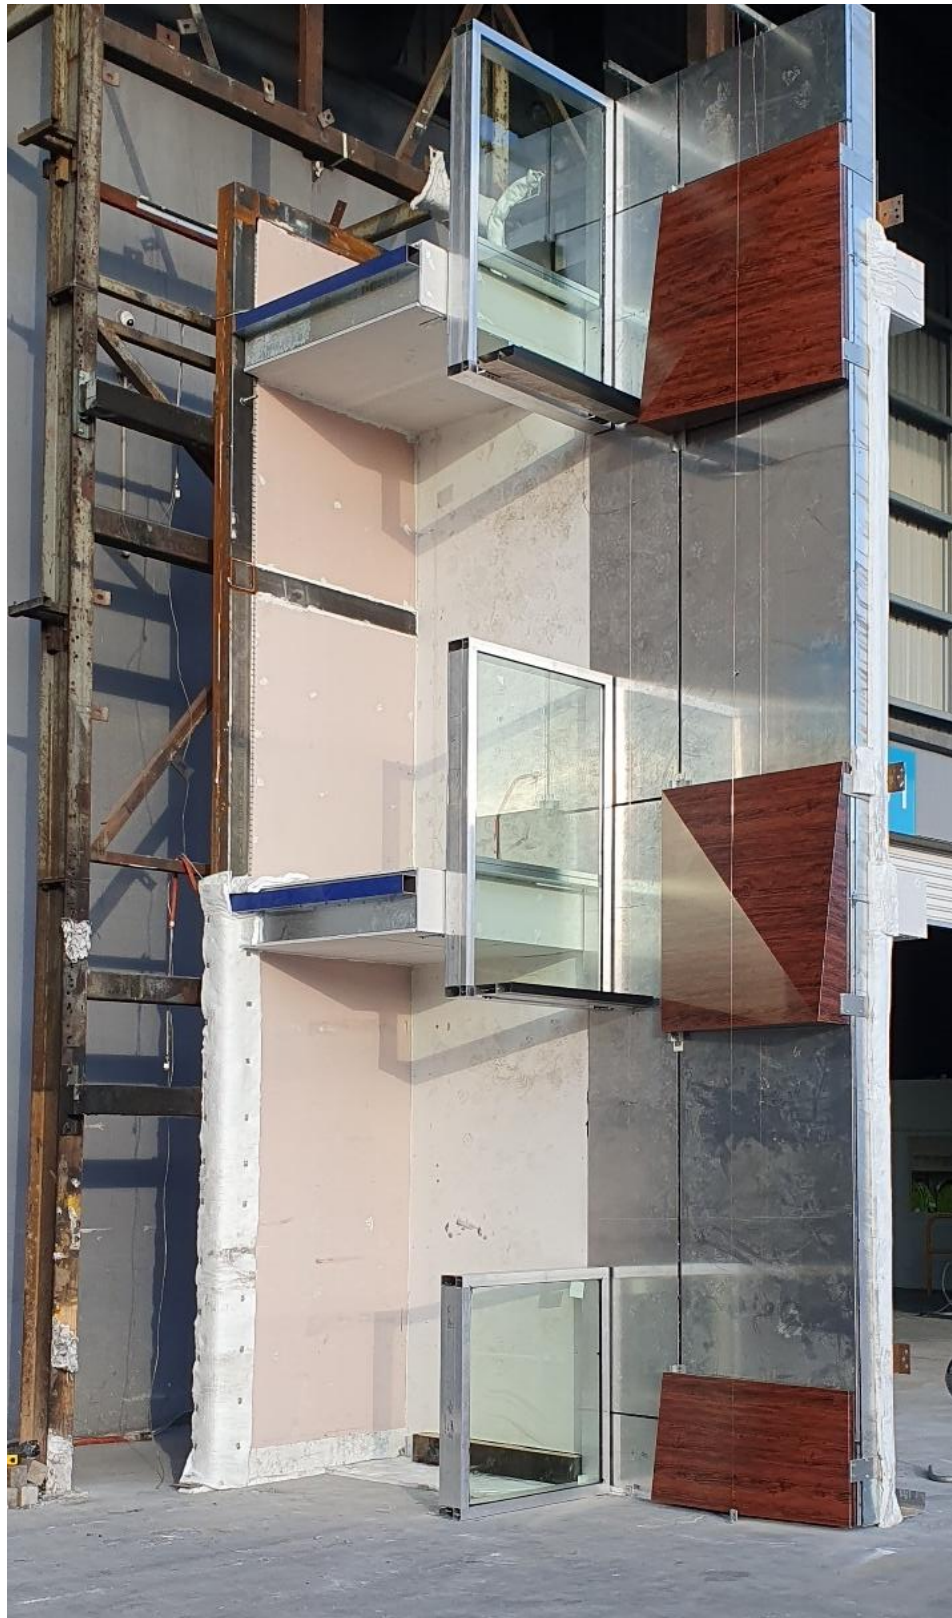
Figure 30 The specimen before the start of the test – exposed side.

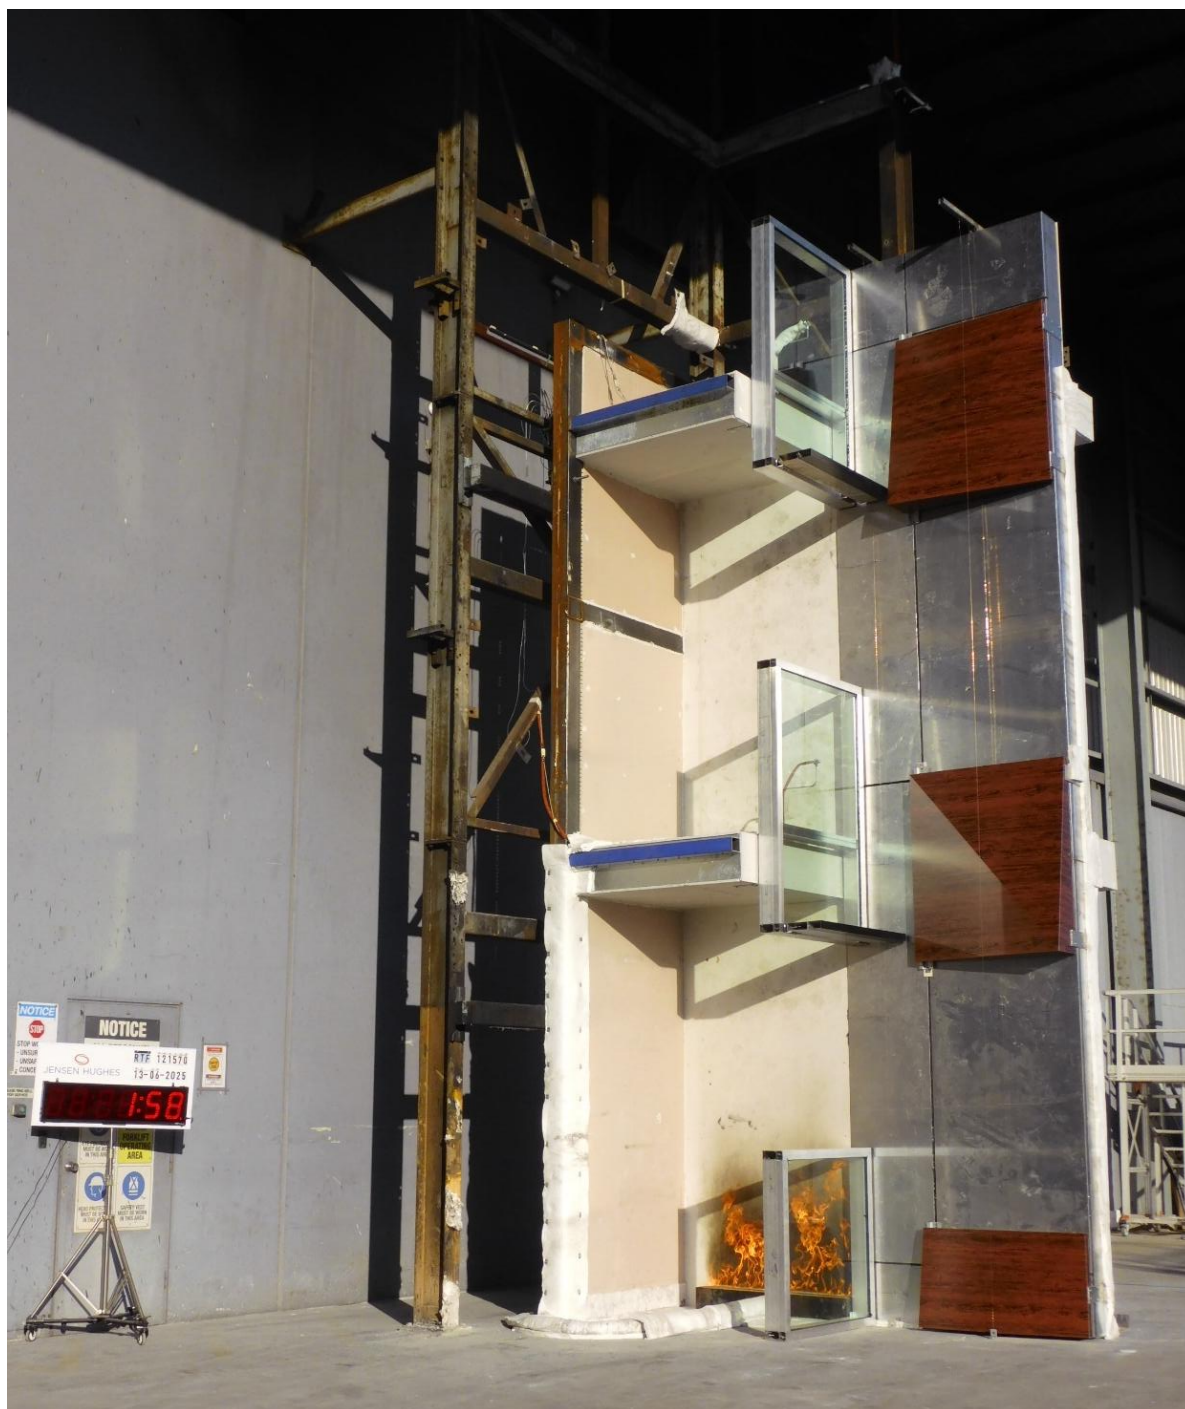
Figure 31 The specimen 1 minute 58 seconds into the test with the burner at 100 kW.

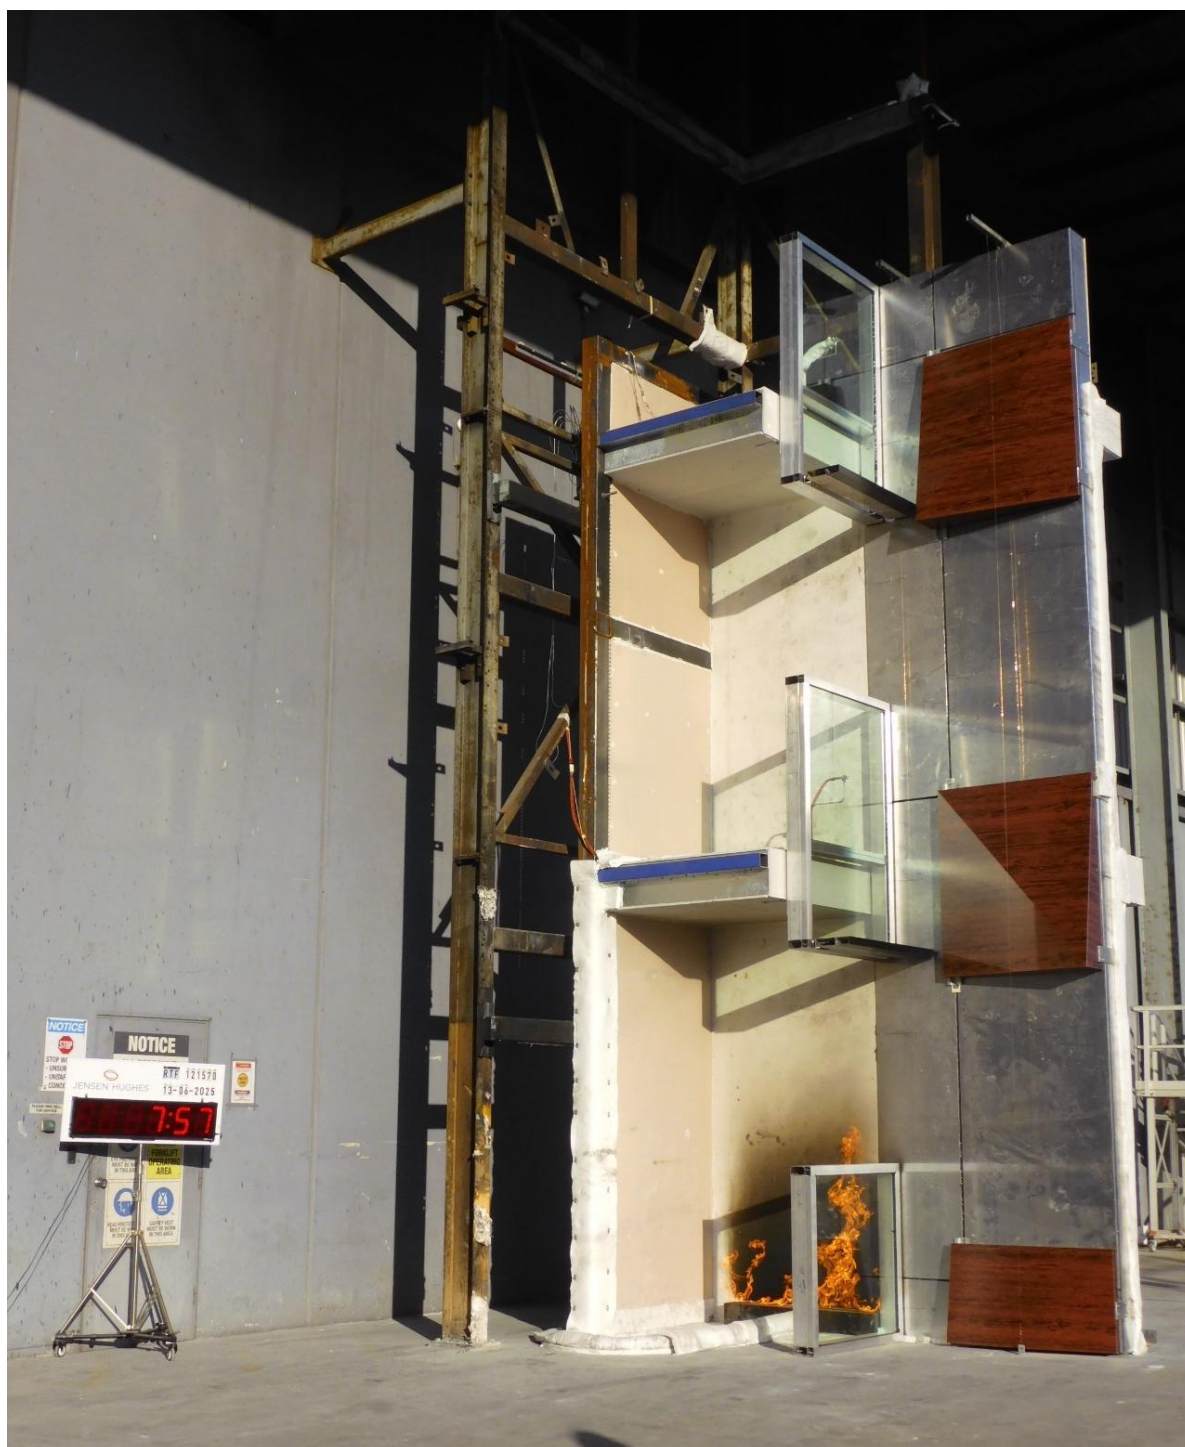
Figure 32 The specimen 7 minutes 57 seconds into the test with the burner at 100 kW.

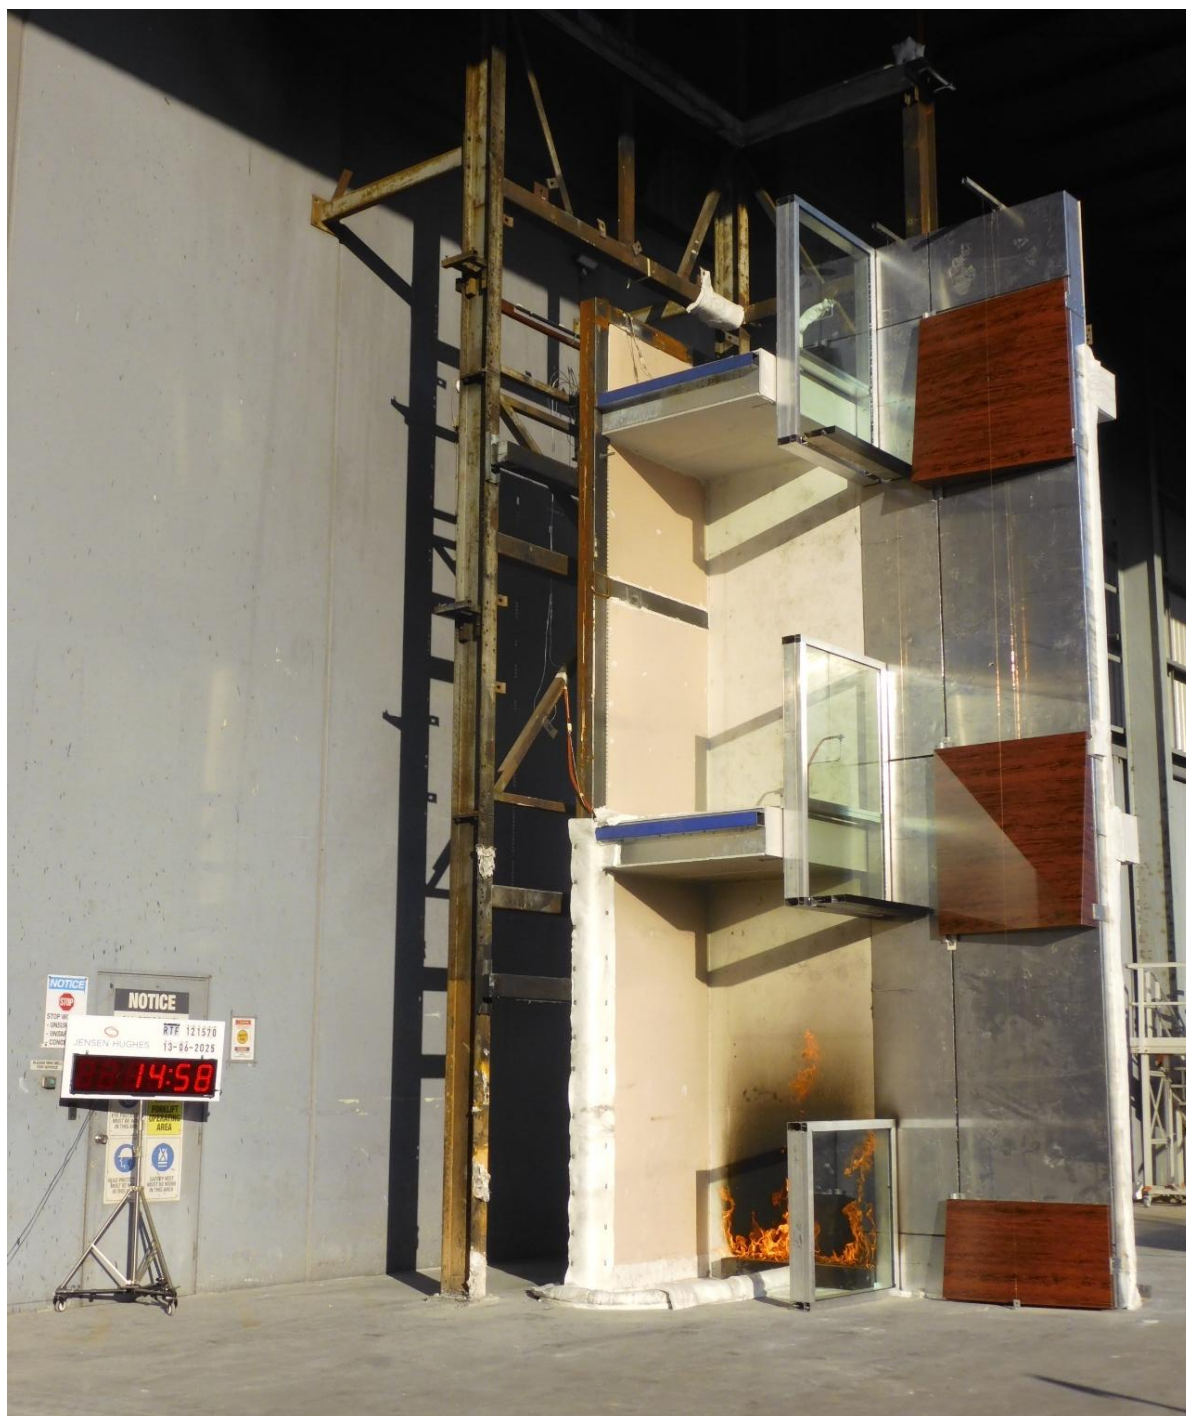
Figure 33 The specimen 14 minutes 58 seconds into the test with the burner at 100 kW.

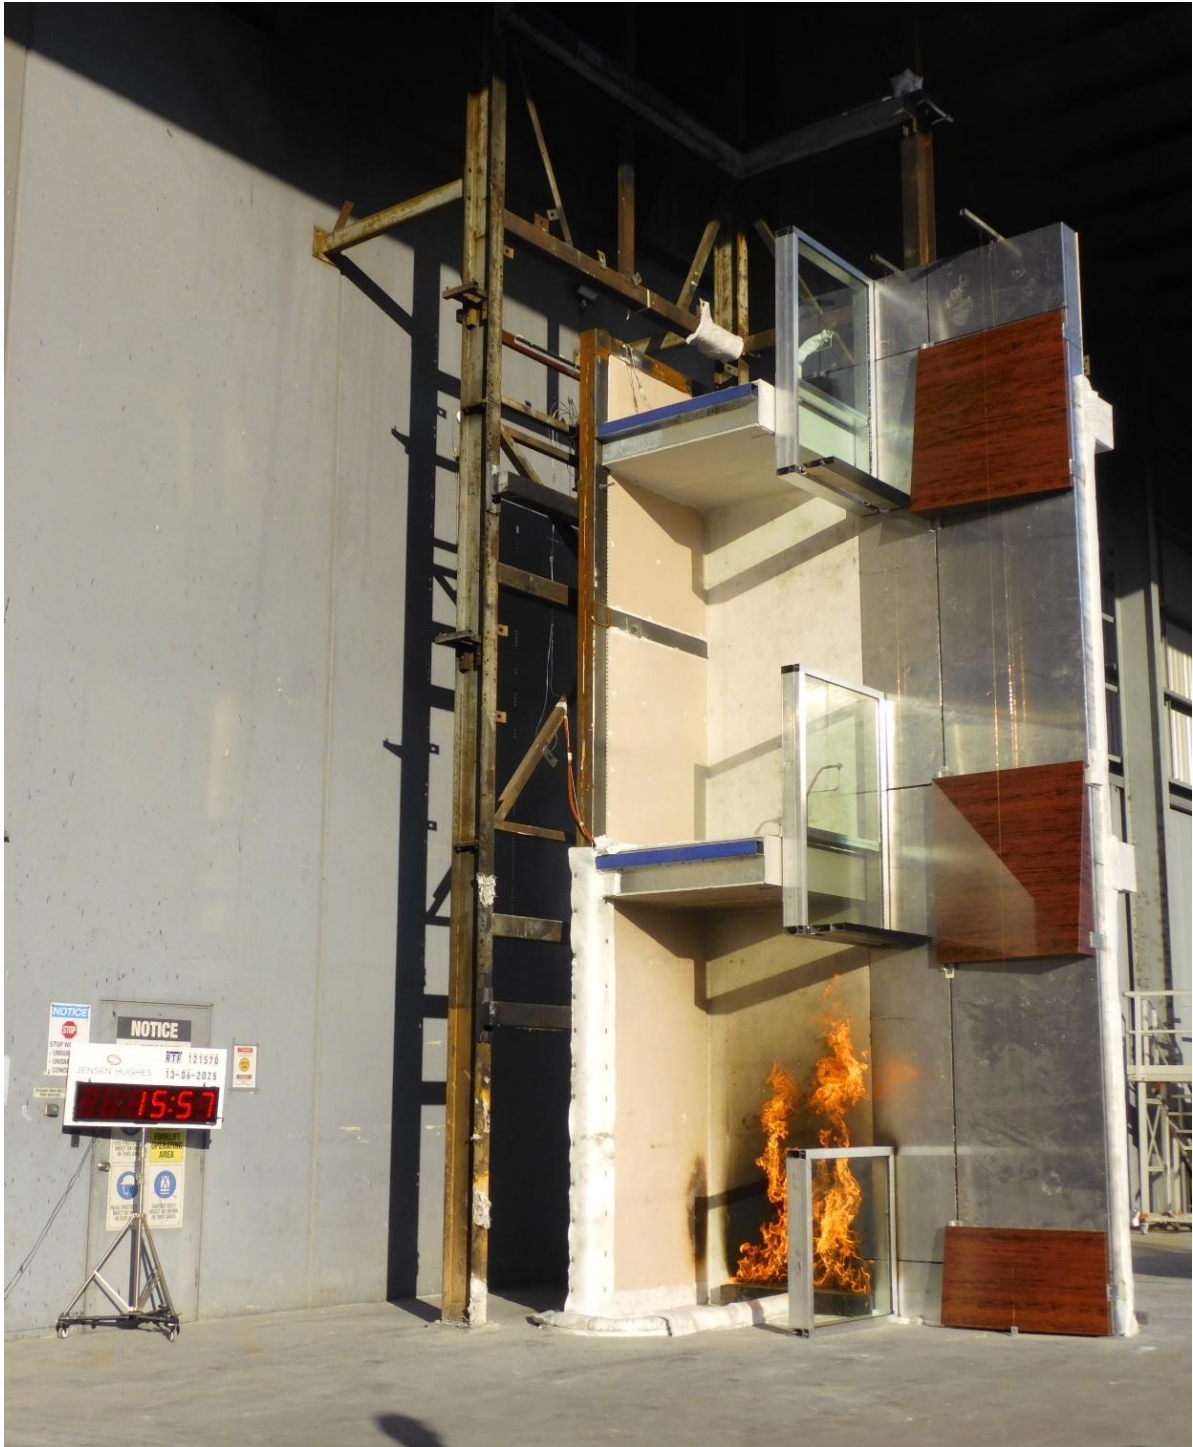
Figure 34 The specimen 15 minutes 57 seconds into the test – 57 seconds after the burner output was increased to 300 kW.

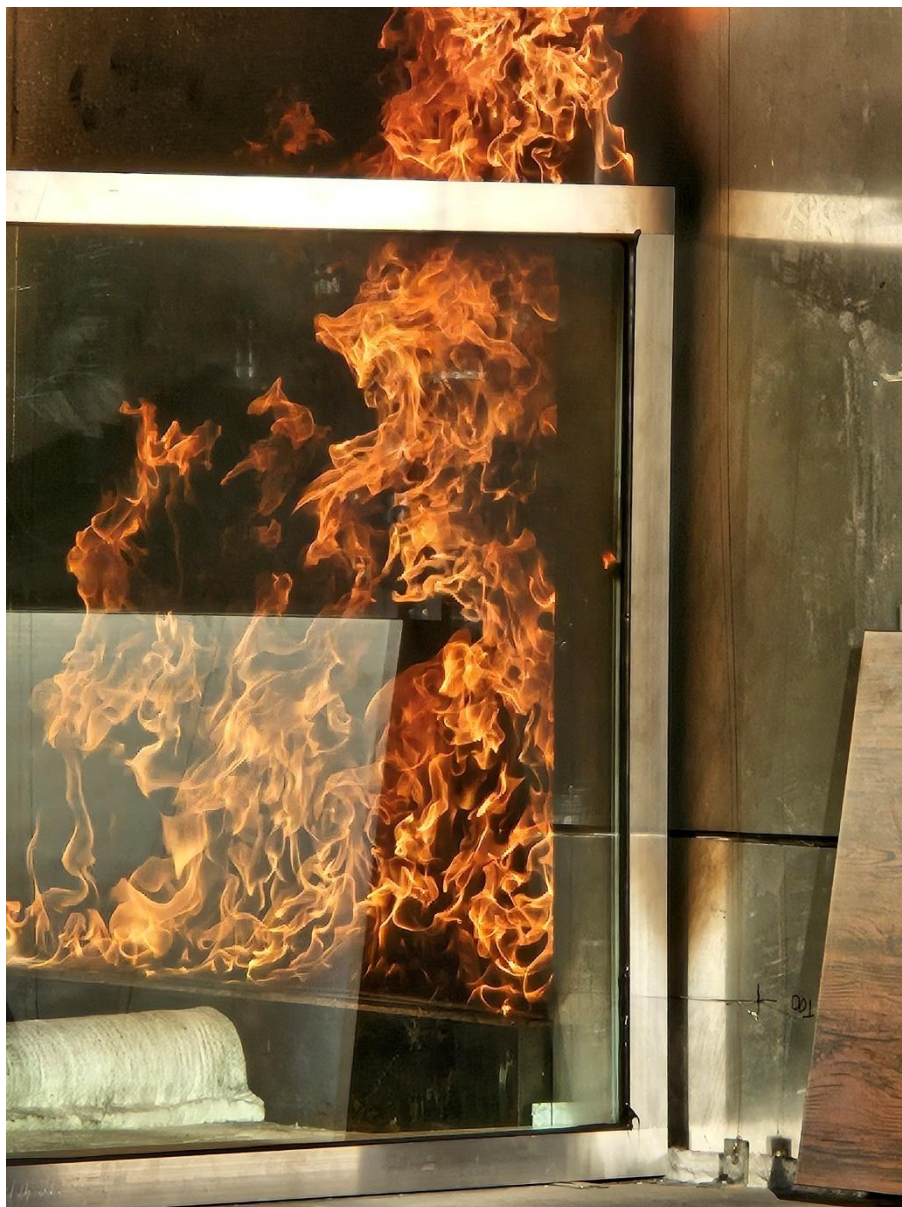
Figure 35 The specimen 17 minutes 30 seconds into the test – sealant around the ground level balustrade on fire.

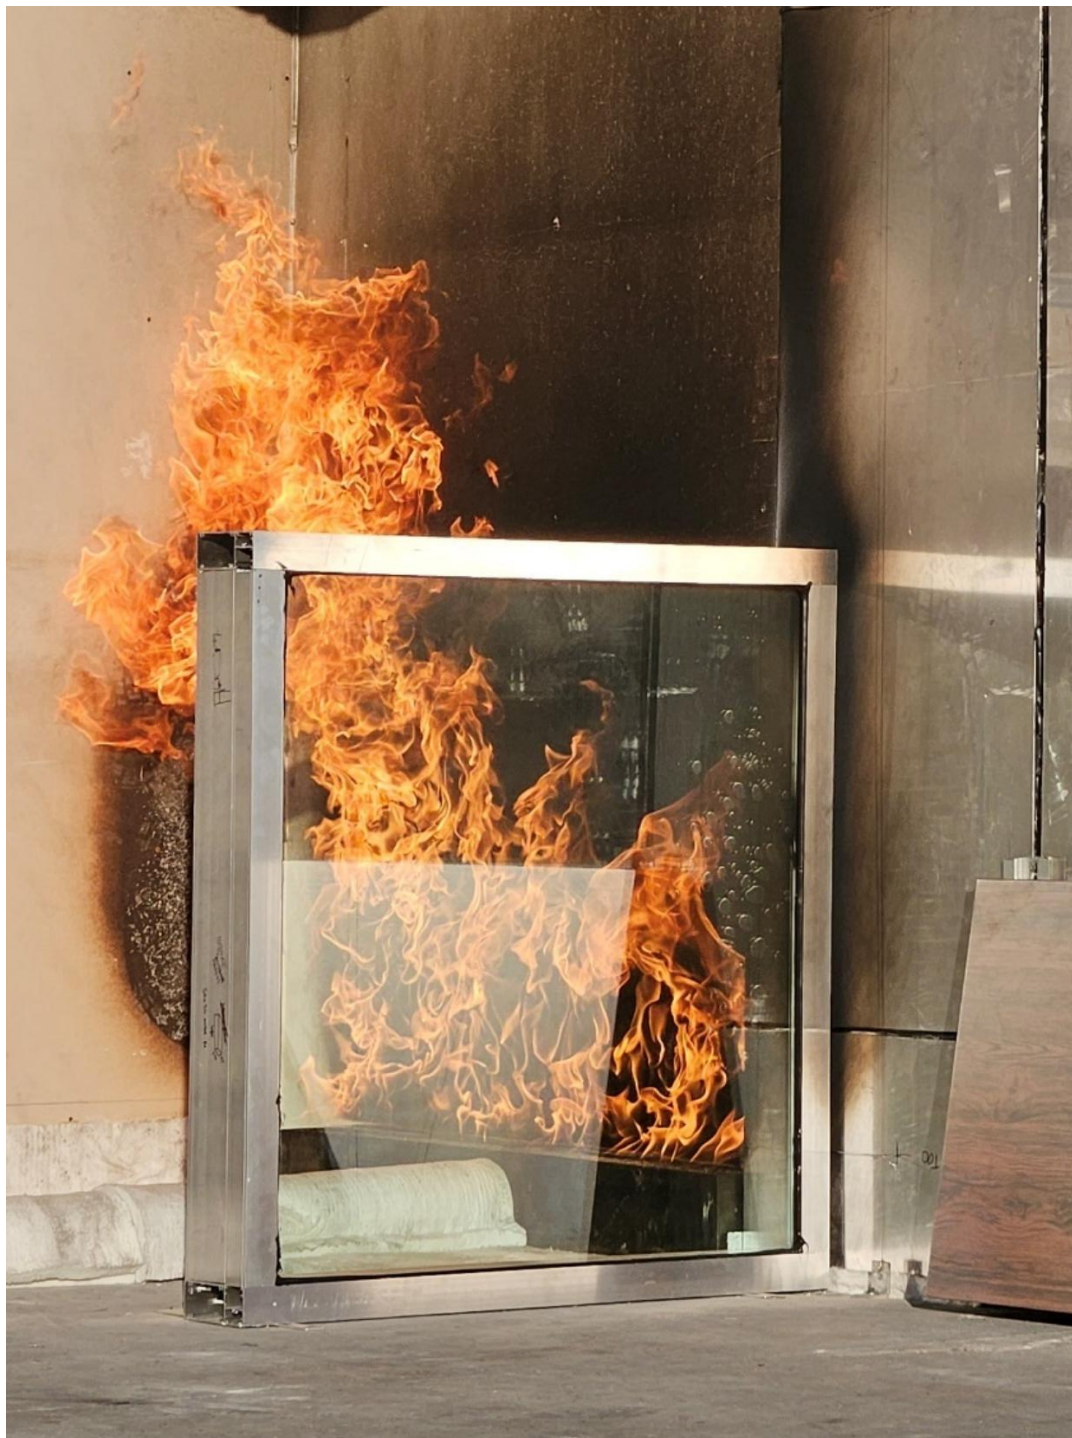
Figure 36 The specimen 18 minutes 40 seconds into the test – formation of bubbles in the PVB interlayer of glazing.

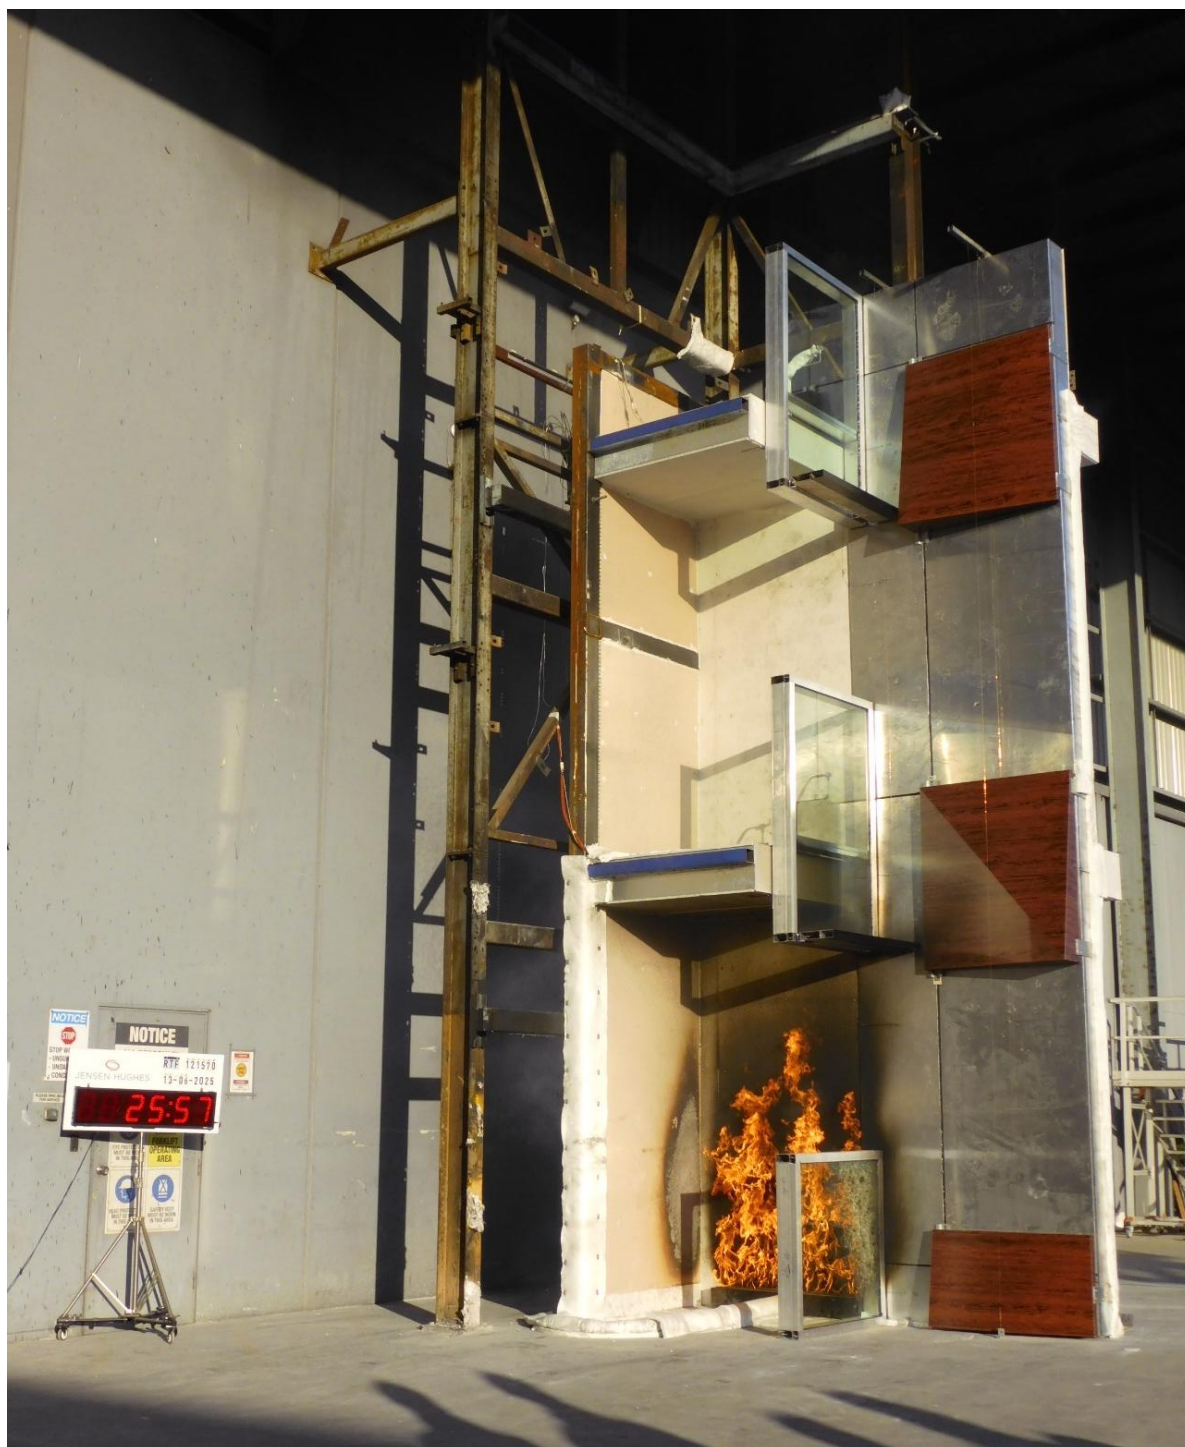
Figure 37 The specimen 25 minutes 57 seconds into the test – 10 minutes 57 seconds after the burner output was increased to 300 kW.

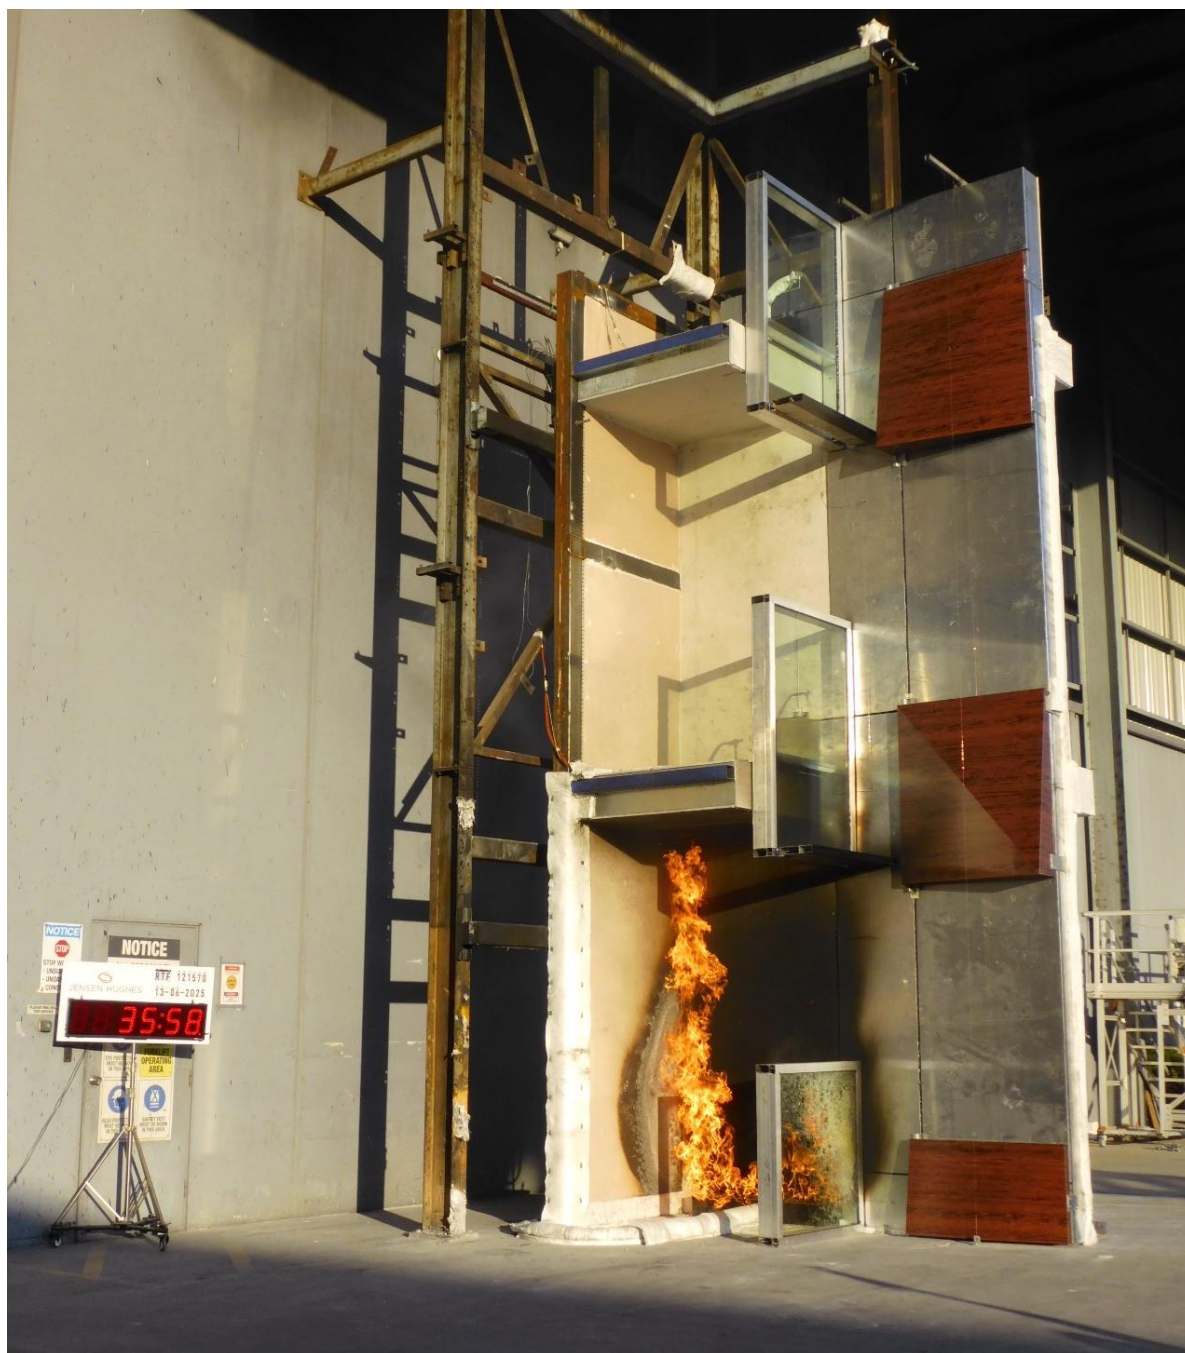
Figure 38 The specimen 35 minutes 58 seconds into the test – 20 minutes 58 seconds after the burner output was increased to 300 kW.
