REACTION TO FIRE TEST REPORT

Test standard: Ad-hoc test based on ISO 13785-1:2002

Product: Aluminium composite panel curtain wall system nominated as being representative of [REDACTED]

Job number: RTF121570

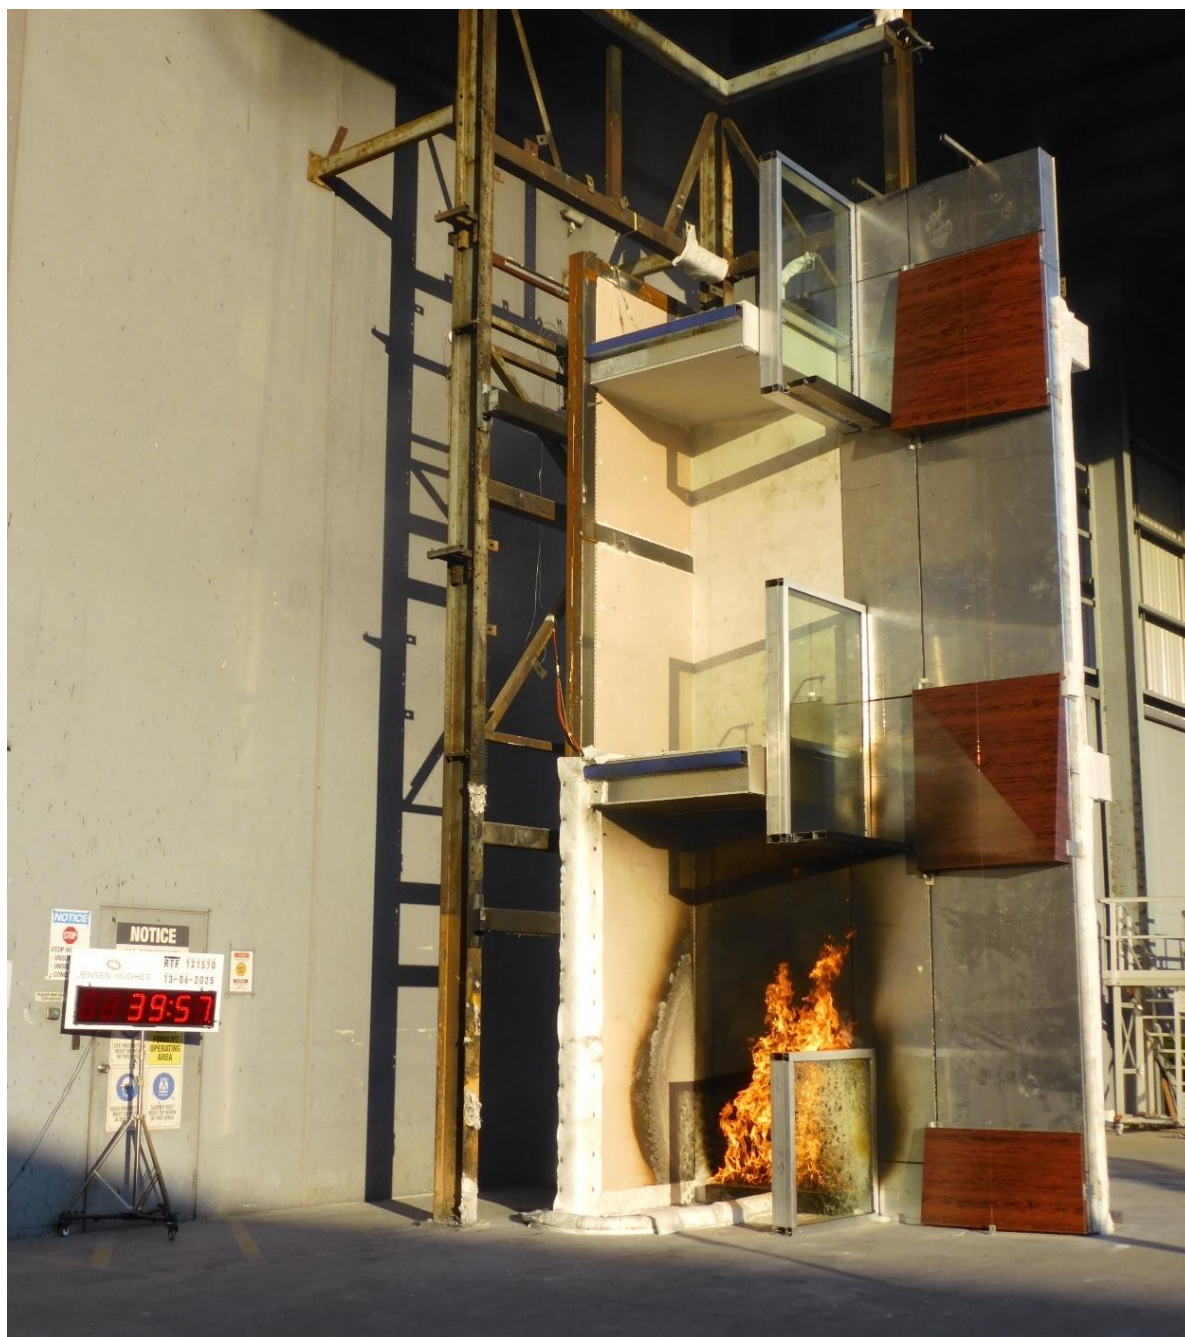
Figure 39 The specimen 39 minutes 57 seconds into the test – 24 minutes 57 seconds after the burner output was increased to 300 kW.

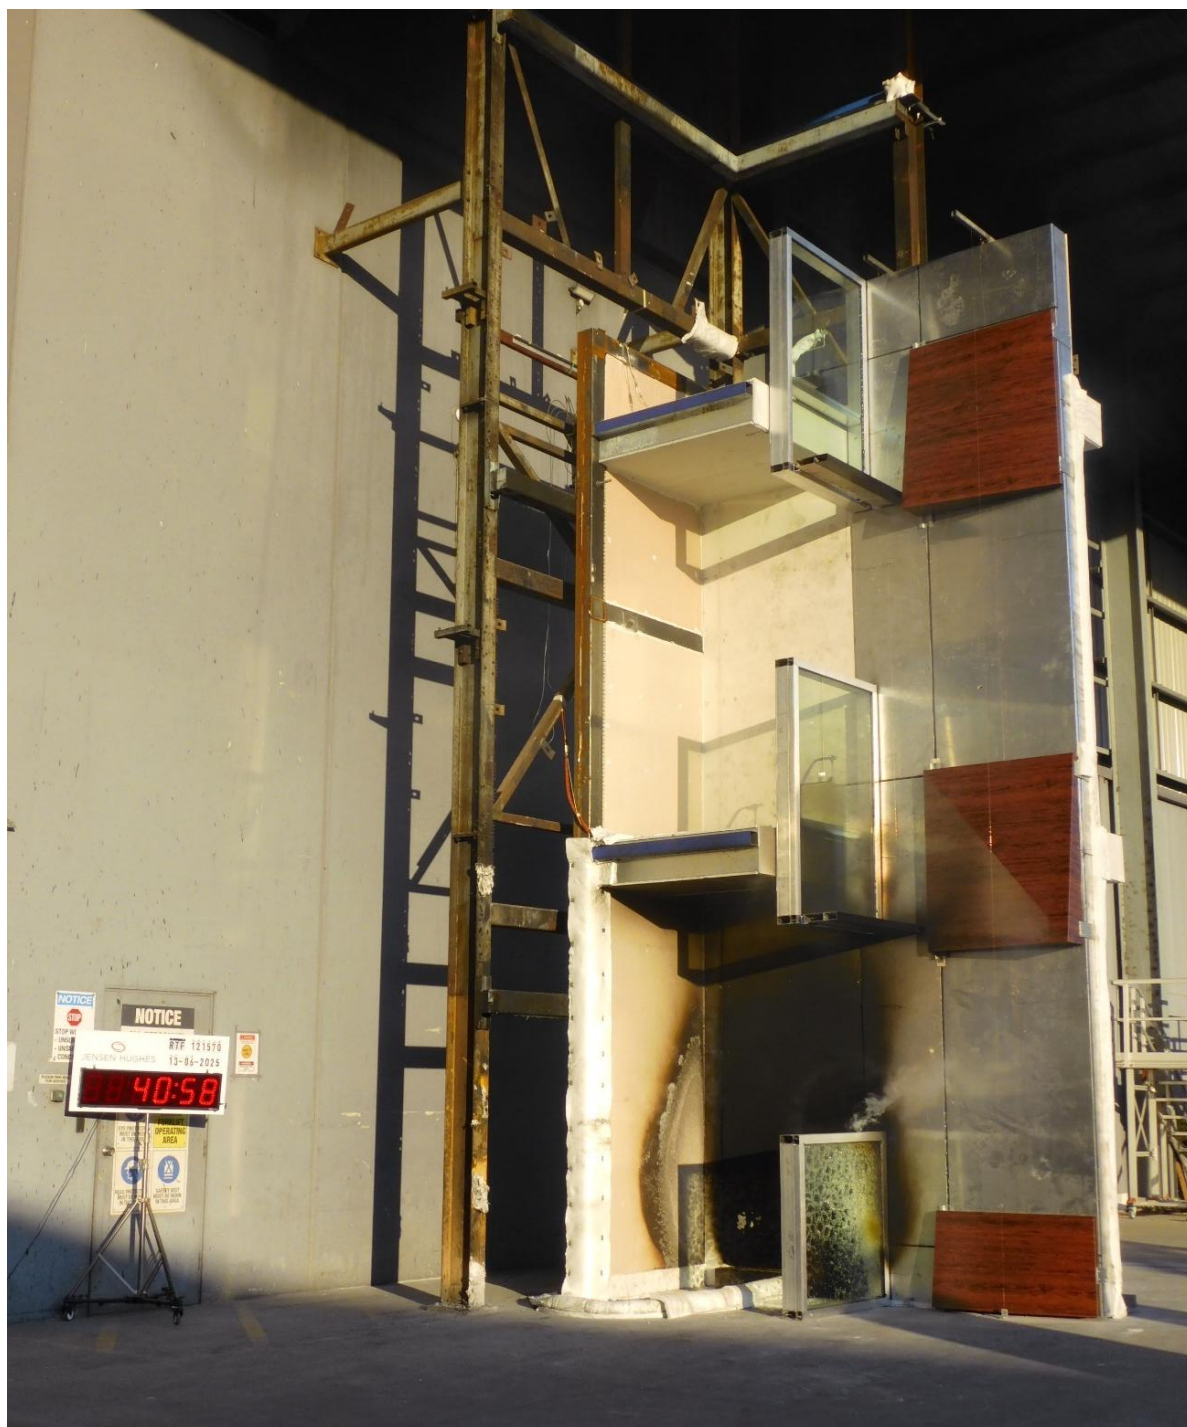
Figure 40 The specimen 40 minutes 58 seconds into the test – 58 seconds after the burner was turned off.

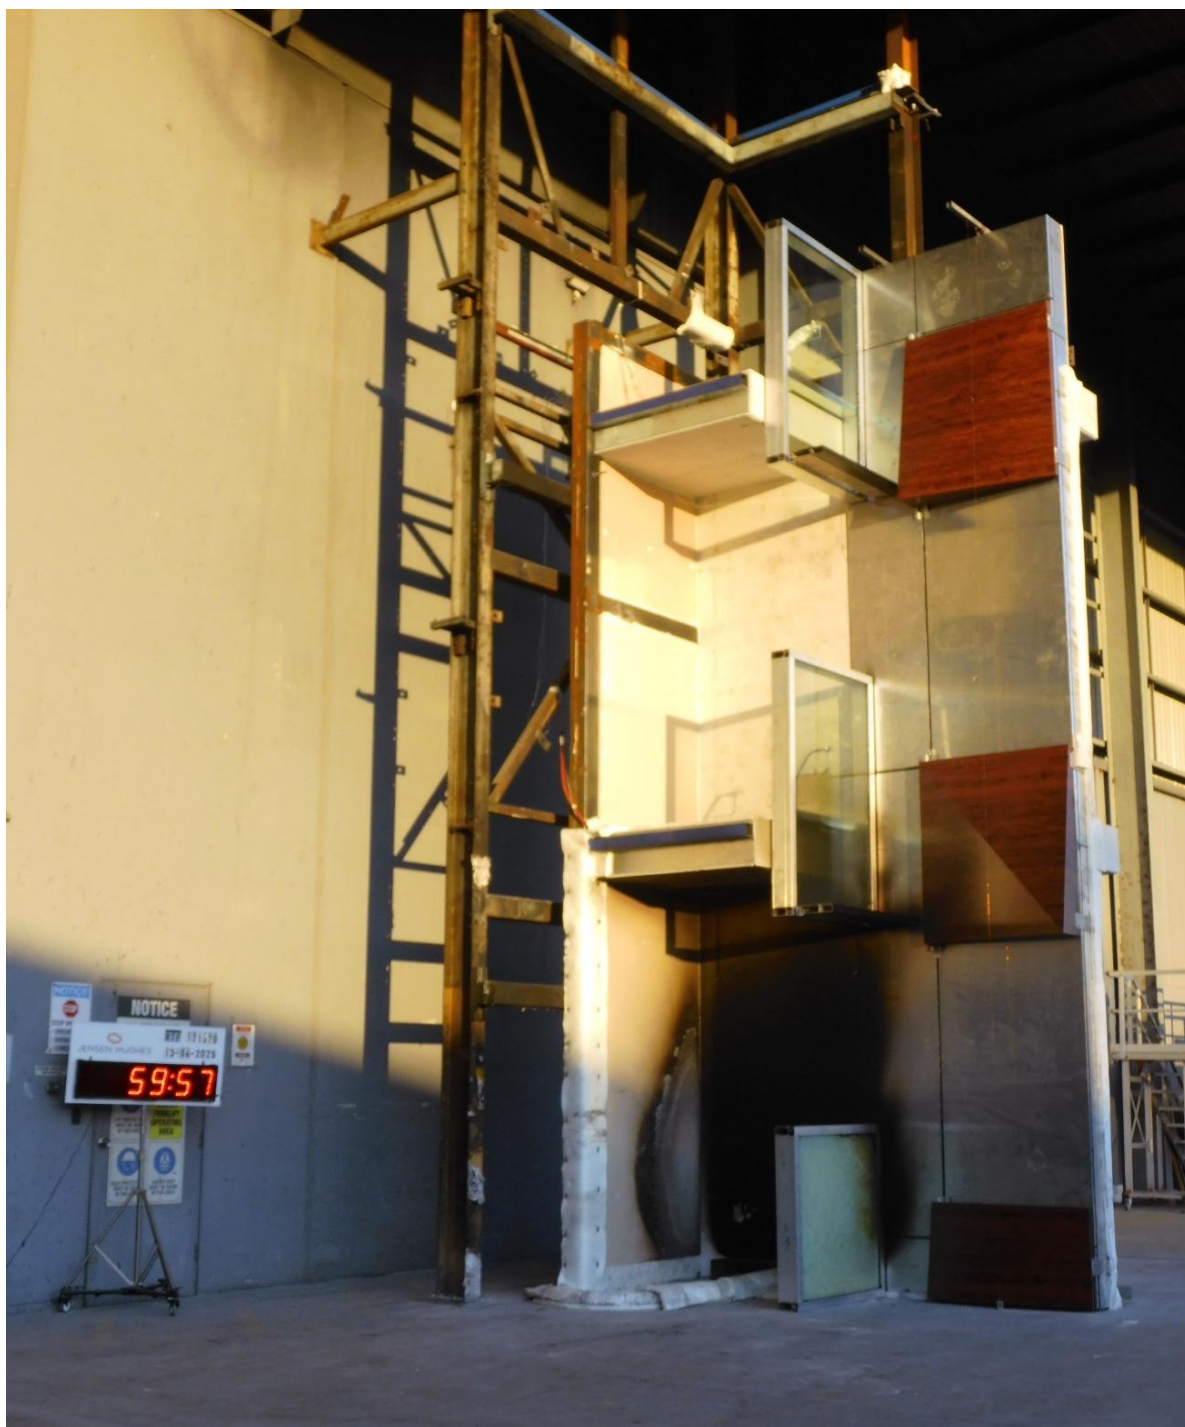
Figure 41 The specimen 59 minutes 57 seconds into the test – 3 seconds before the end of test.

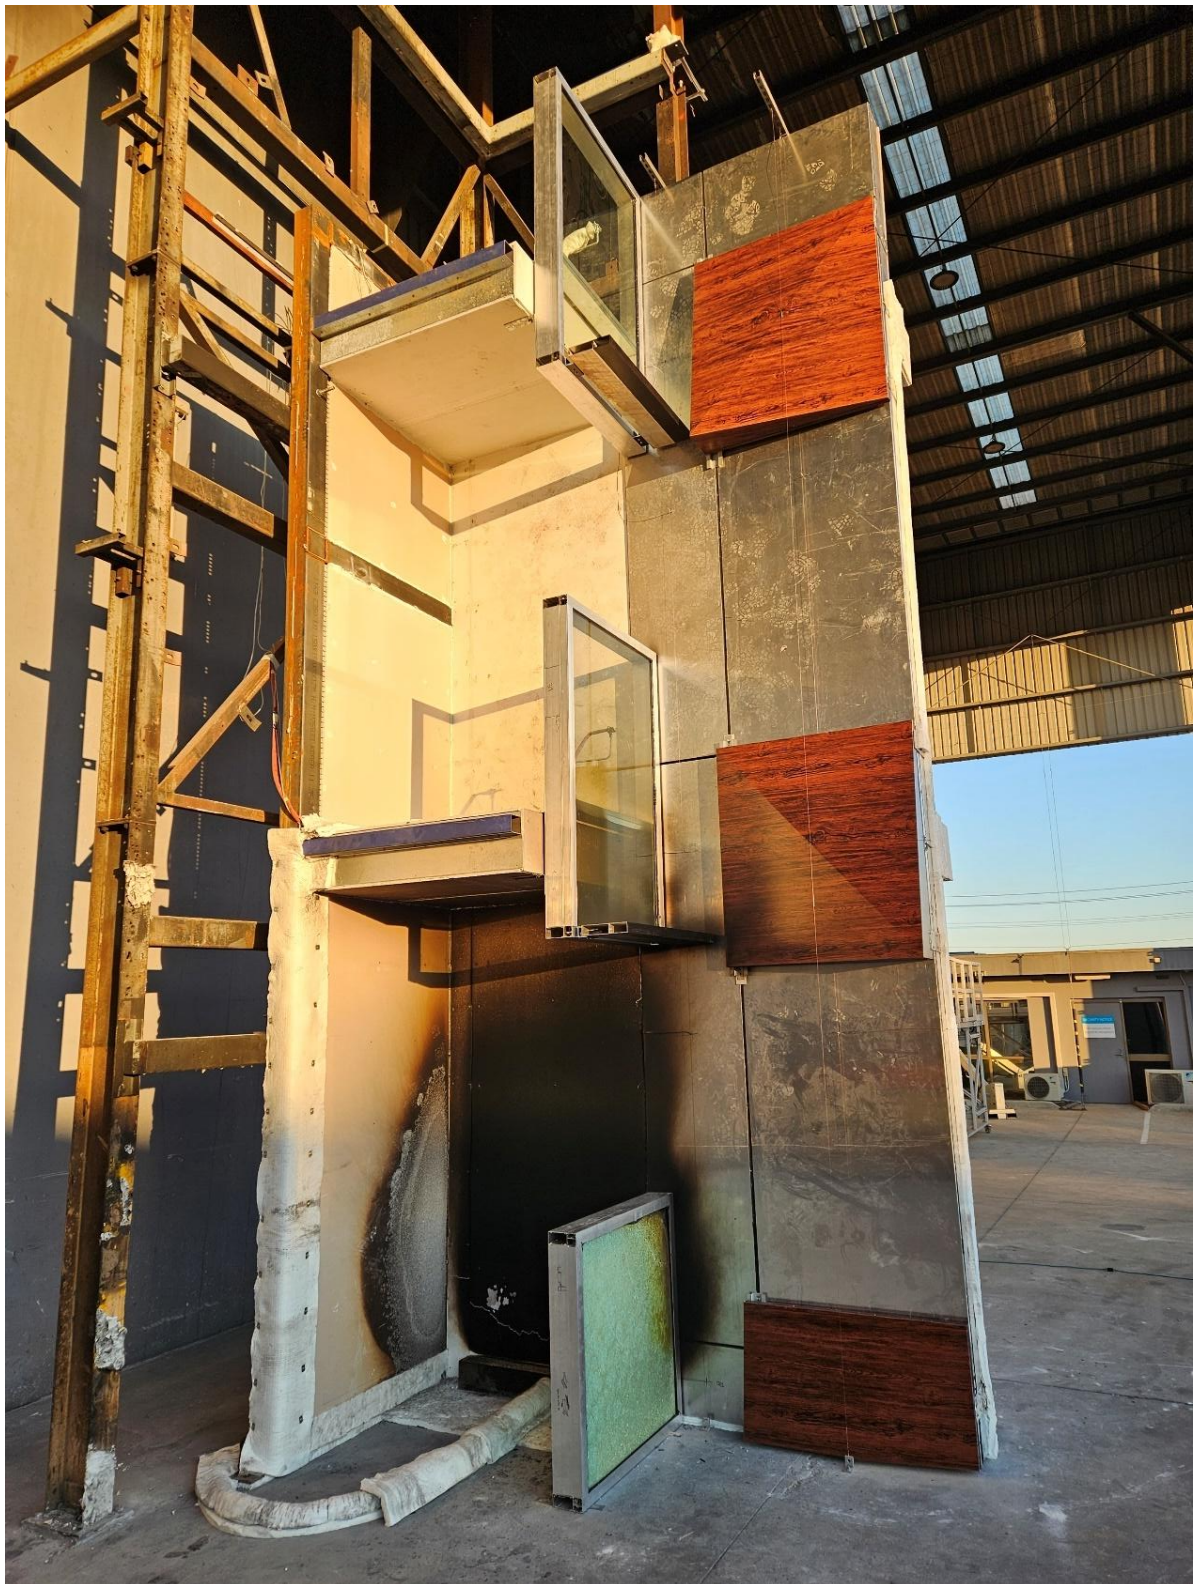
Figure 42 Specimen at the end of the test.

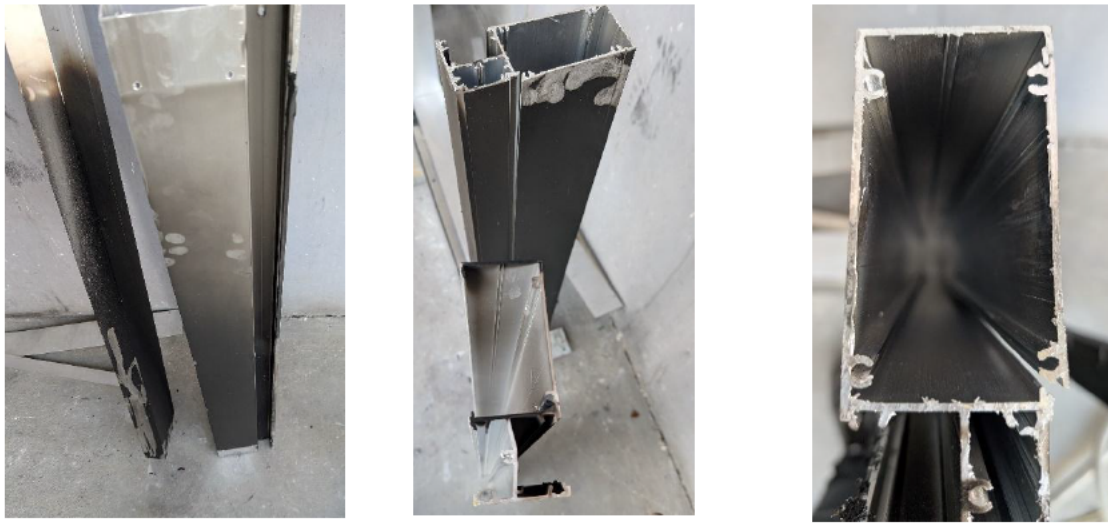
Figure 45 Post test condition of the ground level balustrade.

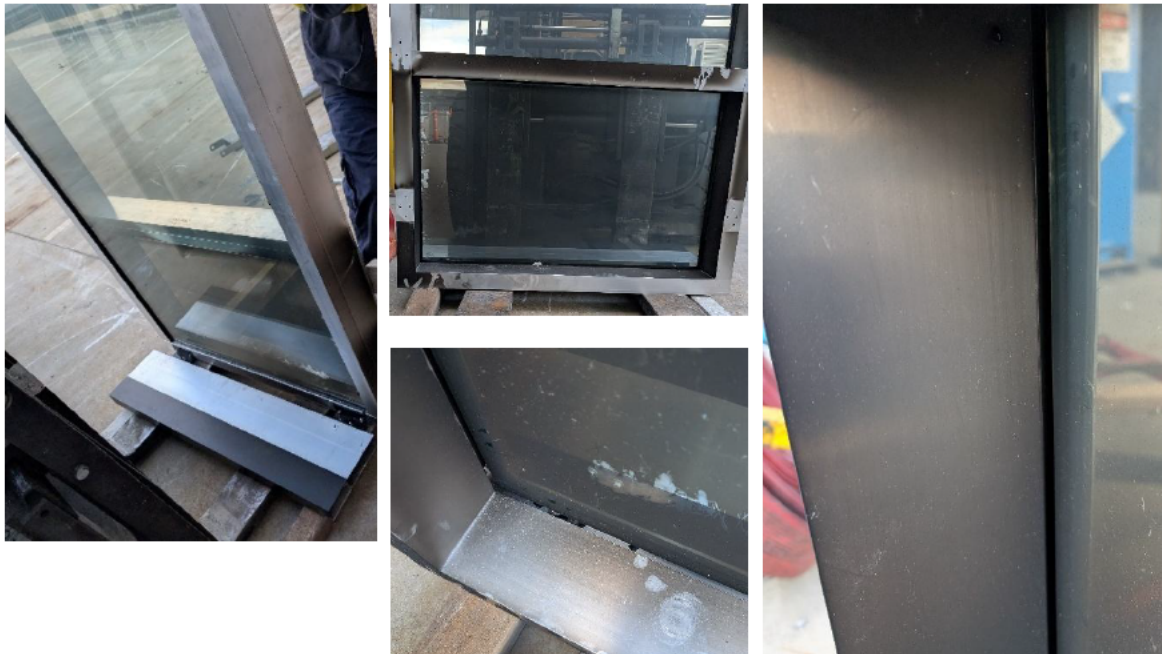
Figure 46 Post test condition of level 1 balustrade.

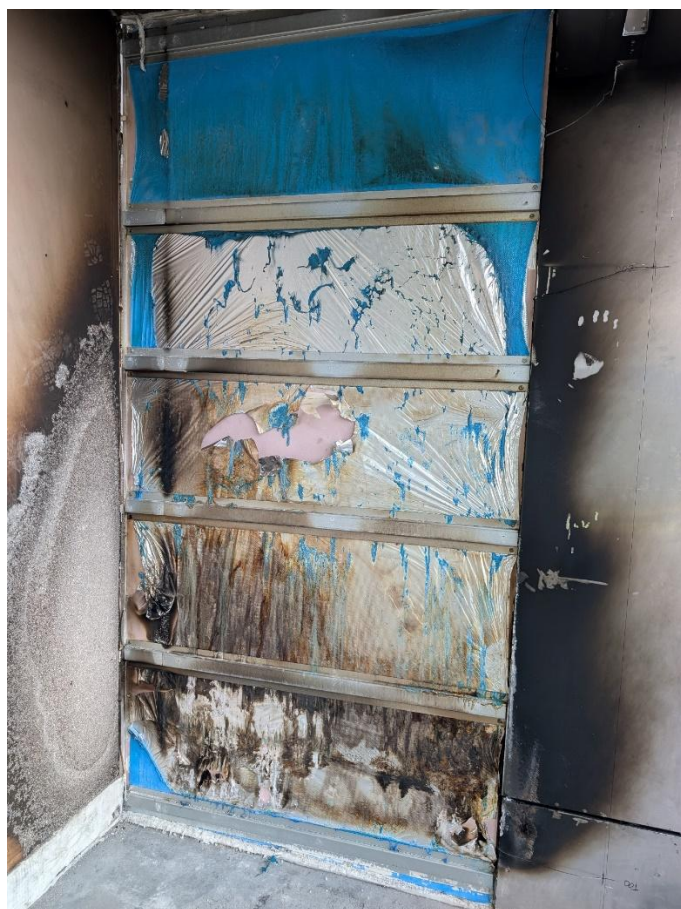
Figure 47 Post test condition behind the MgO board.

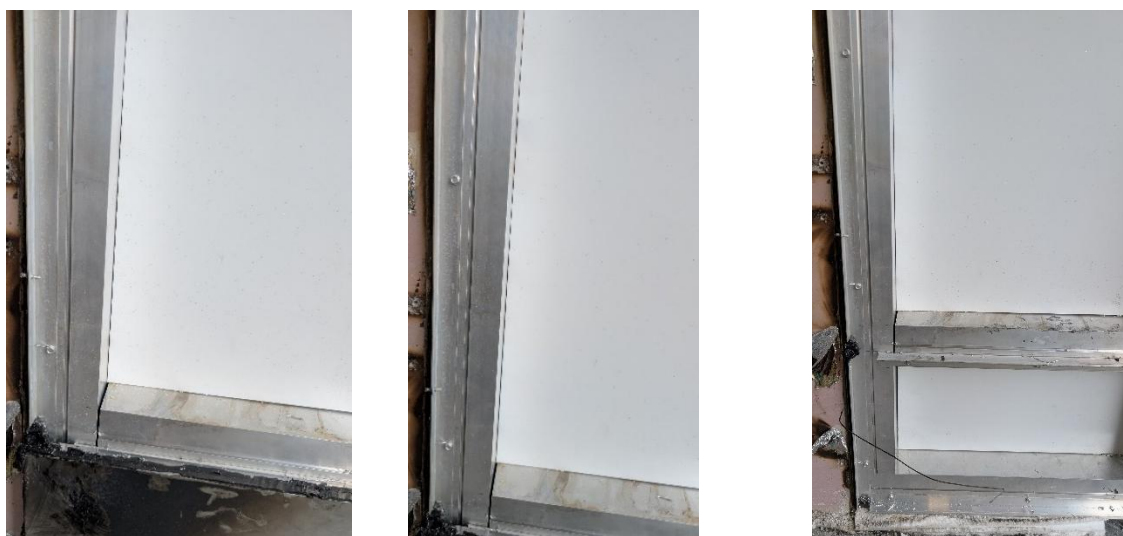
Figure 48 Post test condition of the ACP back pan.

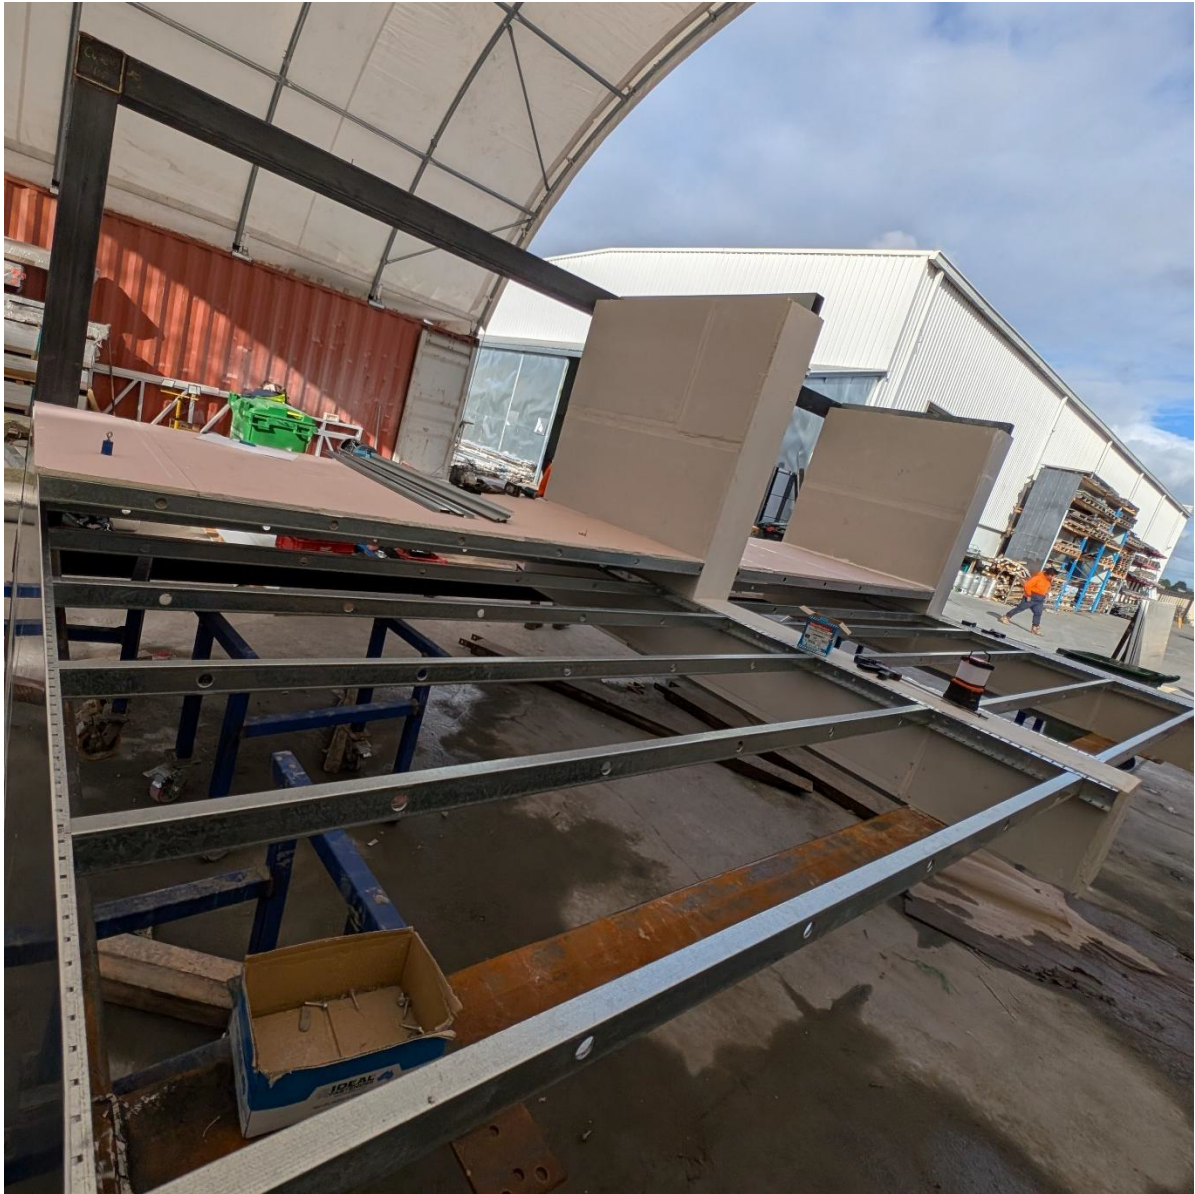
Figure 49 test jig during construction.

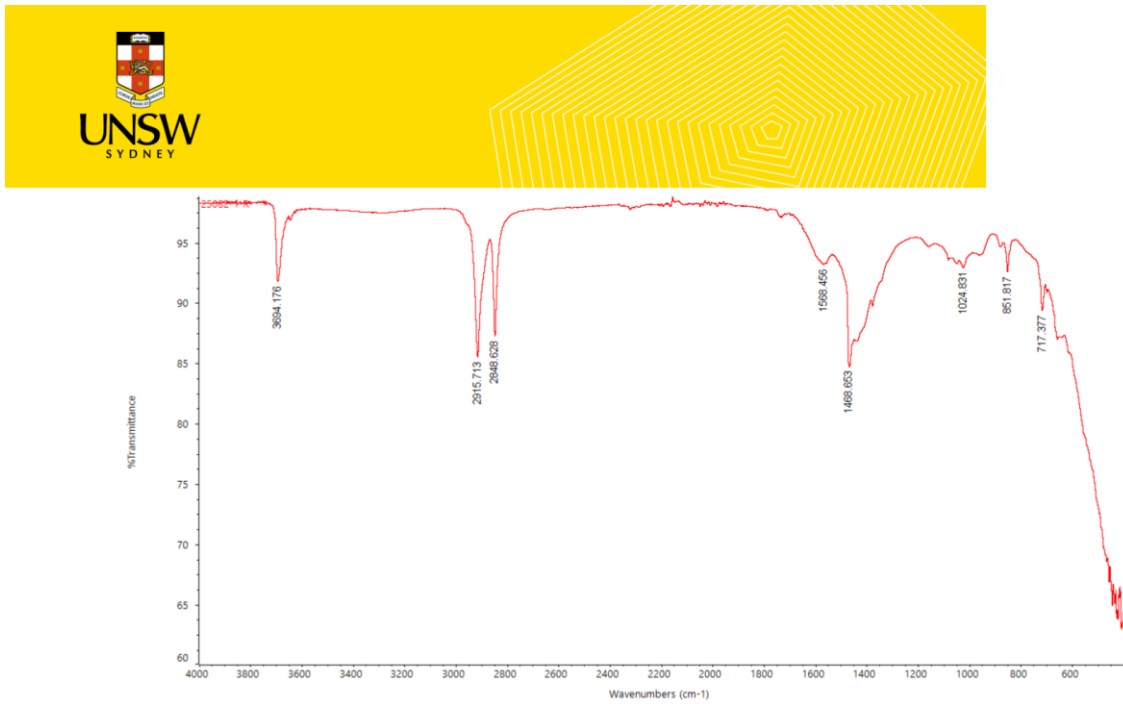
Figure 1. FT-IR spectrum of sample 1
