## Reaction to fire test report

Test standard: Ad-hoc test based off ISO 13785-1:2002

System: Aluminium composite panel curtain wall system nominated as being representative of the in-situ wall located at [REDACTED] – test 2

Job number: RTF250224

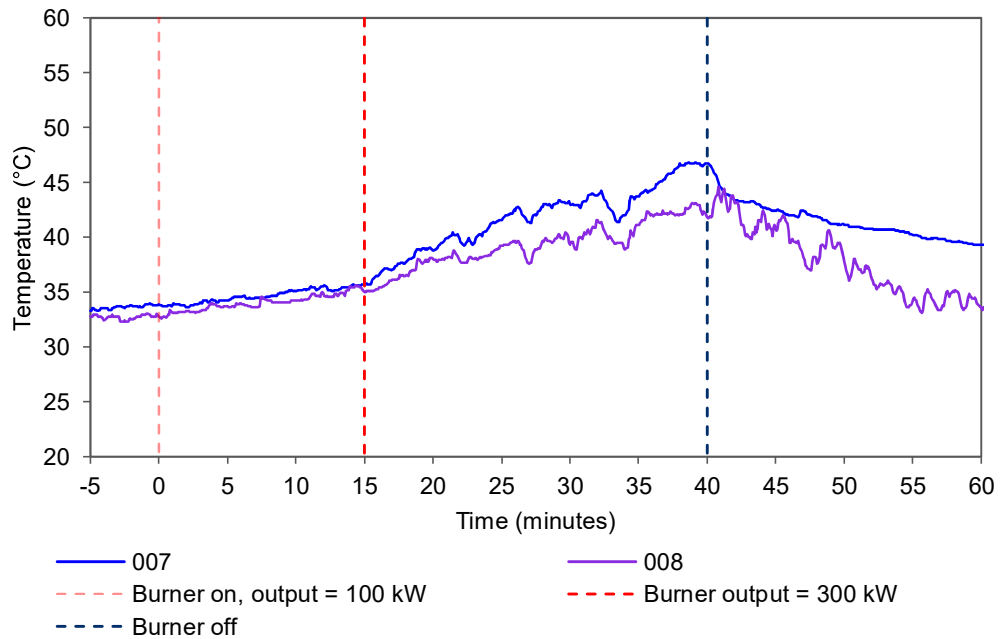
**Figure 5 Internal temperatures of the cavity of module 1 - Temperature vs. time.**

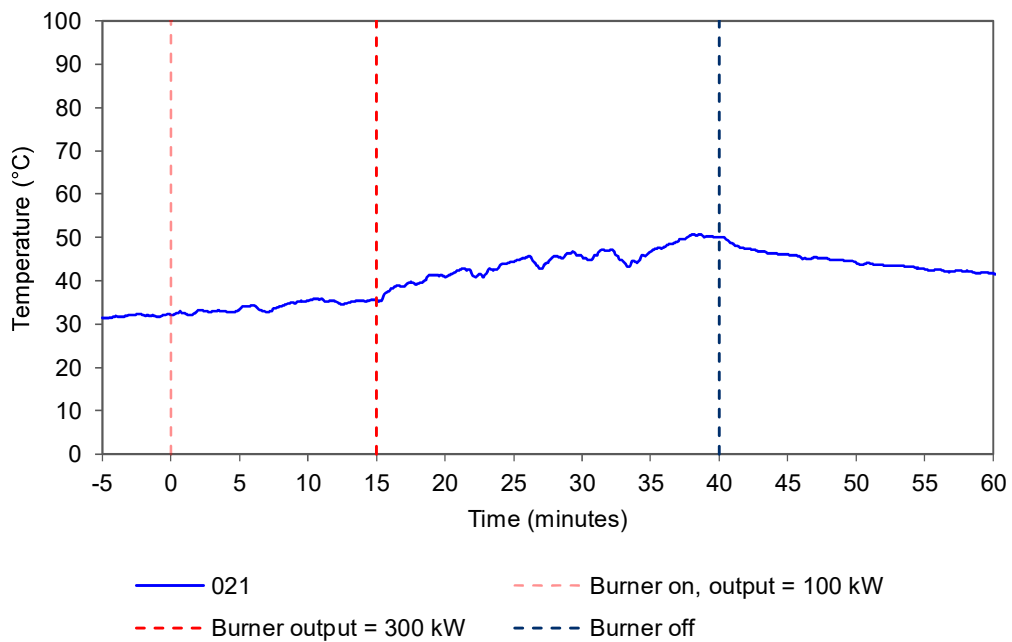
**Figure 9 Internal temperature of the cavity of module 3 - Temperature vs. time.**

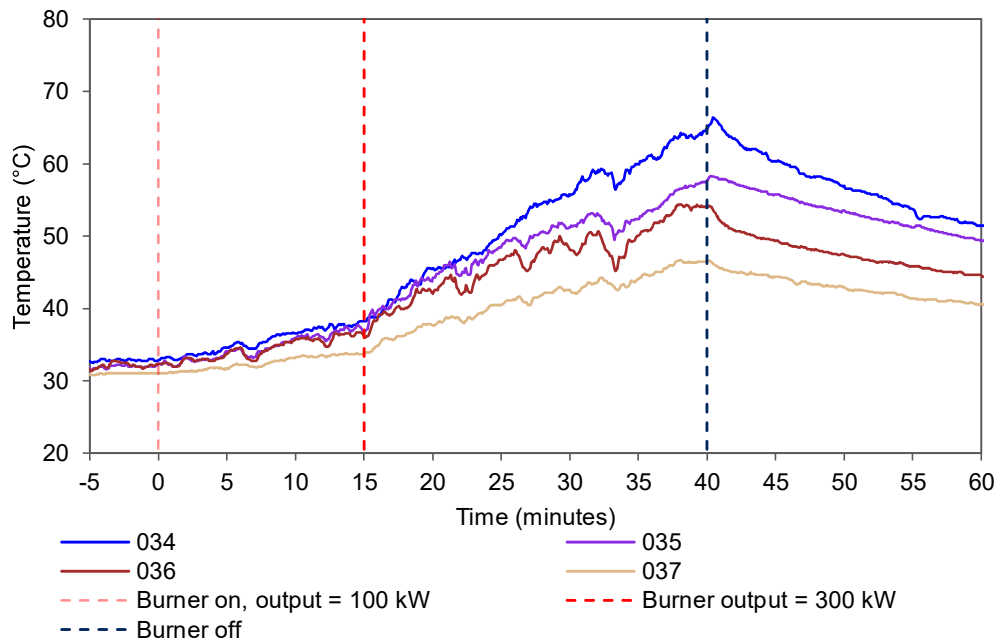
**Figure 12 Internal temperatures of the cavity of module 4 - Temperature vs. time.**

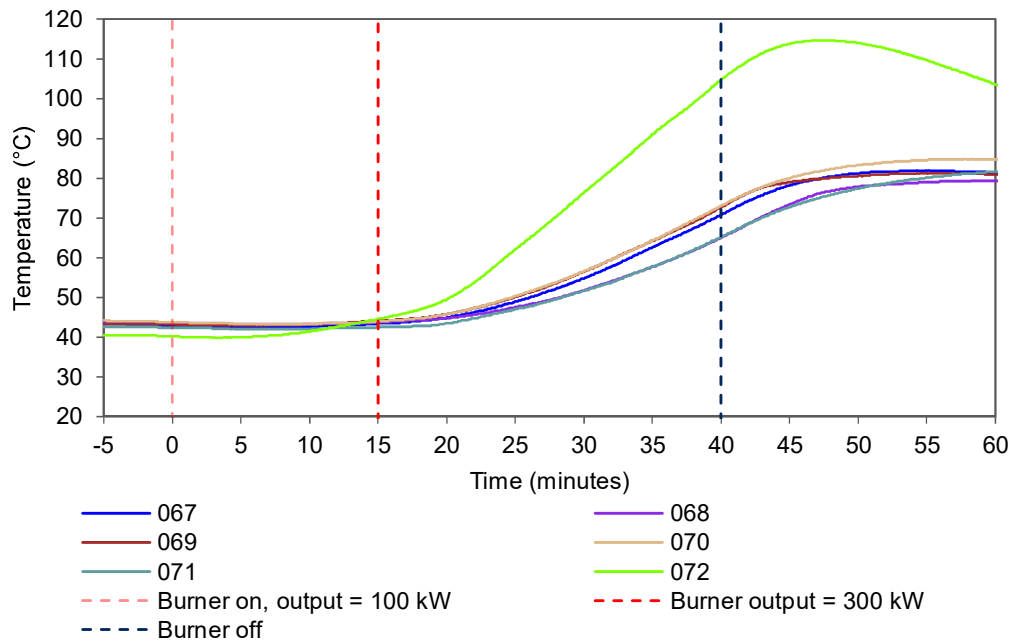
**Figure 18 Internal temperatures of the back pan of module 7 - Temperature vs. time.**

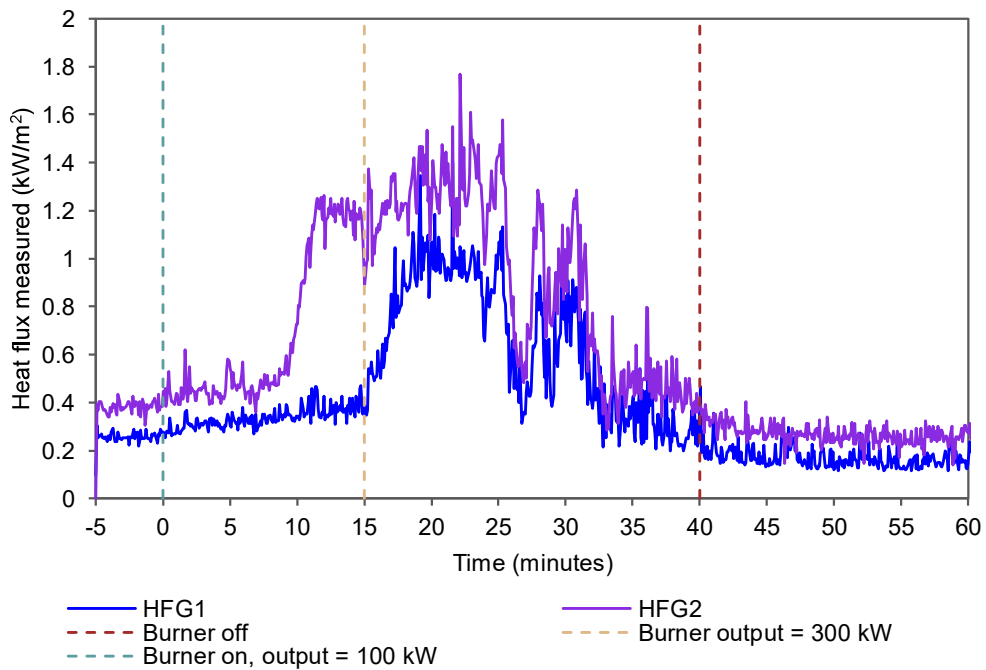
**Figure 21 Measured heat flux data collected by the HFGs – Heat flux vs. time.**

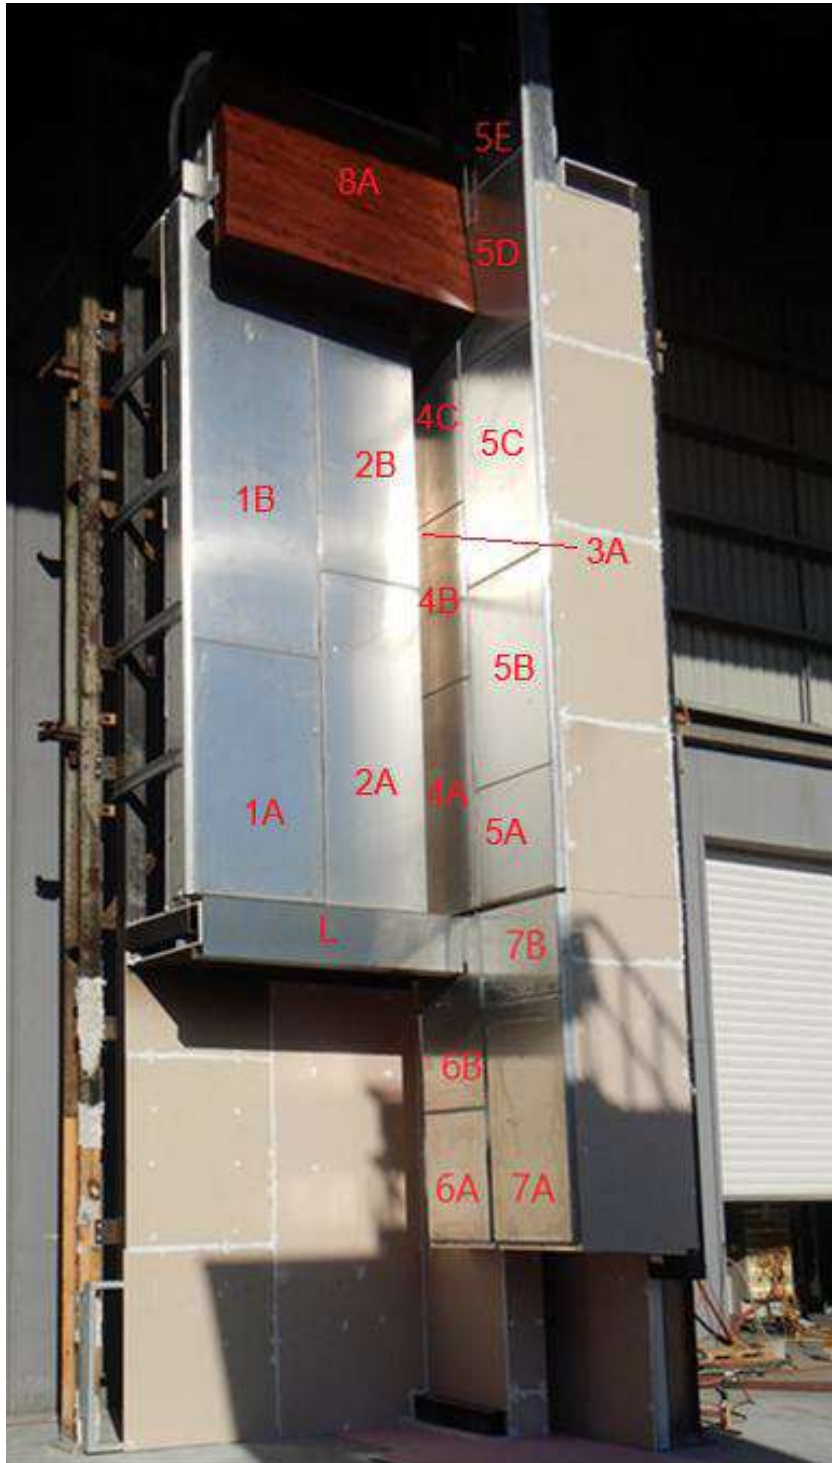
**Figure 37** Designation for the test specimen observations

Figure 37 shows the designations for the test specimen observations.

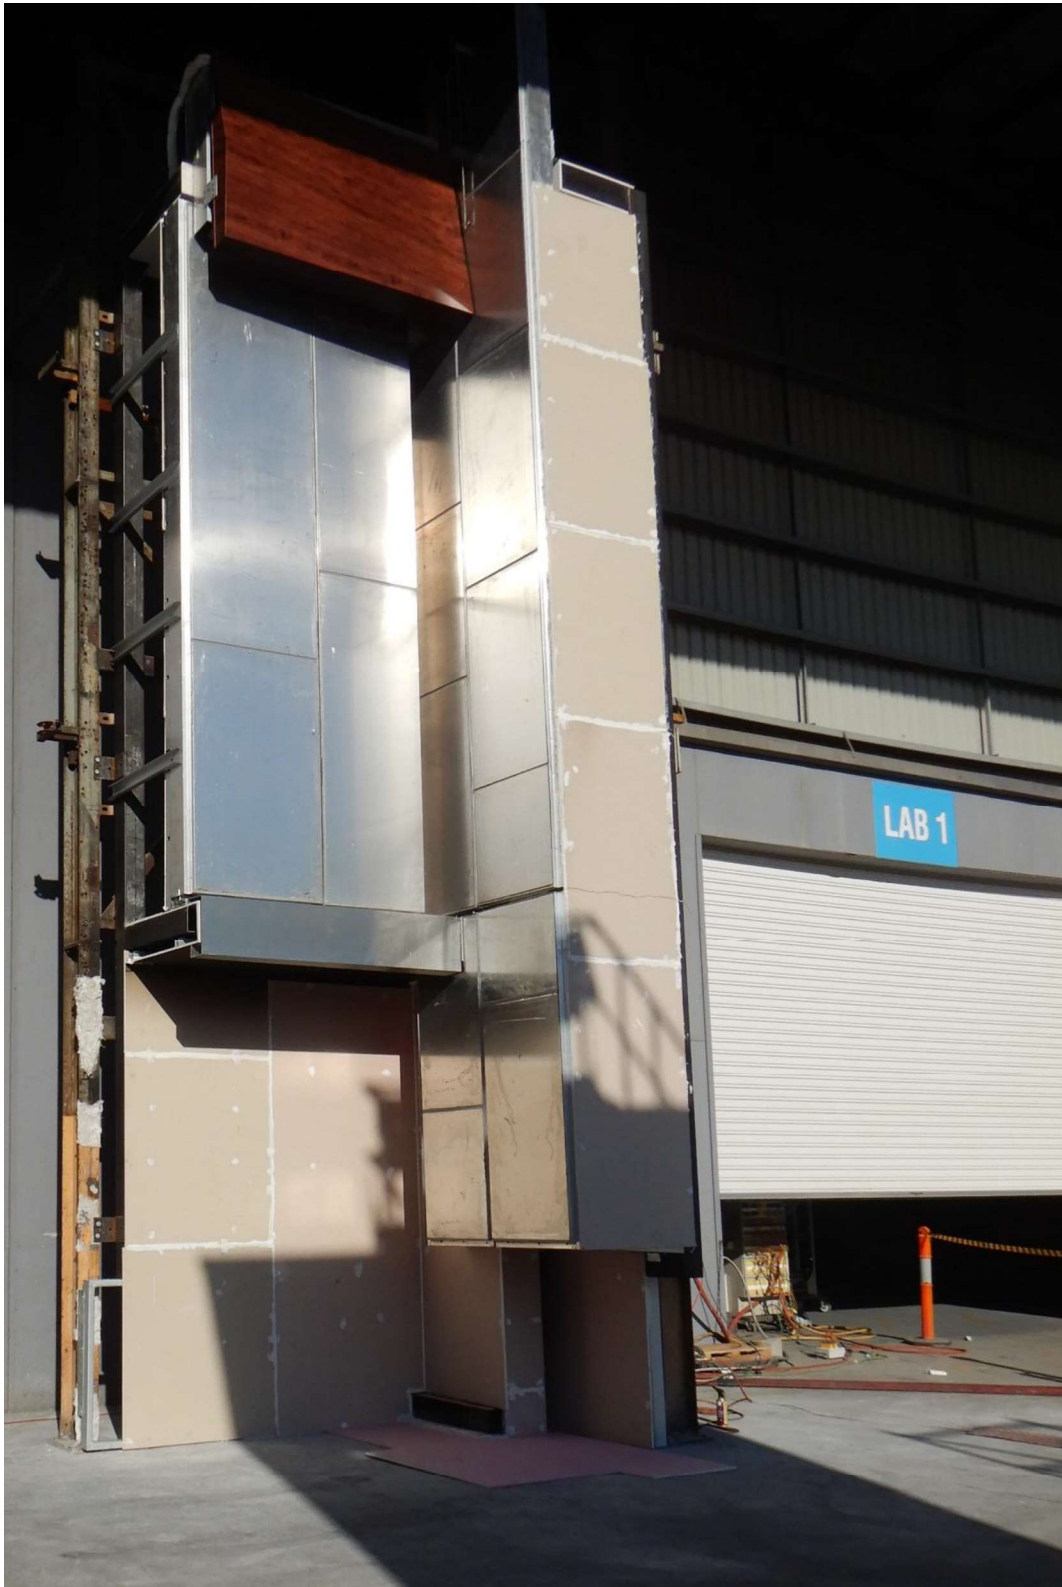
**Figure 38** The specimen before the test – exposed side.

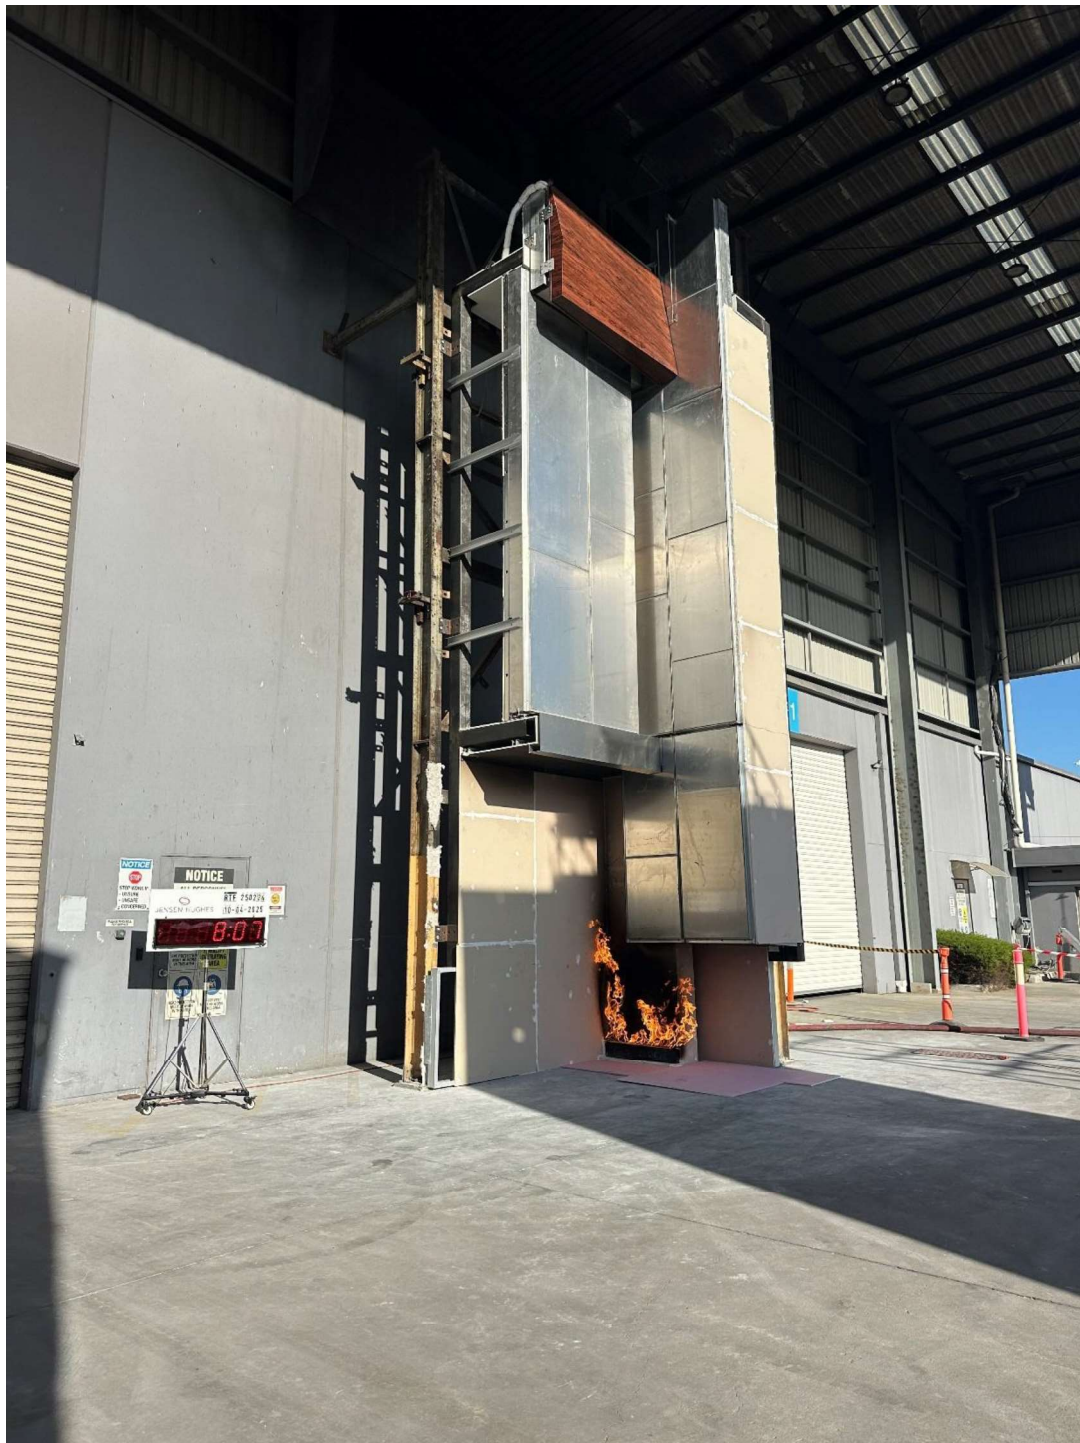
**Figure 39** The specimen 8 minutes 7 seconds into the test with the burner at 100 kW.

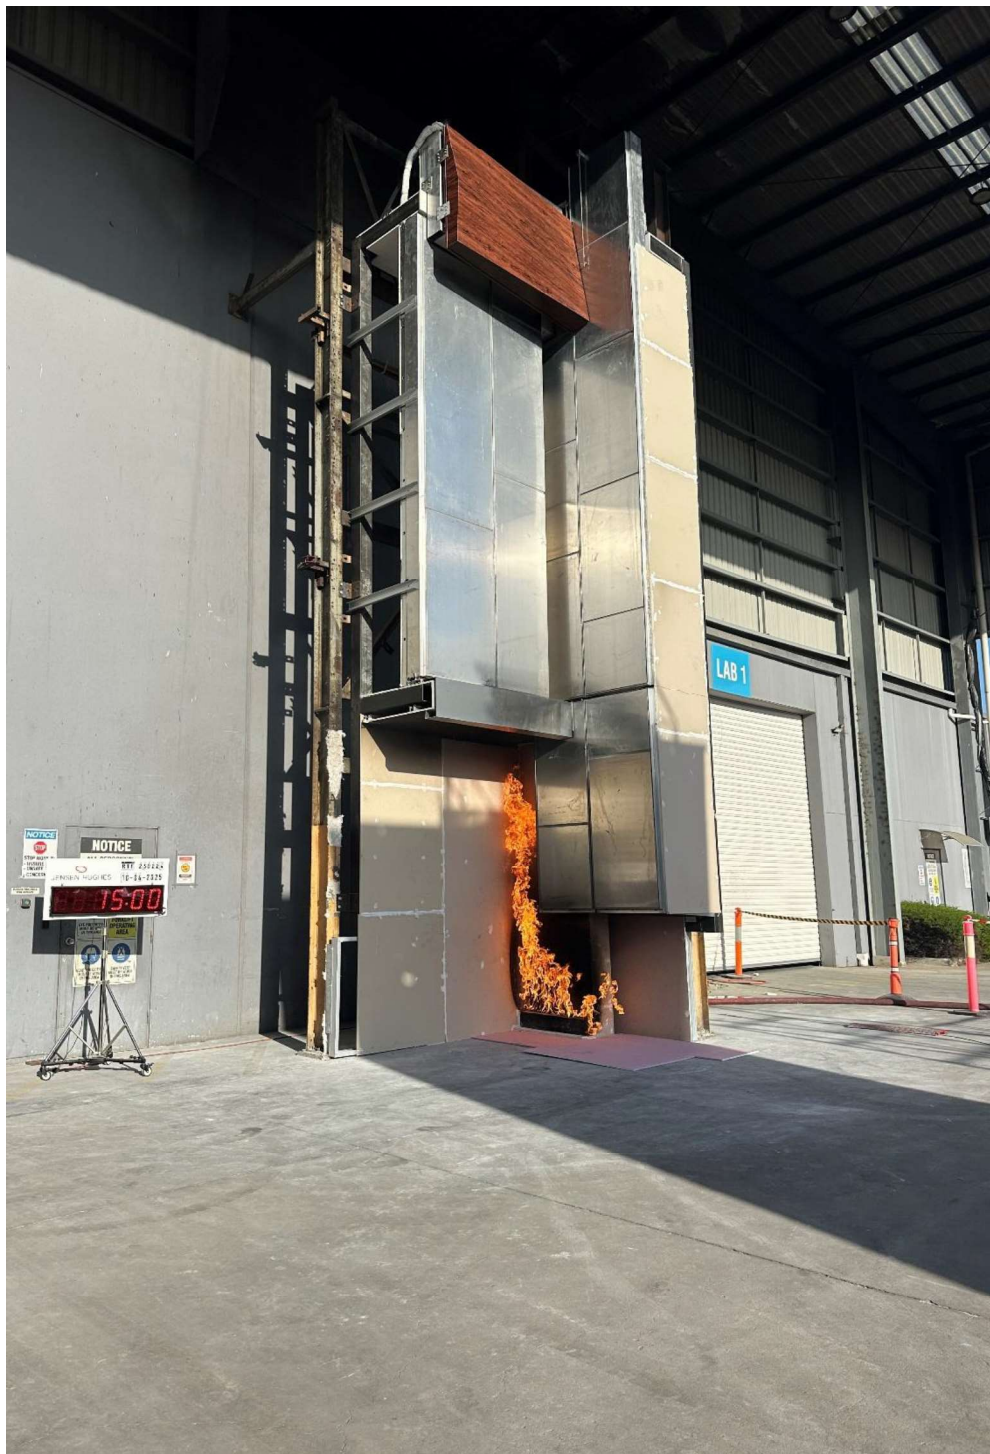
**Figure 40** The specimen 15 minutes into the test, the burner was increased to 300 kW.

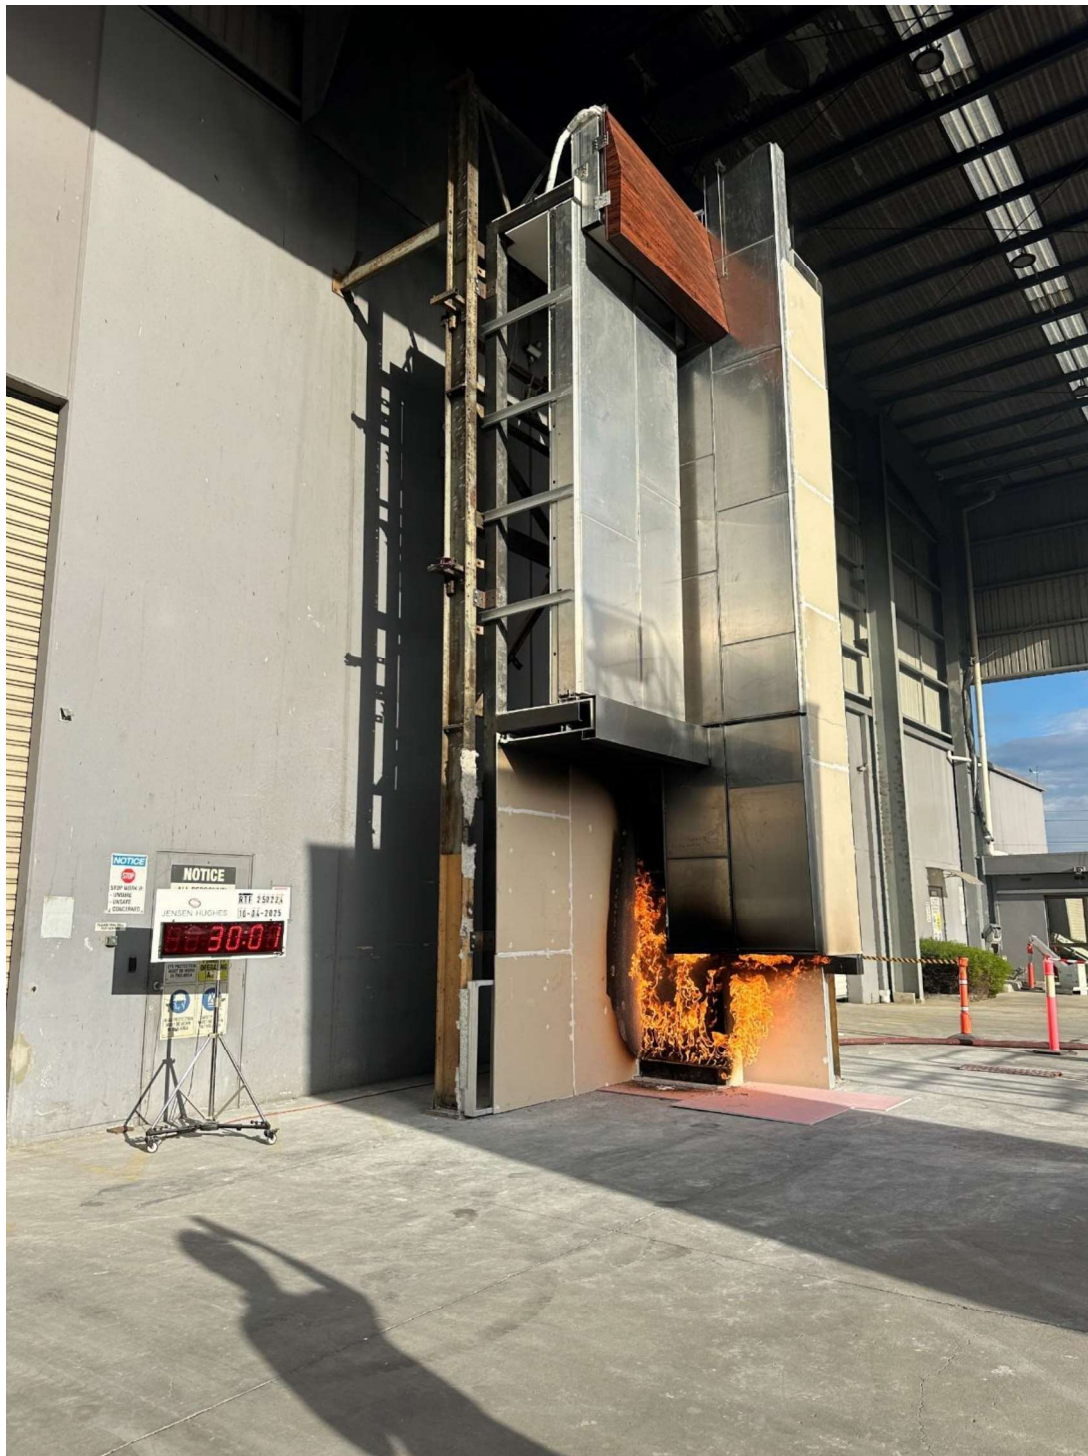
**Figure 41 The specimen 30 minutes 1 second into the test – 15 minutes 1 second after the burner output was increased to 300 kW.**

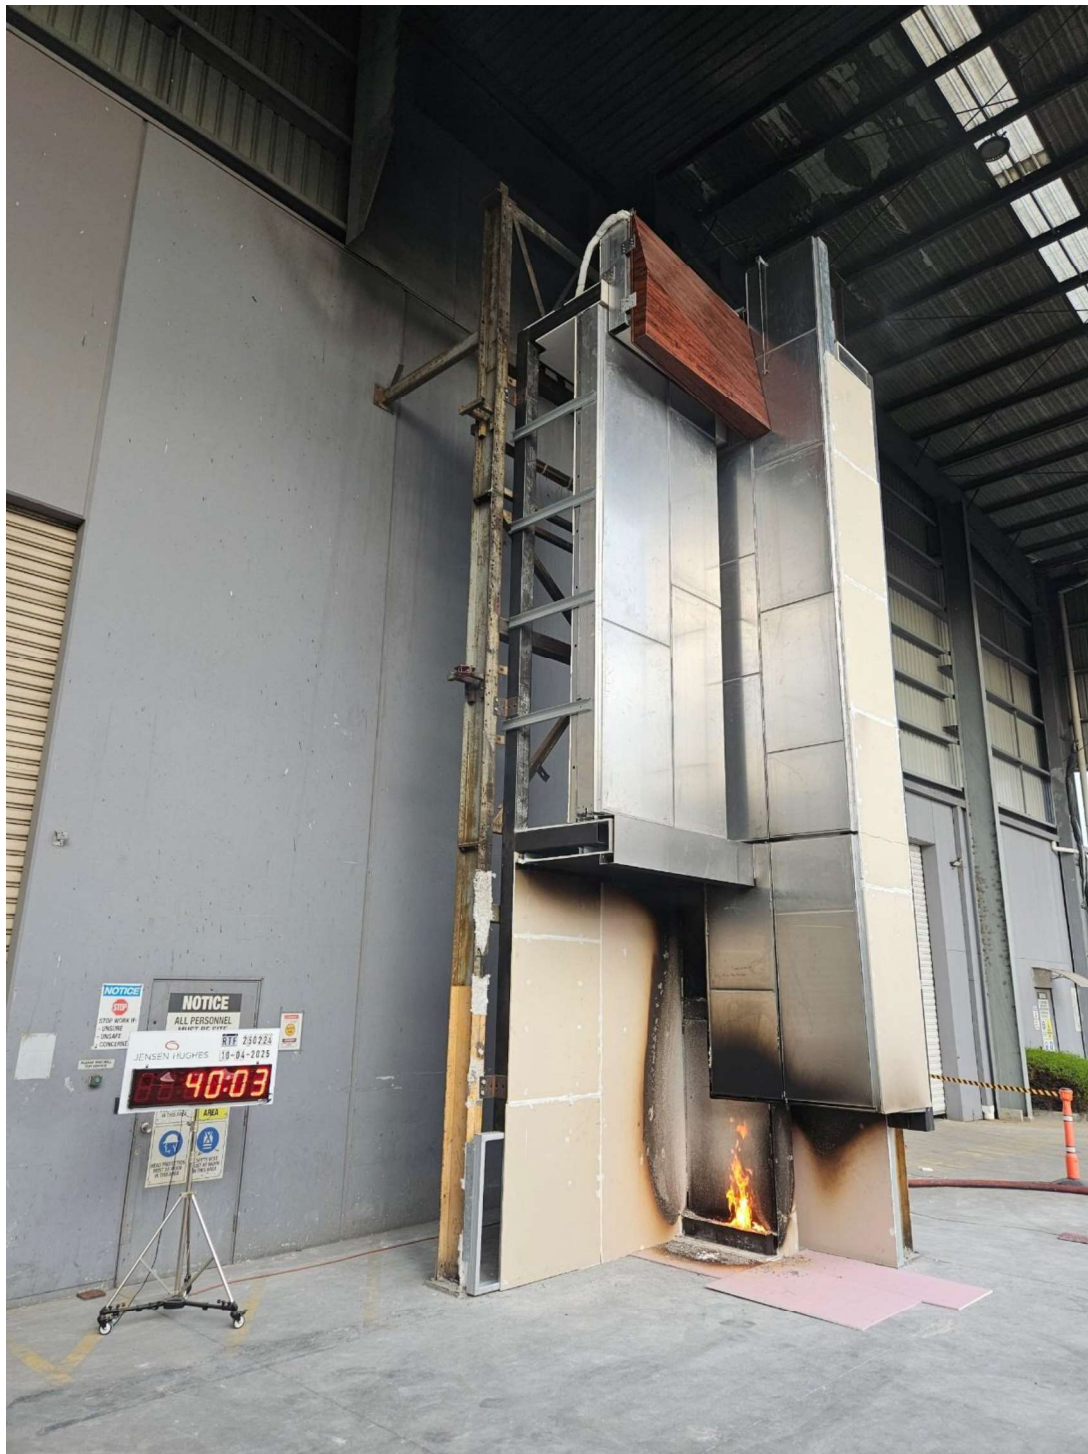
**Figure 42** The specimen 40 minutes 3 seconds into the test – 3 seconds after the burner was turned off.

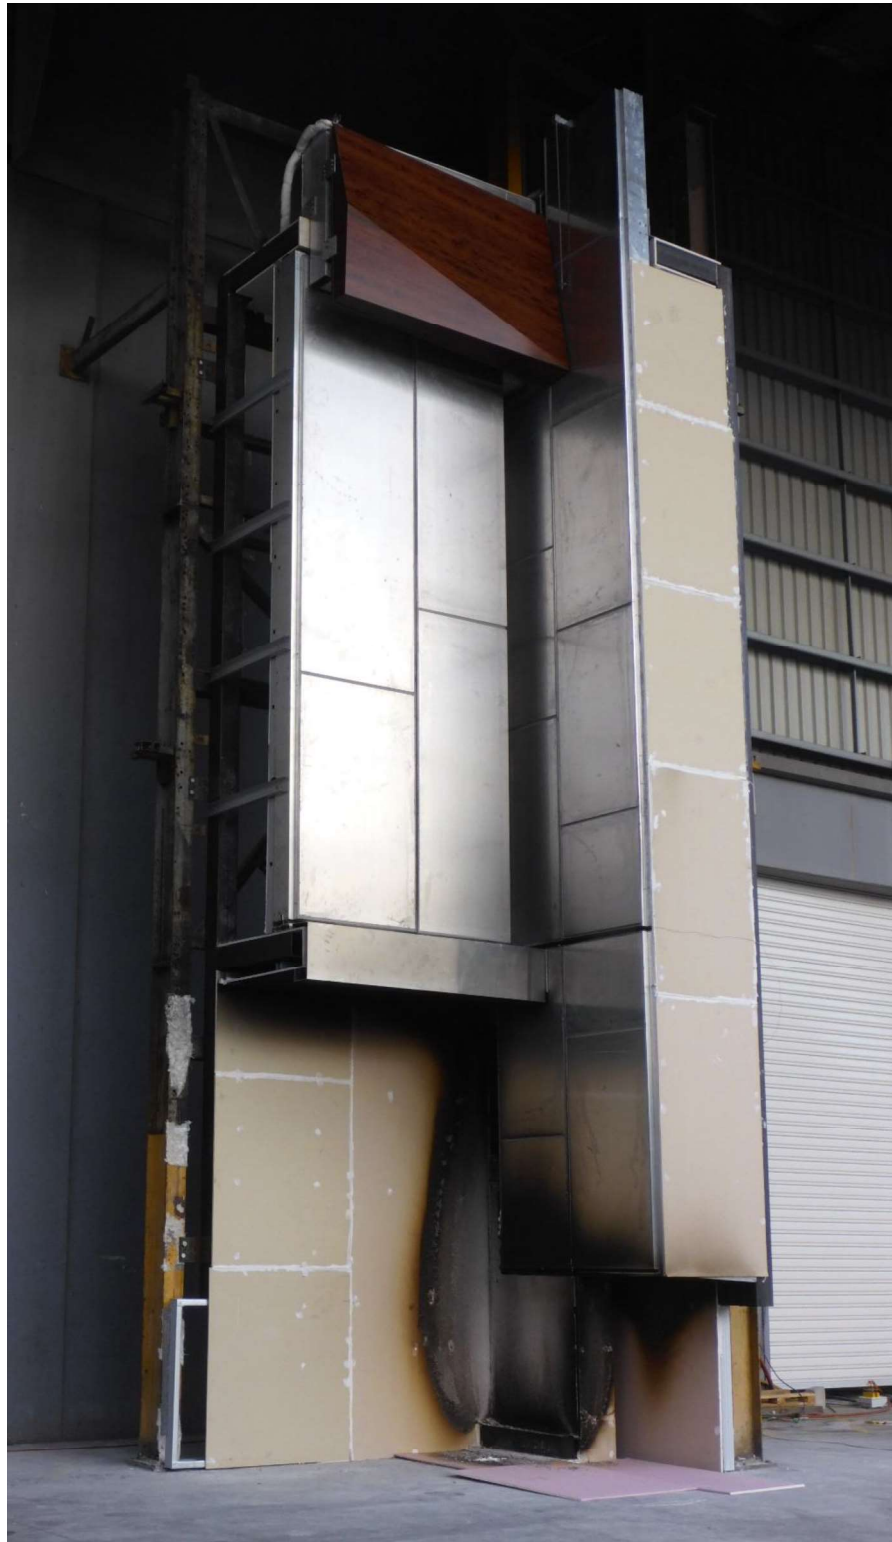
**Figure 43** The specimen before the end of the test – 58 minutes 52 seconds into the test.

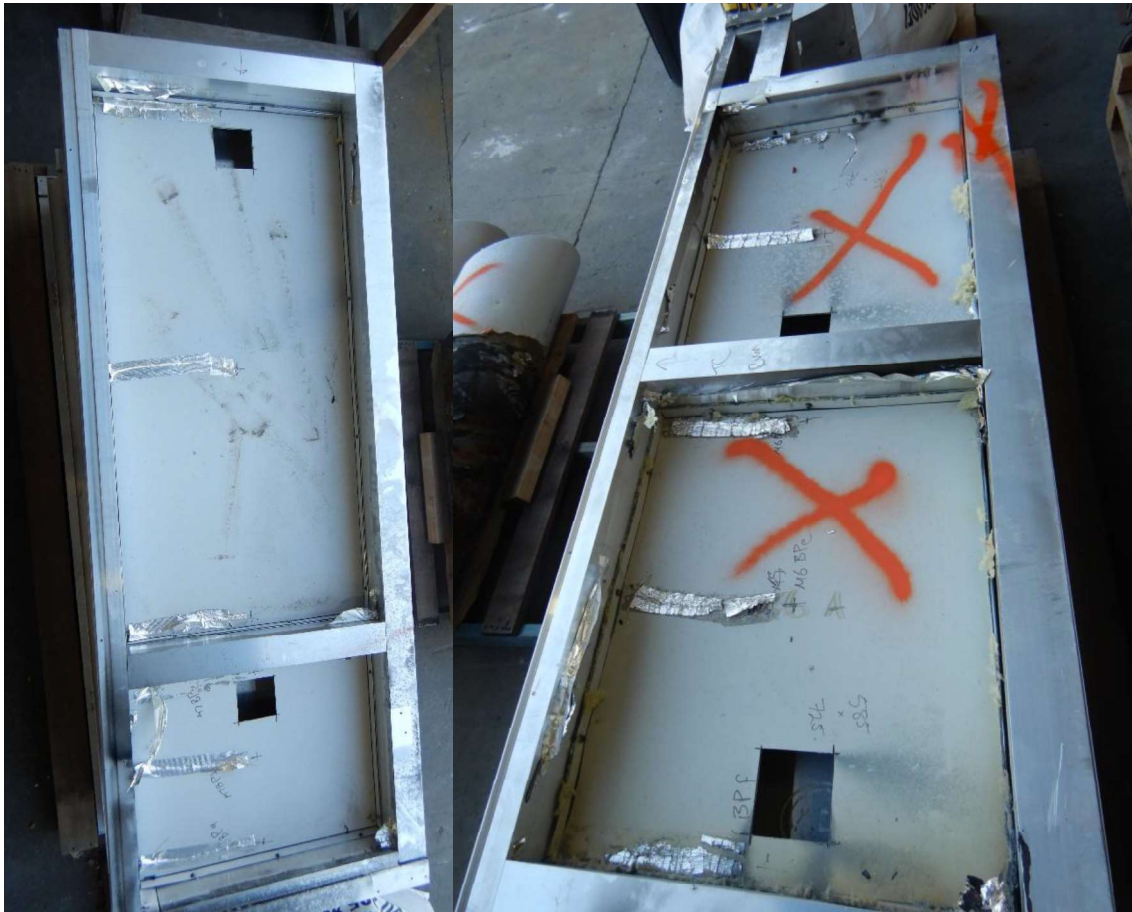
**Figure 44** The unexposed face of backpan of modules 7 and 6, respectively, after sampling at the end of the test.
