# Reaction to fire test report

Test standard: Ad-hoc test based on ISO 13785-1:2002

System: Rendered EPS external façade cladding system, with Z-angle flashing

Job number: RTF240045

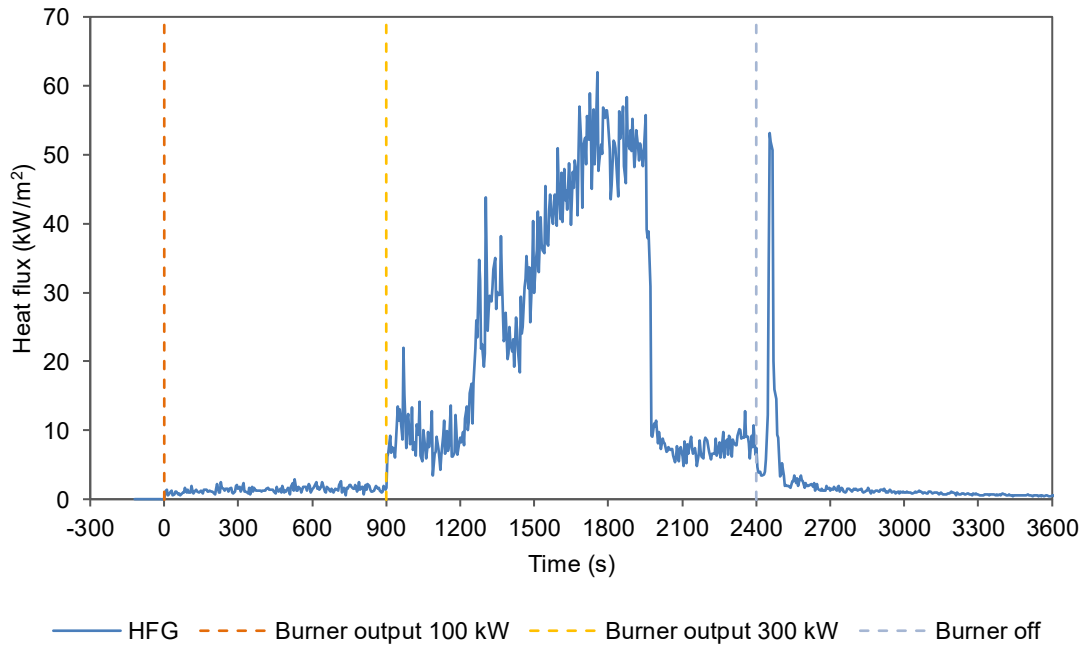
**Figure 4 Heat flux vs time**

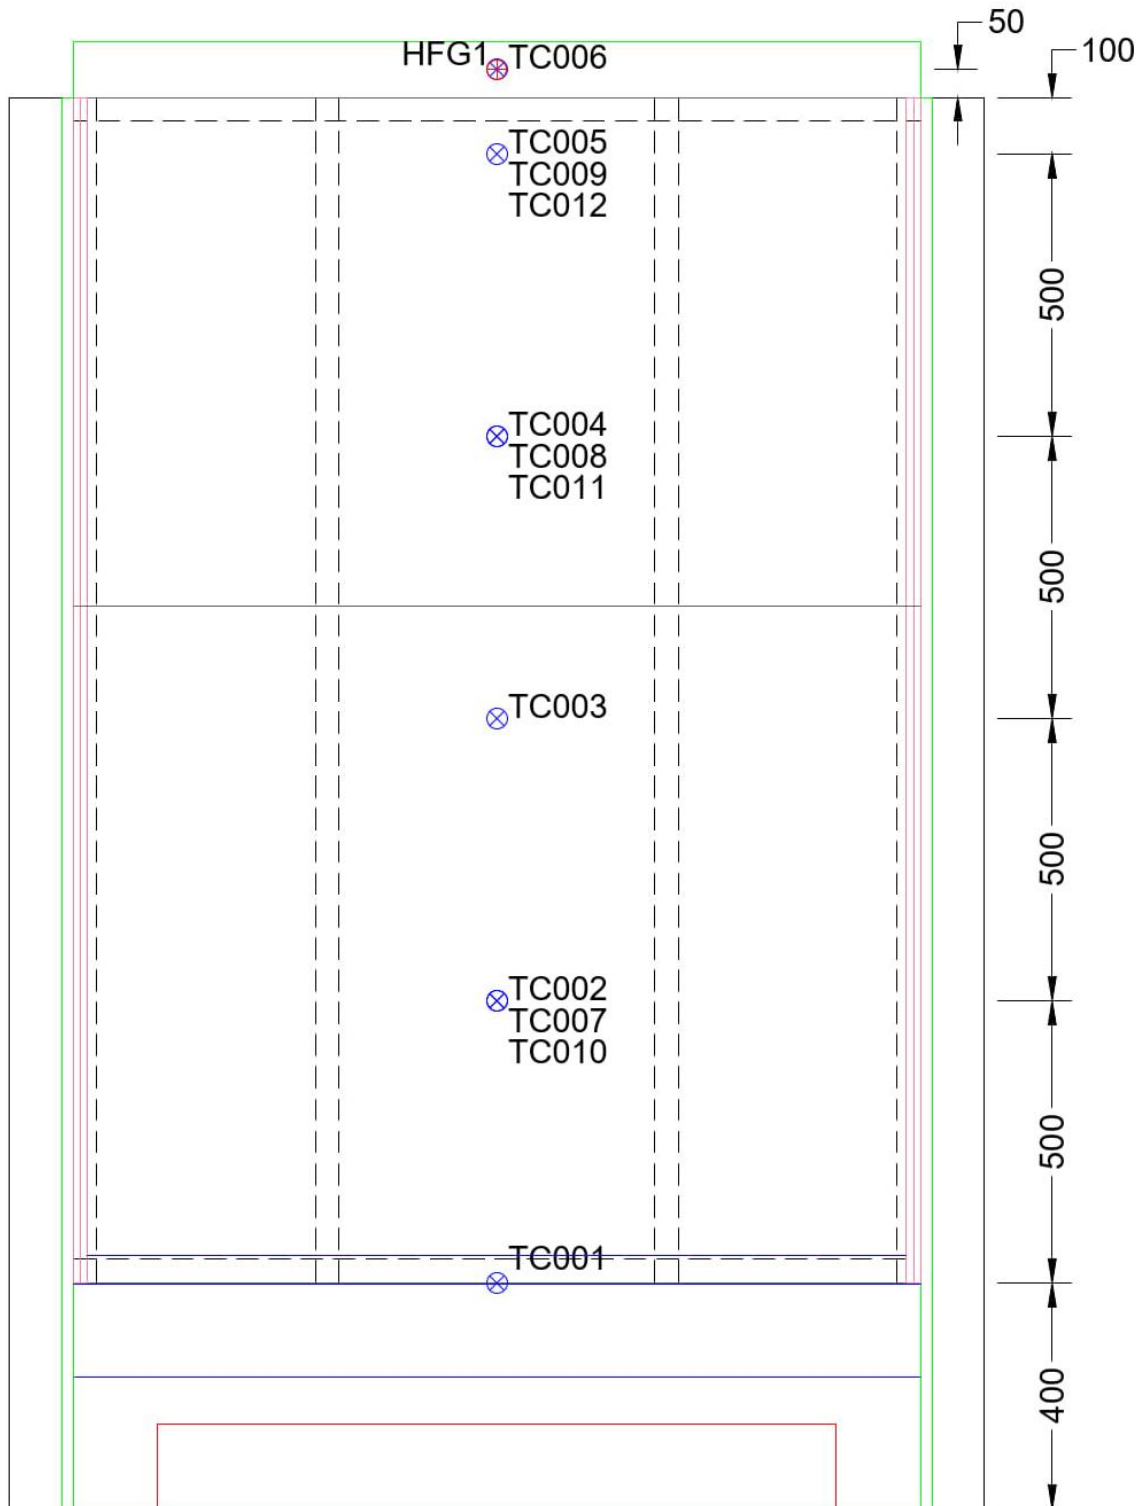
**Figure 14 Instrumentation locations – Exposed side view**

Initial horizontal wind speed	0.1 to 0.2 m/s (measured at a horizontal distance of 500 mm away from the exposed face of the test specimen before the test)	
Test duration	60 minutes	
Instrumentation and equipment	<ul style="list-style-type: none"> <li>6 mineral insulated metal sheathed (MIMS) Type K thermocouples with an overall diameter of 1.5 mm with the measuring junction insulated from the sheath were positioned at various heights, 50 mm in front of the outer face of the test specimen along its vertical centreline. Refer to Figure 14 and Figure 15 for details on positioning.</li> <li>3 MIMS Type K thermocouples with an overall diameter of 1.5 mm with the measuring junction insulated from the sheath were positioned at various heights at mid-depth of the framing cavity of the test specimen. Refer to Figure 14 and Figure 15 for details on positioning.</li> <li>3 MIMS Type K thermocouples with an overall diameter of 1.5 mm with the measuring junction insulated from the sheath were positioned at various heights at a depth of 40 mm from the unexposed face of the cladding of the test specimen. Refer to Figure 14 and Figure 15 for details on positioning.</li> <li>The fire source was a propane (95% purity) gas fuelled box burner; 1.2 m wide × 0.1 m deep × 0.15 m tall. The burner was located on the floor in front of the specimen, with the back edge of the burner in line with the exposed face of the specimen.</li> <li>The incident heat flux 50 mm above and in line with the exposed face of the test specimen was measured using a Schmidt-Boelter type heat flux gauge with a range of 0 - 50 kW/m<sup>2</sup>.</li> <li>The products of combustion were collected in an exhaust hood located centrally above the exposed face of the tested specimen. The hood was connected to an exhaust duct 400 mm in diameter, which had instruments inside to measure the conditions and properties of the combustion products during the test. The hood had specifications based on those given in AS ISO 9705:2003 (R2016), with the only differences being that all four sides had 1 m steel sheet extensions, and there was no fire test room.</li> <li>The volume flow rate was determined using a bidirectional pressure probe attached to a differential pressure transmitter together with a type K MIMS thermocouple positioned near the probe.</li> </ul>

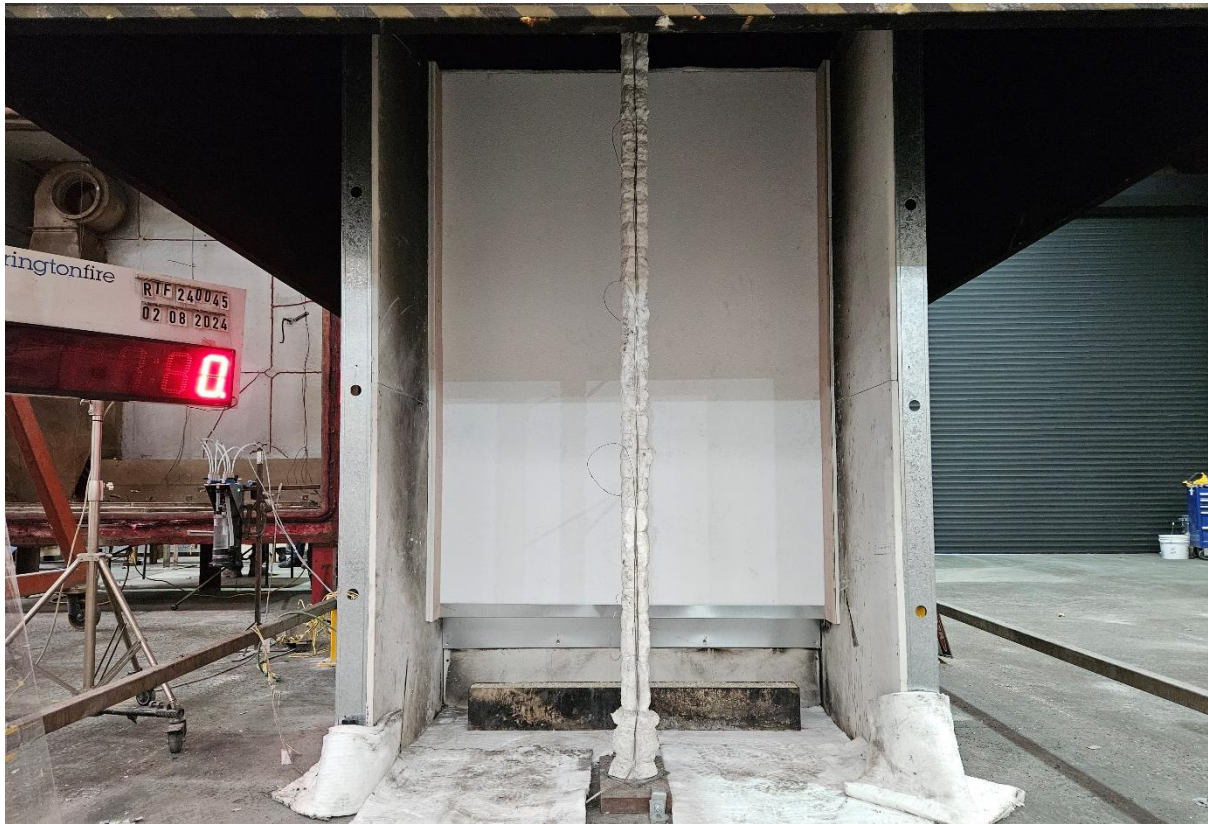
**Figure 16** The specimen before the reaction to fire test – exposed side

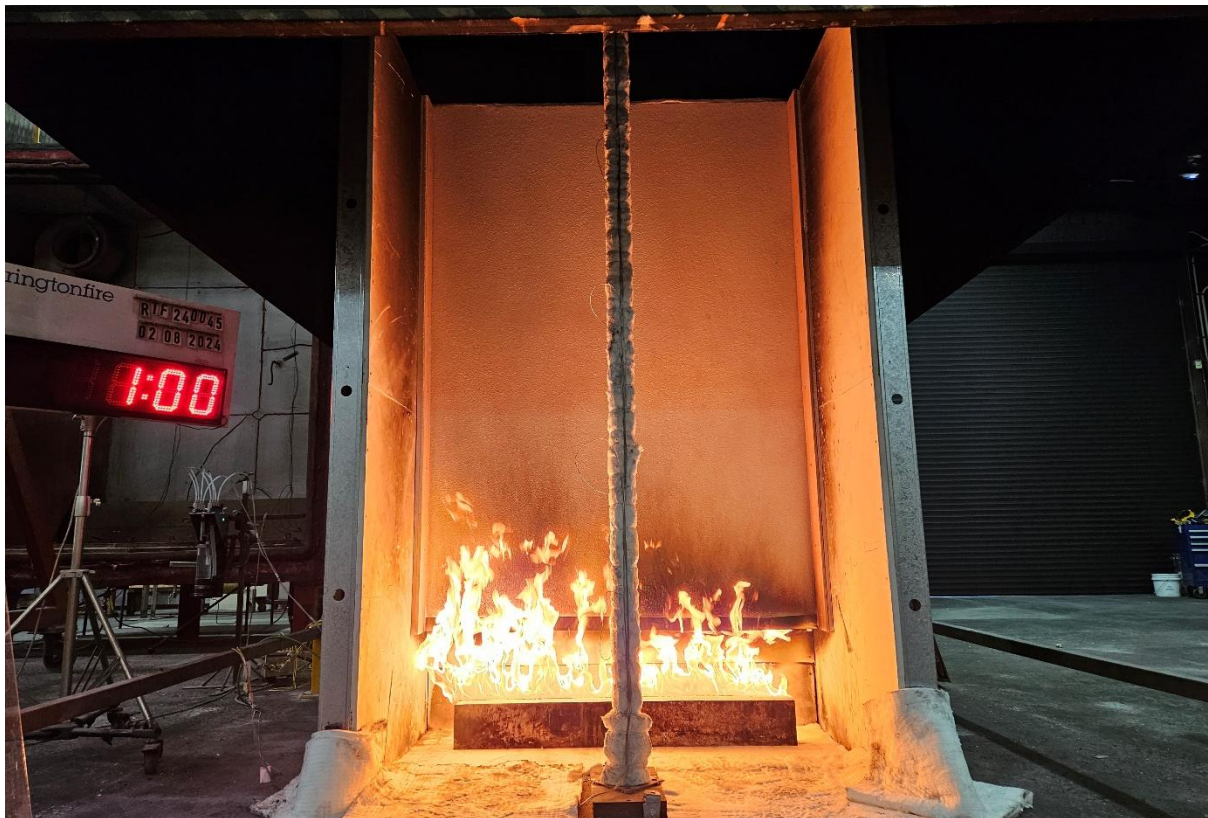
**Figure 18** The specimen 1 minute into the test (burner output at 100 kW)

Time		Observation
Min	Sec	
-2	00	Data collection started.
0	00	The reaction to fire test was started with the burner ignited with a heat output set at 100 kW.
1	04	The steel flashing below the specimen was becoming deformed.
1	43	The bottom portion of the specimen was becoming discoloured.
4	28	The bottom portion of the specimen was flaming.
5	36	The lower left corner of the panel had deformed.
12	31	The bottom portion of the specimen was flaming, near the flashing.
15	00	The heat output of the burner was increased to 300 kW.
17	19	The top edge of the specimen was flaming.
19	27	The unexposed side of the specimen was intermittently flaming. Flaming on the unexposed side was extinguished using water spray.
25	37	A loud cracking sound came from the specimen.
37	57	Cracks were forming in the bottom portion of the specimen.
39	40	The cracks in the bottom portion of the specimen had increased in size.
40	00	The burner was turned off.

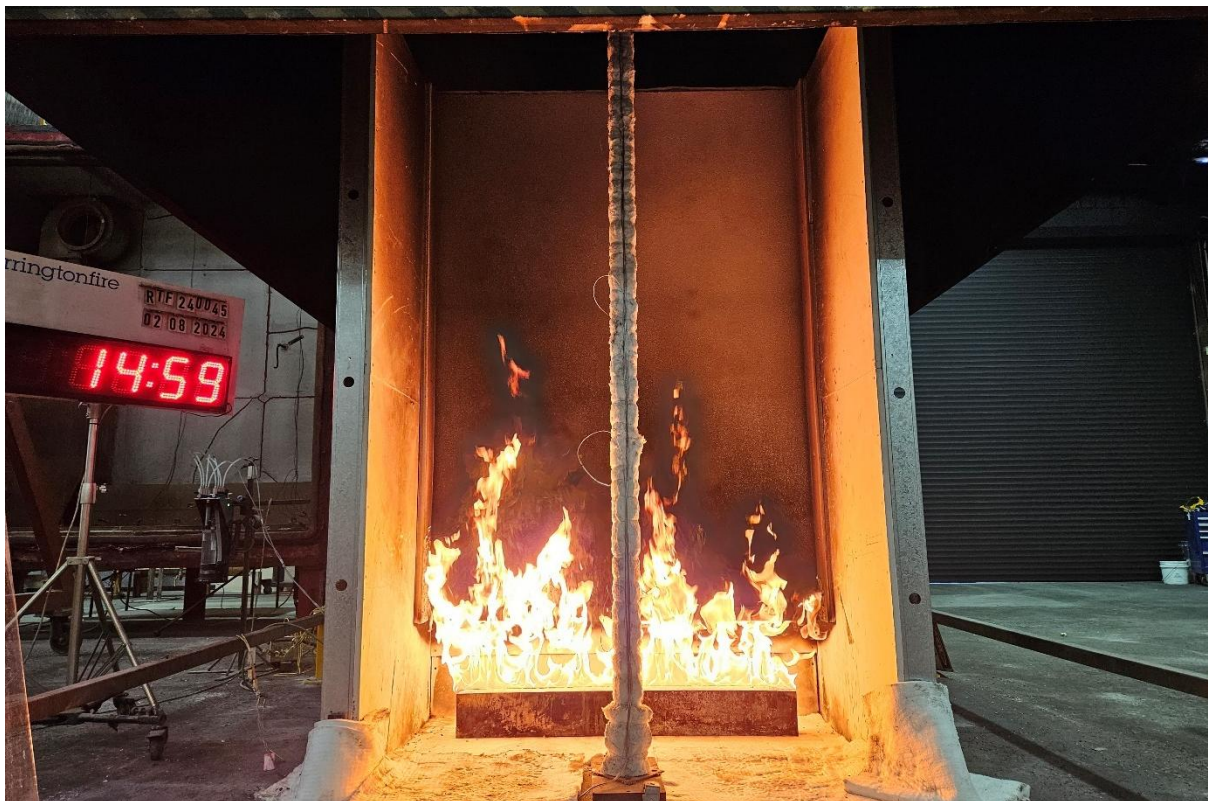
**Figure 19** The specimen 14 minutes 59 seconds into the test (burner output at 100 kW)

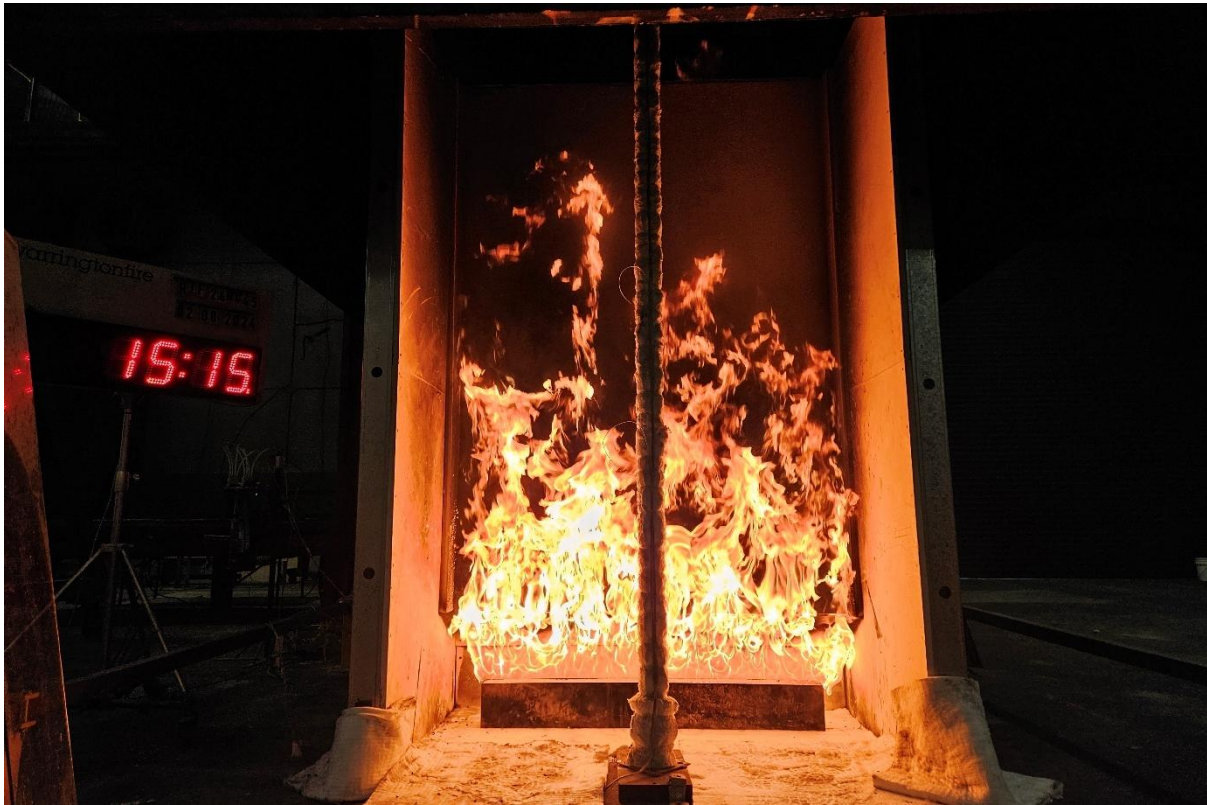
**Figure 20** The specimen 15 minutes 15 seconds into the test (burner output at 300 kW)

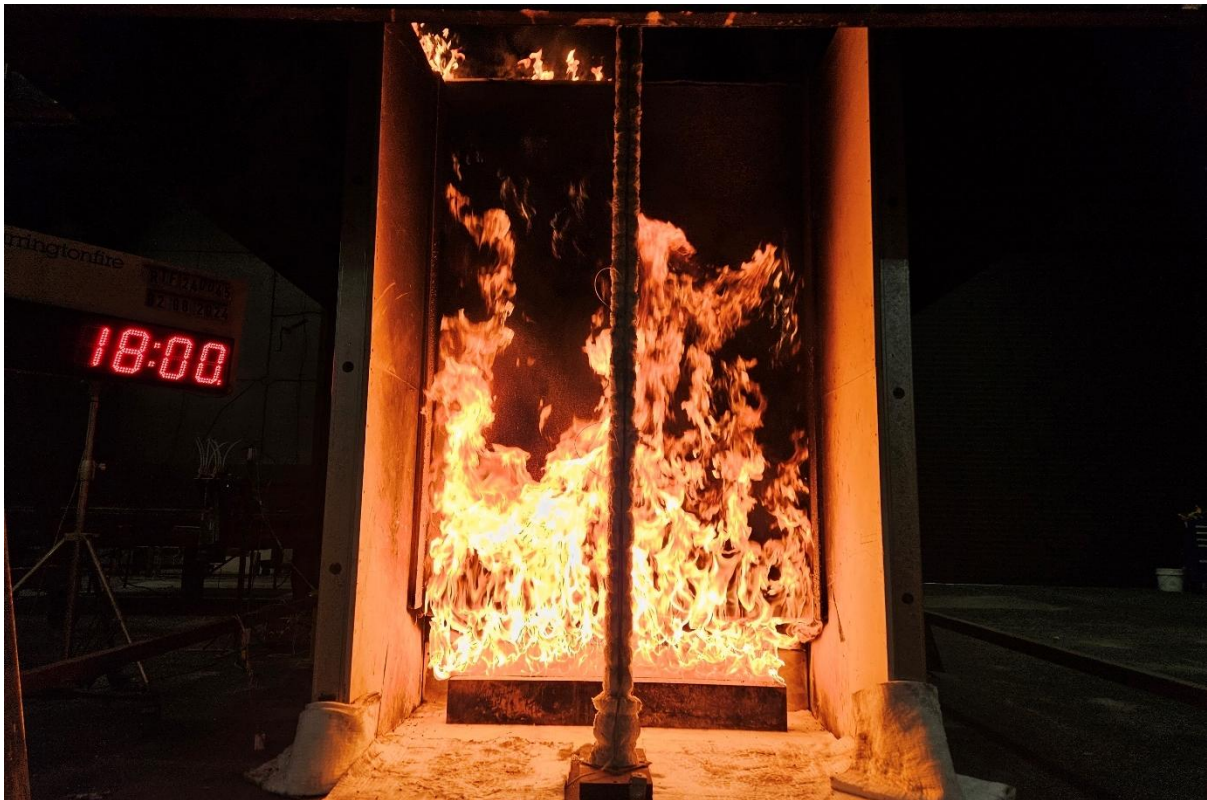
**Figure 21** The specimen 18 minutes into the test (burner output at 300 kW)

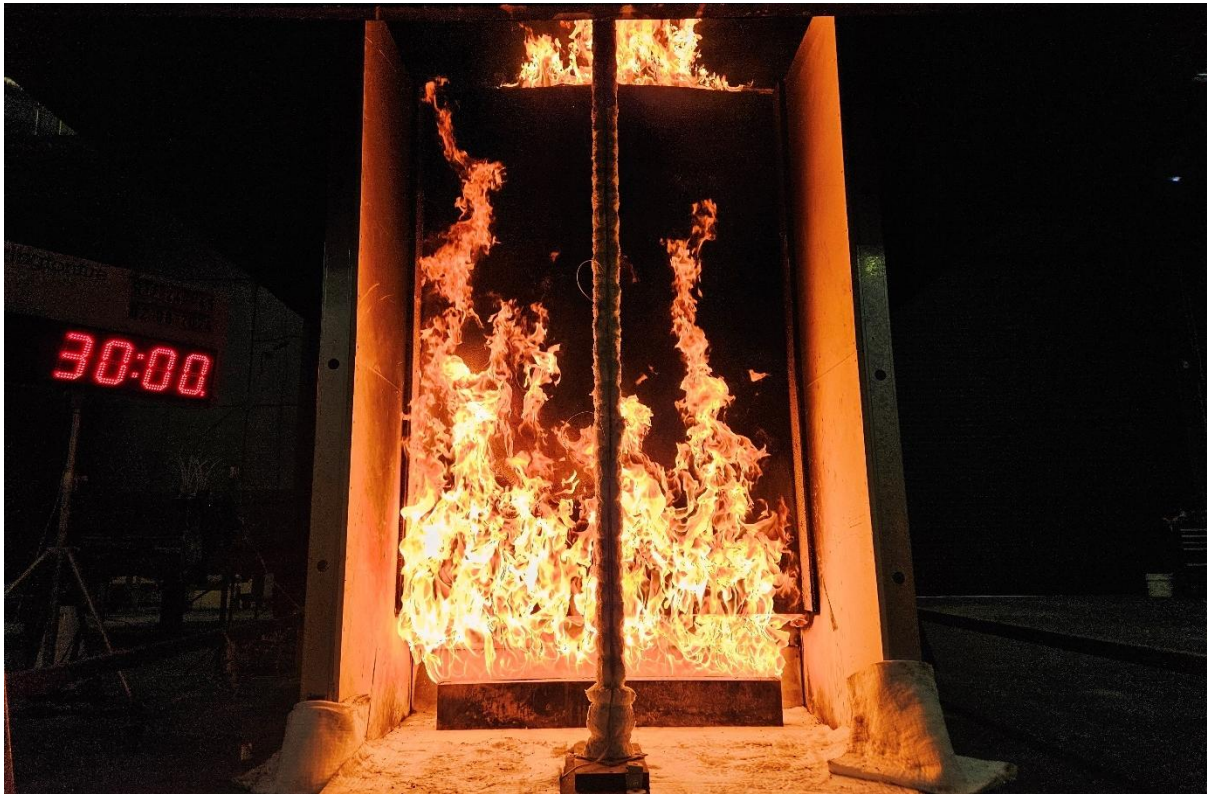
**Figure 22** The specimen 30 minutes into the test (burner output at 300 kW)

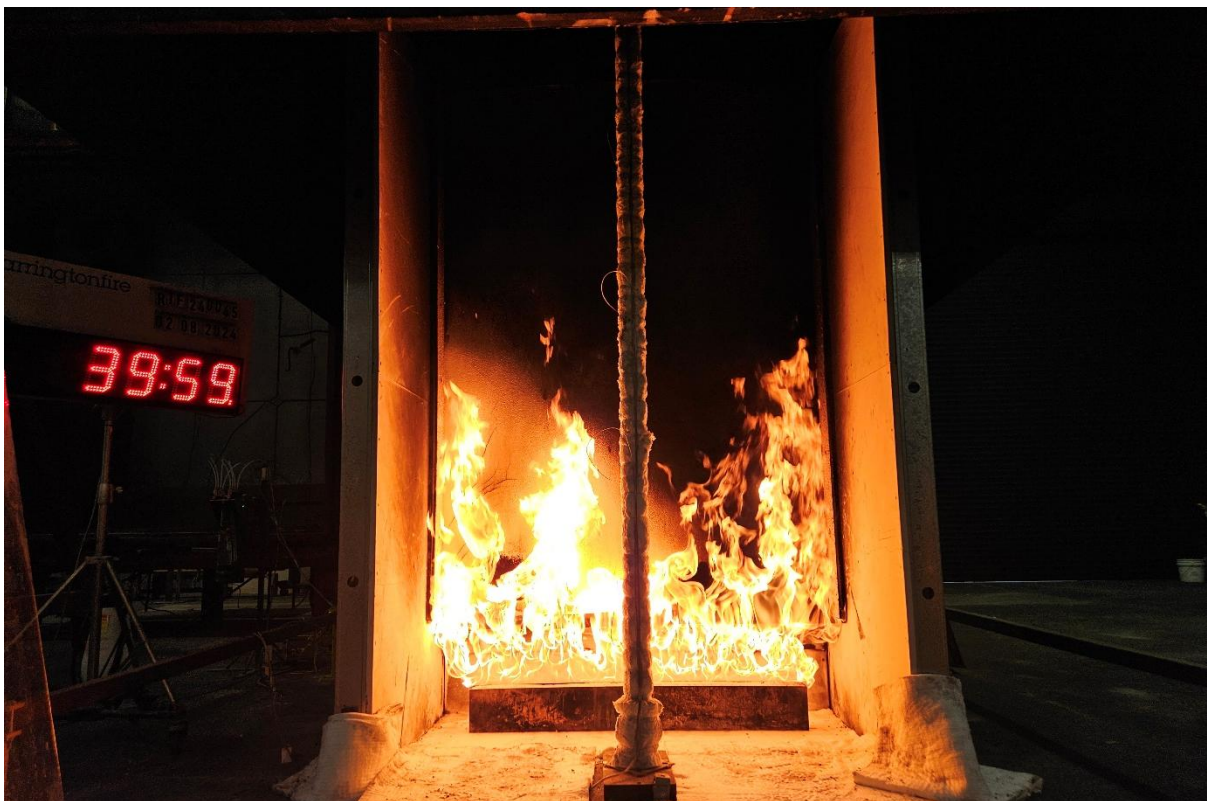
**Figure 23** The specimen 39 minutes 59 seconds into the test (burner output at 300 kW)

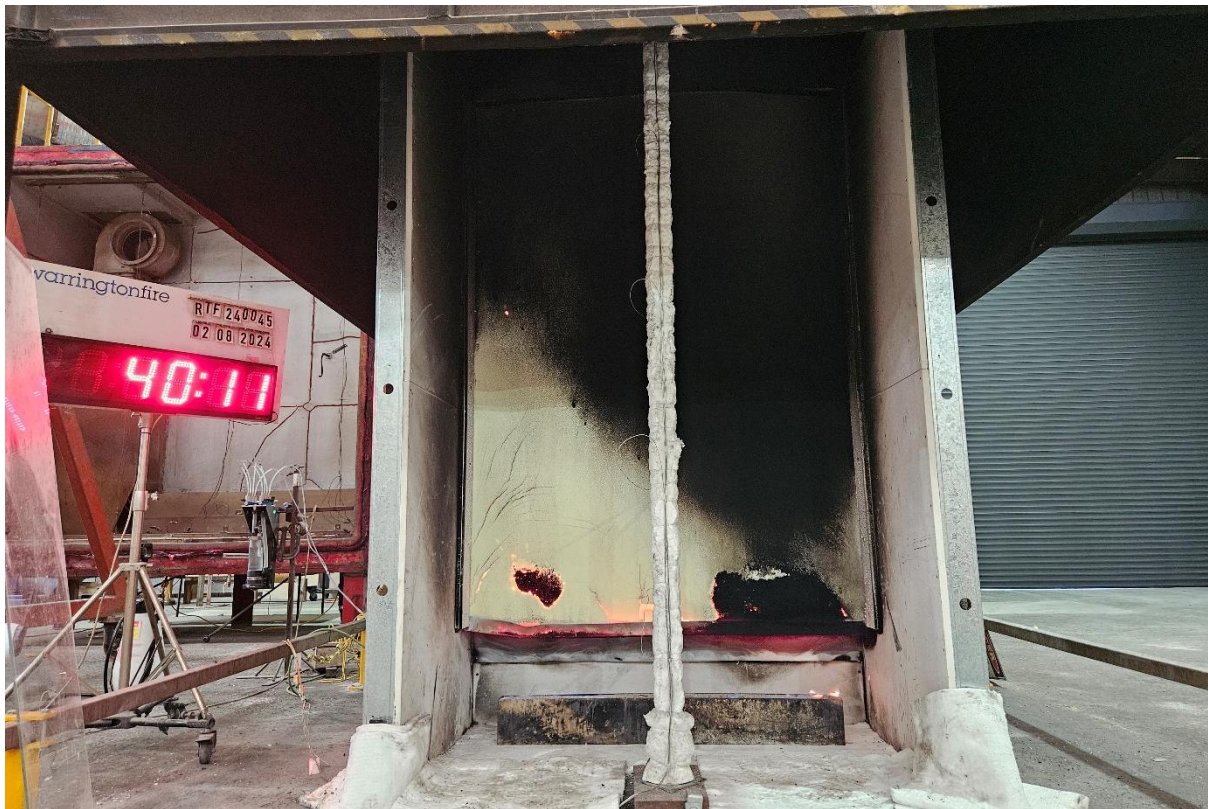
**Figure 24** The specimen 40 minutes 11 seconds into the test (burner off)

40	12	The bottom portion of the specimen was smouldering.
40	40	Flames were increasingly being emitted from the top of the specimen.
40	42	The rendered face of the specimen was cracking and crumbling away.
40	55	The exposed face of the specimen ignited.
41	08	The rendered face of the specimen fell and rested on the burner.
41	29	Flaming of the specimen was decreasing.
45	40	All flaming had stopped.
60	00	The reaction to fire test was ended.

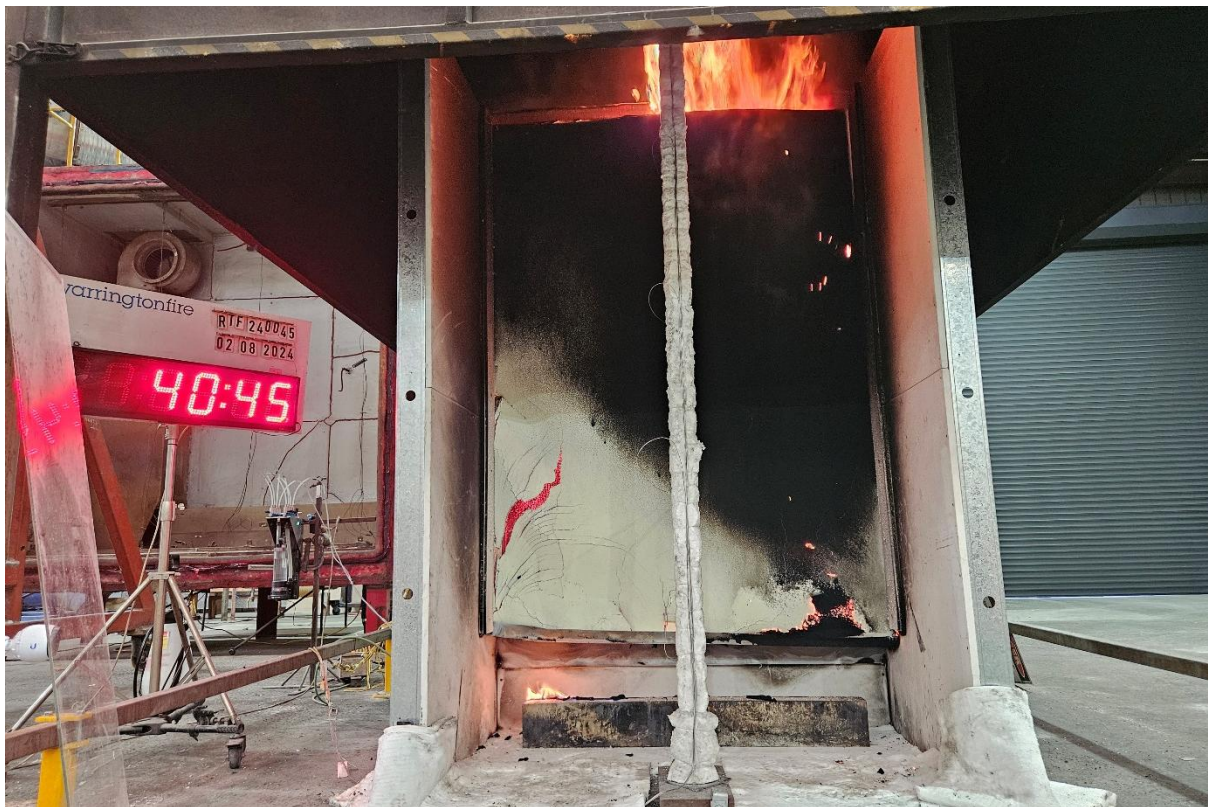
**Figure 25** The specimen 40 minutes 45 seconds into the test (burner off)

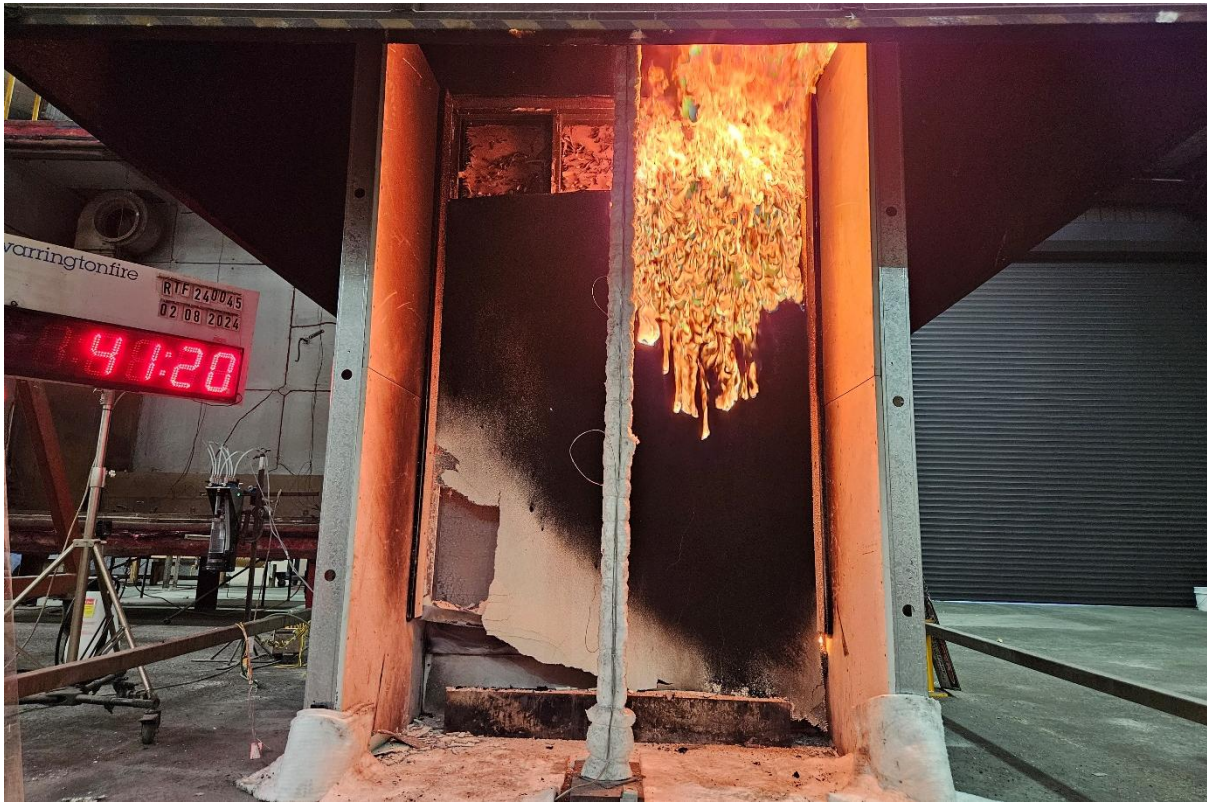
**Figure 26** The specimen 41 minutes 20 seconds into the test (burner off)

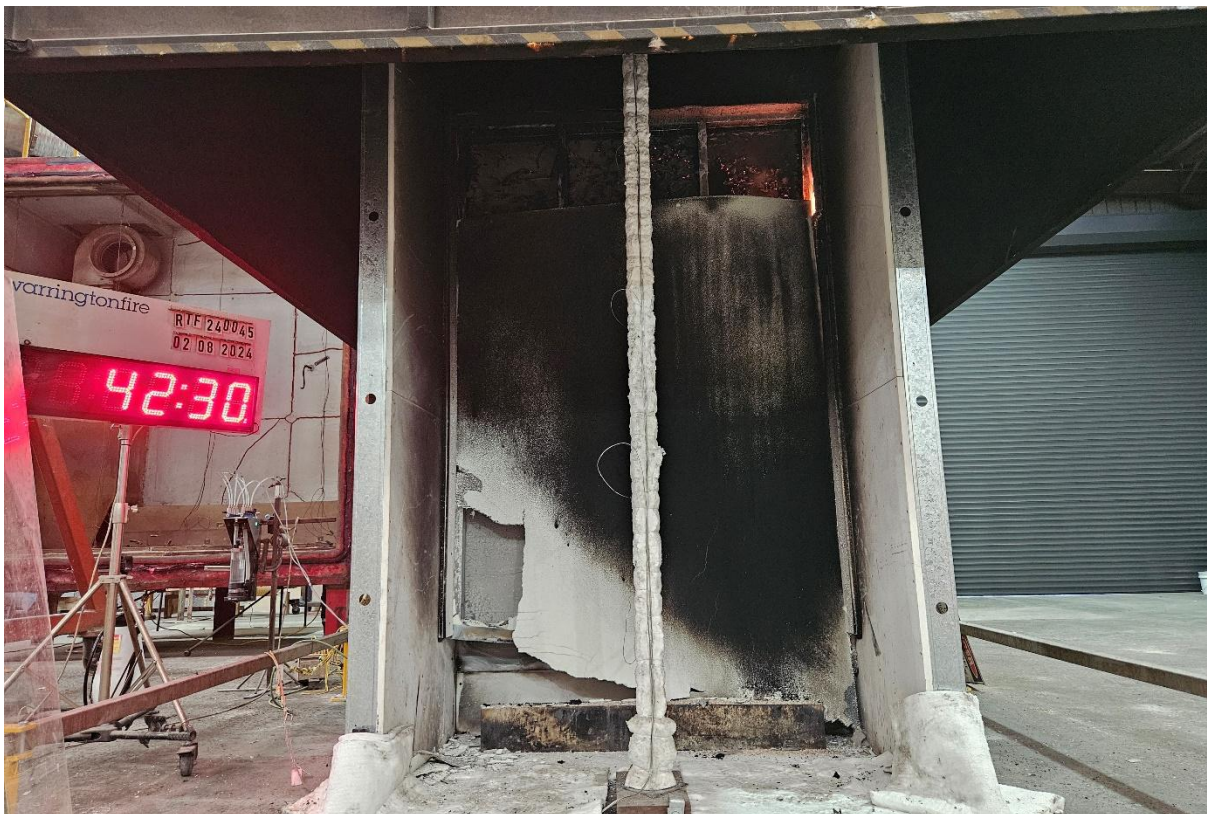
**Figure 27** The specimen 42 minutes 30 seconds into the test (burner off)

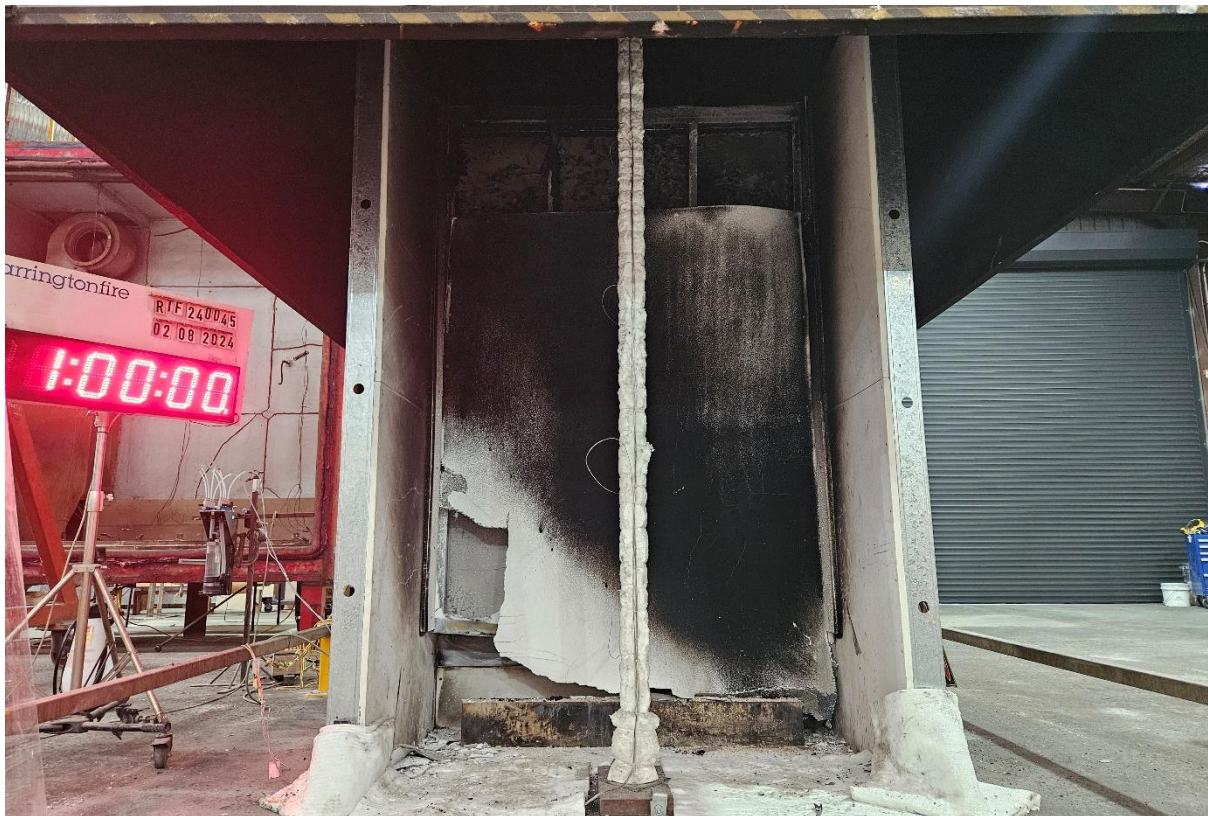
**Figure 28** The specimen at end of the reaction to fire test – exposed side
