Reaction to fire test report

Test standard: Ad-hoc test based on ISO 13785-1:2002

System: AAC external façade cladding system

Job number: RTF240056

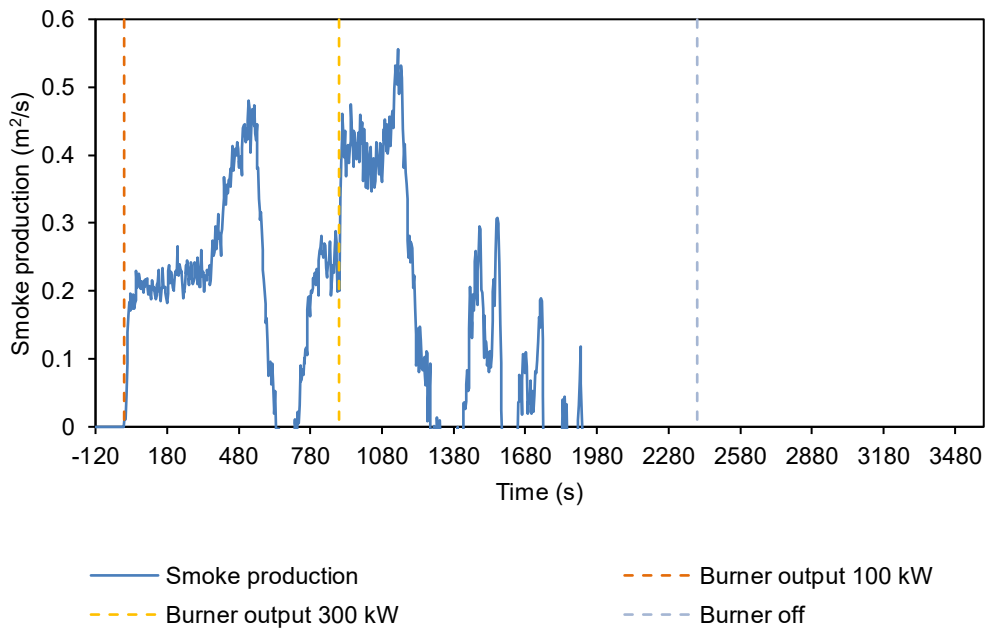
Figure 8 Production of light obscuring smoke vs time, at reference temperature and pressure

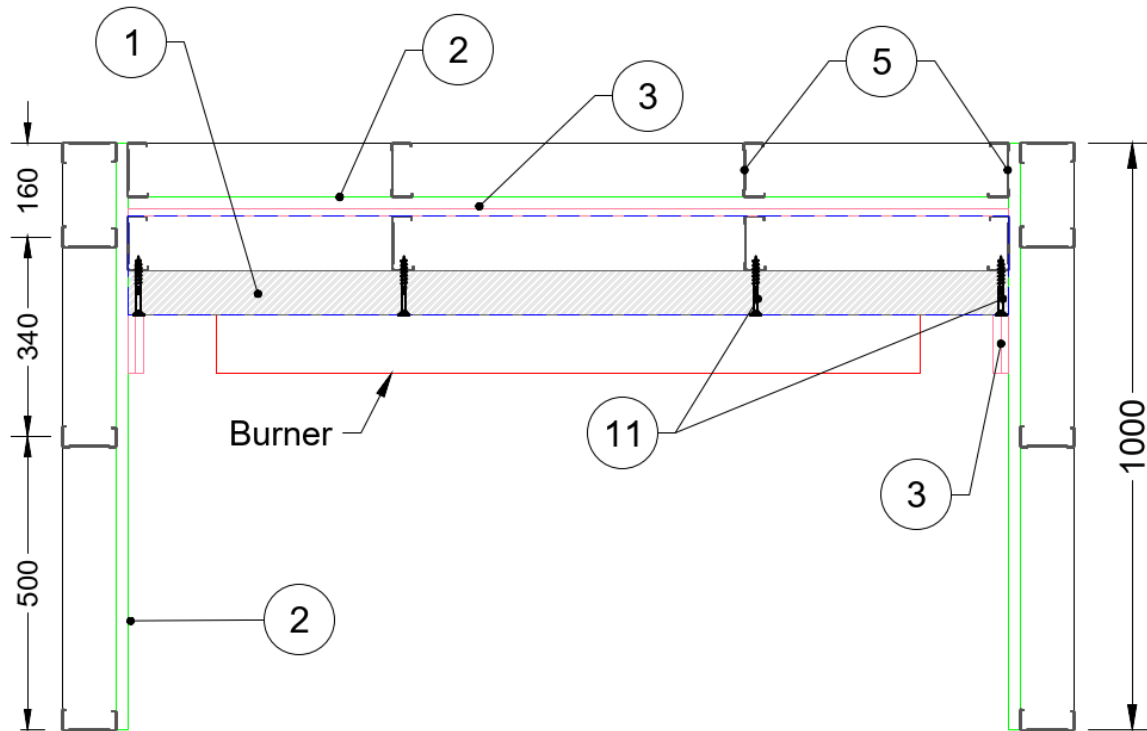
Figure 12 System assembly – Horizontal cross-section B-B

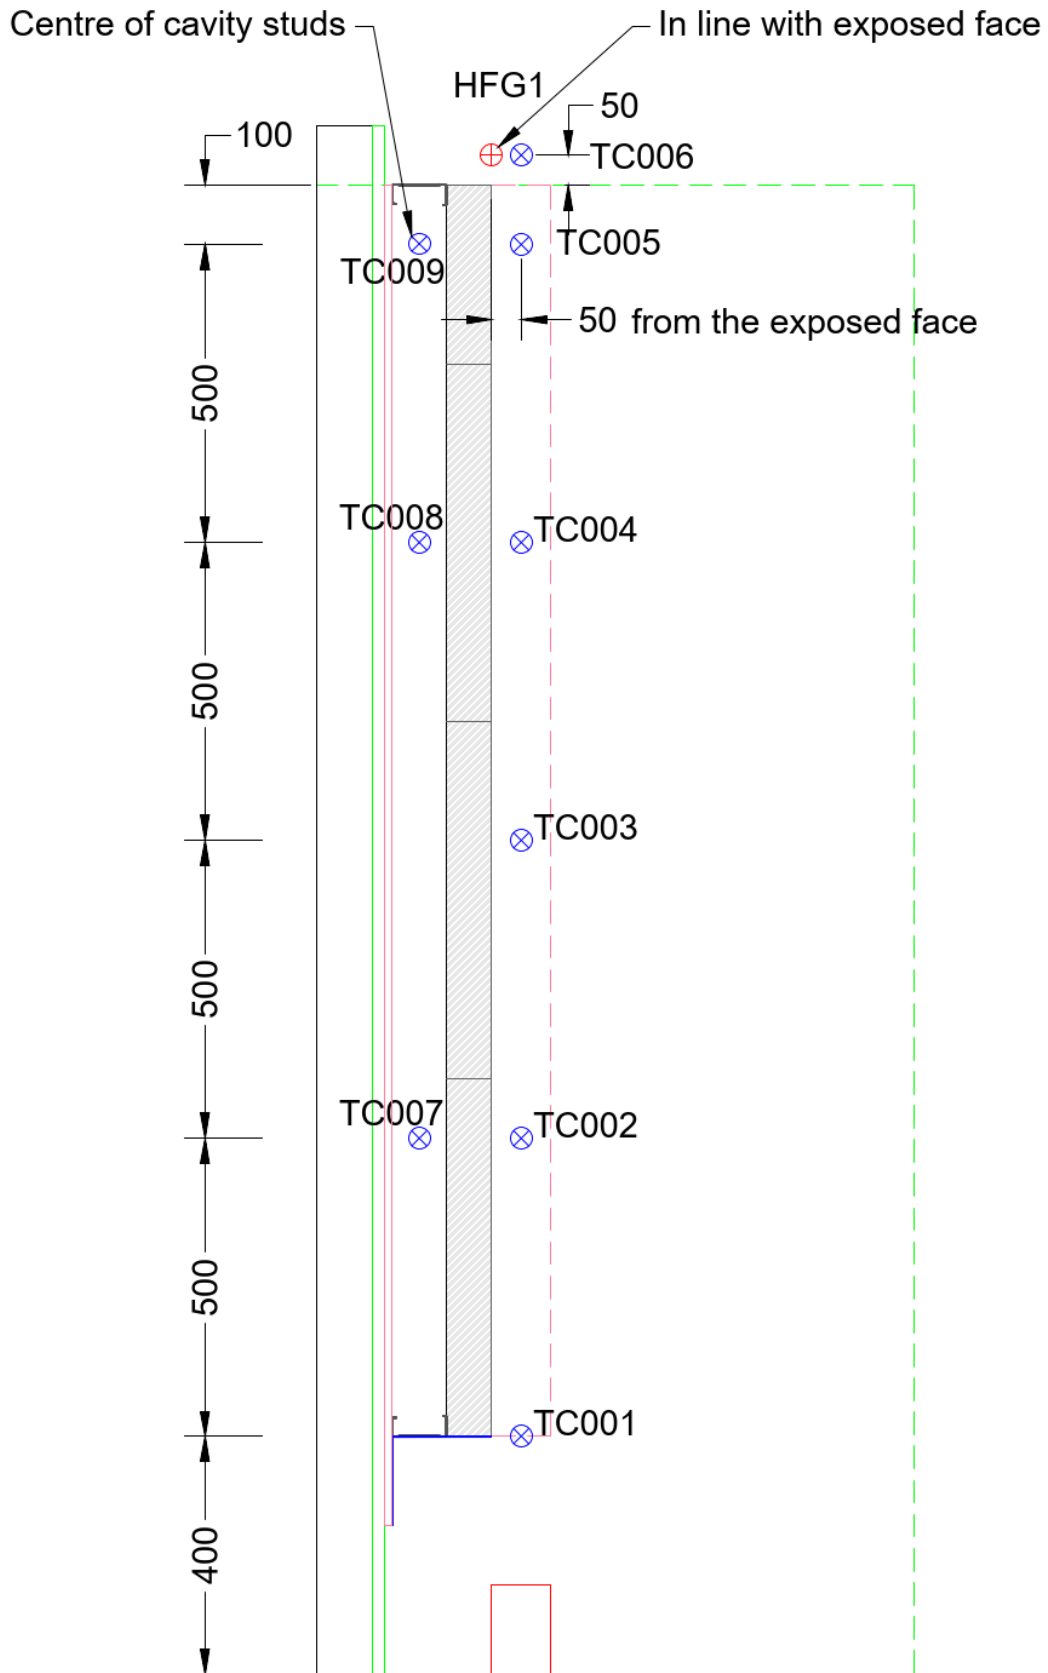
Figure 14 Instrumentation locations – Vertical cross-sectional view

Test duration	60 minutes.	
Instrumentation and equipment	<ul style="list-style-type: none"> 6 mineral insulated metal sheathed (MIMS) Type K thermocouples with an overall diameter of 1.5 mm with the measuring junction insulated from the sheath were positioned at various heights, 50 mm in front of the outer face of the test specimen along its vertical centreline. Refer to Figure 13 and Figure 14 in Appendix C for details on positioning. 3 MIMS Type K thermocouples with an overall diameter of 1.5 mm with the measuring junction insulated from the sheath were positioned at various heights at mid-depth of the framing cavity of the test specimen. Refer to Figure 13 and Figure 14 in Appendix C for details on positioning. The fire source was a propane (95% purity) gas fuelled box burner; 1.2 m wide × 0.1 m deep × 0.15 m tall. The burner was located on the floor in front of the specimen, with the back edge of the burner in line with the exposed face of the specimen. The incident heat flux 50 mm above and in line with the exposed face of the test specimen was measured using a Schmidt-Boelter type heat flux gauge with a range of 0 - 50 kW/m². The products of combustion were collected in an exhaust hood located centrally above the exposed face of the tested specimen. The hood was connected to an exhaust duct 400 mm in diameter, which had instruments inside to measure the conditions and properties of the combustion products during the test. The hood had specifications based on those given in AS ISO 9705:2003 (R2016), with the only differences being that all four sides had 1 m steel sheet extensions, and there was no fire test room. The volume flow rate was determined using a bidirectional pressure probe attached to a differential pressure transmitter together with a type K MIMS thermocouple positioned near the probe. Smoke obscuration measurements were made using a helium-neon laser smoke photometer, as outlined in Annex H of ISO 9705-1:2016. The temperature of the exhaust stream near the light beam was measured using a type K MIMS thermocouple.

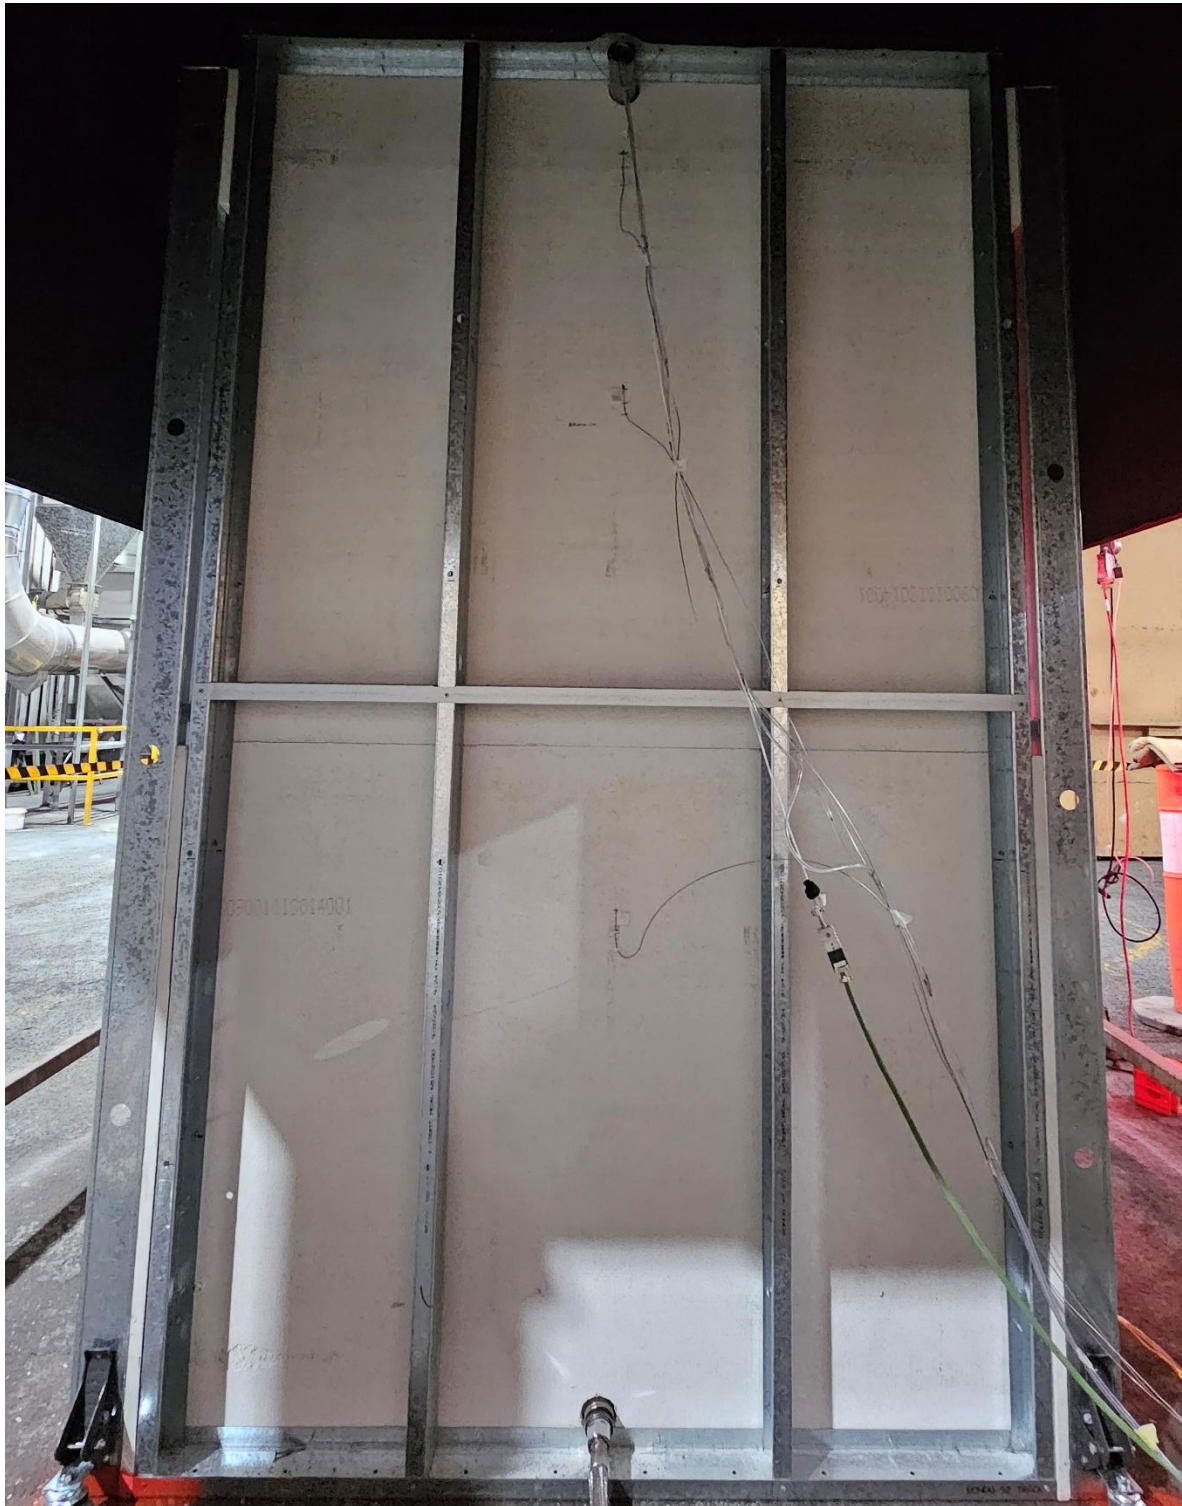
Figure 16 The specimen before the reaction to fire test – unexposed side

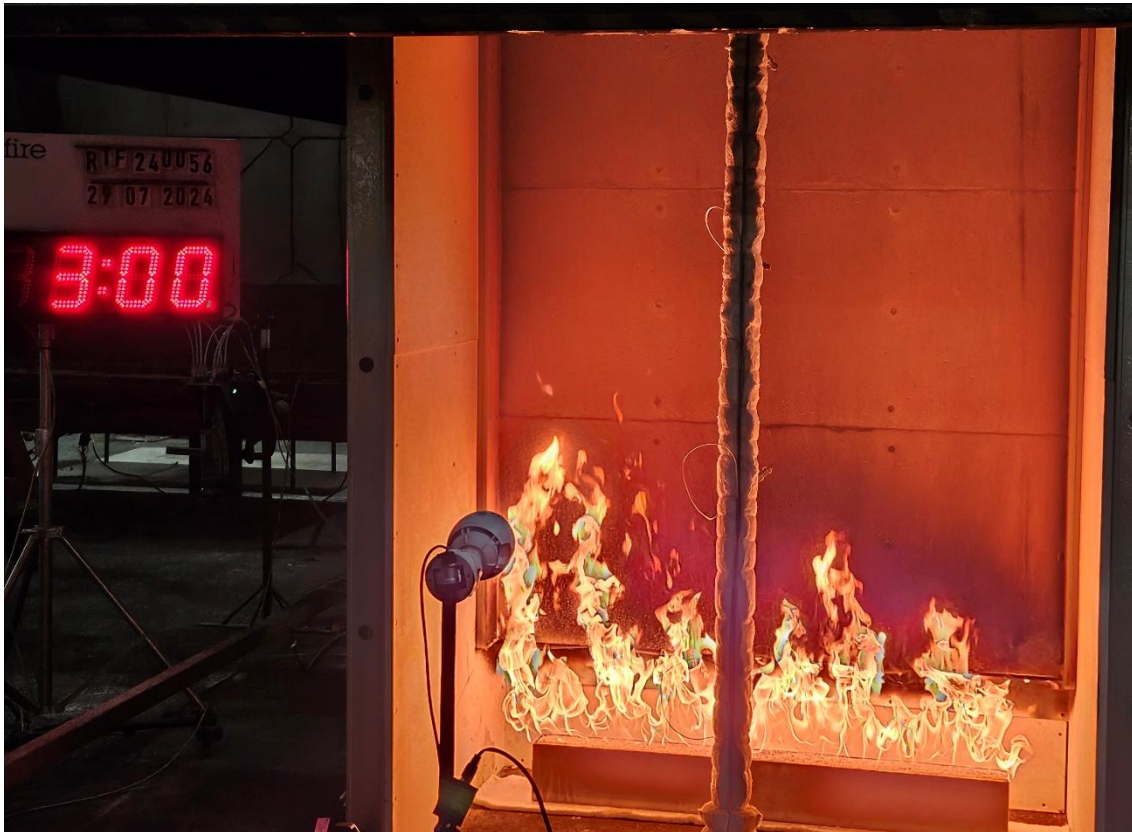
Figure 17 The specimen 3 minutes into the test (burner output at 100 kW)

Time		Observation
Min	Sec	
-2	00	Data collection started.
0	00	The reaction to fire test was started with the burner ignited with a heat output set at 100 kW.
0	31	Discolouration started at the bottom section of the specimen.
1	10	Steel angle at the bottom of the specimen started to deform.
7	13	Charring started at the bottom of the plasterboard strips on the sides.
12	25	Slight discolouration appeared at the bottom section of the west side wall.
15	00	The heat output of the burner was increased to 300 kW.
18	42	Discolouration spread up to cover most of the specimen.
20	09	Some cracks appeared on the bottom west side of the specimen.
40	00	The burner was turned off.
60	00	The reaction to fire test was ended.

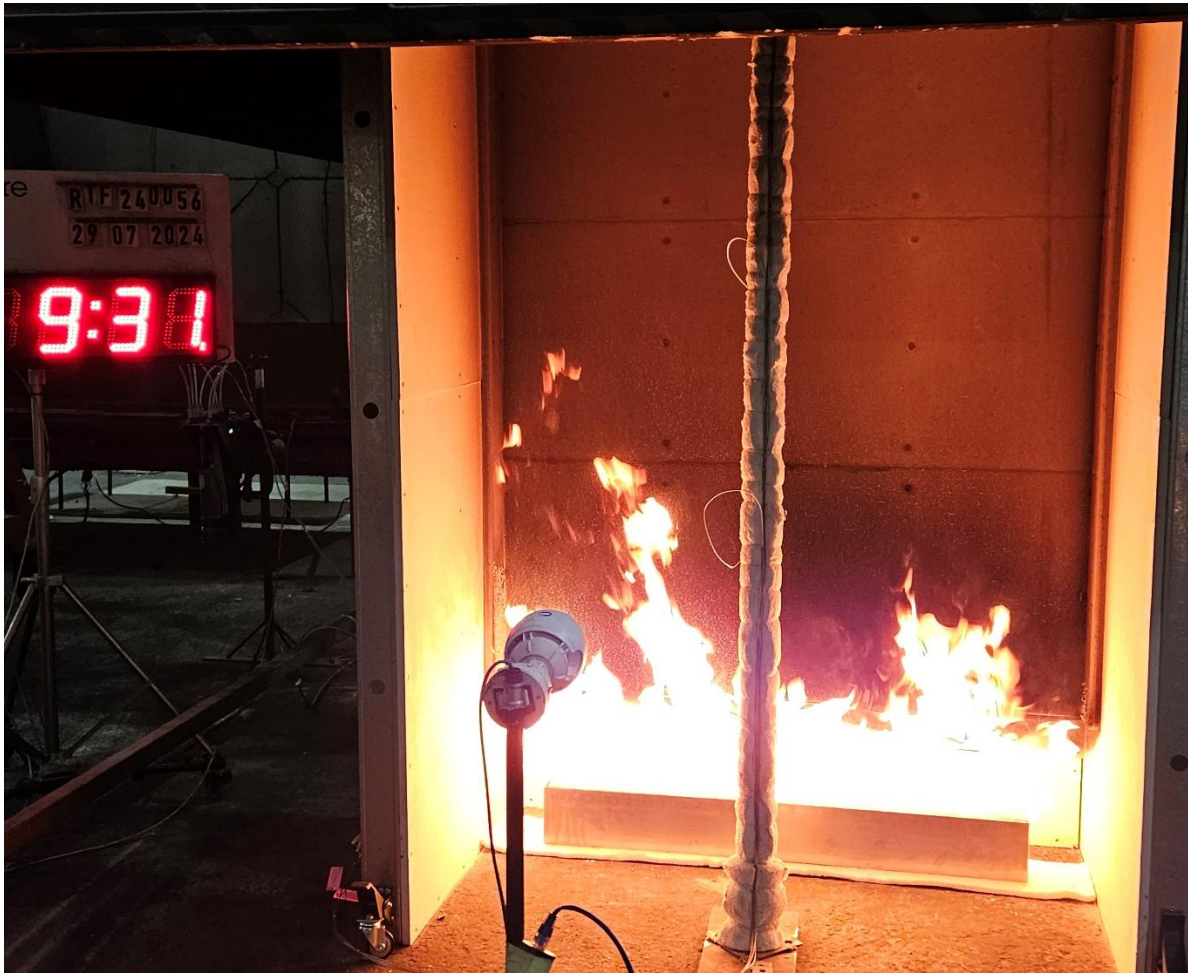
Figure 18 The specimen 9 minutes 31 seconds into the test (burner output at 100 kW)

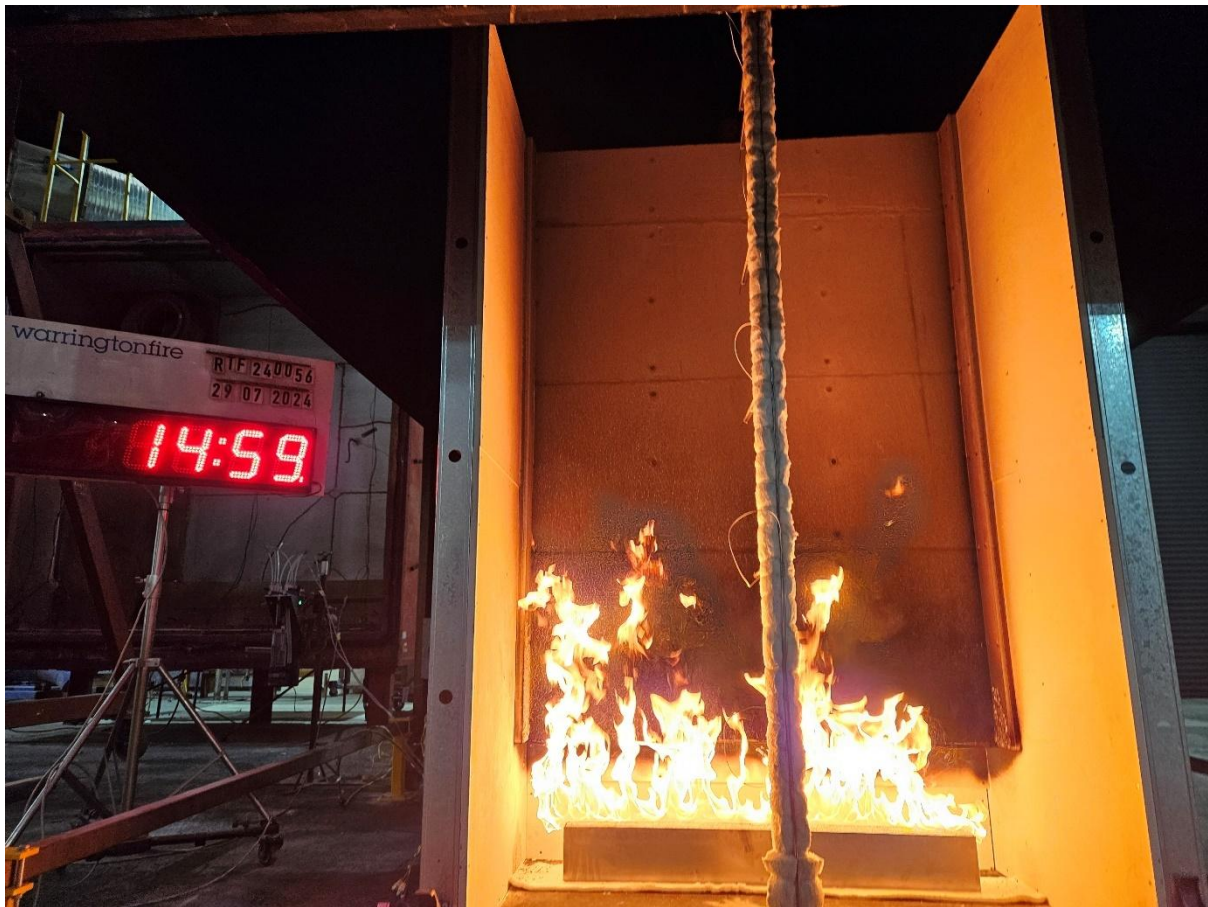
Figure 19 The specimen 14 minutes 59 seconds into the test (burner output at 100 kW)

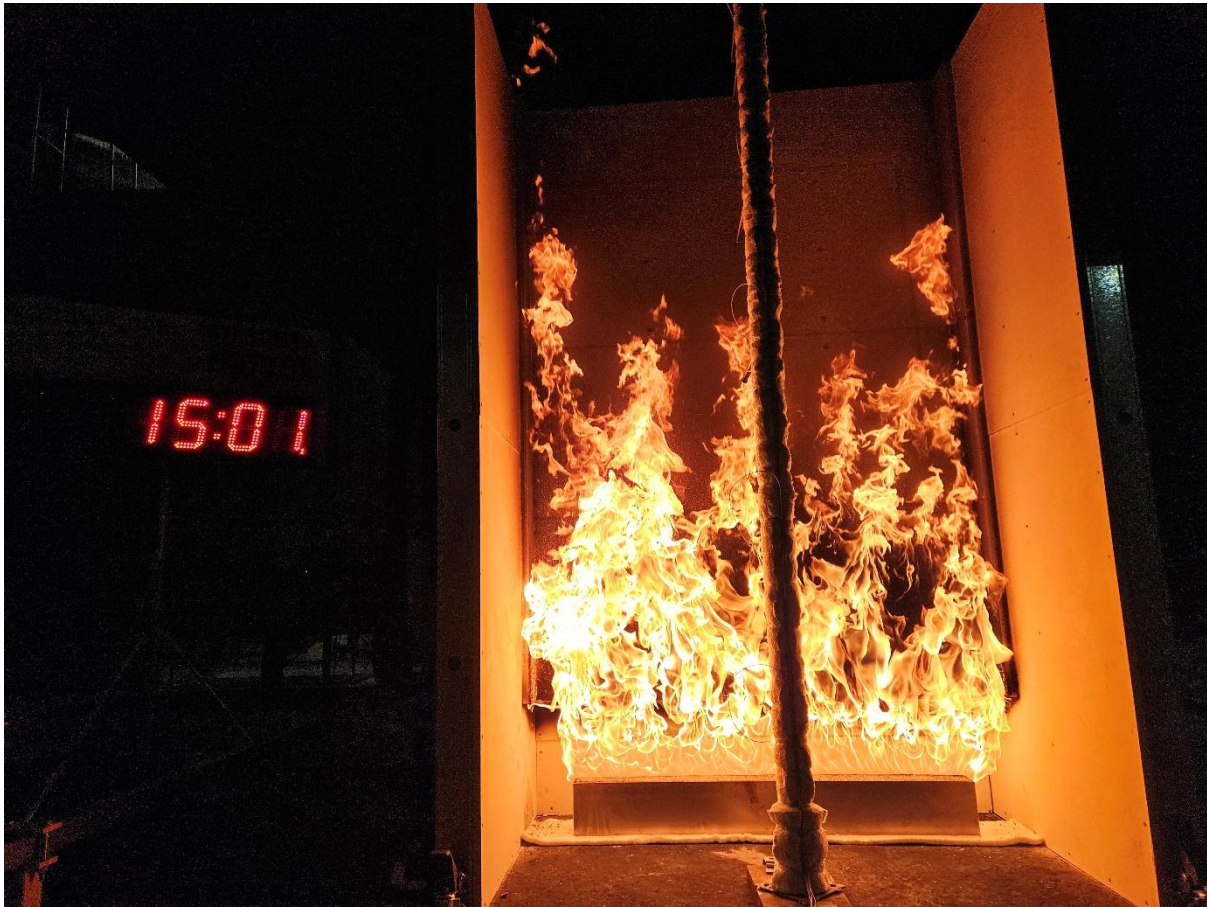
Figure 20 The specimen 15 minutes 01 seconds into the test (burner output at 300 kW)

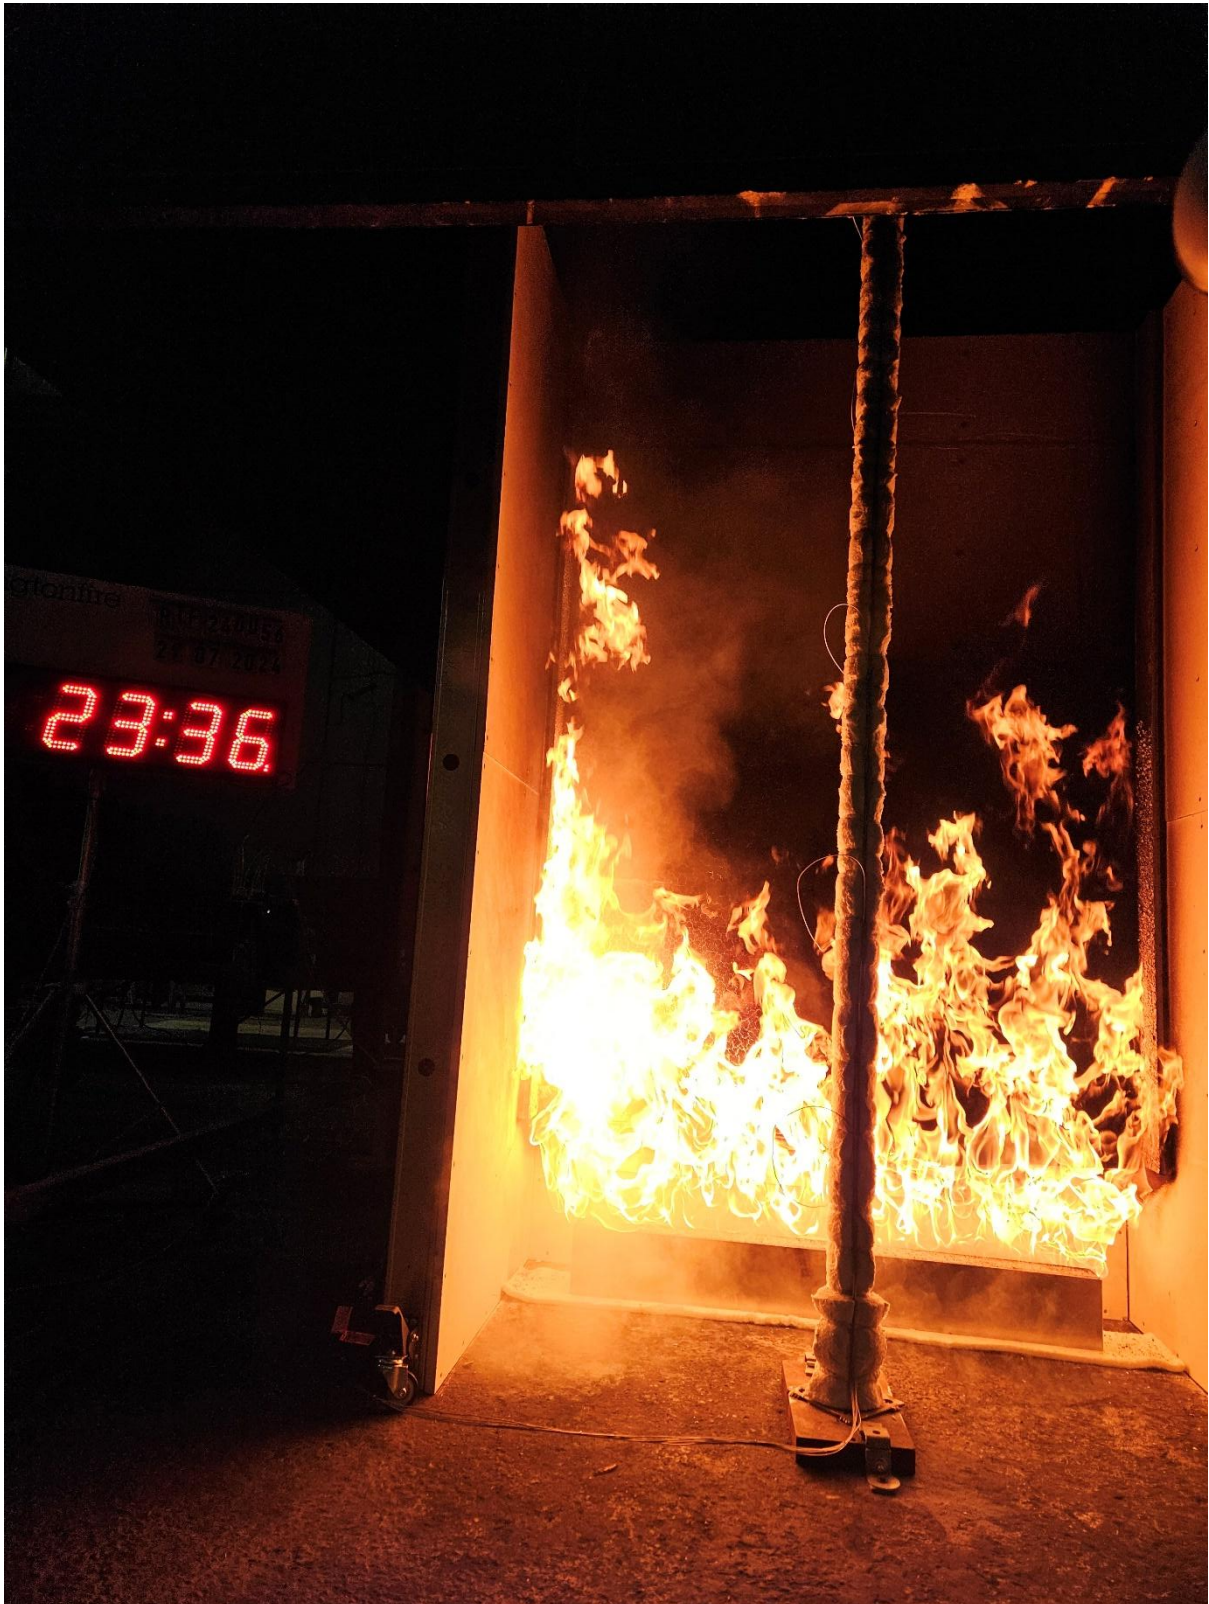
Figure 21 The specimen 23 minutes 36 seconds into the test (burner output at 300 kW)

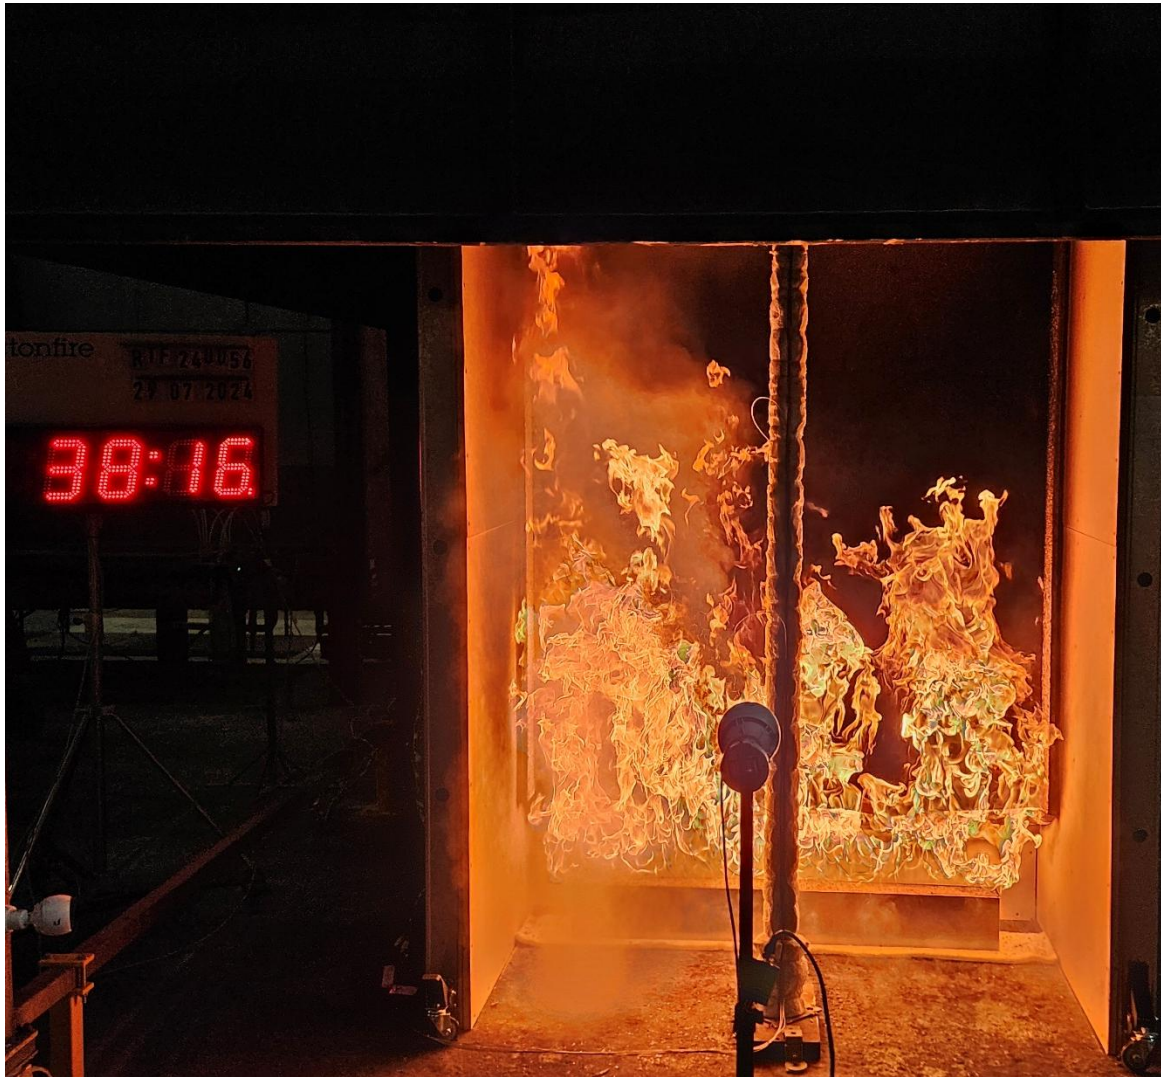
Figure 22 The specimen 38 minutes 16 seconds into the test (burner output at 300 kW)

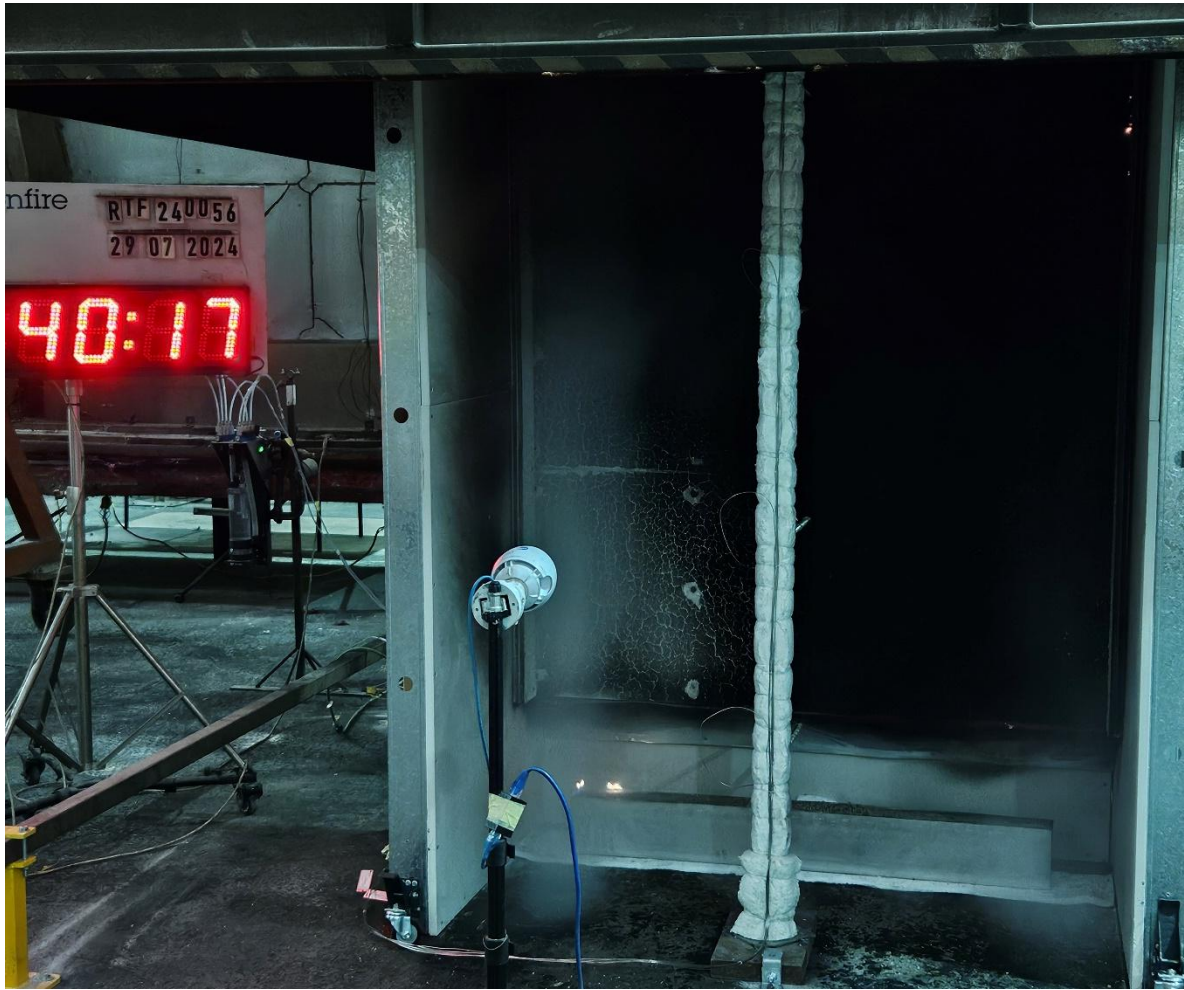
Figure 23 The specimen 40 minutes 17 seconds into the test (burner off)

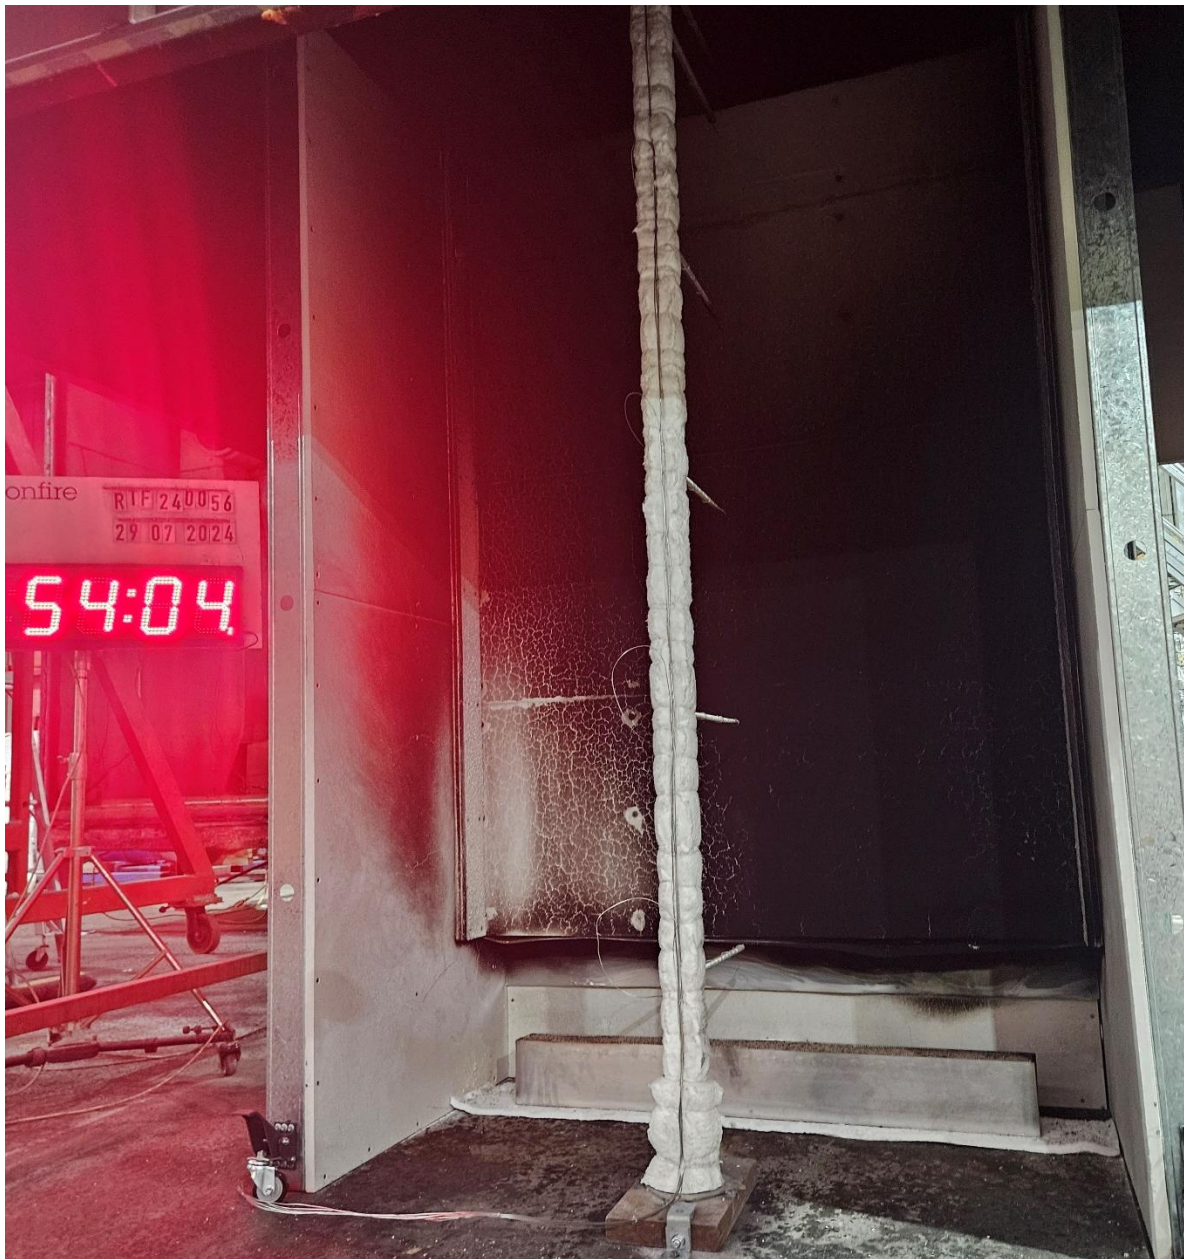
Figure 24 The specimen 54 minutes 04 seconds into the test (burner off)

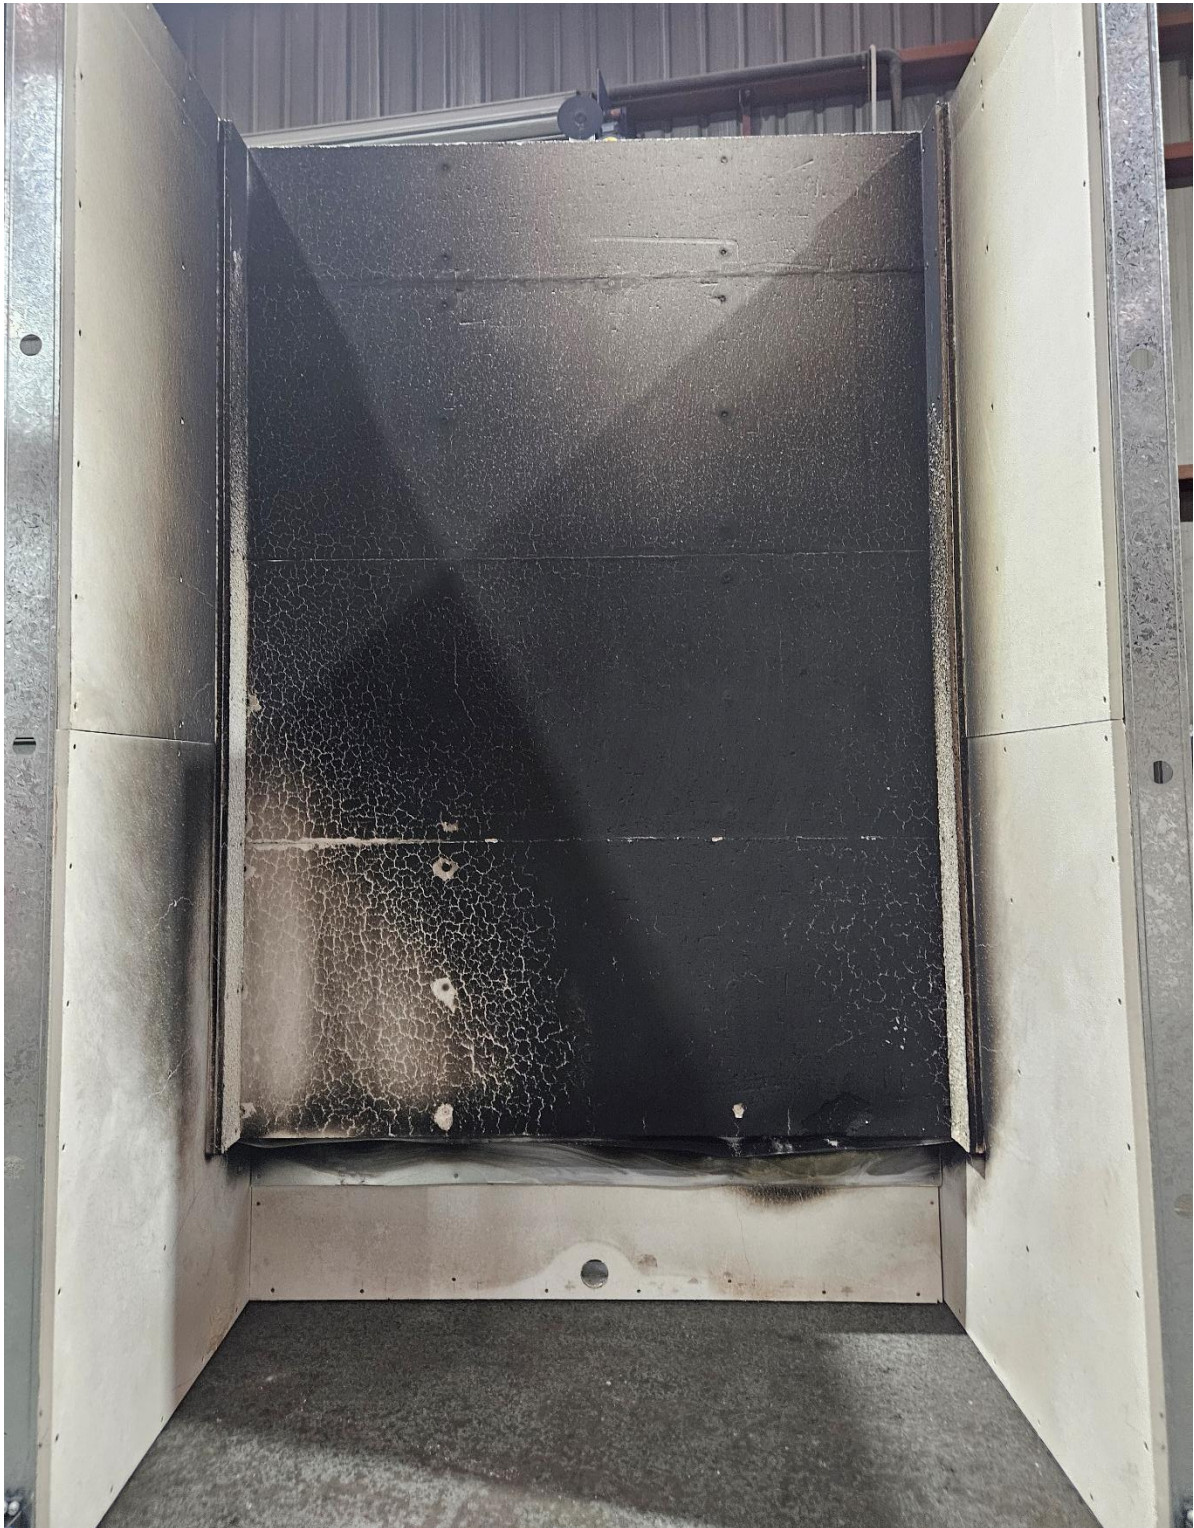
Figure 25 The specimen at end of the reaction to fire test – exposed side

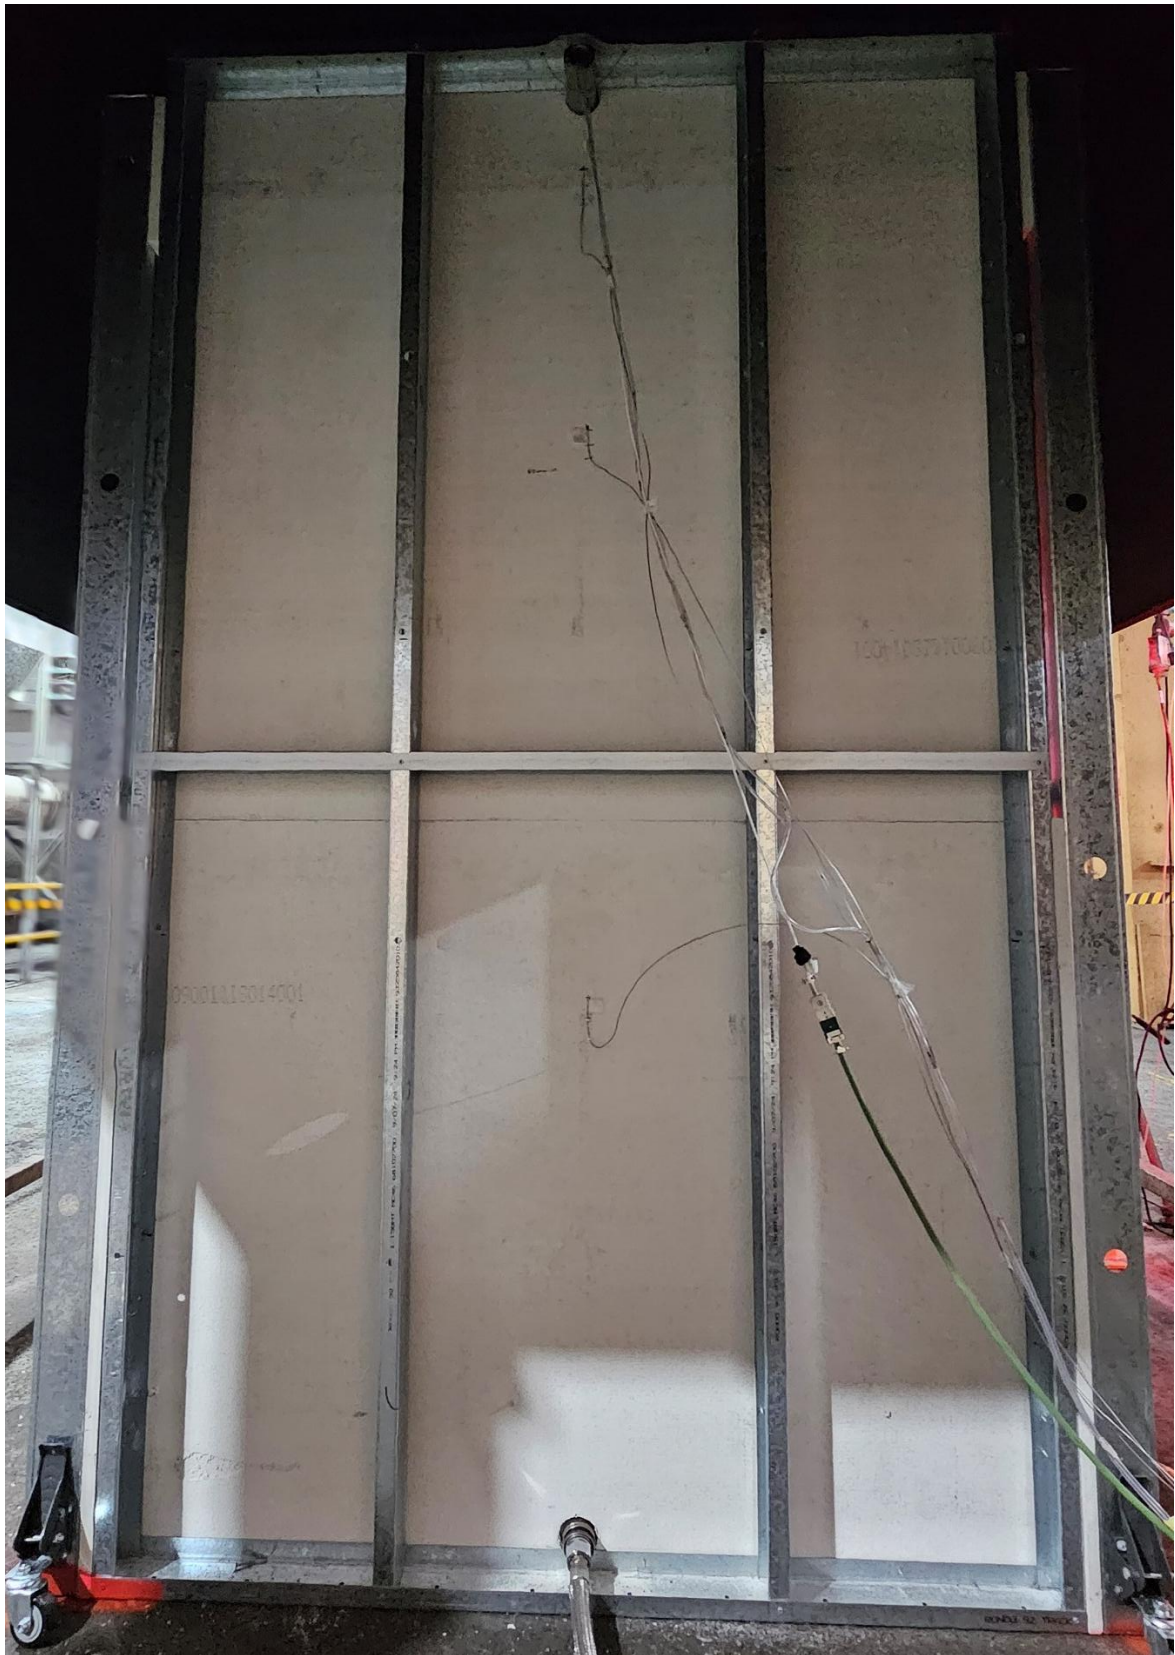
Figure 26 The specimen after the reaction to fire test – unexposed side
