Rail Safety Investigation No 2008 / 03

# **Brief Report**

Pedestrian Fatality V/Line Train 8136 Ardeer 6 March 2008

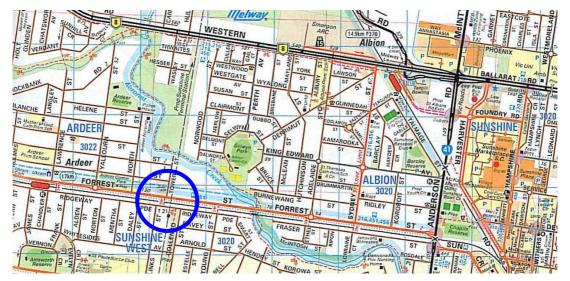
The incident took place between Ardeer and Sunshine Railway Stations opposite Tower Street.

Figure 2. Location of pedestrian crossing
