Office of the Chief Investigator
Transport Safety

**Marine Safety Investigation
Report No 2018/02**

**Navigational occurrence
MV Tomar and *MV CPO Jacksonville*
South Channel, Port Phillip
12 August 2018**

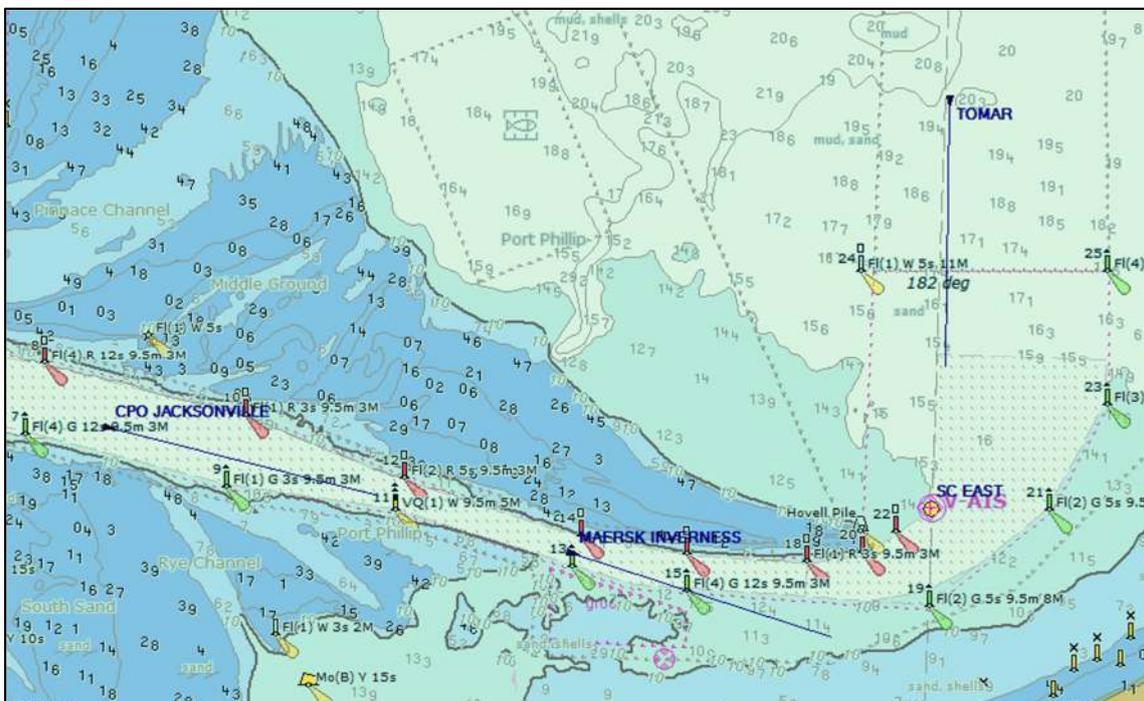
Figure 2: *Tomar*, *Maersk Inverness* and *CPO Jacksonville* approaching Hovell Pile turn at 0304:40.

At 0304:40 the three ships were approaching Hovell Pile, with *Maersk Inverness* due to arrive at the turn first, followed by *Tomar* and then *CPO Jacksonville* (Figure 2).

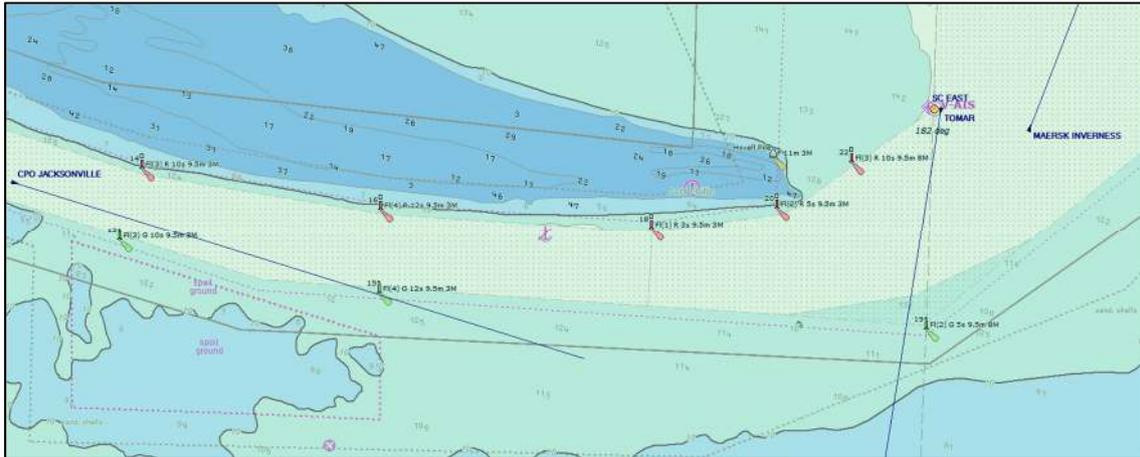
Figure 3: *Tomar*, *Maersk Inverness* and *CPO Jacksonville* at about 0310

At about 0310, when they were approximately east north east of Hovell Pile, *Tomar* and *Maersk Inverness* passed at a separation of about 460 m, while *CPO Jacksonville* was still about 2.2 nm from a position due south of Hovell Pile (Figure 3).
