Reaction to fire test report

Test standard: Ad-hoc test based off ISO 13785-1:2002

Test sponsor: Cladding Safety Victoria (CSV)

System: A cassetted aluminium composite panel wall system

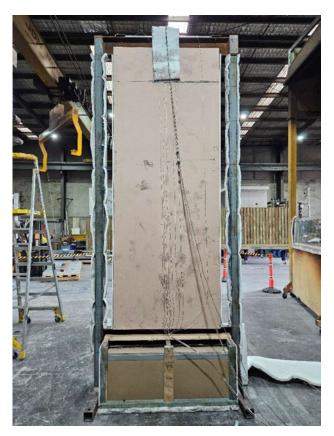
Figure 12 The specimen before the reaction to fire test – unexposed side

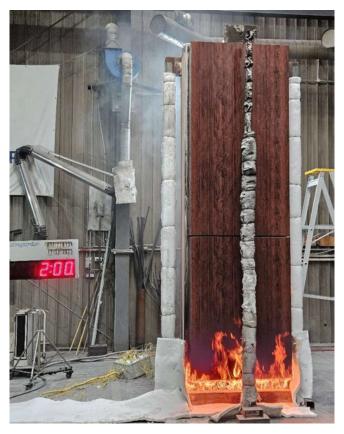
Figure 13 The specimen 2 minutes into the test (burner output at 100 kW)

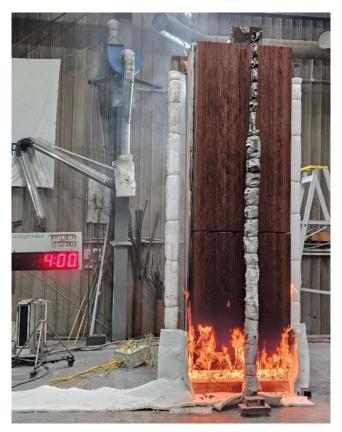
Figure 14 The specimen 4 minutes into the test (burner output at 100 kW)

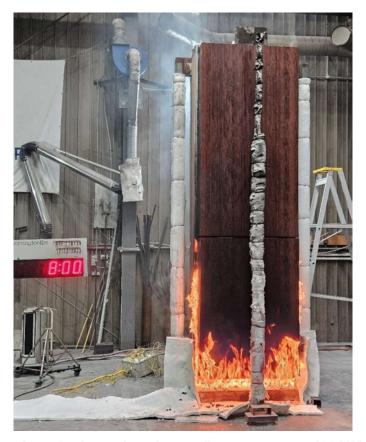
Figure 15 The specimen 8 minutes into the test (burner output at 100 kW)

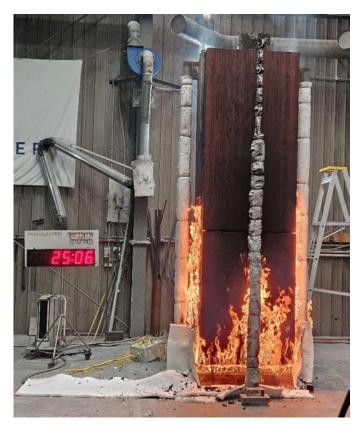
Figure 18 The specimen 25 minutes 6 seconds into the test (10 minutes 6 seconds after burner output was changed to 300 kW)

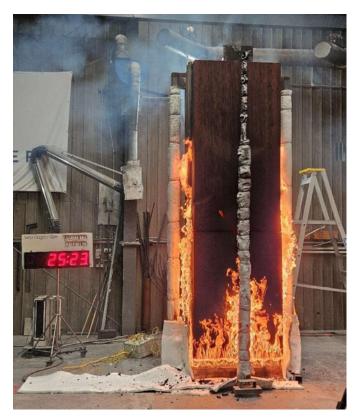
Figure 19 The specimen 25 minutes 23 seconds into the test (10 minutes 23 seconds after burner output was changed to 300 kW)

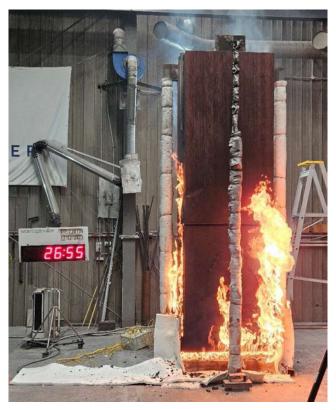
Figure 20 The specimen 26 minutes 55 seconds into the test (11 minutes 55 seconds after burner output was changed to 300 kW)

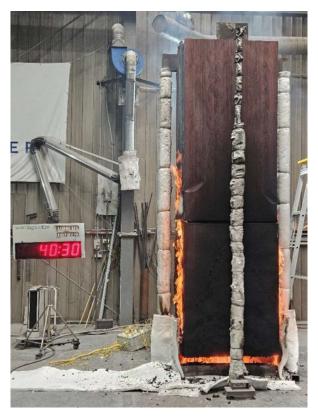
Figure 22 The specimen 40 minutes 30 seconds into the test (25 minutes 30 seconds after burner output was changed to 300 kW)

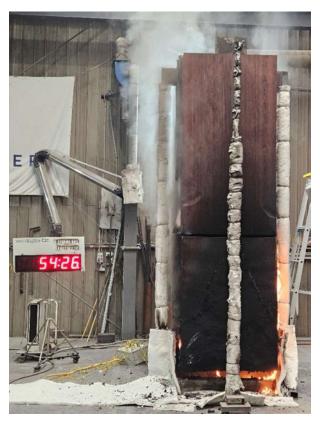
Figure 24 The specimen 54 minutes 26 seconds into the test (14 minutes 26 seconds after burner was switched off)

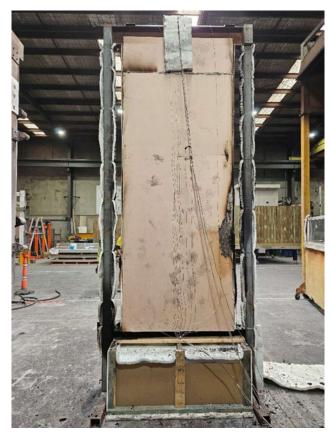
Figure 28 The specimen after the test – unexposed side.

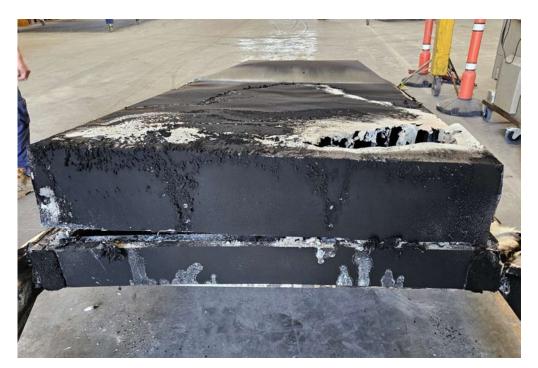
Figure 29 The specimen after the test – underside.
