Reaction to fire test report

Test standard: Ad-hoc test based off ISO 13785-1:2002

Test sponsor: Cladding Safety Victoria (CSV)

System: A cassetted aluminium composite panel wall system

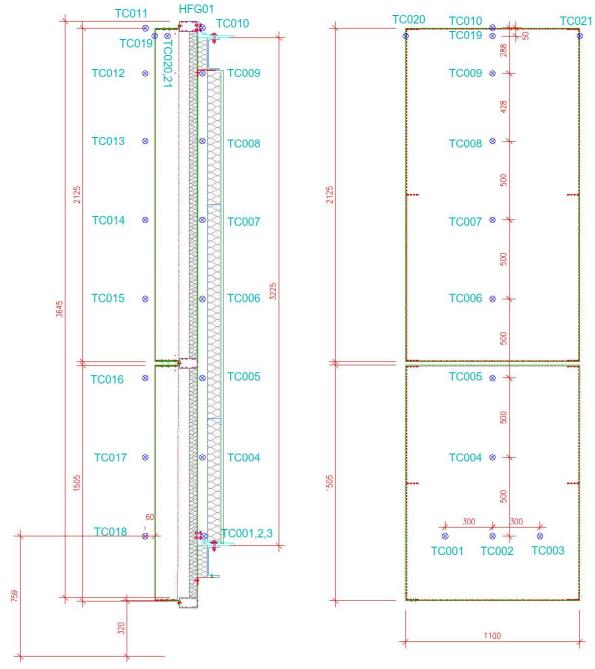
Figure 1 Instrumentation location

| Table 3 Test procedure | | | |
|--|--|---|--|
| Instrumentation and equipment | Eight mineral insulated metal sheathed (MIMS) Type K thermocouples with an overall diameter of 1.5 mm with the measuring junction insulated from the sheath were positioned 60 mm in front of the face of the test specimen. Refer to Figure 1 (TC011 – TC021) for details on positioning. Ten mineral insulated metal sheathed (MIMS) Type K thermocouples with an overall diameter of 1.5 mm with the measuring junction insulated from the sheath were positioned inside the specimen at the centre of the cavity. Refer to Figure 1 (TC001 – TC010) for details on positioning. Three mineral insulated metal sheathed (MIMS) Type K thermocouples with an overall diameter of 1.5 mm with the measuring junction insulated from the sheath were positioned on the face of ACP, 50 mm from the top edge. Refer to Figure 1 (TC019 – TC021) for details on positioning. The incident heat flux on the top of the specimen in line with the front face of test specimen was measured using one Schmidt-Boelter type heat flux gauge with a range of 0-20 kW/m². The fire source was a propane (95% purity) gas burner 1.2 m long × 0.1 m deep × 0.15 m tall. The burner was placed on the floor below the specimen | | |

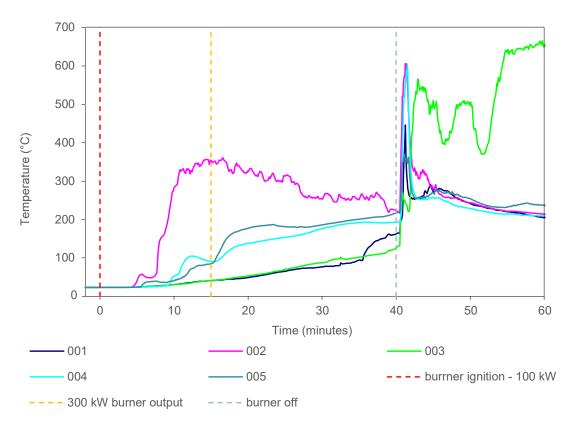
Figure 2 Internal temperature data collected by thermocouples placed within the cavity – between the internal and external segments of the specimen.

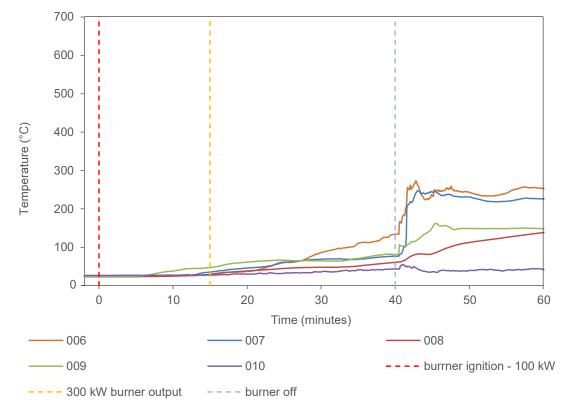
Figure 3 Internal temperature data collected by thermocouples placed within the cavity – between the internal and external segments of the specimen.

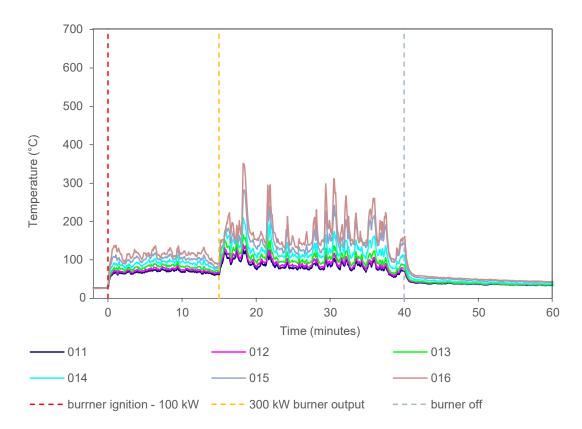
Figure 4 External temperature data collected by thermocouples placed 60 mm from the front face of the specimen.

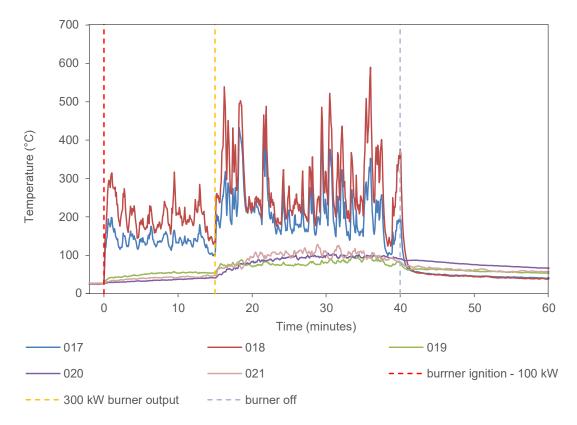
Figure 5 External temperature data collected by thermocouples placed 60 mm from the front face of the specimen.

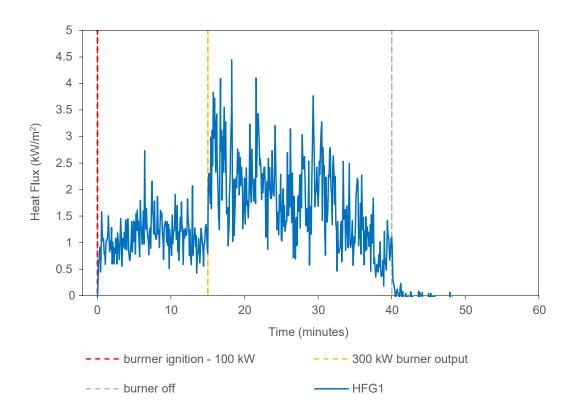
Figure 6 Heat flux data collected by heat flux gauge.

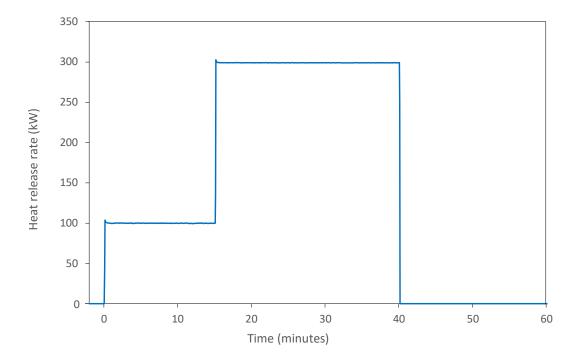
Figure 7 Heat release rate of burner.

| Table 3 Test procedure | | | |
|--|--|---|--|
| Test procedure | At least two minutes of baseline data was collected prior to burner ignition. Temperature and heat flux data was collected at 5 s intervals. The heat output from the burner was held at 100 kW for the first 15 minutes of the test followed by 300 kW for the following 25 minutes of the test. The burner was then turned off and the specimen sprayed with water when excessive flaming was observed. | | |

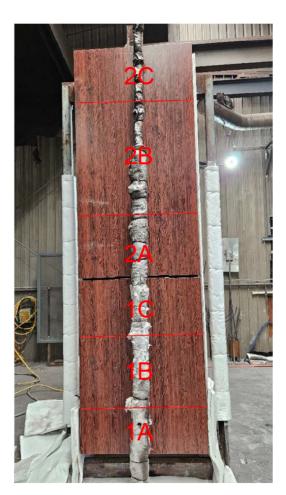
Figure 8 Designation for test specimen observations.

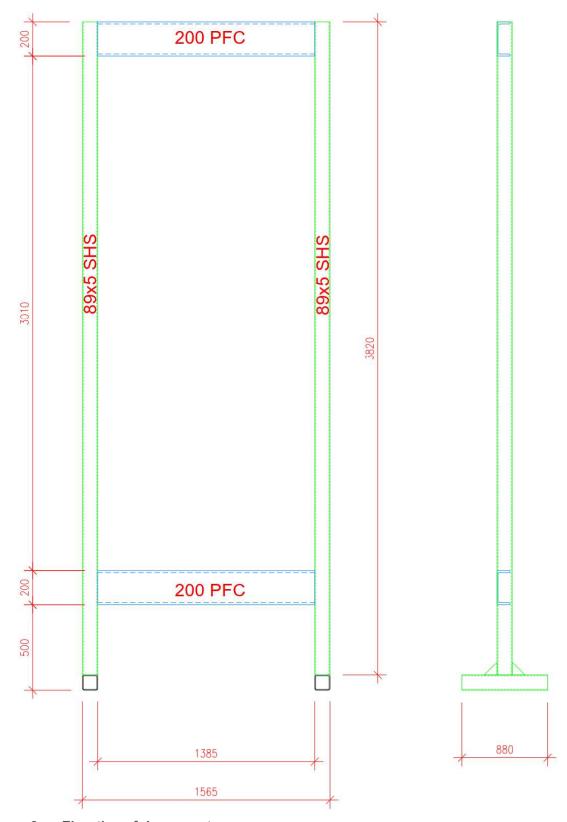
Figure 9 Elevation of rig support.

| Item | Description | | | | |
|---|---|--|--|--|--|
| | Size | 90 mm \times 90 mm \times 5 mm thick and 200 mm \times 90 mm \times 10 mm thick – refer to Figure 9. | | | |

The drawings of the test assembly in Figure 9 to Figure 12 were provided representatives of Warringtonfire. Dimensions, unless specified, are in mm.

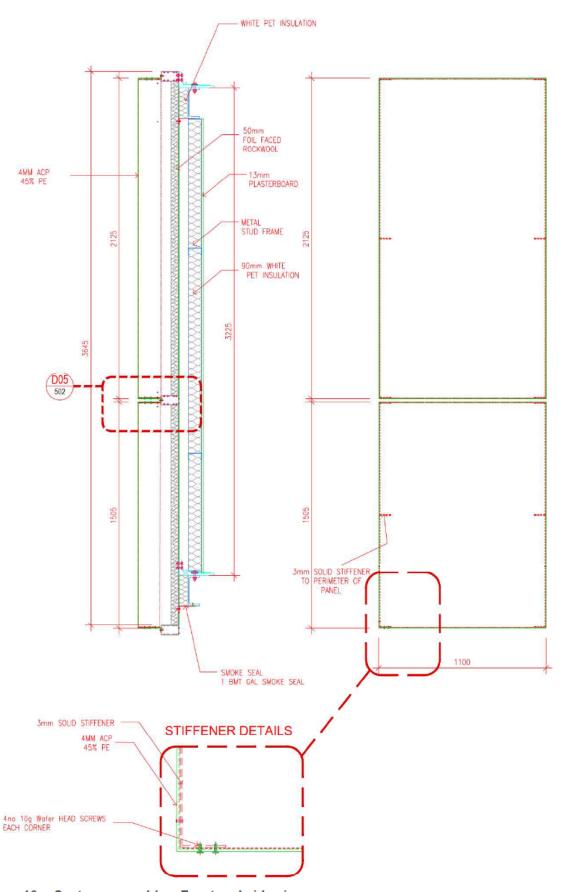
Figure 10 System assembly - Front and side view

| Table 2 Schedule of components | | | |
|---|---|---|--|
| | Size | As shown in Figure 10. | |

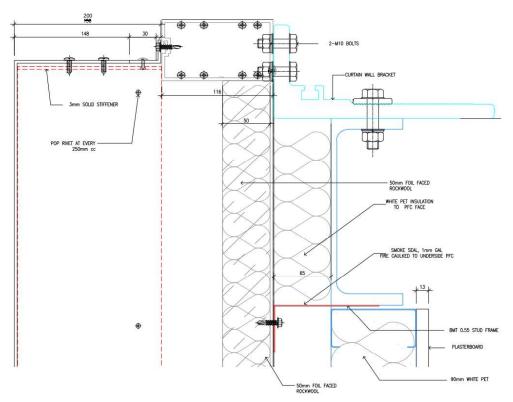
Figure 11 System assembly – top edge detail

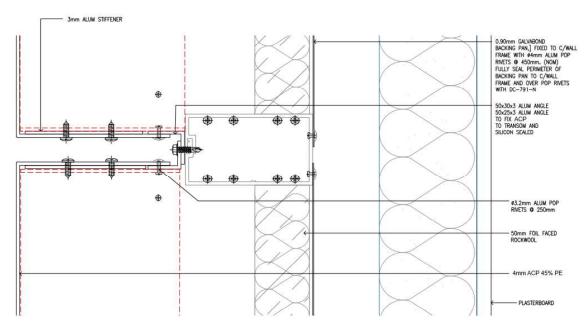
Figure 12 System assembly – middle join detail (D05)

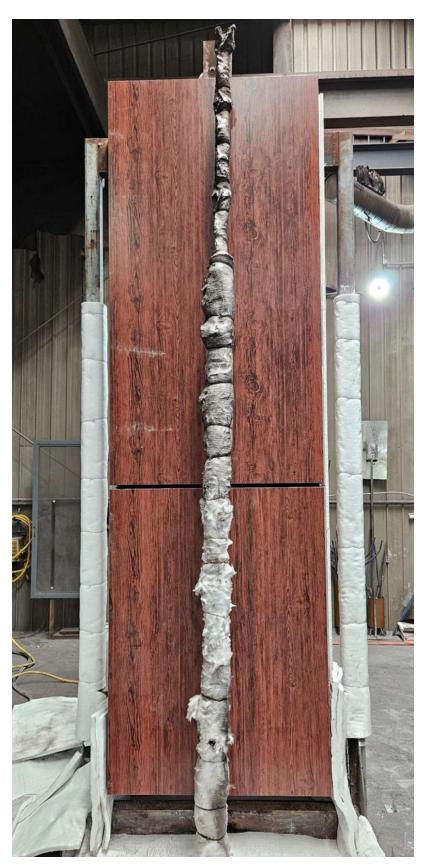
Figure 13 The specimen before the reaction to fire test

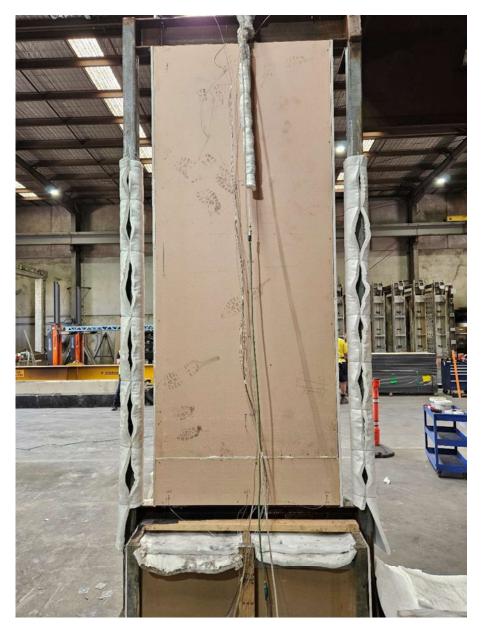
Figure 14 The specimen before the reaction to fire test – unexposed side

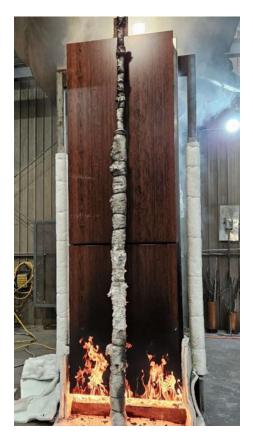
Figure 15 The specimen 12 minutes 56 seconds into the test (burner output at 100 kW)

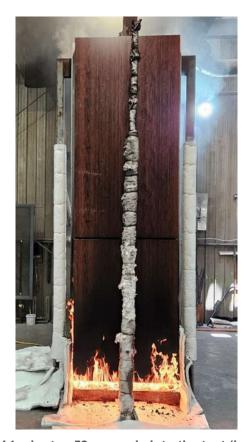
Figure 16 The specimen 14 minutes 59 seconds into the test (burner output at 100 kW)

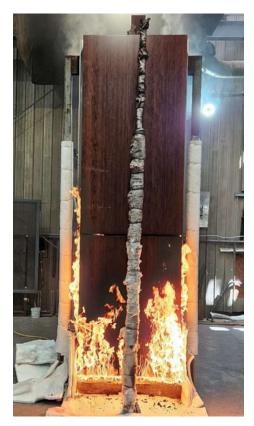
Figure 17 The specimen 15 minutes 30 seconds into the test (30 seconds after burner output was changed to 300 kW)

| Table 4 | | Test observations | |
|---|---|---|---|
| 15 | 00 | All | The burner output was increased to 300 kW. |

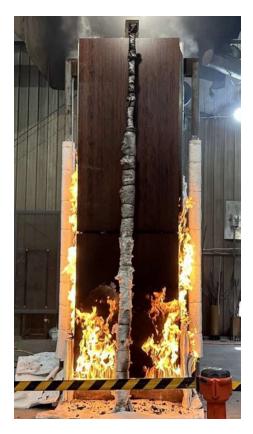
Figure 18 The specimen 20 minutes into the test (5 minutes after burner output was changed to 300 kW)

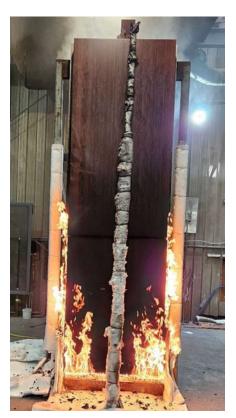
Figure 19 The specimen 33 minutes into the test (8 minutes after burner output was changed to 300 kW)

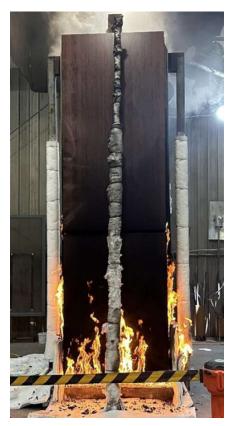
Figure 20 The specimen 39 minutes 42 seconds into the test (24 minutes 42 seconds after burner output was changed to 300 kW)

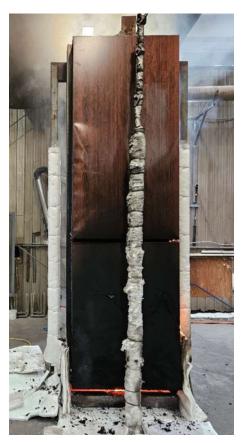
Figure 21 The specimen 41 minutes 50 seconds into the test (1 minute 50 seconds after burner was switched off)

| Table 4 | | Test observations | |
|---|---|---|---|
| 40 | 00 | All | The burner was switched off. |

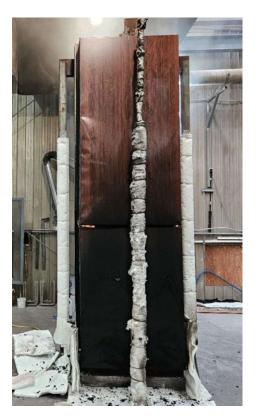
Figure 22 The specimen 50 minutes 3 seconds into the test (10 minutes 3 seconds after burner was switched off)

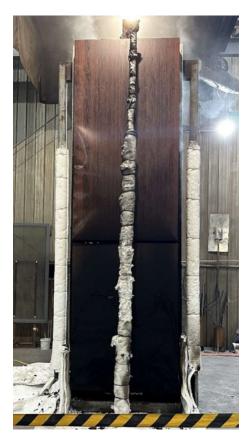
Figure 23 The specimen at the end of the test

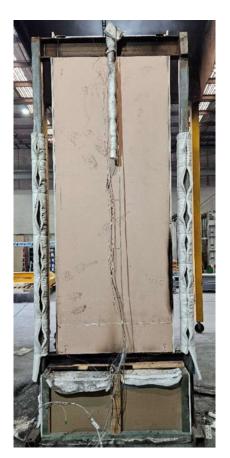
Figure 24 The specimen after the test – unexposed side.

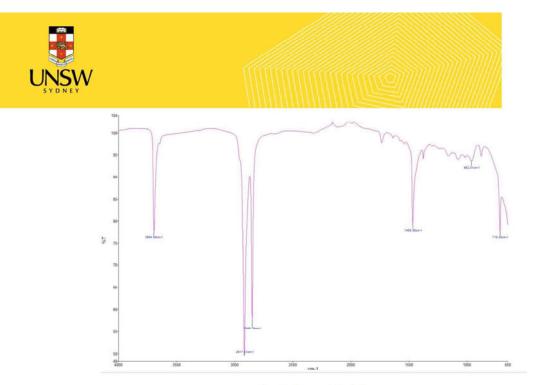
Figure 1. FT-IR spectrum of Sample #1
