Reaction to fire test report

Test standard: Ad-hoc test based off ISO 13785-1:2002

System: A cassetted aluminium composite panel wall system

Job number: RTF230111

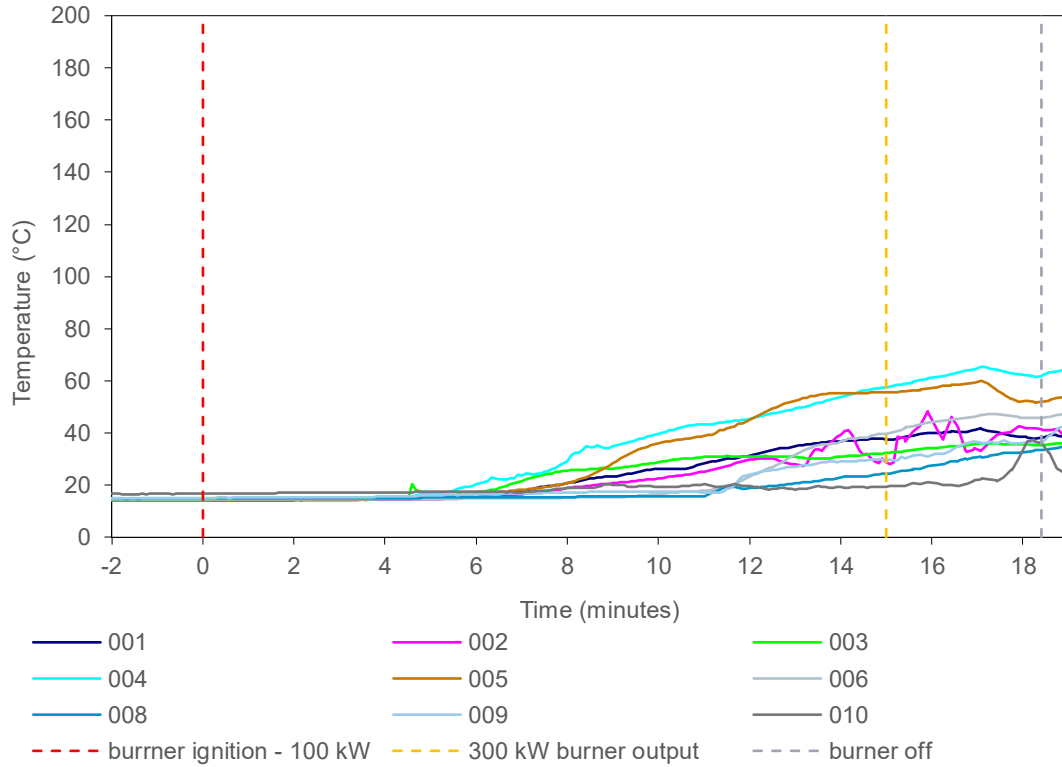
Figure 2 Internal temperature data collected by thermocouples placed within the cavity – between the internal and external segments of the specimen.

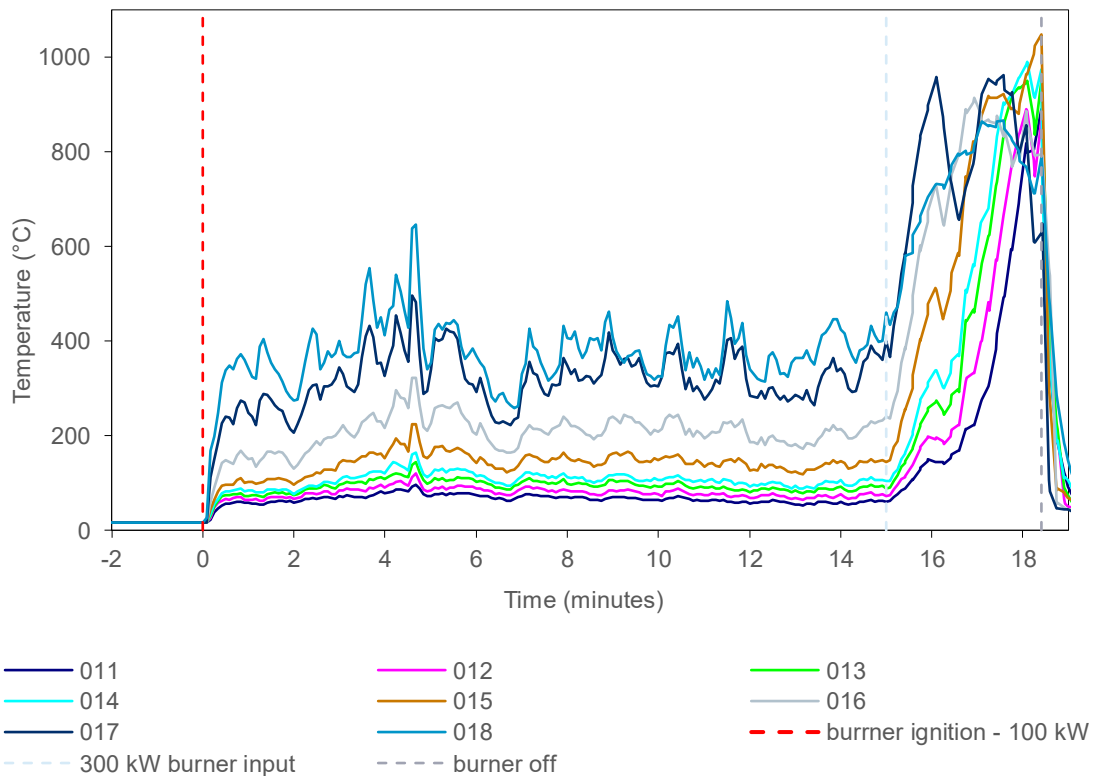
Figure 3 External temperature data collected by thermocouples placed 60 mm from the front face of the specimen.

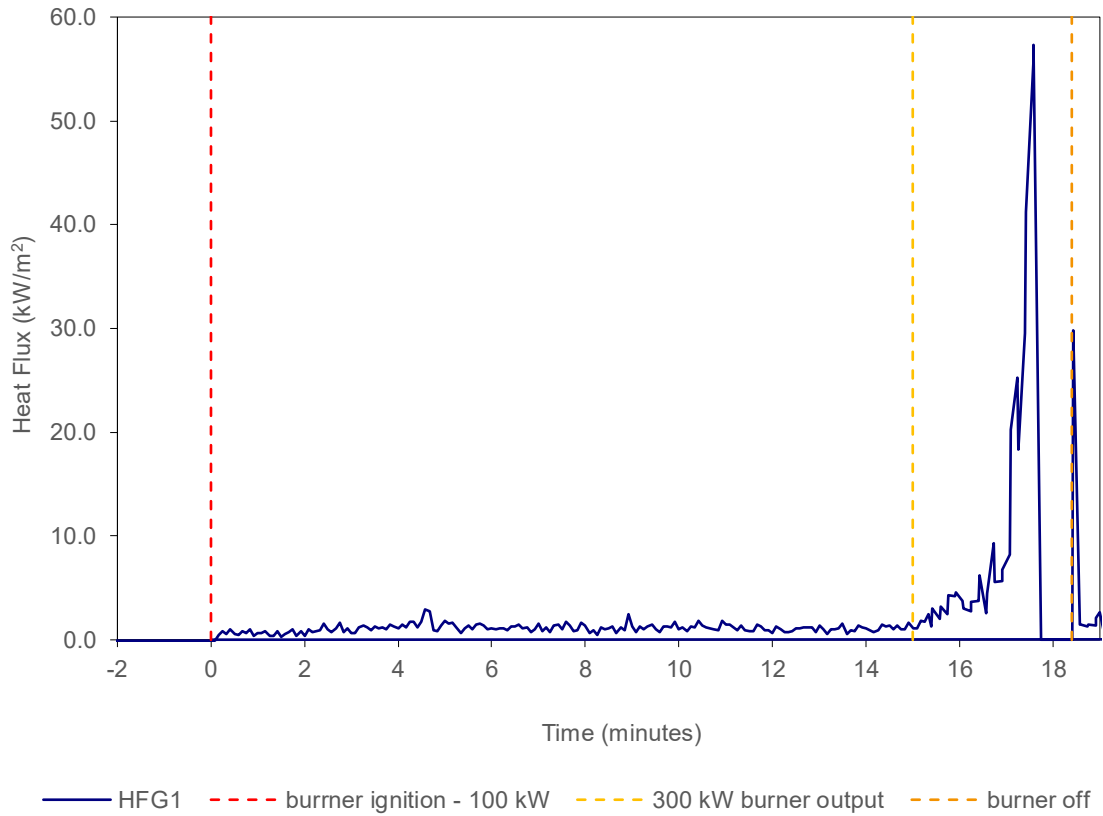
Figure 4 Heat flux data collected by heat flux gauges.

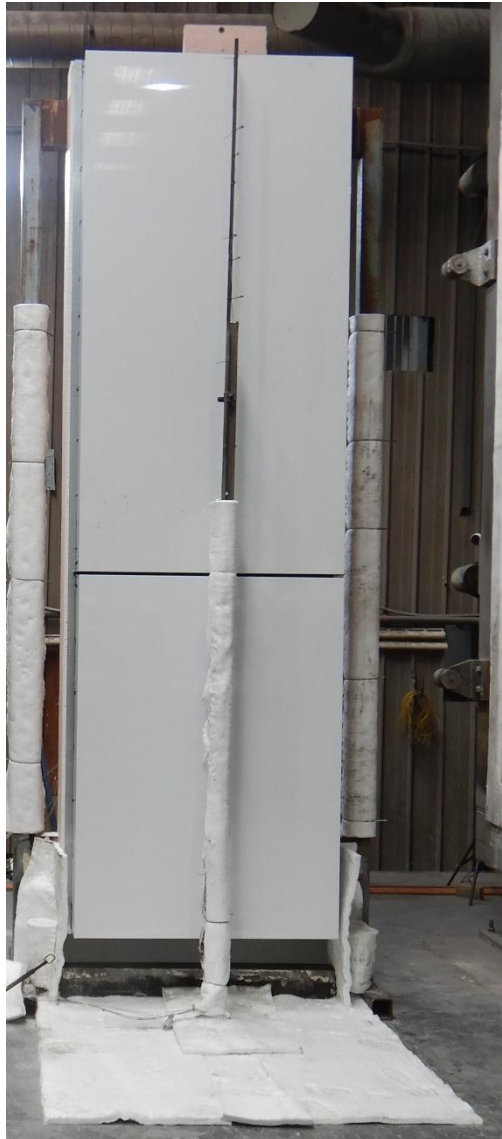
Figure 10 The specimen before the reaction to fire test

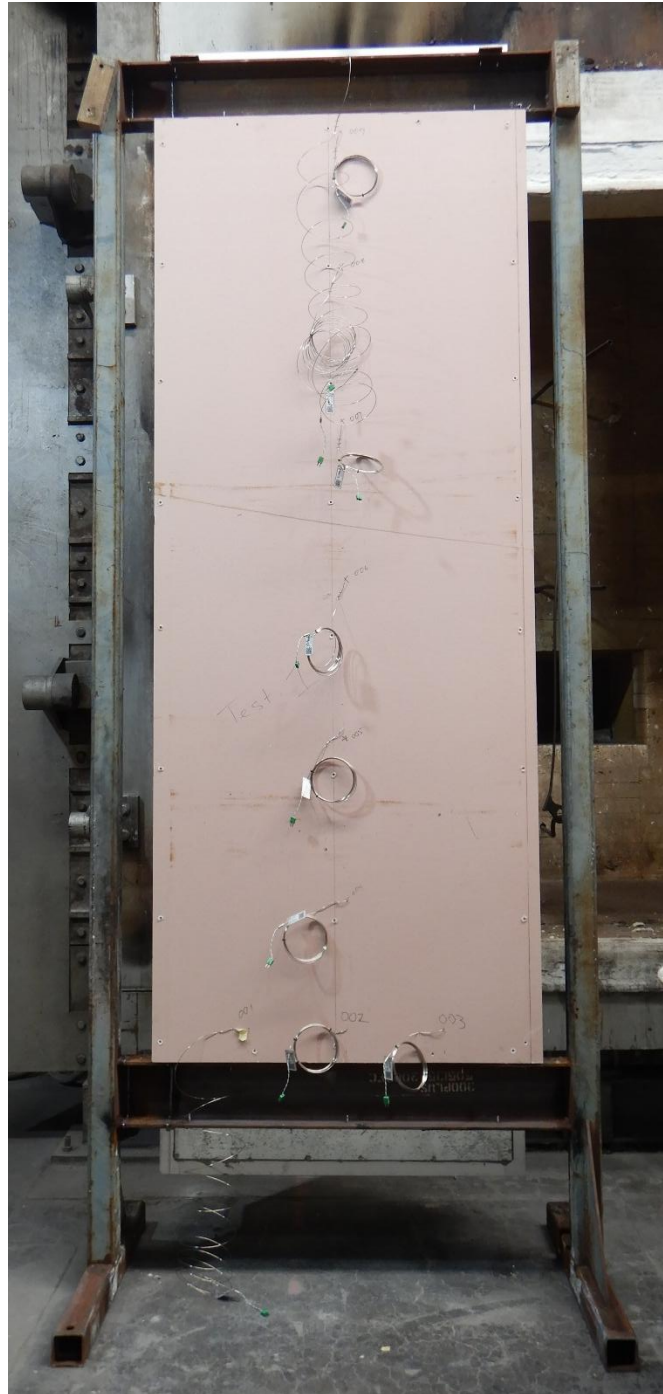
Figure 11 The specimen before the reaction to fire test – unexposed side

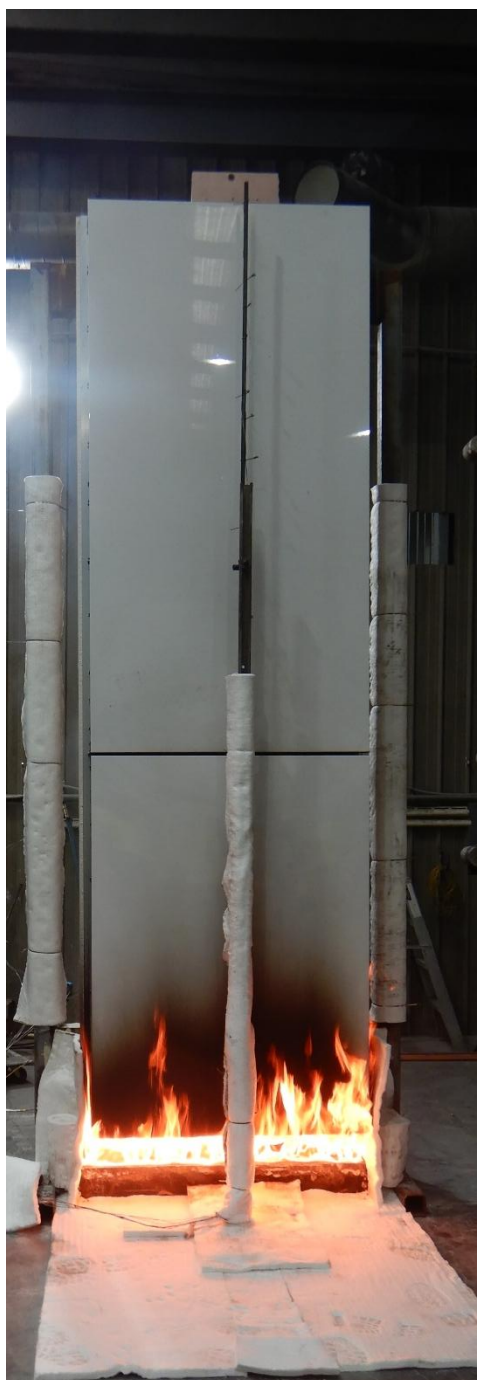
Figure 12 The specimen 1 minute 42 seconds into the test (burner output at 100 kW)

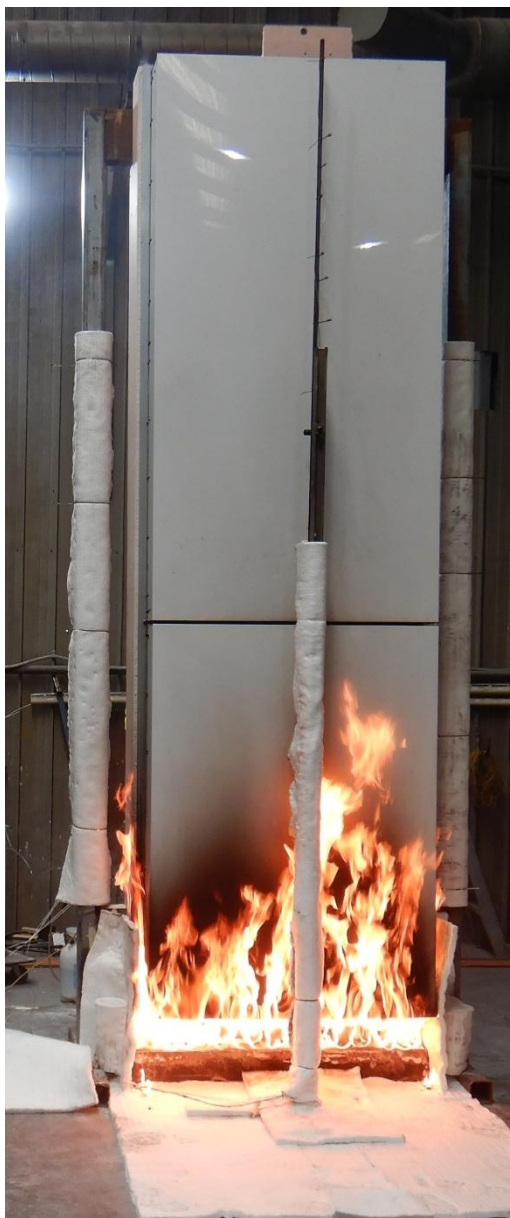
Figure 13 The specimen 3 minutes 11 seconds into the test (burner output at 100 kW)

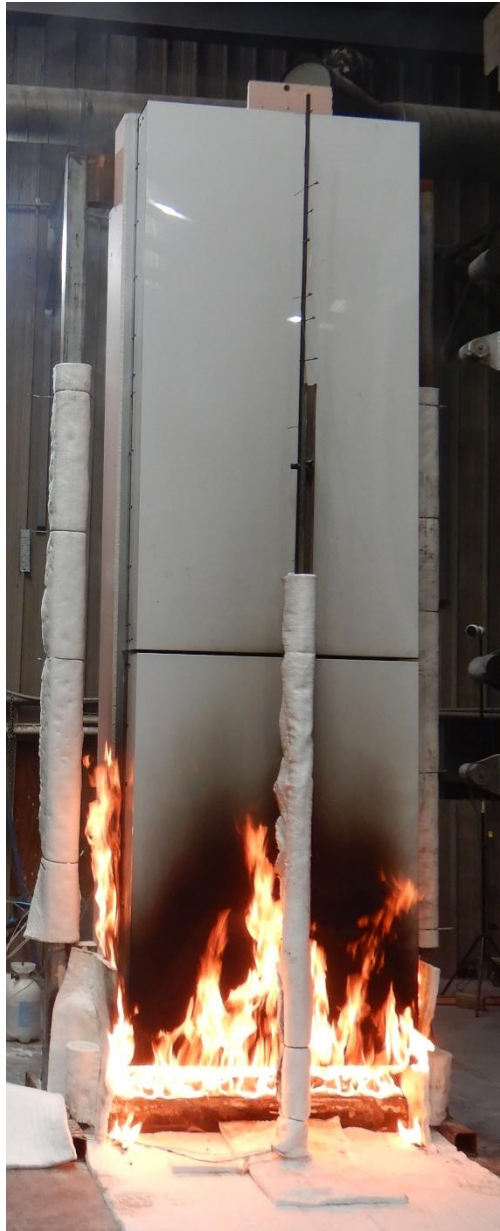
Figure 14 The specimen 4 minutes 53 seconds into the test (burner output at 100 kW)

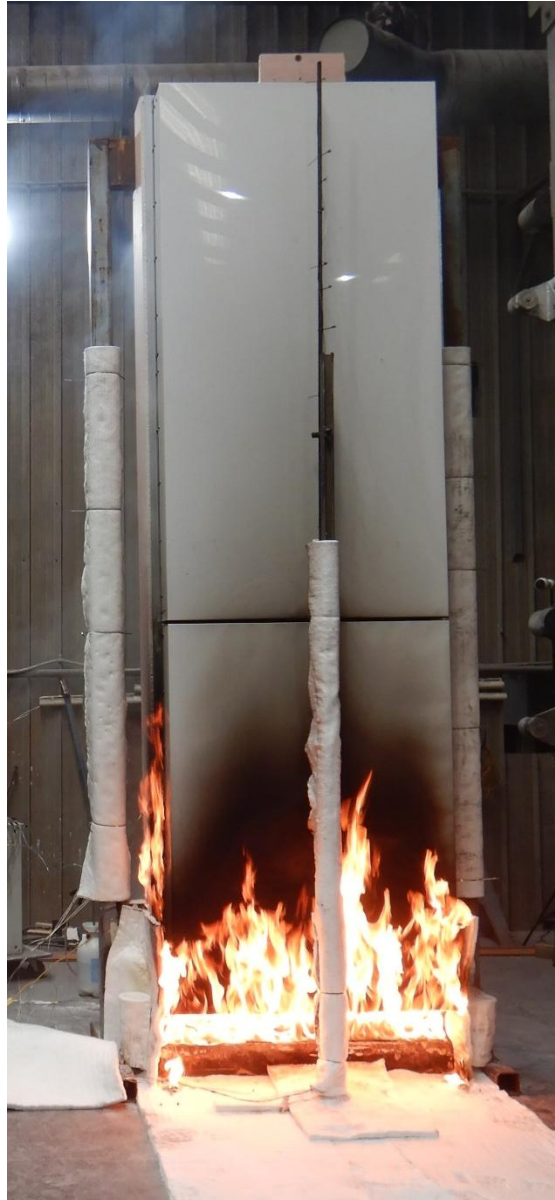
Figure 15 The specimen 9 minutes 53 seconds into the test (burner output at 100 kW)

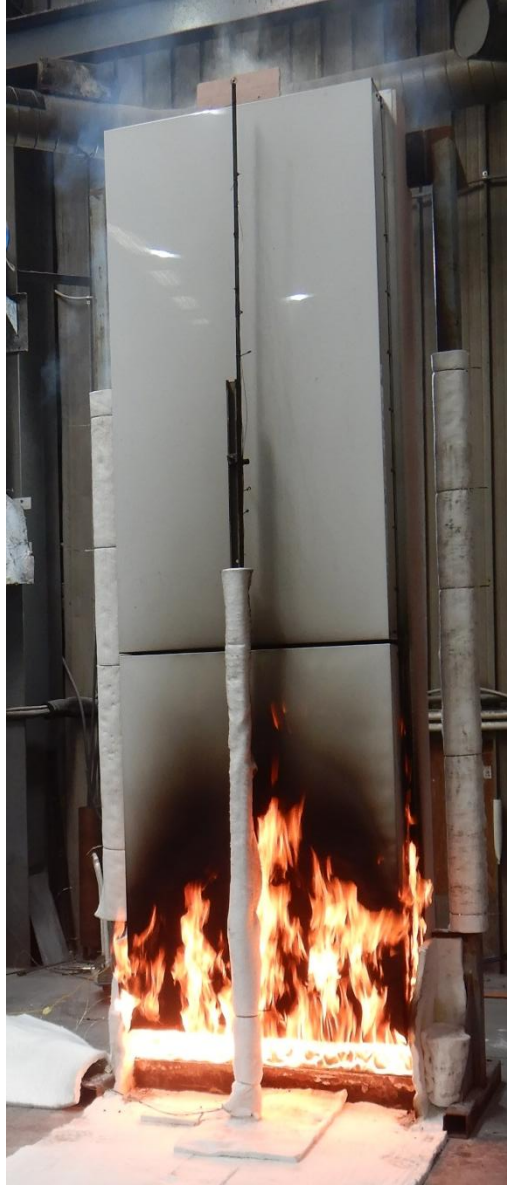
Figure 16 The specimen 13 minutes 14 seconds into the test (burner output at 100 kW)

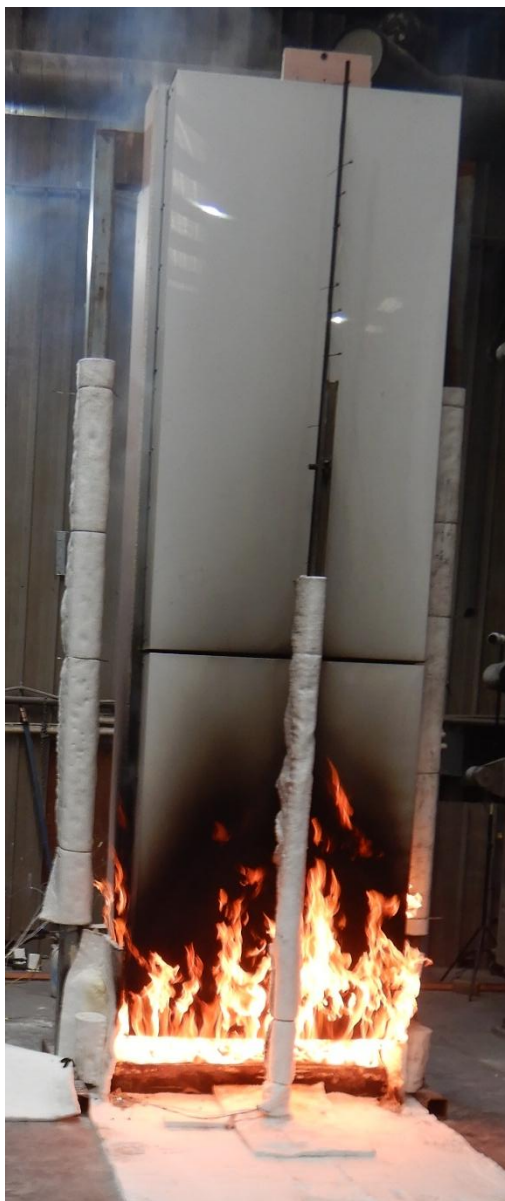
Figure 17 The specimen 14 minutes 45 seconds into the test (burner output at 100 kW)

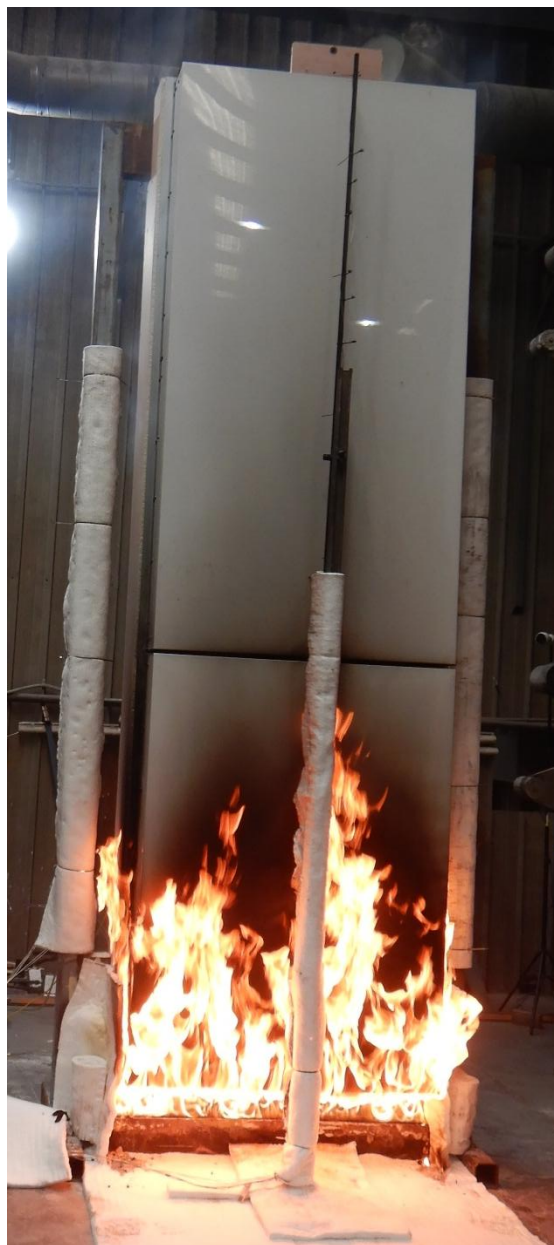
Figure 18 The specimen 15 minutes 2 seconds into the test (2 seconds after burner output was changed to 300 kW)

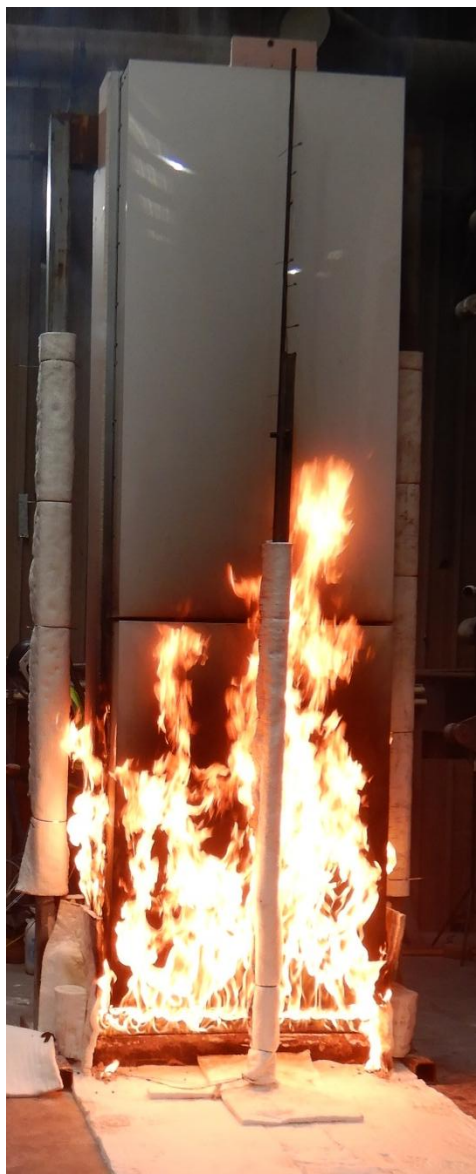
Figure 19 The specimen 15 minutes 41 seconds into the test (41 seconds after burner output was changed to 300 kW)

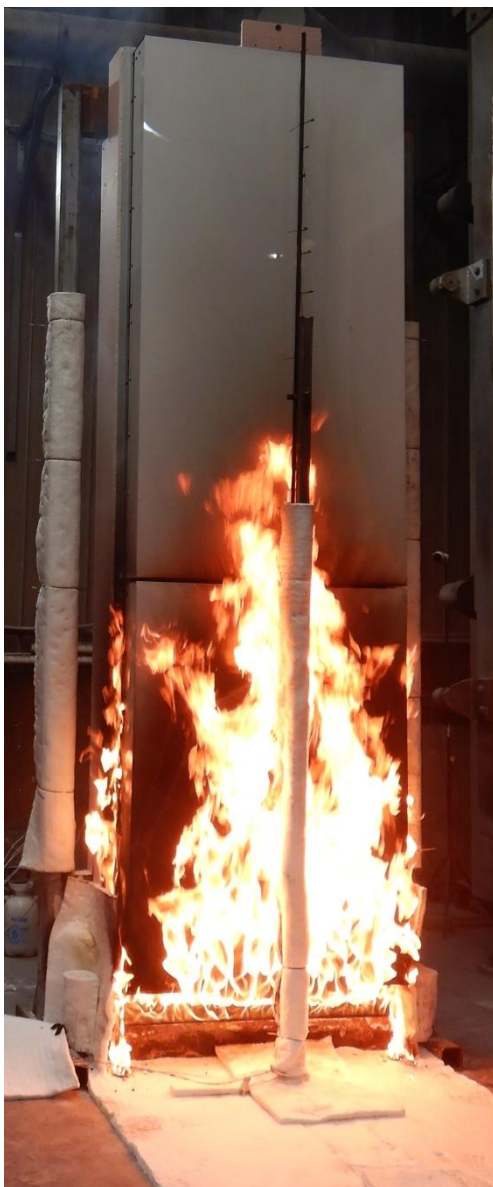
Figure 20 The specimen 15 minutes 56 seconds into the test (56 seconds after burner output was changed to 300 kW)

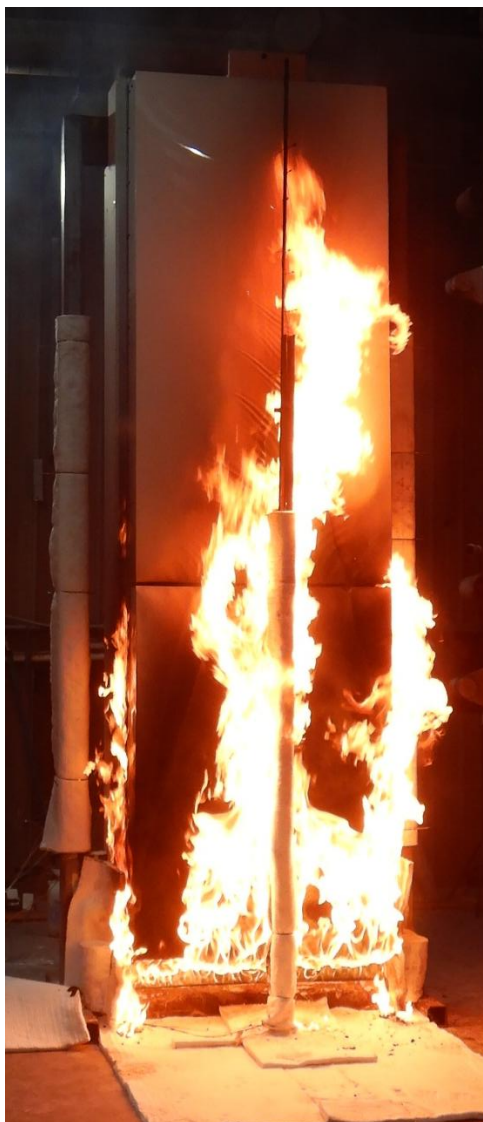
Figure 21 The specimen 16 minutes 55 seconds into the test (1 minute 55 seconds after burner output was changed to 300 kW)

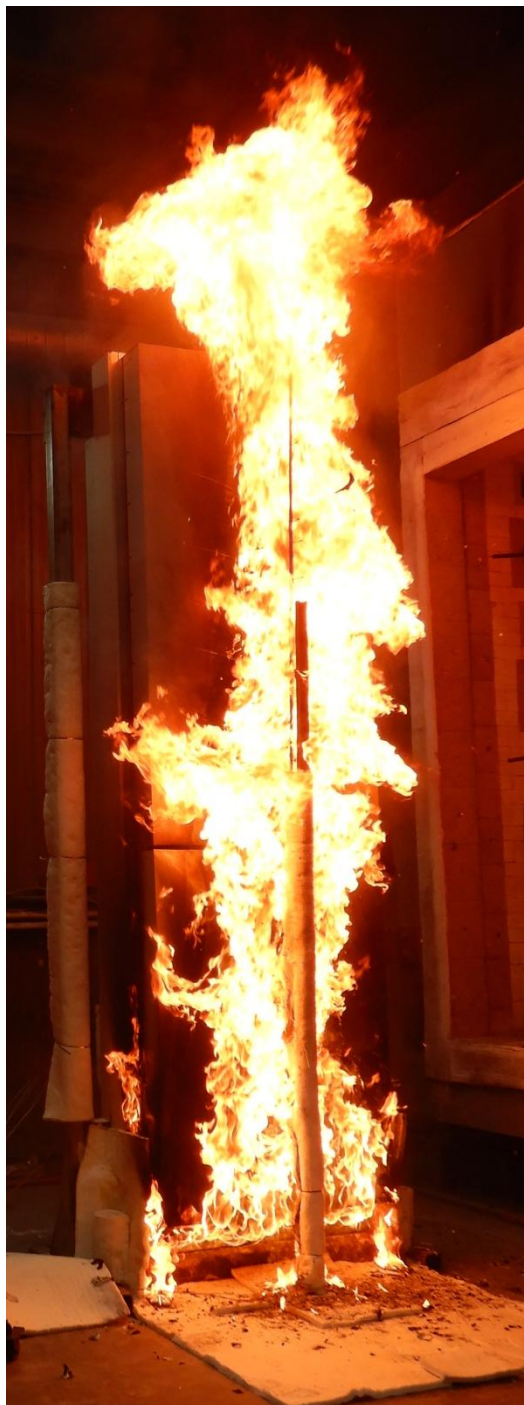
Figure 22 The specimen 17 minutes 45 seconds into the test (2 minutes 45 seconds after burner output was changed to 300 kW)

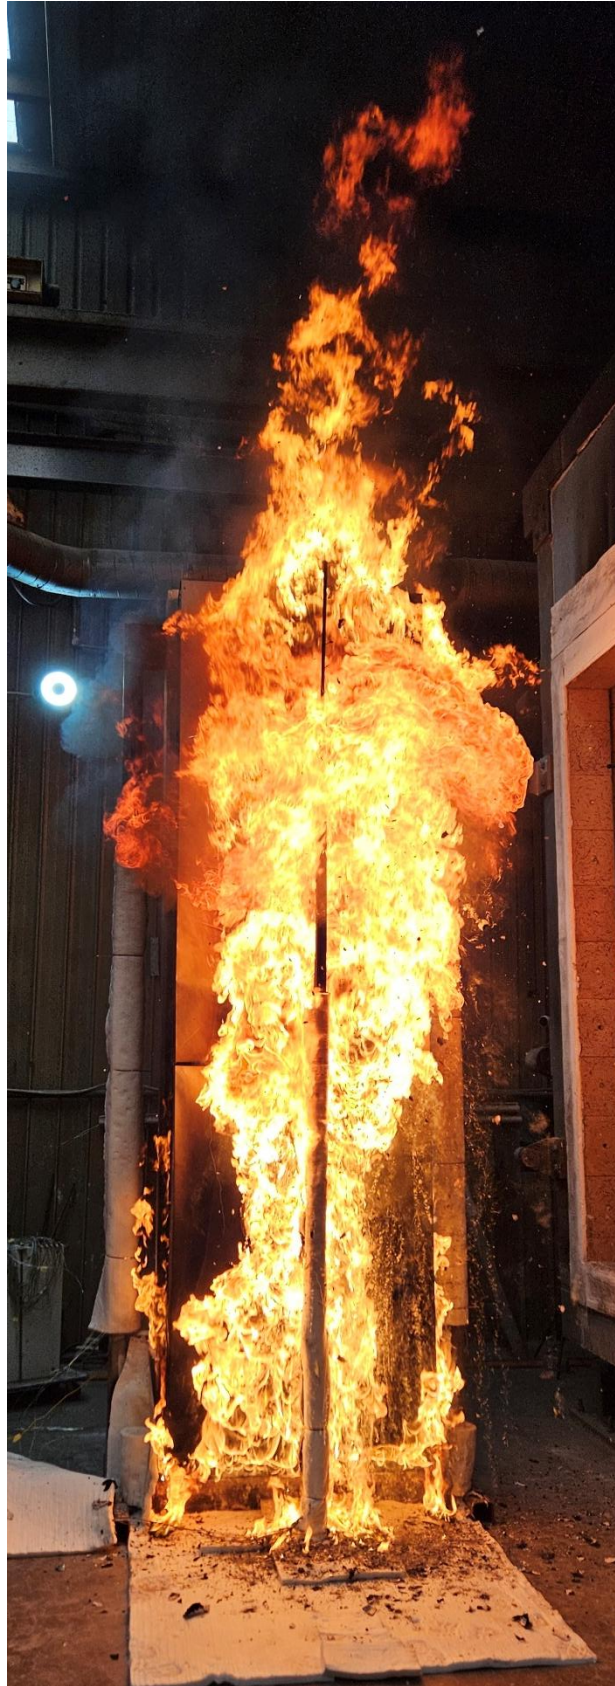
Figure 23 The specimen 17 minutes 52 seconds into the test (2 minutes 52 seconds after burner output was changed to 300 kW)

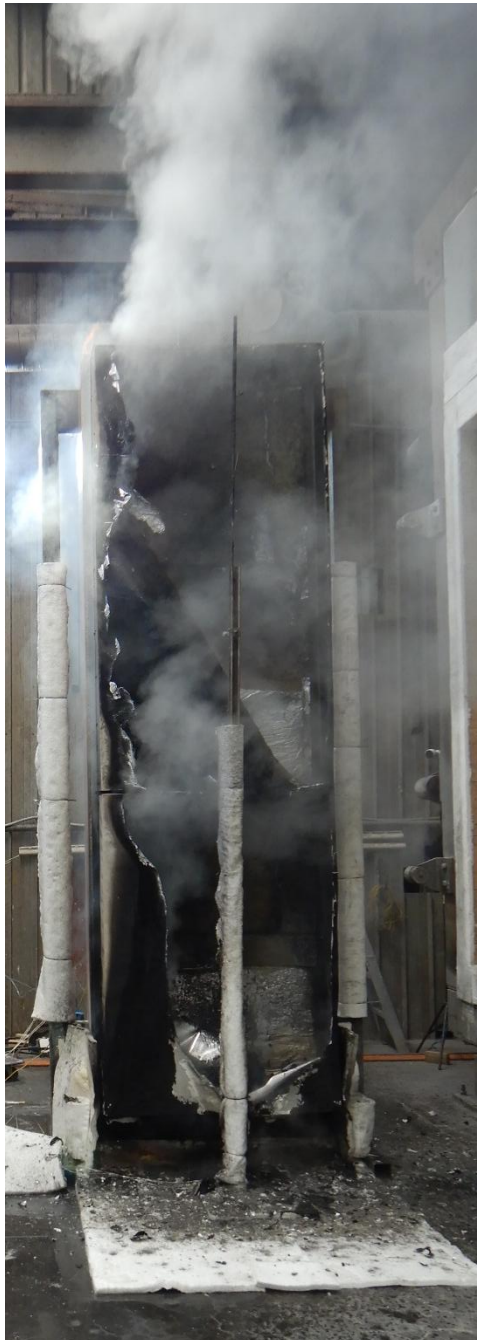
Figure 24 The specimen shortly after being sprayed with water

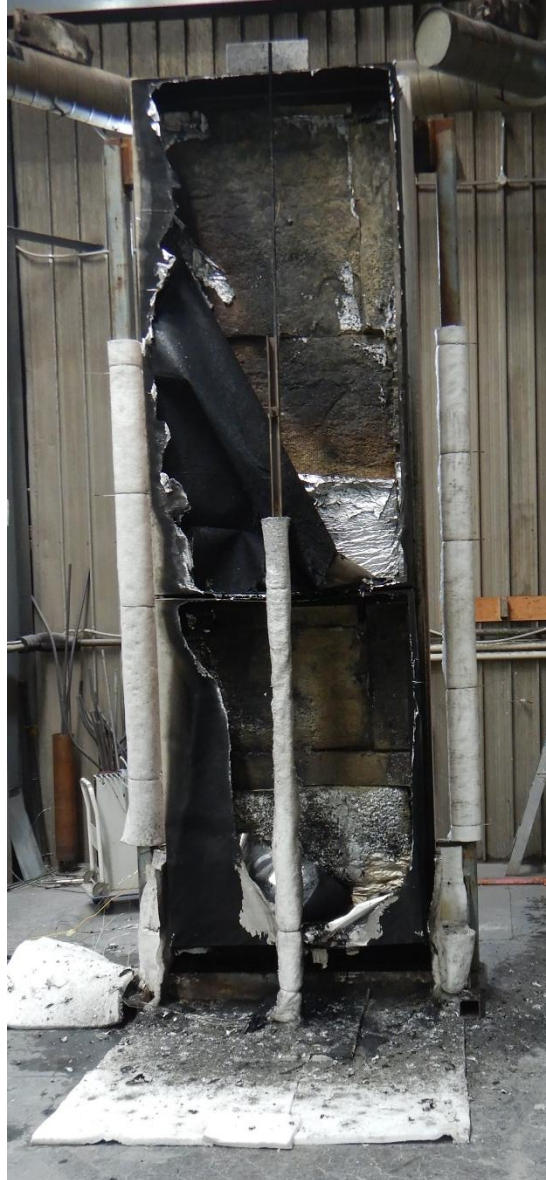
Figure 25 The specimen after the test.

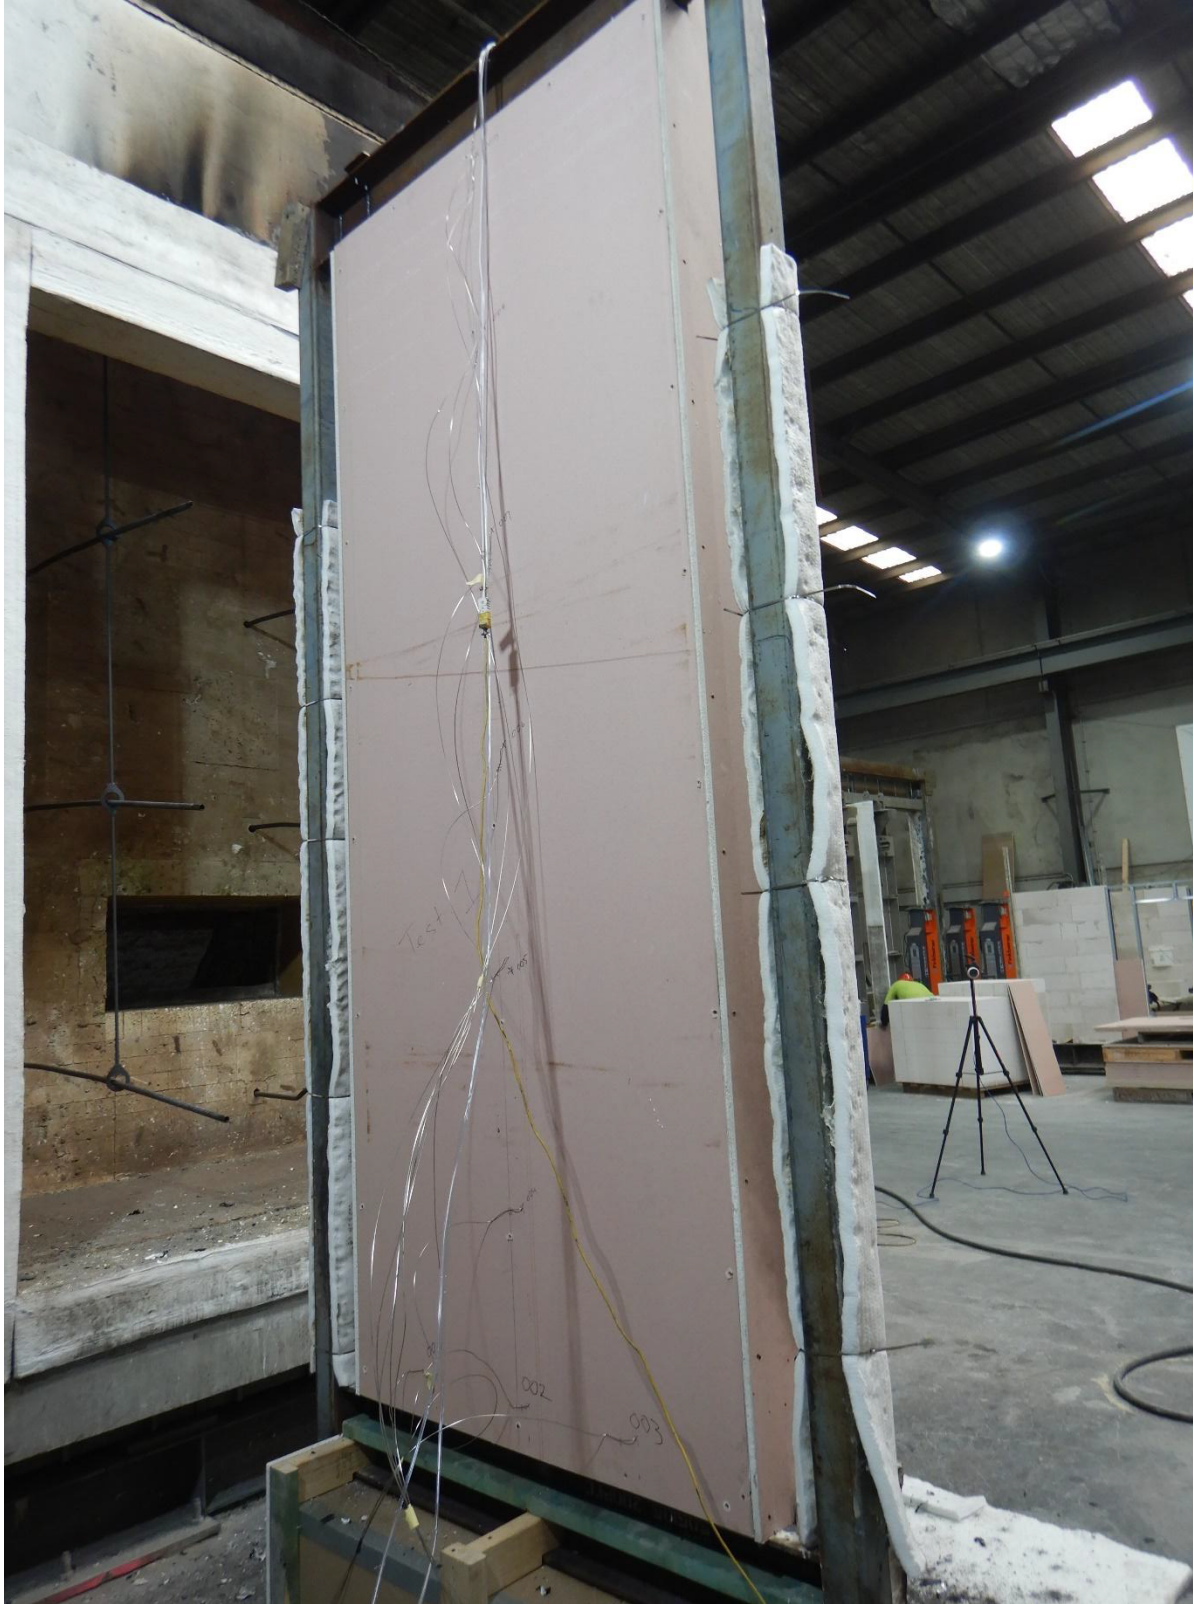
Figure 26 The specimen after the test – unexposed side.

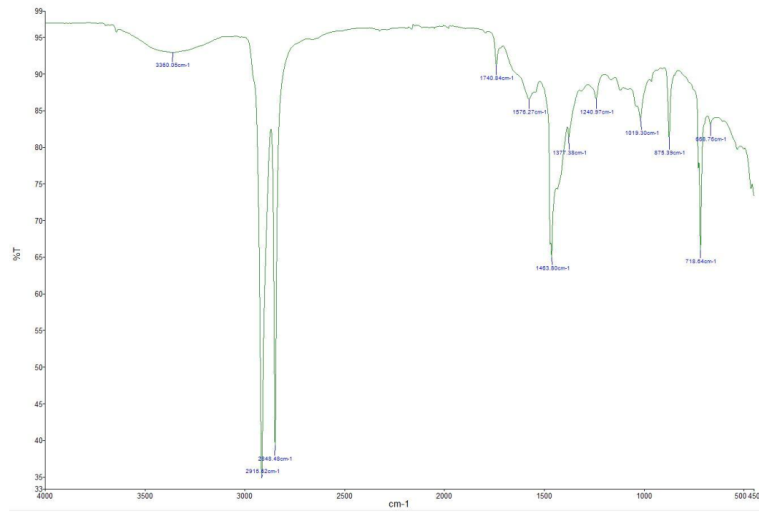
Figure 5 FT-IR spectrum of CSV #09
